NBSIR 76-1181

**METALLURGICAL EVALUATION AND
FRACTURE ANALYSIS OF A
PNEUMATICALLY-BURST SEAMLESS
STEEL COMPRESSED GAS
CYLINDER**

Failure Analysis Report

April, 1977

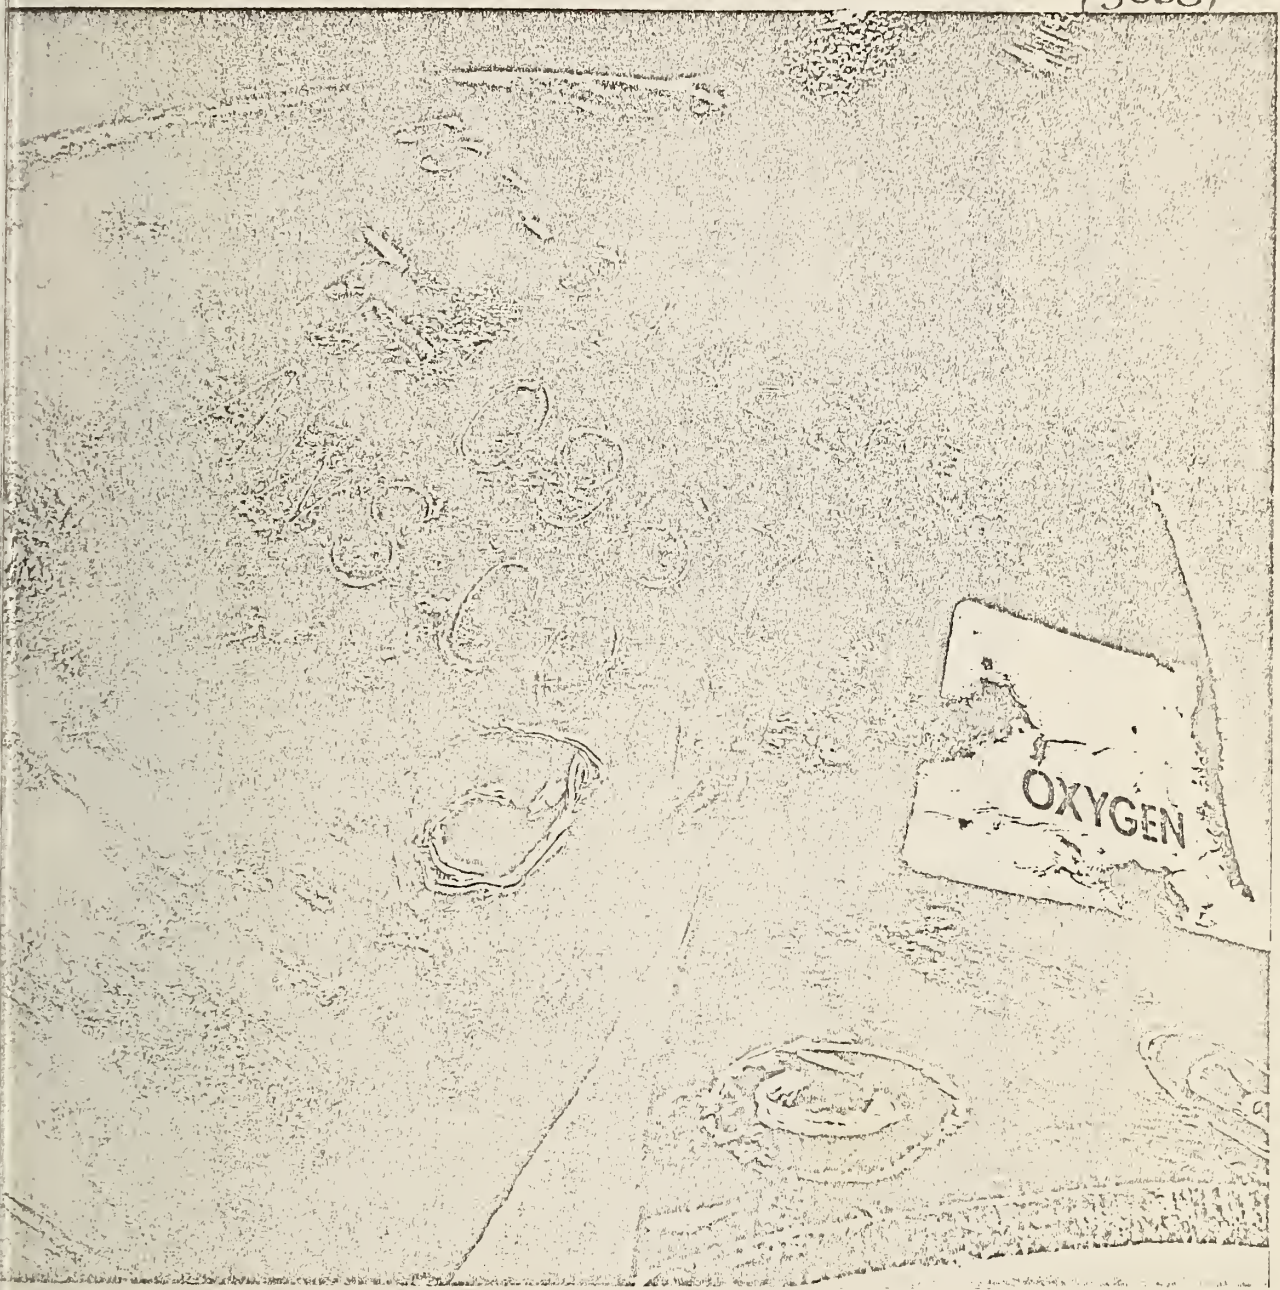
Figure 2a. View of Department of Transportation stampings on gas cylinder T-0967. Note the crack arrest in this half of the neck. X 1

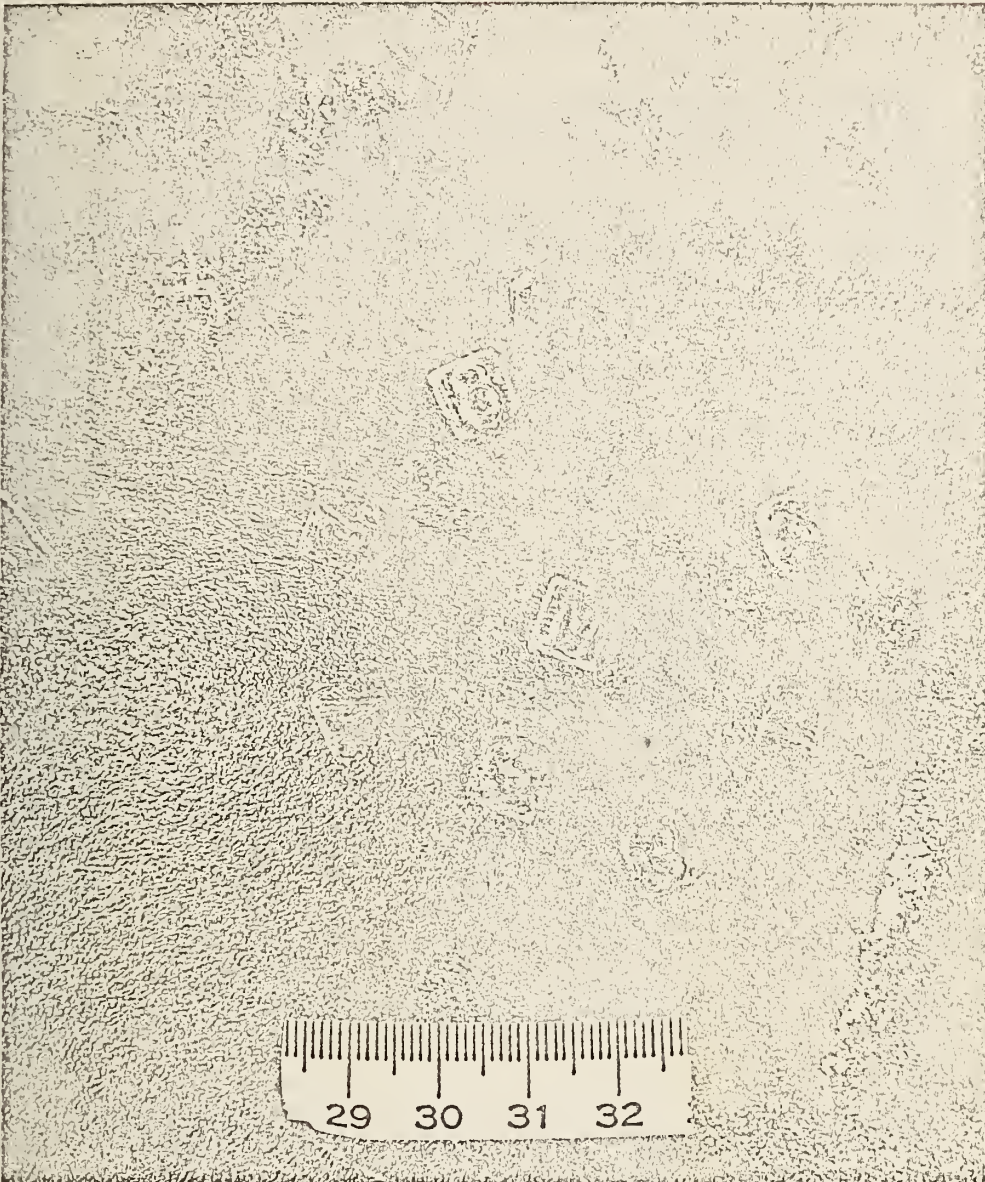
Figure 3. Markings on the bottom of cylinder T-0967, showing the heat code, V18. X 1

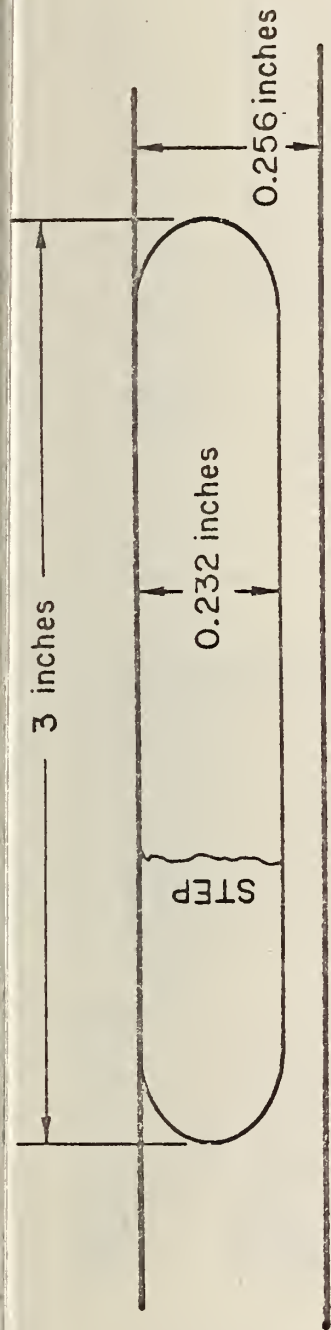
Figure 5 shows the side of the fracture origin labeled a in Figure 1b. The step and highly-reflective band along the inside wall are evident. Dimensions of the fracture origin are shown in the schematic diagram included in Figure 5.

Figure 5. View of the side of the fracture origin labeled a in Figure 1b, with a schematic diagram showing dimensions.

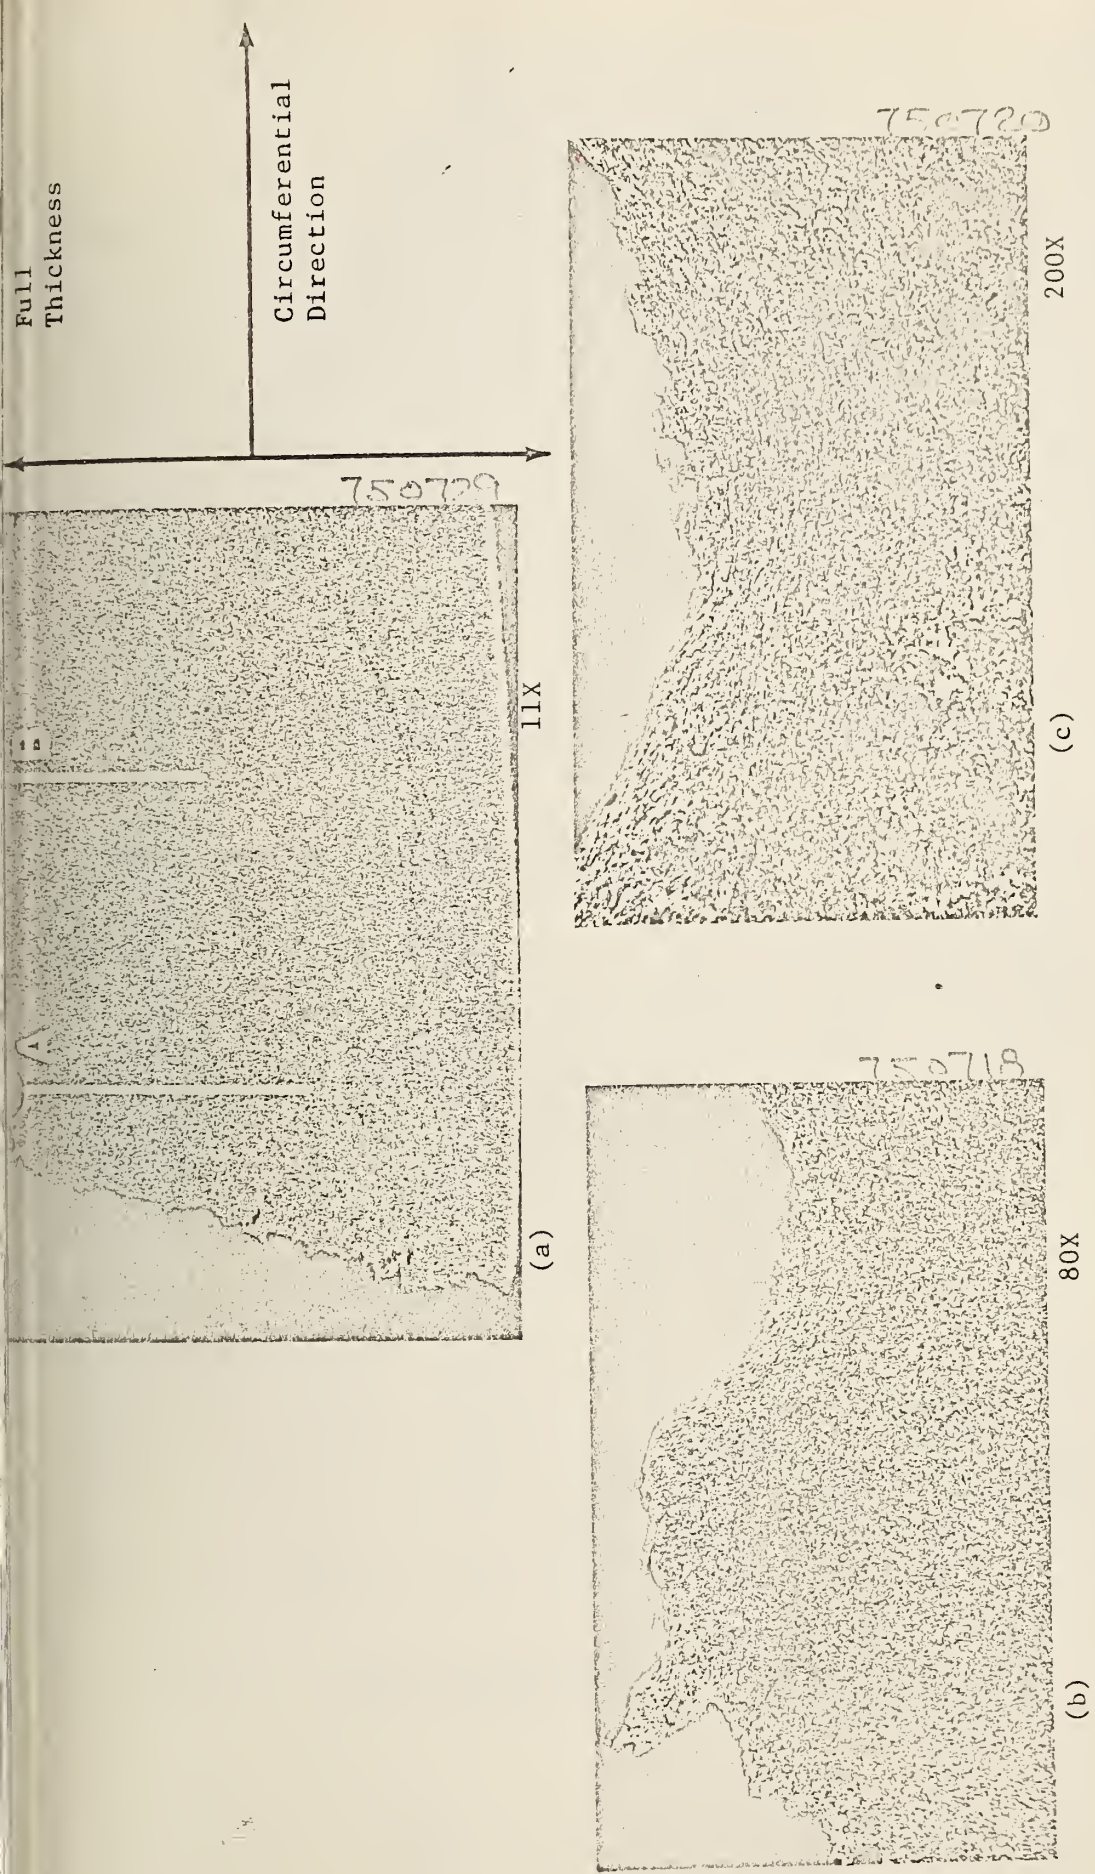
Figure 8 shows the fracture profile at Specimen IV. A gouge near the fracture surface is evident in Figure 8a. The gouge is about 0.02-inches deep. Flowed metal beneath the gouge can be seen in Figures 8b and 8c. The most severely flowed metal seems to penetrate about 0.0006-inches below the bottom of the gouge. Away from the flowed metal, the microstructure has the usual appearance of a quenched and tempered steel. These observations --- a gouge, flowed metal beneath the gouge, and a typical quenched and tempered microstructure --- were found in Specimens II and III, also, indicating a reasonably uniform disturbance throughout the region shown in Figure 7. A crack in the bottom of the gouge was detected in the fracture profile of Specimen II, as shown in Figure 9.

In Figure 8, evidence of a 0.02-inch deep gouge and evidence of flowed metal beneath the gouge was shown for the fracture profile of Specimen IV. Two Knoop microhardness traverses were made on this metallographic specimen, along the lines labeled A and B in Figure 8a. The purpose of making these hardness measurements was to search for evidence of strain hardened metal beneath the gouge. To facilitate accurate measurement, hardness was measured using the Knoop microhardness technique. The range of Knoop hardness numbers measured, 257 to 313, corresponds roughly to Rockwell hardness numbers on the C-scale of 21 to 30.

Figure 8. Fracture profile at region labeled IV in Figure 7. (a) Gouge in outside wall at fracture profile. (b) and (c) Evidence of flowed metal beneath gouge. Lines in Figure (a) show approximate paths for microhardness measurements reported in section 5.3.

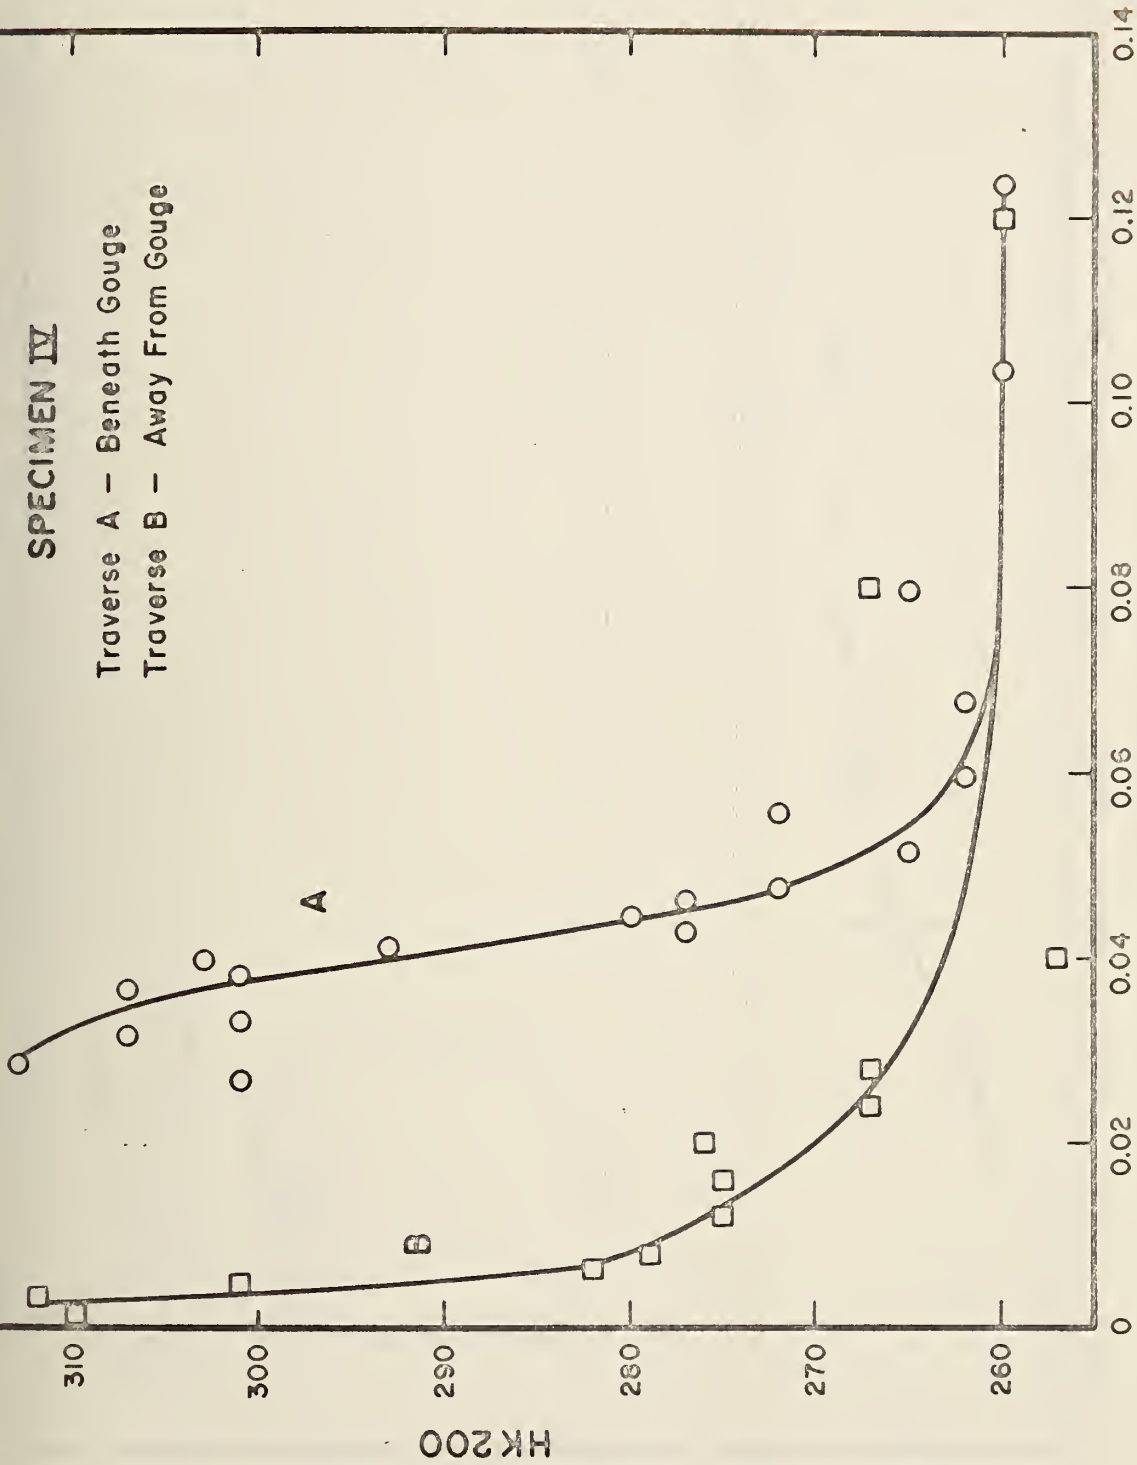
Figure 16. Knoop hardness vs. distance below surface for the fracture profile of Specimen IV in Figure 7.

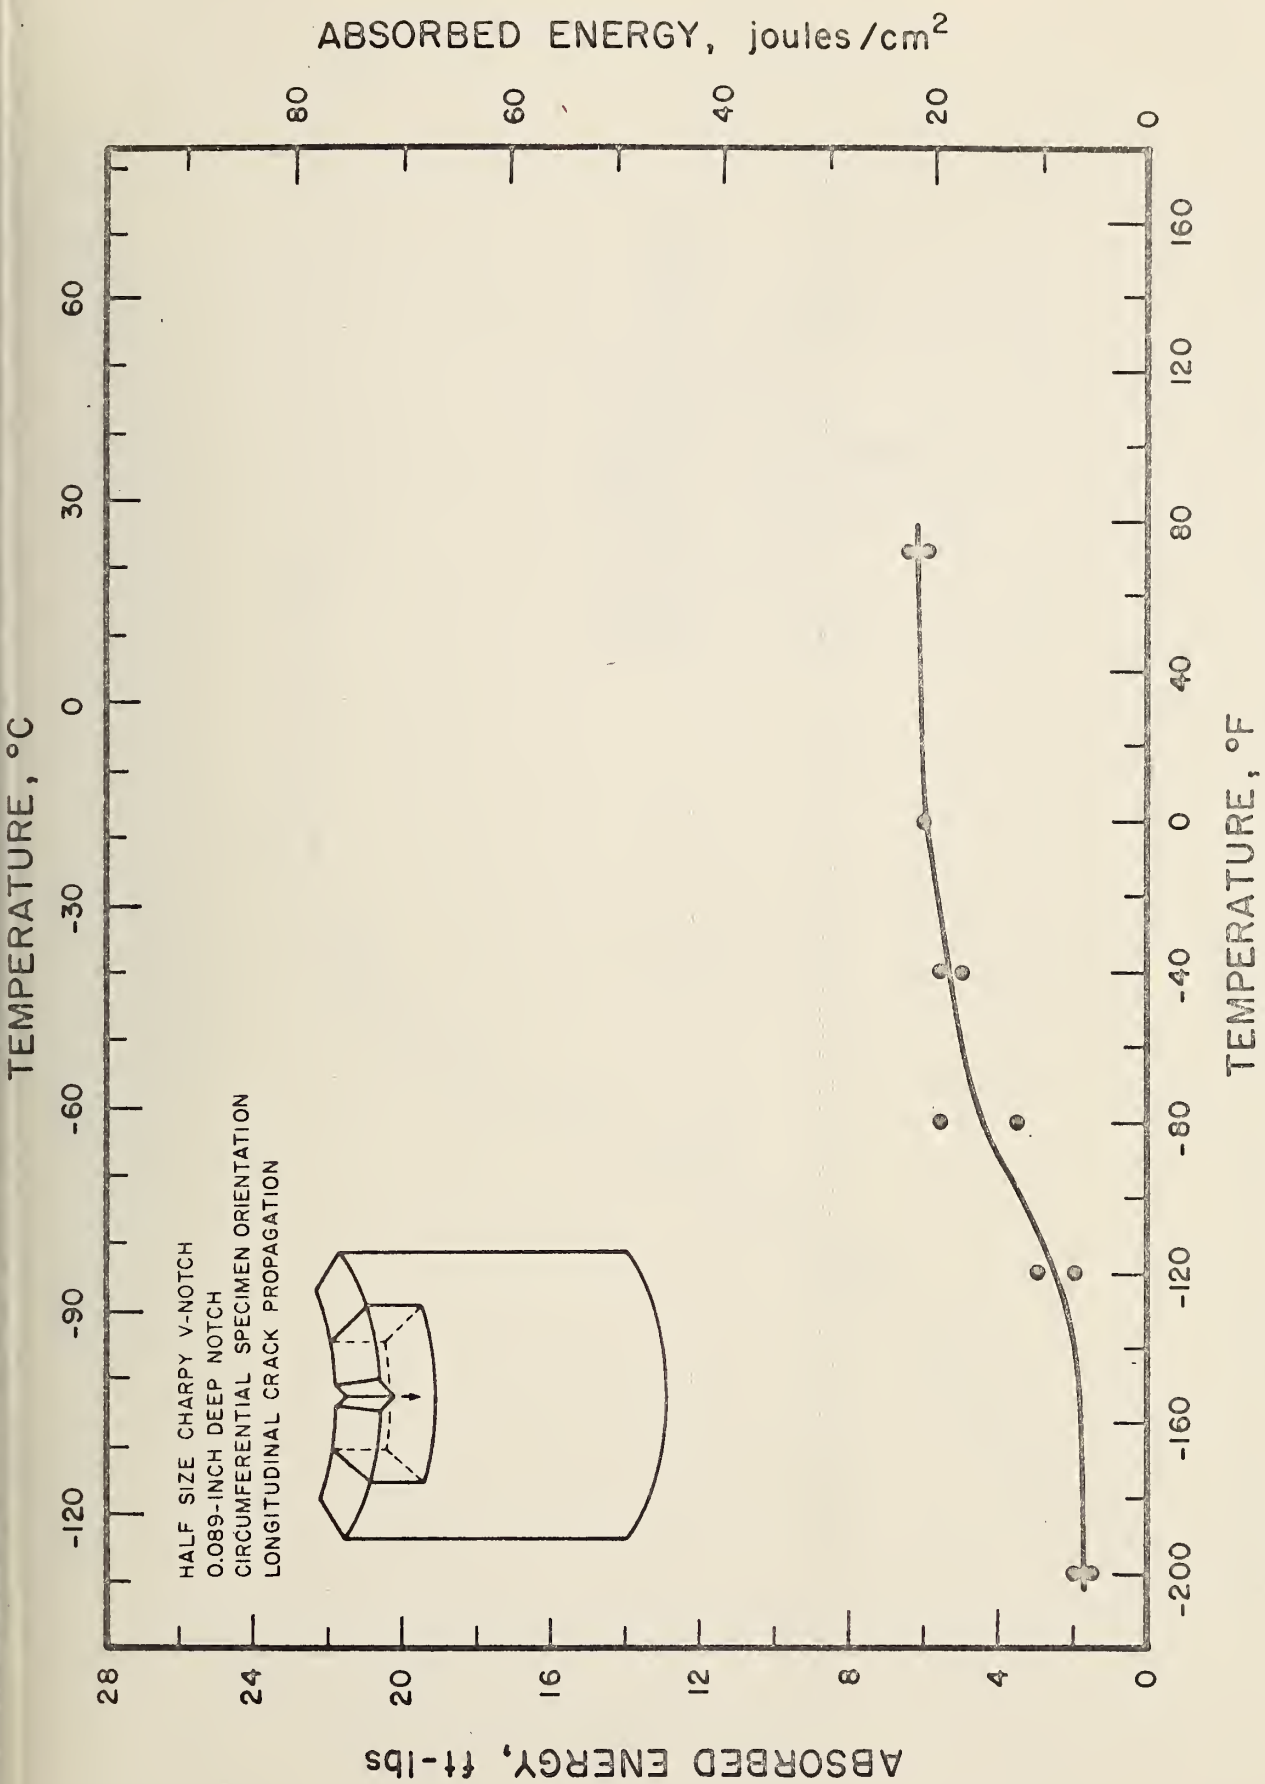
Results in Figures 17 and 18 show a transition from higher to lower values of toughness, starting at about -40°F. At and above 0°F, these results show that there is less resistance to longitudinal crack propagation than to circumferential crack propagation. The absorbed energy data show an increase in resistance by a factor of 3.6, and the lateral expansion data show an increase in resistance by a factor of 3.3. Hence, the manner in which gas cylinder T-0967 failed --- three full-length longitudinal tears --- is consistent with these results. As noted in Section 5.2.1, the primary reason for longitudinal crack propagation in a cylindrical pressure vessel is the fact that the hoop stress is twice as large as the axial stress.

Figure 17a. Absorbed energy versus temperature for longitudinal crack propagation.

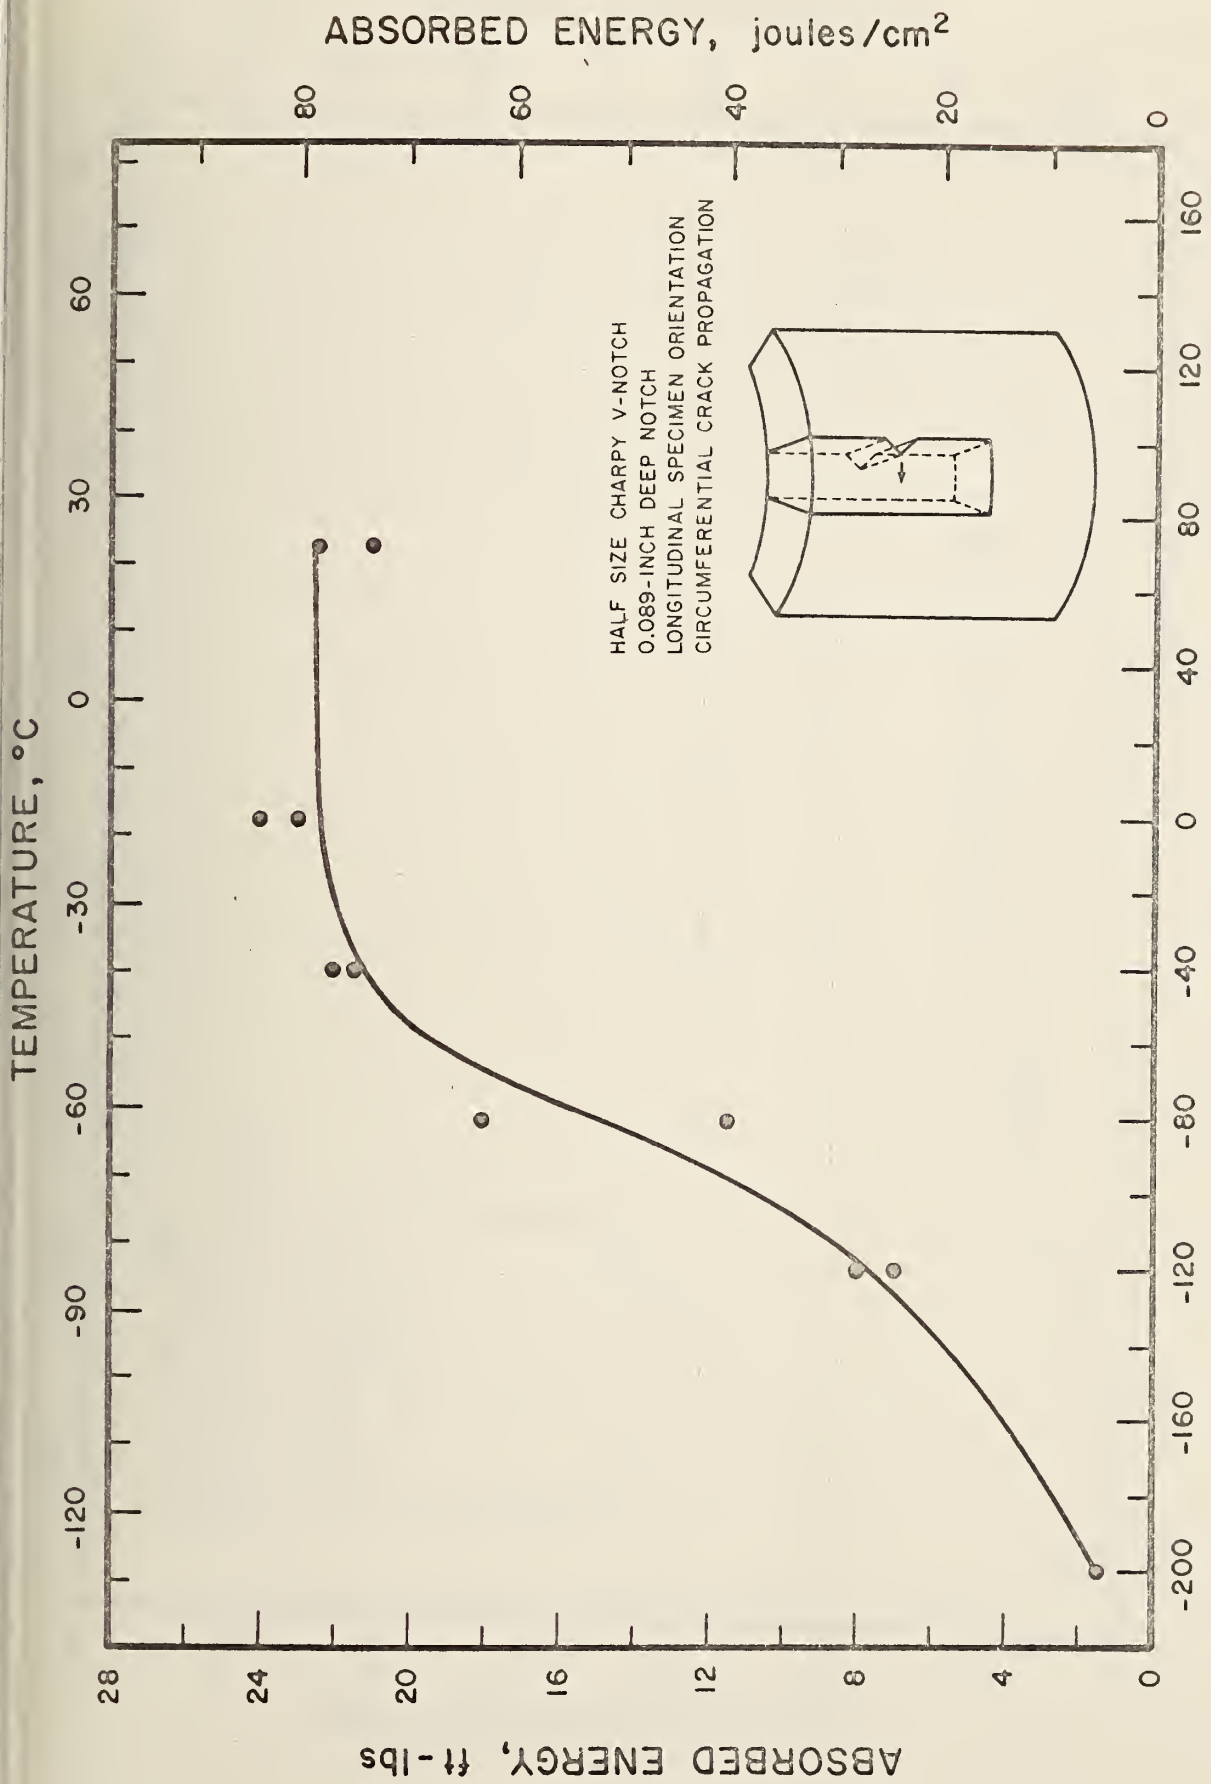
Figure 17b. Absorbed energy versus temperature for circumferential crack propagation.

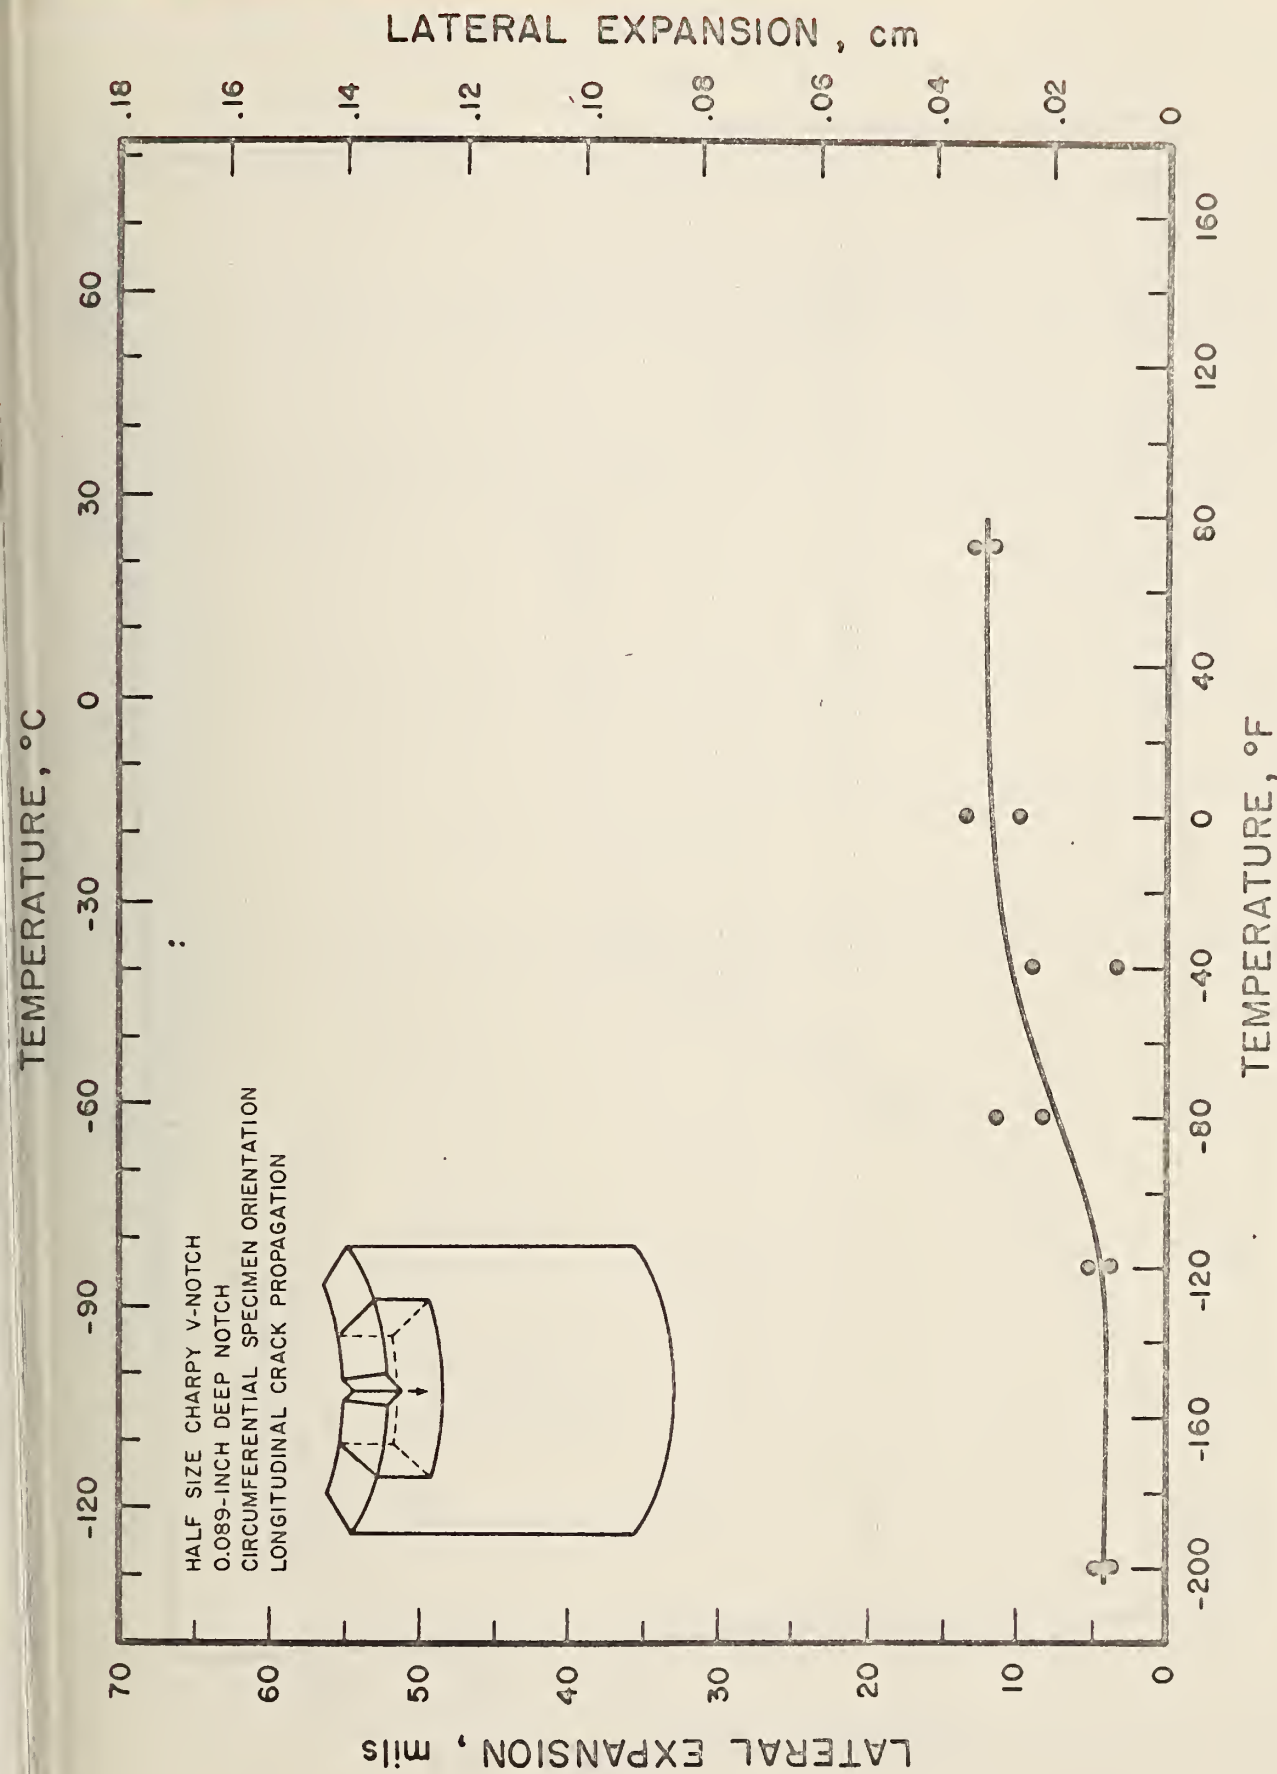
Figure 18a. Lateral expansion versus temperature for longitudinal crack propagation.

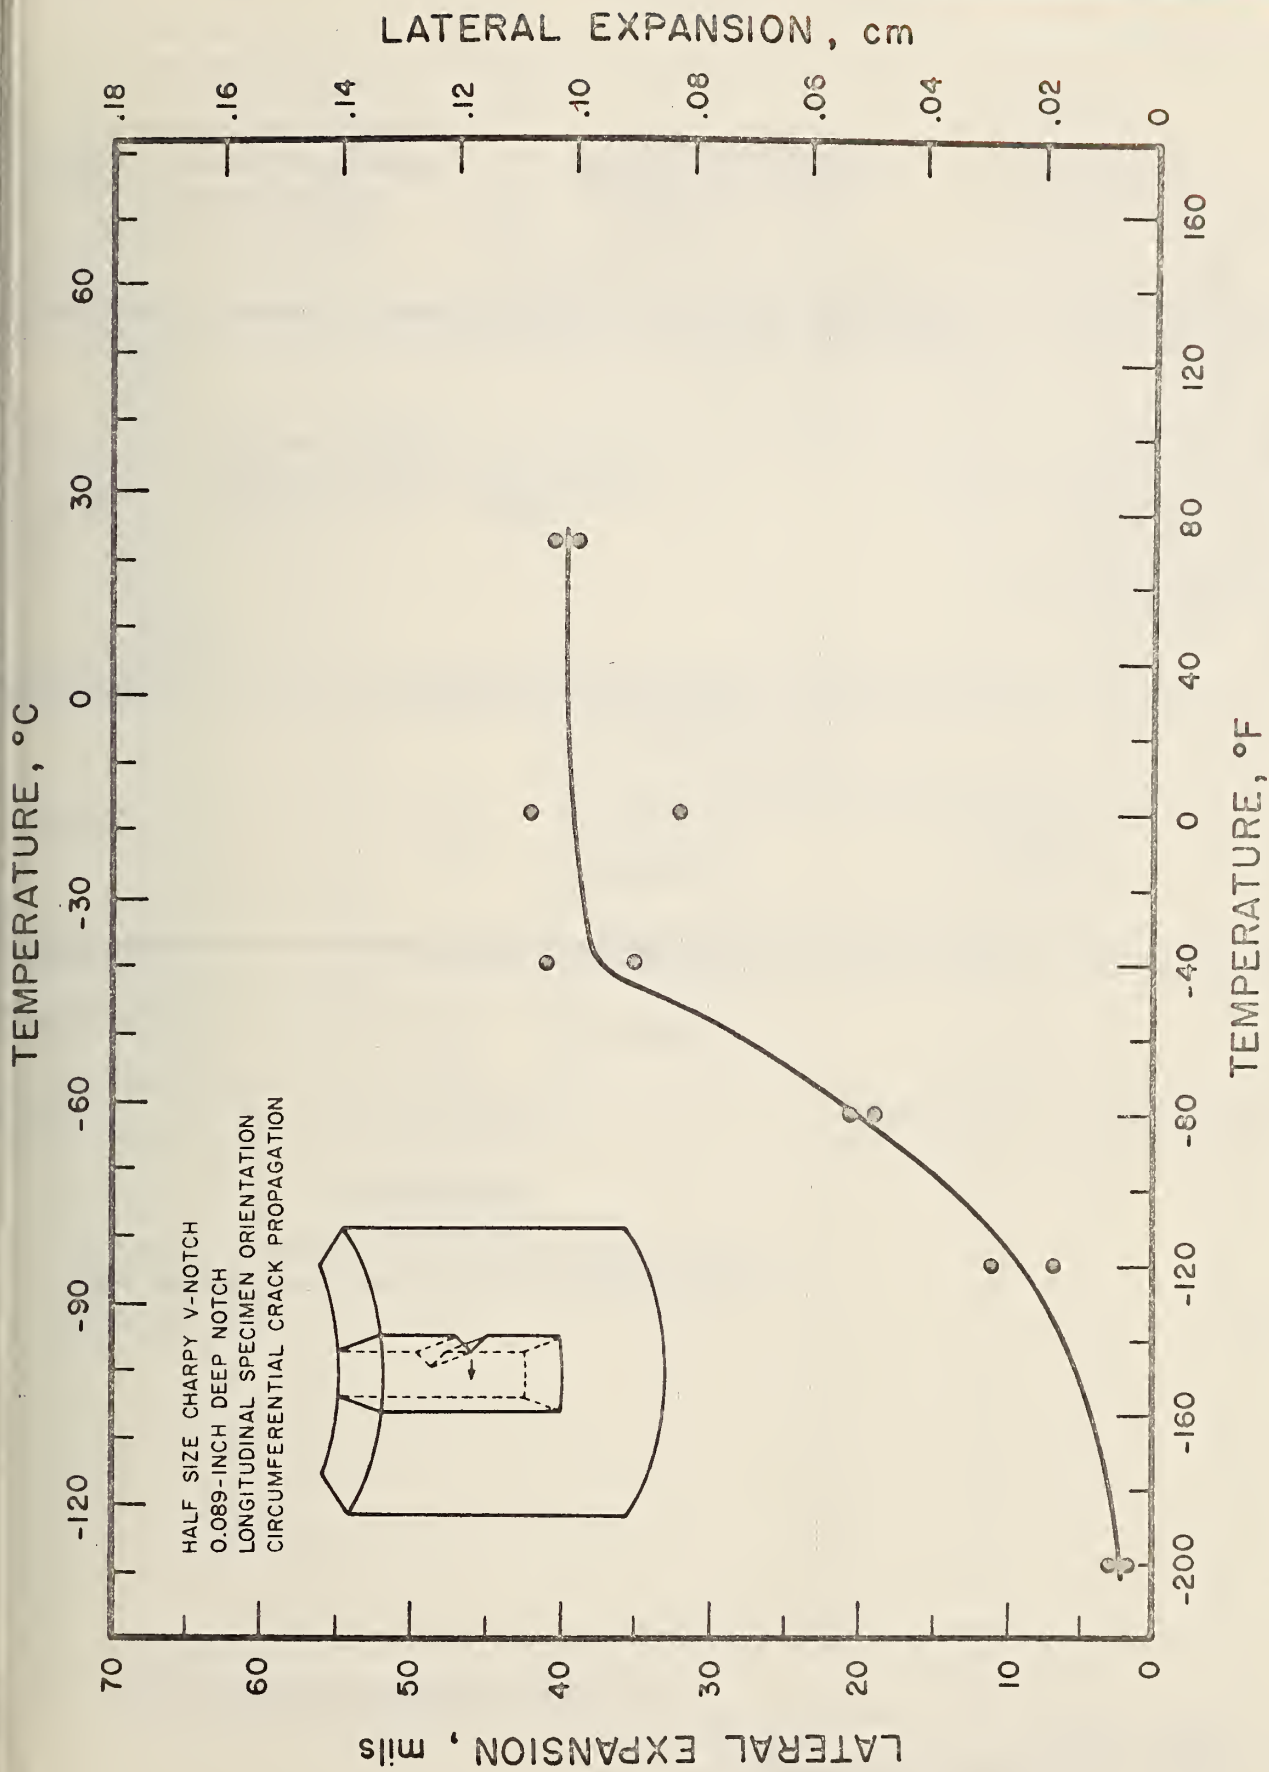
Figure 18b. Lateral expansion versus temperature for circumferential crack propagation.
