NBSIR 77-1198 (R)

Examination of 3/4 Inch Steel Pipe Natural Gas Service Lines, Delmarva Power and Light Company, Wilmington, Delaware

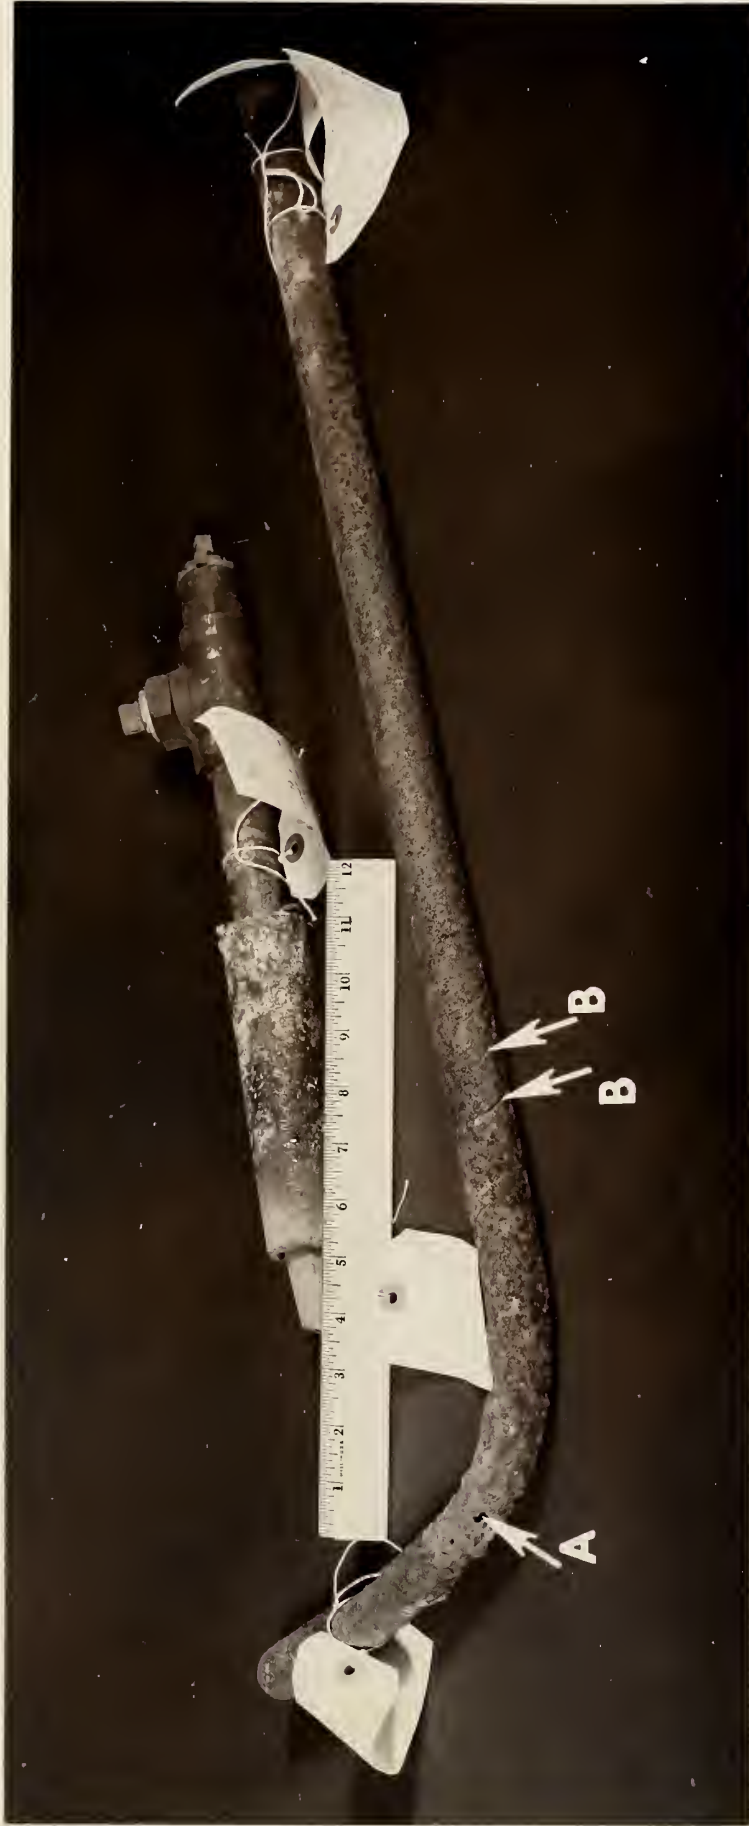
Figure 1. Steel pipe natural gas service line from 13 Clayton Court, Edgemoor Gardens, Wilmington, Delaware as received at NBS. Item 1 is at the bottom in the figure and item 2 is at the top. Before being cut apart in the field, the left end of item 2 had been attached to the right end of item 1. Arrow A indicates the location of pipe perforations. Arrows B indicate the location of mechanical damage.

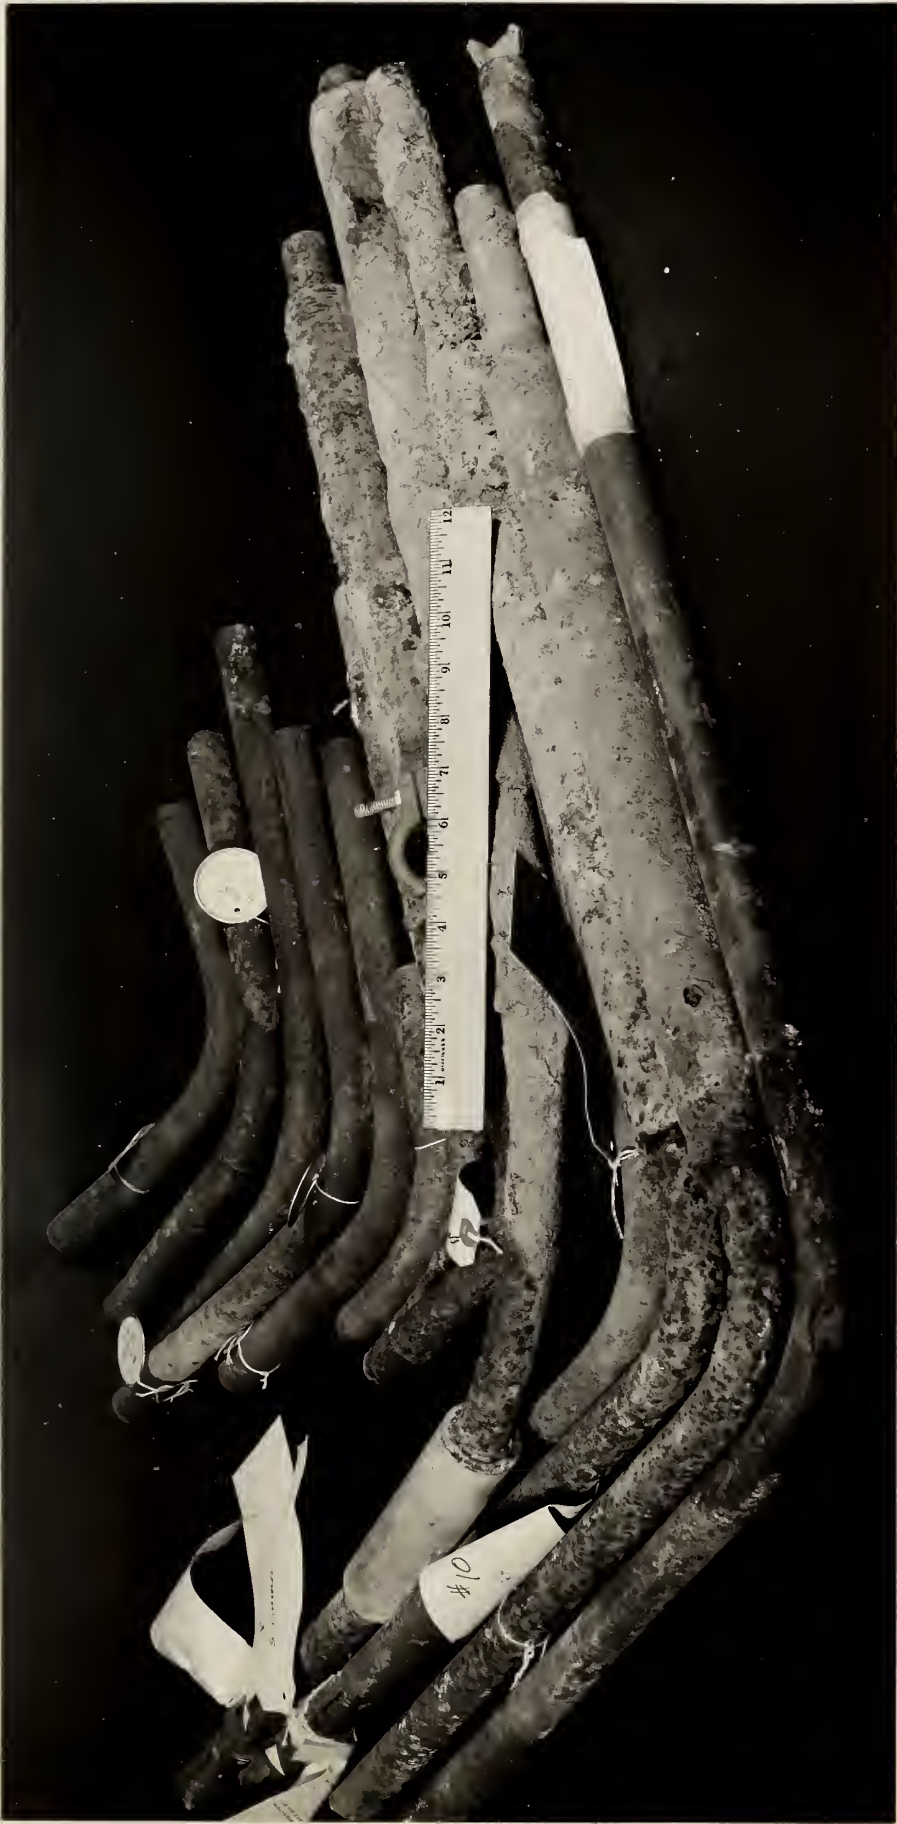
Figure 2. Thirteen steel pipe natural gas service lines from Edgemoor Gardens, Wilmington, Delaware as received at NBS.
X 1/4

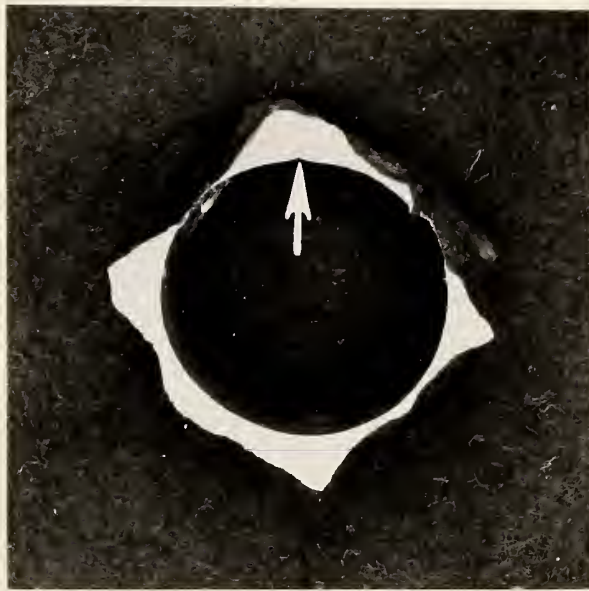
Figure 4. Cross section through severely corroded region of pipe from 13 Clayton Court. The welded seam is indicated by the arrow. X 2

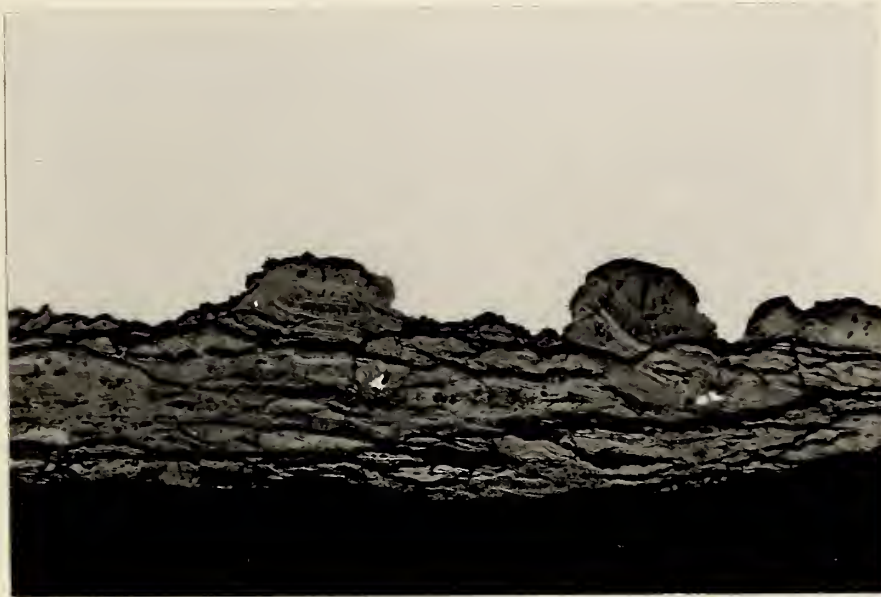
Figure 5. Unetched cross section through pipe from 13 Clayton Court. Light region is pipe material. Light gray region adjacent to the pipe material is corrosion product. As polished. X 100

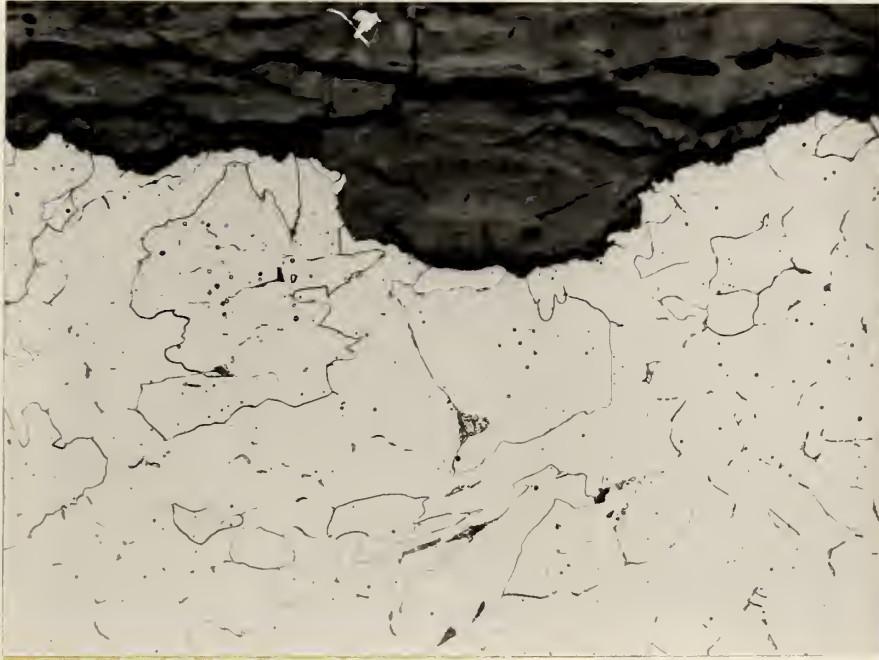
Figure 6. Etched cross section through pipe from 13 Clayton Court.
Dark gray material at the top is corrosion product.
Microstructure consists primarily of ferrite with some
pearlite.

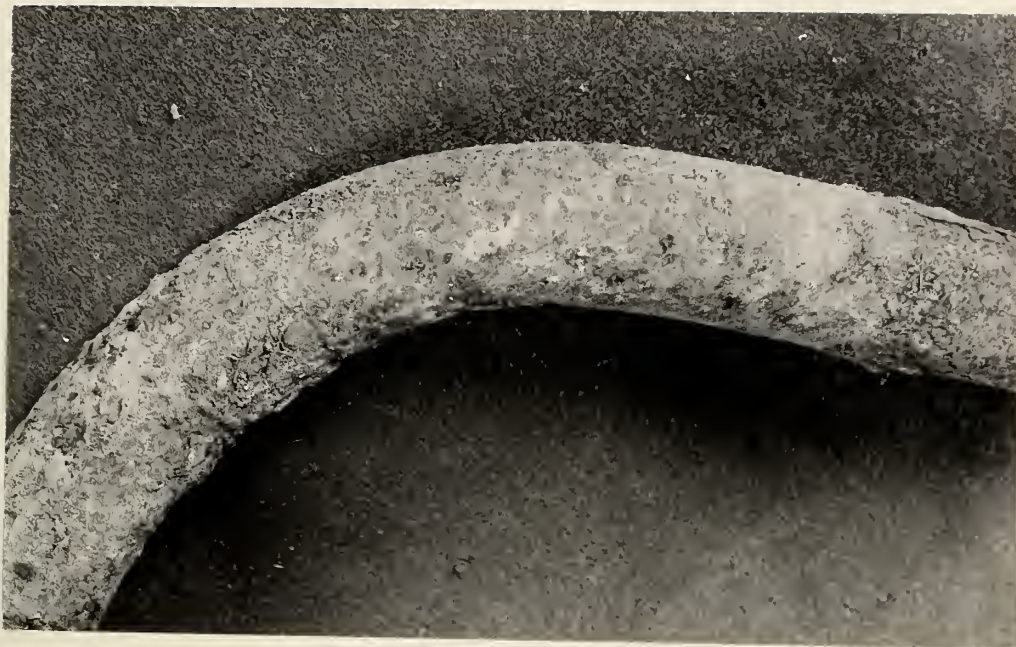
- a. Bend region of pipe as received at NBS showing corrosion. X 1
- b. Cross section through bend showing cross sectional deformation. The welded seam is indicated by the arrow. X 2

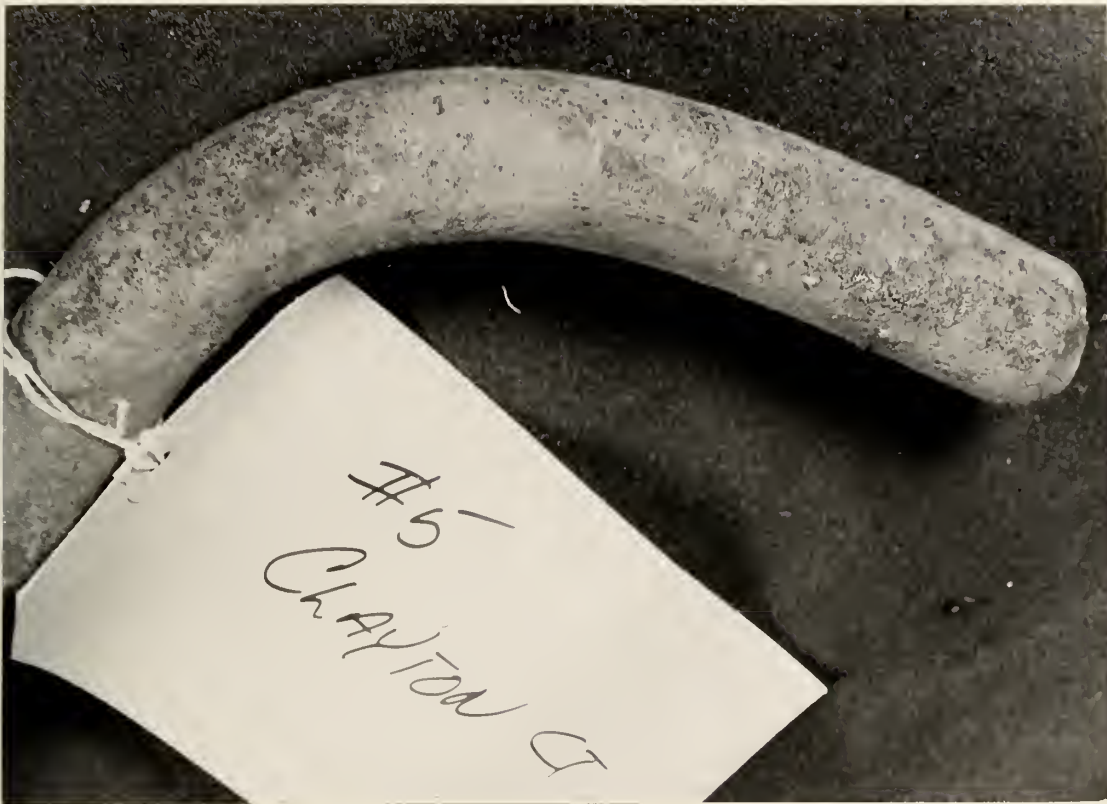
- a. Bend region of pipe as received at NBS showing corrosion. X 1
- b. Cross section through a corroded region not at the bend in the pipe. The welded seam is indicated by the arrow. X 2

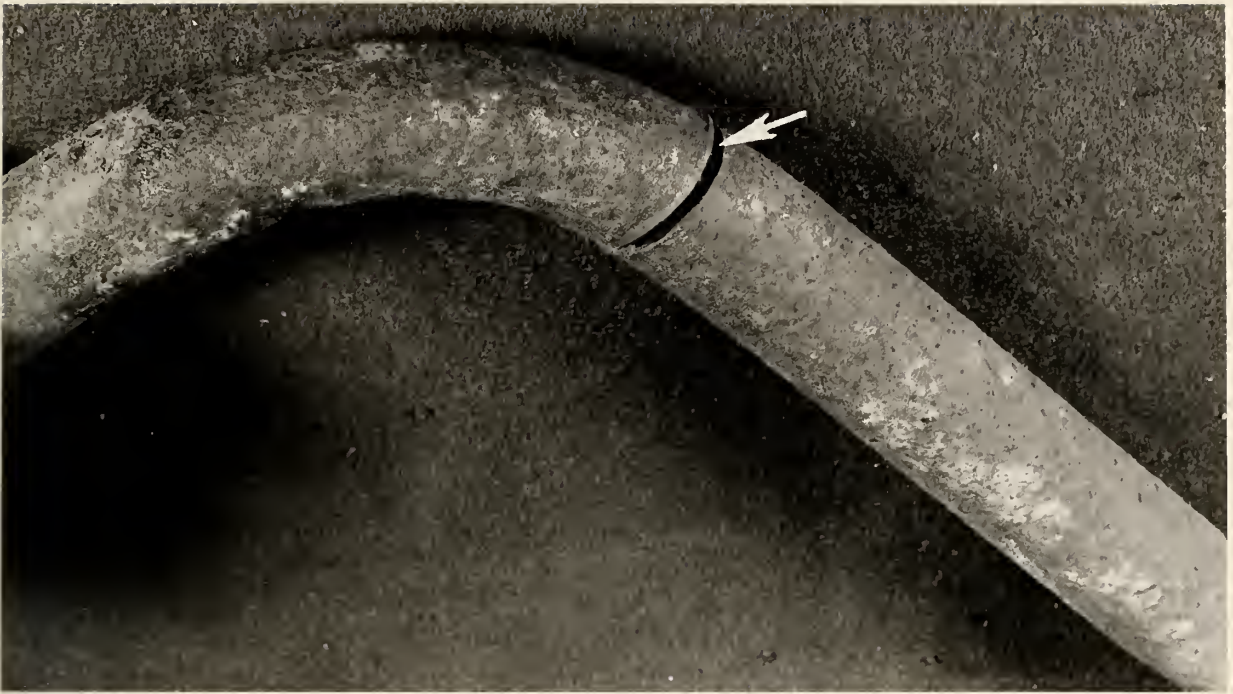
- a. Bend region of pipe as received at NBS showing corrosion. X 1
- b. Cross section through bend showing cross sectional deformation. The welded seam is indicated by the arrow. X 2

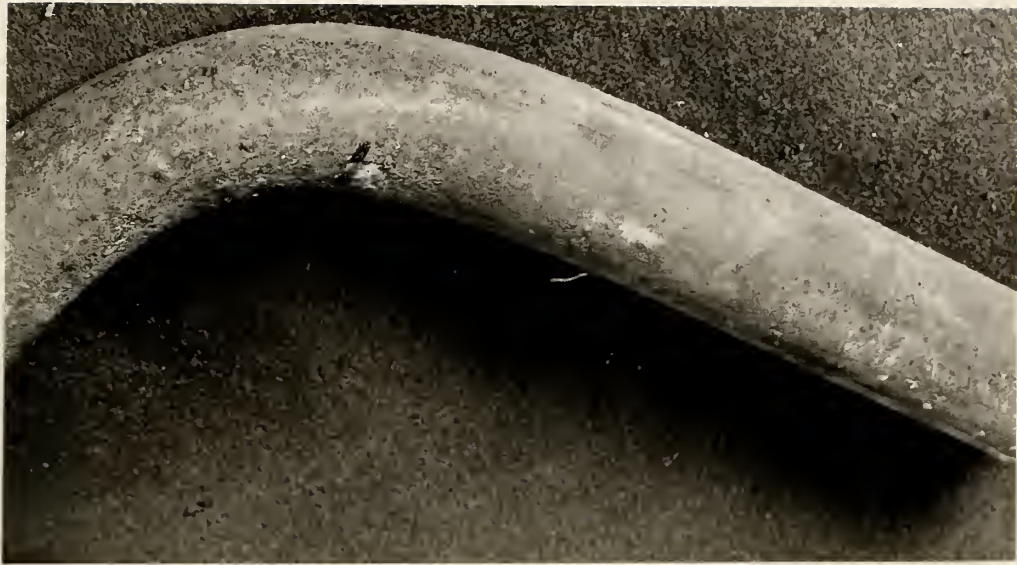
c. Cross section through region shown in figure 10b. The welded seam is indicated by the arrow. X 2

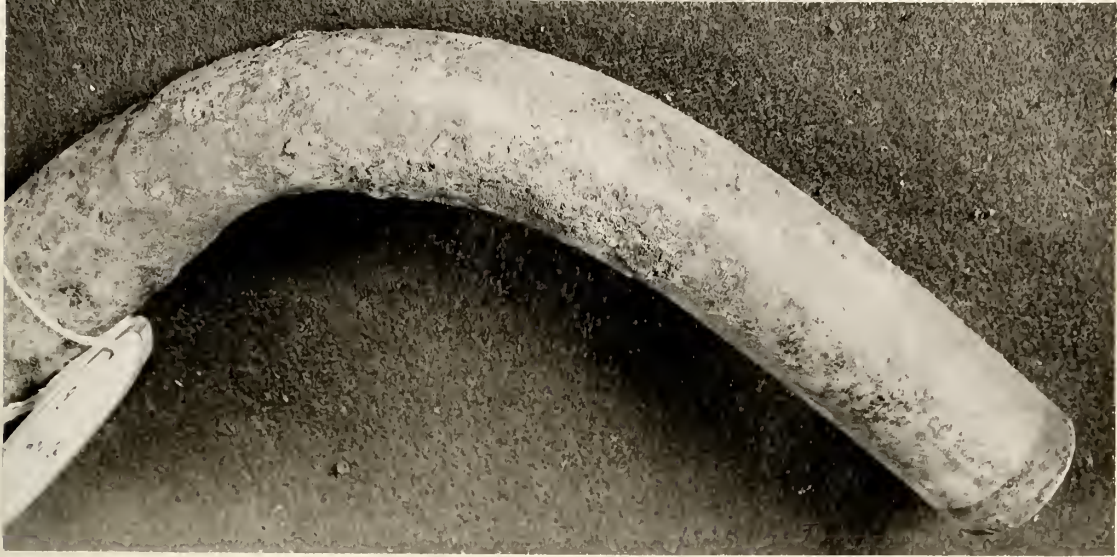
- a. Bend region of pipe as received at NBS showing corrosion. X 1
- b. Cross section through bend showing cross sectional deformation. The welded seam is indicated by the arrow. X 2

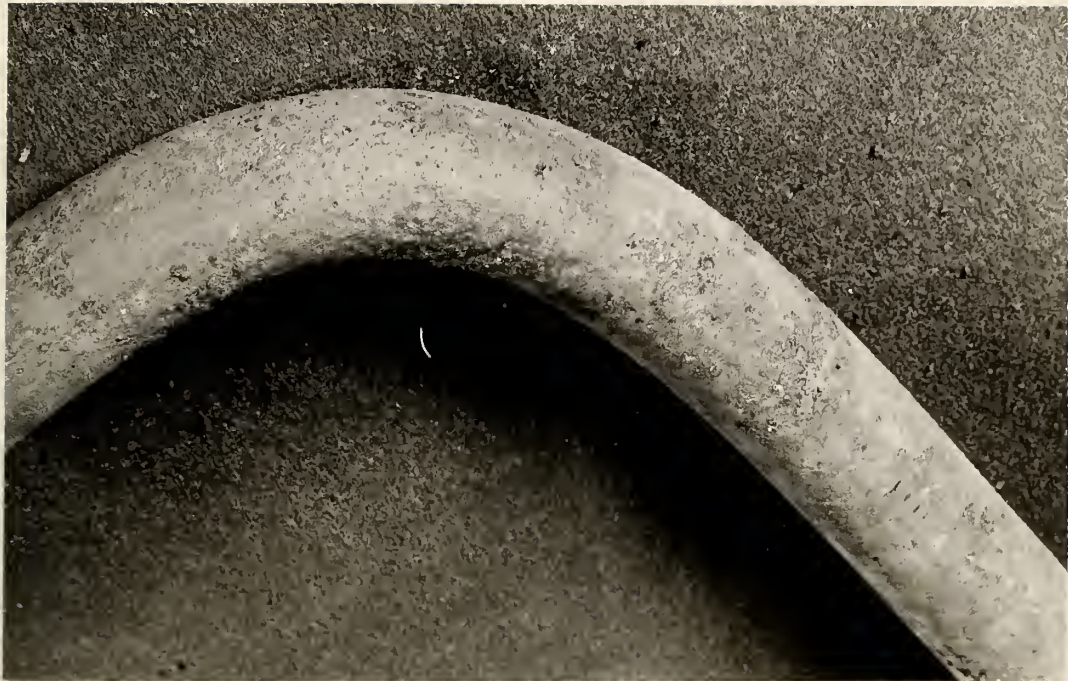
- a. Bend region of pipe as received at NBS showing corrosion. X 1
- b. Region of severe corrosion at end of bend (arrows). X 1
- c. Cross section through pipe in region of severe corrosion shown in figure 12b. The welded seam is indicated by the arrow. X 2
- d. Cross section through bend showing cross sectional deformation. The welded seam is indicated by the arrow. X 2

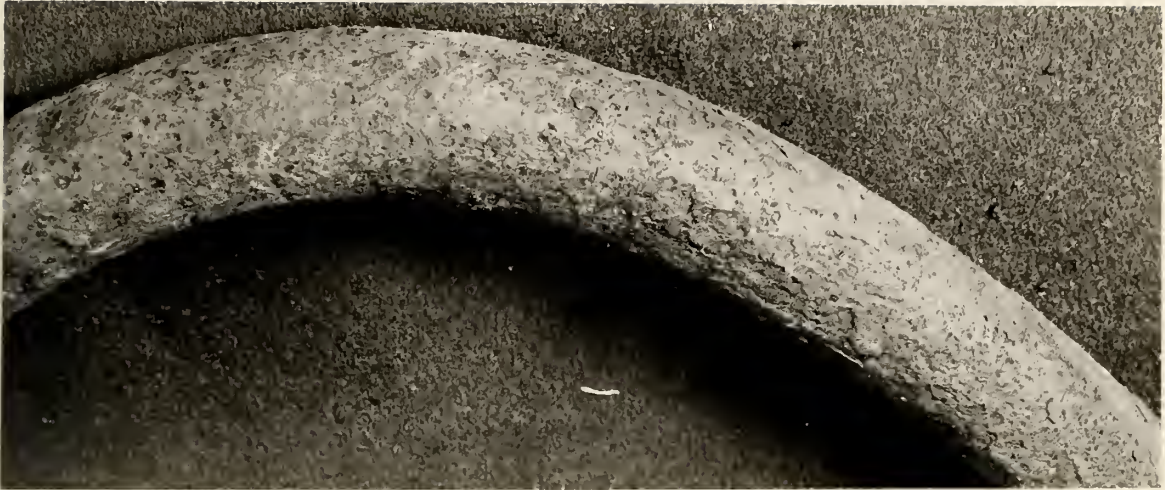
- a. Bend region of pipe as received at NBS showing corrosion. X 1
- b. Cross section through bend showing cross sectional deformation. The welded seam is indicated by the arrow. X 2

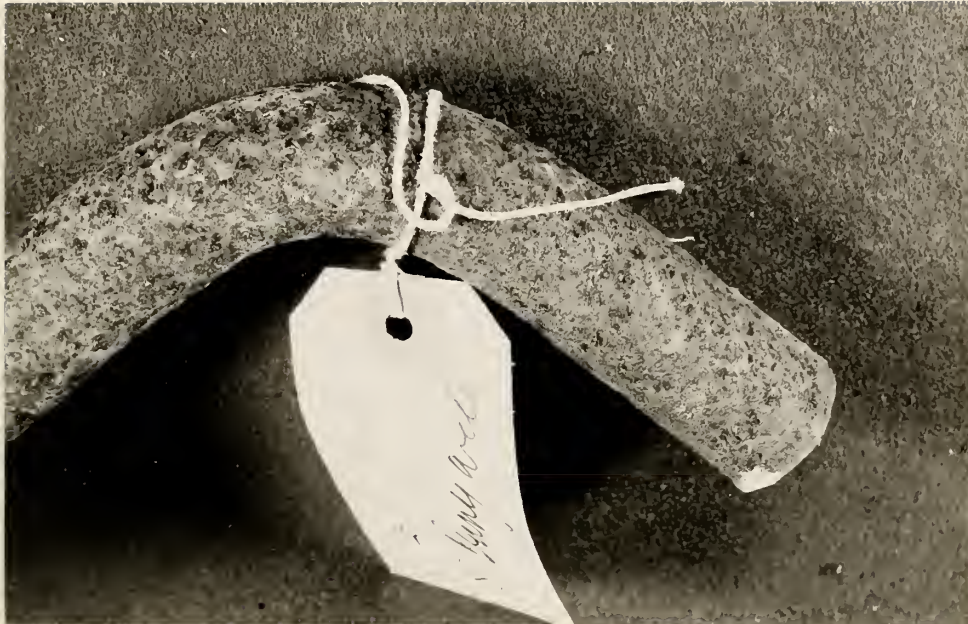
- a. Bend region of pipe as received at NBS showing corrosion. X 1
- b. Cross section through bend showing essentially no cross sectional deformation. The welded seam is indicated by the arrow. X 2

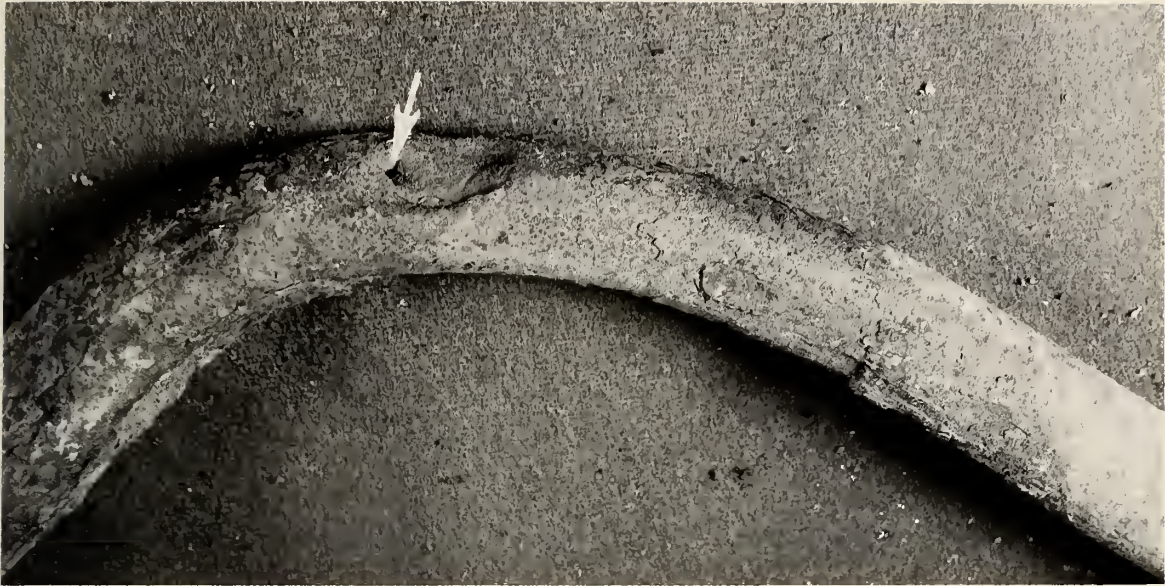
- a. Bend region of pipe as received at NBS showing corrosion. X 1
- b. Cross section through one of the more severely corroded regions not in the bend. The dark areas between about 10 and 11 o'clock represent porosity. The welded seam is indicated by the arrow. X 2

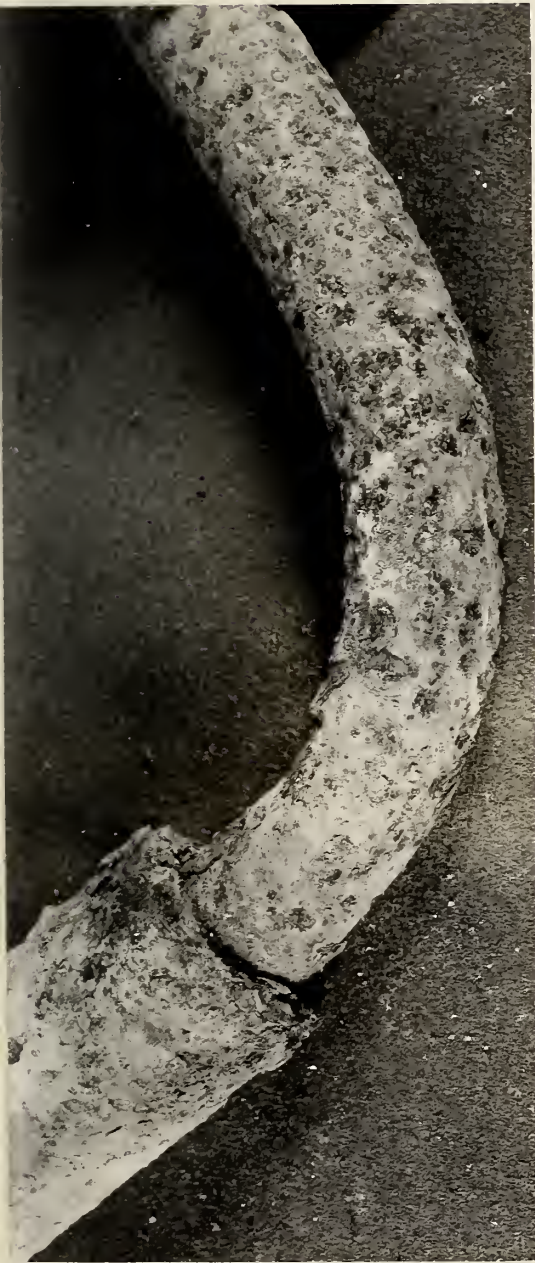
- a. Bend region of pipe as received at NBS showing corrosion, depression, and perforation (arrow). X 1
- b. Cross section through perforation showing extent of depression. Except for the depression, there is little evidence of cross sectional deformation in this figure. The welded seam is indicated by the arrow. X 2

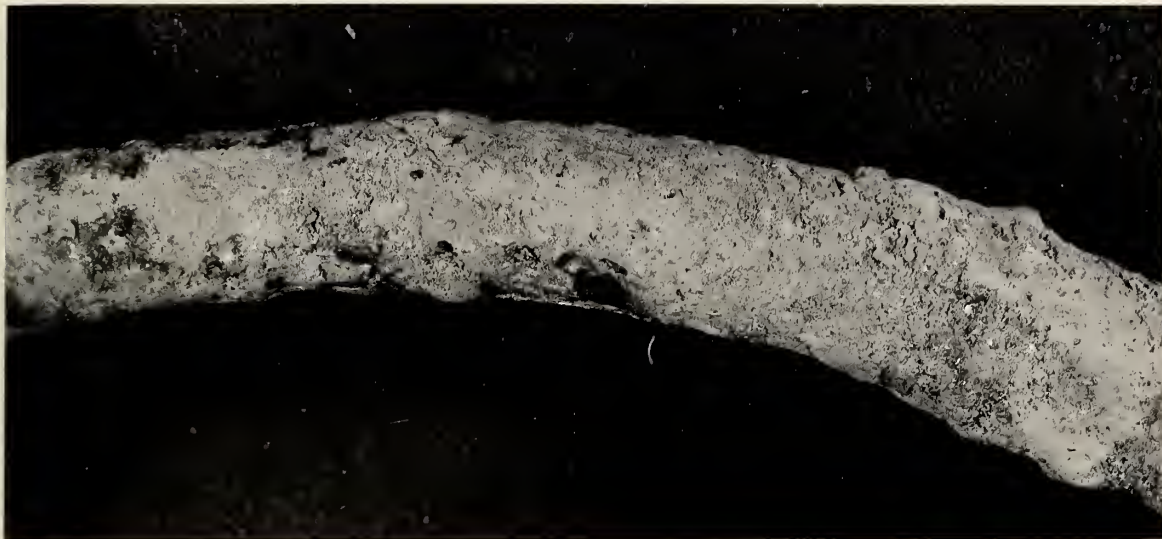
- a. Bend region of pipe as received at NBS showing corrosion. Part of the sleeve that had been covered by the pipe that had been covered by the sleeve (to the right of the line A-A). X 1
- b. End of the sleeve and part of the pipe that had been covered by the sleeve (to the right of the line A-A). X 1
- c. Cross section through beginning of bend. The welded seam is indicated by the arrow. X 2

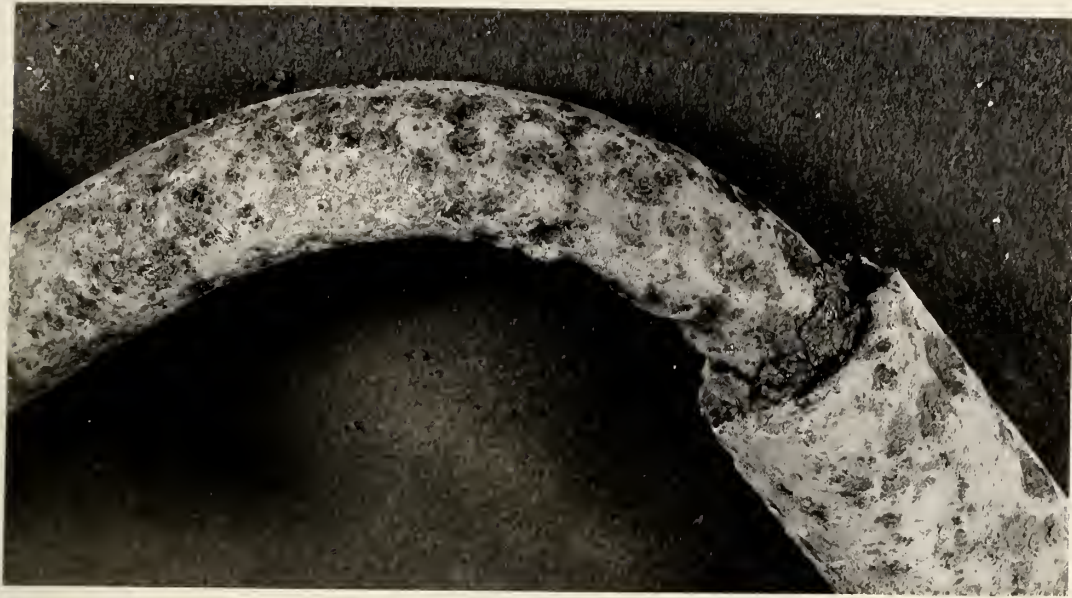
- a. Bend region of pipe as received at NBS showing soil and corrosion. X 1
- b. Cross section through one of the more severely corroded regions adjacent to the bend. The welded seam is indicated by the arrow. X 2

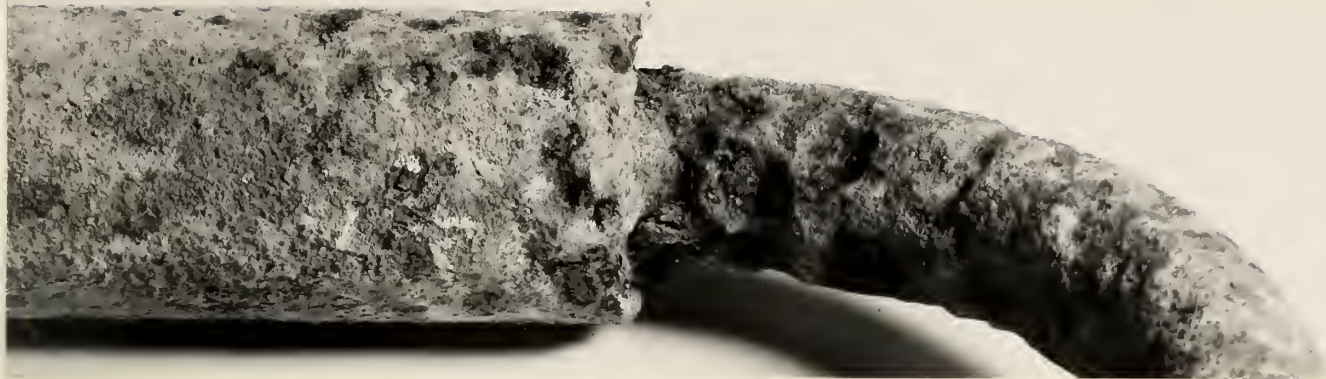
- a. Bend region of pipe as received at NBS showing corrosion. The end of a sleeve can be seen at the right. X 1
- b. Cross section through one of the more severely corroded regions of the bend. The welded seam is indicated by the arrow. X 2

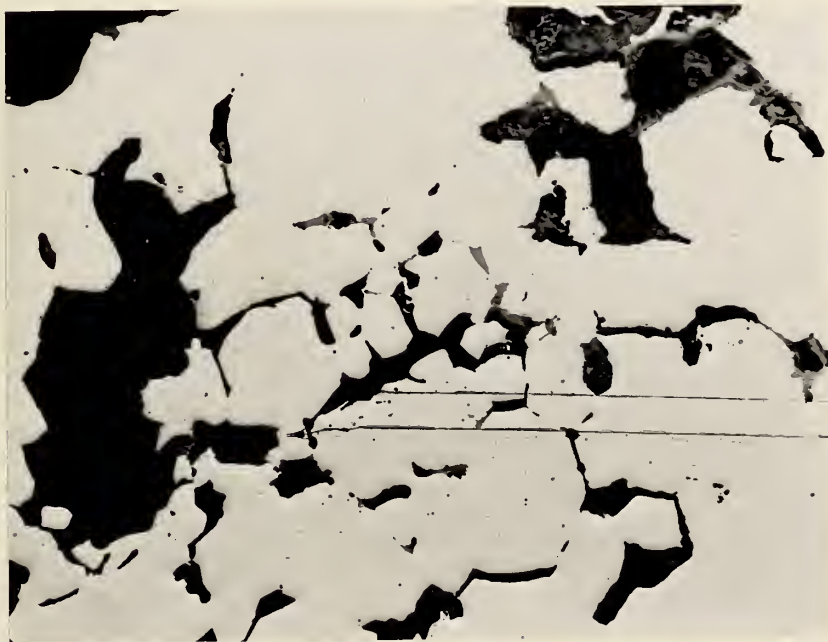
Figure 23. As-polished cross section through the pipe from 31 S. Bennywell showing porosity. The location of the porosity in the pipe wall can be seen in figure 15b. The two parallel, nearly horizontal lines about 1/3 the distance from the bottom of the figure are polishing scratches caused by foreign material being dragged from the pores. X 40

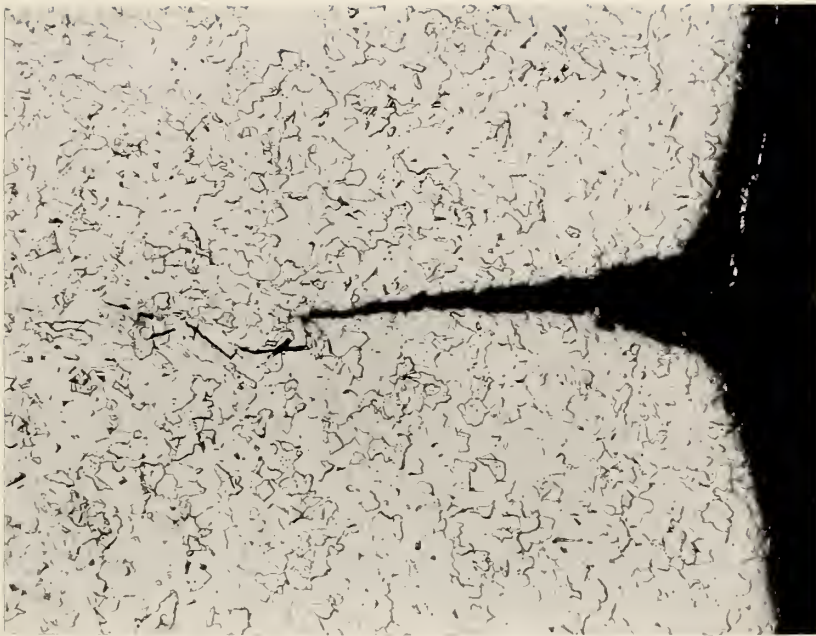
Figure 24. Etched cross section through the bend of the pipe sample from 8 Clayton Ct. showing cracking of the weld at the inside of the pipe. The inside wall surface of the pipe is vertical at the right.

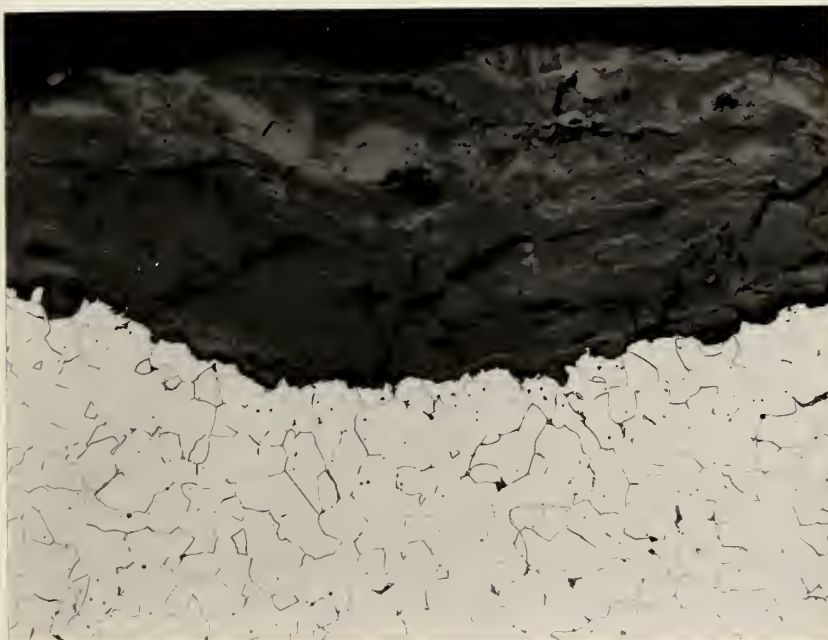
Figure 25. Etched cross section through pipe sample designated 10. The light gray material covering approximately the upper one-half of the figure is corrosion product.

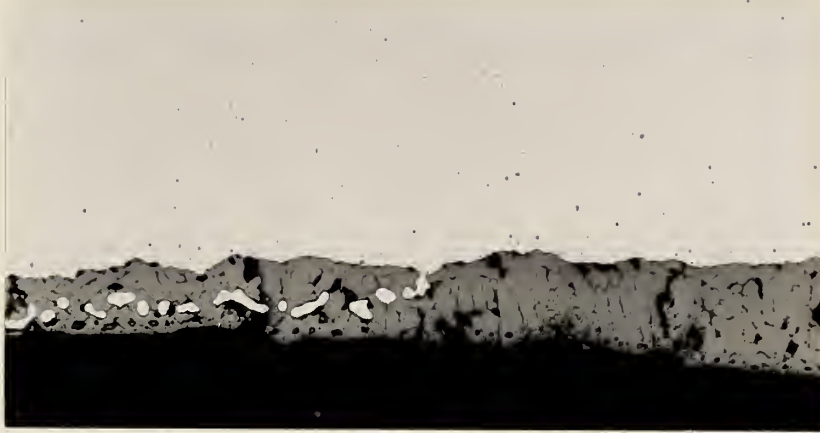
Figure 26. As-polished cross section through pipe sample from 31 S. Bennywell showing corrosion product on the inside of the pipe. The corrosion product is light gray. X 100

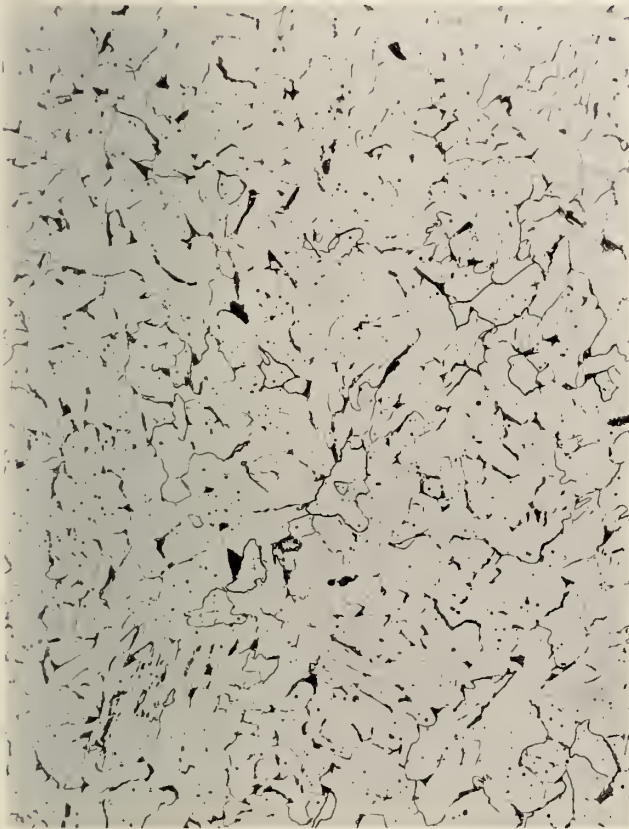
Figure 27. Etched cross section through pipe sample from 8 Clayton Ct. showing microstructure consisting of ferrite and a small amount of pearlite. Etchant: 1% nital X 100

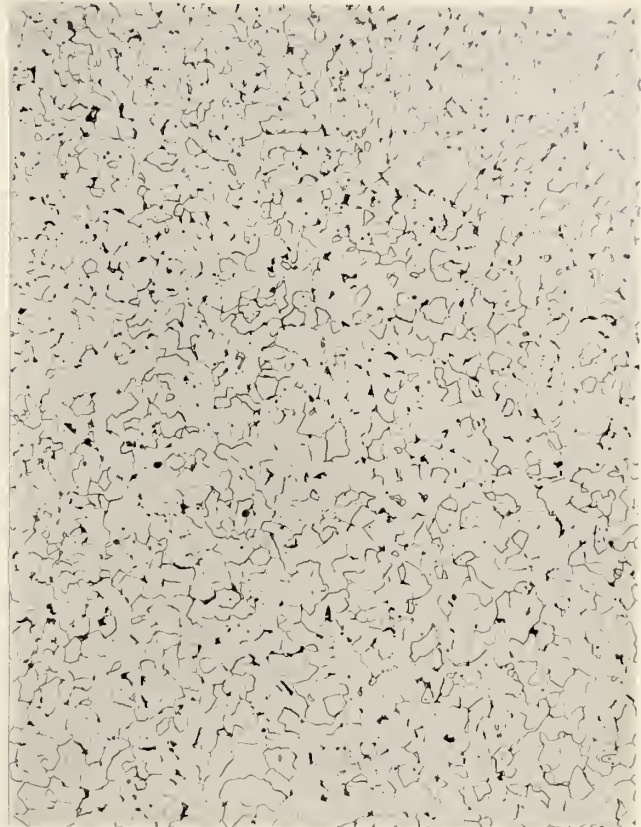
Figure 28. Etched cross section through pipe sample designated 7 showing microstructure consisting of ferrite and a small amount of pearlite. The grain size is smaller and the grains are more nearly equiaxed than in the microstructure shown in figure 27. Etchant: 1% nital X 100

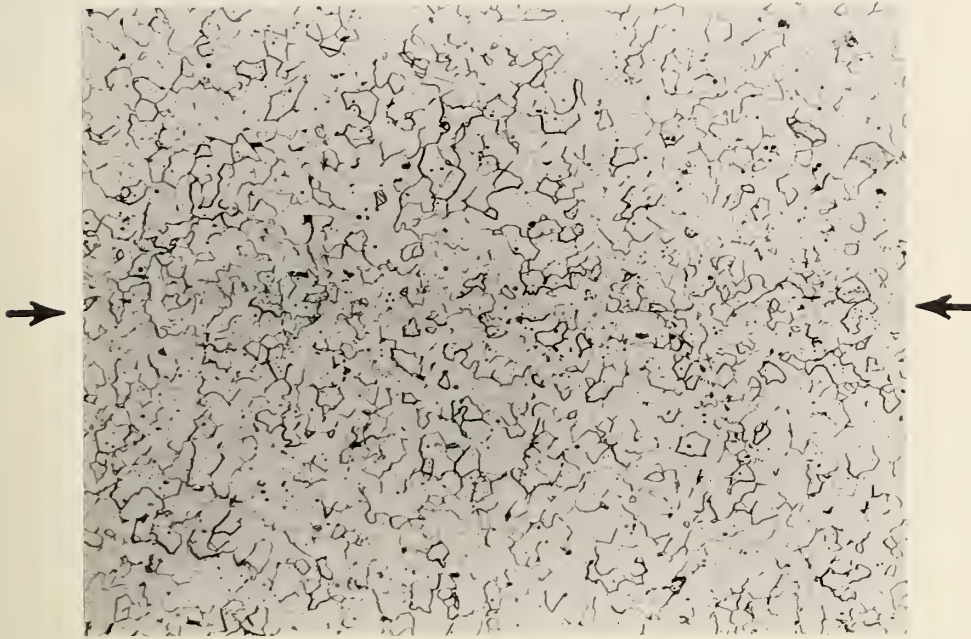
Figure 29. Etched cross section through pipe sample designated 10 showing the microstructure at the weld (between arrows) and on both sides of the weld.
Etchant: 1% nital X 100

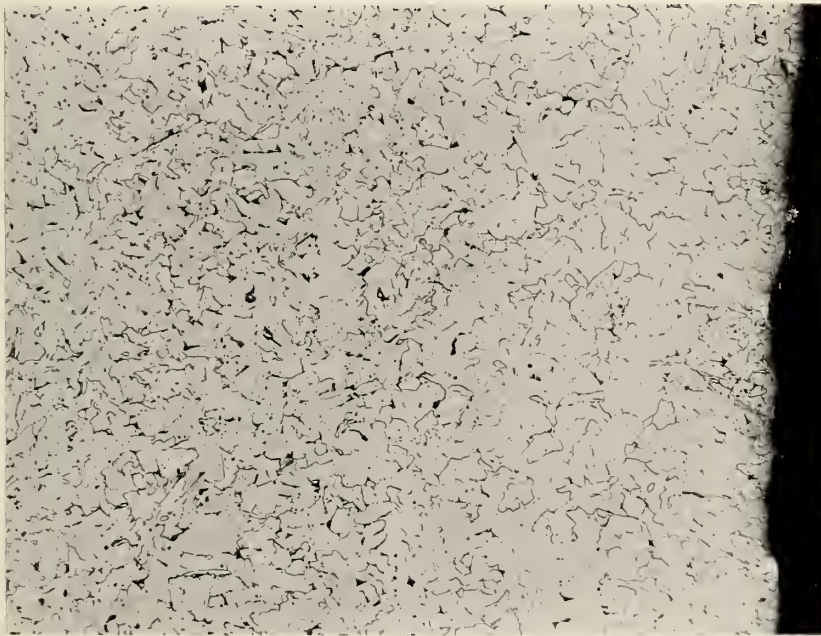
Figure 30. Etched cross section through pipe sample from 8 Clayton Ct. showing decarburization adjacent to the pipe surface (vertical at the right) in a slightly corroded region. Note that there are fewer of the small dark areas near the surface than in the left of the figure.
Etchant: 1% nital X 50

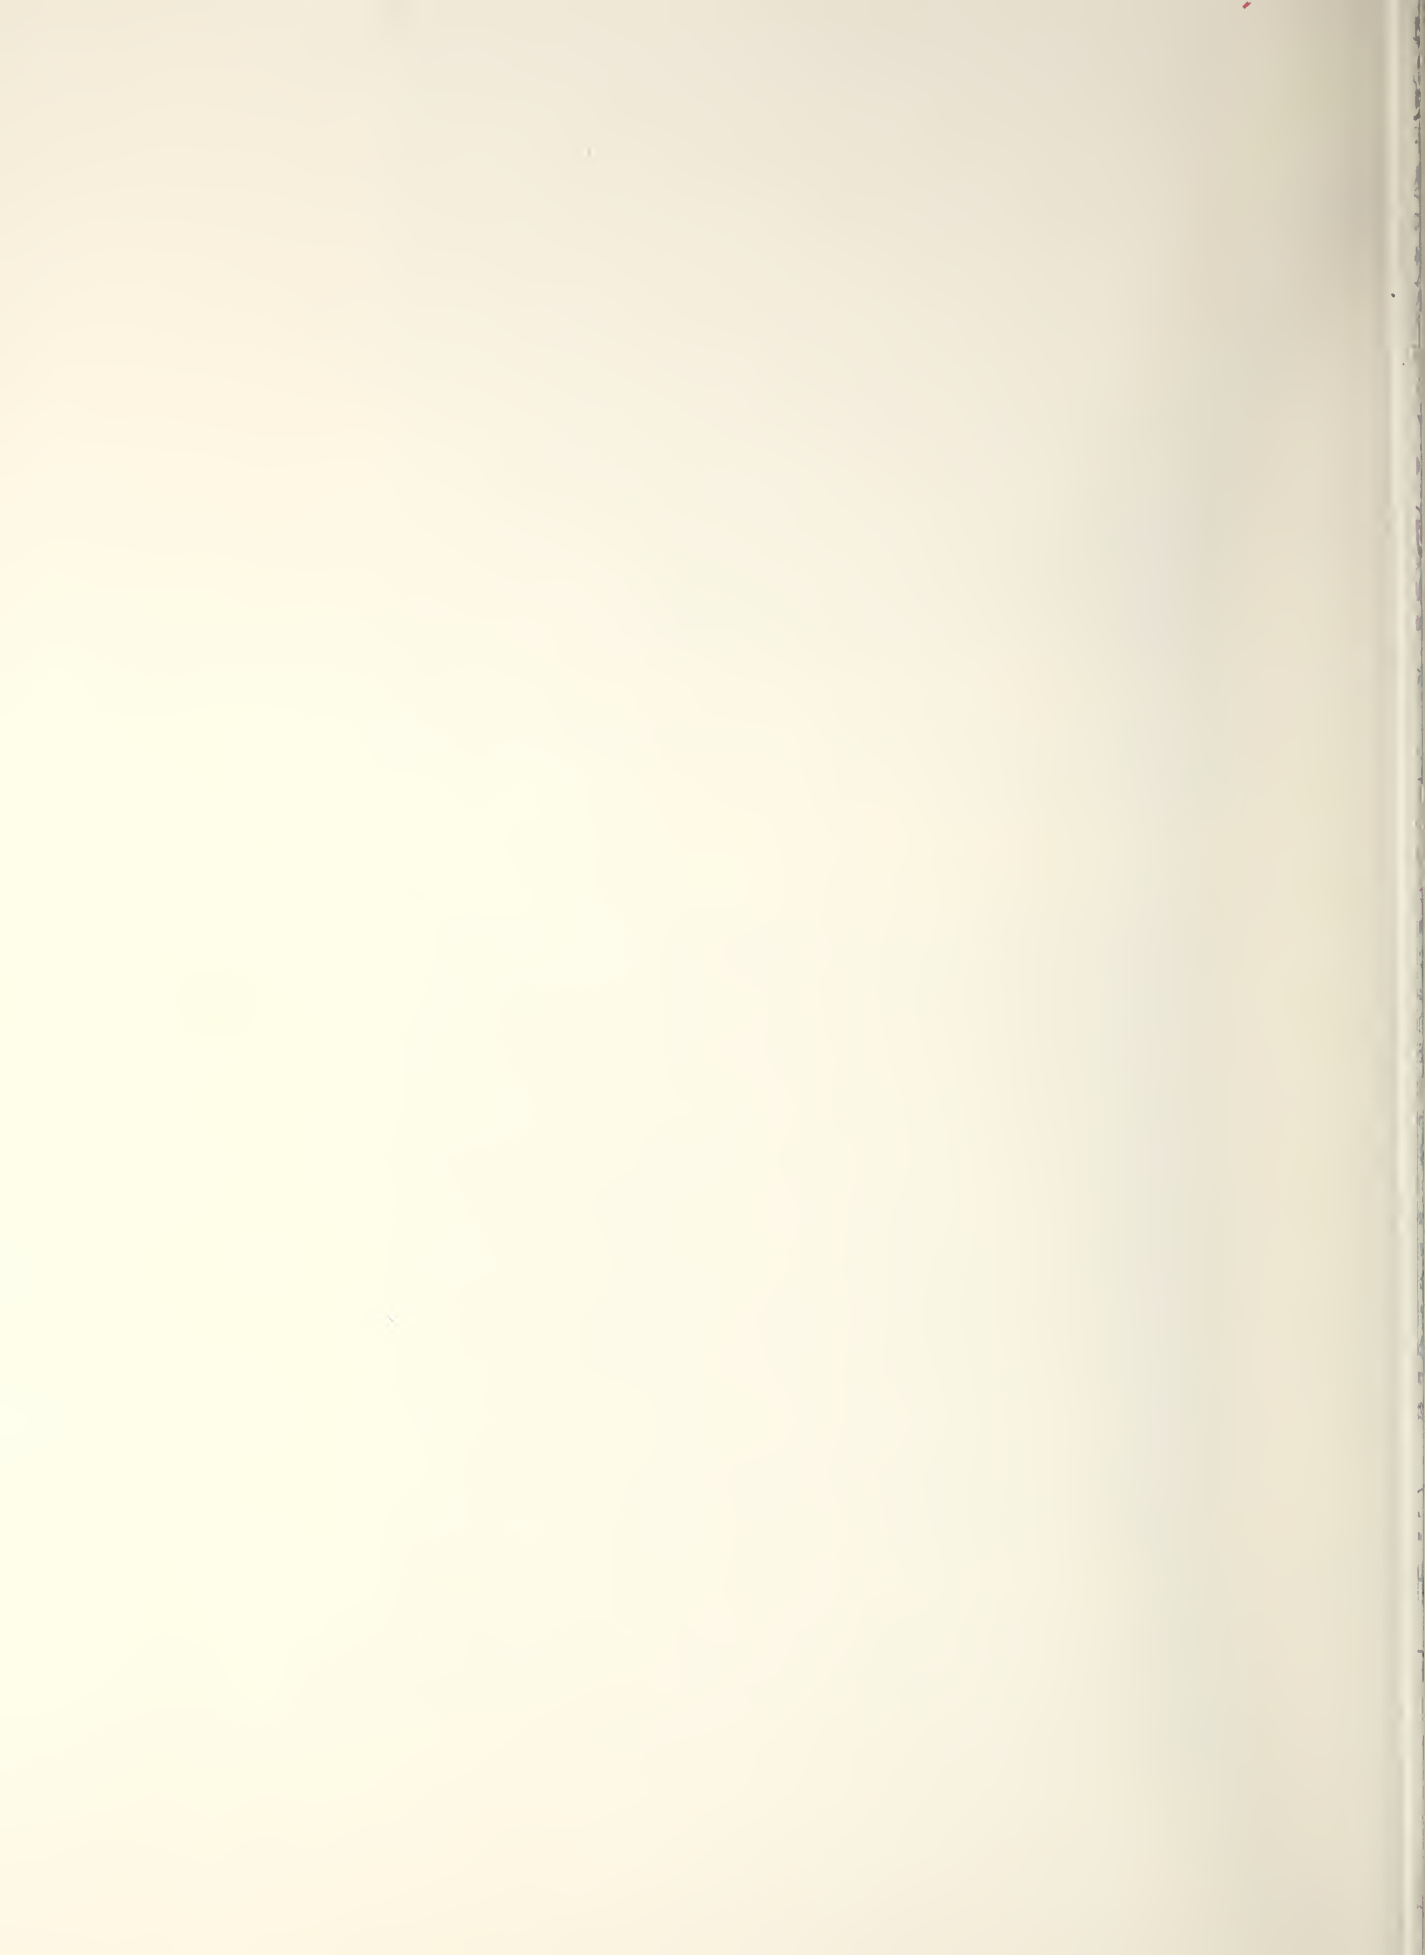
U.S. DEPT. OF COMM. BIBLIOGRAPHIC DATA SHEET	1. PUBLICATION OR REPORT NO. NBSIR 77-1198 (R)	2. Gov't Accession No.	3. Recipient's Accession No.
4. TITLE AND SUBTITLE EXAMINATION OF 3/4 INCH STEEL PIPE NATURAL GAS SERVICE LINES, DELMARVA POWER AND LIGHT COMPANY, WILMINGTON, DELAWARE		5. Publication Date	6. Performing Organization Code
