NBSIR 77-1292 R

FILE COPY  
DO NOT REMOVE

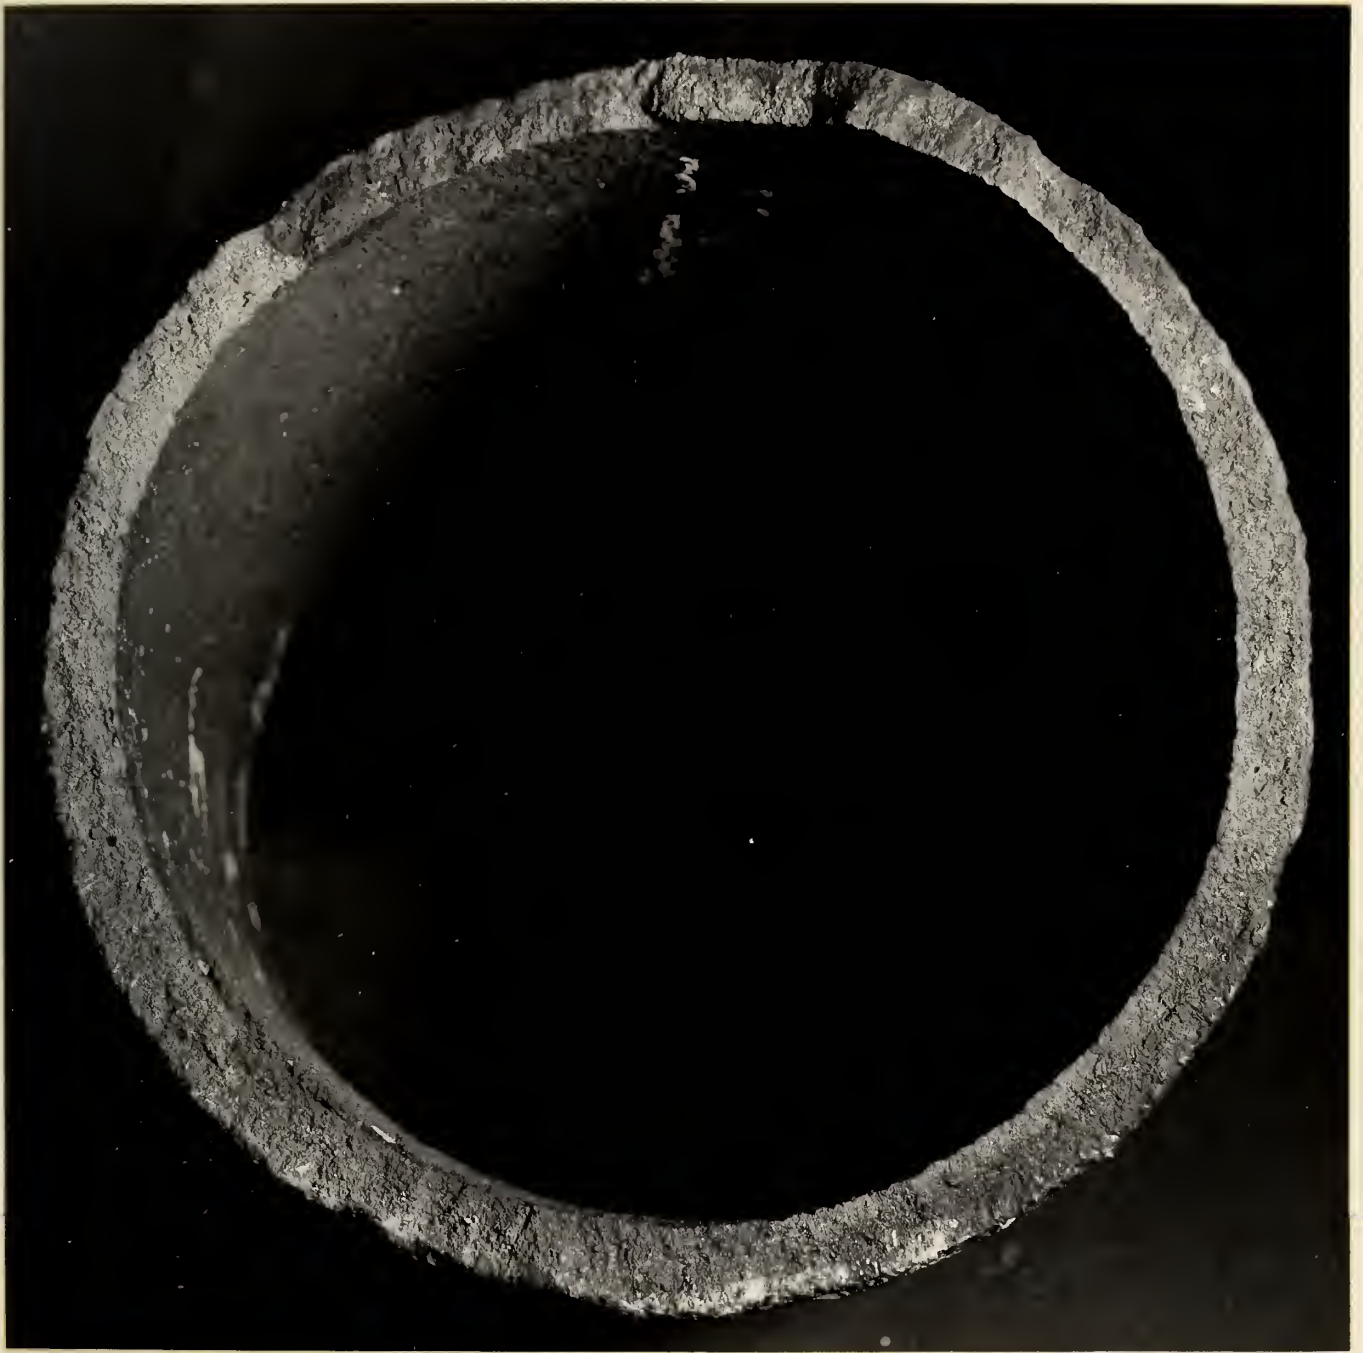
Figure 2. Fracture surface designated W as received at NBS. The top of the pipe, as marked before the pipe was sent to NBS, is at the top in the photograph. X 1

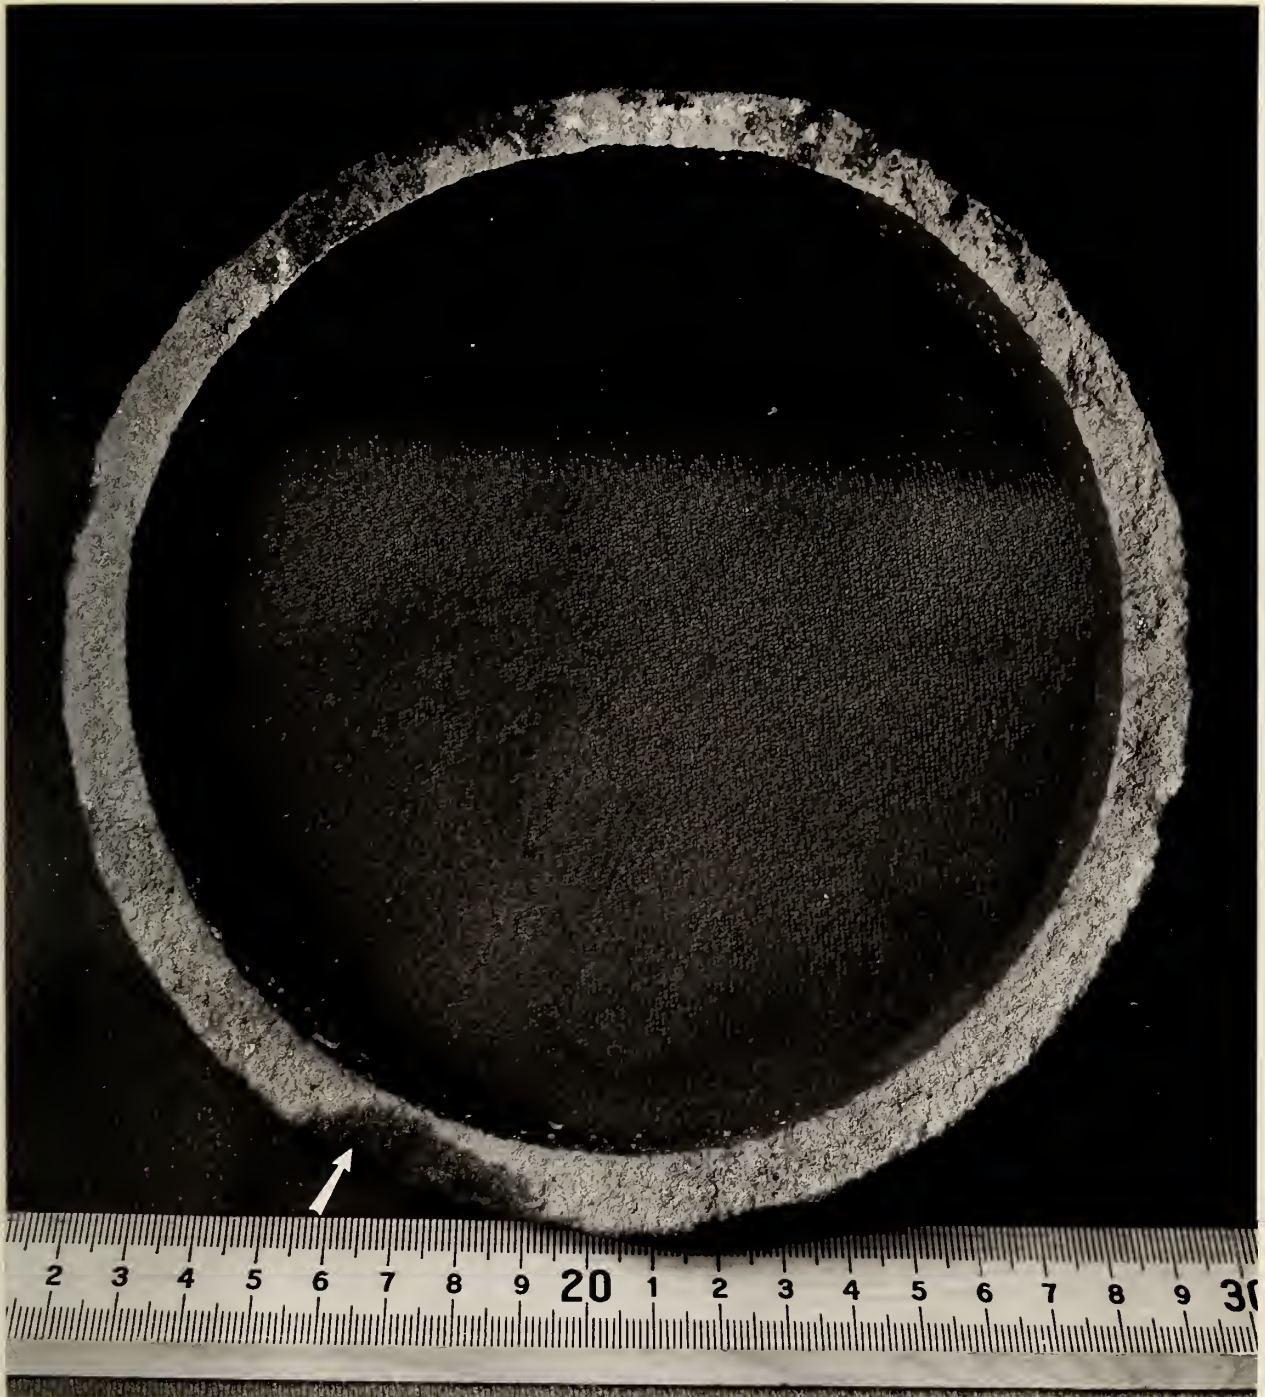
Figure 3. Fracture surface designated W after ultrasonic cleaning. The designated top of the pipe is at the top in the photograph. The arrow indicates the region of graphitization near the bottom of the fracture. The dark regions near the top are deposits that were not removed by the cleaning procedure. X 1

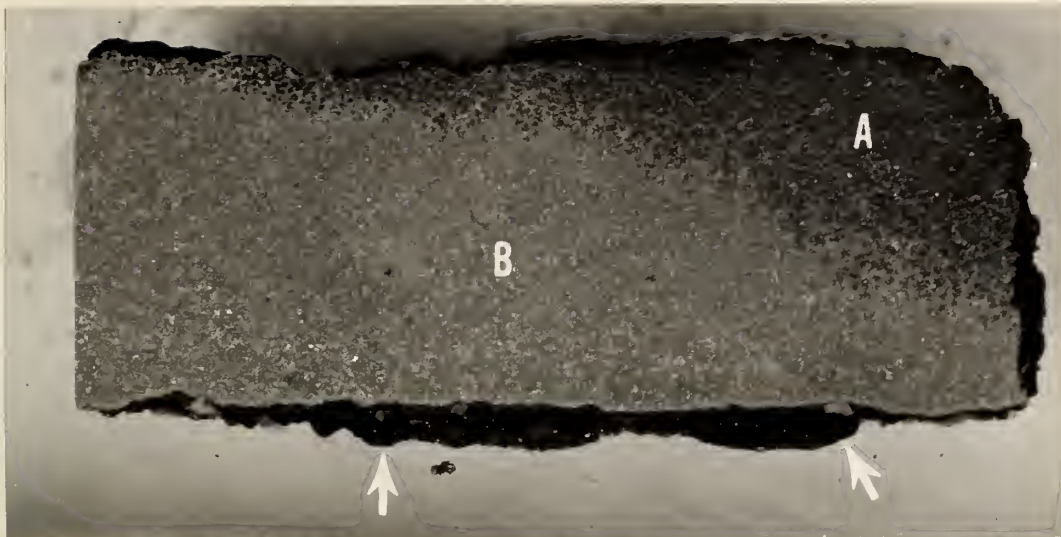
Figure 5. Longitudinal section through pipe intersecting fracture at location of deepest penetration of graphitization. Fracture profile is vertical at the right. The outside surface of the pipe is horizontal at the top. Region A has been graphitized, whereas region B has not. The very dark areas indicated by arrows are deposits on the inside surface of the pipe.  
Etchant: 1% nital

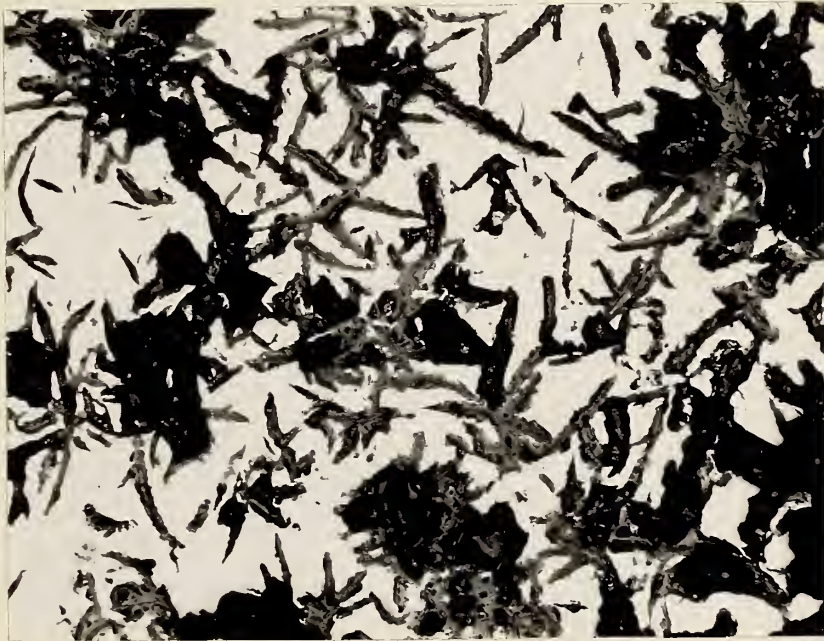
Figure 6. As-polished section through pipe in a partially graphitized region. The darkest areas have been graphitized. The light gray thin areas are graphite flakes.  
Unetched

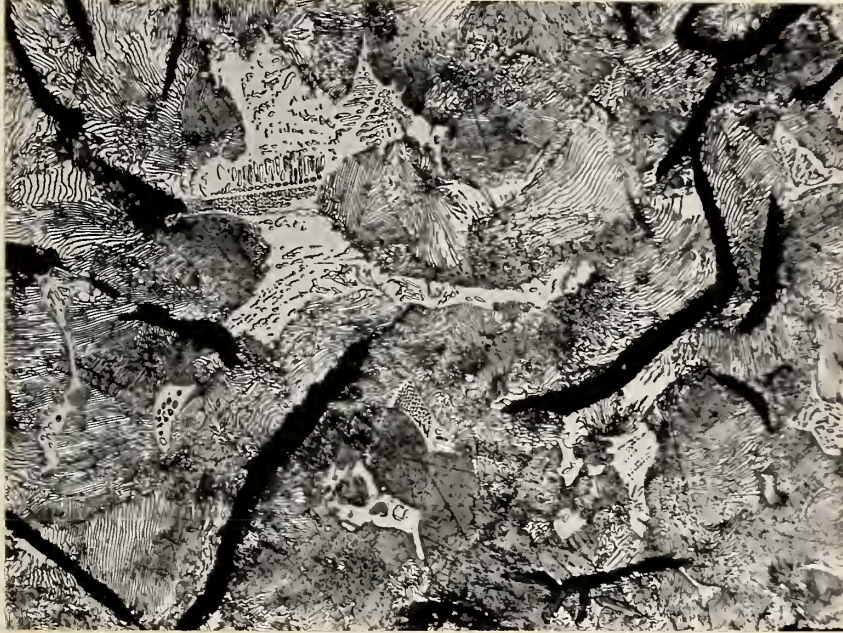
Figure 7. Representative microstructure of the pipe material in an area that has not been graphitized. The thin, dark particles are graphite flakes. White areas are cementite. Fingerprint areas and gray areas are pearlite. Small rounded particles are steadite (iron-iron phosphid eutectic).  
Etchant: 1% nital

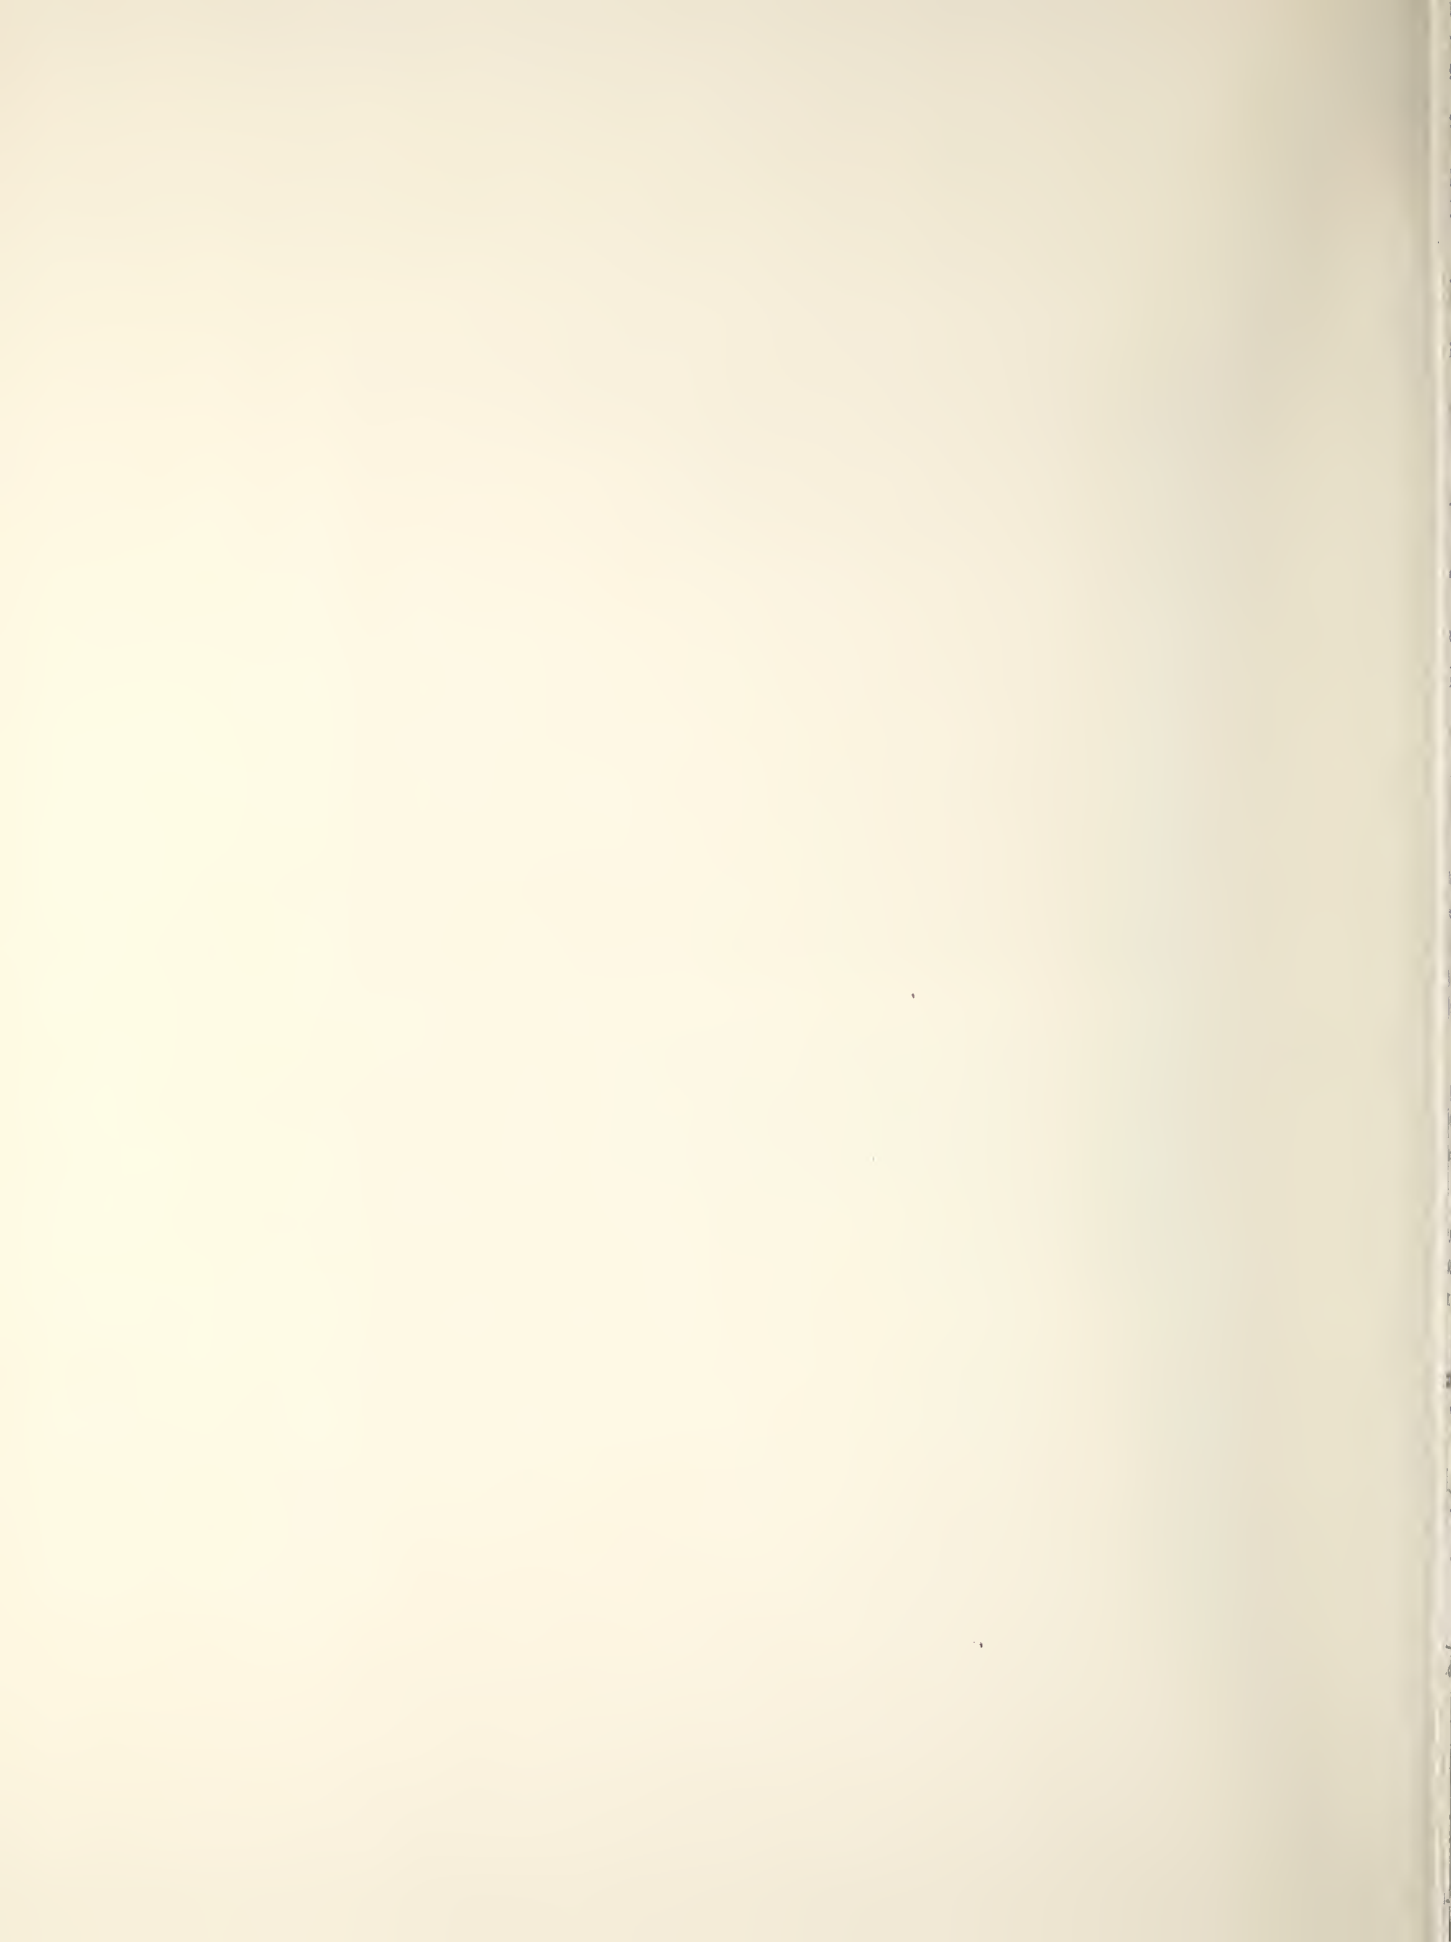
U.S. DEPT. OF COMM. BIBLIOGRAPHIC DATA SHEET	1. PUBLICATION OR REPORT NO. NBSIR 77-1292	2. Gov't Accession No.	3. Recipient's Accession No.
4. TITLE AND SUBTITLE EXAMINATION OF FAILED SIX INCH CAST IRON PIPE NATURAL GAS MAIN, PUBLIC SERVICE ELECTRIC AND GAS COMPANY, FAIRVIEW, NEW JERSEY		5. Publication Date	6. Performing Organization Code
