NBSIR 78-1415

Fire Endurance Tests of Residential Walls Containing Branch Circuit Wiring - Preliminary Findings

Lionel A. Issen

February 1978

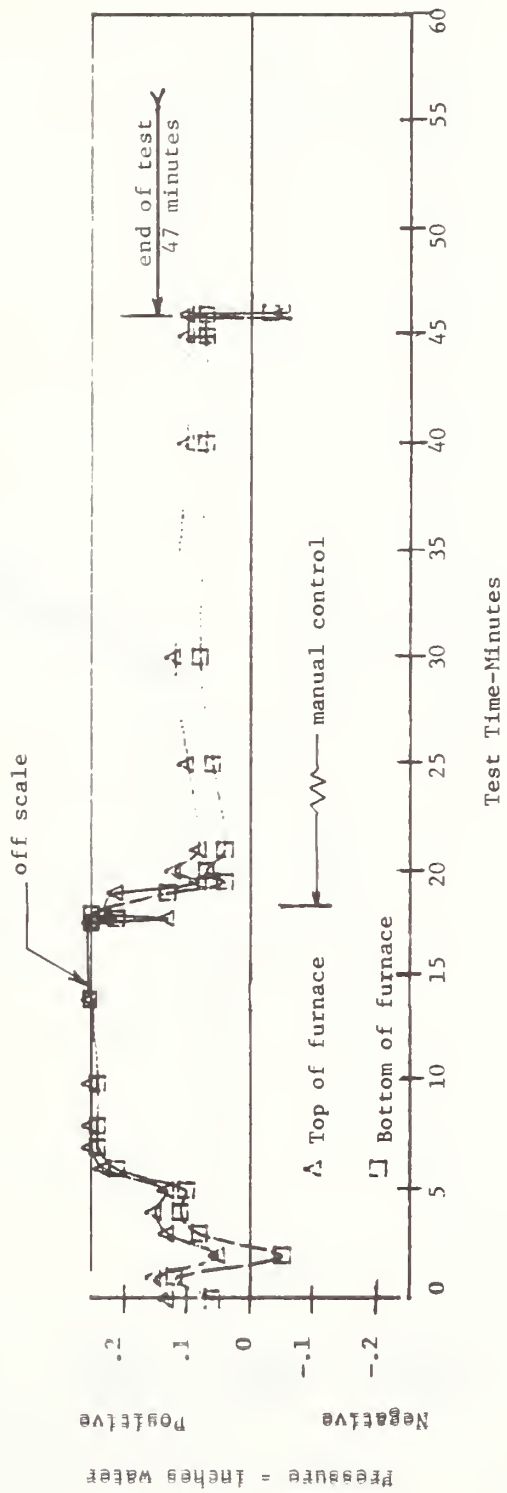
A malfunction of the furnace exhaust damper control system during the first 16 minutes of the first test resulted in high furnace pressures. At 16 minutes the automatic damper controls were disconnected and the furnace pressure was controlled manually for the balance of the test at approximately + 0.1 inch water column. This value is representative of the overpressure in a room during a severe fire. The measured furnace pressure history is shown in figure 11.

High furnace pressures produce a more severe fire exposure on a wall than do low or negative pressures. This is shown in test FE 1 by comparing the temperatures of the switch boxes on the fire side with those on the room side (figures 12-15). The fire side temperatures showed a steady rise for the first 16 minutes of test time, followed by a decreasing temperature for about 8-10 minutes. These temperatures remained higher until about 25-30 minutes into the test when both the fire side and room side temperatures rose sharply. This sharp rise in temperature coincided with the observation that the fire side gypsum board was deteriorating.

Figure 11. Test FE 1 - Furnace pressure

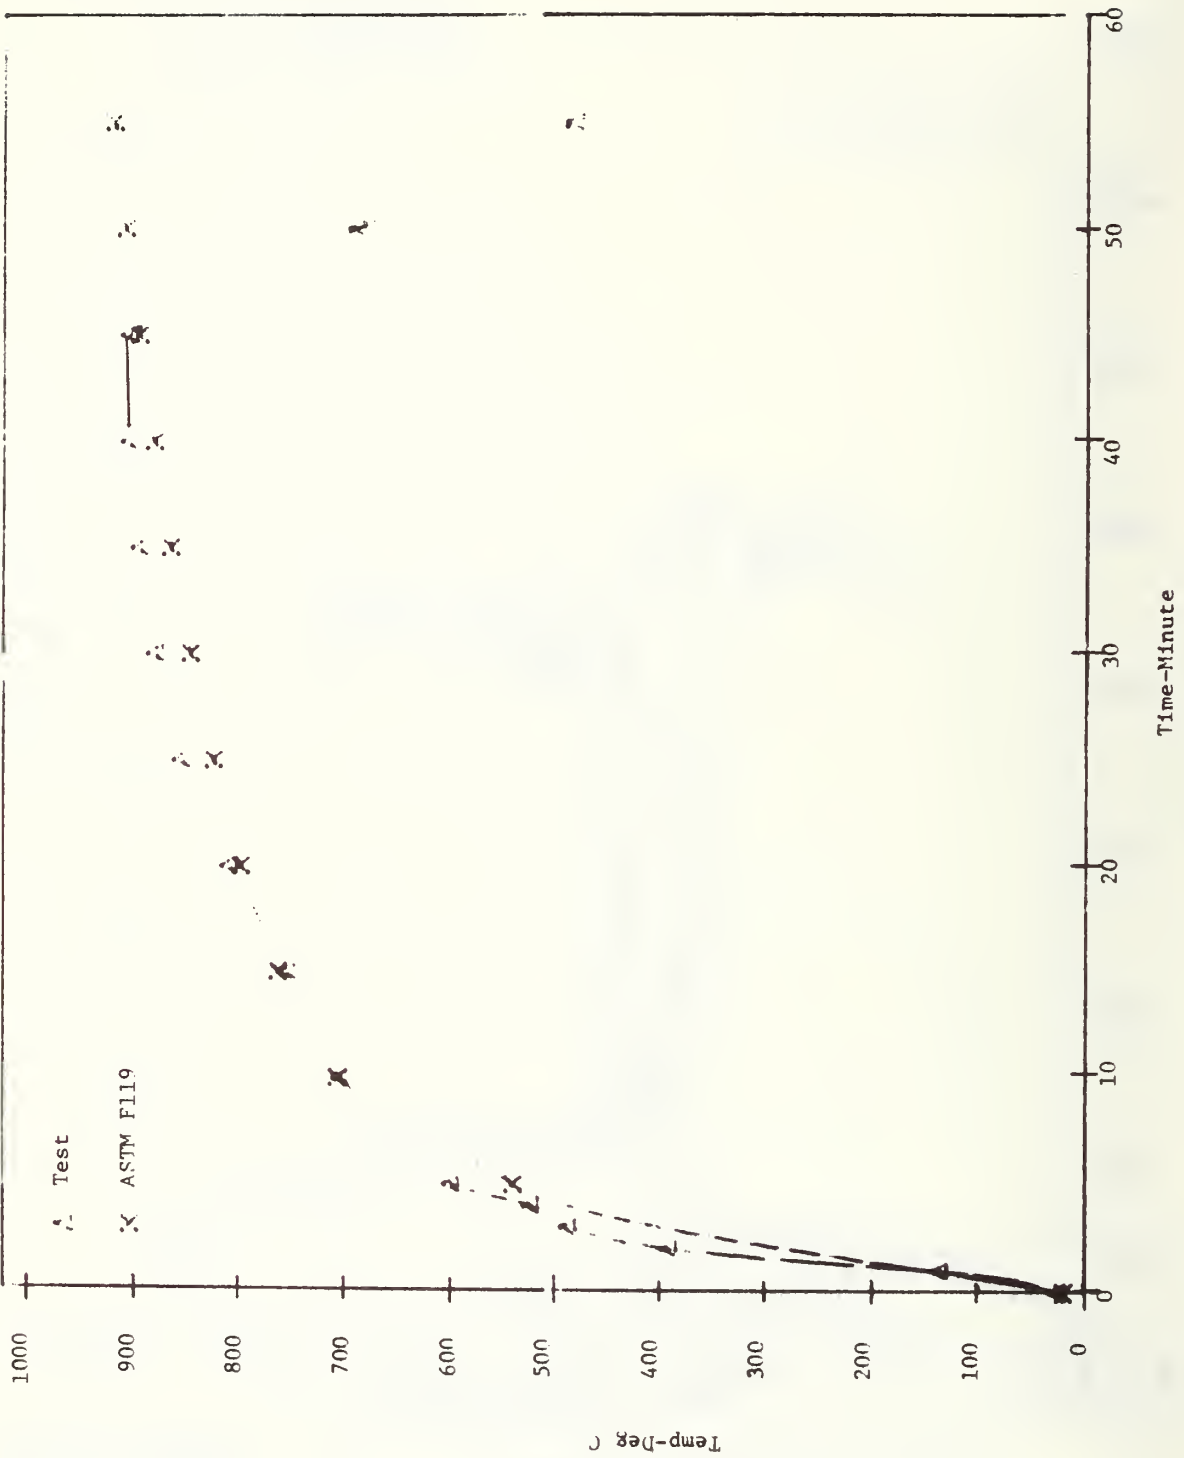
The furnace temperatures, which were controlled to follow the standard ASTM E-119 curve [2], are shown in figure 26. The correction to the fire endurance based on the method given in ASTM E-119 was + 0.7 minute. The average unexposed surface temperature measured by t/cs 39 to 50, away from the switch and outlet boxes, is shown in figure 27.

Figure 26. Test FE 1 - Furnace temperatures

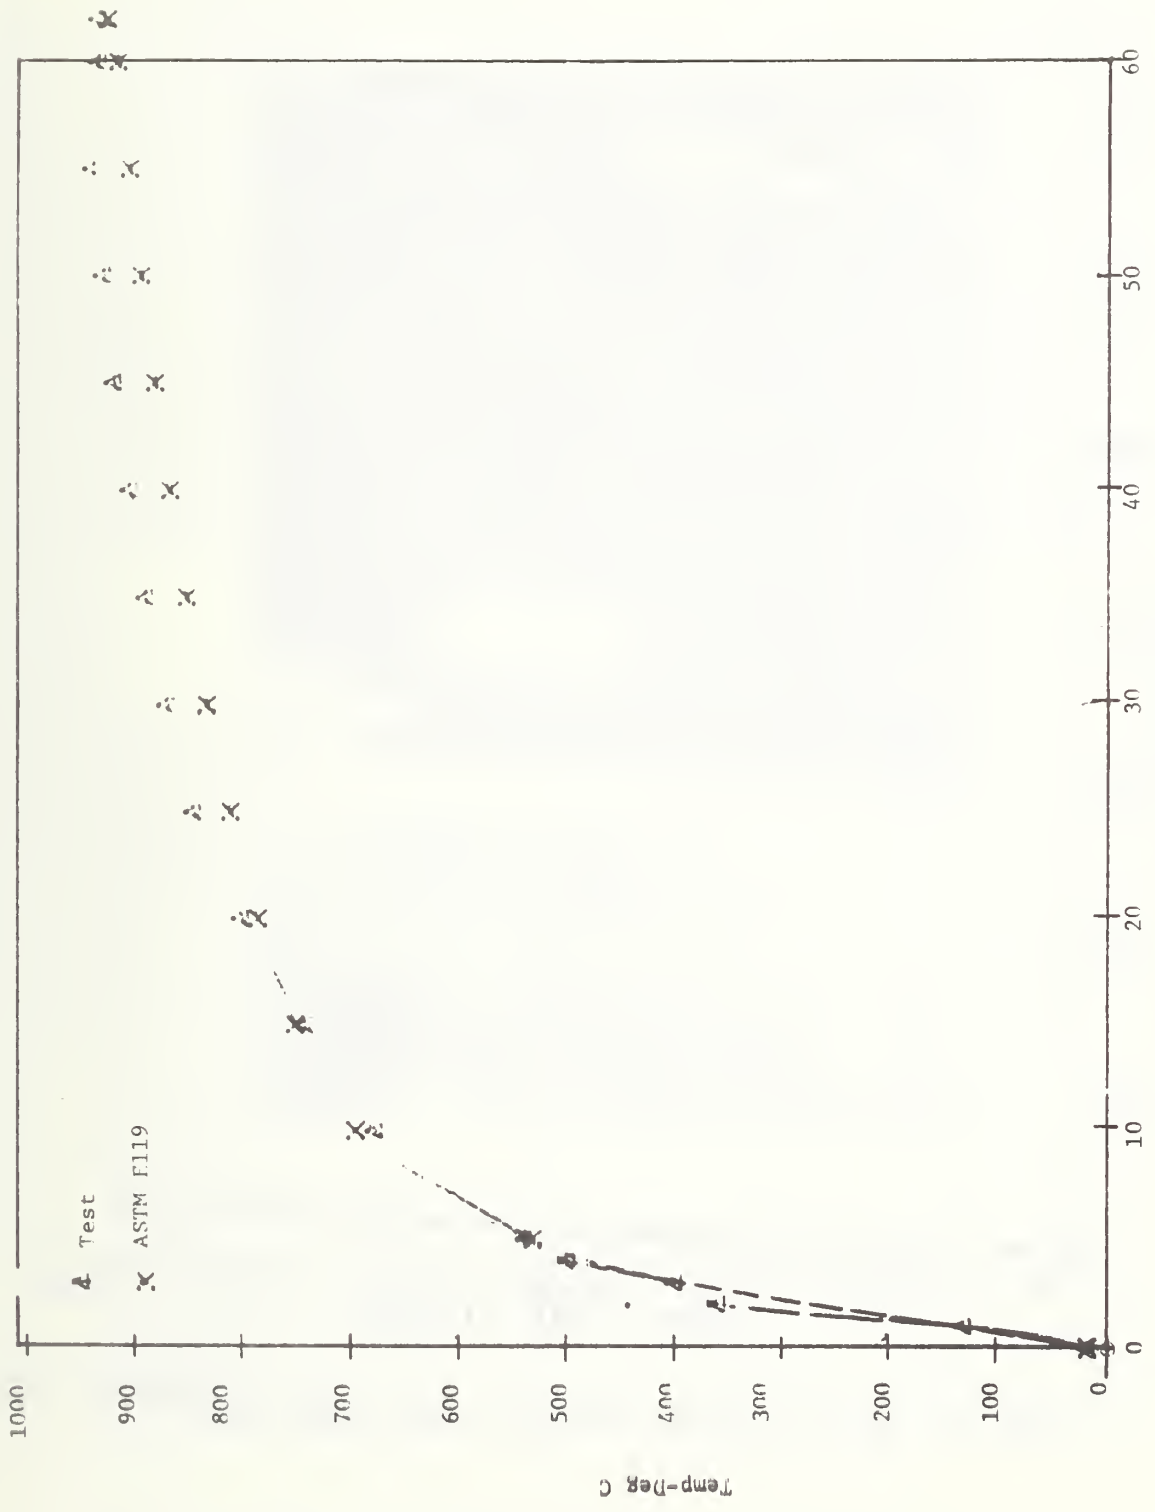
The average furnace temperature which was constrained to follow the standard ASTM E-119 [2] time-temperature curve is shown in figure 39. The correction to the fire endurance based on the method given in ASTM E-119 was + 0.9 minutes.

Figure 39. Test FL 2 - Furnace temperatures

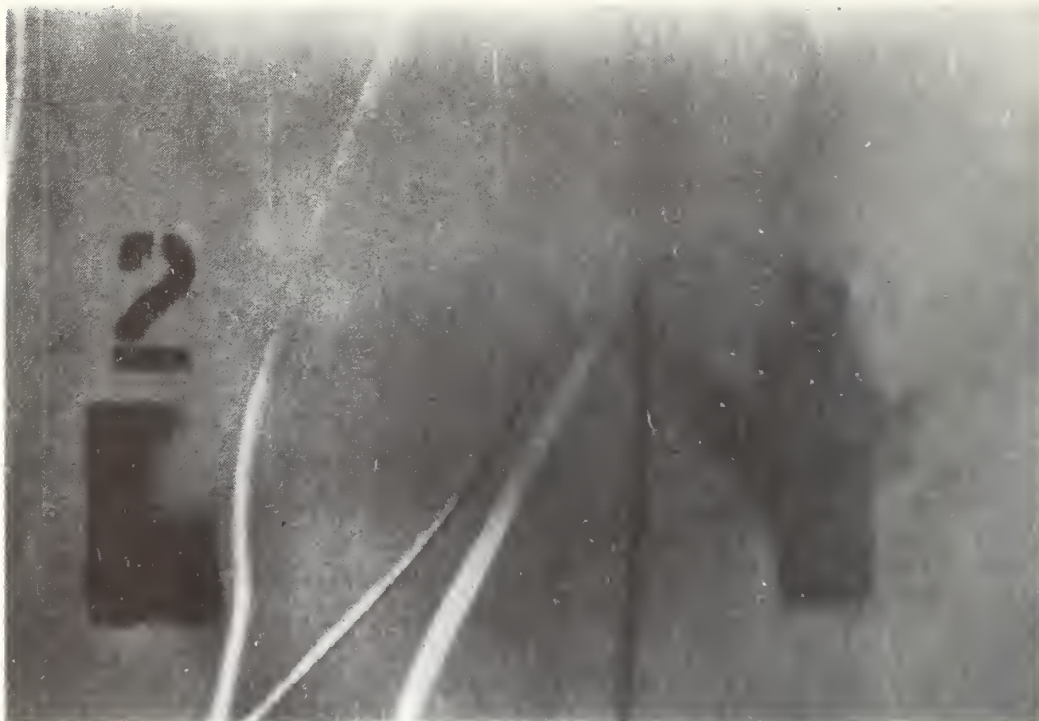
Figure 42. Test FE 1 - Smoke coming out of AC (2) insulated and NM uninsulated (3) switches

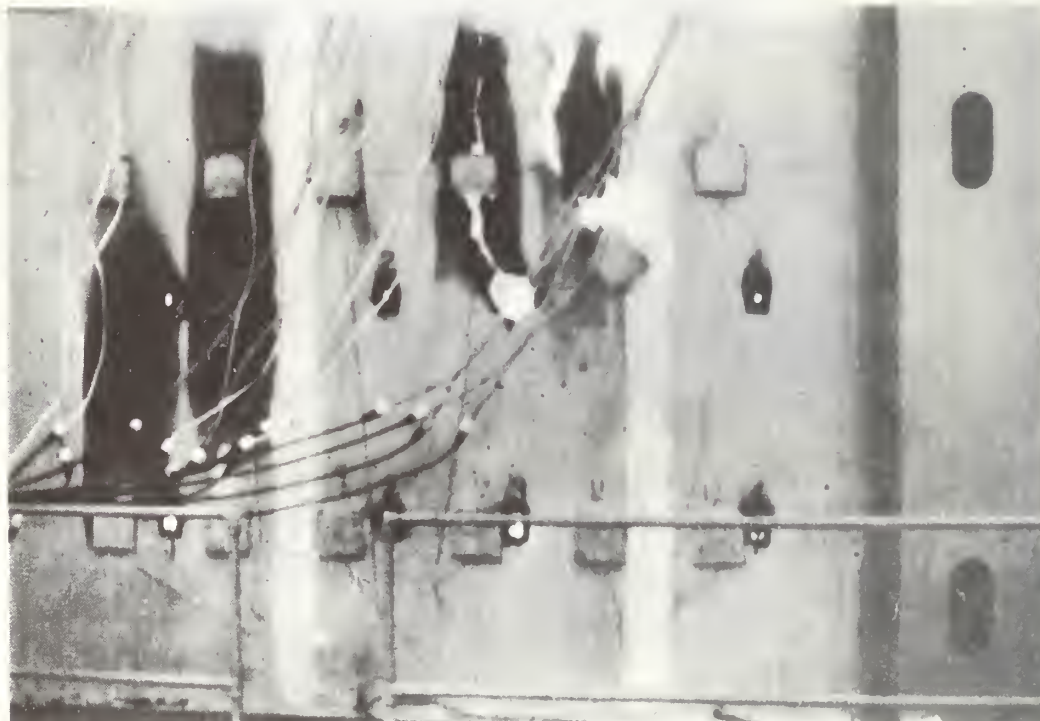
Figure 43. Test FE 1 - Front of furnace at end of test

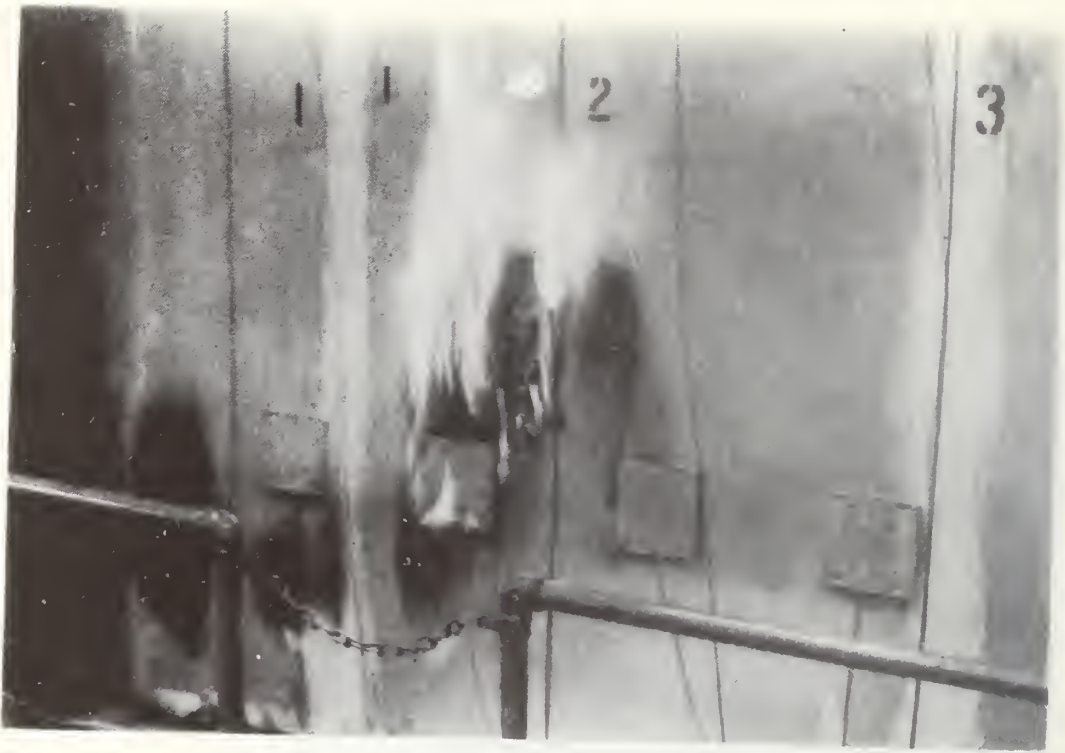
00:59 Burn-through at a point about 1-1/2 feet above the bottom and 6 inches from the left edge (west).

Burn-through at the middle of the wall just after the test was ended, see figure 45.

Figure 45. Test FE 2 - Burn-through at end of test
