NBSIR 78-1470

Examination of Failed Four Inch Diameter Cast Iron Pipe Natural Gas Main, Hamden, Connecticut

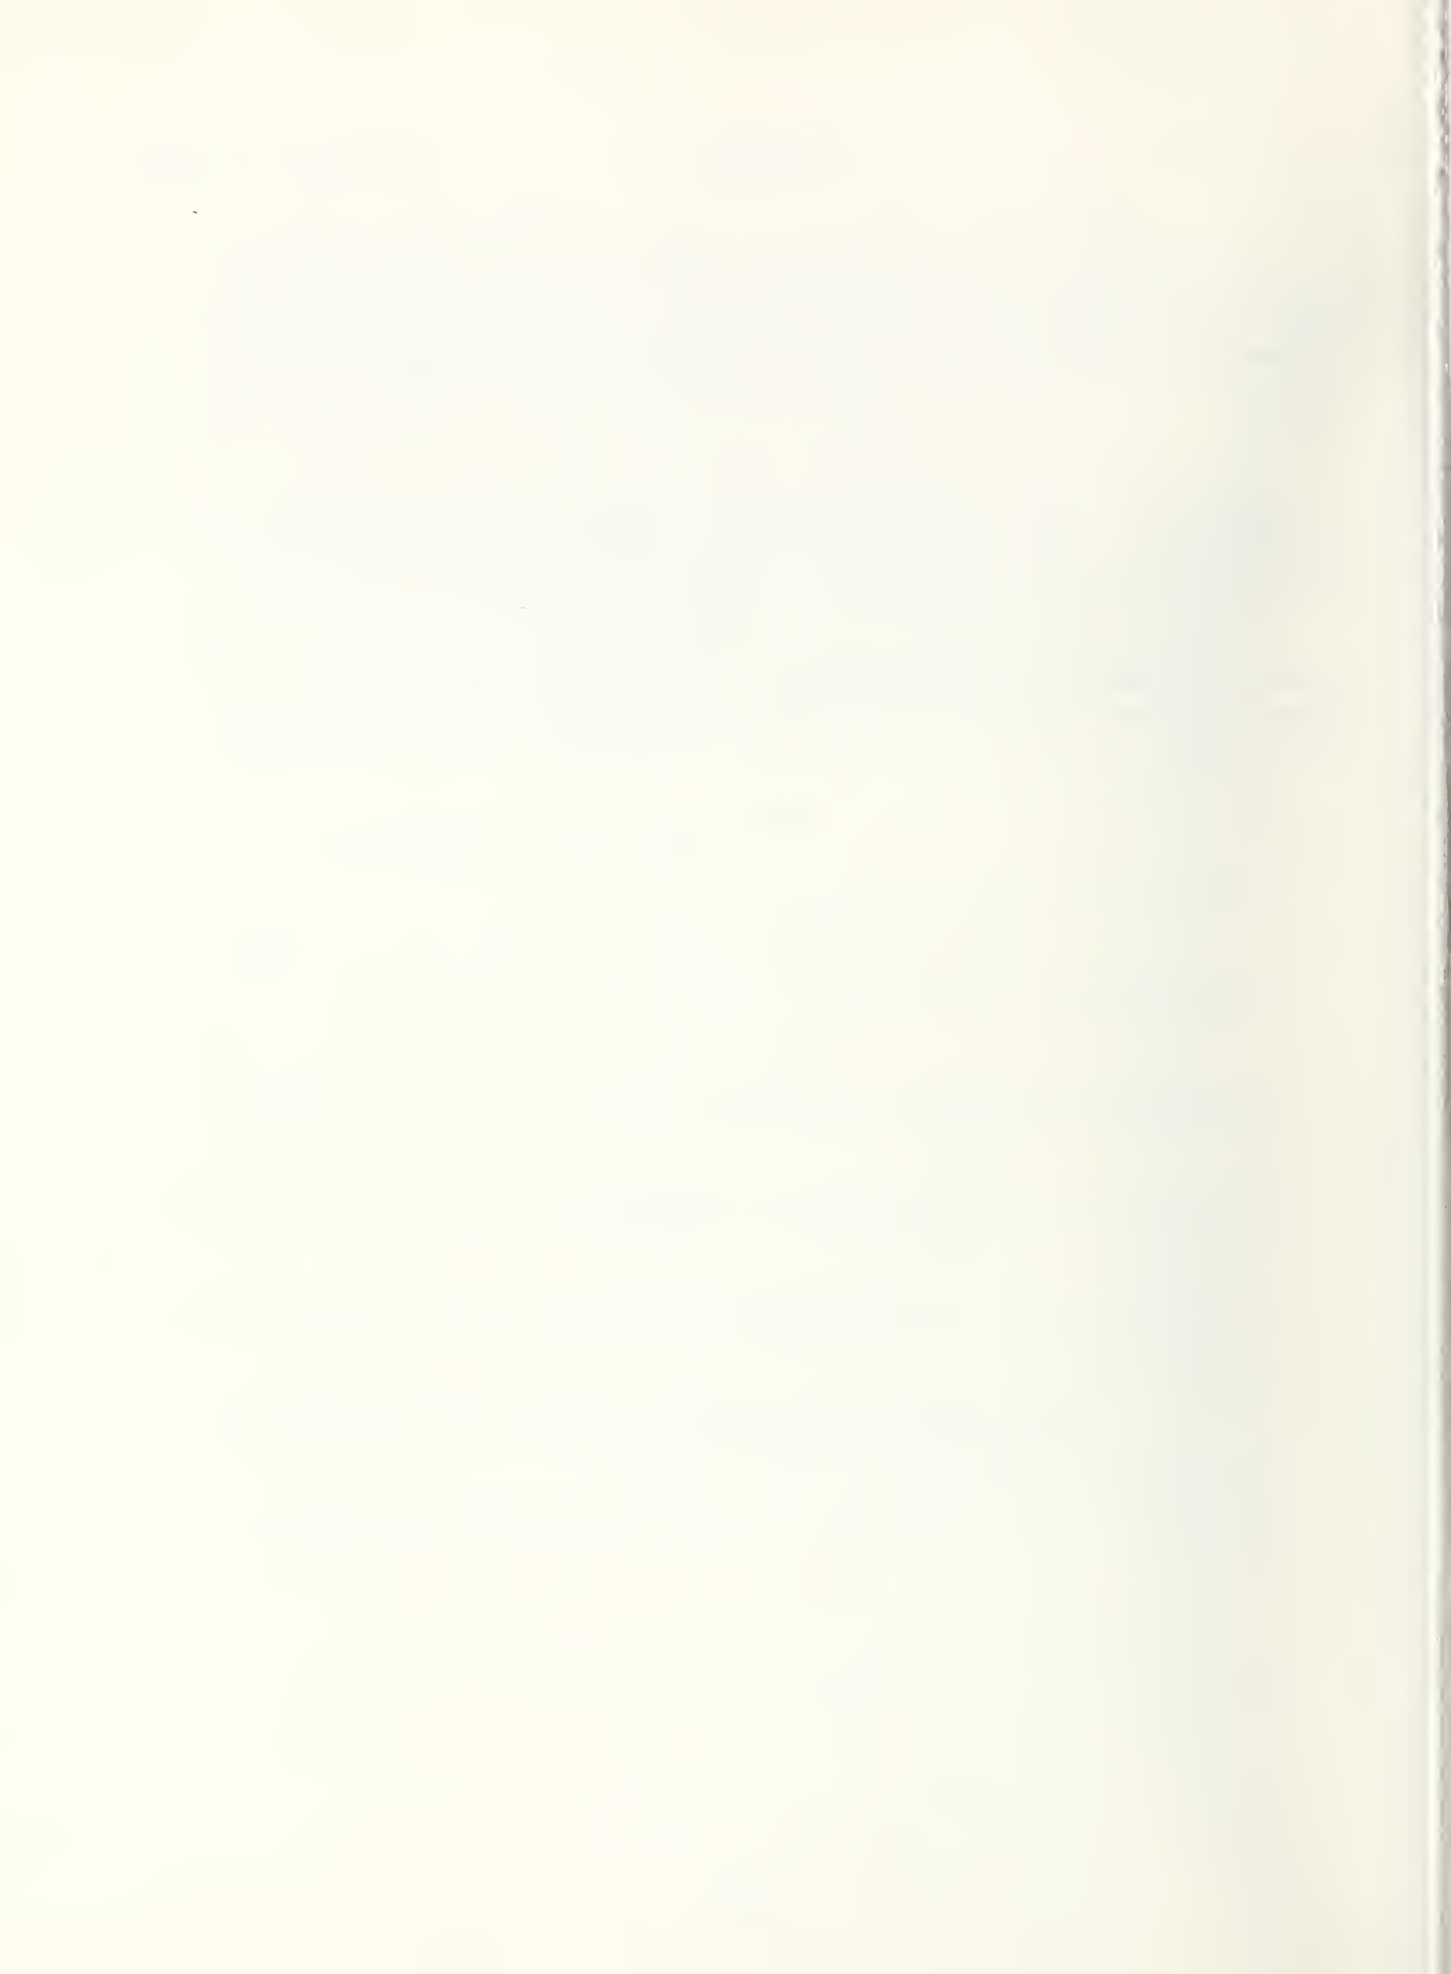
Examination of Failed Four Inch Diameter Cast Iron Pipe Natural Gas Main,
Hamden, Connecticut

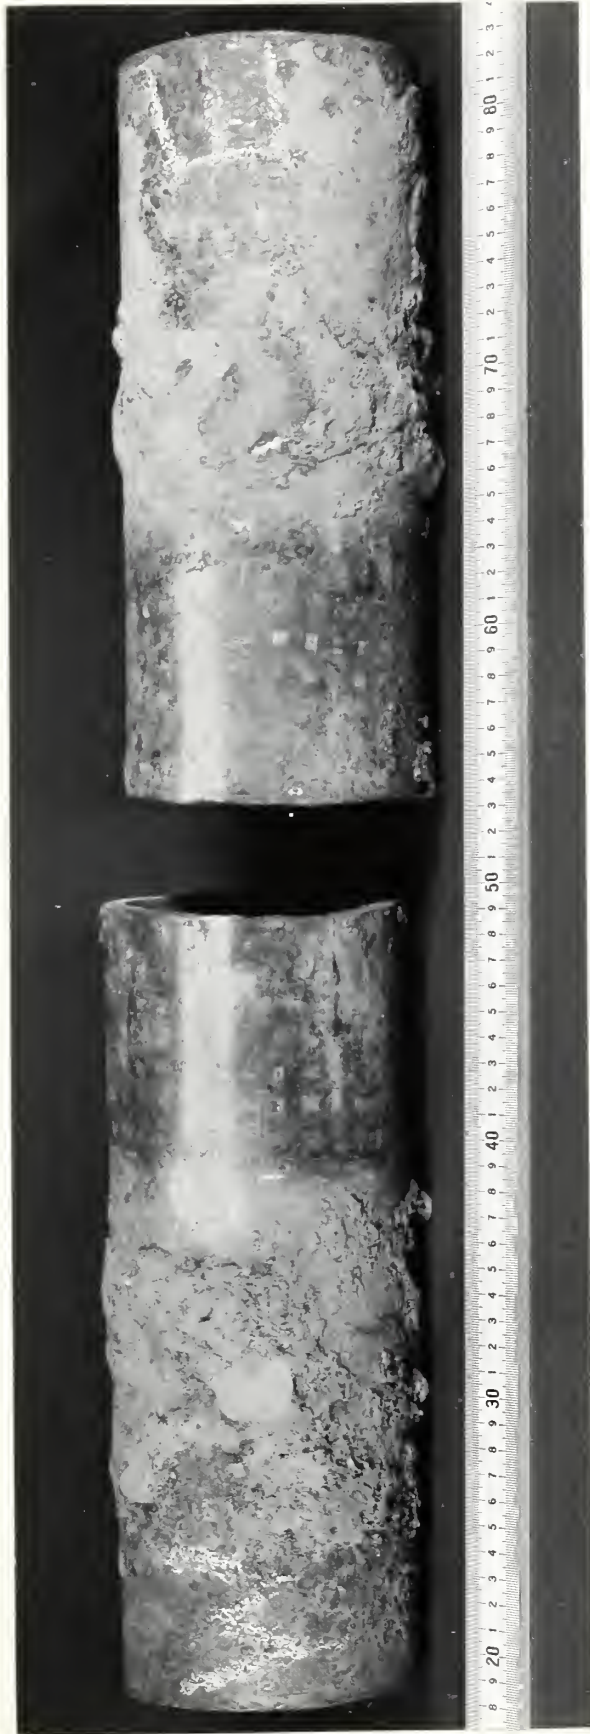
Figure 1. The two pieces of four inch cast iron pipe as received at NBS. The letters W and E are at what was reported to be the top of the pipe. The mating fracture surfaces are at the center. X 1/3

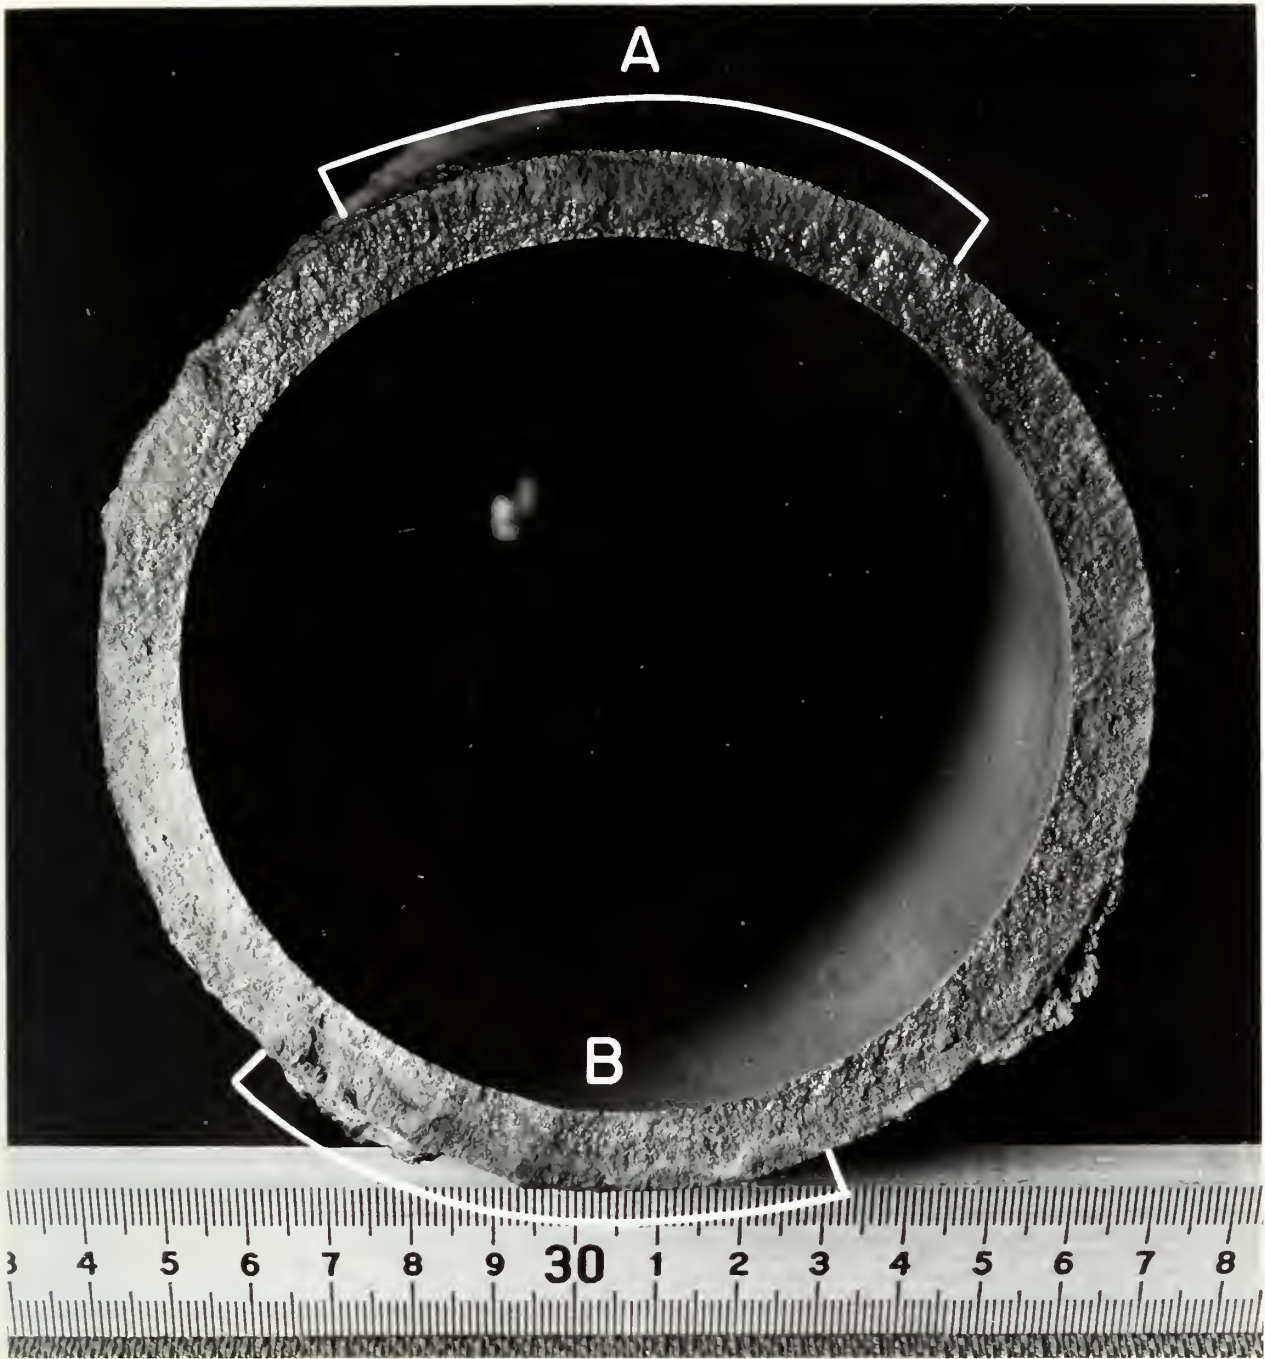
Figure 2. Fracture surface of the piece of pipe designated E as received at NBS before cleaning. Regions designated A and B are of special interest and are discussed in the text of the report. The top of the pipe as it lay in the ground is at the top in the figure. X 1

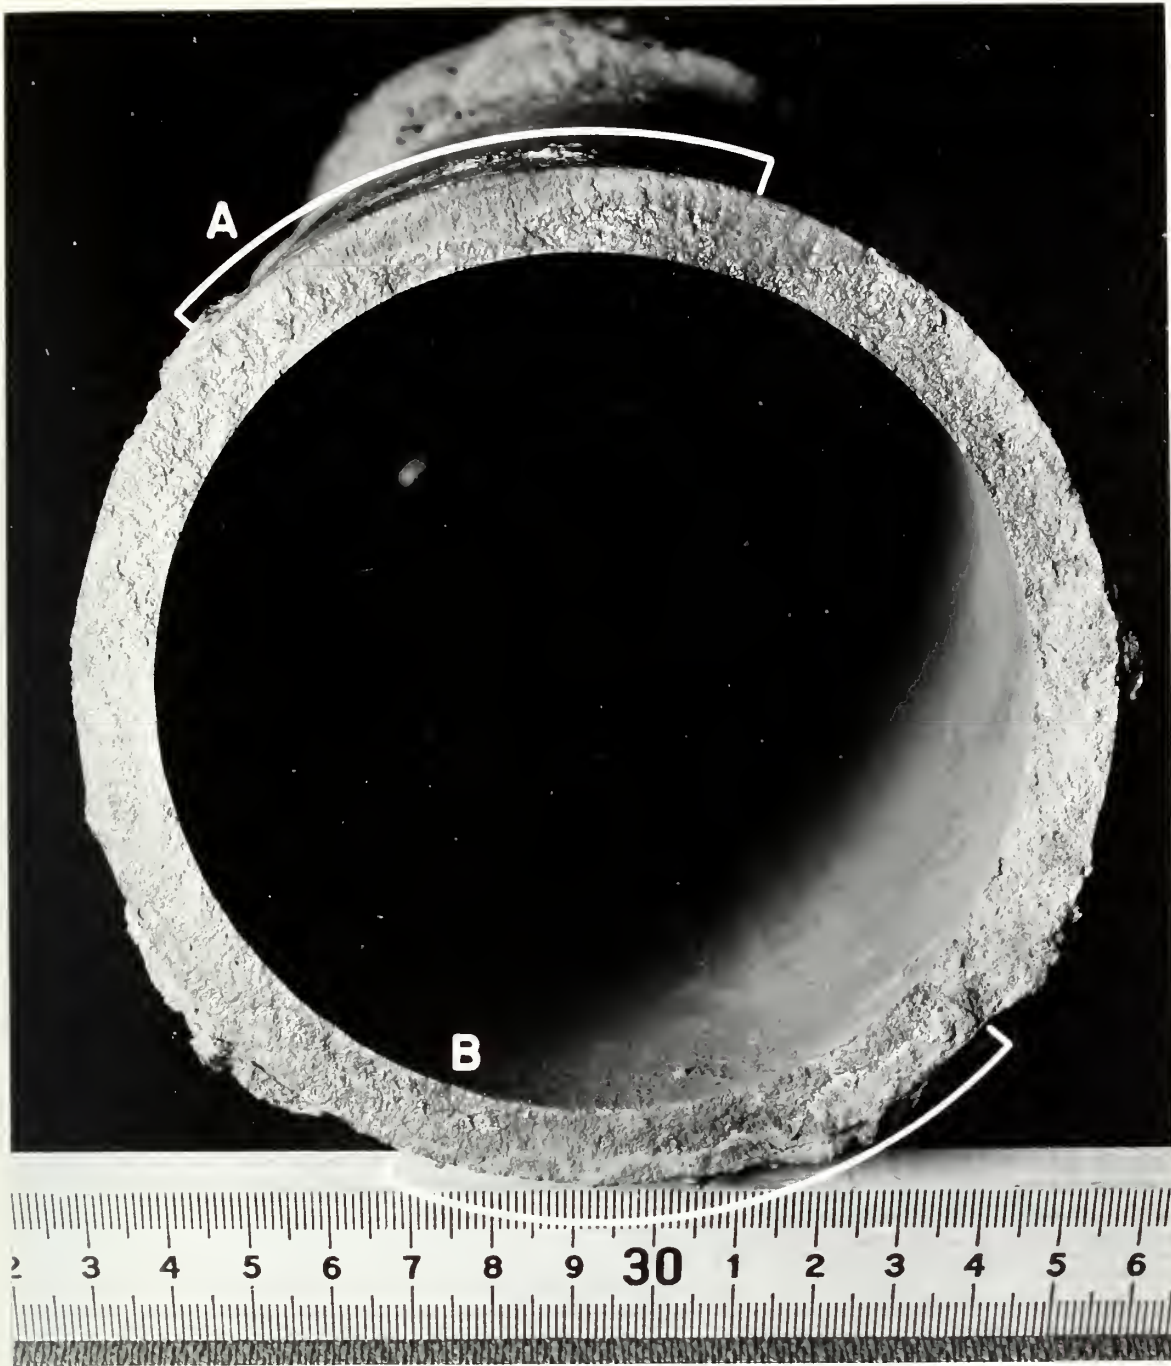
Figure 3. Fracture surface of the piece of pipe designated W as received at NBS. Regions designated A and B are in the mating locations to the similarly designated regions in figure 2. The top of the pipe as it lay in the ground is at the top in the figure. X 1

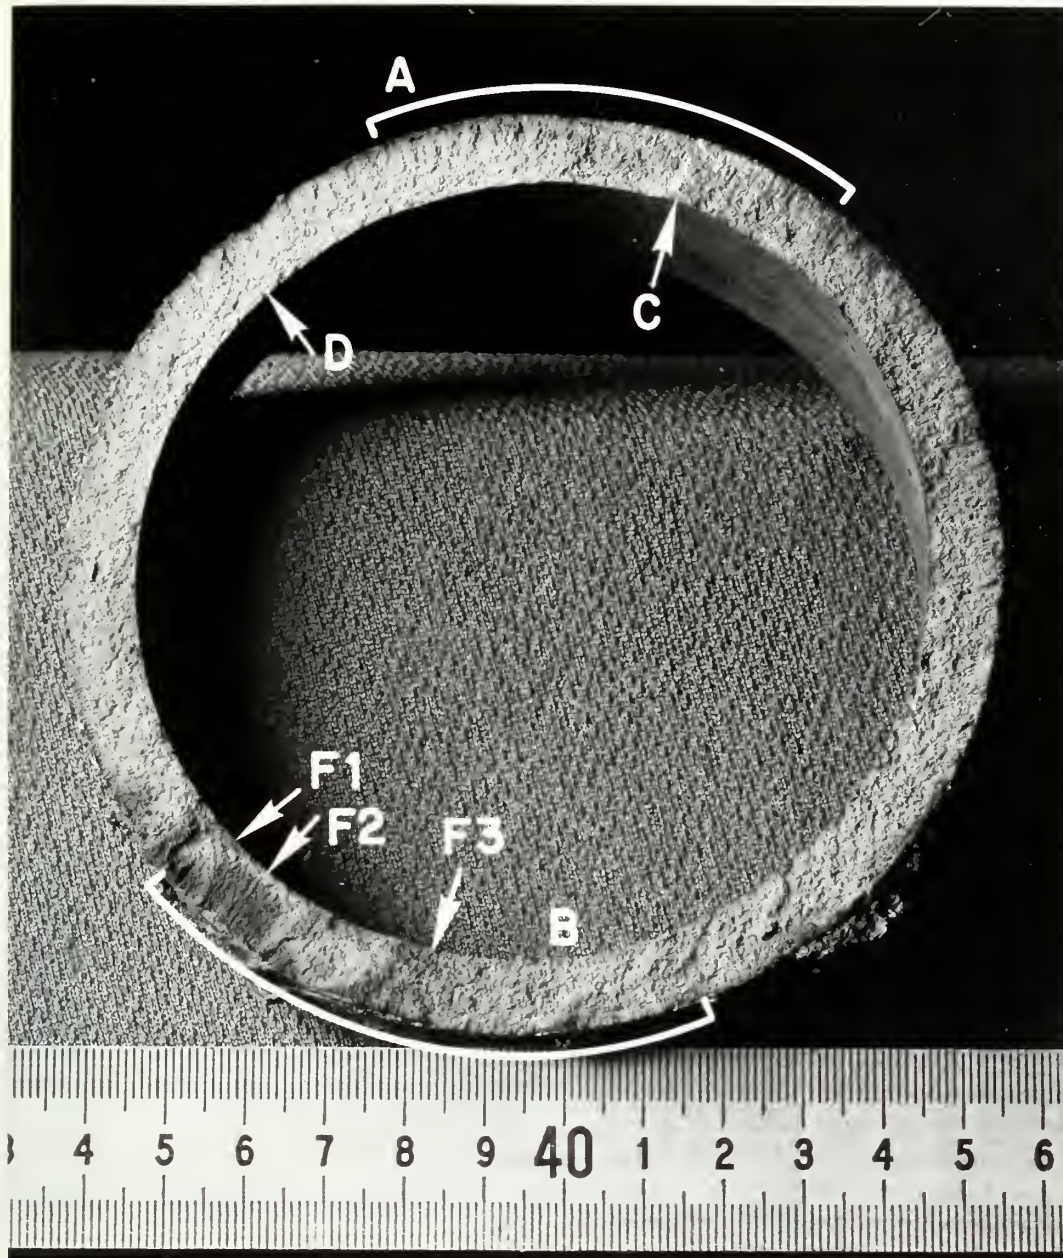
Figure 4. Fracture surface of the piece of pipe designated E after ultrasonic cleaning. The region labeled A has suffered apparent mechanical damage. The region labeled B exhibits graphitization. Arrows C, D, F1, F2, and F3 indicate the locations where sections were taken for metallographic examination.

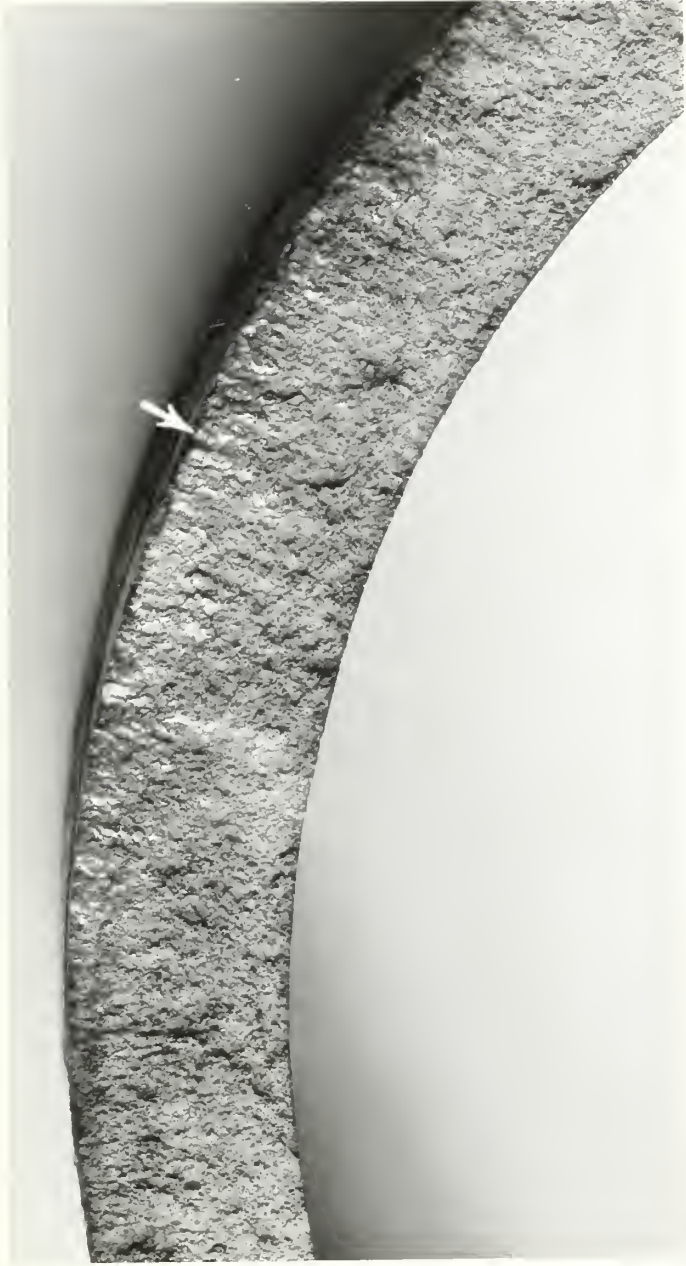
Figure 5. The region designated A in figures 2, 3, and 4 at a higher magnification. This photograph was taken after the fracture had been cleaned. The shiny areas indicate apparent mechanical damage. The arrow indicates the apparent shear lip. X 3

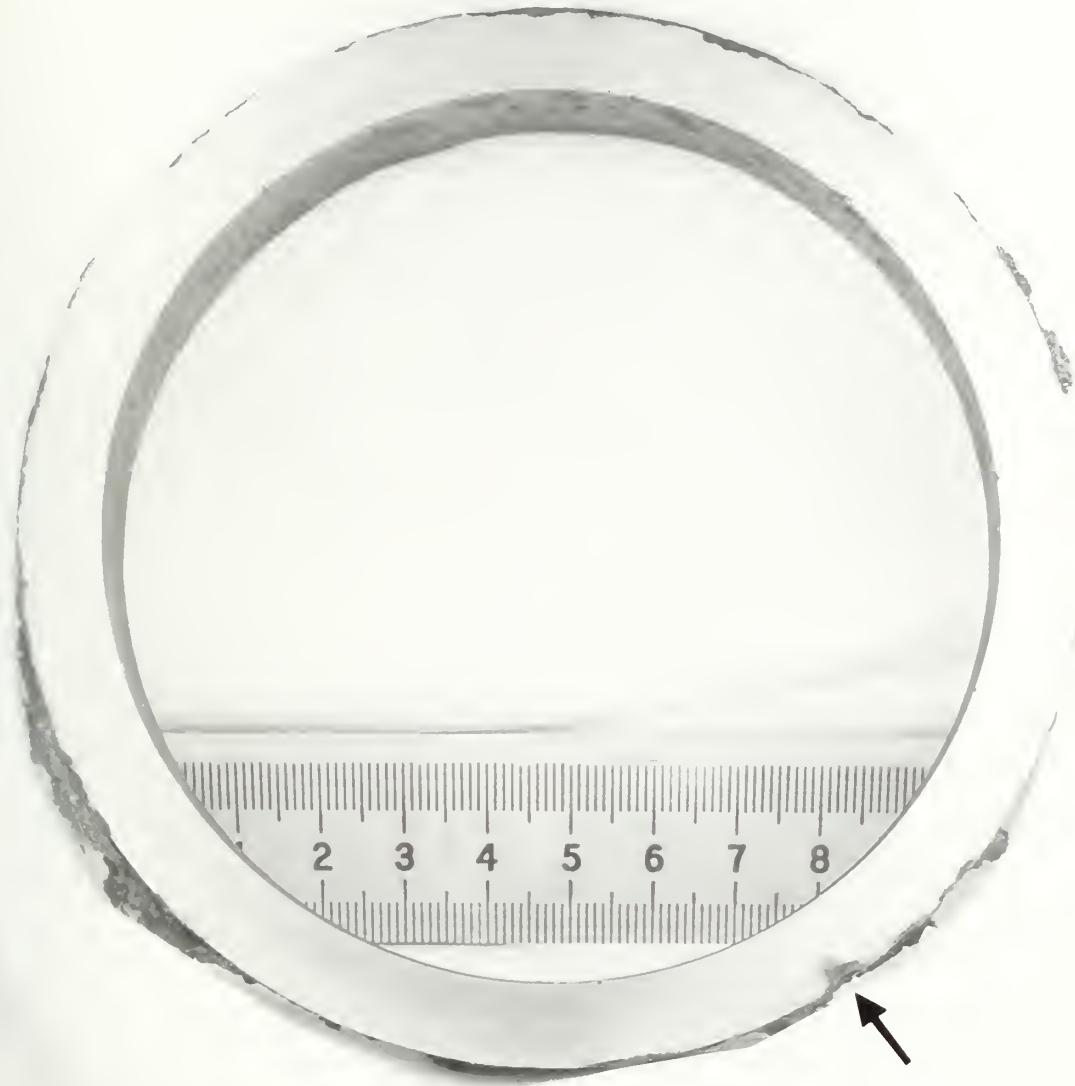
Figure 6. Polished transverse section through the piece of pipe designated E about 2 cm from the fracture. One region of significant graphitization is indicated by the arrow. Minor graphitization is evident in other regions of the section.

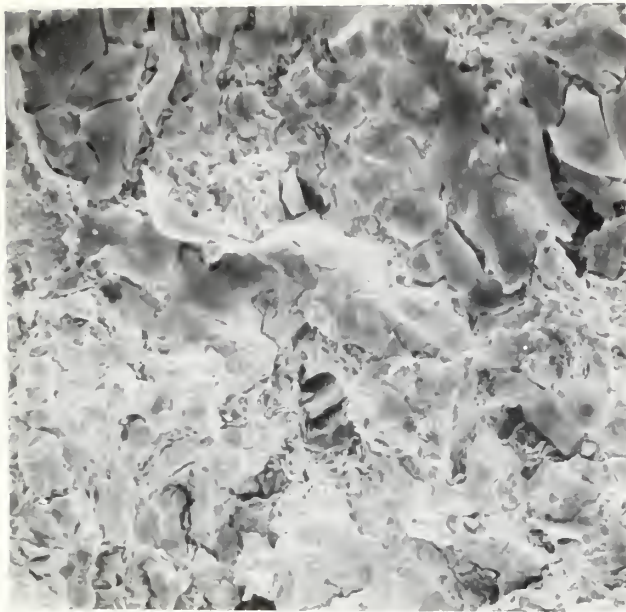
Figure 7. SEM fractograph in the vicinity of C, figure 4. A considerable amount of apparent corrosion product is evident. The predominant mode of fracture is cleavage. X 525

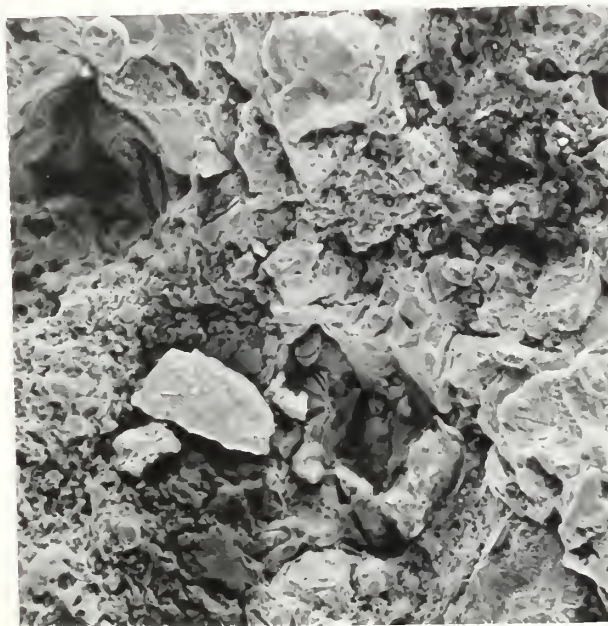
Figure 8. SEM fractograph in the vicinity of D, figure 4, exhibiting cleavage as the predominant mode of fracture. X 525

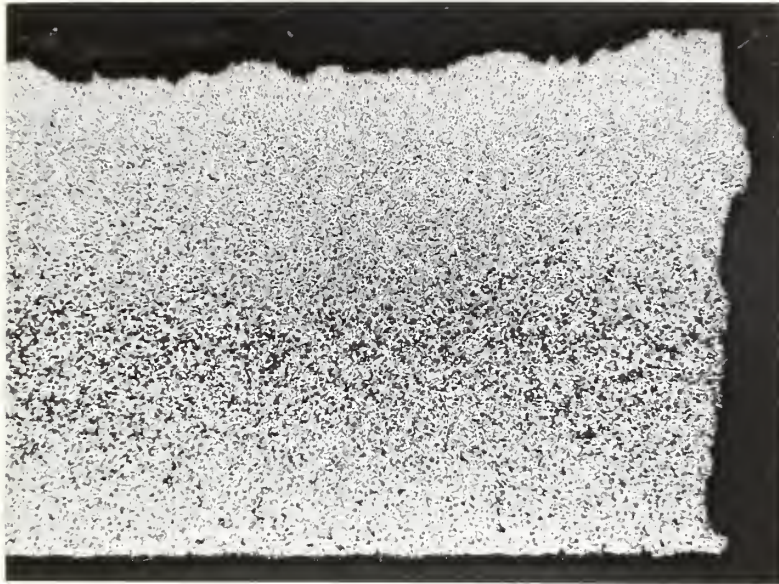
Figure 9. Longitudinal section C near the top of the pipe. The outside of the pipe is horizontal at the top, the inside is horizontal at the bottom. The fracture profile is vertical at the right. A small amount of graphitization is evident at the outside surface.

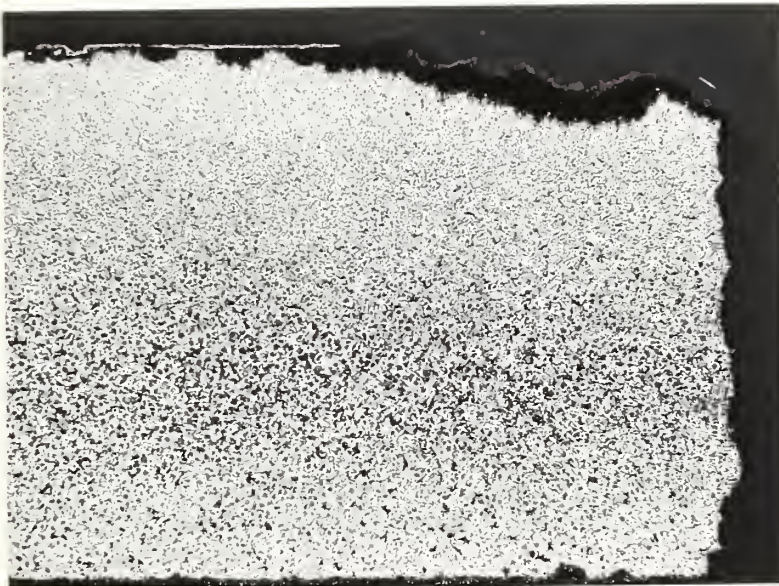
Figure 10. Longitudinal section D in about the 10:30 o'clock position when facing the fracture designated E. The outside of the pipe is horizontal at the top, the inside is horizontal at the bottom. The fracture profile is vertical at the right. Somewhat more graphitization is evident in this section than in the one shown in figure 7.

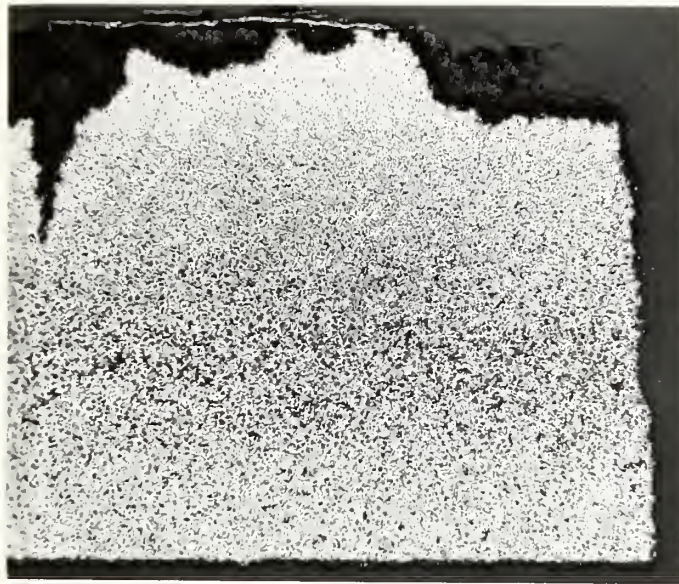
Figure 11. Longitudinal section F2 at about the 7:30 o'clock position when facing the fracture designated E. The outside of the pipe is horizontal at the top, the inside is horizontal at the bottom. The fracture profile is vertical at the right. A considerable amount of graphitization is evident.
As polished

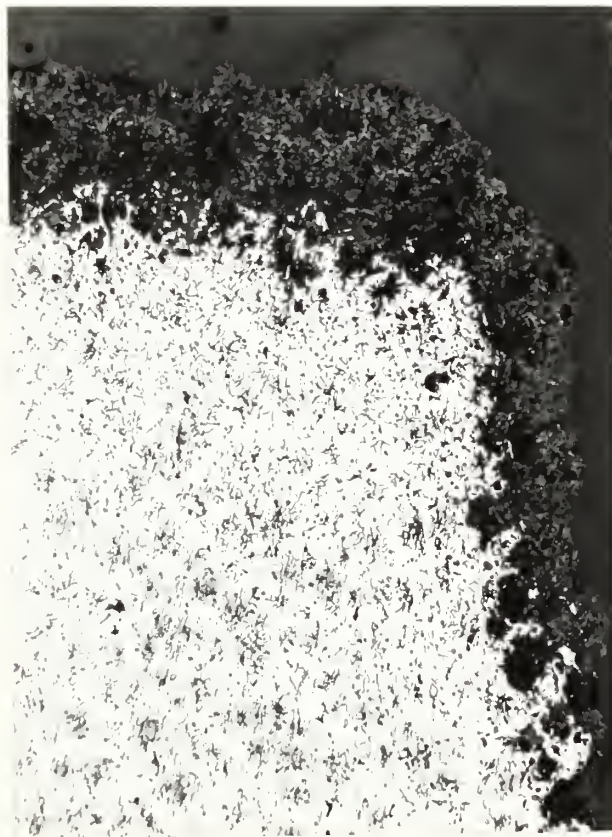
Figure 12. Longitudinal section F2 showing graphitization at the outside of the pipe (horizontal at the top) and along the fracture (vertical at the right).
As polished

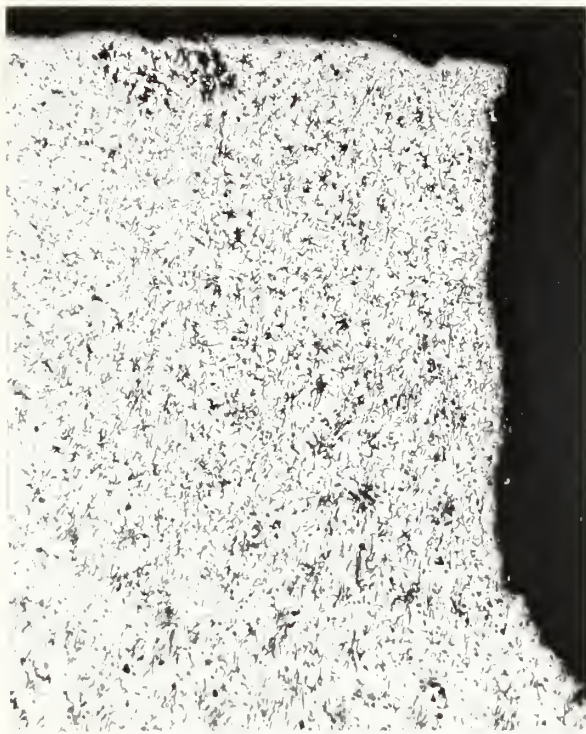
Figure 13. Longitudinal section C showing the profile (vertical at the right) of the unusually flat region of the fracture near the outside of the pipe (horizontal at the top).
As polished X 50

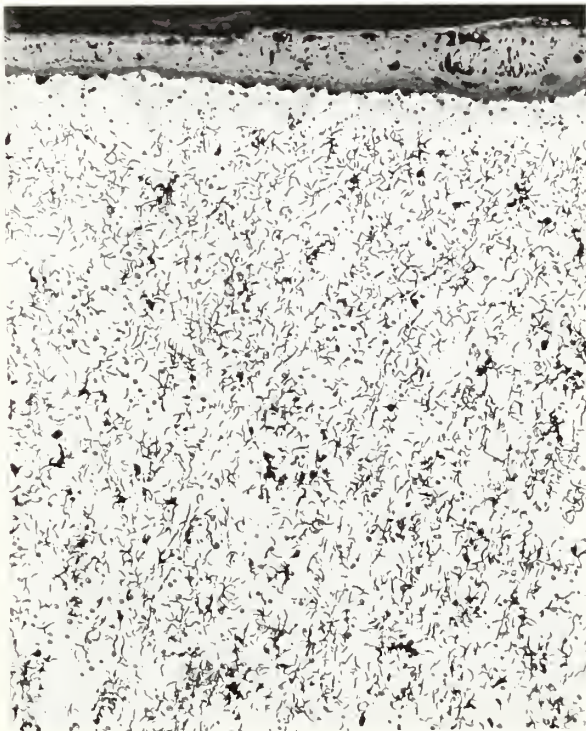
Figure 14. Longitudinal section D showing the representative unetched microstructure near the outside of the pipe. The graphite flakes are mostly type A.
As polished X 100

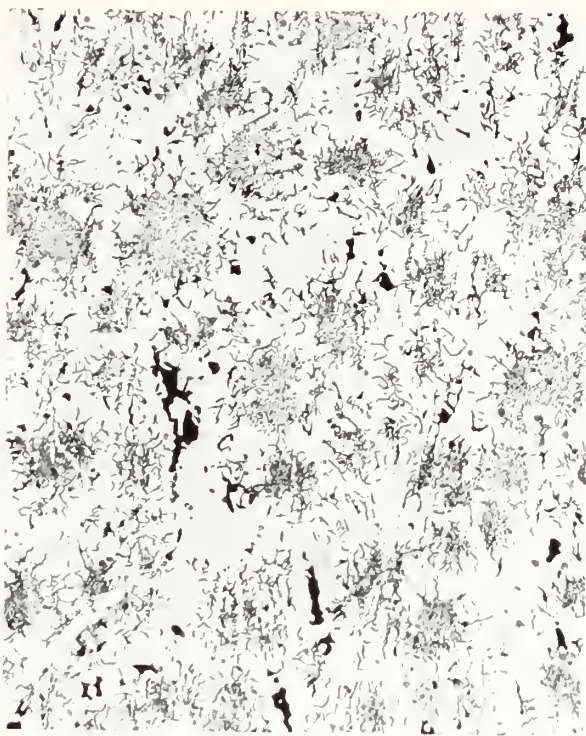
Figure 15. Longitudinal section D showing the representative unetched microstructure at the center of the pipe wall thickness. The graphite flakes are mostly type B with some type E. As polished X 100

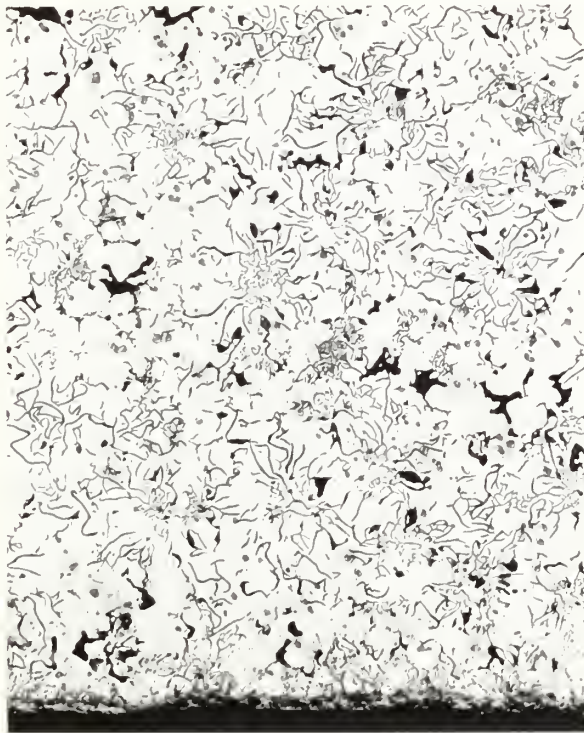
Figure 16. Longitudinal section D showing the representative unetched microstructure adjacent to the inside of the pipe. The graphite flakes are a mixture of types A and B. As polished X 100

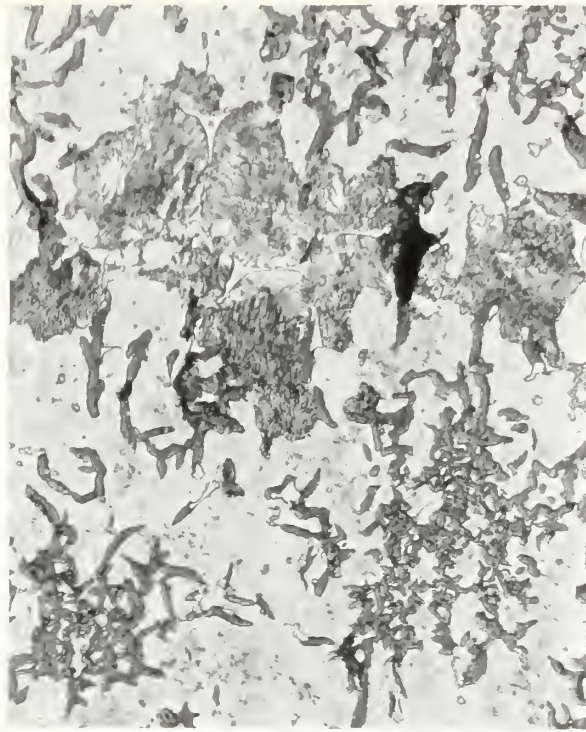
Figure 17. Longitudinal section D showing the representative etched microstructure near the center of the pipe wall. The microstructure consists primarily of graphite flakes, pearlite (fingerprint pattern), and ferrite (light colored phase).
Etchant: 1% nital X 500

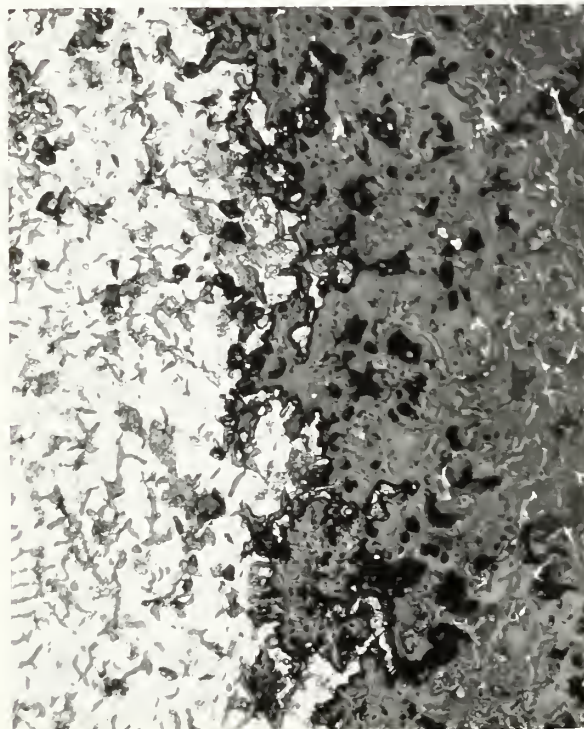
Figure 18. Longitudinal section F2 showing the etched microstructure adjacent to the fracture and the graphitization at the fracture.
Etchant: 1% nital X 200

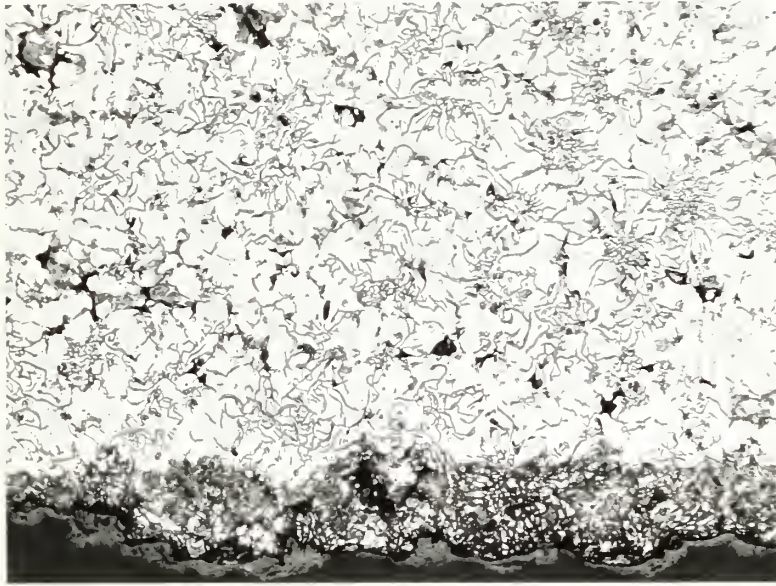
Figure 19. Longitudinal section F2 showing etched microstructure adjacent to the inside of the pipe (horizontal at the bottom). The layer of high pearlite concentration adjacent to the inside of the pipe is evident. Etchant: 1% nital X 100

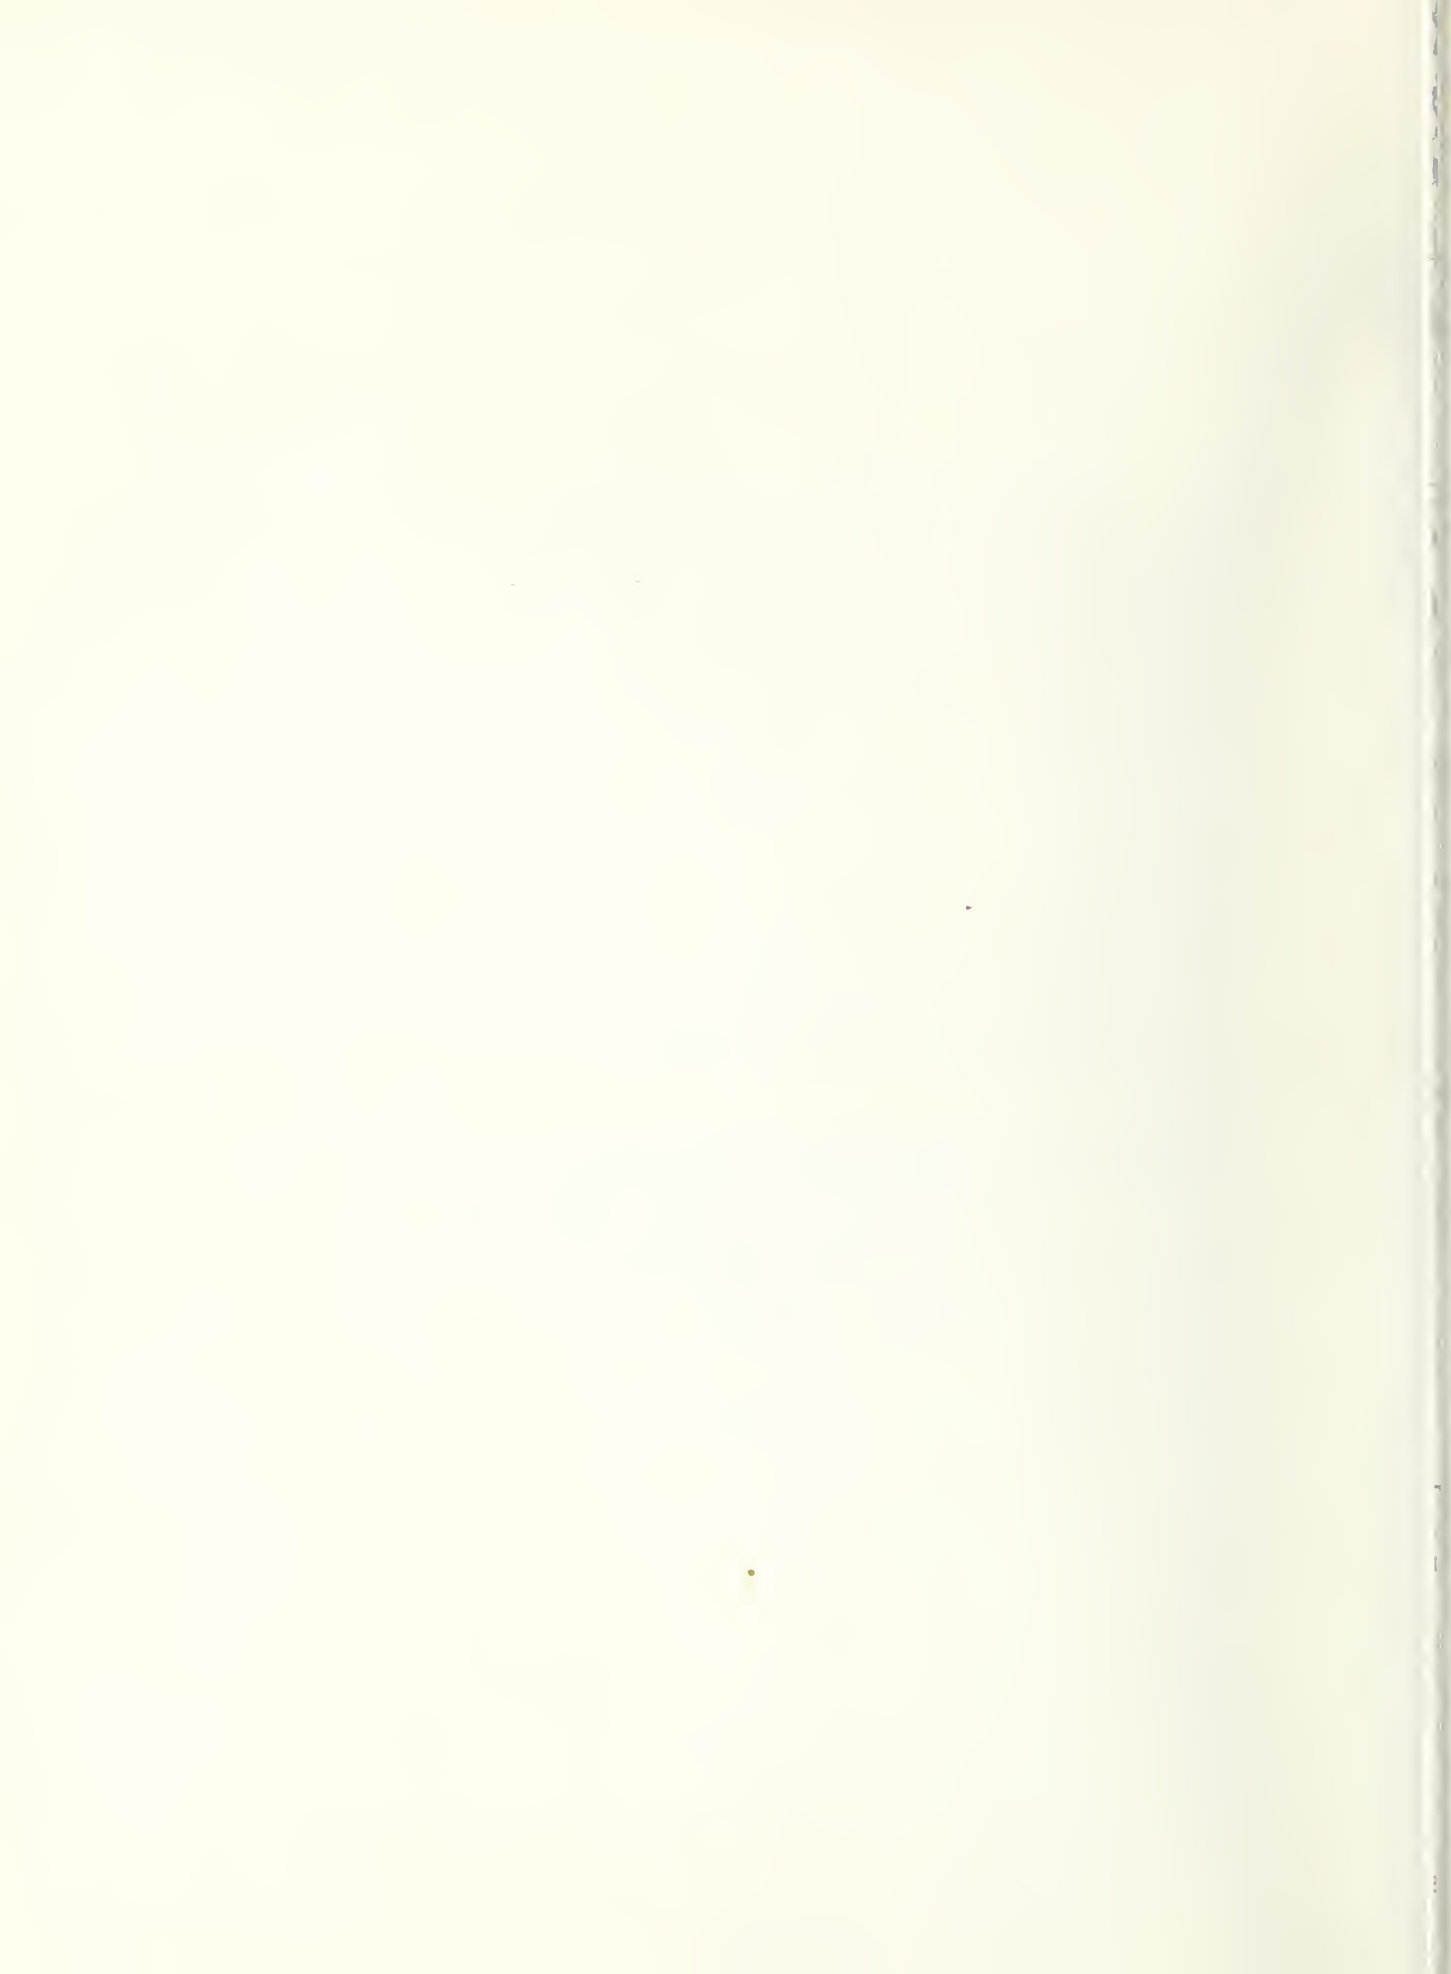
U.S. DEPT. OF COMM. BIBLIOGRAPHIC DATA SHEET	1. PUBLICATION OR REPORT NO. NBSIR 78-1470	2. Gov't Accession No.	3. Recipient's Accession No.
TITLE AND SUBTITLE EXAMINATION OF FAILED FOUR INCH DIAMETER CAST IRON PIPE NATURAL GAS MAIN, HAMDEN, CONNECTICUT		5. Publication Date April 1978	6. Performing Organization Code
AUTHOR(S) T. Robert Shives		8. Performing Organ. Report No. NBSIR 78-1470	
PERFORMING ORGANIZATION NAME AND ADDRESS NATIONAL BUREAU OF STANDARDS DEPARTMENT OF COMMERCE WASHINGTON, D.C. 20234		10. Project/Task/Work Unit No. 5620412	11. Contract/Grant No.
Sponsoring Organization Name and Complete Address (Street, City, State, ZIP) National Transportation Safety Board Washington, D.C. 20594		13. Type of Report & Period Covered Failure Analysis	14. Sponsoring Agency Code
