NBSIR 78-1470

Examination of Failed Four Inch Diameter Cast Iron Pipe Natural Gas Main, Hamden, Connecticut

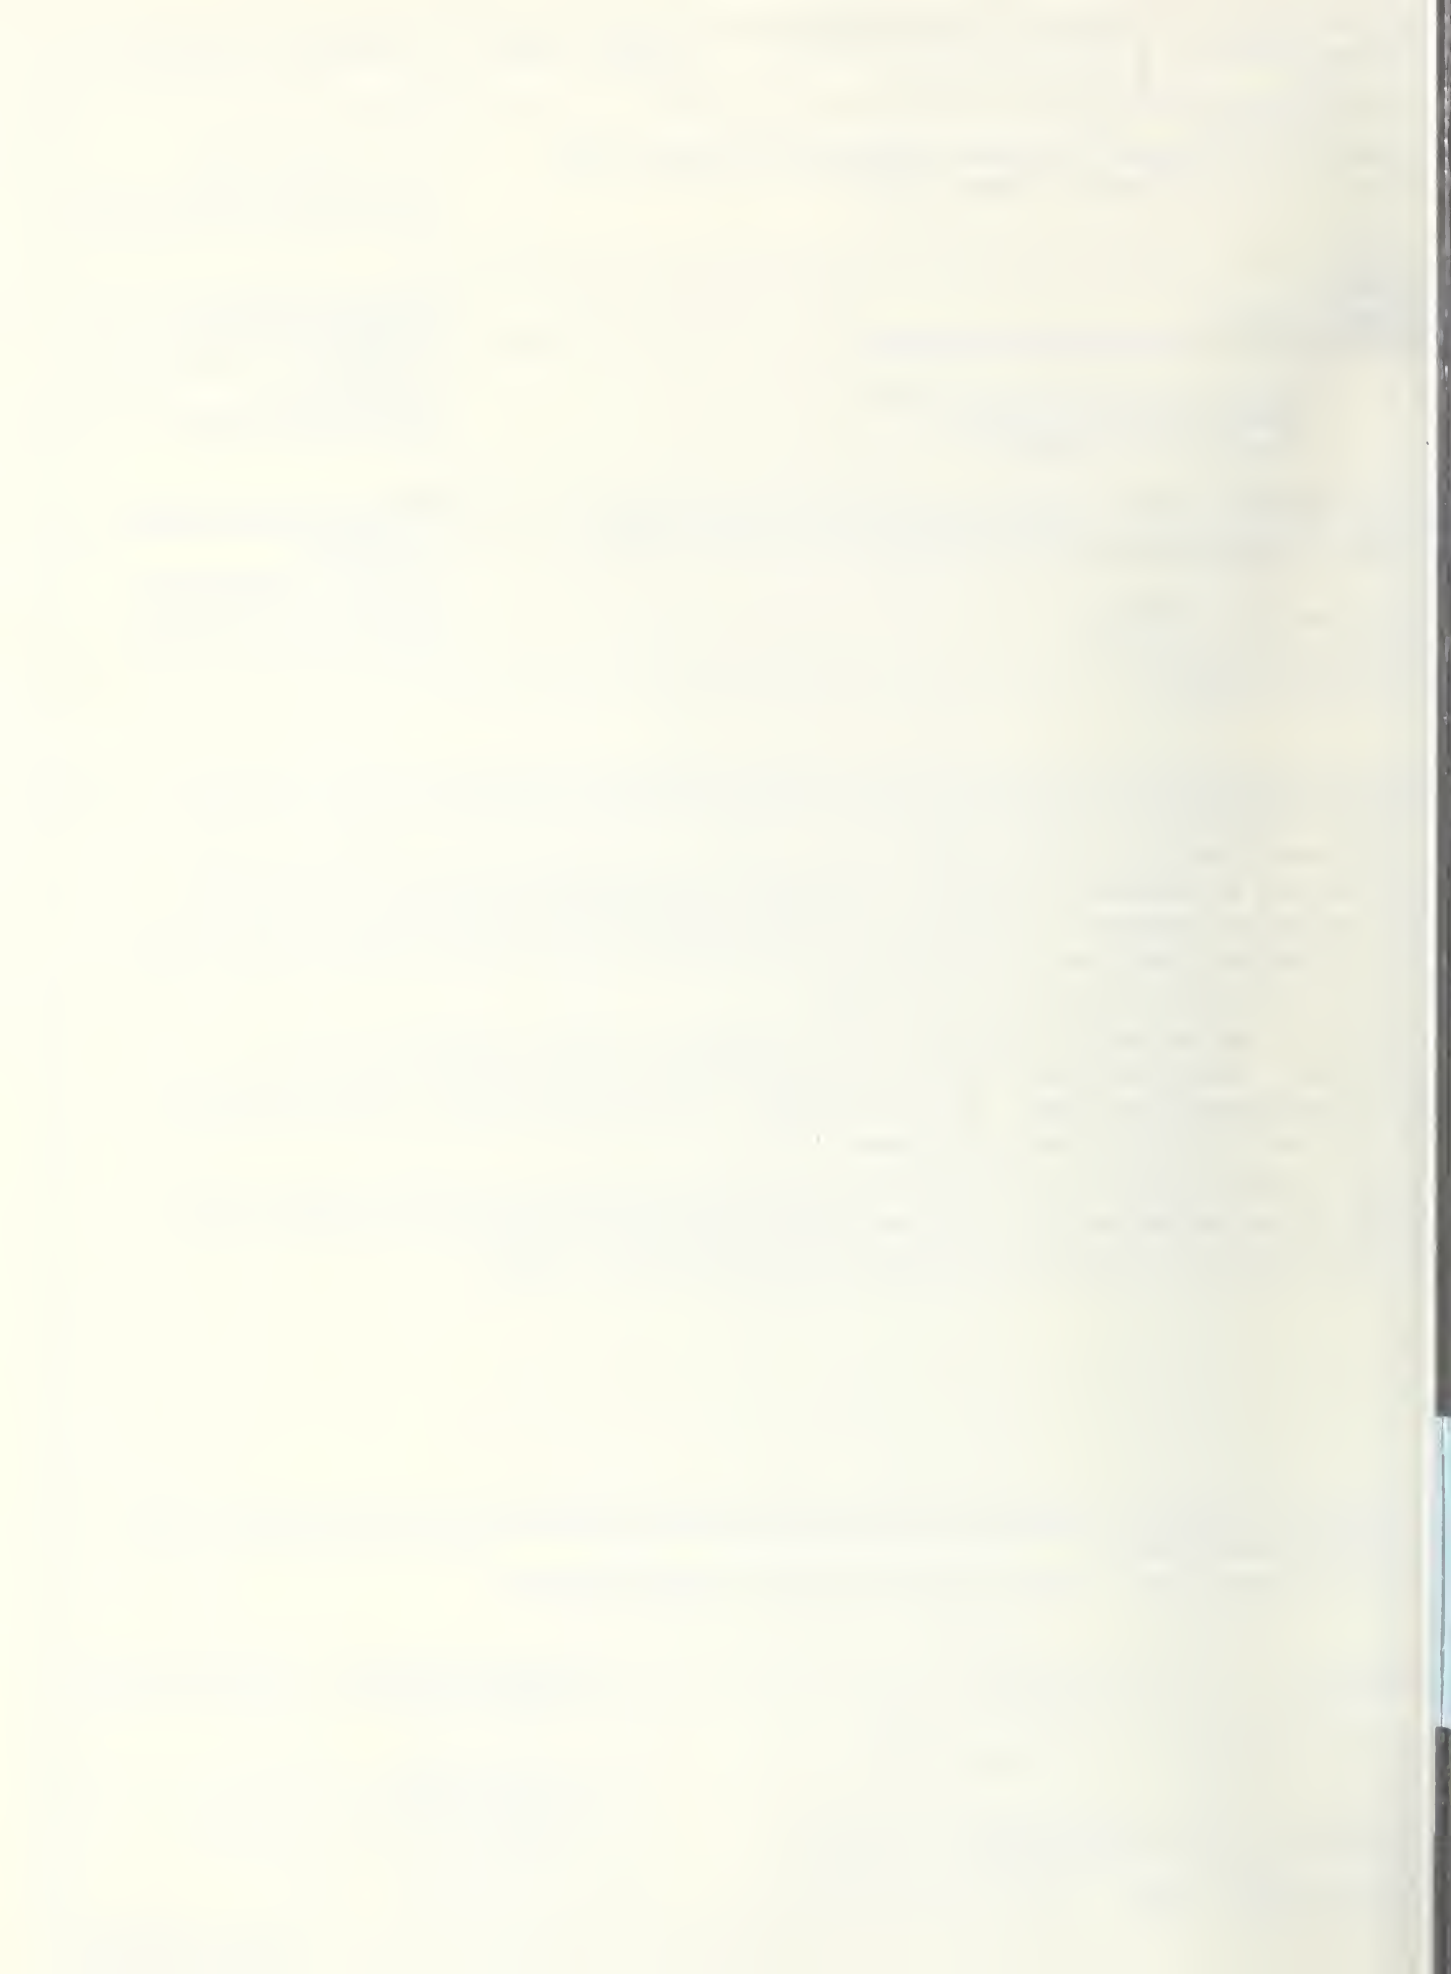
AVAILABILITY <input type="checkbox"/> Unlimited	19. SECURITY CLASS (THIS REPORT) UNCLASSIFIED	21. NO. OF PAGES
<input checked="" type="checkbox"/> For Official Distribution. Do Not Release to NTIS	20. SECURITY CLASS (THIS PAGE) UNCLASSIFIED	22. Price
<input type="checkbox"/> Order From Sup. of Doc., U.S. Government Printing Office Washington, D.C. 20402, SD Cat. No. C13		
<input type="checkbox"/> Order From National Technical Information Service (NTIS) Springfield, Virginia 22151
