A11104 498572

NBSIR 78-1572

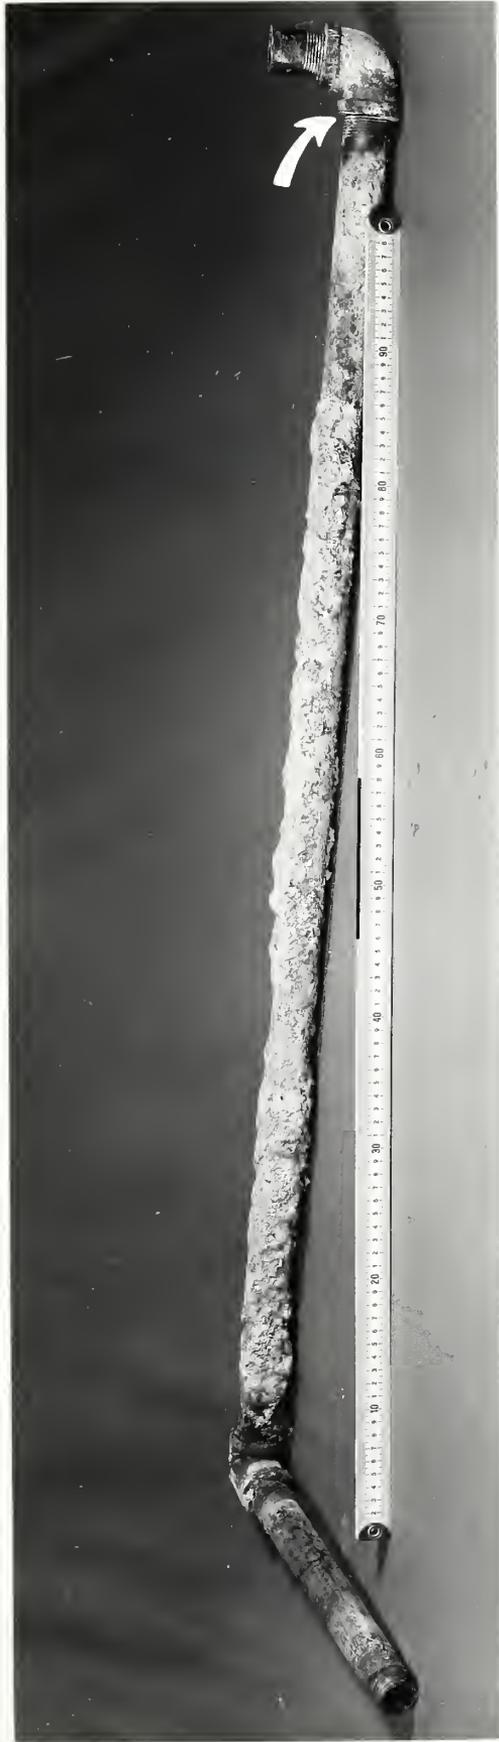
Figure 1. Pipe sample as received at NBS. Arrow indicates location of crack. Long length of pipe was vertical in service. End of pipe with crack was at the bottom as the pipe was oriented in service. Accumulation of soil and corrosion product can be seen on long length of pipe. X 1/6

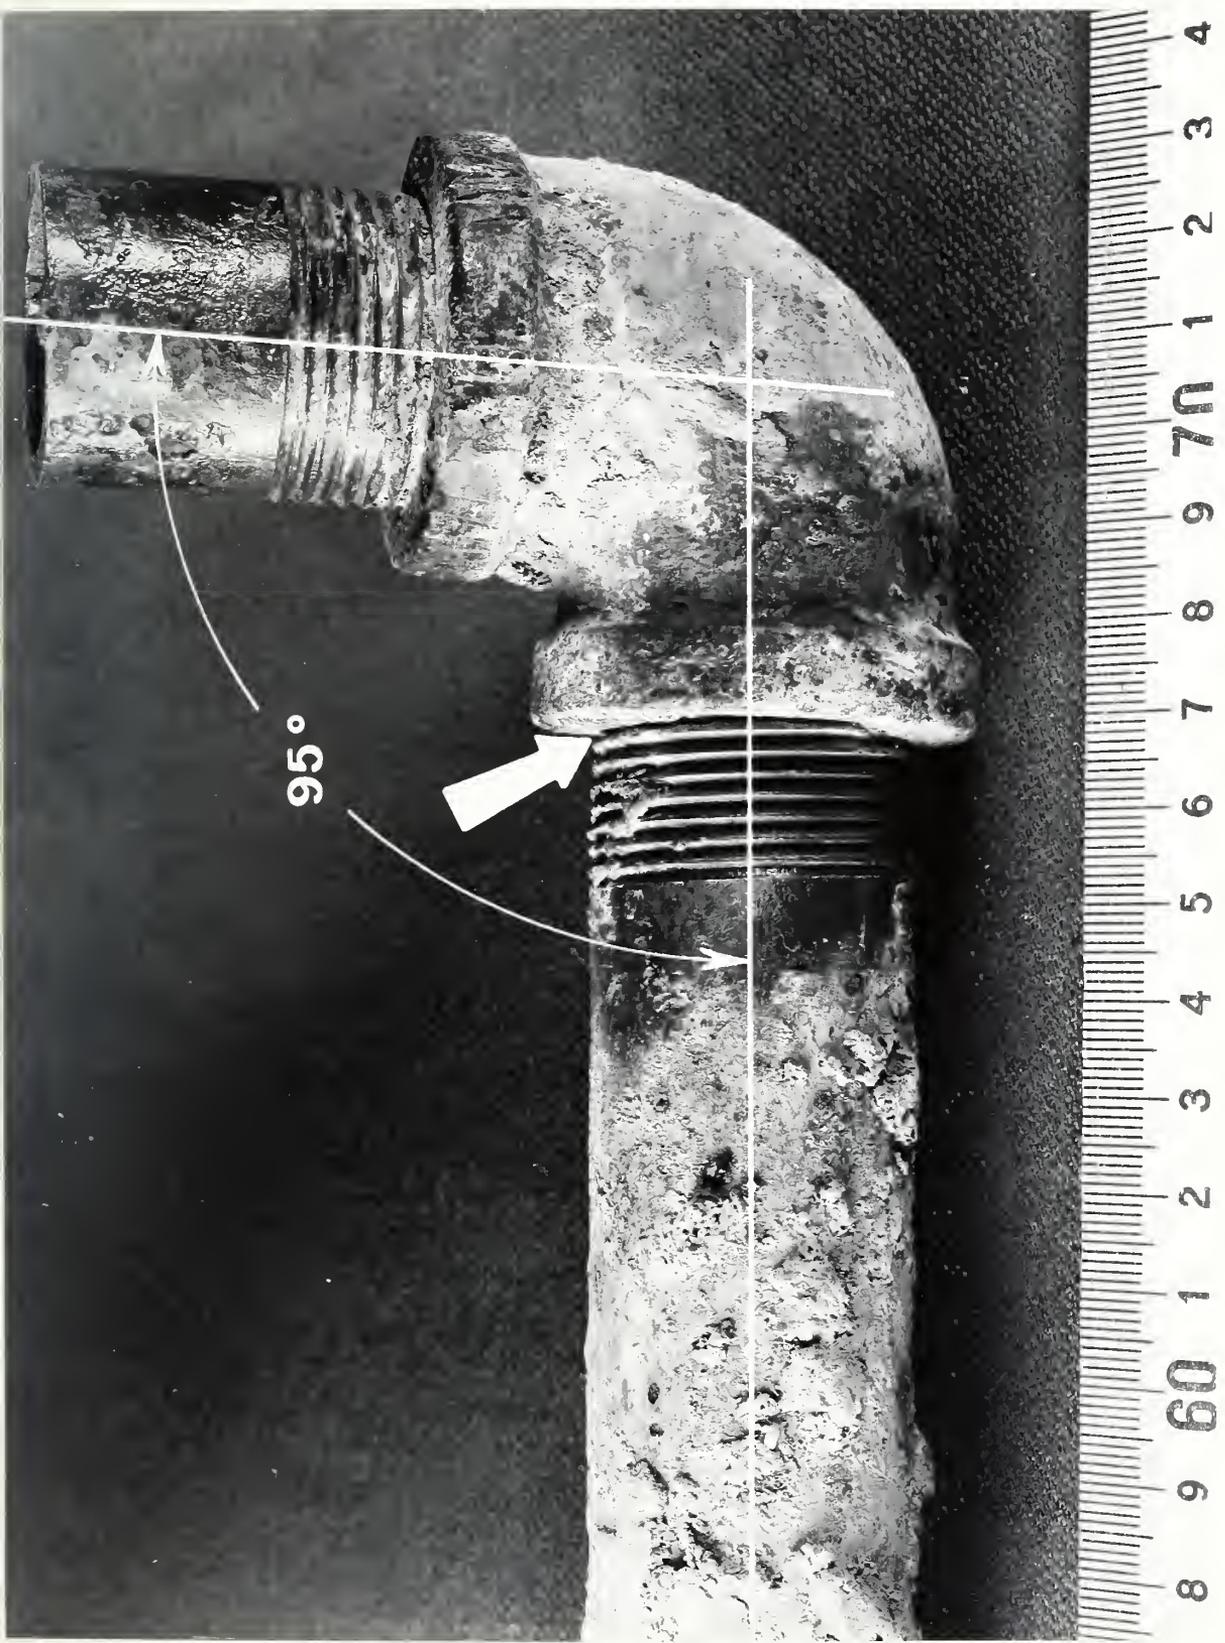
Figure 2. Part of the submitted pipe including the crack (arrow). When received at NBS, the crack faces had separated somewhat and the angle at the nominal 90° bend was about 95°. The region of the pipe near the crack that had been cleaned by the gas company can be seen. X 1.3

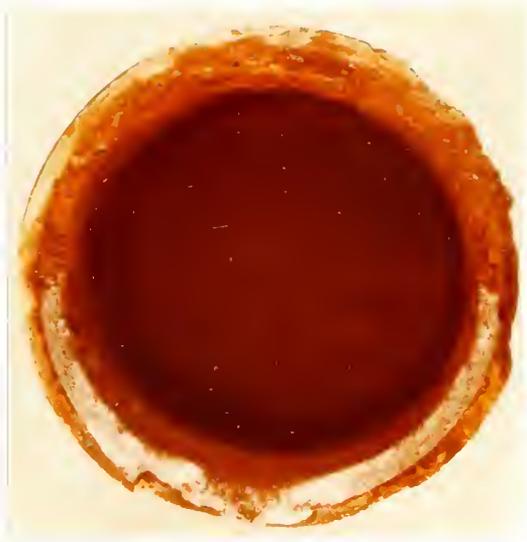
Figure 3. Fracture surface after fracture was completed at NBS and before it was cleaned. The corroded part of the fracture (approximately the top half in the figure) is the field fracture. The bottom half is that part of the fracture completed in the laboratory. X 2

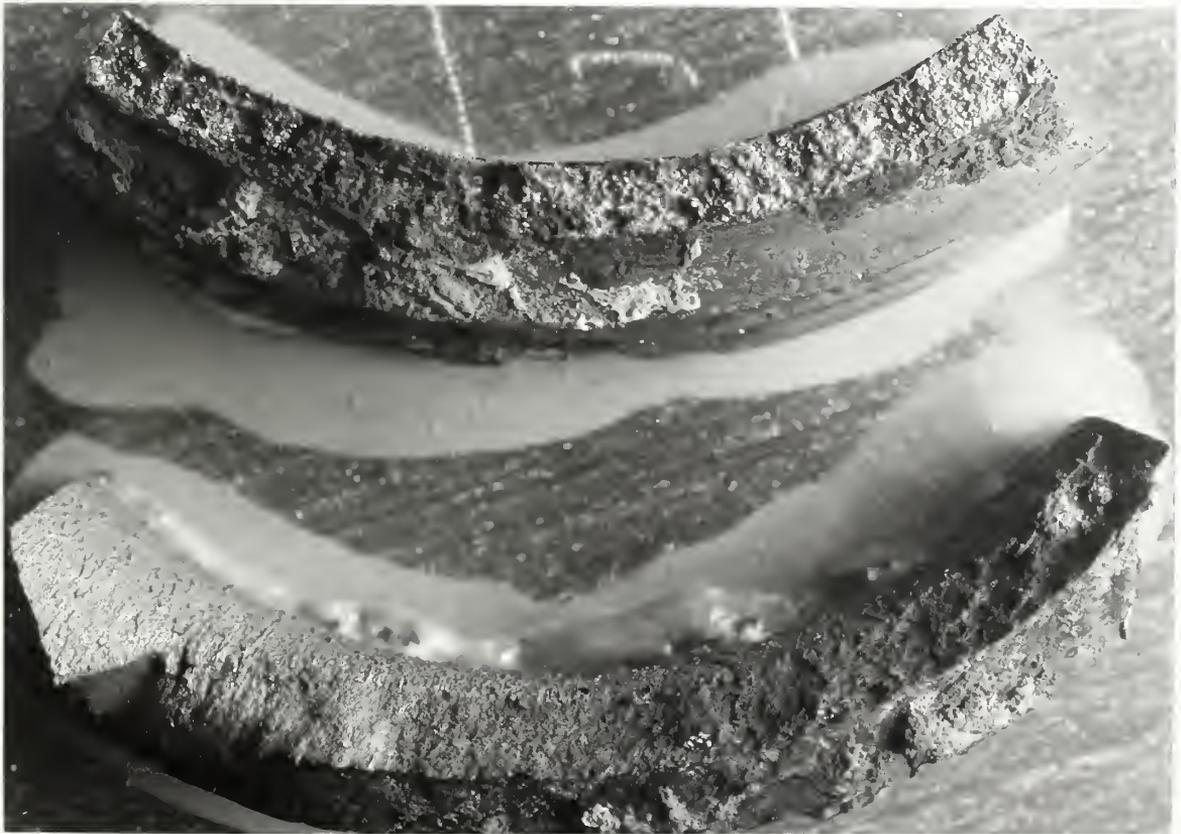
Figure 4. Parts of the field fracture (top) after cleaning and the NBS completed fracture (bottom). Magnification is higher than in figure 3. X 7

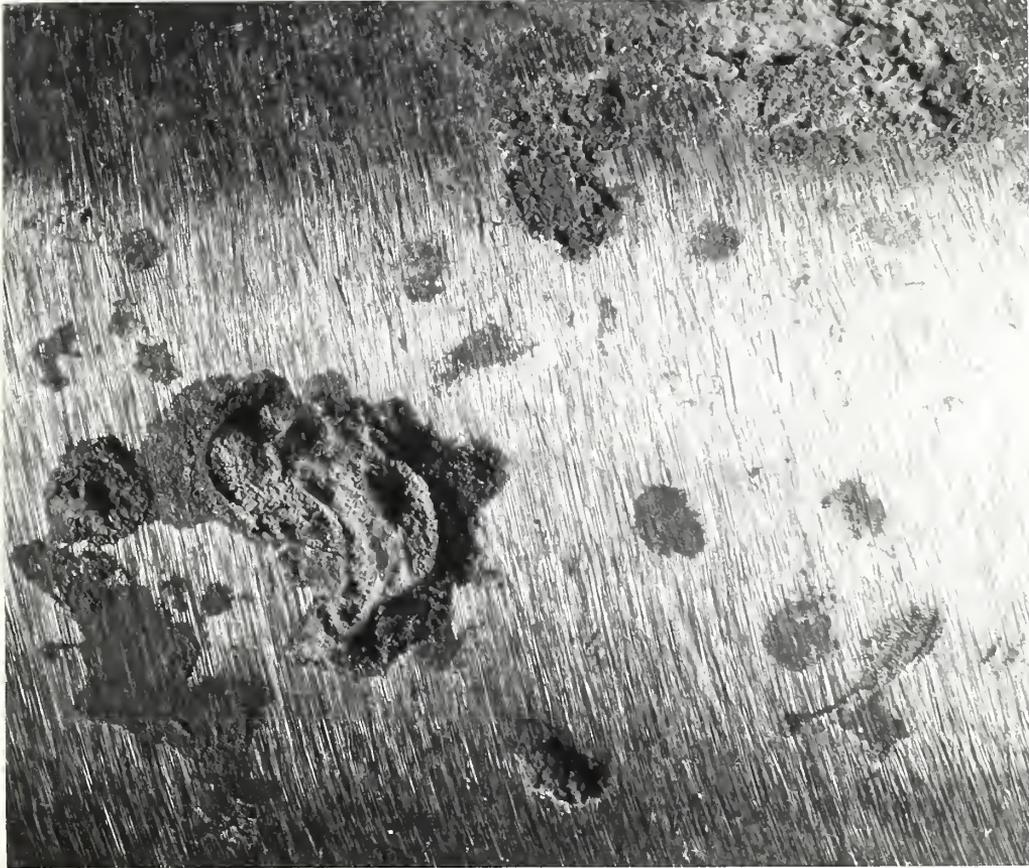
Figure 5. Part of the piece of pipe containing the crack about 2 inches from the crack. The pipe surface has been cleaned of soil and scale in this region revealing extensive pitting corrosion. X 7

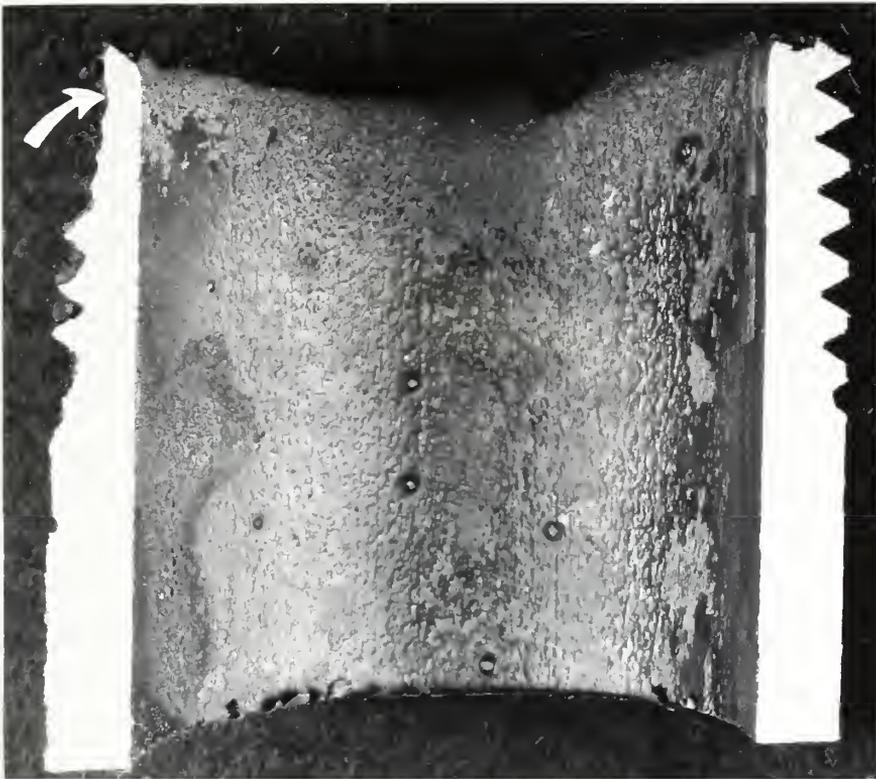
Figure 7. Longitudinal section through the pipe intersecting the fracture (horizontal at top). The threads are severely corroded on the left. The arrow indicates the region of severest corrosion in the section. On the right, corrosion is minimal. X 3

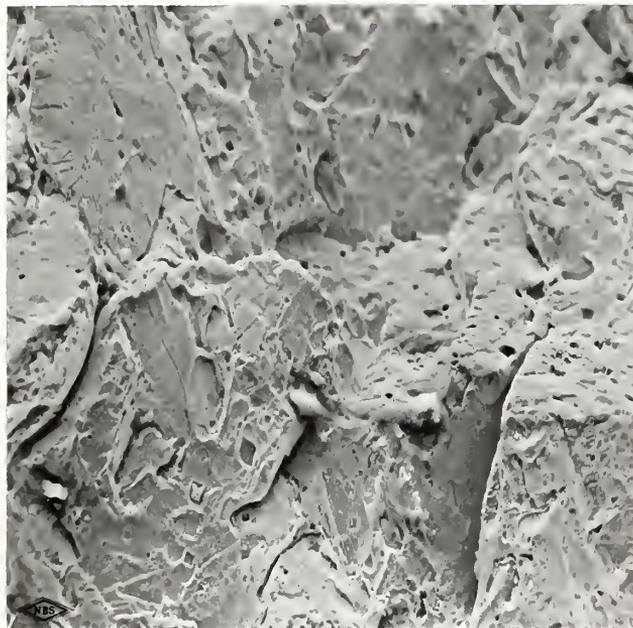
Figure 8. SEM fractograph of the field fracture. Cleavage is the predominant fracture mode. X 255

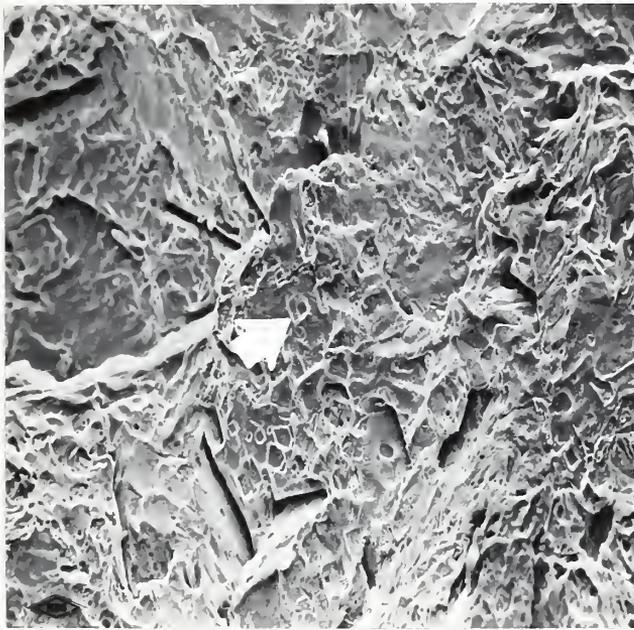
Figure 9. SEM fractograph of the field fracture in a different area from that shown in figure 8. Cleavage is the predominant fracture mode. The geometric depressions appear to be etch pits. One of these depressions is indicated by the arrow. X 240

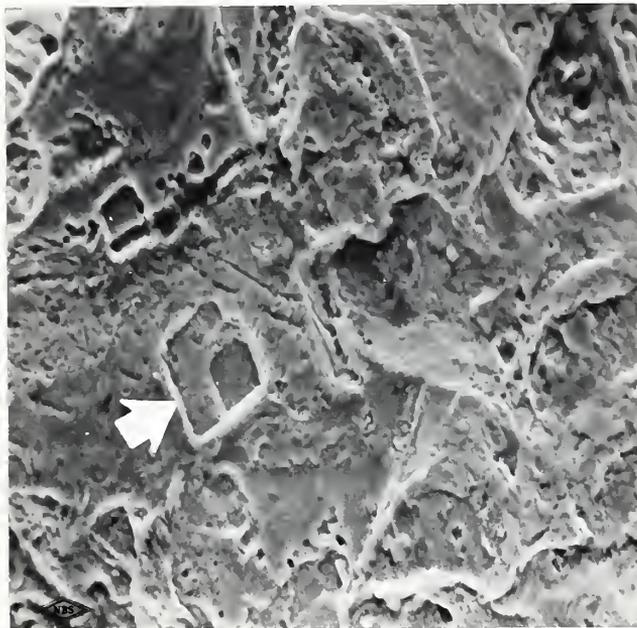
Figure 10. Part of the field shown in figure 9, but at higher magnification. The arrow indicates an apparent etch pit. X 1200

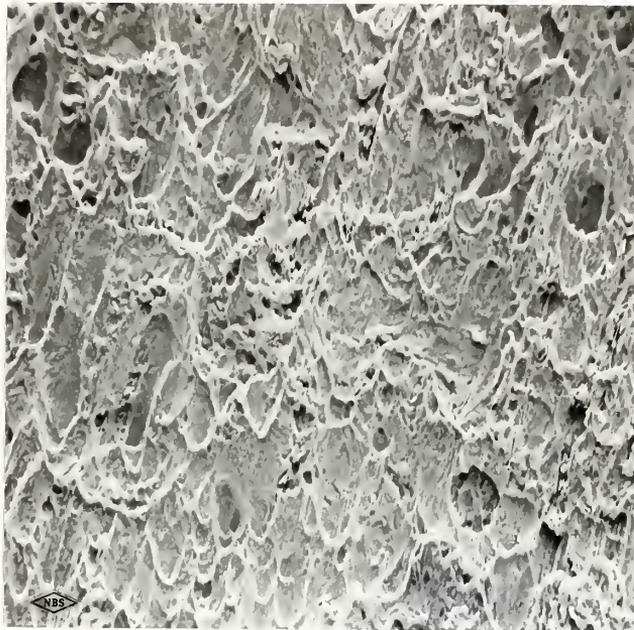
Figure 11. SEM fractograph of the part of the fracture completed at NBS. Dimpled rupture is the predominant fracture mode. X 450

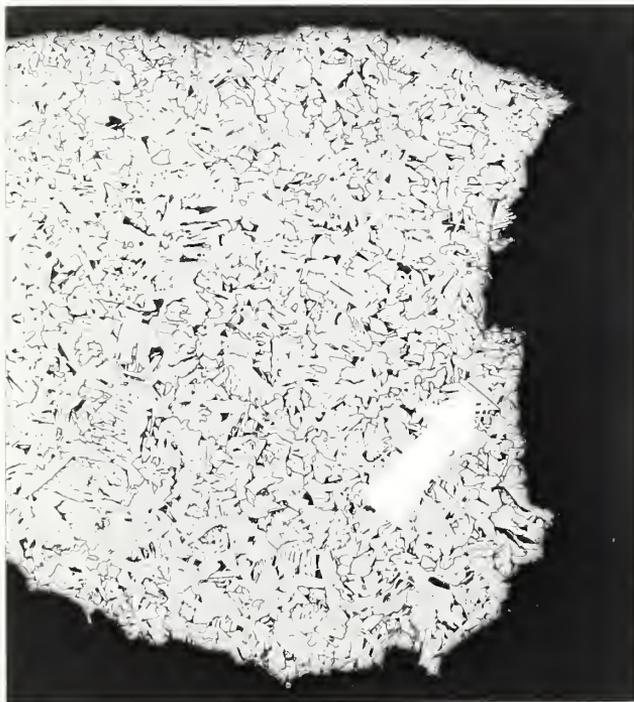
Figure 12. Longitudinal section intersecting the field fracture adjacent to a region where the pipe threads were severely corroded. The fracture profile is vertical at the right. The inside wall surface is horizontal at the top and the corroded threads are horizontal at the bottom. There is some apparent deformation at the fracture adjacent to the inside of the pipe. The crack path is transgranular. The arrow indicates a region of mechanical twinning.
Etchant: 1% nital X 50

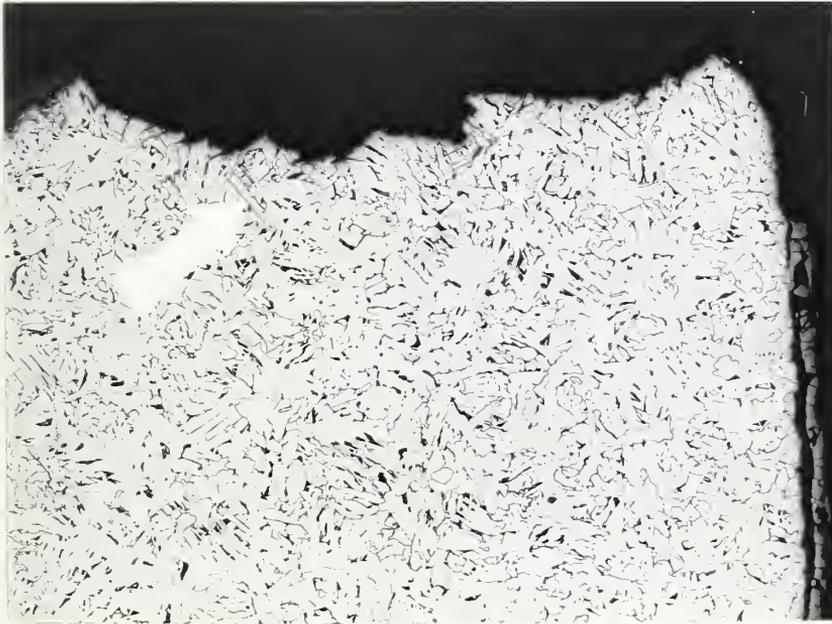
Figure 13. Longitudinal section through the pipe showing the field fracture profile (vertical at the right) adjacent to a region where the pipe threads were corroded very little. The inside wall surface of the pipe is horizontal at the bottom and the thread roots are just beyond the top of the figure. There is some deformation at the fracture adjacent to the inside wall surface. The arrow indicates a region of mechanical twinning.
Etchant: 1% nital X 50

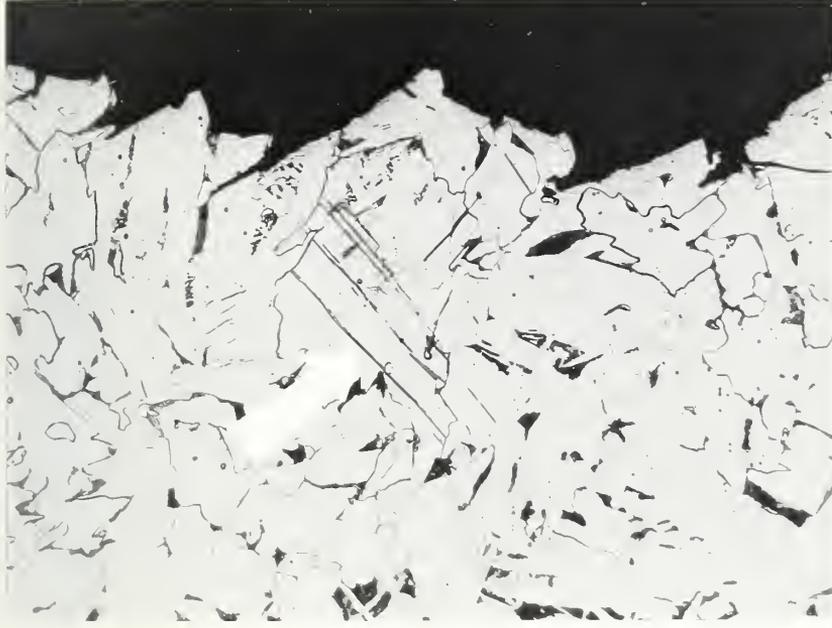
Figure 14. Part of the field shown in figure 13 at higher magnification. The arrow indicates the same region of mechanical twinning as indicated in figure 13. Some secondary cracking can be seen.
Etchant: 1% nital X 200

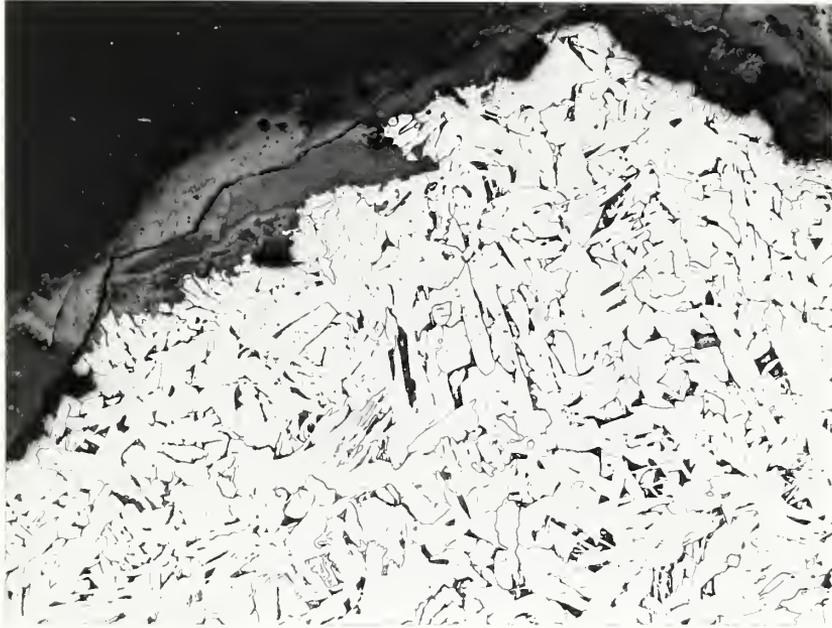
Figure 15. Etched longitudinal section showing part of one of the corroded threads. The grey material along the thread surface is corrosion product.
Etchant: 1% nital X 100

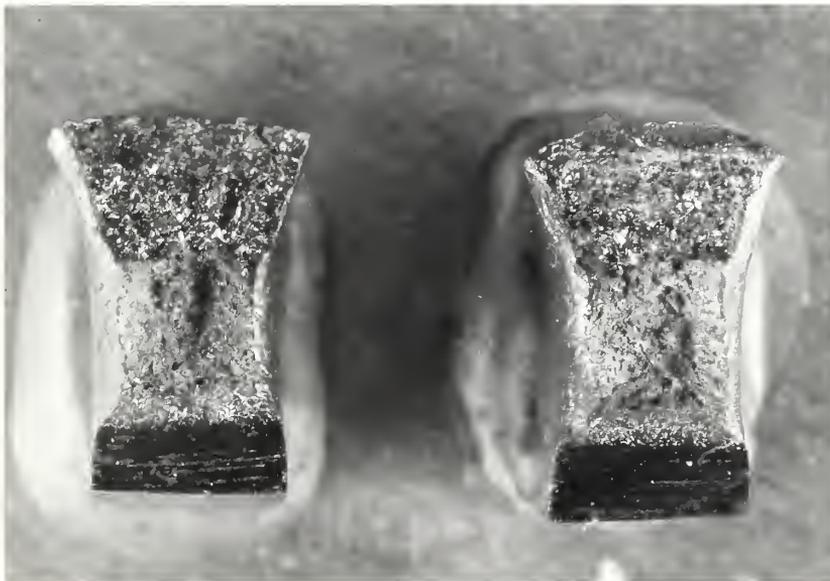
Figure 16. Fracture surfaces of impact specimens tested at NBS. The specimen tested at 0°C is at the left, the one tested at room temperature is at the right. In each case, the notch is at the bottom, dimpled rupture is exhibited in the center region, and cleavage is exhibited in the upper region. A large amount of lateral expansion can be seen in the upper region. X 10

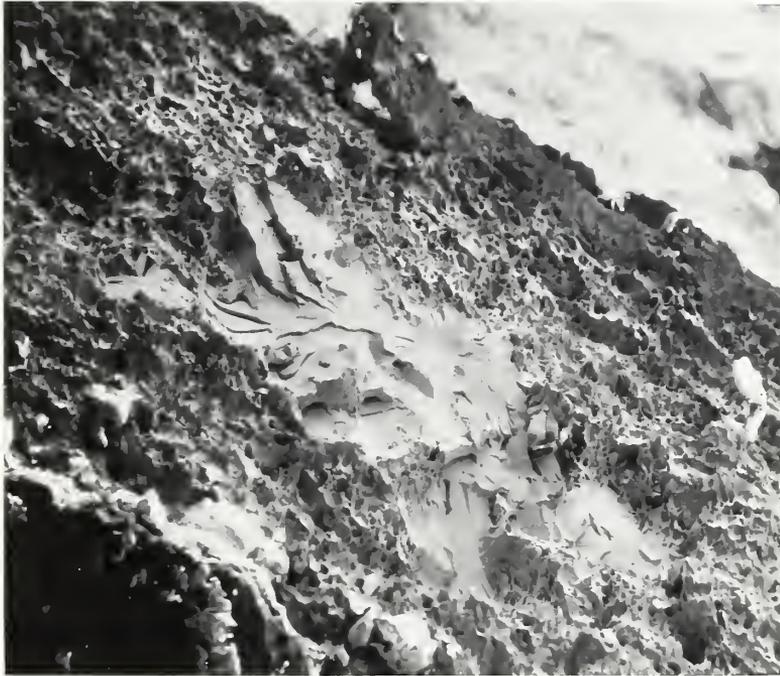
Figure 17. SEM fractograph from the pipe sample tested in tension at 0.02 inch per minute. There is a region of cleavage in the center of the figure. The rest of the fracture exhibited dimpled rupture.
