# **Analysis of the Pneumatic Burst of a Large Seamless Steel Pressure Vessel in Natural Gas Service**

**U.S. DEPARTMENT OF TRANSPORTATION  
MATERIALS TRANSPORTATION BUREAU  
Office of Hazardous Materials Regulations  
Washington, D.C. 20590**

NBSIR 78-1589

Failure Analysis Report

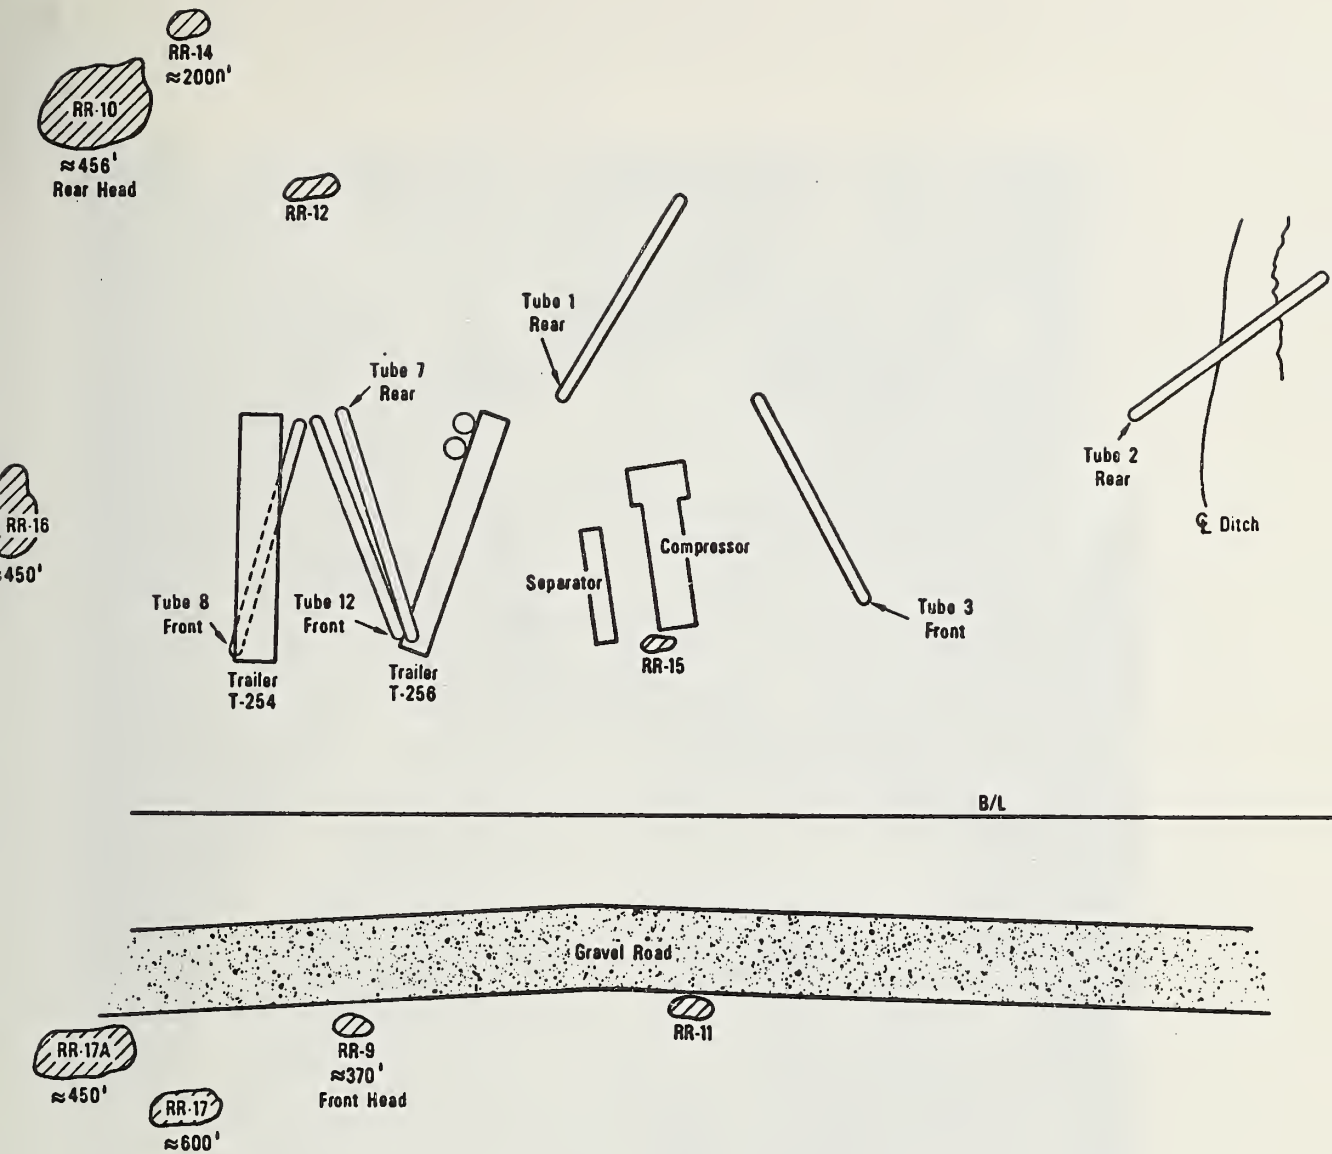
A diagram showing the incident site afterwards appears in Figure 1. The layout of the site itself was traced from a surveyor's diagram provided to NBS by the Kentucky State Fire Marshal's Office. The positions of the pieces of the burst cylinder were noted by Mr. Rodney Raby\* of that office. The location of two pieces, RR-18 and RR-19 was not established.

Figure 1. Incident site after the pneumatic burst. Number by each piece indicates approximate distance from remains of trailer T-256, for those pieces for which this information was provided. The relative sizes of the pieces is indicated roughly by the size in the figure. The position of each piece was indicated by Mr. Rodney Raby of the Kentucky State Fire Marshal's Office. The positions of pieces RR-18 and RR-19 were not identified.

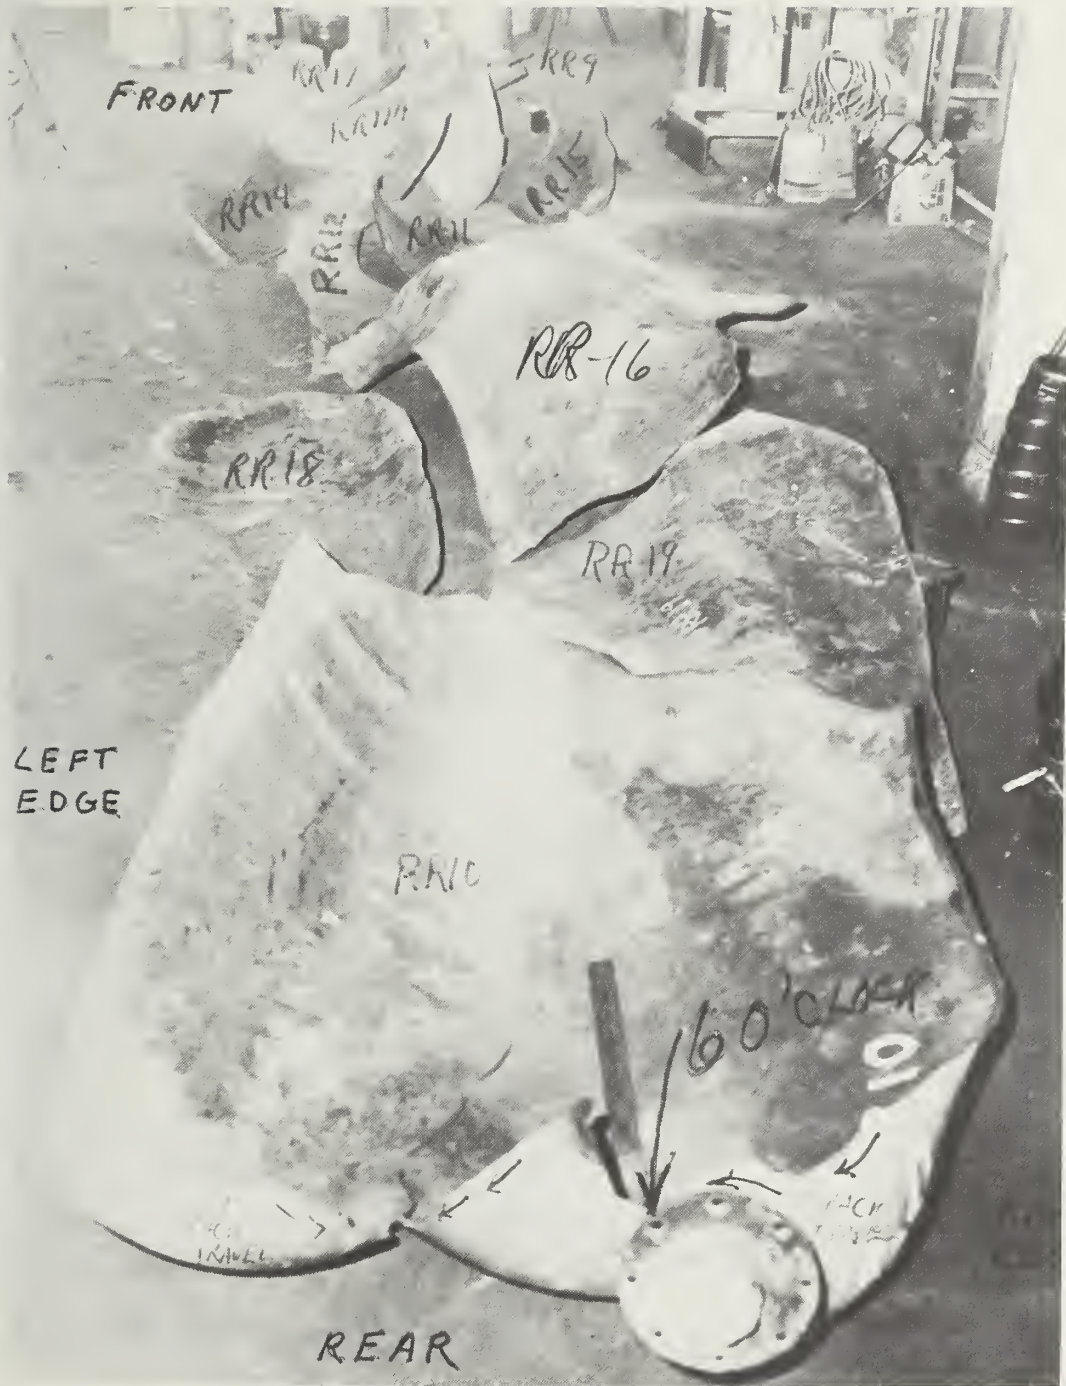
Review of color photographs of the pieces of cylinder 9959 and visual inspection of the pieces laid out as in Figure 2a did not reveal any signs of heating. Evidently, all pieces escaped significant heating from the fire which occurred shortly after the cylinder ruptured.

Figure 2a. Eleven pieces of cylinder 9959 laid out on the floor at Gladstone Laboratories, Inc. The rear head is in the foreground. (Photo courtesy of M. Bolinger, Jr., Gladstone Laboratories, Inc., Cincinnati, Ohio).

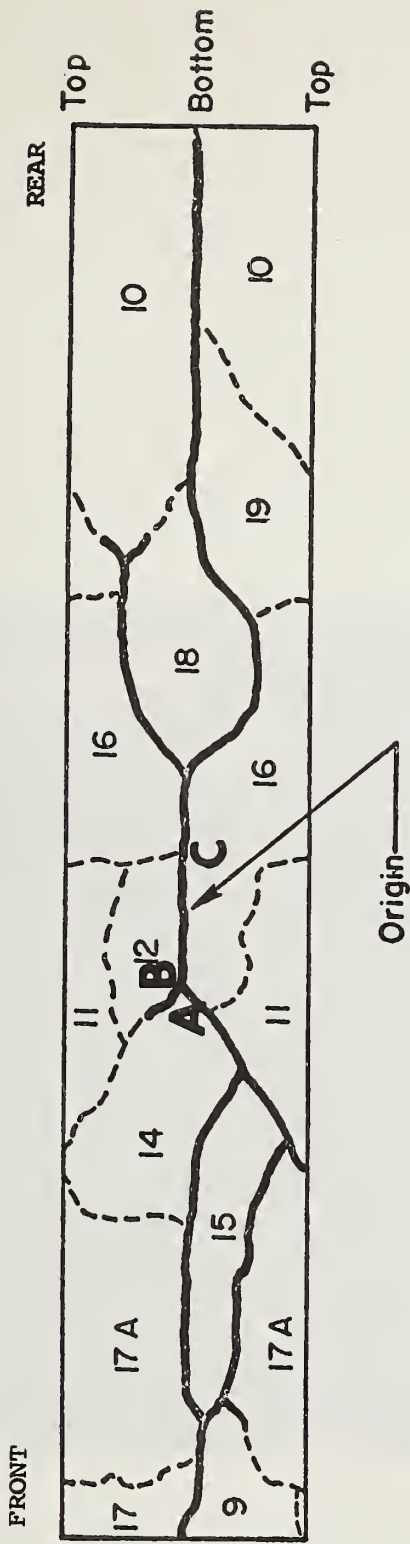
The primary fracture path is marked by the heavy black lines in Figure 2b. Secondary fracture paths are indicated by the dashed lines. They probably developed in response to bending loads on an already-fractured section of the cylinder.

Figure 2b. Diagram of the eleven pieces of cylinder 9959, showing approximate locations of the fracture paths. The heavy black line shows the path of the primary fracture. The dashed lines indicate secondary fracture paths. (Diagram courtesy of W. Maxey, Battelle Memorial Institute, Columbus, Ohio).

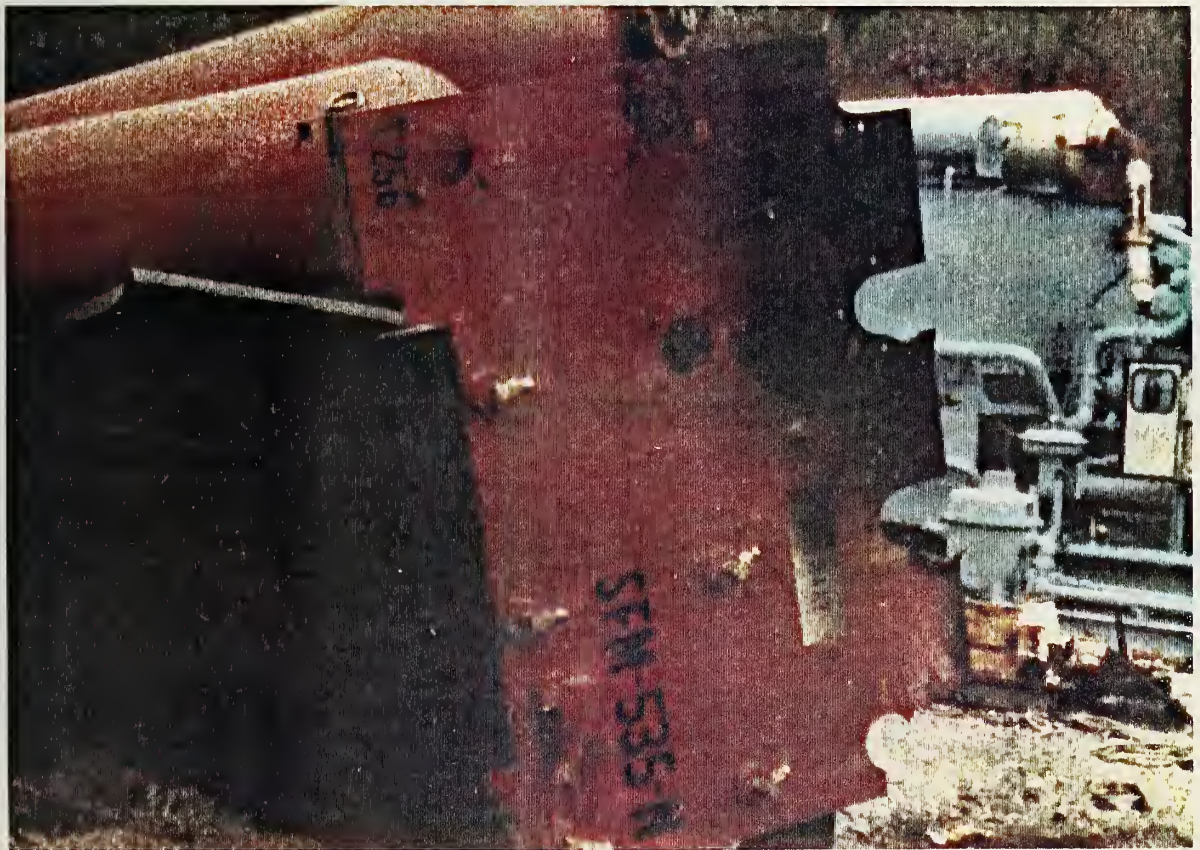
Figure 3. Remains of trailer T-256 after the incident, as seen from front. (Photo courtesy of Mr. W. Piehl, Western Sales and Testing, Inc., Amarillo, Texas.)

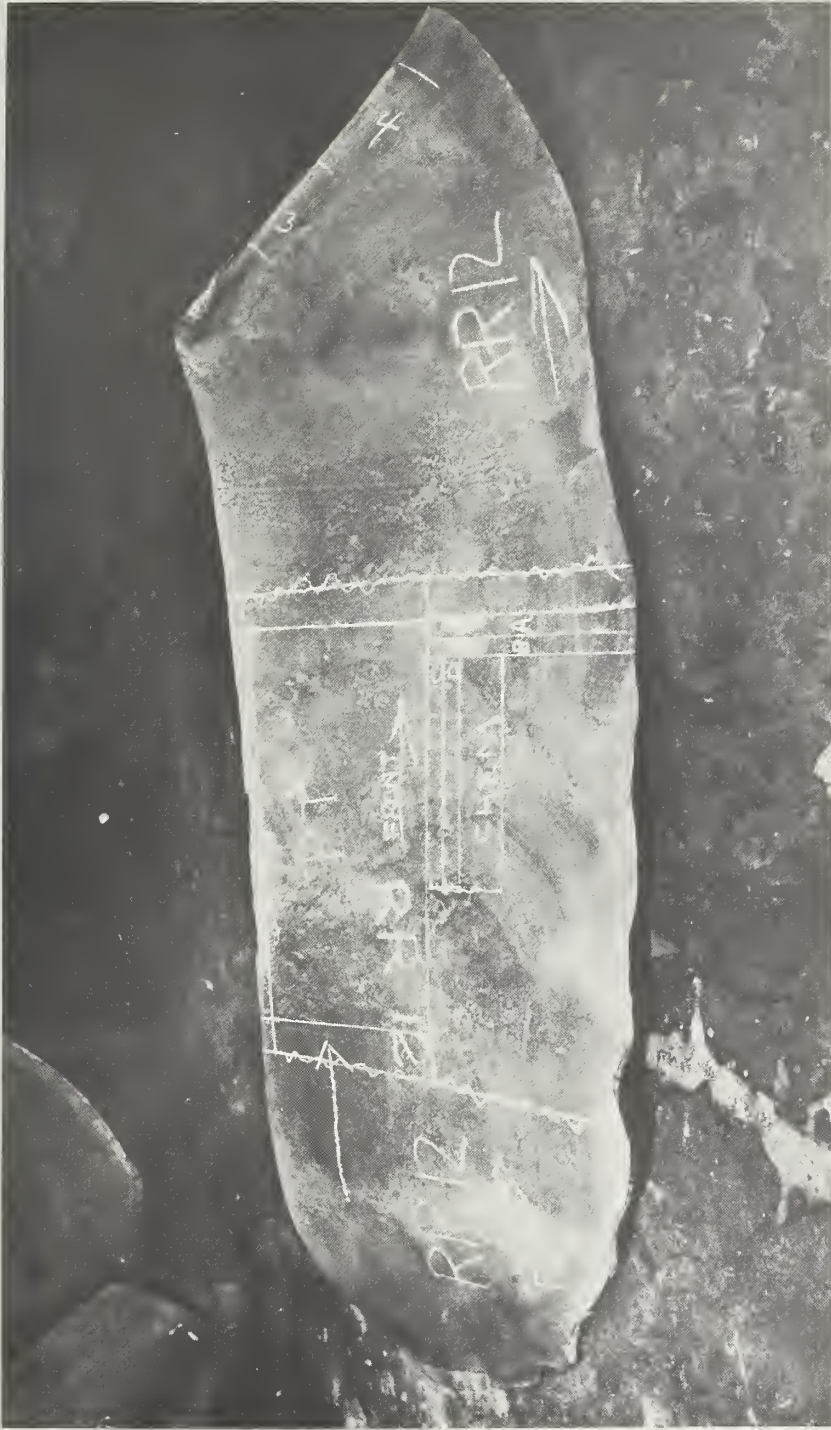
The edge of piece RR-12 containing the fracture origin appears in Figure 5. It is located along the fracture edge where the words "saw cut" appear upside down. One side of the fracture origin was removed from piece RR-12 by sawing along the "saw cut" line. The other side has been preserved intact on piece RR-16. Care was exercised in the sawing so that coolant from the band saw did not flow over the fracture surface. A heavy deposit of various products coated the entire fracture surface.

Figure 5. Inside wall of piece RR-12 showing location of specimen taken for chemical analysis. The arrows point in the longitudinal direction. This piece is about 30-inches wide by about 50-inches long. (Photo courtesy of M. Bolinger, Jr., Gladstone Laboratories, Inc., Cincinnati, Ohio.)

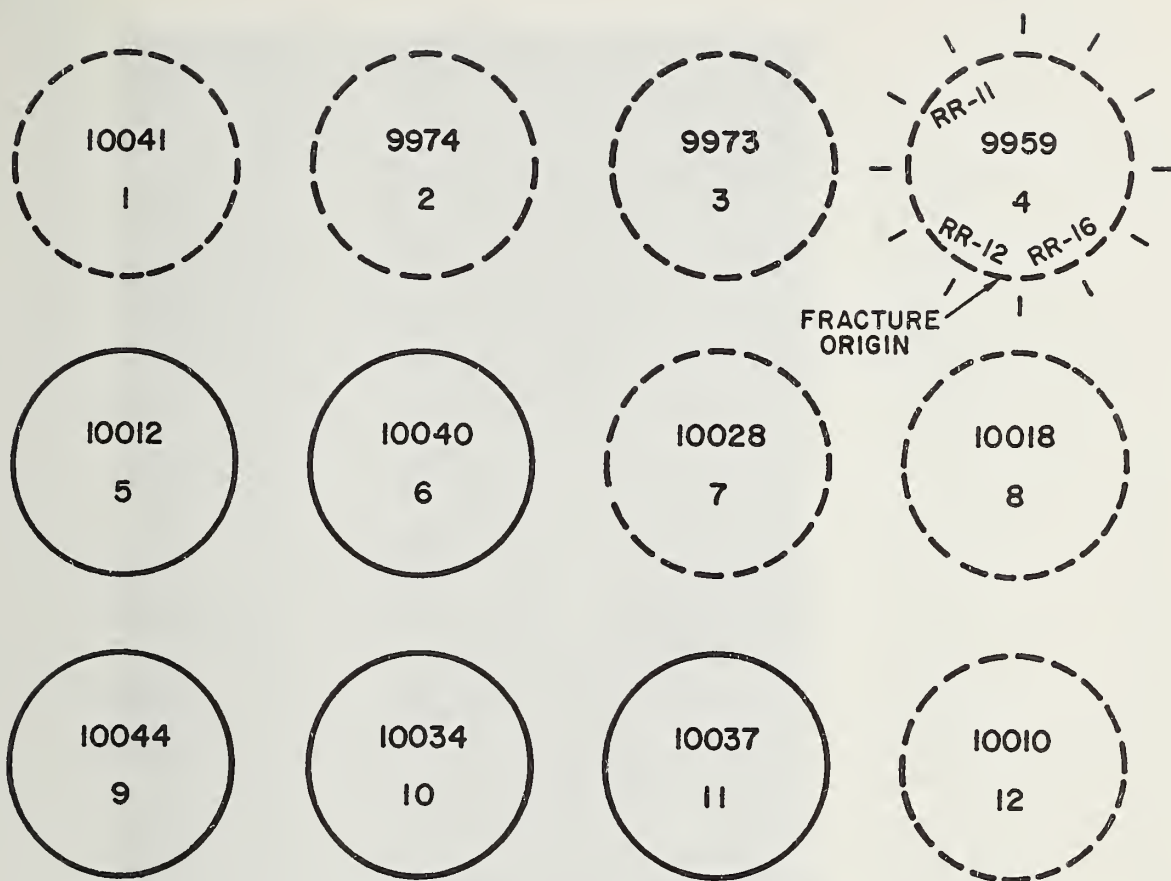
TUBE TRAILER T-256  
( Viewed from rear )

The cylinder which ruptured was in the top row of a four-wide by three-high array of cylinders on the tube trailer. It was on the outside at the right, as viewed from the rear of the trailer, Figure 6. The serial number stamped in the cylinder is 9959. For convenient reference to positions of cylinders on the tube trailer, the cylinders are numbered 1 through 12, as shown in Figure 6. Thus, the cylinder which ruptured is also designated as cylinder 4.

Figure 6. Array of specification DOT-3T cylinders on tube trailer T-256 as viewed from the rear. The cylinder which ruptured is on the top row at the right. The location of the fracture origin is shown. It was 12.5 feet from the front head. The "RR- " designations assigned to the pieces near the fracture origin are indicated. (Identification number for each tube supplied by Jack B. Kelly Enterprises, Inc., Amarillo, Texas.)

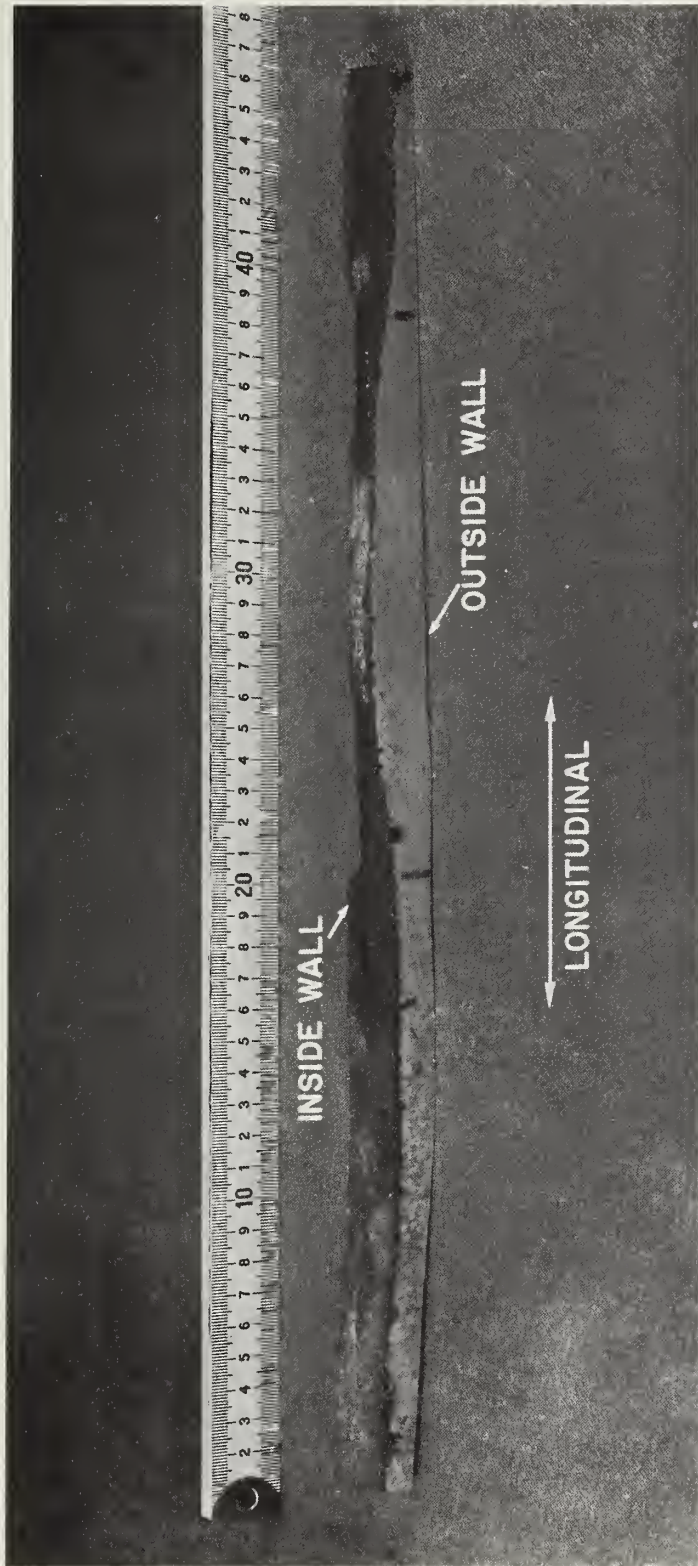
It is possible that the fracture origin was not a single crack, but rather, three cracks that linked up, as suggested in Figure 7. Figure 7a is an overall view of the 17-inch long segment sawed from RR-12. This segment was about 1/2-inch wide at one end and 3/4-inches wide at the other. The outside wall is facing the viewer in Figure 7a. A view directly down on the fracture origin appears in Figure 7b. Figure 7c is an artist's sketch clarifying Figure 7b and showing the position of the fracture origin on the 17-inch long segment. The step in the fracture origin between labels "1" and "2" is suggestive of 2 cracks. Yet a third crack is suggested by the asymmetry of the fracture origin in the region labeled "3".

Figure 7a. Seventeen-inch long segment cut from edge of piece RR-12 along the line labeled "saw cut" in Figure 5. The scale is in centimeters. The fracture origin is opposite "31" on the scale. The transition from flat fracture to full slant fracture occurs to either side of the fracture origin, between 20 and 39 on the scale.

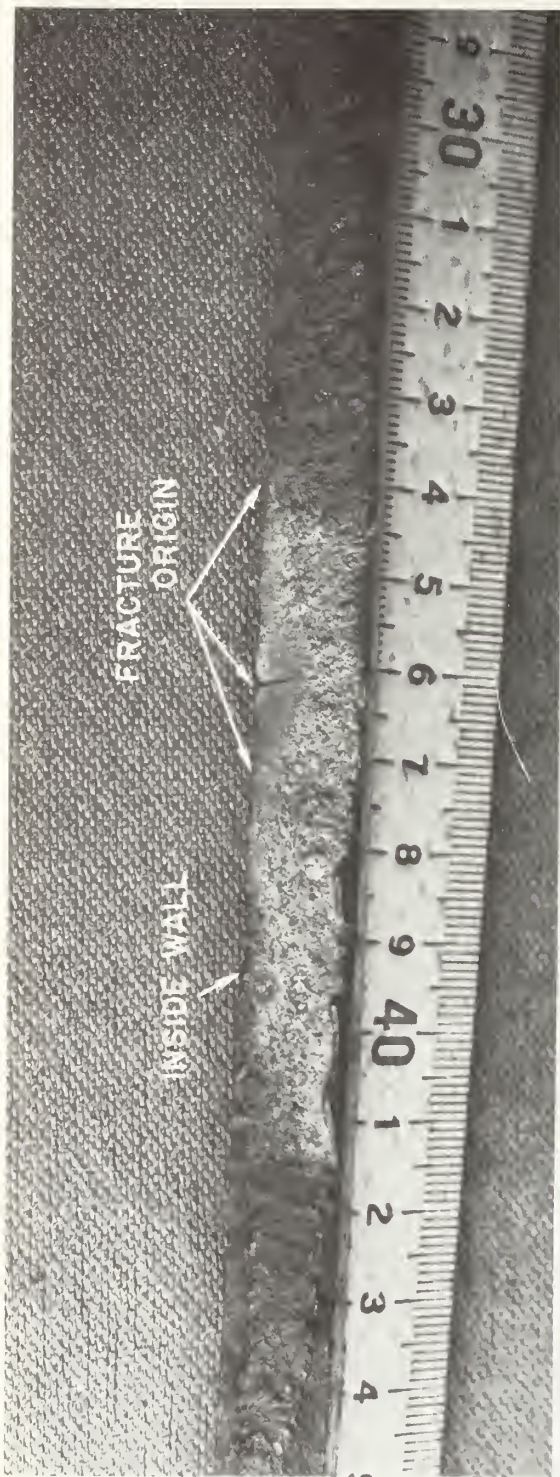
The fracture origin was a thumbnail-shaped part-through crack about 1.3-inches long and 0.25-inches deep. It reached from the inside wall to the mid-wall position. The long axis of the crack was approximately parallel to the longitudinal axis of the cylinder.

Figure 7b. View of fracture origin looking directly down on it. The scale is against the outside wall.

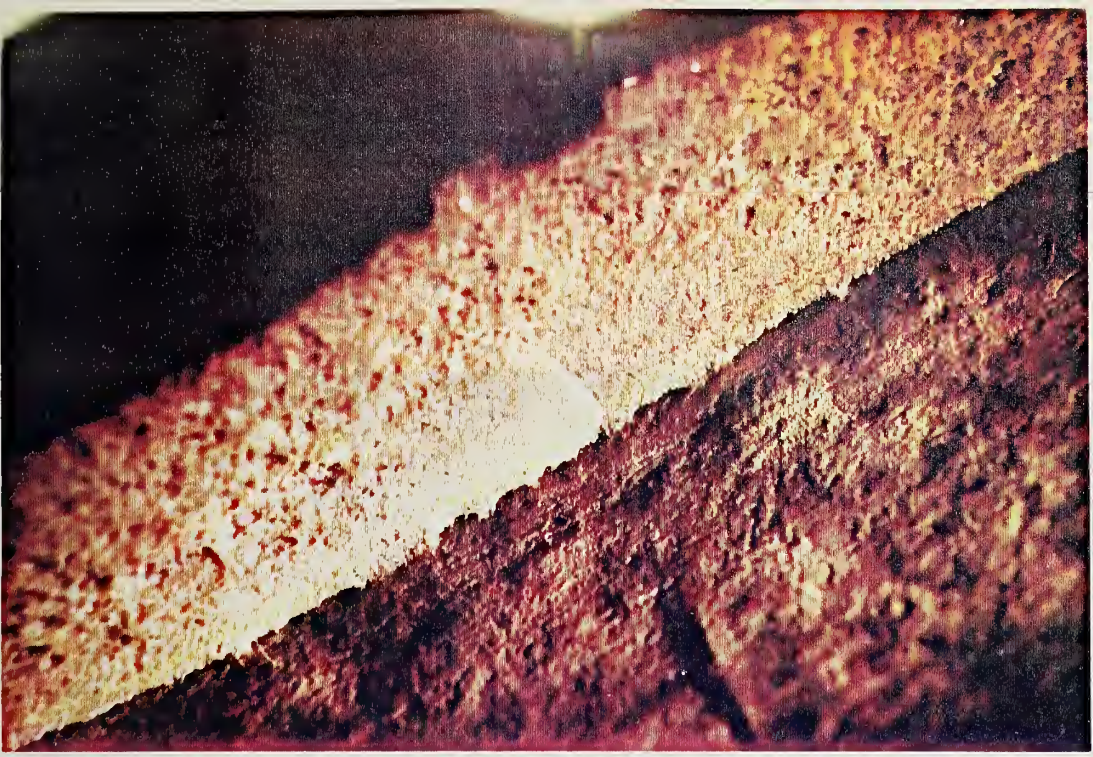
Tiny shear lips were noted along the edge of the fracture origin which intersected the inside wall. These show up in Figures 8a and 8b. The presence of a shear lip suggests internal crack growth, with the shear lip forming at the time of catastrophic separation. The shear lip is probably in the decarburized layer (see Section 5.3), which was detected along the inside wall of the cylinder.

Figure 8a. Fracture origin on piece RR-12 before cleaning, viewed toward inside wall.

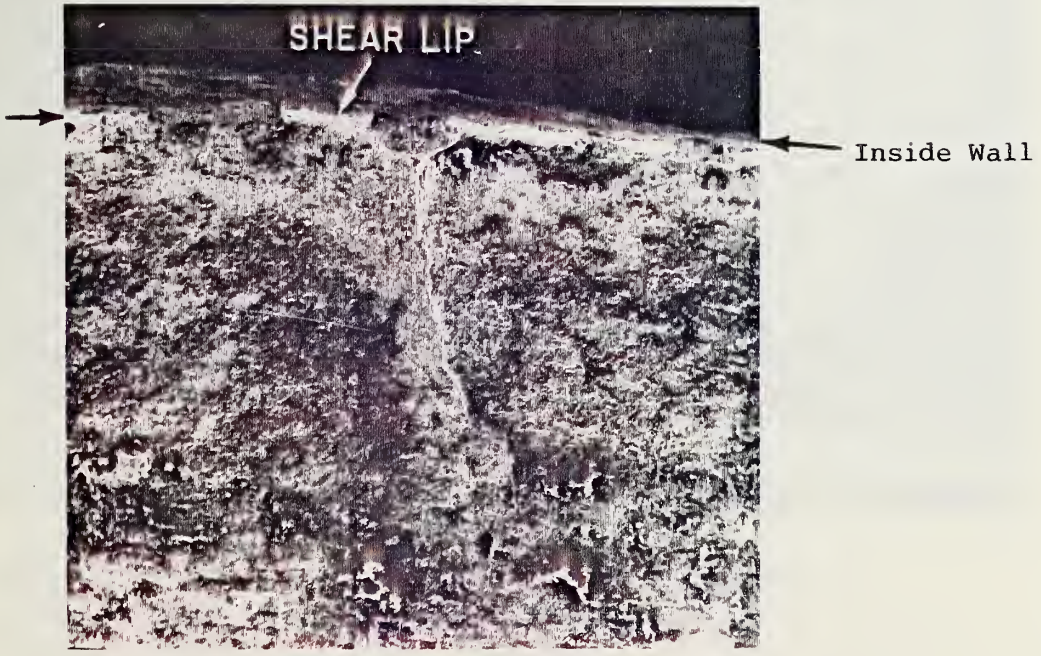
Figure 8b. Close-up view of step on fracture surface. Shear lips show up as intermittent white markings along inside wall. These shear lips are probably in the decarburized layer (see Section 5.3).

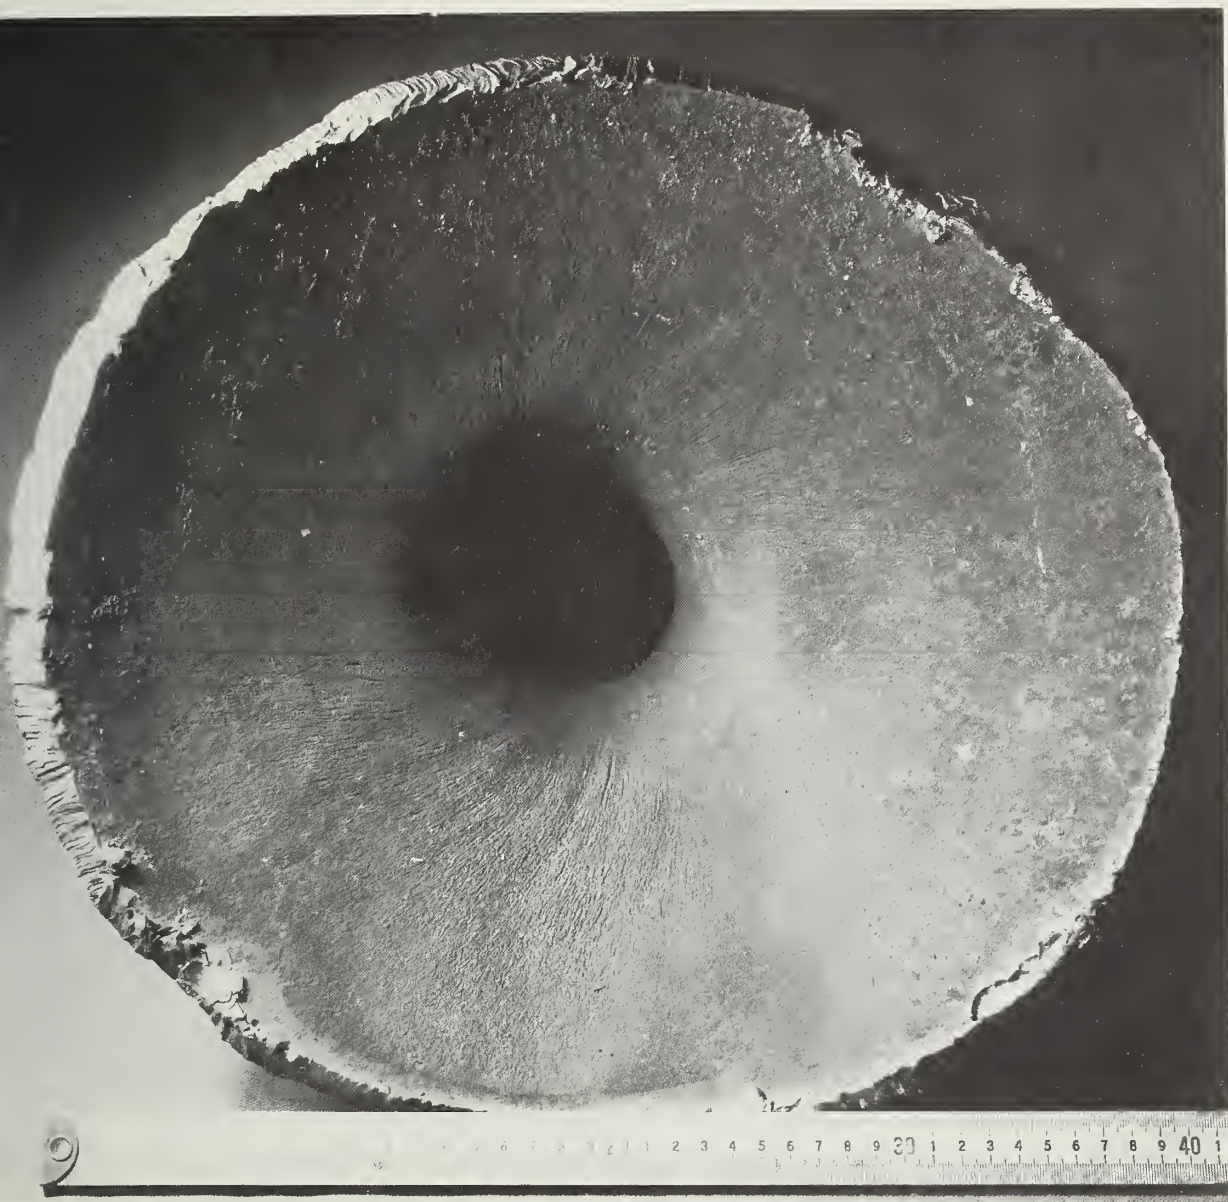
Near each head, the fracture path followed forging seams which formed from gathered metal that accumulated when the heads were forged, Figure 9a. Such forging seams were found at the heads of other

Figure 9a. Forging seams evident on inside wall at front head of cylinder 10041. The scale is in centimeters.

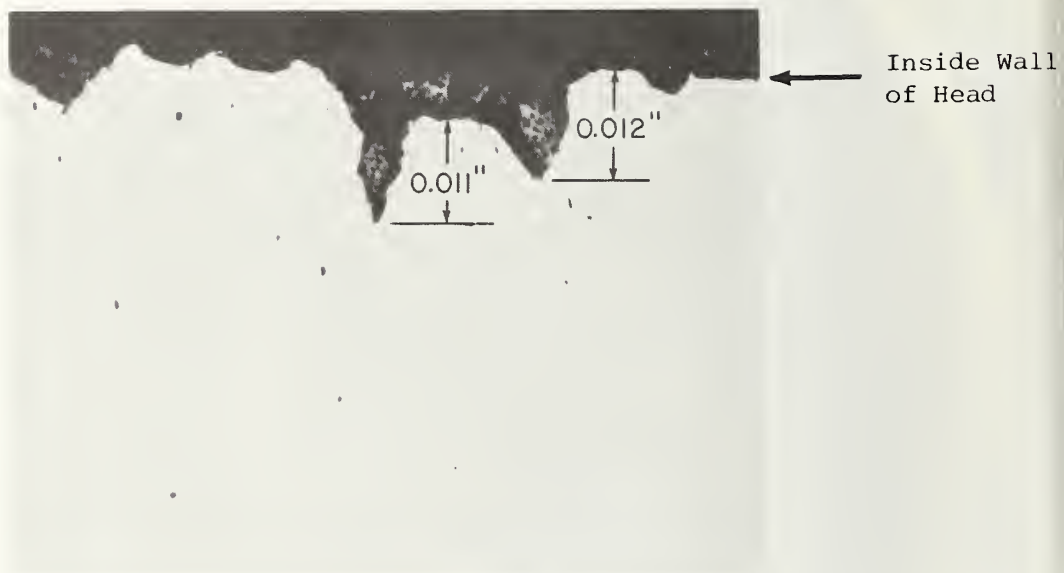
Figure 9b. Cross-section of typical forging seams found in front head of cylinder 10041.

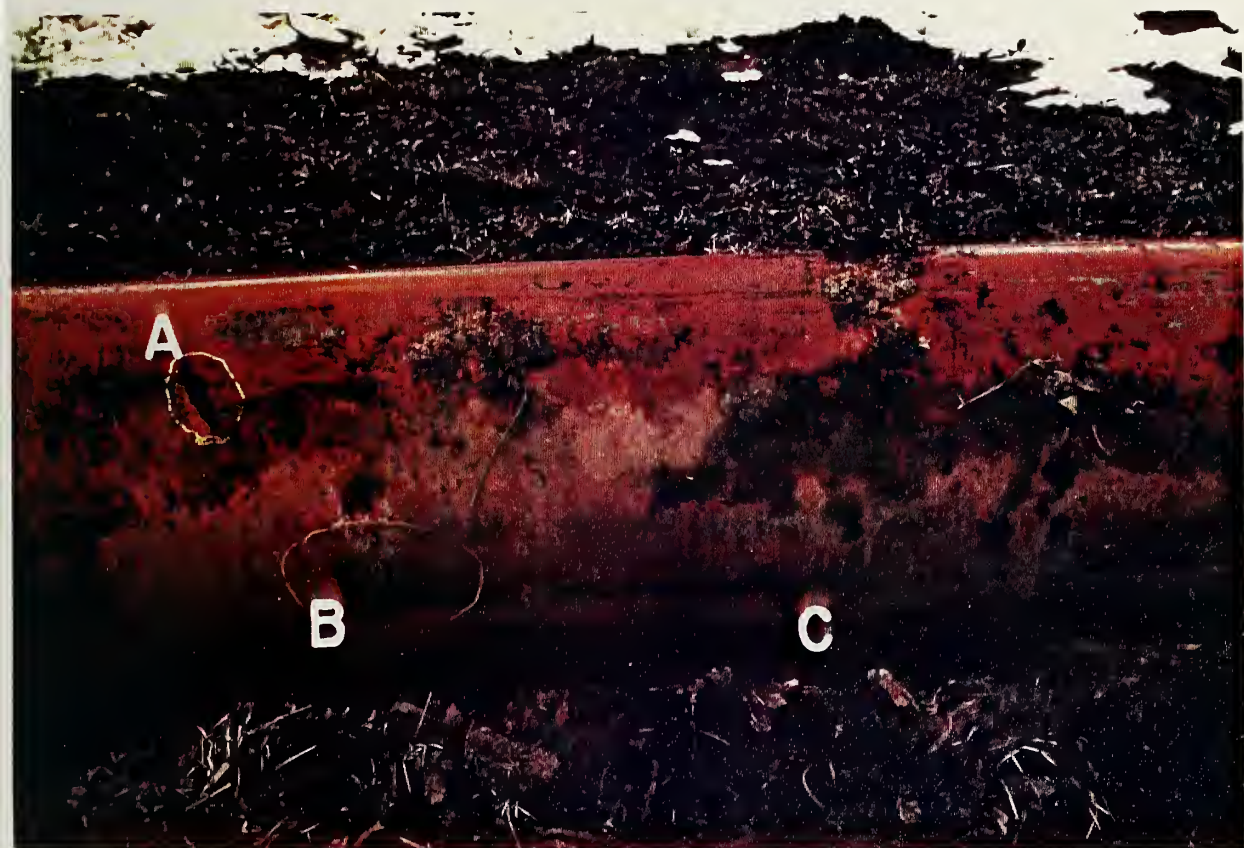
Figure 10a. Hit mark on cylinder number 8 (see Fig. 6 for location) made by opening flap of piece RR-16. The lines AB and BC in this figure correspond to the lines AB and BC in Figure 2b. The rear head of the cylinder is to the right.

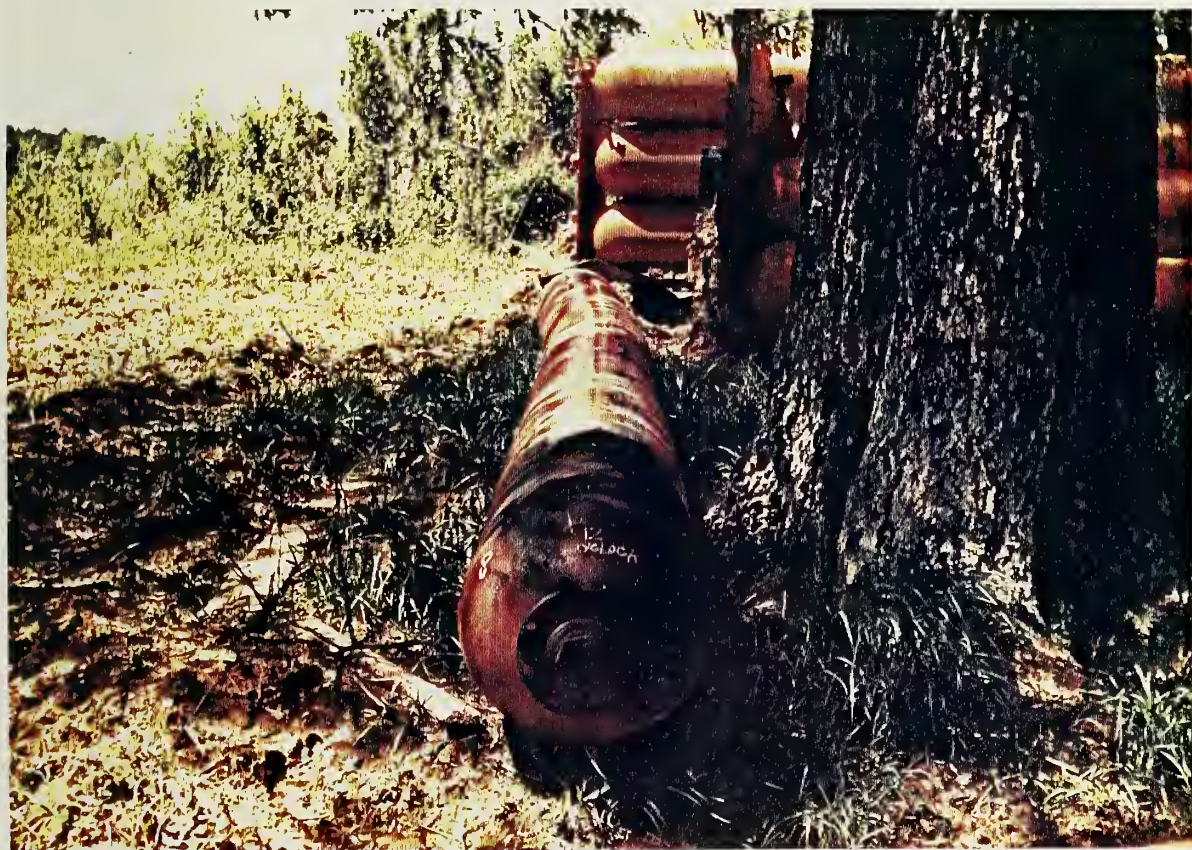
Figure 10b. Bowing of cylinder Number 8 due to the blow resulting in the hit mark shown in Figure 10a.

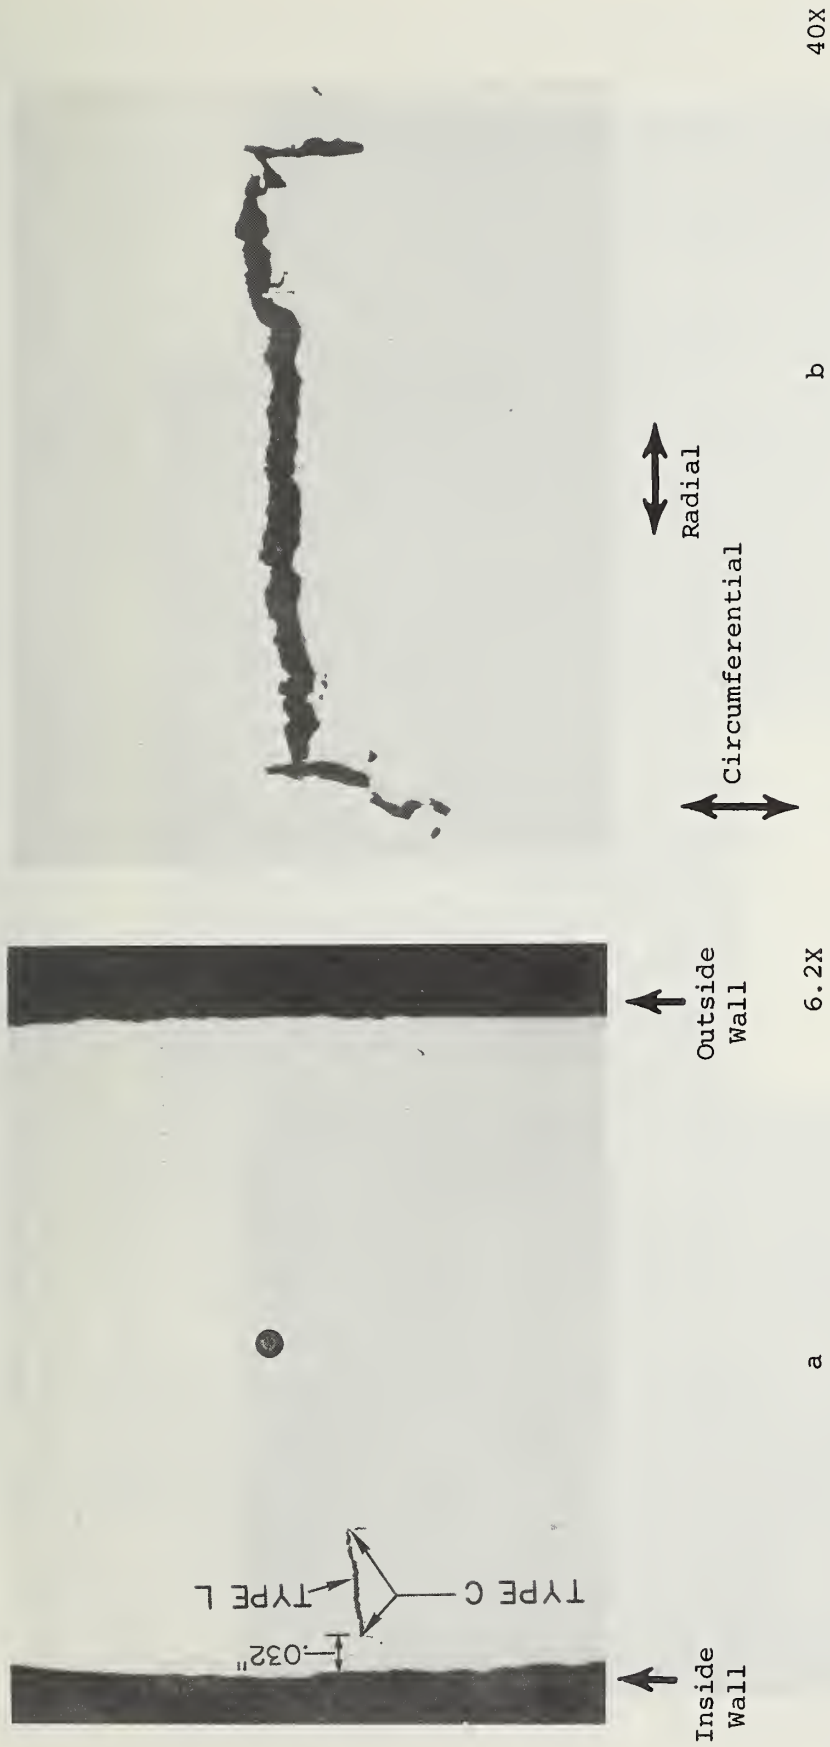
Figure 11. Type L and type C cracks detected in specimen TR-1. (See Figure 7c for specimen location.) The large black circle is a Rockwell C-scale hardness indentation. The row of tiny black dots is a series of Knoop microhardness indentations. (a) Transverse section showing full wall thickness. (b) Close-up view of the cracks.

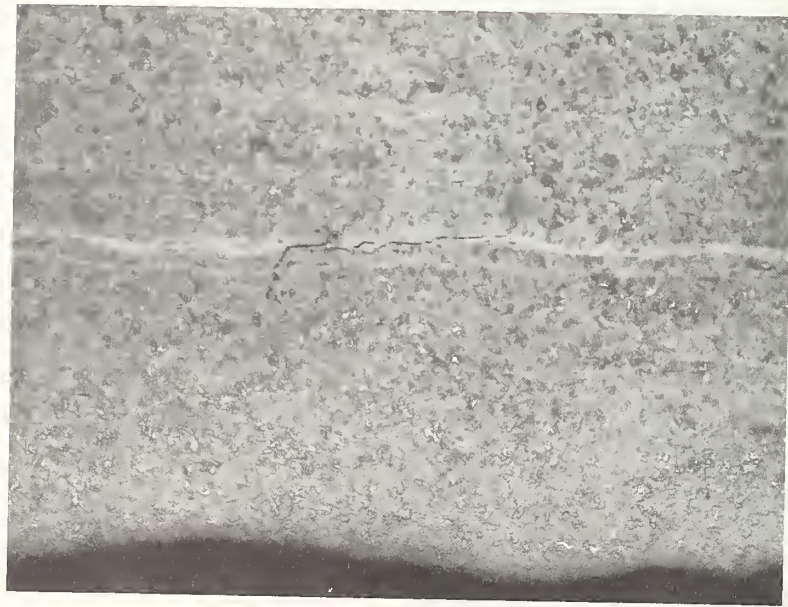
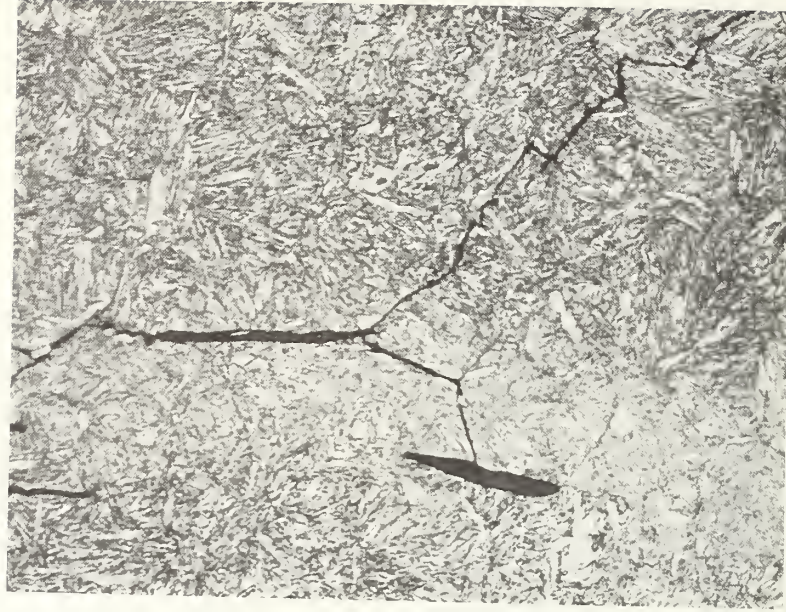
Figure 12. Intergranular crack path at tip of type C crack found in white-etching microzone specimen TR-6. (See Figure 7c for specimen location.) (a) Transverse section showing relationship of crack to inside wall. (b) Intergranular crack path developing at tip.

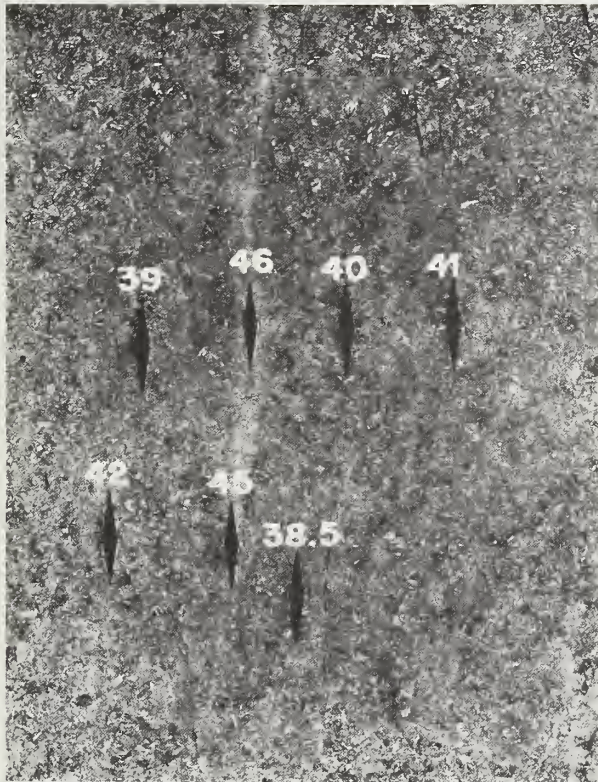
Figure 13. White-etching microzones found near inside wall in transverse specimen L. Rockwell C-scale hardness equivalents are shown. (see Figure 7c for specimen location.)

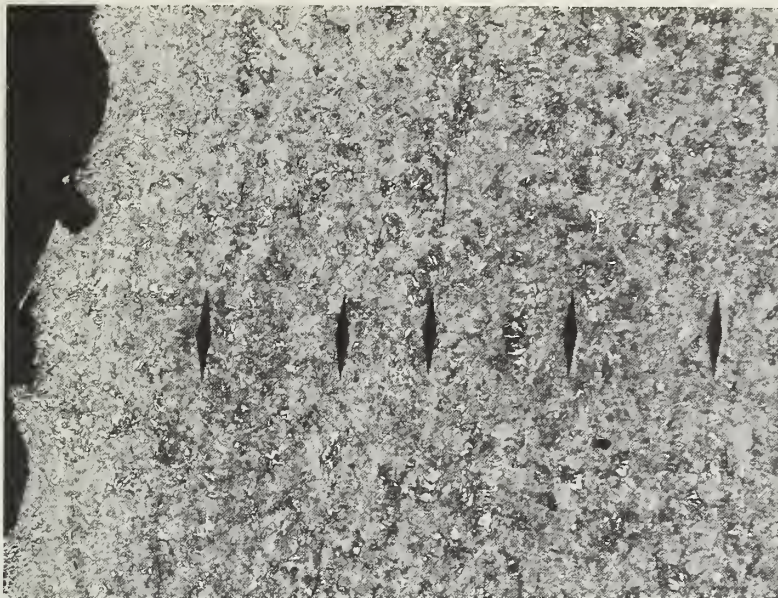
Figure 14. Banding near inside wall detected in transverse section taken from a ring cut near the front head of cylinder 10041.

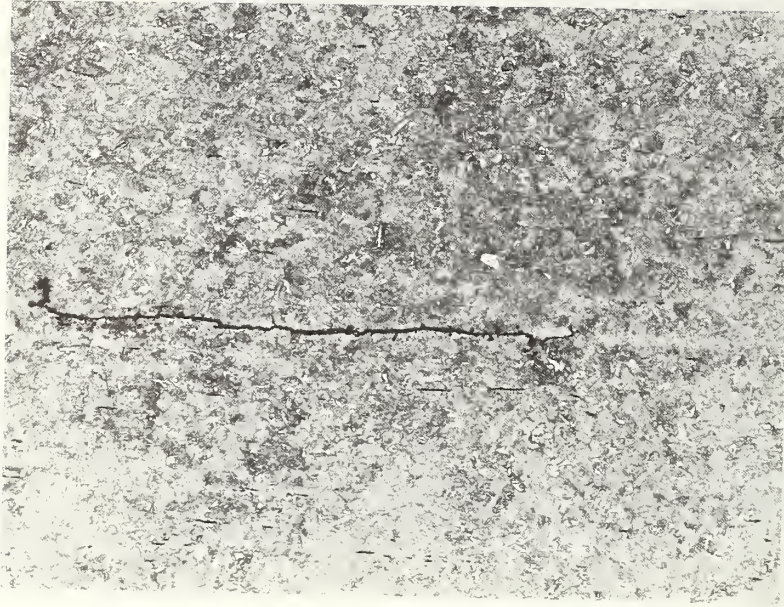
Incipient type L cracks which appear to have originated at radial jogs in a type C crack. This cracking was found in specimen TR-5. (a) As polished section showing cracks, (b) Same section as in 16a after etching with ammonium molybdate.

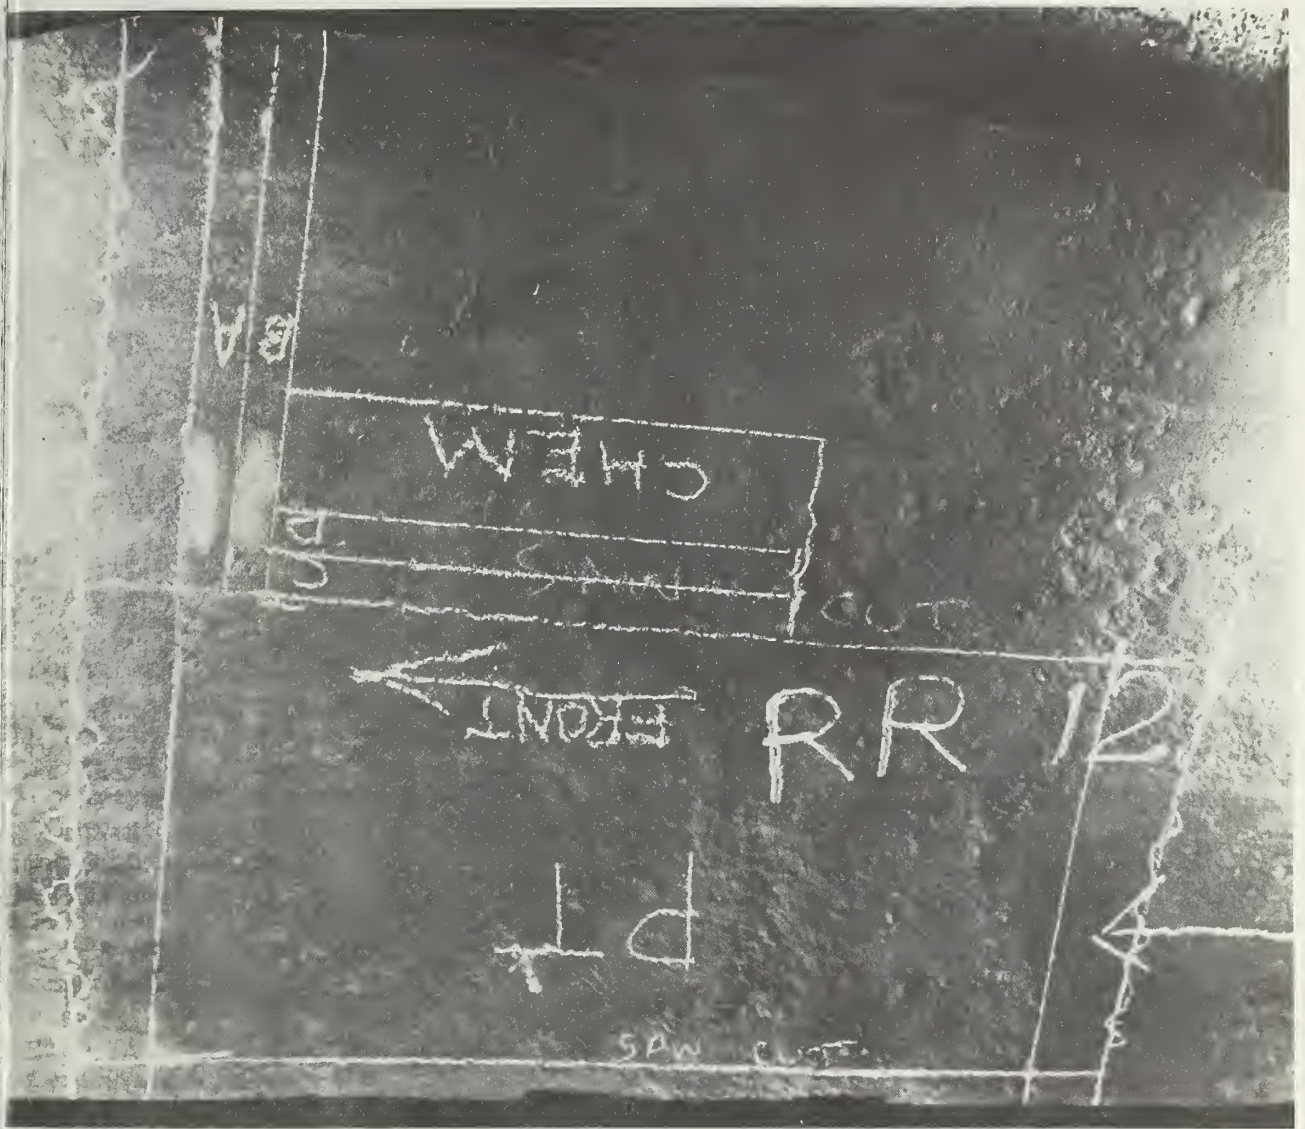
Figure 18a. A portion of piece RR-12 showing the general surface topography of the inside wall near the fracture origin. The fracture origin is along the bottom near the words "saw cut." (Photo courtesy of M. Bolinger, Jr., Gladstone Laboratories, Inc., Cincinnati, Ohio.)
