# **Analysis of the Pneumatic Burst of a Large Seamless Steel Pressure Vessel in Natural Gas Service**

**U.S. DEPARTMENT OF TRANSPORTATION  
MATERIALS TRANSPORTATION BUREAU  
Office of Hazardous Materials Regulations  
Washington, D.C. 20590**

NBSIR 78-1589

Failure Analysis Report

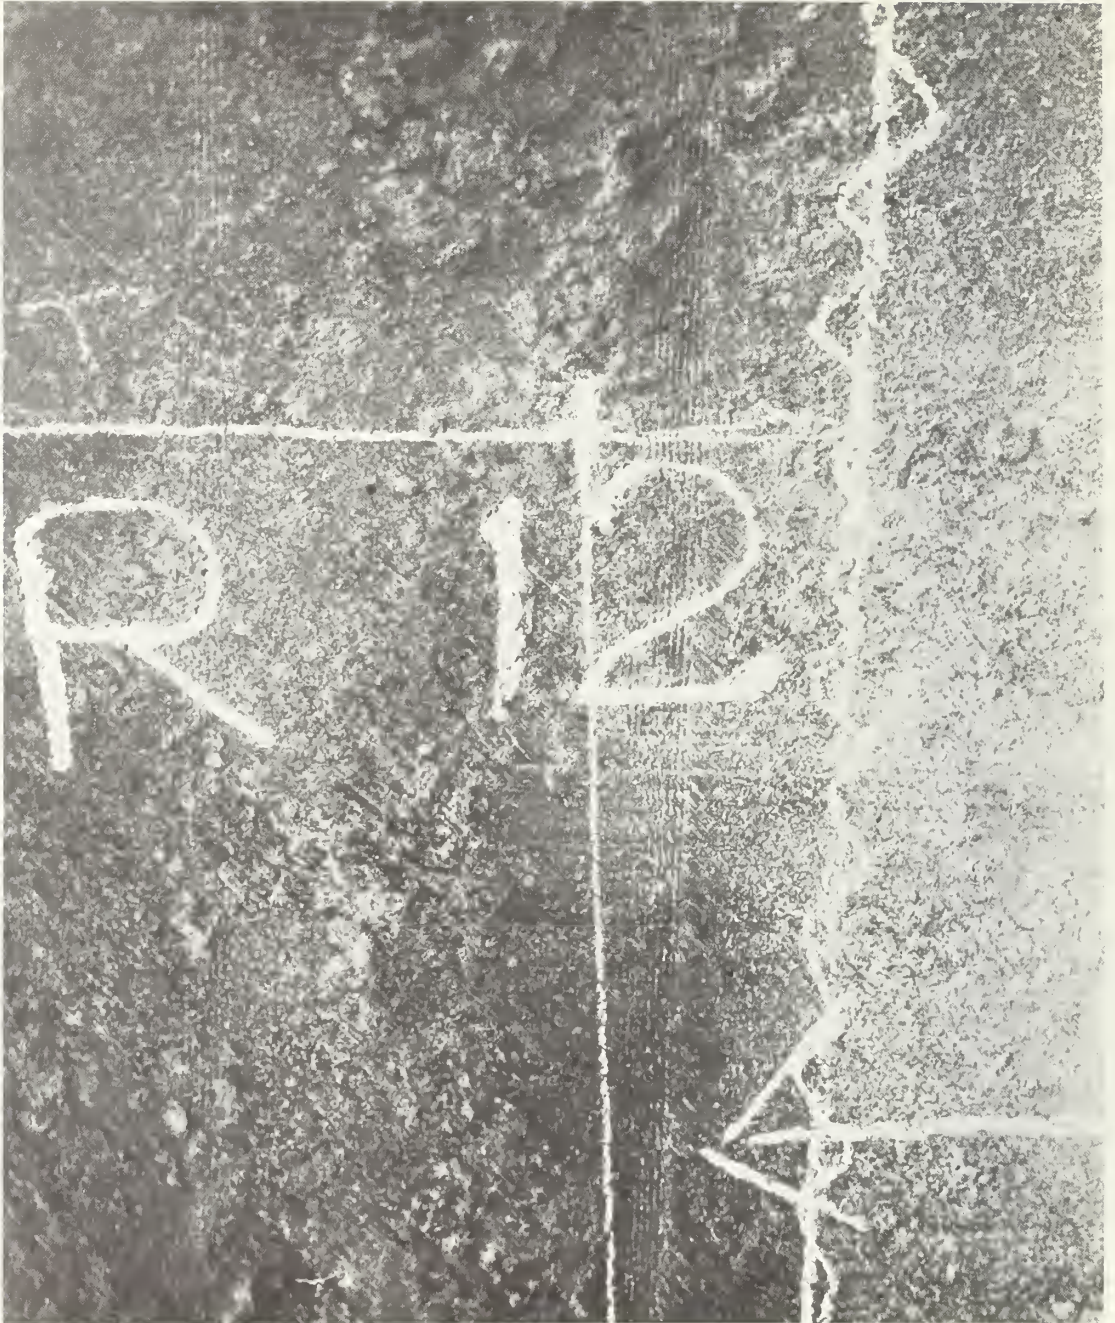
Figure 18b. A view of piece RR-12 showing sets of parallel lines running in the circumferential direction. (Photo courtesy of M. Bolinger, Jr., Gladstone Laboratories, Inc., Cincinnati, Ohio.)

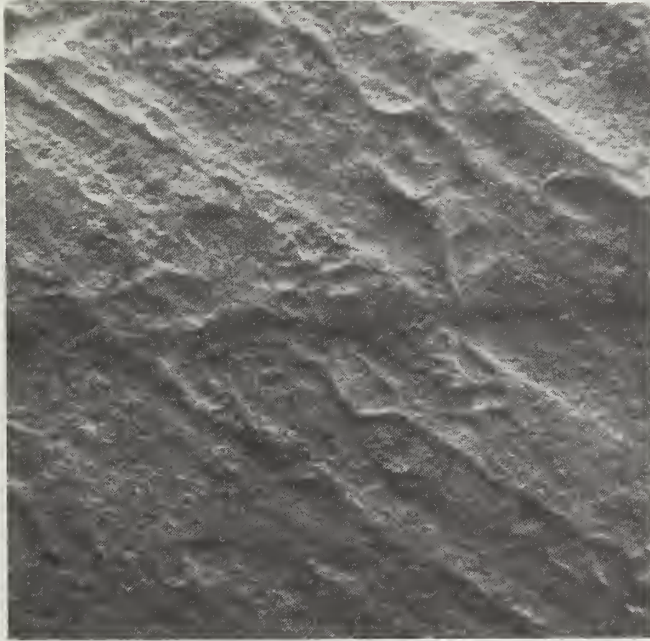
Figure 19. Surface topography of the inside wall of specimen TR-1 near the fracture origin after solution cleaning, showing craters and grinding scratches. (Photo obtained in scanning electron microscope.)

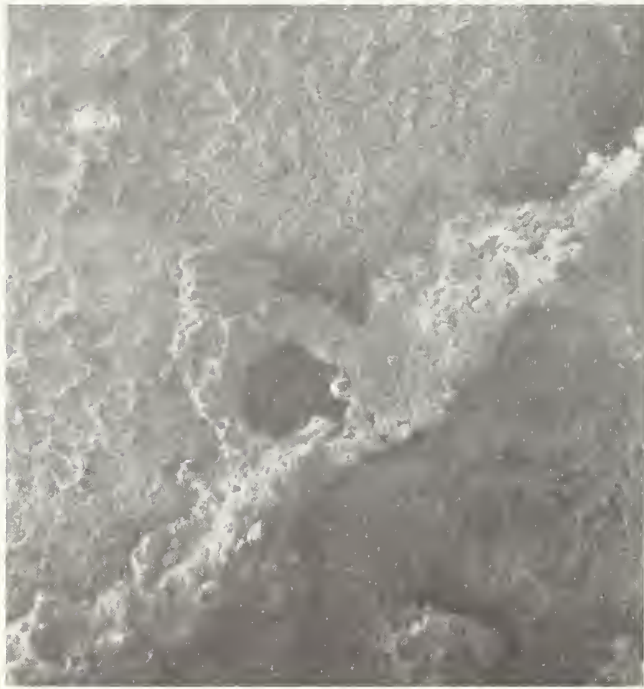
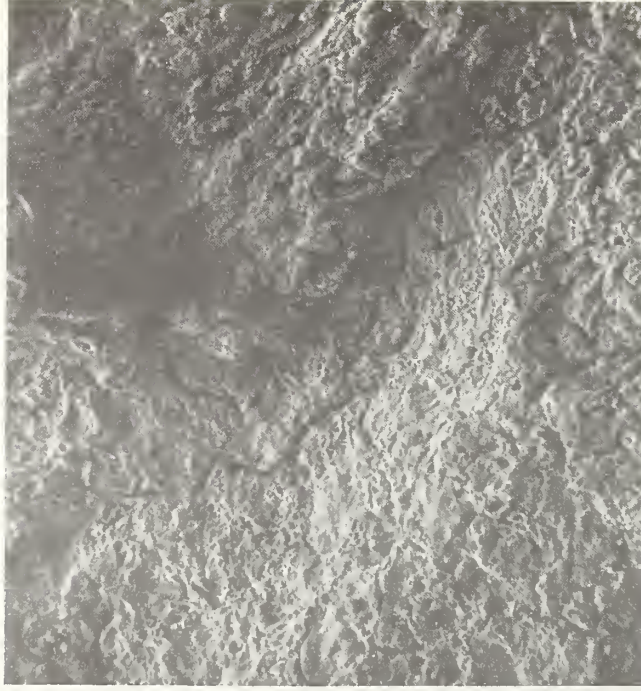
Figure 20. The inside wall of specimen TR-5 near the fracture origin after partial solution cleaning. (a) Low magnification view of uneven regions. (Remaining surface product runs from 2 o'clock to 8 o'clock) (b) Uneven region at higher magnification. (Photo obtained in scanning electron microscope.)

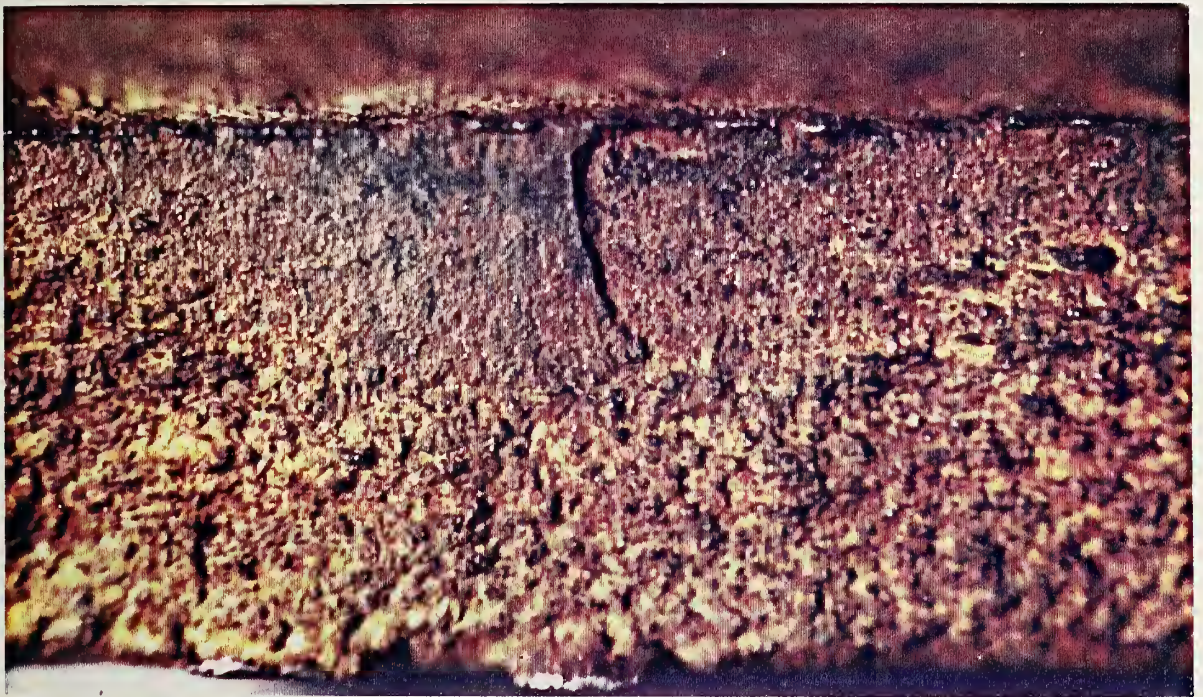
Figure 21. Close-up view of the fracture origin after stripping three cellulose acetate replicas. The black product on the fracture surface became evident as the orange-brown product was stripped away. This view is towards the inside wall.

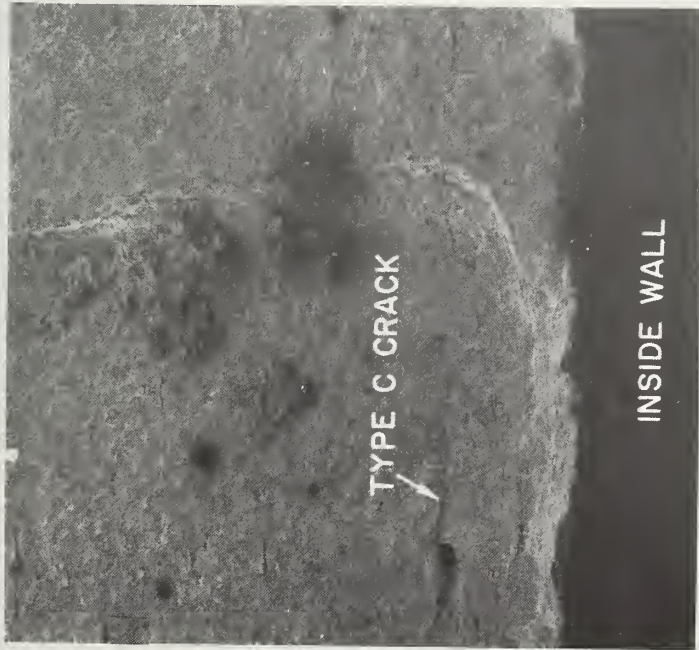
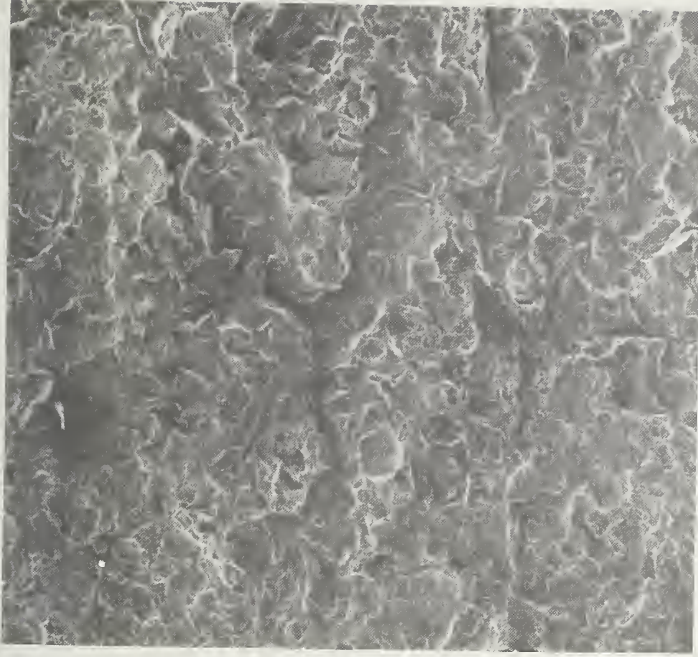
Figure 22. Scanning electron microscope views of fracture origin after cleaning with buffered HCl solution. (a) Region of step, showing a type C crack, (b) Region away from step, showing "plateaus and valleys" structure.

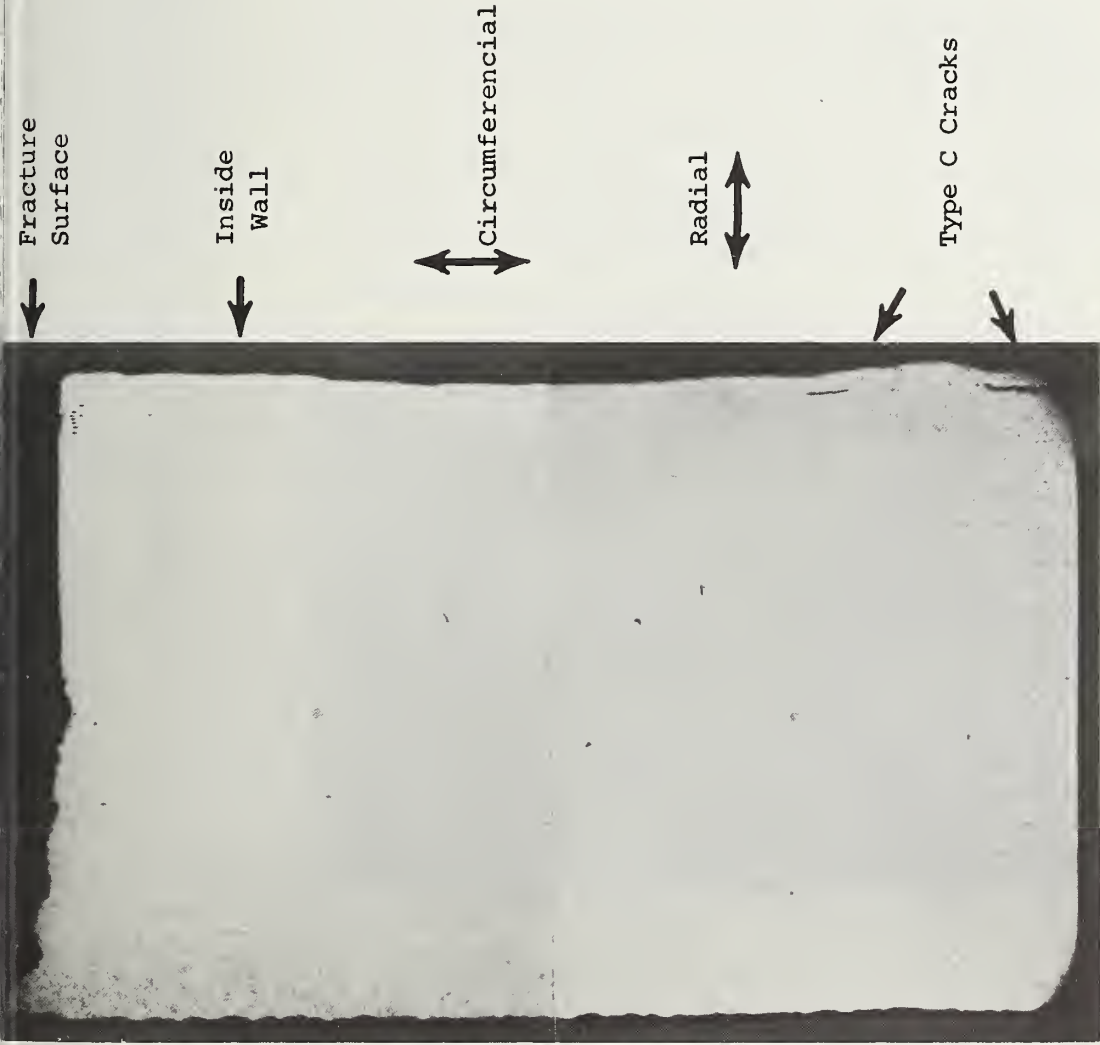
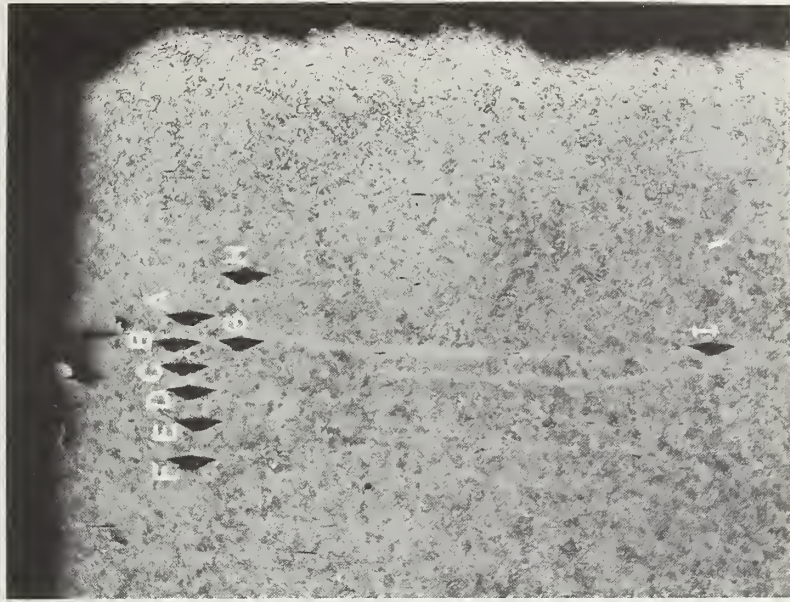
Figure 23. Transverse section through fracture origin. (a) Full thickness view, showing extremely flat fracture surface at origin and two type C cracks in banded region near inside wall. A 45° shear lip appears at the outside wall. (b) Close-up view of the region of the microhardness indentations at the top right in Figure 23a.

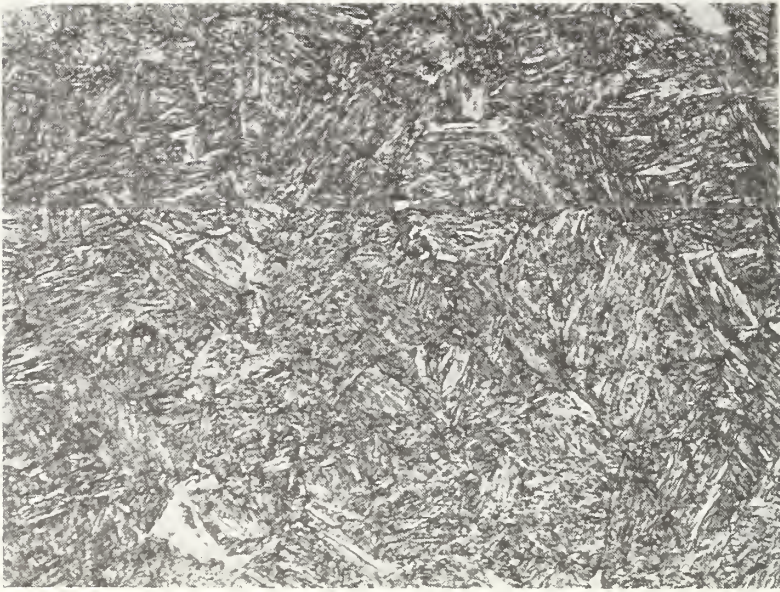
Figure 24. Typical microstructure of tempered bainite found in cylinder 9959.  
Etchant: Picral 1000X

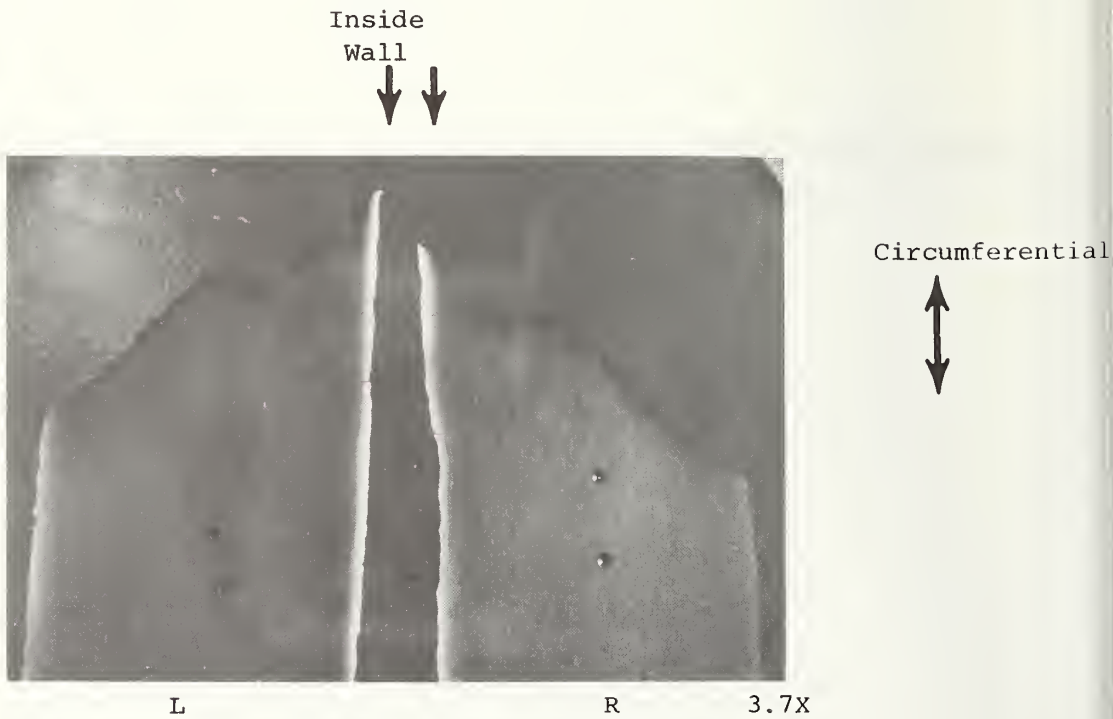
Figure 25. Transverse sections from ends of the segment from piece RR-12 shown in Figure 7c.
