Div. 562
NBSIR 80-1985R

FILE COPY
DO NOT REMOVE

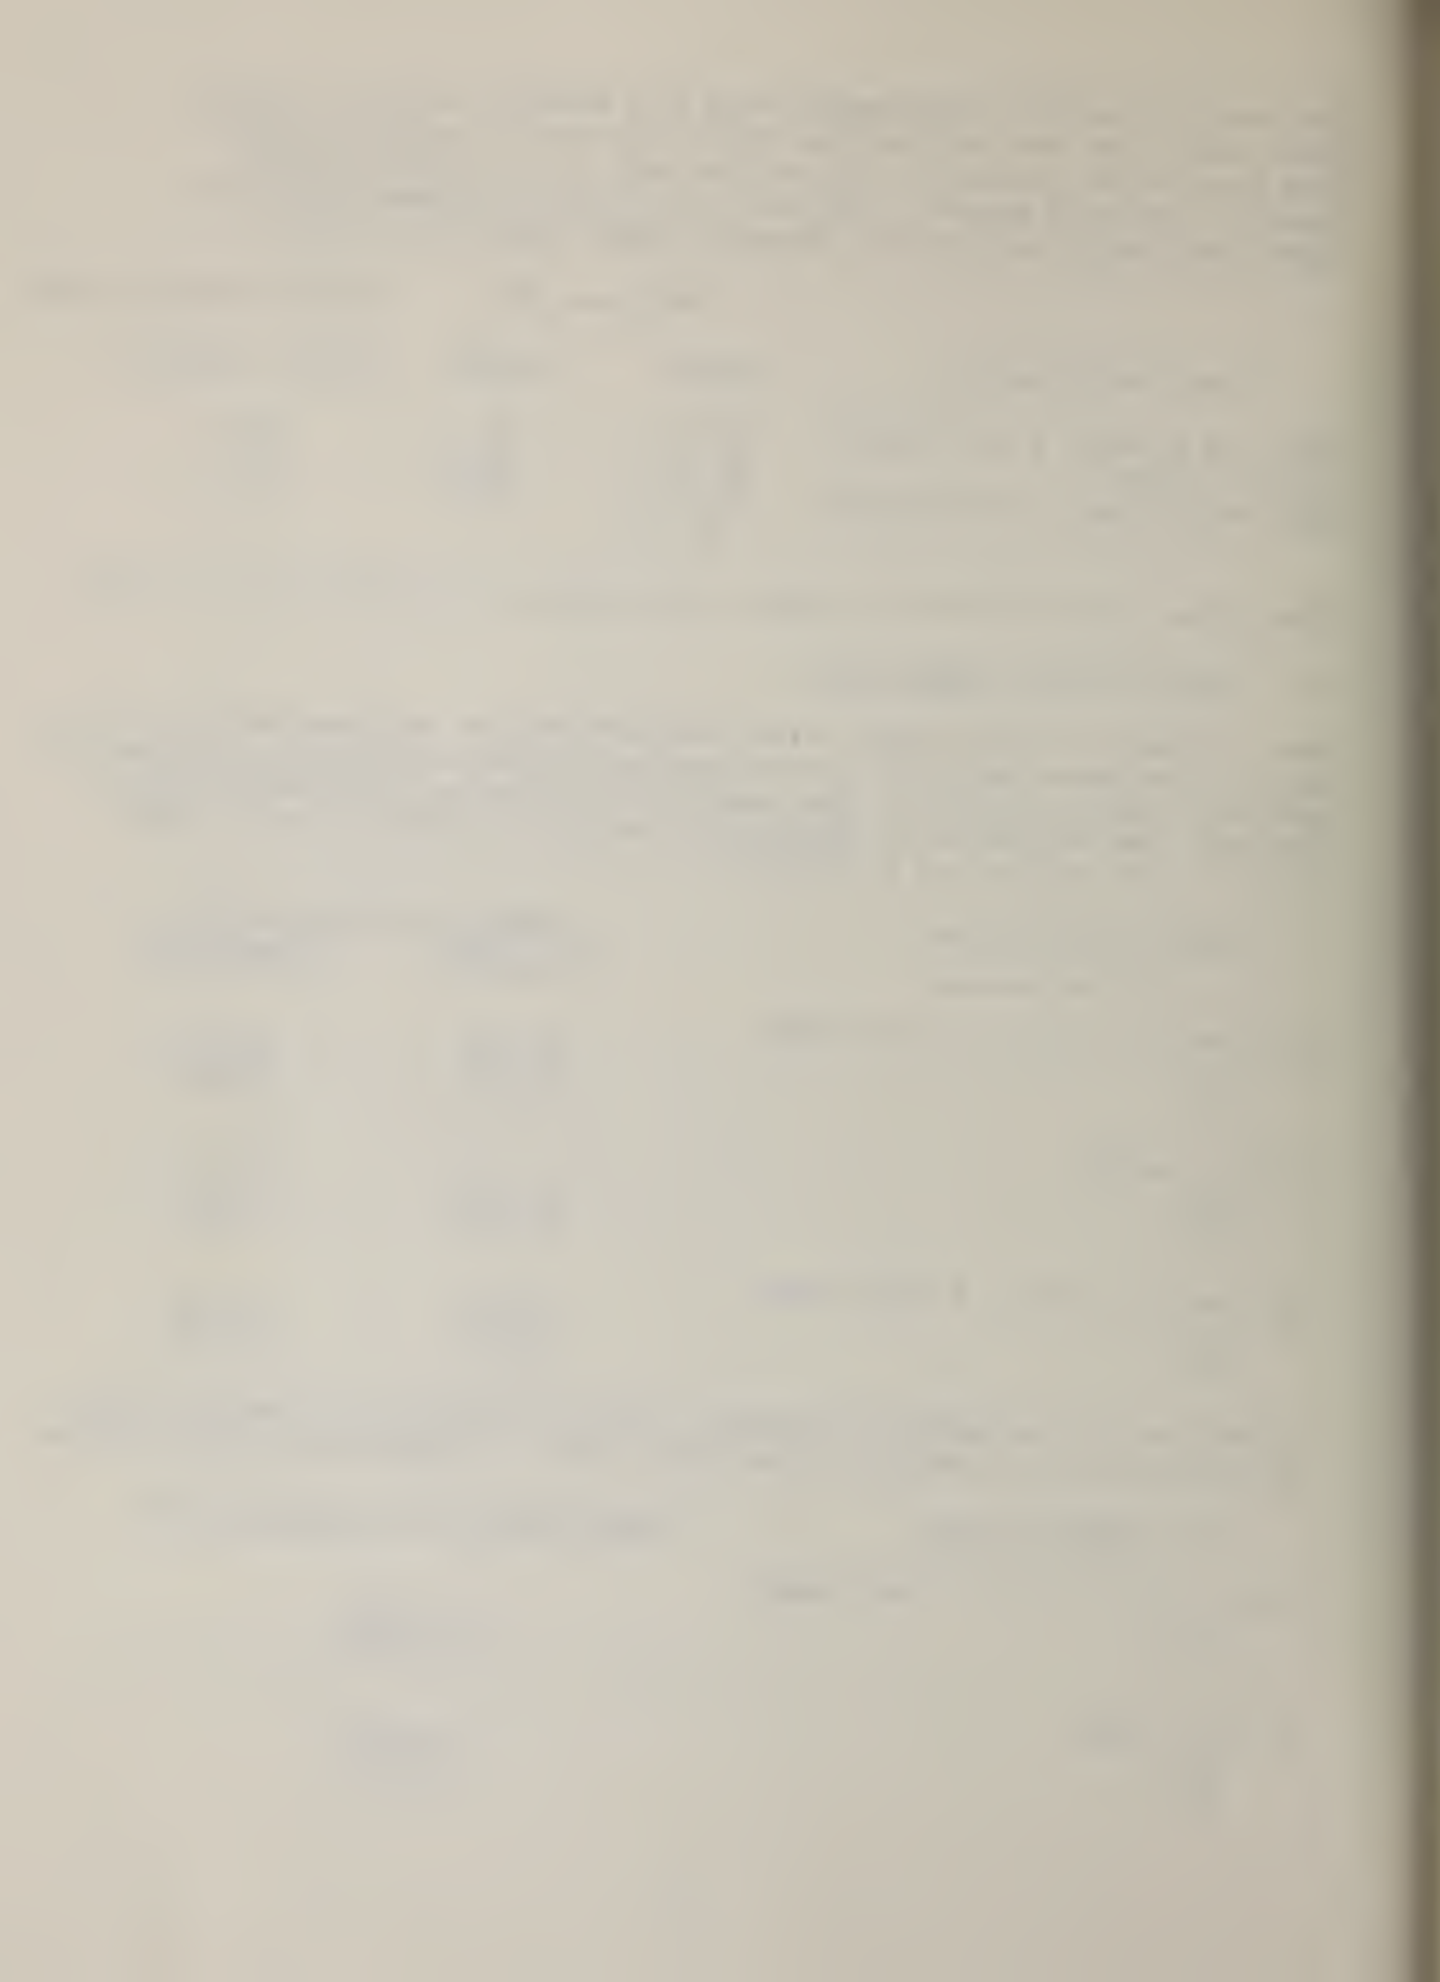
East end of 16 foot, 9 inch length

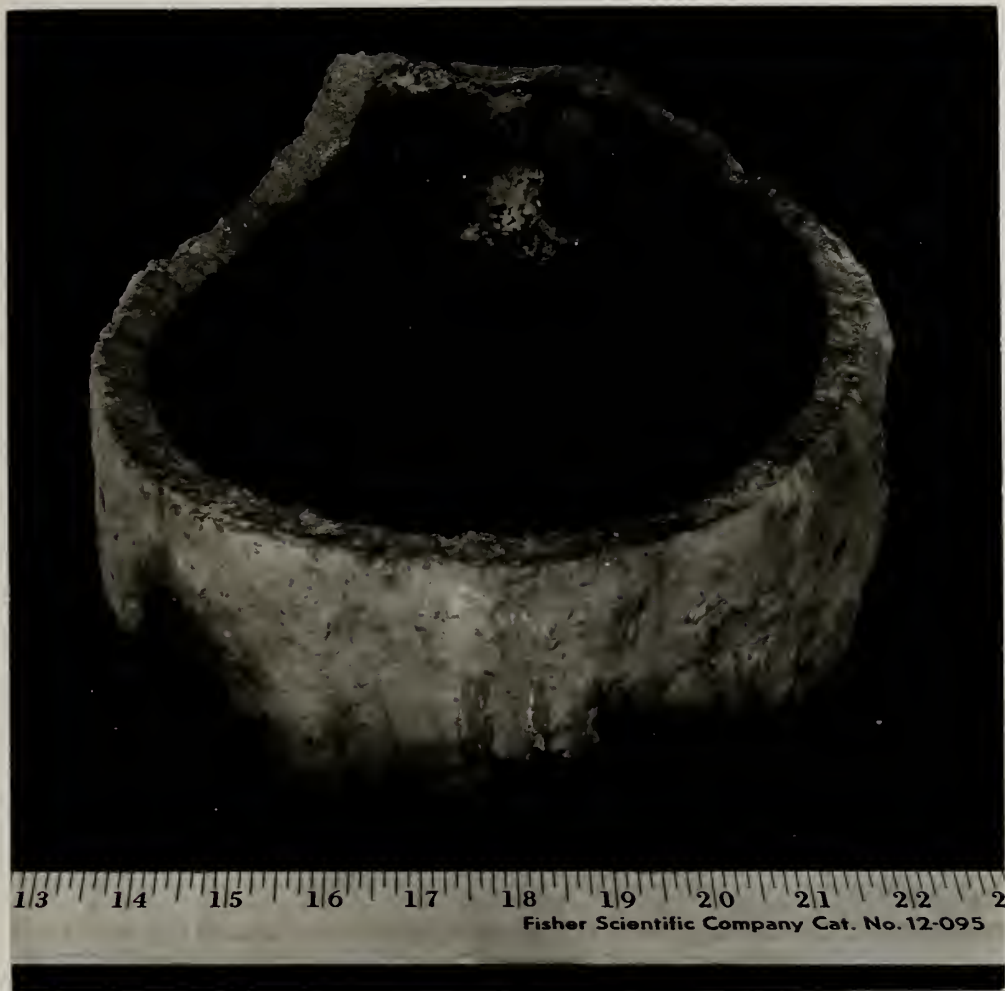
Figure 1. Piece of eight inch diameter gray cast iron gas pipe containing one face of the fracture from the 16 foot, 9 inch length of pipe. The piece of pipe is shown as received at NBS. What was reported to be the top of the pipe as it was oriented in service is at the bottom in the figure. x 1/2

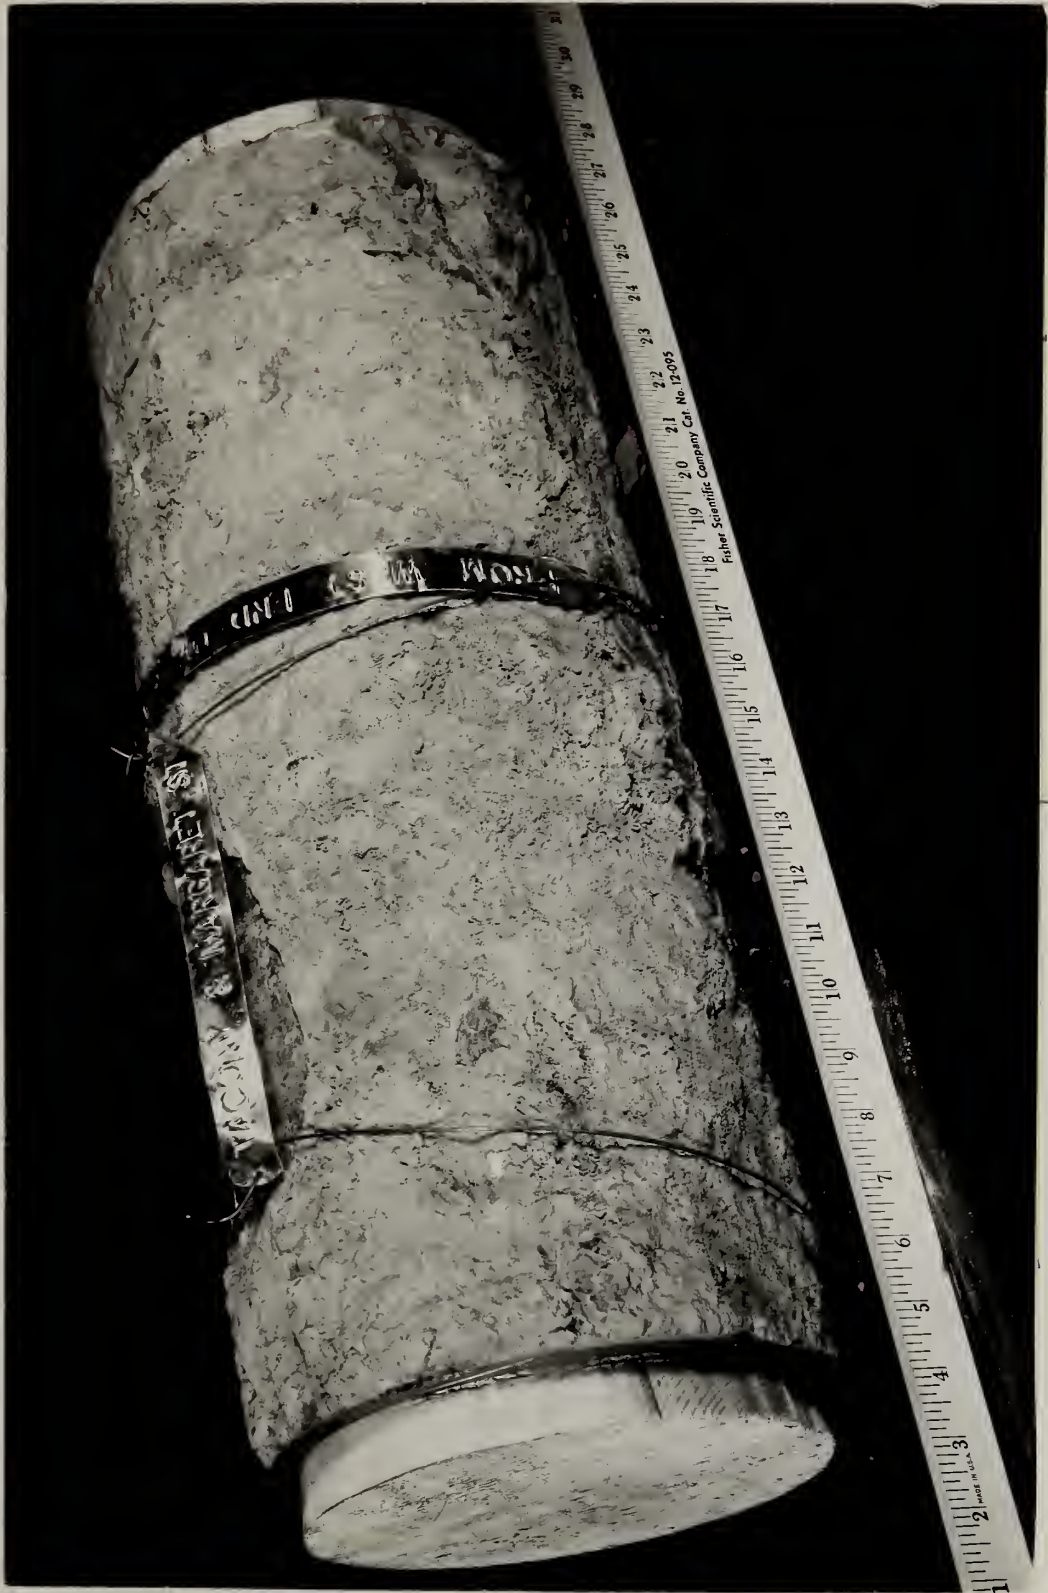
Figure 2. Two-foot length of pipe identified as being from west end of 16 foot, 9 inch length as received at NBS. This length did not contain a fracture. X 1/3

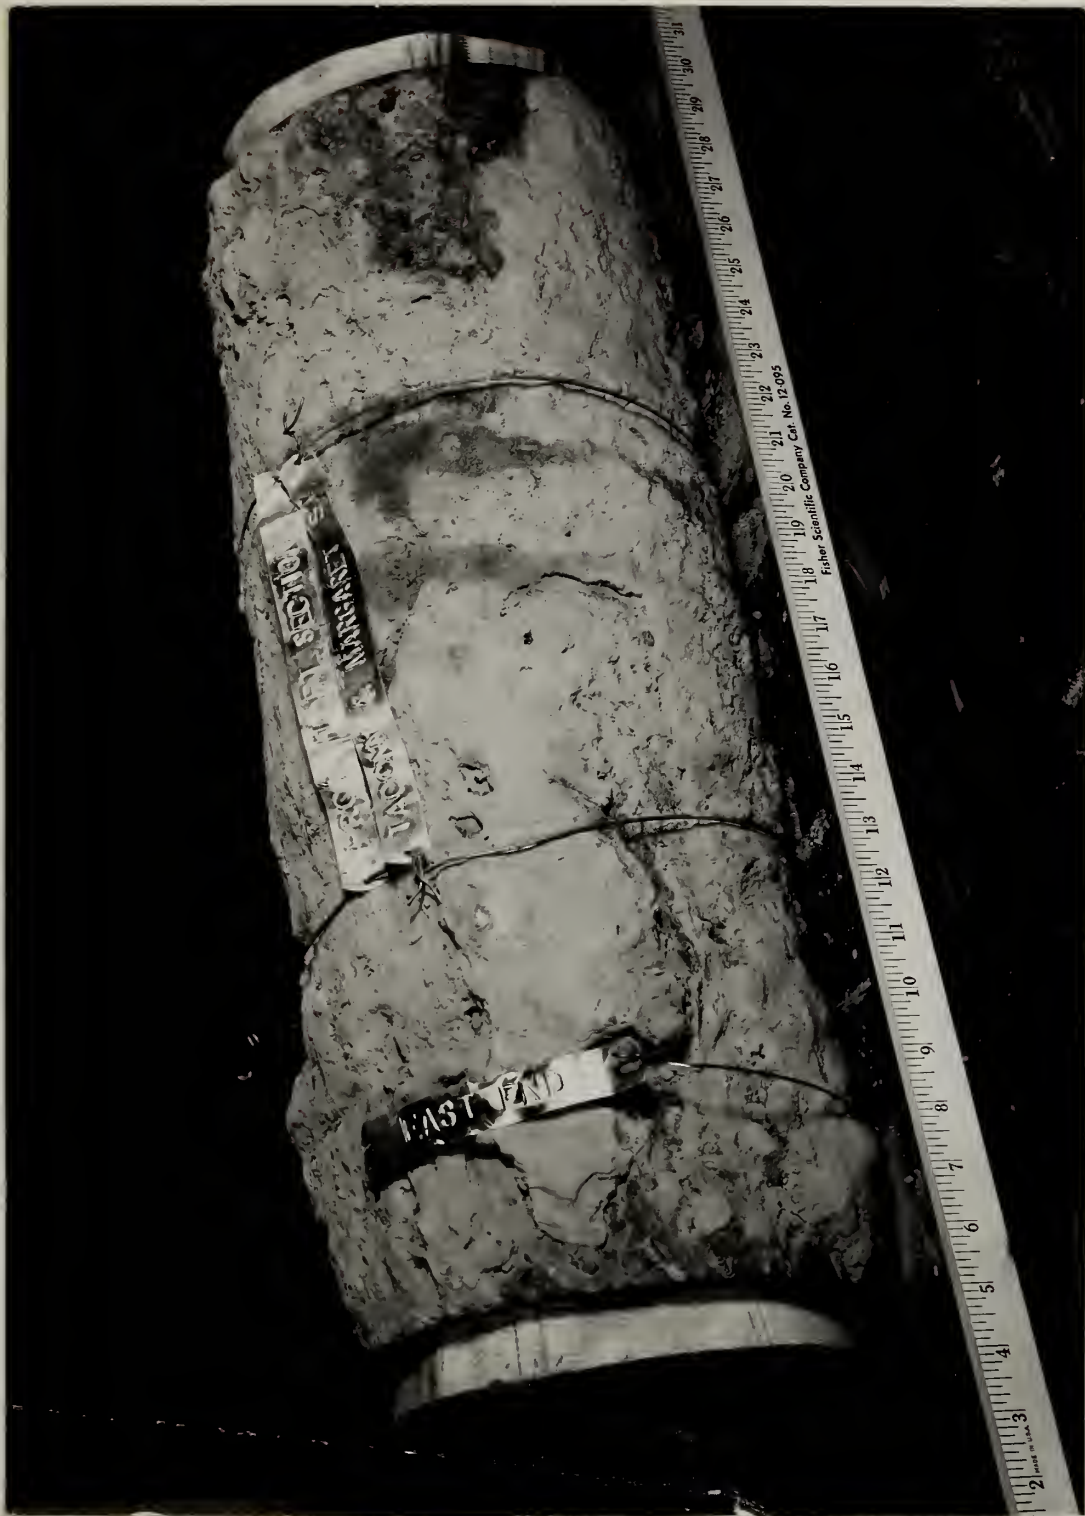
Figure 3. Two-foot length of pipe identified as being from the 11 foot length as received at NBS. This length did not contain a fracture. X 1/3

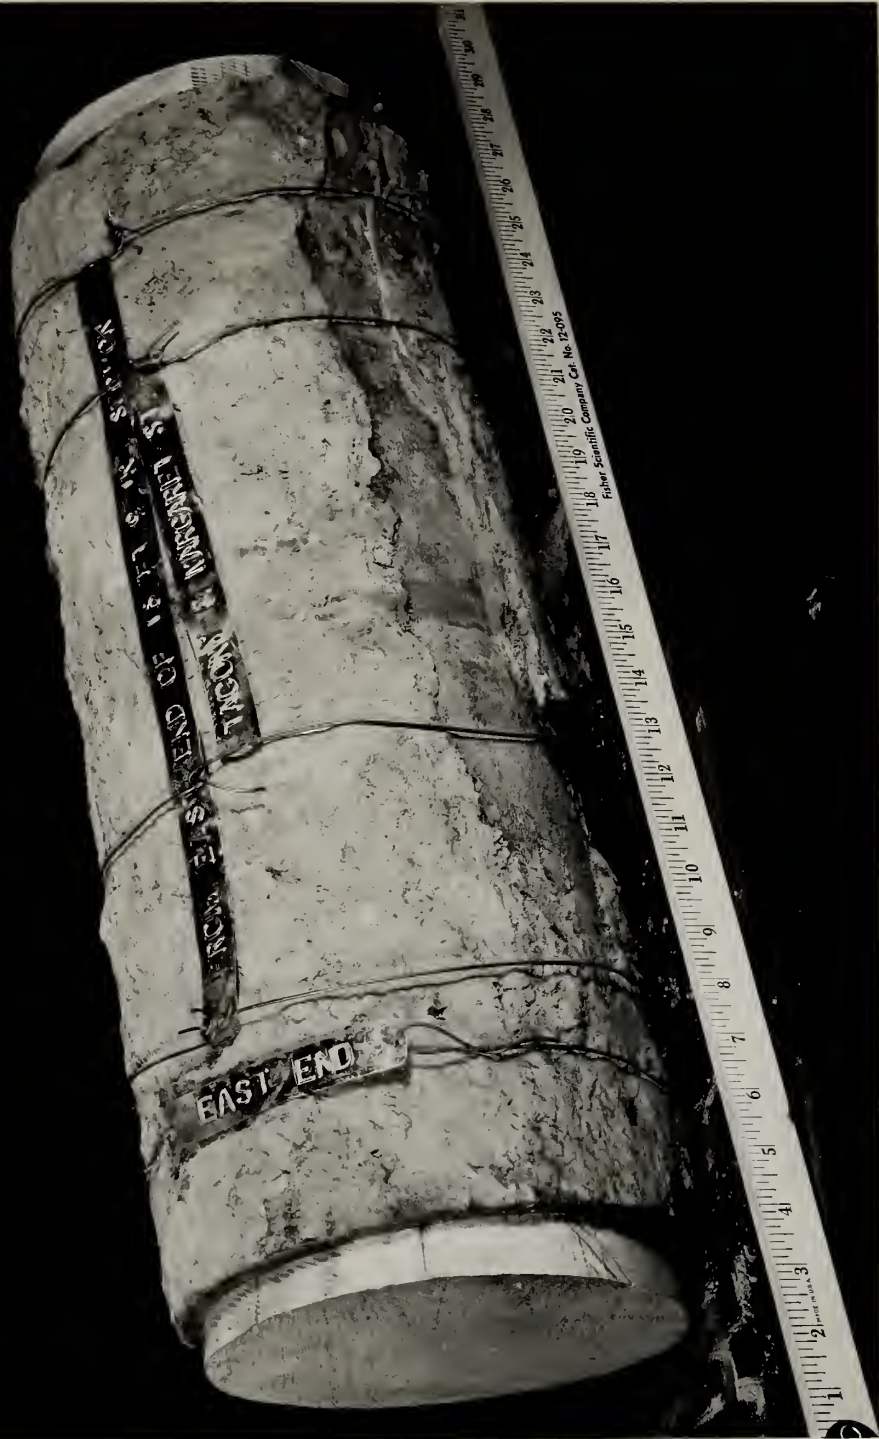
Figure 4. Two-foot length of pipe identified as being from east end of 16 foot, 9 inch length as received at NBS. This length did not contain a $\frac{1}{3}$ X fracture.

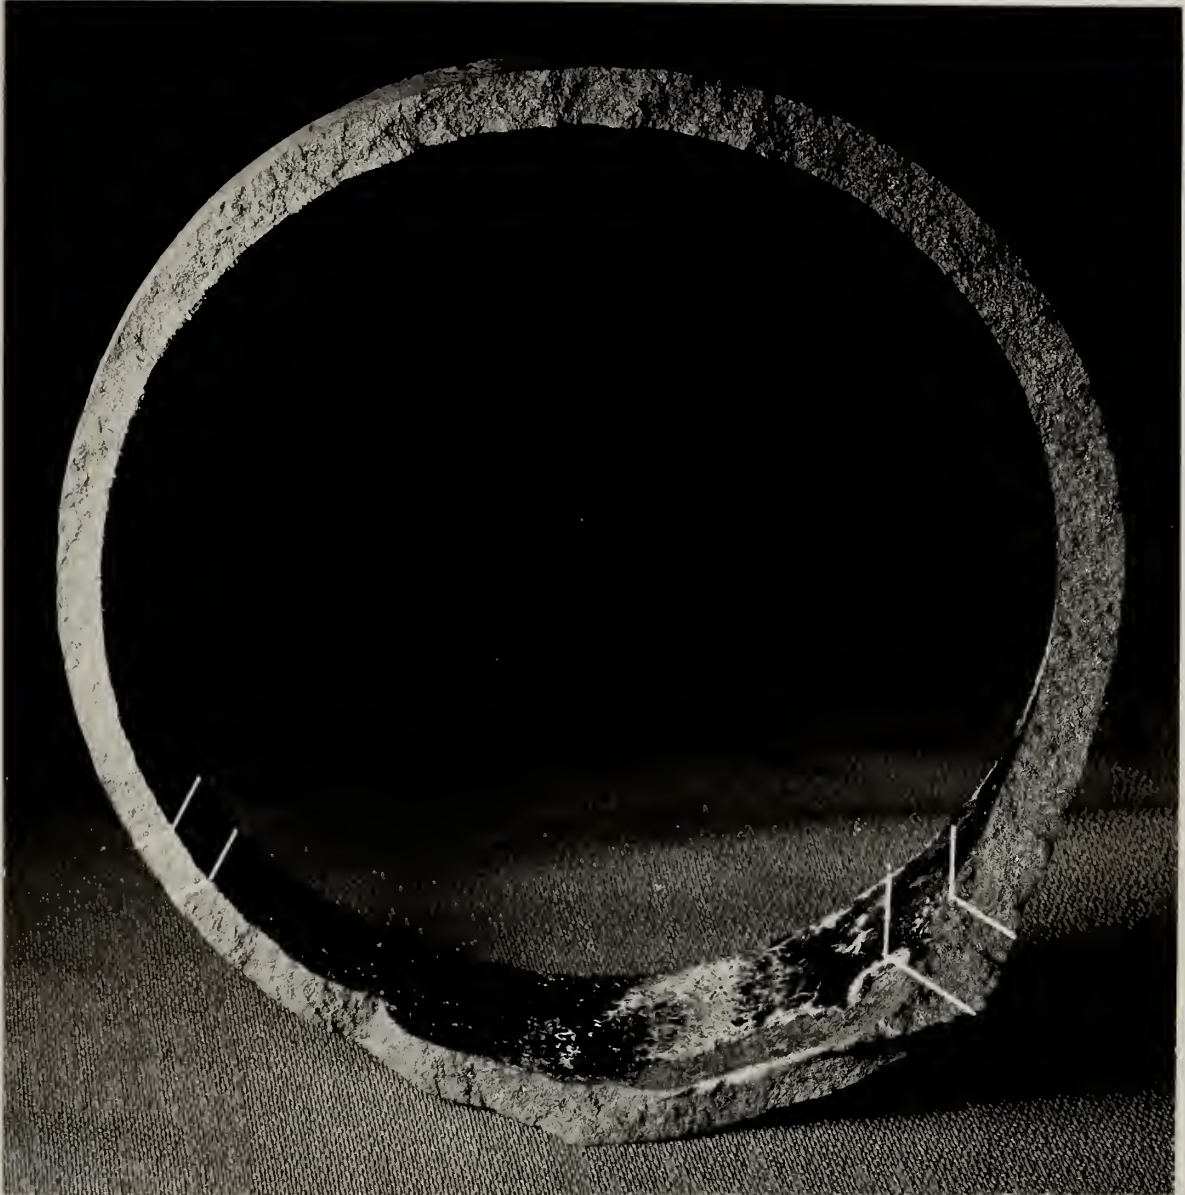
Figure 5. Fracture surface after cleaning. What was reported to be the top of the pipe as it was oriented in service is at the top in the figure.

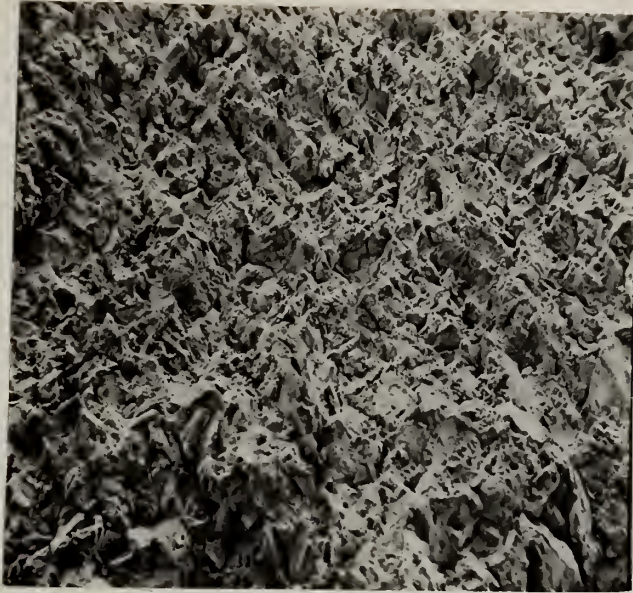
Figure 6. SEM fractograph showing representative features of the fracture surface. X 19

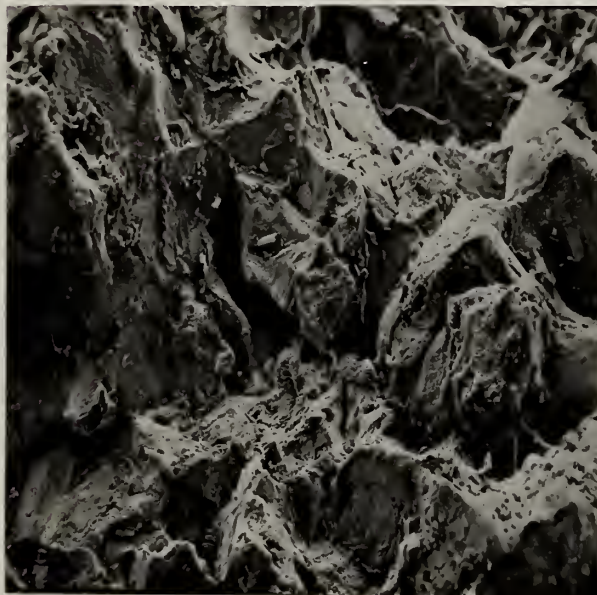
Figure 7. SEM fractograph at higher magnification than in figure 6. Cleavage is the predominant fracture mode. There is some evidence of rather mild corrosive attack. X 107

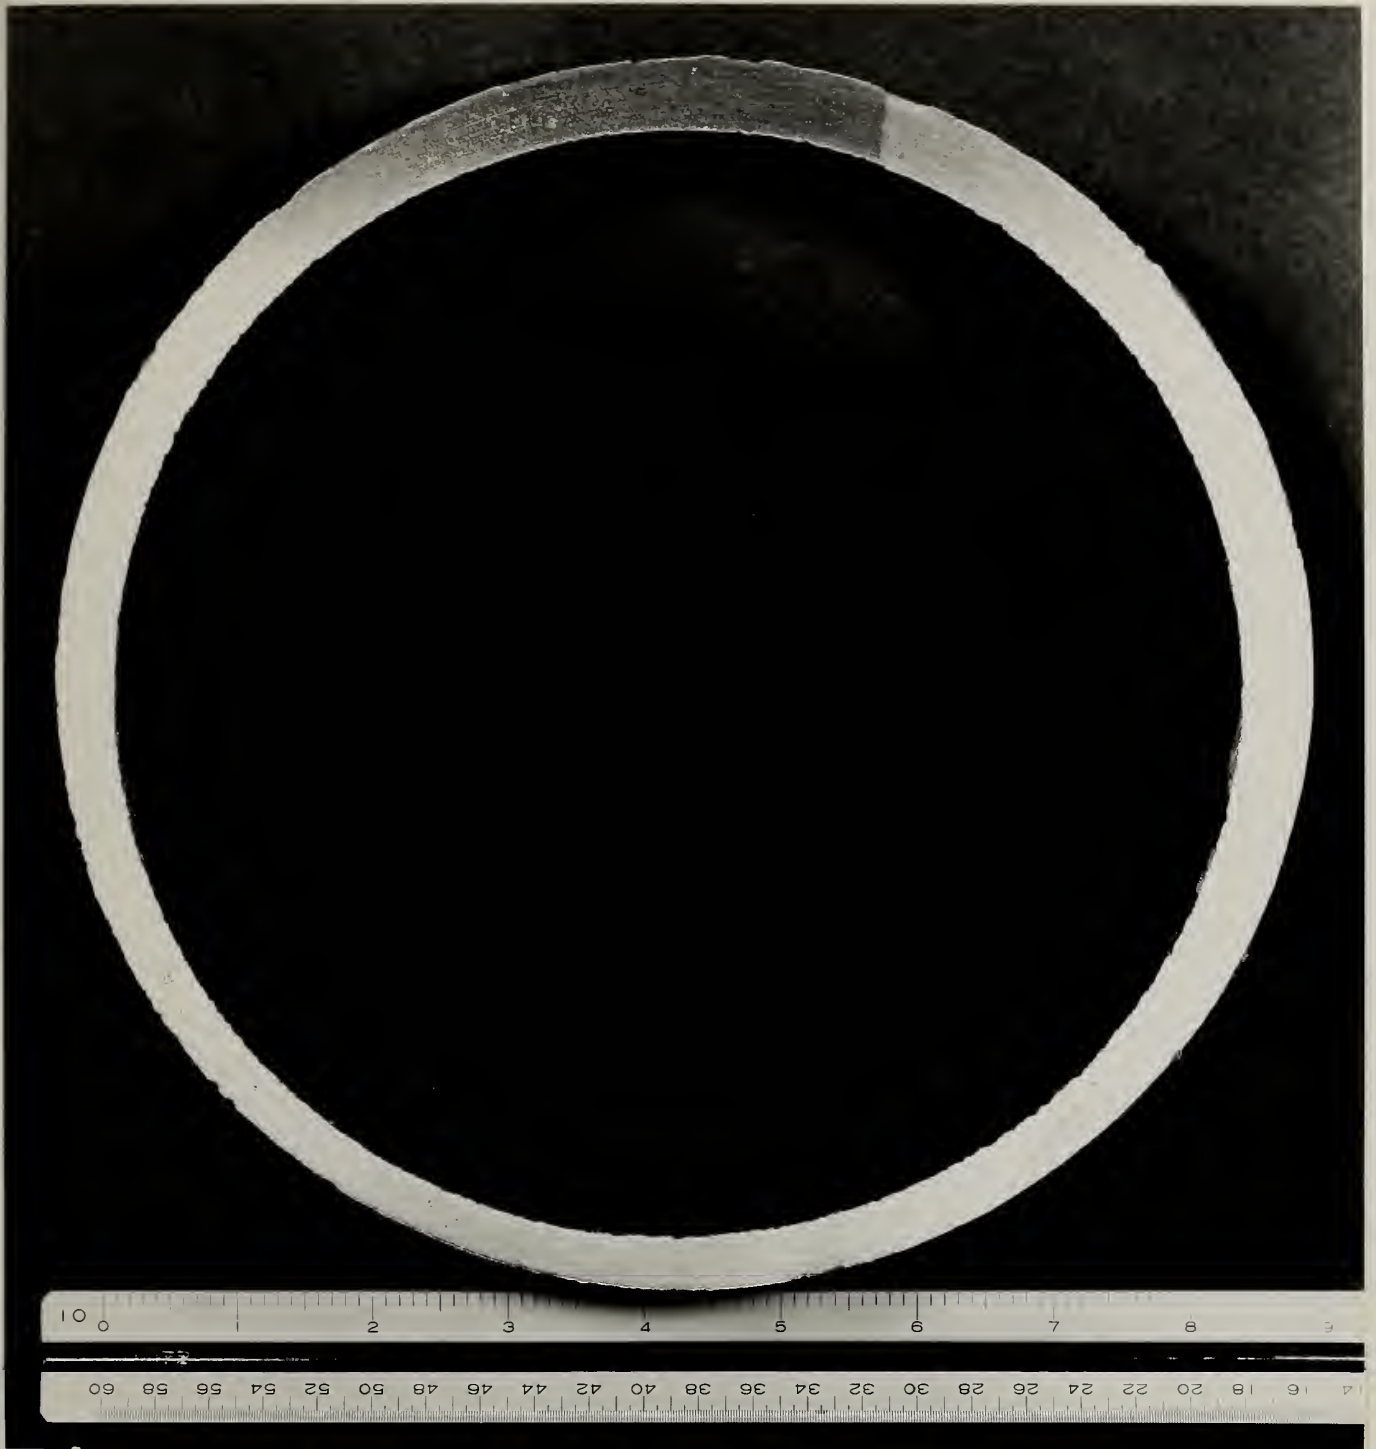
Figure 8. Polished transverse section through the piece of pipe shown in figure 1 ranging from 1/4 to 2 inches from the fracture. No significant graphitization is evident at this section. X 0.8

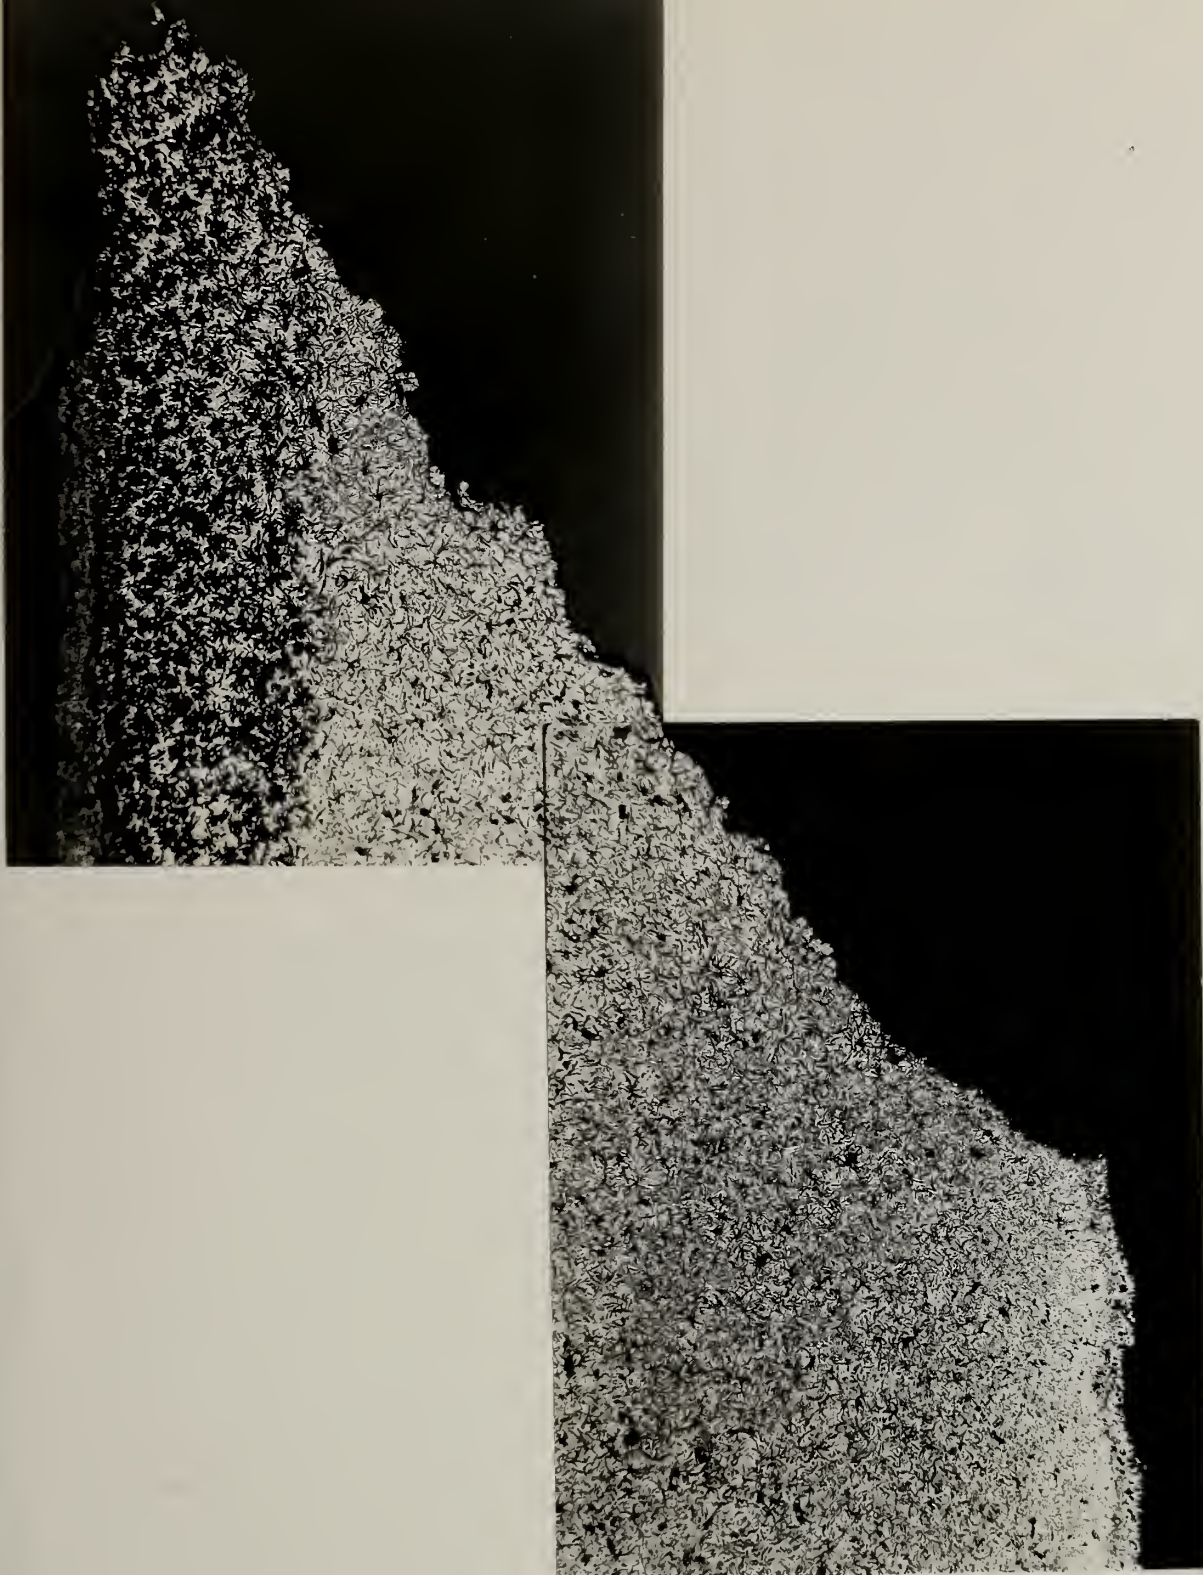
Figure 9. Etched longitudinal section intersecting the fracture at the location indicated at the lower right in figure 5. The fracture profile runs at about 45° from the upper left to the lower right. The outside pipe wall is vertical at the left and the inside pipe wall is vertical at the right. Some graphitization can be seen adjacent to the outside wall surface.

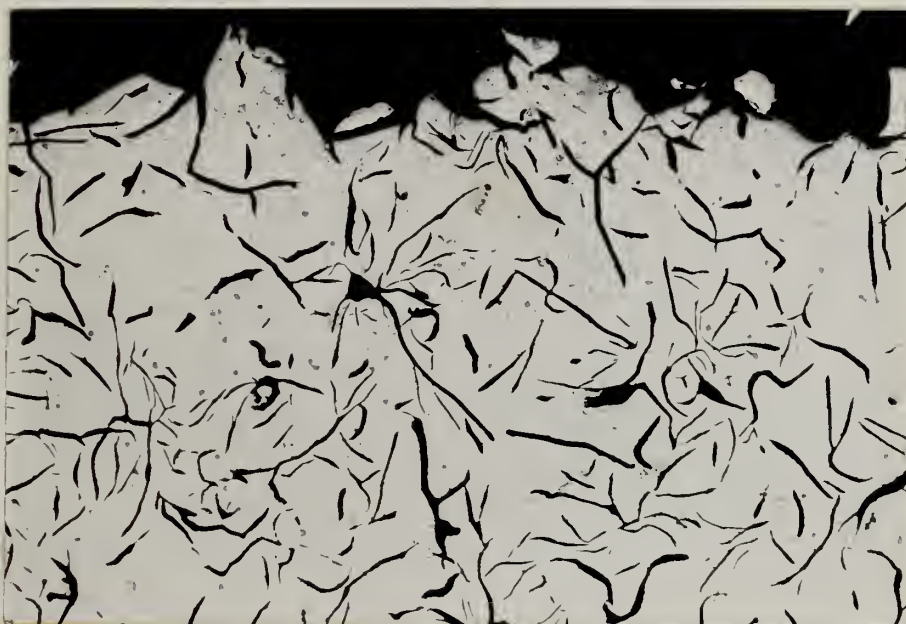
Figure 11. Unetched longitudinal section showing the fracture profile horizontally at the top. The field shown is not adjacent to either the inside or the outside wall of the pipe. The graphite flakes are present in a type A distribution.
As polished X 100

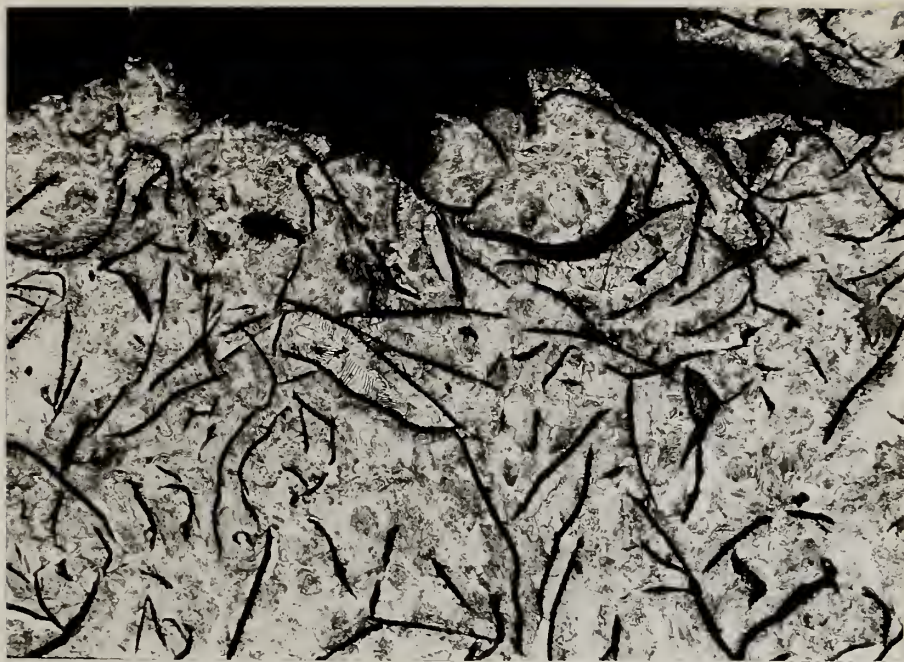
Figure 12. Etched longitudinal section showing the fracture profile horizontally at the top. This microstructure is representative of the material except for a region adjacent to the inside wall.
Etchant: 1% nital X 100

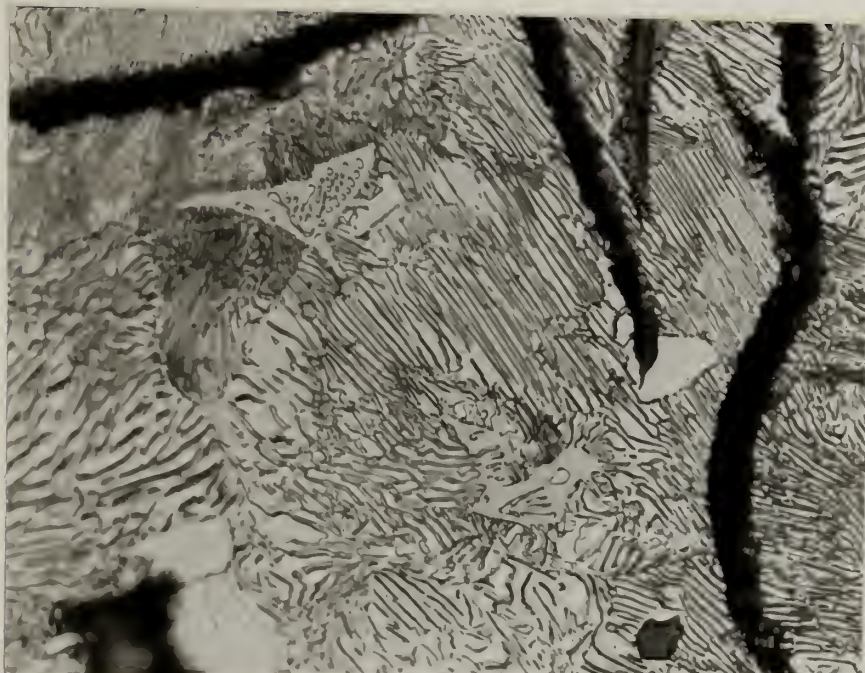
Figure 13. Etched longitudinal section showing representative microstructure of the pipe material except for the region adjacent to the inside wall. This figure is at a much higher magnification than figure 12. The microstructure consists of graphite flakes, pearlite (finger-print pattern), ferrite (light gray patches), and what is probably steadite (small rounded region within the ferrite patches).
Etchant: 1% nital X 1000

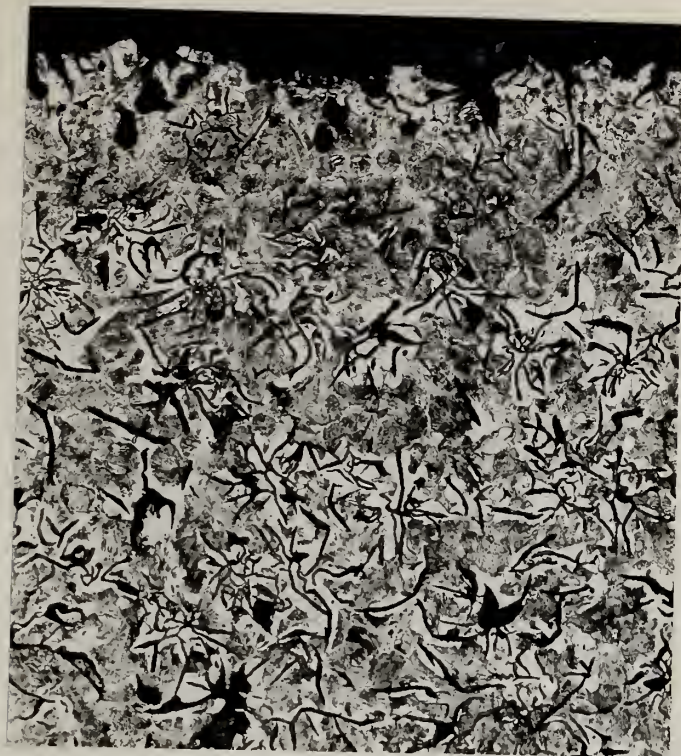
Figure 14. Etched longitudinal section showing the fracture profile horizontally at the top. The field shown is representative of the microstructure adjacent to the inner wall of the pipe. Etchant: 1% nital X 100

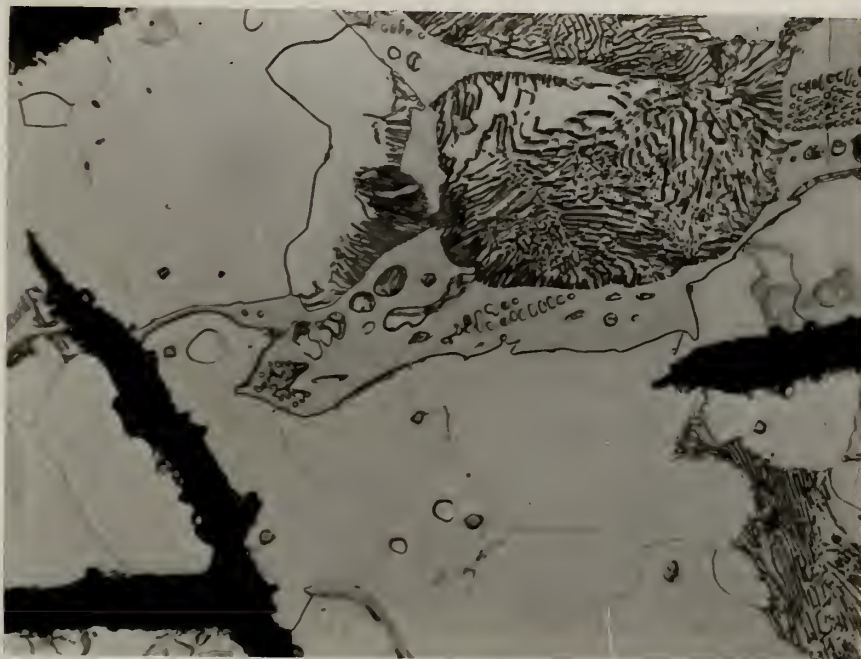
Figure 15. Etched longitudinal section showing the representative microstructure adjacent to the inner pipe wall surface. This figure is at a much higher magnification than figure 14. The microstructure consists of graphite flakes, pearlite, ferrite and what appears to be steadite. Etchant: 1% nital X 1000
