NBSIR 80-2036R

Examination of Failed Six-Inch Diameter Cast-Iron Pipe Water Main, Philadelphia, Pennsylvania

Failure Analysis Report

Prepared for
National Transportation Safety Board
Washington, D.C. 20594

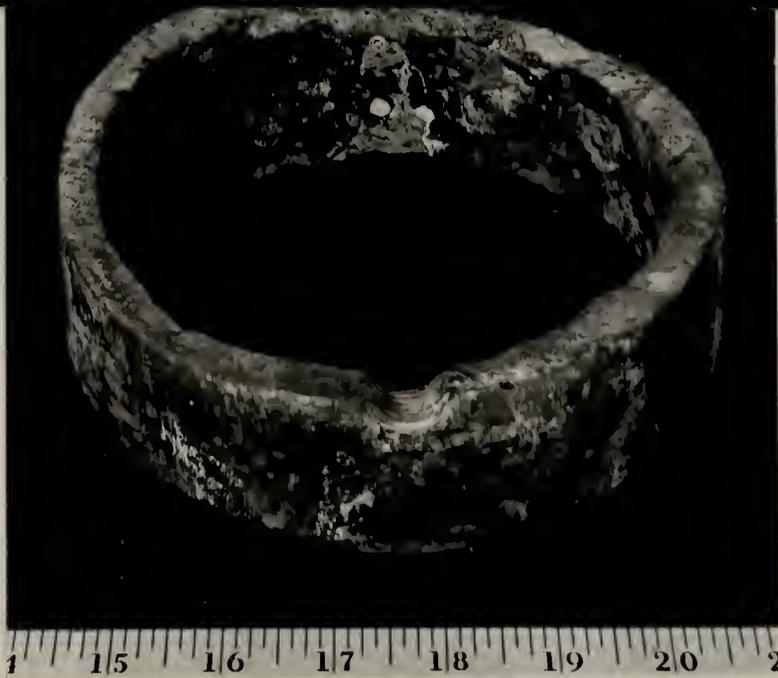
Pieces of the water main pipe containing one fracture face from each of the three fractures were submitted to NBS for examination. The parts, designated W1, W2, and W3, are shown as received at NBS in figures 1, 2, and 3, respectively. The pieces shown in figures 1 and 2 were complete, intact transverse sections. The pieces shown in figure 3 (W3) were from a transverse section that included the end of the pipe length. It was reported that this section was fractured longitudinally into the three pieces shown while being removed from the adjoining pipe length. The fracture in W1 passed through the approximate center of a service tap hole in the pipe.

One of the fractures passed through the approximate center of a service tap hole in the pipe. This tap hole would have reduced the cross section of the pipe in the plane of the fracture which, in turn, would reduce the load carrying capacity of the pipe somewhat at this location. A significant amount of graphitization was found adjacent to the fractures.

Figure 1. Piece of submitted pipe designated W1 as received at NBS showing the fracture surface. The fracture passed through a service tap hole. X 2/3

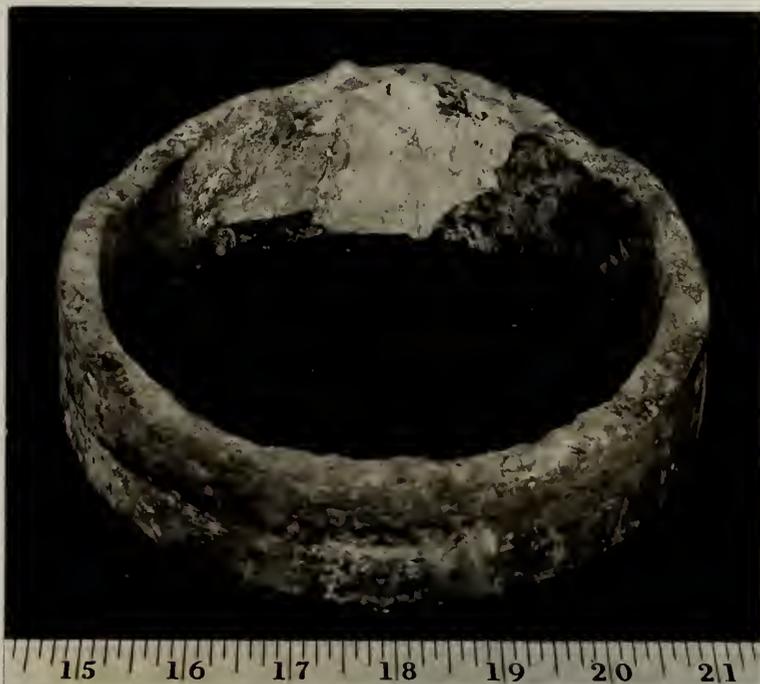
Figure 2. Piece of submitted pipe designated W2 as received at NBS showing the fracture surface. X 2/3

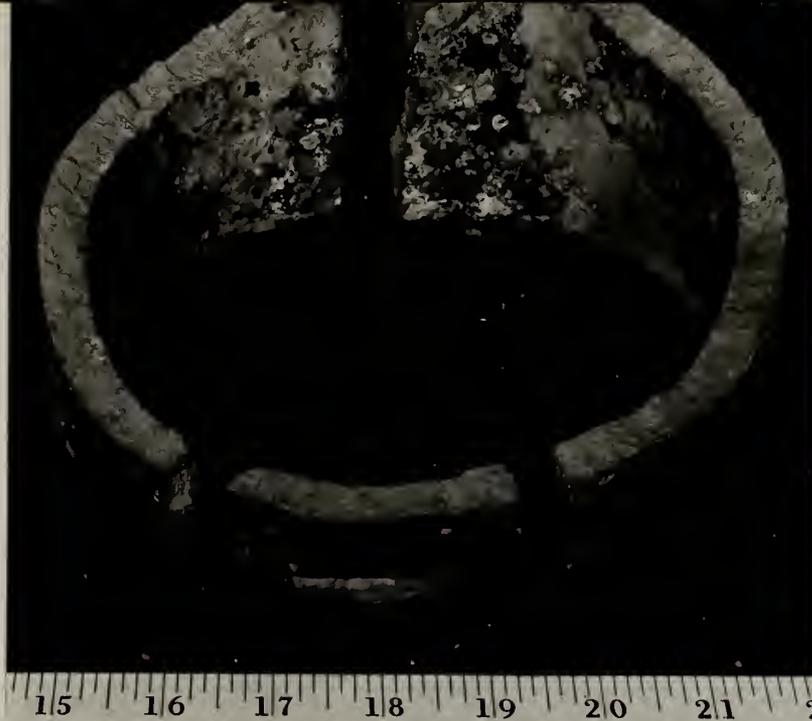
Figure 3. Pieces of submitted pipe designated W3 as received at NBS showing the fracture surface. These pieces had formed a continuous transverse section which was fractured longitudinally into three pieces in the field when it was removed from the adjoining pipe length. X 2/3

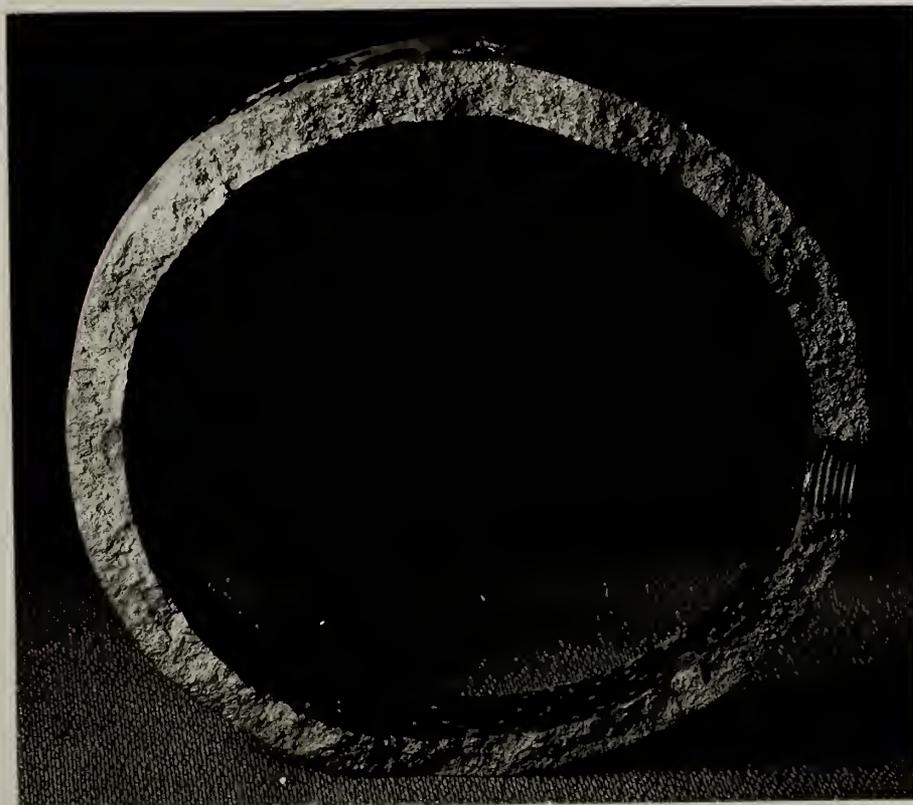
All three fracture surfaces were covered with corrosion product. The fracture surfaces were cleaned ultrasonically at the same time the pipe walls were cleaned. Some of the corrosion product adhered tightly to the fracture surfaces, and much of it remained on the surfaces after cleaning. The fact that the corrosion product was difficult to remove indicates that the pipe had probably been broken for some time. The cleaned surfaces of fractures W1, W2, and W3 are shown respectively in figures 4, 5, and 6.

Figure 4. Fracture surface W1 after cleaning. X 2/3

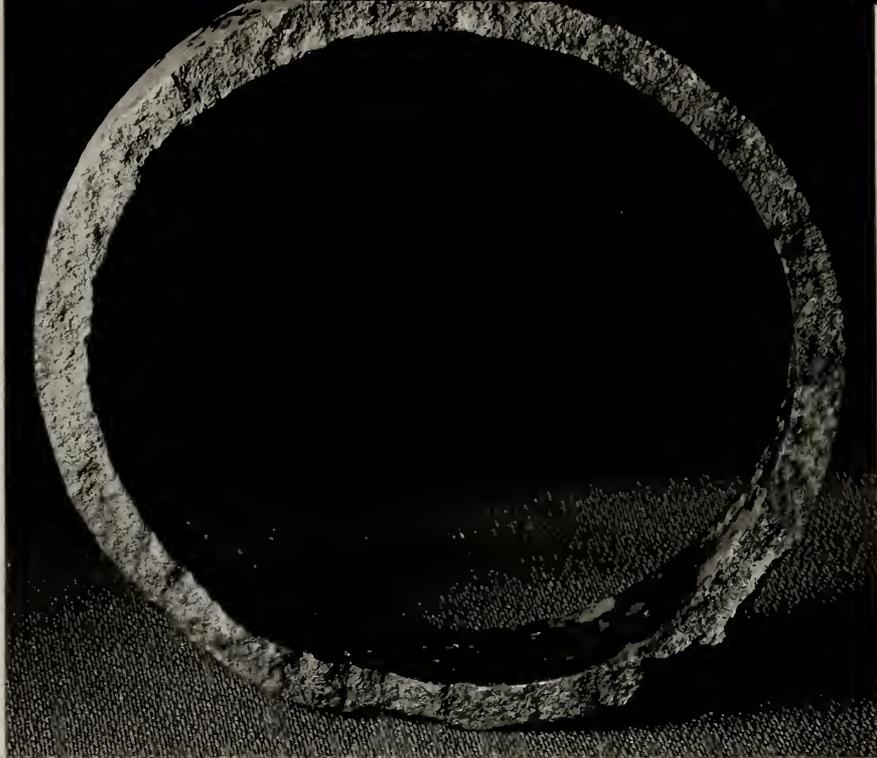
Figure 5. Fracture surface W2 after cleaning. X 2/3

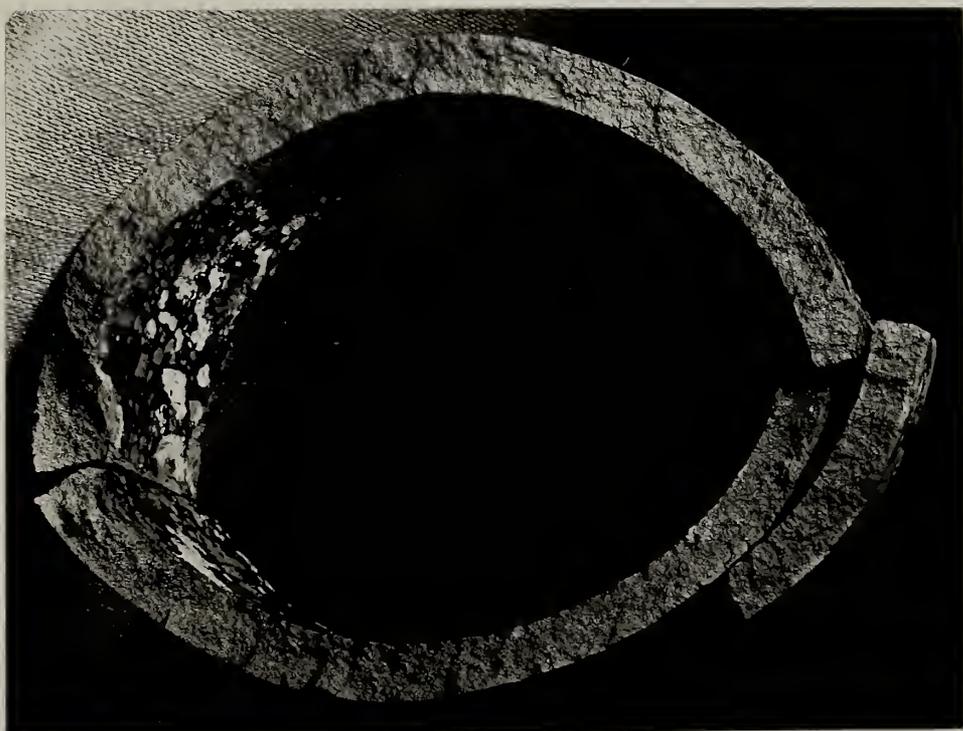
Figure 6. Fracture surface W3 after cleaning. X 2/3

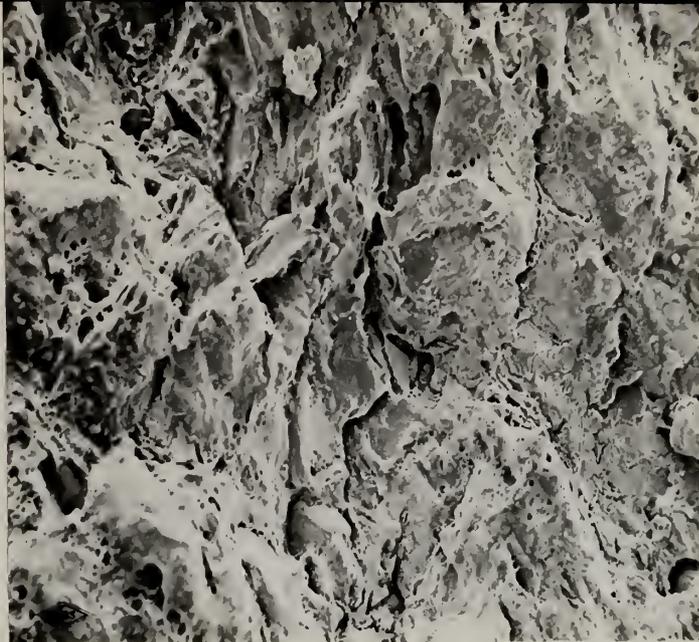
Visually and macroscopically, all three fractures appeared similar. Therefore, a detailed fractographic examination was performed on only one of the fracture surfaces. After cleaning, part of the fracture surface from the piece of pipe designated W1 was examined with the scanning electron microscope (SEM). Many of the fracture features had been obliterated by the corrosion process, but the fracture mode appeared to be predominantly cleavage. Cleavage indicates a very low ductility or brittle fracture, which would be expected for an overload fracture in gray cast iron.

A low magnification SEM fractograph is shown in figure 7. Although some of the detail has been lost due to the corrosion process, and some is masked by the corrosion product that remained on the fracture surface, evidence of cleavage can still be seen. A much higher magnification SEM fractograph is shown in figure 8. Corrosion product remaining on the fracture surface is quite evident.

Figure 7. SEM fractograph of W1. The fracture mode is predominantly cleavage. X 185

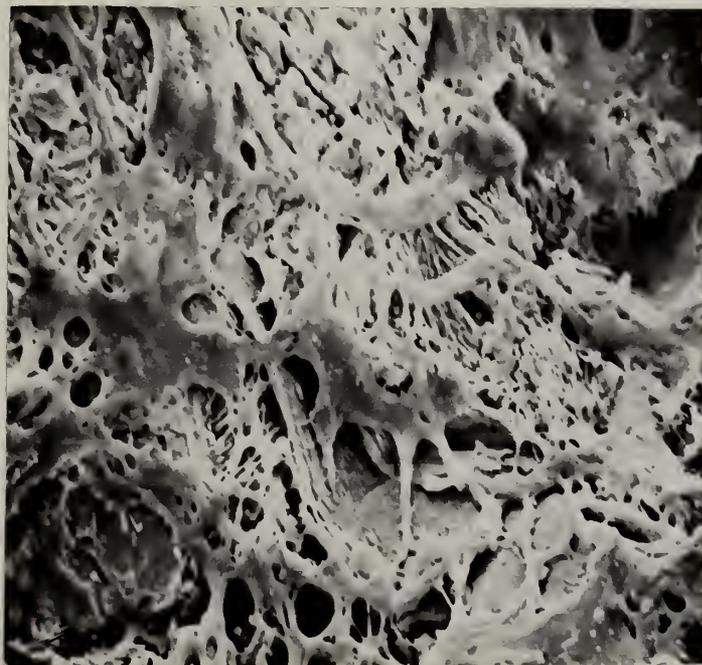
Figure 8. SEM fractograph of W1 at much higher magnification than figure 7. Corrosion product is evident. X 1000

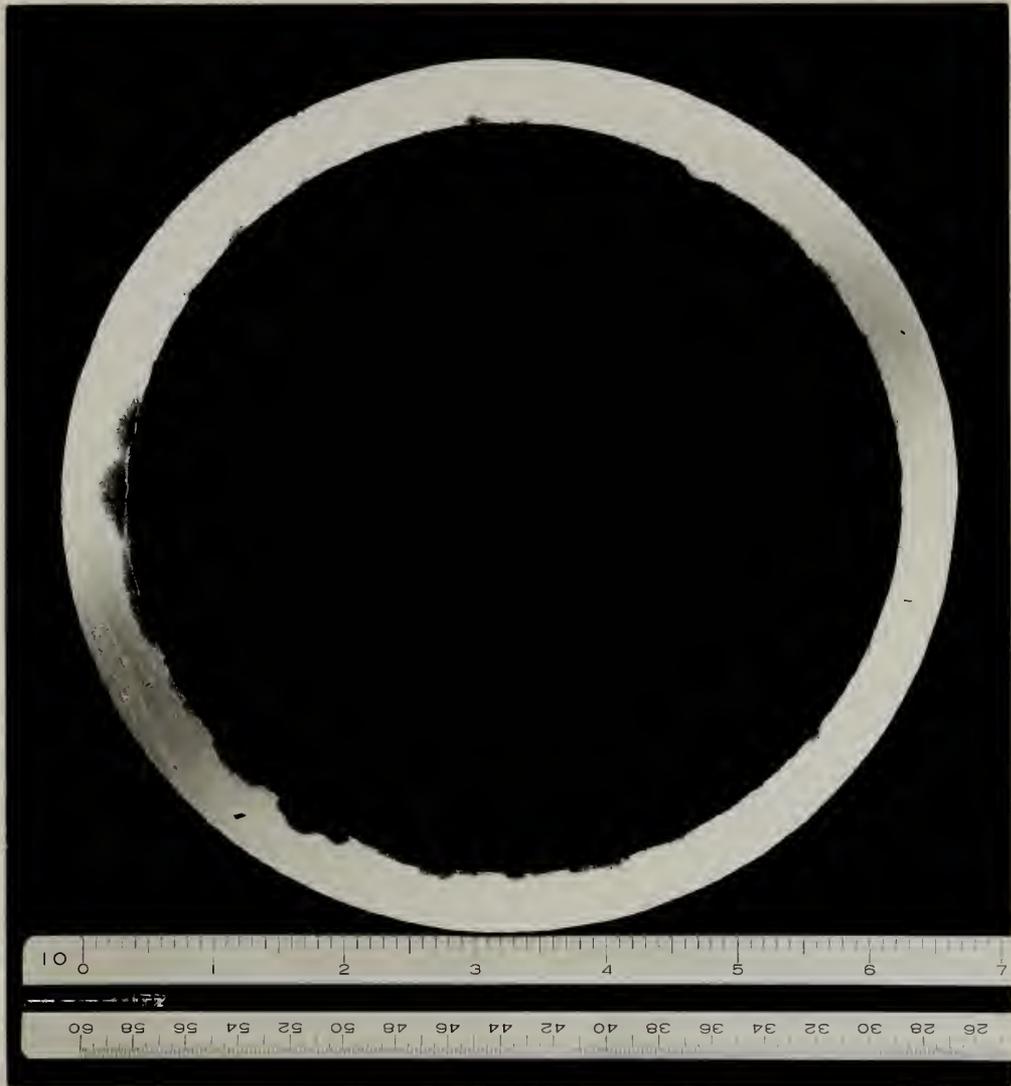
Transverse sections were taken close to each of the three fractures. These sections were polished metallographically to determine the extent of graphitization. The sections from W1, W2, and W3 are shown in figures 9, 10, and 11, respectively. Some graphitization adjacent to the inside wall surface is evident in each section, and in some regions, the depth of the graphitization is significant. In one region in the section from W1 (figure 9), graphitization starting at the inside had penetrated about 1/3 of the pipe wall thickness.

Figure 9. Transverse section through W1 about 3/4 inch from the fracture showing graphitization adjacent to the inside wall surface. X 2/3

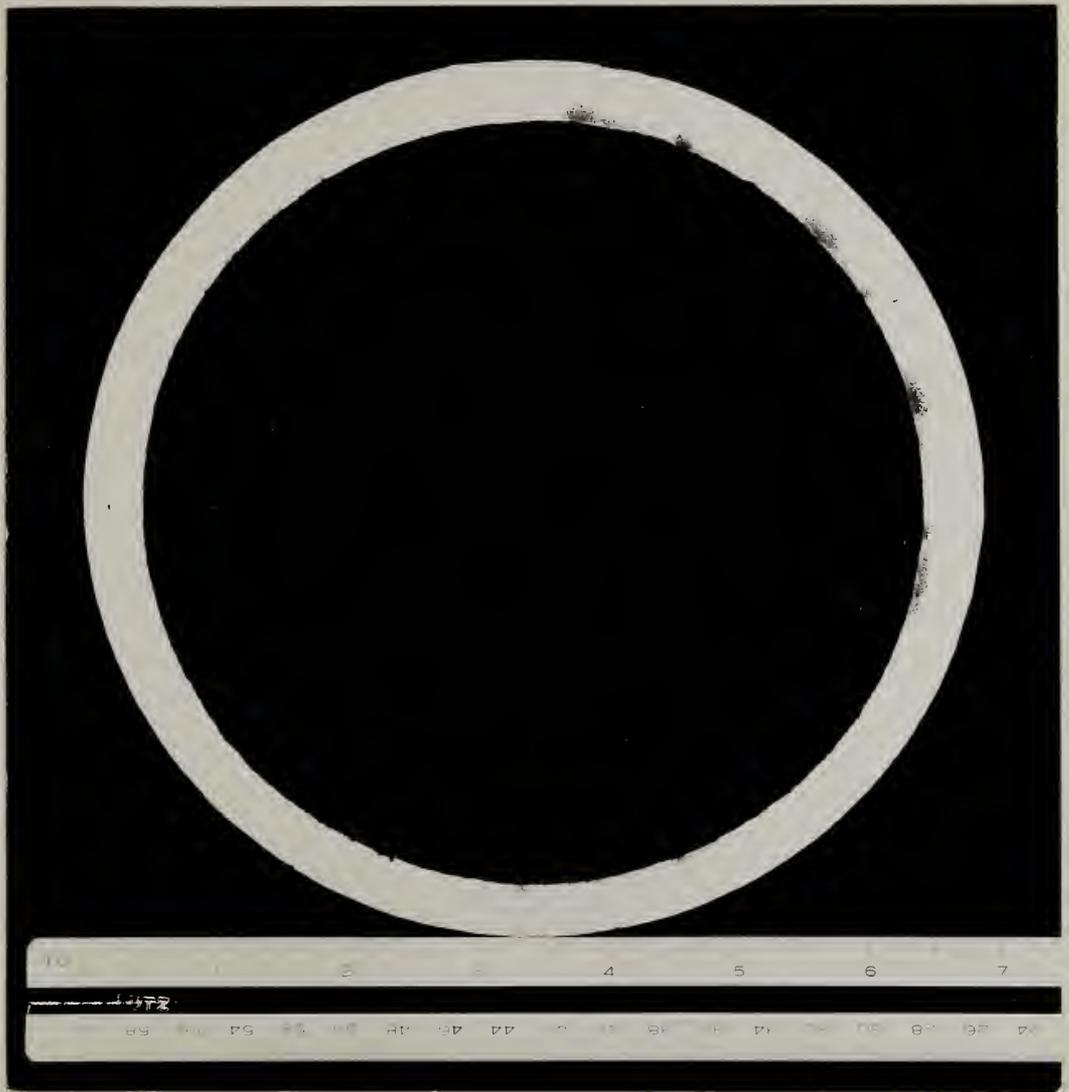
X 2/3

Rockwell K (HRK) hardness measurements were taken on the transverse section from W2 that is shown in figure 10. Ten measurements were made around the circumference. The range in hardness was HRK 85 1/2 to 97 and the average value was 92.8. The approximate equivalent Brinell (HB) hardness values range from 136 to 176 and the approximate equivalent HB average is 159. The variation in hardness is rather large, but the average hardness is typical for ordinary gray cast iron¹.

Figure 10. Transverse section through W2 about 3/4 inch from the fracture showing some graphitization adjacent to the inside wall surface.

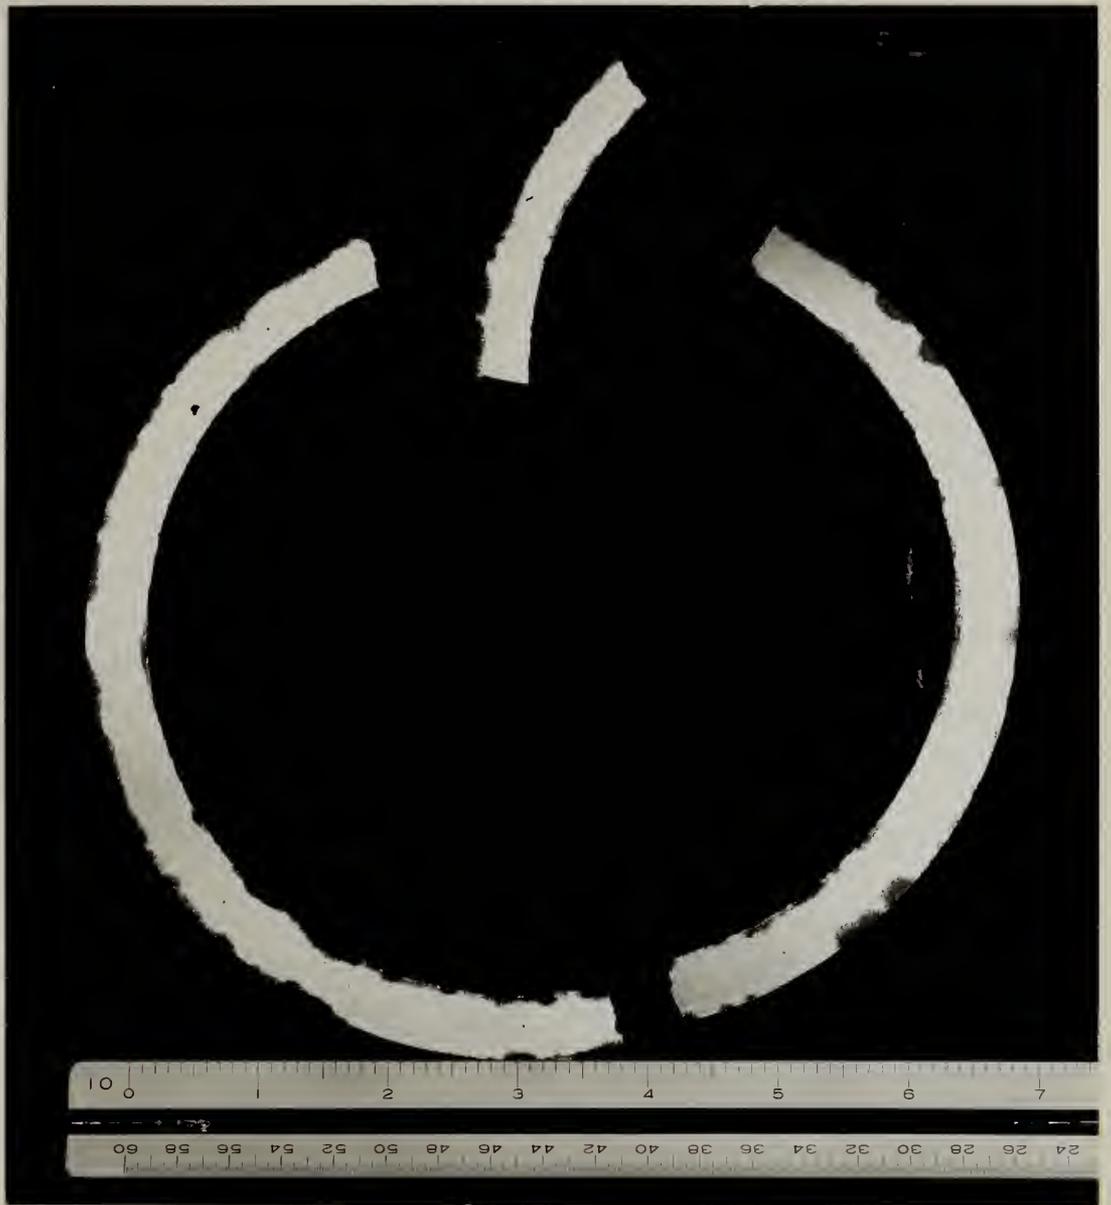
The transverse sections from W1 and W2 exhibited essentially no evidence of graphitization adjacent to the outside wall surface, but there was significant graphitization adjacent to the outside wall surface of W3 over most of the circumference of the section. This section is very close to the end of the pipe length.

In a region near the end of the pipe length, there was graphitization adjacent to both the inside and outside wall surfaces of the pipe. Away from the end of the pipe, graphitization was found only adjacent to the inside wall surface. The graphitization would have also reduced the effective cross section of the pipe somewhat.

Figure 11. Transverse section through W3 ranging from about 1/2 to 2 inches from the fracture showing graphitization adjacent to both the inside and outside wall surfaces. X 2/3

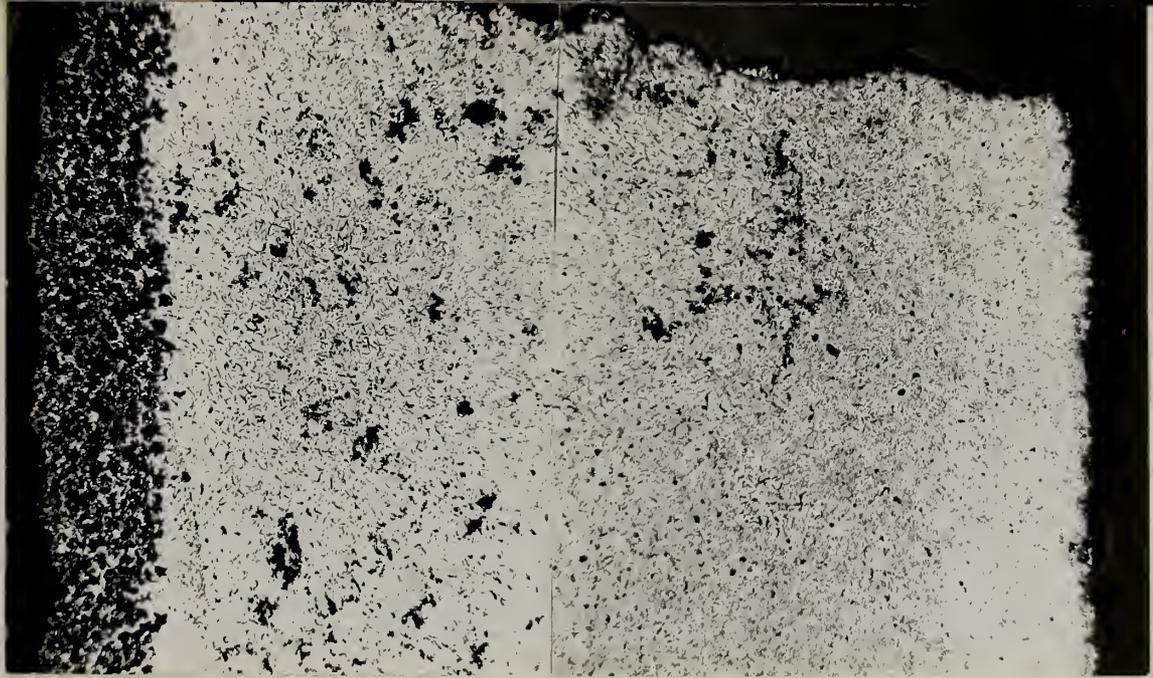
X 11

An etched longitudinal section through W1 showing the entire pipe wall thickness with the fracture profile horizontal at the top appears in figure 12. This section passes through a region of graphitization which can be seen adjacent to the inside wall surface at the left. An as-polished longitudinal section through W1 showing part of the fracture profile at higher magnification appears in figure 13. The thin, dark particles are graphite flakes with an essentially type A distribution². A longitudinal section showing the entire wall thickness of W3 slightly removed from the fracture appears in figure 14. This figure is at a lower magnification than figure 12. It should be noted that the region shown is very near the end of the pipe length where it connected to another pipe length while in service. There is significant graphitization adjacent to both the inside and outside wall surfaces.

Figure 12. Etched longitudinal section through W1 showing the fracture profile (horizontal at the top). The entire wall thickness of the pipe is shown. The inside wall surface is at the left and the outside wall surface is at the right. Significant graphitization can be seen adjacent to the inside wall surface. Etchant: 1% nital

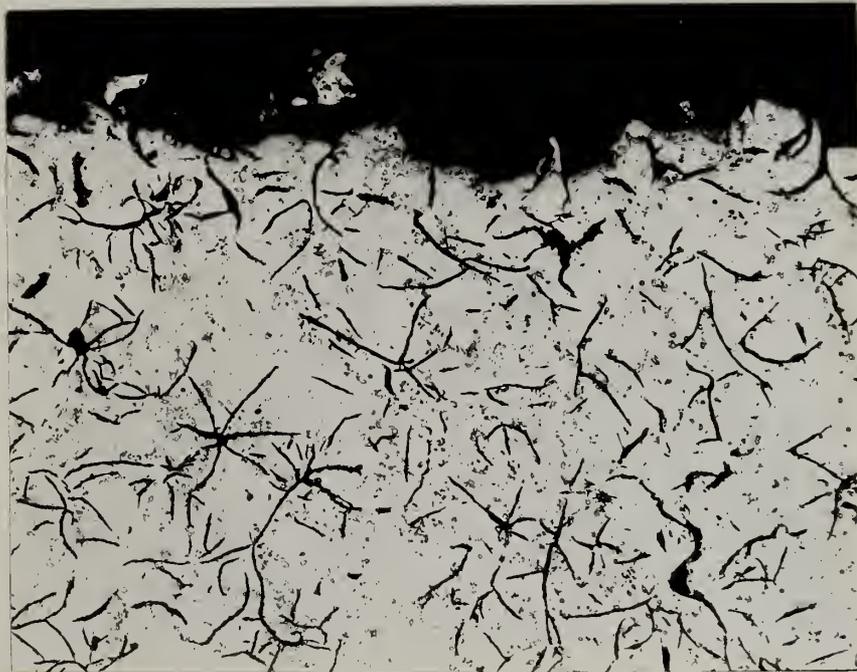
X 100

Figure 13. Unetched longitudinal section through W1 showing the fracture profile (horizontal at the top). The thin, dark particles are graphite flakes. The small gray particles appear to be non-metallic inclusions. As polished

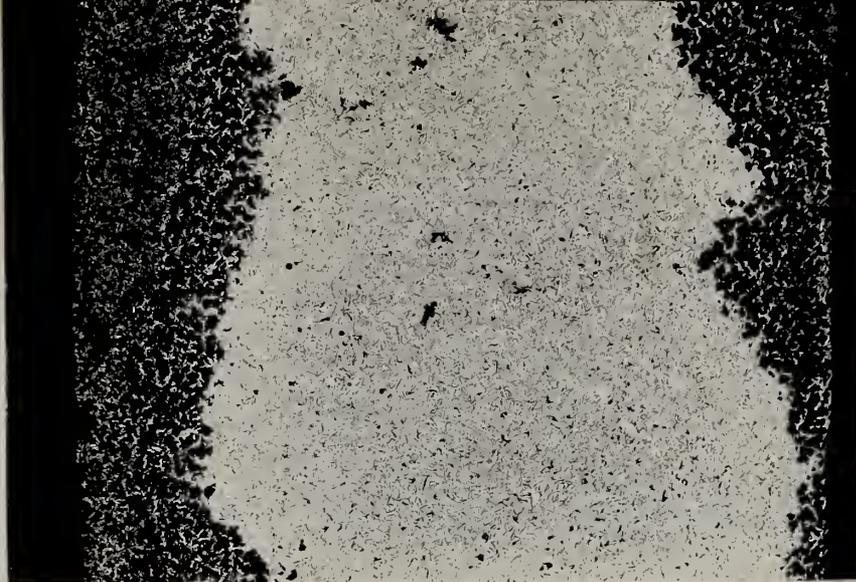
Figure 14. Etched longitudinal section showing the entire wall thickness of W3. Graphitization is evident both adjacent to the inside wall surface (left) and adjacent to the outside wall surface (right).
Etchant: 1% nital X 8

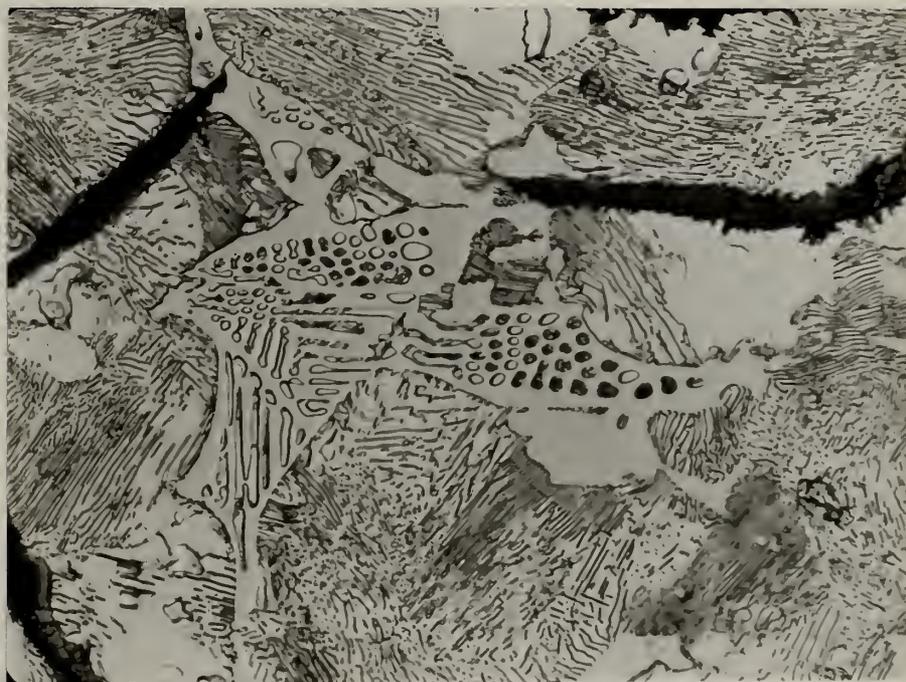
An etched longitudinal section through W1 in a region which has not been subject to graphitization is shown in figure 15 at much higher magnification than in figure 13. The microstructure consists of graphite flakes (long, thin, dark particles), pearlite (fingerprint pattern), ferrite (light gray patches), and probably steadite (small, rounded particles within the ferrite patches). A region in a longitudinal section through W1 exhibiting almost total graphitization is shown in figure 16.

Figure 15. Etched longitudinal section through W1 in a region which has not been graphitized. The microstructure consists of graphite flakes (long, thin dark particles), pearlite (fingerprint pattern), ferrite (light gray patches), and probably steadite (small rounded particles within the ferrite patches).
Etchant: 1% nital X 1000

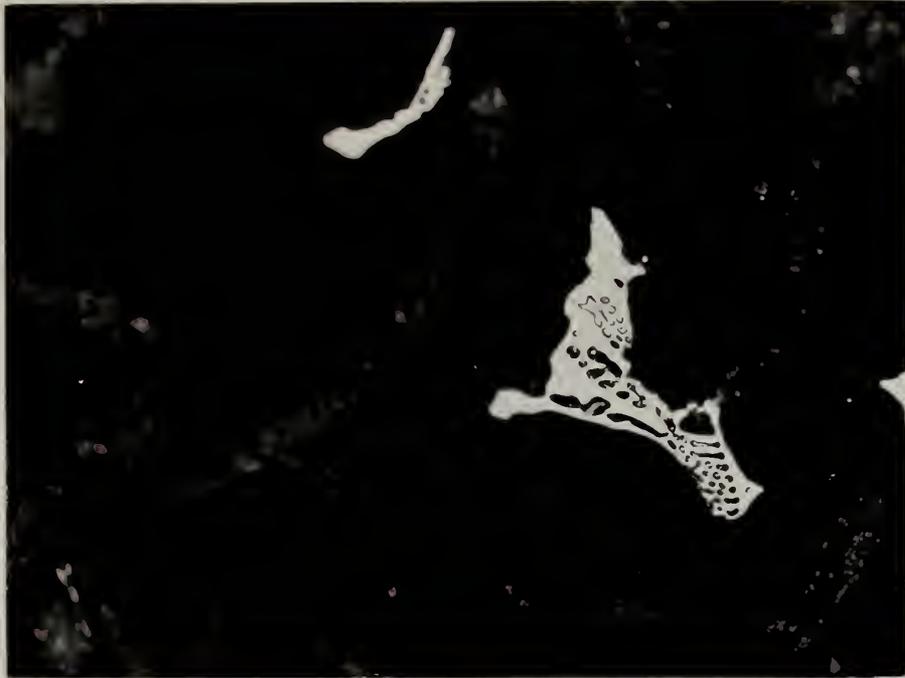
X 1000

Figure 16. Etched longitudinal section through W1 in a region that has been essentially totally graphitized.
Etchant: 1% nital
