**NBSIR 80-2043**

# **Examination of Expanded Metal Grating Material Used for Fencing along the United States-Mexico Border**

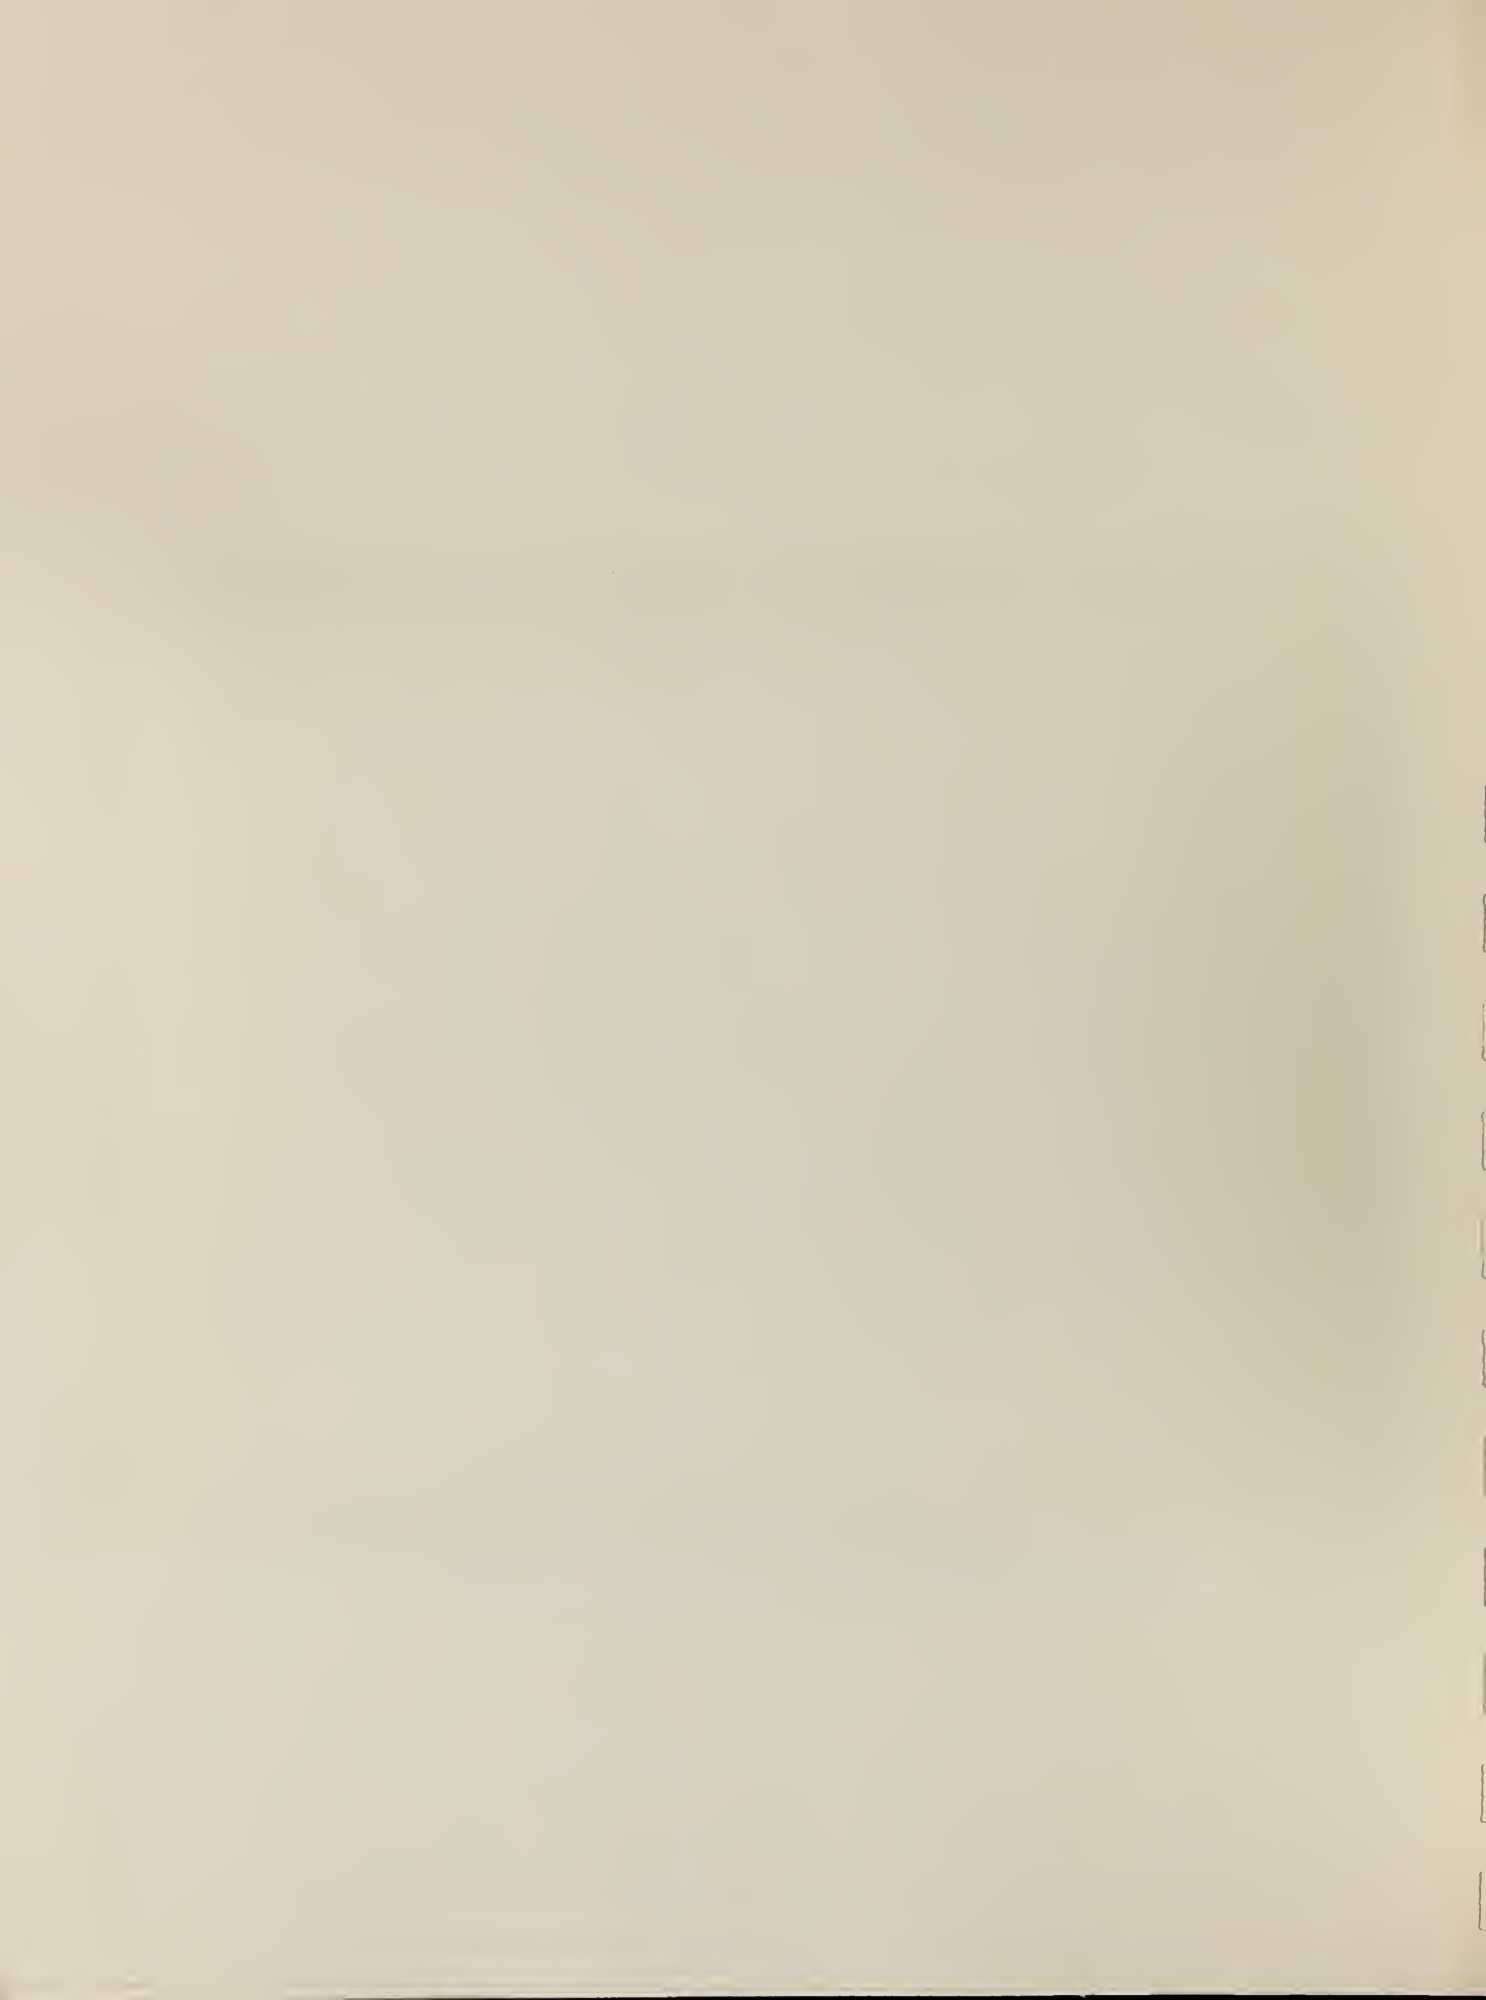
Figure 3. Galvanized expanded steel fencing sample from San Luis, Arizona as received at NBS. X 1/3

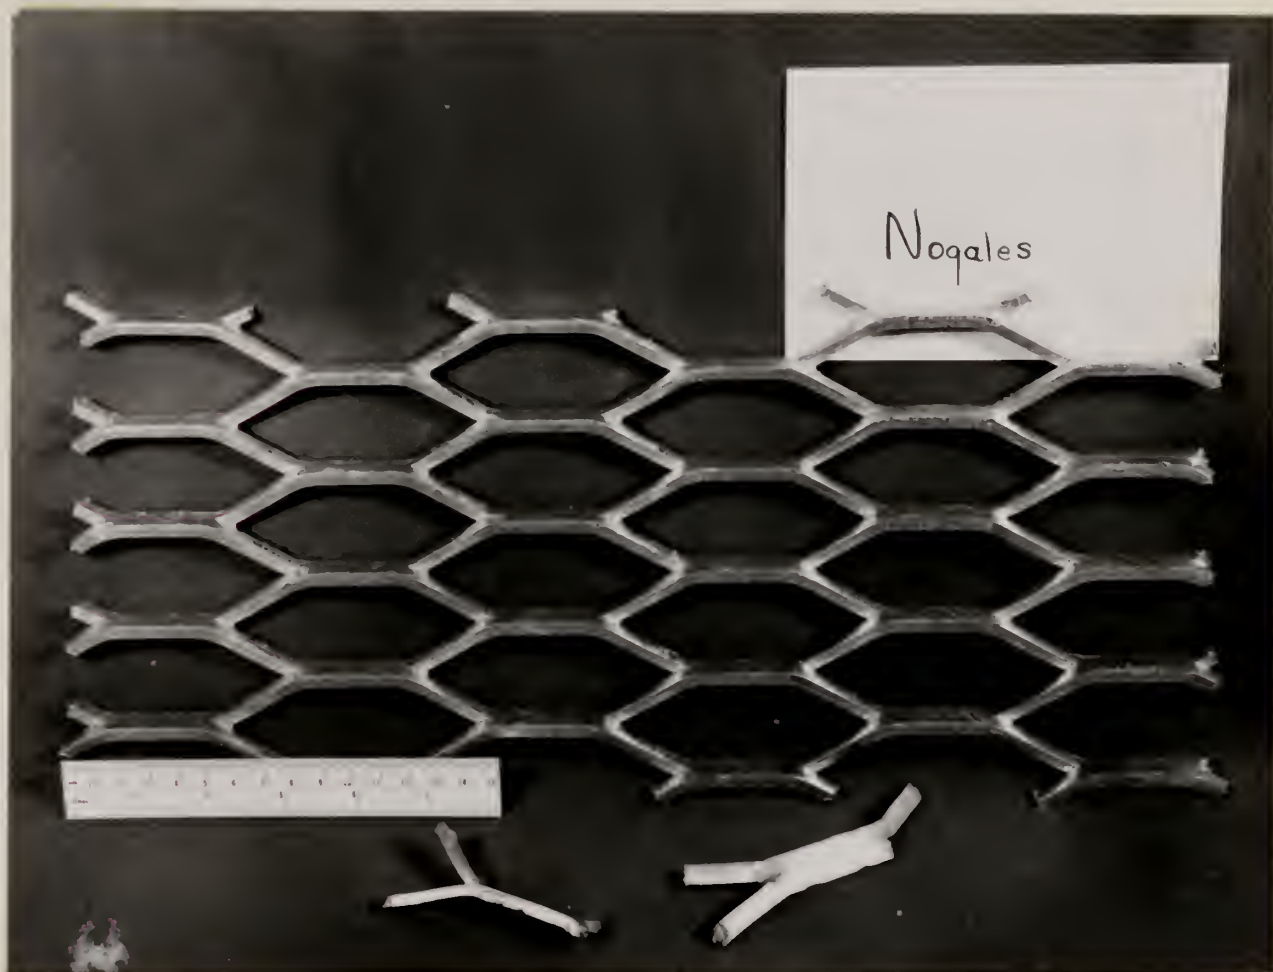
Figure 4a. Galvanized expanded steel fencing samples from Nogales, Arizona as received at NBS. The two small pieces had been fractured from the fencing before the material was submitted for examination.

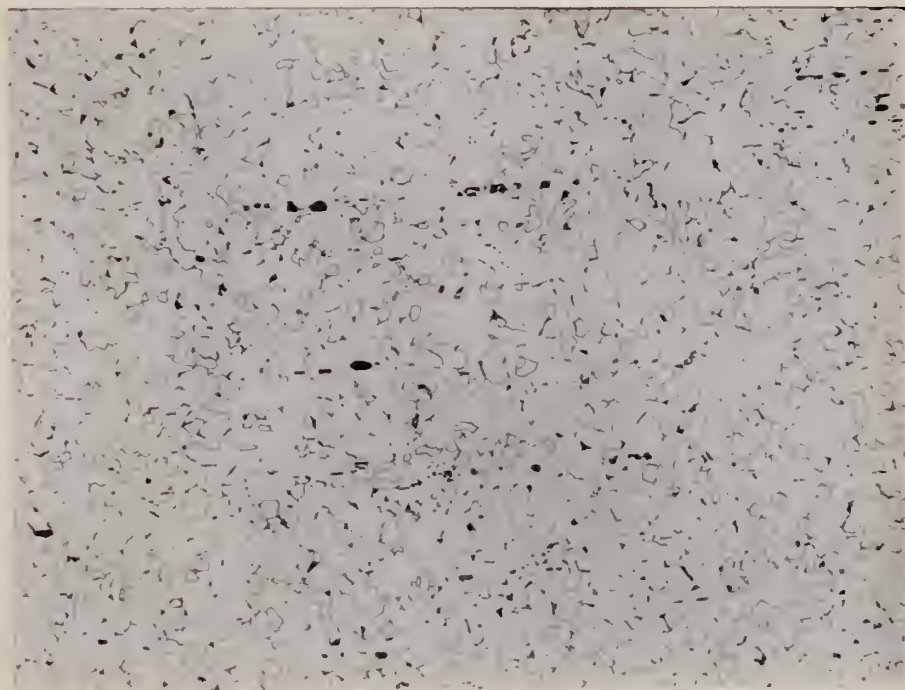
Figure 12. Etched section parallel to the plane of the expanded steel fencing material from San Ysidro. The direction of the long diagonal of the openings is horizontal. The microstructure consists essentially of equiaxed grains of ferrite and a very small amount of pearlite.  
Etchant: 1% nital X 100

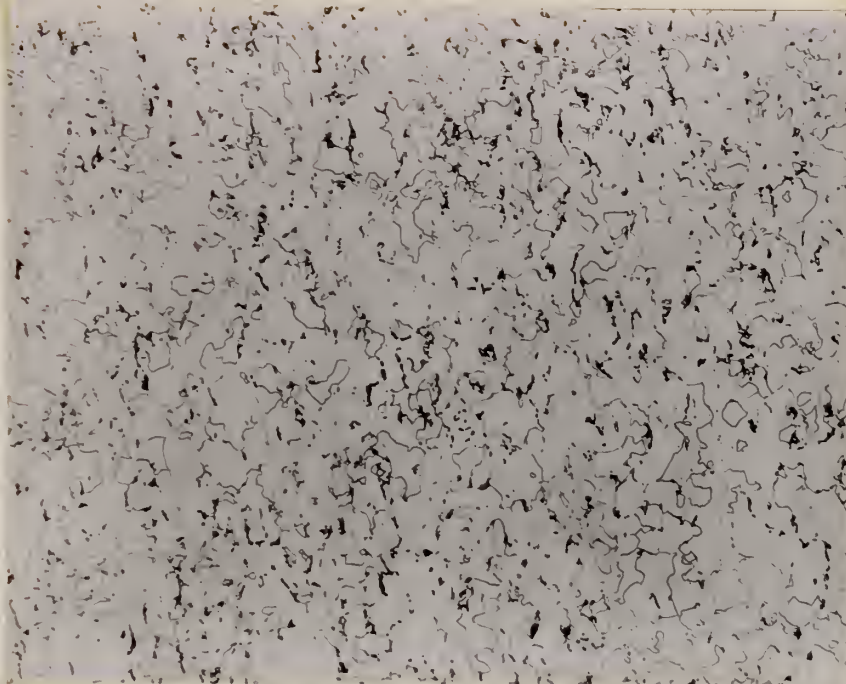
Figure 13. Etched section parallel to the plane of the expanded steel fencing material from El Paso. The direction of the long diagonal of the openings in the material is horizontal. The microstructure consists essentially of equiaxed grains of ferrite and some pearlite (dark patches). There appears to be some directionality in the pearlite patches which is perpendicular to the long diagonal of the openings. This indicates that the rolling direction was probably perpendicular to the long diagonal of the openings.  
Etchant: 1% nital

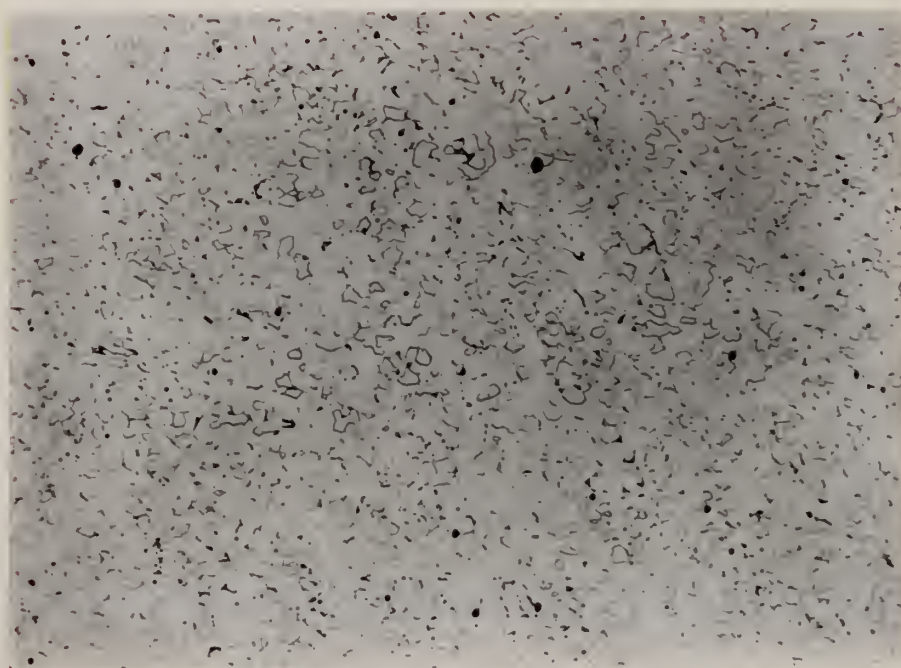
Figure 14. Etched section parallel to the plane of the expanded steel fencing material from San Luis. The direction of the long diagonal of the openings in the material is horizontal. The microstructure consists essentially of equiaxed grains of ferrite and a very small amount of pearlite.  
Etchant: 1% nital

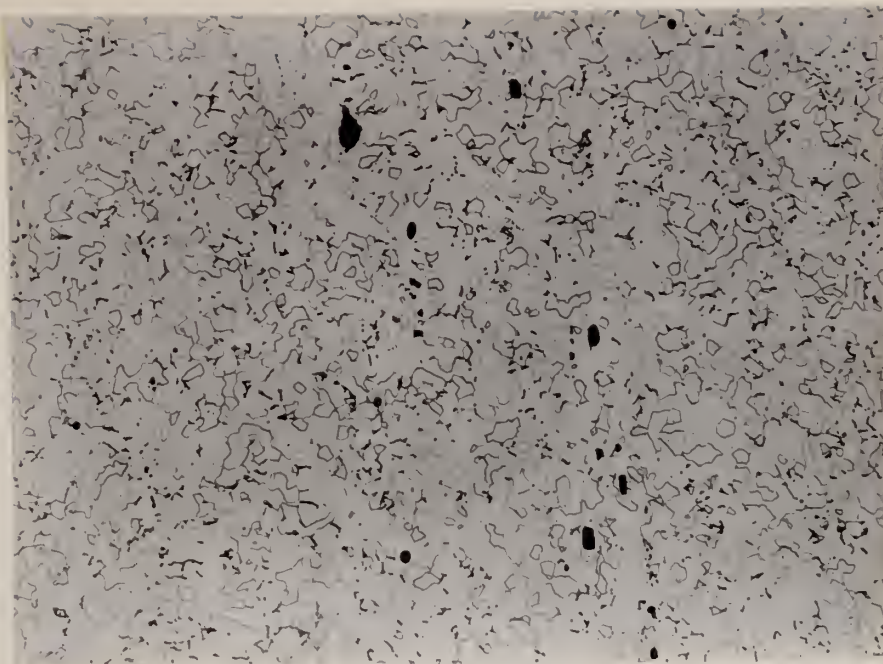
Figure 15. Etched section parallel to the plane of the expanded steel fencing material from Nogales A. The direction of the long diagonal of the openings in the material is horizontal. The microstructure consists essentially of equiaxed grains of ferrite and a small amount of pearlite.  
Etchant: 1% nital

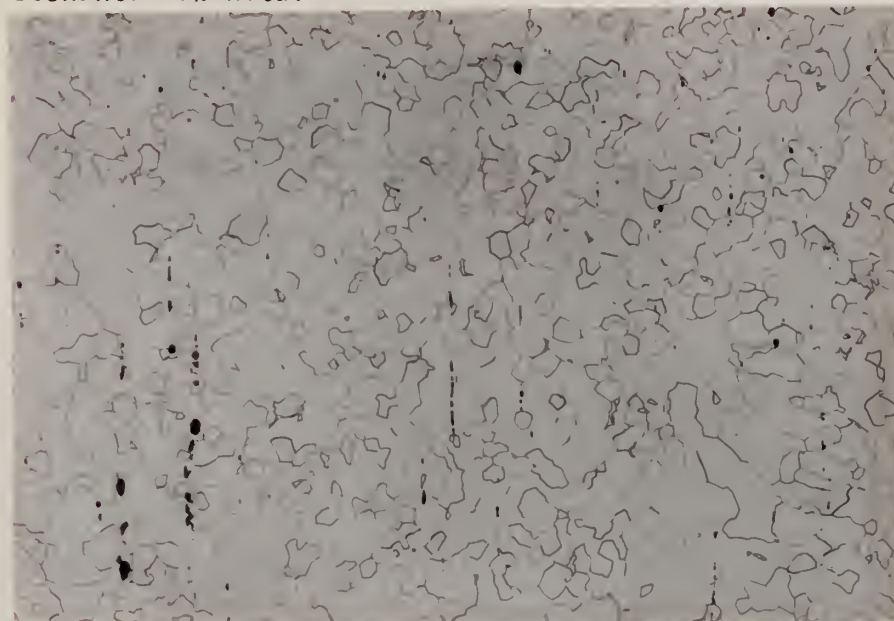
Figure 16. Etched section parallel to the plane of the expanded steel fencing from one of the small pieces of material from Nogales. The direction of the long diagonal of the openings in the material is horizontal. The microstructure consists of ferrite with essentially no pearlite. The grain size is somewhat greater than that of the field shown in figure 15.  
Etchant: 1% nital

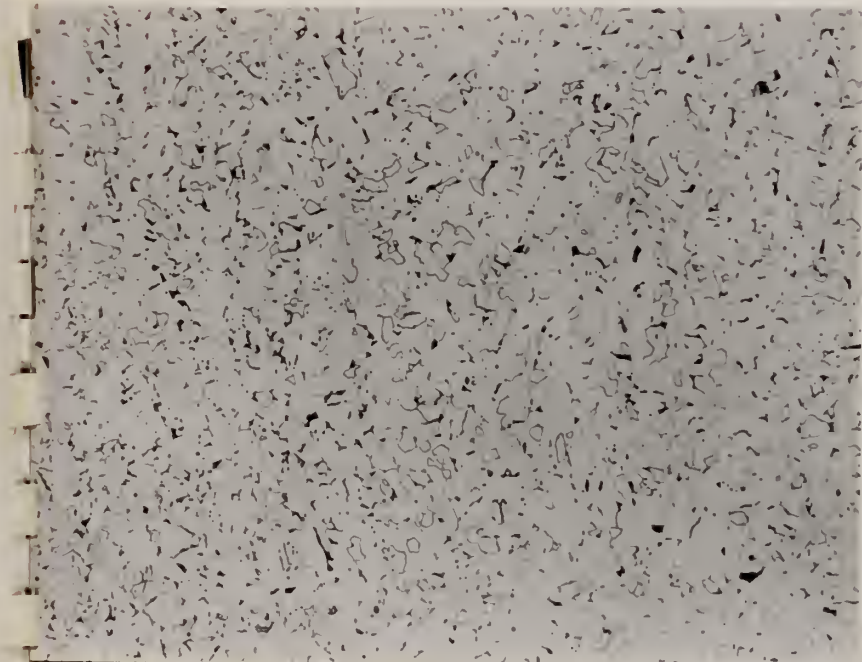
Figure 17. Etched section through material from San Ysidro. This section is perpendicular to both the plane of the fencing and the long diagonal of the openings in the material. The direction of the short diagonal of the openings is horizontal. As in the section shown in figure 12, the microstructure consists essentially of equiaxed grains of ferrite with some pearlite.  
Etchant: 1% nital X 100

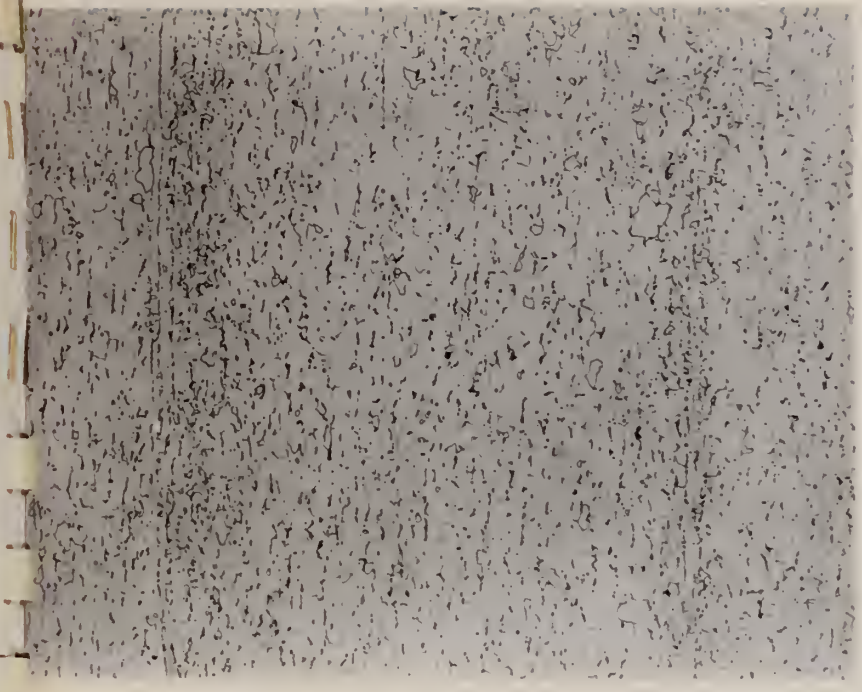
Figure 18. Etched section through material from El Paso. This section is perpendicular both to the plane of the fencing and the long diagonal of the openings in the material. The direction of the short diagonal of the openings in the material is horizontal. The microstructure consists of ferrite and pearlite, and there is definite directionality that indicates that the rolling direction is perpendicular to the direction of the long diagonal of the openings.  
Etchant: 1% nital X 100

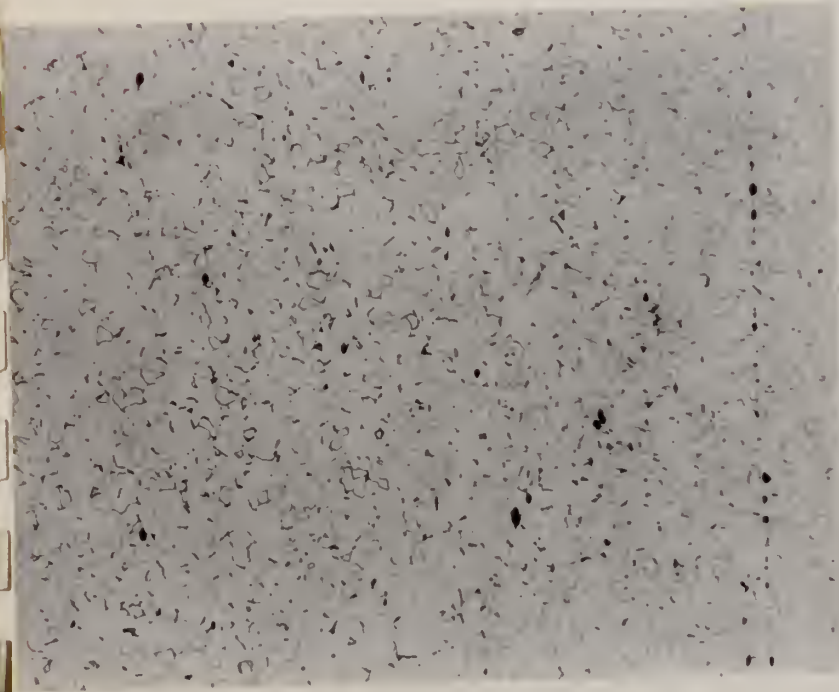
Figure 19. Etched section through material from San Luis. This section is perpendicular both to the plane of the fencing and the long diagonal of the openings in the material. The direction of the short diagonal of the openings in the material is horizontal. As in the section shown in figure 14, the microstructure consists essentially of equiaxed grains of ferrite and some pearlite. Etchant: 1% nital X 100

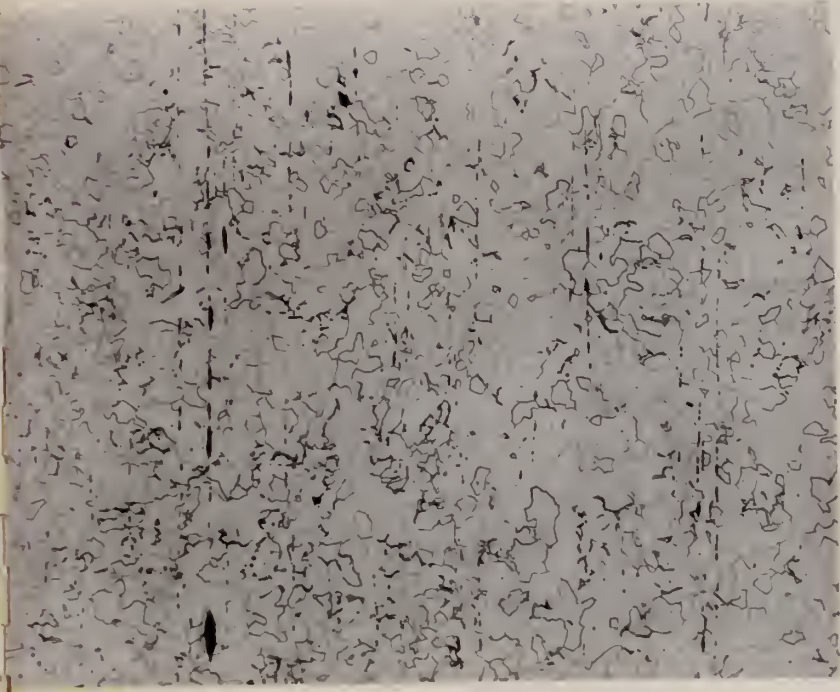
Figure 20. Etched section through material from Nogales A. This section is perpendicular both to the plane of the fencing and the long diagonal of the openings in the material. The direction of the short diagonal of the openings is horizontal. The microstructure consists of ferrite with a very small amount of pearlite. Etchant: 1% nital X 100

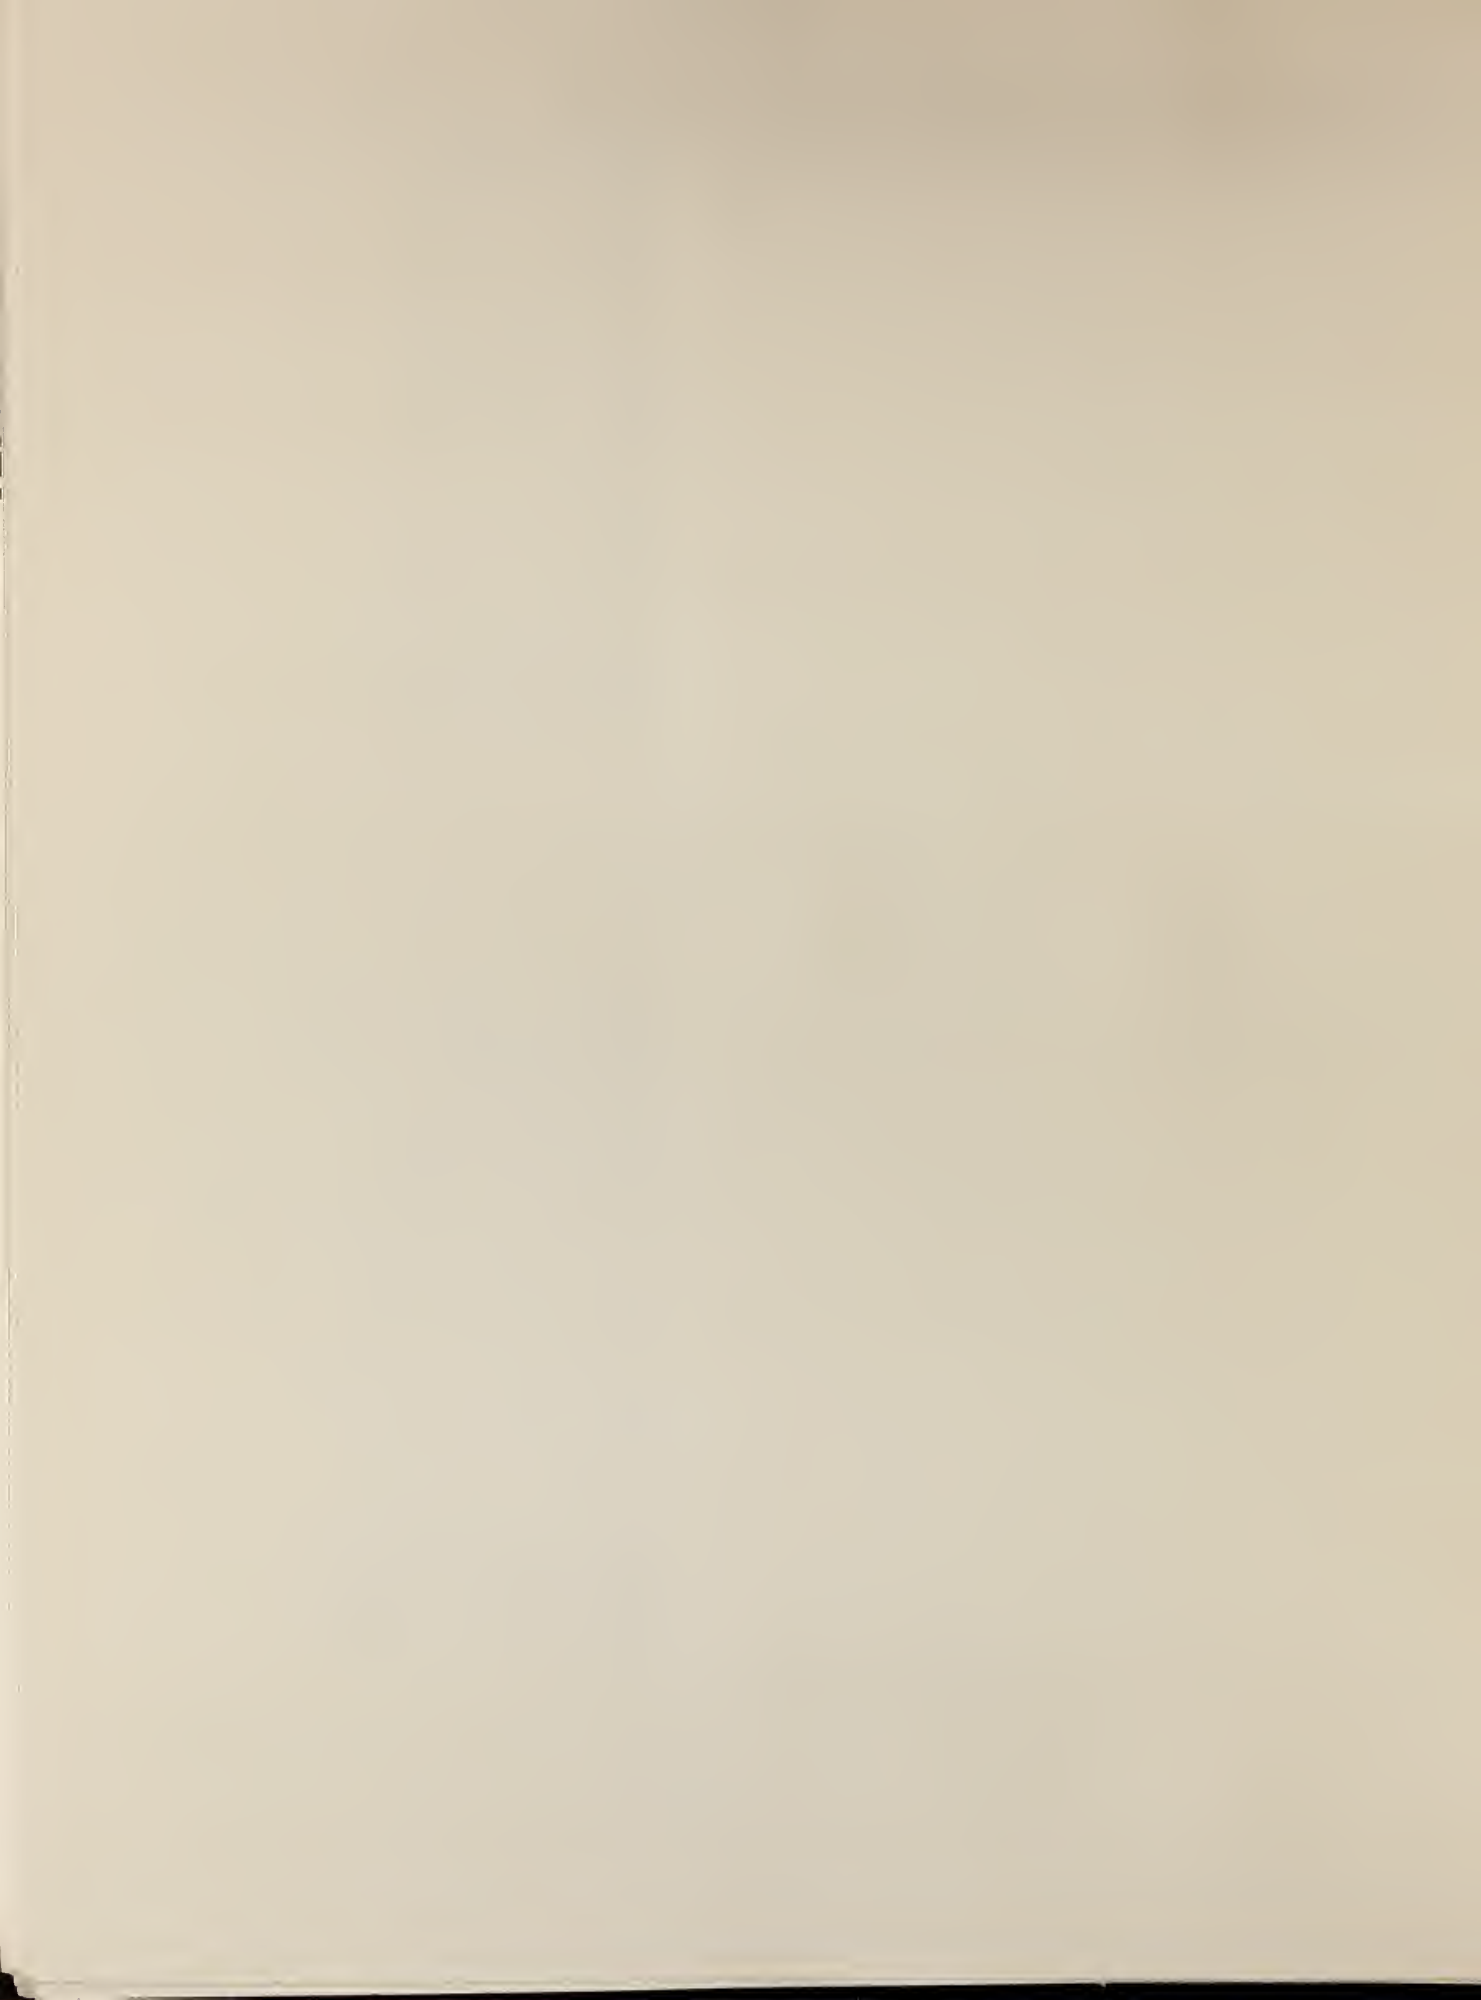
U.S. DEPT. OF COMM. BIBLIOGRAPHIC DATA SHEET	1. PUBLICATION OR REPORT NO.  NBSIR 80-2043	2. Govt. Accession No.	3. Recipient's Accession No.
4. TITLE AND SUBTITLE  Examination of Expanded Metal Grating Material Used for Fencing along the United States-Mexico Border		5. Publication Date  MAY 1980

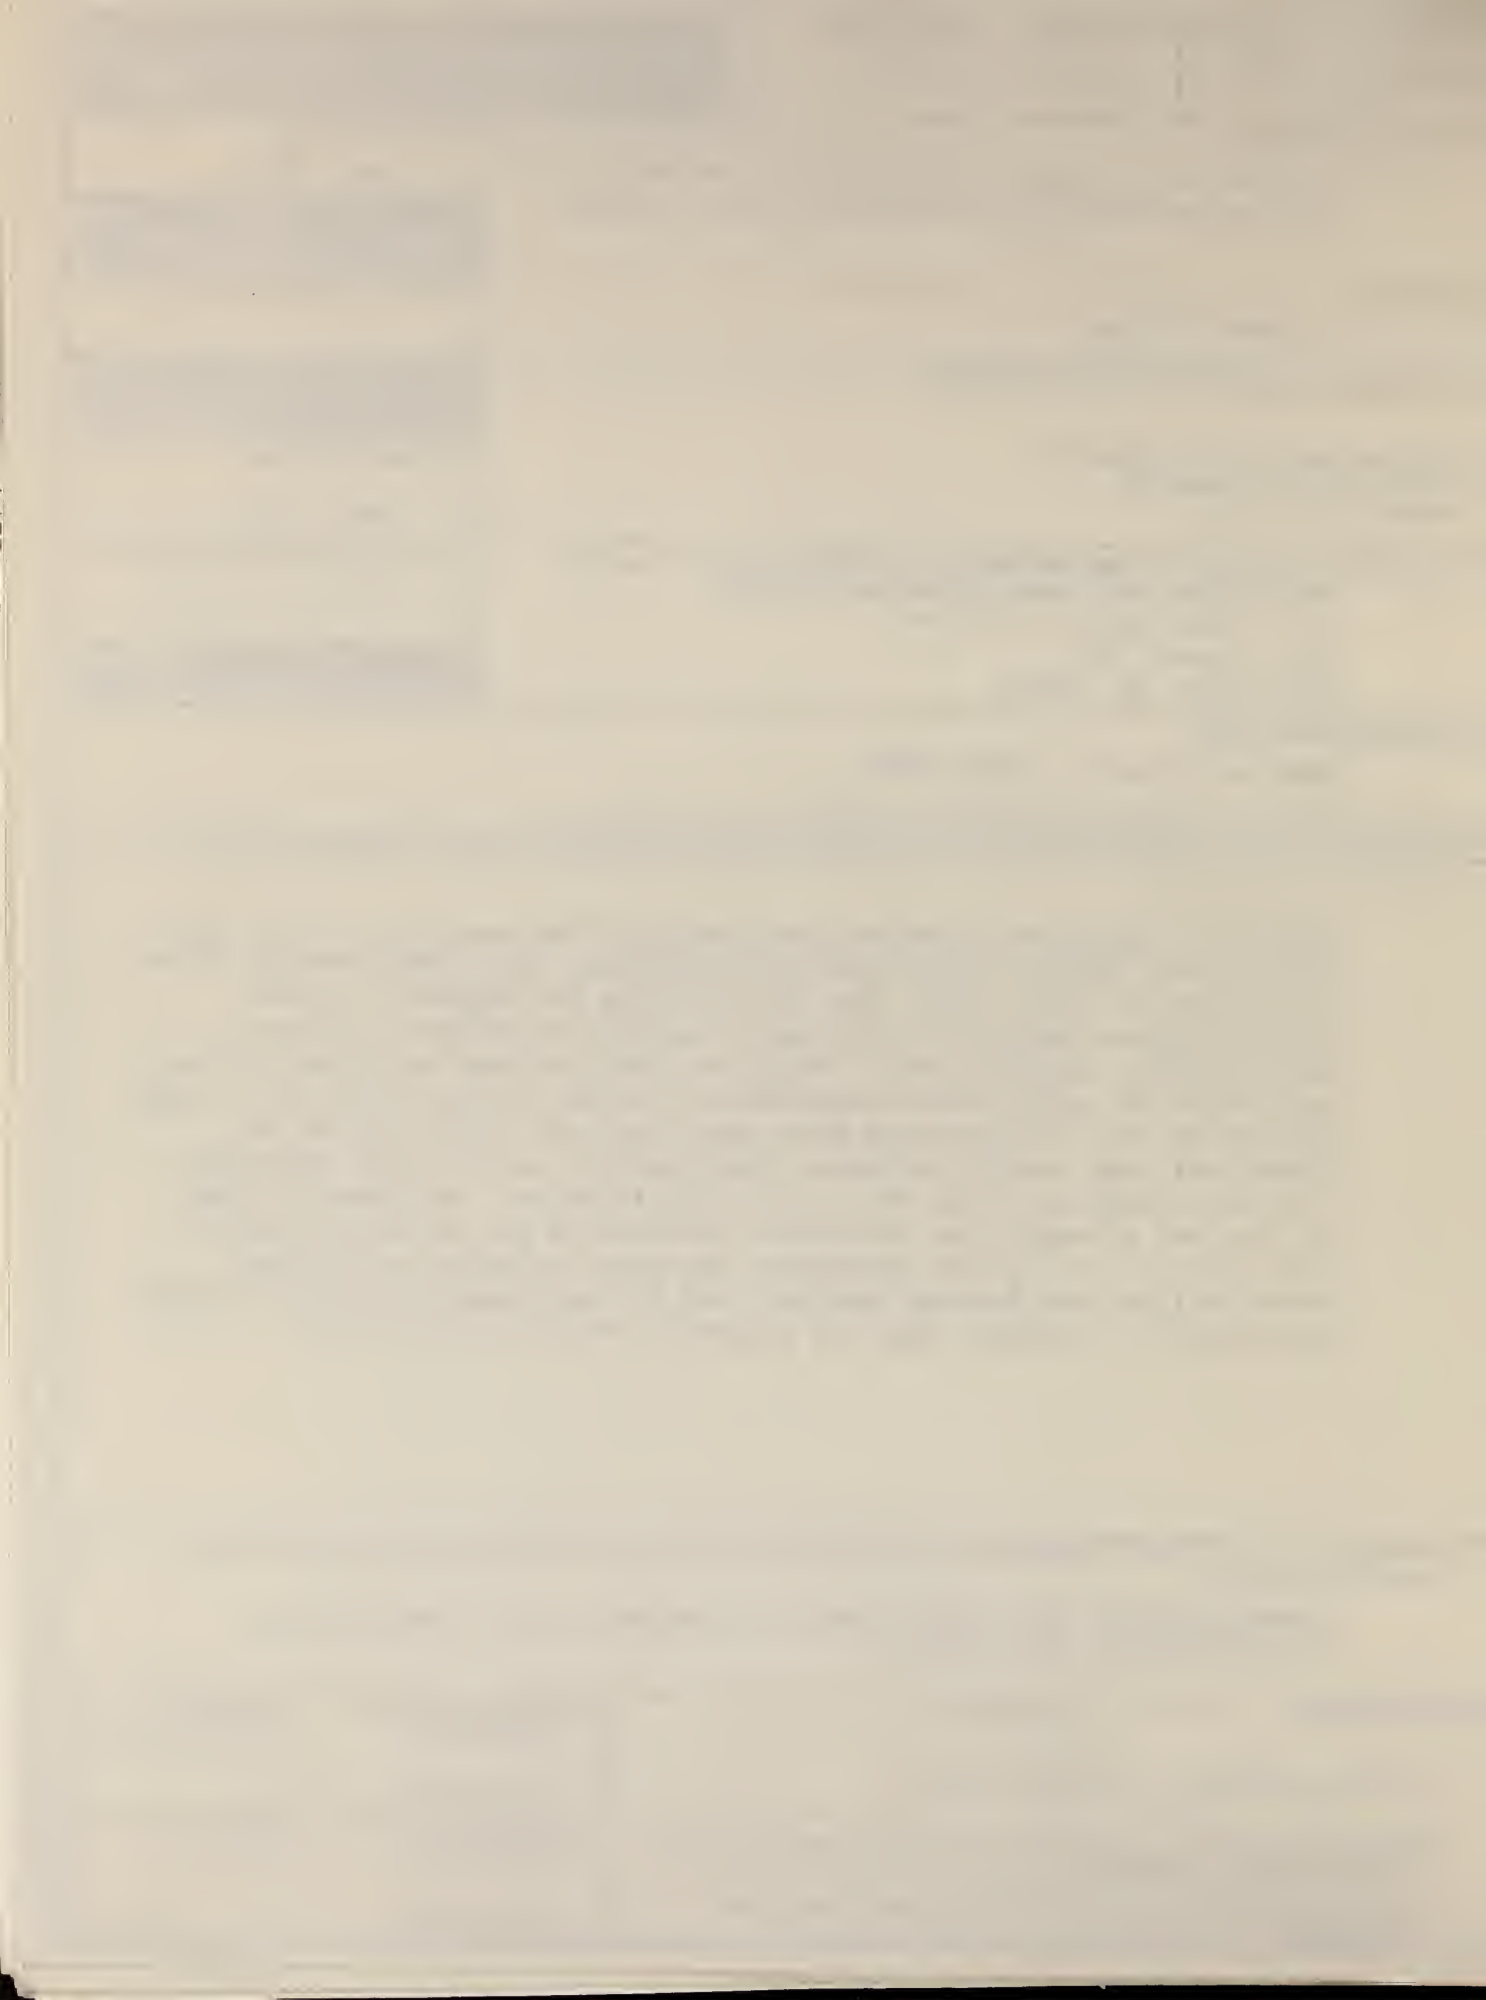
18. AVAILABILITY  <input type="checkbox"/> Unlimited  <input type="checkbox"/> For Official Distribution. Do Not Release to NTIS	19. SECURITY CLASS (THIS REPORT)  UNCLASSIFIED	21. NO. OF PRINTED PAGES	
<input checked="" type="checkbox"/> Order From Sup. of Doc., U.S. Government Printing Office, Washington, DC 20402, SD Stock No. SN003-003-  <input type="checkbox"/> Order From National Technical Information Service (NTIS), Springfield, VA, 22161	20. SECURITY CLASS (THIS PAGE)  UNCLASSIFIED	22. Price
