NAT'L INST. OF STAND & TECH R.I.C.

A11105 891139 211

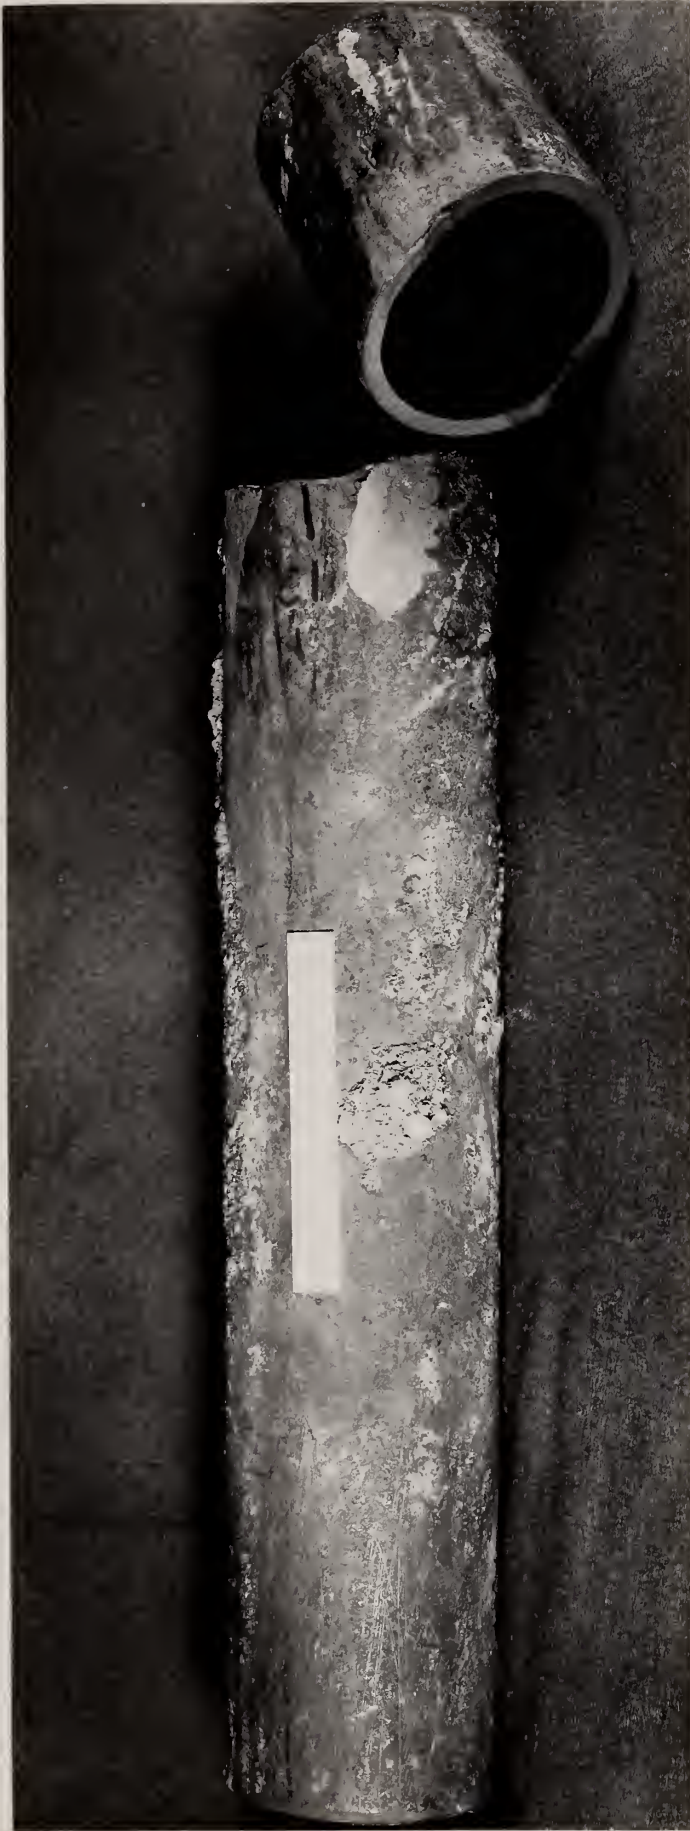
Figure 1. The two pieces of the fractured four-inch diameter cast iron pipe as received at NBS. After documentary photographs were taken, the smaller piece was given to Tim Dunn of Dunn Laboratories, Inc., on March 20, 1980, the same day both pieces were received. The larger piece on the left was retained at NBS for examination.

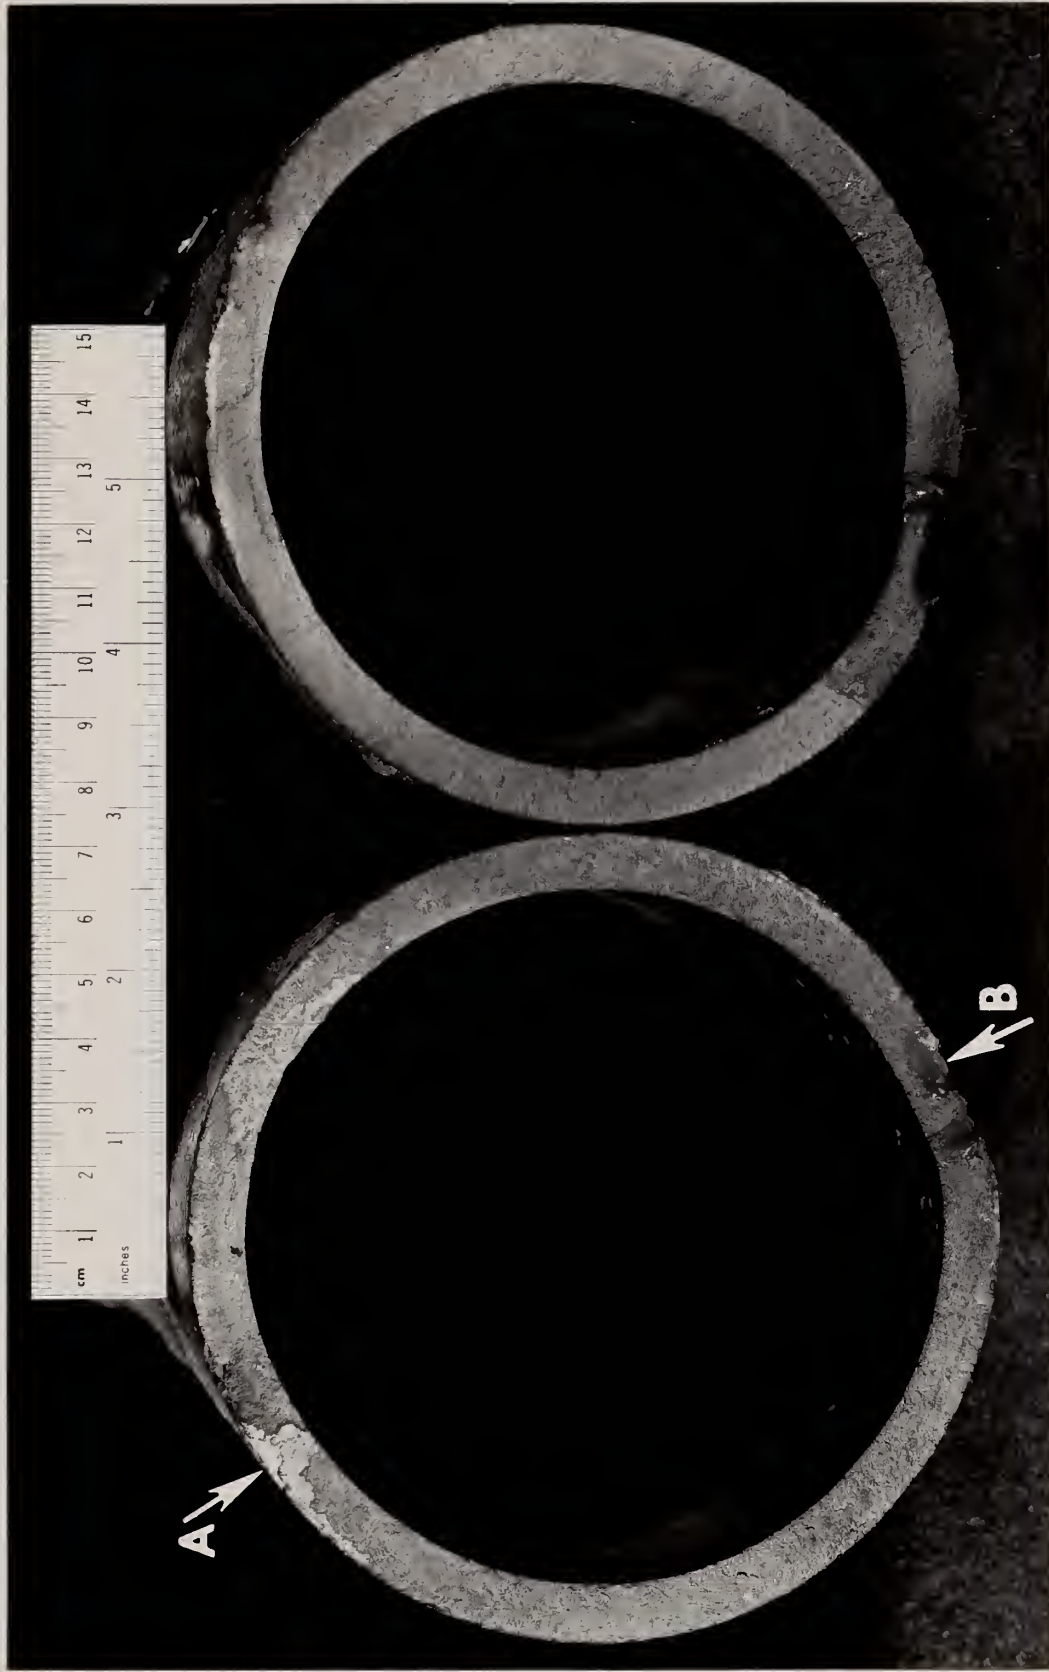
Figure 2. Mating fracture surfaces of the failed pipe as received at NBS. The piece of pipe on the left was retained at NBS for examination. The top of the pipe in the figure corresponds to the top of the pipe as it was oriented in service. The arrows indicate regions of the fracture surface where there is possible graphitization or more severe corrosion than on the rest of the fracture surface.

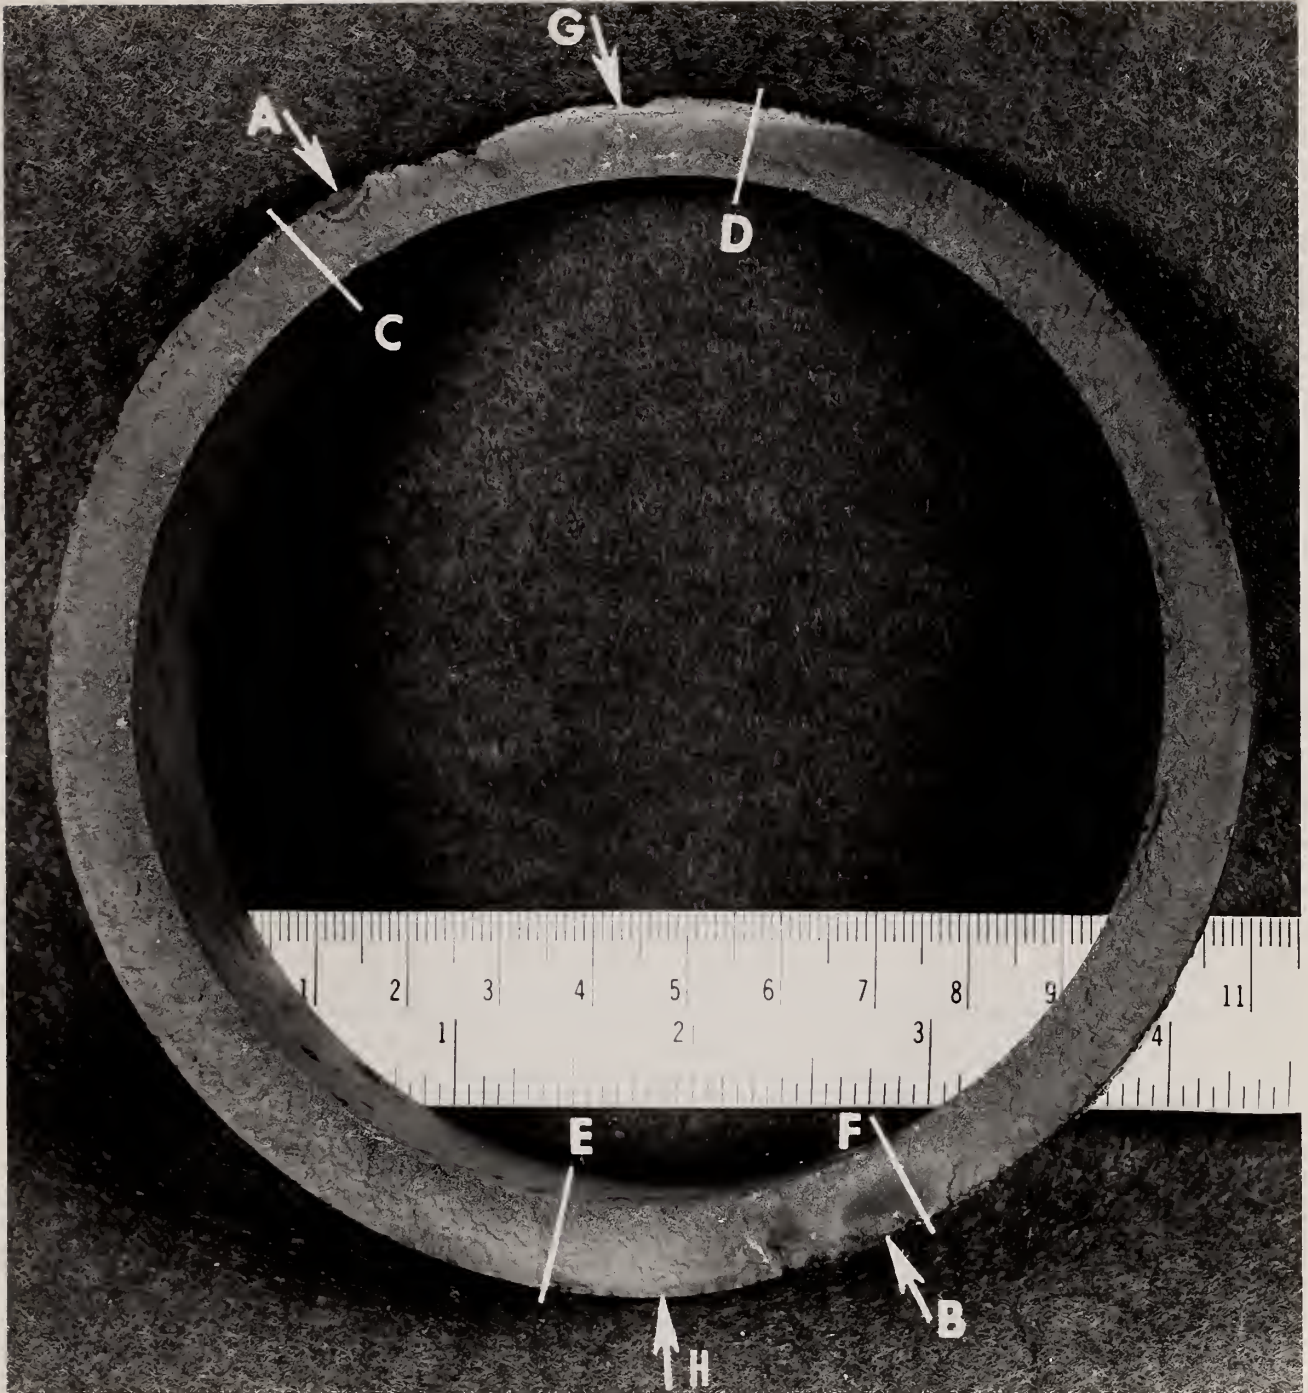
Figure 3. Fracture surface after cleaning with buffered hydrochloric acid. Arrows A and B indicate the same regions as arrows A and B, respectively, in figure 2. The regions between lines C and D and between lines E and F were examined with the SEM. Longitudinal sections for metallographic examination were taken at arrows A, G, H, and B.

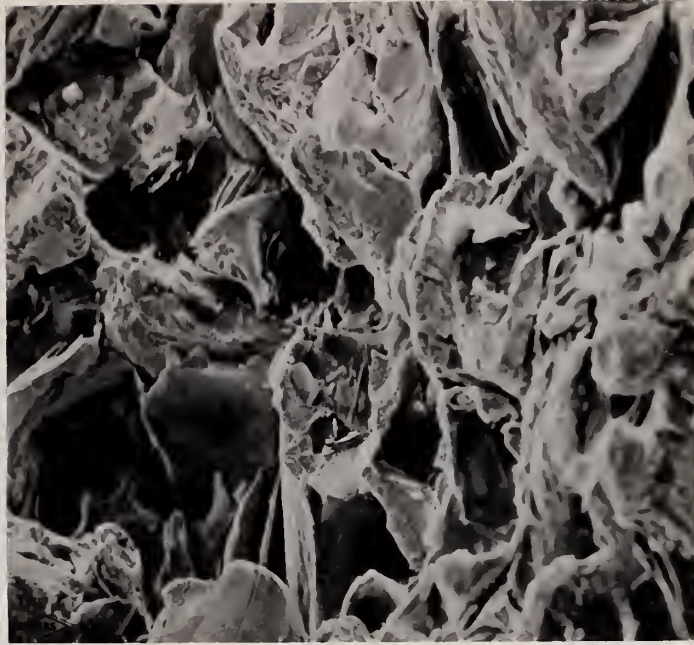
Figure 4. SEM fractograph from the region indicated by arrow B in figure 3 near the inside edge of the fracture. The primary fracture mode is cleavage. X 550

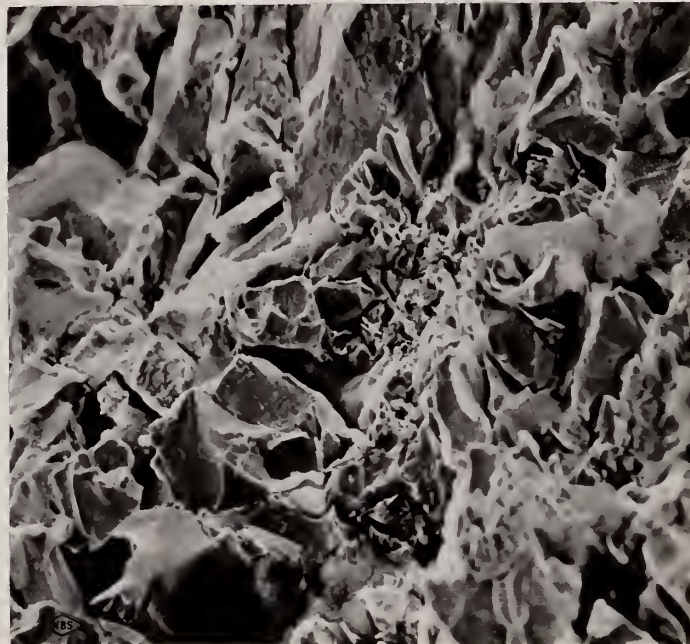
Figure 5. SEM fractograph from the region indicated by arrow G in figure 3. The primary fracture mode is cleavage. X 475

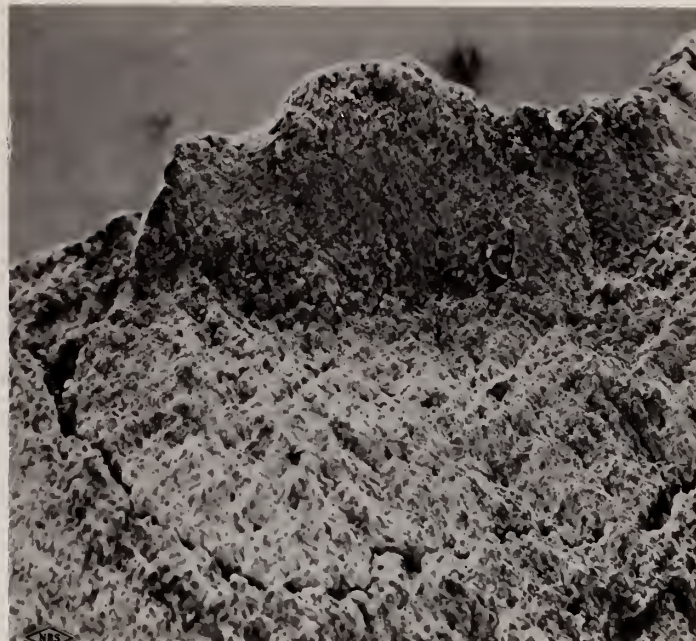
Figure 6. Low magnification SEM fractograph from the region indicated by arrow A in figure 3. A region of graphitization can be seen about to separate from the pipe. X 20

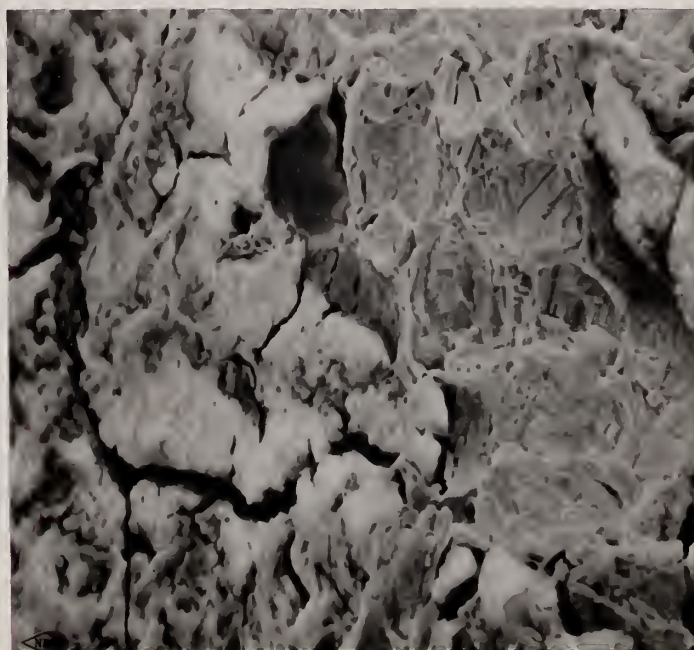
Figure 7. SEM fractograph from the region indicated by arrow B in figure 3 near the outside edge of the pipe. Corrosion product is covering the fracture surface. X 950

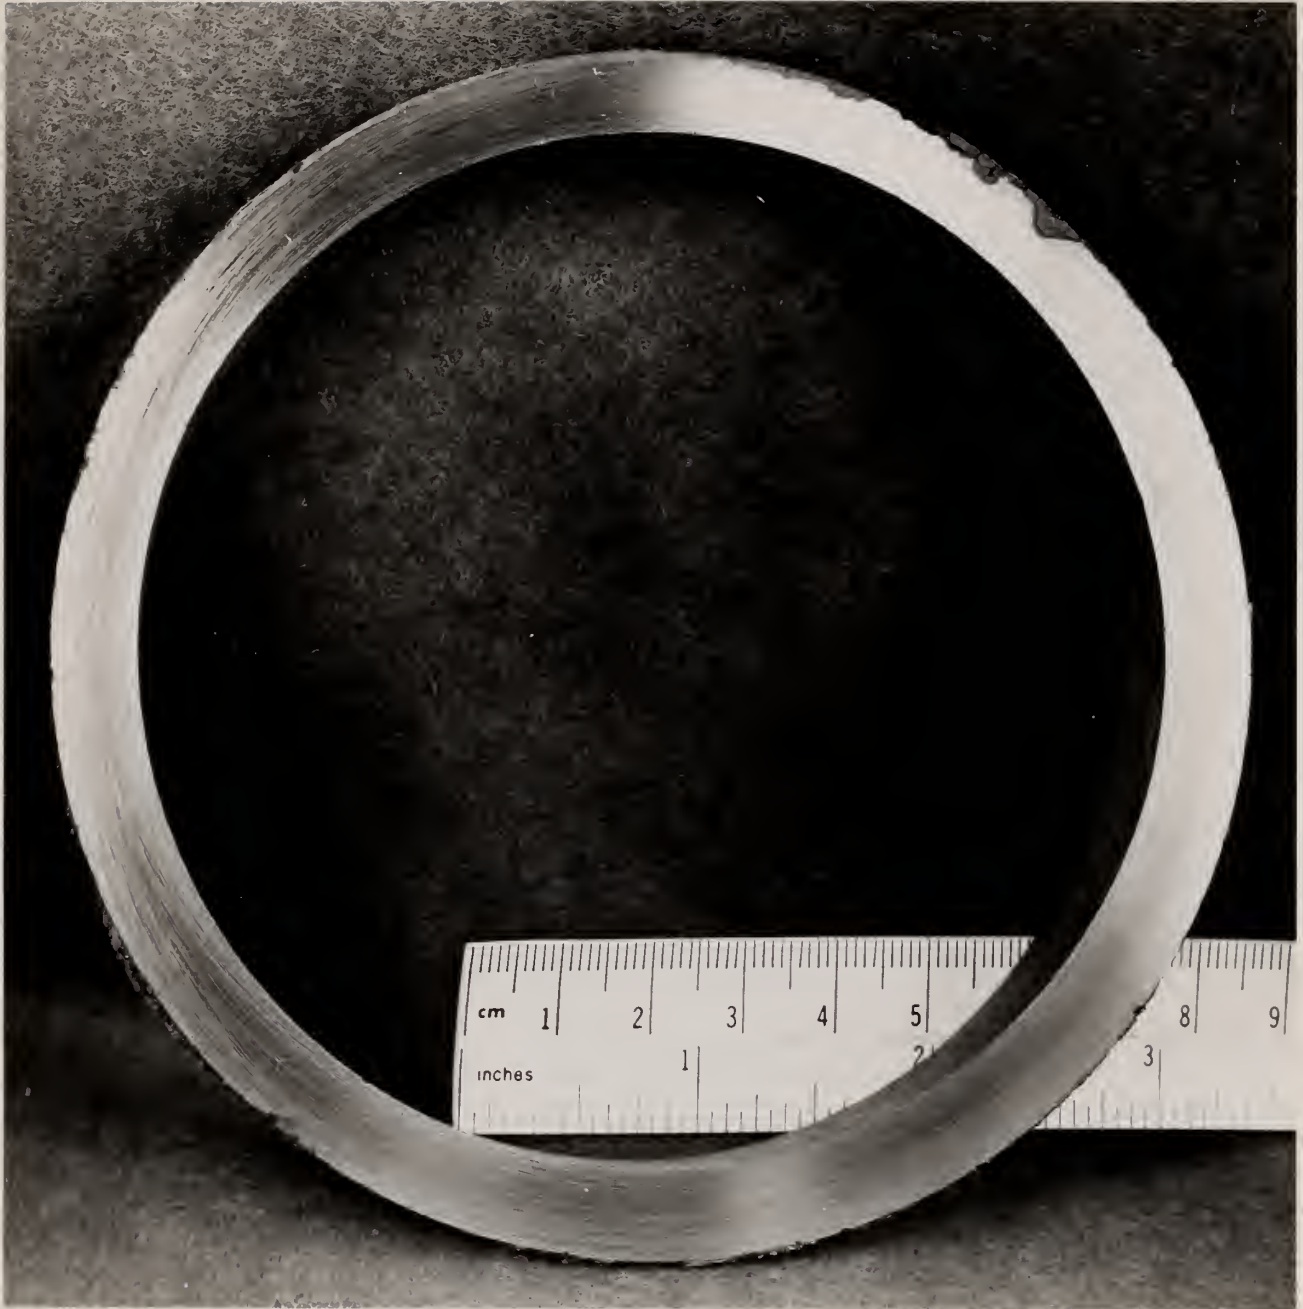
Figure 8. Polished cross section through the pipe sample ranging from about 1/2 to 2 inches from the fracture. Some localized graphitization is evident, especially between 12:00 and 2:00 o'clock. The top of the pipe in the figure corresponds to the top of the pipe as it was oriented in service.

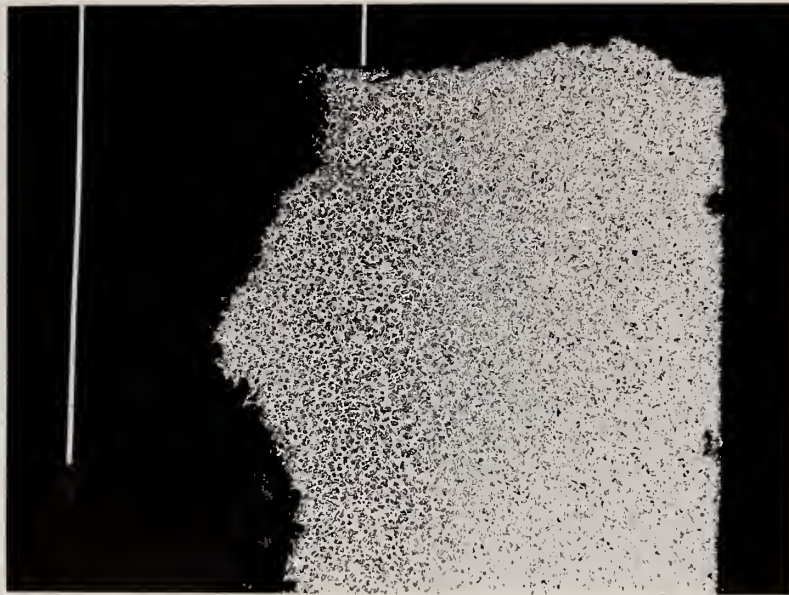
Figure 9. Longitudinal section through the pipe at arrow A, figure 3, showing the fracture profile horizontally at the top. Graphitization at the outside wall surface (vertical at the left) is evident. The inside wall surface is vertical at the right. The vertical line at the far left represents the original outside wall surface. The other vertical line represents the approximate extent of graphitization at the fracture.
Etchant: 1% nital

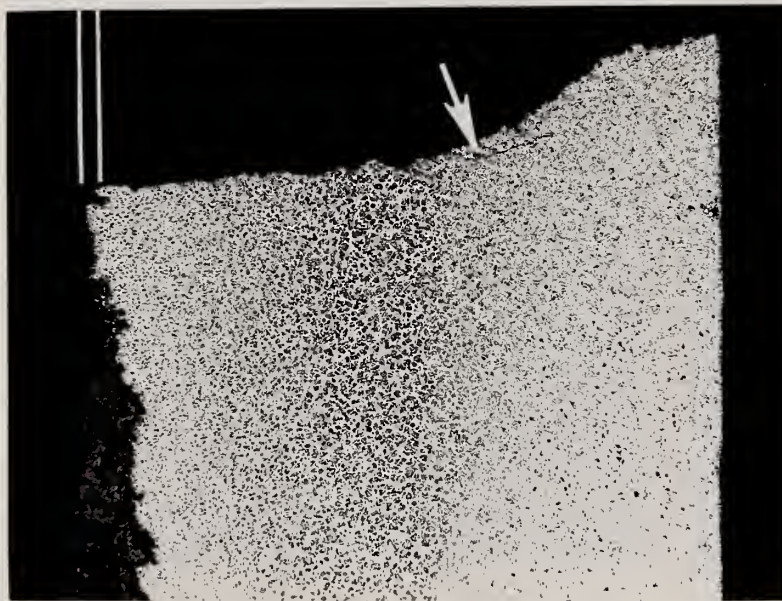
Figure 10. Longitudinal section through the pipe at arrow G, figure 3, showing the fracture profile horizontally at the top. Graphitization at the outside wall surface (vertical at the left) away from the fracture can be seen. The inside wall surface is vertical at the right. The vertical line at the far left represents an extension of the original outside wall surface. The other vertical line represents the approximate depth of graphitization at the fracture. The arrow indicates a secondary crack.
Etchant: 1% nital

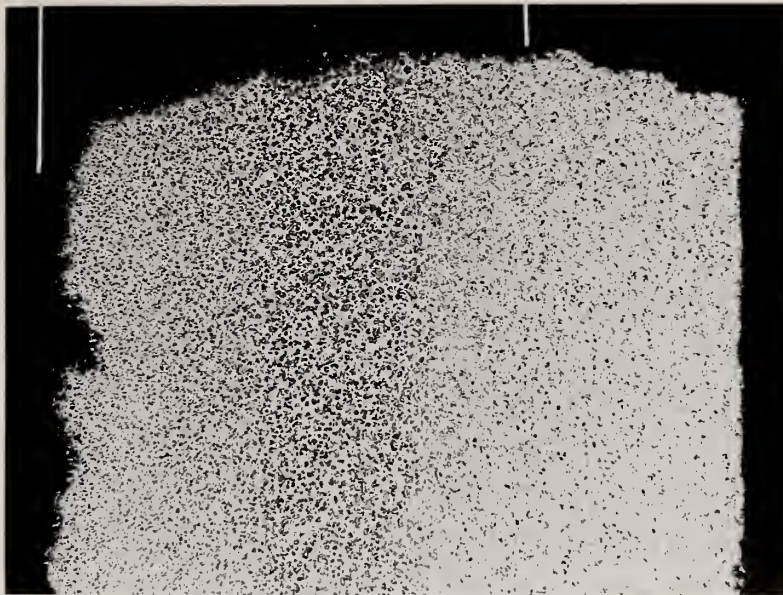
Figure 11. Longitudinal section through the pipe at arrow H, figure 3, showing the fracture profile horizontally at the top. The outside wall surface is vertical at the left and the inside wall surface is vertical at the right. Graphitization at the fracture surface is evident. The vertical line at the far left represents an extension of the original outside wall surface. The other vertical line represents the approximate depth of graphitization at the fracture.
Etchant: 1% nital

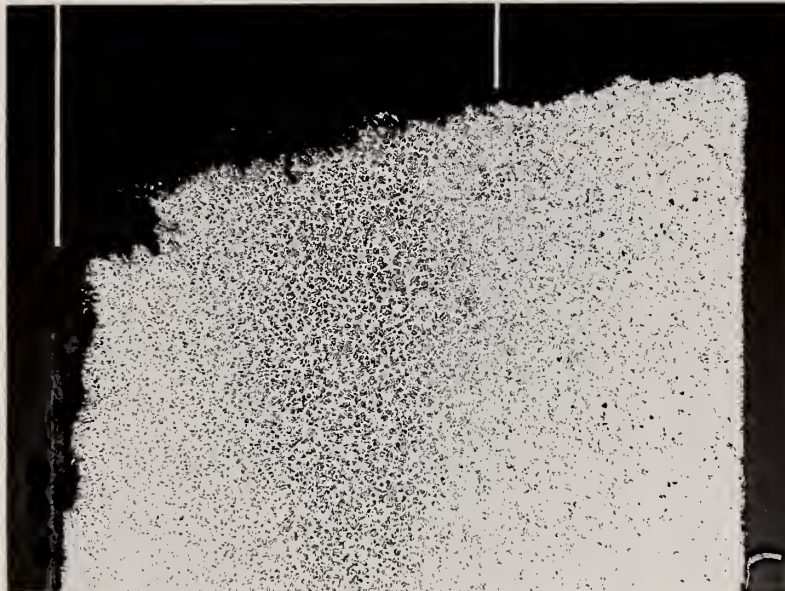
Figure 12. Longitudinal section through the pipe at arrow B, figure 3, showing the fracture profile horizontally at the top. Graphitization is evident both on part of the fracture surface and at the outside wall surface (vertical at the left). The inside wall surface is vertical at the right. The vertical line at the far left represents an extension of the original outside wall surface. The other vertical line represents the approximate depth of graphitization at the fracture.
Etchant: 1% nital

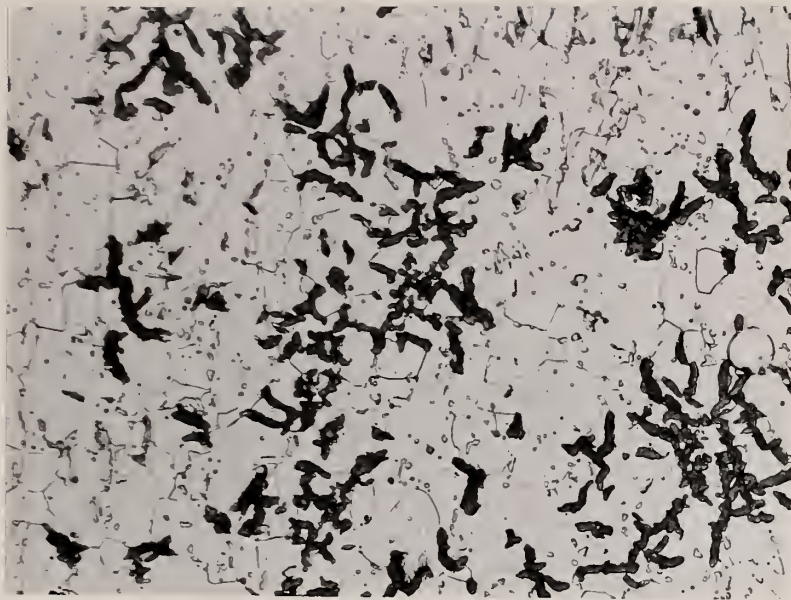
Figure 13. Longitudinal section through the pipe wall showing the representative microstructure of the material near the outside wall surface. The microstructure consists primarily of type B graphite flakes in the ferrite matrix. There are some rounded particles of apparent steadite (iron-iron phosphide eutectic).
Etchant: 1% nital

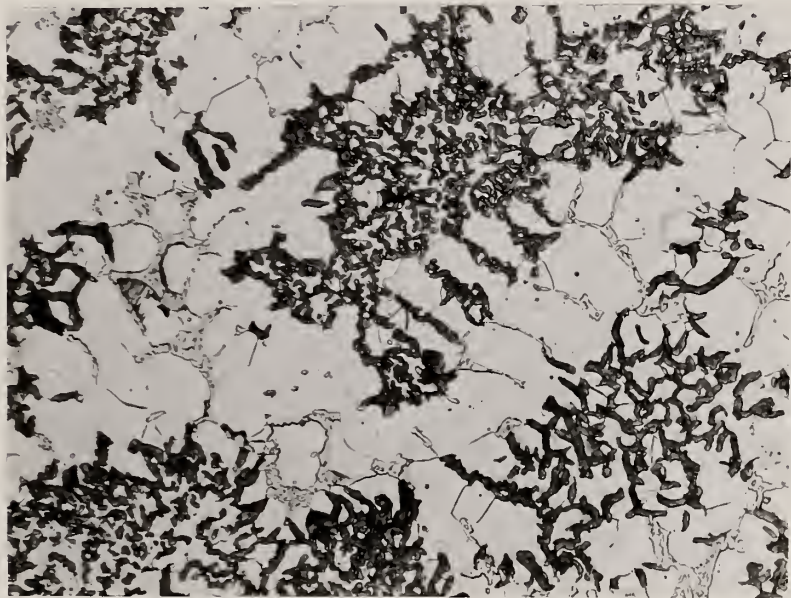
Figure 14. Longitudinal section through the pipe wall showing the representative microstructure of the material near the midthickness of the wall. The microstructure consists primarily of type E graphite flakes in a ferrite matrix. There is a small amount of what appears to be steadite (iron-iron phosphide eutectic) present in interdendritic patches.
Etchant: 1% nital

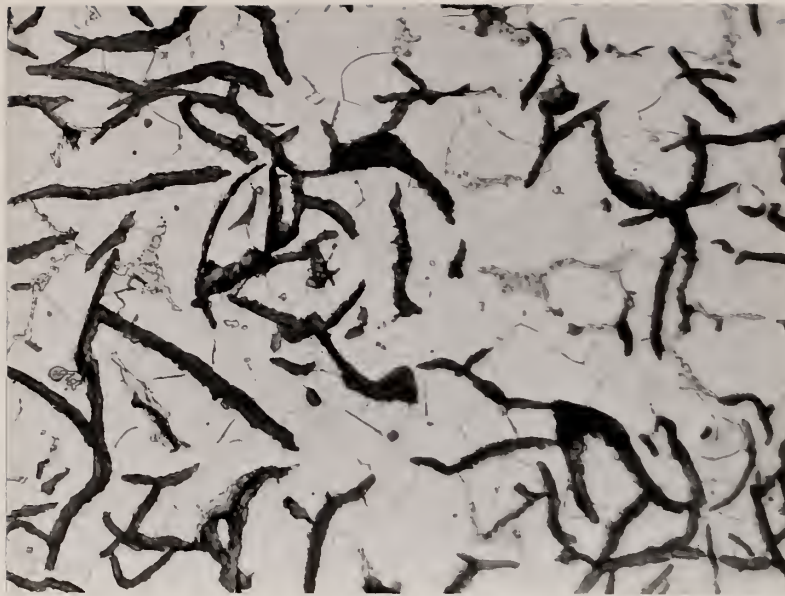
Figure 15. Longitudinal section through the pipe wall showing the representative microstructure of the material near the inside wall surface. The microstructure consists primarily of type A graphite flakes in a ferrite matrix. There are some patches which appear to be steadite (iron-iron phosphide eutectic).
Etchant: 1% nital

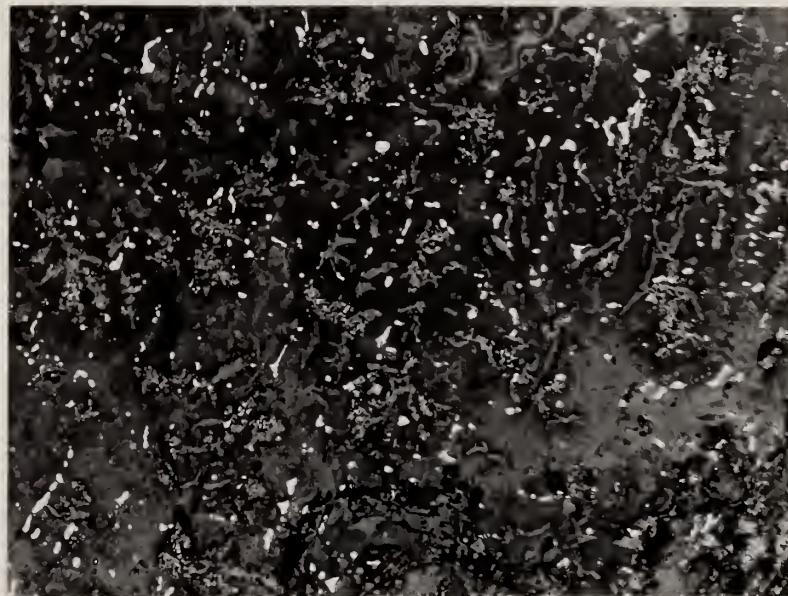
Figure 16. Longitudinal section through the pipe wall showing a representative field of essentially total graphitization.
Etchant: 1% nital

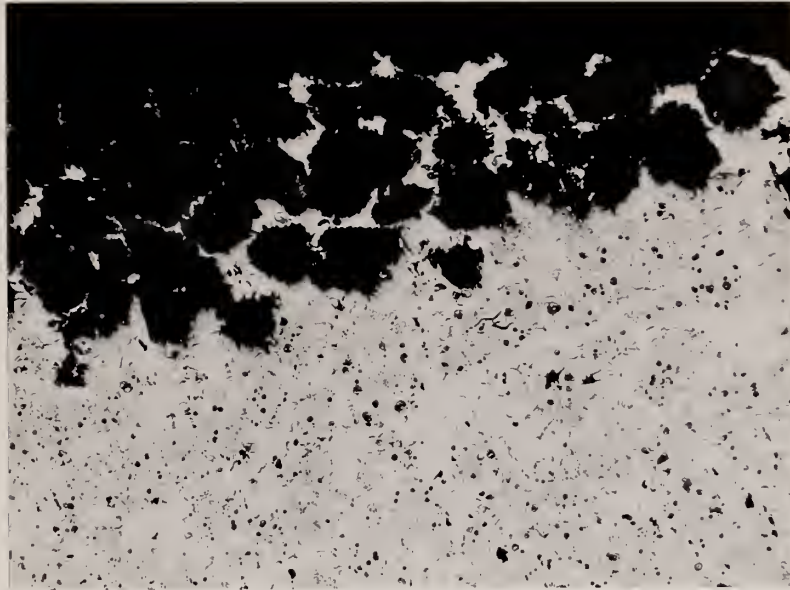
Figure 17. Longitudinal section through the pipe wall at arrow H, figure 3, showing the fracture profile horizontally at the top. Graphitization at the fracture surface can be seen.
As polished X 100

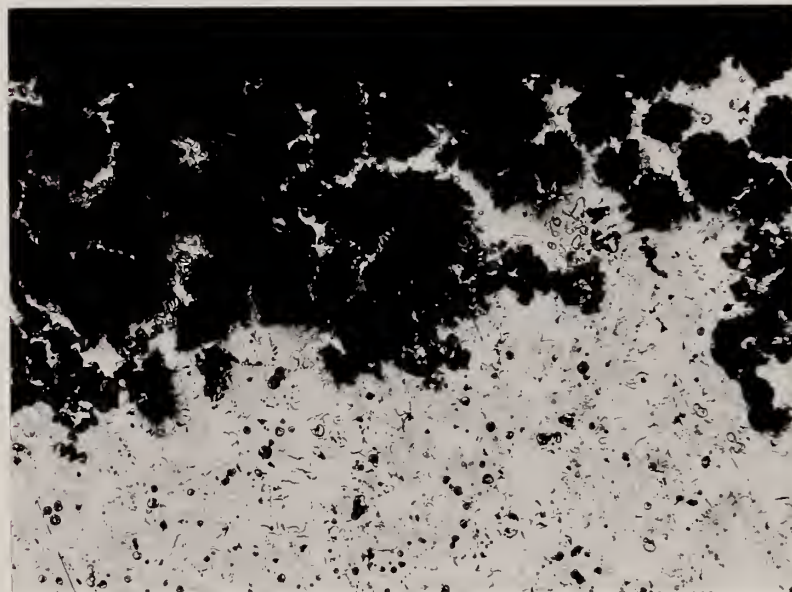
Figure 18. Longitudinal section through the pipe wall at arrow B, figure 3, showing the fracture profile horizontally at the top. Graphitization at the fracture can be seen.
As polished X 100
