NBSIR 81-2326

Investigation of Solar Collector Fire Incident

August 1981

William D. Walton

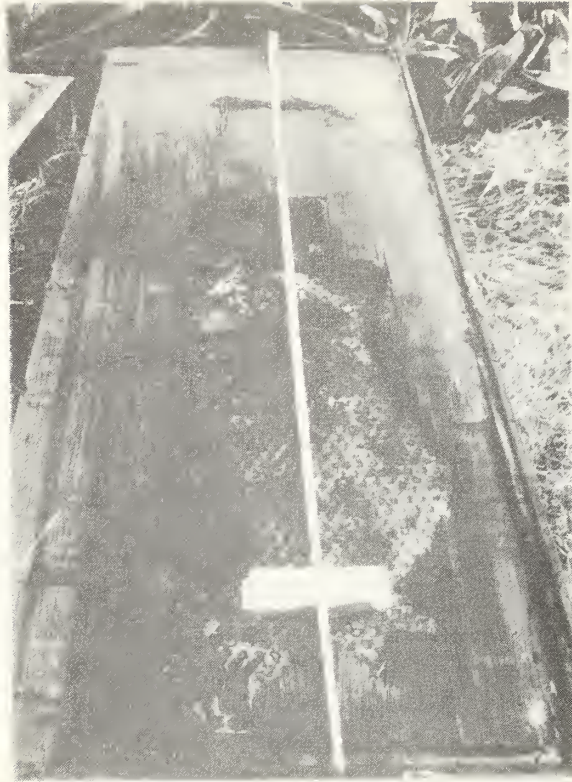
Figure 9. Collector involved in the fire - view of plywood back

At no time did the firefighters observe open flaming, but there was considerable smoke in the ceiling area. The fire damage was limited to a single collector (number 4 on lot 33), the roof, and one joist space directly below the collector. After extinguishment, the absorber plate of the collector could be seen by looking through the hole in the ceiling from inside the house. Figures 9 and 10 show the collector involved in the fire after it had been removed from the house. In figure 9 the view is of the back of the collector with what is believed to be the upper end of the collector as it was mounted, at the bottom of the picture. Figure 10 shows the same collector with the plywood back turned over so

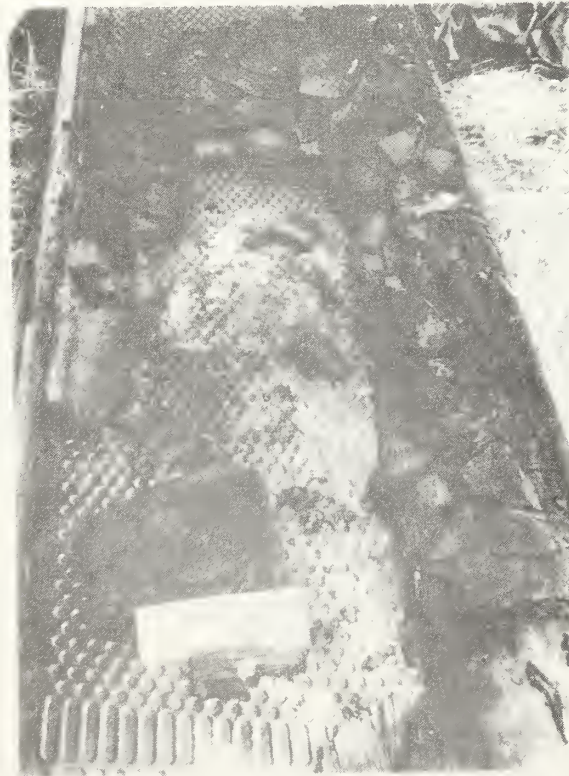
Figure 10. Collector involved in the fire - view of interior side of plywood

While it appears to be unlikely there are potentially several other materials in which self heating could have occurred within the collector assembly. Polyurethane foam has been known to self heat especially when freshly made and stacked in large piles [7]. There is very little information available on the temperatures at which rigid polyurethane foam degrades when heated for extended periods of time. This is due in part to the fact that its composition and properties vary widely. The evidence in this case indicates that the polyurethane was not providing substantial heat since the foam in the collectors not involved in the fire were blackened from the absorber side and the plywood blackened only when directly exposed to the absorber or when the foam layer was very thin. The urethane foam may have contributed to the fire when ignited by the glowing plywood. The fact that a considerable amount of the foam remained along the sides of the collector in which the fire originated as shown in figure 10 tends to support these conclusions.

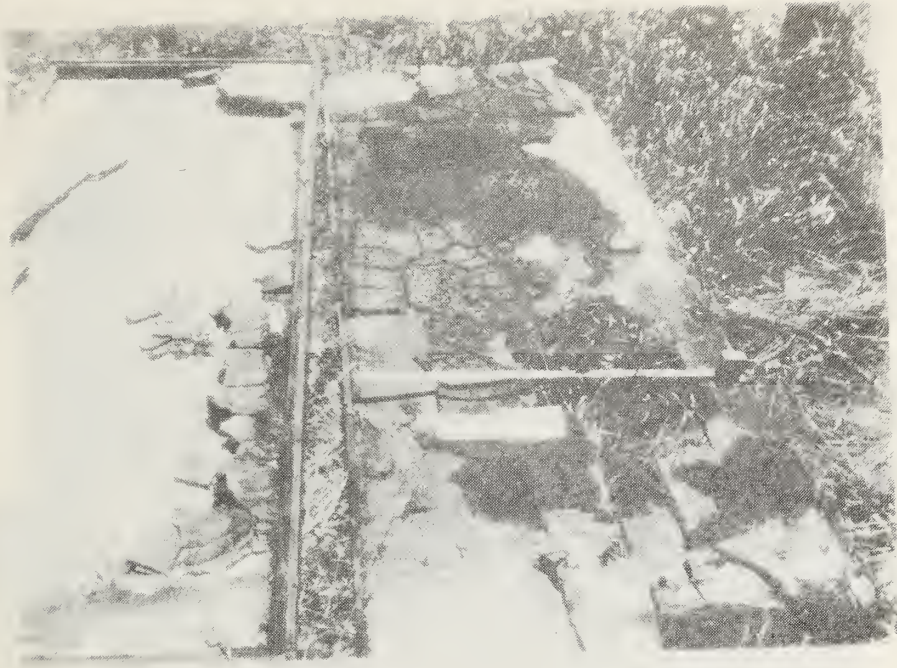
Figure 11. Collector 3, lot 33

A few days after the fire the building contractor removed the collector involved in the fire and the two adjacent collectors in order to repair the roof. Collector number 3, which is shown in figure 11 with a hole in the back, was most likely not involved in the fire. The hole was created by one of the workmen when the collector was removed from the house. This collector shows substantial thermal degradation, apparently from solar heating. Collector number 5 showed only moderate degradation.

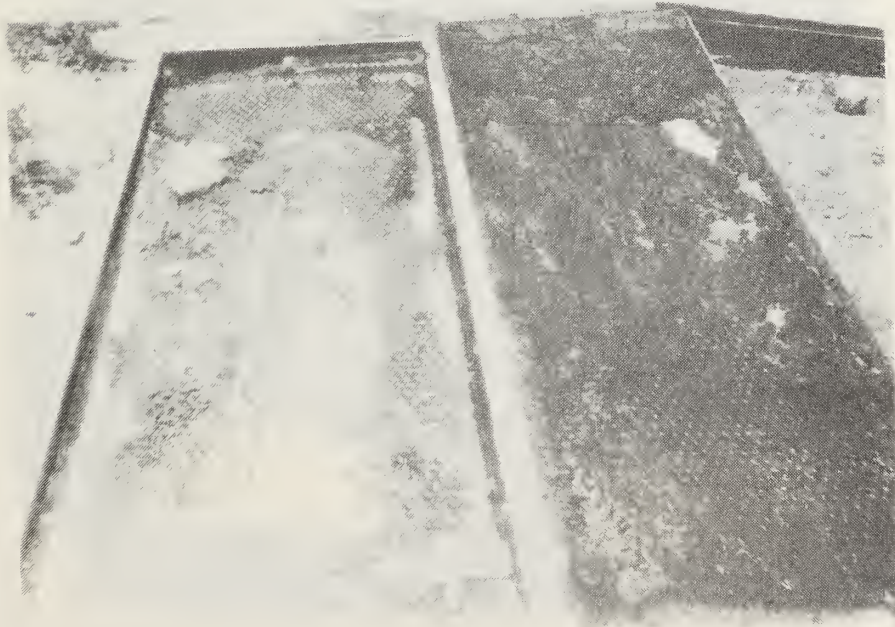
Figure 12. Collector typical of lesser degradation

Examination of the collectors at the site revealed that in all the collectors the urethane foam had thermally degraded to some extent. Figure 12 shows a collector which is typical of those with the least amount of urethane foam degradation found at the site. In this picture, the plywood back with the foam attached is on the right and the remainder of the collector with absorber plate visible is on the left. The end of the collector which had been mounted towards the peak of the roof is at the top of the picture. It can be seen from the small piece of foam sitting on the upper left of the absorber plate that the blackening of the foam had not progressed through to the plywood. Although the foam had lost some of its original thickness and some cracking occurred, it remained substantially intact.

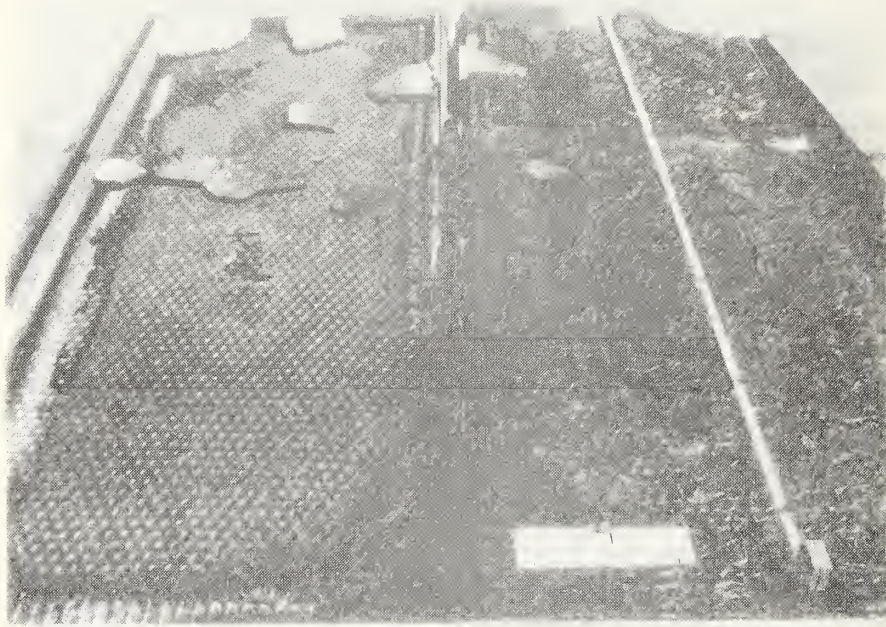
Figure 13. Collector typical of more severe degradation

Figure 13 shows a collector which was typical of those at the site with more severe degradation. The collector in the photograph is in the same orientation as the collector in figure 12. In this case, the foam sitting on the absorber has darkened all the way through and some areas of the foam are at approximately one-half the original thickness. In addition, large cracks have formed throughout the foam layer. Close examination reveals a darkening of the inside of the plywood backing approximately 3 feet (0.9 m) down from the upper end of the collector.

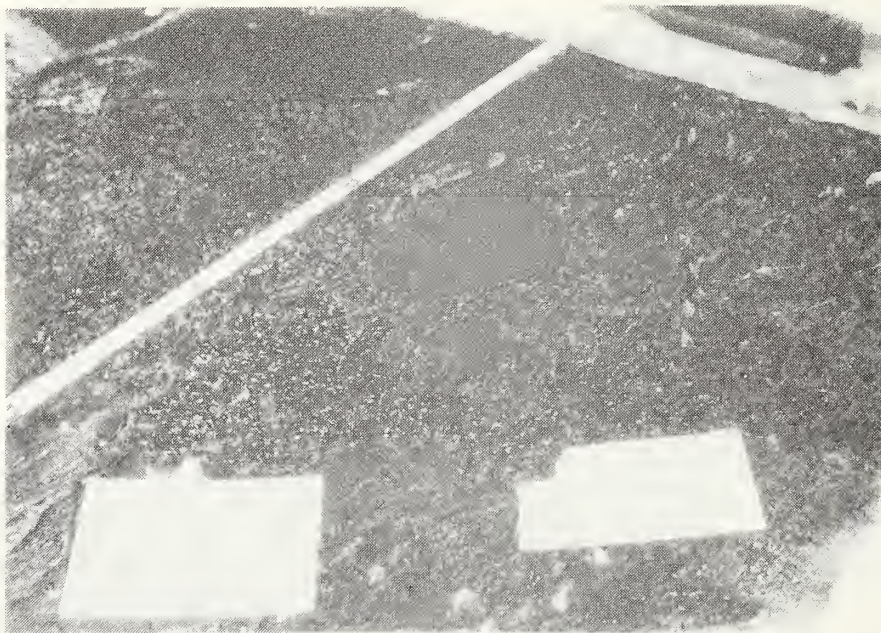
Figure 14. Close-up view of collector with severe degradation

Figure 14 shows a close-up of the upper two feet (0.6 m) of the foam and plywood backing from the inside of a severely degraded collector. The urethane foam which remains has been reduced to a layer approximately 1/4 inch (0.6 cm) thick. The plywood backing has blackened considerably and begun to crack.

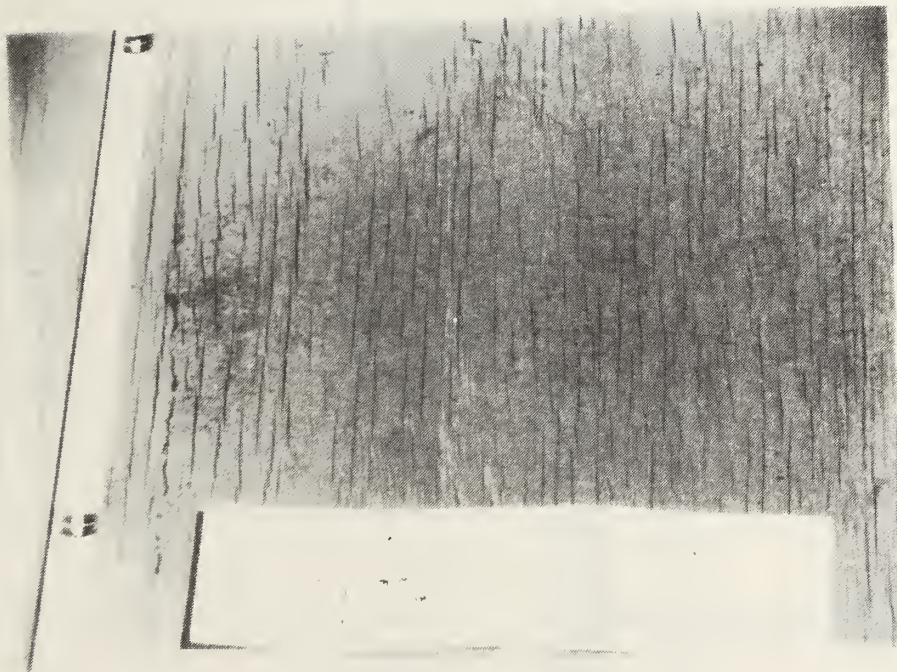
Figure 15. Back of collector with severe degradation

Severely degraded collectors also show degradation on the outside of the plywood backing. Figure 15 shows the back center of a collector between one and two feet from the end which was toward the roof peak when mounted. Cracking and a slight darkening of the wood is visible in this case.

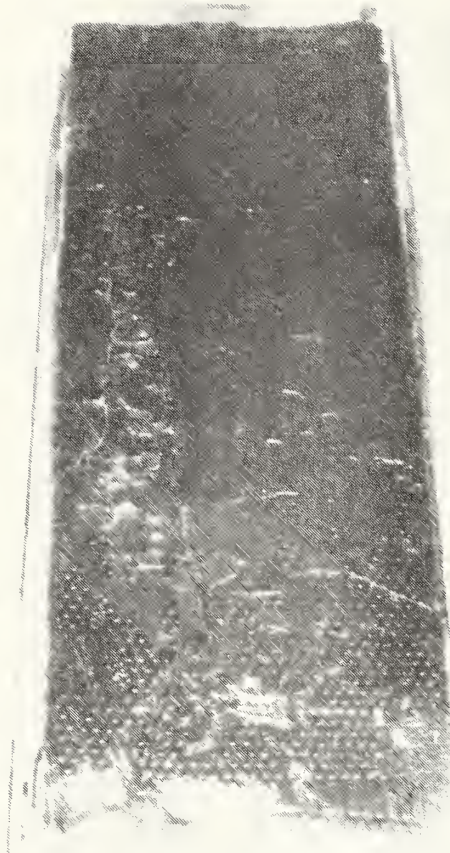
Figure 20. Collector after 30-day stagnation exposure

The results of the test conducted for DOE and similar tests conducted for the manufacturer show, within the accuracy of the measurement, no degradation of thermal performance at the end of 30 days. The collector in the DOE testing was later opened for inspection, which is not a normal part of the testing procedure. The foam insulation in this collector had degraded to a lesser extent, but in similar fashion to those from the site of the fire. Figure 20 shows the inside of the collector which was mounted on a test rack with the back exposed to the air during the tests. Figure 21 summarizes the conditions to which the collector was exposed. The minimum daily solar radiation required by the test procedure is $1500 \text{ BTU/ft}^2/\text{day}$ ($4725 \text{ Whr/m}^2/\text{day}$).

The results indicate that even though there is no measurable change in thermal performance of the collector over the 30-day stagnation test period, significant material degradation may actually be taking place.

- A. Consideration should be given to issuing a bulletin to the industry describing the potential fire hazard.
 - B. Collectors should be opened at the end of the 30-day stagnation test and examined for signs of material degradation. If combustible materials have degraded further testing should be conducted.
