NBSIR 81-2374

Investigation of Construction Failure of Harbour Cay Condominium in Cocoa Beach, Florida

September 1981

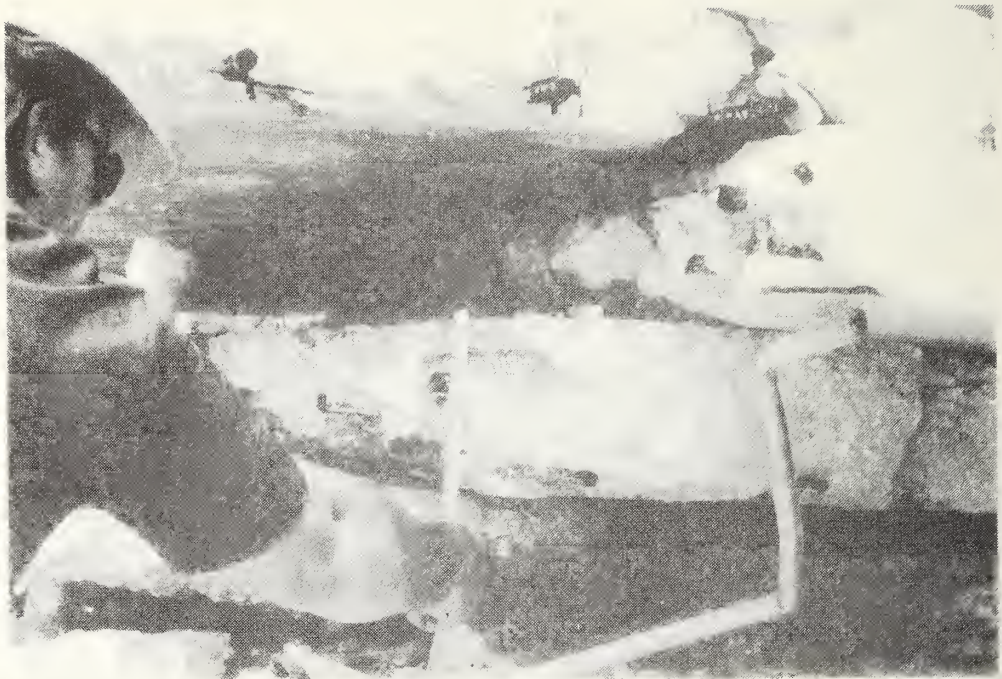
Figure 2.4 Field measurement of top bar cover in column strip

There is, therefore, an inconsistency in the construction documents. The structural drawings indicated a 3/4-in (19-mm) cover for the top slab bars, whereas the chair height indicated on the steel supplier's shop drawings would result in more than 3/4-in cover for the top bars in the column strips of the slabs. The record copies of the shop drawings contained numerous check marks. One of the six pages bore the handwritten words "approved as noted" and the signature of the design engineer of record.

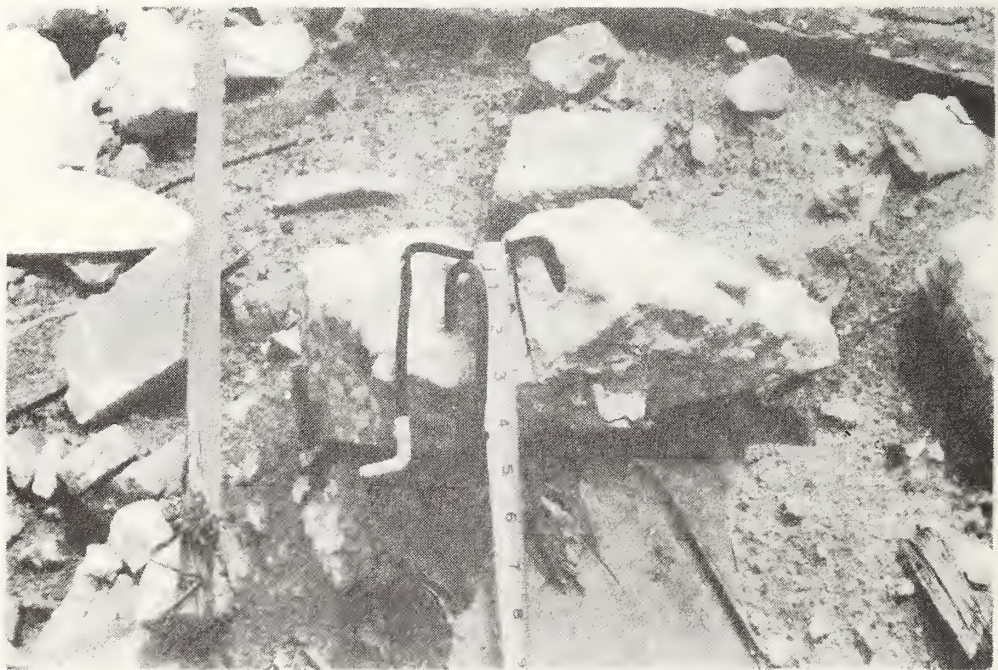
Figure 2.5 Field measurement of chair heights for top bars in column strip

The calculated effective depth at a column where the top reinforcement in the slab consists of #8 and #9 bars is 5.3 in (135 mm). This is obtained by adding to the 4-1/4-in (108-mm) chair height the average diameter of the two bars. If the effective depth is taken to the centroid of the bars, as defined in section 2.1 of the ACI Code [2.1], its value would be 5.28 in (134 mm) or 5.35 in (136 mm) depending on which size bar is assumed to be at the top. Considering all the columns and using both methods of calculation, the effective depth is found to fall in the range of 4.97 to 5.35 in (126 to 136 mm). These figures will be somewhat less along the sides of columns at the edges of balcony and walkway

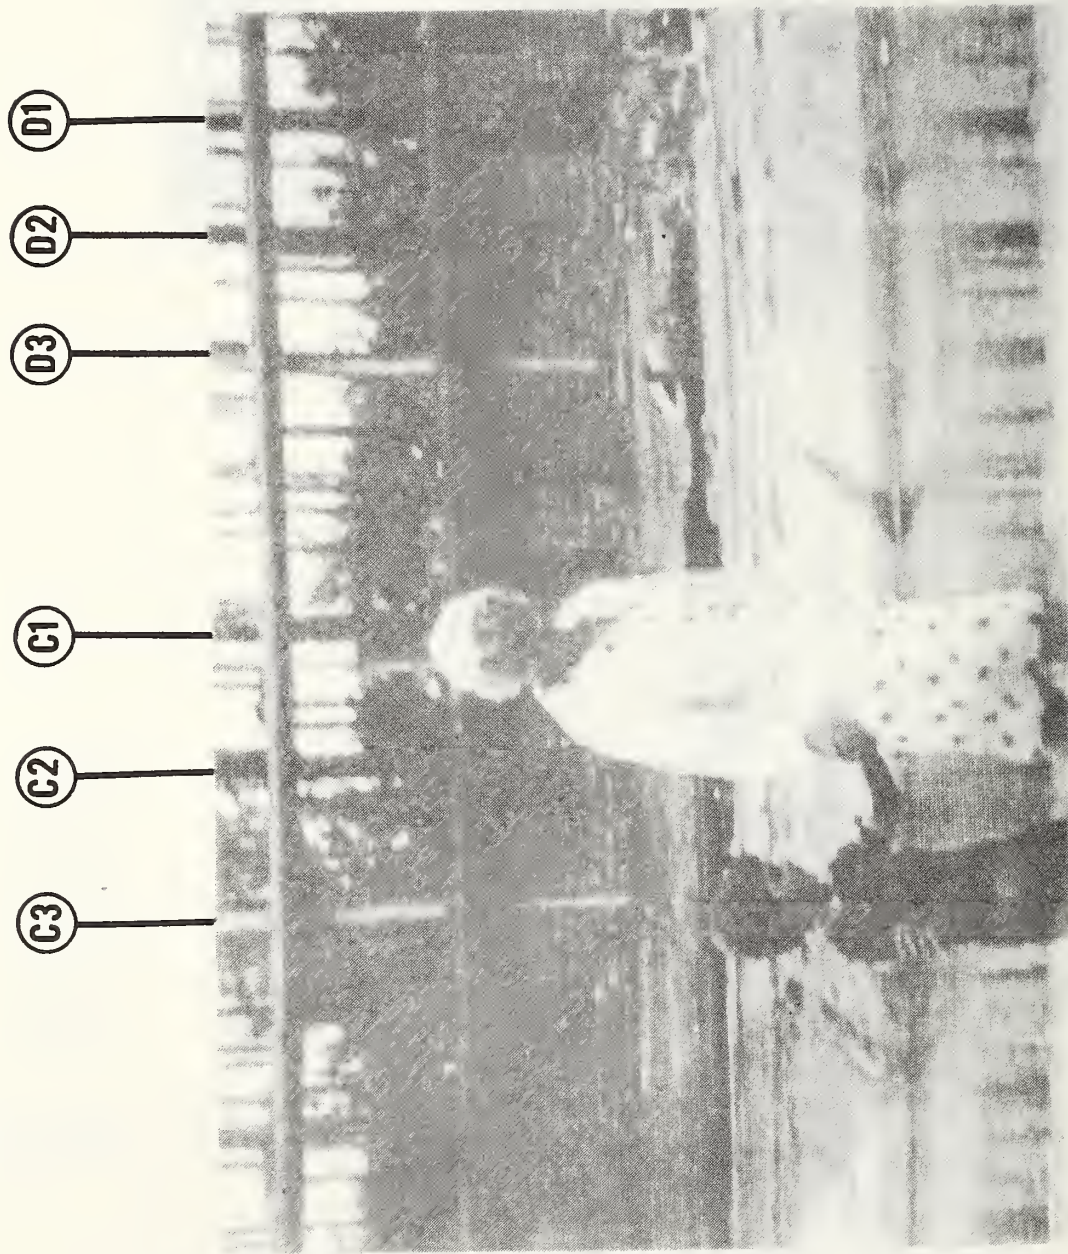
Figure 2.13 Partial view of bay CD from east side of building

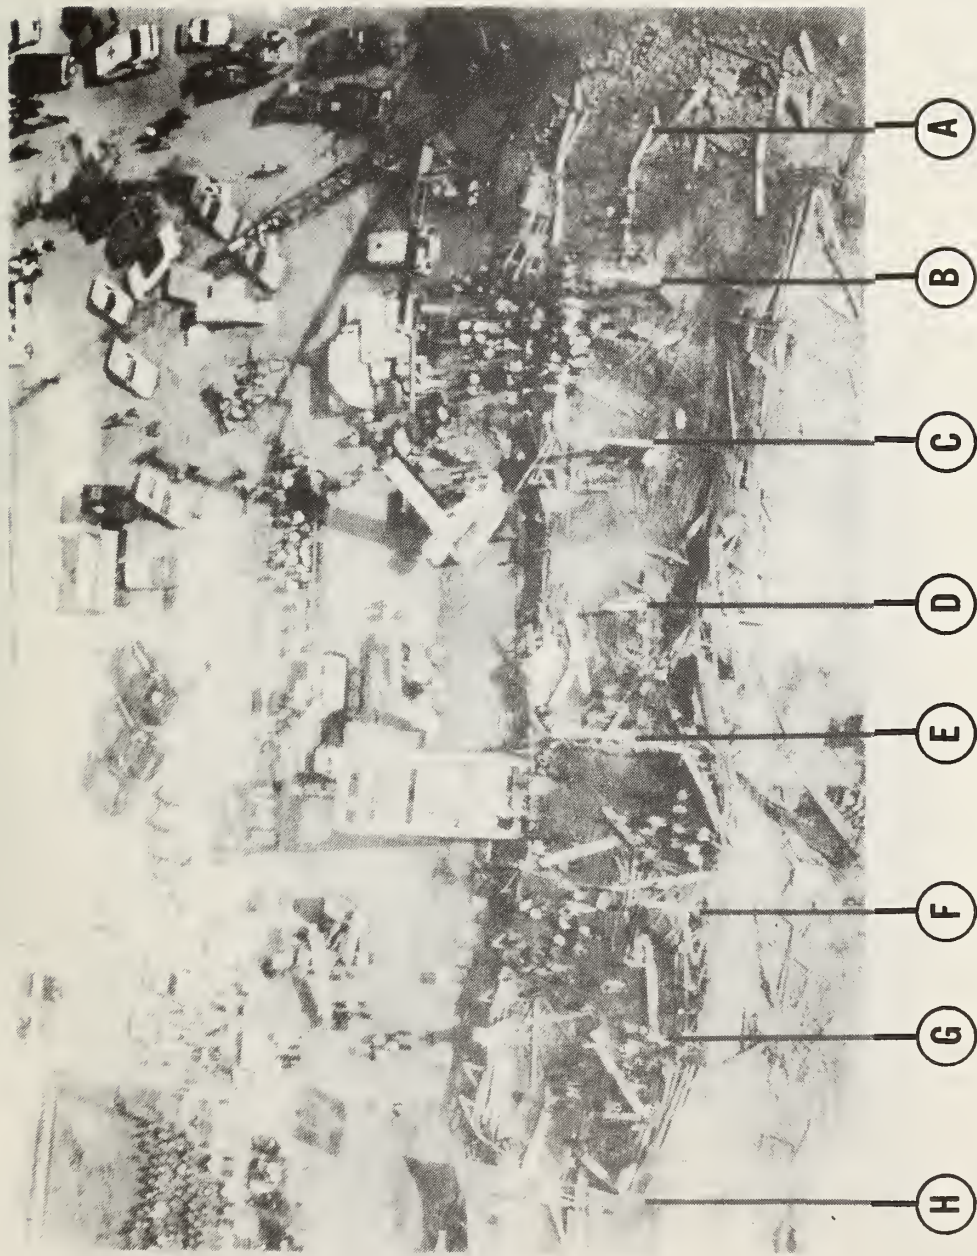
Figure 2.16 General view of wreckage after the collapse

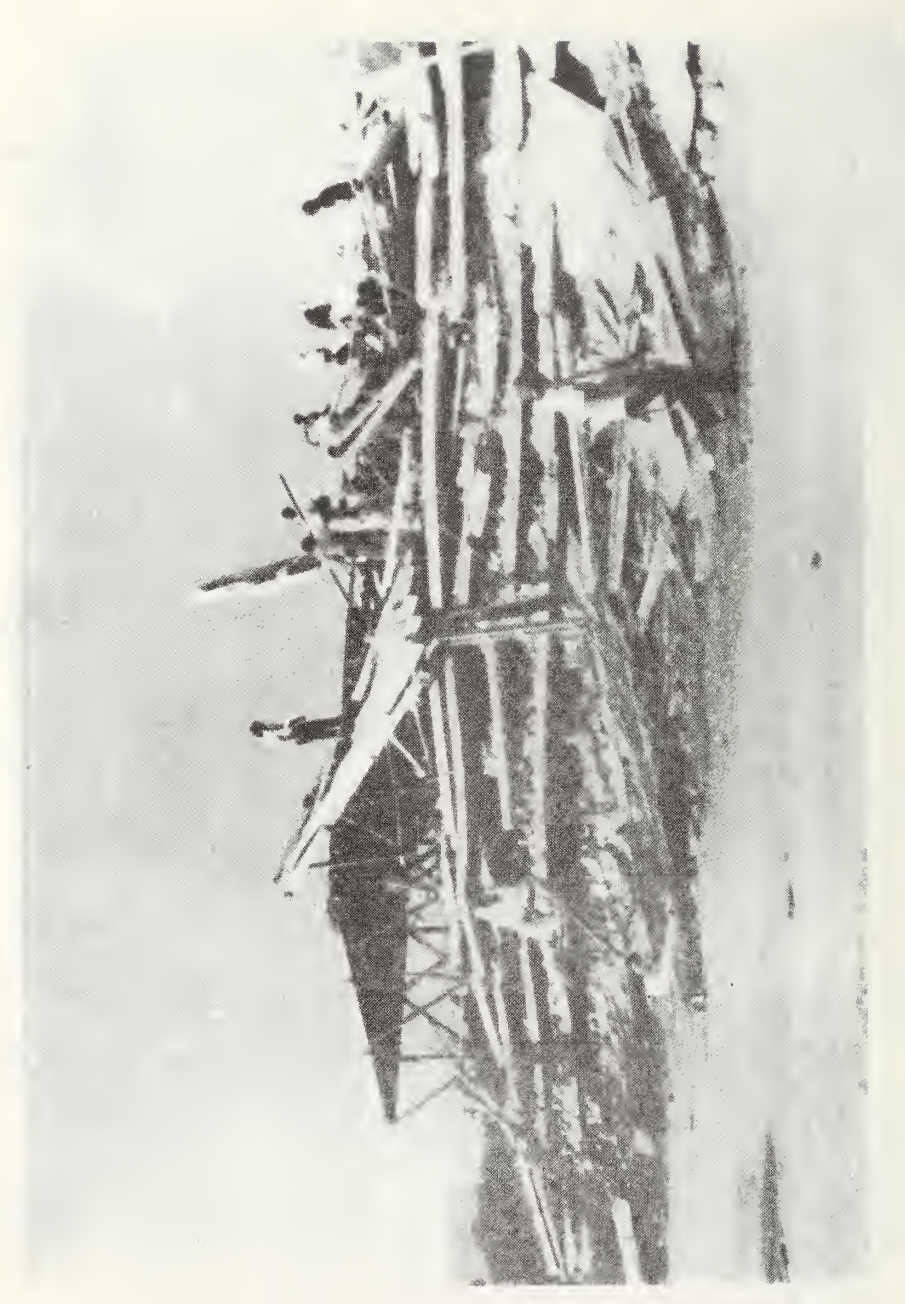
Figure 2.17 View of debris at north end of building after the collapse

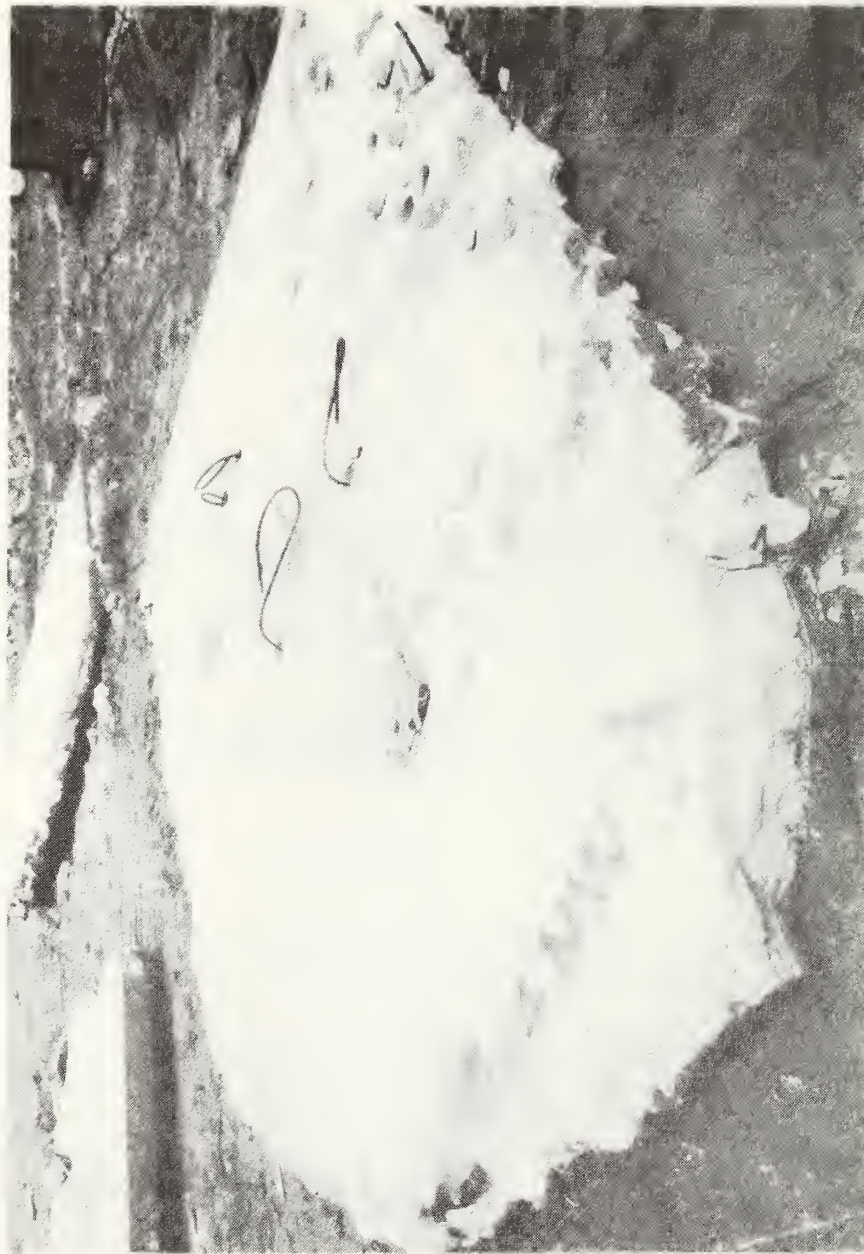
Figure 3.1 An identified portion of slab removed from the north-west section of the fourth floor

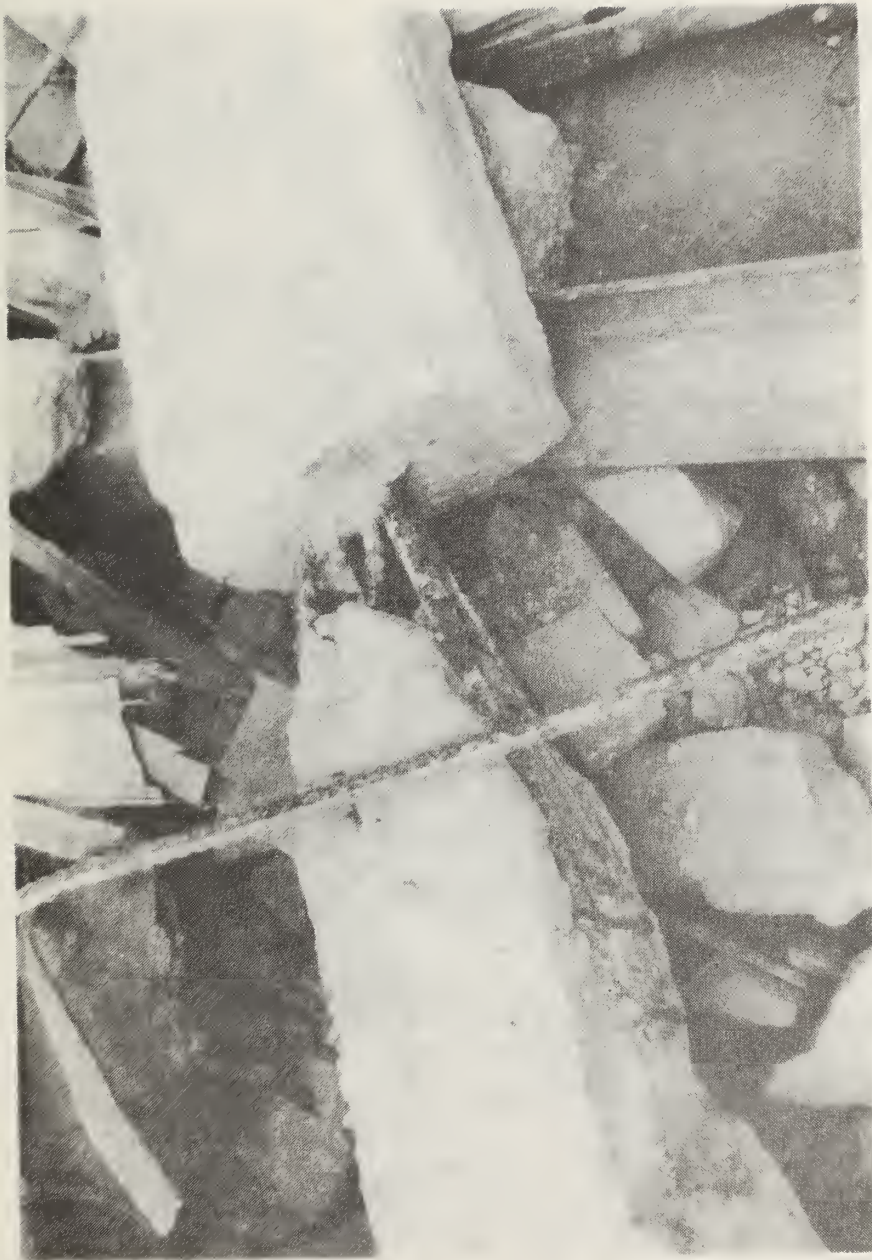
1. The slabs broke away from the columns at the slab-column interface (figure 3.2).
2. One or two bottom slab bars were placed through some columns. In many other columns no such evidence was noted.
3. In some cases, the vertical reinforcement above the floor level was bent severely during fabrication (figure 3.2).
4. Column size measurements agreed with the structural drawings.

Three workers (#40, #45, #73) mentioned that the construction joints at the middle of the building were not of good quality. They were described as "ragged", "cracked", and "honeycombed". Two workers (#45, #14) mentioned that they saw rebars showing on the faces of some columns. The incomplete filling of the column forms was probably due to congestion of steel (see figure 3.3), which, according to a supervisor (#72) was so severe in some of the second and third floor columns that the top reinforcing steel in the slabs could not pass through. In order to pass slab bars through some columns, the protruding column reinforcement was "bunched together" and the slab bars were placed alongside the column bars (figure 3.2).

Figure 3.2 Severely bent column reinforcement
