NBSIR 82-2465

Investigation of the Kansas City Hyatt Regency Walkways Collapse

February 1982

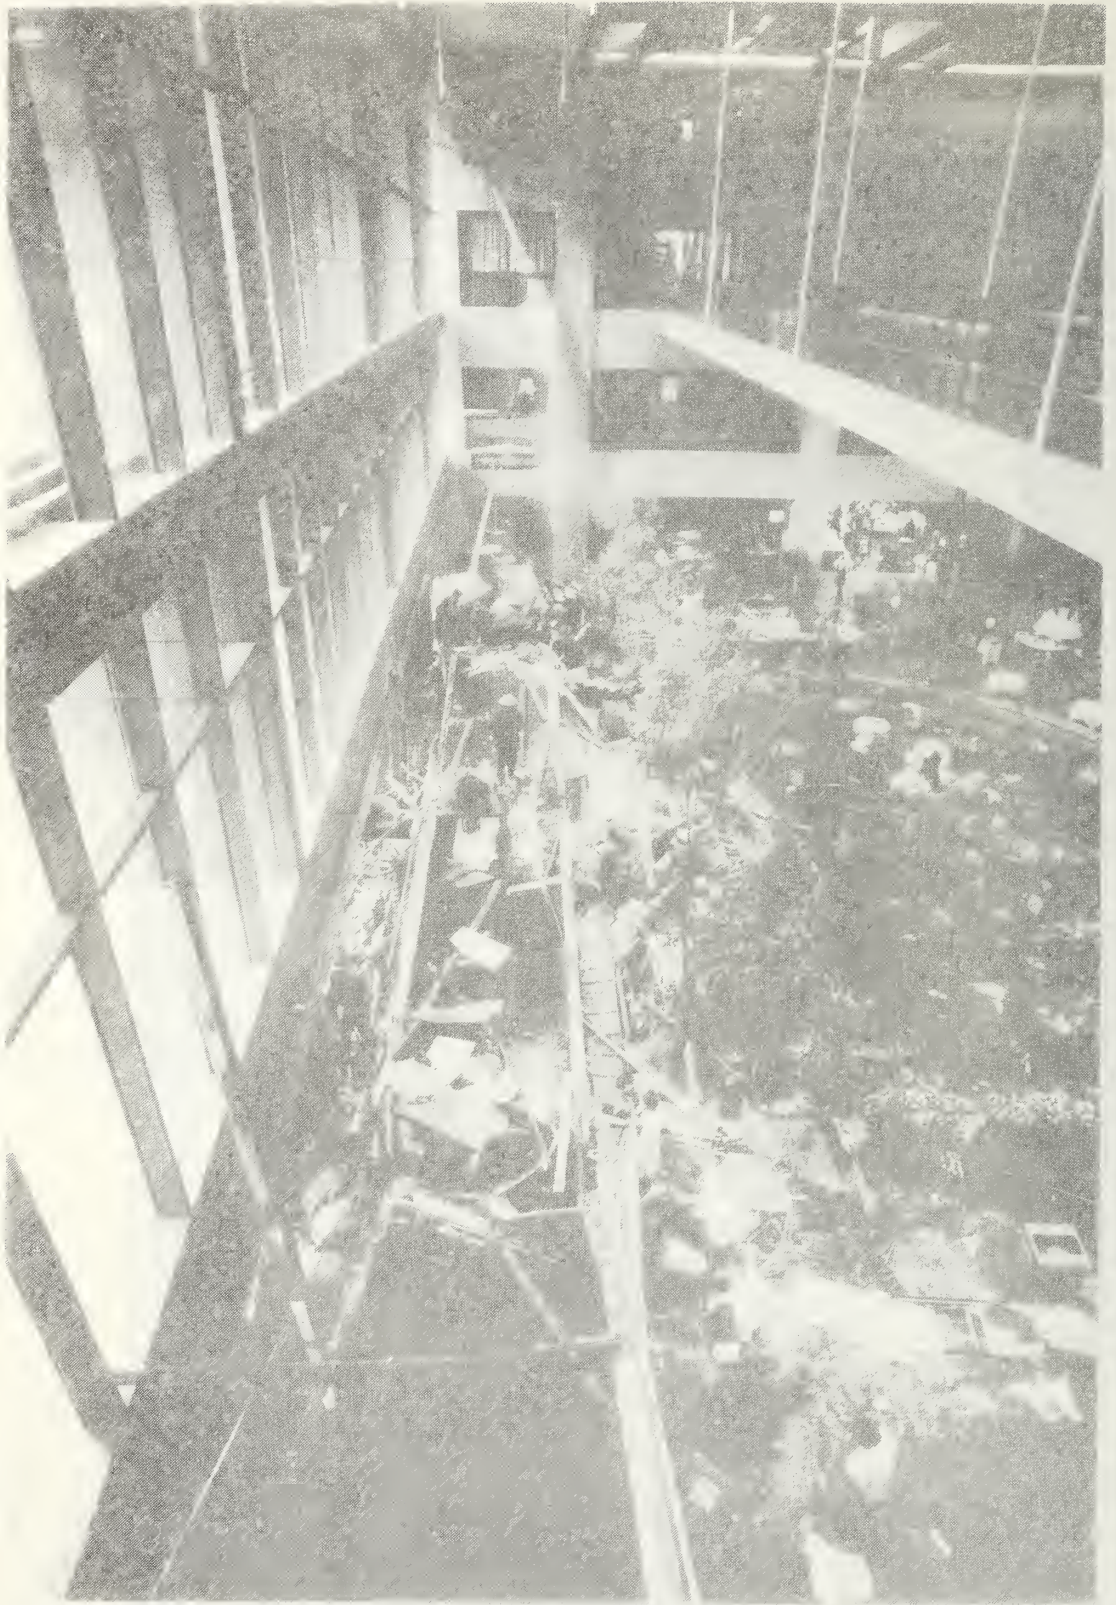
Figure 4.1 Walkways shortly after the collapse. View is to the west-northwest with span U7-8 sloping down and to the right. Spans U8-9 and U9-10 are visible behind the trees. Photo by Greg Smith, reprinted by permission of The Kansas City Times, © 1981, The Kansas City Star Company.

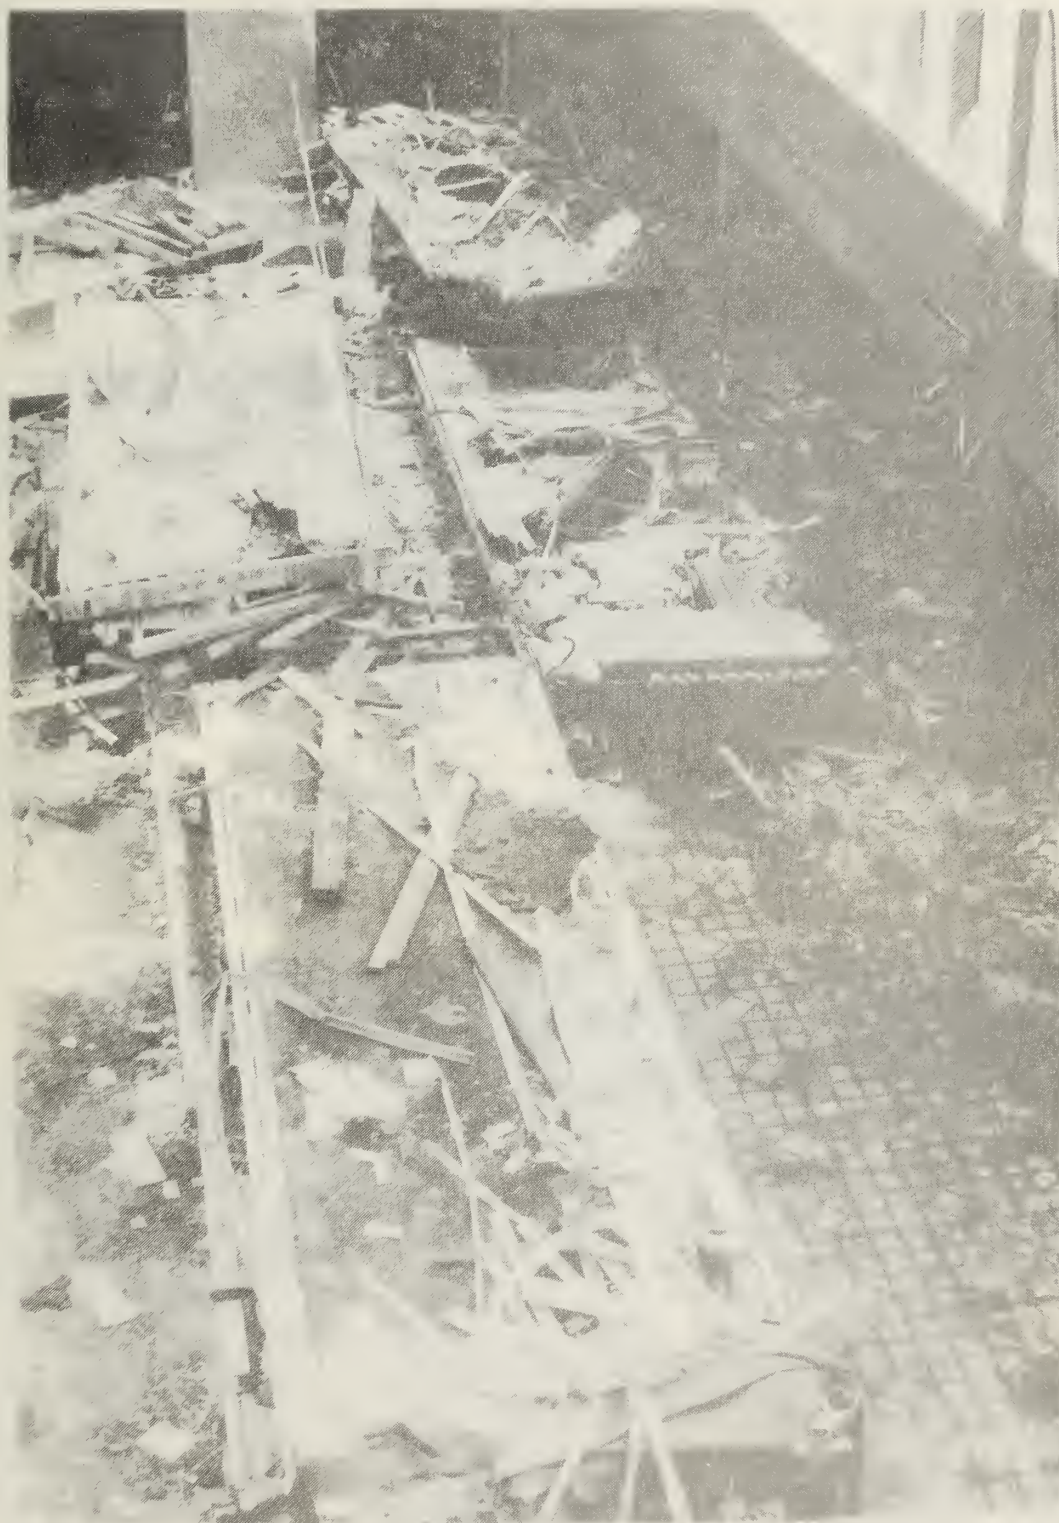
Figure 4.2 Walkways shortly after the collapse. View is directly to the north along the axis of the walkways. Span U7-8 is in foreground and third floor walkway is at upper right. Water is coming from broken sprinkler pipes. Photo by Greg Smith, reprinted by permission of The Kansas City Times, © 1981, The Kansas City Star Company.

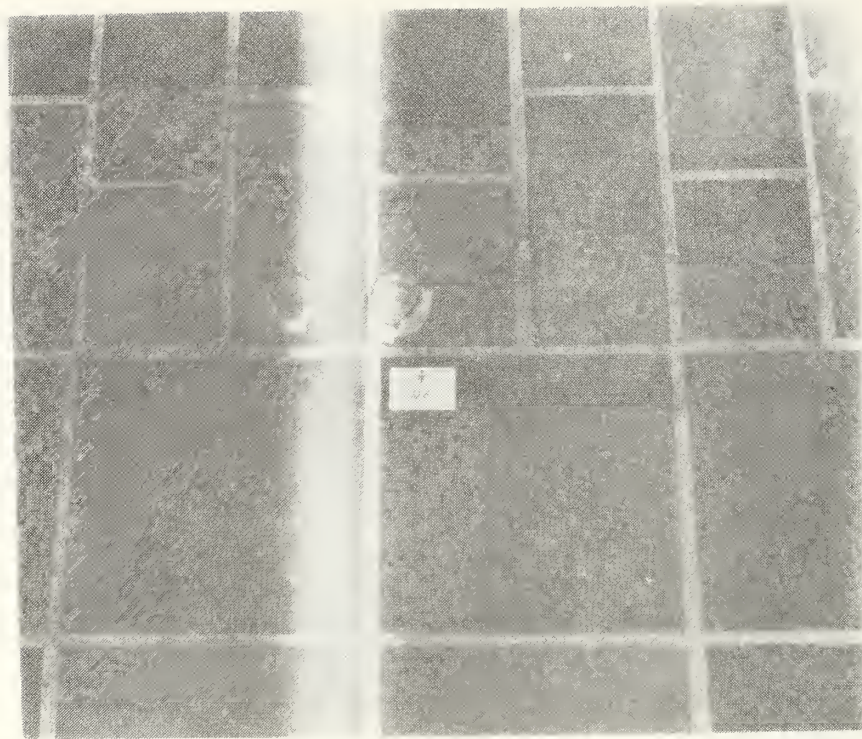
Figure 5.3 Tile damage caused by second floor hanger rod 10E.

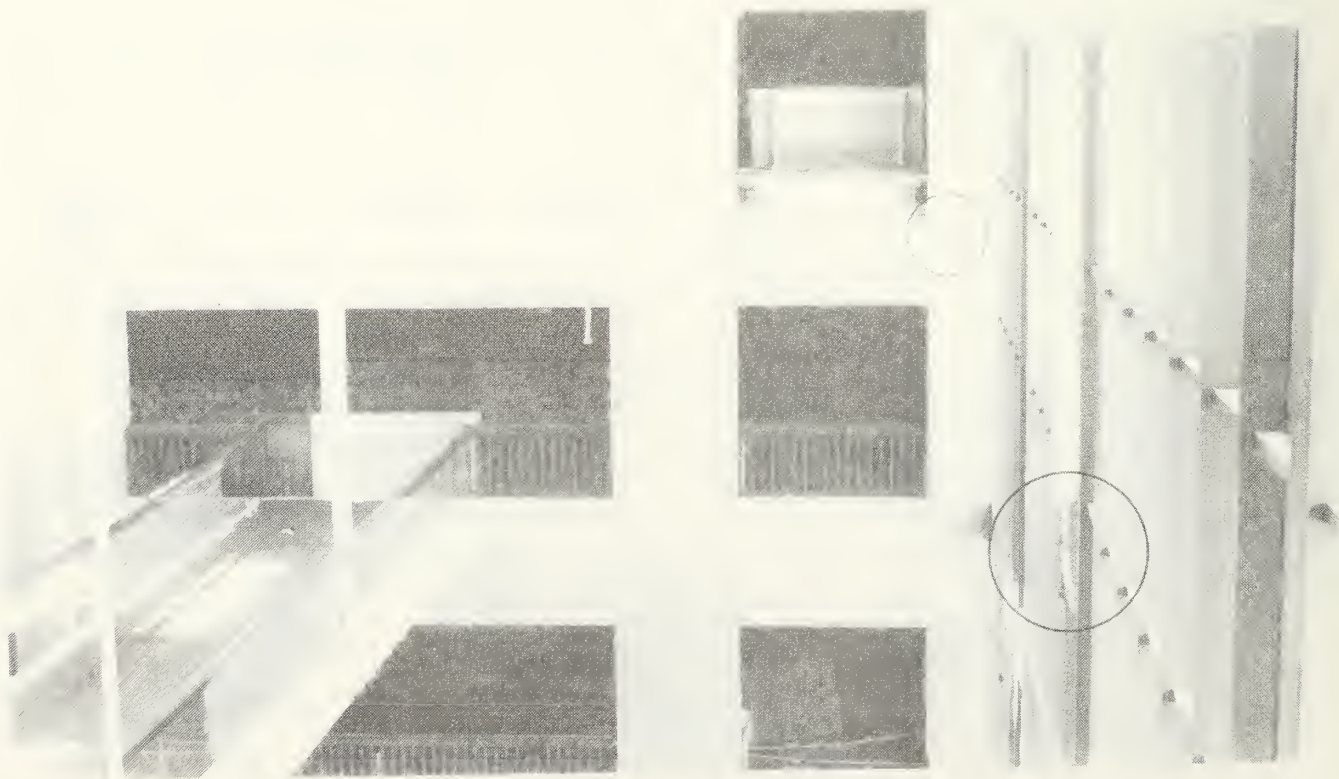
One final observation of importance is the pronounced bend to the west at the bottom end of hanger rod 10UW and a lesser bend at the bottom of hanger rod 8UW as can be seen in figure 5.4. Not apparent in figure 5.4 is a slight bend at the bottom of hanger rod 9UW which was detected after the hanger rods had been removed to the warehouse. The absence of appreciable distortions in hanger rods 8UE, 9UE, and 10UE strongly suggests that failure initiated along the east line of hanger rods.

Figure 5.4 Fourth floor to ceiling hanger rods. View from fourth floor looking south.

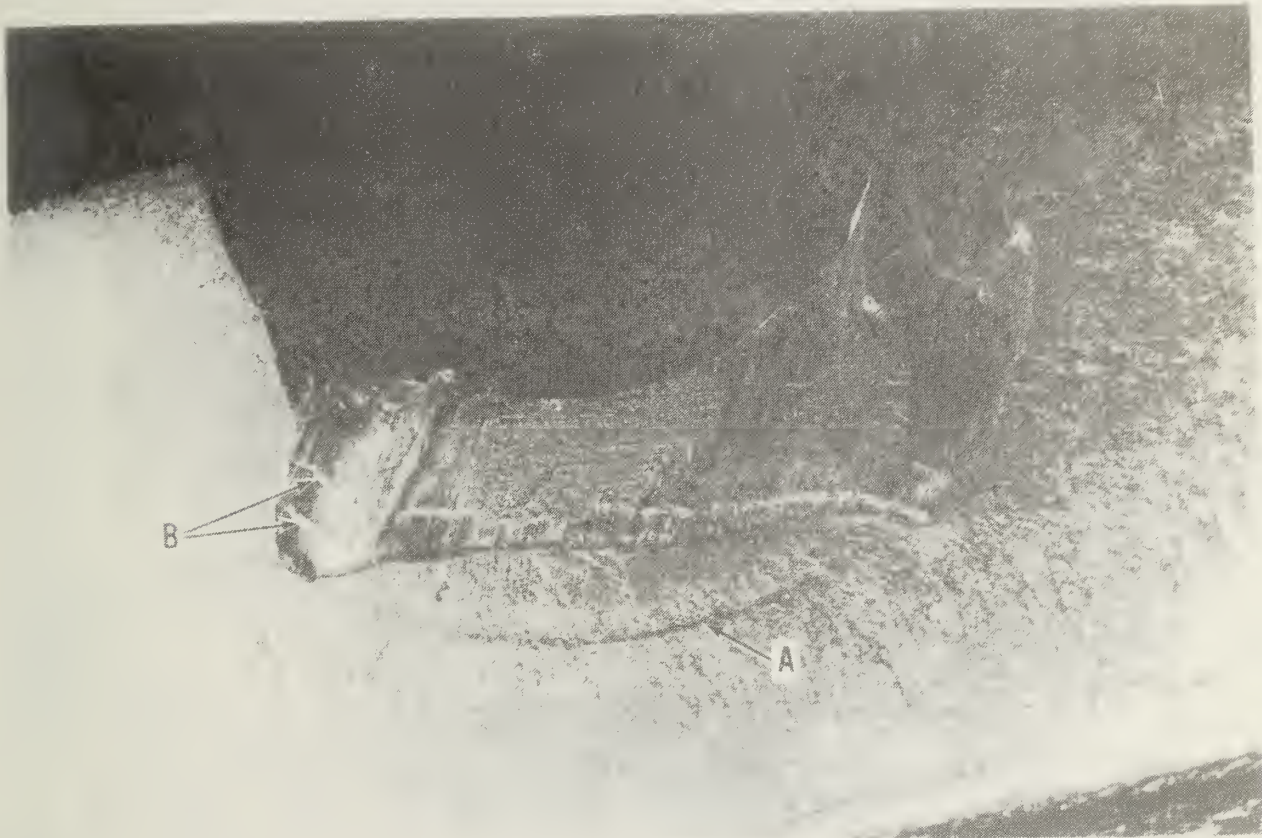
Figure 5.10 Deformation at underside, outer hole, location 9UE due to pull-through of washer/nut assembly. Note imprint of washer (A) and evidence of slip-stick progressive failure (B).

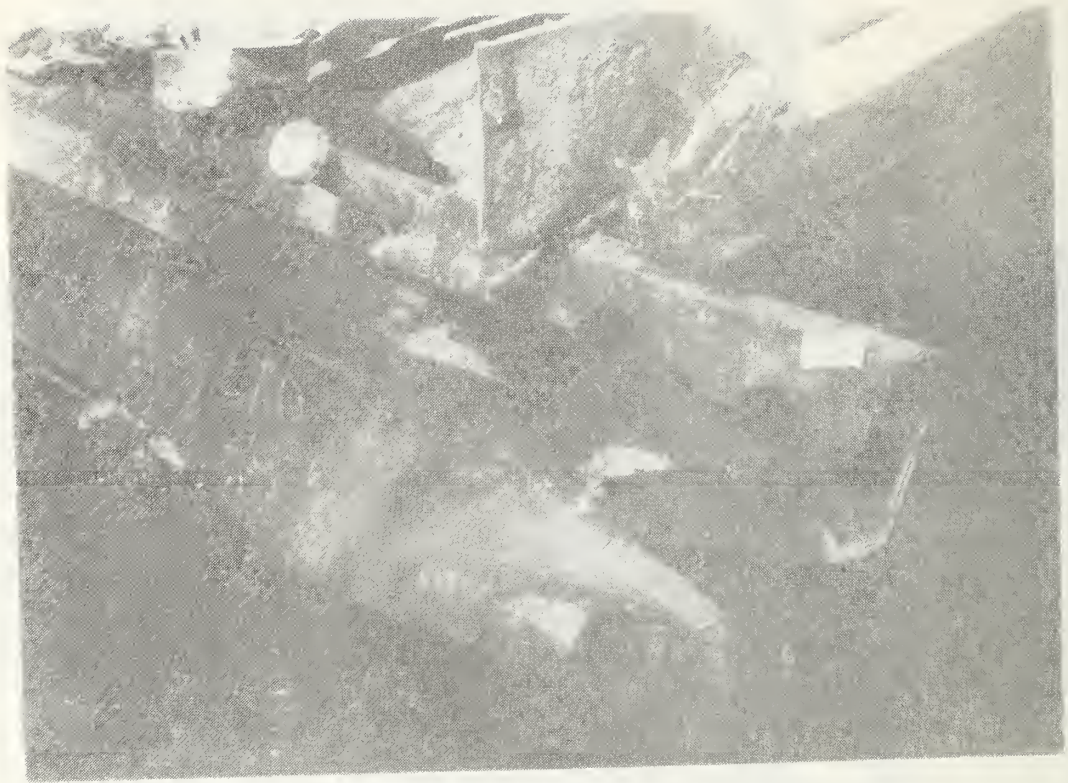
Figure 5.11 Box beam at location 10UW (Span U9-10).

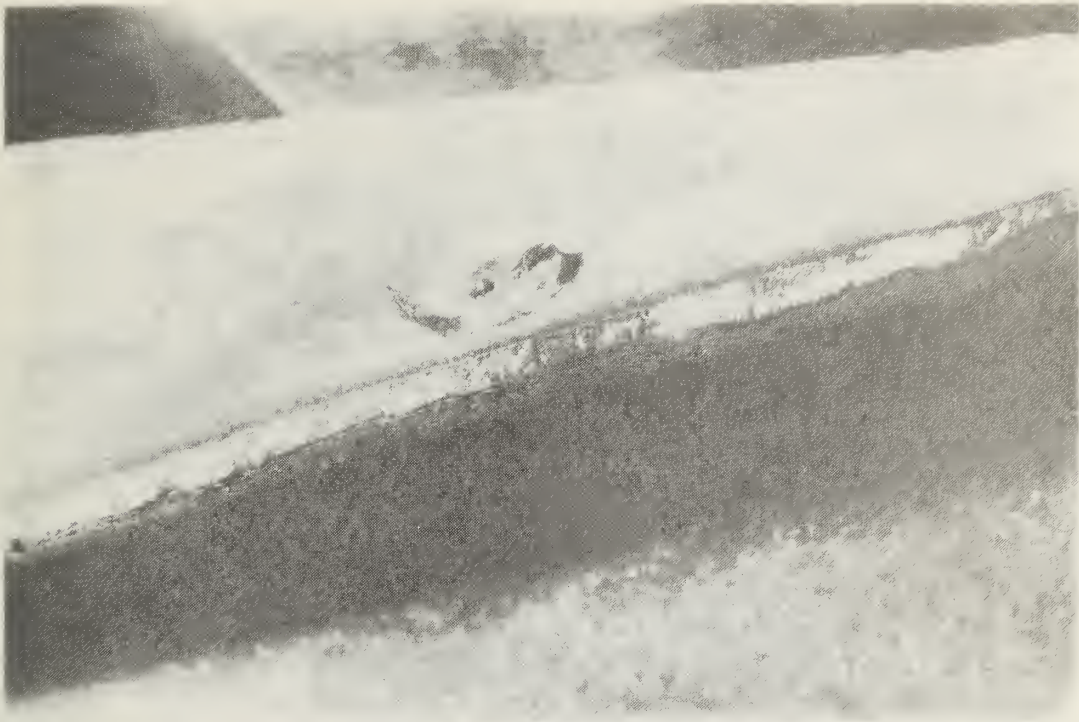
Figure 5.15 Weld penetration at location 8UW, upper flange.

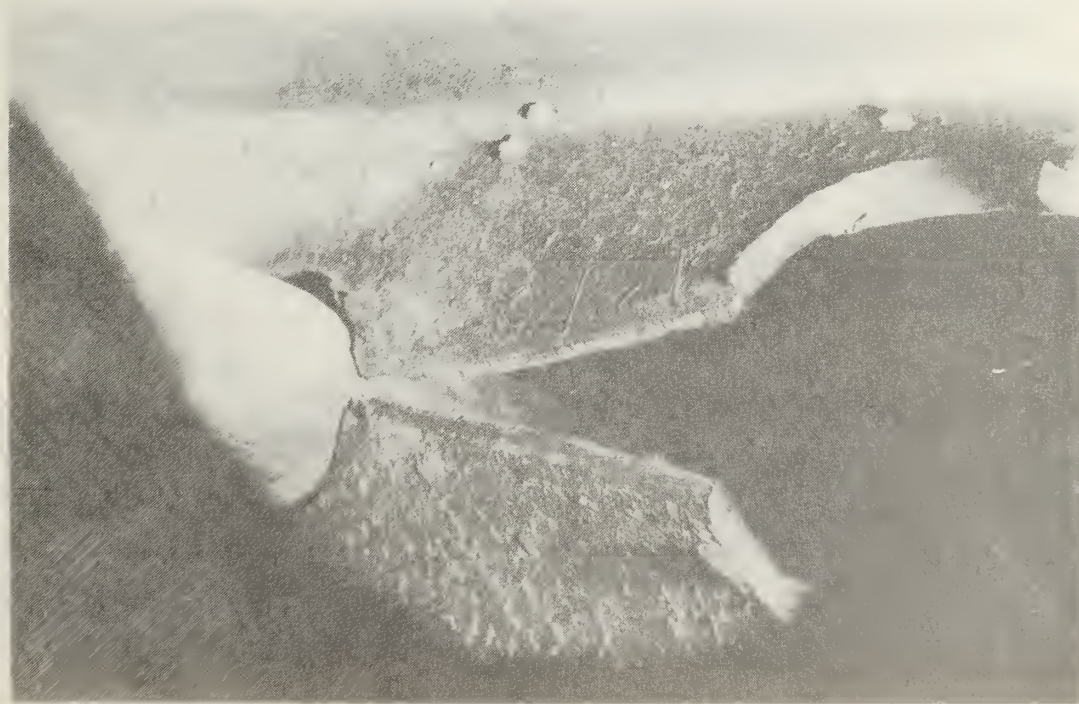
Figure 5.16 Fracture through the weld at location 9UE, lower flange. Weld porosity denoted by arrows.

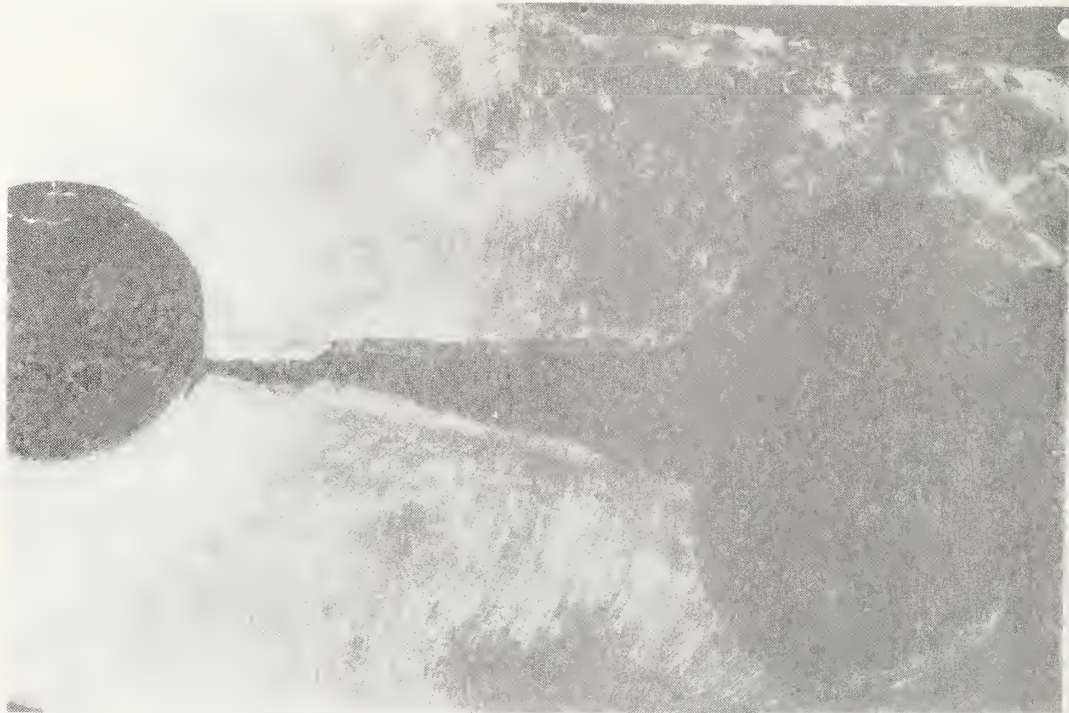
Figure 5.17 Fusion line weld fractures between hanger rod holes, upper flange weld, locations 9UE(a) and 8UE(b).

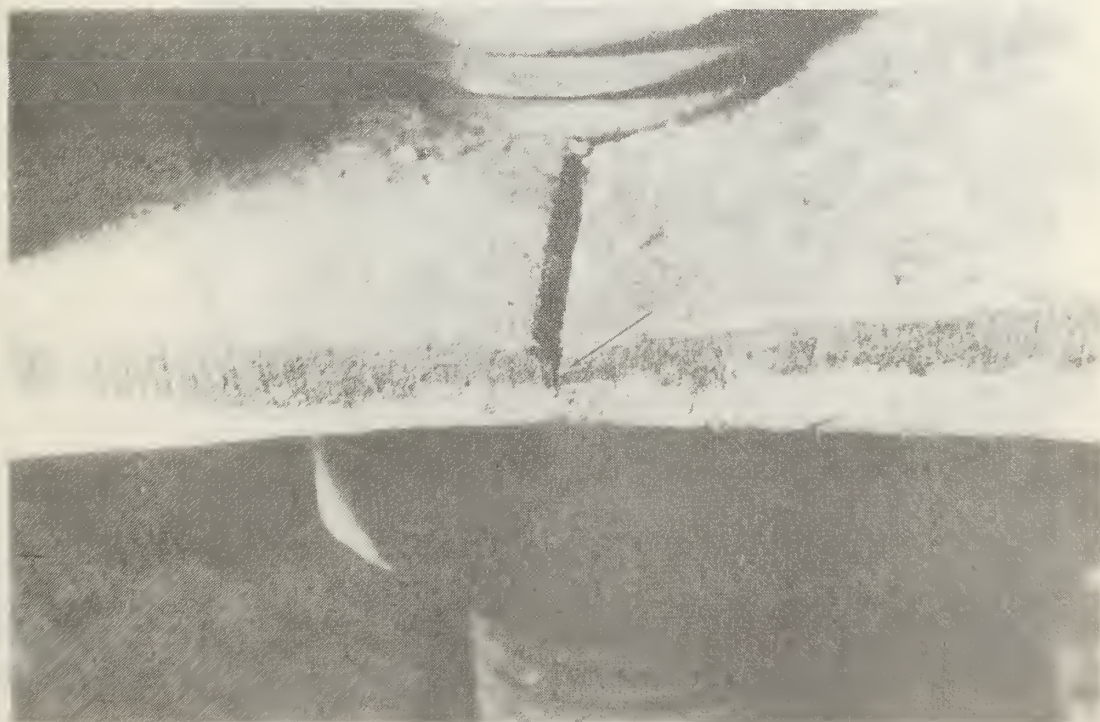
b) Location 8ME. End crack.

Figure 5.18 Apparent cracks (arrows) in lower welds of box beams in third floor walkway.

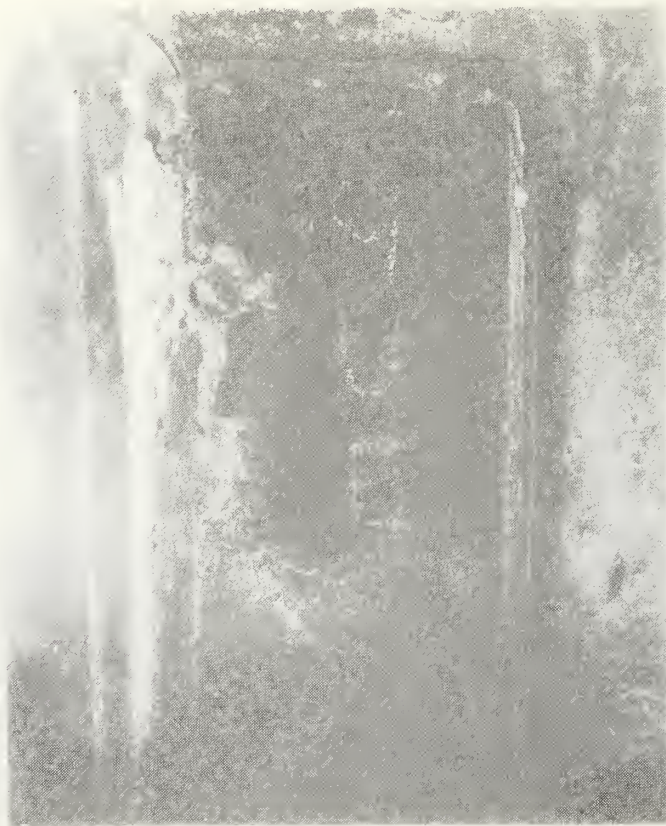
Figure 5.20 Shear failure at bottom and pull-out failure at top of clip angle, location 9UE, north side.

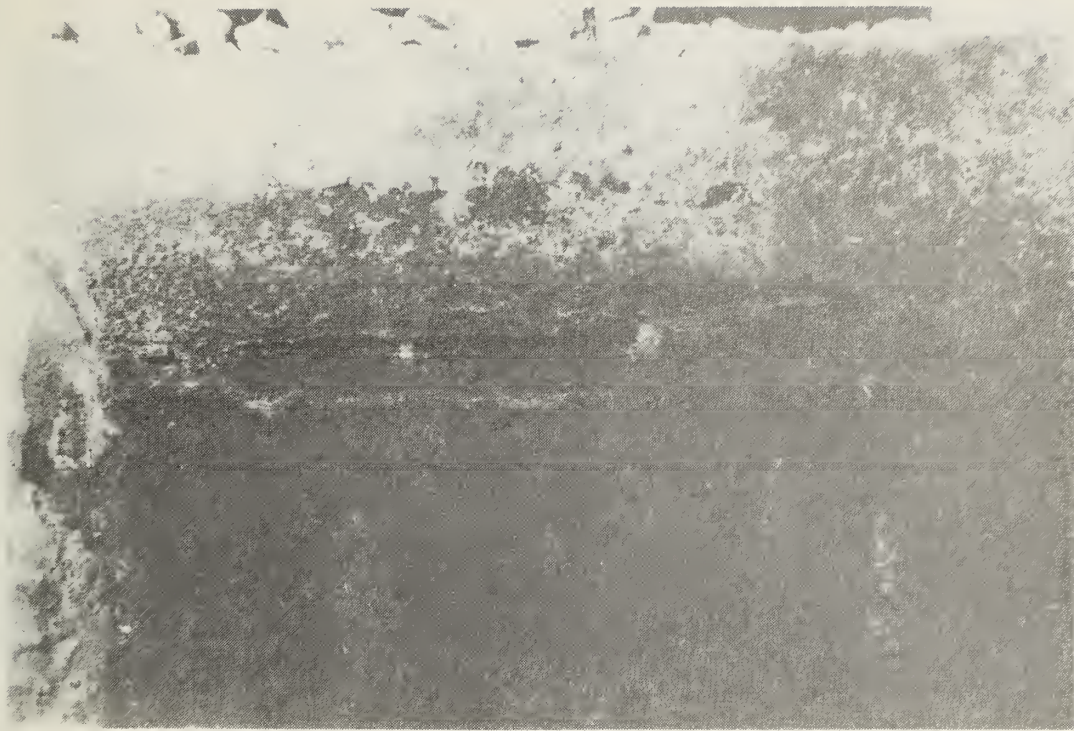
Figure 5.21 Pull-out failure of top fillet weld on box beam web, location 9UE, north side.

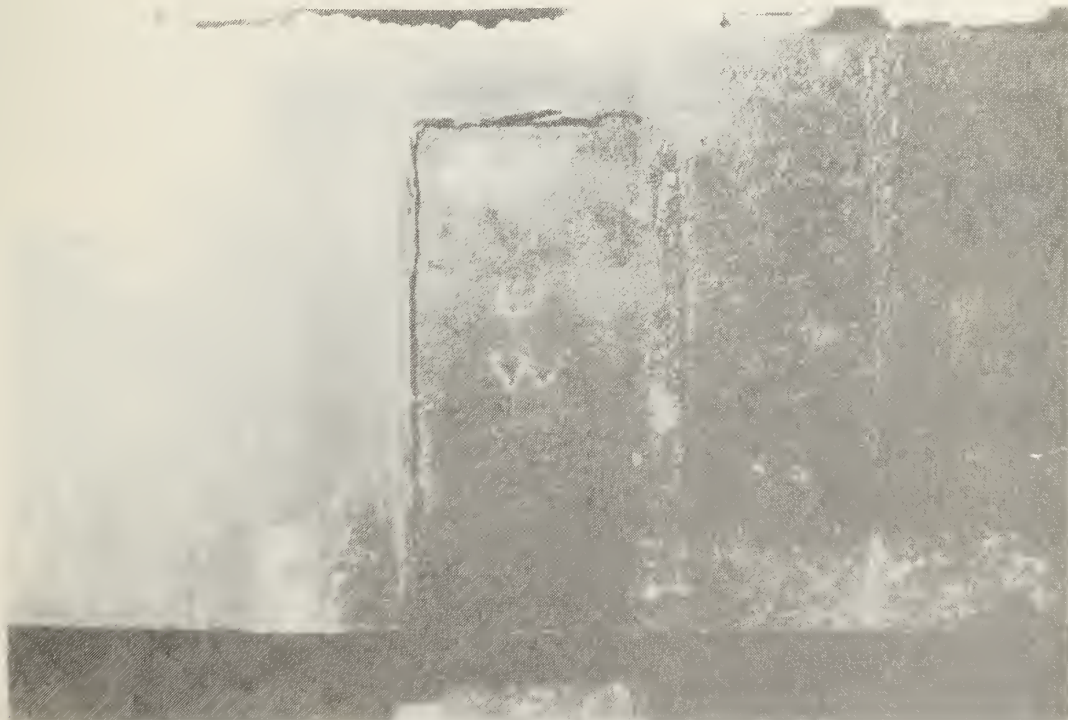
Figure 5.22 Shear failure in clip angle fillet weld at location 9UW, north side. This weld and the corresponding weld at location 9LW did not show evidence of a pull-out (tensile) failure at the top fillet weld.

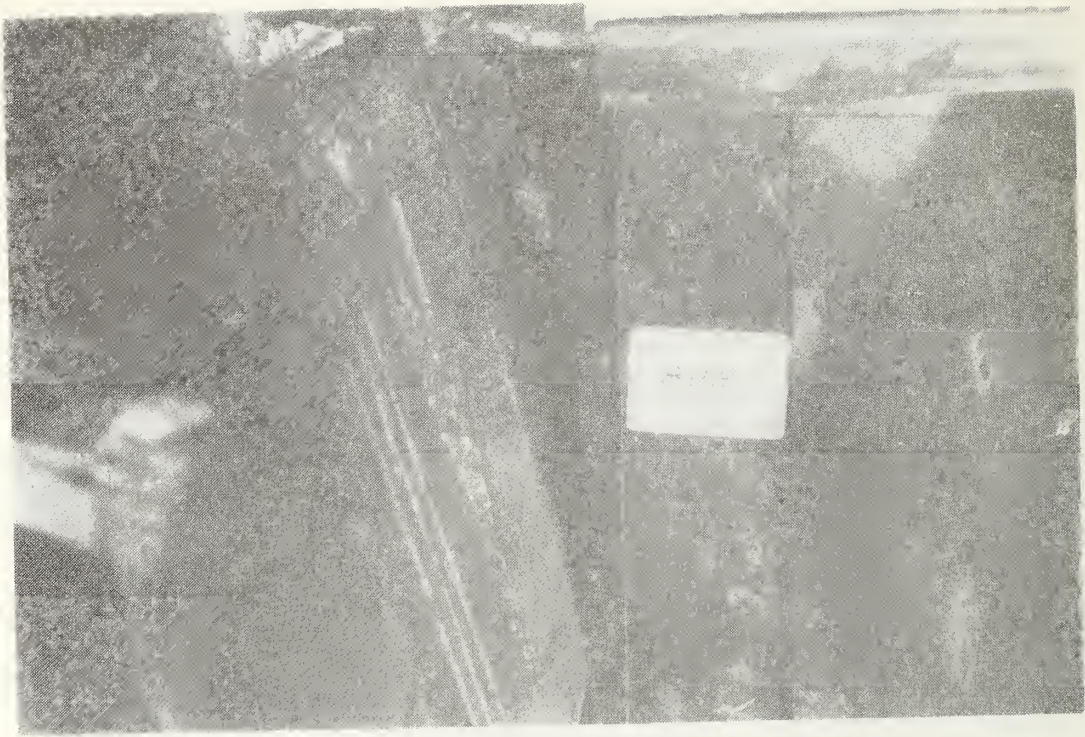
Figure 5.23 Tearing of top end of north clip angle at location 8UE.

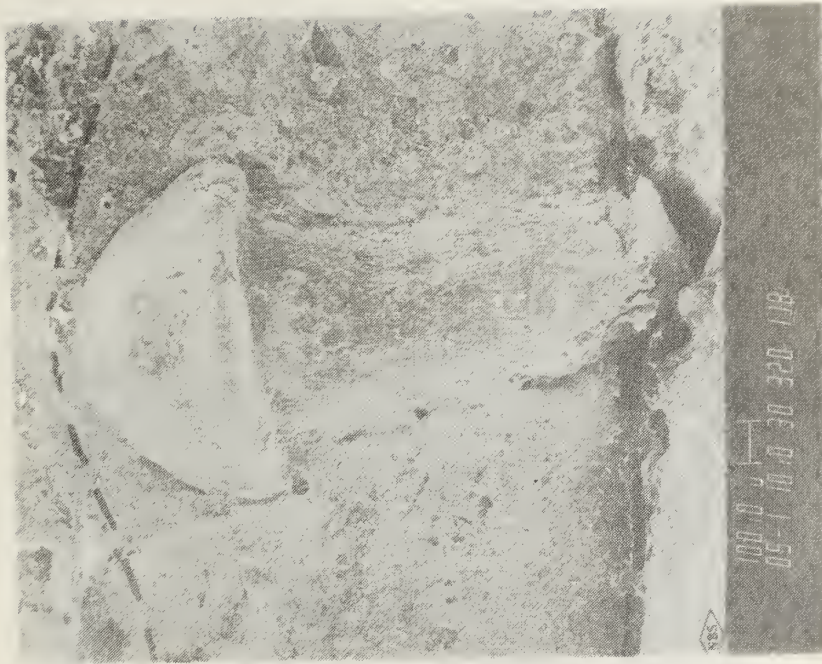
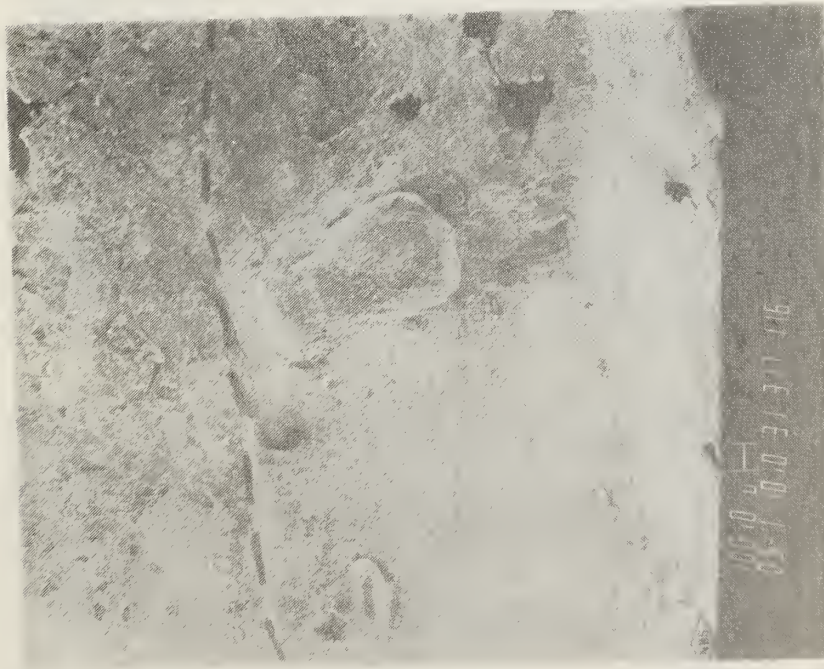
Figure 8.3 Photomicrographs showing that the crack initiated at the root of the weld and propagated to the exterior of the box beam (location 9UE). Figure (a) is located 3 mm from the end of the beam. Crack is propagating downward and slightly to the right. Figure (b) is located 18 mm from end of beam. Magnification (a) X30 and (b) X60.

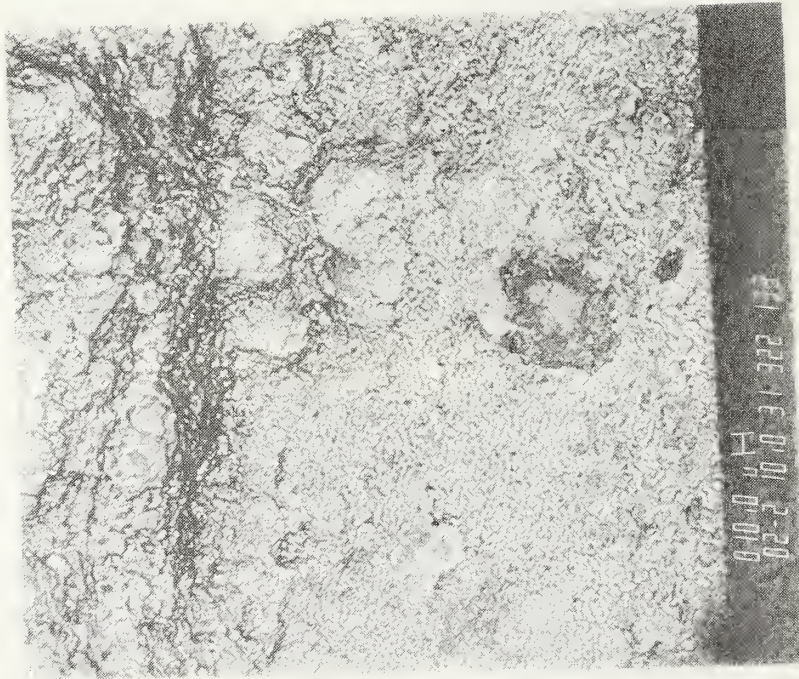
Figure 8.4 Photomicrograph of a replica from the shear lip region at location 8UE. The surface oxidation has removed the fine shear dimpled rupture features in this area. Magnification X250.

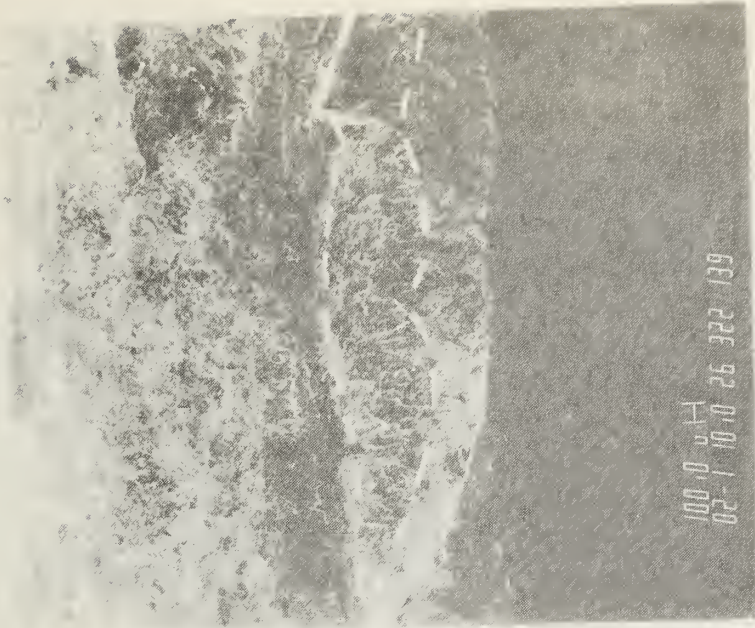
Figure 8.5 Fractographic evidence of preexisting cracks in walkway box beam exterior longitudinal welds at locations a) 9UW, b) 9UE, c) 8UW. Regions interpreted as cracks outlined by dashed lines. Magnifications X55, X250 and X25, respectively.

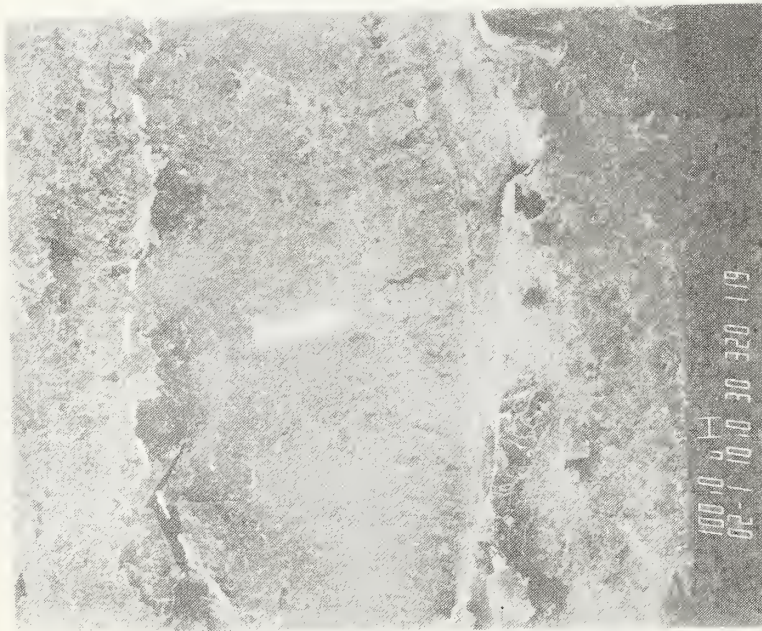
Figure 8.6 Evidence of fracture initiation from upper surface of interior tack weld (dashed line) at location 9UE. Direction of propagation is toward the weld root (arrow) normal to the welding direction. Magnification X25.

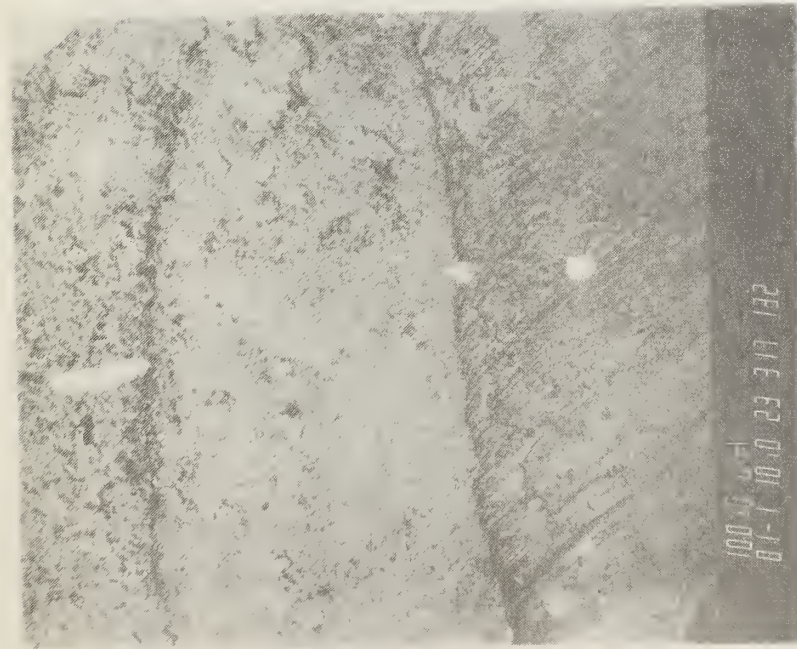
7. Two regions of washer imprints were observed on the bottom surfaces of the box beam flanges. The outermost region contains the imprint of the washer and shows shallow striations. Nearer the hanger rod hole, there was a transition to a more deeply abraded region. This region showed evidence that the failure proceeded in a slip-stick manner.

Figure 8.8 Abrasion pattern on bottom flange at location 9UE (north). Arrow denotes initial washer imprint. (A) denotes change in abrasion mechanism. (B) denotes a slip-stick region in progressive failure. Magnification X15.

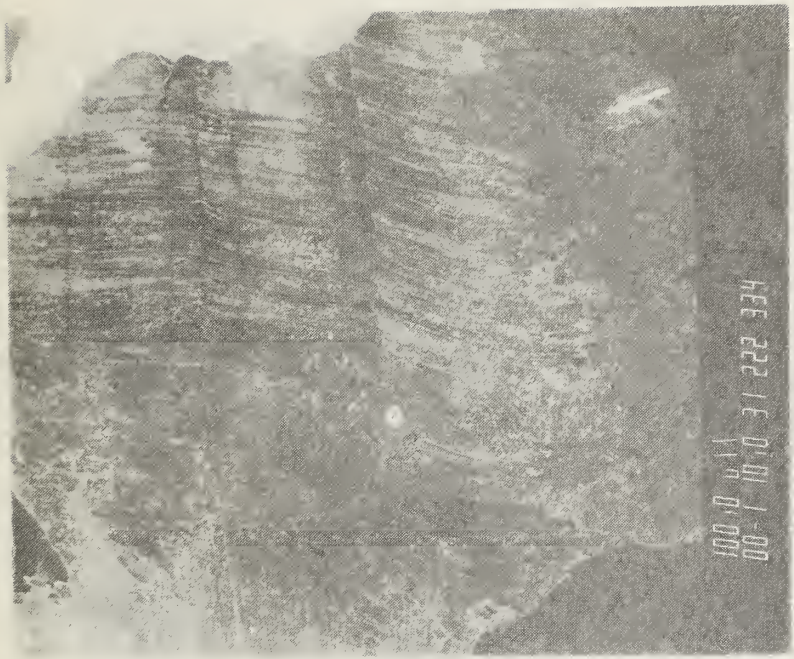
Figure 8.9 Abrasion pattern on bottom flange at location 10UE (south) showing multiple slip-stick regions. Arrow denotes initial washer contact. Magnification X15.

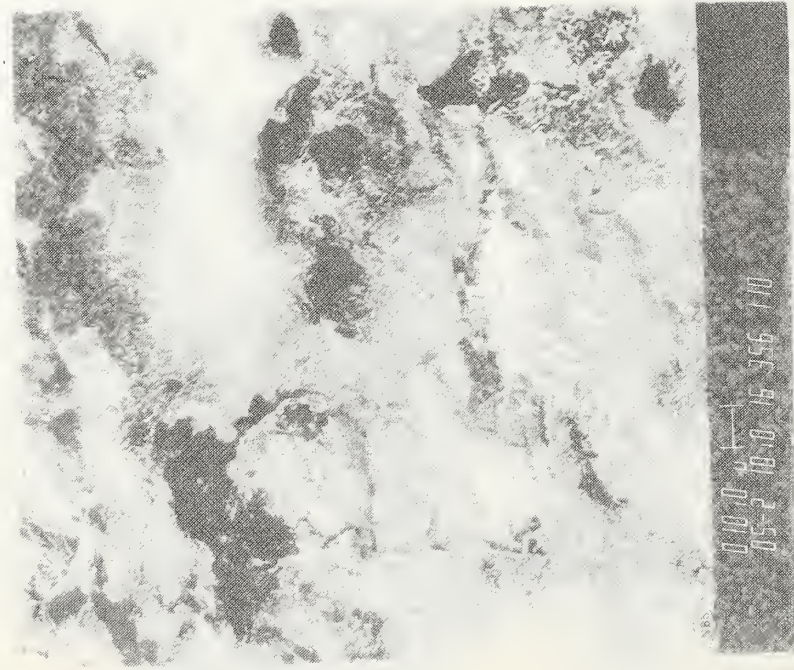
Figure 8.22 Fracture appearance in the preexisting crack region (a) and in the region of final crack propagation (b) at location 9UE adjacent to the outer hanger rod hole. Magnification X550.
