A11103 737965

NBSIR 82-2465 (A)

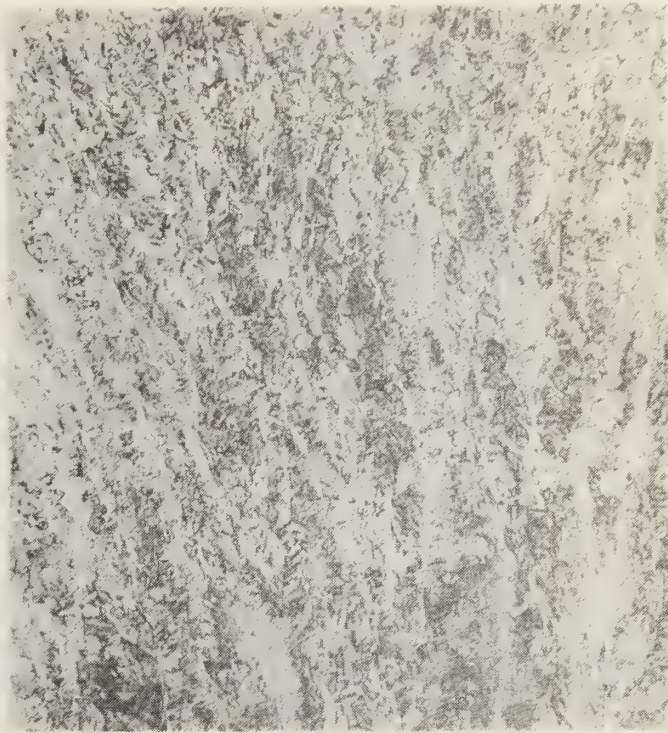
Figure A7.4.1-3 Microstructure representative of the weld metal in transverse section through NBS weldment IC. The microstructure appears to consist primarily of bainite. Etchant: two percent nital. X200

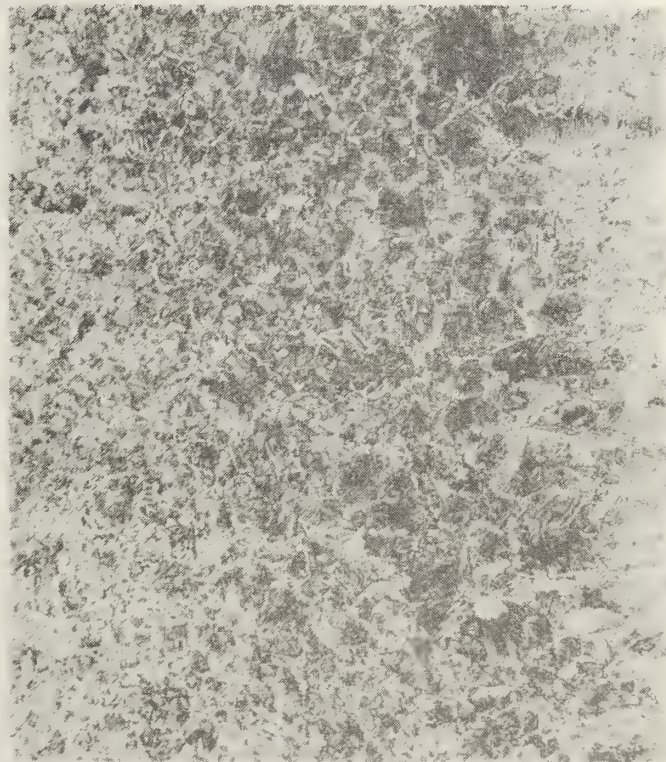
Figure A7.4.1-4 Transition region from weld metal (right) to heat affected zone (left) in transverse section through NBS weldment IC. Etchant: two percent nital. X200

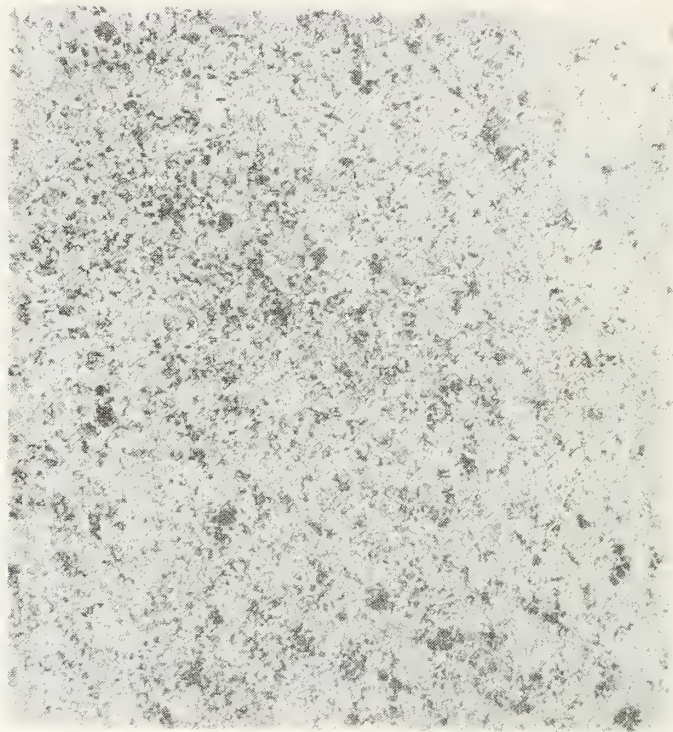
Figure A7.4.1-5 Representative microstructure of the heat affected zone in transverse section through NBS weldment IC. The microstructure consists of ferrite, primarily as a network in prior austenite grain boundaries, bainite, partially spheroidized carbides, and tempered martensite. Etchant: two percent nital. X200

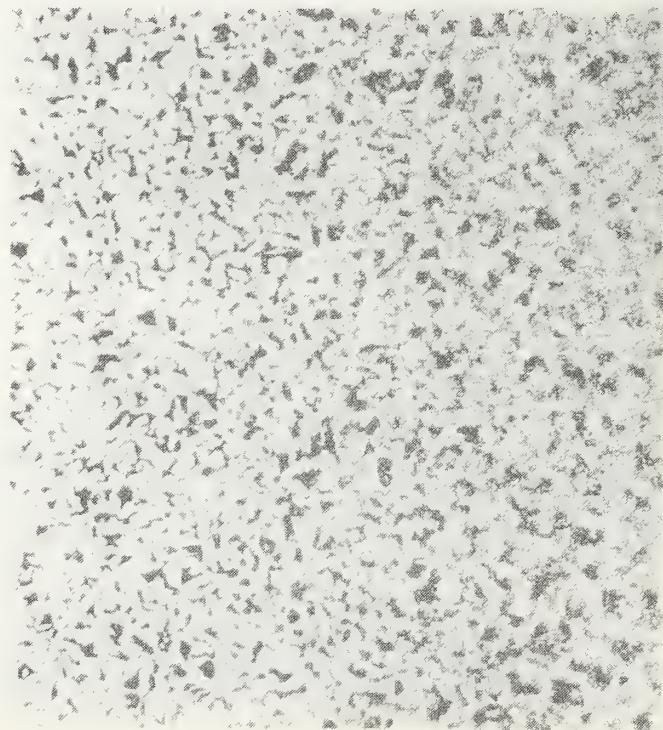
Figure A7.4.1-6 Microstructure representative of the transition region from the heat affected zone (right) to base channel material (left) in NBS weldment IC. Etchant: two percent nital. X200

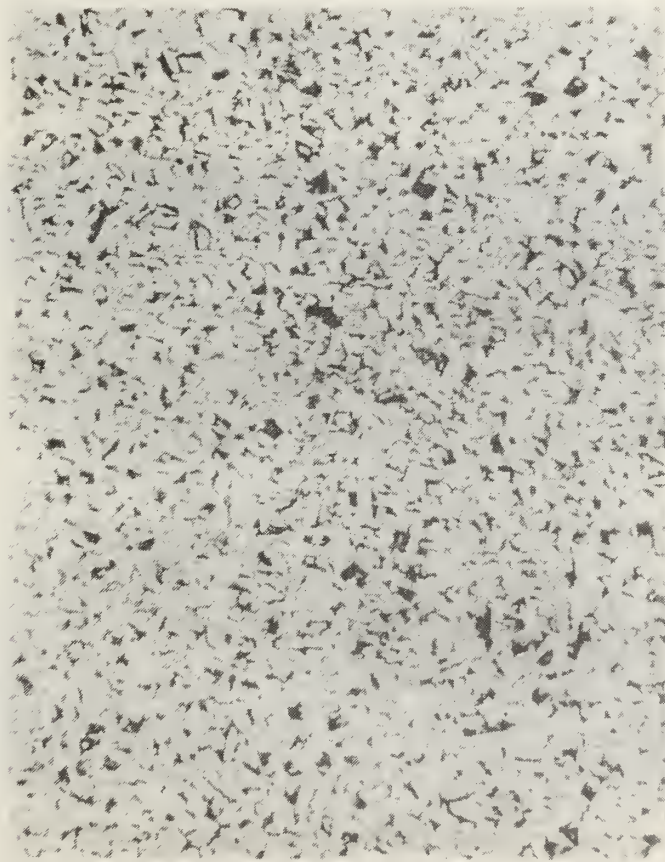
Figure A7.4.1-7 Microstructure representative of the base channel material from NBS weldment IC. The microstructure consists of relatively fine grained ferrite (light) and pearlite (dark) in a normalized condition. Etchant: two percent nital. X200

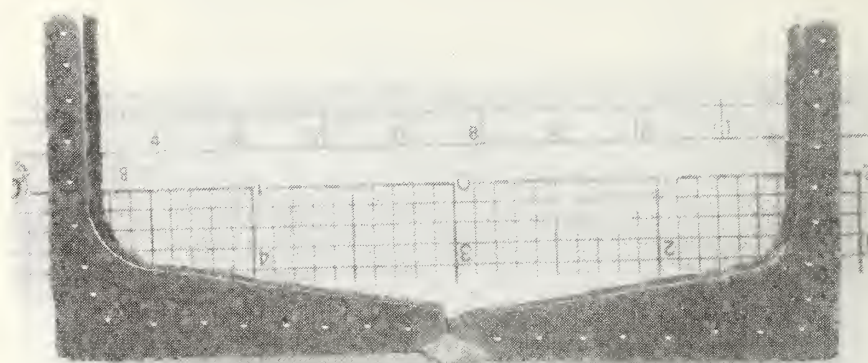
Figure A7.4.1-8 Transverse section 1B1 through the bottom of walkway box beam 9U (NBS 1). The north channel of the box beam is to the left and the south channel is to the right. The weld connecting the flanges of the two channels used to fabricate the box beam is in the center. Parts of the web regions of each channel had been removed before this photograph was taken. The indentations appearing on the surface of the section are the result of hardness measurements. Etchant: two percent nital. ~X1

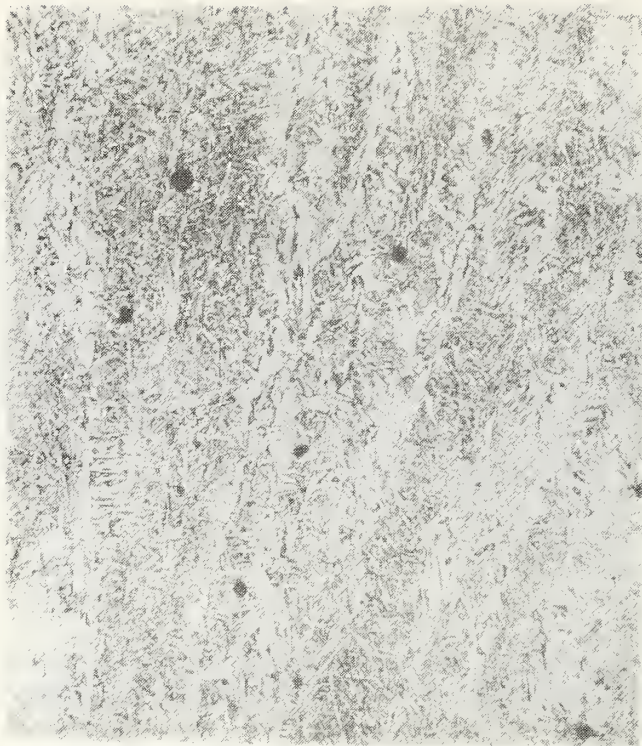
Figure A7.4.1-12 Representative microstructure of the weld metal in transverse section 1BM1 through box beam 9U (NBS 1). The microstructure consists primarily of bainite. Some inclusions are evident. Etchant: two percent nital. X200

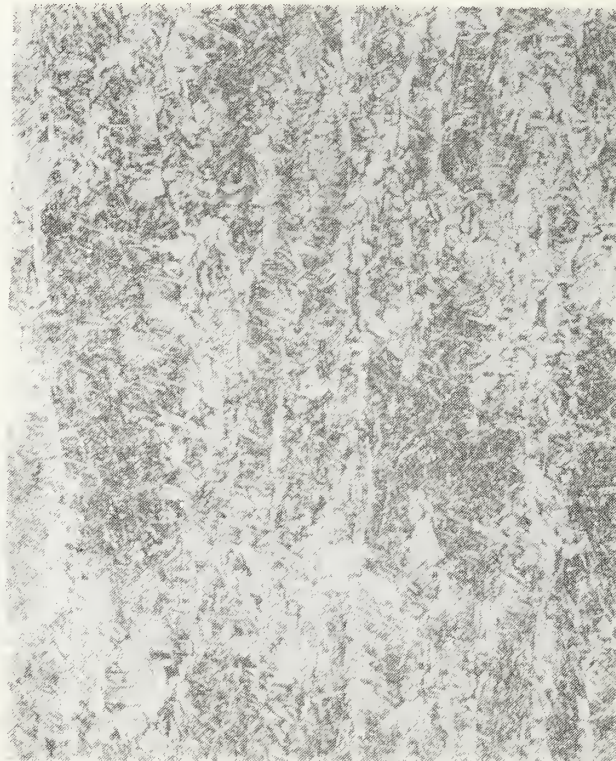
Figure A7.4.1-13 Representative microstructure of the weld metal in transverse section 1BM2 through box beam 9U (NBS 1). The microstructure consists primarily of bainite. Etchant: two percent nital. X200

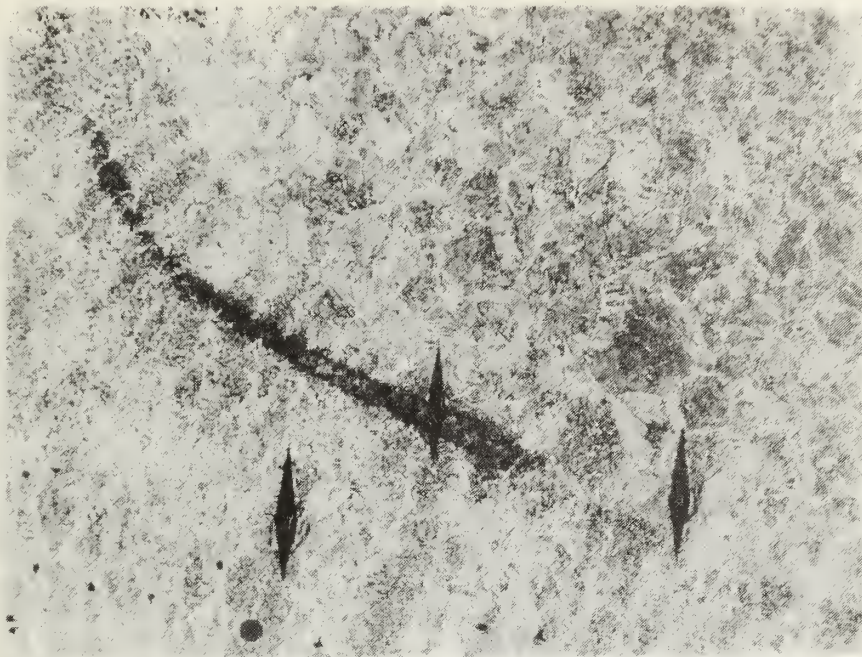
Figure A7.4.1-14 Patch of hard material (dark streak) at the transition from weld metal (top right) to the heat affected zone (bottom left) in section 1B1. The elongated dark areas are hardness impressions. Etchant: two percent nital. X100

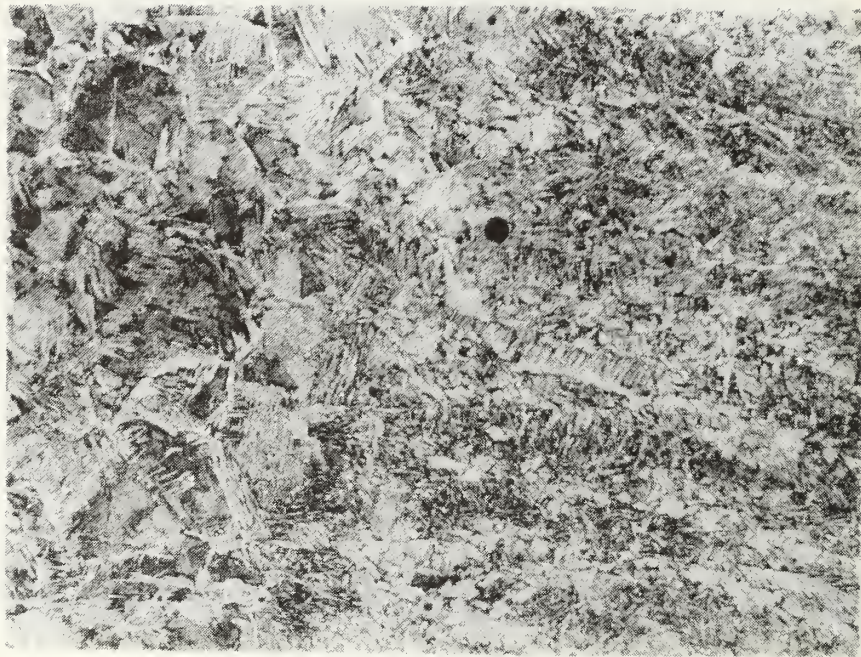
Figure 7.4.1-16 Transition zone from weld metal (right) to heat affected zone (left) in section 1BM2. Some inclusions can be seen. Etchant: two percent nital. X200

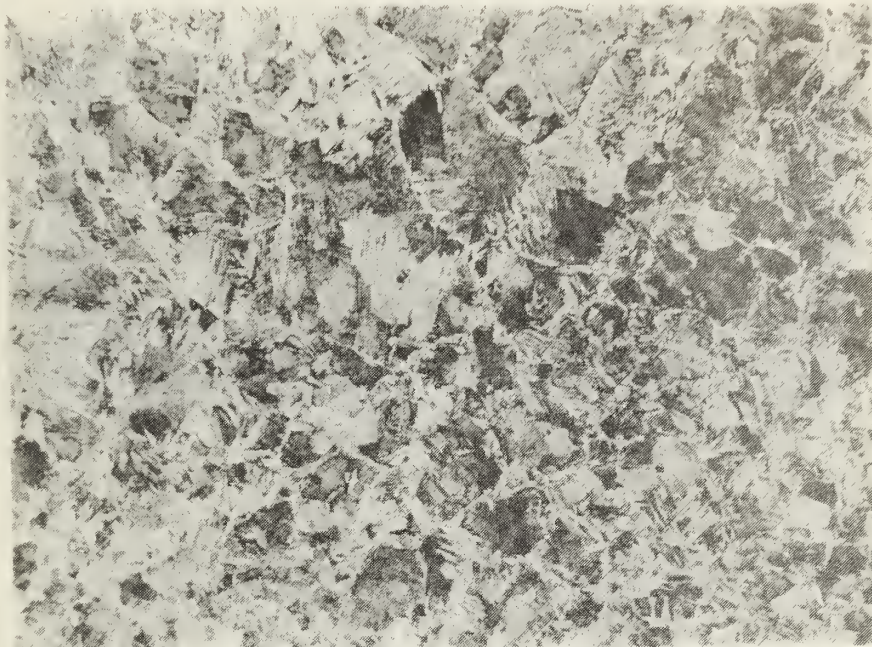
Figure 7.4.1-18 Region representative of the heat affected zone in section 1BM2. The microstructure appears to consist of ferrite, both as a network in prior austenite grains and as needles, bainite, partially spheroidized carbides, and tempered martensite. Etchant: two percent nital. X200

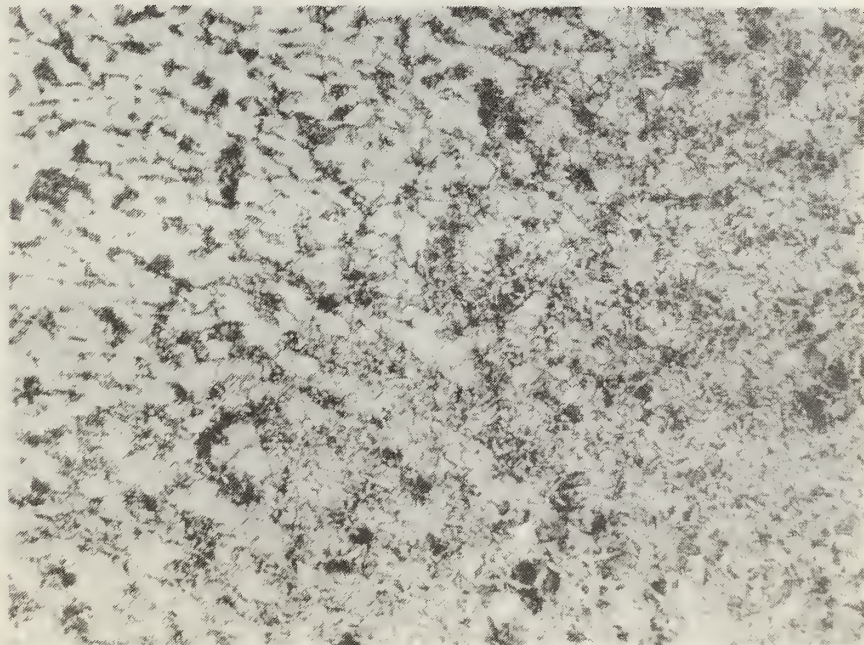
Figure A7.4.1-19 Transition from heat affected zone (right) to base channel material (left) in section 1BM2. Etchant: two percent nital. X200

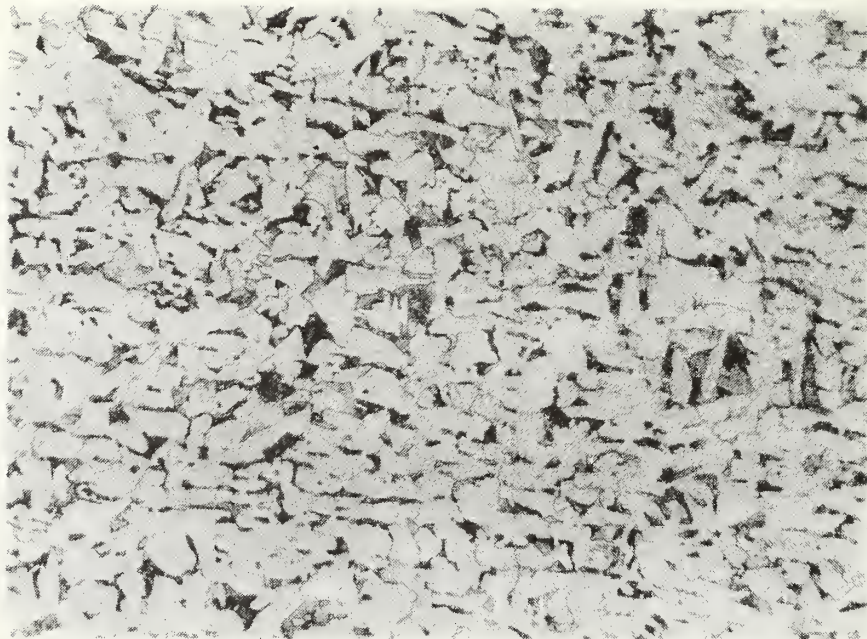
Figure A7.4.1-20 Region representative of base channel material in section 1BM1. The microstructure consists primarily of ferrite (light) and pearlite (dark) in the normalized condition. Etchant: two percent nital. X200

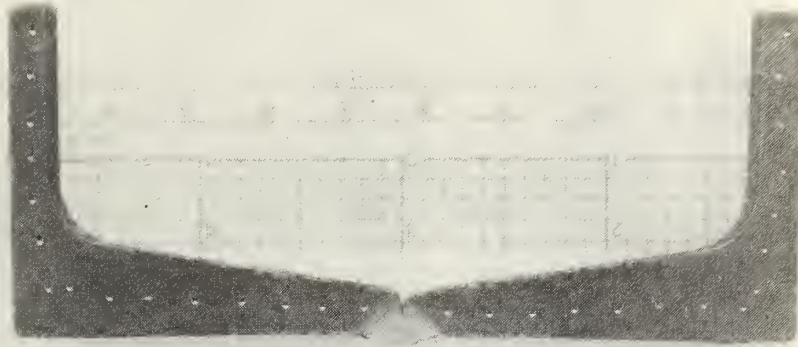
Figure A7.4.1-21 Transverse section 2BM1 through bottom of walkway box beam 8L (NBS 2). The north channel of the box beam is to the left and the south channel is to the right. The weld connecting the flanges of the two channels used to fabricate the box beam is in the center. Parts of the web regions of each channel had been removed before this photograph was taken. The indentations appearing on the surface of the section are the result of hardness measurements. Etchant: two percent nital. ~X1

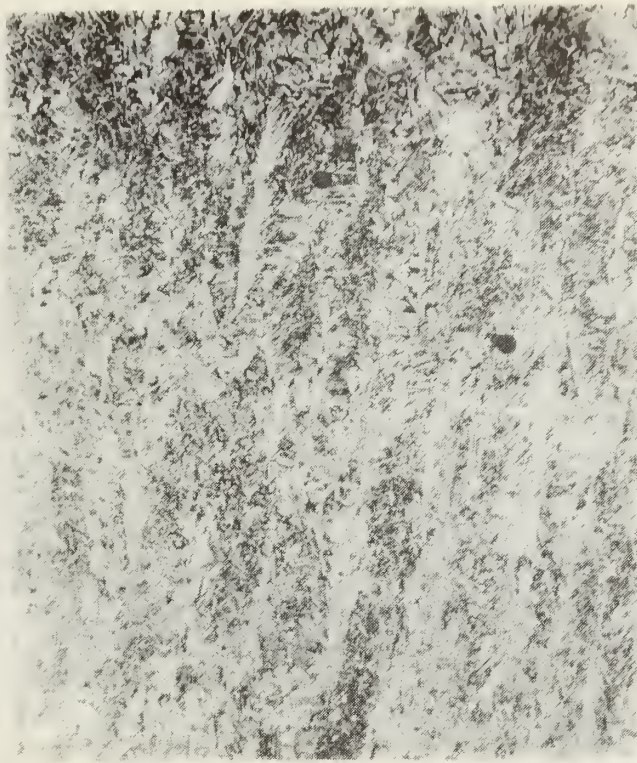
Figure A7.4.1-25 Representative microstructure of the weld metal in transverse section 2BM1 through box beam 8L (NBS 2). The microstructure appears to consist primarily of bainite. Some inclusions are evident. Etchant: two percent nital. X200

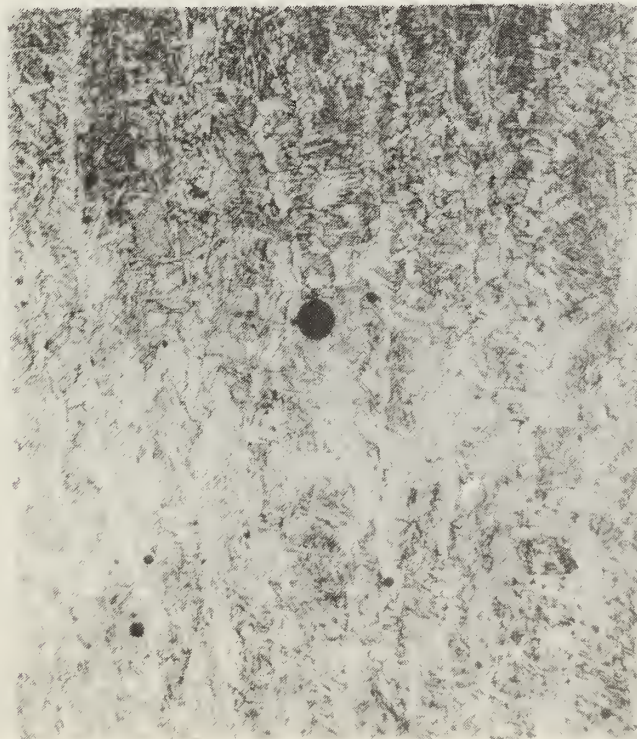
Figure A7.4.1-26 Representative microstructure of the weld metal in transverse section 2BM2 through box beam 8L (NBS 2). The microstructure appears to consist primarily of bainite. Some inclusions are evident. Etchant: two percent nital. X200

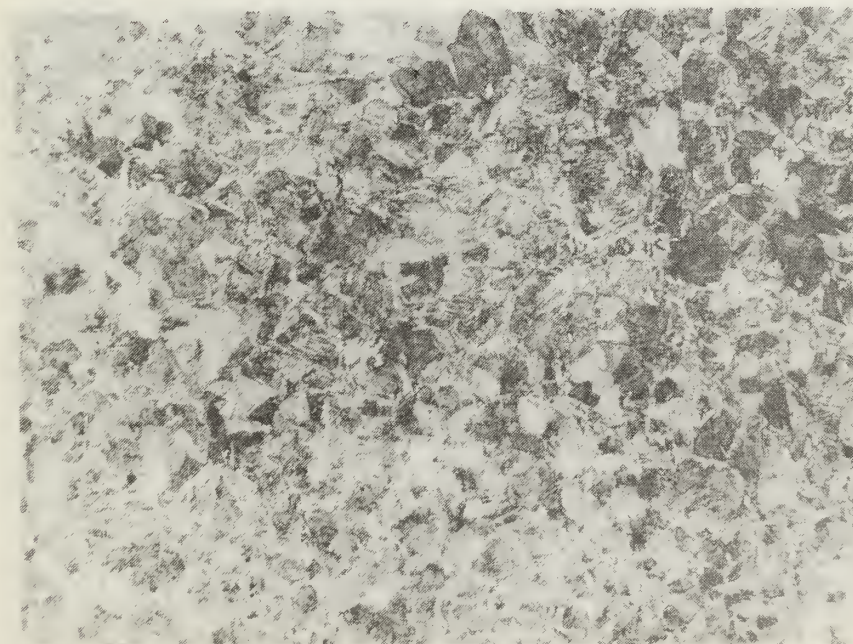
Figure A7.4.1-30 Representative microstructure of the heat affected zone in section 2BM1. The microstructure appears to consist of ferrite, both as a network in prior austenite grain boundaries and as needles, bainite, partially spheroidized carbides, and tempered martensite. Etchant: two percent nital. X200

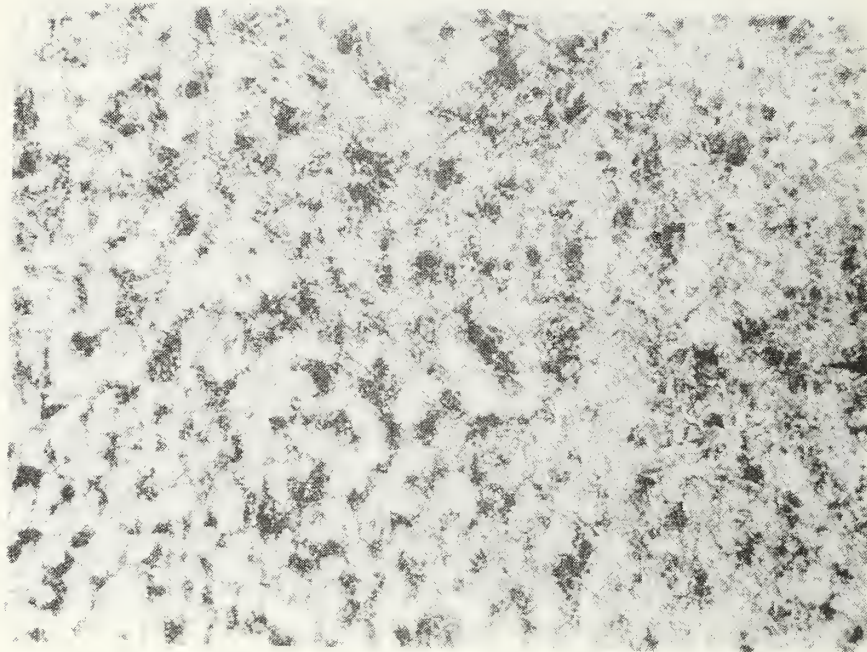
Figure A7.4.1-31 Transition region from heat affected zone (right) to base channel material (left) in section 2BM1. Etchant: two percent nital. X200

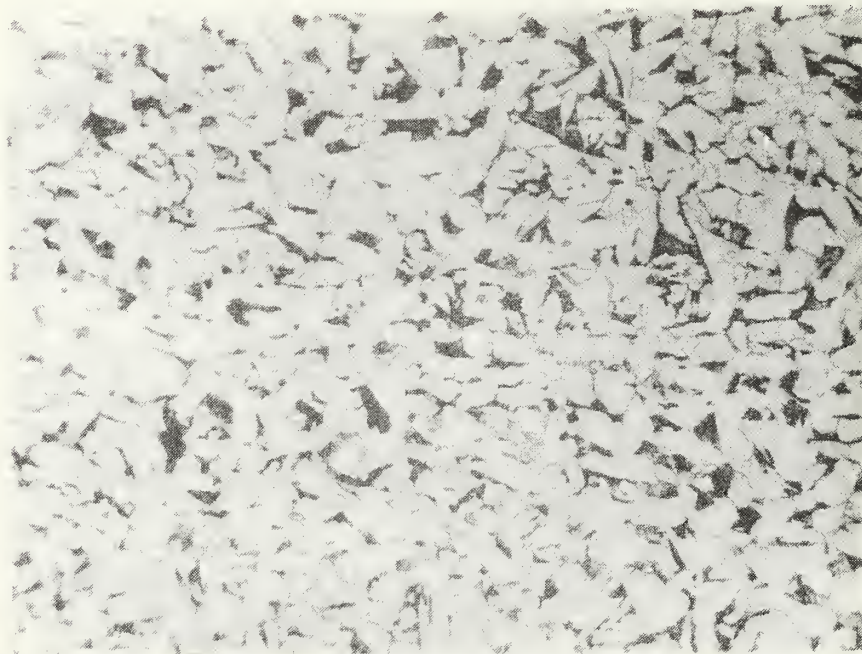
Figure A7.4.1-32 Region of section 2BM1 representative of the base channel material in both sections through box beam 8L. The microstructure consists primarily of ferrite (light) and pearlite (dark) in the normalized condition. Etchant: two percent nital. X200

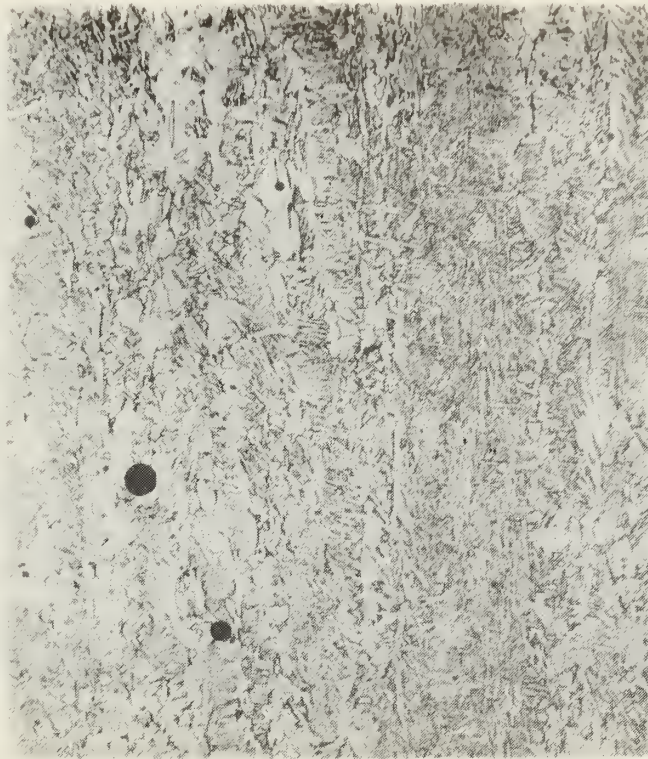
Figure A7.4.1-37 Representative microstructure of the weld metal in transverse section 3BM1 through box beam 9M (NBS 3). The microstructure consists primarily of bainite. Several inclusions are evident. Etchant: two percent nital. X200

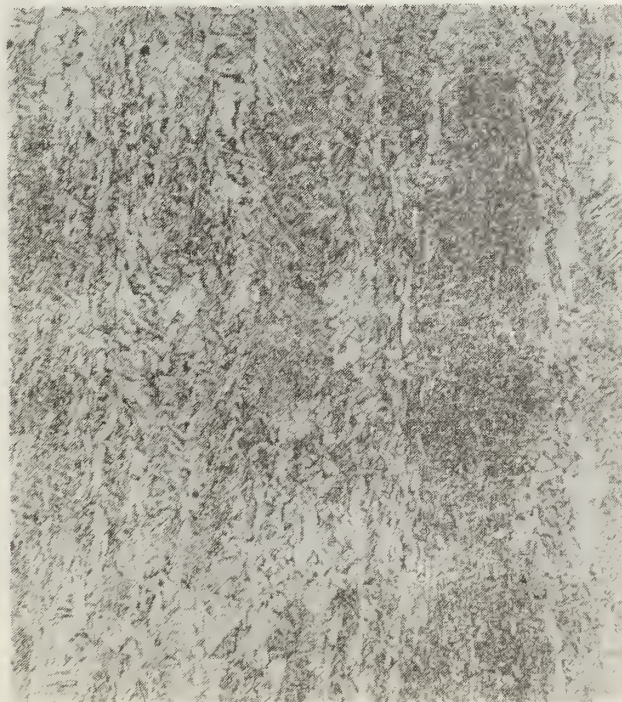
Figure A7.4.1-38 Representative microstructure of the weld metal in transverse section 3BM2 through box beam 9M (NBS 3). The microstructure consists primarily of bainite. Etchant: two percent nital. X200

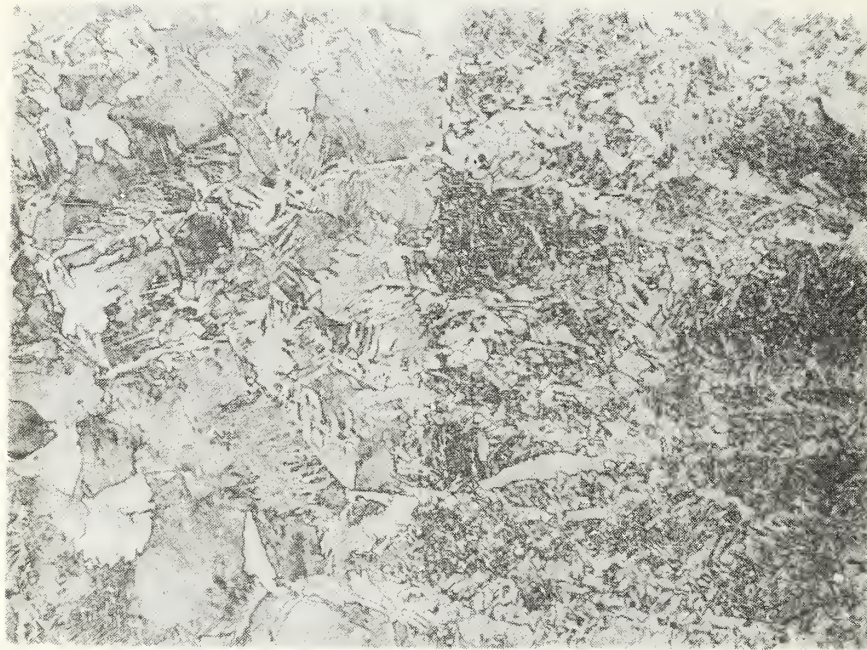
Figure A7.4.1-39 Transition zone from weld metal (right) to heat affected zone (left) in section 3BM2. Some inclusions can be seen primarily in the weld metal. Etchant: two percent nital. X200

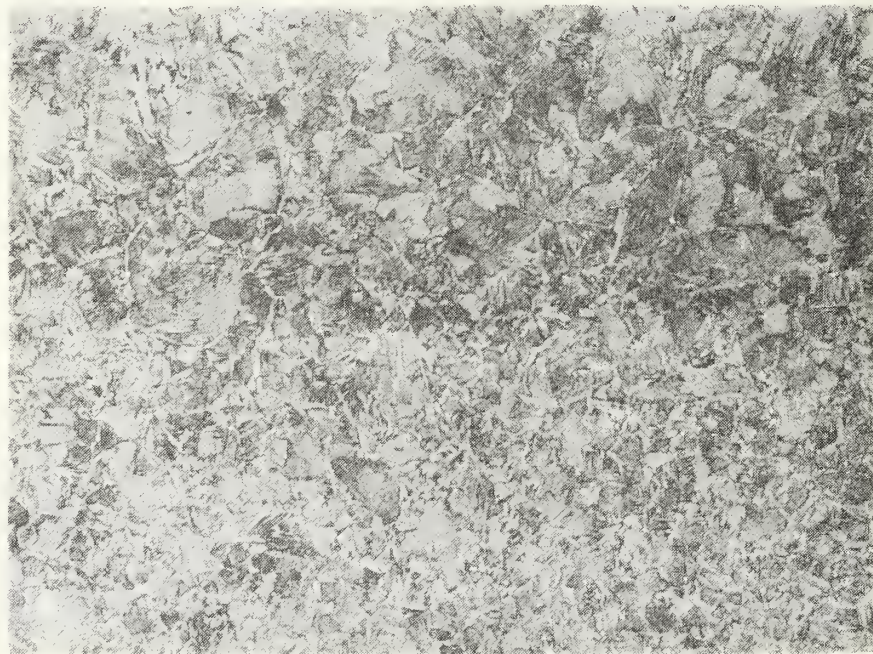
Figure A7.4.1-40 Region representative of the heat affected zone in section 3BM1. The microstructure appears to consist of ferrite both as a network in prior austenite grain boundaries and as needles, bainite, partially spheroidized carbides, and tempered martensite. Etchant: two percent nital. X200

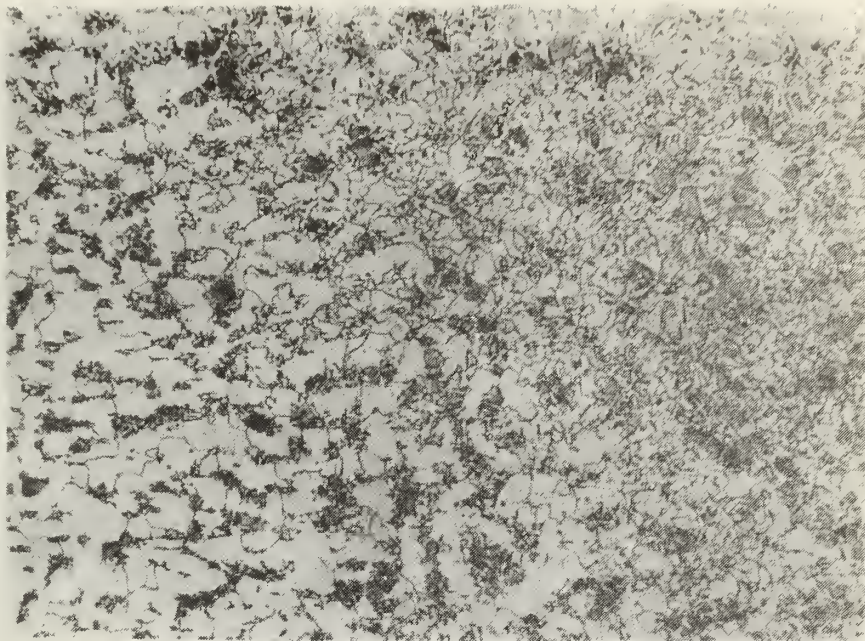
Figure A7.4.1-41 Transition zone from heat affected zone (right) to base channel material (left) in section 3BM2. Etchant: two percent nital. X200

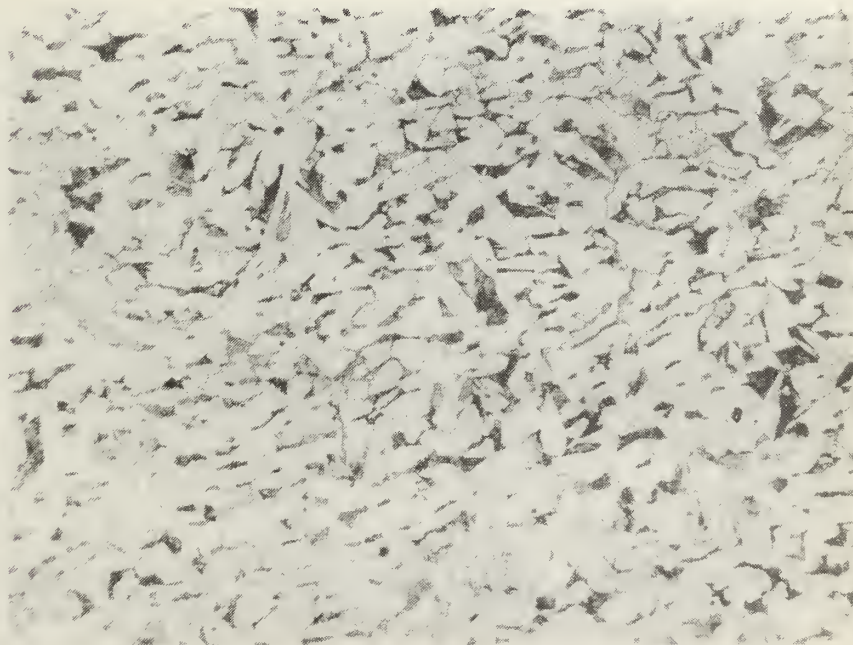
Figure A7.4.1-42 Representative region of base channel material in section 3BM1. The microstructure consists of ferrite (light) and pearlite (dark) in the normalized condition. Etchant: two percent nital. X200

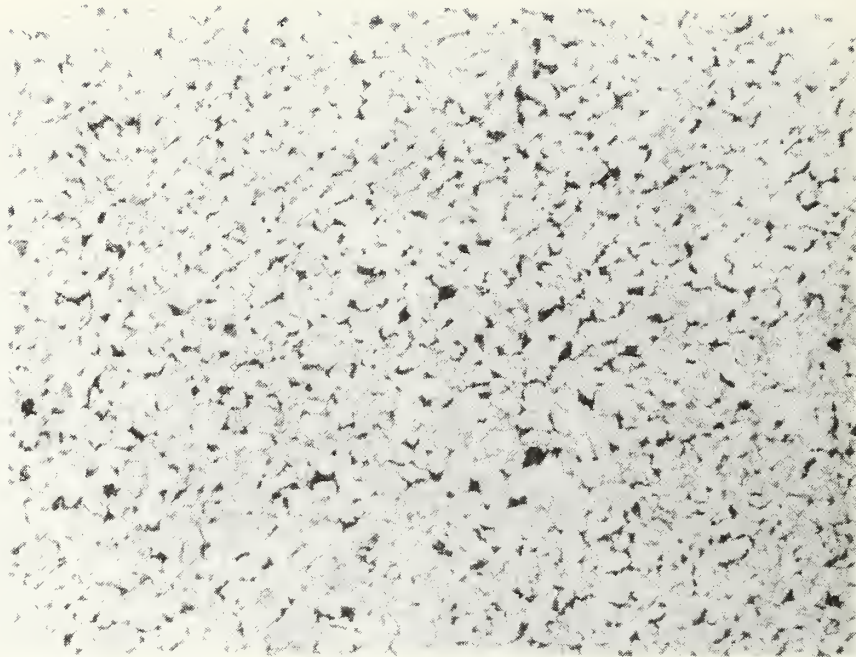
Figure A7.4.2-1 Transverse section through hanger rod NBS 5A showing the representative microstructure. The microstructure consists of relatively fine grained ferrite (light) and pearlite (dark) in a normalized condition. Etchant: two percent nital. X100

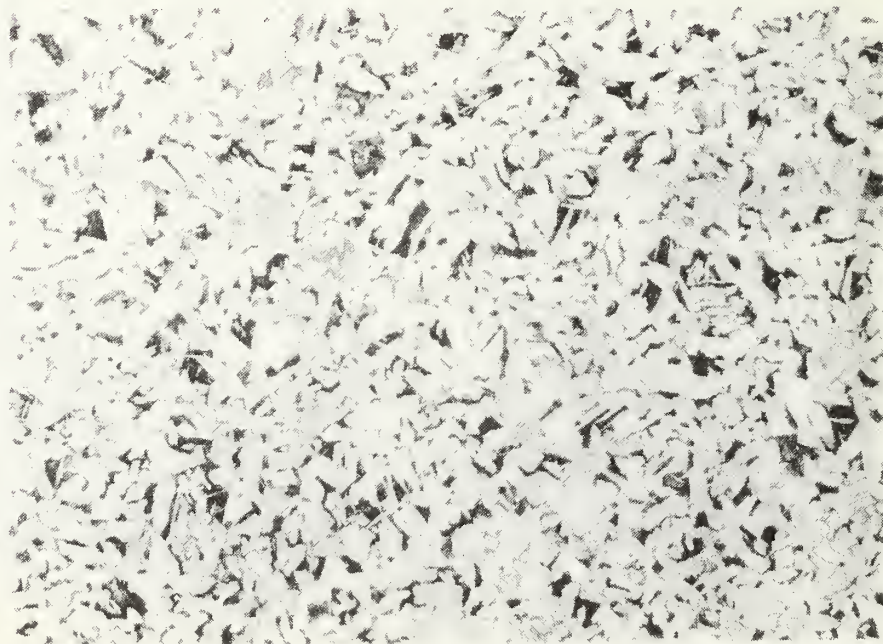
Figure A7.4.2-2 Transverse section through hanger rod NBS 5B showing the representative microstructure. The microstructure consists of ferrite (light) and pearlite (dark) in a normalized condition. Etchant: two percent nital. X100

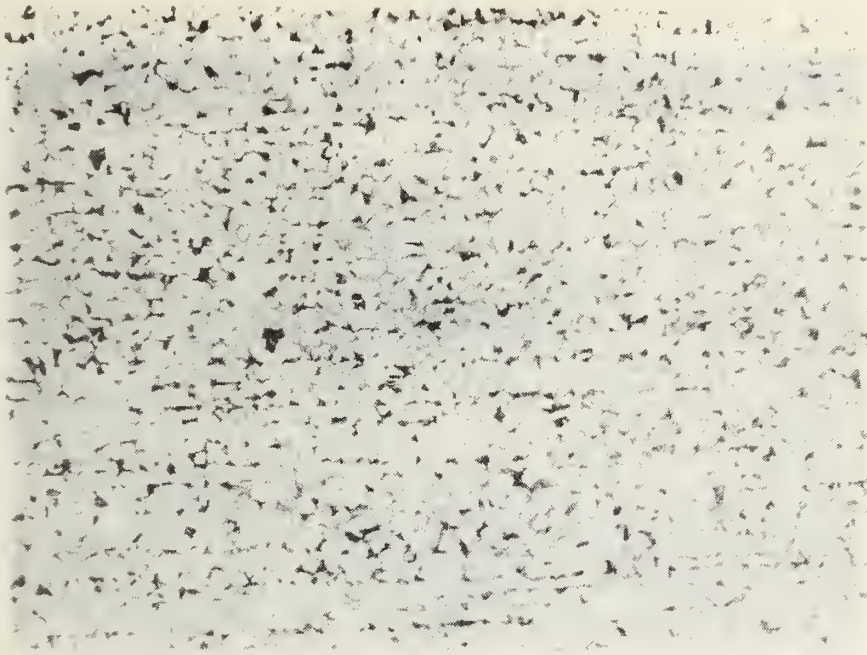
Figure A7.4.2-3 Longitudinal section through hanger rod NBS 5A showing the normalized microstructure consisting of ferrite and pearlite. Etchant: two percent nital. X100

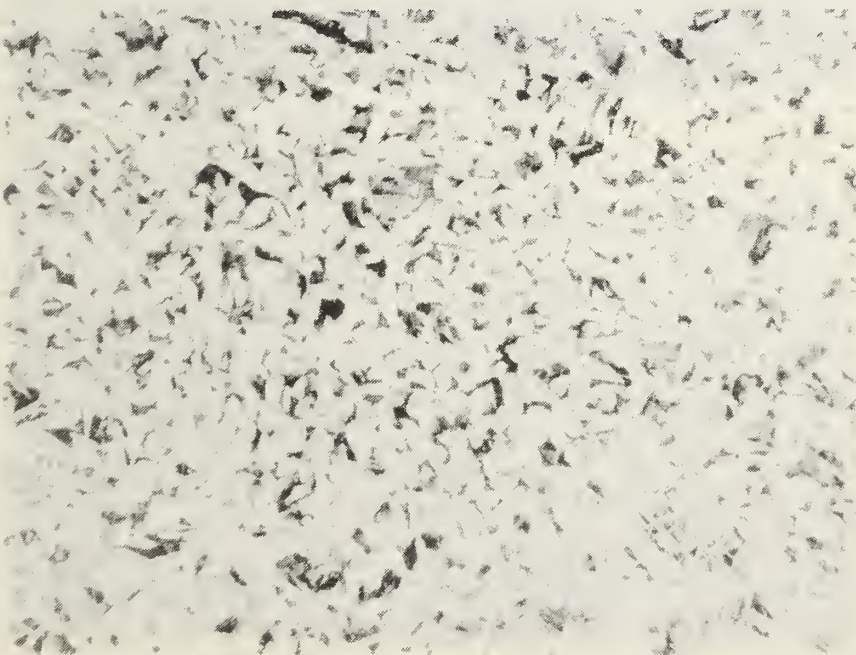
Figure A7.4.2-4 Longitudinal section through hanger rod NBS 5B showing the normalized microstructure consisting of ferrite and pearlite. Etchant: two percent nital. X100

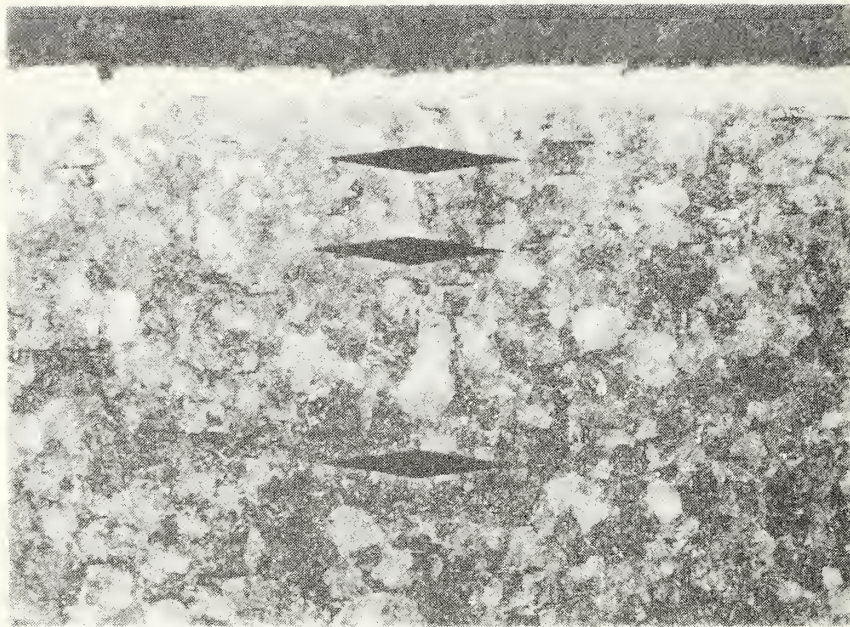
Figure A7.4.3-1 Microstructure of washer from location 9MW in the walkway debris. The thin, light layer at the surface (horizontal near the top in the figure) is the decarburized layer at the washer surface. The microstructure consists primarily of tempered martensite. Etchant: Picral. X200

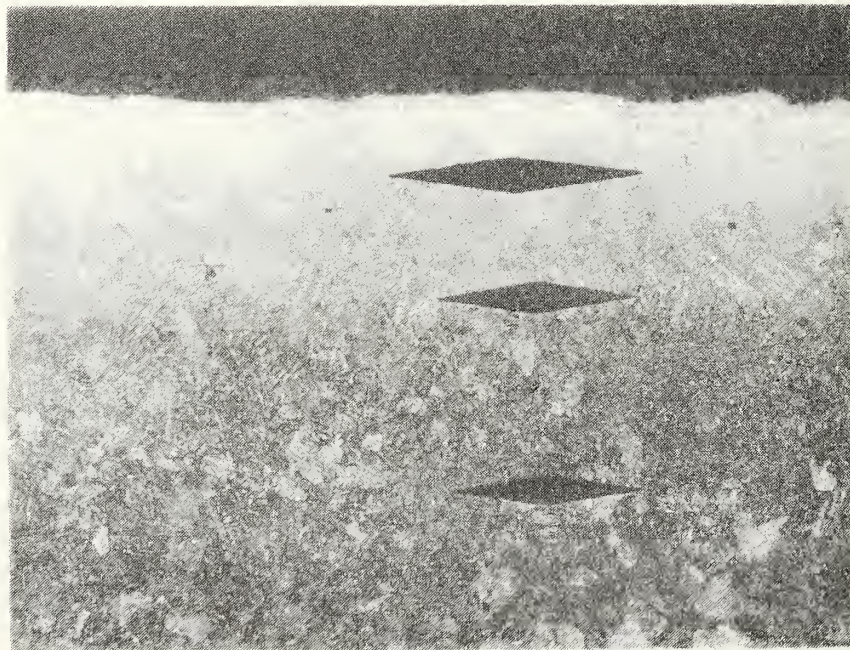
Figure A7.4.3-2 Microstructure of NBS hard washer. The light layer at the surface (horizontal near the top in the figure) is decarburized. The microstructure consists primarily of tempered martensite. Etchant: Picral. X200
