NBSIR 82-2593

# Investigation of Construction Failure of the Riley Road Interchange Ramp, East Chicago, Indiana

October 1982

N. J. Carino  
H. S. Lew  
W. C. Stone  
R. M. Chung

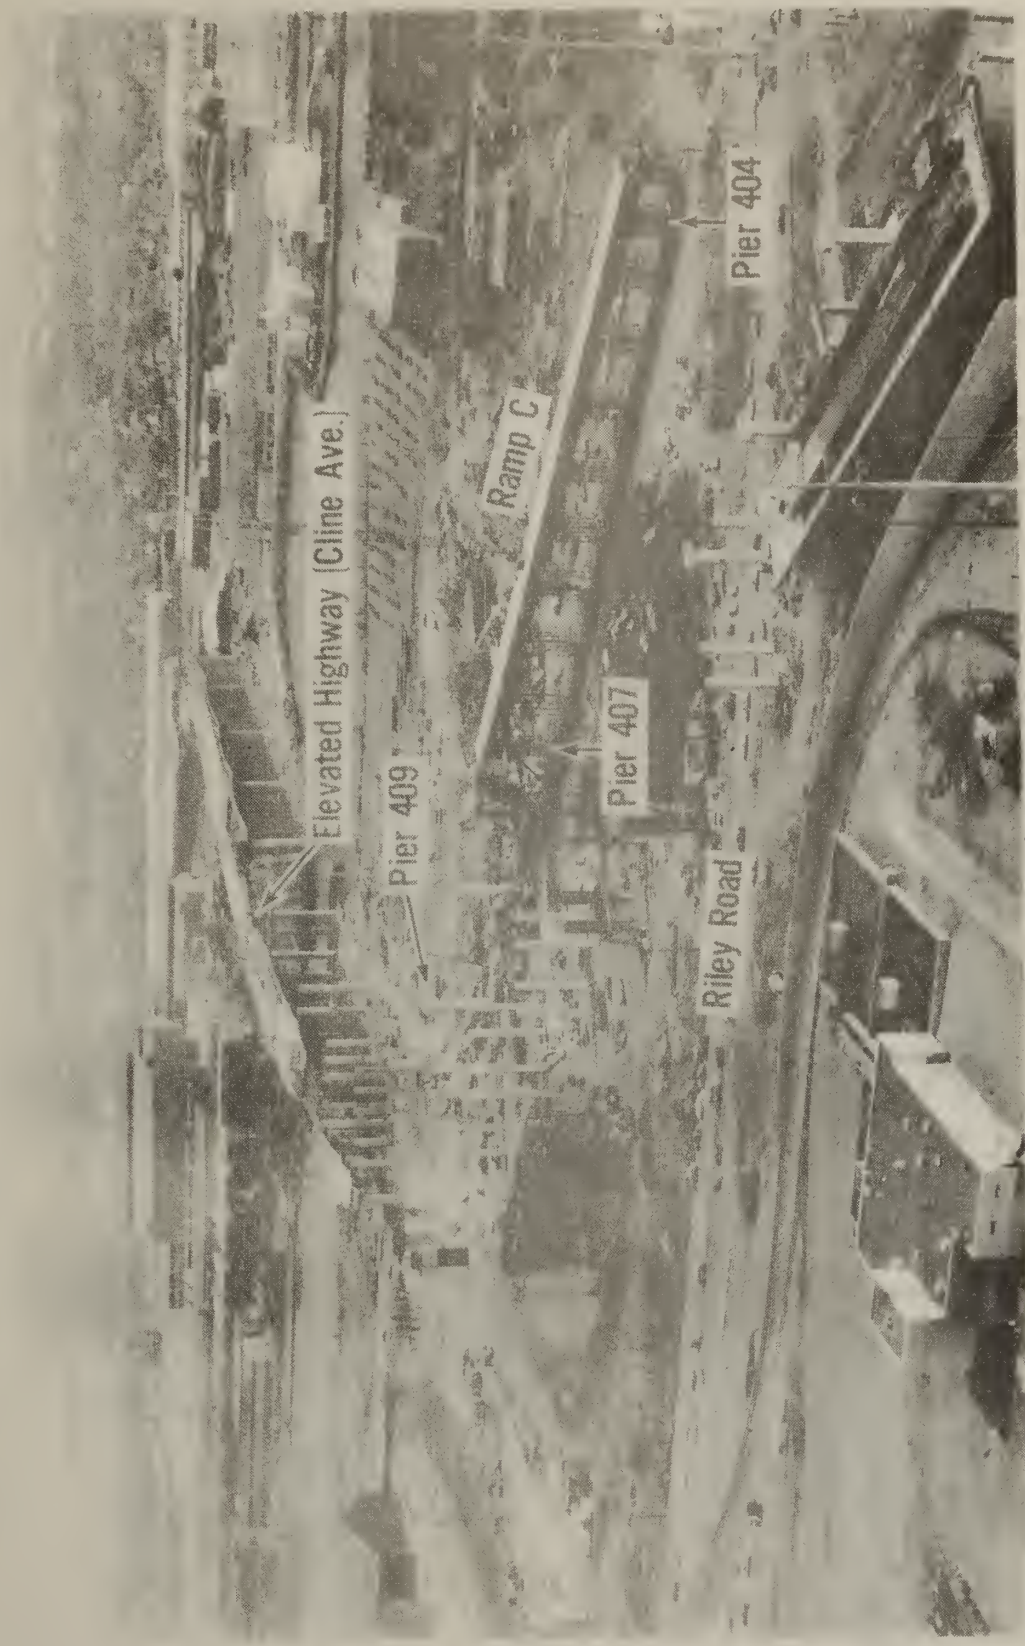
The structure, known as Ramp C, is located at the interchange of Riley Road and Cline Avenue in East Chicago, Indiana. It is intended to move traffic from Riley Road onto the eastbound lane of Cline Avenue. Figure 2.1 is a view looking east taken shortly after the failure, and shows the portion of the ramp which remained standing. The ramp was to be built in two phases. In the first phase, the portion from pier 404 to an expansion joint beyond pier 409 was being built. In the second phase, the portion west of pier 404 and passing over Riley Road would be built. At the time of the collapse work was in progress east of pier 407 in the first portion.

Figure 2.1 Overall view of the collapse site, looking from west to east.  
(Courtesy of Post-Tribune, Gary Indiana)

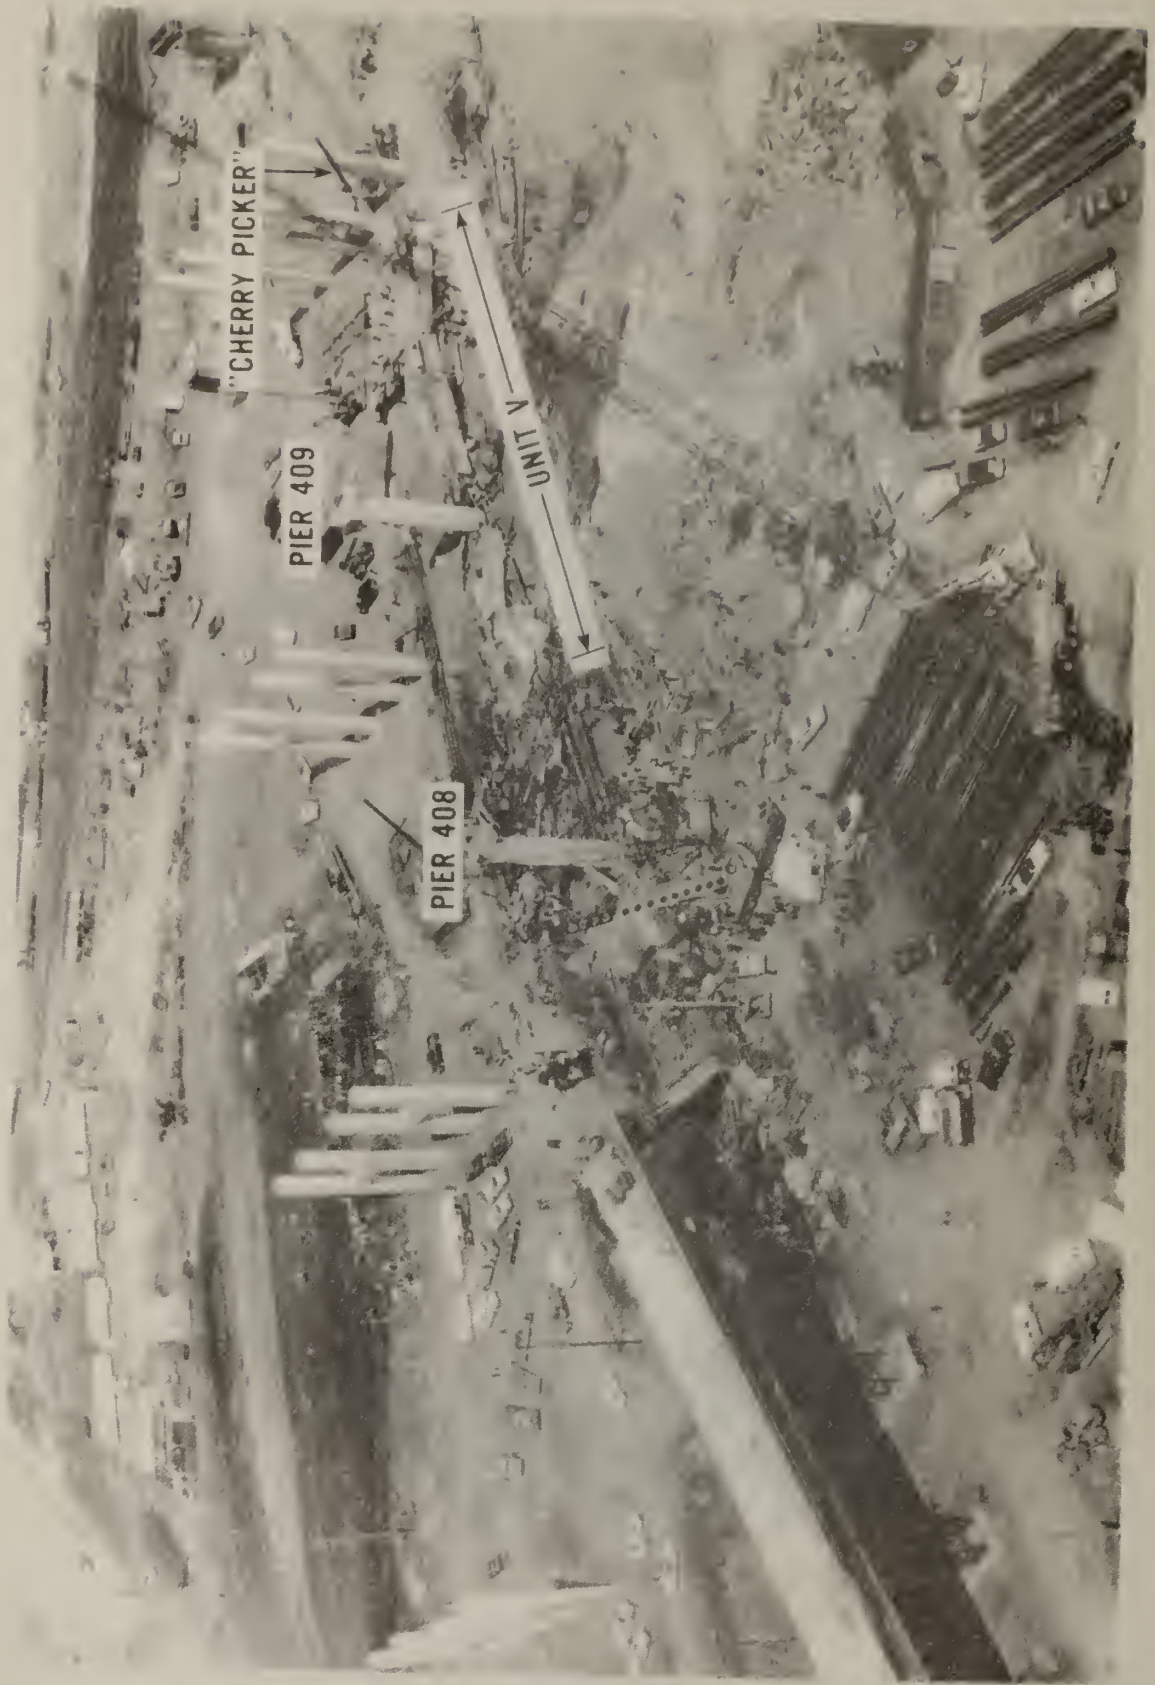
Figures 2.14, 2.15, and 2.16 are aerial photographs taken on the day of the failure. They show the location of the debris before a significant amount of it had been moved for rescue operations.

Figure 2.14 View of collapse as seen from the southwest (courtesy of Post-Tribune, Gary, Indiana)

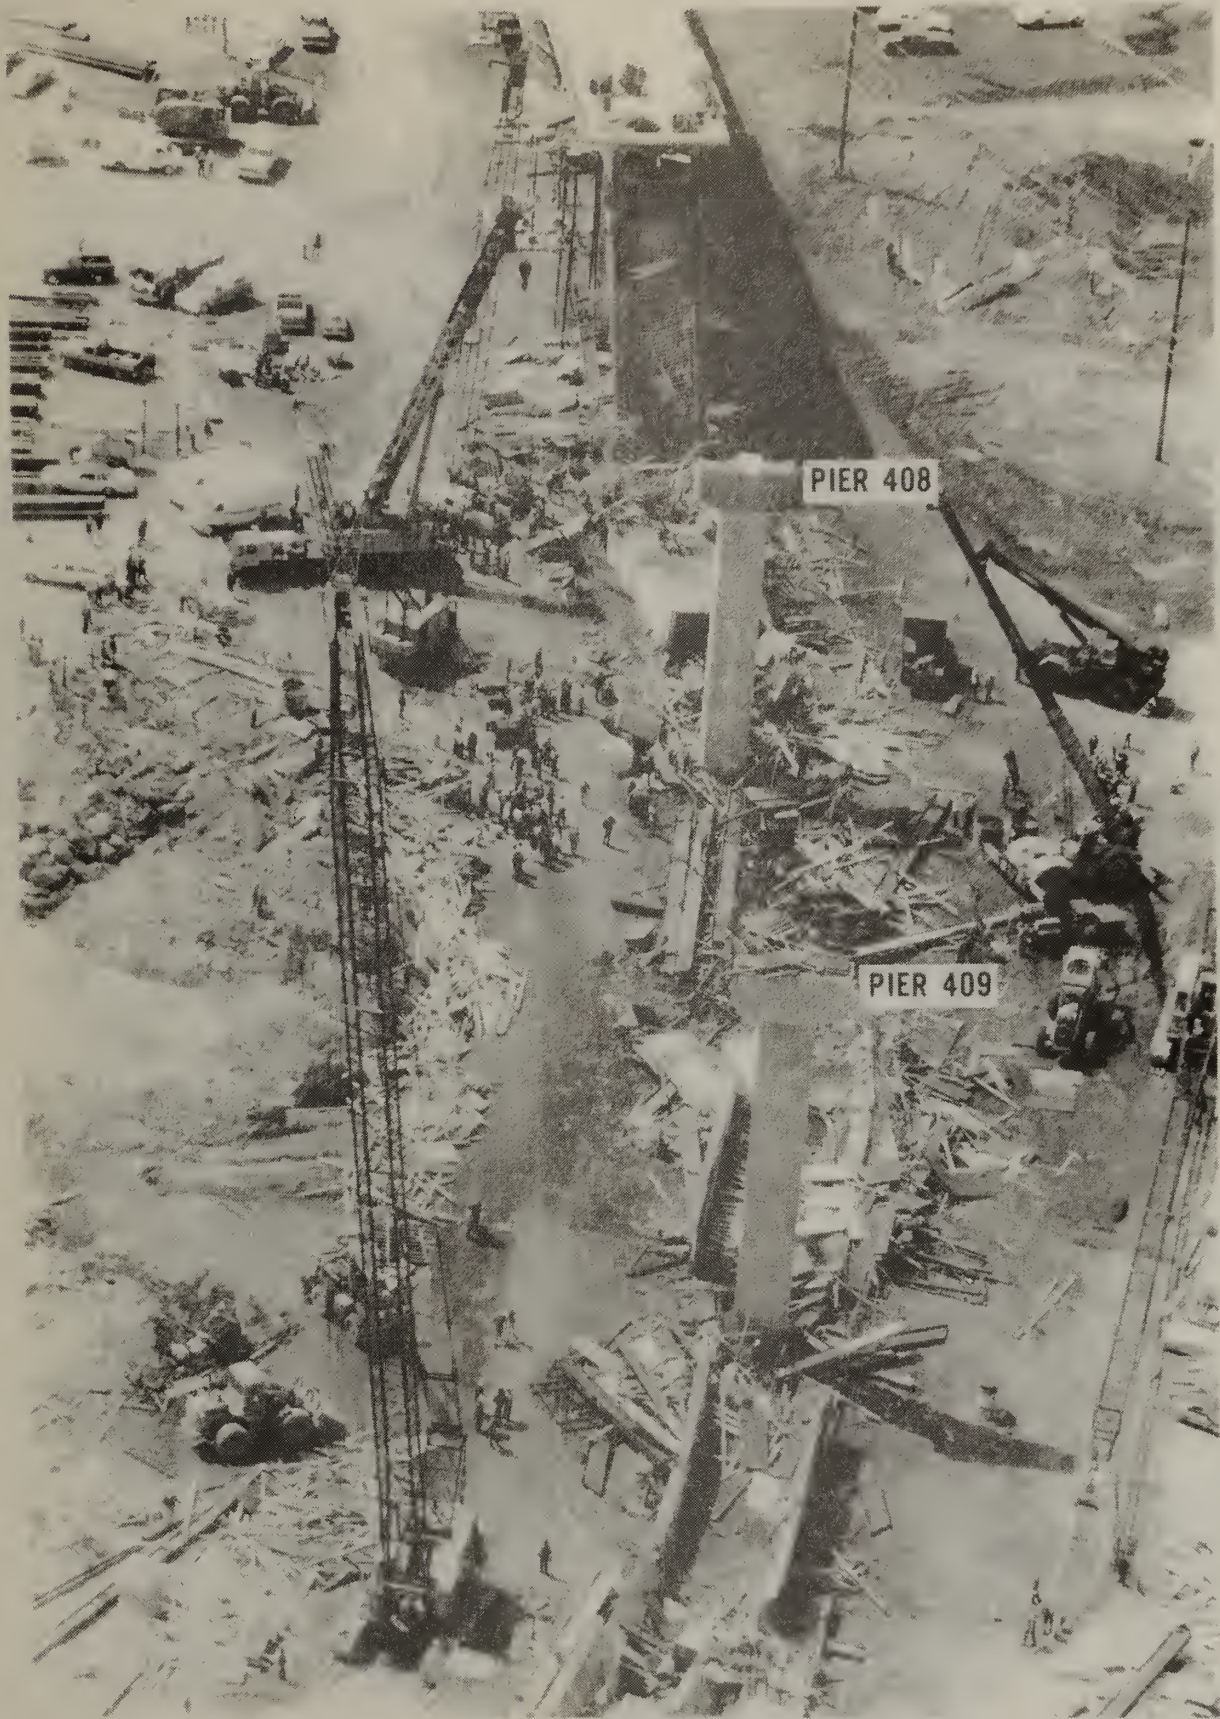
Figure 2.15 View of collapse as seen from the east. (Courtesy of Post-Tribune, Gary Indiana)

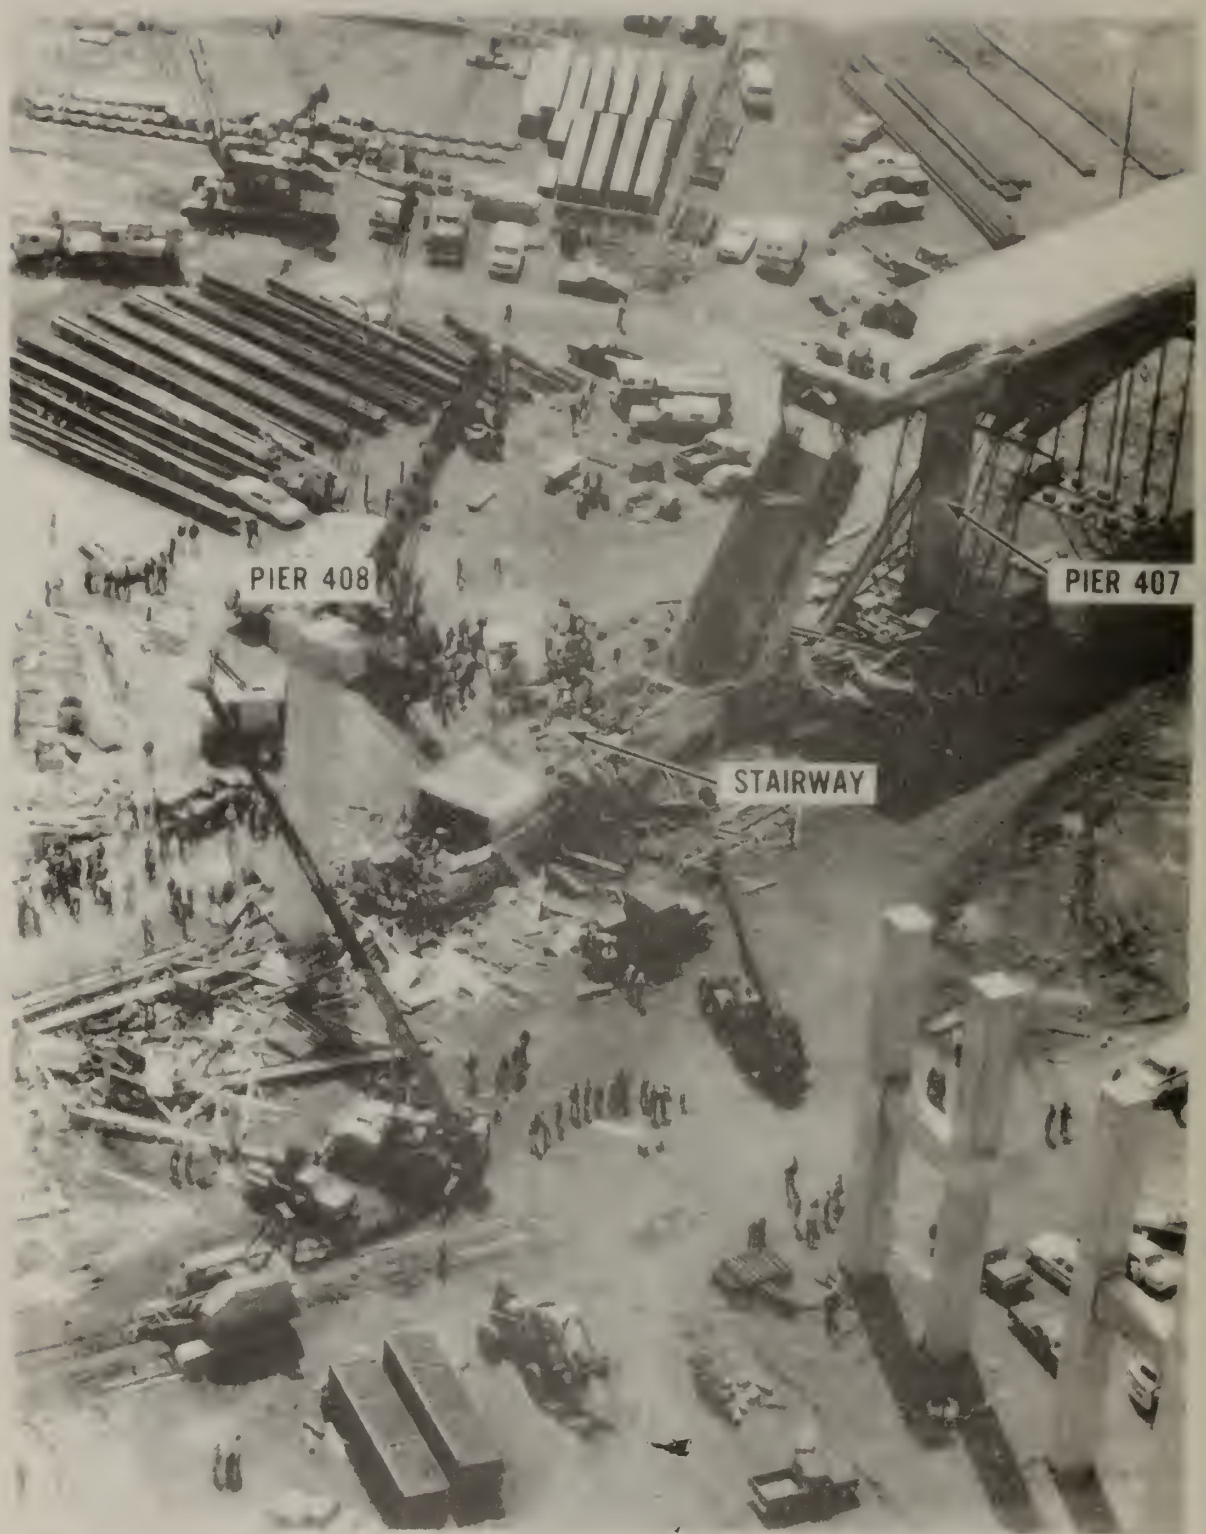
Figure 2.16 View of collapsed unit IV as seen from the northeast. (Courtesy of Post-Tribune, Gary Indiana)

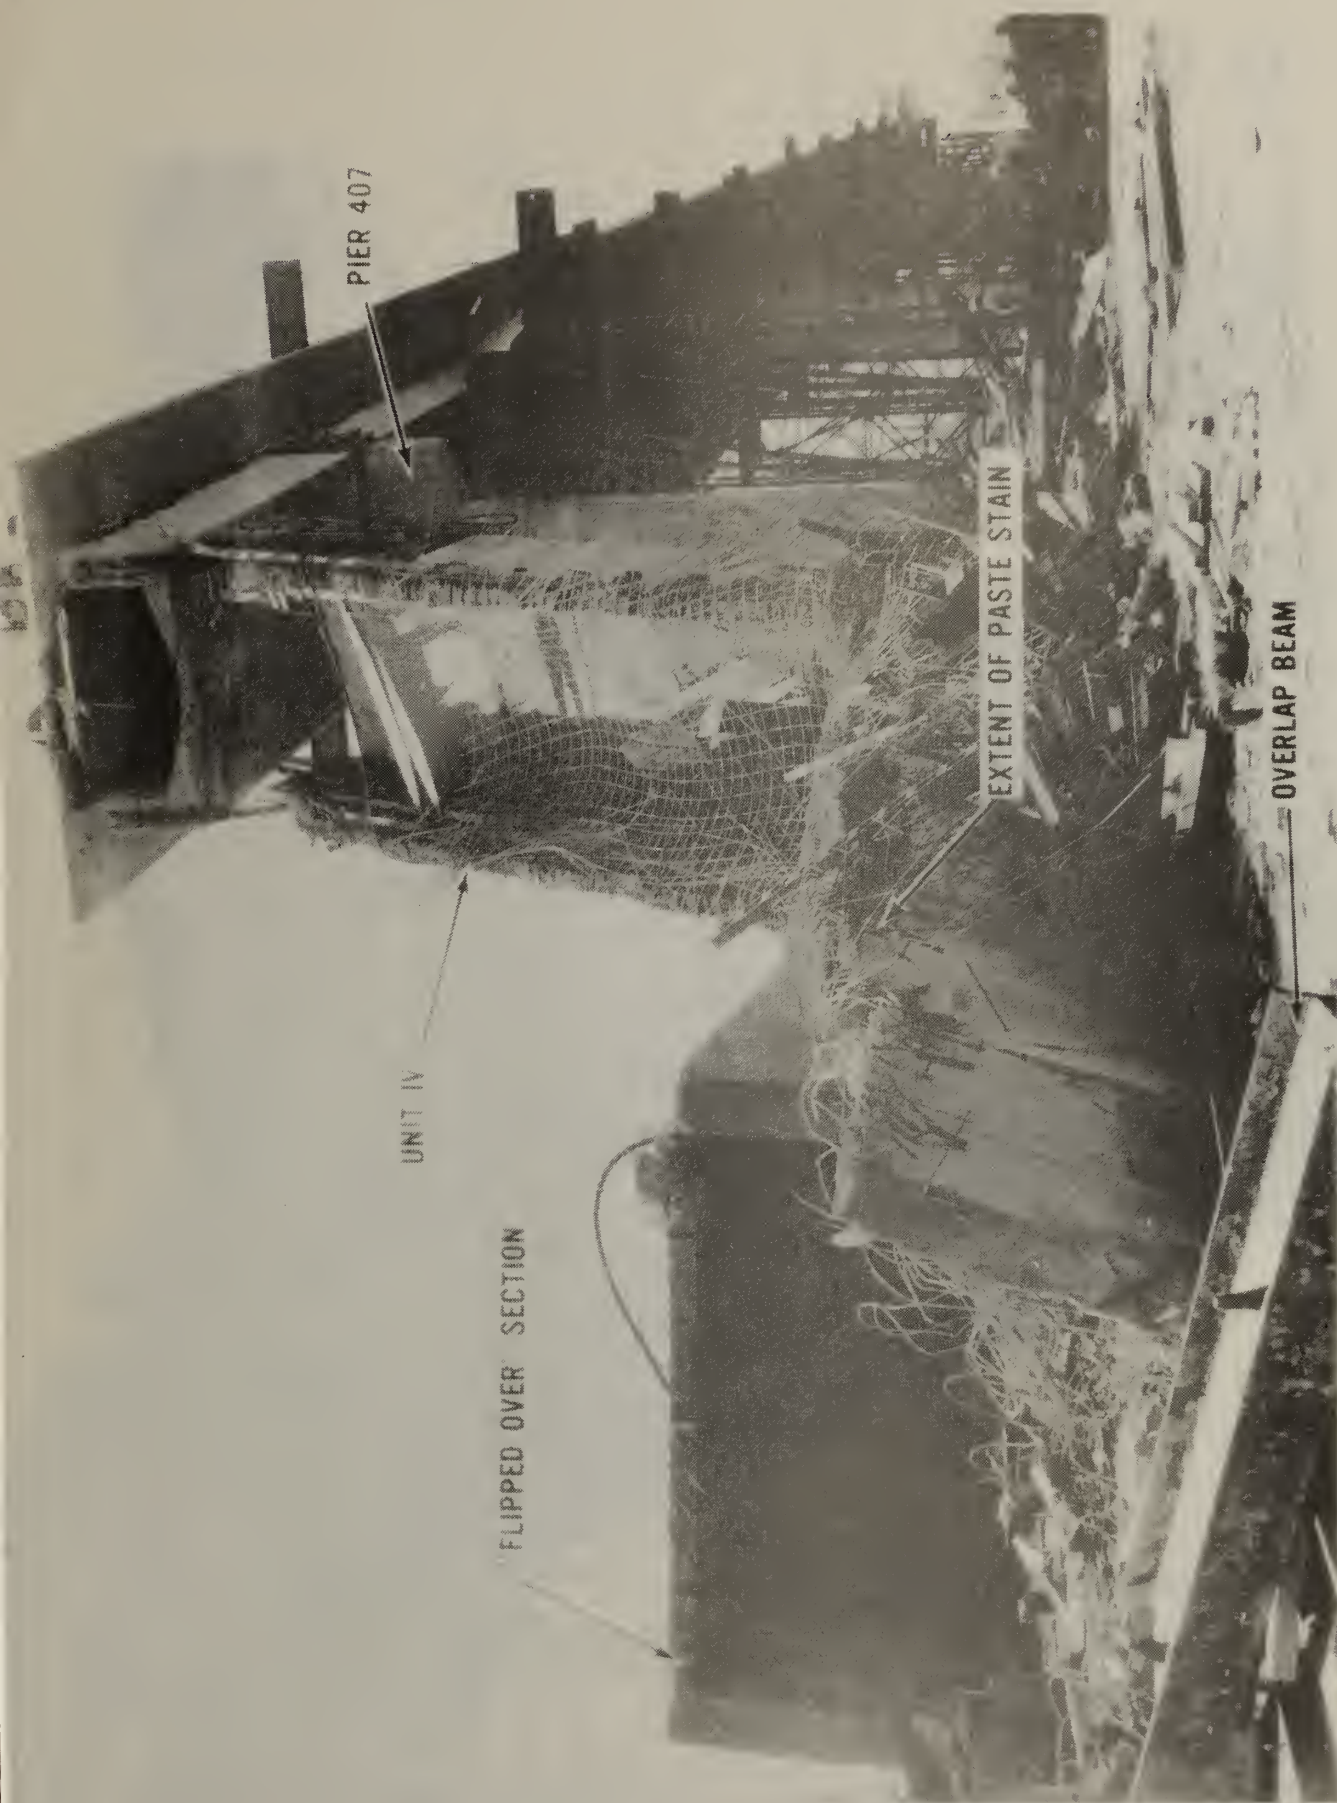
concrete plant, 140 yd<sup>3</sup> (107 m<sup>3</sup>) of concrete had been delivered for the top slab. From field measurements it was found that the diaphragm had been filled to an elevation of about 5 ft (1.5 m), thus it was calculated that the top slab had been placed to a point about 20 ft (6.1 m) west of pier 408, when the collapse initiated. This estimate was corroborated by worker statements and by measurements of the extent of the cement paste stain on the northern side wall of unit IV (see figure 2.17).

Figure 2.17, 2.18, and 2.19 are ground level views of unit IV. Figure 2.17 is a view from the northeast and shows the portions of unit IV that were adjacent to pier 408. Stains due to fresh cement paste can be seen on the northern side wall. The stained region ends at about 20 ft (6 m) from the end of the unit, and this is assumed to indicate how much of the top-slab concrete had been placed. In the foreground of figure 2.17 is seen a short, steel beam that was originally located next to the cap of pier 408. The purpose of this beam is discussed in subsection 3.2.4.

Figure 2.17 Unit IV as viewed from the northeast

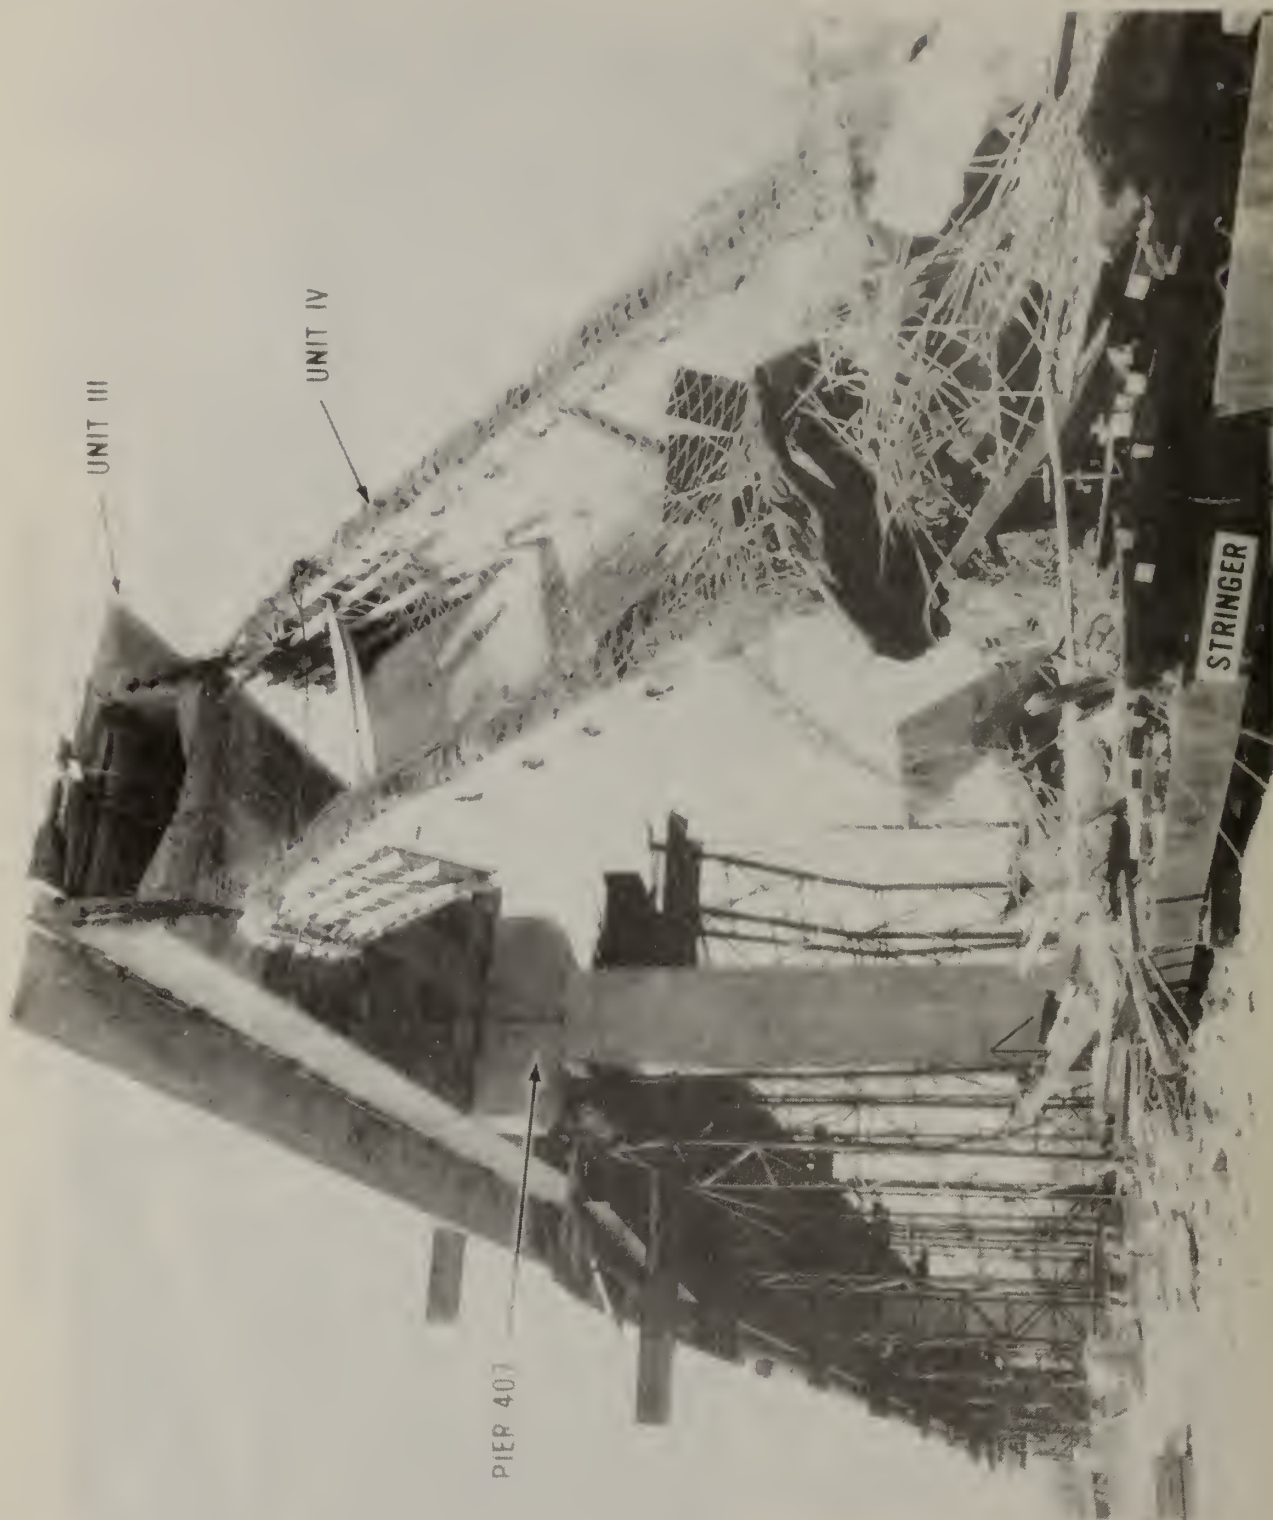
Figure 2.18 Partial view of unit IV from the southeast

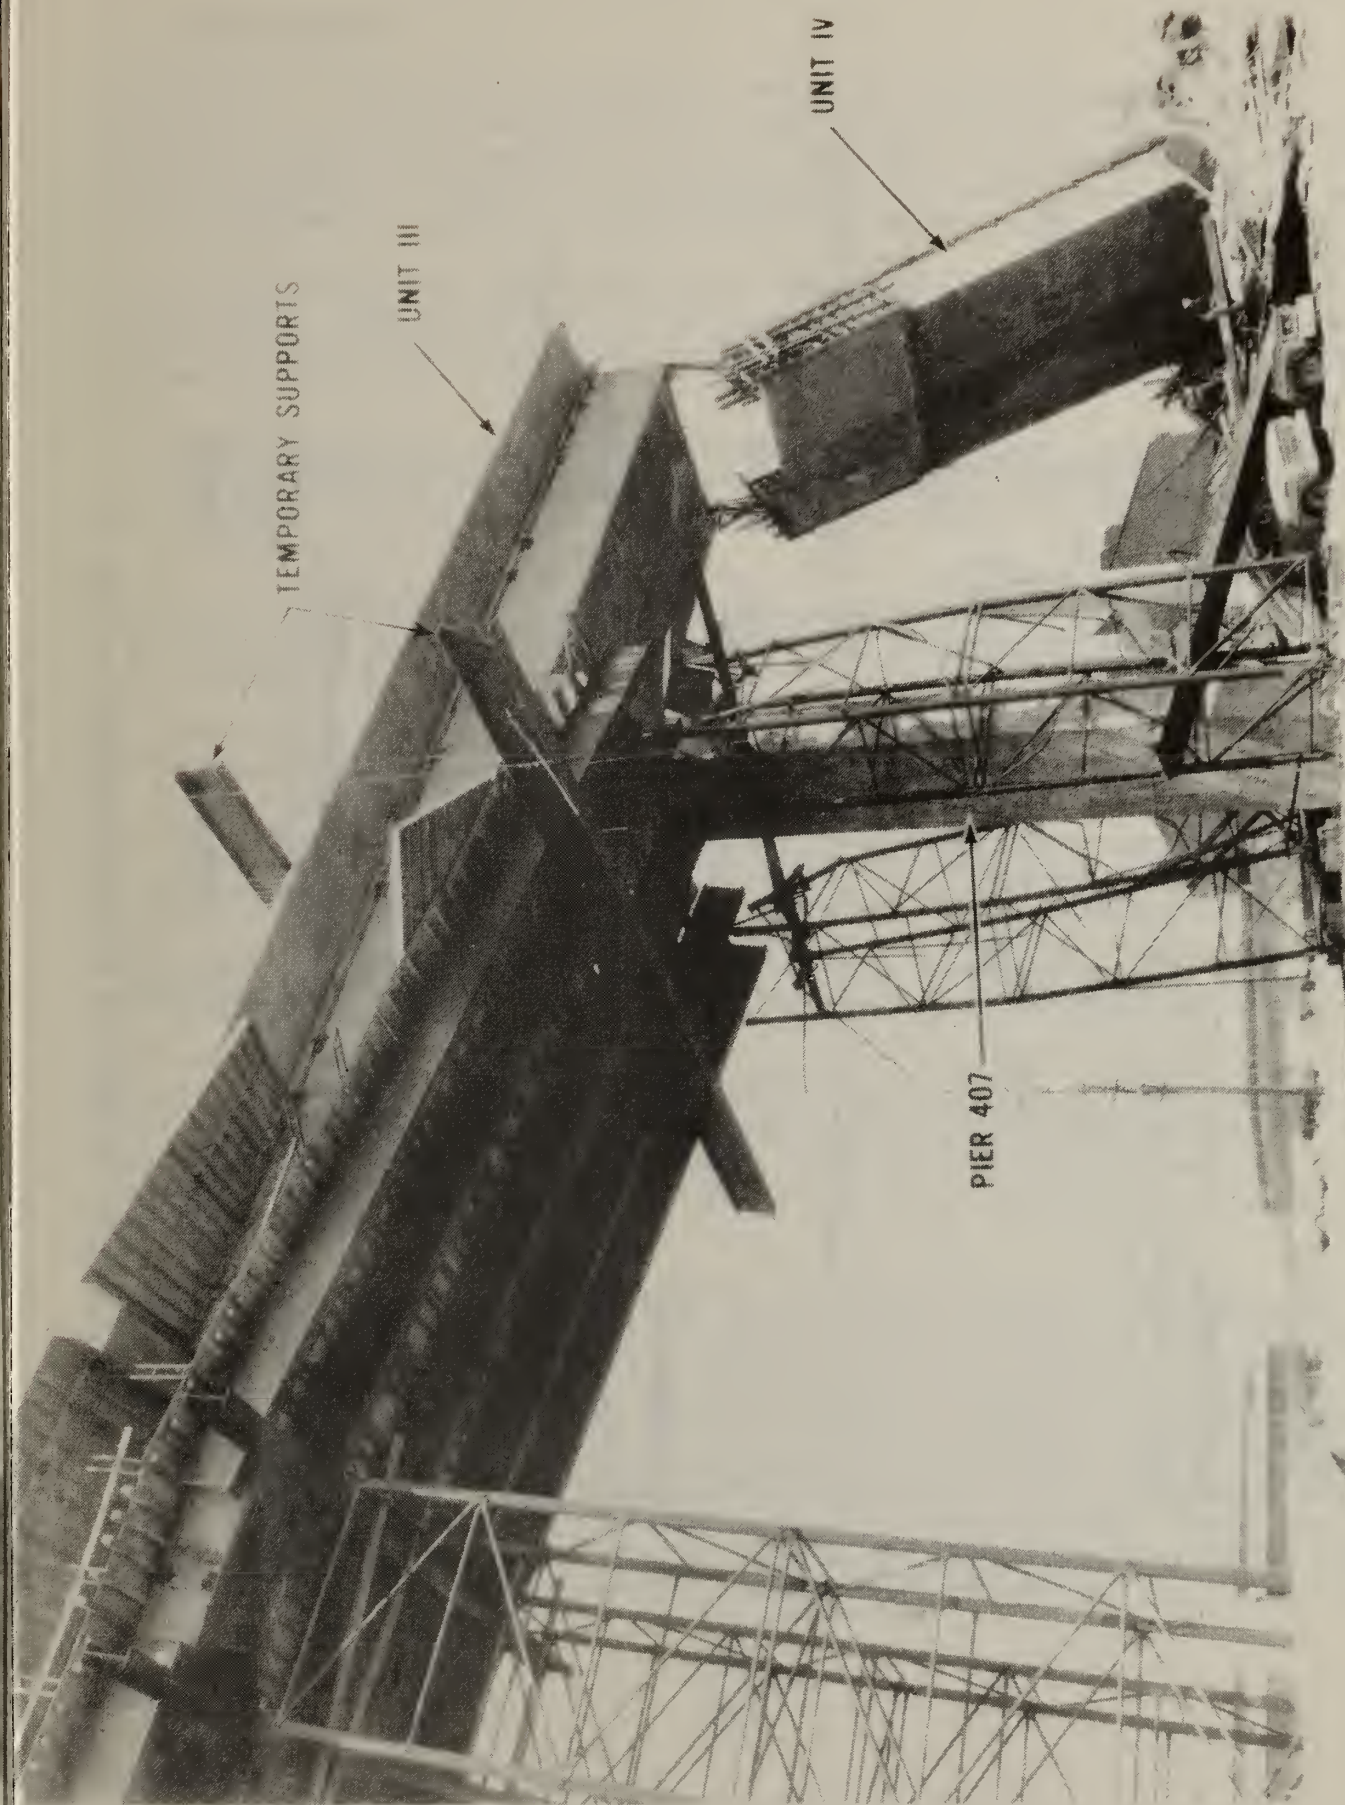
Figure 2.19 is a view of the hanging portion of unit IV as seen from the southwest. The portion of the floor slab that is a lighter shade is the portion cast two days before the failure. Also seen are the damaged shoring towers at pier 407. The two transverse beams on unit III were added after the collapse to help support the stringers which were originally supported by the towers at pier 407. Figure 2.19 also shows some of the falsework details to be discussed in section 3.2.

Figure 2.19 View of the hanging portion of unit IV from the southwest

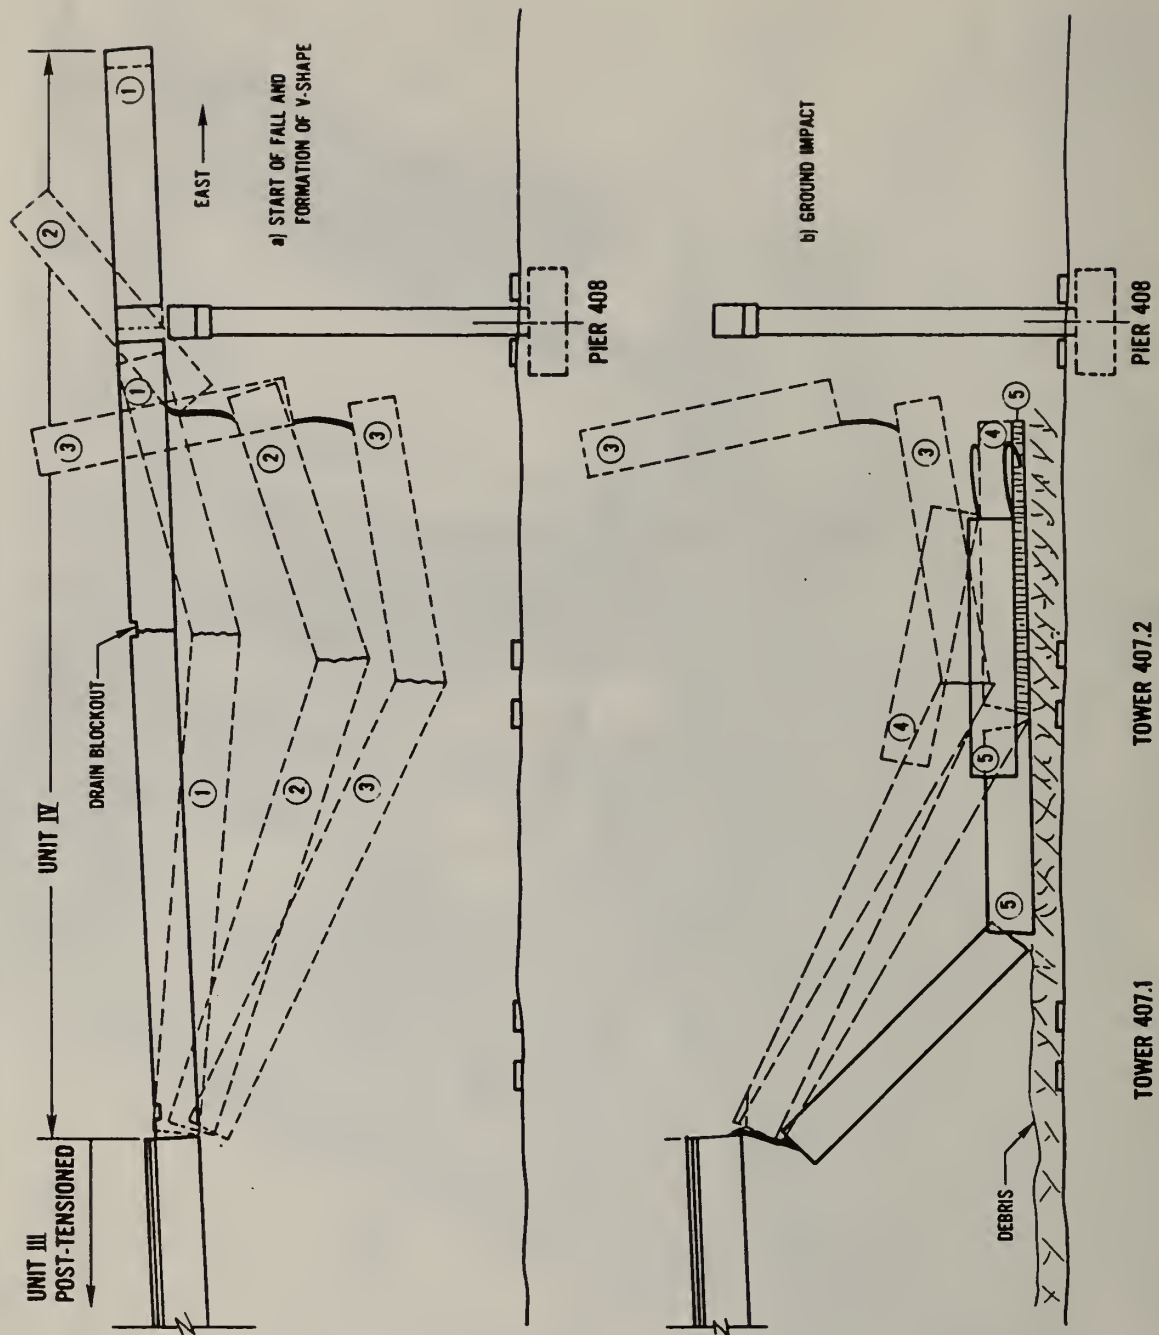
Figure 2.20 is a reconstruction of a possible mechanism of the collapse of unit IV. Field observations after the failure revealed a large gap in the northern wall of unit IV at approximately the same cross section containing the drain blockout on the south wall (see figure 2.9). Thus, it is suggested that unit IV developed initial cracking at the location of the cross-section with the blockout. As the unit fell it dragged with it the portion east of pier 408 (#1)\*, because the tendons were wedged in place at the jacking end of unit IV.

Figure 2.20 Possible of collapse sequence for unit IV

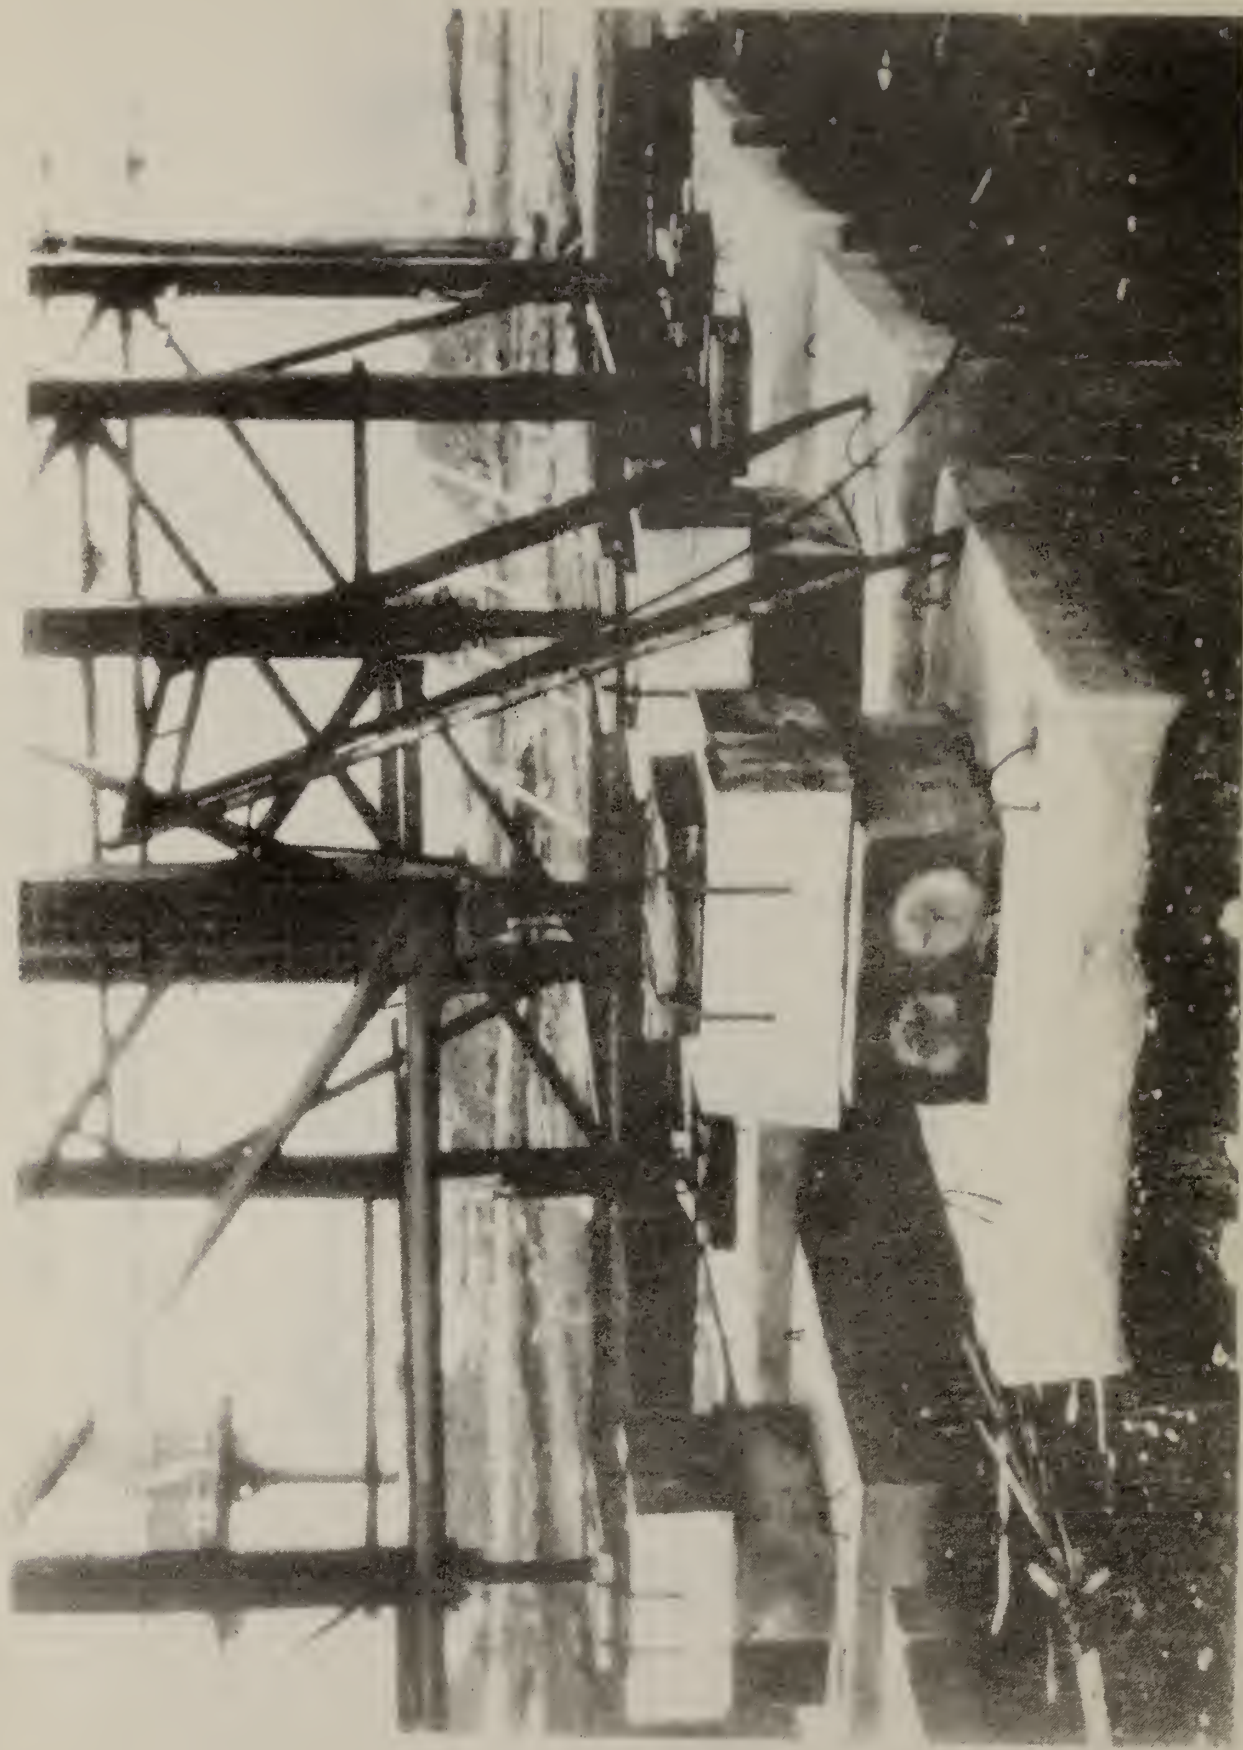
Figure 3.5 View of bottom of shoring towers at 407.1,  
looking from south to north

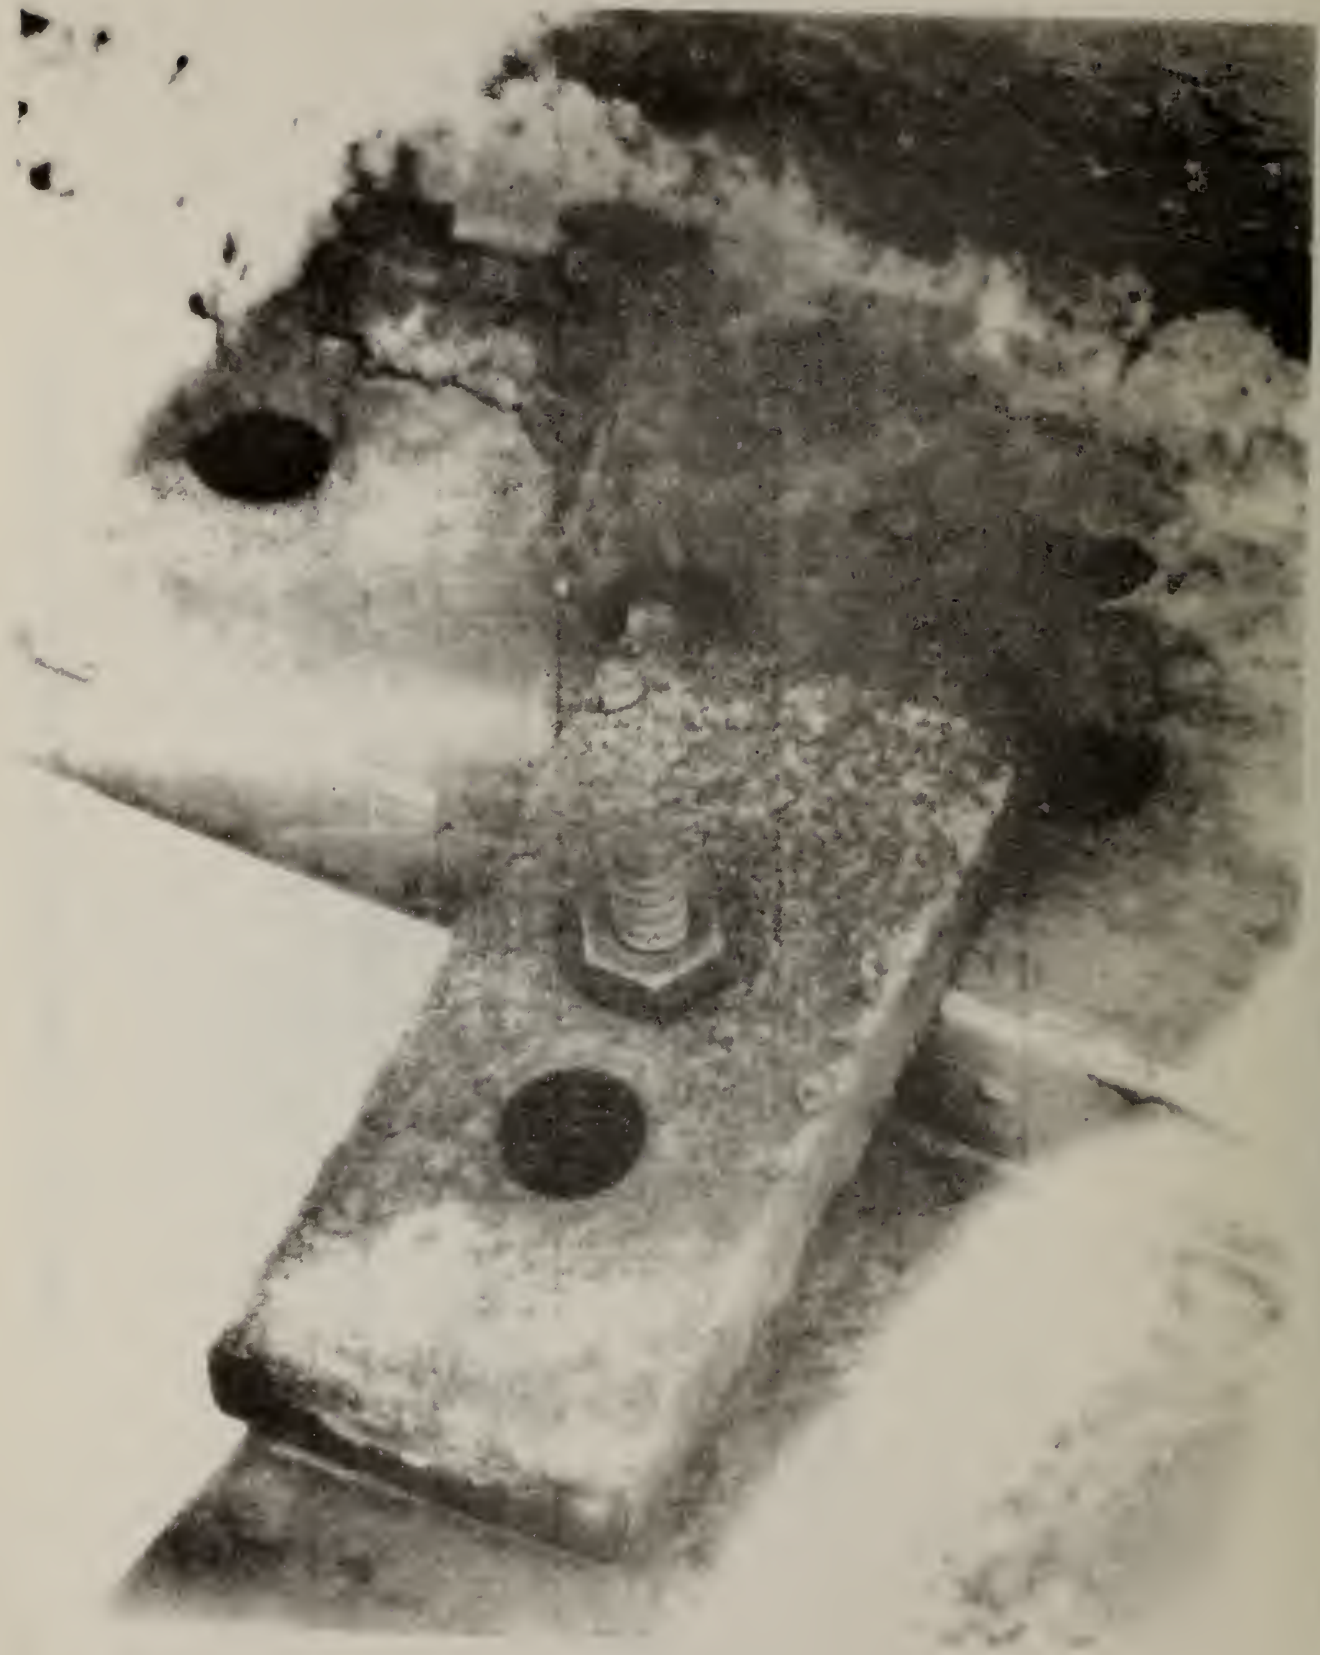
The structural drawings called for 1-in (25-mm) steel bolts to connect certain stringers to the cross-beams. No evidence of these bolts was found during the

field investigation. A frictional clip was used in place of the bolts, but no documentation was found authorizing this substitution. The drawings also specified wedges between crossbeams and stringers to compensate for the slope of the roadway. There was no evidence that wedges were used, and no documentation was found approving their omission. In addition, no calculations were found for the engineering design of the concrete pads, and the construction sequence deviated from that specified in the drawings.

Figure 3.13 Connection detail employed in place of specified bolted connection
