NBSIR 82-2593

# Investigation of Construction Failure of the Riley Road Interchange Ramp, East Chicago, Indiana

October 1982

N. J. Carino  
H. S. Lew  
W. C. Stone  
R. M. Chung

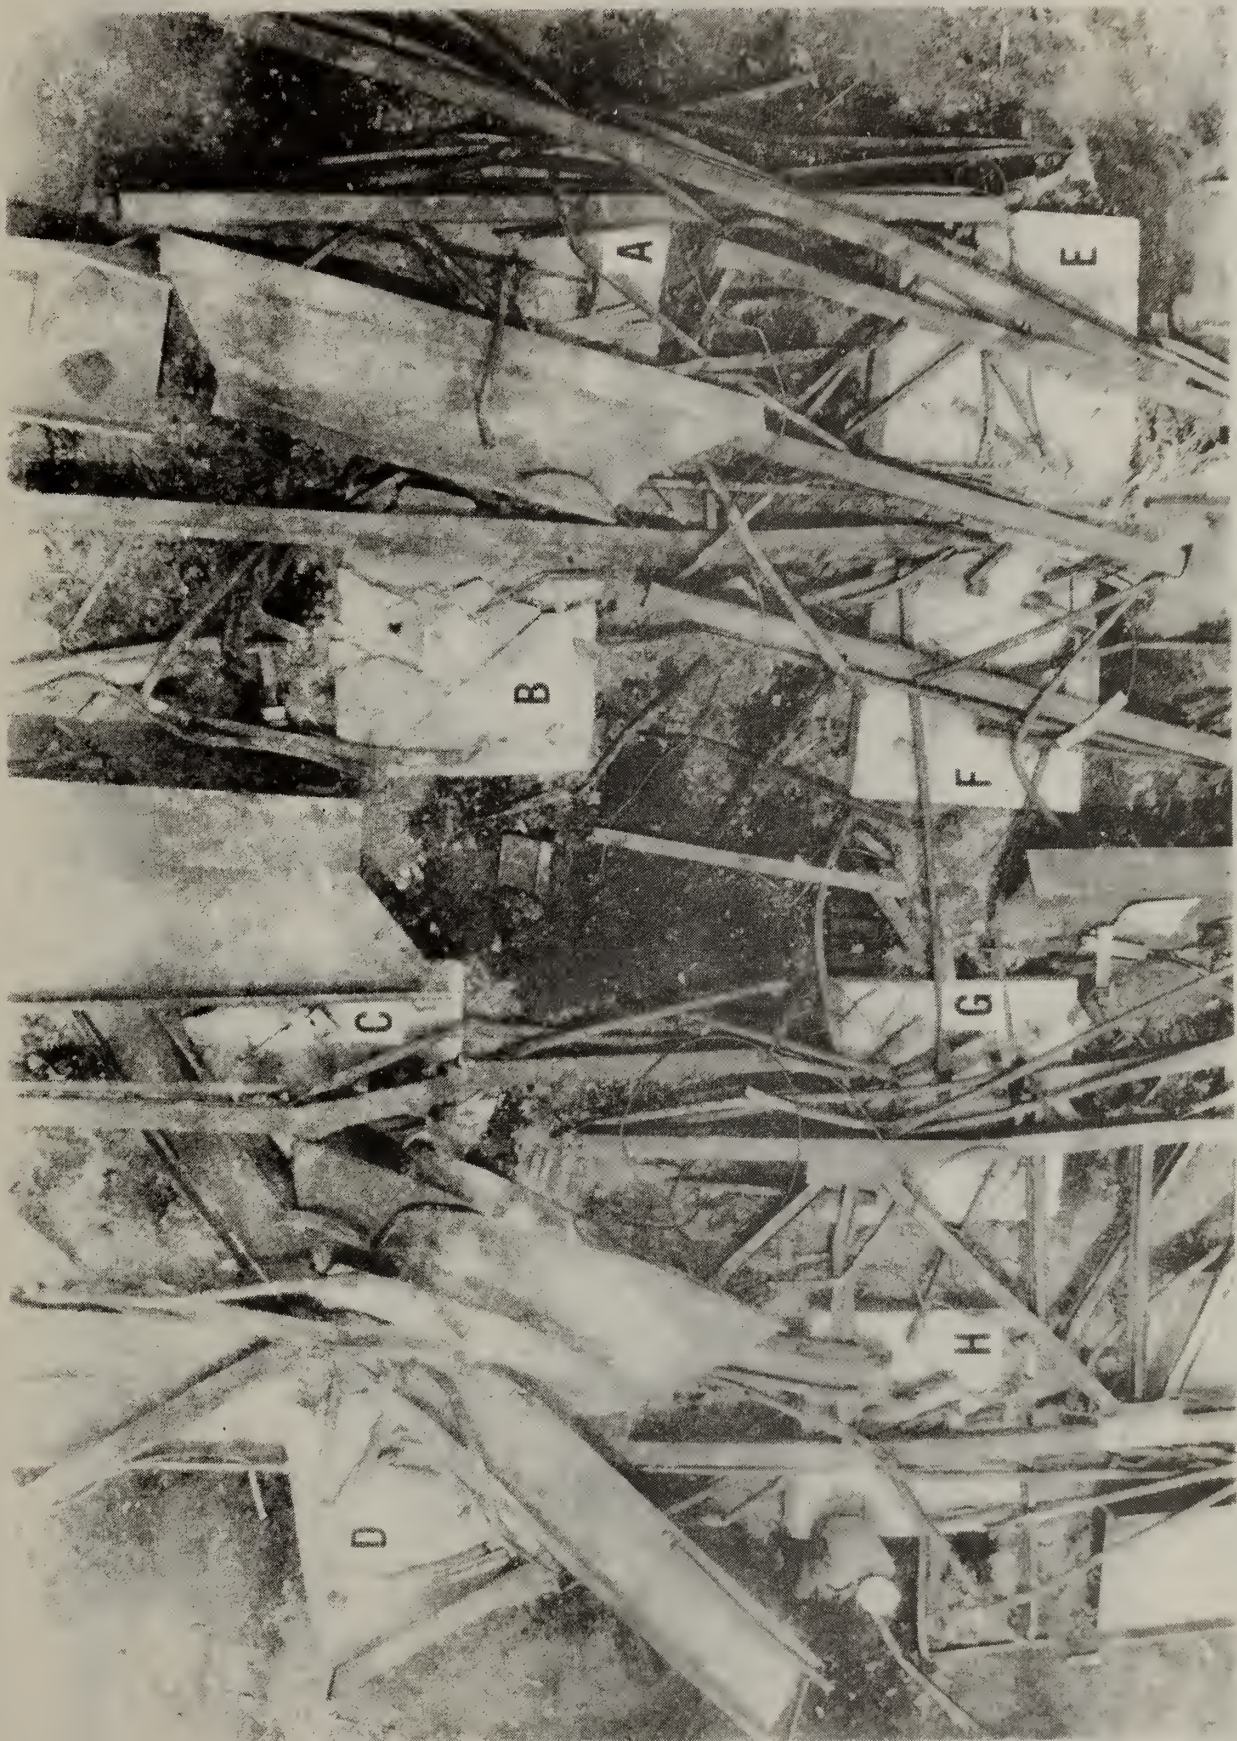
Figure 3.24 Close-up view of cracked concrete pads at tower location 407.2 (north is to the right)

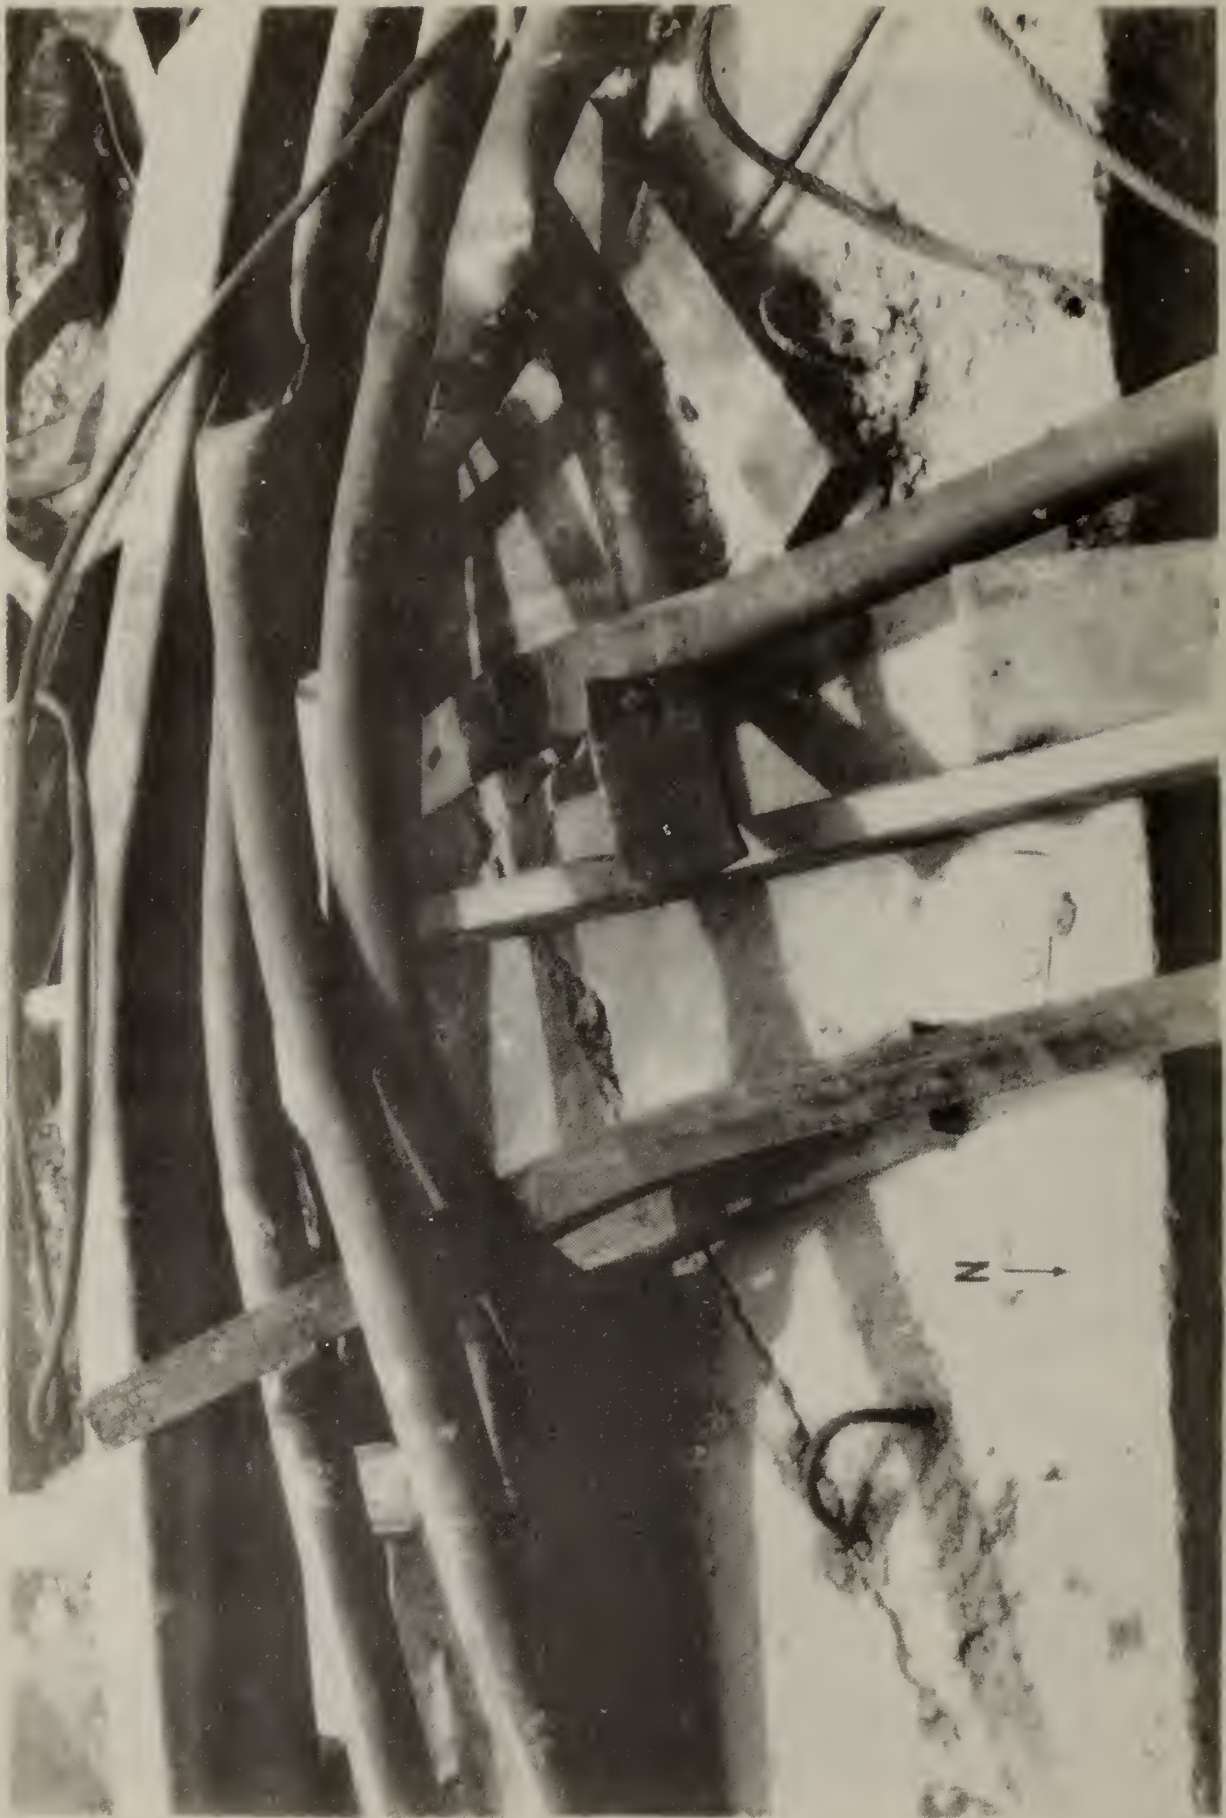
Figure 3.25 Cracking pattern of concrete pad 407.2-G

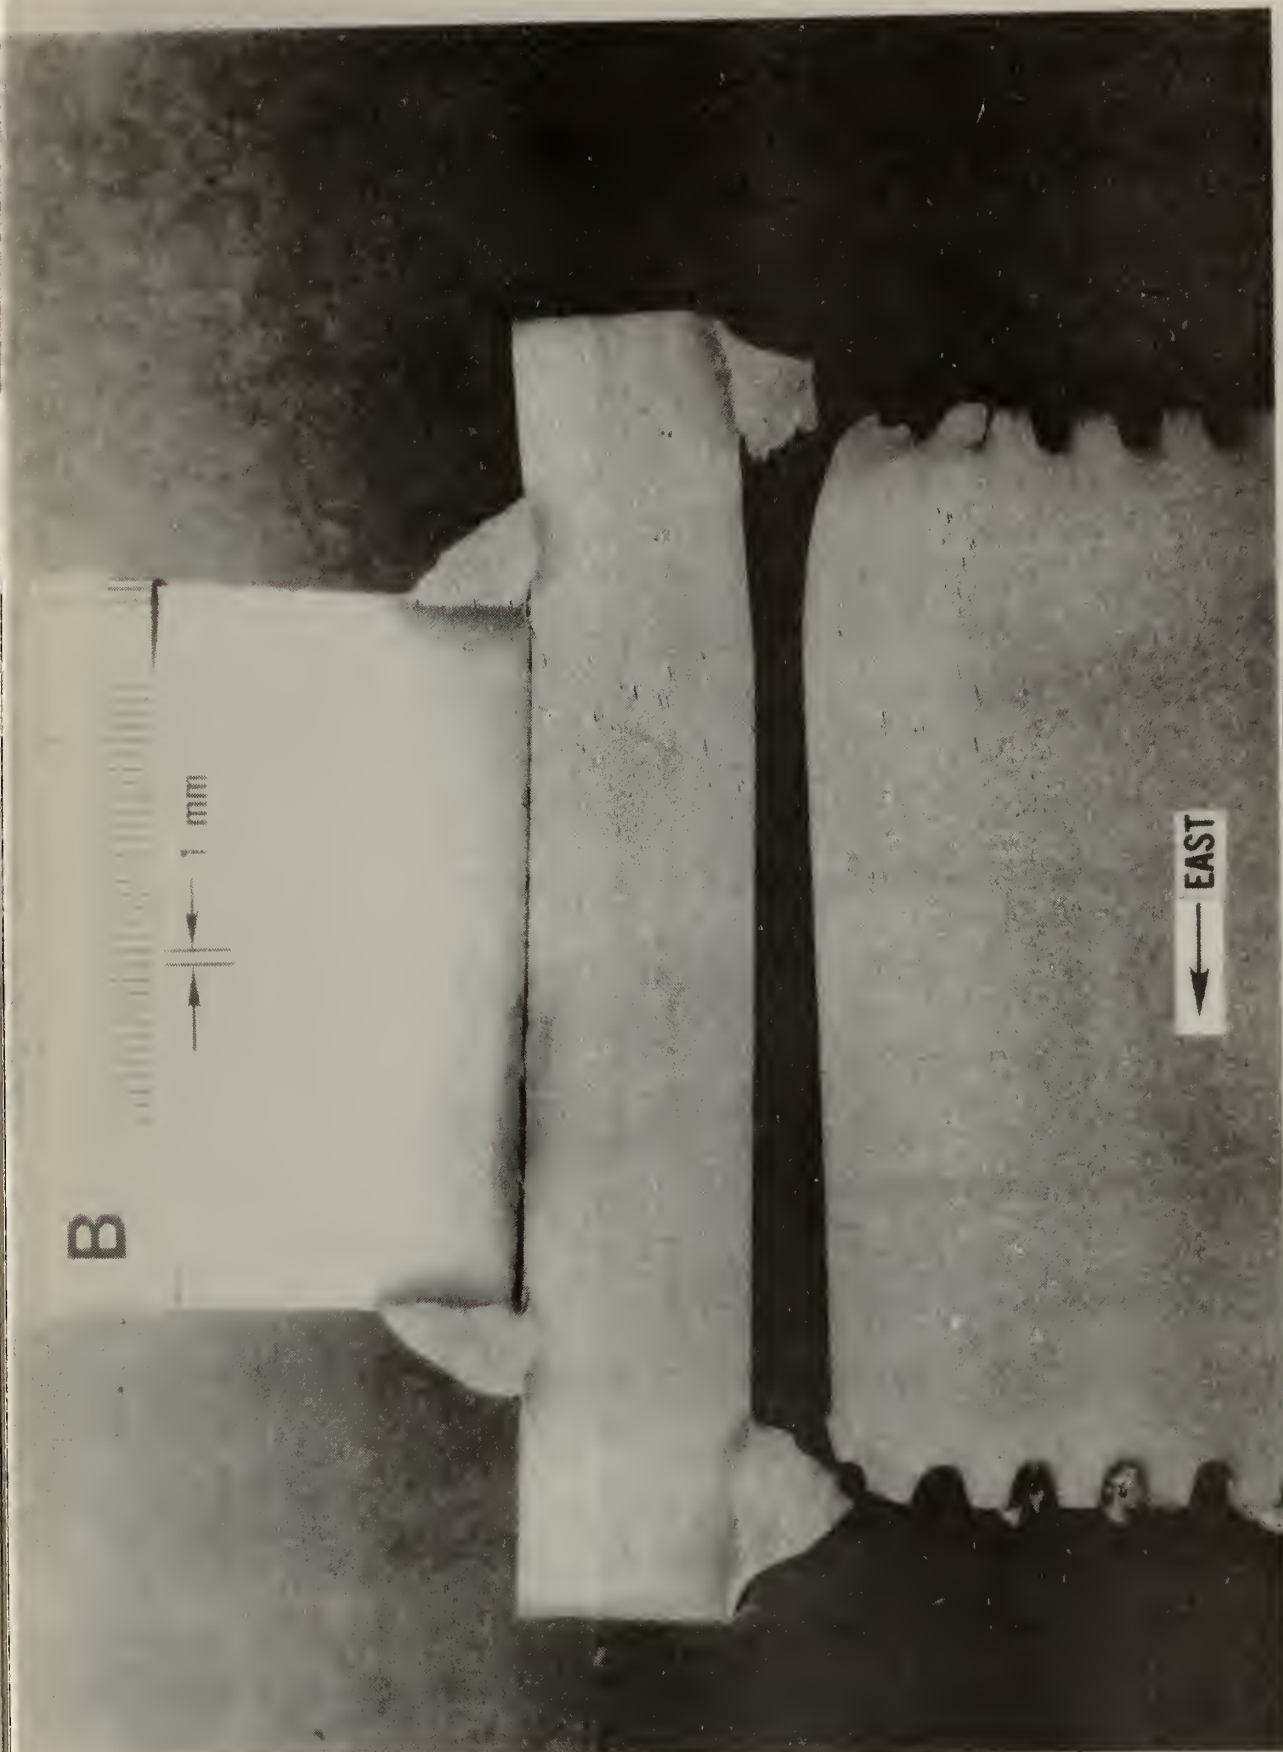
Figure 4.20 Cross-section of screw jack from leg B in tower 407.2(N)

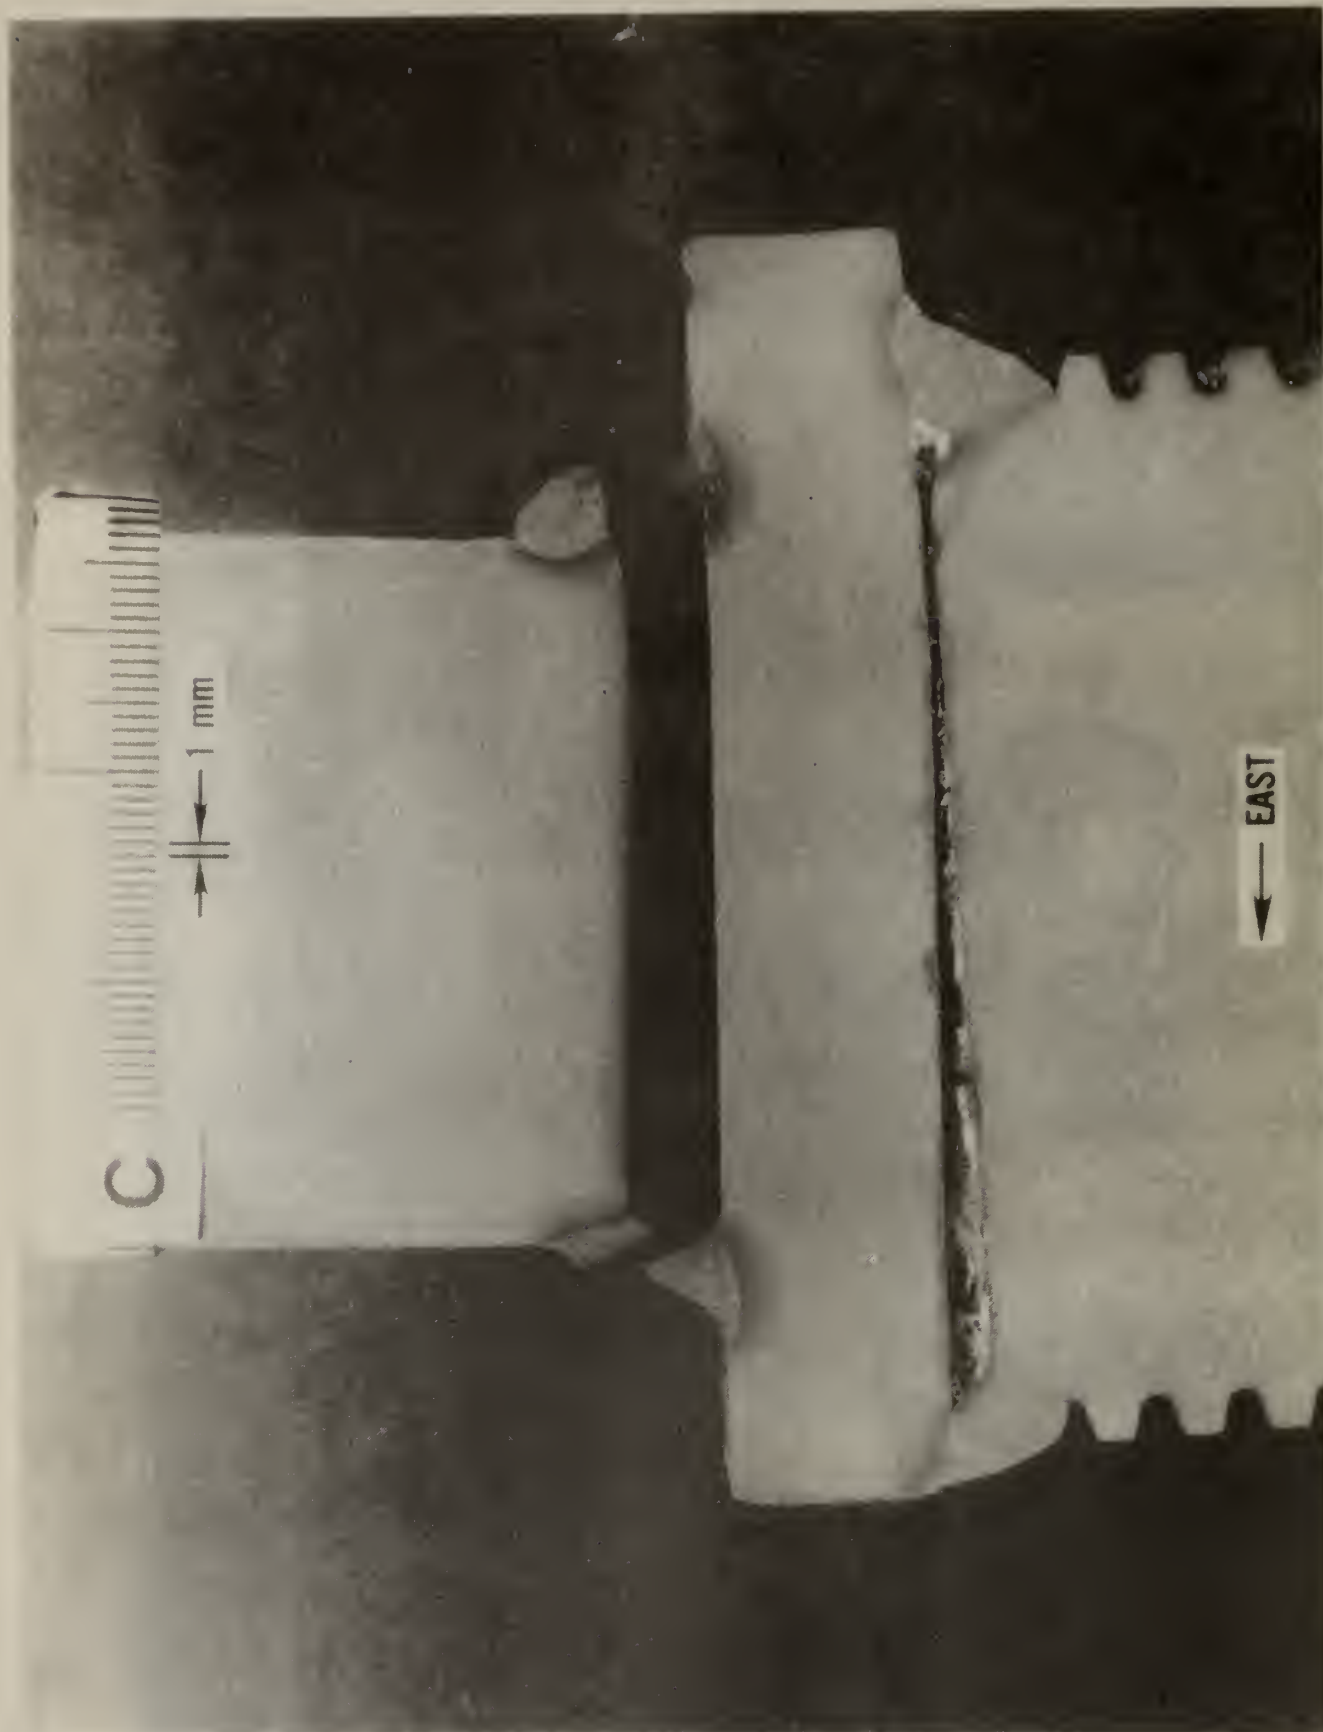
Figure 4.21 Cross-section of screw jack from leg C in tower 407.2(S)

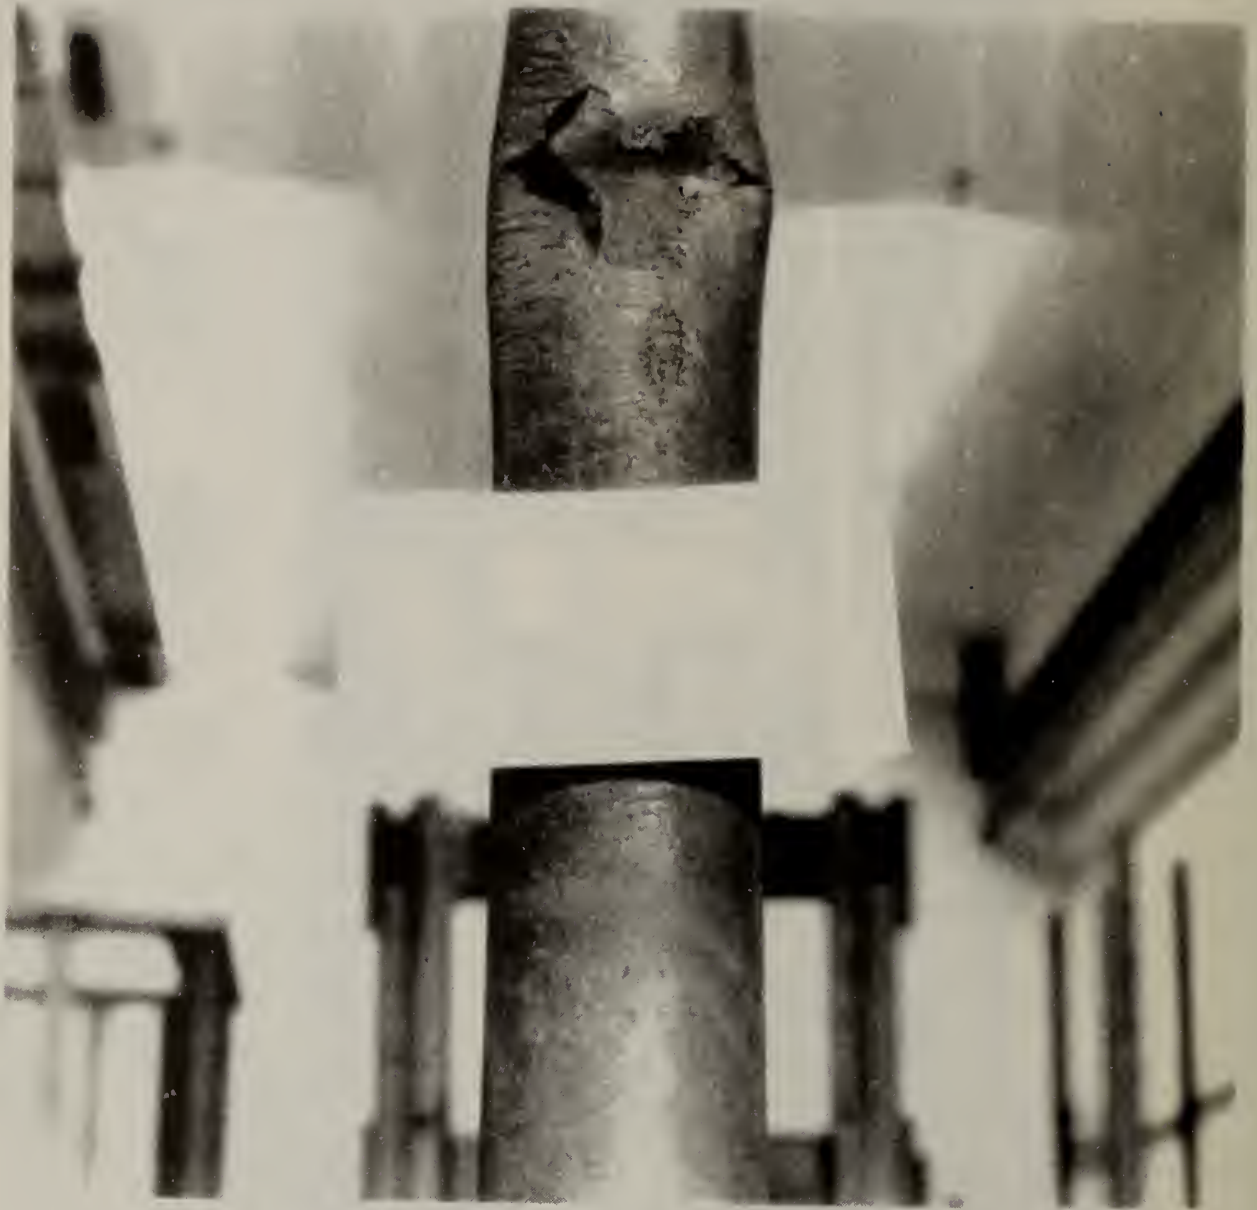
Figure 4.33 Close up view of corroded region near coupler of brace #3

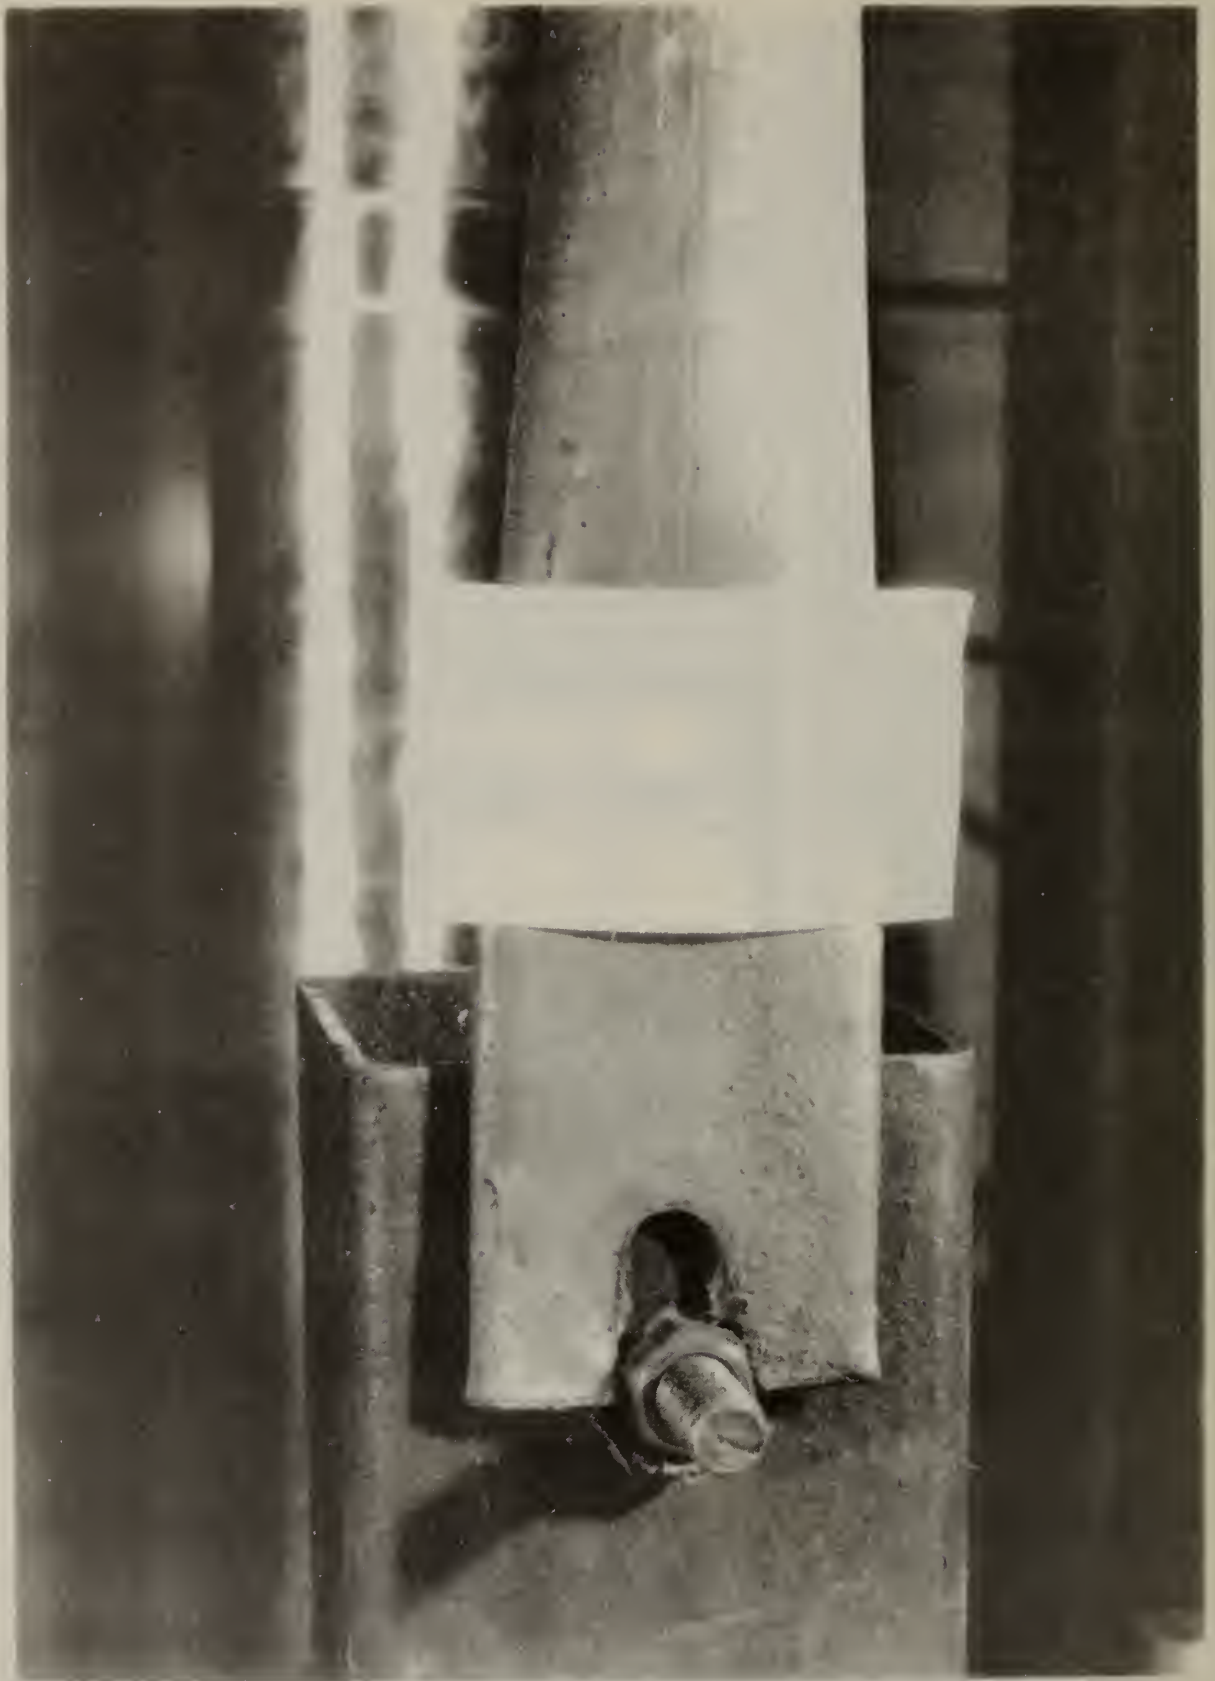
Figure 4.35 Tearing failure at bolt connection of brace #5

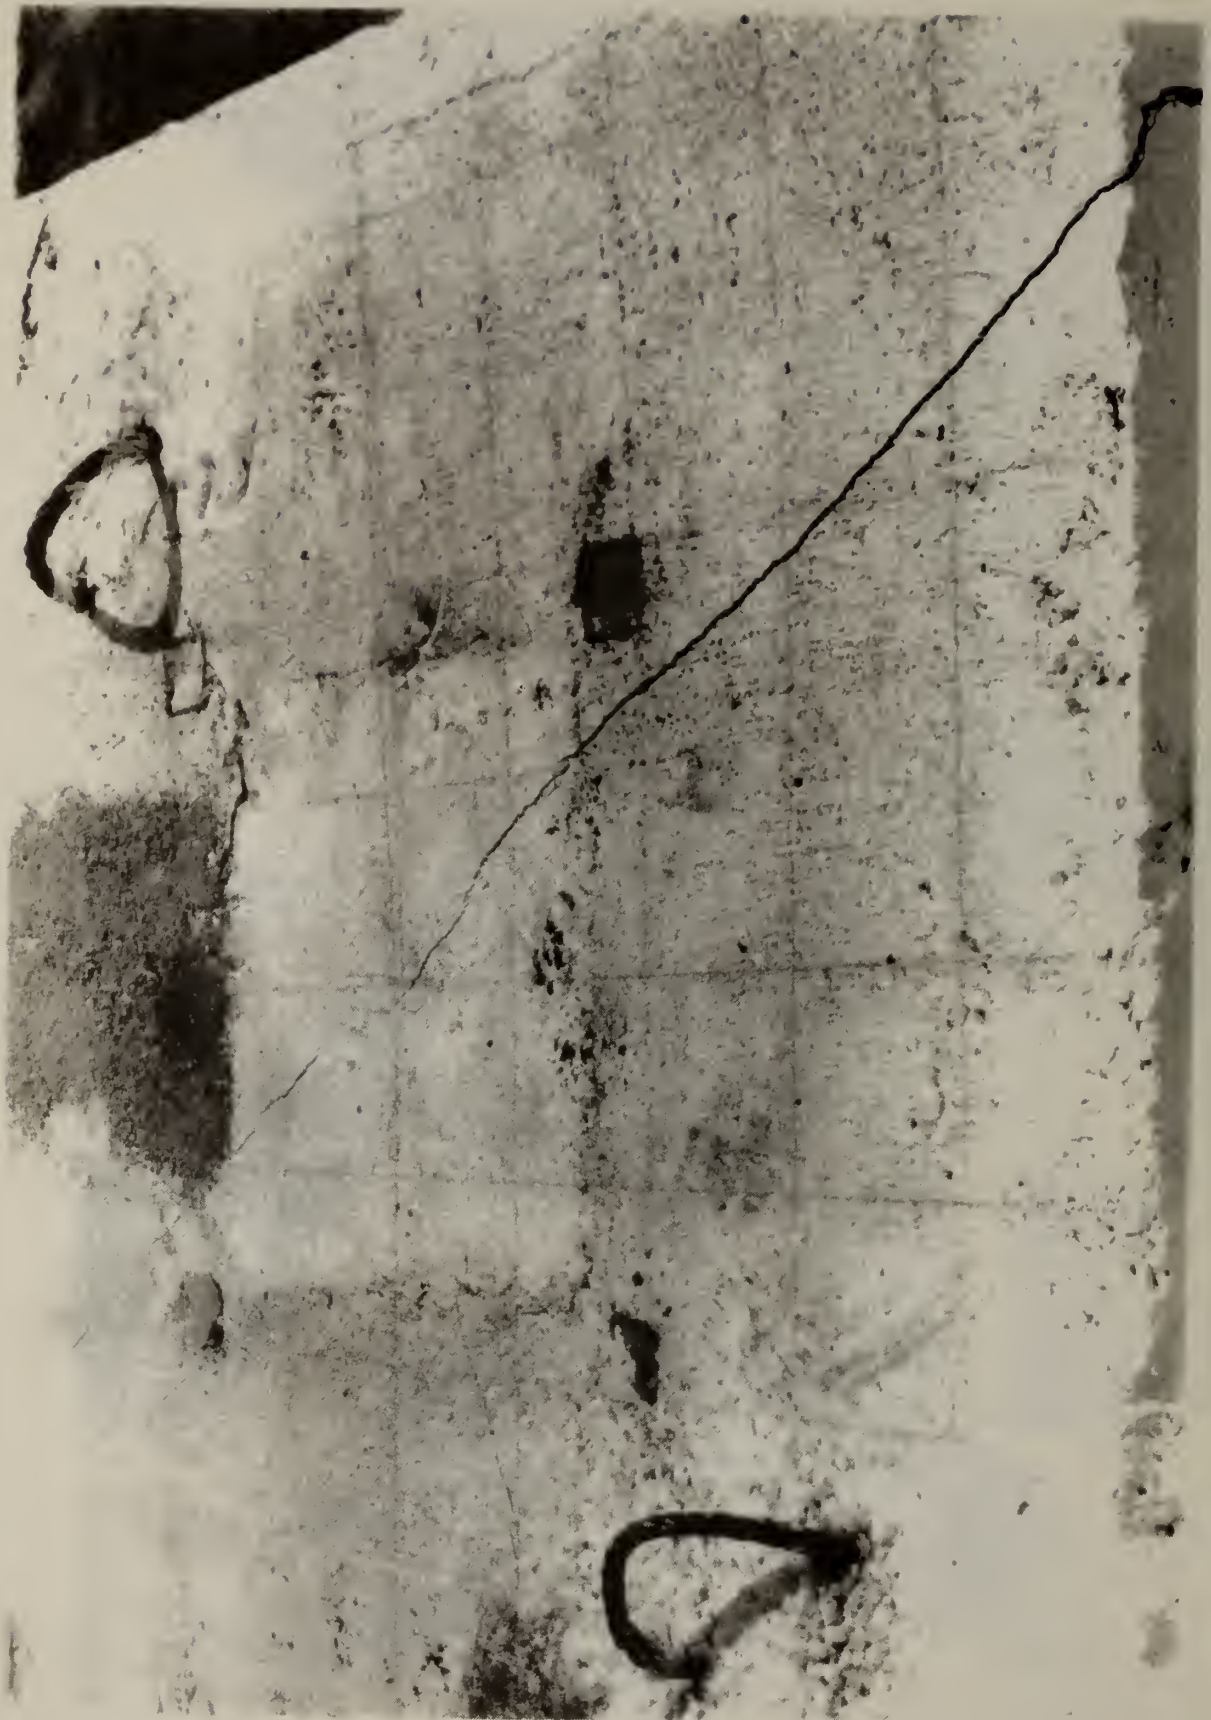
Figure 4.41 Pad crack pattern: diagonal

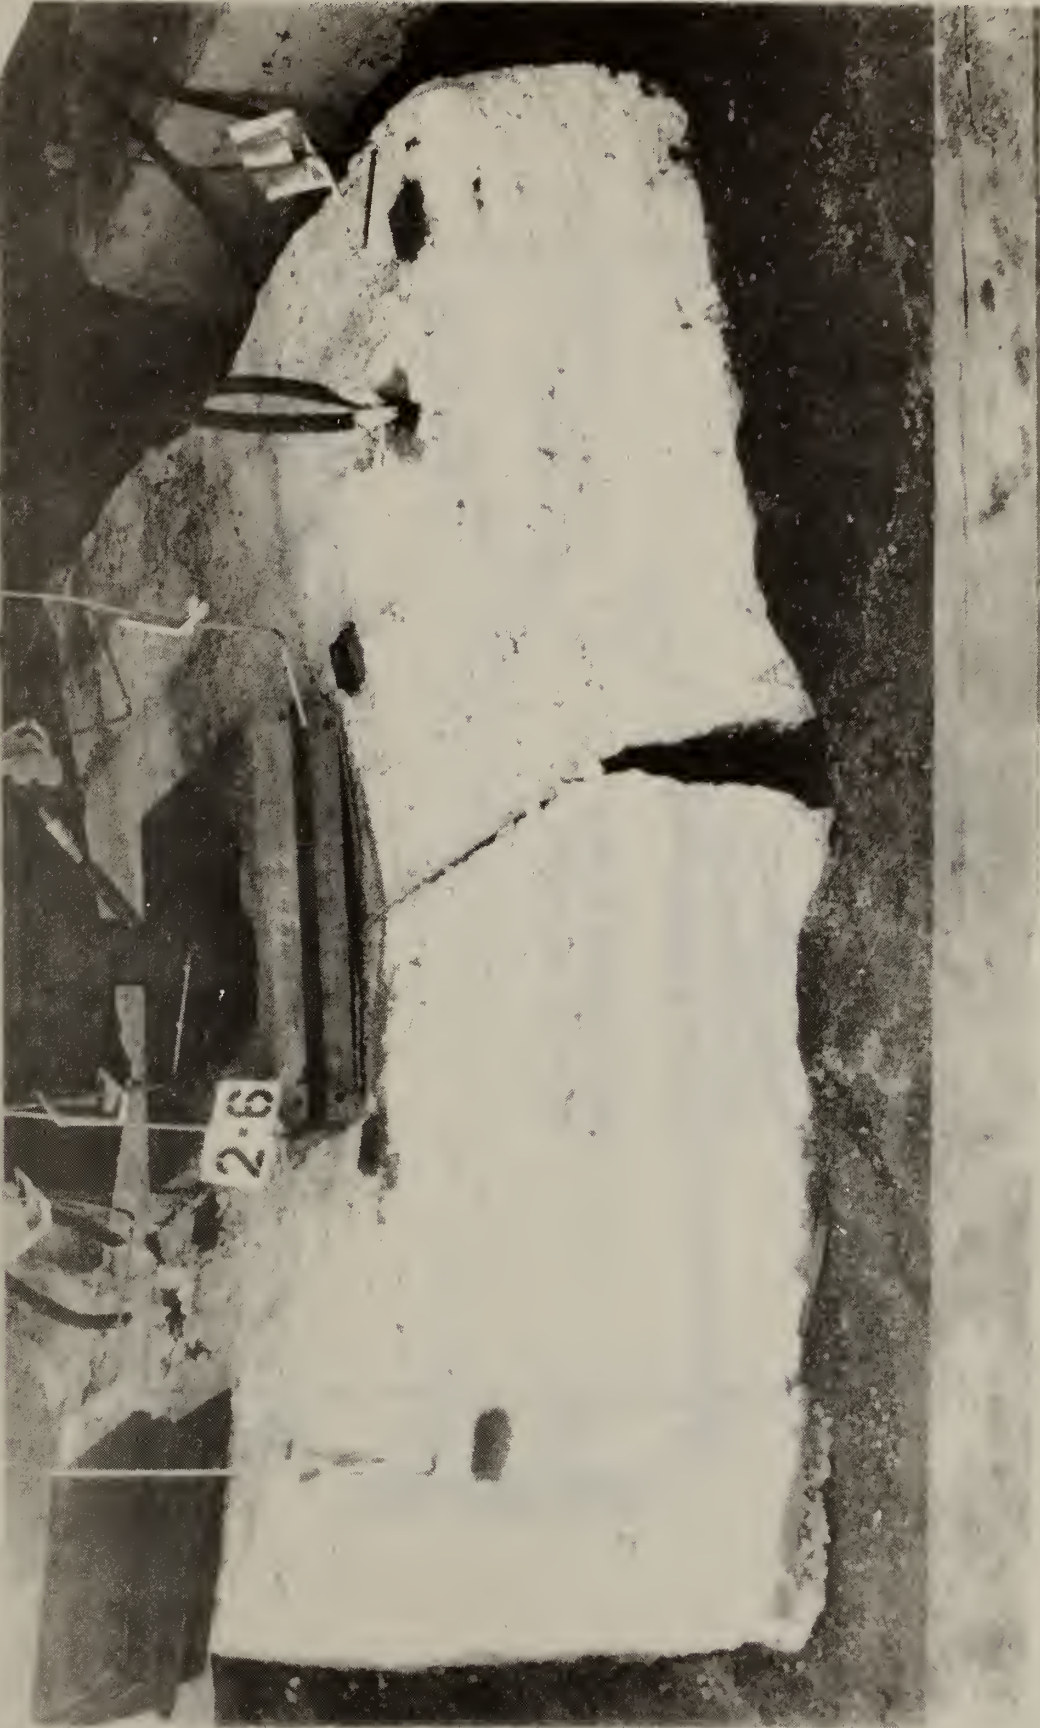
Figure 4.42 Pad crack pattern: transverse

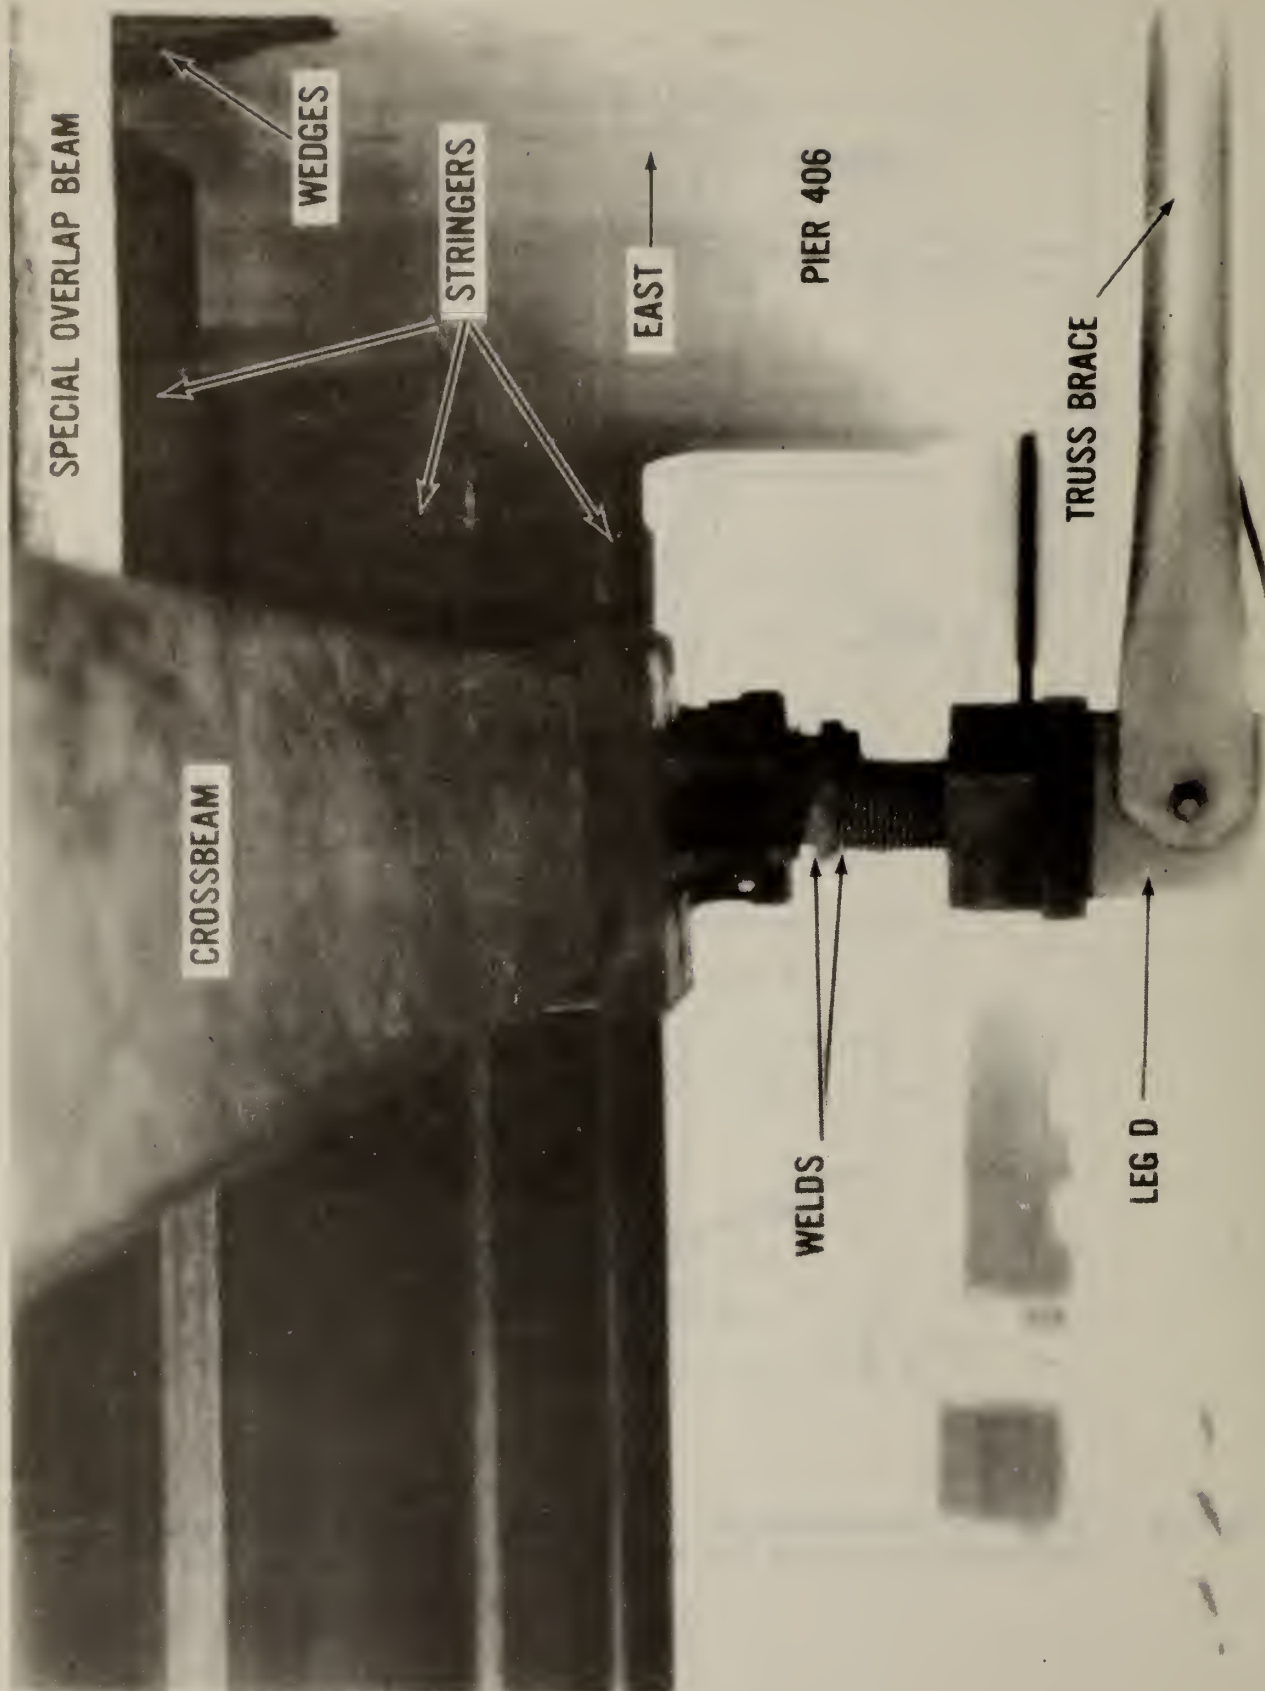
Figure 6.8 Bending of U-head on west side of pier 406
