ASBESTOS SURVEY OF THE FEDERAL BUILDING AND COURT HOUSE AT 450 GOLDEN GATE AVENUE, SAN FRANCISCO, CALIFORNIA

NBSIR 83-2650

James H. Pielert

February 1983

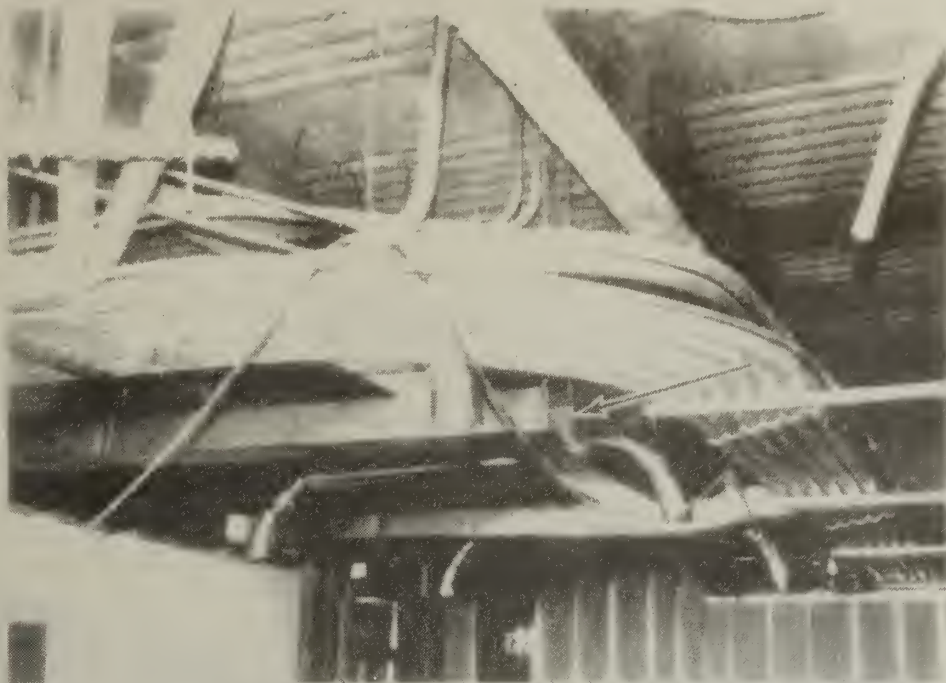
Figure 5 shows the air plenum area in Room 15219 with the suspended ceiling removed. Damage to fireproofing can be seen in figure 6 (addition of piping), figure 7 (addition of wall partitions), and figure 8 (addition of pipe hanger to beam flange).

Figure 5. Air plenum area in Room 15219 with the suspended ceiling removed. (Note arrow pointing to open air return duct which collects return air in the open plenum)

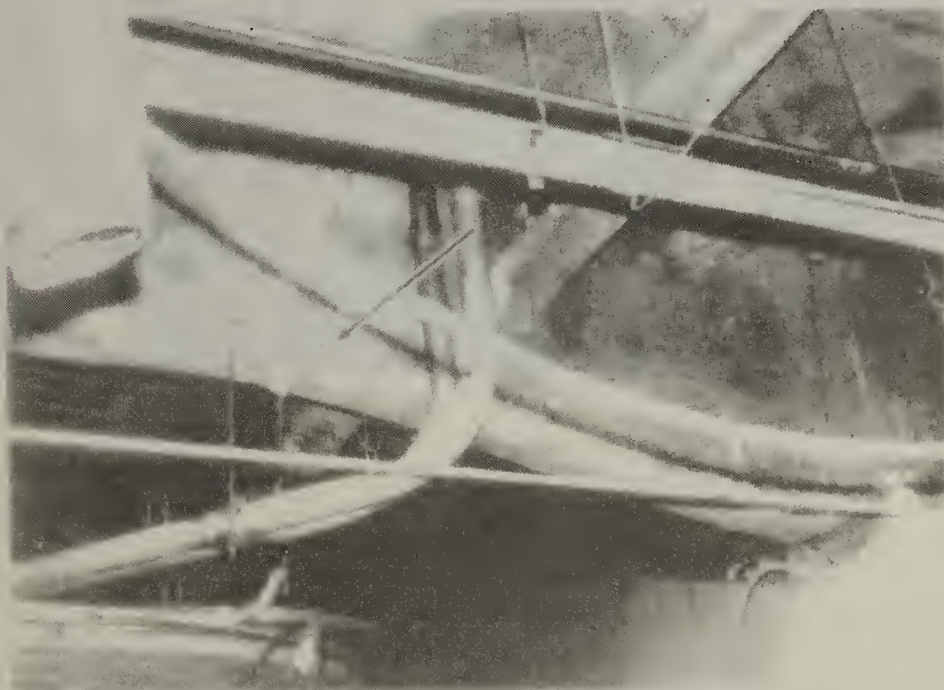
Figure 6. Damage to fireproofing due to renovation of plumbing system in Room 15219

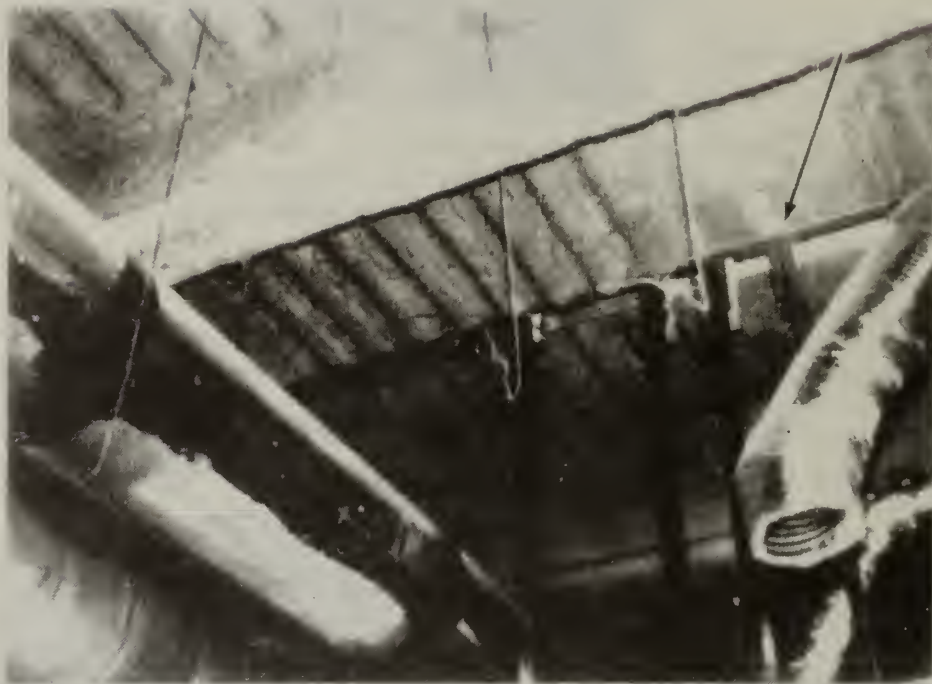
Figure 7. Damage to fireproofing due to addition of partition system in Room 15219

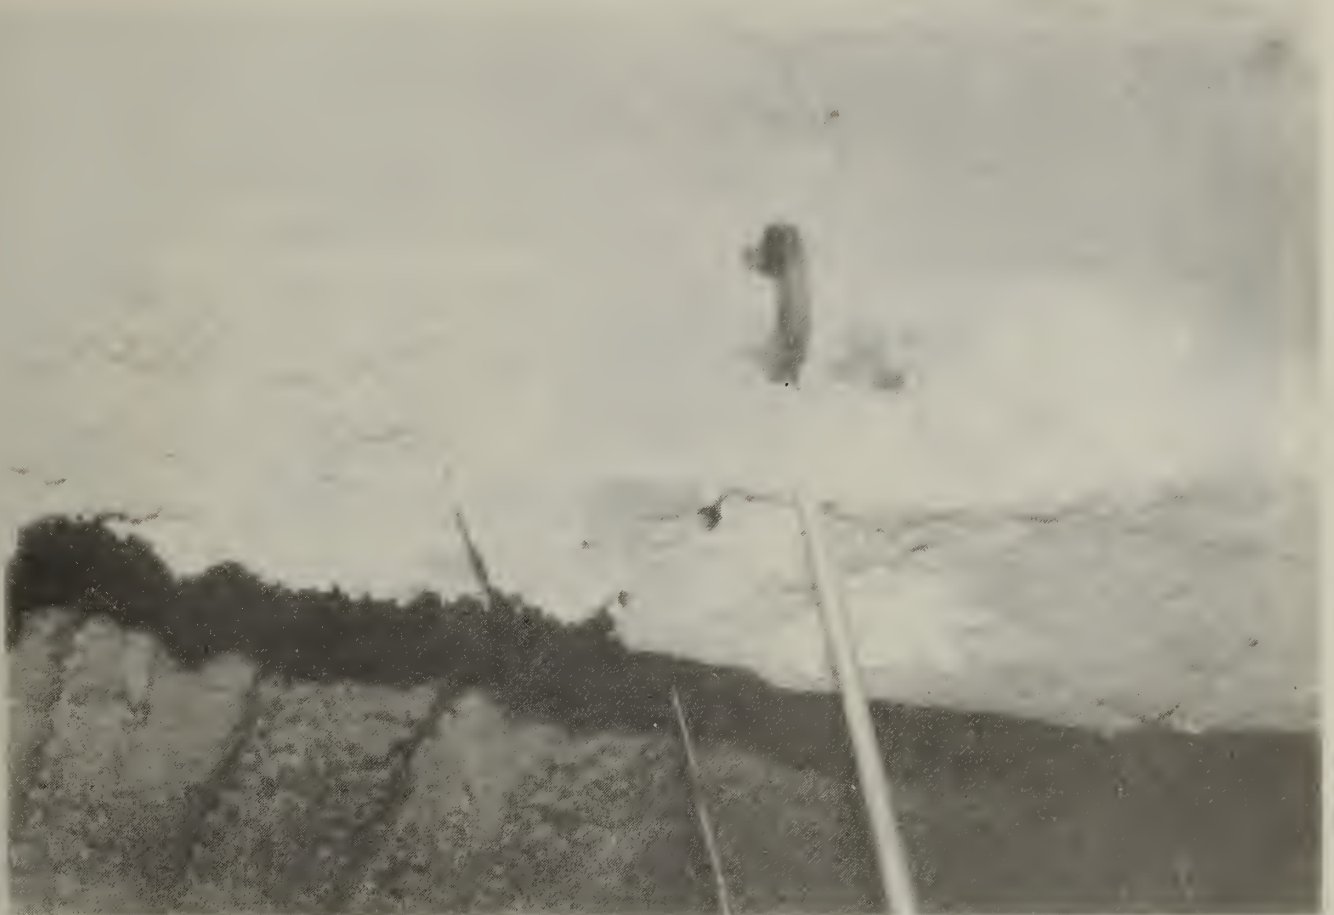
Figure 8. Damage to fireproofing due to addition of pipe hanger to beam flange adjacent to Room 15219

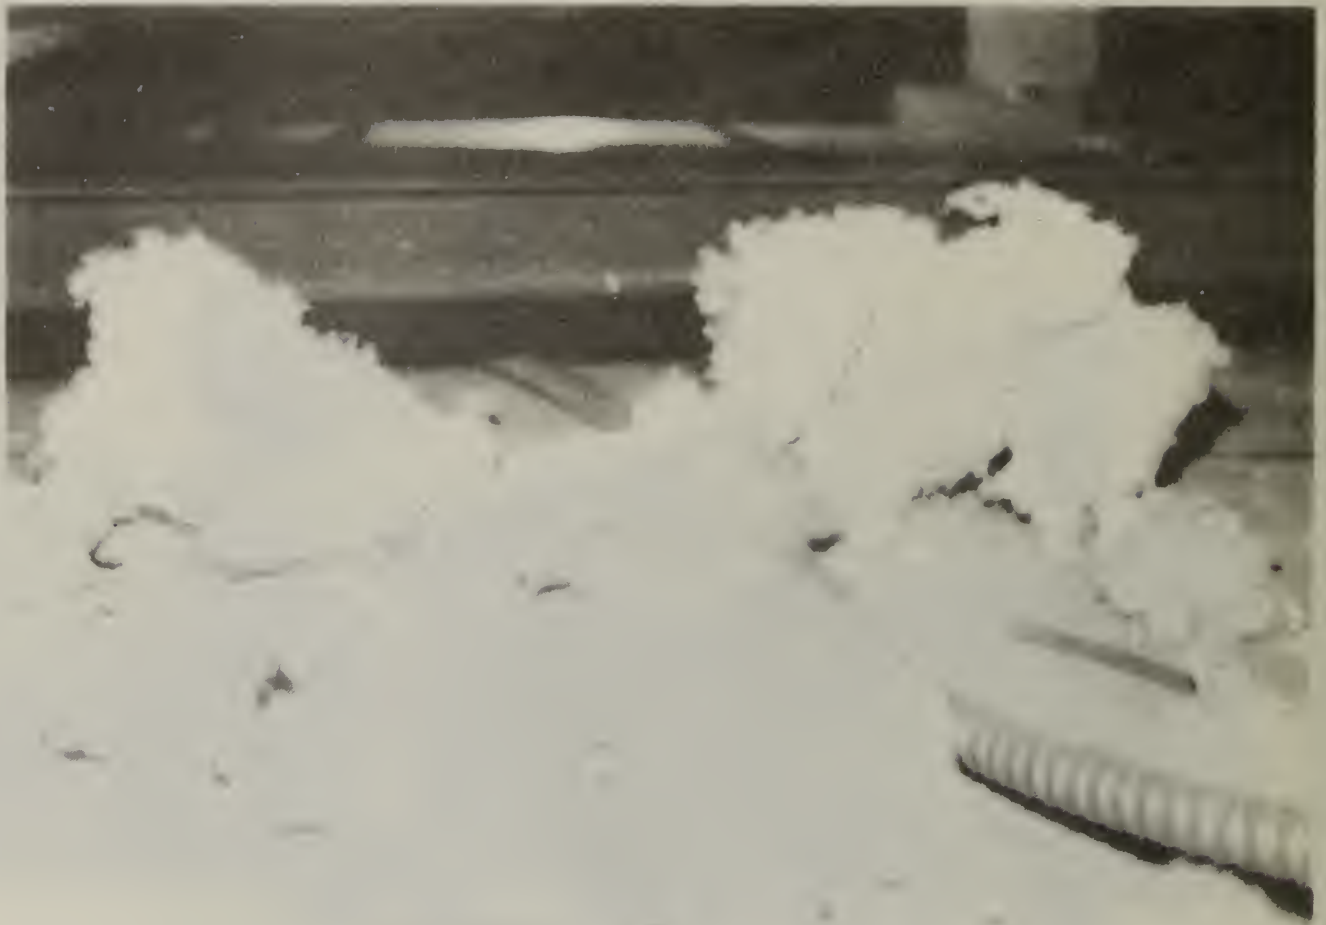
Ceiling tiles were lifted in several areas of the building and the condition of the fireproofing noted. Figure 9 shows dislodged fireproofing remaining on suspended ceiling tiles after installation of fire sprinkler system adjacent to the Drug Enforcement Administration (Rooms 8440 and 8450).

Figure 9. Pieces of fireproofing remaining on suspended ceiling after installation of fire sprinkler system (Rooms 8440 and 8450)

- B. There is evidence of damaged fireproofing, including dislodged material lying on tiles in the ceiling air return plenum (see figure 9).
- C. Air samples collected and analyzed according to OSHA regulations (29 CFR 1910.1001) showed the presence of fibers below the current levels of 2.0 f/cc for airborne concentrations of asbestos fibers (see section 4.2.5). However, the phase contrast microscopy method used to count fibers:

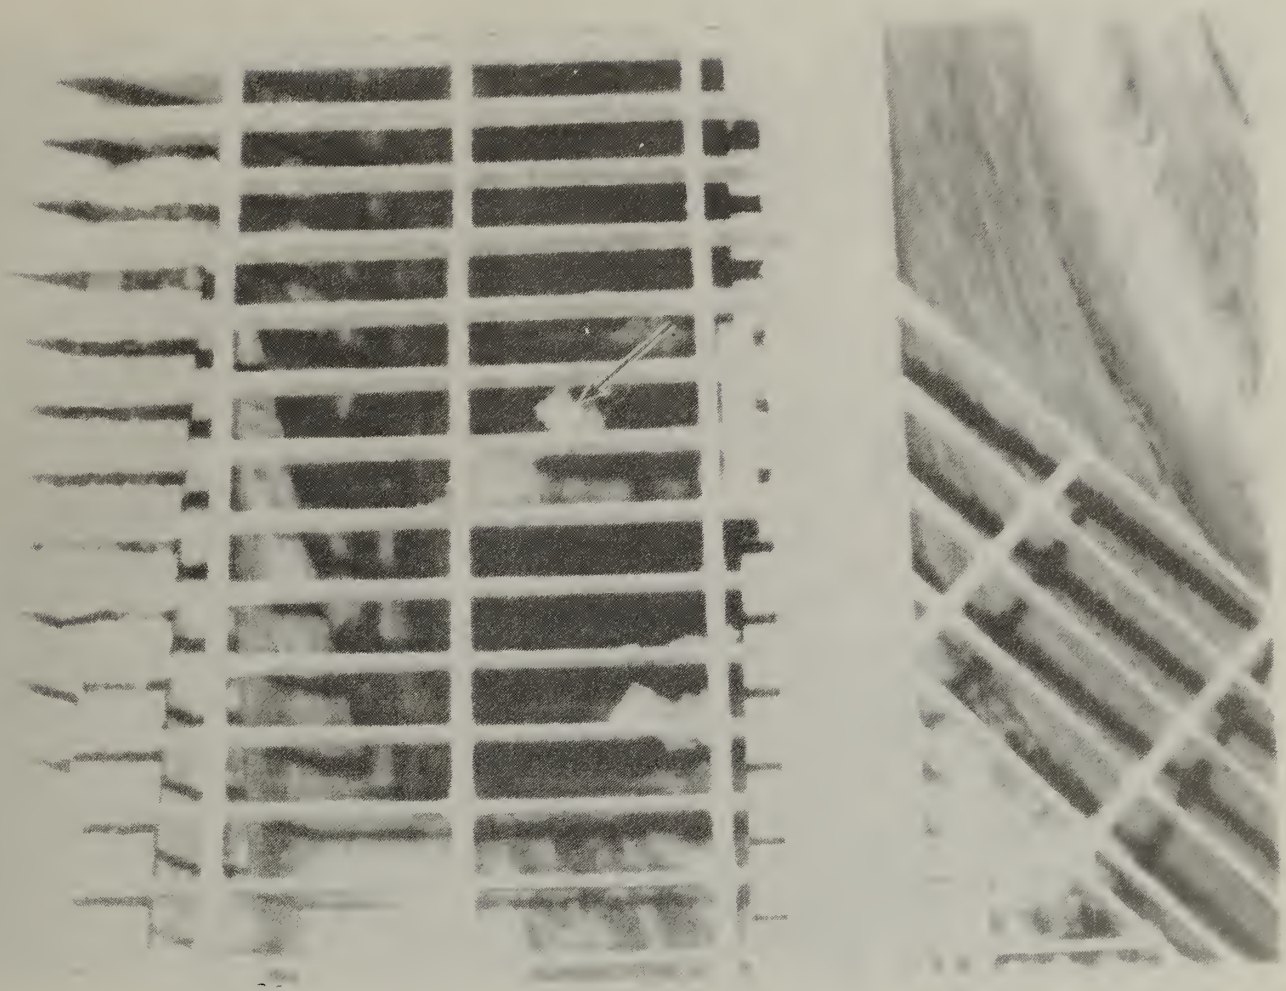
Figure 10. Fireproofing particles lying on the catwalk in the east end high velocity return air shaft (Room 13114 accessway)

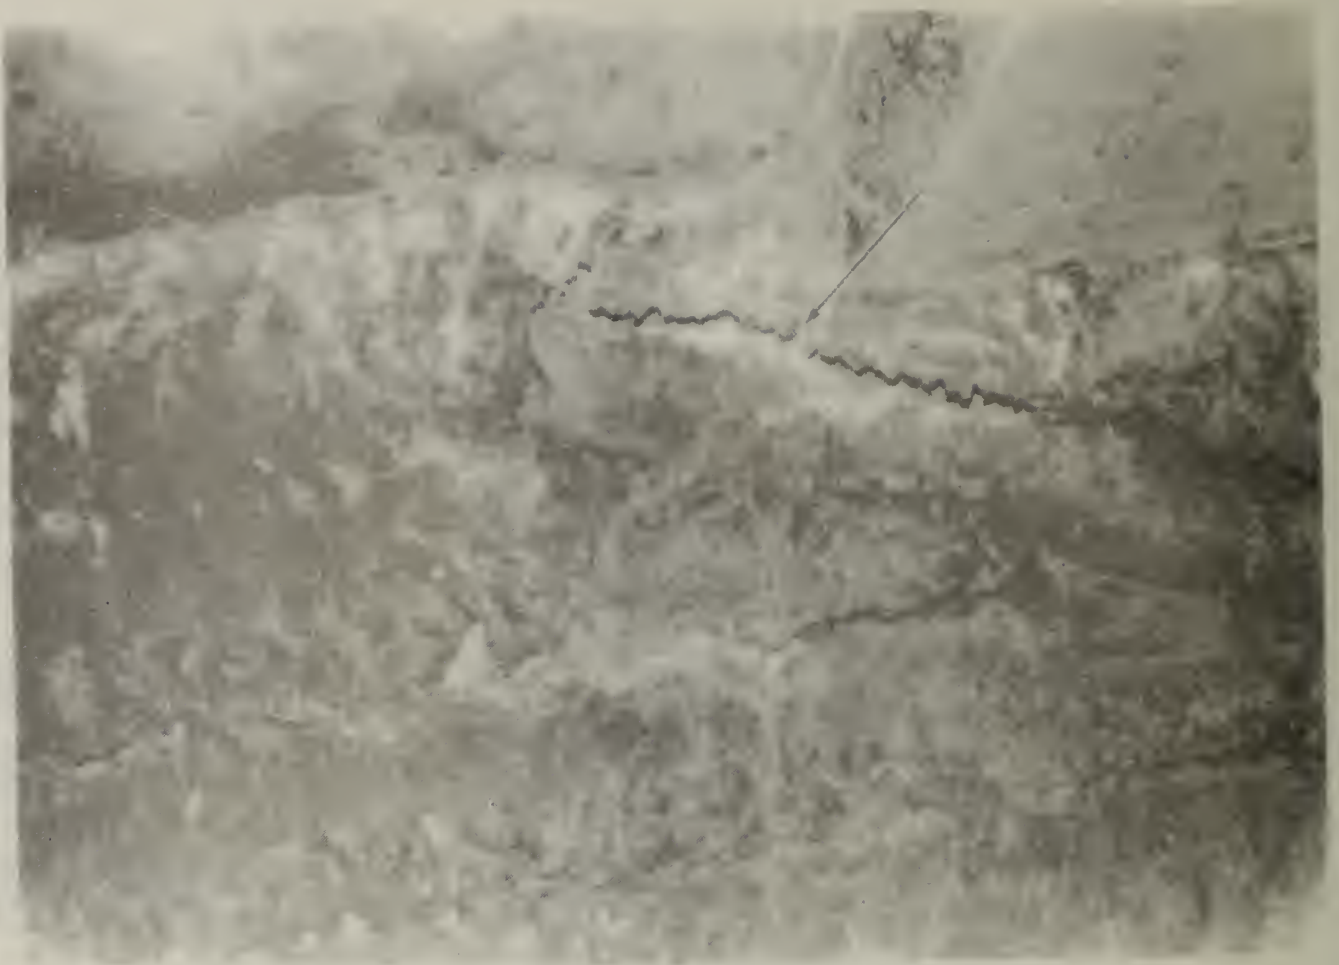
Figure 11. Naturally deteriorating fireproofing on structural members
in main kitchen storage Room 2212

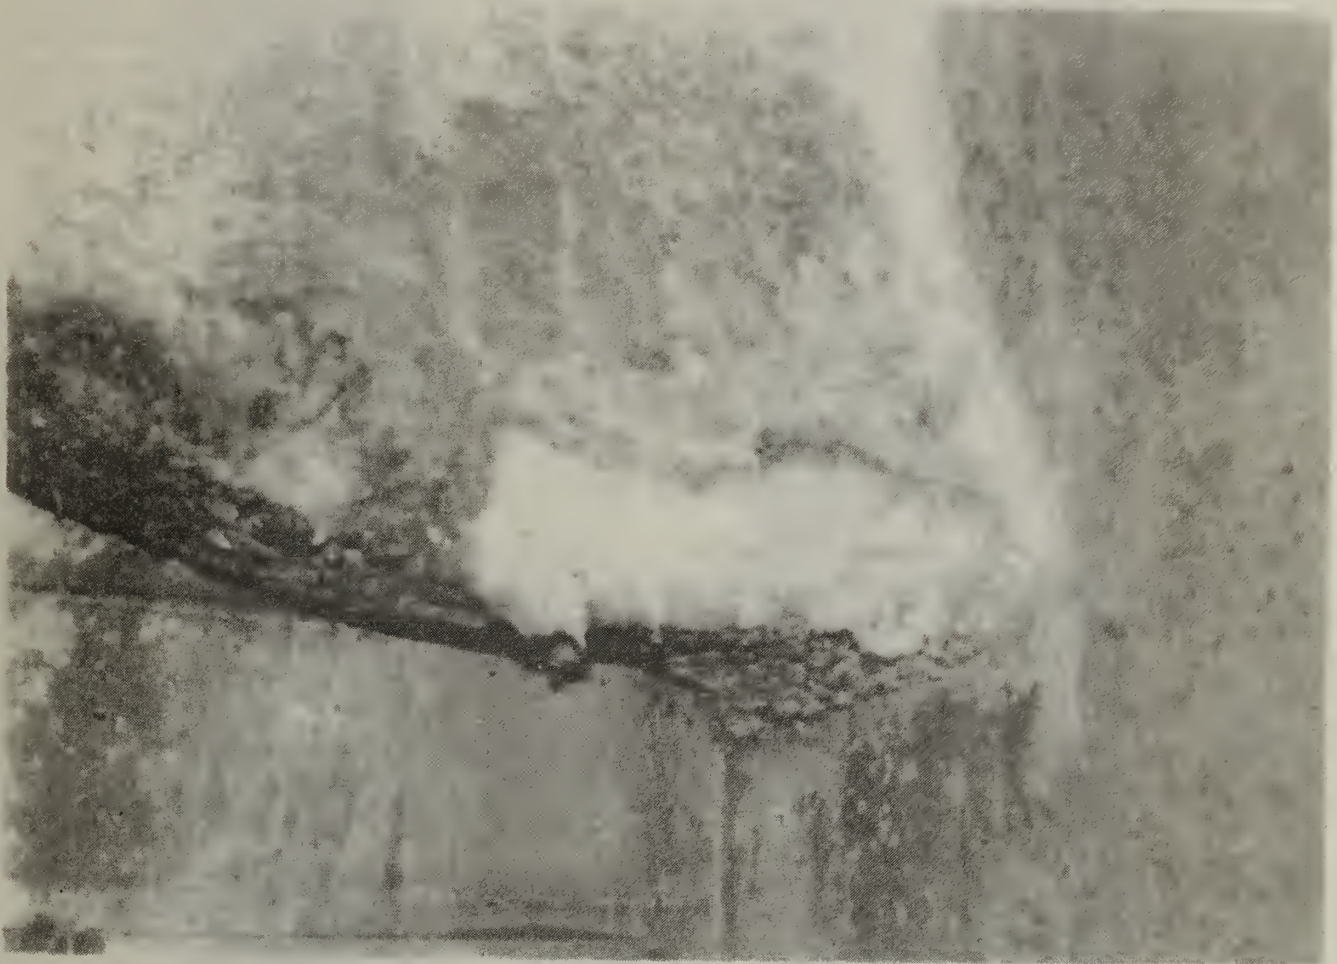
Figure 12. Physical damage to fireproofing on beam in Main Kitchen Storage Room 2212

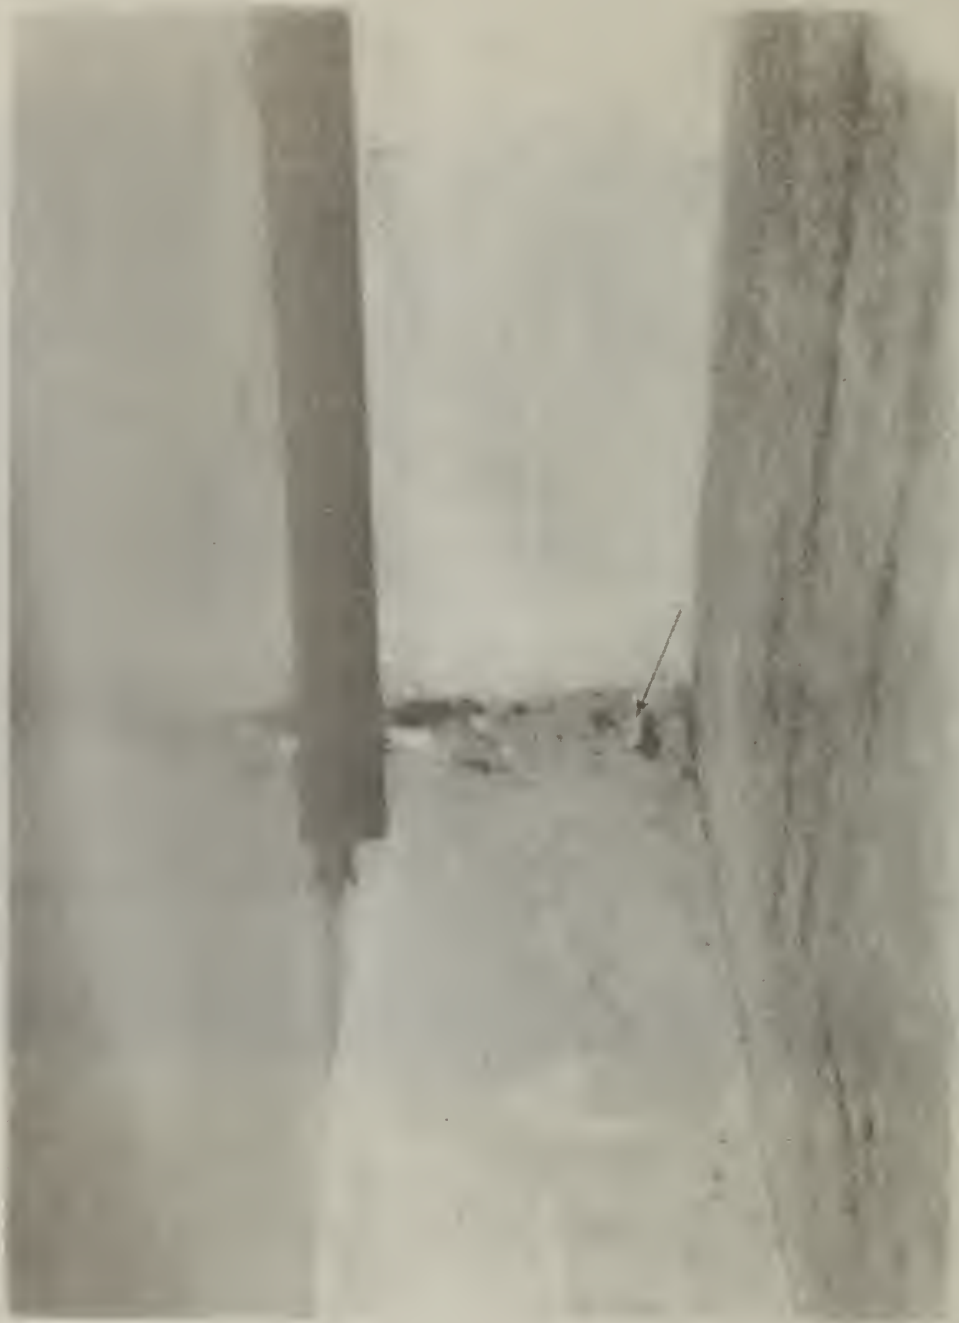
Figure 13. Pieces of fireproofing on floor of Main Kitchen Storage Room 2212

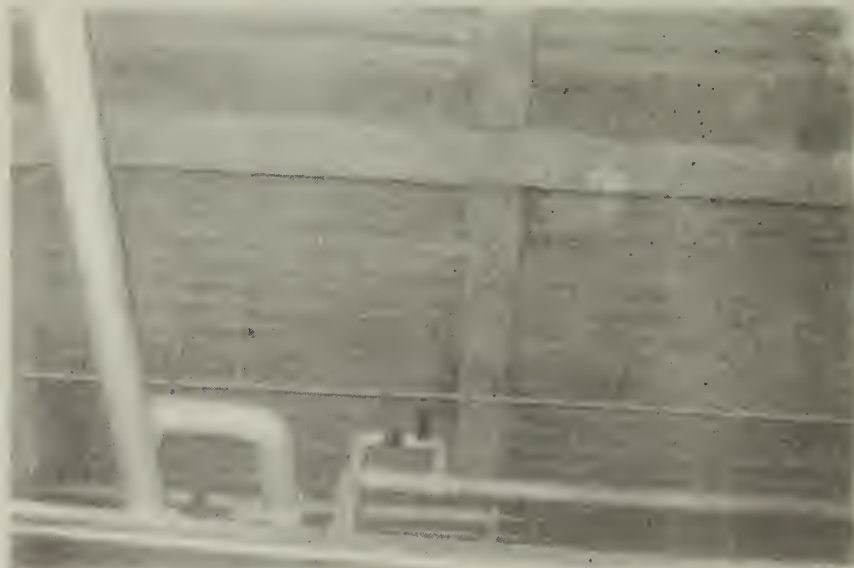
Figure A.2. Room 20407C - Ceiling of outside air supply plenum fan room with no apparent damage to fireproofing.

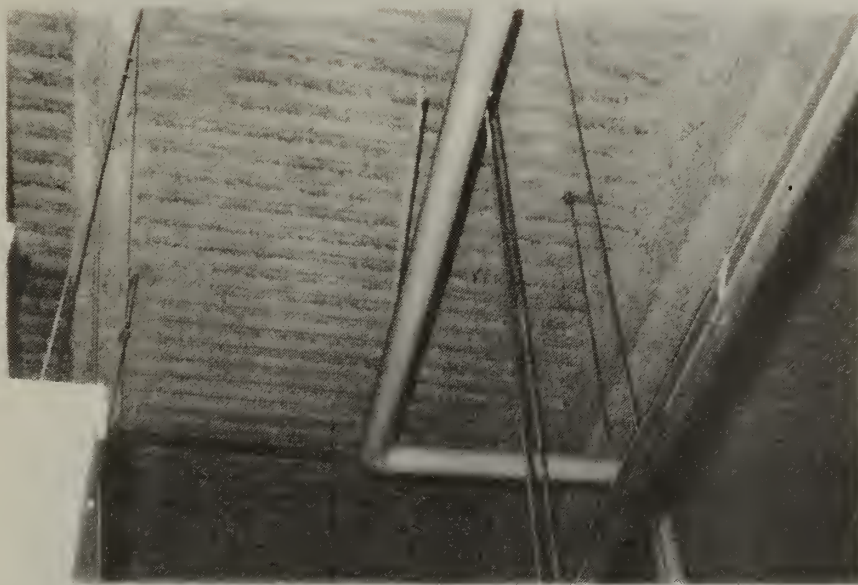
Figure A.3. Ceiling of equipment room of penthouse with no apparent damage to fireproofing (note original attachment of hangers to steel deck).

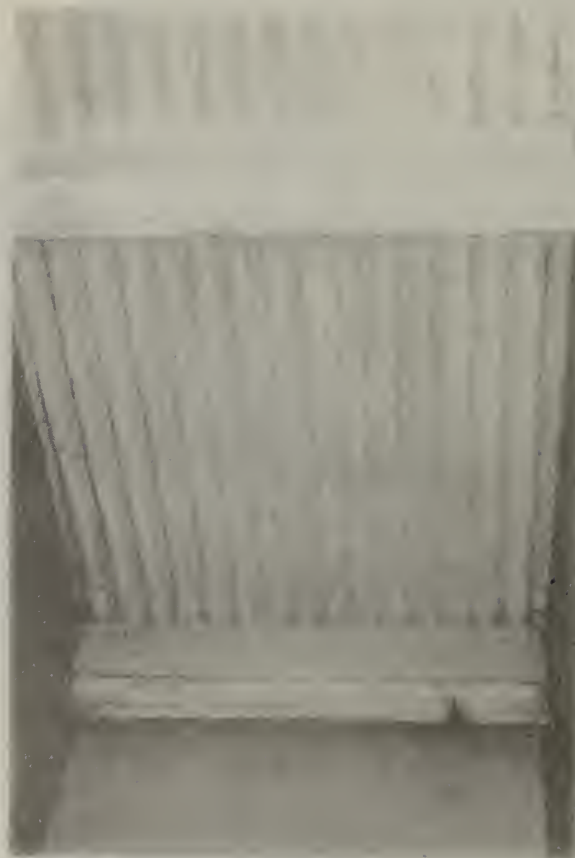
Figure A.4. Stairwell ceiling adjacent to penthouse with no apparent damage to fireproofing

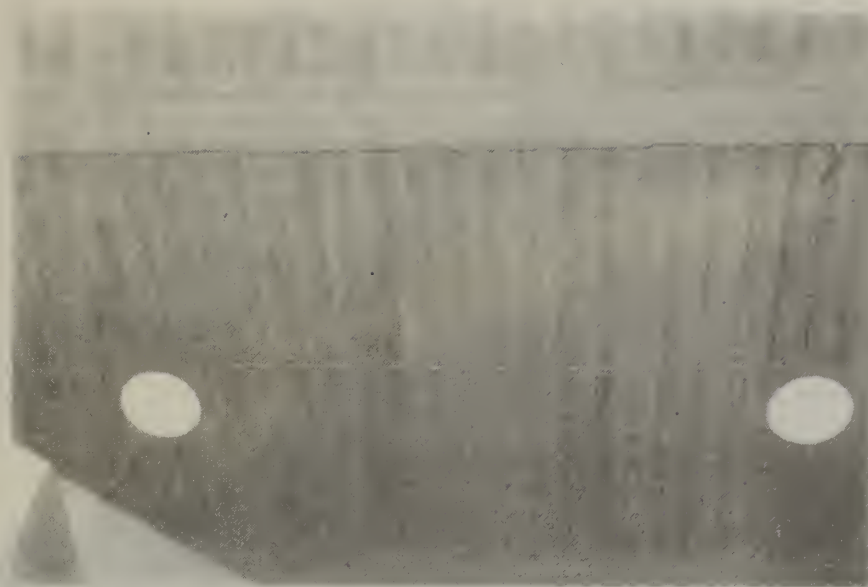
Figure A.5. Ceiling of window cleaning equipment room with no apparent damage to fireproofing

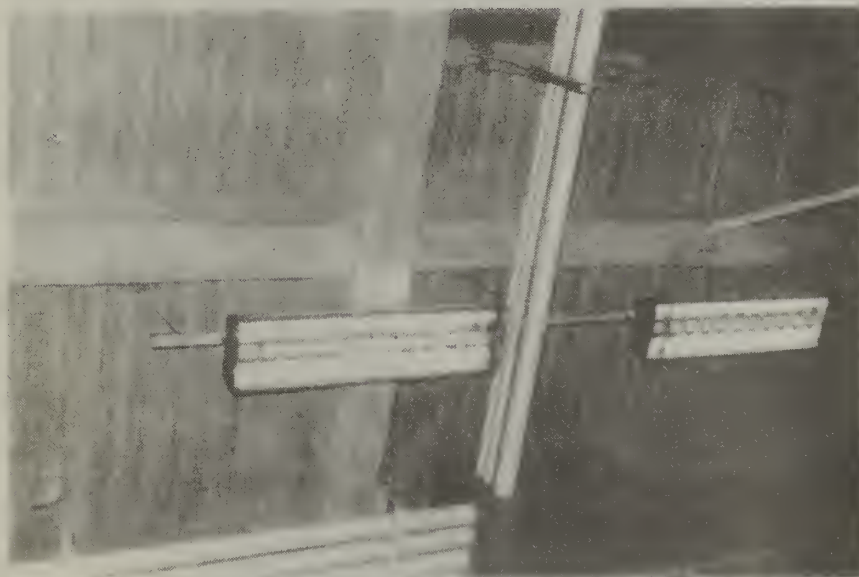
Figure A.6. Room 20408 - ceiling of electrical substation with no apparent damage to fireproofing

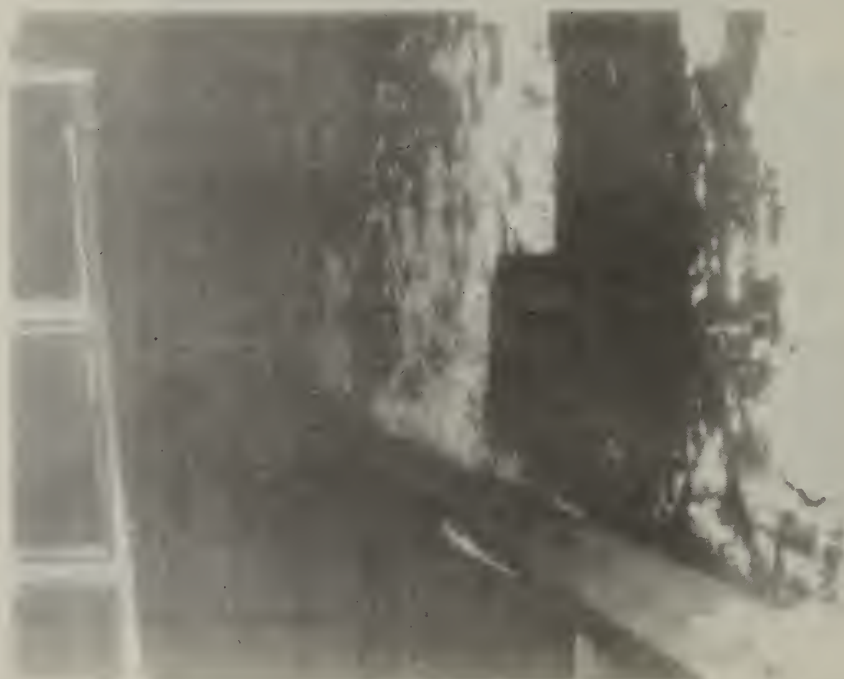
Figure A.8. Zone 3 elevator hoist room adjacent to roof - fireproofing removed from beam

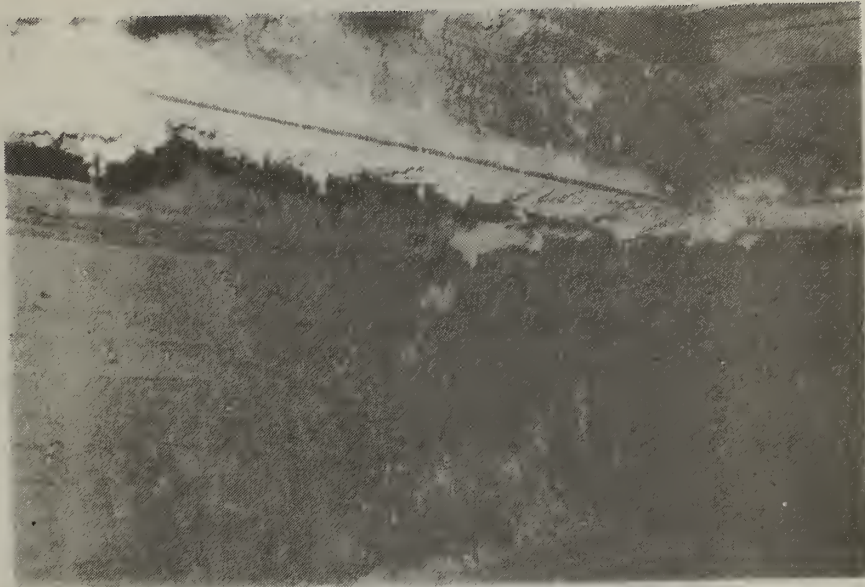
Figure A.9. Zone 3 elevator hoist room adjacent to roof - physical damage to fireproofing caused by roofing contractor

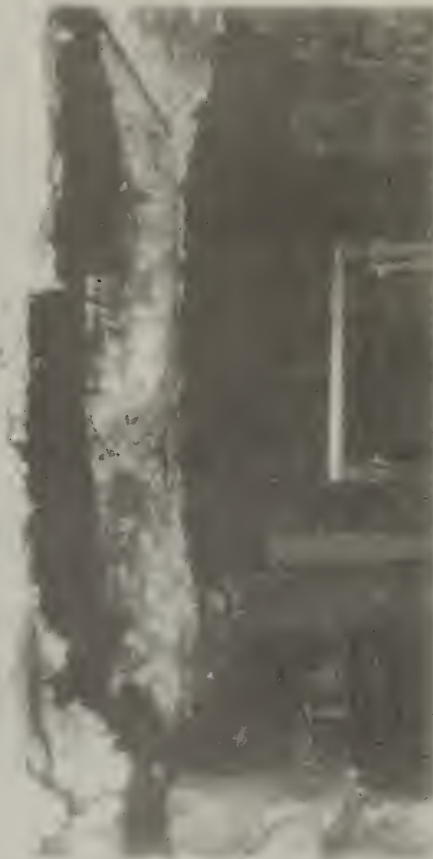
Figure A.10. Zone 3 elevator hoist room adjacent to roof - physical damage to fireproofing caused by roofing contractor.

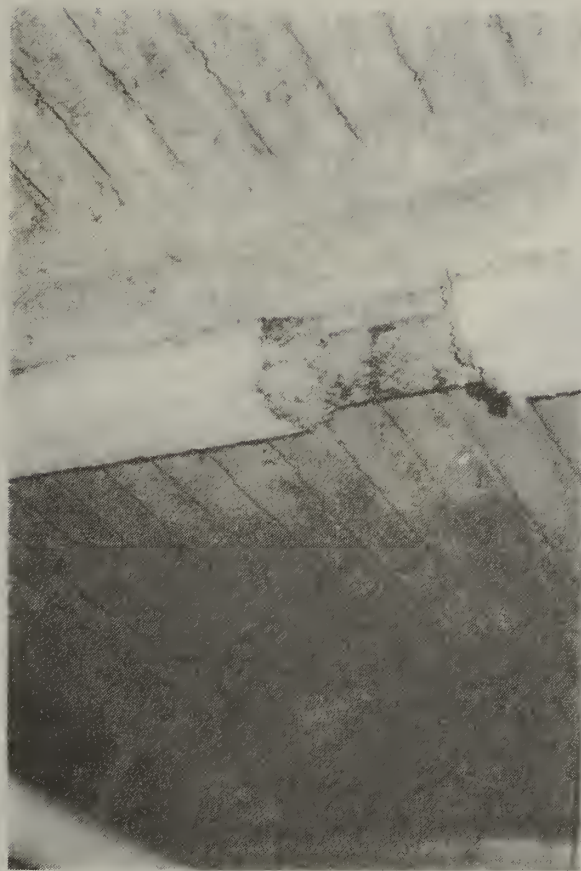
Figure A.11. Room 20408 - ceiling of electrical substation with portions of fireproofing removed from beam flange

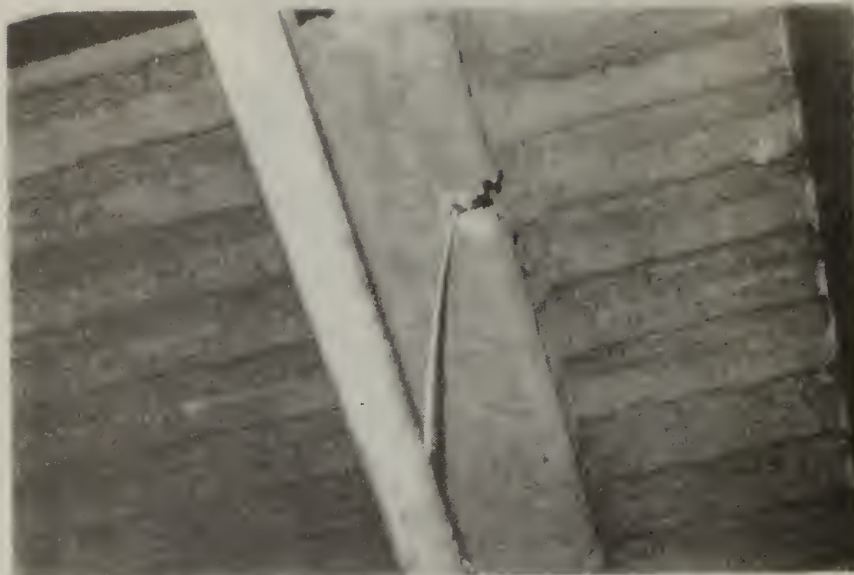
Figure A.12. Room 11006 - ceiling of electrical closet with physical damage to fireproofing caused by installation of hanger

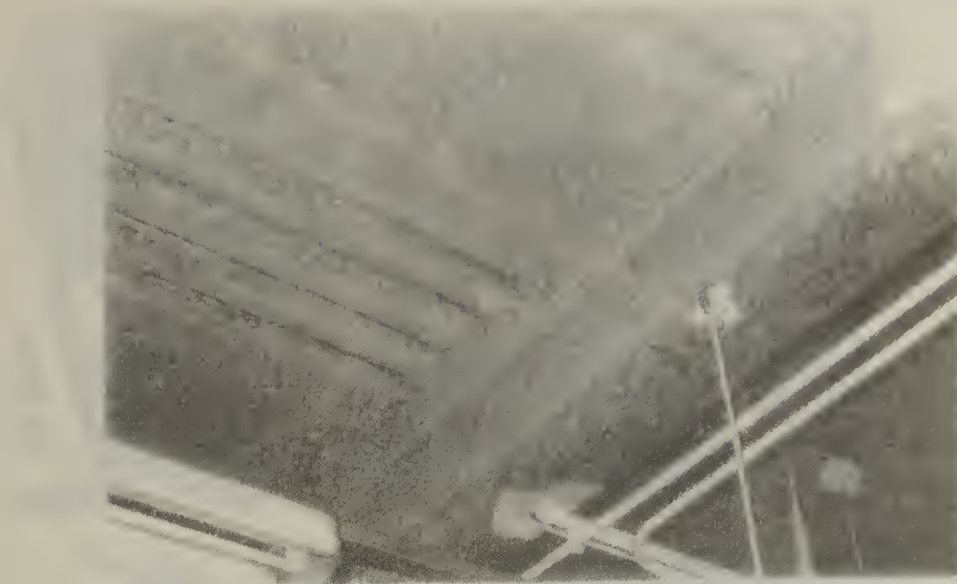
Figure A.13. Room 12207 - ceiling of zone 1 elevator machine room showing patching of fireproofing damaged during installation of hangers for ductwork

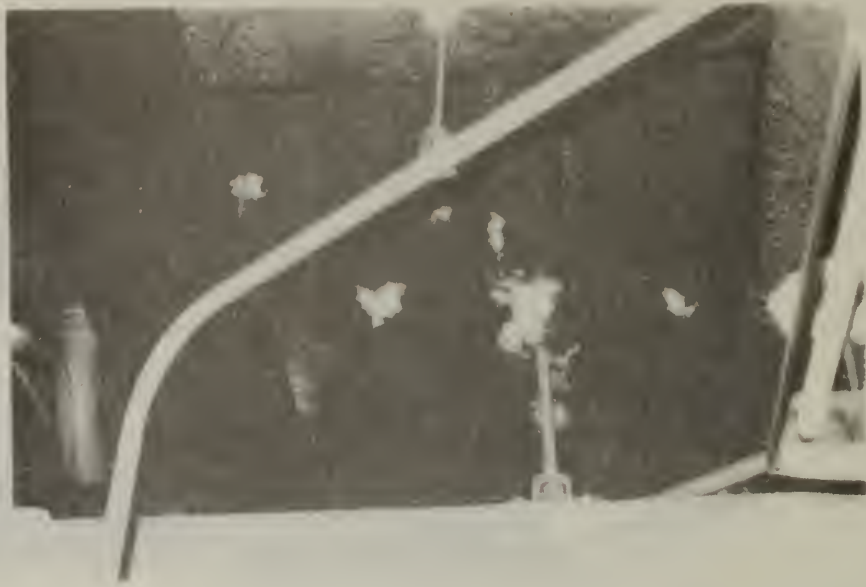
Figure A.15. Room 18204 - ceiling of zone 2 elevator control room showing patching of fireproofing during electrical and plumbing modifications

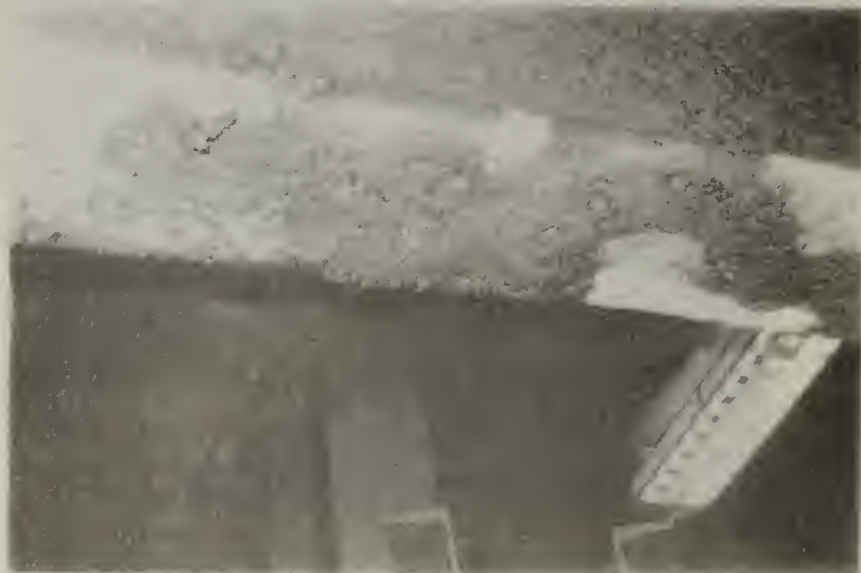
Figure A.16. Room 18204 - beam in zone 2 elevator control room showing patching of fireproofing

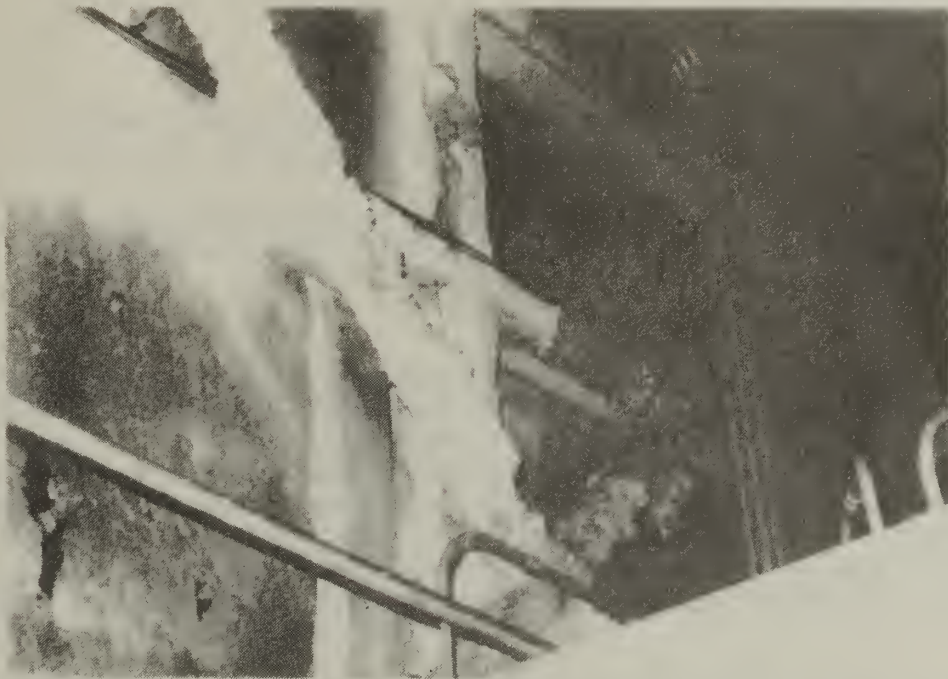
Figure A.17. Upper elevator for machine room - damaged fireproofing on structural bracing members
