EXAMINATION OF A PRESSURE VESSEL THAT RUPTURED AT THE CHICAGO REFINERY OF THE UNION OIL COMPANY ON JULY 23, 1984

National Bureau of Standards
U.S. Department of Commerce
Boulder, Colorado 80303

March 1986

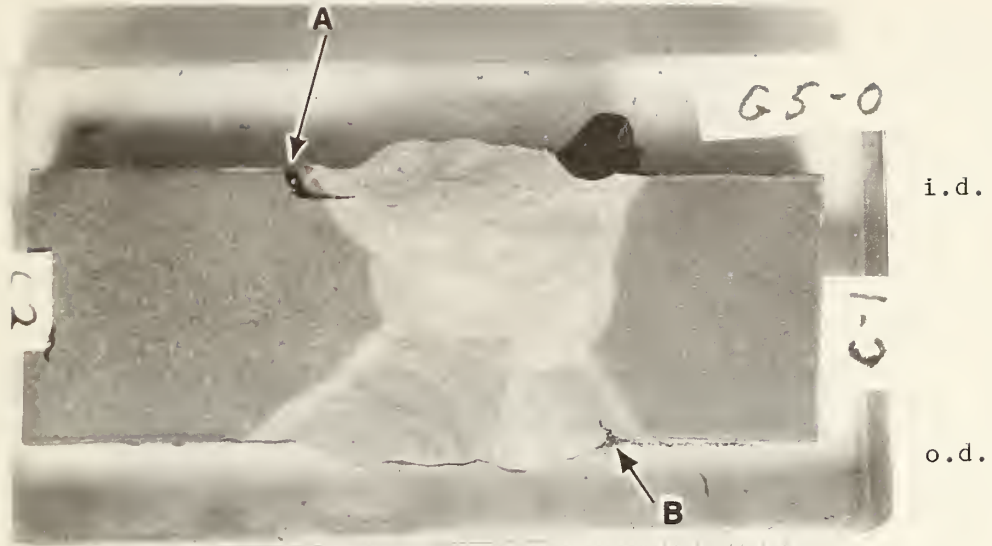
Figure 11. Macrostructure of Weld 1/2 at CC 1.5 m.
Etchant: 2% nital

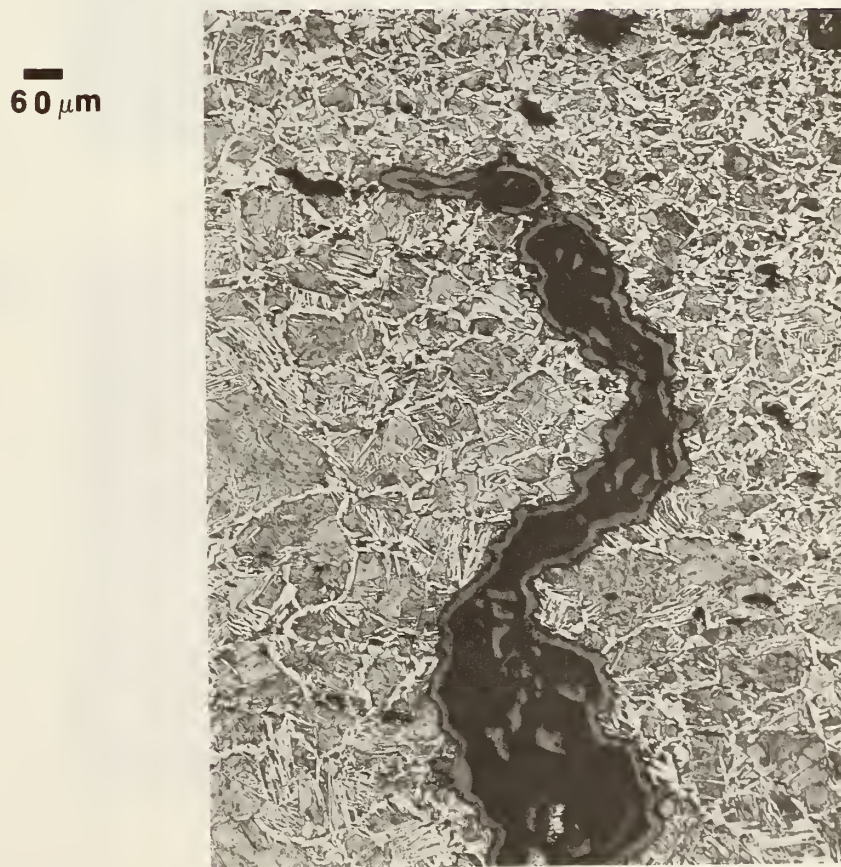
Figure 12. Microstructure near crack B in HAZ 1 shown in Figure 11.
Etchant: 2% nital

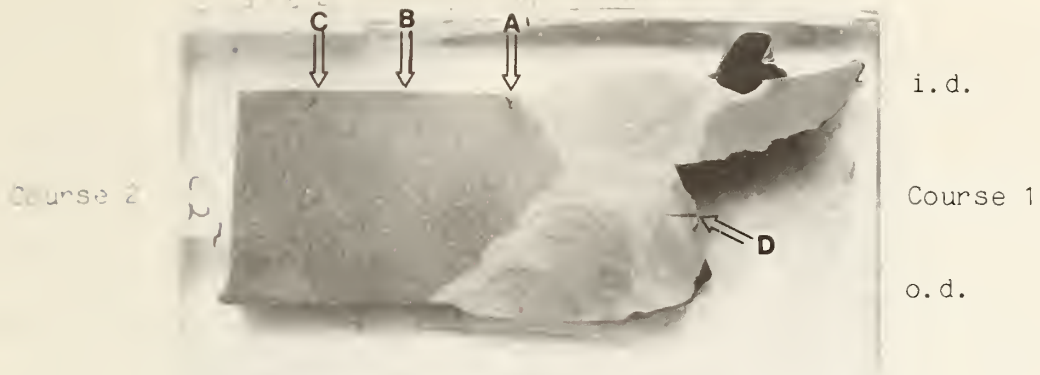
a. Macrostructure of Weld 1/2 at CC 1.0 position

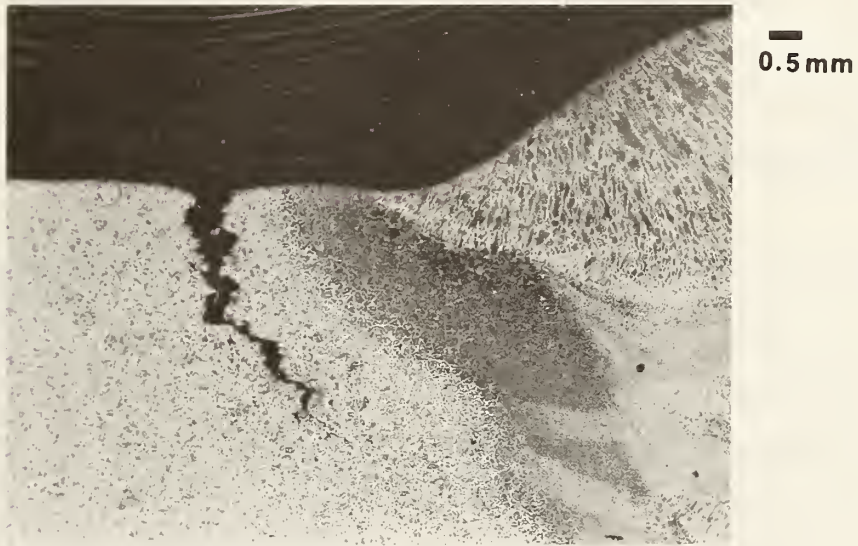
b. Crack at location A in Figure 17a

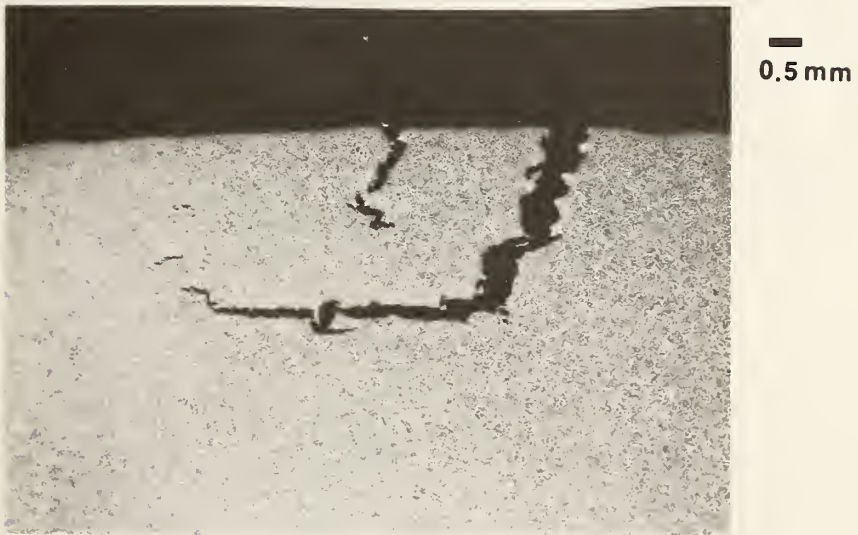
c. Cracks at location C in Figure 17a

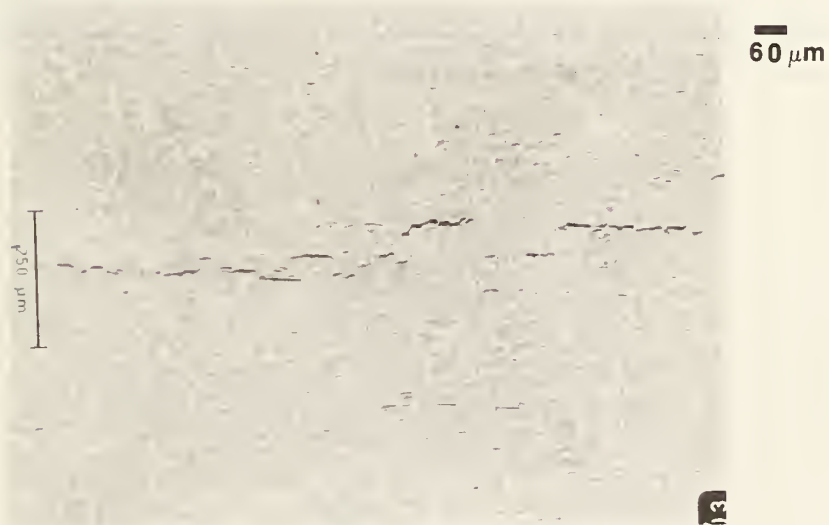
b. Cracks in Course 2 of Specimen I2 of Weld 2/3

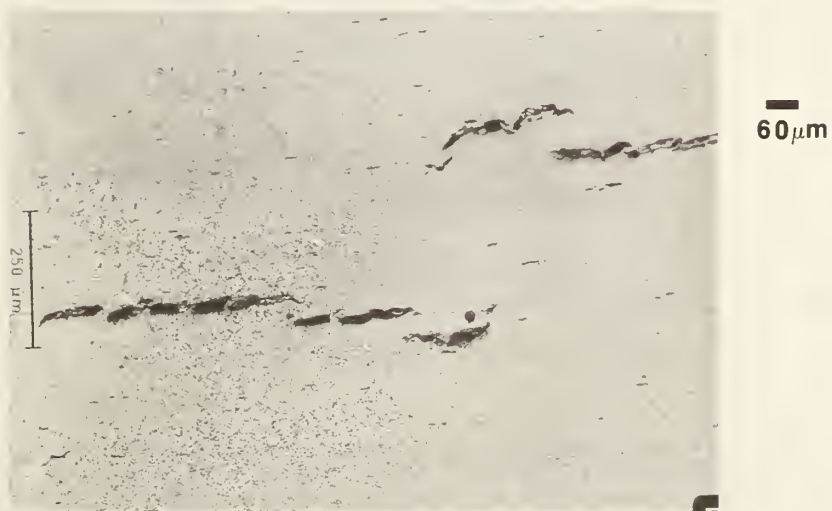
c. Cracks in HAZ 3 of Specimen I2 of Weld 2/3

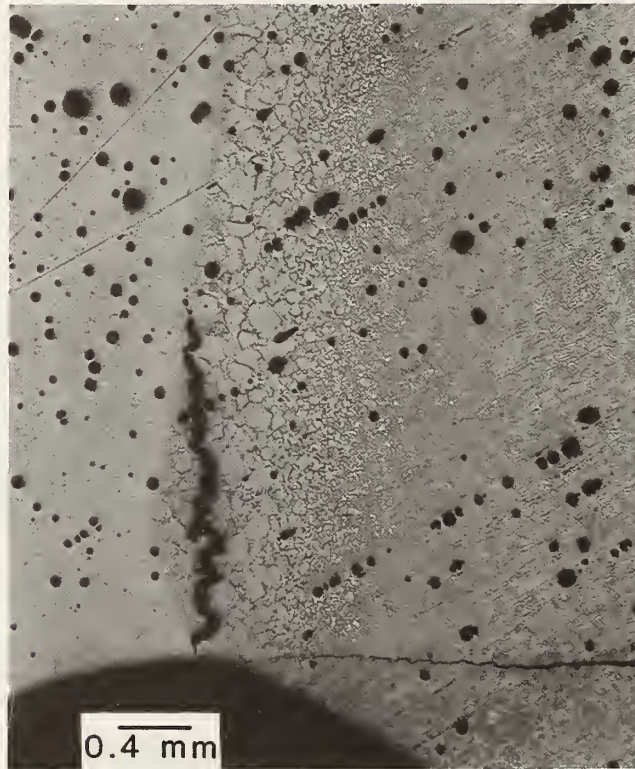
b. Root cracking in y-groove test in HAZ 1

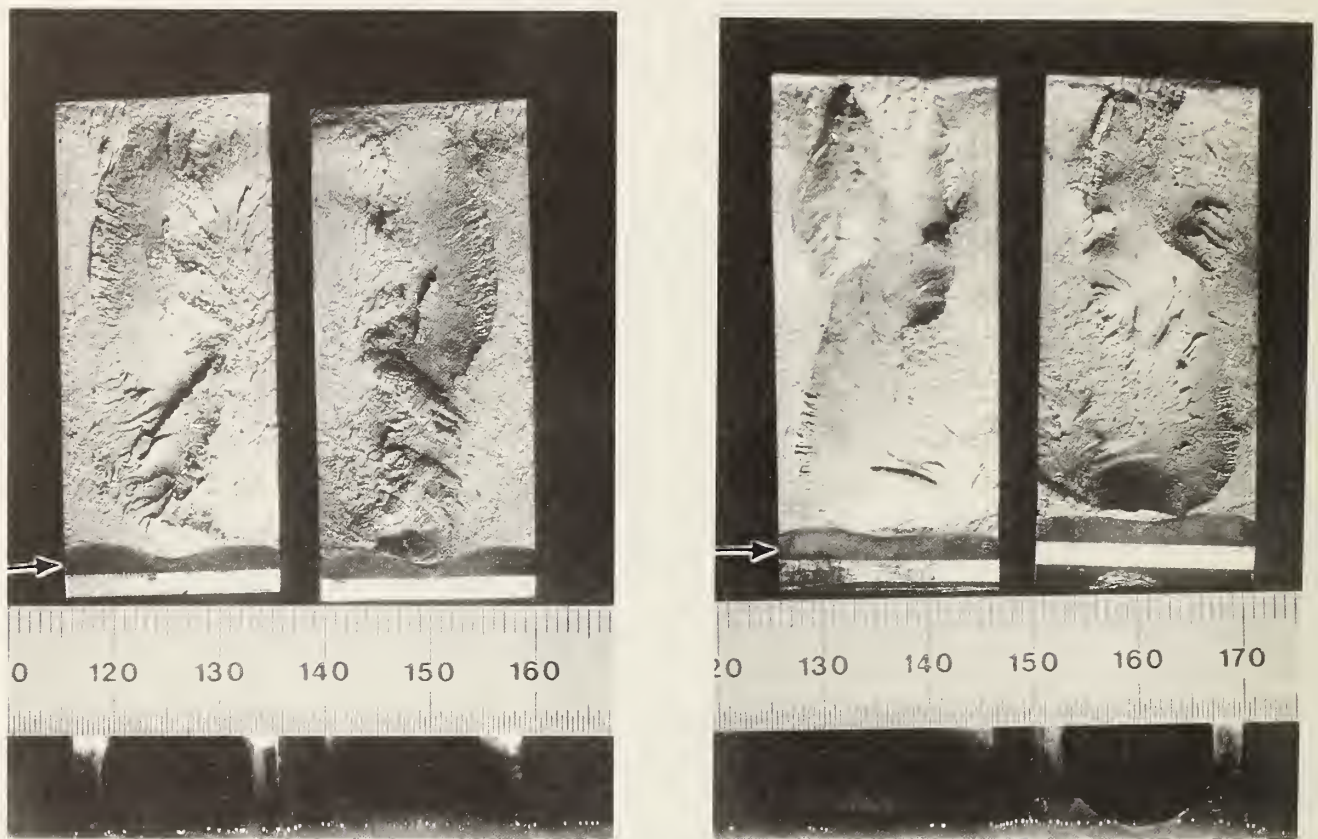
Figure 27. Fracture surfaces of specimens after completion of fracture mechanics tests of stress corrosion cracking susceptibility. Arrows point to fatigue precracks.

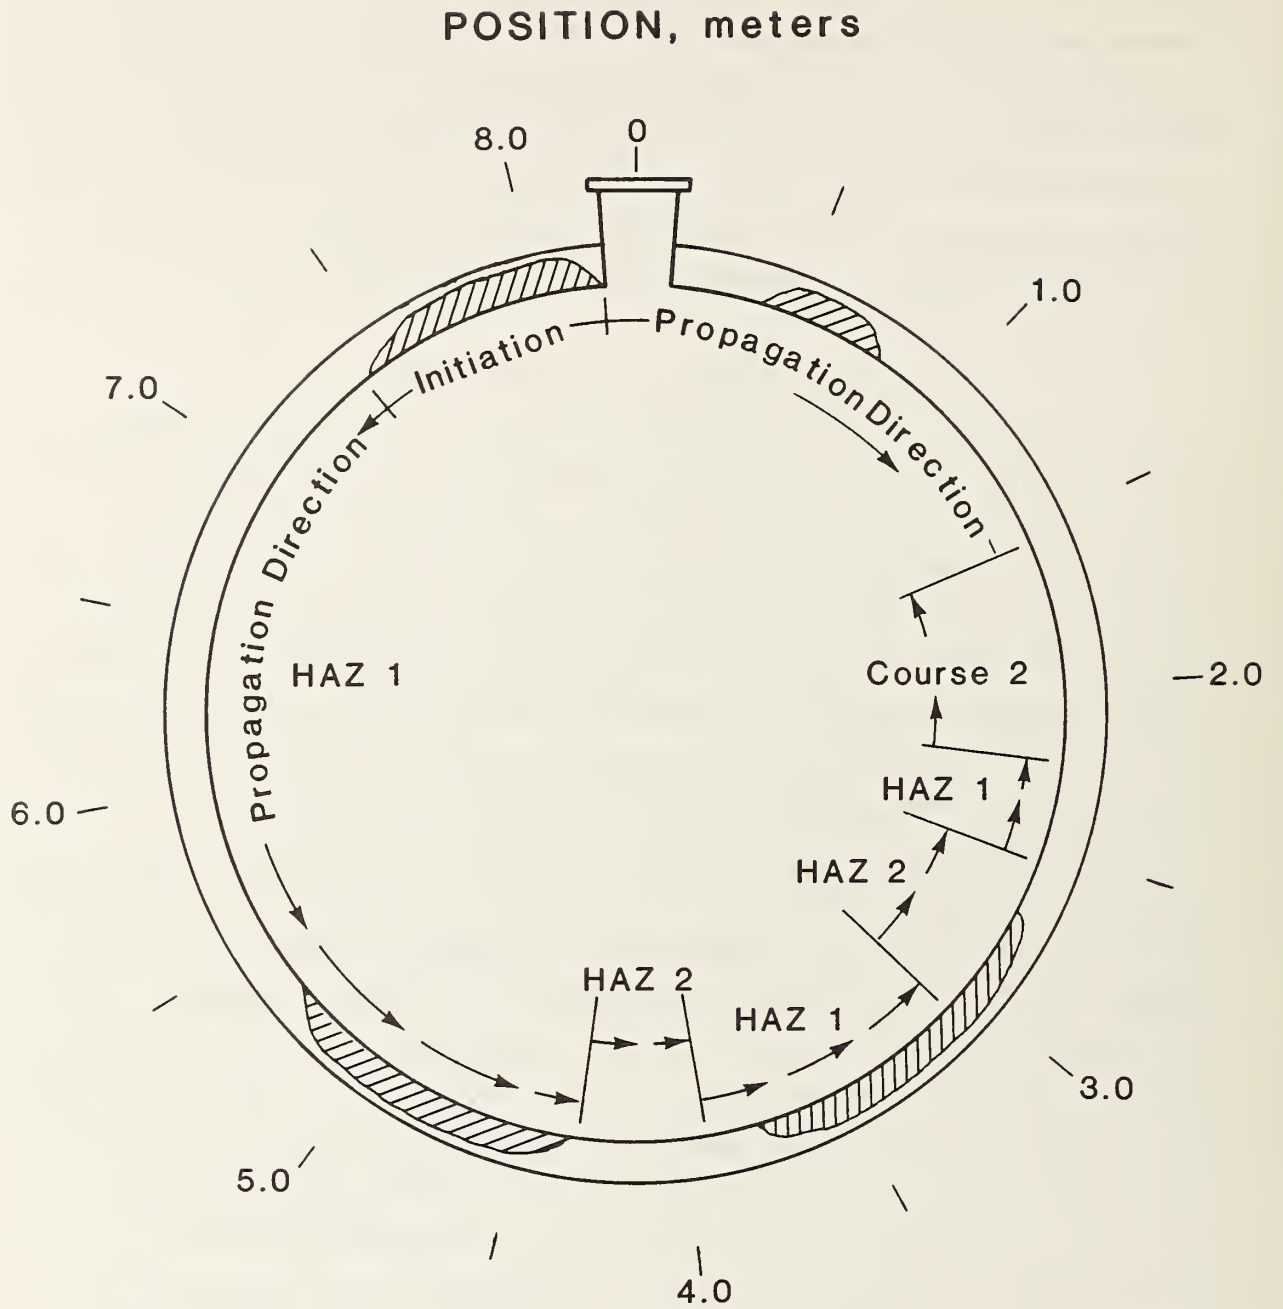
In addition to locating the regions of pre-existing cracks, Figure 28 summarizes the observations regarding the paths and directions of fracture propagation. These observations were made directly on the fracture surfaces of Rings 1 and 2. The crack that initiated the fracture, referred to as the initiation, was 800 mm (31 in.) in length and was in HAZ 1 between CC 7.4 m and CC 8.2 m. The fracture propagation from the CC 7.4 m end occurred along HAZ 1. It temporarily jumped into HAZ 2 between CC 4.3 m and CC 3.9 m and again between CC 3.1 m and CC 2.5 m. At the locations where the fracture jumped out of HAZ 1 (CC 4.3 m and CC 3.1 m), the fracture tunneled a short distance under Weld 1/2 along HAZ 1. This suggests that the crack was propagating in the counterclockwise direction (see Figure 28) and continued in this direction for a short distance beyond the place where it jumped to HAZ 2. A similar indication of counterclockwise propagation was observed at CC 2.75 m, where the crack veered upward through Weld 1/2 into Course 2. The path of the fracture within Course 2 was clearly delineated by chevron markings that pointed to the origin. It propagated through Course 2 in the

Figure 28. Sketch of fracture surface showing pre-existing cracks (shaded areas), fracture path, and direction of fracture propagation.

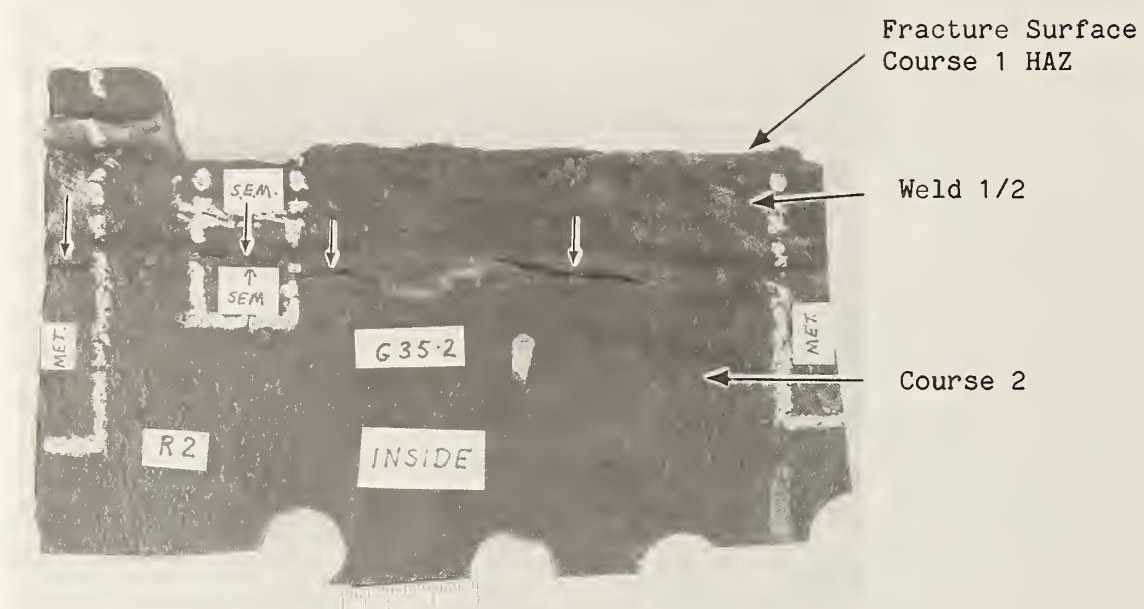
The crack was confined to the HAZ of the circumferential welds because it was a low energy fracture. There was essentially no shear lip formation at the crack border until the final stage of cracking; shear lips developed when the crack veered up into Course 2. The plate orientation was such that the minimum toughness path was in the circumferential direction. The Charpy toughness results indicated that the weld metal toughness (160 J, 124 ft·lbf) was considerably higher than the HAZ toughness (70 J, 54 ft·lbf). Thus, deviation from the HAZ was energetically unfavorable.

Figure 29. Section of fracture removed for metallographic studies with arrows showing cracks on inside surface of HAZ 2.

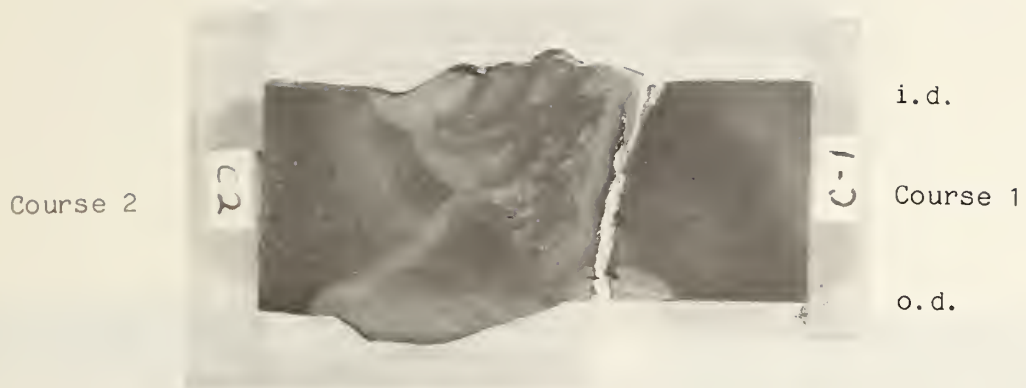
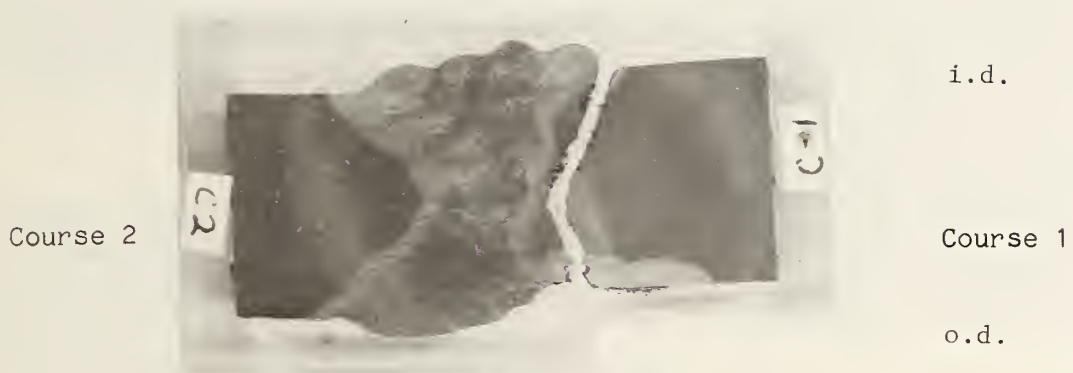
a. Section at CC 7.6 m

b. Section at CC 7.4 m

Figure 31. Metallographic sections through the fracture surface at the location of the initiation crack.

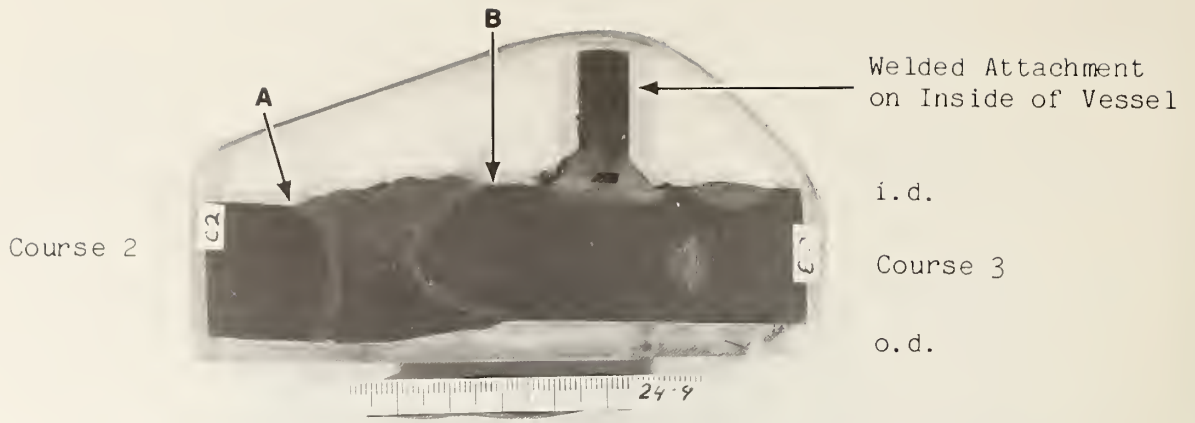
Several long cracks were detected in the HAZ of Weld 2/3 above the initiation site in Weld 1/2. Metallographic sections were taken through the cracks at CC 7.6 m (Figure 32) and at CC 5.9 m (Figure 33). These cracks were examined metallographically and then broken open to expose the fracture surface for fractographic examination. In both cases, a black deposit was

a. Macrostructure of Weld 2/3 at CC 7.6 m

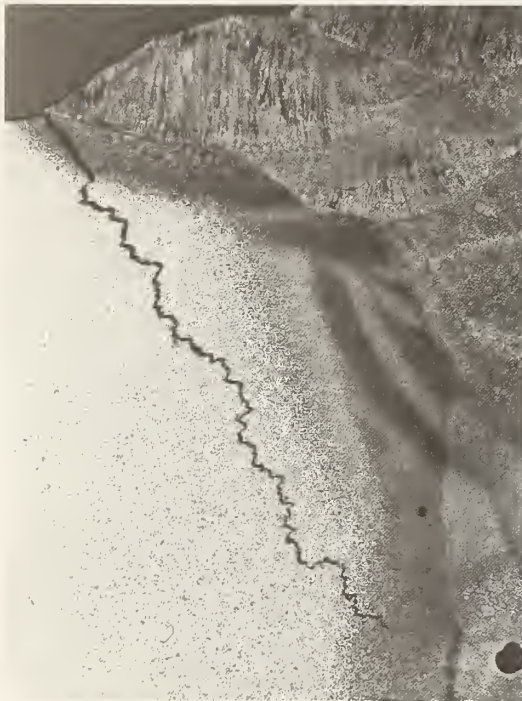
b. Crack in HAZ 2 at location A in Figure 32a

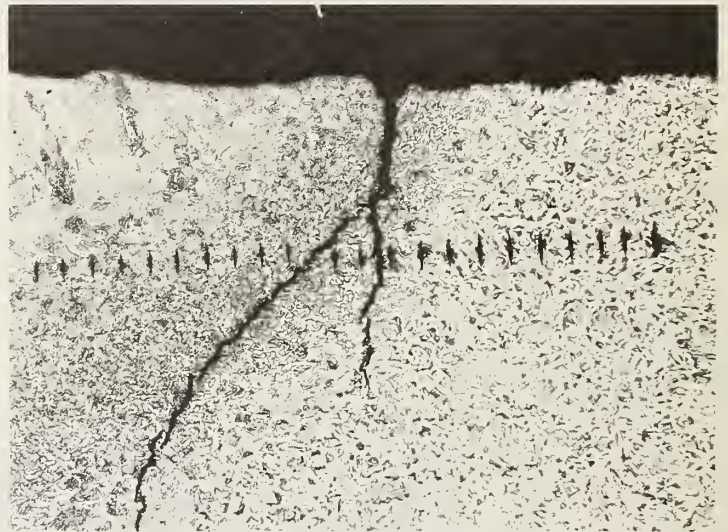
c. Crack in HAZ 3 and microhardness indentations at location B in Figure 32a

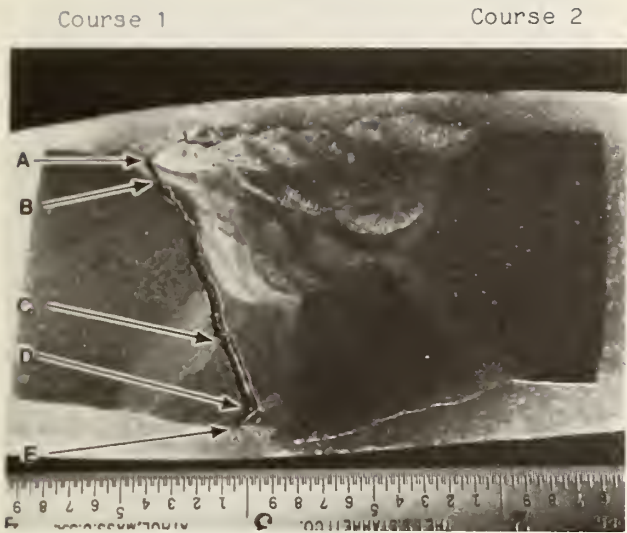
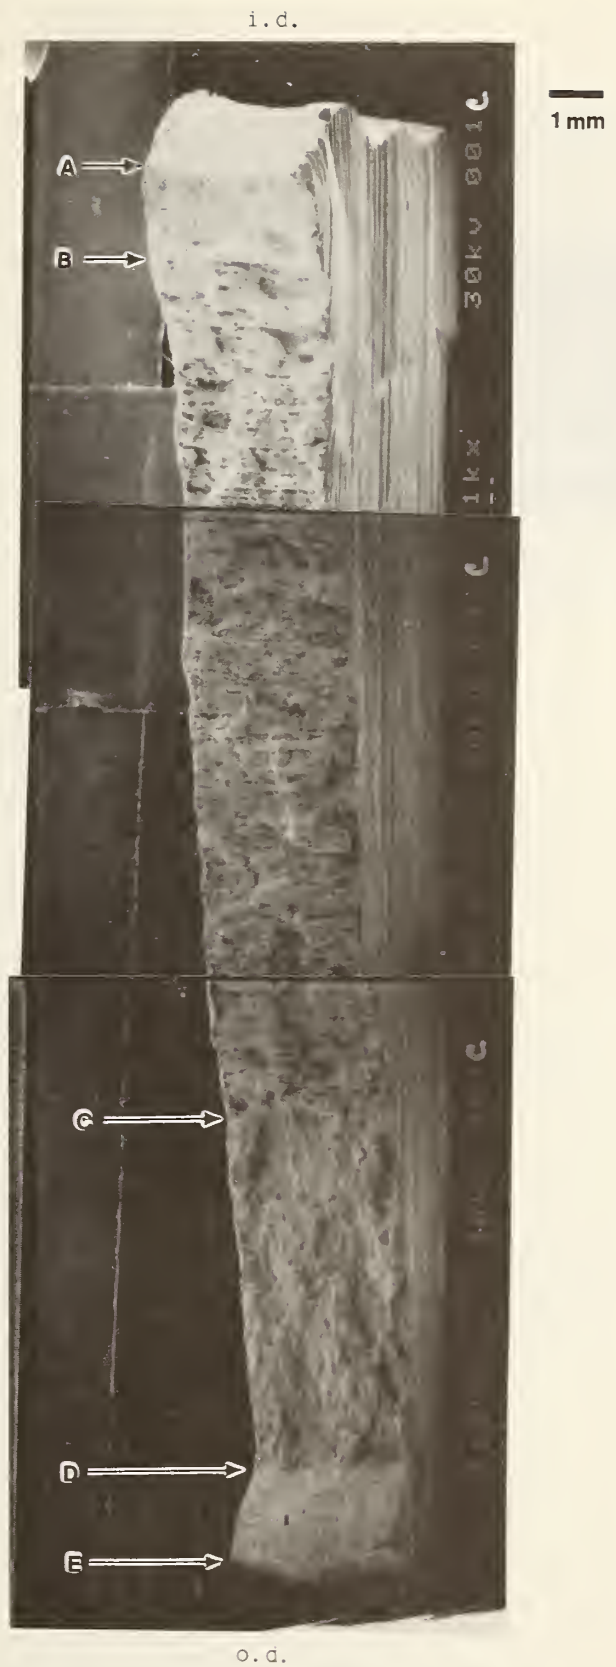
Figure 35. FMI [1] photographs of the macrostructure of Weld 1/2 and fractograph at CC 5.2 m. The letters show corresponding areas.

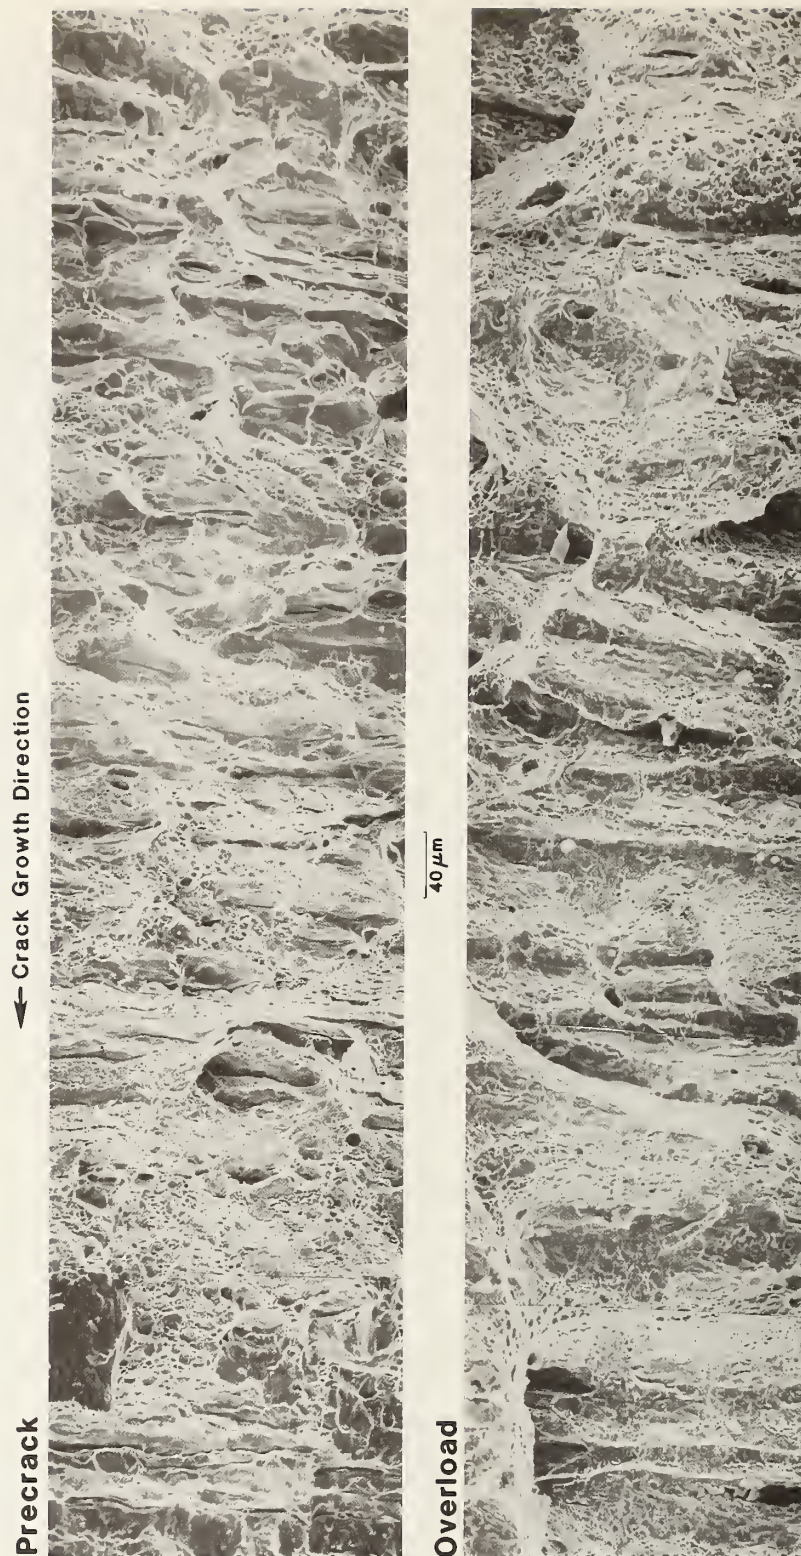
The crack in Weld 2/3 at CC 7.6 m was located directly above the initiation site and is thought to be equivalent to the pre-existing cracks near Weld 1/2. This crack, shown in Figure 32b, was broken open at room temperature to expose the fracture surface for SEM studies. There was a heavy, loose black corrosion product near the inside vessel surface, but the end of the crack had a very thin black deposit. This region was examined by SEM, and the fractographic features of the crack were compared with the features of

a. Fractograph of pre-existing crack that was originally covered with a black deposit

Figure 37. Fractographs of the crack in HAZ 2 (shown in Figure 32) of Weld 2/3 at CC 7.6 m.
