T.R. Shives  
DIU-430 ext. 5711  
pages 55

~~NBSIR 85-3383~~

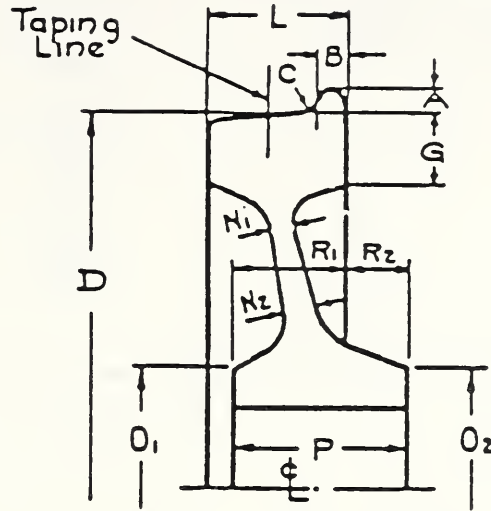
<u>Dimension</u>	<u>AAR Specification</u>	<u>Wheel F1</u>	<u>Wheel F2</u>
A	$1 \frac{1}{16}$	1-11/32*	1-10/32***
B	$1 \frac{5}{32}$	1-9/32	1-8/32
C	$1 \frac{11}{16}$	NA	NA
D	$3 \frac{3}{8}$	34-17/32**	NA
G	$2 \frac{3}{4}$ Min	2-5/16*	2-7/16***
L	$5 \frac{1}{2}$	5-1/2	5-17/32
N <sub>1</sub>	$\frac{3}{4}$ Min	13/16	7/8
N <sub>2</sub>	1 Min	1-1/2	1-1/2
O <sub>1</sub>	$10 \frac{3}{4}$	11-9/32**	NA
O <sub>2</sub>	$10 \frac{3}{4}$	11-5/32**	NA
P	$7 \frac{1}{8}$	6-15/16	6-29/32
R <sub>1</sub>	$4 \frac{5}{16}$	4-5/16	4-9/32
R <sub>2</sub>	$2 \frac{11}{16}$	2-21/32	2-11/16
Max Finish Bore	$8 \frac{1}{2}$	7-31/32	NA
Min Hub Wall	$1 \frac{1}{8}$	1-1/2	1-1/2***

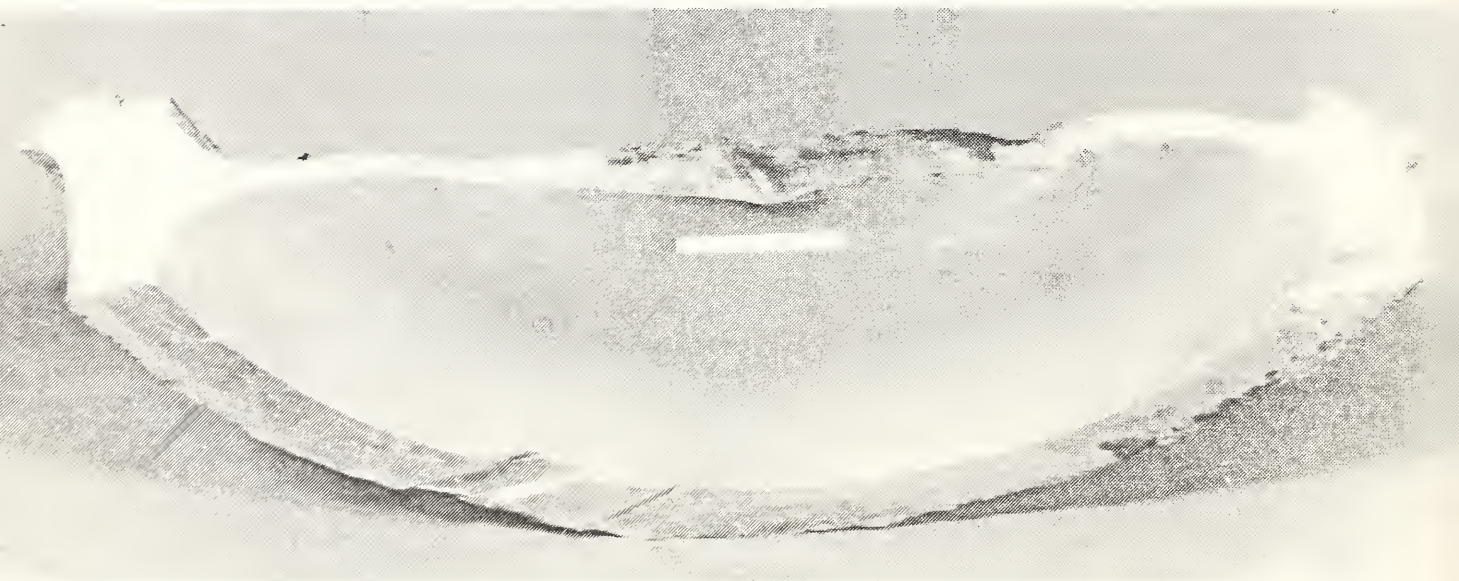
Figure 2. Part of the east wheel (F1) that had fractured from the main part of the wheel. This part is the mate to the part of the wheel shown on the right in figure 1.

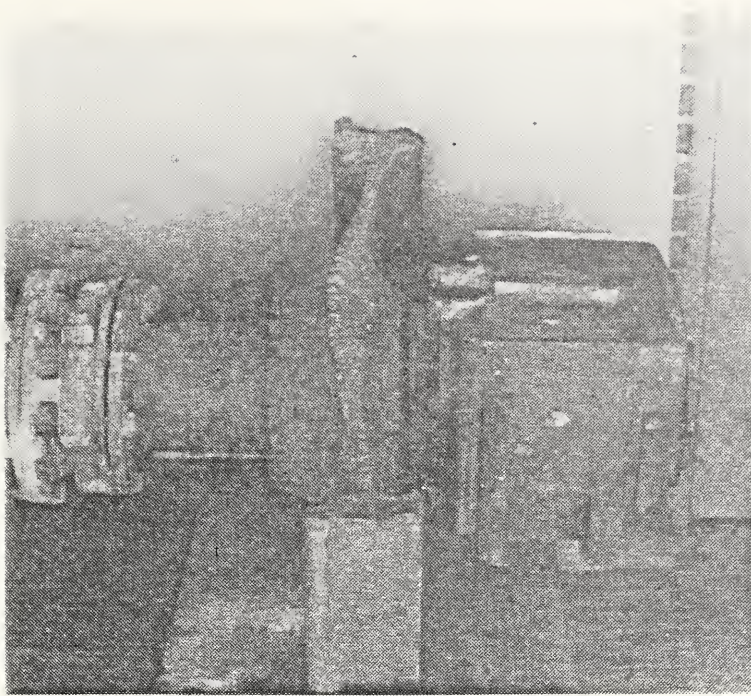
Figure 3. Wheel F1 as received at NBS showing the chordal fracture.

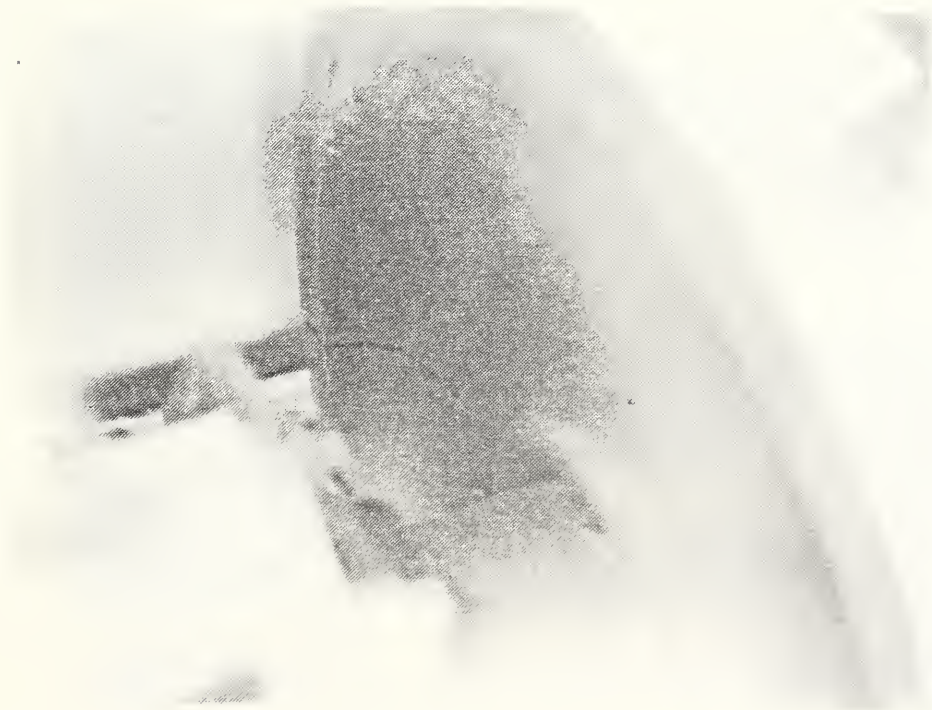
Figure 4. Wheel F2 as received at NBS showing the radial fracture.

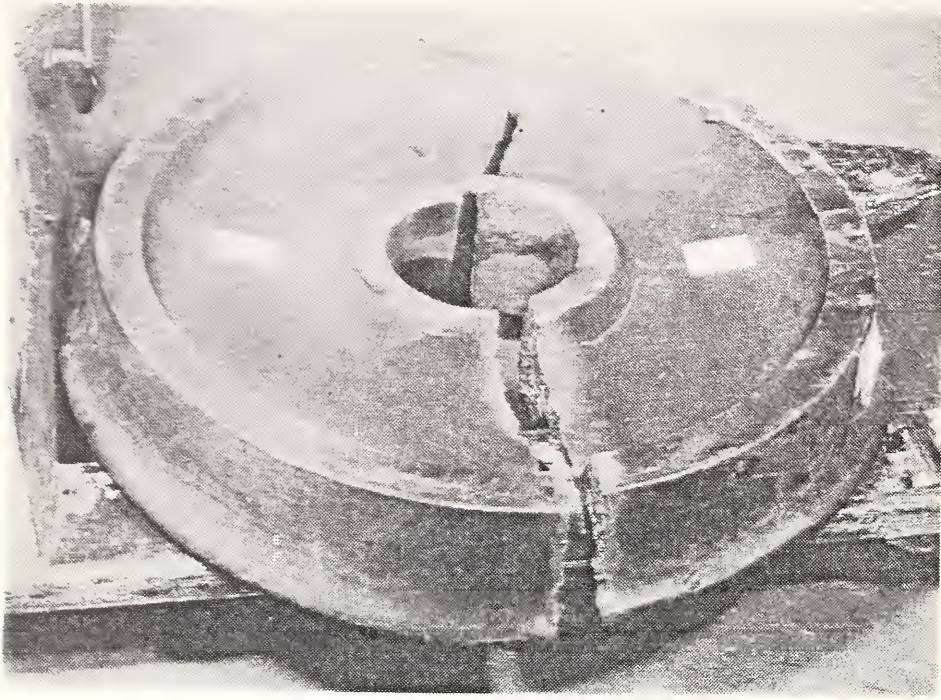
Figure 5. The two pieces of wheel F2 after torch cutting. Piece F2L is at the left and piece F2S is at the right.

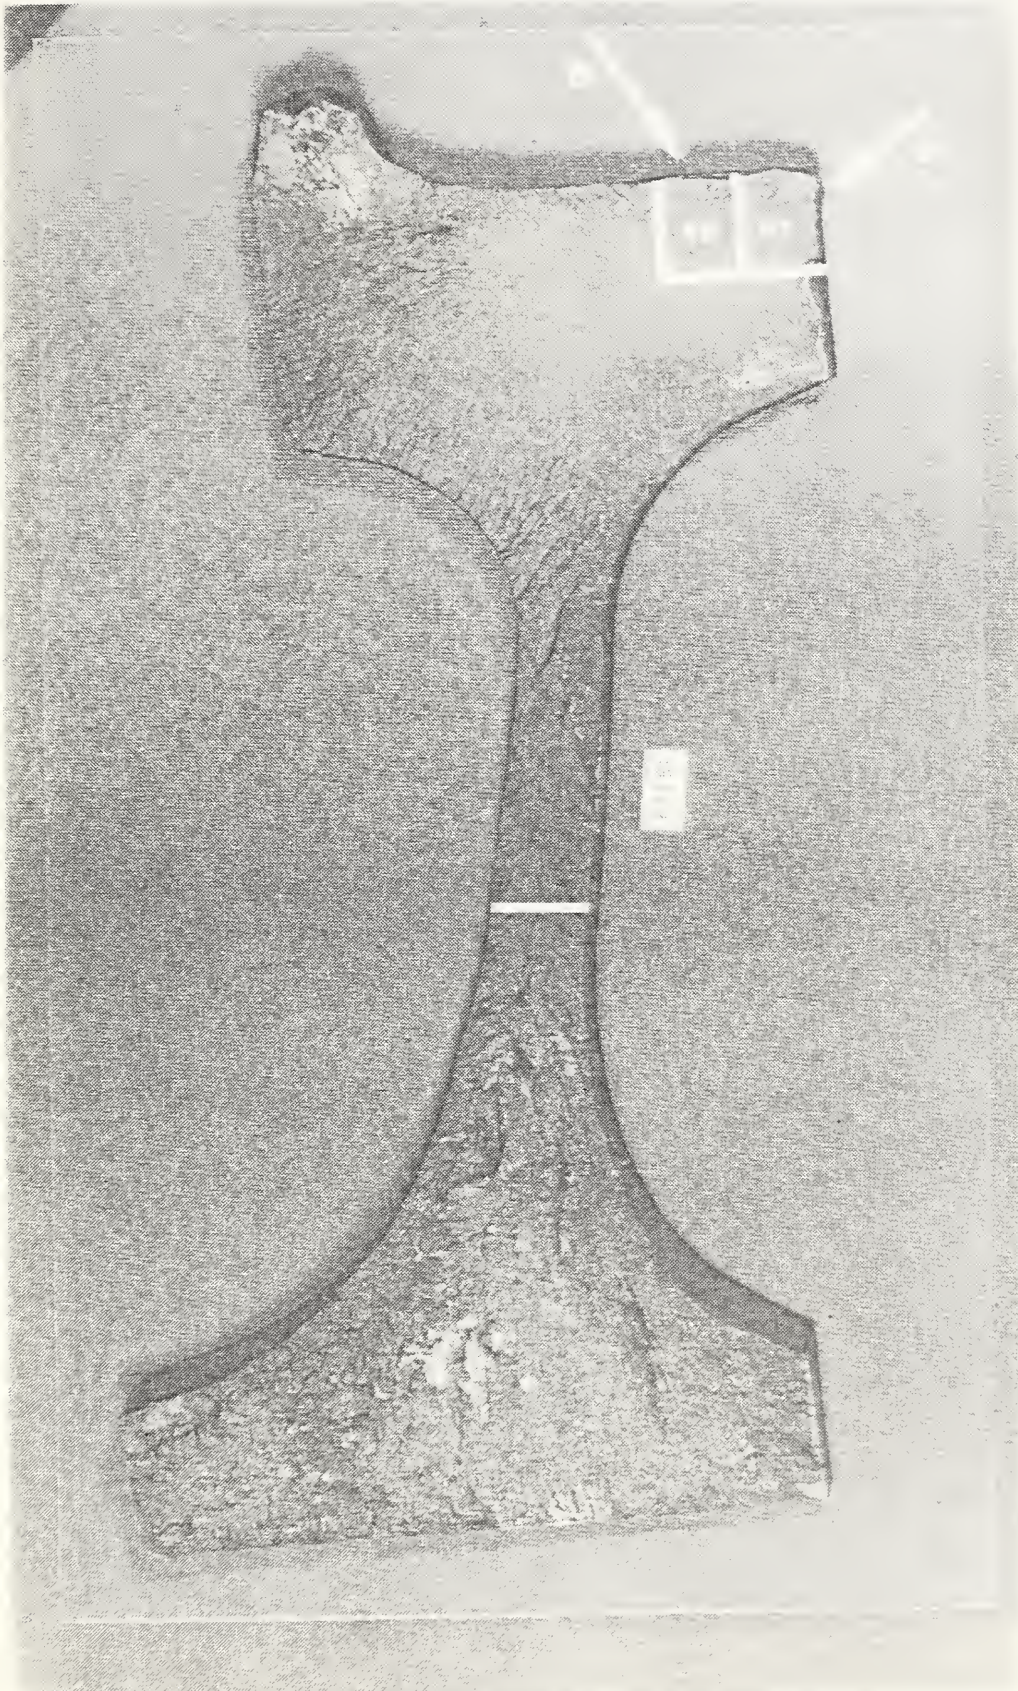
Figure 13. Fracture surface of wheel piece F2SB1 showing the location of sections A1 and A2, and the lower part which was returned to the FRA.

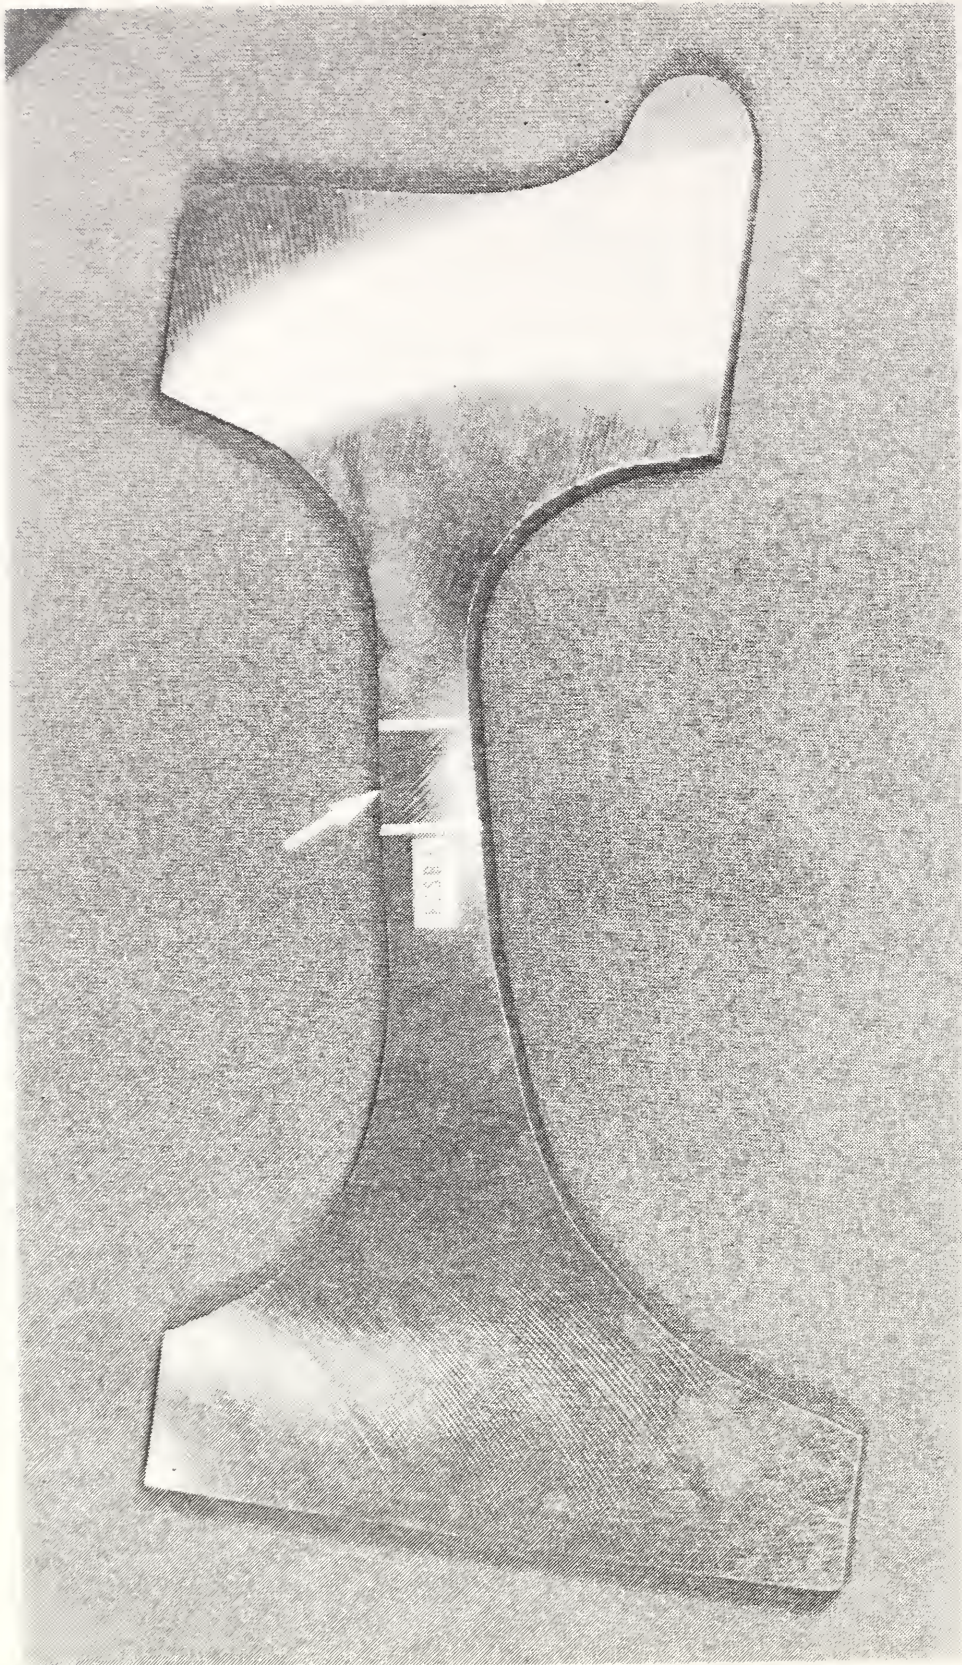
Figure 14. Wheel section F2SB2 showing the location of the sample taken for chemical analysis.

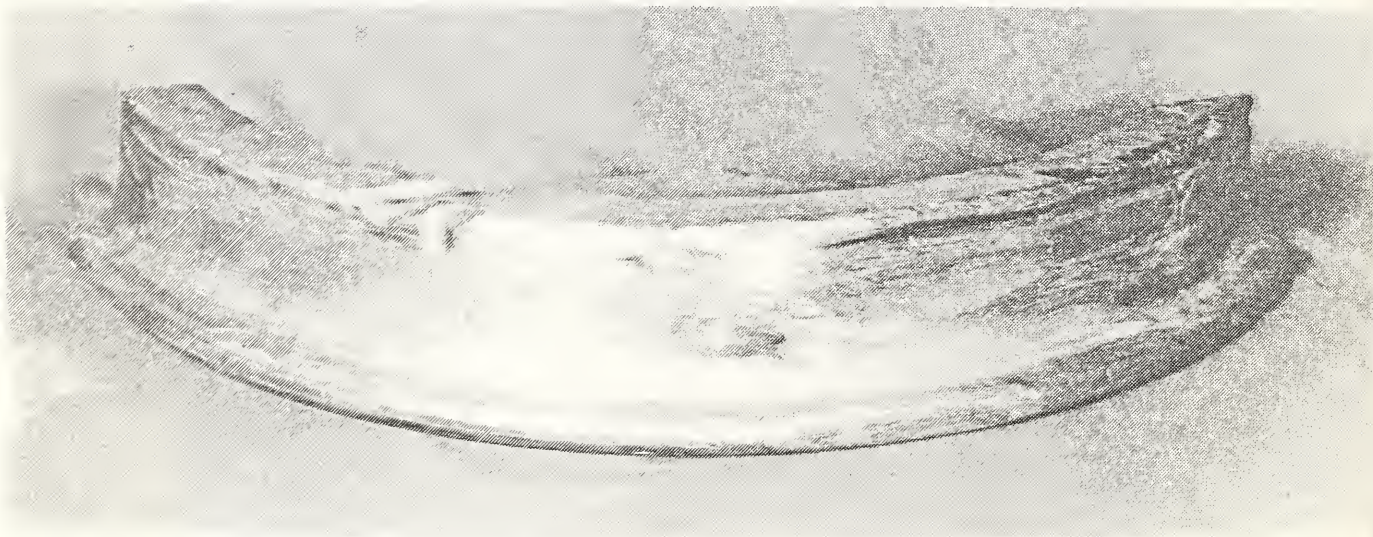
Figure 18. Wheel piece F1S with the outside of the wheel facing up showing mechanical damage to the tread and outside of the wheel adjacent to the tread.

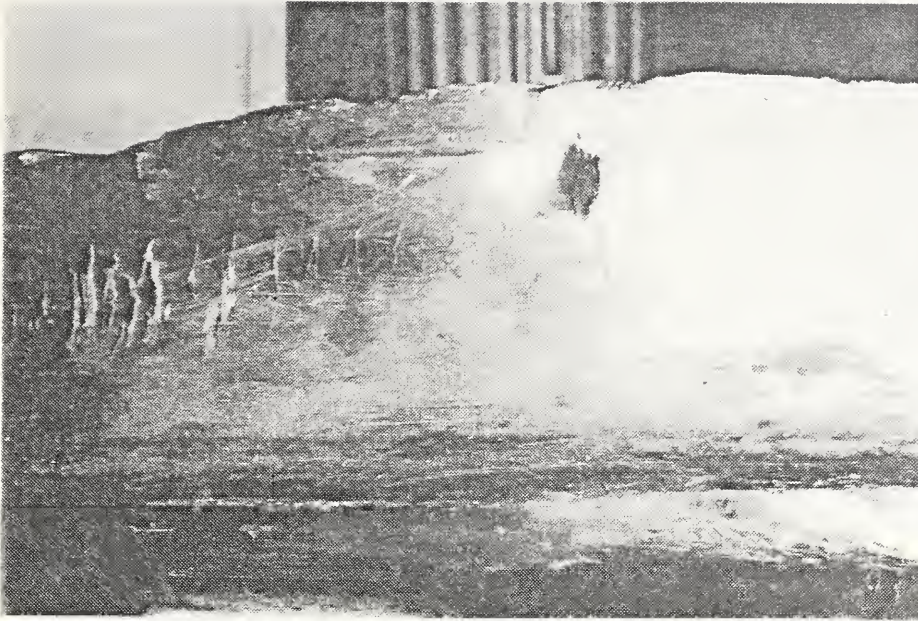
Figure 19. Region of the tread of wheel piece F1S exhibiting galling and gouging.

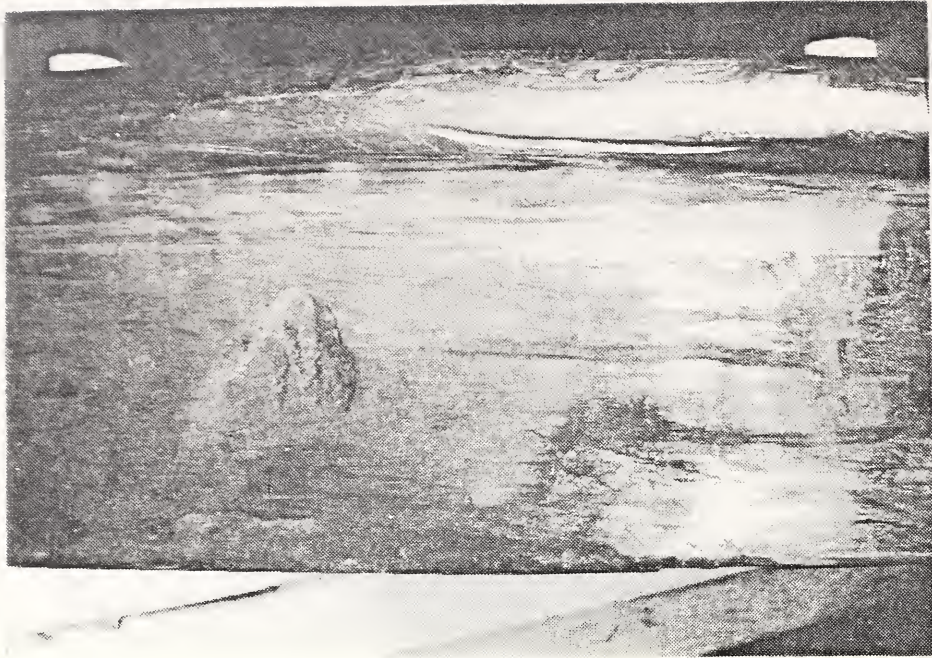
Figure 21. Example of mechanical damage on the tread of wheel piece F2L.

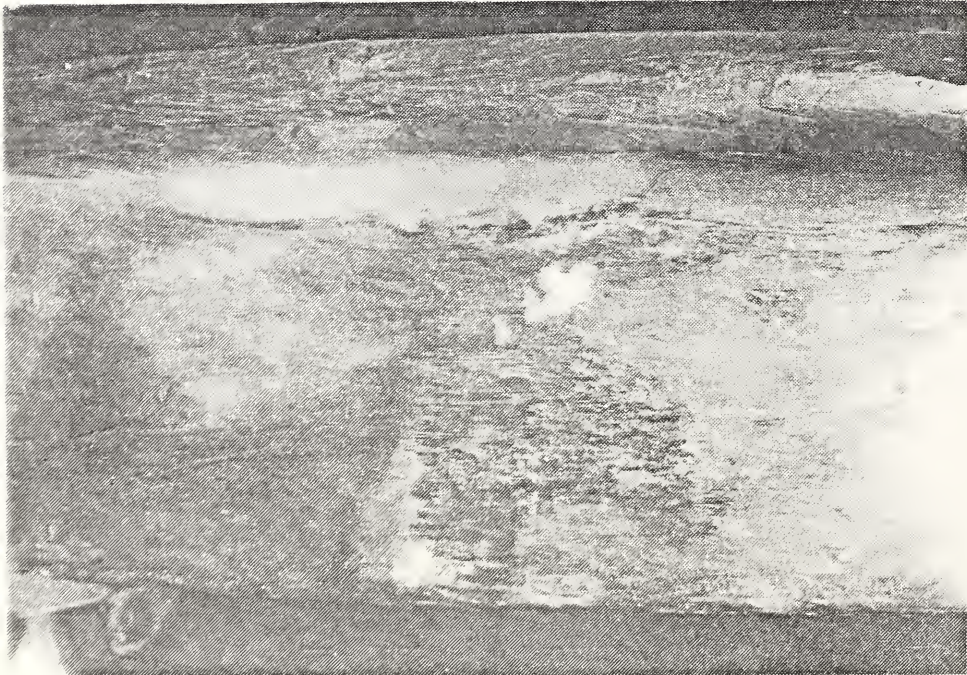
Figure 22. Mechanical damage on the tread of wheel piece F2S.

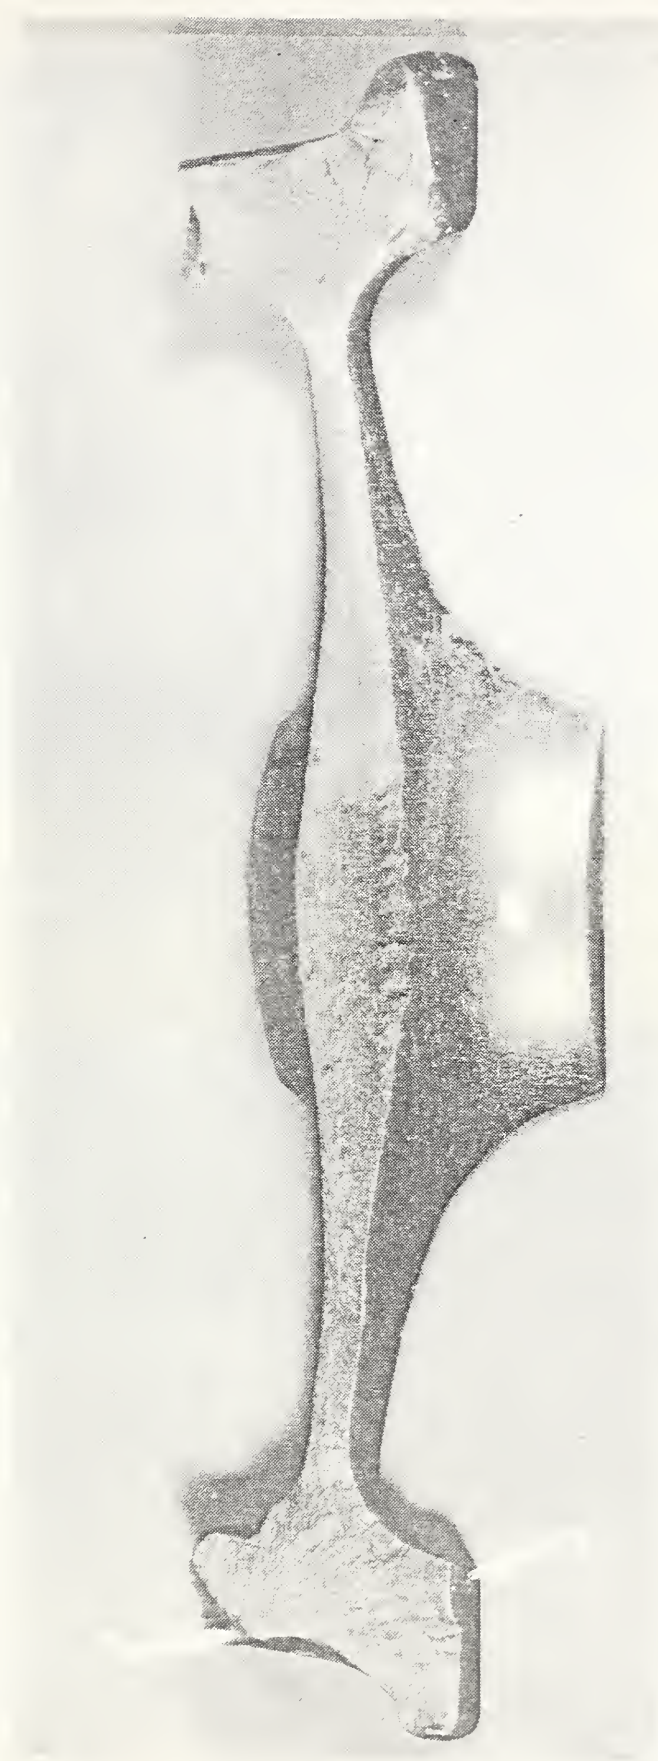
Figure 23. Fracture surface of wheel piece F1LB1. Arrow A indicates region of probable fracture initiation. Arrow B indicates depression common to both mating wheel pieces F1L and F1S.

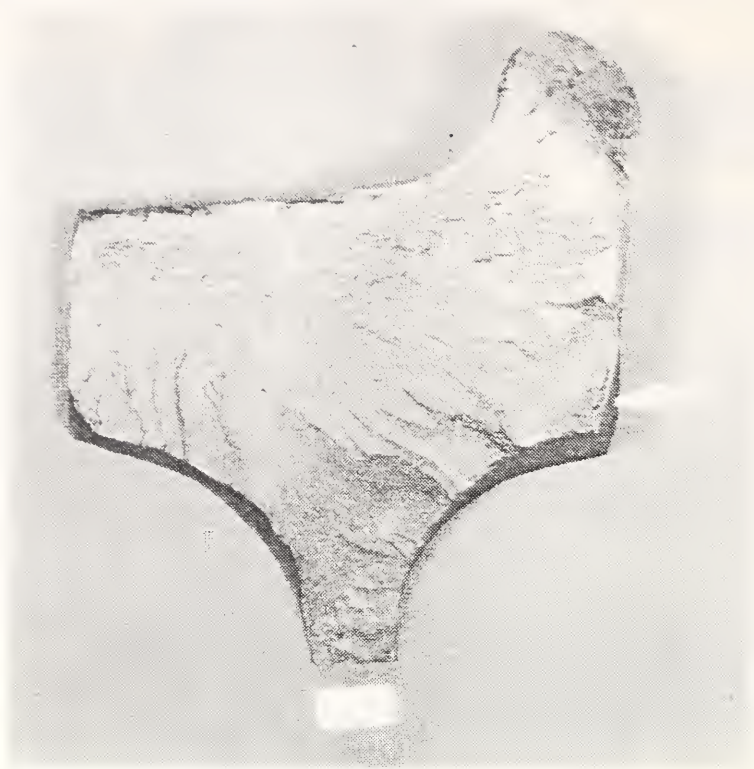
Figure 24. Wheel piece F1SA1 showing part of the fracture corresponding to the mating fracture shown in figure 21. The arrow indicates the depression that was exhibited by both fractured pieces F1L and F1S. X1/2

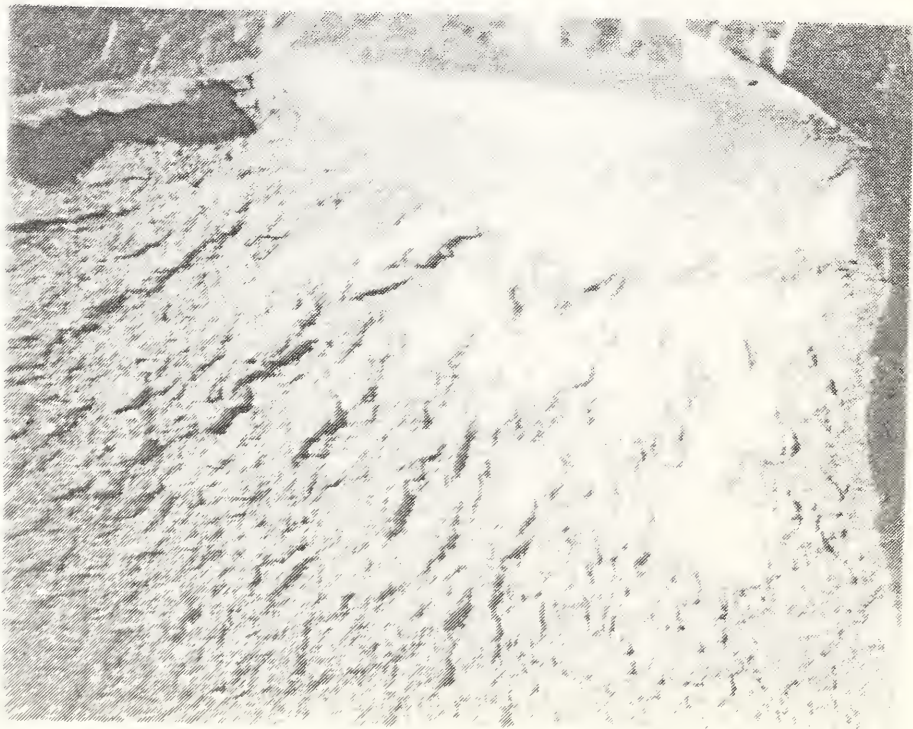
Figure 25. Fracture surface of specimen A1 from wheel piece F2SB1 in the region of the fracture initiation. X6

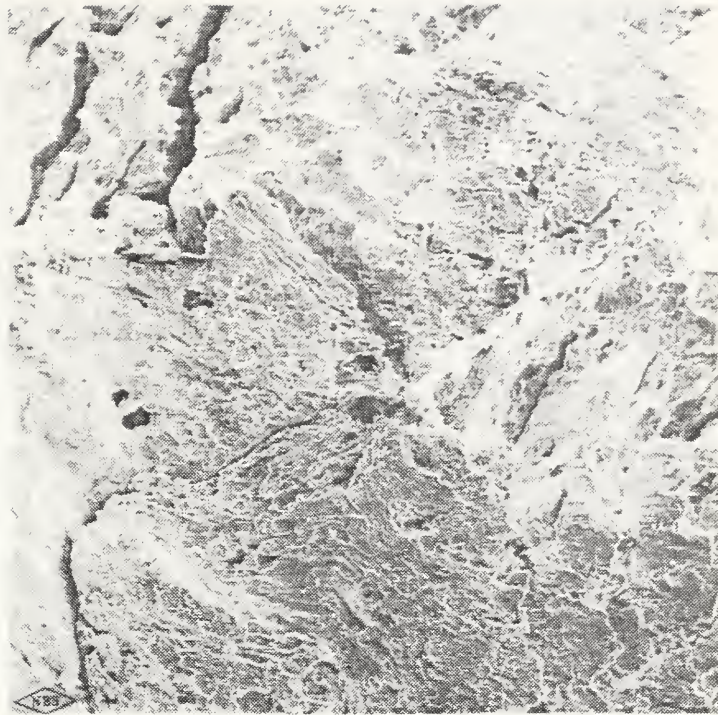
Figure 26. SEM fractograph of the "smeared" region of specimen A1 from wheel piece F2SB1. Grain boundary cracking is evident. X500

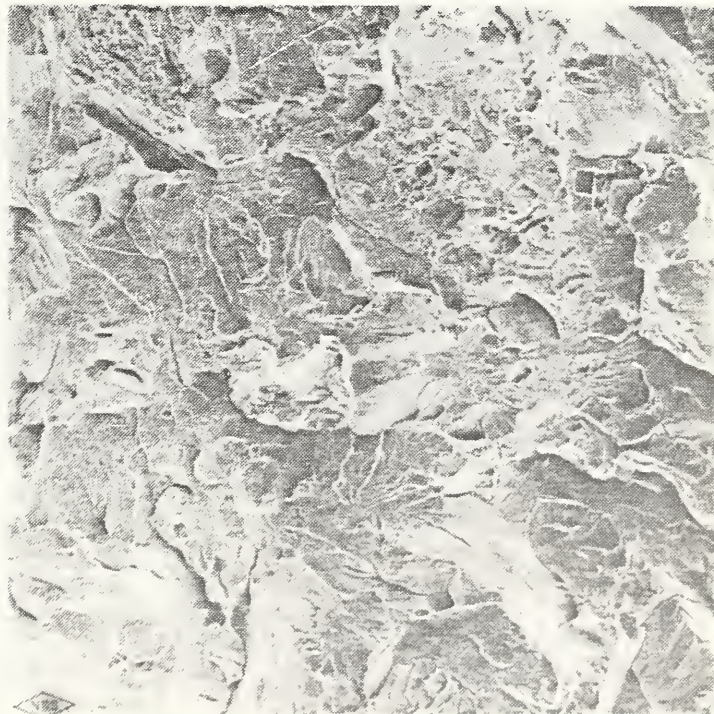
Figure 27. SEM fractograph of a region adjacent to the smeared region of specimen A1 from wheel piece F2SB1. Cleavage is the predominant fracture mode. X500

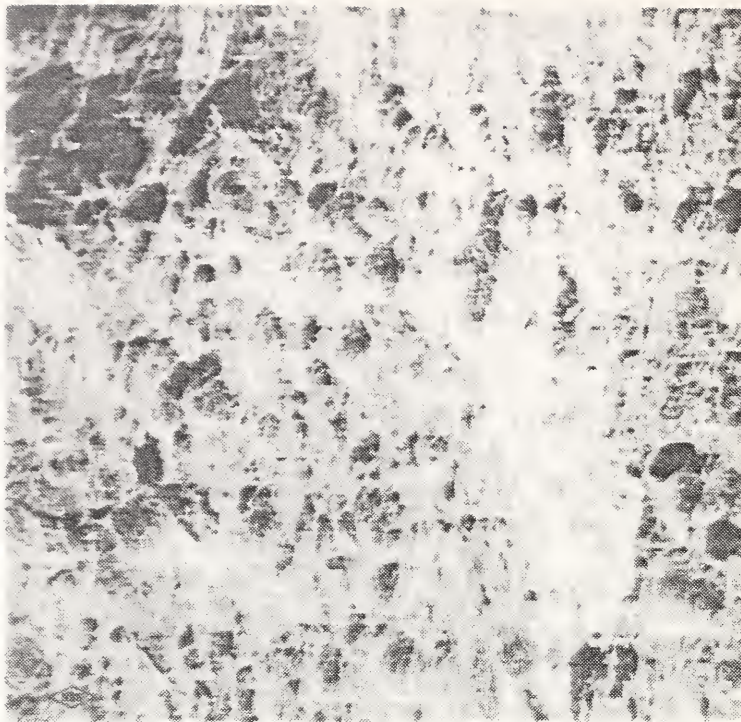
Figure 28. SEM fractograph representative of the heavily oxidized region of specimen A2 from wheel piece F2SB1. The effects of corrosion can be seen. X500

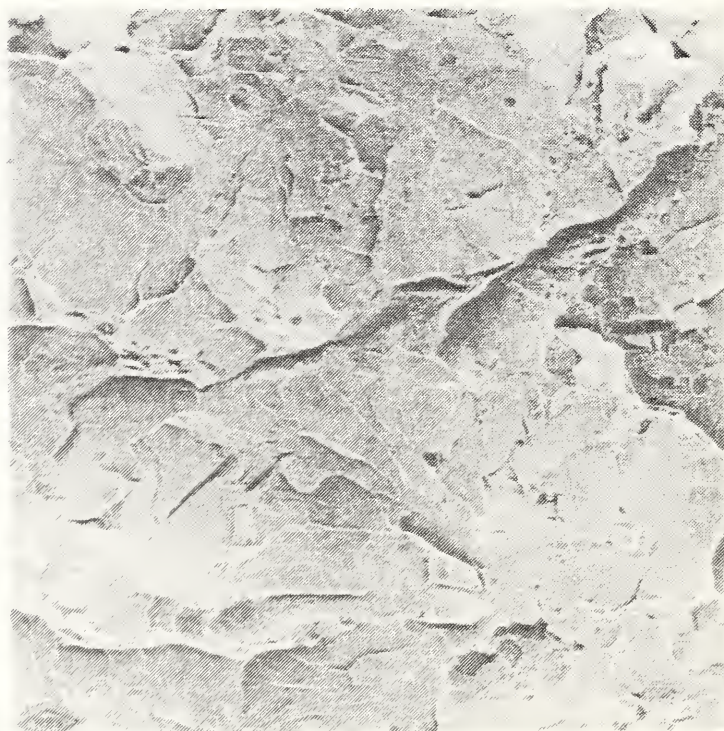
Figure 29. SEM fractograph from specimen A2 in a region near the tread, but removed from the heavily oxidized area. Cleavage is the predominant fracture mode. X500

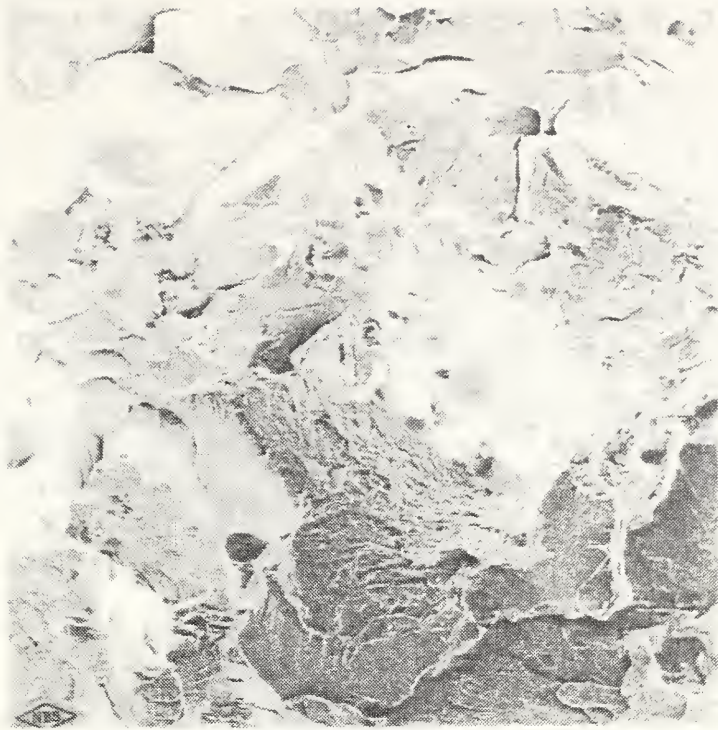
Figure 30. SEM fractograph in a region well removed from the tread of specimen A2 from wheel piece F2SB1. X500

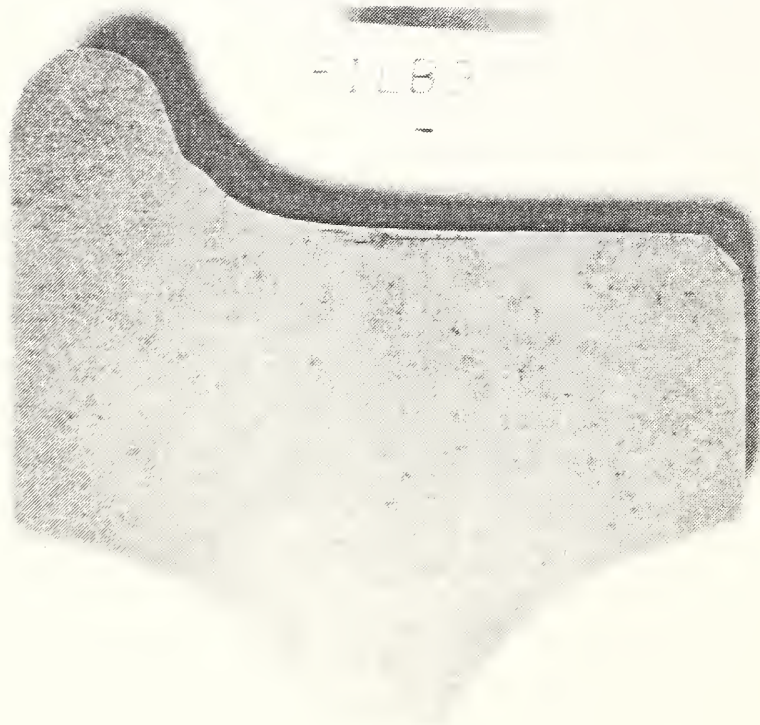
Figure 41. Wheel piece F1LB3 deep etched showing crack parallel and adjacent to the tread.  
Etchant: Boiling 50% HCl, 50% H<sub>2</sub>O

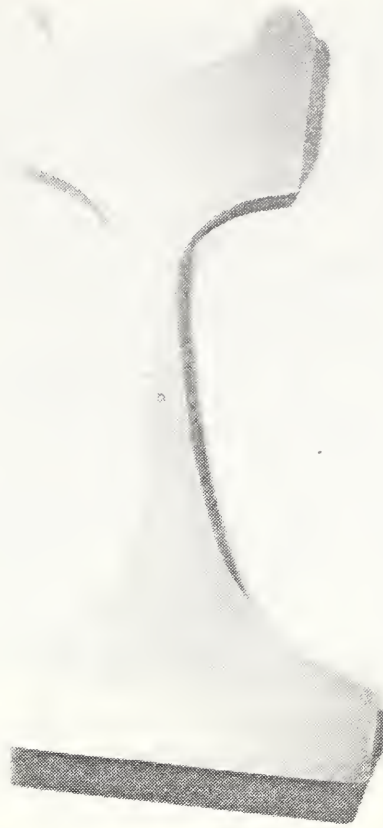
Figure 42. Wheel piece F2LA2 etched to reveal the region of the tread that had been overheated. Etchant: 2% nital

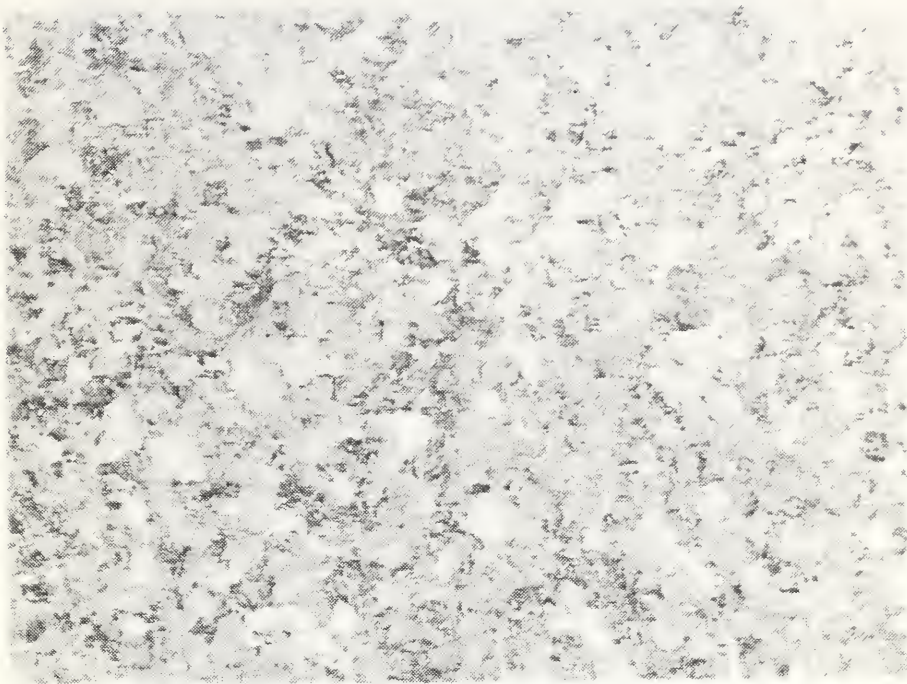
Figure 46. Representative microstructure of wheel piece F2LA2 away from the tread.  
Etchant: 2% nital X100

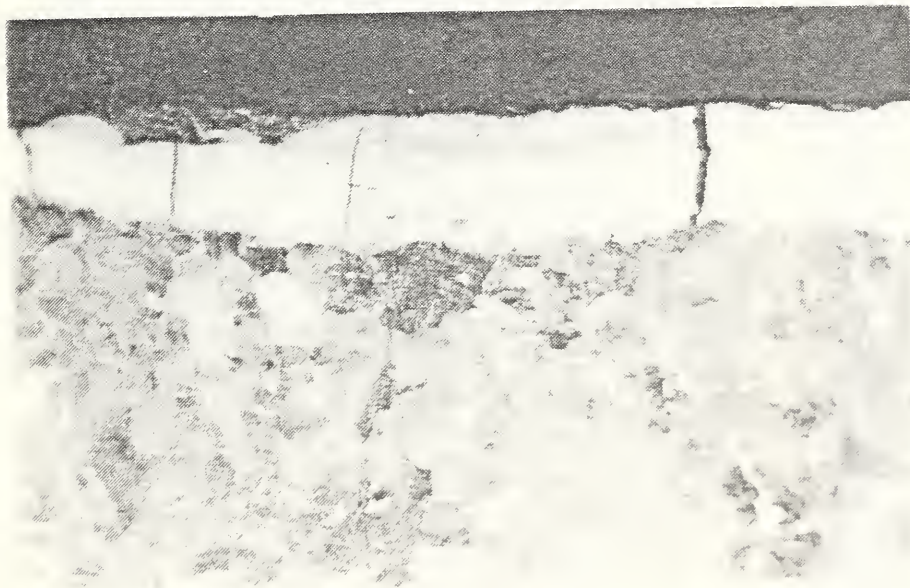
Figure 47. Microstructure of wheel piece F2LA2 at the hub showing an overheated area (white) with radial cracks.  
Etchant: 2% nital X500

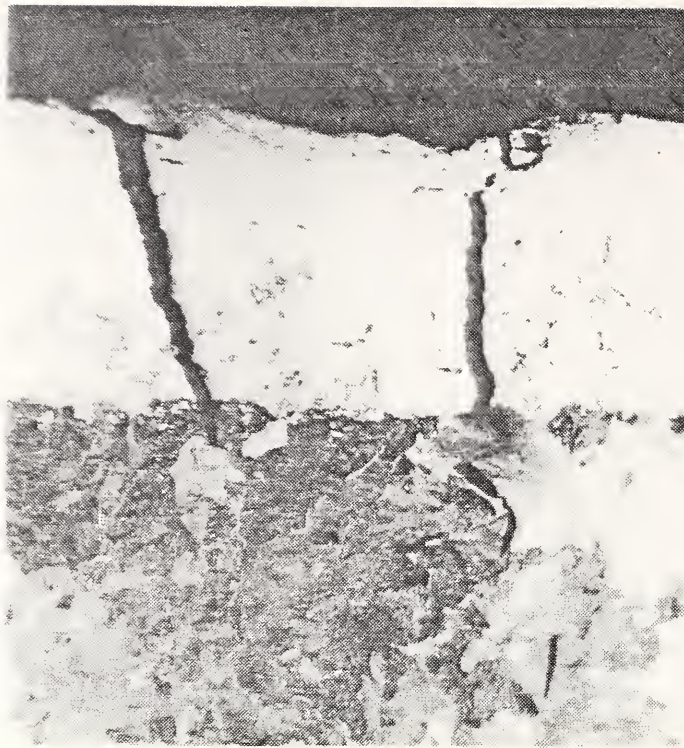
Figure 48. Heat affected area at the hub of wheel piece F2LA2 showing cracks penetrating into material unaffected by overheating. Etchant: 2% nital X500

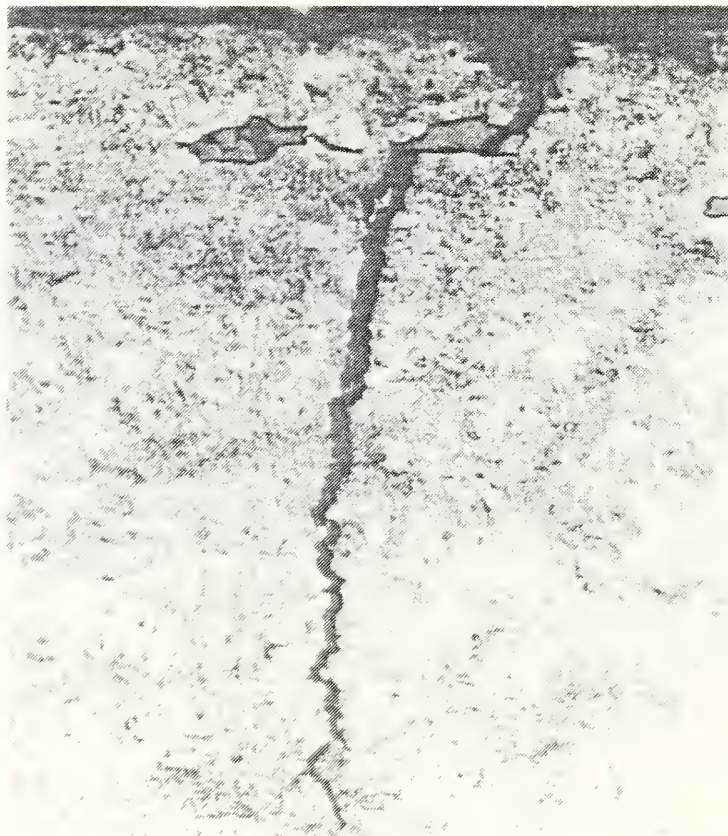
Figure 49. Cracks at inclusion near tread surface (horizontal at the top in the figure) of wheel piece F2SB1-A2. Etchant: Picral X1000

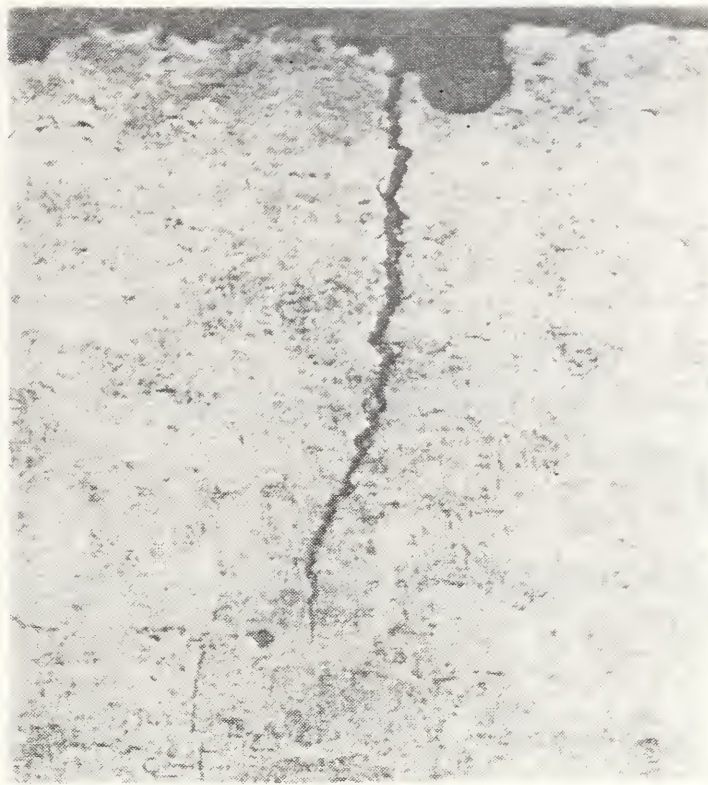
Figure 50. Crack at the tread surface of wheel piece F2SB1-A2 in a region close to the crack shown in Figure 49.  
Etchant: Picral X1000

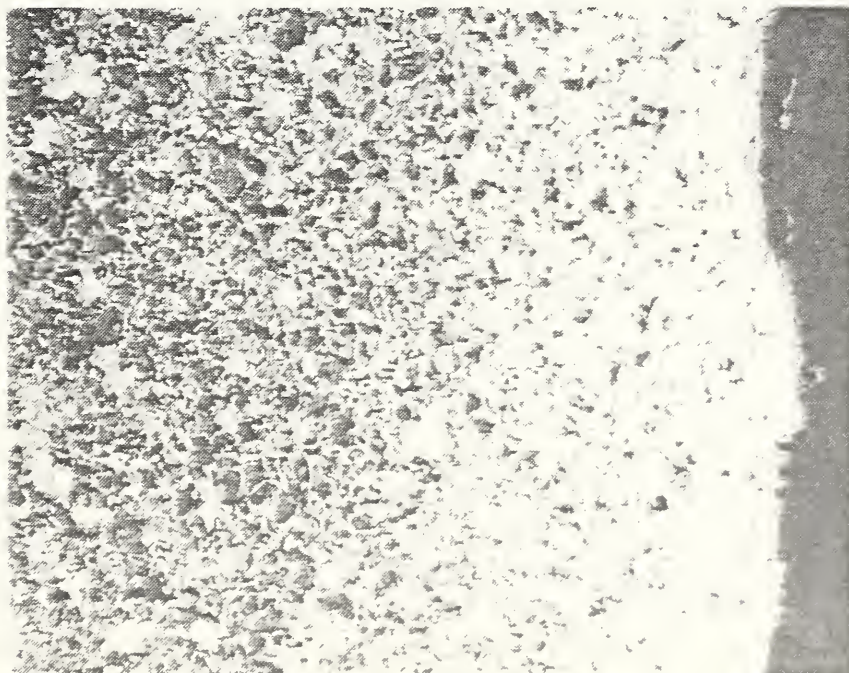
Figure 51. Inboard edge of the web of wheel piece F2LA2 showing decarburization near the surface.  
Etchant: 2% nital X100
