NBSIR 86-3387

**INVESTIGATION OF THE CORROSION OF
ALUMINUM STANDING-SEAM
ROOFING AT AN ARMY FACILITY**

Robert G. Mathey

June 1986

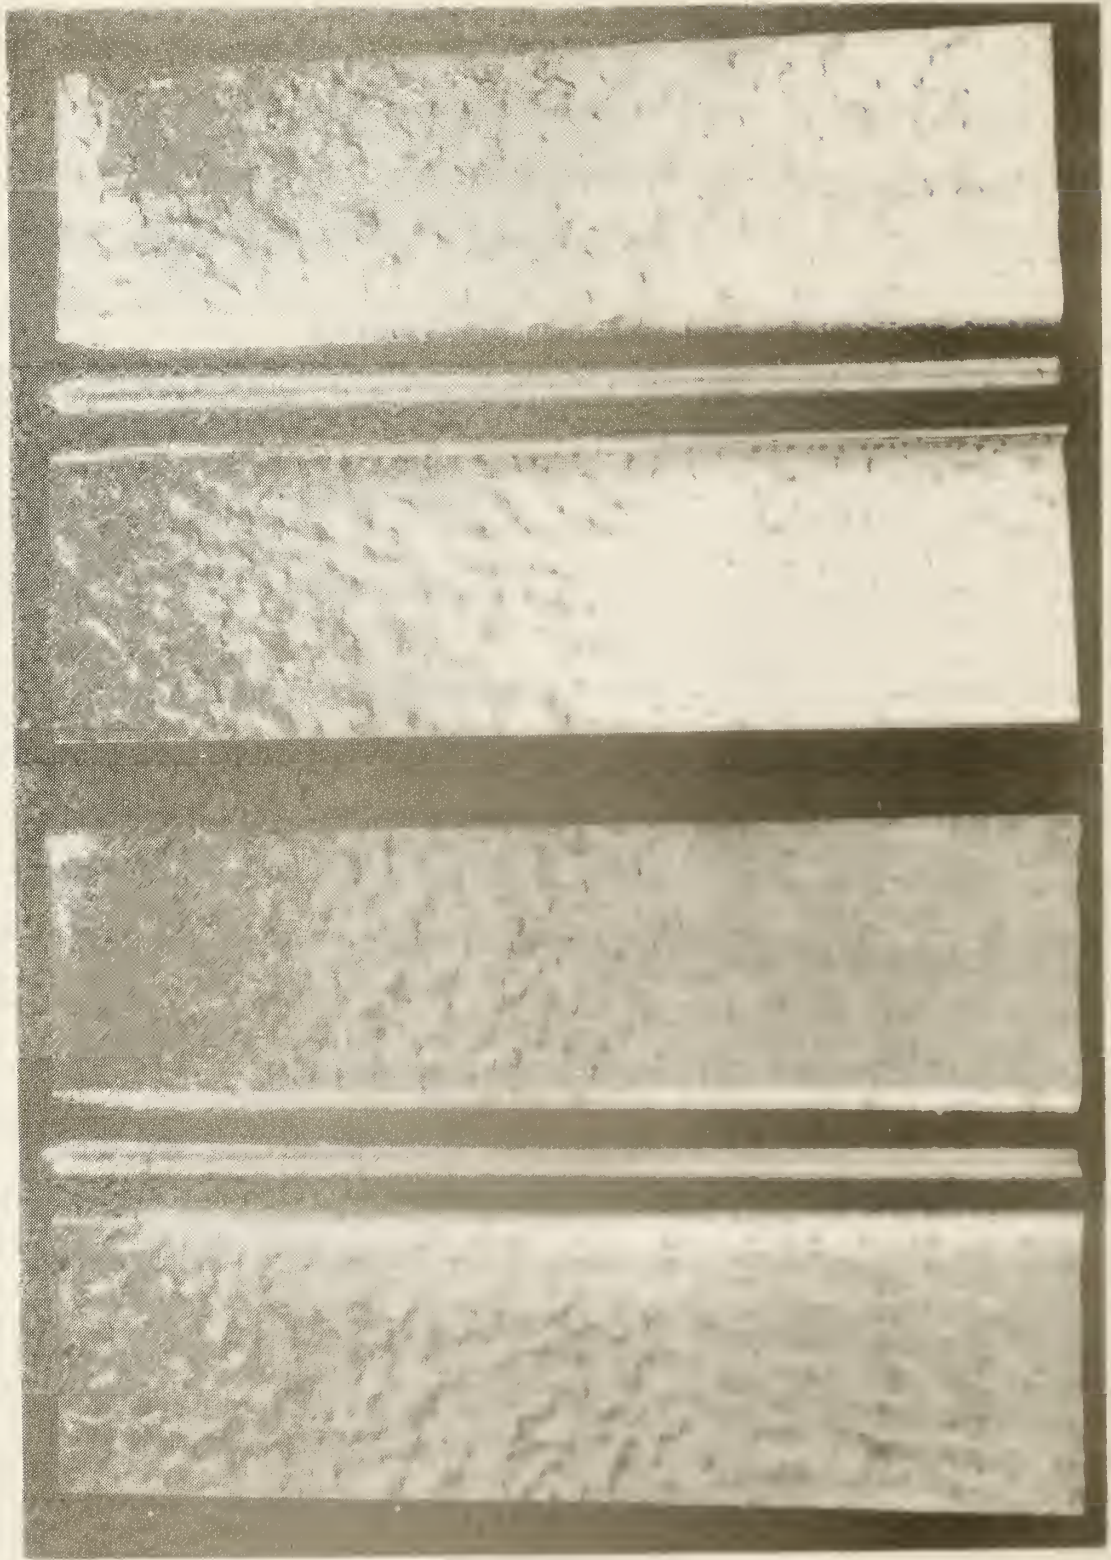
ASTM Standards G1-81 [4] and G48-76 [5] were considered in examining and determining the extent of corrosion. It can be seen from the photograph (figure 3) of a typical exposed and control sample, that the exposed sample on the left has less gloss and greater surface roughness than the control sample on the right. Also, it can be seen that the surface of the exposed sample contains many small dark spots. It is thought that these dark spots represent incipient corrosion. Photomicrographs (10x) of a portion of the surfaces of typical exposed and control samples after the second exposure are presented in figures 4 and 5, respectively. The dark spots on the exposed sample seen in figure 3 are shown in more detail in figure 4. At the dark spots (incipient corrosion) there was essentially no pitting. The total time of outdoor exposure at DCSC of the exposed samples was 33 months and 26 days.

Figure 3. Exposed (left) and control (right) specimens

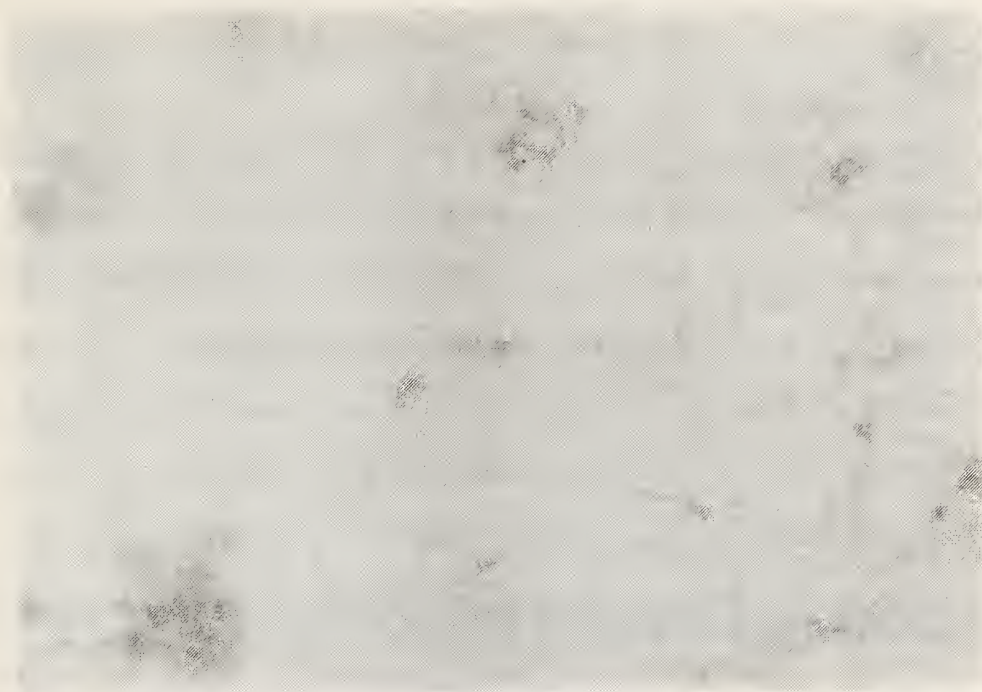
Figure 4. Photomicrograph (10x) of portion of surface area of exposed sample
