**NBSIR 86-3492**

# **Evaluation of Cracking in Aluminum Cylinders**

Final Report

This work was sponsored by  
**Department of Transportation**  
**Washington, DC 20590**

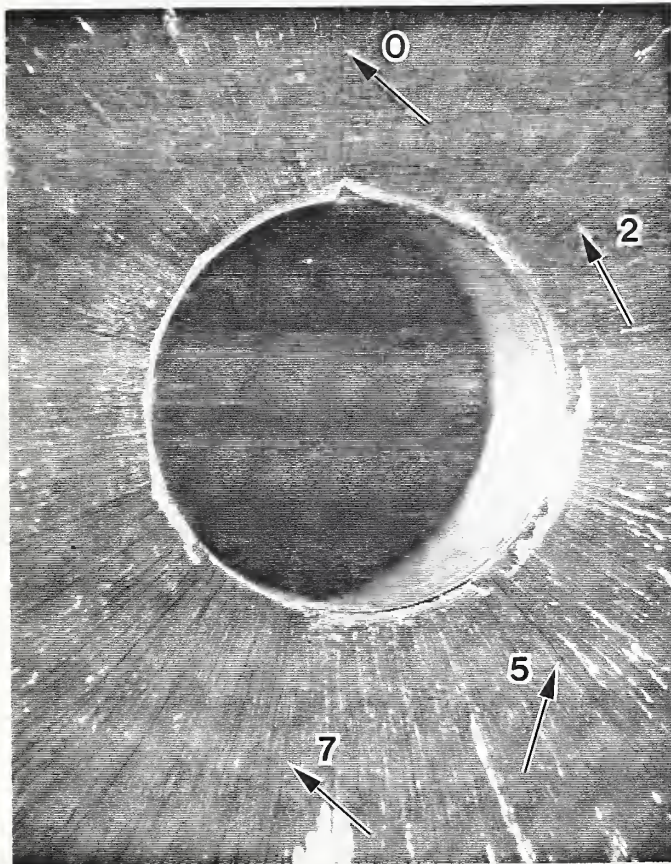
Fig. 3

The heads of the cylinders were then cut off and examined in more detail using a binocular microscope and viewed from the inside of the head. The crack-like indications could be seen more clearly in this way than by examination through the threaded hole with the mirrors. All cylinder heads were photographed from the inside at a magnification ranging from 2X to 12X to show the exact location and appearance of the crack-like indications. In each case, the most prominent crack-like indication was designated the "0" position and the other locations were designated as positions of the clock, i.e., 3, 6, 9, etc. An example is shown in Figure 3.

(Numbers Show Position of Cracks)

Macroscopic View of Inside of  
Cylinder Head      Mag. 3x

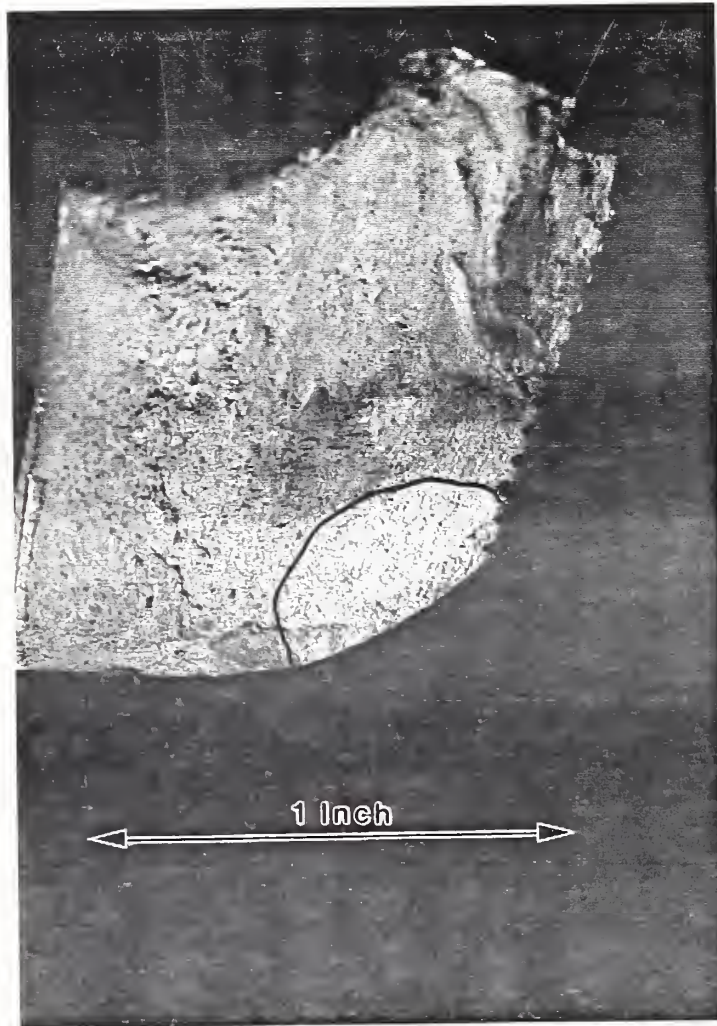
Fig. 4

To determine the extent of cracking, each cylinder head was cut into sections. In each cylinder, the region that had the largest or most distinct crack-like indication by visual examination was first examined. For cylinders numbered T-262190, T-256255, WK-27055, and WK-31631 three-point bend specimens were cut from the neck area at the "0" position location and broken open to delineate the extent of the crack. The extent of cracking can be clearly seen by visual examination of the fracture surface of the three-point bend specimen and the length and depth of the crack can be readily measured as shown by the example in Figure 4.

Example of Cracked Area in  
Three-Point Bend Specimen

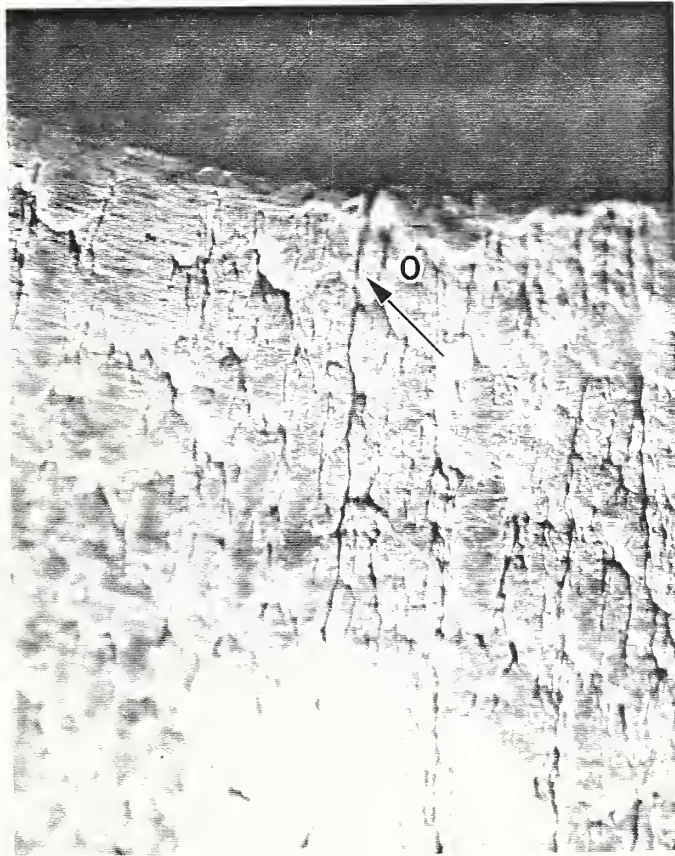
Fig. 7

neck area of the cylinder showed crack-like indications in the neck area of the cylinder and the cylinder was removed from service for further examination. The detailed visual examination conducted as part of this investigation showed crack-like indications at positions "0", "3", and "6". All the crack-like indications appeared to be approximately 1/4-inch long on the inside surface of the neck just below the straight drilled portion of the neck. Visual examination showed that none of the crack-like indications extended into the threads of the cylinder. An example of the most distinct crack-like indication found by visual examination at position "0" is shown in Figure 7.

Crack-Like Indication

Cyl. No. U-53388      Mag. 10x

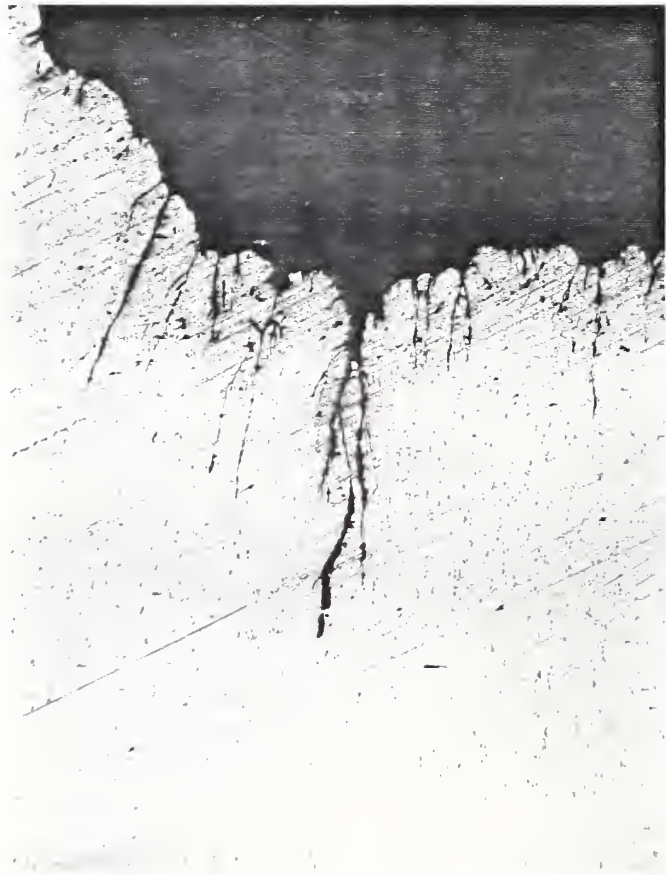
Fig. 8

Metallographic examination of the crack-like indication at position "0" was conducted with successive sections taken starting from the lower part of the inside of the neck of the cylinder. As shown in Figure 8, the crack-like indications were identified by metallographic examination to be distinct cracks. Multiple cracks and branching cracks were found that originated at the root of the metal folds in the cylinder neck. The maximum depth of the crack measured on the metallographic specimen (d) was approximately 0.043-inch and the metallographic examination showed that the crack was approximately 1/4-inch long and did not extend into the smooth drilled area outside of the neck area of the cylinder. This examination did confirm that the crack-like indications that were observed by visual examination in the neck of the cylinder were definitely cracks and that multiple cracks existed that could not be distinguished by visual observation from the folds in the neck of the cylinder. The thickness of the cylinder neck is approximately 1-1/16 inch, so as shown in Figure 9, the total depth of cracking is limited to less than 5% of the wall thickness of the neck after 12 years of service. This amount of crack growth is not considered to be critical or to degrade the structural integrity of the cylinder at this time. Due to the limited extent of cracking at position "0", the other cracks at positions "3" and "6" were not examined metallographically at this time.

Primary Crack in Cylinder Neck

Cyl. No. U-53388      Mag. 40x

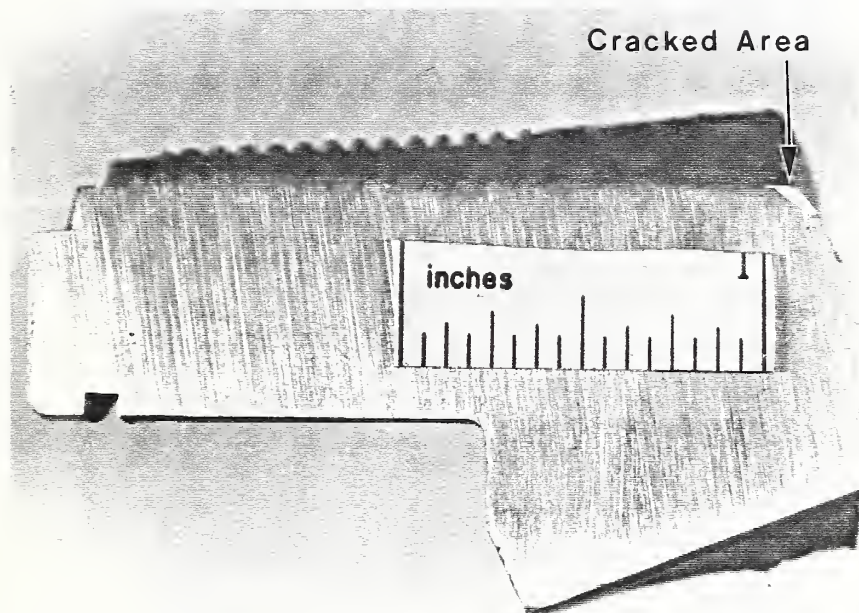
Fig. 9

Both of the DOT-3A1 1800 cylinders show evidence of numerous small cracks in the neck of the cylinder below the straight drilled part below the threads. These cracks were all less than 0.050-inch deep and were about 1/4 to 3/4 -inch long. No deep cracks were found in either of these cylinders. It is noteworthy that distinct but shallow cracks were found in cylinder number U-419288 which had been in service for only about six months. These cracks had the same general appearance as the cracks in the cylinder number U-53388 that had been in service for approximately 12 years. This indicates that the crack initiation occurs at the time of manufacturing or very shortly thereafter. There was no indication that significant crack propagation had occurred in either of these cylinders. Careful visual inspection using a bright light, a dentist mirror, and optical magnification of about 10X readily found cracks in the neck of this type of cylinders. However, it is not possible from the visual inspection alone to determine the depth of the cracks and to determine if they will significantly degrade the structural integrity of the cylinders. No evidence exists which shows that cracks of less than 0.050-inch deep (less than 5% of the thickness of the necks) will significantly reduce the strength of the cylinder or cause leaking unless substantial crack propagation occurs.

Extent of Primary Crack

Cyl. No. U-53388

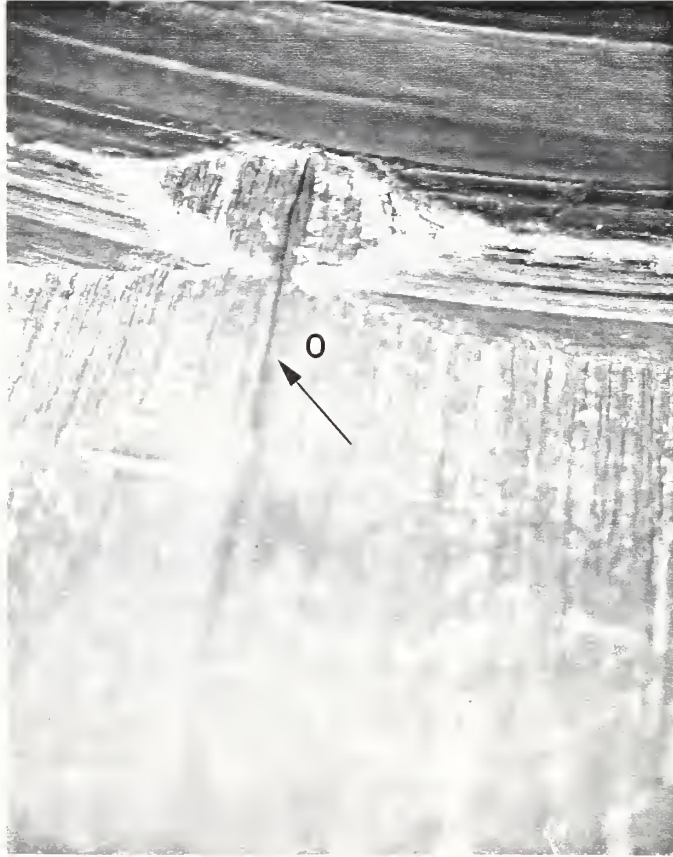
Fig. 10

This cylinder was manufactured to DOT specification 3A1 and the date of the first hydrostatic test was May 1985. The neck and threaded area of the cylinder were examined visually in early 1986 and the cylinder was removed from service at that time due to the appearance of crack-like indications in the neck. The detailed visual examination conducted as part of this investigation showed the presence of crack-like indications at positions "0", "1", "3", "5", "6", "7", "8", "10" and "11". All of the crack-like indications appeared to be approximately 1/4-inch long and none extended into the straight drilled portion of the cylinder head above the neck. An example of the most distinct crack-like indication found by visual examination at position "0" is shown in Figure 10.

Crack-Like Indication

Cyl. No. U-419288      Mag. 6x

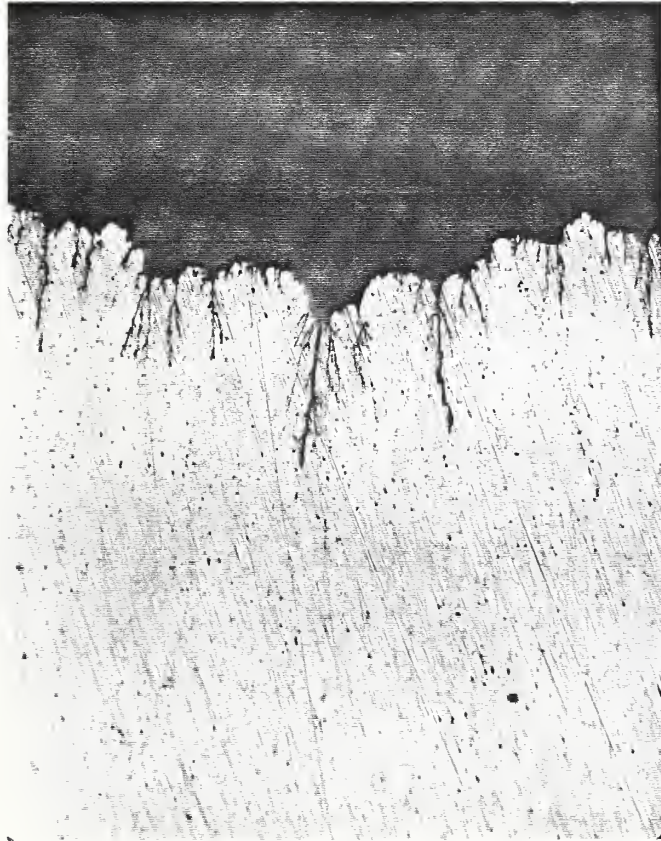
Fig. 11

Metallographic examination of the crack-like indication at position "0" was conducted with successive sections taken starting from the lower part of the inside of the neck of the cylinder. As shown in Figure 11, the crack-like indications were found by metallographic examination to be distinct cracks. Multiple cracks and branching cracks were found that originated at the root of the metal folds in the cylinder neck. The maximum depth of the crack measured on the metallographic specimen was approximately 0.022 inch and the metallographic examination showed that the crack was approximately 1/2-inch long but did not extend into the smooth drilled area outside of the neck area of the cylinder. This examination did confirm the crack-like indications that were observed by visual examination in the neck of the cylinder were definitely cracks and that multiple cracks existed that could not be distinguished by visual observation from the folds in the neck of the cylinder. The thickness of the cylinder neck is approximately 1-inch, so as shown in Figure 12, the total depth of cracking is limited to less than 5% of the wall thickness of the neck. This amount of crack growth is not considered to be critical or to degrade the structural integrity of the cylinder at this time. Due to the limited extent of cracking at position "0", the other cracks at positions "1" through "11" were not examined metallographically.

Primary Crack in Cylinder Neck  
Cyl. No. U-419288      Mag. 40x

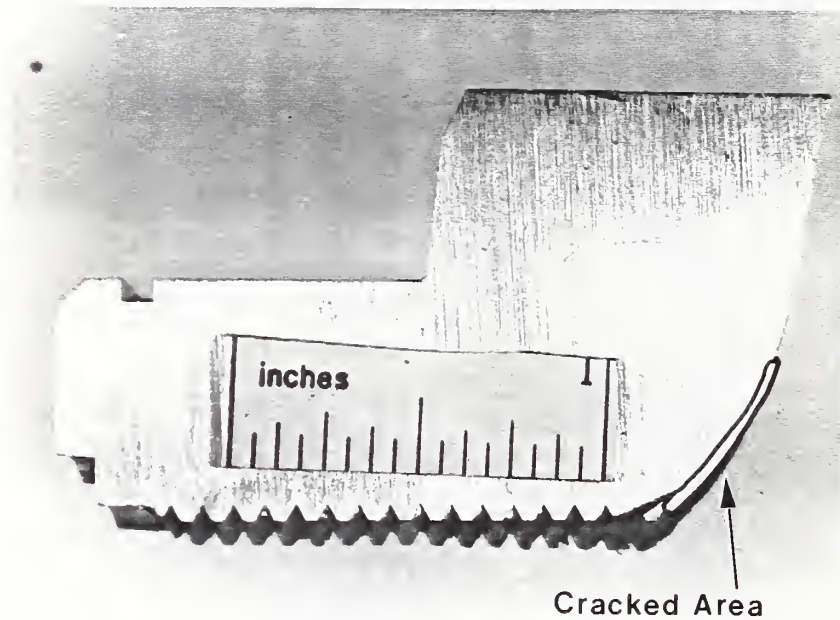
Fig. 12

Extent of Primary Crack

Cyl. No. U-419288

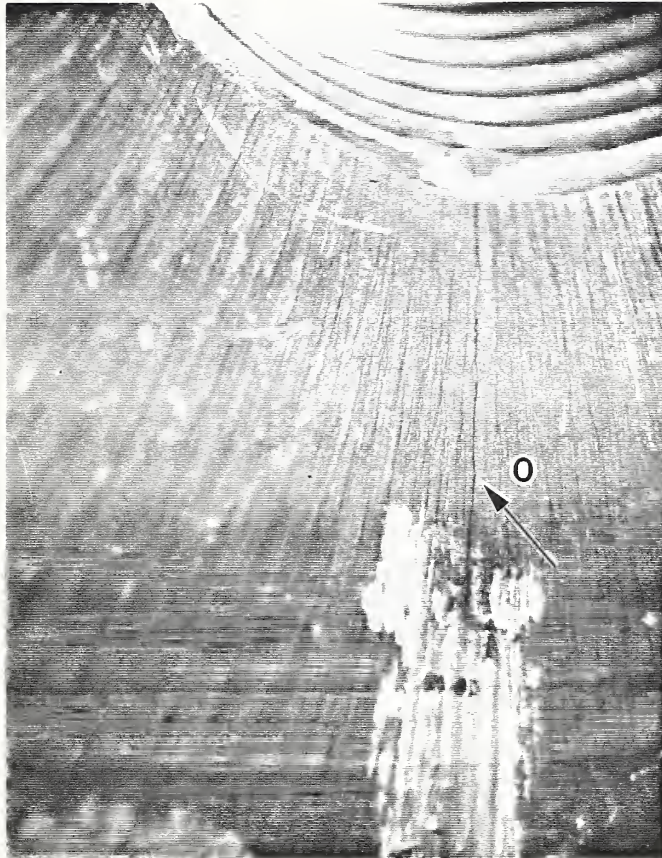
Fig. 13

The detailed visual examination conducted as part of this investigation showed crack-like indications at positions "0", "2", "3", "6", and "9". All of the crack-like indications appeared to be approximately 1/4 to 1/2-inch long and none extended into the threaded portion of the cylinder head above the neck. An example of the most distinct crack found by visual examination at position "0" is shown in Figure 13.

Crack-Like Indication

Cyl. No. T-266763      Mag. 10x

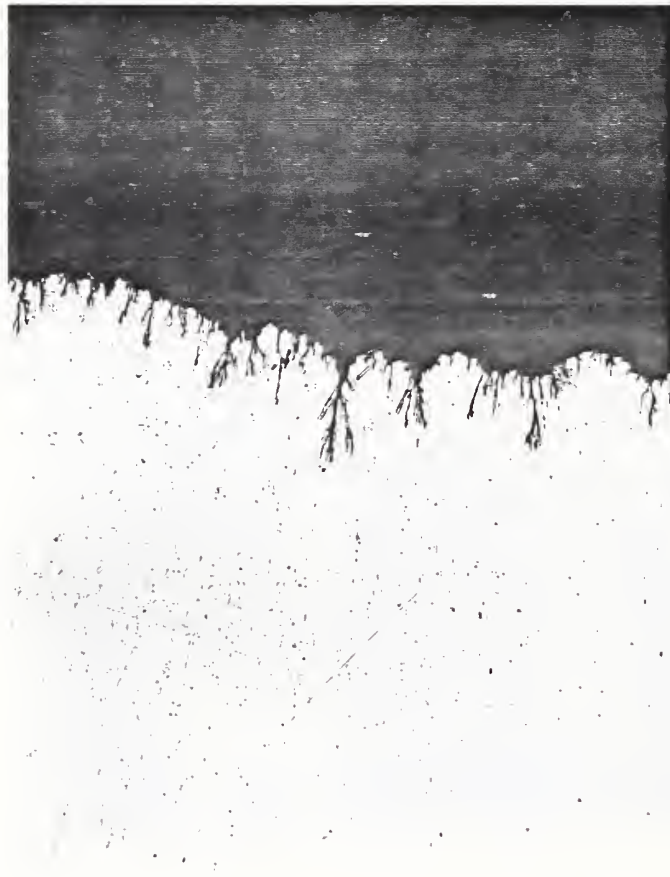
Fig. 14

Metallographic examination of the crack-like indication at position "0" was conducted with successive sections taken starting from the lower part of the inside of the neck of the cylinder. As shown in Figure 14, the crack-like indication was found by metallographic examination to be a distinct crack. Multiple cracks and branching cracks were found that originated at the root of the metal folds in the cylinder neck. The maximum depth of the crack measured on the metallographic specimen (d) was approximately 0.023-inch and the metallographic examination showed that the crack was approximately 1/2-inch long but did not extend into the threaded area outside of the neck area of the cylinder. This examination confirmed that crack-like indications that were observed by visual examination in the neck of the cylinder were definitely cracks and that multiple cracks existed that could not be distinguished by visual observation from the folds in the neck of the cylinder. The maximum thickness of the cylinder neck is approximately 1-inch, so as shown in Figure 15, the total depth of cracking is limited to less than 5% of the wall thickness of the neck. This amount of crack growth is not considered to be critical or to degrade the structural integrity of the cylinder unless further crack growth occurs. Due to the limited extent of cracking at position "0", the other cracks at positions "2" through "9" were not examined metallographically at this time. Only metallographic examination was done on this cylinder (no three-point bend specimens were tested).

Primary Crack in Cylinder Neck

Cyl. No. T-266763      Mag. 40x

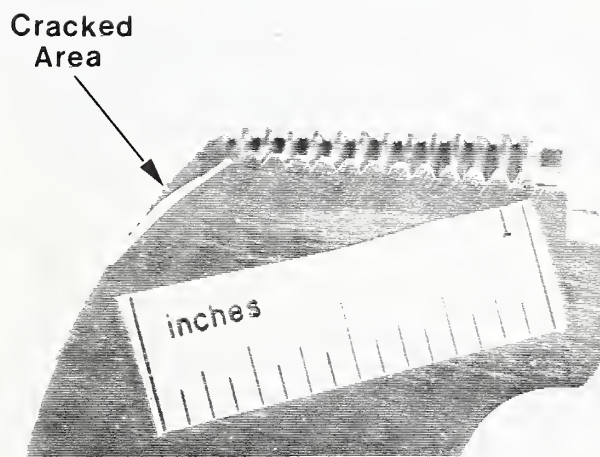
Fig. 15

Extent of Primary Crack

Cyl. No. T-266763

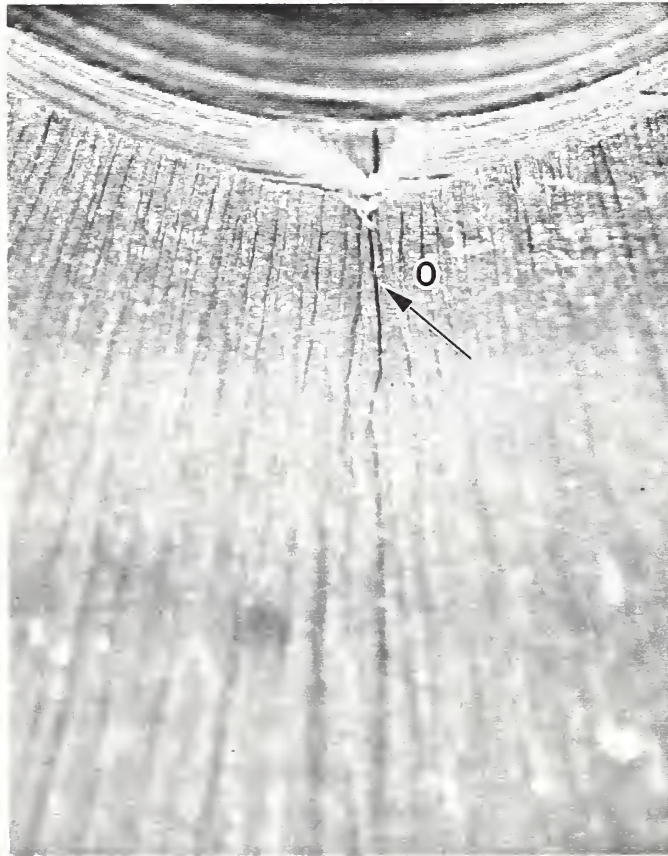
Fig. 16

Visual examination showed the presence of crack-like indications at positions "0", "2", "3", "5", "6", "7", "9" and "10". The crack-like indication at position "0" was about 1-inch long extended into the first thread and the rest of the crack-like indications were approximately 1/4- to 1/2-inch long and did not extend into the threaded portion of the cylinder head above the neck. An example of the most distinct crack found by visual examination at position "0" is shown in Figure 16.

Crack-Like Indication

Cyl. No. T-262190      Mag. 10x

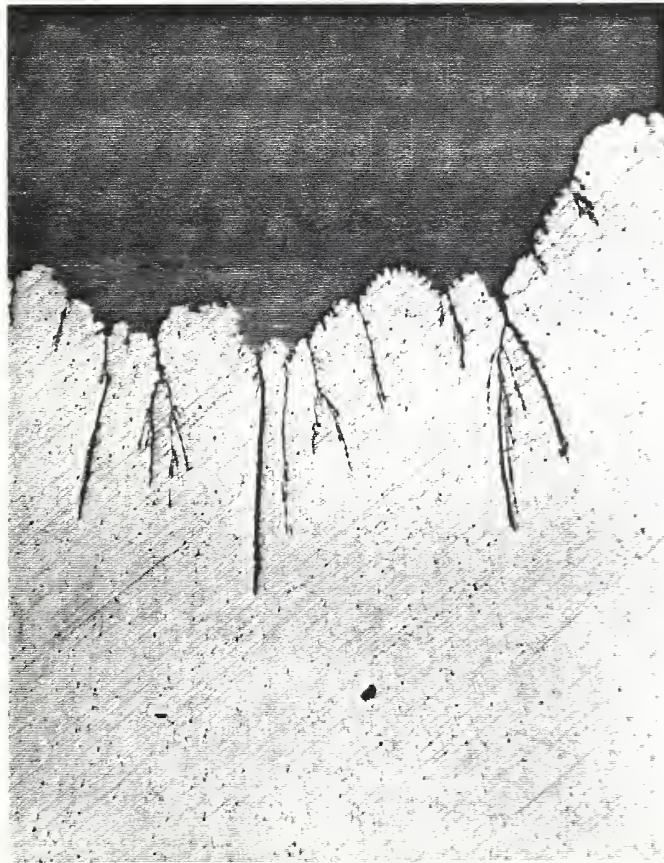
Fig. 17

Metallographic examination of the crack-like indication at position "6" was conducted with successive sections taken starting from the lower part of the inside of the neck of the cylinder. As shown in Figure 17, the crack-like indications were found by metallographic examination to be distinct cracks. Multiple cracks and branching cracks were found that originated at the root of the metal folds in the cylinder neck. The maximum depth of the crack at position "6" that was measured on the surface of the metallographic specimen (d) was approximately 0.039-inch and the metallographic examination showed that the crack was approximately 3/8-inch long but did not extend into the threaded area outside of the neck area of the cylinder. This examination did confirm that the crack-like indications were definitely cracks and that multiple cracks existed that could not be distinguished by visual observation from the folds in the neck of the cylinder. The maximum thickness of the cylinder neck is approximately 1-1/8-inch, so as shown in Figure 18, the total depth of cracking is limited to less than 5% of the wall thickness of the neck. This amount of crack growth is not considered to be critical or to degrade the structural integrity of the cylinder at this time. Due to the limited extent of cracking at position "6", the other cracks at positions "2" through "10" were not examined metallographically at this time.

Primary Crack in Cylinder Neck  
Cyl. No. T-262190      Mag. 40x

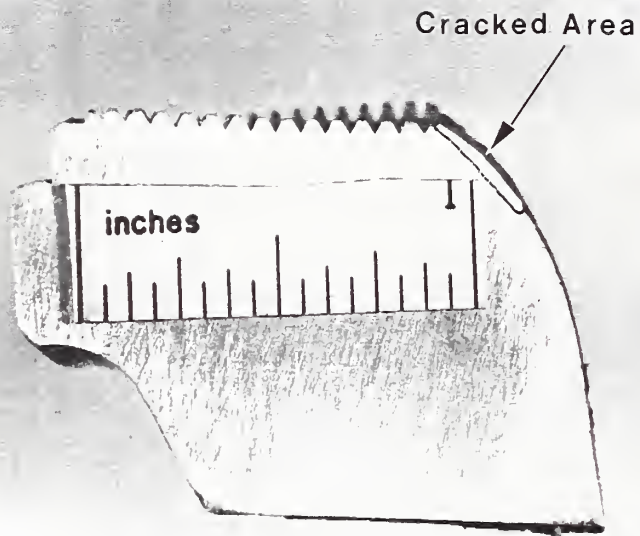
Fig. 18

Extent of Primary Crack

Cyl. No. T-262190

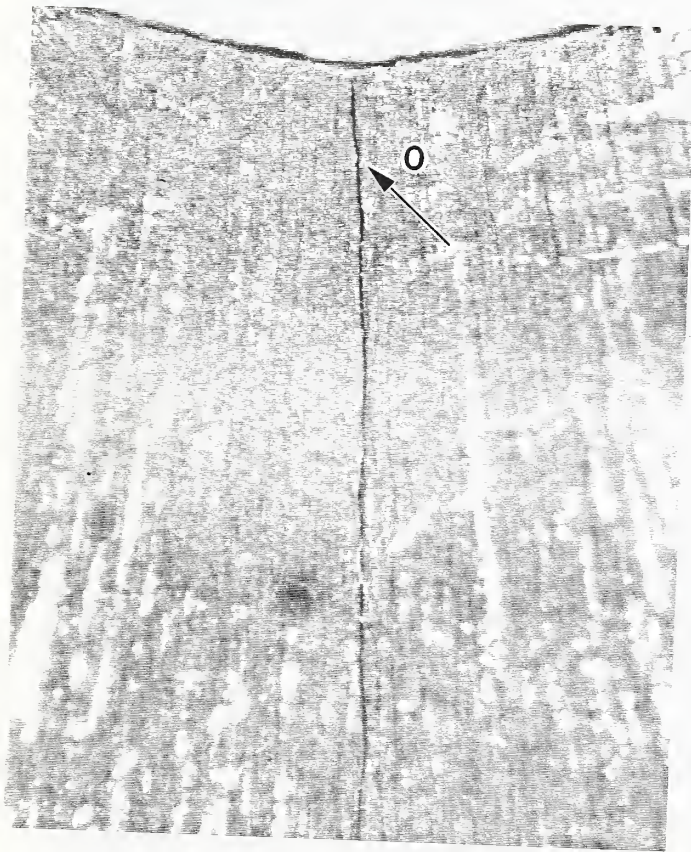
Fig. 19

Visual examination showed the presence of crack-like indications at positions "0", "3" and "8". The crack-like indication at position "0" was about 1-inch long. The crack-like indications at positions "3" and "8" were approximately 1/2-inch long. None of the crack-like indications extended into the threaded portion of the cylinder head above the neck. An example of the most distinct crack-like indication found by visual examination at position "0" is shown in Figure 19.

Crack-Like Indication

Cyl. No. T-256255      Mag. 12x

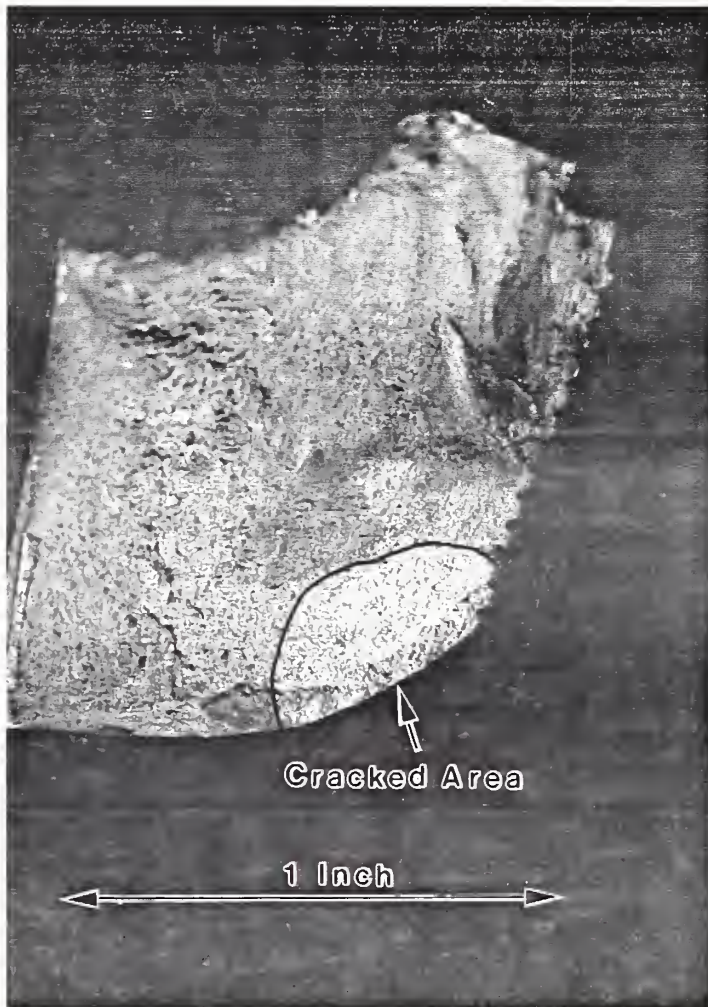
Fig. 20

A three point bend specimen was made at position "0" and broken open to delineate the crack. This crack was very distinct as shown in Figure 20. The crack was about 0.30-inch deep and 5/8-inch long. The maximum thickness of the cylinder neck is approximately 1-inch, so the crack is nearly 1/3 of the way through the neck of the cylinder. This crack clearly shows the extent of cracking that can occur in these DOT-3Al type cylinders and shows that even a crack of this depth does not extend into the threaded area of the neck and would not be detected just by looking only at the threaded area of the cylinder. This was the largest crack that was detected in the eight cylinders that were examined in this investigation. An analysis of the structural significance of this crack was not made but it is reasonable to expect that a crack of this depth would grow to the extent that leakage of the cylinder would occur before the next required hydrostatic test. No metallographic examination was done of the crack at position "0". The scanning electron microscope examination that was done of the fracture surface and did indicate that the crack growth was by the slow crack growth mode previously found in the high pressure aluminum cylinders (Ref.2).

The results of these tests show conclusively that substantial cracking can occur in DOT-3Al cylinders at a service pressure of 2216 psi after only five years of service. This is particularly well shown by the substantial crack found in cylinder No. T-256255. Other cracks in the same cylinder and in the other two cylinders examined were less than 0.050-inch and are not believed to be structurally significant at this time but may be initiation sites for crack propagation that in the future will degrade the structural integrity of the cylinder. From the visual inspections done in this investigation, including the

Extent of Primary Crack  
Three-Point Bend Specimen

Cyl. No. T-256255

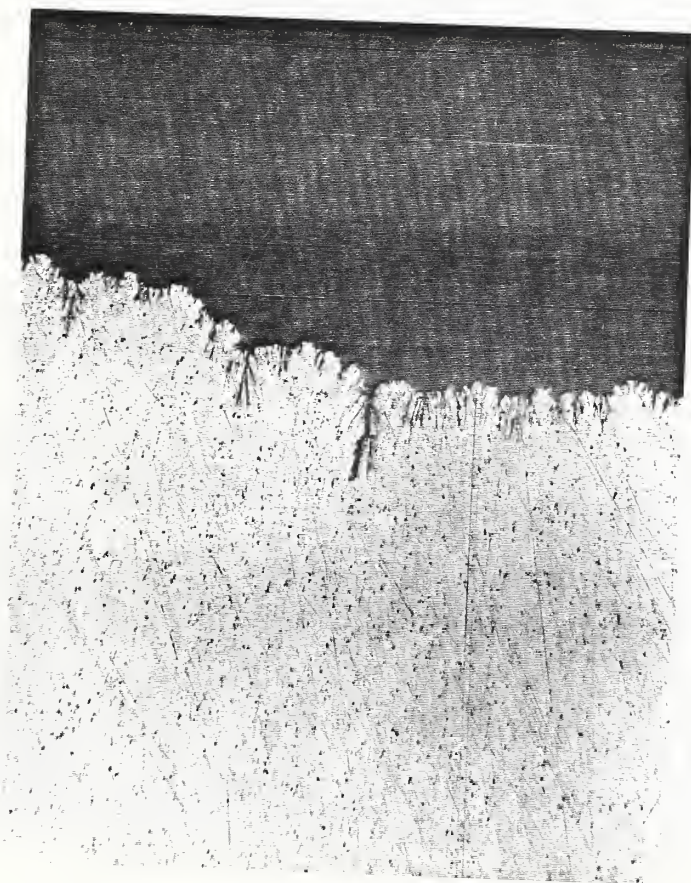
Fig. 21

Metallographic examination of the crack at position "3" was conducted with successive sections taken starting from the lower part of the inside of the neck of the cylinder. As shown in Figure 21, the crack-like indications were identified by metallographic examination to be distinct cracks. Multiple cracks and branching cracks were found that originated at the root of the metal folds in the cylinder neck. The maximum depth of the crack measured on the metallographic specimen (d) at position "3" was approximately 0.020-inch deep and the metallographic examination showed that the cracks were approximately 3/4-inch long but did not extend into the threaded area outside of the neck area of the cylinder. This examination did confirm that the crack-like indications that were observed by visual examination in the neck of the cylinder were definitely cracks and that multiple cracks existed that could not be distinguished by visual observation from the fold in the neck of the cylinder.

Crack at Position '3'

Cyl. No. T-256255      Mag. 40x

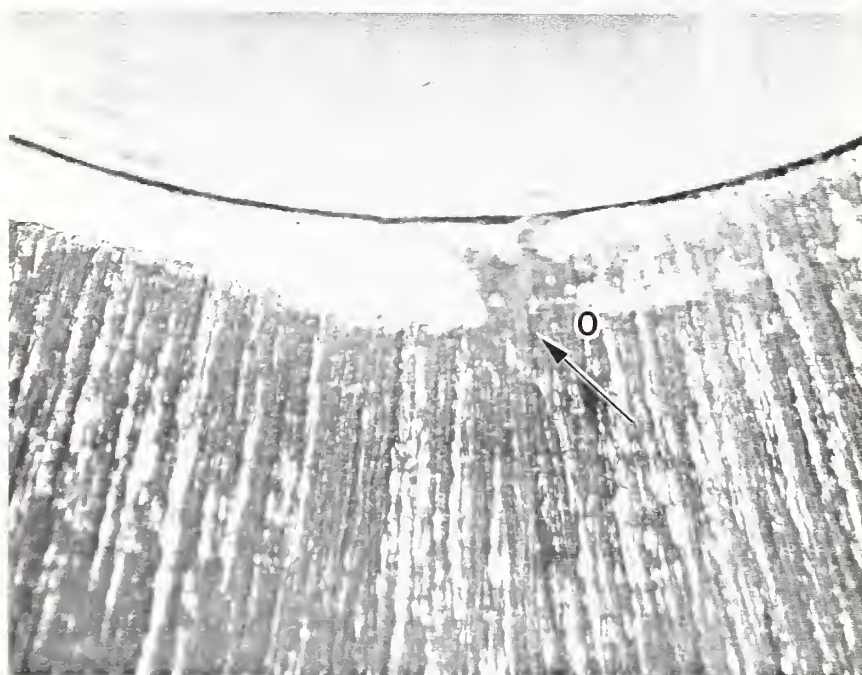
Fig. 22

Visual examination showed the presence of crack-like indications at positions "0", "6" and "10". All the crack-like indications were approximately 1/2-inch long and none extended into the threaded portion of the cylinder head above the neck. An example of the most distinct crack found by visual examination at position "0" is shown in Figure 22. No three point bend specimens were taken from this cylinder.

Crack-Like Indication

Cyl. No. WK-31111      Mag. 12x

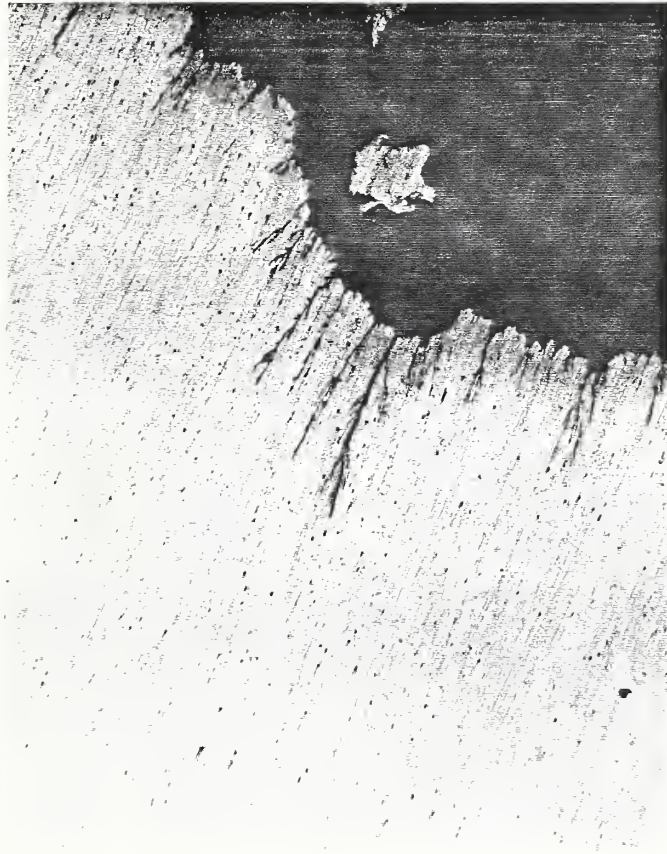
Fig. 23

Metallographic examination of the crack-like indications at position "0" was conducted with successive sections taken starting from the lower part of the inside of the neck of the cylinder. As shown in Figure 23 distinct cracks were found in the wall of the neck region of the cylinder. Multiple cracks and branching cracks were found that originated at the root of the metal folds in the cylinder neck. The maximum depth of the crack at position "0" that was measured on the metallographical specimen was approximately 0.031-inch and the metallographic examination showed that the crack was approximately 1/4-inch long but did not extend into the threaded area outside of the neck area of the cylinder. This examination confirmed the crack-like indications which were observed by visual examination in the neck of the cylinder were definitely cracks and that multiple cracks existed that could not be distinguished by visual observation from the fold in the neck of the cylinder. The maximum thickness

Primary Crack in Cylinder Neck  
Cyl. No. WK-31111      Mag. 40x

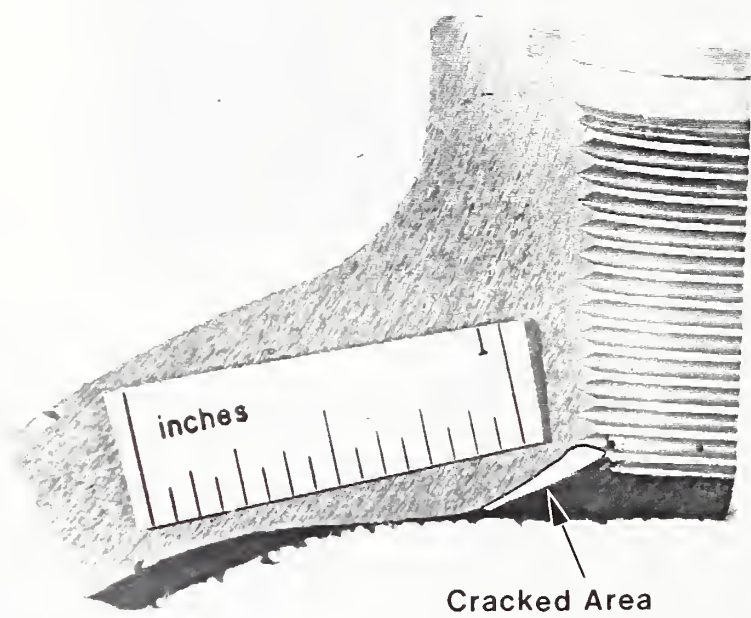
Fig. 24

of the cylinder neck is approximately 3/4-inch, so as shown in Figure 24, the total depth of cracking is limited to less than 5% of the wall thickness of the neck. This amount of crack growth is not considered to be critical or to degrade the structural integrity of the cylinder at this time. Due to the limited extent of cracking at position "0", the other crack-like indications at positions "6" and "10" were not examined metallographically at this time.

Extent of Primary Crack

Cyl. No. WK-31111

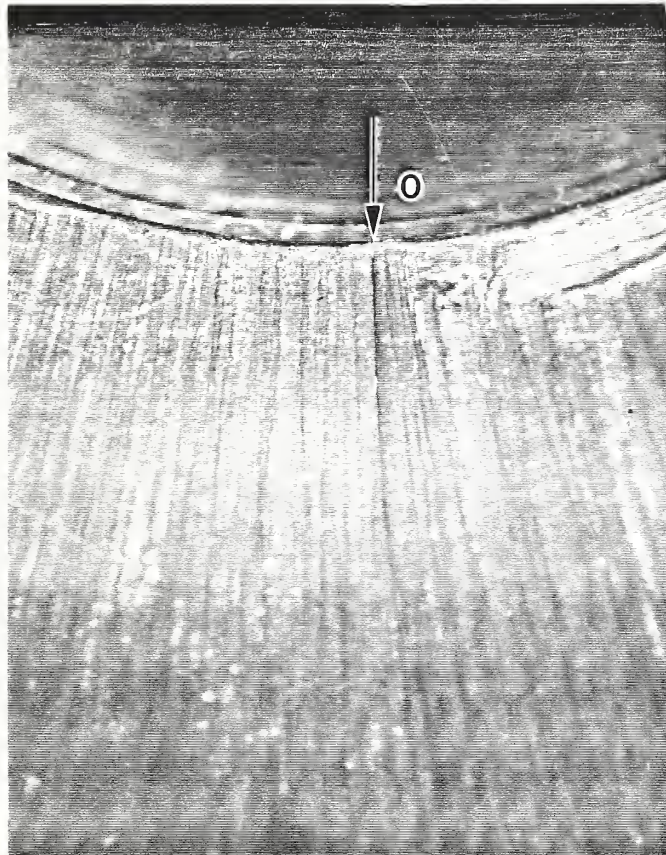
Fig. 25

Visual examination conducted as part of this investigation showed the presence of crack-like indications at positions "0" and "2". Both crack-like indications were approximately 1/2-inch long. Neither of the crack-like indications extended into the threaded portion of the cylinder head above the neck. An example of the most distinct crack found by visual examination at position "0" is shown in Figure 25. A three point bend specimen was cut from the cylinder at position "0" and tested in an attempt to delineate the crack at this position. This specimen did not fracture at the correct position to determine the crack size in this manner. However, the size of the crack at this position could still be determined by metallographic examination.

Crack-Like Indication

Cyl. No. WK-32699      Mag. 10x

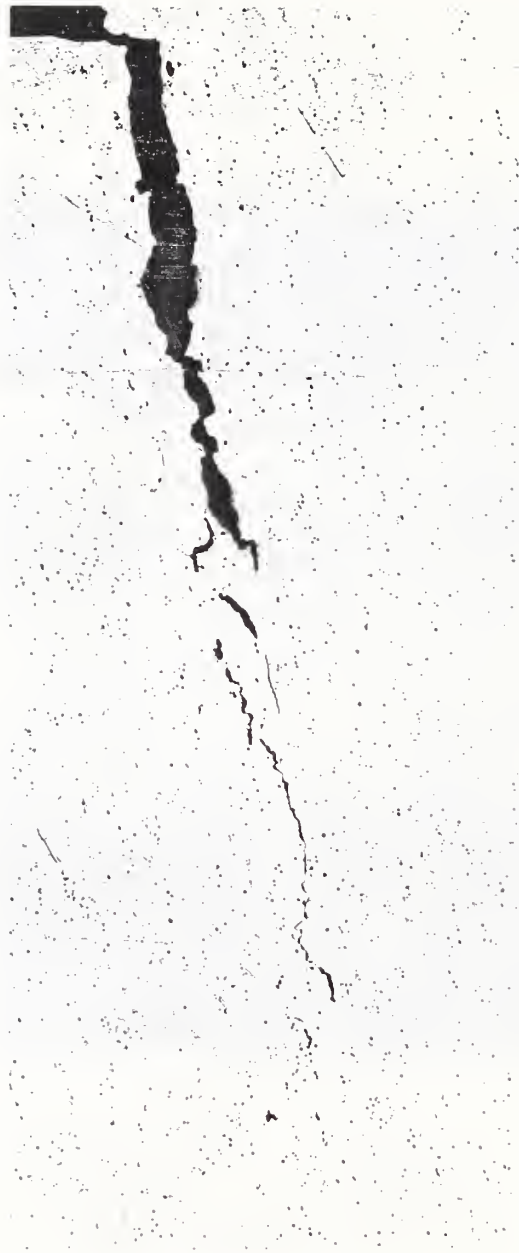
Fig. 26

Metallographic examination of the crack-like indication at position "0" was conducted with successive sections taken starting from the lower part of the inside of the neck of the cylinder. As shown in Figure 26, the crack-like indication was identified by metallographic examination to be a distinct crack. Multiple cracks and branching cracks were found that seemed to originate at the root of the metal folds in the cylinder neck. The maximum depth of the crack measured on the metallographic specimen (d) at position "0" was approximately 0.126-inch and the metallographic examination showed that the cracks were approximately 5/8-inch long but did not extend into the threaded area outside of the neck area of the cylinder. This is a substantial crack and indicates that substantial crack propagation had occurred during the three years that the cylinder was in service. The maximum thickness of the cylinder neck is approximately 3/4-inch, so as shown in Figure 27, the total depth of cracking was approximately 8% of the thickness of the neck. This crack clearly shows the extent of cracking that can occur in this type of hoop wrapped cylinder and shows that even a crack of this length and depth does not extend into the threaded area of the neck and would not be detected just by only inspecting the threads of the cylinder. An analysis of the structural significance of this crack was not made at this time but it is expected that a crack of this depth would grow to the extent that leakage of the cylinder could occur before the next required hydrostatic test. This examination did confirm that the crack-like indications observed by visual examination in the neck of the cylinder were definitely cracks and that multiple cracks

existed that could not be distinguished by visual observation from the fold in the neck of the cylinder. The other crack at position "2" was not examined metallographically at this time.

Primary Crack in Cylinder Neck  
Cyl. No. WK-32699      Mag. 40x

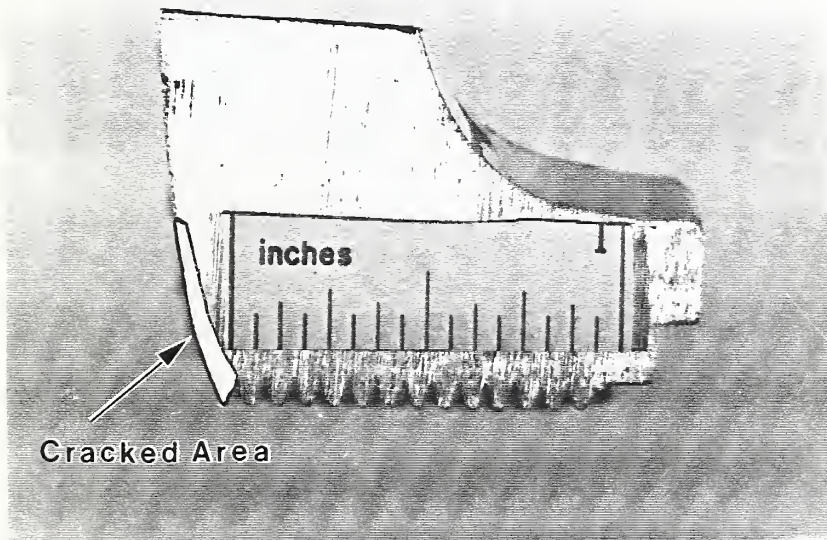
Fig. 27

Extent of Primary Crack

Cyl. No. WK-32699

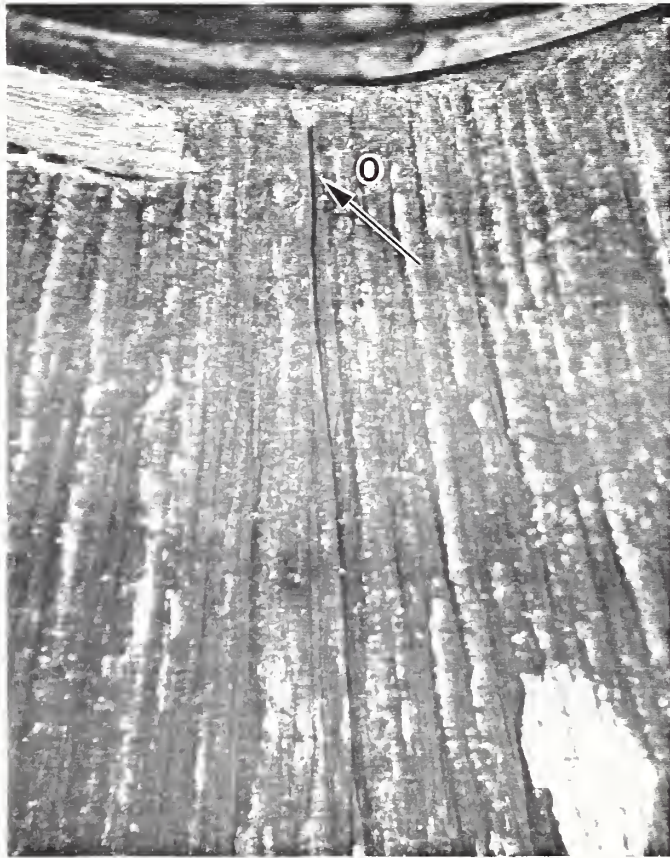
Fig. 28

The detailed visual examination conducted as part of this investigation showed the presence of crack-like indications at positions "0," "1," "2," "3," "5," "6" "8", "9", "10", and "11. The crack-like indications were approximately 1/2-inch long and that none extended into the threaded area of the cylinder head above the neck. An example of the most distinct crack-like indication found by visual examination at position "0" is shown in Figure 28. A three point bend specimen was cut from the cylinder at position "0" and tested in an attempt to delineate the crack at this position. This specimen did not fracture at the correct position to determine the crack size in this manner. However, the size of the crack at this position could still be determined by metallographic examination.

Crack-Like Indication

Cyl. No. WK-31631      Mag. 12x

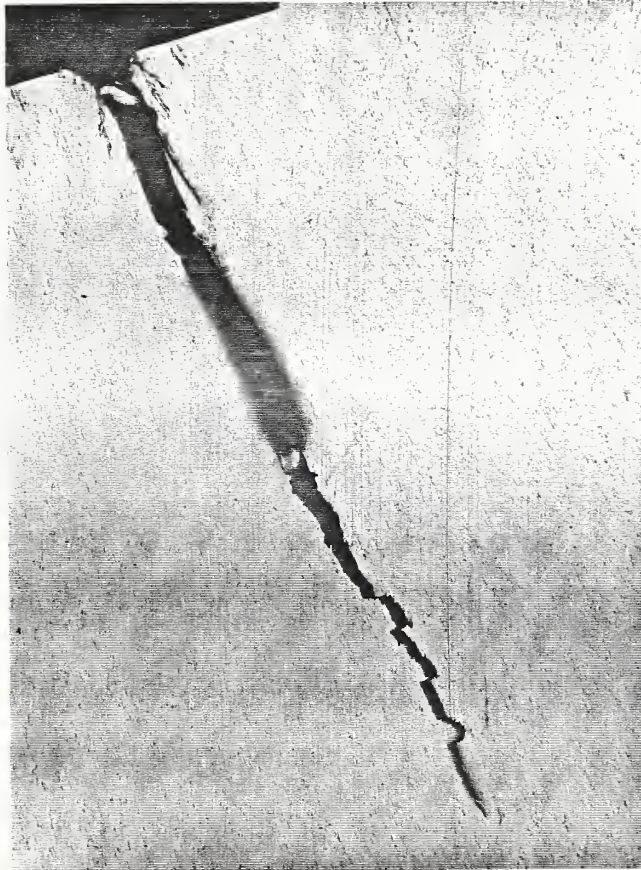
Fig. 29

Metallographic examination of the crack-like indication at position "0" was conducted with successive sections taken starting from the lower part of the inside of the neck of the cylinder. As shown in Figure 29, distinct cracks were found in the wall of the neck region of the cylinder. Multiple cracks and branching cracks were found that originated at the root of the metal folds in the cylinder neck. The depth of the largest crack measured on the metallographic specimen (d) at position "0" was approximately 0.236-inch and the metallographic examination showed that the crack was approximately 5/8-inch long but did not extend into the threaded area outside of the neck area of the cylinder. This is a substantial crack and indicates that substantial crack propagation has occurred during the three years that the cylinder was in service. The maximum thickness of the cylinder neck is approximately 3/4-inch, so as shown in Figure 30, the total depth of cracking was approximately 15% of the thickness of the neck. This crack clearly shows the extent of cracking that can occur in these hoop wrapped cylinders and shows that even a crack of this depth does not extend into the threaded area of the neck and would not be detected by only looking at the threads of the cylinder. An analysis of the structural significance of this crack was not made at this time but it is expected that a crack of this depth would be expected to grow to the extent that leakage of the cylinder would occur before the next required hydrostatic test. This examination did confirm that the crack-like indications observed by visual examination in the neck of the cylinder were definitely cracks and that multiple cracks existed that could not be distinguished by visual observation from the fold in the neck of the cylinder. The other crack-like indications at positions "1" through "11", were not examined metallographically at this time.

Primary Crack in Cylinder Neck  
Cyl. No. WK-31631      Mag. 18x

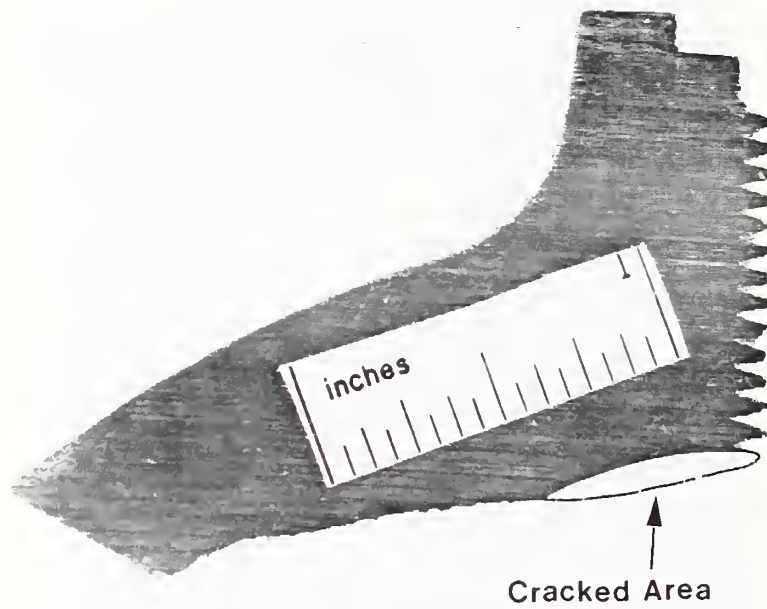
Fig. 30

Two of the three DOT-E-7235 2216 hoop-wrapped cylinders showed significant cracks that were from 8% to 15% through the thickness of the neck of the cylinder after only three years of normal service. This indicates that this cylinder series is definitely subject to crack propagation during normal service.

Extent of Primary Crack

Cyl. No. WK-31631
