# Report to Congress on the Structural Assessment of the New U.S. Embassy Office Building in Moscow

Center for Building Technology  
National Engineering Laboratory  
National Bureau of Standards  
Gaithersburg, MD 20899

April 15, 1987

**NBSIR 87-3636**

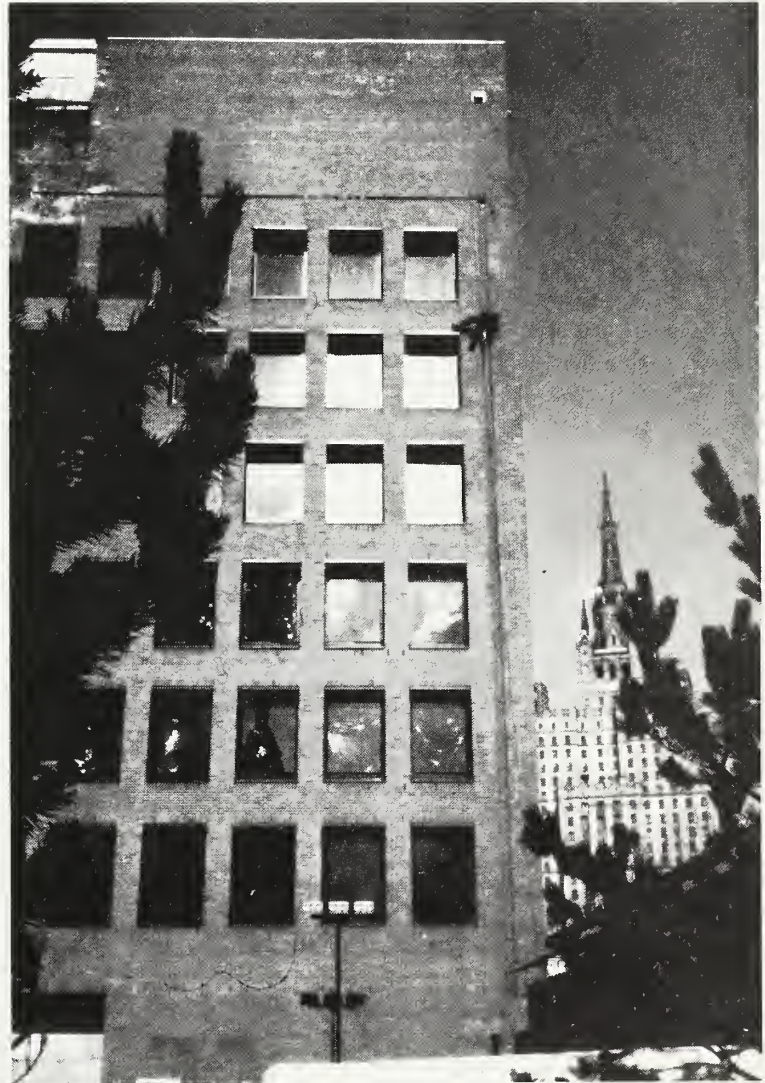
***COVER PHOTOGRAPH: NBS Engineer Inspecting the South Elevation,  
East Corner, of the New U.S. Embassy  
Office Building***

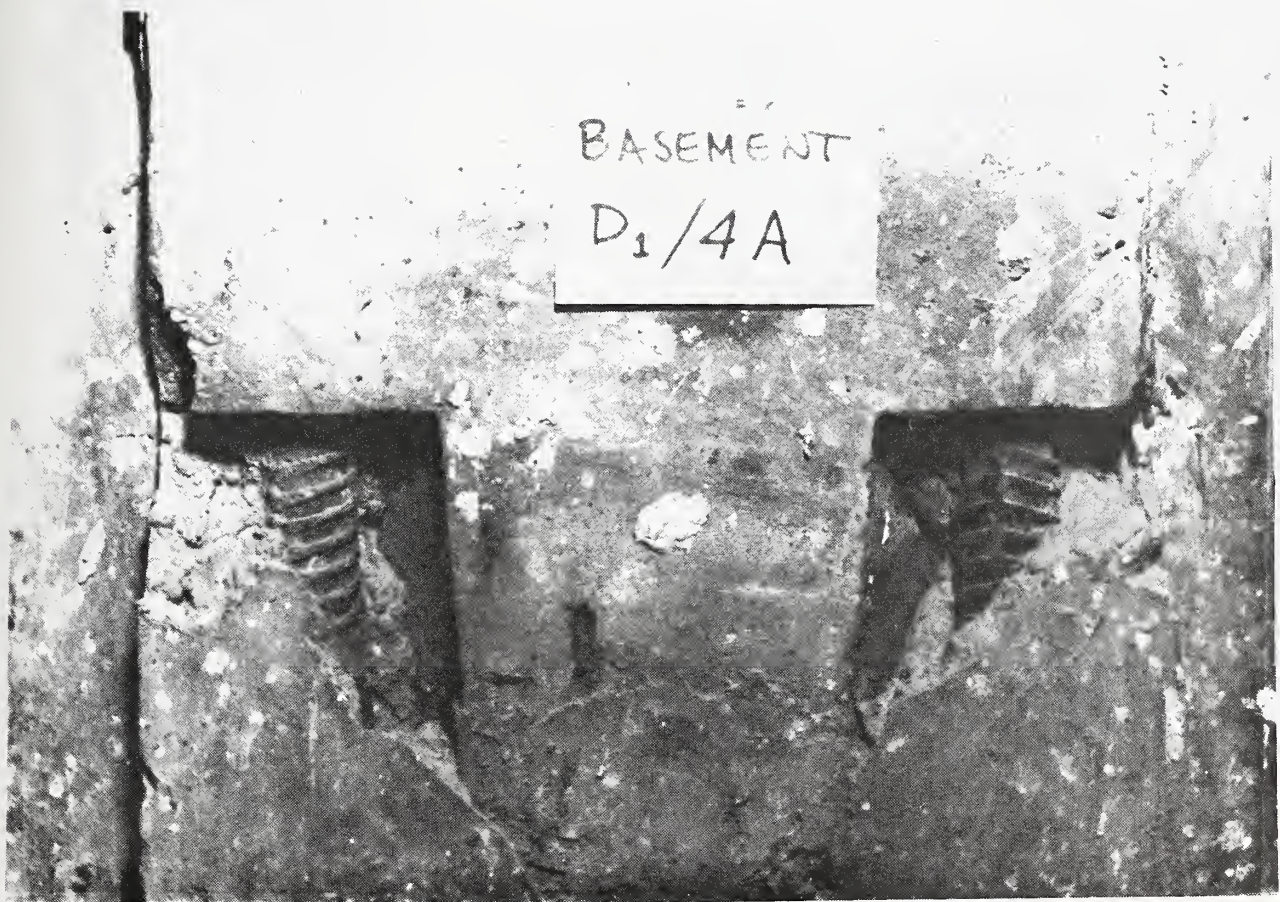
The as-built conditions of some joints between precast elements were found to have significant deviations from the design. Notable among these were the incompletely grouted and concreted joints between segments of reinforced concrete columns. Some of these were immediately visible as shown in figure 12. Other defective joints were concealed by surface concreting of the joint but were revealed by drilling and viewing with a borescope. Figure 13 shows an interior view of an ungrouted joint and indications of distress at the seating button at the end of the column

Figure 12 DEFECTIVE JOINT FOR COLUMN D1/4A

Site investigation showed that the integrity of all joints of reinforced concrete columns is questionable. Laboratory studies showed that failure to place grout and concrete in the joint severely reduces the column strength. Each such joint should be exposed and drilled to determine whether the joint area is filled with grout and concrete, and each deficient joint should be filled. The estimated cost for this remedial measure is \$132,000.

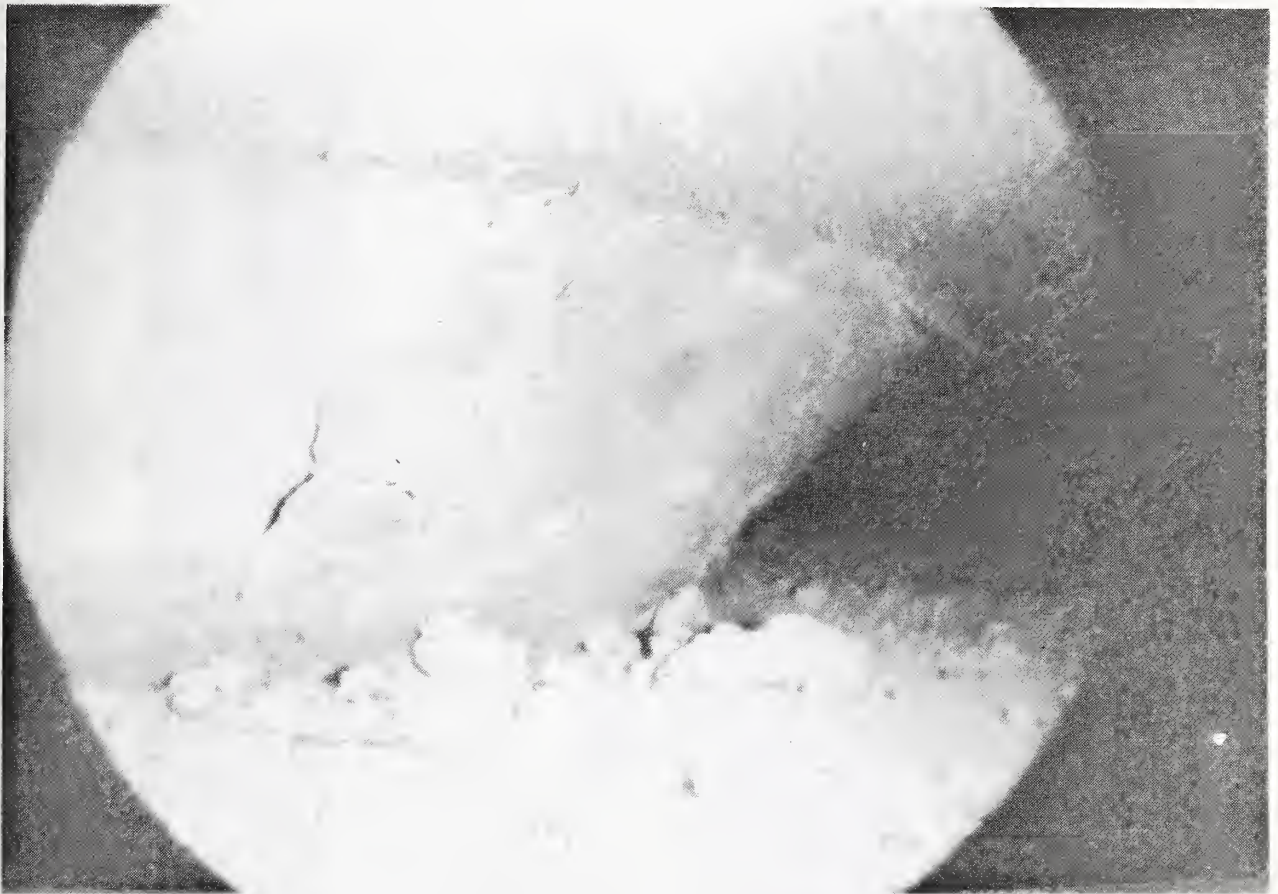
Figure 13 BORESCOPE PHOTOGRAPH INSIDE JOINT SHOWING EVIDENCE OF DISTRESS IN SEATING "BUTTON" DUE TO LACK OF GROUT

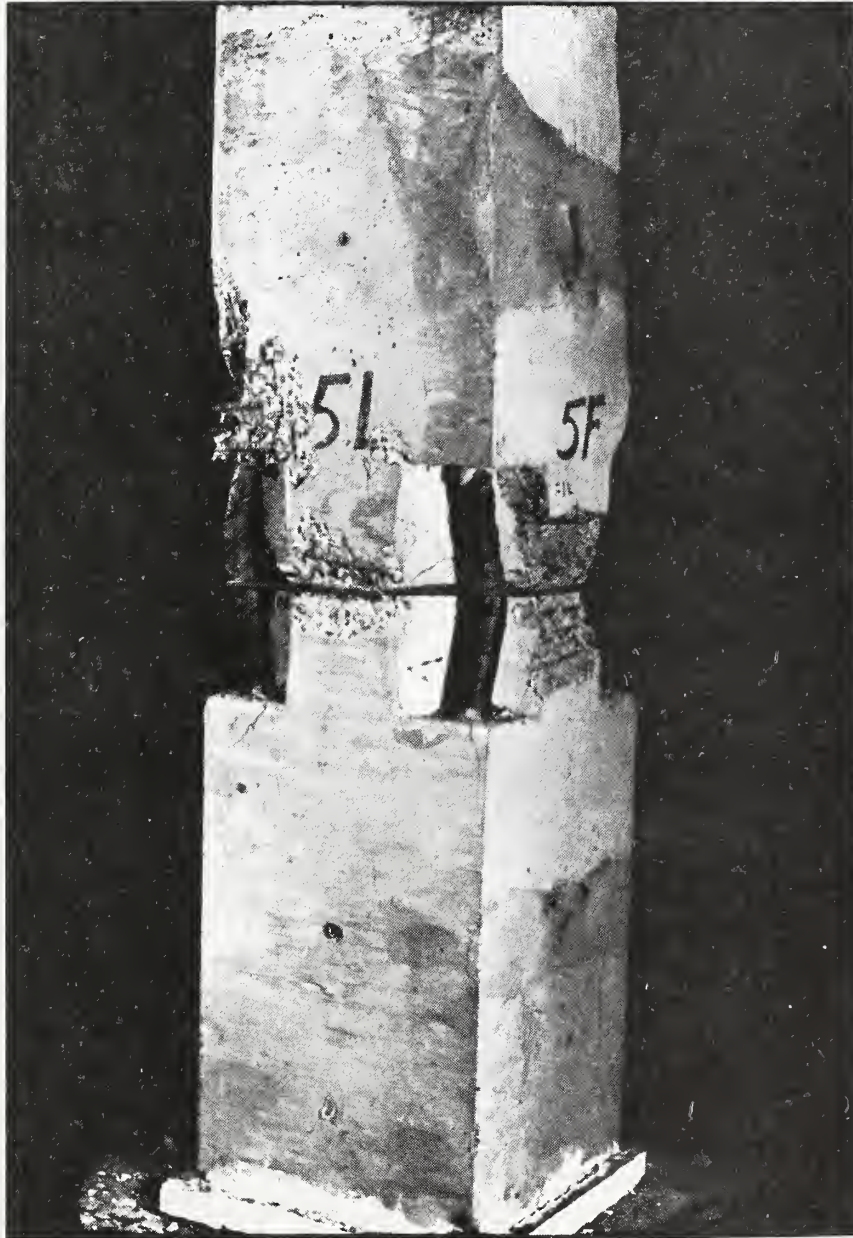
segment. Laboratory tests at NBS on facsimilies of complete and incomplete joints, figure 14, show that strength is degraded as much as 56 percent by incompletely grouted and concreted joints. Deficiencies also were found in completion of the vertical joints, figure 15, and horizontal joints, figure 16, between shear wall panels. Few of the shear wall joints investigated were properly grouted and concreted. The bond between the topping and the floor planks was assessed by sounding and coring at a number of locations. In no core sample was the topping soundly bonded to the floor plank.

Figure 14 NBS TEST OF COLUMN JOINT

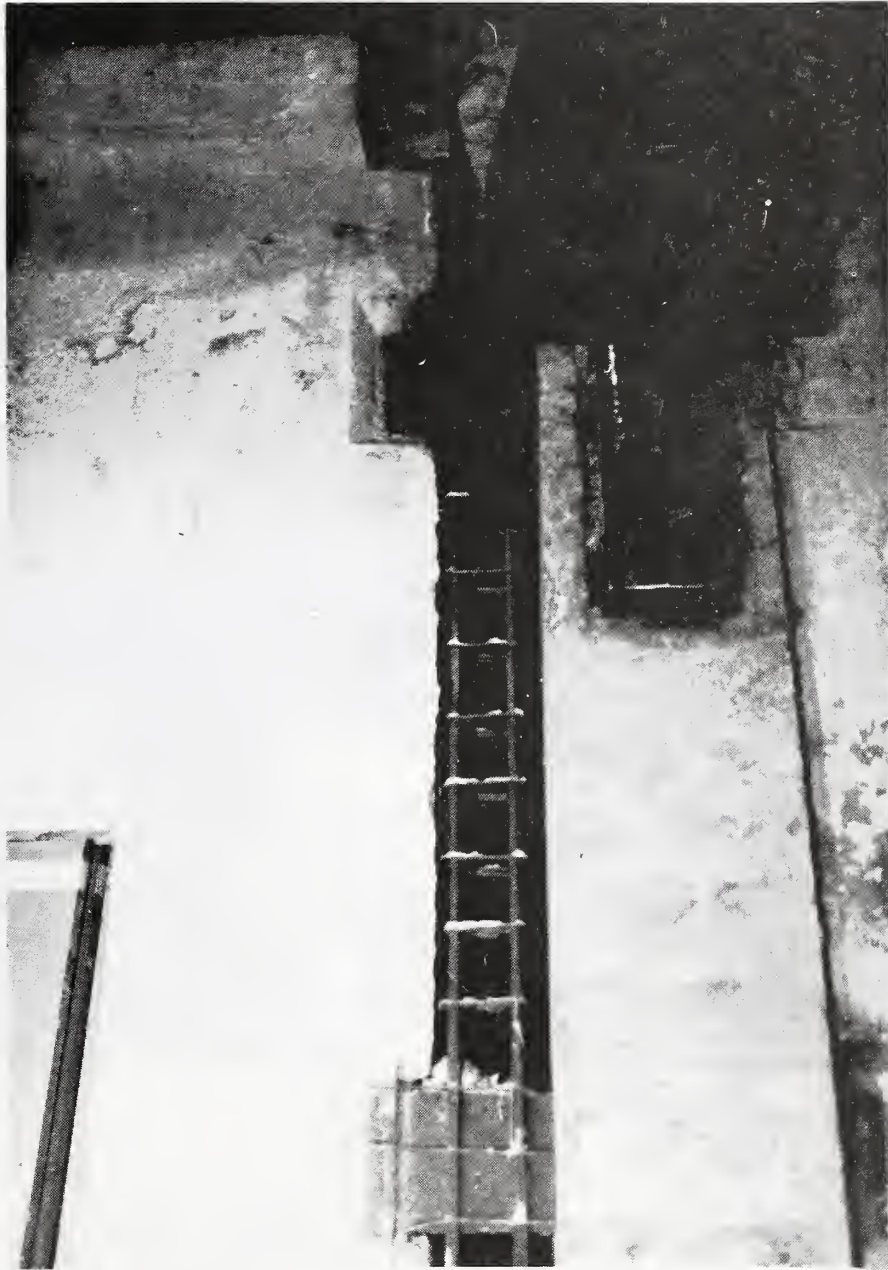
Figure 15 OPEN SHEAR WALL TO COLUMN JOINT  
AT COLUMN

Site investigation showed that few observed shear wall joints were grouted and concreted in accord with the plans and with the requirements for appropriate strength and stiffness. Each vertical and horizontal joint of each shear wall panel should be exposed, inspected for complete grouting and concreting of the joint, and filled if needed. The estimated cost for this remedial measure is \$155,000.

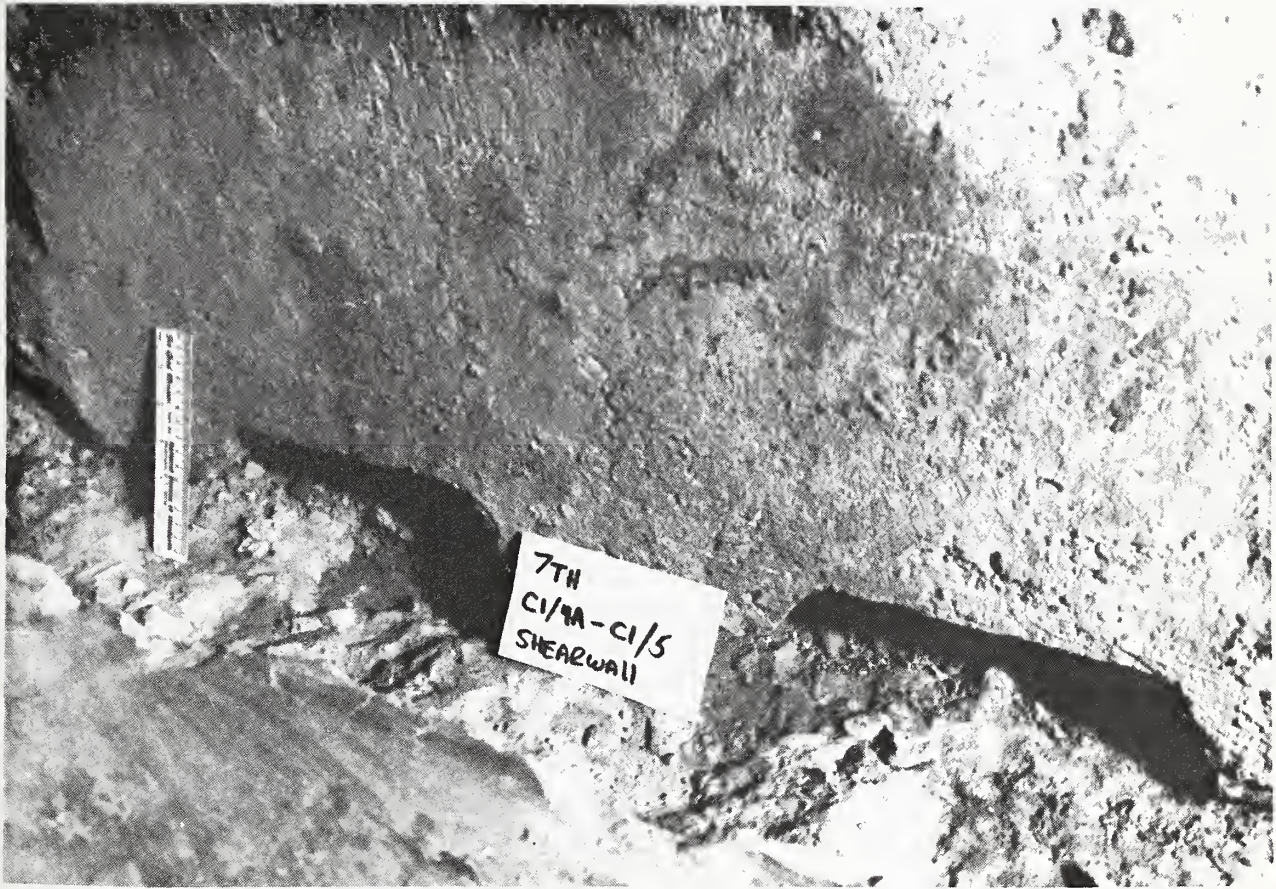
Figure 16 INCOMPLETE FILLING OF A HORIZONTAL SHEAR WALL JOINT

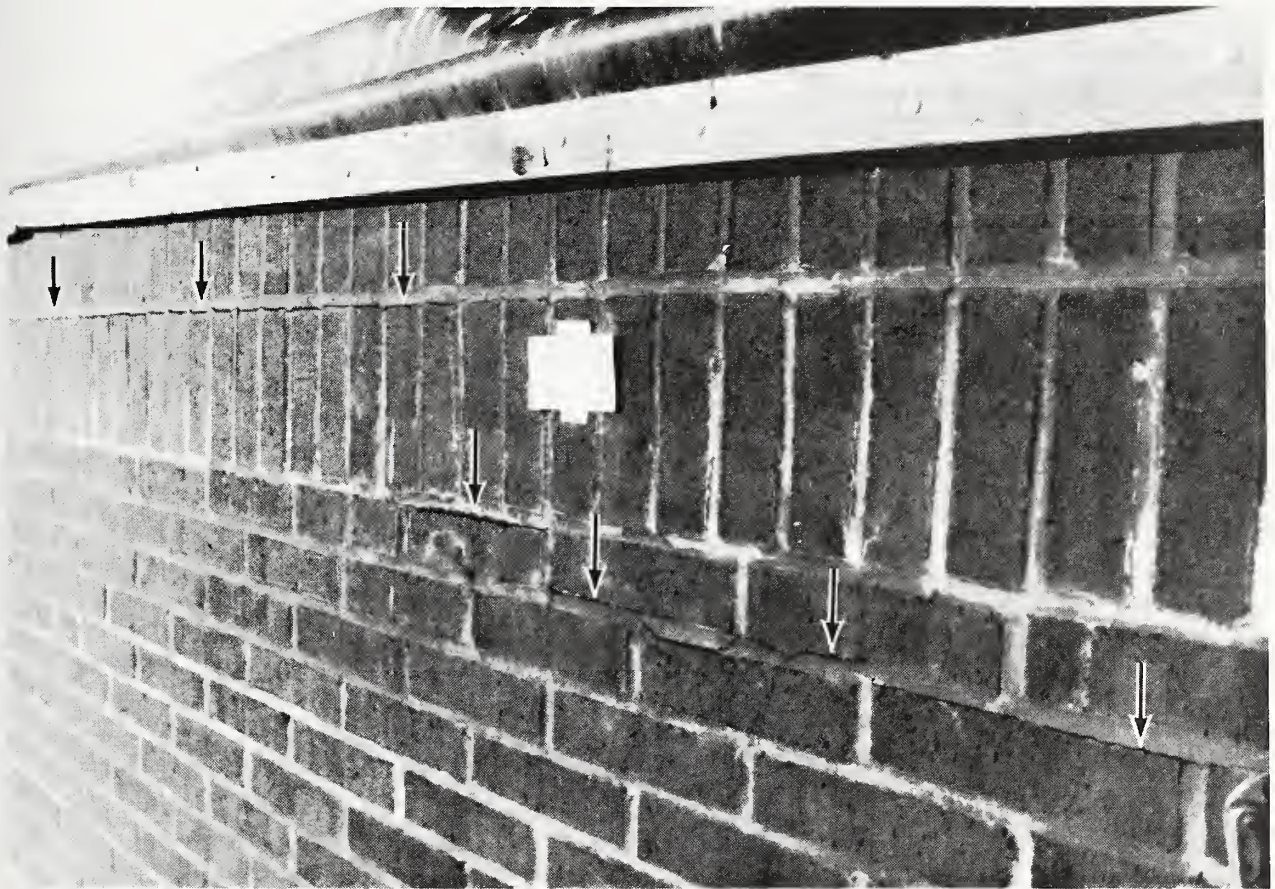
A detailed visual examination of the exterior brick masonry walls was performed from ground level and by descending the building (see cover photograph). The exterior walls showed vertical cracking on all four sides of the building. An example is shown in figure 17. Vertical cracks on two of the corners run from ground elevation to the top of the seventh story. Vertical cracks were seen in five piers between windows at the second story columns. The most severe horizontal cracking occurs in the parapet walls, all of which have horizontal cracks either on the inside, the outside, or on both sides. An example is shown in figure 18. Vertical cracks also were noted in the parapet walls. The penthouse walls show both horizontal and vertical cracks, but they are fewer in number and smaller in size than the parapet cracks.

Figure 18 HORIZONTAL CRACKS IN SOUTH FACE OF  
PARAPET WALL

Parapet walls should be taken down to a level below substantial horizontal cracking, anchored to the structural system below, and restored with properly designed and constructed masonry. The estimated cost for this remedial action is \$385,000.
