# The Whittier Narrows Earthquake of October 1, 1987

## A Reconnaissance Report

By H. S. Lew

NBSIR 87-3667

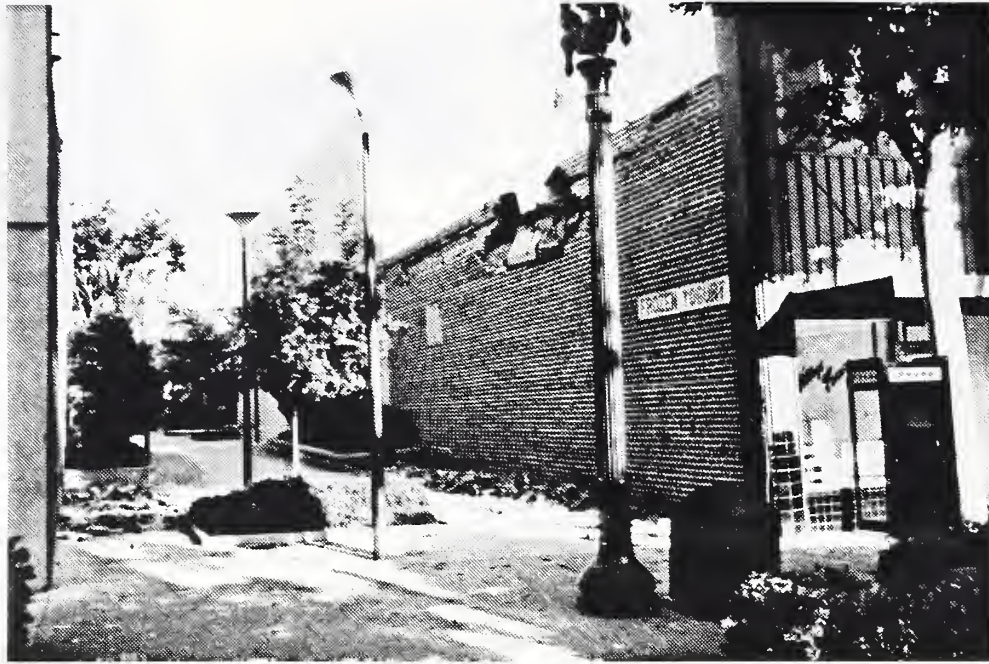
Photo 3 Typical collapse of unreinforced brick wall, Whittier.

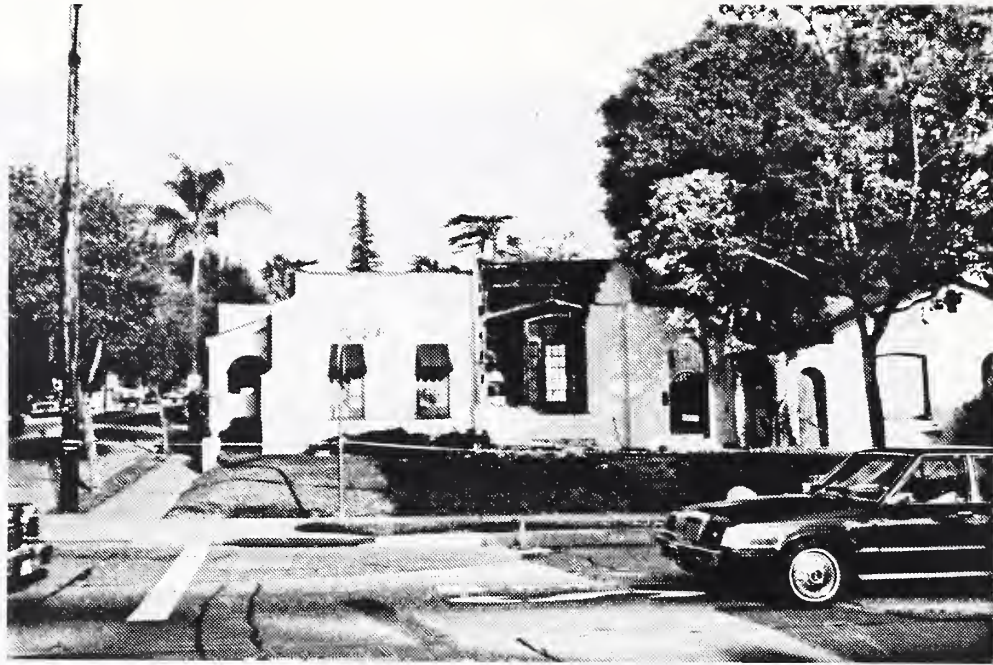
Photo 7 Many houses with unreinforced hollow clay tile walls sustained severe damage. This house at the corner of Greenleaf Avenue and Beverly Blvd. in Whittier lost the front wall.

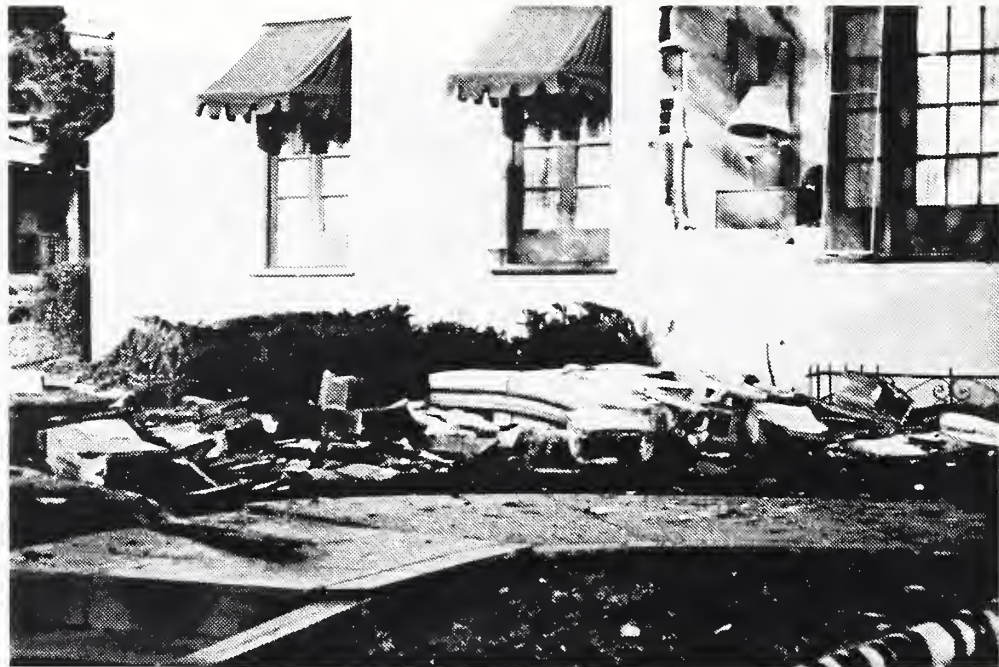
Photo 8 Large pieces of clay tile fell on the front yard of the house shown in Photo 7.

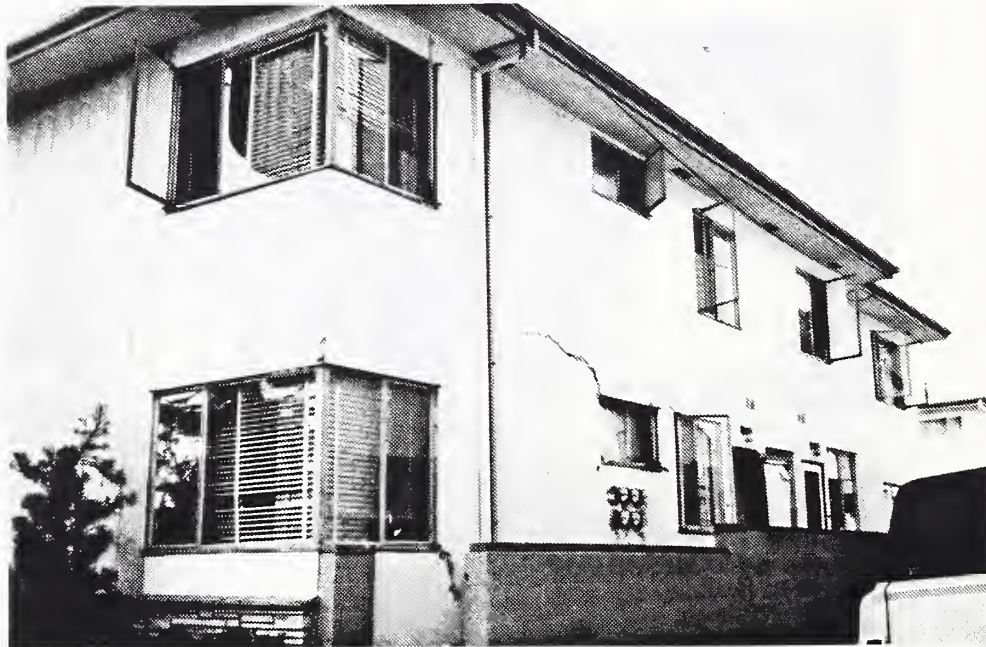
Photo 16 Large cracks developed at the corners of window openings. Note broken window panes at the corner of the building, Whittier.

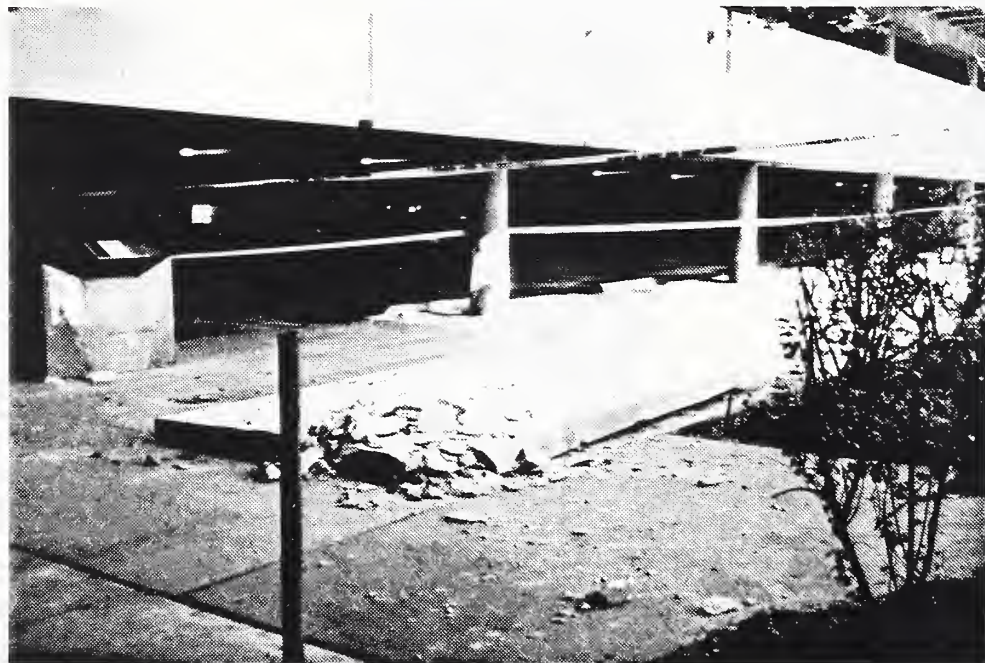
Photo 24 A precast concrete fascia unit fell two stories and fatally injured a passer by. This was the only fatality of the earthquake due to a structural failure.

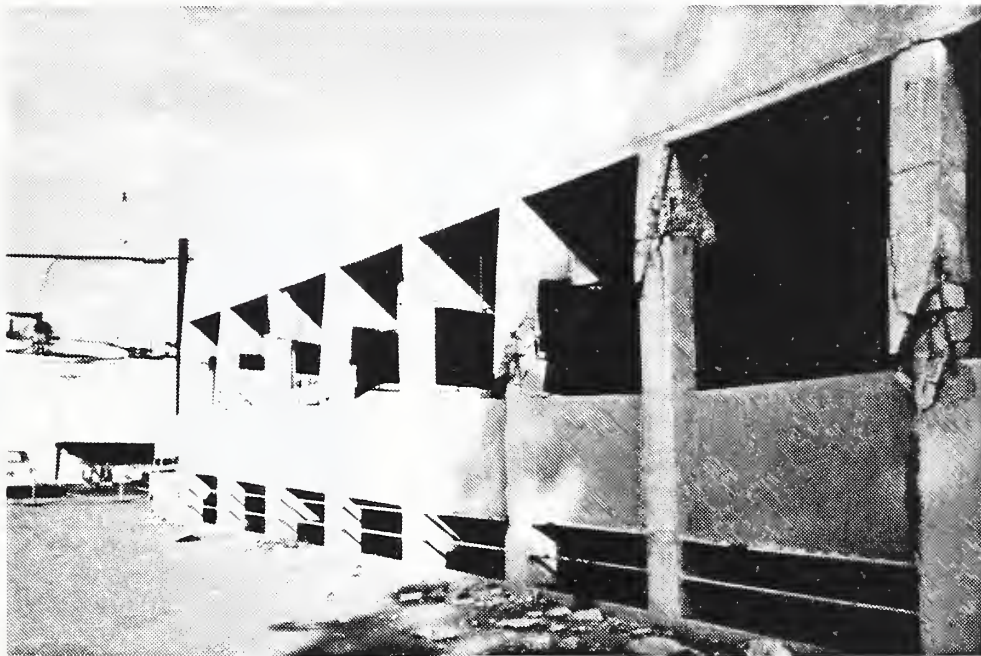
Photo 26 Extensive damage to relatively short columns and the ends of deep beams.

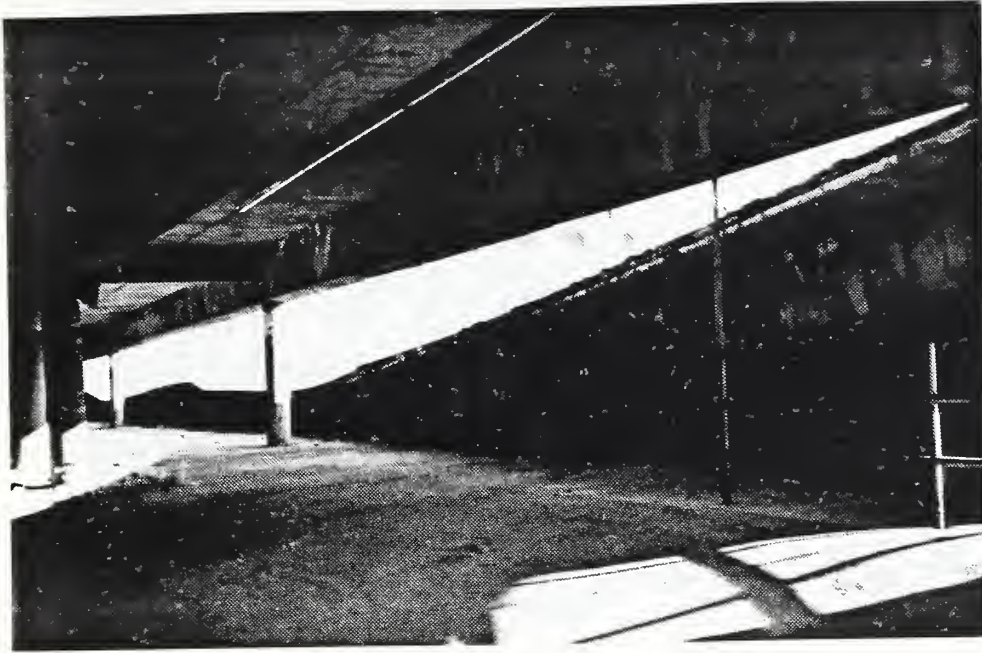
Photo 29 A collapsed upper level portion of the parking garage.

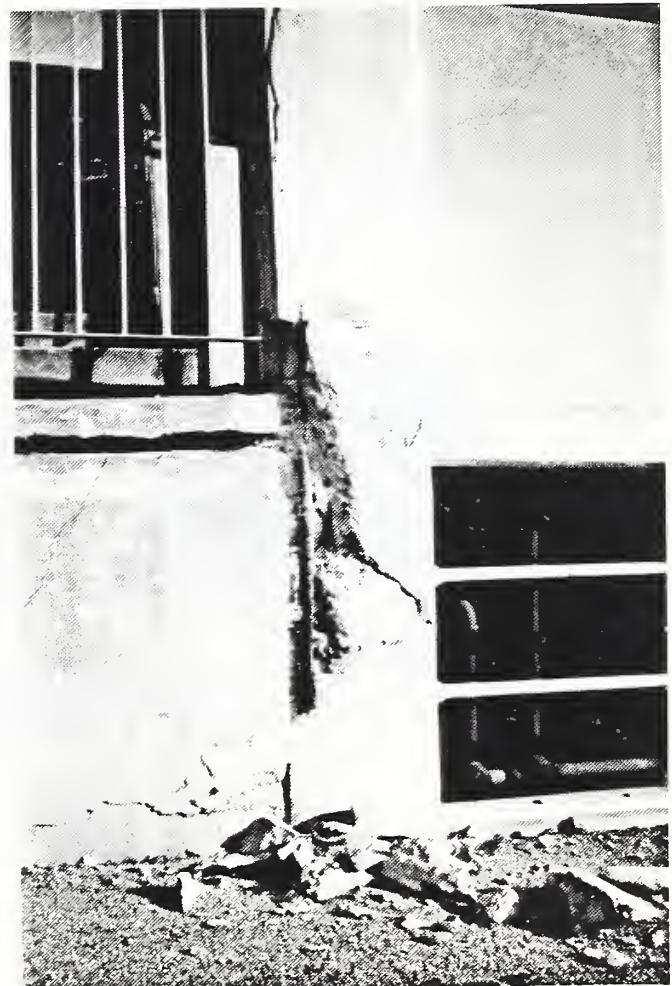
Photo 30

Damage to a concrete column between the ground level and the lower level. Note that no ties are around the vertical bar.

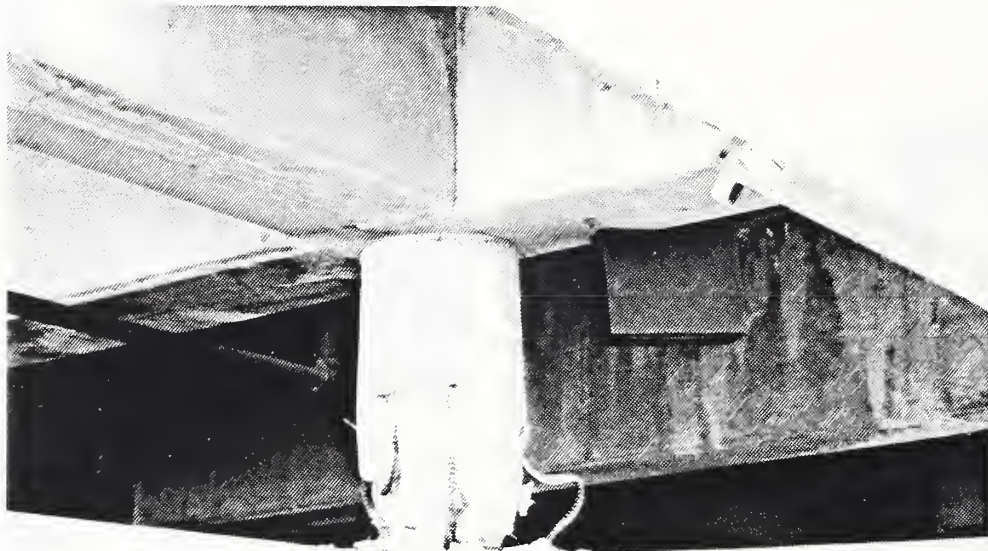
Photo 32 Non-ductile failure of a short column. Note fractured #2 tie and buckled vertical bars.

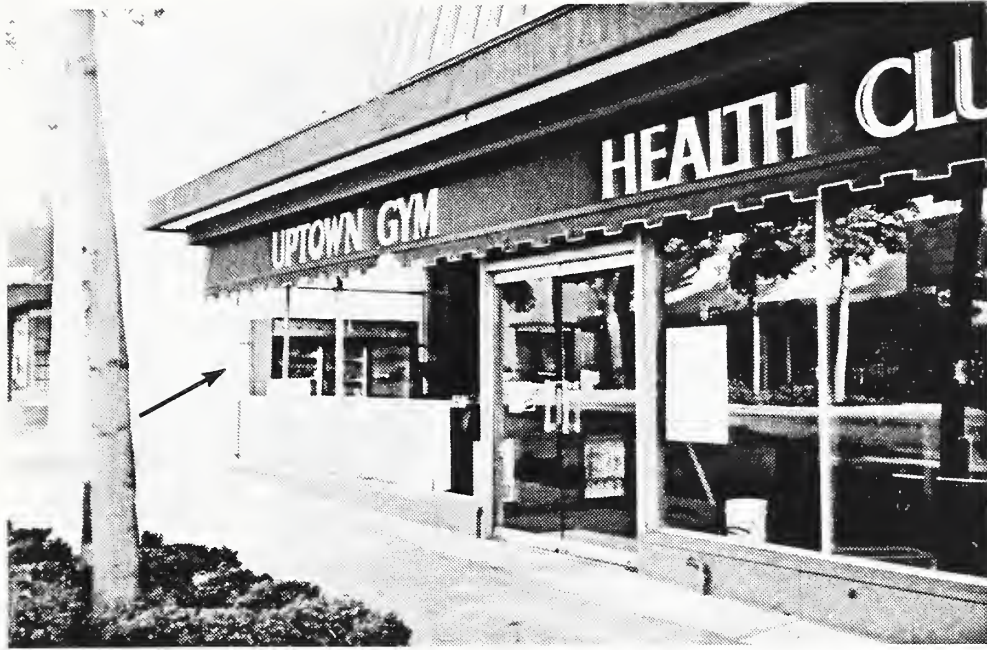
Photo 33 Distortion of the building caused damage to windows at the corner of the building in the Uptown Whittier shopping section.

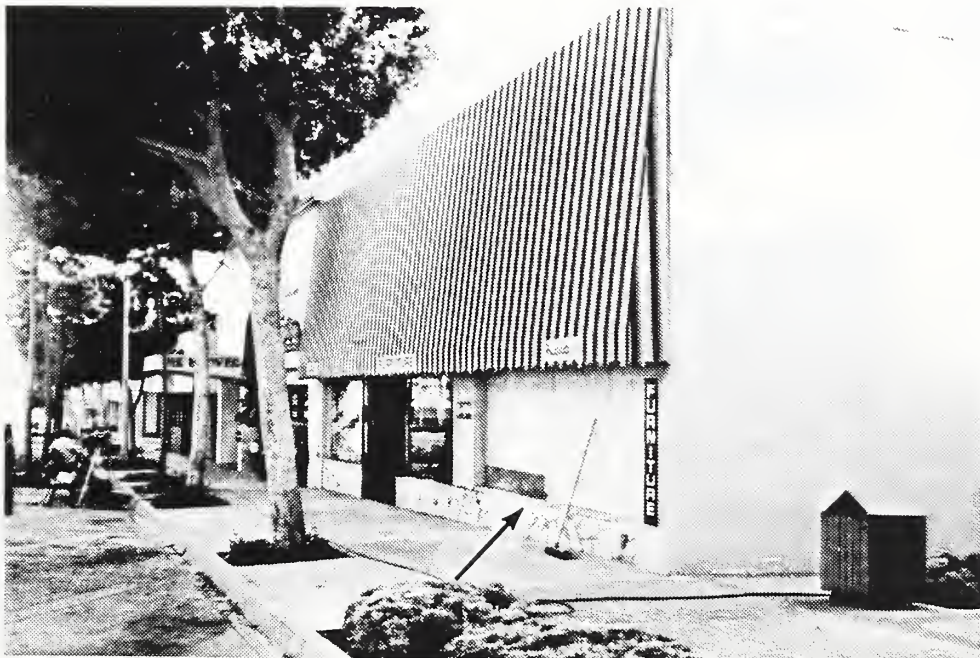
Photo 34 Damage glass in a store in the Uptown Whittier shopping section.

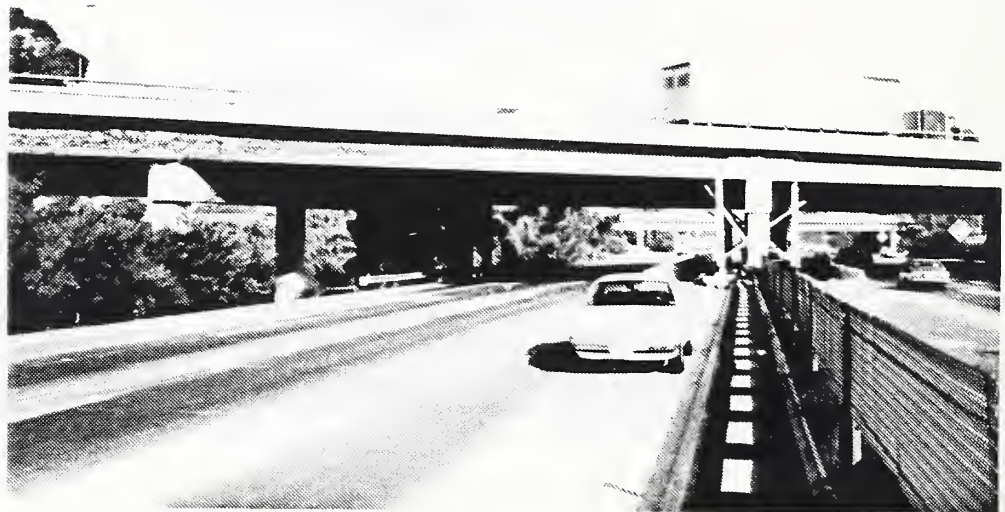
Photo 40 Interstate I-605/I-5 interchange. Temporary shores have been installed at the center bent which supports the I-605 overcrossing. The bent has five concrete columns.

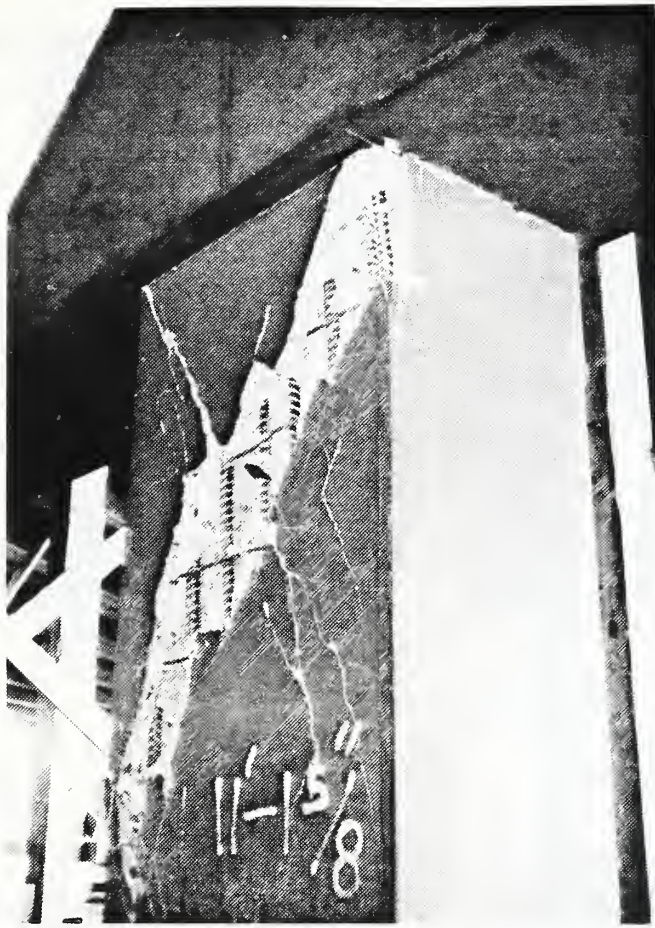
Photo 41

Close-up view of damaged column in the center bent.
