Investigation into the Ashland Oil Storage Tank Collapse on January 2, 1988

NBSIR 88-3792

Issued June 1988

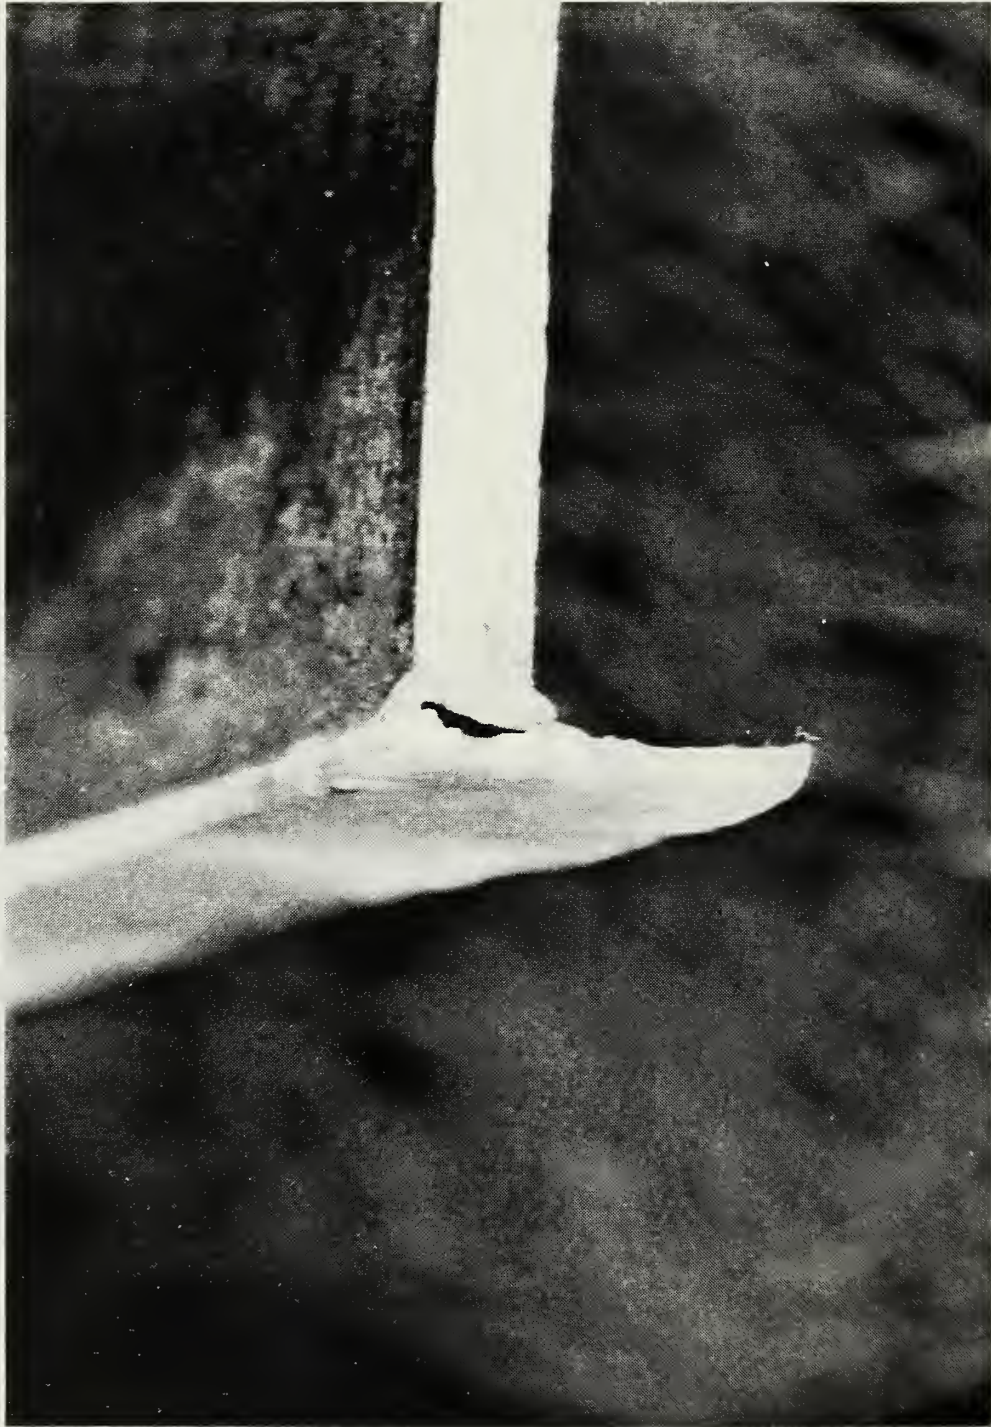
Figure 3.6 - Tear in Tank Bottom at Inside Fillet Attaching First Shell Course and Bottom Plate

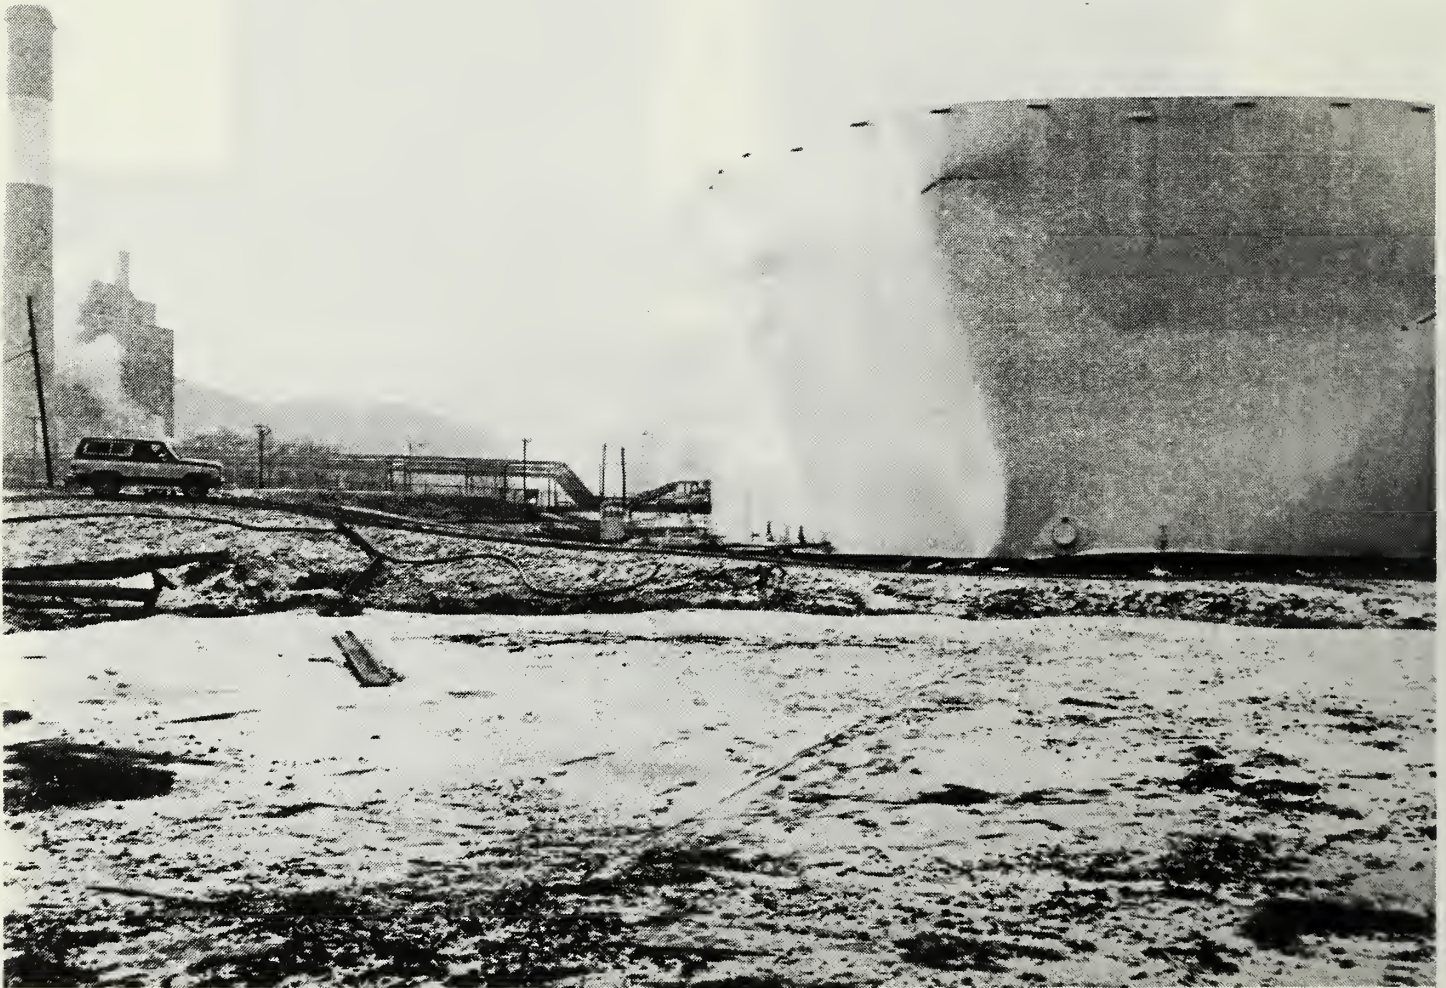
Figure 3.8 - Tank No. 1367 Dented in the Collapse of Tank No. 1338

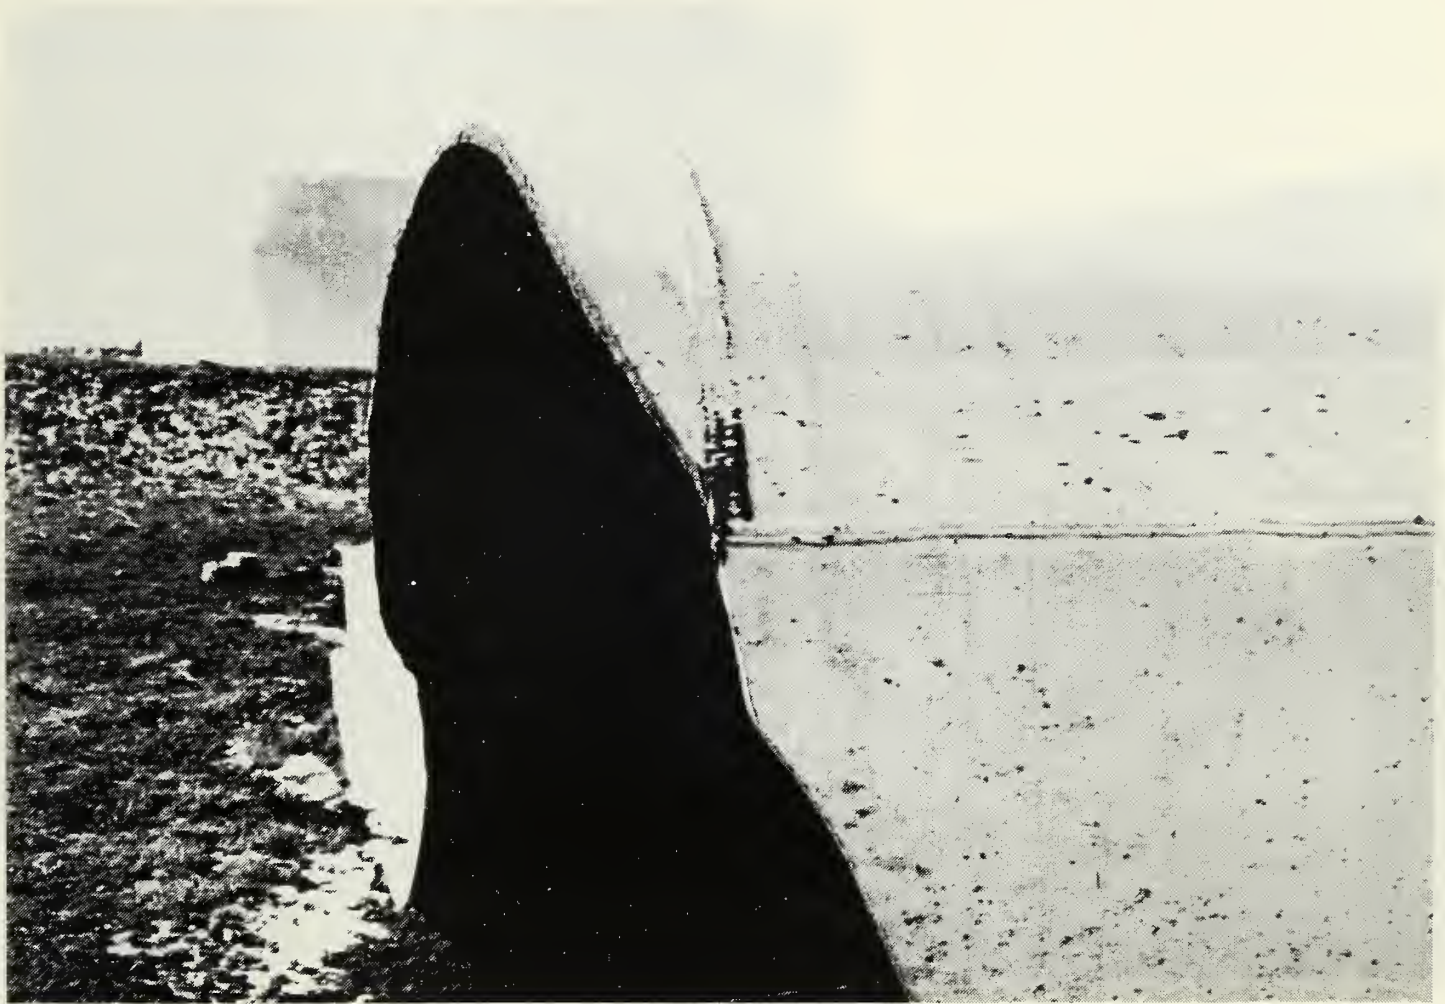
Figure 3.9 - Right Side of Fracture

One side of the fracture in the tank wall came to rest inside the dike area near Tank No. 1366. It is shown in Figure 3.9. The fracture surface was flat and perpendicular to the tank wall indicating that it was a brittle fracture. Chevrons were evident on the fracture surface (see Figure 3.10). The chevrons pointed to a dark area extending about two-thirds of the way through the plate thickness (see Figure 3.11). The location of this dark area is just below the horizontal weld, between the first and second shell courses, and just to the left (looking from the outside of the tank) of a vertical seam in the second course. The fracture was believed to have initiated at this point and extended to the top and bottom of the tank wall. A diagram showing the path of the fracture is shown in Figure 3.12. Note that the fracture neither started nor propagated in the welds.

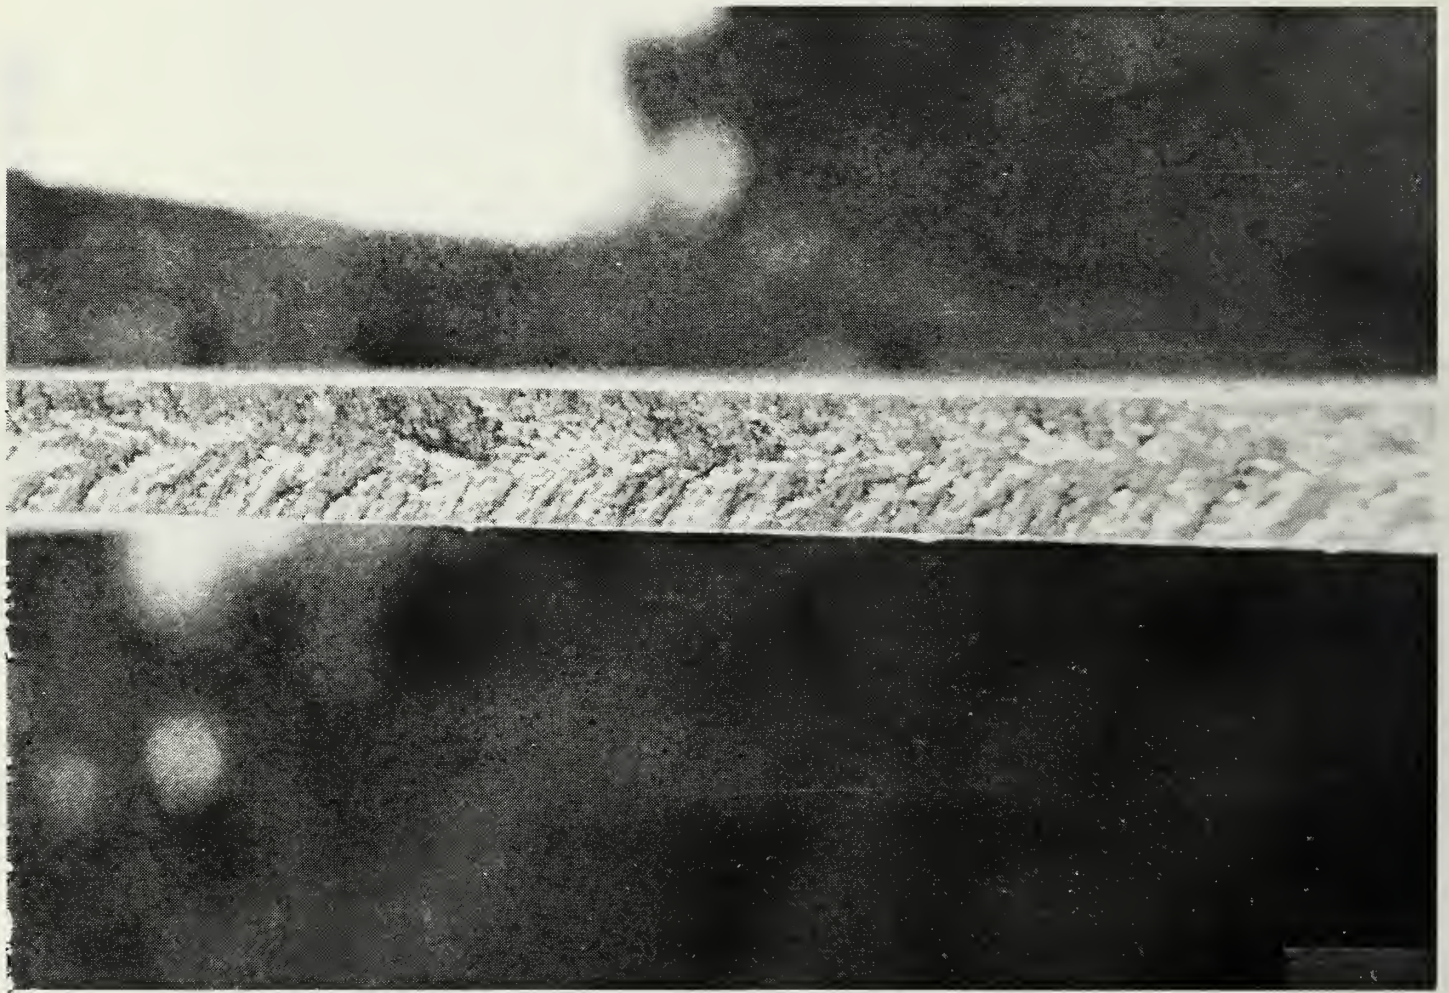
The flat surface of the fracture of the shell indicated that it was a result of brittle fracture. Chevron-like markings were evident on the fracture surface. These pointed to a flaw extending about two-thirds of the way through the plate thickness and located about 8 ft above the base of the tank, just below the horizontal weld between the first and second shell courses, and just to the left (looking from the outside of the tank) of a vertical seam in the second course. The chevron markings, pointing to the flaw from above and below, are convincing evidence that the fracture of the shell initiated at this flaw.

Figure 3.10 - Chevrons in Fracture Surface

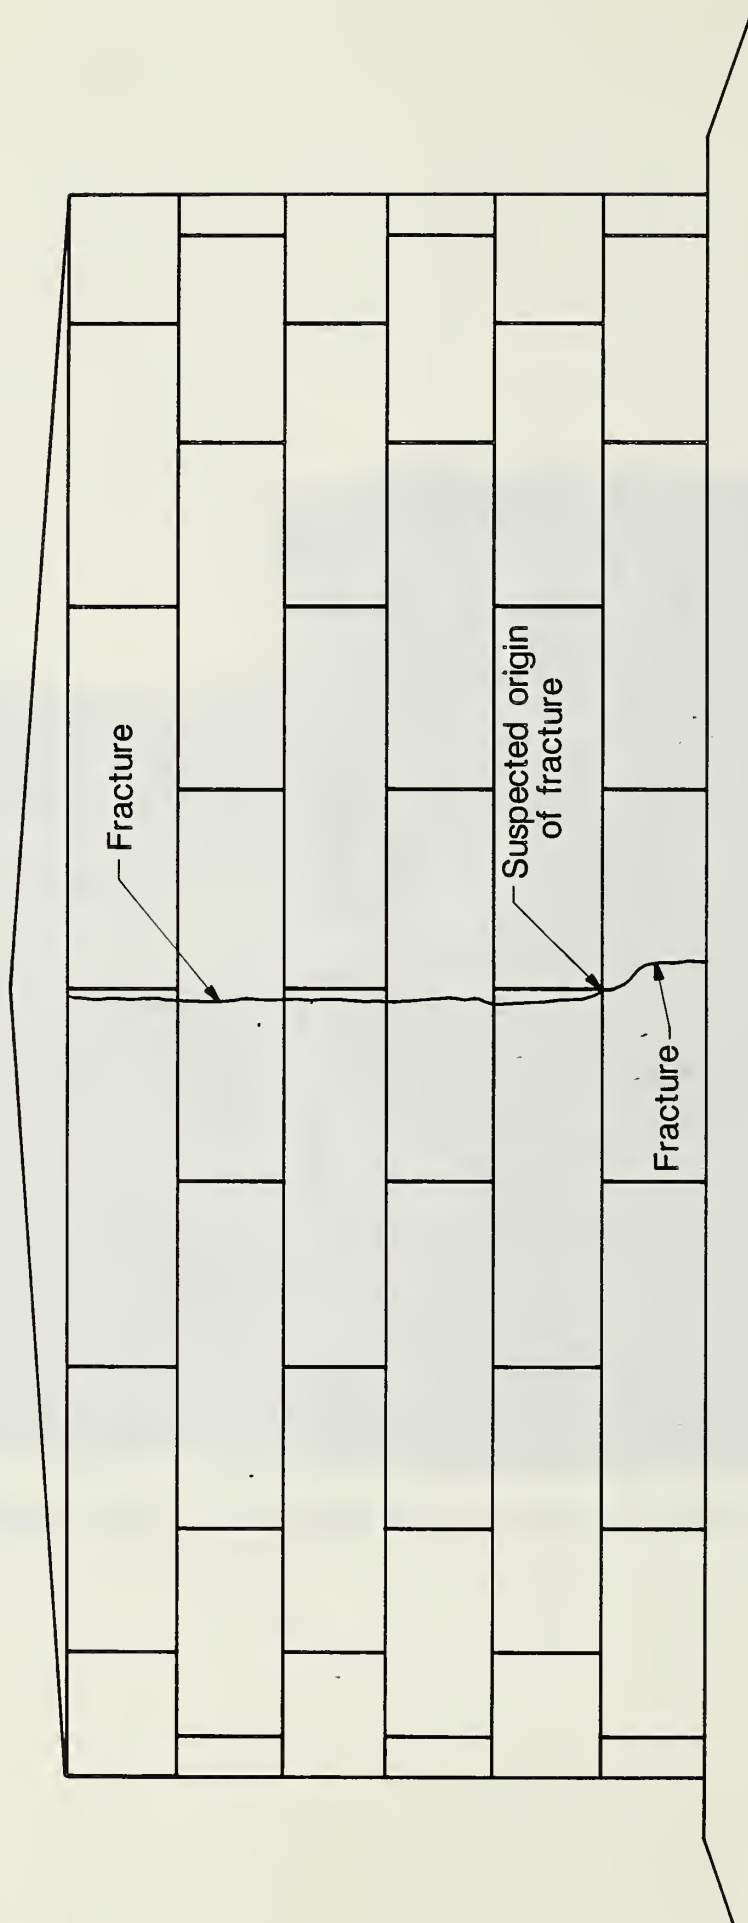
The failure of the tank was caused by a brittle fracture that initiated at a flaw in the tank shell about 8 ft above the base and just below the horizontal weld between the first and second courses of steel. The fracture propagated to complete rupture of the tank shell because the steel lacked sufficient toughness to arrest a propagating fracture at the temperature and stresses existing in the tank shell.

Figure 3.12 - Approximate Path of Fracture in Tank Wall

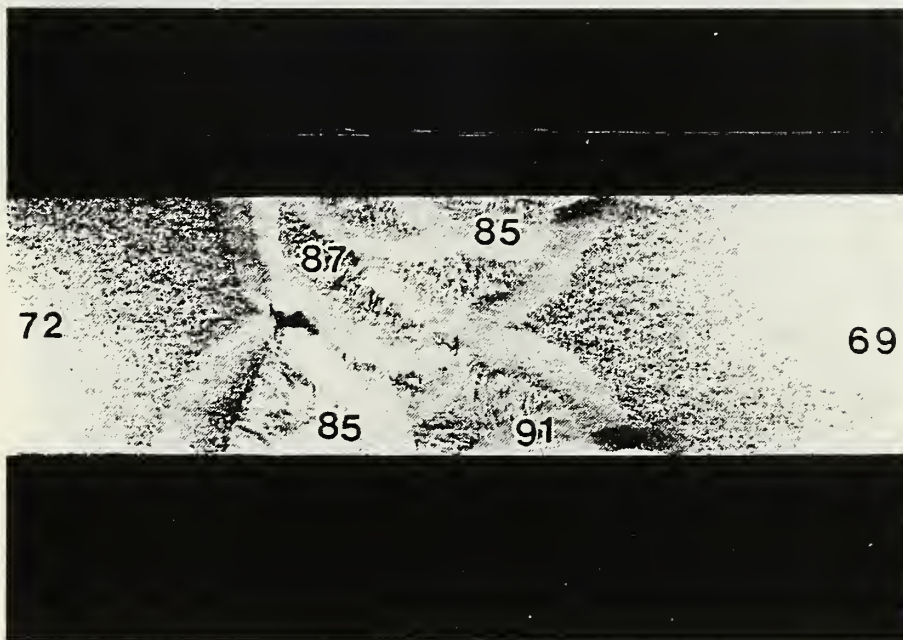
Figure 7.19 - Defects in Horizontal Weld Metal after Grinding Welds

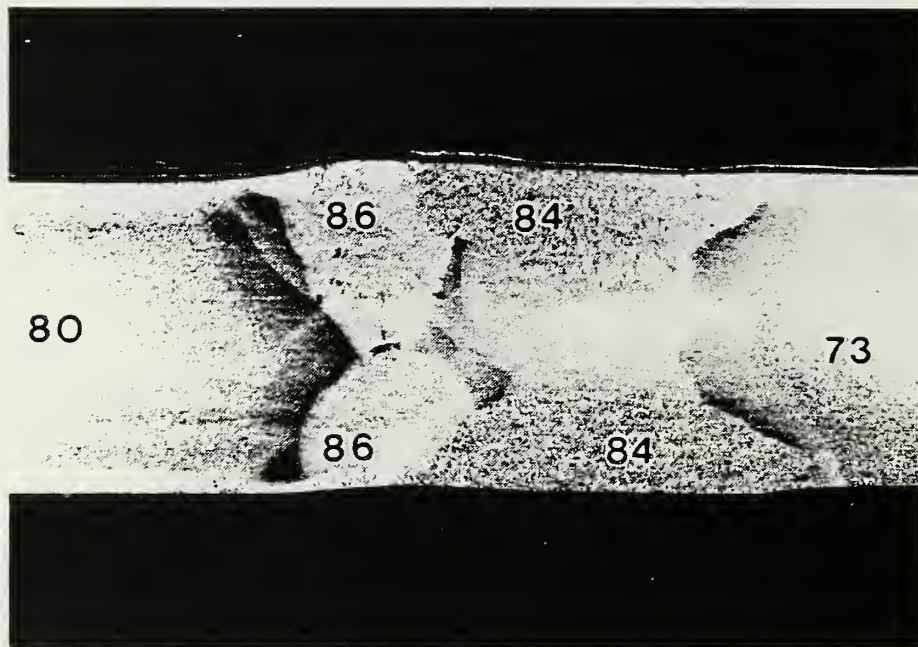
Figure 7.20 - Defects in Vertical Weld Metal

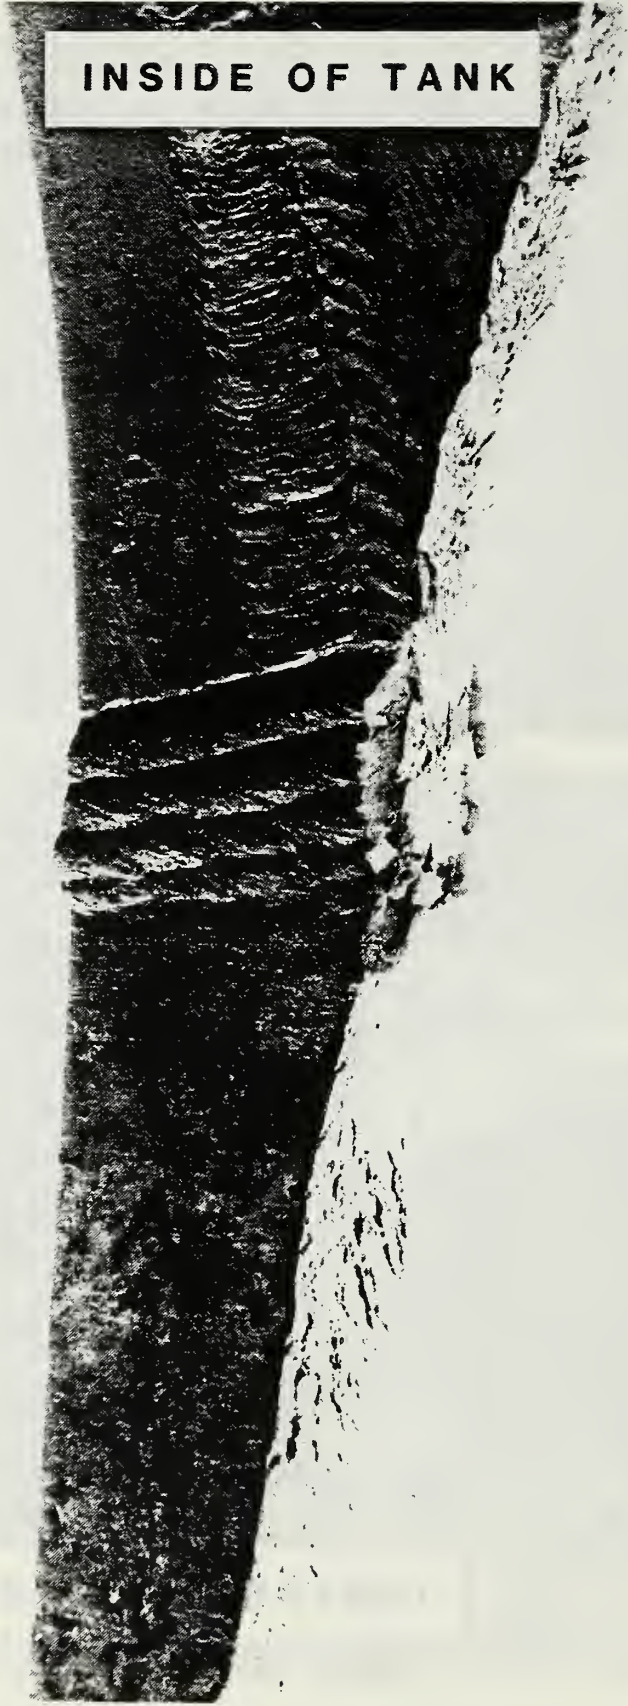
The flaw at which the fracture initiated was determined by Battelle to be present prior to the reconstruction of the tank at the Floreffé site. Deposits on the surface of the flaw indicate it was formed during a cutting operation.

Figure 7.22 - Fracture Surface Defect

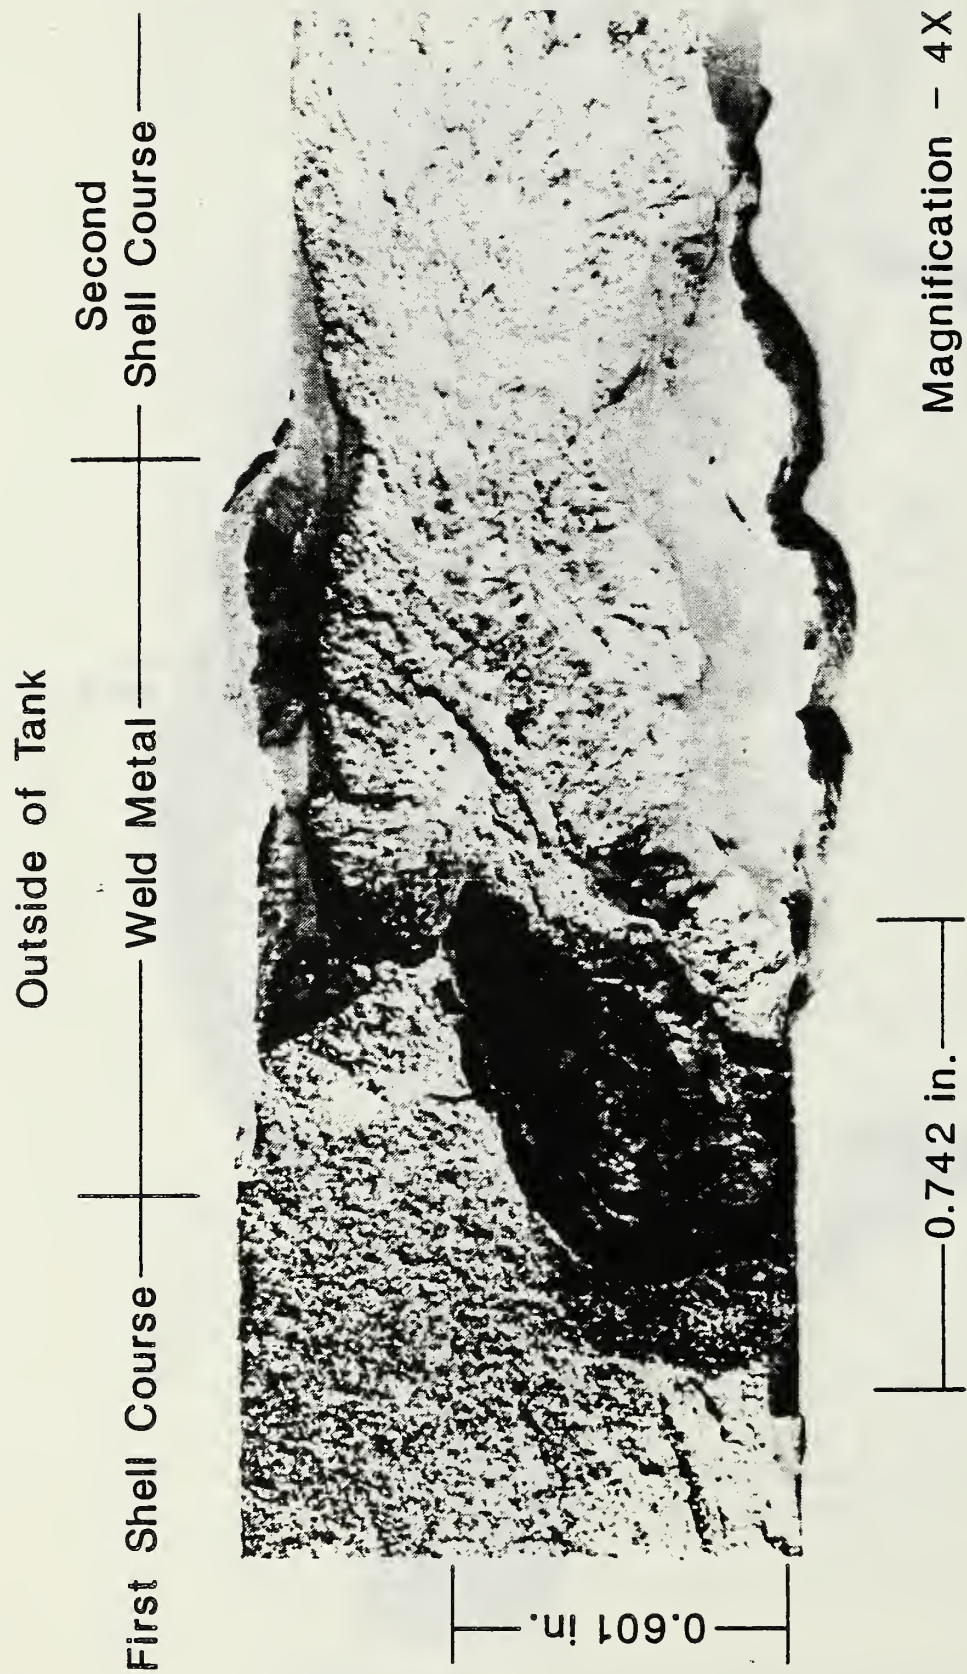
Figure 7.24 - Defect on Fracture Surface

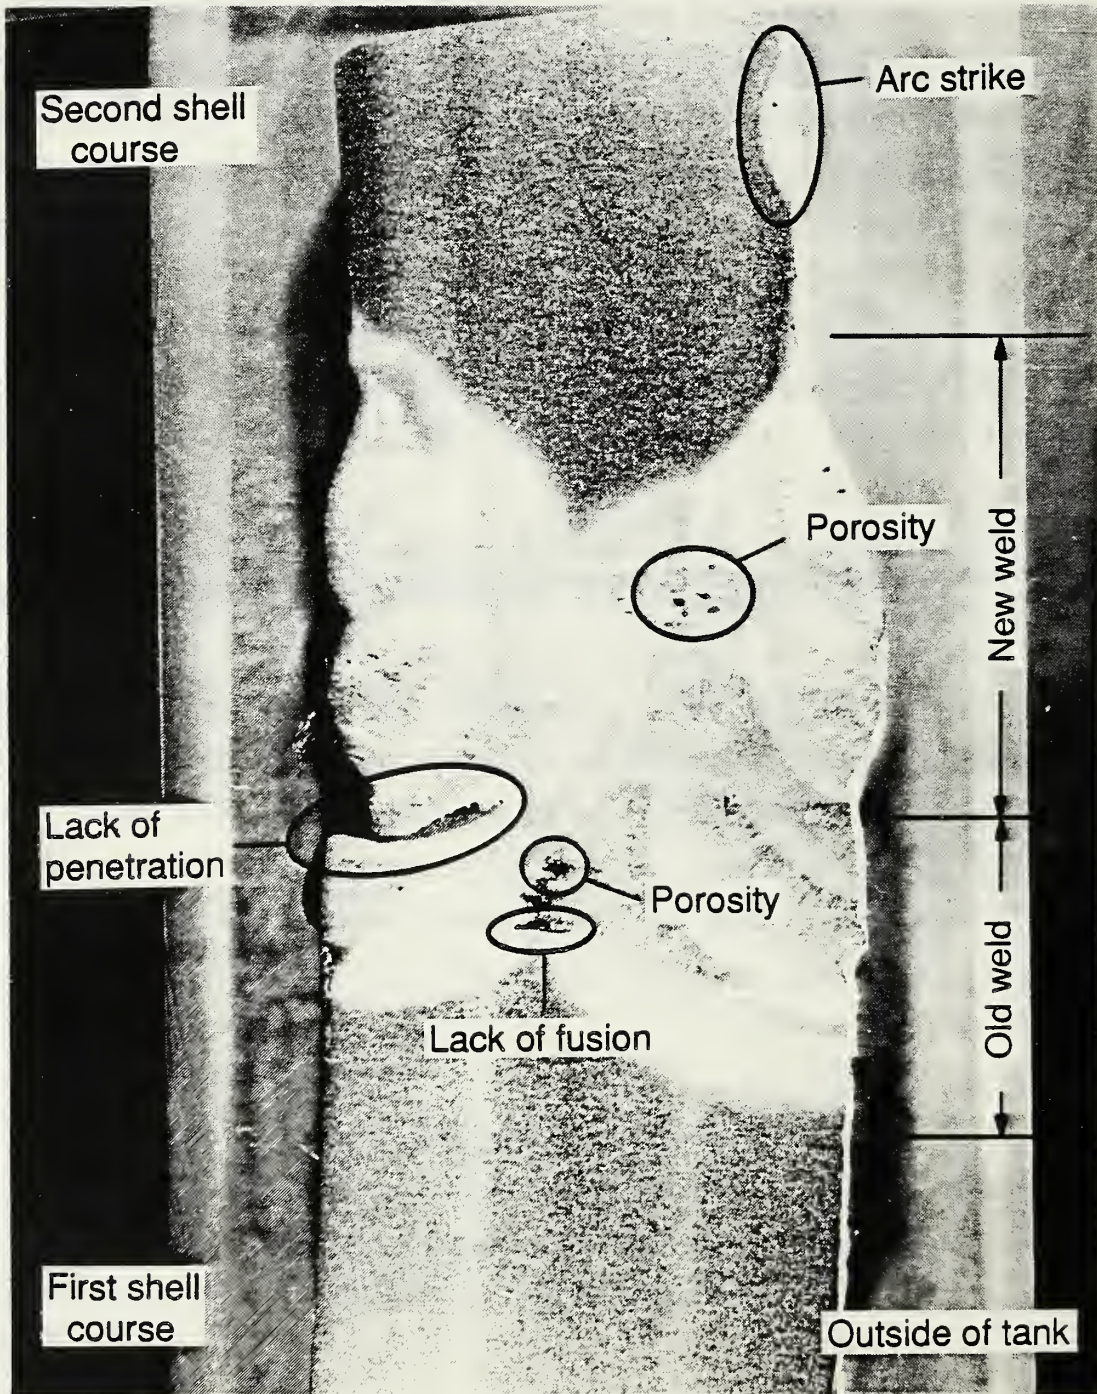
Although the weld quality did not conform to API 650, the weld quality was not a contributing factor in the initiation or propagation of this fracture. However, welding adjacent to the flaw contributed to embrittlement of the metal.

Figure 9.1 - Defects in a Horizontal Weld between the First and Second Shell Courses
