NBSIR 88-3820

July 1988

**COLLAPSE OF MASONRY WALL UNDER
CONSTRUCTION IN PAWTUCKET, RI,
OCTOBER 28, 1985**

Felix Y. Yokel

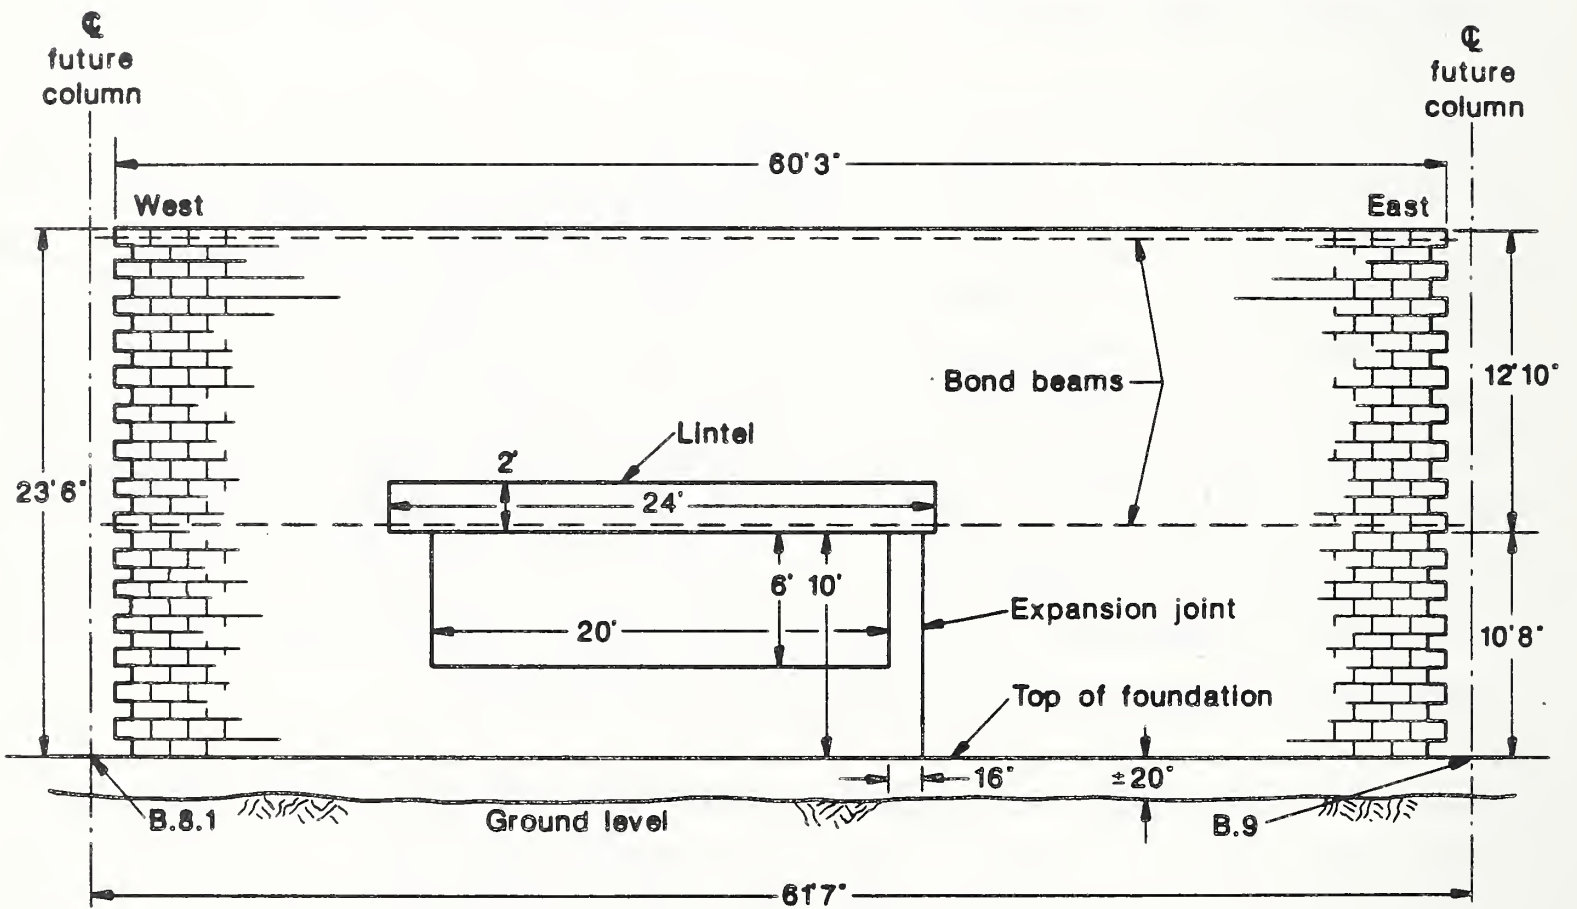
Figure 1: Elevation of Wall at the Time of Collapse, Looking from South.

The wall extended from east to west, was 60 ft-3 in. long and 23 ft-6 in. high and had a 6x20 ft window opening 4 ft above the base of the wall and 25 ft-8 in. from its east end (see figure 1). The wall was supported by wooden braces. The collapse was apparently triggered by a wind gust from the northerly direction.

It is also important to note that the ground elevation at the leeward side of the wall was below the base of the wall (part of the foundation was exposed-see figure 1). At the east end of the wall the ground elevation was approximately 20 inches below the base of the wall and at the west end the ground elevation was approximately 10 inches below the base of the wall.

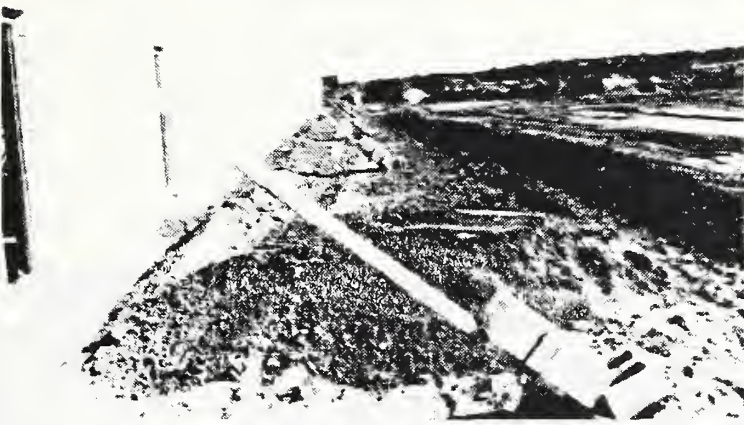
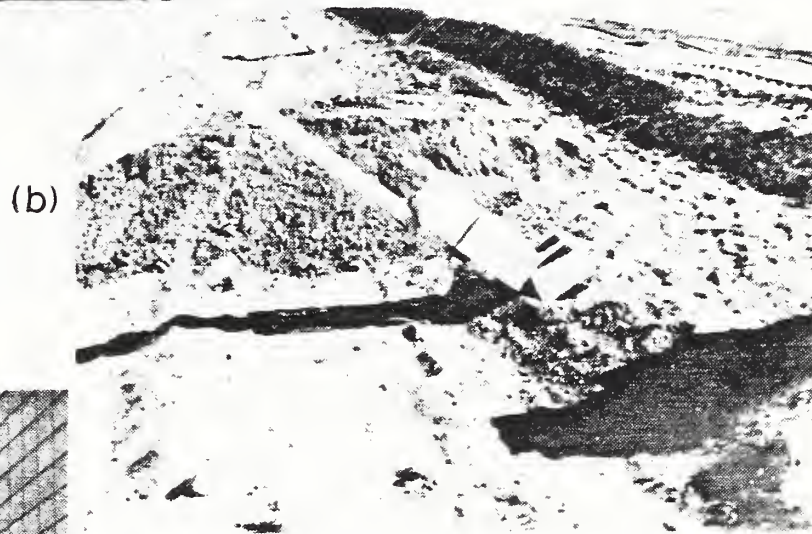
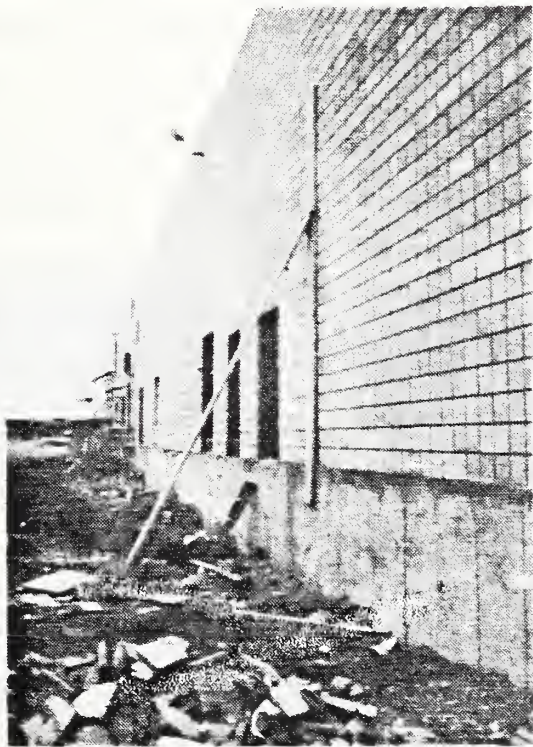
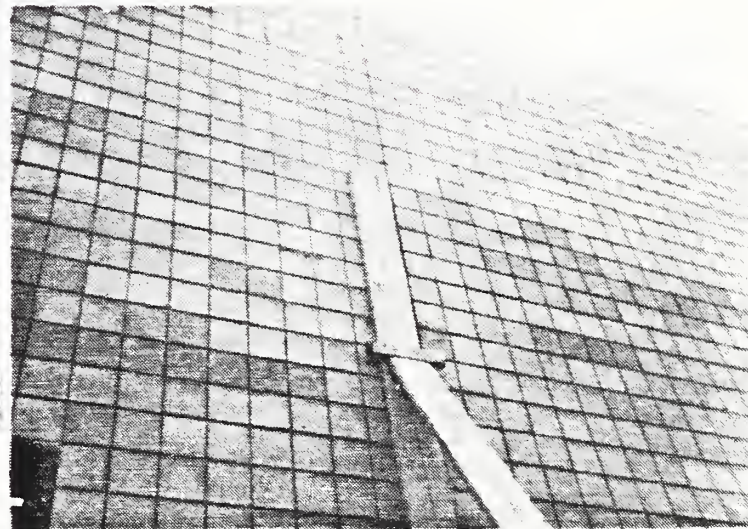
Figure 3: Braces Supporting Other Walls on Construction Site (photograph taken on day of collapse).

Figure 3 shows braces supporting walls on the same construction site that did not collapse in the accident. The photographs were taken on the day of the accident. The braces shown in figure 3(a) consisted of two 16 ft long 2x10 planks. The upright plank had a 2x4 cleat nailed to it which resisted the upward thrust of the diagonal strut. The diagonal strut rested on the soil with no noticeable embedment and no footing to resist downward thrust, and no stakes were driven into the soil to resist horizontal forces and displacements. The diagonal struts are restrained by one concrete masonry block placed at their lower end and weighted down by two concrete masonry blocks, apparently to hold them in place. A closeup photograph of the lower end of the diagonal strut is shown in figure 3(b). Figure 3(c) shows a strut which was inclined at a very steep angle, apparently to brace a higher wall. The upper portion of that latter brace is shown in figure 3(d). The vertical bracing members examined in the field were not nailed or otherwise attached to the masonry wall and were held in place by the horizontal thrust exerted by the diagonal member (aided by the weight of the two masonry blocks resting on the diagonal member).

The evidence shown in figure 3 indicates for the braces shown that: (1) the two 16 ft long planks were used even when the wall was very high (in the latter case the angle of inclination of the

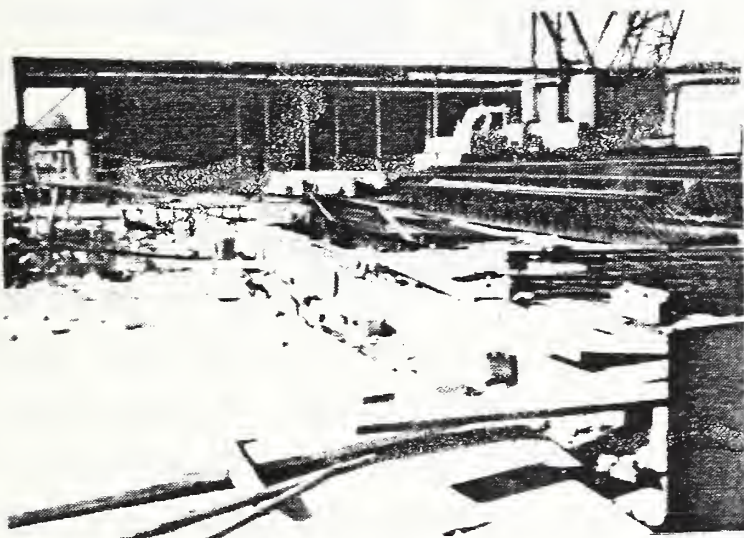
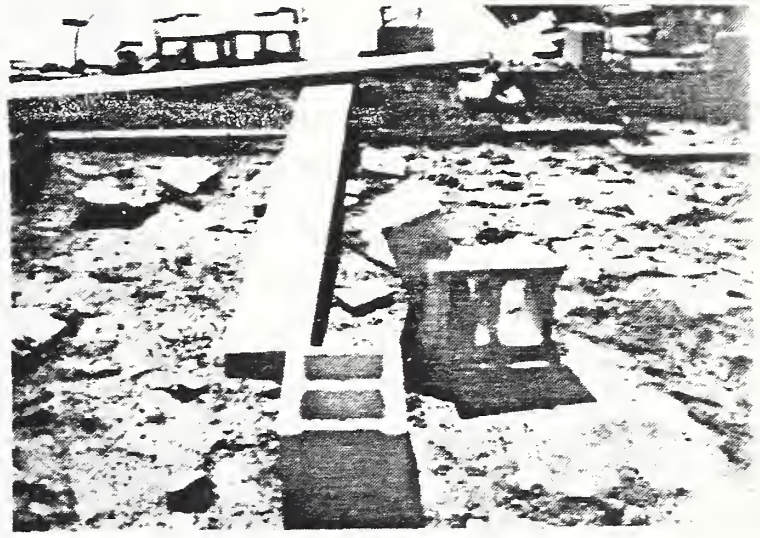
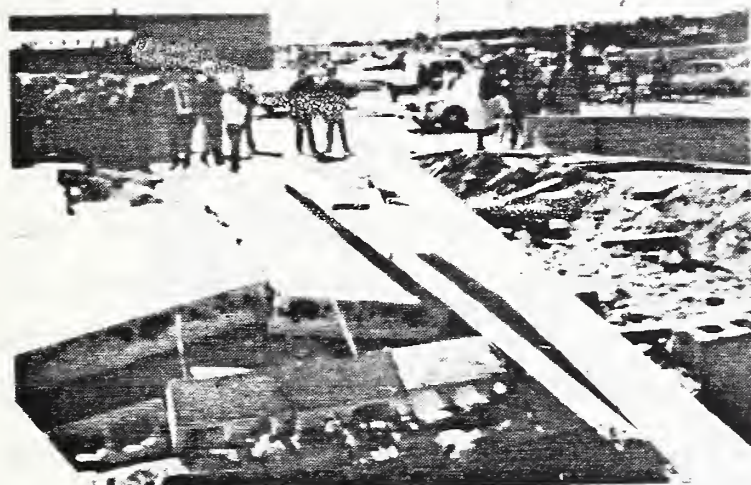
Figure 4: Collapsed Braces on the Windward Side of the Wall.

Figure 4 shows the evidence of bracing found on the windward (north) side of the collapsed wall. Figure 4(a) shows a view from east to west. It shows collapsed braces at the east end of the wall (column B9 in plan drawing A 1.1, dated July 15, 1985) and near the center of the wall (to the east of the window opening). It can be seen that, like the braces shown in figure 3, each brace consisted of two 16-ft long 2x10 planks, one of which had a cleat nailed to it. Figure 4(b) shows an end view of the collapsed brace in the center of the wall together with the three concrete blocks which were used to restrain the diagonal strut. Figure 4(c) shows the brace at the west end of the wall (col B8.1) and figure 4(d) shows the restraining concrete blocks for the brace in figure 4(a). The western diagonal was restrained by a pipe (not shown). The distance from the lower end of the vertical plank to the underside of the cleat was 9 ft 9 in for the brace at the east and west end of the wall and 10 ft -4in. for the brace at the center.

It is concluded from figure 4 that: (1) the braces used on the windward side of the collapsed wall were similar to those shown in figure 3; (2) the wall was supported by three braces on the windward side; (3) the height at which the diagonal struts supported the wall equaled or exceeded the distance from the bottom of the vertical plank to the underside of the cleat, but could not be less than that distance (for instance in figure 3(c) the bottom of the vertical plank is higher than the ground, but

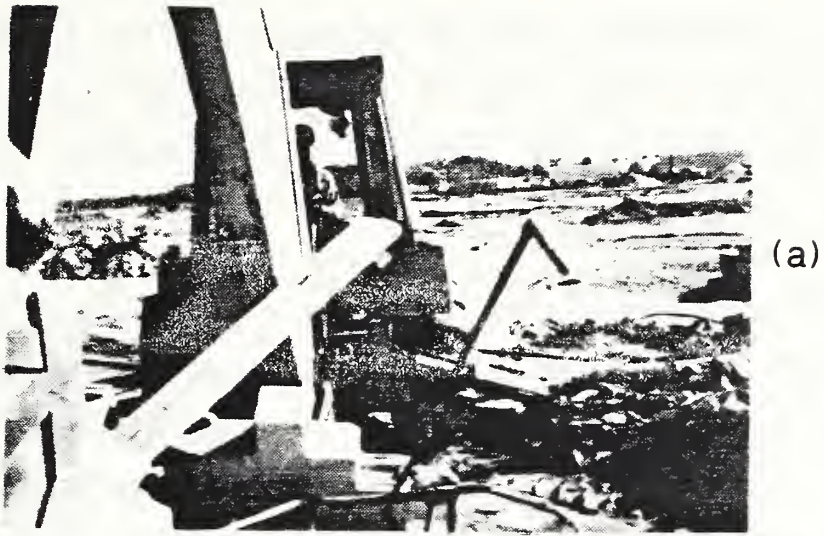
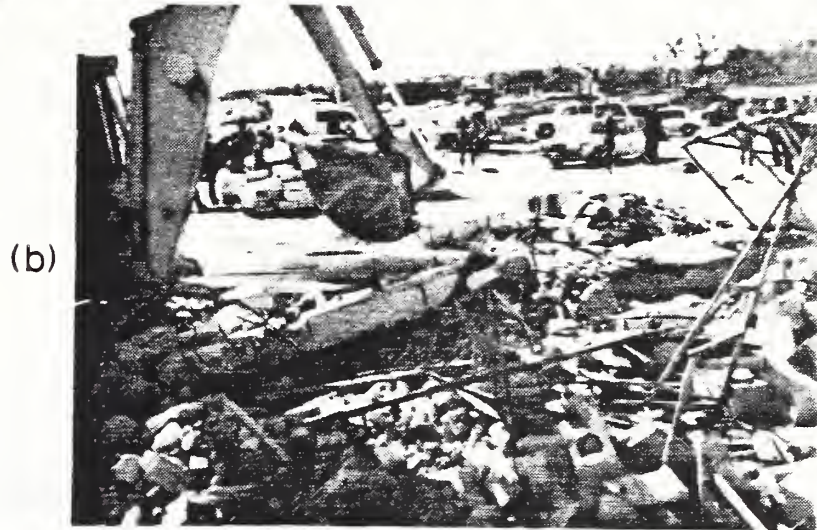
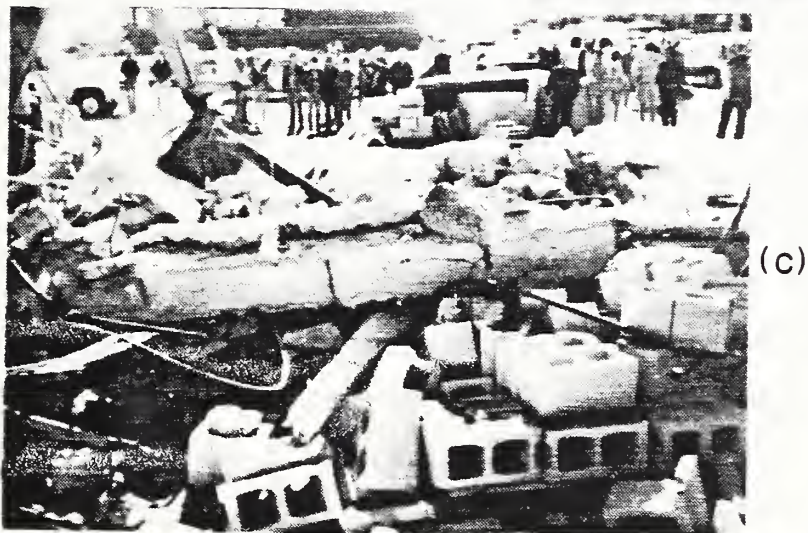
Figure 5: Bracing Members Found on Leeward Side of Wall.

Figure 5 shows some of the evidence of bracing found on the leeward (south) side of the collapsed wall. In this instance, bracing members were damaged either by the wind load prior to the collapse or by the falling debris from the wall. Figure 5(a) shows a vertically split 2x10 plank at the east end of the wall (col.B9). This was a vertical bracing member and the cleat that has been nailed to it near the upper end can be seen in the picture. Figure 5(b) shows a shattered 2x10 plank on the west end of the wall. Figure 5(c) shows a broken 2x10 plank, covered by debris, near the west end of the wall, looking south. Examination of the field evidence which started within about 60 minutes after the collapse and continued through the removal of the debris turned up components of two braces similar to those shown in figure 3. There is no evidence that there was a third brace near the center of the wall. The location of the cleats in the two braces found was 16 inch from the top of the vertical plank to the underside of the cleat for the brace at the east end of the wall, and 24 inches from the top of the plank to the underside of the cleat for the brace at the west end of the wall.

It is deduced from figure 5 and observations reported by OSHA inspectors that, on the leeward side, the wall was probably supported by two braces located near the two ends of the wall, which were similar to the braces shown in figure 3, and that near the east end of the wall (B9 in plan drawing A 1.1) the point of

- (a) 2x10 plank with cleat near East end of wall.
- (b) Shattered 2x10 plank near West end of wall.
- (c) Broken 2x10 plank near West end of wall, looking South.

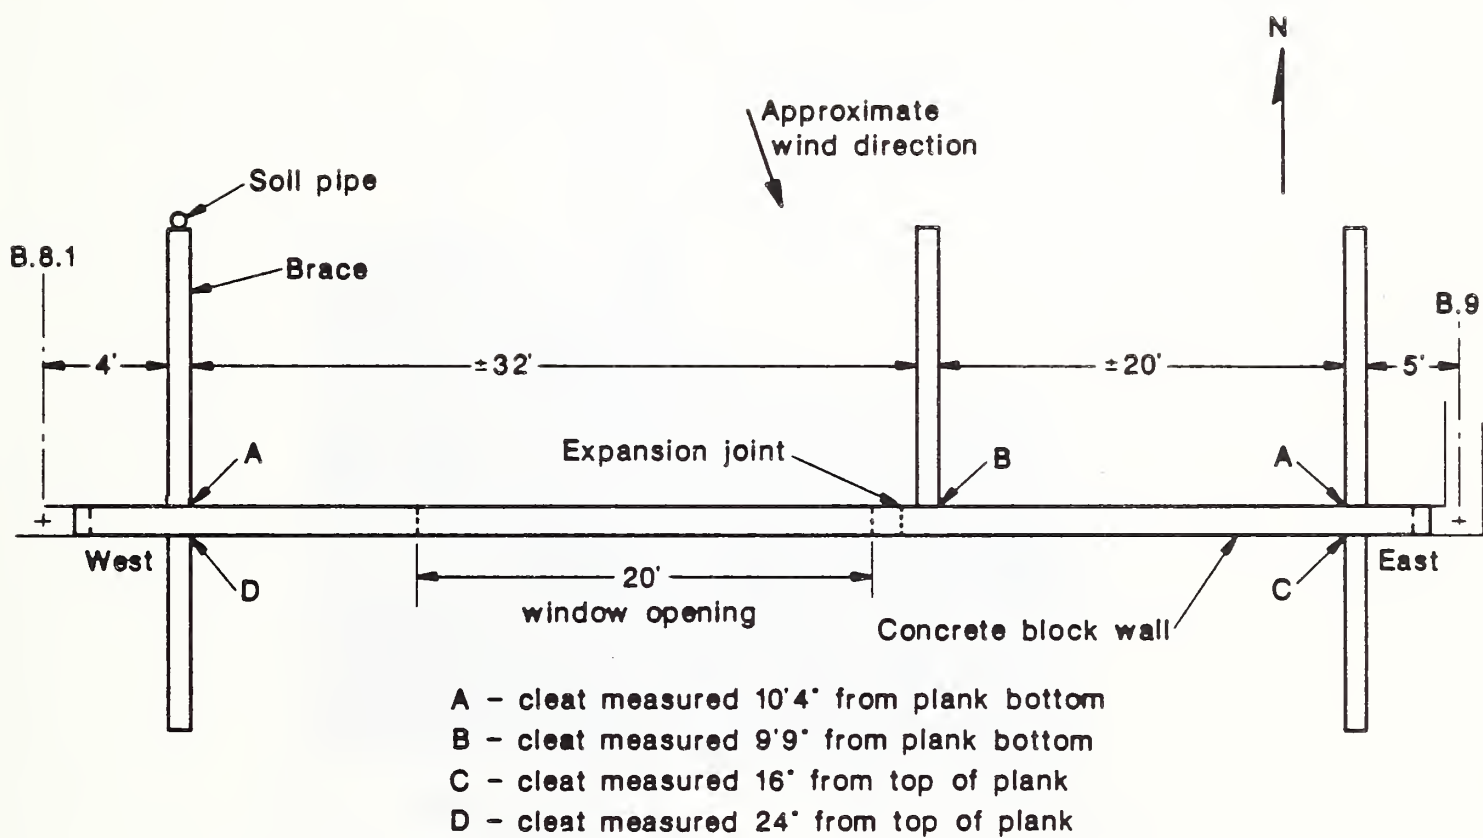
Figure 6: Top View of the Collapsed Wall Showing Probable Bracing Location

Figure 6 shows a plan view of the wall and the probable location of the braces on both sides of the wall, based on measurements and observations by OSHA inspectors who visited the site after the collapse. The cross section of the collapsed wall and the probable geometry of the braces on the leeward side which was deduced from the available evidence is shown in figure 7. There was 8 in. block to an elevation 10 ft-8 in. above the base of the wall and 12 inch block above that elevation. It is therefore logical, that the support was provided above the 10 ft-8 in. elevation from the base of the wall. Evidence from field observations supplied by OSHA inspectors indicates that during construction the overhanging portion of the 12 in wall was supported by vertical 2x4 shores to prevent uneven settlement of the mortar bed. No traces of these 2x4 shores were found in the debris of the collapsed wall, indicating that these support members were probably removed before the collapse. Figure 8 shows the photograph of another wall on the construction site from which the 2x4 shores were removed, which was taken one day after the collapse.

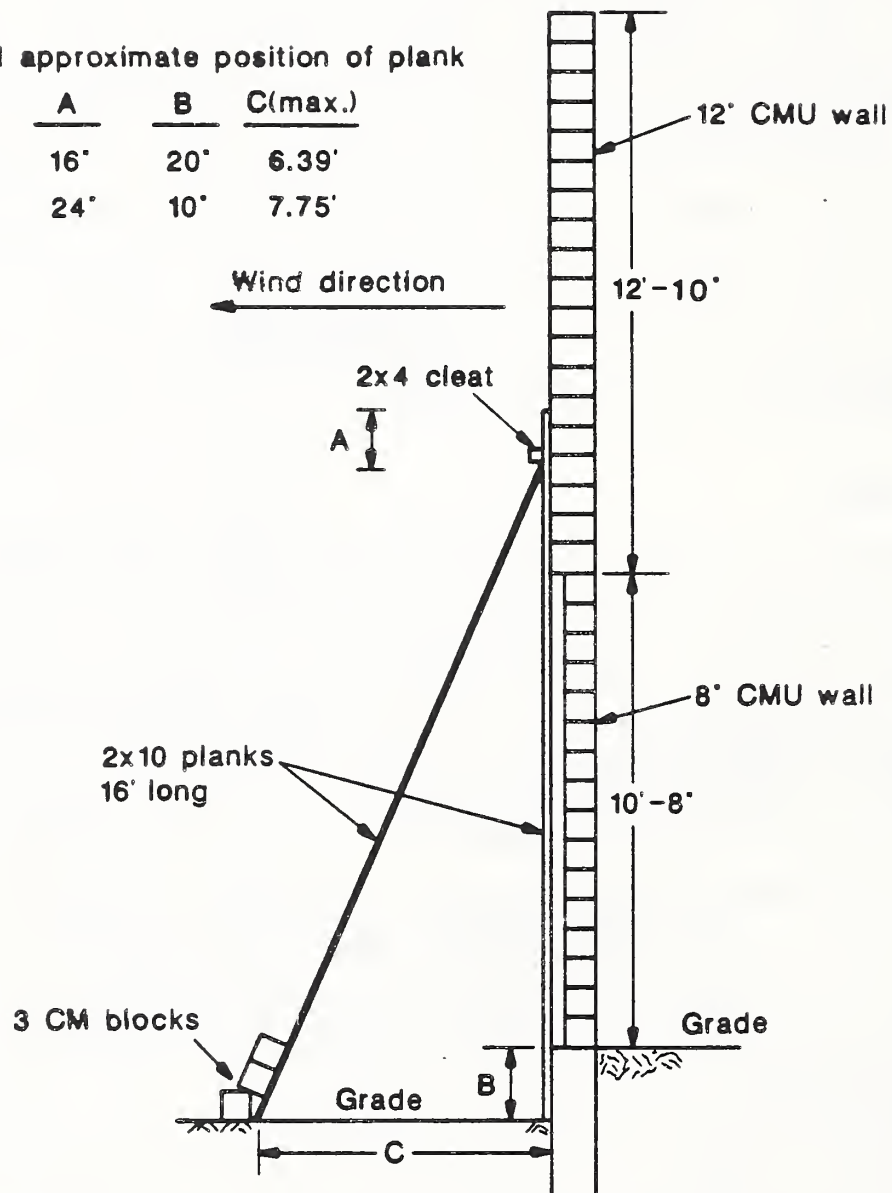
Figure 7: Probable Bracing Configuration on Leeward Side of Collapsed Wall.

Several possible failure mechanisms could have led to the collapse of the braces shown in figure 7. Possible failure mechanisms considered are: (1) structural failure of diagonal plank; (2) upward sliding of vertical plank; (3) kickout or settlement of diagonal plank at ground level; (4) shortening of diagonal plank as a result of sag. These failure mechanisms are discussed below.

The actual dimensions of the 2x10 strut are 1.5 in. x 9.25 in. The 1.5 in. narrow dimension, combined with the 16 ft length make this strut a very slender member. Neither of the ends of the strut has any significant restraint against rotation, so that the strut will act like a column which is pin ended at both ends. Its propensity for buckling is enhanced by the initial downward sag, caused by its own weight. The upper bound for the ultimate buckling load can be calculated by the "Euler equation":

Since the window opening is nearer to the west end, the east end brace which has a lower load capacity was probably more heavily loaded. But even if both struts failed simultaneously, the maximum overturning moment over the base of the wall that could be resisted by the braces was 7,600 ft-lb. This compares with an estimated wind induced overturning moment of 26,900 ft-lb. Thus if the braces alone had to resist the wind load, their failure under the prevailing wind condition was a probable event.

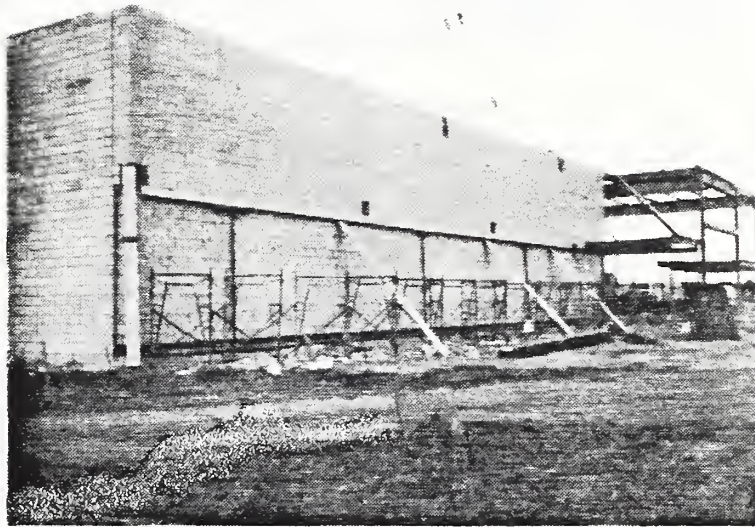
Figure 8: Wall on the Same Construction Site from which the 2x4 Planks Supporting the Overhanging Wall Were Removed.

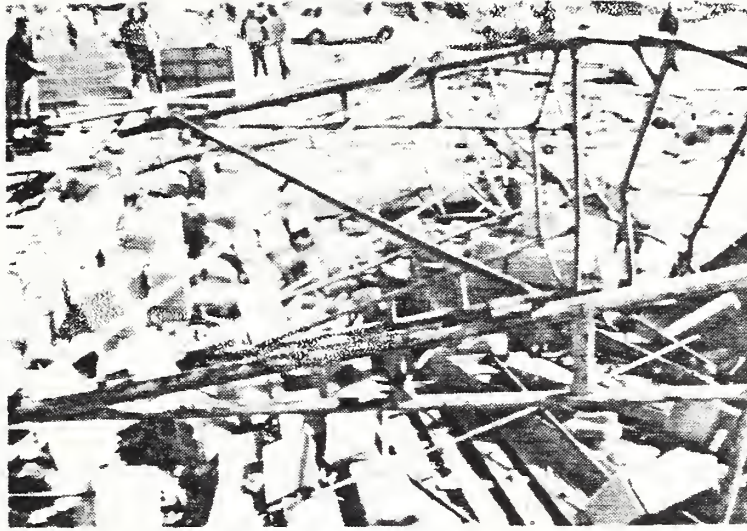
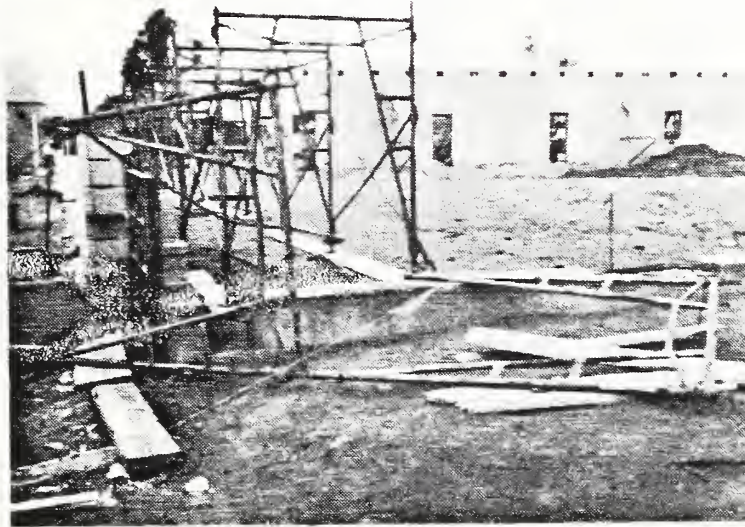
Figure 9: Scaffolding that was Used Along the Collapsed Wall.

Evidence from photographs and reports by OSHA inspectors from the collapse site indicates that in addition to the braces described above there were scaffolds adjacent to the wall. These consisted of scaffolds under the window opening and scaffolds on the leeward side at the two ends of the wall. The scaffolds under the window opening were originally used to provide support to the concrete forms for the lintel. The scaffolds were adjusted by screw jacks at the bottom. After the lintel was poured, the screw jacks were relaxed to remove the forms. Evidence provided by the OSHA inspectors indicates that after removal of the forms these screw jacks were tightened lightly, but no upward thrust was exerted against the wall. The scaffolds at the two ends of the wall were left in place for future use to finish the connection of the ends of the wall to the columns which were to be erected at both ends of the wall. These scaffolds did not bear against the wall. The remains of the scaffold that supported the lintel form are shown in figure 9(a). Figure 9(b) shows a scaffold recovered from the wall (on side) and an undamaged scaffold. The probable position and configuration of the scaffolds prior to the collapse is shown in figures 10 and 11. There is no indication that these scaffolds could provide significant lateral support to the wall.

- (a) Remain of Scaffold that Supported Lintel Forms.
- (b) Scaffold Recovered from Collapsed Wall (on side).

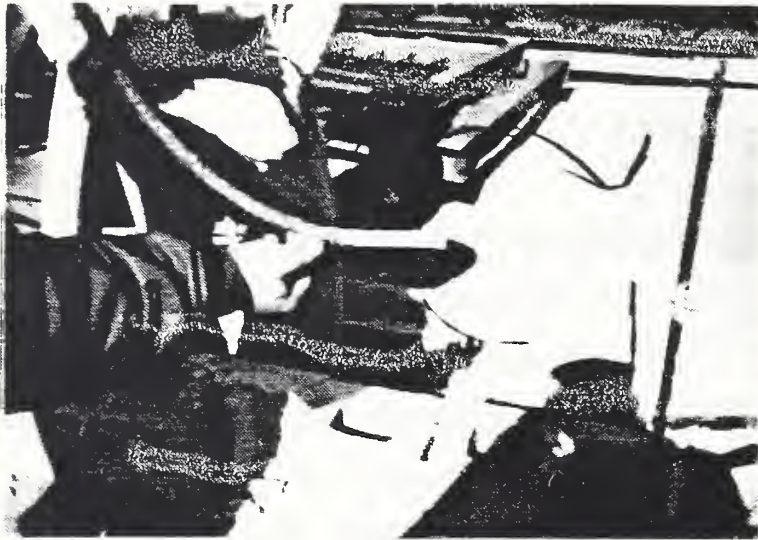
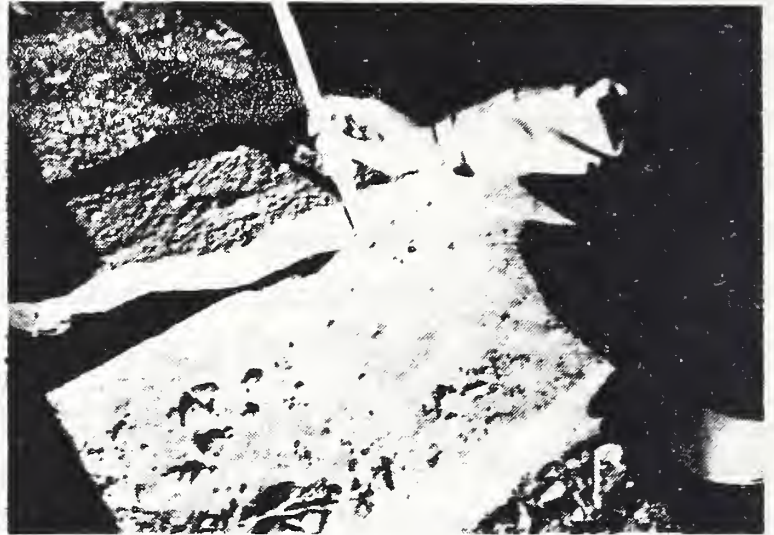
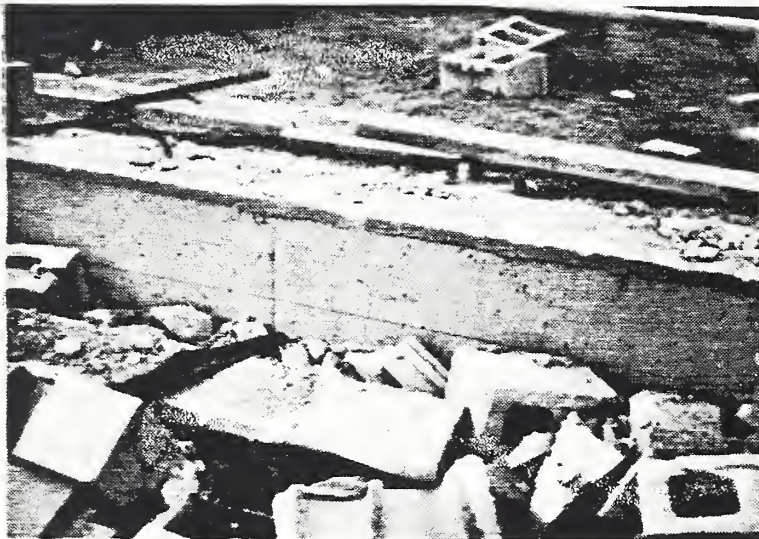
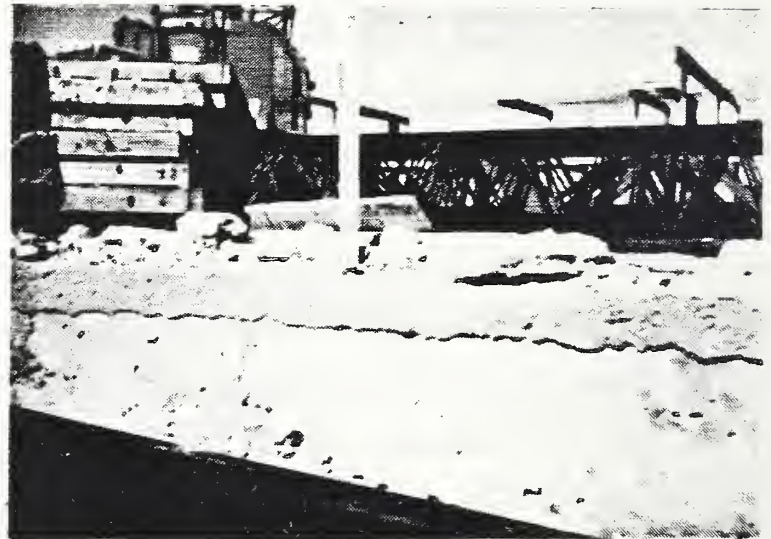
Figure 12: Pulled Out Dowel and Unbonded 2" Concrete Cap on Footing of Collapsed Wall.

Available records indicate that the dowels were omitted when the original footing was poured. To remedy this situation, the contractor drilled holes into the foundation and grouted the #5 dowels into these holes. No #6 dowels were found at the collapse site even though they were called for in the plans. The depth to which the holes were drilled was 5 inches, and sometimes somewhat

less. Thus the dowels were embedded in the foundation a maximum of 5 inches (the plans called for 2 ft-6 in. embedment). However even the 5 in. embedment was not fully effective. Apparently the top of the foundation, as originally poured, was about 2 in. below its intended elevation. To remedy this situation, a 2 in. concrete cap was poured. As a result, the dowels were embedded 3 inches in the foundation and 2 inches in the cap, which was not bonded to the foundation.

The above-discussed situation is illustrated in figure 12. Figure 12(a) shows a dowel which was pulled out of the foundation by an OSHA inspector. The part of the dowel that was embedded in the foundation can be seen by its white coloration (the rest of the dowel was not embedded in concrete at all). Figure 12(b) shows the 2-in. concrete cap, figure 12(c) shows the foundation with the cap and a solitary dowel, and figure 12(d) shows the depth of the hole from which a dowel was pulled out. In accordance with oral statements to the author by the OSHA inspectors who visited the site one man could extract the dowels from the foundation with ease, by pushing them to the side in two opposite directions and then pulling up. Minimum embedment for #5 dowels that would permit development of their tensile strength would have to be 24 dowel diameters or 15 inches. If the 2 inch cap is added to this, the dowel would have to be embedded at least 17 inches to be fully effective. It should also be noted, that even with the 3 inch actual embedment it would not have been as easy to extract the dowels, had they been effectively grouted (it would take about 1,100 lb to pull out the bars if the grout achieved 1/2 its 28-day strength).

- (a) Dowel pulled out by inspector.
- (b) 2" unbonded concrete cap.
- (c) Footing with concrete cap and remaining dowel.
- (d) Depth of hole from which dowel was Pulled.

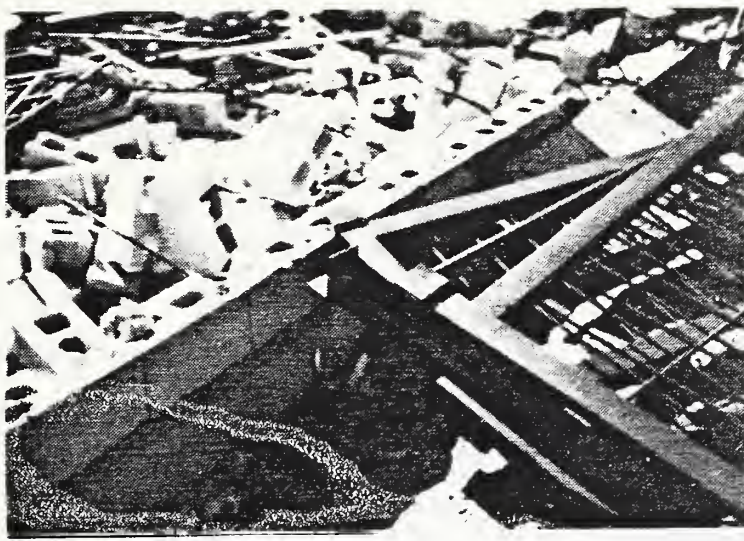
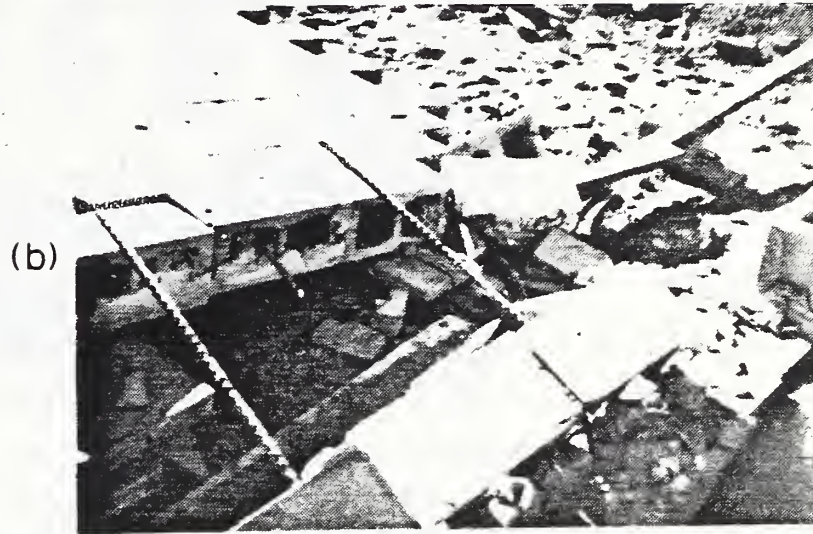
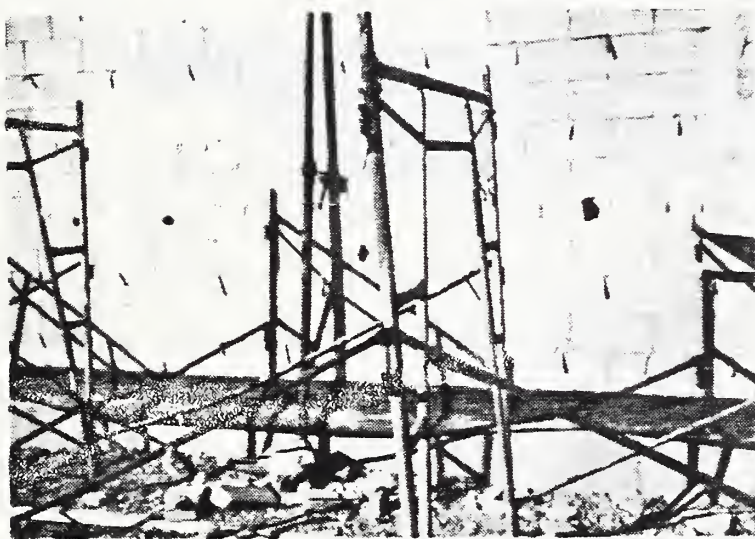
Figure 13: Grouting of Dowels and Other Masonry Reinforcement into Masonry Cores.

The dowel shown in figure 12(a) was not grouted into the masonry cores. This is further illustrated in figure 13(a) which shows

- (a) Failure surface with protruding ungrouted dowel.
- (b) End view of collapsed wall with ungrouted reinforcement bars.
- (c) Holes opened in wall that did not collapse. Cores were found to be ungrouted, and in some instances lacked specified reinforcing bars.

dowels and other reinforcement protruding from masonry units. The bars were rust colored, an indication that they were not embedded in grout. This is further illustrated in figure 13(b). Figure 13(c) shows holes which were opened to inspect other masonry walls on the same project. In many cores which were intended to be reinforced no grout was found, and in some cores the reinforcing bars were also missing.

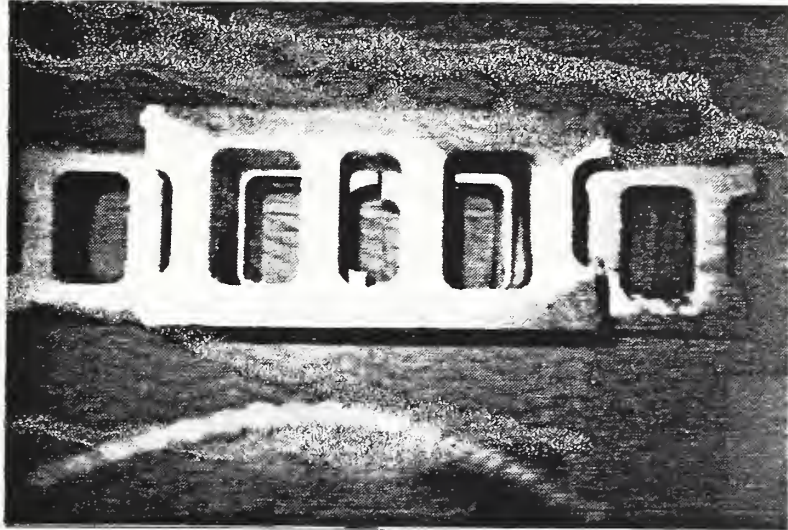
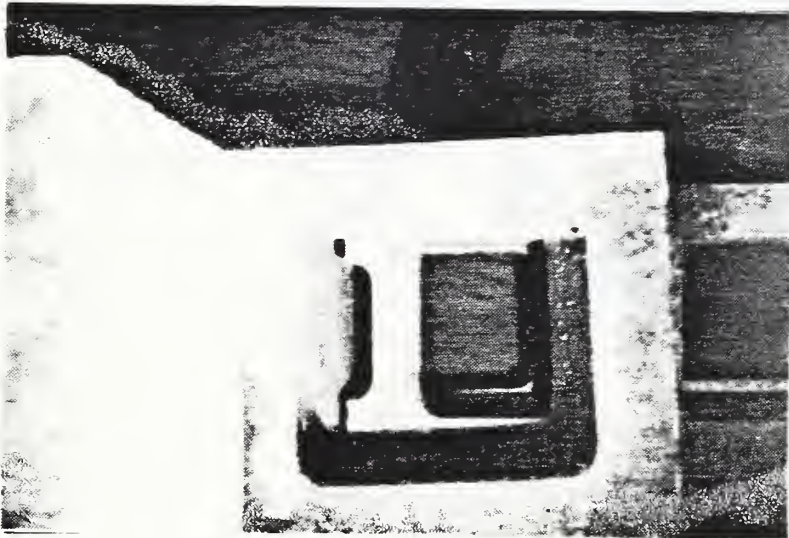
The masonry units actually used in the construction were standard units rather than the special units specified in the plans, which are specifically designed so that the cores of the units line up. The resulting problem is illustrated in figure 14. Figure 14(a) shows stacked special units where the cores line up. Figure 14(b) shows stacked standard units, where part of the core is blocked by successive courses of masonry. This results in cores which are more difficult to fill with grout in a satisfactory manner. While present standards (6,7) permit the use of such units, they do not recommend it. There is also no evidence that cleanout windows were used at the bottom of the grouted cores to permit removal of debris from the cores before they were grouted.

Figure 14: Core Alignment in Stacked Masonry Units
(a) Stacked Ivory Type block (cores aligned).
(b) Stacked standard CMU units (cores not aligned).

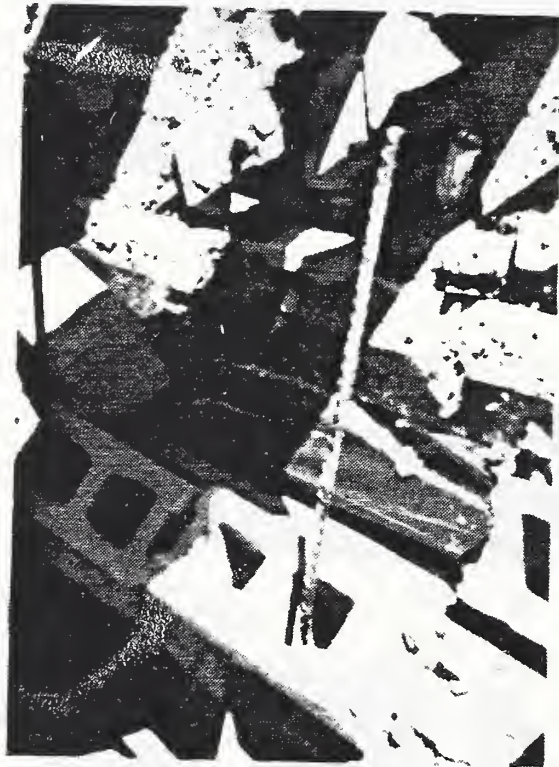
The flashing, which consisted of a vinyl strip, was put over the top of the first course of masonry rather than the second course. This resulted in a situation where a substantial portion of the top of the first-course unit was covered by flashing, the bottoms of the cores to be grouted were partially blocked by flashing, and one mortar bed was laid on top of flashing thus interrupting the tensile bond. A slot was cut in the flashing where there were dowels. This permitted placement of the flashing around the dowel, but blocked the rest of the core. Thus even if some of the grout reached this level (much of it did not), the flashing prevented it from reaching the top of the foundation. Figure 15 shows the flashing strip with the slot to accommodate the dowel, peeled away from the top of the first course of masonry.

Figure 15: Flashing Strip Peeled Away from Top of First Course of Masonry.

As previously noted, the flashing, which was placed at the leeward side of the wall covered the top surface of the first masonry course. This is well illustrated in figure 15. Note also that the top side of the first course units shows no sign of any mortar bonding. The geometry of the flashing was such that it interrupted the mortar bond on the leeward side of the wall. Different parts of the failure surface are shown in figures 16(a) to (d). It appears that the combination of the effects of the flashing and the 2 in. unbonded concrete cap on top of the foundation was to lower the tensile resistance of the mortar bond at the base of the wall below that normally expected even from an unreinforced masonry wall.

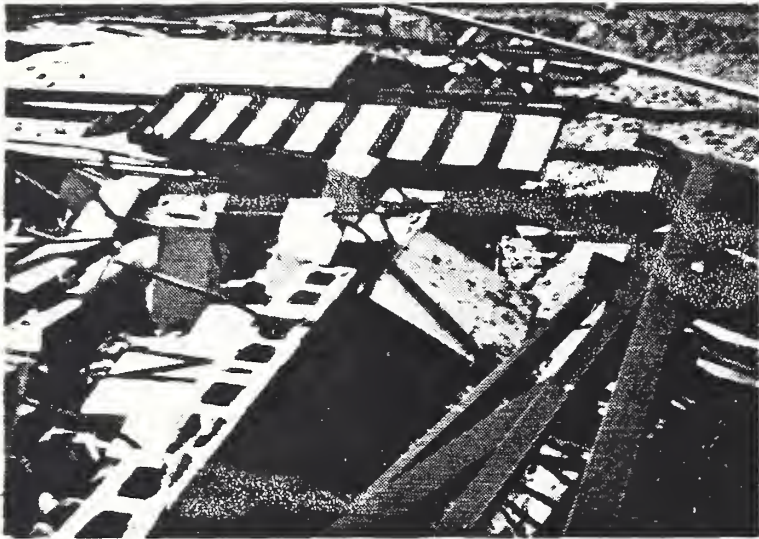
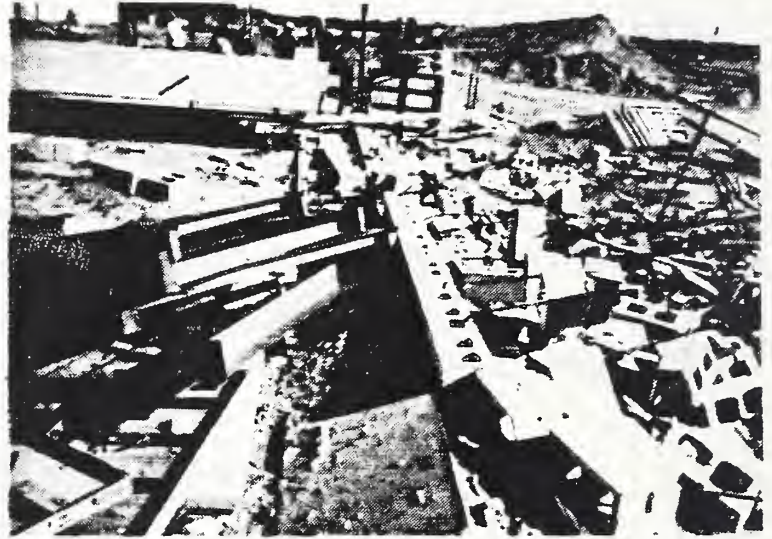
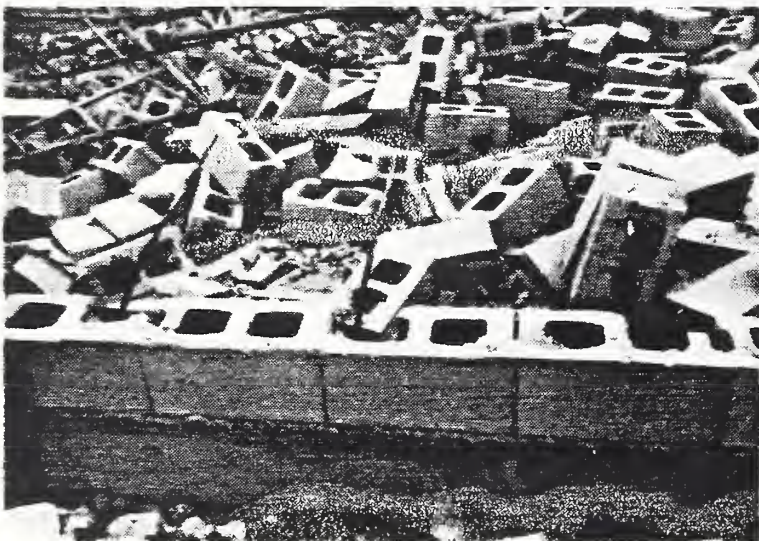
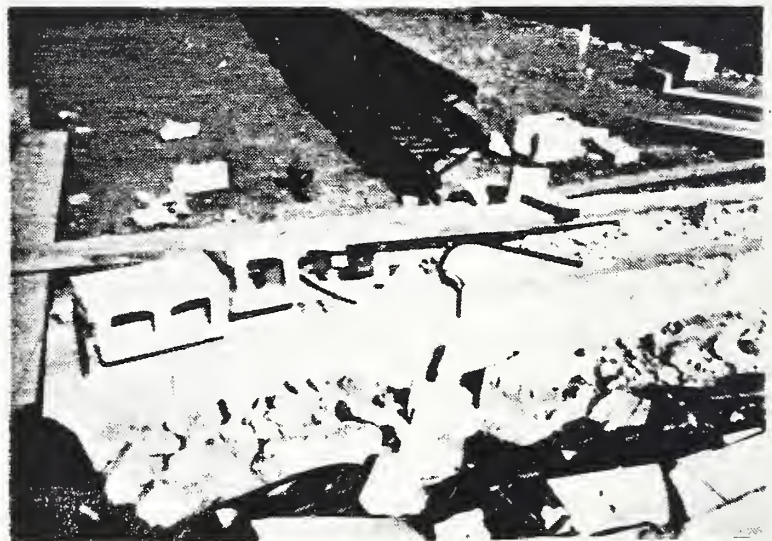
Figure 16: Failure Surface; Almost No Evidence of Effective Mortar Bonding Can Be Detected.

Since the only sound reported by eye witnesses before the wall impacted on the ground was that of failing timber, it is unlikely that any significant mortar bond failure occurred during the collapse, since such a failure tends to be associated with a sharp, explosive noise. Thus, probably there was no effective mortar bond at the time of the failure.
