NISTIR 4525

# Cleaning of Aged EPDM Rubber Roofing Membrane Material for Patching: Analytical Techniques for Surface Characterization

Interim Report

February 1991

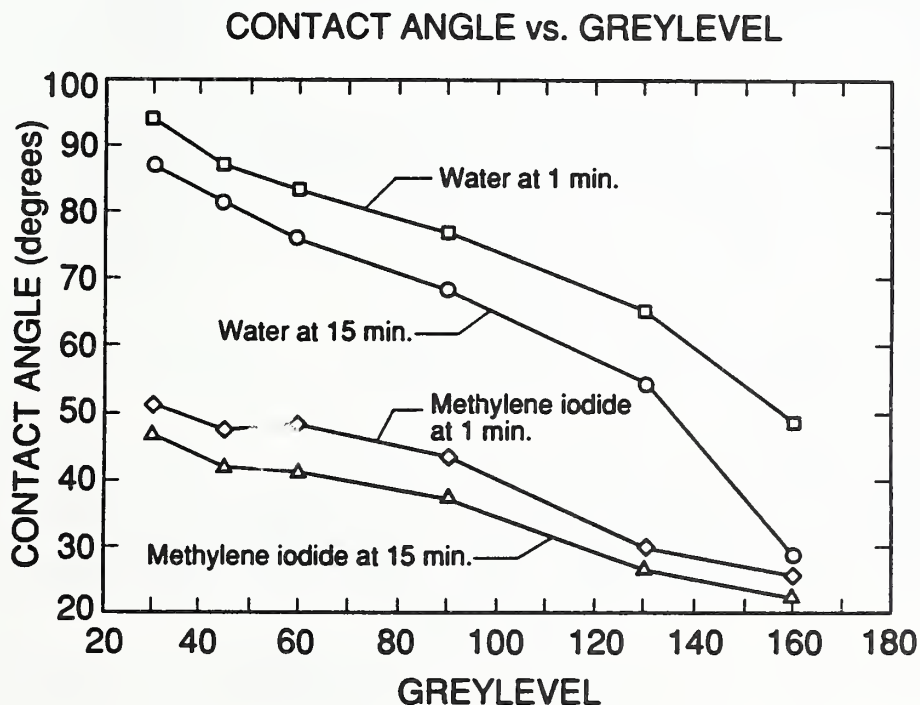
Contact angles of a polar liquid (water) and a nonpolar liquid (methylene iodide) on the EPDM sheets having different greylevels were measured using a contact angle goniometer. Figure 1 shows that the contact angles (obtained both at 1 and 15 minutes after a drop of liquid was deposited on the surface) decreased as the greyscale level increased. It may also be seen that water is more sensitive to the amount of release agent than methylene iodide. This is evident by the greater decrease of the water contact angle as the greyscale level of the surface increased.

Figure 1. Contact angle of water and methylene iodide on EPDM rubber at 1 and 15 minutes as a function of surface contaminant coverage (expressed in terms of greylevel)

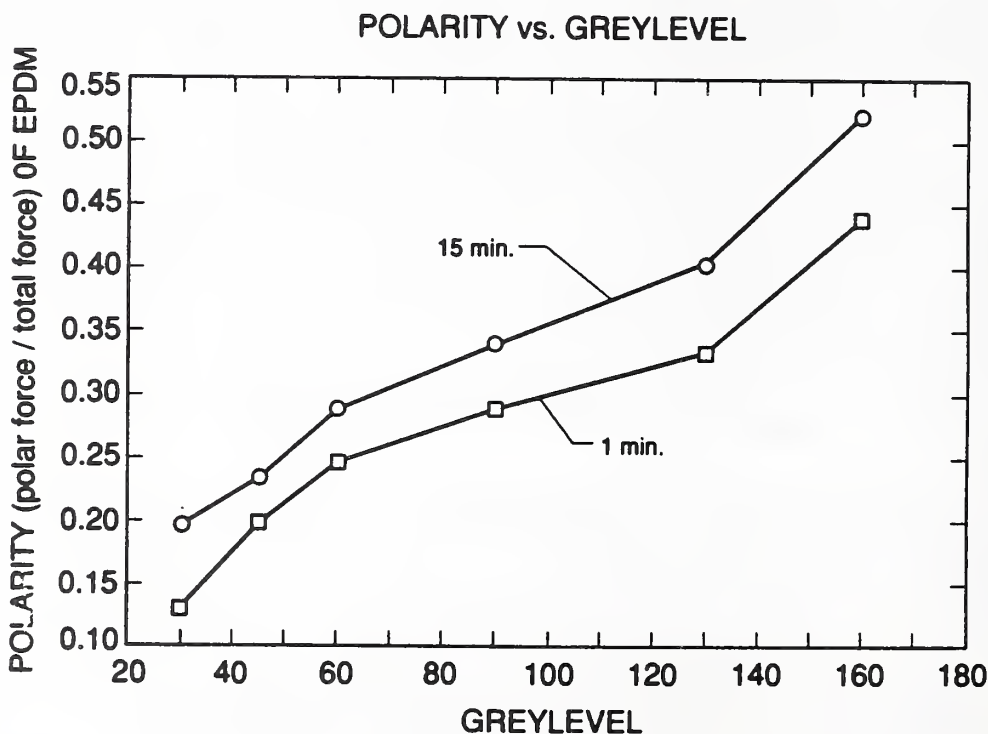
The contact angle data were used to calculate the polarity of EPDM (Figure 2) using the harmonic-mean approach proposed by Wu [6]. As is evident in Figure 2, the cleaned specimens (greyscale level 30) had the lowest polarity which would be expected for a composite hydrocarbon material such as EPDM rubber.

Figure 2. Polarity (polar force/total force) of EPDM rubber determined for 1- and 15-minute contact angles as a function of surface contaminant coverage (expressed in terms of greylevel)
