NISTIR 4972

Observations From a Field Study of the Performance of Polymer-Modified Bitumen Roofing

Walter J. Rossiter, Jr.
Randy D. Denchfield*

Building and Fire Research Laboratory
Gaithersburg, Maryland 20899

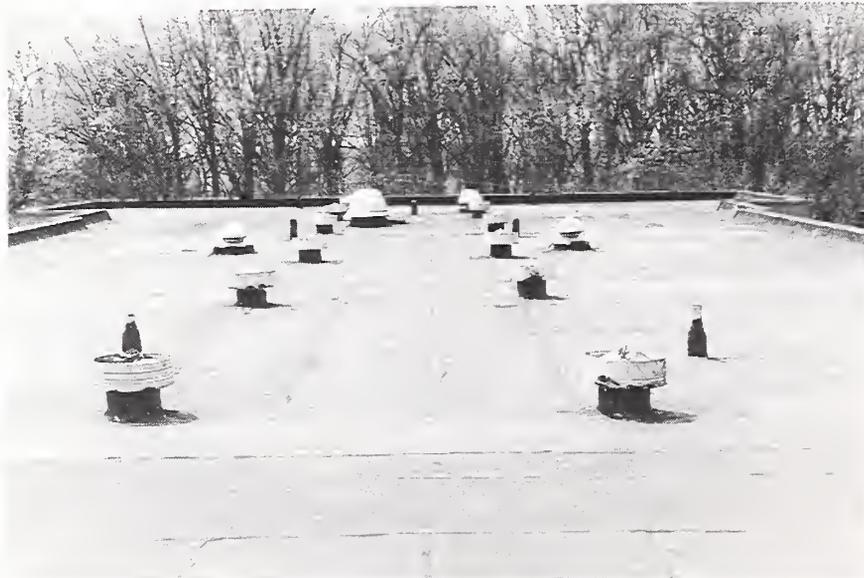
Considering the limitations mentioned above, the overall performance of these relatively young roofs was considered to be satisfactory. This was not unexpected and consistent with previous comments on performance by members of the CIB/RILEM Committees and others cited previously [9,10,13]. About 70 percent of the roofs were classified as being visually in fine condition (ratings 4 & 3 combined). Fig. 2 shows a field view of a typical roof that was performing satisfactorily.

Figure 2. Example of a roof that was providing satisfactory performance

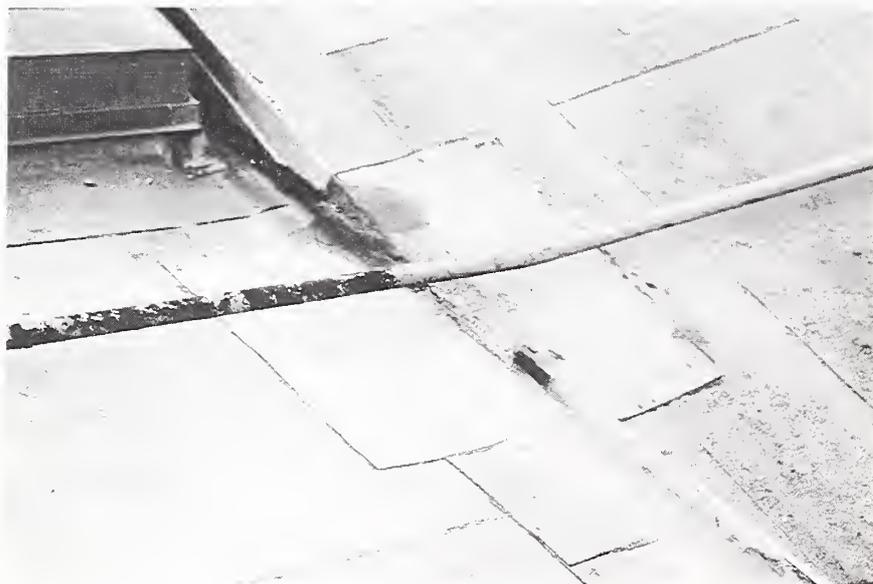
The vast majority of the roofs were reportedly watertight at the time of the inspections, albeit many (about 30%) had experienced minor leaks at some point in their brief lifetimes. Sources of leaks included both membranes and flashings, but the leaks were not always directly attributable to the use of a modified-bitumen membrane. As is often the case with low-sloped roofing, the roof included details that would be difficult to make watertight no matter the type of membrane installed. Fig. 3 shows a junction of two roof sections near a penetration. Reportedly, this area of the roof was constantly leaking. The incidence of leaks served as a reminder that, in addition to good materials, the other principles of sound roofing practice, i.e., good design, good installation, and good maintenance, apply equally to modified-bitumen roofing. Although a leak may be readily repaired, the consequential damages (e.g., deterioration of components or loss of thermal efficiency) of water penetrating the roof can be high.

Figure 3. Junction of two roof sections that was difficult to keep from leaking

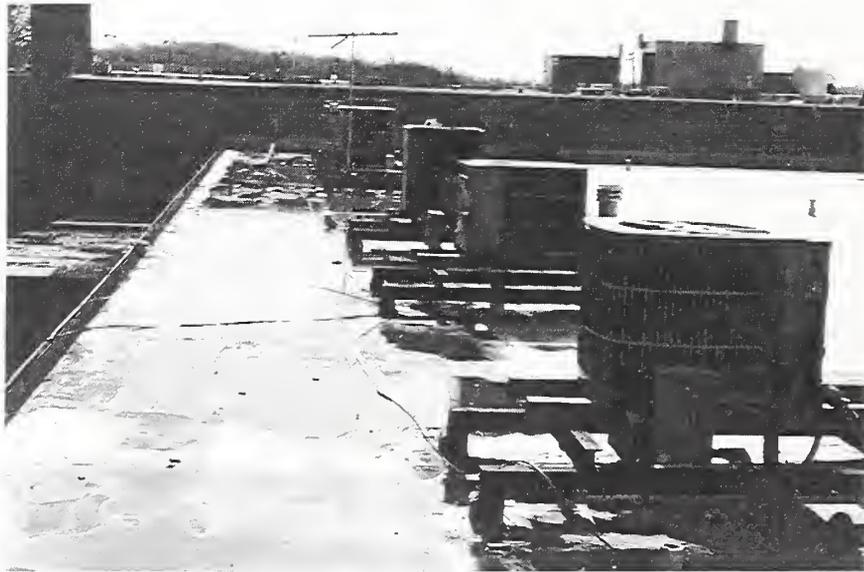
3.1.1 Ponding. For the majority of the roofs, sufficient slope was present and the roofs generally drained well. Nevertheless, typical of low-sloped roofing, slope was not always adequate over all sections of the roof. Over 50 percent of the roofs were noted as having some degree of ponding. Generally the extent was minor, as evidence by limited areas of standing water or dirt accumulated on the surface where water had collected and evaporated. Fig. 4 shows a small roof section near a gutter-edge that had insufficient slope.

Figure 4. Limited ponding along a roof edge that lacked sufficient slope

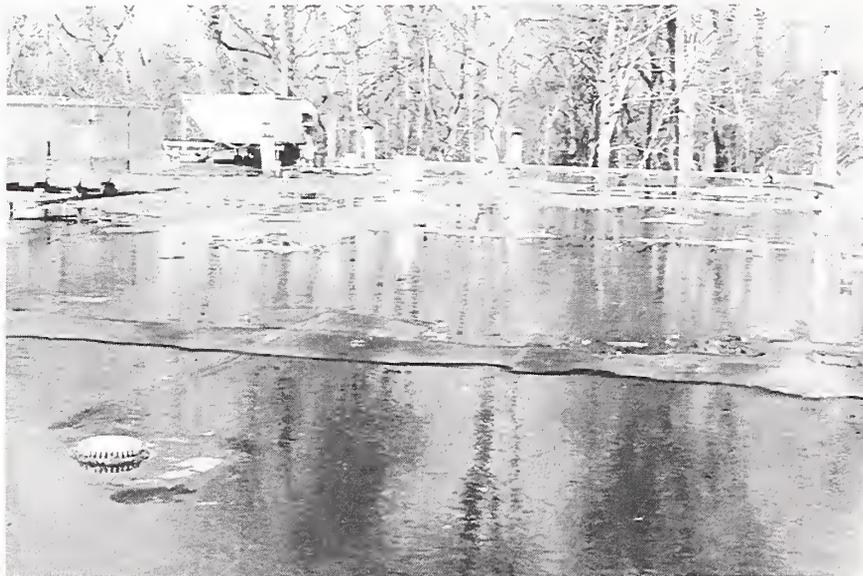
Five roofs were categorized as being extensively ponded (Fig. 5). In these cases, the modified bitumen had been applied in a re-roofing application, where opportunity was available to install slope or drains. Good roofing practice dictates that water be drained from the roof as experience has shown that ponding water can be detrimental to roof membranes [16]. Moreover, when roofs adequately drain, the consequences of unexpected leaks damaging the building and its contents may be minimized.

Figure 5. Example of a roof that had extensive ponding

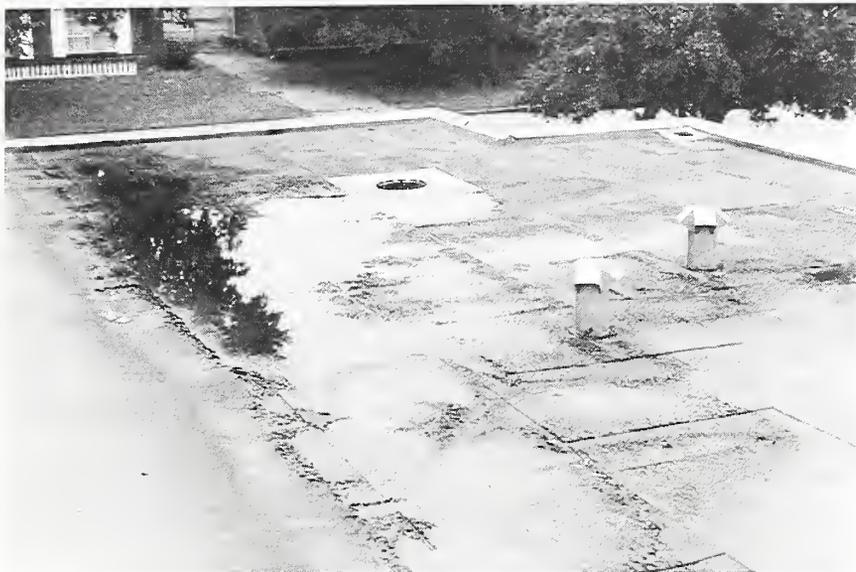
The many observations of ponding raised questions regarding the membrane material's ability to resist ponded water. European experience with modified-bitumens has indicated that water has not, in general, affected the performance characteristics of the modified bitumens, provided that the reinforcement is sufficiently impregnated and coated [12]. Individual products have experienced loss of low-temperature flexibility, bitumen adhesion to reinforcement, and granule imbedment. In the present study, some SBS granule-surfaced roofs had undergone extensive granule loss and cracking in ponded areas, particularly where dirt and other debris had accumulated, although the membranes were functional in those locations (Fig. 6). The surface deterioration in these ponds has at times been referred to as "mud cracking." On some roofs, the observations recorded gave hints that the environment of the pond may contribute to the granule loss. For example, it was observed on one roof that granule loss had noticeably occurred where effluent from an air-conditioner ran across the membrane surface and ponded.

Figure 6. Ponded roof area that experienced significant granule loss

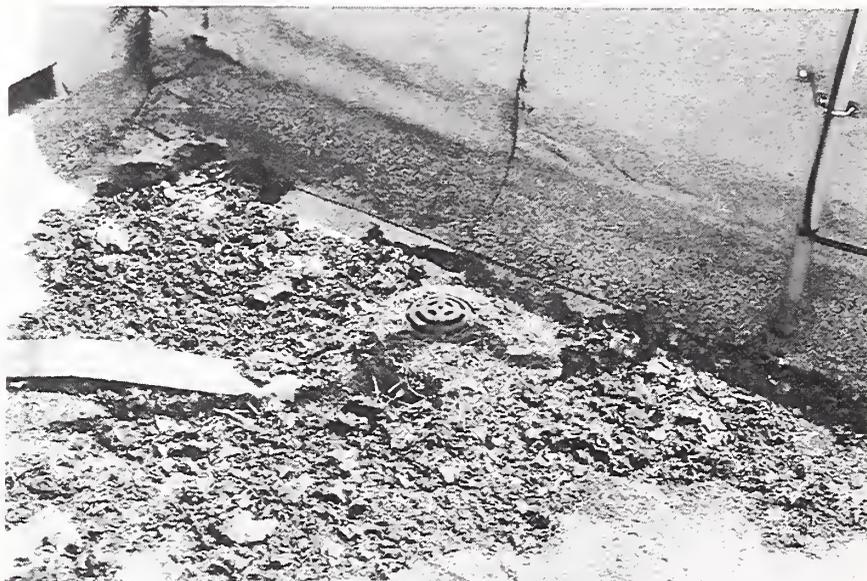
3.1.2 Lack of Maintenance and Abuse. Historically, lack of routine maintenance and abuse of low-sloped roof systems have plagued their performance. It was not surprising to find evidence that modified bitumens are no exception. Many items for maintenance and repair were observed including the deficiencies noted elsewhere in this report. Fig. 8 shows a clogged drain, which was a signal seen too often that the roof under inspection had been neglected.

Figure 8. A drain clogged with leaf debris

Examples of abuse included rocks, glass bottles and other objects thrown on the roofs, foot-traffic damage (loss of granules) by individuals not authorized to be on the roofs and, in one case, a bullet hole. Such observations provided sufficient evidence that modified-bitumen roofing are no exception to standard practice that periodic maintenance inspections and repair (where warranted) are a necessity, and that unauthorized use of the roof is to be avoided.

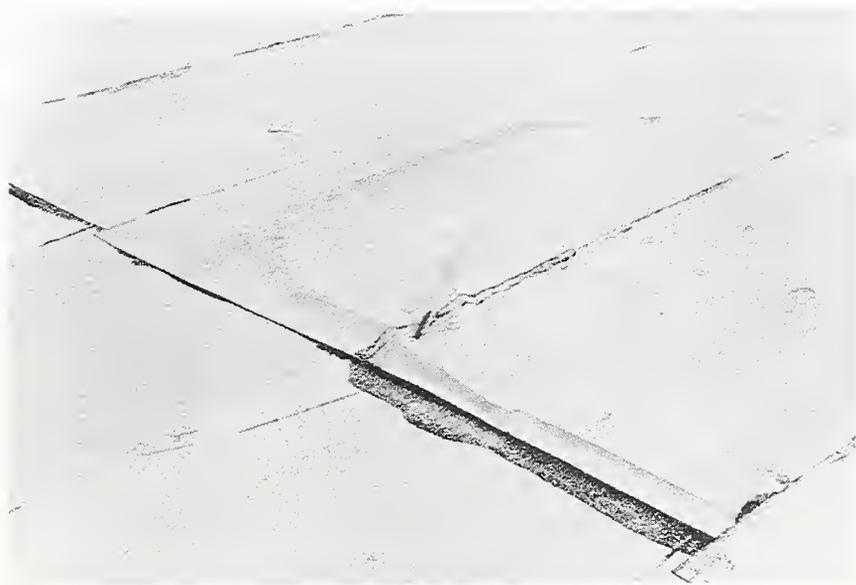
3.2.1 Blisters. The observations regarding blistering were positive. With one exception, this phenomenon, which has long been among the serious defects for built-up bituminous roofing (BUR), was not found to be a significant deficiency in the roofs inspected. Nine membranes, representing a cross-section of both APP modifieds with and without a base ply and SBS modifieds with a base ply, contained minor blistering (three or four blisters of relatively small size). Because cutting of the membranes was beyond the scope of the project, the location of the blisters (e.g., between plies or at the interface of the membrane and substrate) was not known. One roof with an SBS membrane applied over a lightweight concrete fill was seriously blistered to the extent that considerable patching had been performed. The unrepaired blisters had the shape of long, narrow ridges (Fig. 9), and one was found during the inspection to have short split (about 75 mm or 3 in.) on the top of the ridge. The observations that blistering can occur in modified bitumens serve as a reminder that, as with BUR membranes, care must be exercised to minimize incorporation of voids in the asphalt layers, and to assure that moisture is not entrapped in the system [9,17].

Figure 9. Ridge-like blisters in an SBS membrane

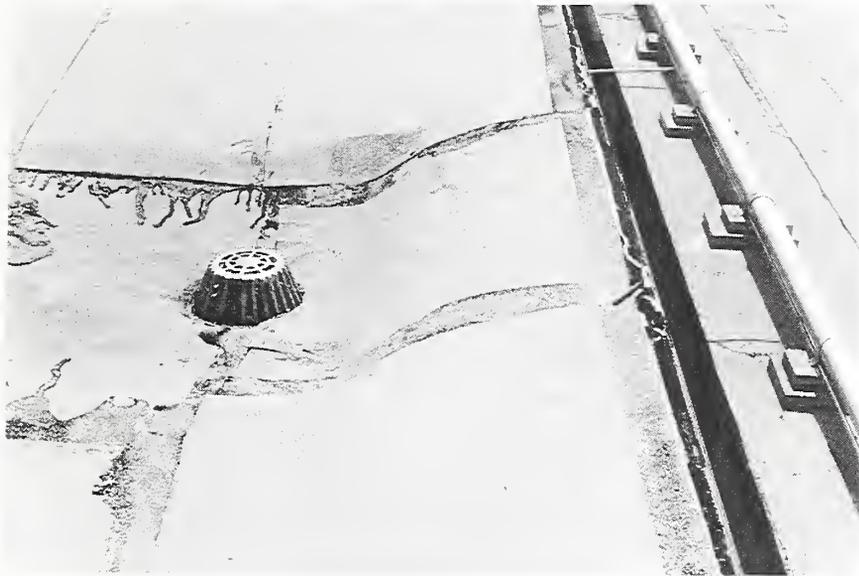
3.2.2 Slippage. Slippage, whereby one or more plies of a bituminous membrane slide down a slope often exposing a base ply or substrate, was observed on seven roofs. All roofs had SBS membranes with base plies installed using conventional roofing asphalt, and were located in the warm climates of Dallas and Jacksonville. The membrane ply sheets were applied parallel to the slope, which was about 40 mm/m (1/2 in./ft) for the roofs in question. The extent of the problem was, in some cases, limited to small highly sloped sections of a roof (Fig. 10); whereas, in other cases, it occurred over large sections of the field of the roof (Fig. 11). In no case had slippage occurred to the extent that the roofs were reported to be leaking through the membrane.

Figure 10. Slippage of the membrane on the slope of a drain slump; note the membrane wrinkling

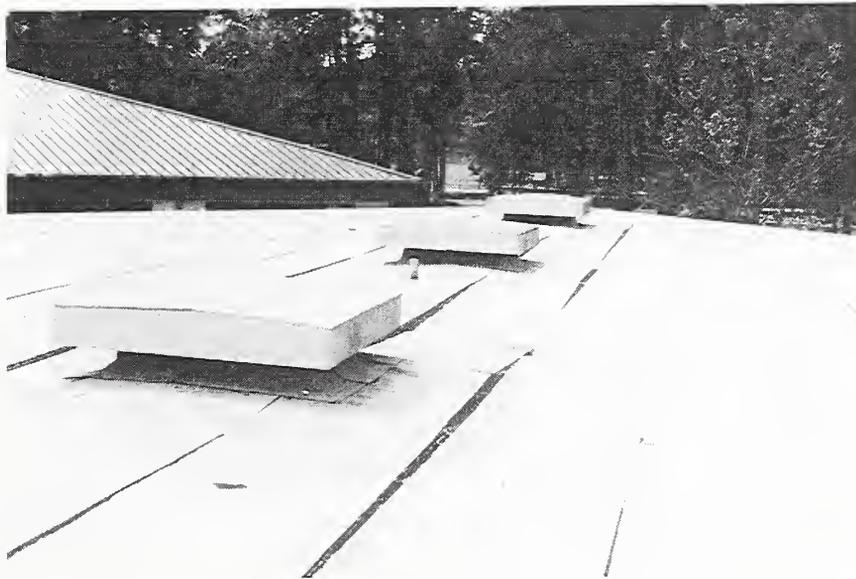
Figure 11. Slippage of an SBS membrane in the field of the roof

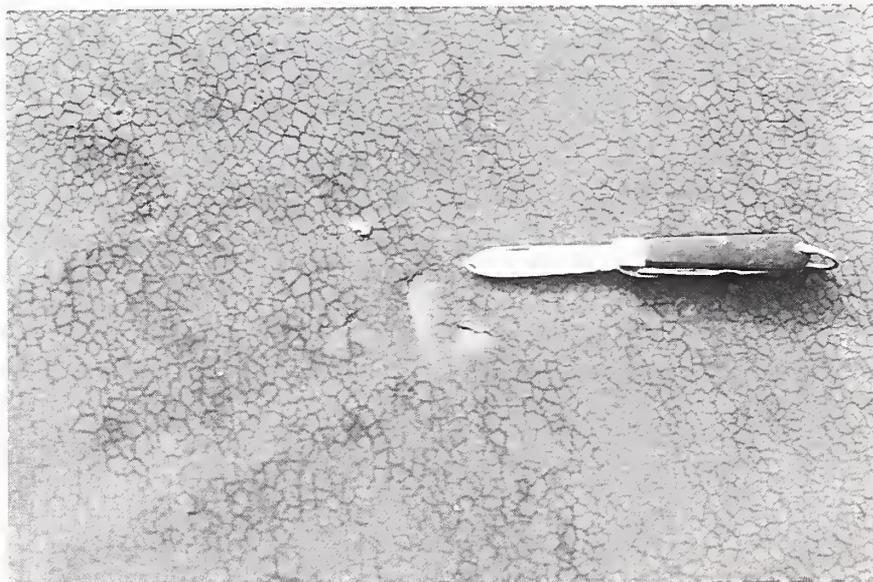
3.2.3 Punctures. Puncturing of the membranes inspected was almost non-existent. Only one of the 53 roofs was found to have a puncture of unknown cause (Fig. 12). The majority of the roofs had some equipment such as ventilators and air-conditioners, which necessitated some degree of foot traffic. The finding that the roofs were virtually puncture-free was consistent with past experiences in the United States. Puncturing of modified bitumens has not been singled out as a major problem in any reports describing field performance [8-10,13,14].

Figure 12. Puncture of an APP membrane; its cause was not established

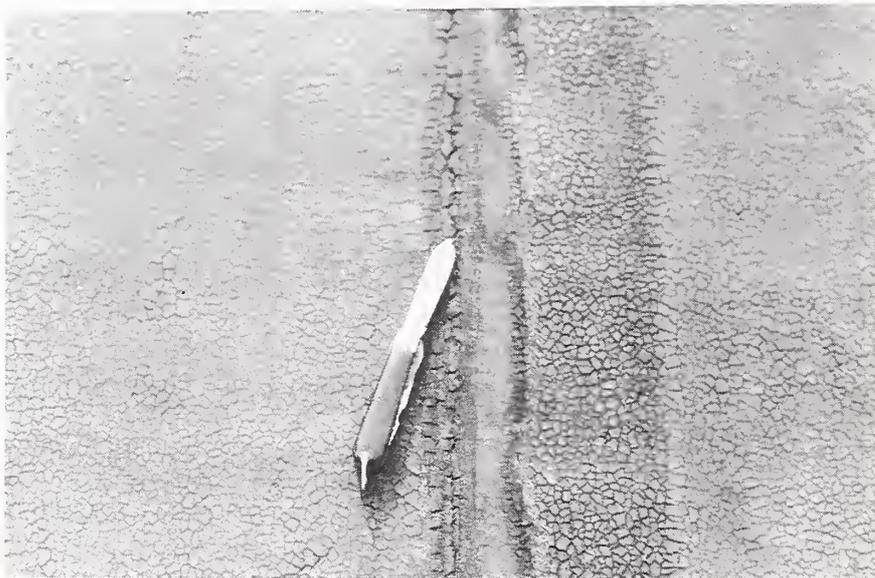
Two roofs were observed where extensive cracking of the membrane was apparent (Fig. 14). These roofs were about 8 years old when inspected, although their ages when the cracking initiated were not

Figure 14. An example of an unsurfaced APP membrane whose surface was extensively cracked

known. The cracking resembled "alligatoring" that occurs with conventional roofing asphalts as they weather. The cracks extended into the membrane material, but the depth was not determined as samples for analysis were not obtained. Neither roof was reportedly leaking through the membrane. In one case, an aluminized coating had been applied as a possible protective measure against further deterioration. The coating was only 6-months old when the roof was observed, and some cracking of the coating had occurred in locations corresponding to the cracks in the modified-bitumen surface. In a related observation, the surface of an exposed APP membrane was found to be generally in acceptable condition with the exception of two sheets that contained surface cracking similar to that just described.

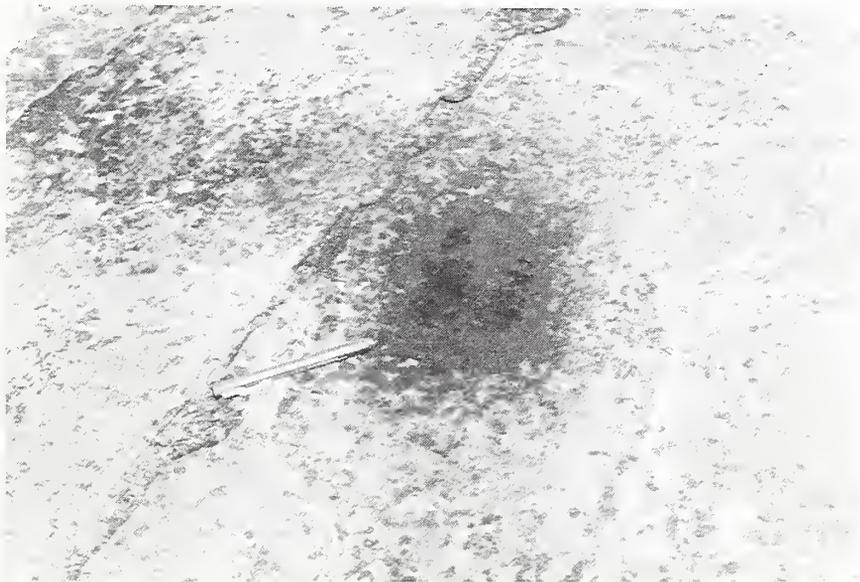
Another observation noted for the unsurfaced APP membranes was the presence of a thin layer of an oily exudate on some areas of the roofs (Fig. 15). The exudates were not considered to be a cause of concern with regard to membrane performance. However, their

Figure 15. Section of an APP unsurfaced membrane having an oily exudate

presence can adversely affect adhesion of coatings applied directly to the surface of weathered membranes [21]. Coating of unsurfaced new and aged APP membranes is a current issue in the U.S. industry [22].

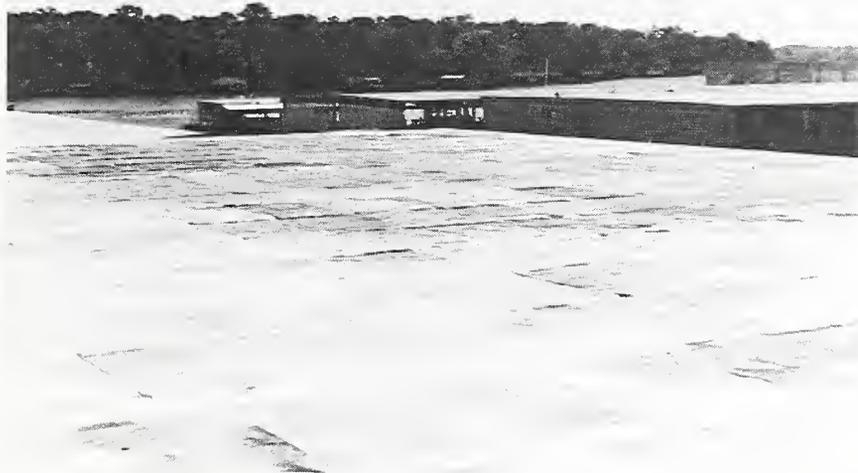
Figure 16. An 96-month old aluminized coating; the darker sections are due more to dirt collection in ponds than coating erosion

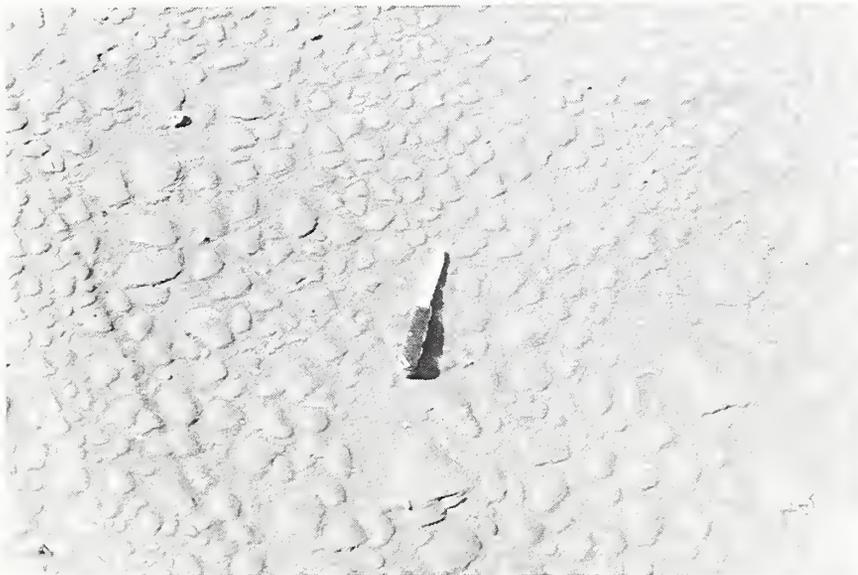
Other types of coatings on APP membranes were asphalt emulsions (2 roofs) and a white synthetic (1 roof). One of the asphalt emulsion coatings was in satisfactory condition after 39 months exposure; whereas the other was seen to have agglomerated on the roof surface (Fig. 17) during coating application. In the latter case, the 2-year old APP membrane was primed with solvent-based primer before application of the coating. Apparently the emulsion coating was incompatible with the primed membrane surface and, consequently, did not wet the surface when applied. As to the white synthetic, it had severely flaked from the membrane, particularly in ponded areas.

Figure 17. An asphalt emulsion coating that apparently agglomerated on the roof surface

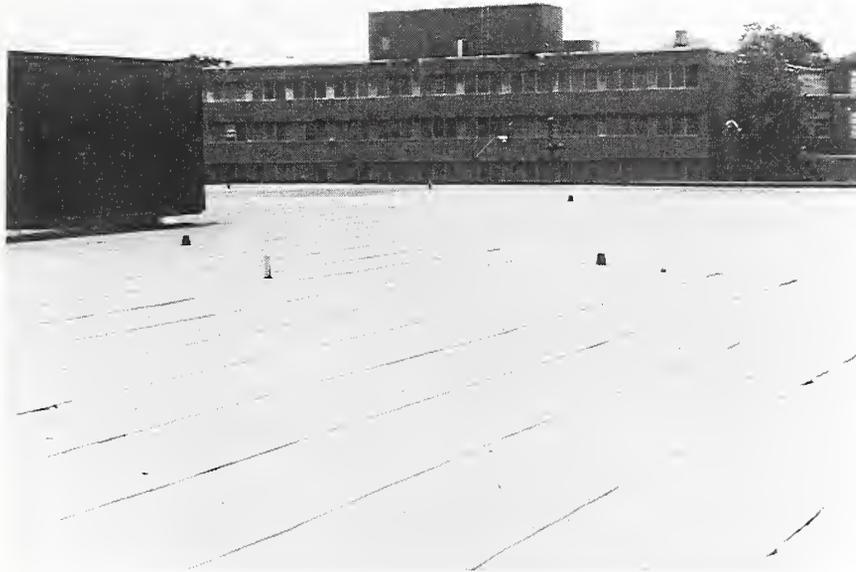
3.3.2 SBS Membranes. The majority of the SBS modified-bitumen membranes contained granule surfacings (Table 2), which was not unexpected since it is general industry practice for providing surface protection to these systems. Other than extensive granule loss in areas of ponds (Section 3.1.1), the majority of the surfaces of these SBS membranes exposed normally to weather was seen to be in acceptable condition (Fig. 18). As previously stated, instances of abuse due to unauthorized foot traffic resulted in excessive granule loss (Fig. 19).

Figure 18. A typical granule-surfaced SBS roof

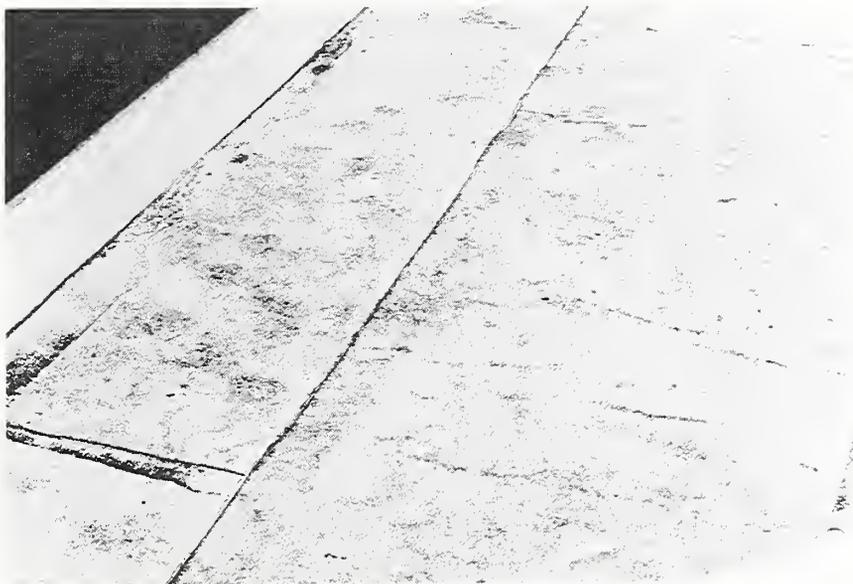
Figure 19. Granule loss of an SBS membrane at a high school; students often climbed on the roof

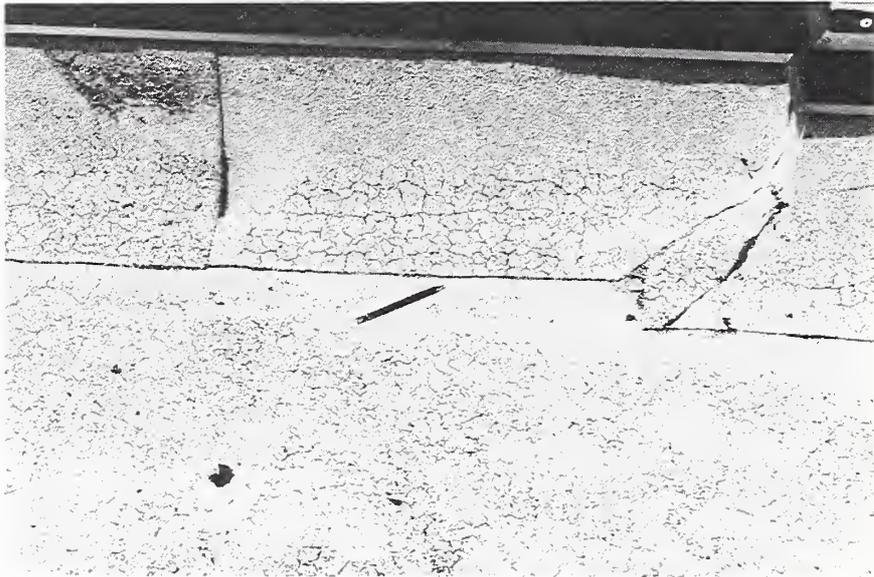
In addition to granule loss, cracking of granule surfaces, as shown in Fig. 20, was observed on a couple of roofs. When present, such cracking was generally limited to a few sheets. Also, the inspections included two roofs where a few sheets of the membrane material developed small blisters (or bubbles) in the granule surfacings (Fig. 21). These blisters resembled those that develop at times in the granule surfaces of asphalt shingles. At one location, the defect had been extensive enough that sheets with blisters had been overlaid with additional membrane material.

Figure 20. Cracking of a granule-surfaced SBS membrane material including the base flashing

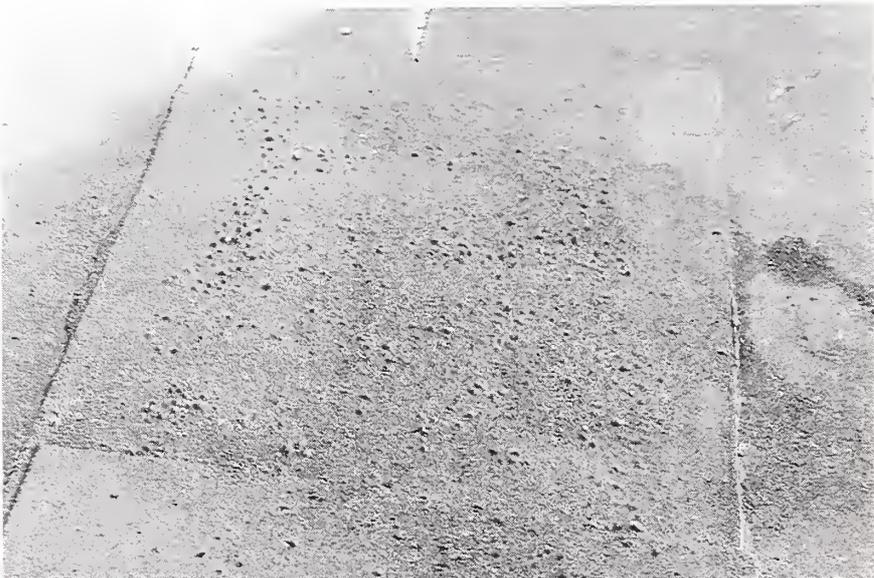
Figure 21. Small blisters in the granule-surfacing of an SBS sheet

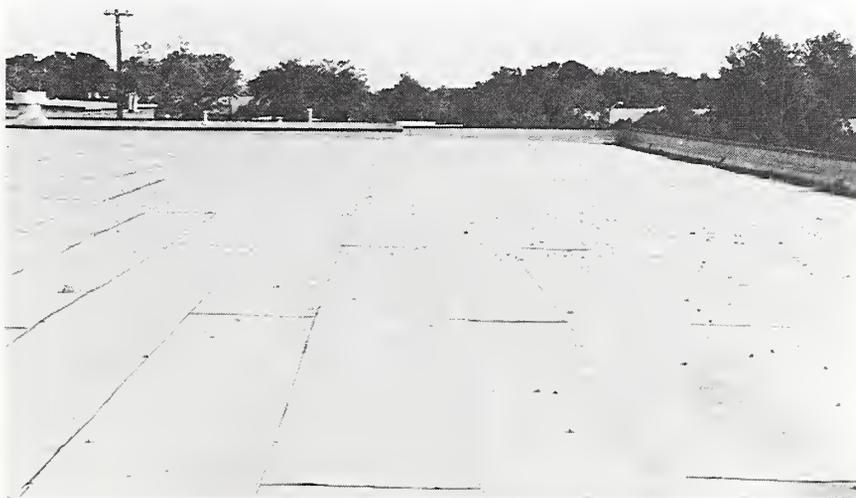
Figure 22. A foil-surfaced SBS membrane in acceptable condition although thrown rocks produced some small punctures in the foil

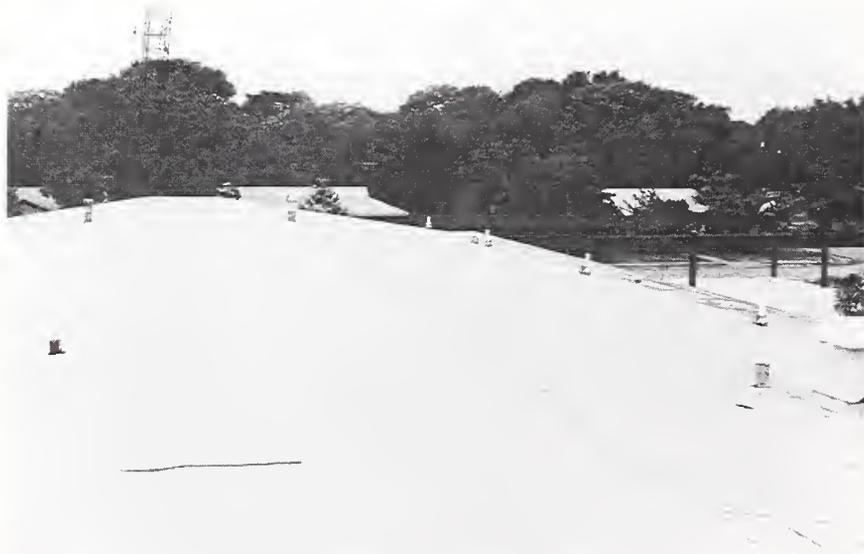
With the exception of one membrane product, observations concerning the performance of the laps of both the APP and SBS roofs inspected were favorable. For the roofs in general, the laps appeared to be intact and tight, and signs of potential trouble areas such as excessive wrinkling or buckling were not found. Fig. 23 illustrates laps typical of those observed with many of the SBS membranes. Many sections of laps were probed with the tip of a blunt blade. The technique was rough, but the laps generally resisted the probe. As a complement to the NIST observations, it is noted that four complementary reports from RCI included incidents of lap openings. All were described as being minor problems.

Figure 23. Laps of a SBS membrane illustrative of many observed; the end and sides laps were tight

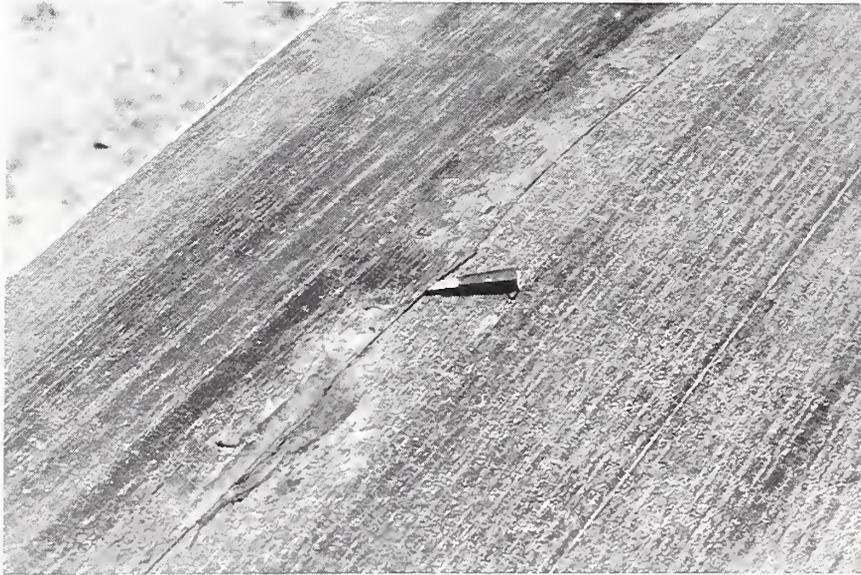
The exception to the generally positive findings on lap performance involved membranes constructed from a torch-applied APP product that had been, but is no longer, available from a particular manufacturer. Twelve of the 53 roofs included in the study had such membranes. For 5 of these 12 roofs, the visual evidence was that the laps were in satisfactory condition without signs of disbond or lap repair. The ages of these roofs ranged from 54 to 96 months. In contrast, six of these membranes, with ages ranging from 74 to 131 months when inspected, showed indications of serious lap problems at some point during their service. One of these roofs was found to have sections (a few millimeters to a half of meter in length) of laps that were unbonded (Fig. 25), and a number of patches had been made. Note in Fig. 25 that no unusual signs of distress such as pulling or rippling of the membrane were apparent where the blade is inserted in the section of open lap. Five of the other roofs had laps with a considerable number of patches, as exemplified in Fig. 26. Generally the patches were located randomly across the membrane. However, the relatively large roof depicted in Fig. 26 had the patches concentrated in relatively small areas, while other sections were patch-free.

Figure 25. An opening in a lap of an APP membrane

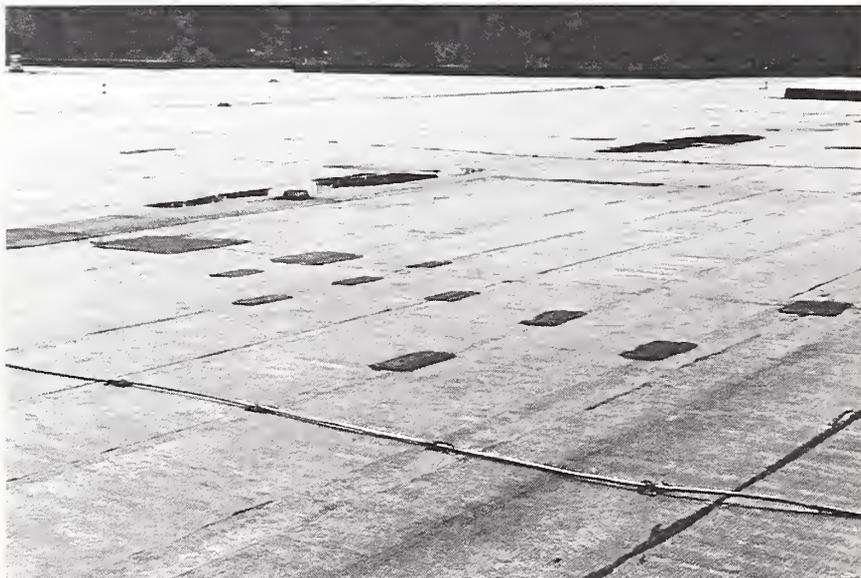
Figure 26. Example of an APP membrane with repair patches made to the laps

In the case of half of the repaired roofs, the ages of the membranes when seam patches were first applied were reported to be about 24 to 36 months; for the others, the ages of initial patching were unknown. But even when the ages were not known, those accompanying NIST staff were quite positive that the roofs in question were leak-free when installed. Although scant, these few details on age indicate that time was a factor influencing the performance of these laps. However, little other information was gleaned from these individuals regarding factors affecting the lap performance.

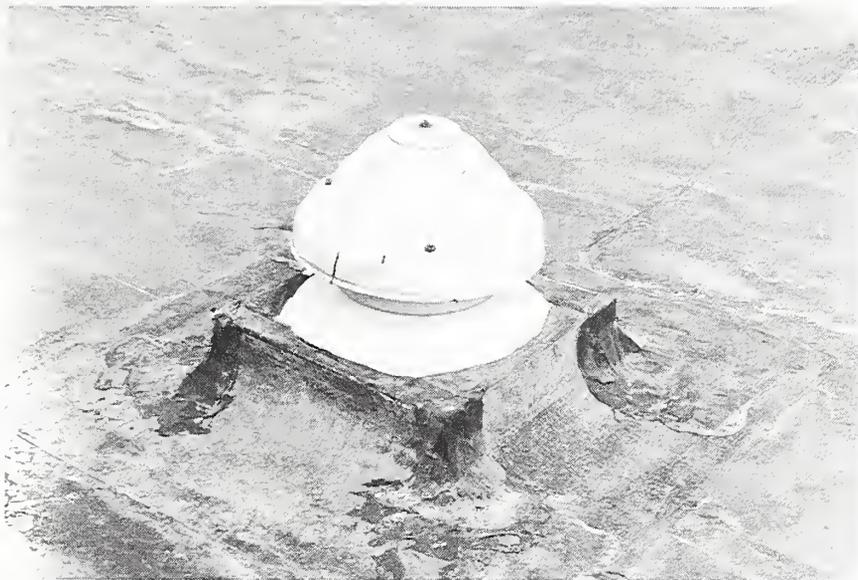
The flashings at penetrations and perimeters were generally in good condition. Poor flashing performance was never found to be a major problem on any roof. In most cases, the modified-bitumen membrane material was used as the base flashing. As an example, Fig. 27 shows a curb-mounted ventilator with a base flashing fabricated from the APP membrane material. One granule-surfaced SBS membrane system often had foil-faced base flashings.

Figure 27. Flashing of a ventilator penetration of an APP membrane
