NISTIR 5353

Source of Phenol Emissions Affecting the Indoor Air of an Office Building

February 1994 Building and Fire Research Laboratory National Institute of Standards and Technology Gaithersburg, MD 20899

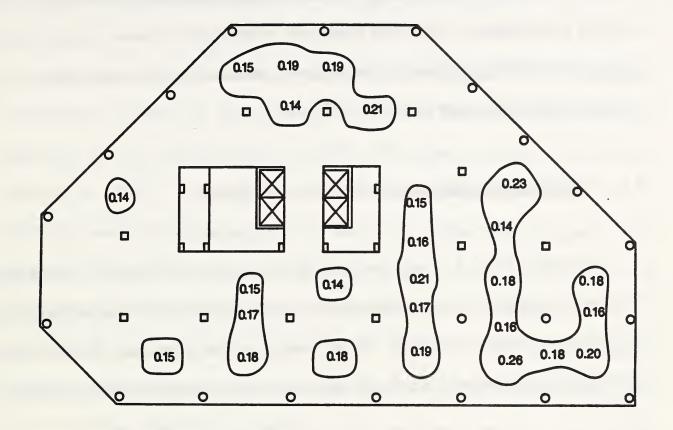
An example of a deflection diagram from the GSA report [14] is shown in Figure 2. In this figure, the contour lines indicate the boundaries of each of the sunken areas in the floor and, thus, the probable boundaries of the "puddles" of inorganic floor-leveling material. For this reason, the deflection diagrams have often been called "puddle diagrams". The numbers within each puddle indicate the depth by which the floor is out-of-level in units of feet; thus, 0.2 is 0.2 feet so that the floor is 61 mm (2.4 inches) out-of-level at this location.

Figure 2. Deflection diagram for Floor 4 of SSMC-1. Numbers indicate out-of-levelness dimensions in feet.

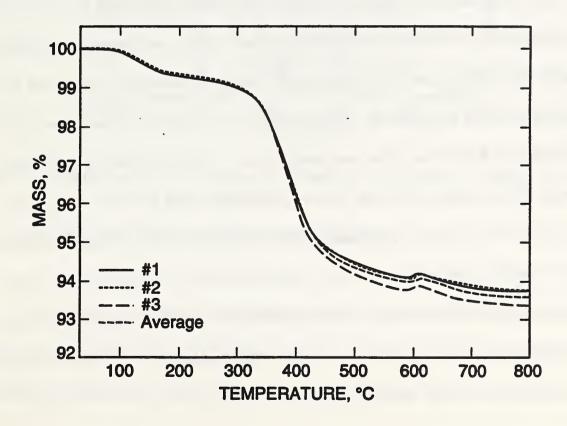
materials. (Refer to Table 5 and Appendix A for data on the other samples taken from Floors 2 through 5). At temperatures between 200° C and 800° C, the epoxy binder undergoes thermal degradation causing the epoxy resin to break down into small molecular units by pyrolysis or oxidation which are volatilized along with the high boiling organic compounds, like amines. From the TG curve, the epoxy binder comprised approximately 5.7 % of the total mass of the leveling material (Figure 3). The remaining 0.8 % of the volatile material (100 % - 93.5 % - 5.7 % = 0.8 %) was volatilized between room temperature and 200° C. This would include volatile organic compounds like phenol which might contribute to the indoor air quality complaints in SSMC-1. Of this 0.8 %, between 0.1 and 0.2 % was water².

Figure 3. Thermogravimetric curve for one of the fourth floor composite samples heated from room temperature to 800 °C.

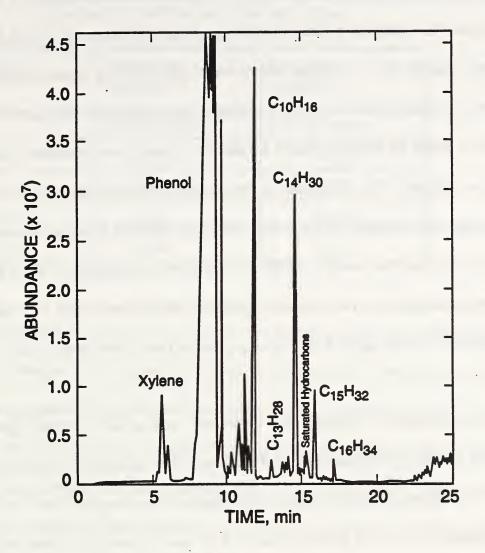
In the GC/MS experiment (see Appendix B), a one-gram sample of granulated floorleveling material was placed in a stream of nitrogen which could be sampled by GC/MS. The volatile organic emissions from the leveling material were monitored at room temperature and 100° C. A GC/MS spectrum taken at 100° C is presented in Figure 4. The GC/MS spectrum at room temperature is similar to the one shown in Figure 4, except that the areas under the peaks are less. From this analysis, it was concluded that **phenol** is emitted from the leveling material along with smaller quantities of **xylene**, ethyl benzene, and higher molecular weight hydrocarbons, such as terpenes. These volatile organic compounds are the same as those reported by Carnow I [5].

Figure 4. GC/MS spectrum of the epoxy floor-leveling material taken at 100 °C.
