**NISTIR 5389**

# **Analysis of Failed Dry Pipe Fire Suppression System Couplings From The Filene Center at Wolf Trap Farm Park for the Performing Arts**

March 1994

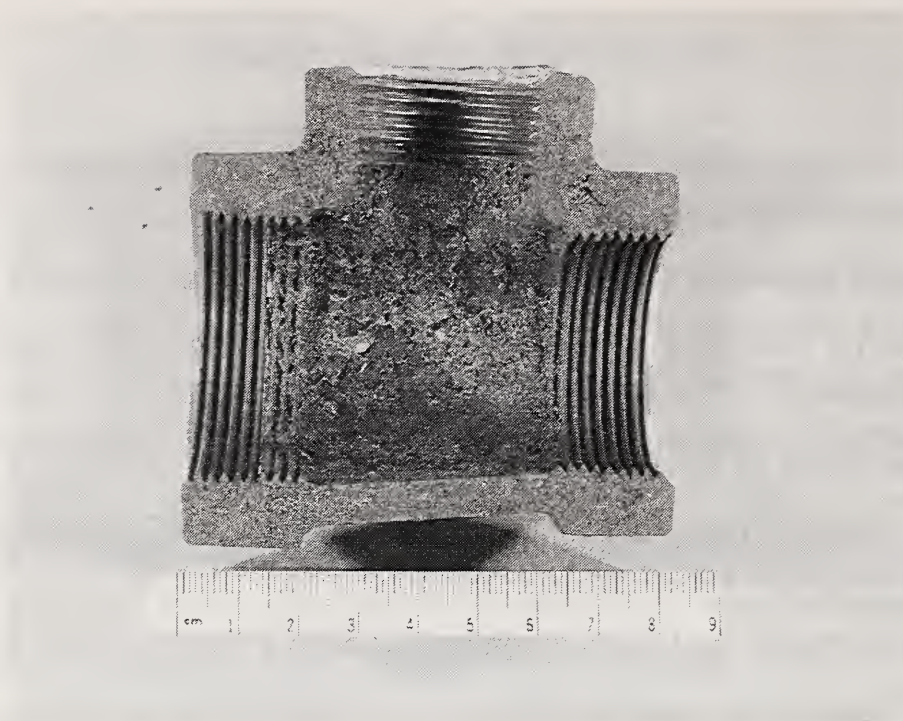
The optical analysis of the failed "T" couplings revealed that the stresses which ultimately produced the fractures were purely circumferential. Circumferential, or hoop, stresses are in-plane, principle stresses which occur in thin-walled, cylindrical or spherical pressure vessels.<sup>(9)</sup> In most cases where water is constricted and allowed to freeze, circumferential stresses result from the expansion of the water and failures from this type of stress generally are

symmetrical about the long axis of the component.<sup>(9)</sup> In the case of the "T" couplings, casting seams were present along the long axis. In general, the seam is the weakest part of a casting and as a result, the principal cracks are believed to have nucleated in this region and propagated along the length, effectively splitting the couplings in two. This type of failure is shown in Figure 1.

**Figure 1** Optical micrograph showing a brittle fracture along the casting seam of a failed cast iron coupling taken from the Filene Center.

The results of this analysis also indicate that the potential for catastrophic failure of the couplings within this fire suppression system may be reduced by a total replacement of the gray cast iron couplings with a material which is more resistant to brittle fracture. Some carbon steel alloys may be suitable for this purpose. The best recommendation to alleviate this problem is to remove all of the water from the system. More drains located in the key low points throughout the system could reduce the amount of residual water substantially .

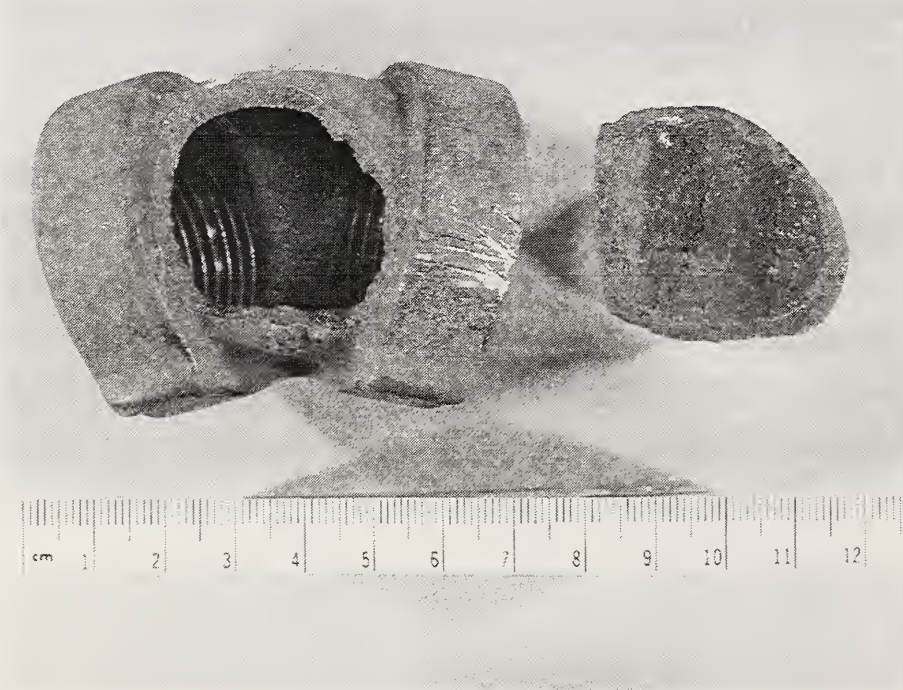
The failures observed in the elbow sections were also determined to be the result of the stresses induced by the expansion of water. In these specimens, failures were observed in the "knee" region of the casting as shown in Figure 2. The radius, or knee, is typically the weakest region in an elbow fitting.

**Figure 2** Optical micrograph showing a brittle fracture located in the radius of a failed cast iron elbow taken from the Filene Center.

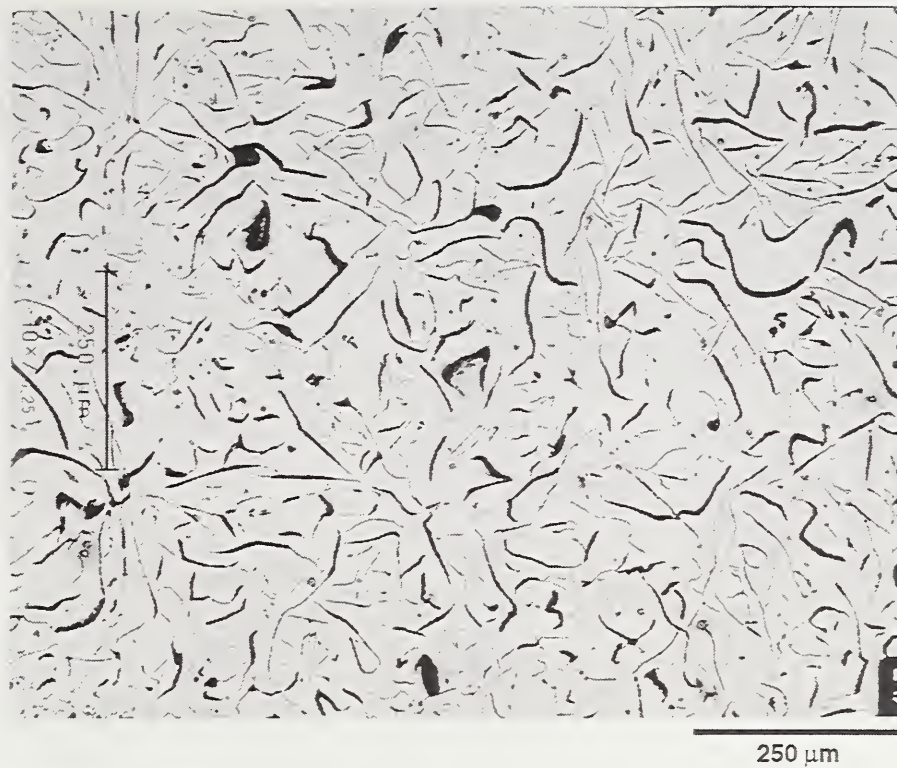
Sections were cut from the couplings and prepared for metallographic analysis using standard procedures.<sup>(5)</sup> The polished surfaces were analyzed in both the "as polished" and the etched conditions. A 2% solution of concentrated nitric acid in methanol (nital) was the etchant used for this analysis. Figures 3 and 4 are representative micrographs of a coupling section in the as polished and etched conditions, respectively. The microstructure is composed of graphite flakes in a pearlite matrix, and on this basis, the material was determined to be a Class 30 cast gray iron.<sup>(6,7)</sup>

**Figure 3** Optical micrograph in the "as polished" condition showing the microstructure of a failed cast iron coupling taken from the Filene Center.

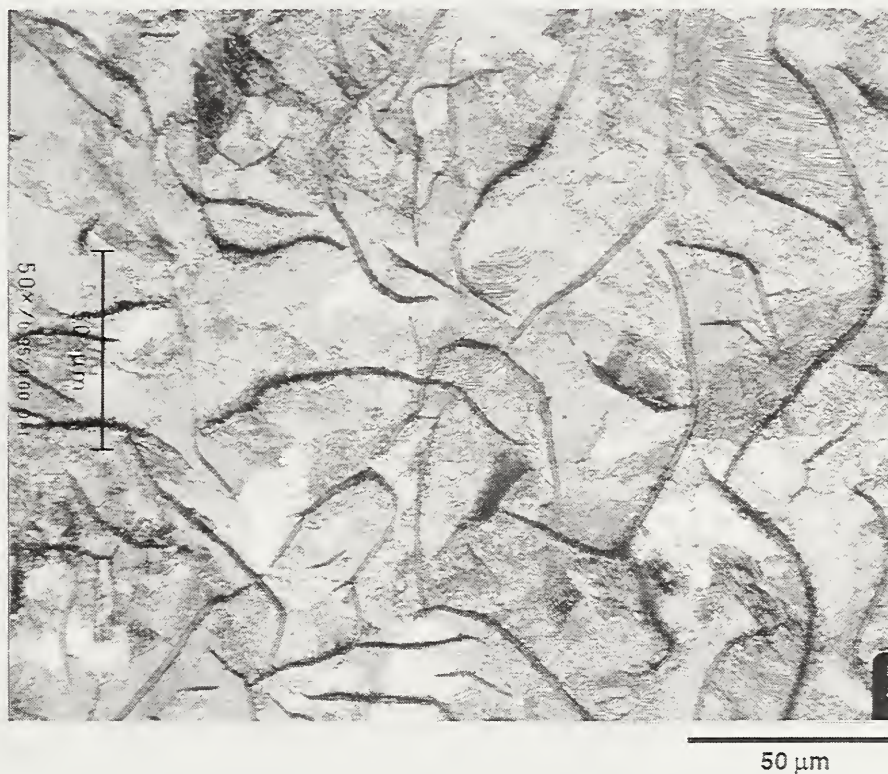
**Figure 4** Optical micrograph showing the graphite flakes in a pearlite matrix microstructure of a failed cast iron coupling taken from the Filene Center . Etchant: 2% nital

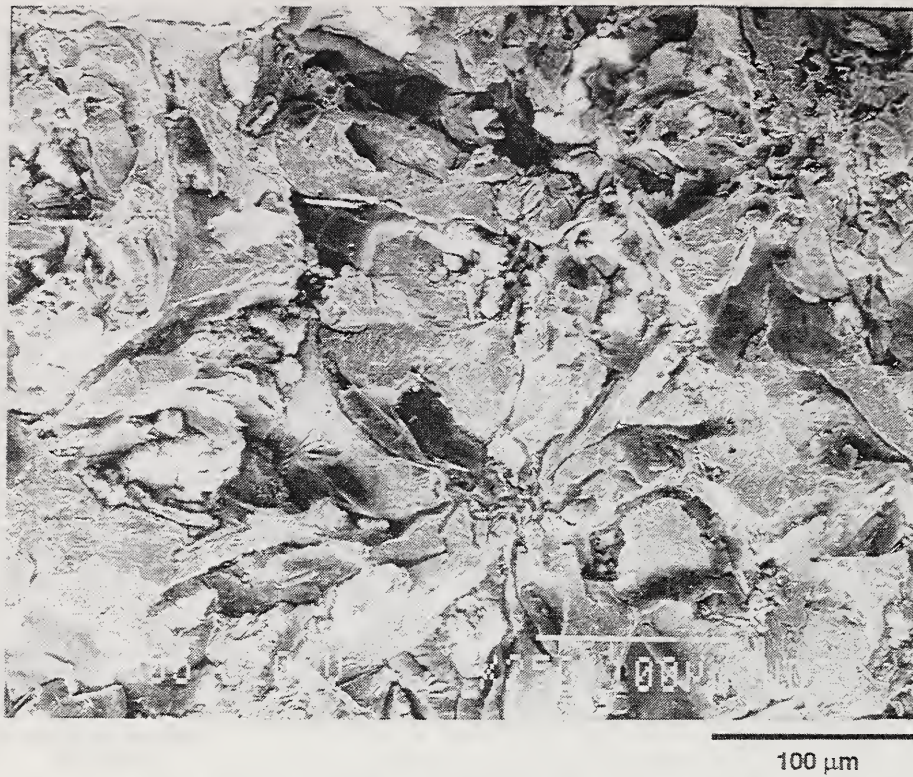
In addition to the metallographic examination, a fractographic analysis was performed on the couplings. This technique was used to verify whether the fractures were ductile or brittle in nature. Figures 5 and 6 are scanning electron micrographs which exhibit the brittle-type features that were observed on all of the coupling fracture surfaces.

The mechanical properties of gray cast irons like the type used in the Filene Center fire suppression system are strongly dependent on the concentration and coarseness of the graphite flakes. While the graphite flakes increase the overall mechanical strength of cast iron, they tend to reduce the fracture resistance of the bulk and also act as internal notches; thereby serving as crack initiation sites.<sup>(7)</sup> Gray cast irons, in general, possess relatively low mechanical strength due to the interlaced network of graphite flakes. The interfaces between the graphite flakes and the matrix are also very weak, so once a crack has initiated in this material, little or no resistance to propagation is provided by the bulk.<sup>(7)</sup> This poor interfacial strength generally results in a brittle type of fracture along the network of graphite flakes as shown in Figure 5. Fracture of this type was observed in all of the specimens provided from the Filene Center.

**Figure 5** Low magnification scanning electron micrograph showing brittle cracking along the graphite matrix interfaces on a fracture surface taken from a failed cast iron coupling at the Filene Center.

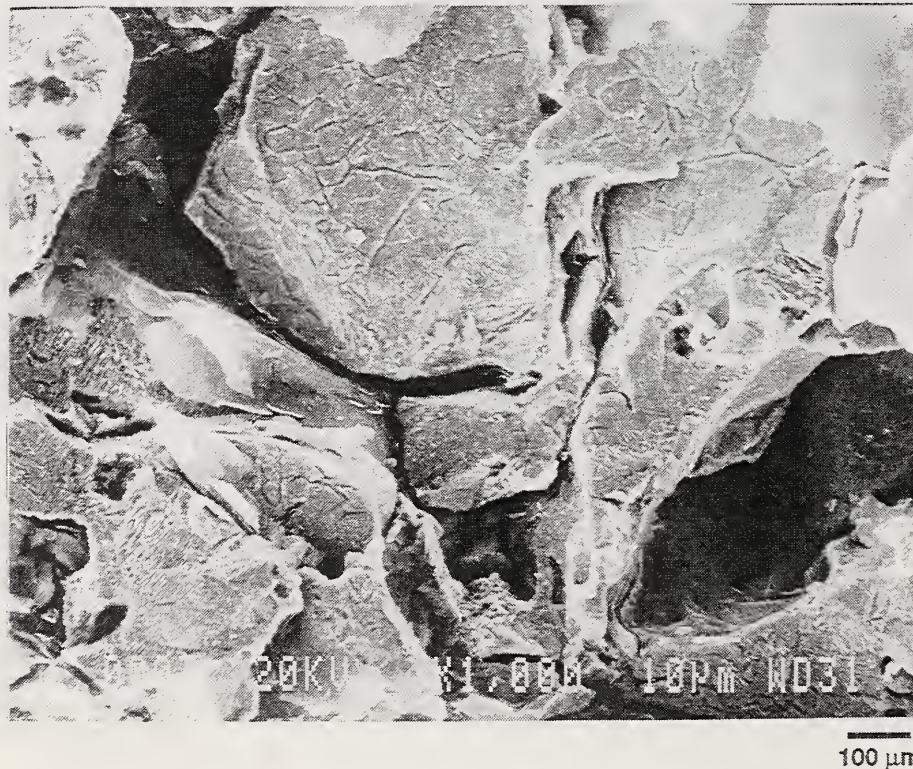
crystallographic planes.<sup>(10)</sup> This particular type of brittle fracture is known as cleavage and the characteristic features of a cleavage fracture are flat facets similar to those shown in Figure 6. The results of the fractographic analysis indicated that the fractures were completely brittle in nature and composed mostly of cleavage. No deformation indicative of a ductile type fracture was observed anywhere on the surfaces analyzed.

**Figure 6** High magnification scanning electron micrograph showing the observed cleavage facets on the fracture surfaces taken from failed cast iron couplings at the Filene Center.
