1994 Northridge Earthquake

Performance of Structures, Lifelines and Fire Protection Systems

NISTIR 5396

March 1994
Building and Fire Research Laboratory
National Institute of Standards and Technology
Gaithersburg, MD 20899

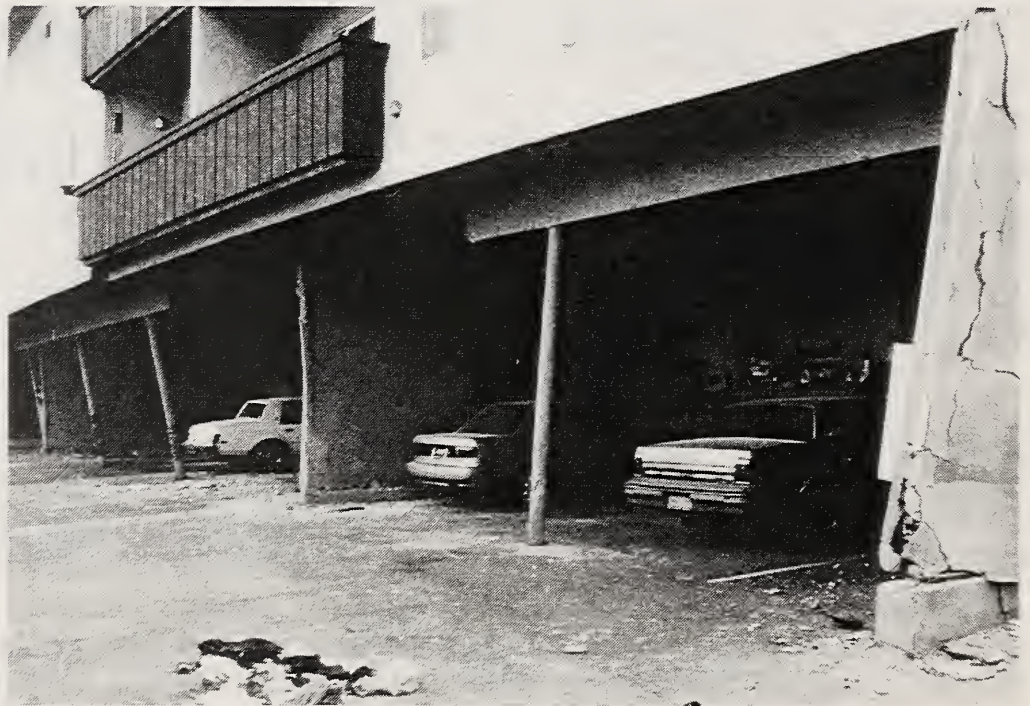
Figure 3.5 Steel pipe columns between parking bays supported the upper stories of the Northridge Meadows apartment buildings. Few of the buildings in the north half of the complex collapsed, but all were damaged.

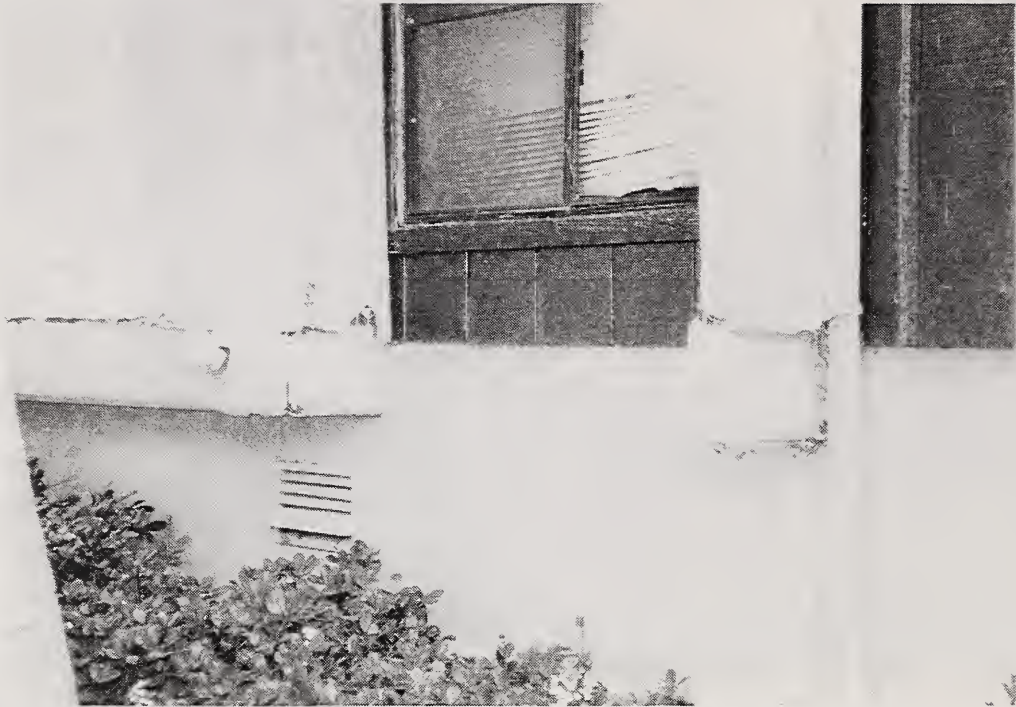
Figure 3.8 Horizontal cracks at the interface of the foundation wall (usually concrete) and the first story (typically wood-framed with stucco facade) were often seen in damaged low-rise apartment buildings.

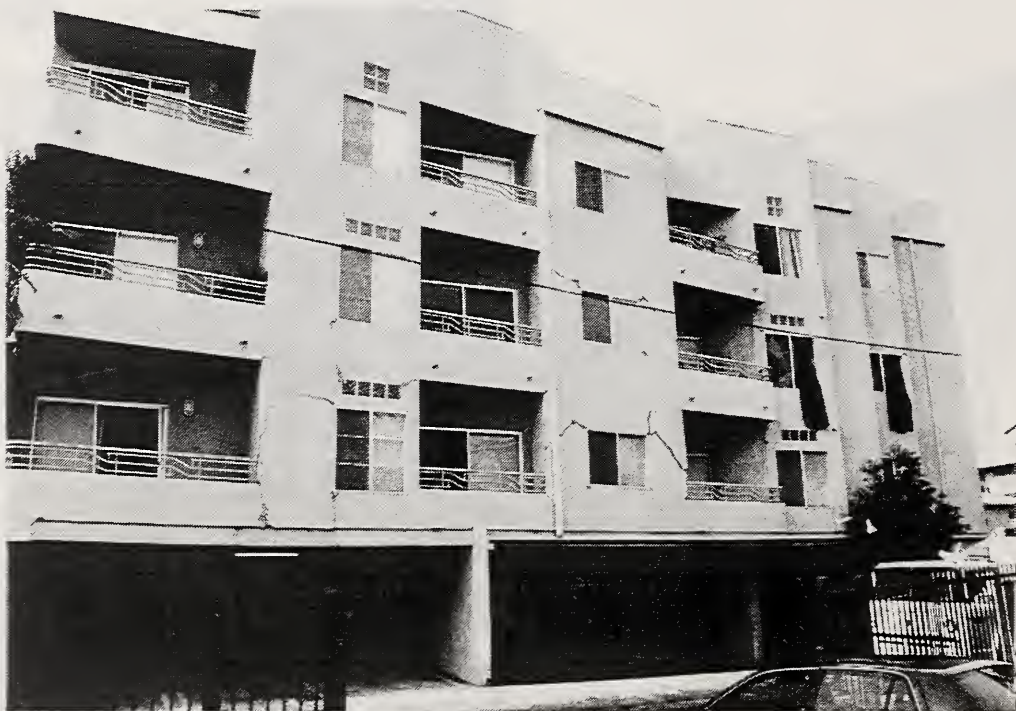
Figure 3.9 Typical damage in to low-rise apartment buildings included diagonal cracks in the stucco facade at the corners of windows and other openings.

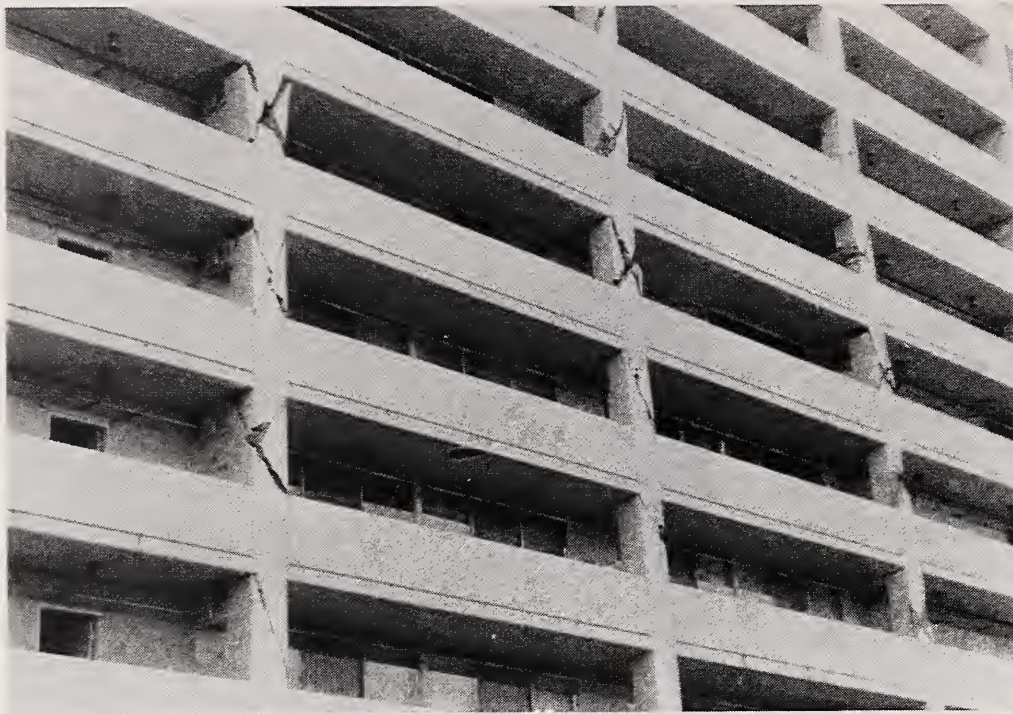
Figure 3.14 The back of the Champagne Towers building was badly damaged. The railings here are solid infill, which effectively stiffen the lower half of the columns. The shortened upper half of the columns were forced to accommodate all the displacement, and they failed in shear.

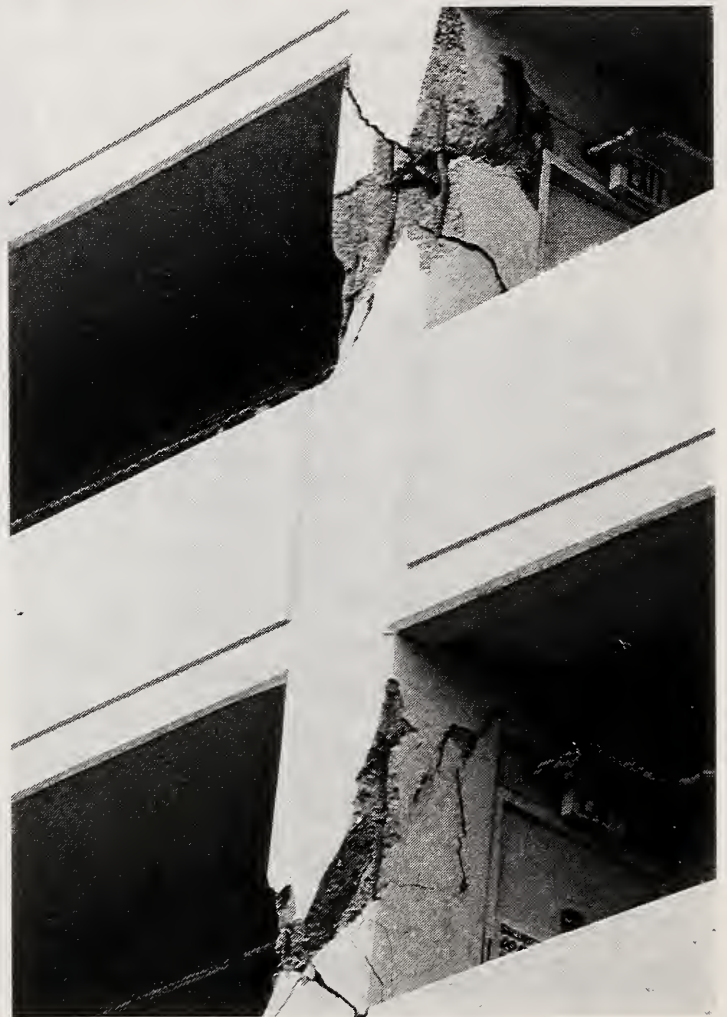
Figure 3.15 A closer view of the failed columns at the back of Champagne Towers shows minimal transverse reinforcement.

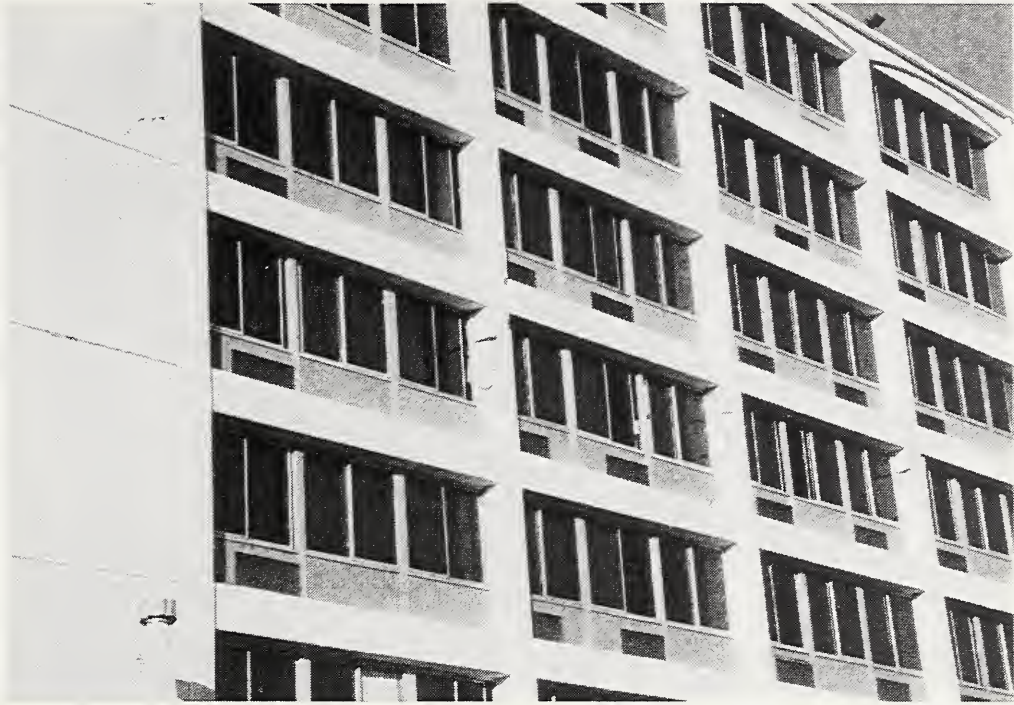
Figure 3.16 The bottom two stories of the concrete frame Holiday Inn in Van Nuys were damaged in the 1971 San Fernando quake and subsequently repaired. In the 1994 Northridge quake, damage was concentrated at the top of the fourth floor columns.

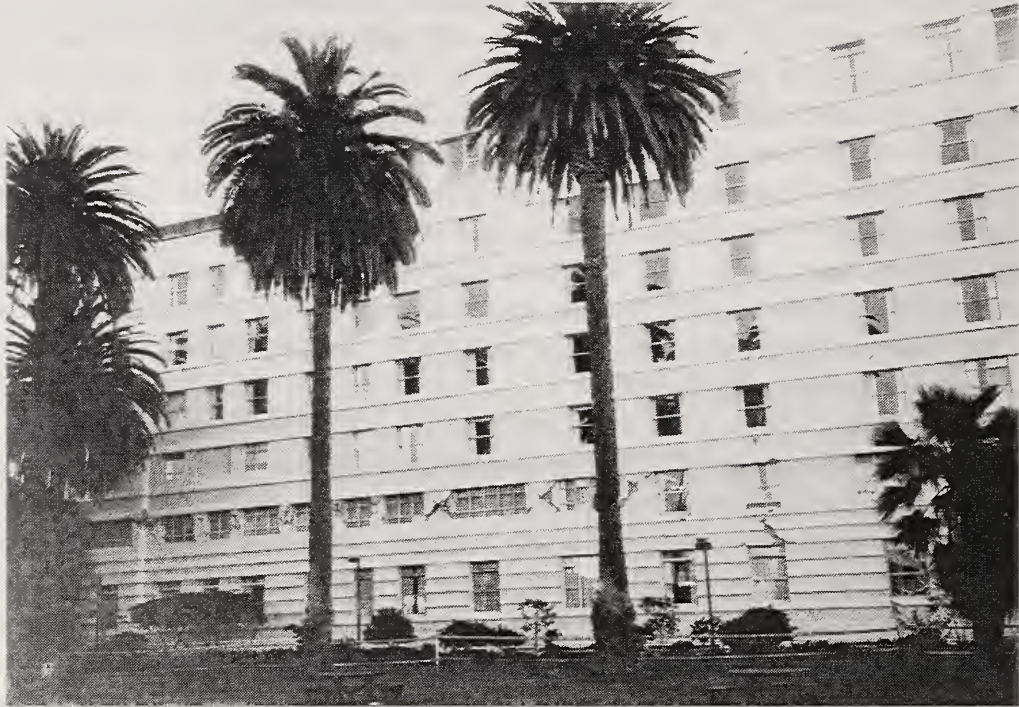
Figure 3.23 The seven-story northwest wing of St. John's hospital in Santa Monica experienced severe X-cracking in the piers between the second story windows.

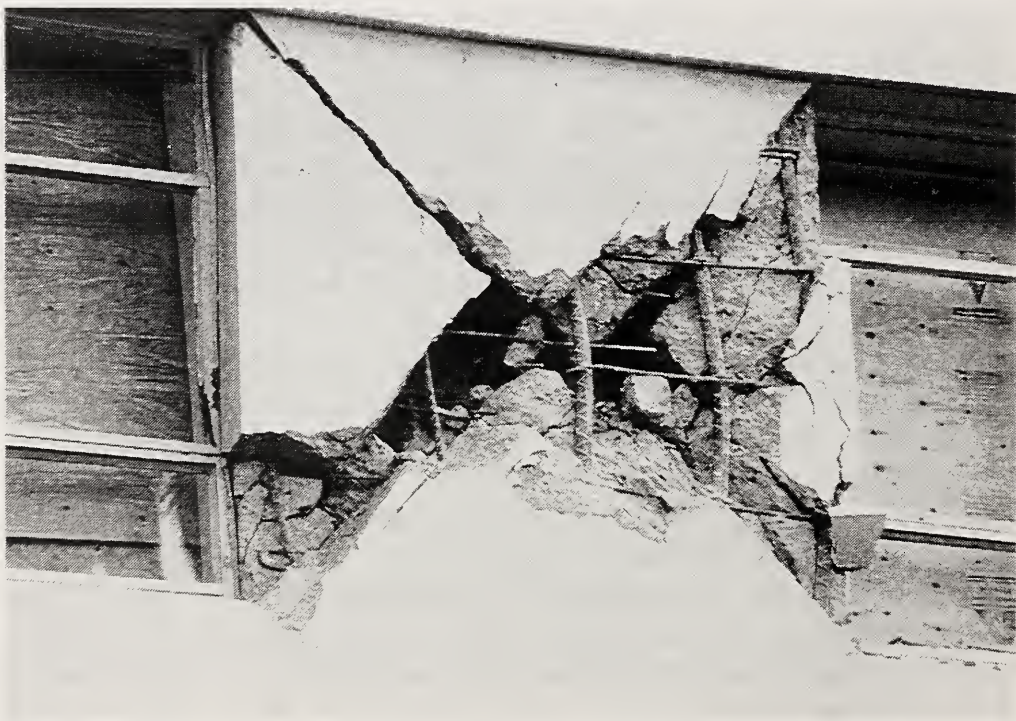
Figure 3.24 The transverse reinforcement in the St. John's hospital window piers was spaced at about 150-200 mm on center with 90° hooks at the ends, typical for construction of its age (about 50 years old).

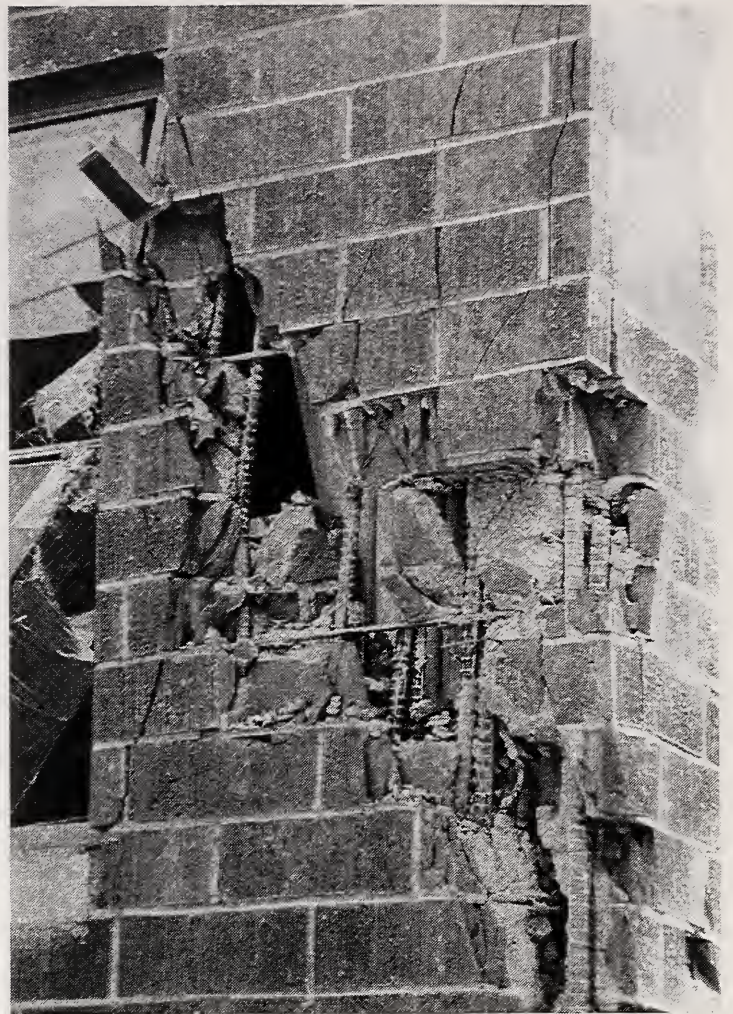
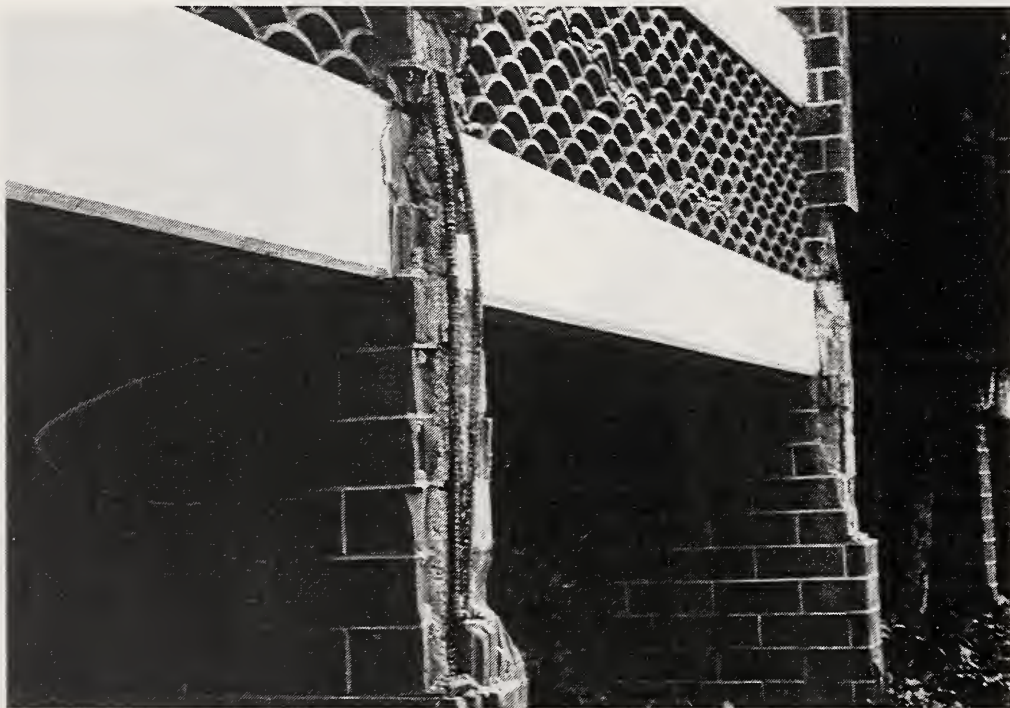
Figure 3.28 Two faces of the Berkley Convalescent Hospital had wing walls separating balconies. The ends of these wing walls spalled at the lower stories.

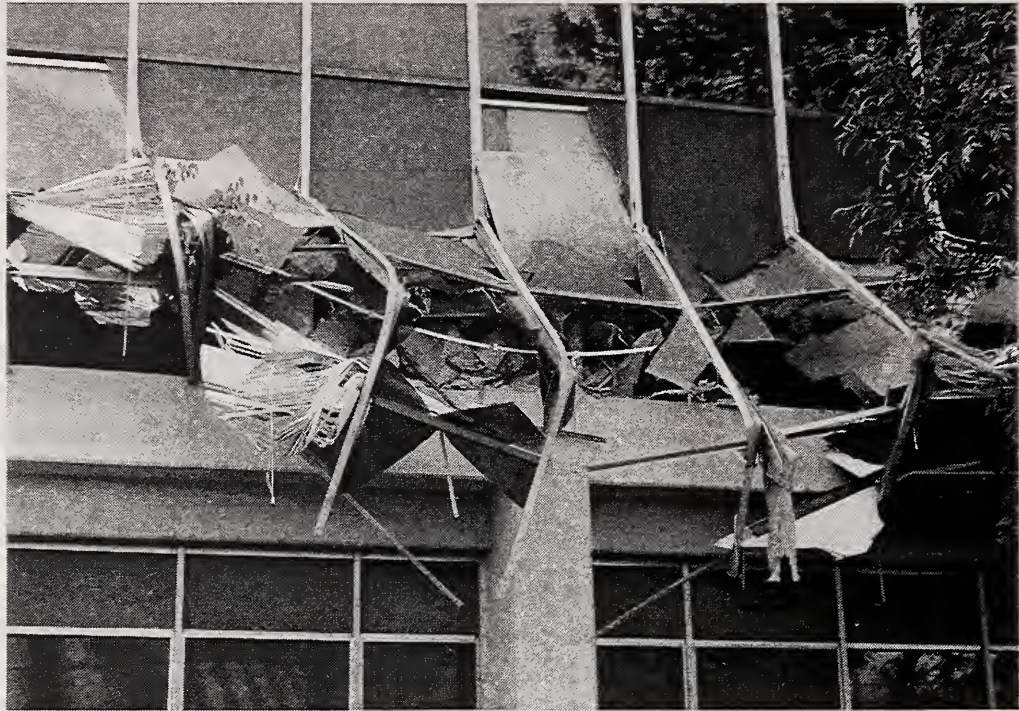
Figure 3.41 The second story of the concrete frame Kaiser Permanente office building on Balboa Avenue in Northridge completely collapsed. The first story was relatively undamaged, suggesting it was far stiffer than the story above.

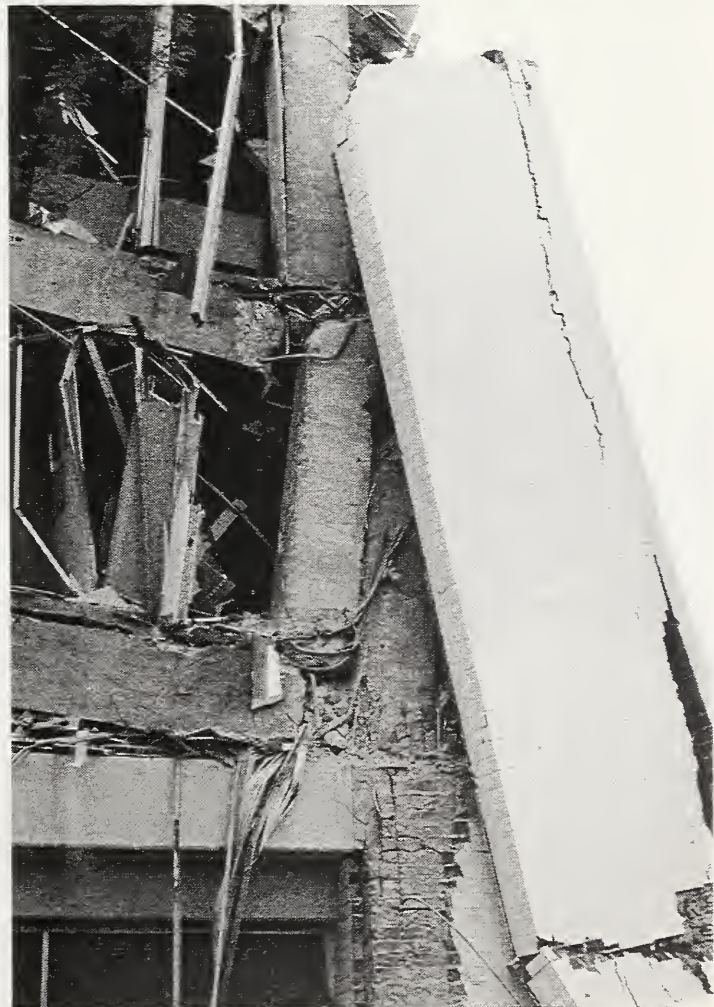
Figure 3.44 The exposed concrete
frame of the Kaiser Permanente
building, revealing deep beams,
suggests that the building had a strong-
beam, weak-column configuration.
Except for the second story columns,
the columns and beams remained intact
while the joints disintegrated.

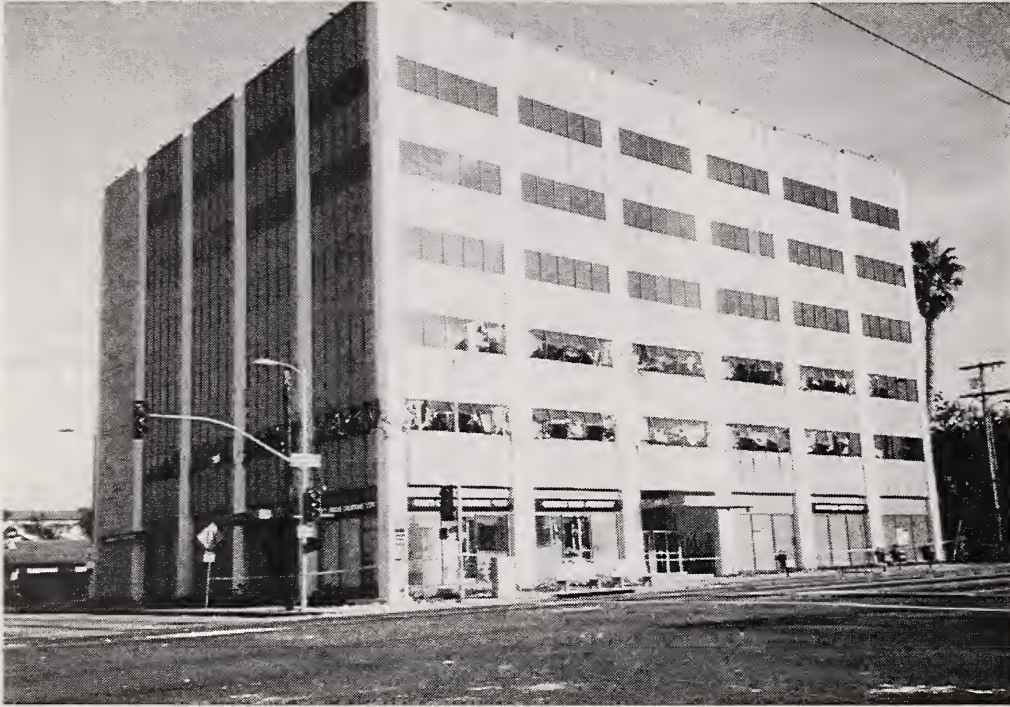
Figure 3.45 The six-story L-shaped concrete-frame Barrington Building on Olympic Boulevard in West Los Angeles lost its vertical-load carrying capacity at the second story.

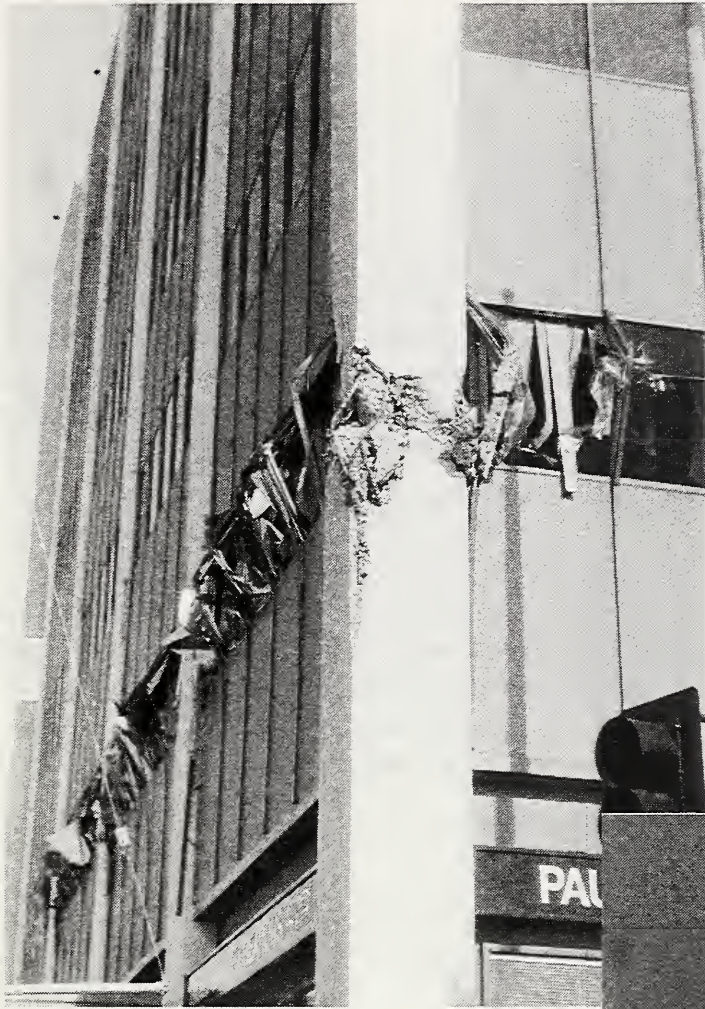
Figure 3.47 The cracking in the concrete columns at the second story was so extensive that the vertical-load carrying capacity of the building was affected. The building settled 50-100 mm at the second story, as these bulging window frames attest. The worst damage was at the southeast corner, the outside corner of the L-shape, pictured here. The building, which developed a slight list, was demolished within days of the quake.

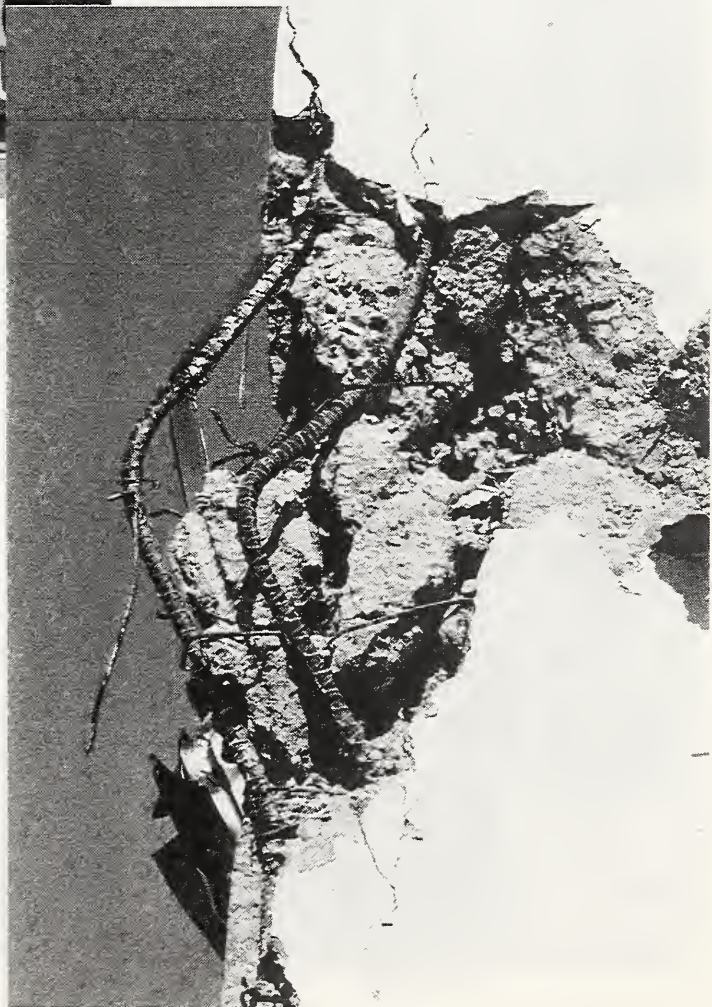
Figure 3.48 A close up of the damaged southeast corner of the Barrington Building shows the widely spaced, undeformed bars used for transverse reinforcement.

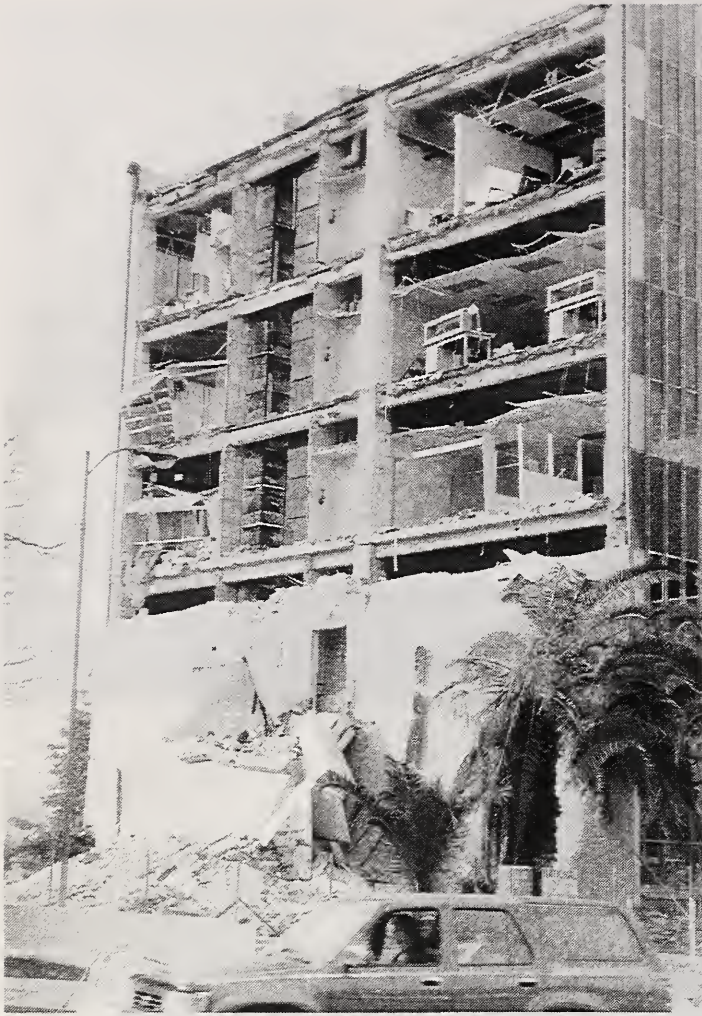
Figure 3.49 The east end wall and stair tower of a five-story apparently steel-framed office building on Sherman Way in Reseda collapsed. The enclosing masonry wall became detached from the structure and slid to the ground, with the upper stories remaining intact. The doorway opening in the wall, shown here resting at about the second story level, originally provided access from the top story to the stair tower.

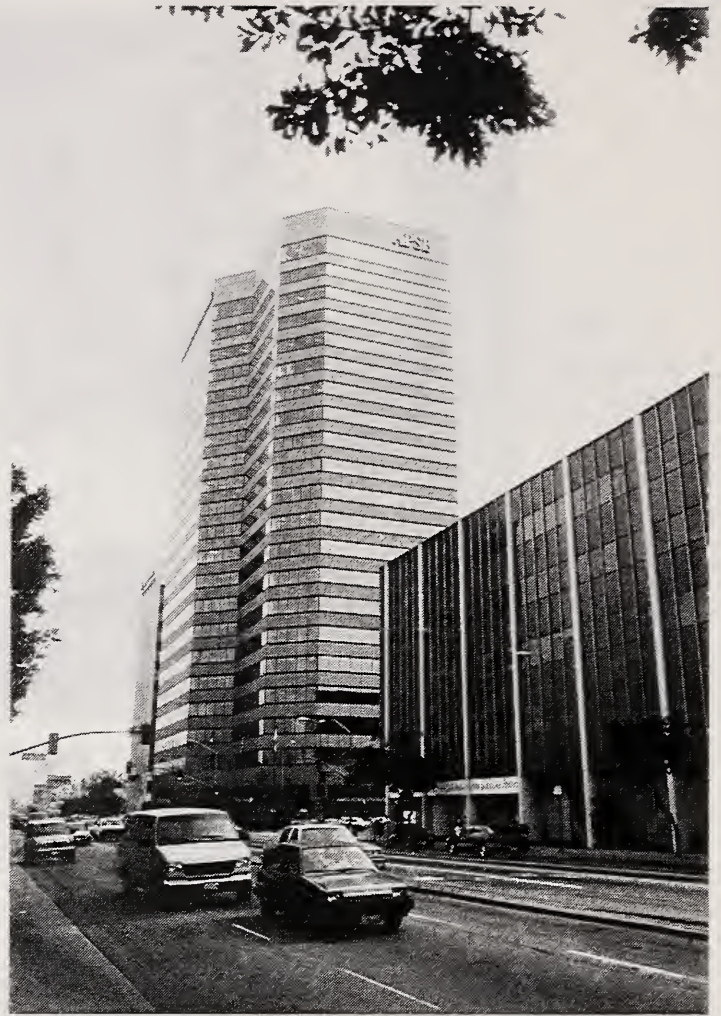
Figure 3.58 The reinforced masonry facade of this steel-framed building was badly damaged.

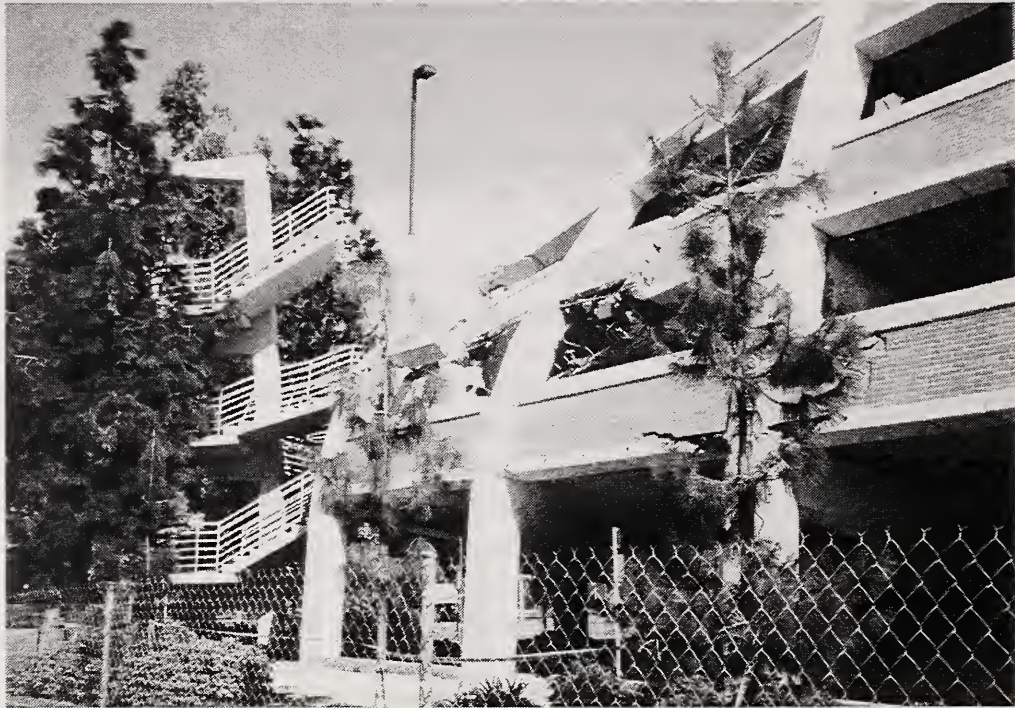
Figure 3.60 The three-year old four-level parking garage at the Northridge campus of California State University partially collapsed in the earthquake. The collapse apparently started at the interior, causing the exterior walls to be pulled in to the middle of the structure. Precast concrete "trees" were connected to form a moment-resisting frame at the exterior of the structure.

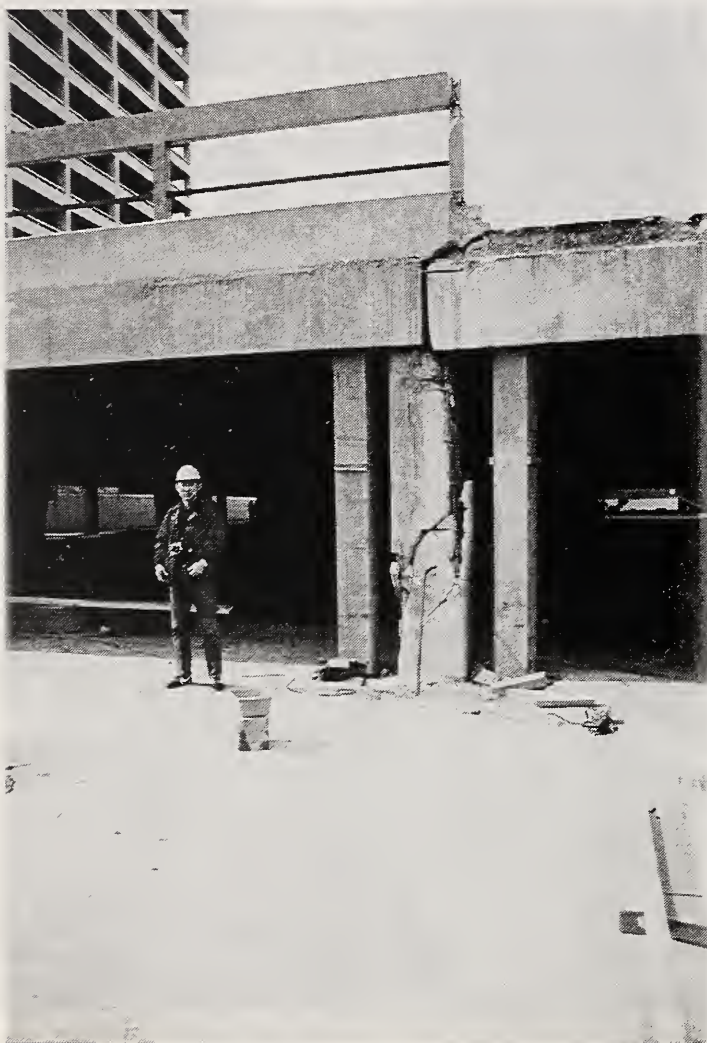
Figure 3.65 The exterior columns of the Trans World Bank parking garage, which had not been strengthened, were badly damaged.

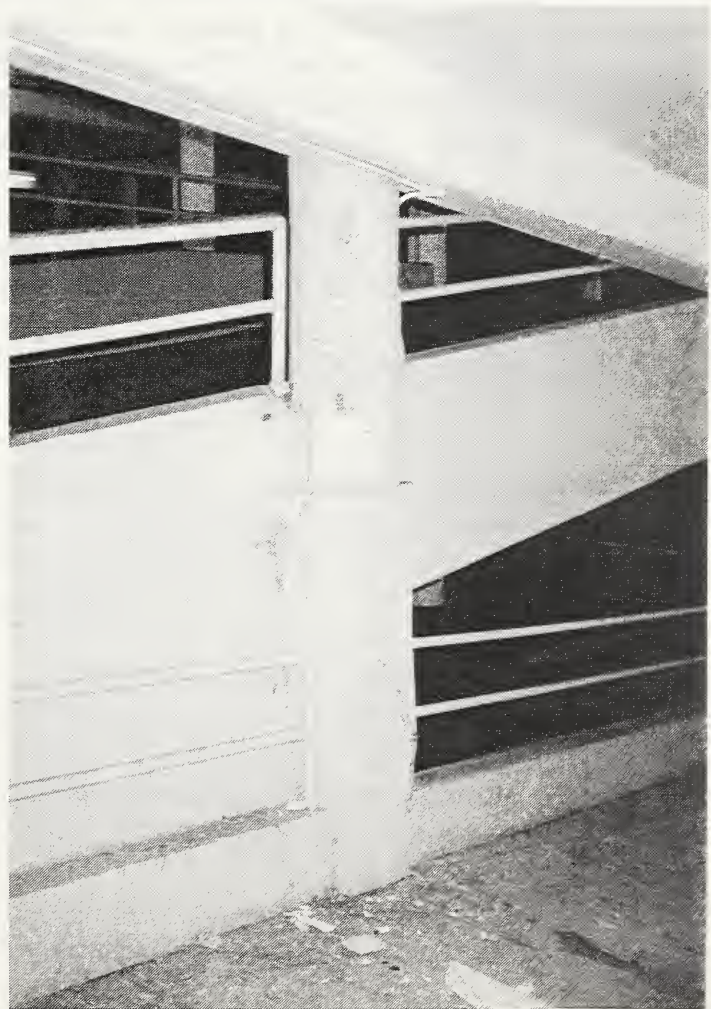
Figure 3.67 - In parking garages, ramps can cause unintentionally shortened columns, which are vulnerable to damage, as shown here.

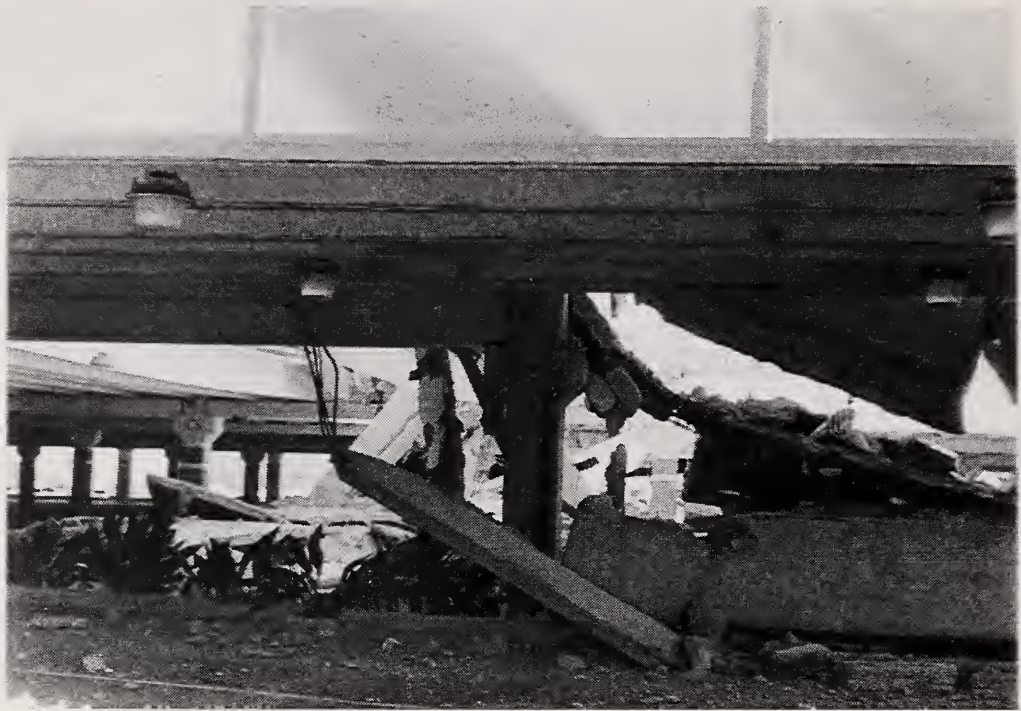
Figure 3.68 In precast parking garages, the support of the double-tees that comprise the floors is a vulnerable link in the system. This garage, at the north end of the Northridge Fashion Center, illustrates a common failure: the double-tees pulled off their supports, leaving the column-beam frame essentially intact.

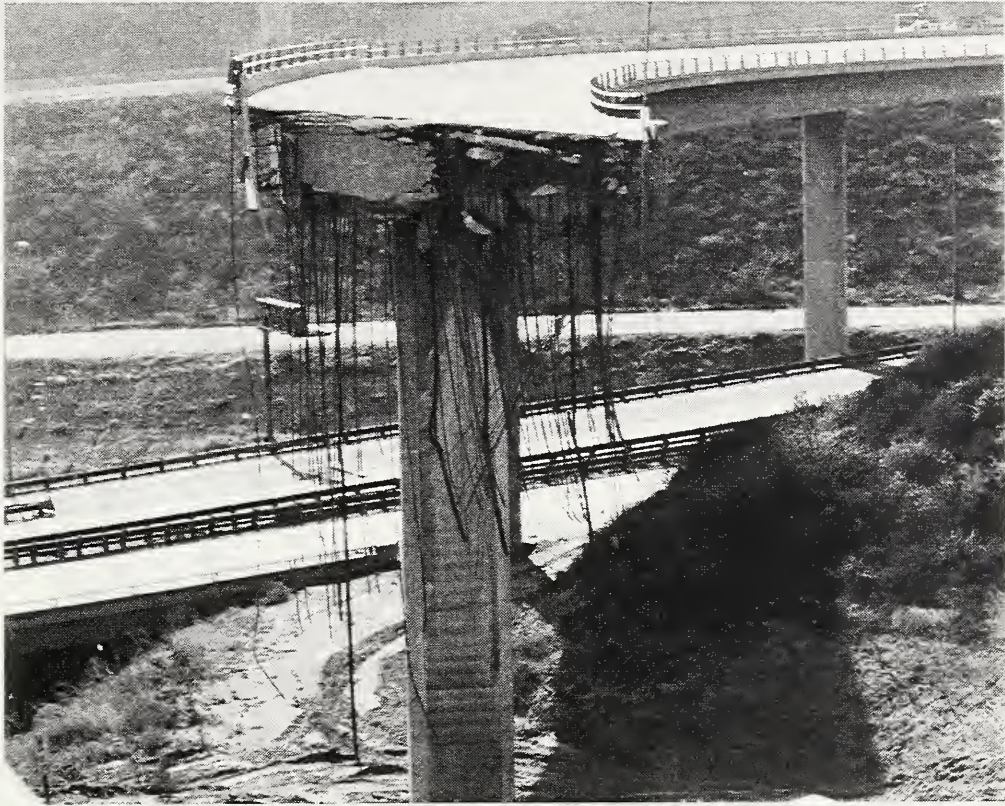
Figure 4.15 View of the flexural failure at Pier 3 of the SR14/I5 North Connector Overcrossing, looking to the south

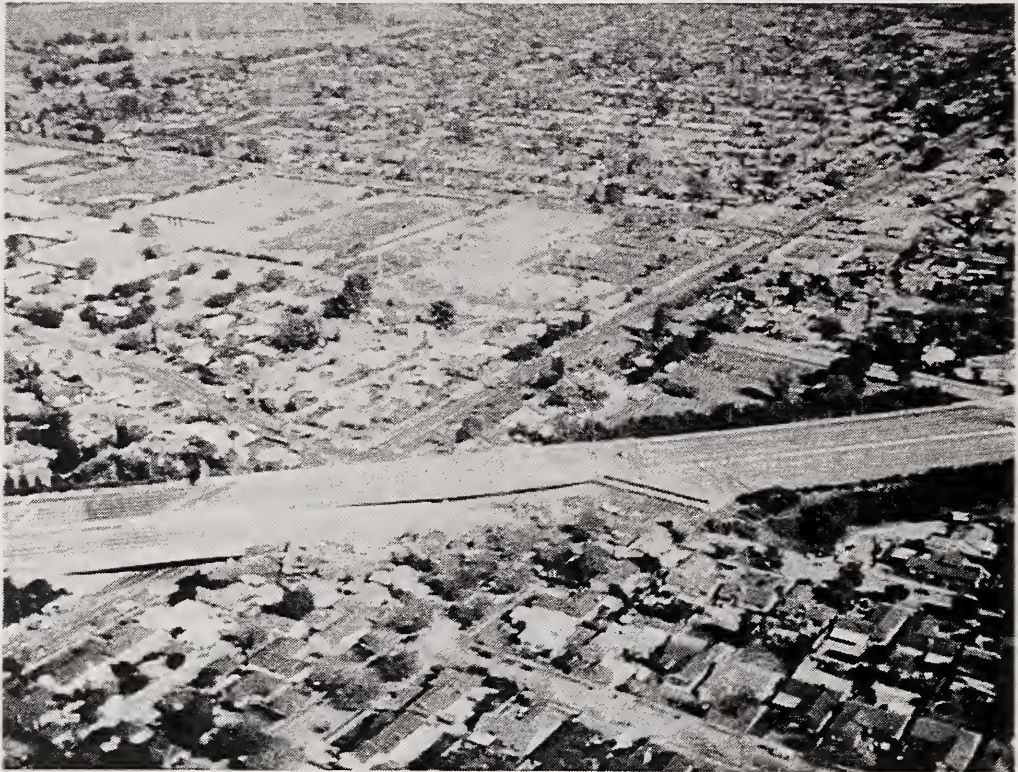
Figure 4.19 Aerial view of the SR118 Mission-Gothic Undercrossing, looking to the north showing collapsed eastbound bridge (Courtesy of FHWA)

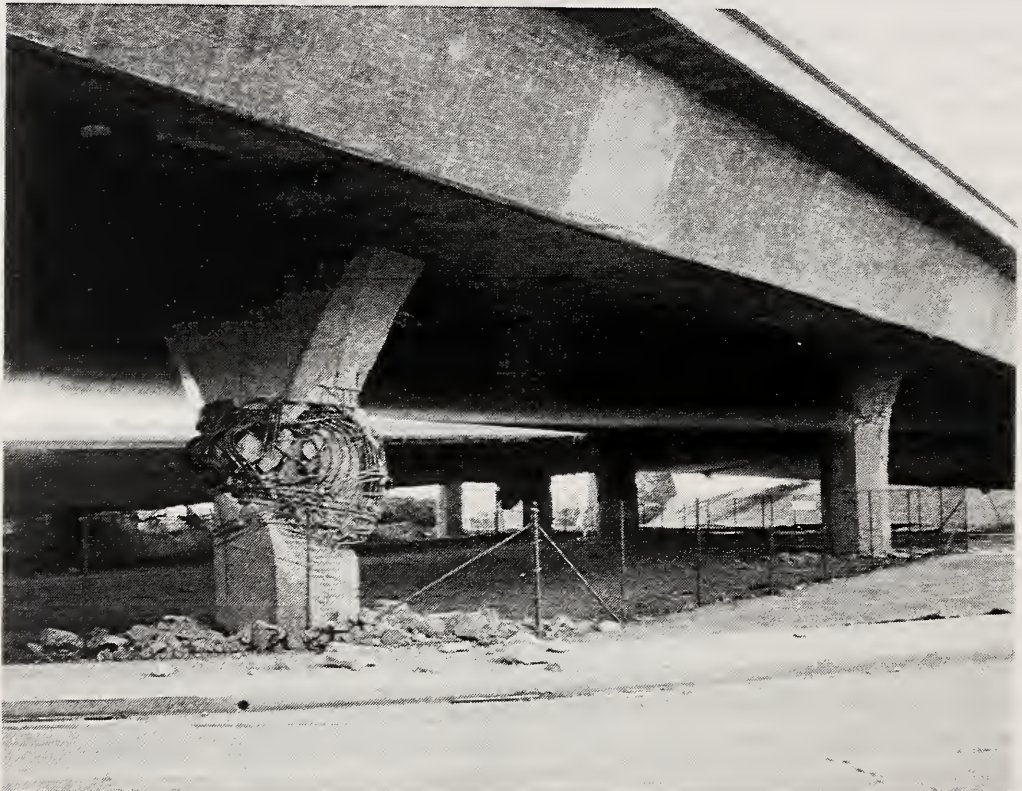
Figure 4.20 Damage to piers of the SR118 Mission-Gothic Undercrossing, looking to the northwest at the north face of the westbound bridge, Bents 3 (foreground) and 2.

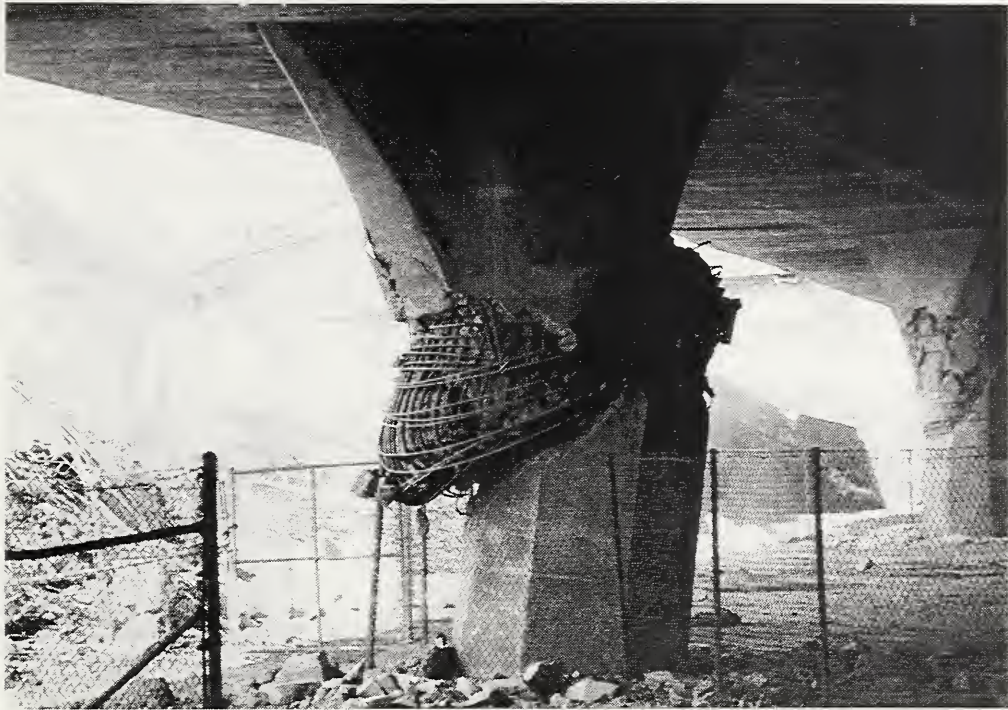
Figure 4.21 Damage to a pier of the SR118 Mission-Gothic Undercrossing, looking to the northwest at the southernmost pier of Bent 3 of the westbound bridge.

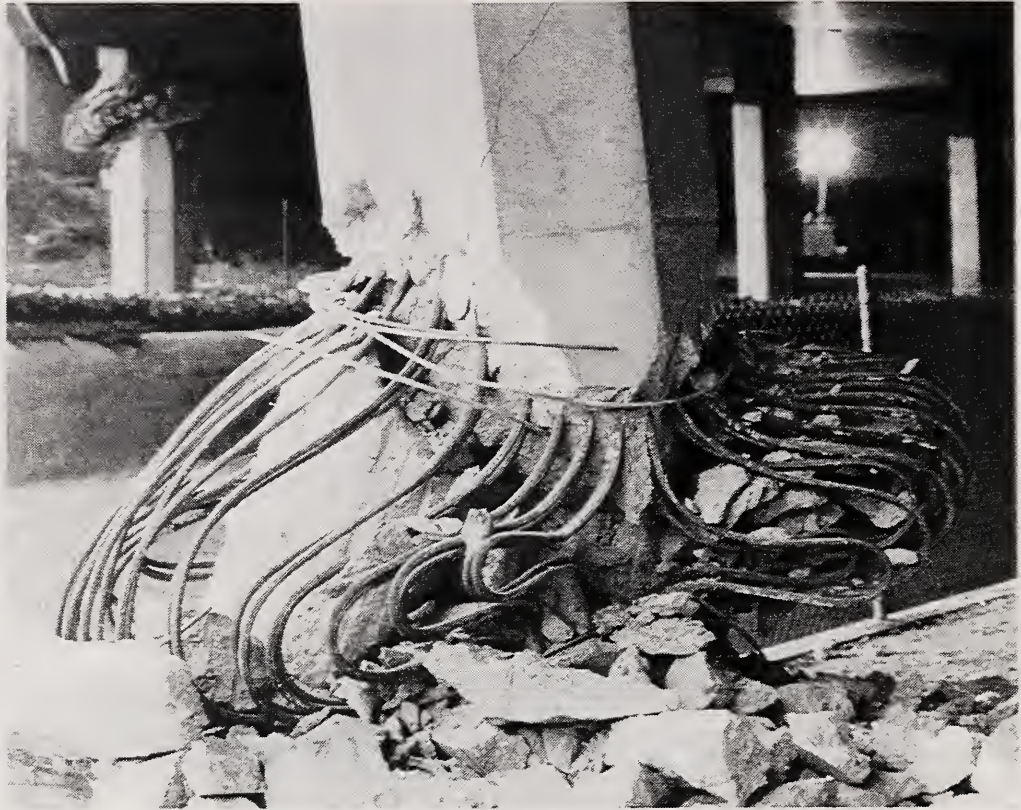
Figure 4.27 Damage to pier 3S-1 of State Route 118 at Bull Creek Canyon Channel, looking to the northwest

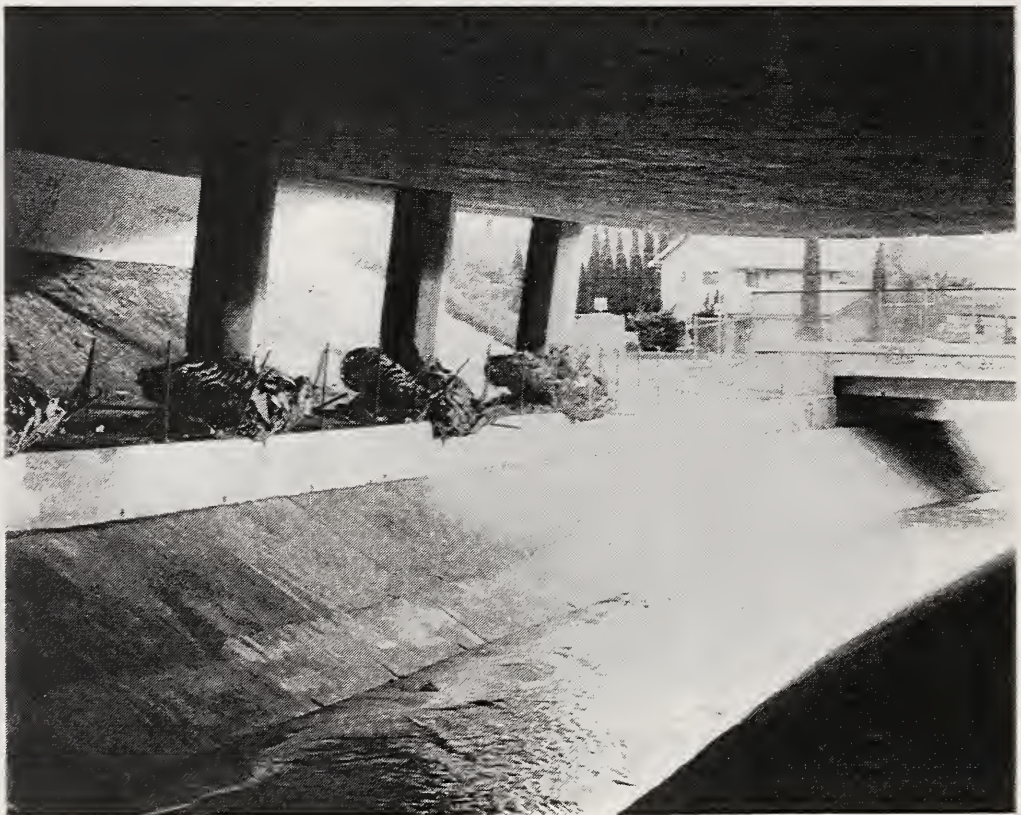
Figure 4.28 Damage to piers of Bent 3S of State Route 118 at Bull Creek Canyon Channel, looking to the southeast.

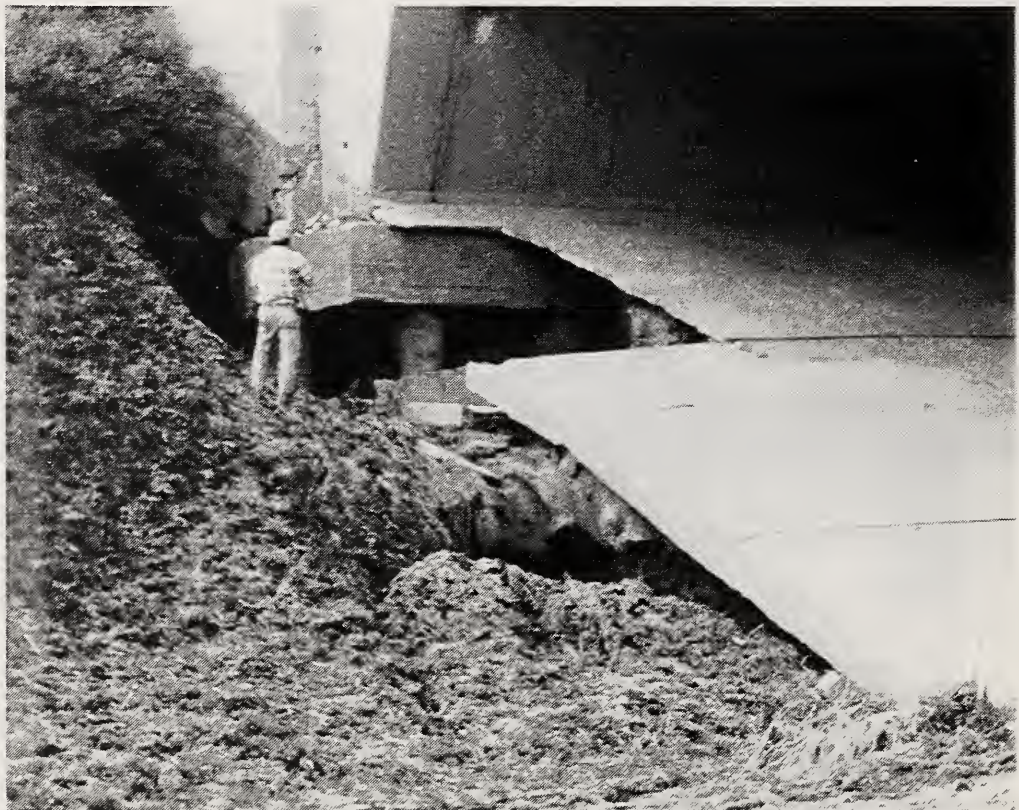
Figure 4.32 SR118 Balboa Avenue Overcrossing, view of the washout on the east side of the south abutment, caused by a ruptured water main
