1994 Northridge Earthquake

Performance of Structures, Lifelines and Fire Protection Systems

NISTIR 5396

March 1994
Building and Fire Research Laboratory
National Institute of Standards and Technology
Gaithersburg, MD 20899

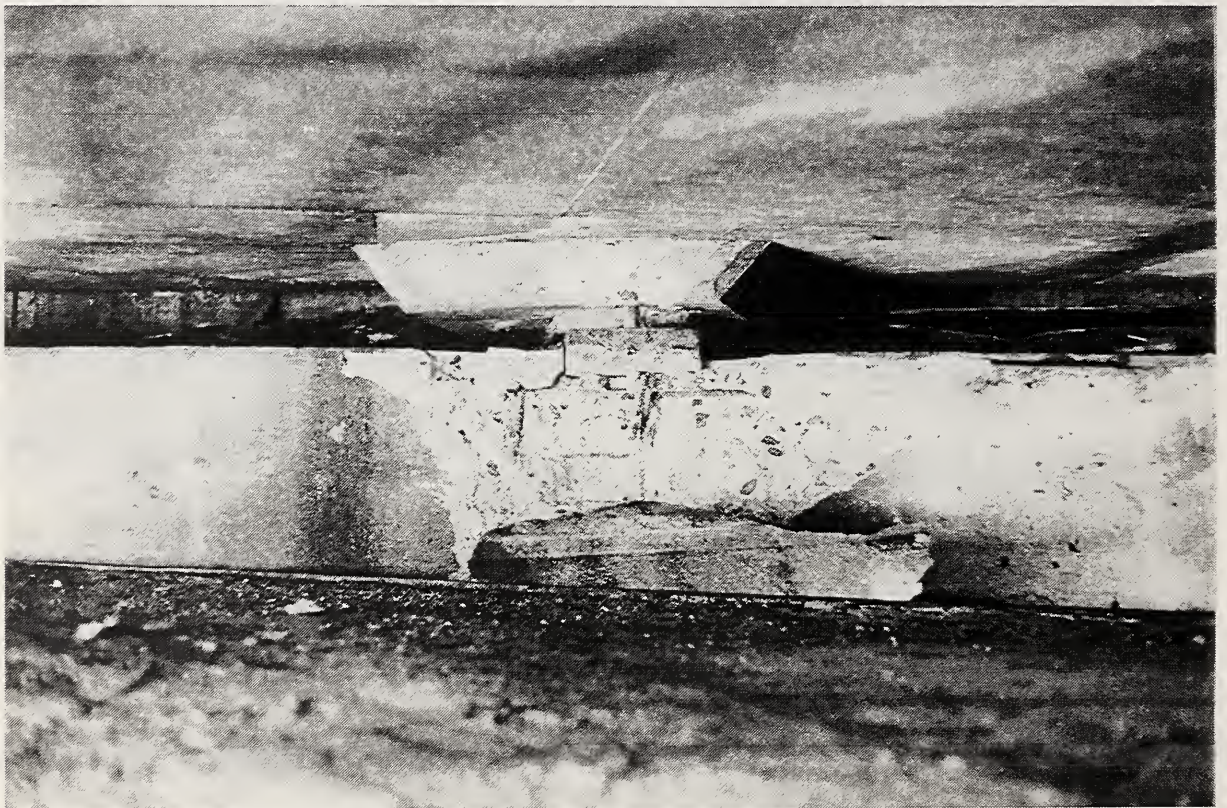
Figure 4.48 Abutment damage at sliding-type bearing

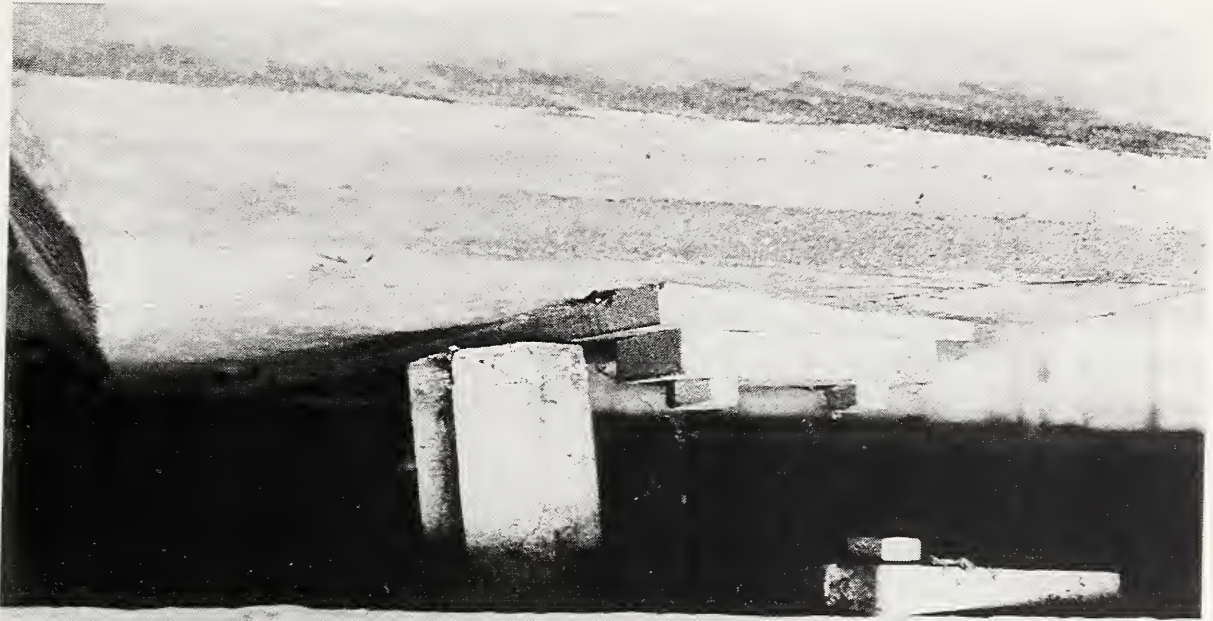
Figure 4.49 Displaced bearing block in rocker-type bearing

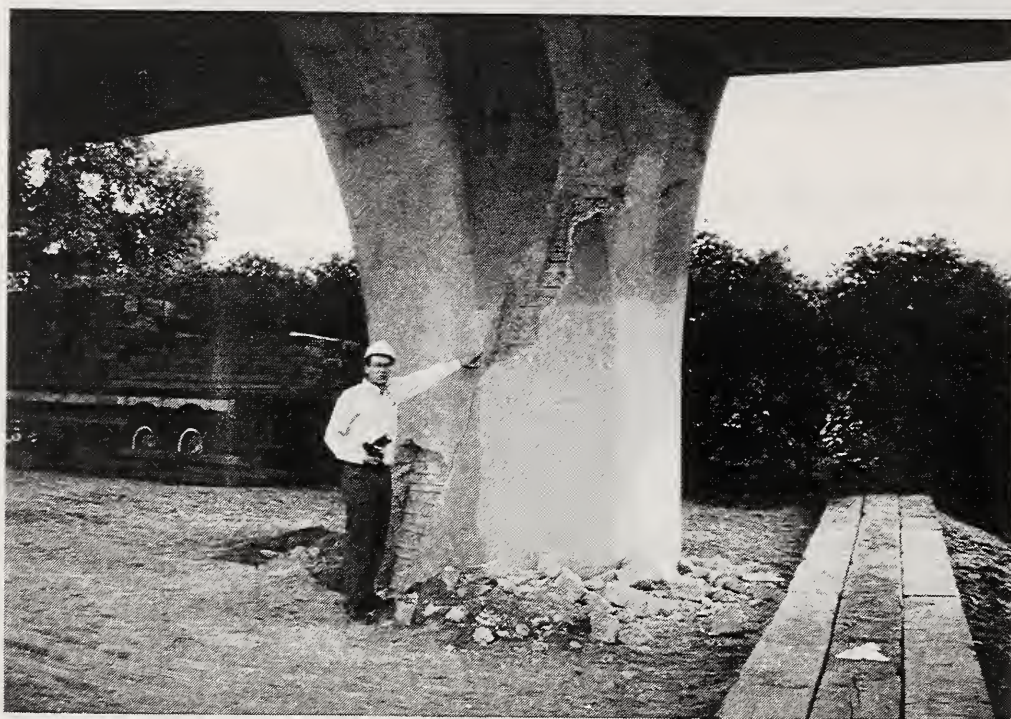
Figure 4.51 View of the westernmost pier at the Interstate 5, State Route 118, Southwest Connector, looking to the southeast. Loose cover concrete has been removed by Caltrans.

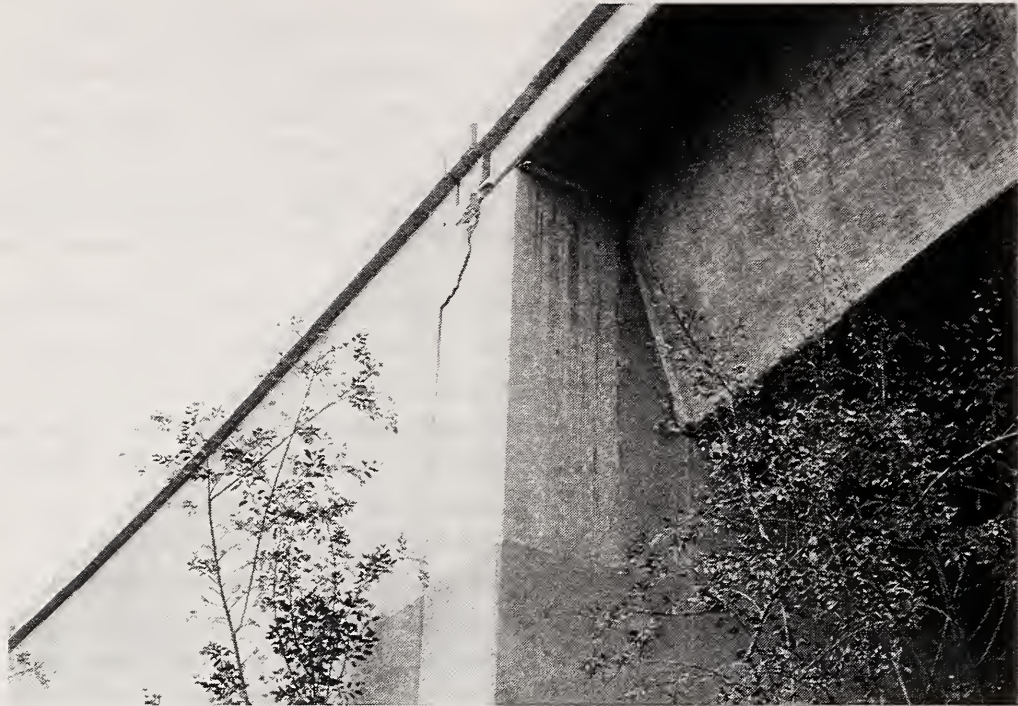
Figure 4.57 Close-up of abutment wall cracking at the east end of the ramp connecting eastbound SR118 with northbound I210

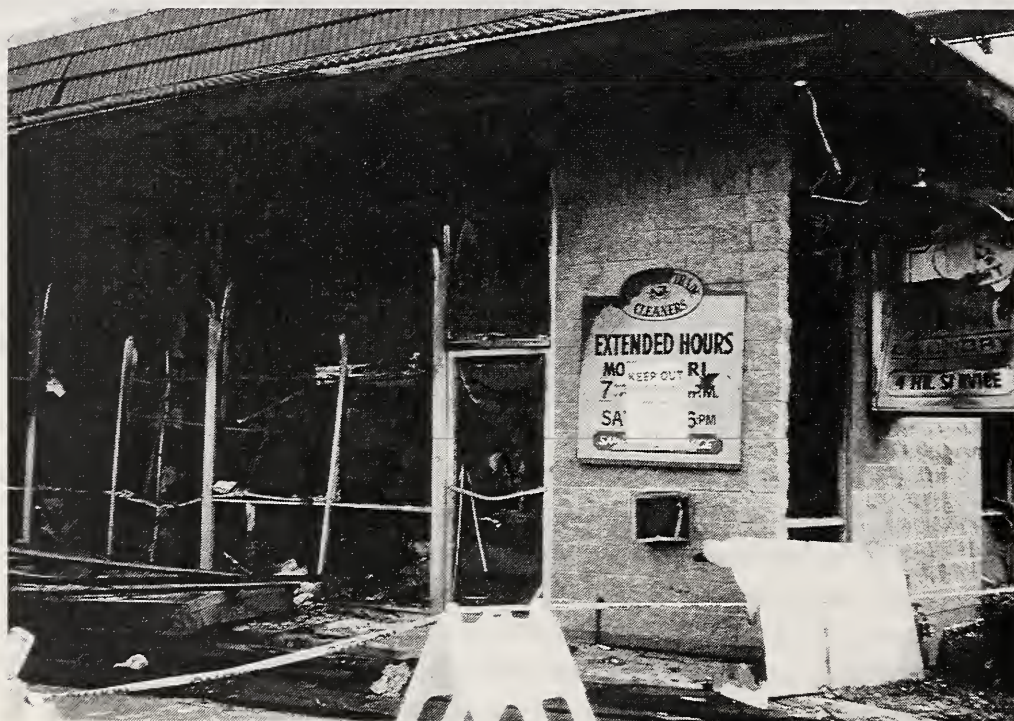
Figure 6.1 Fire damage in a single story commercial building.

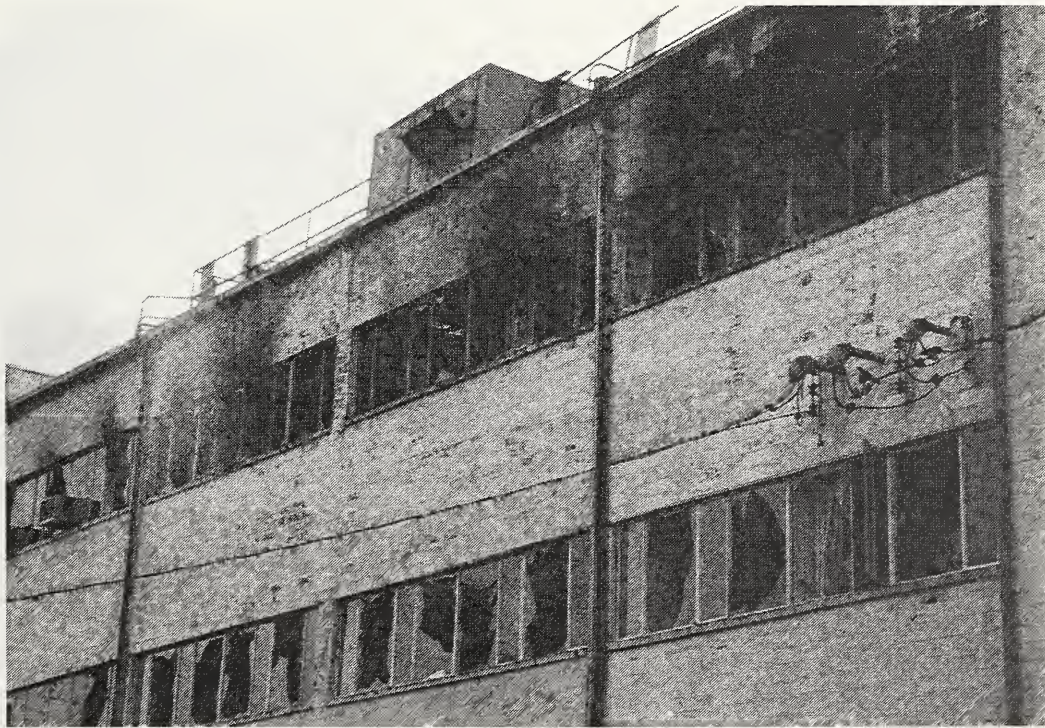
Figure 6.3 Fire damage in a three story commercial building.

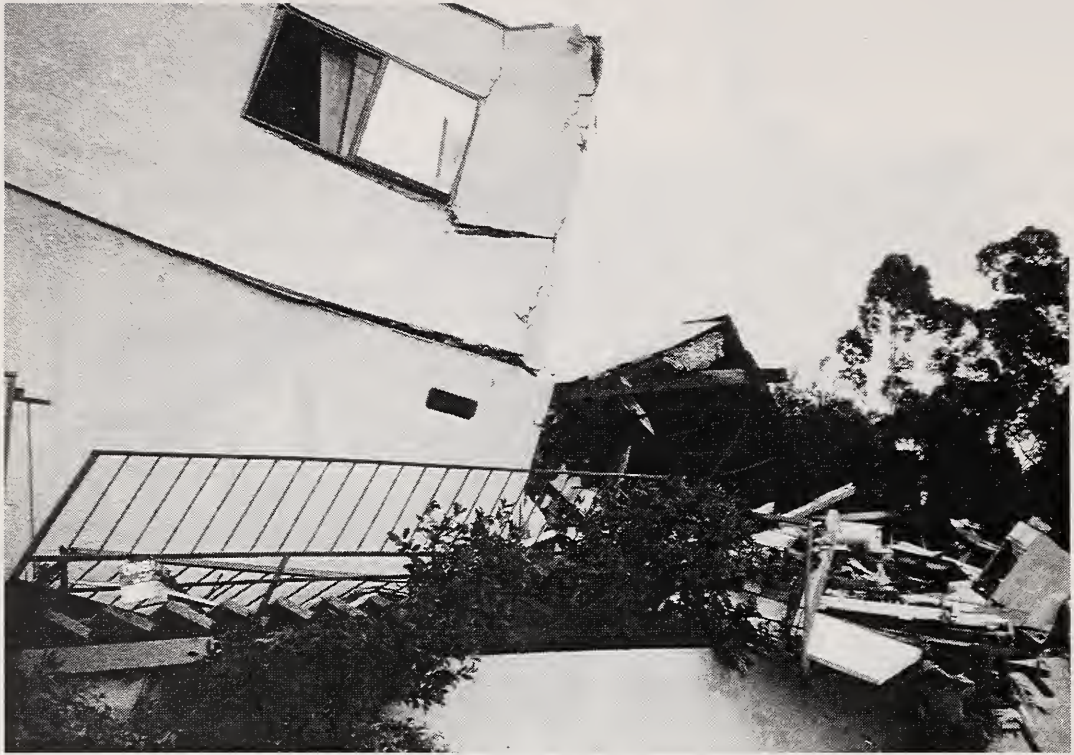
Figure 6.4 Partially collapsed apartment building with fire damage in the rear.

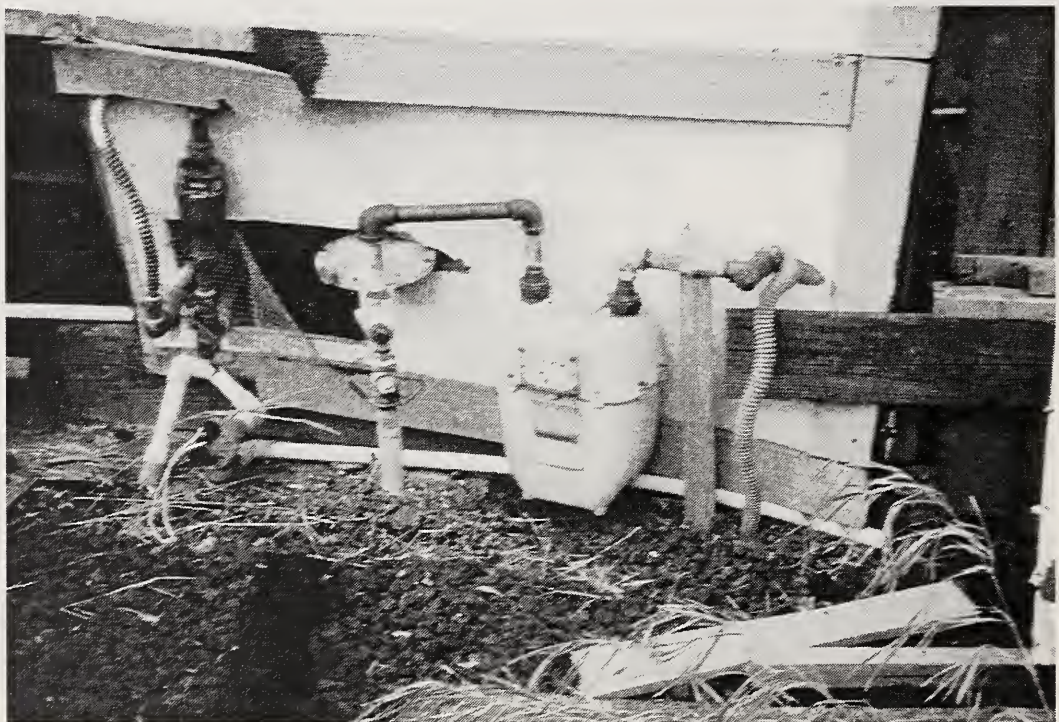
Figure 6.5 Damaged gas service in a manufactured housing development.
