NISTIR 5488

Performance of HUD-Affiliated Properties During the January 17, 1994 Northridge Earthquake

Prepared for:
U.S. Department of
Housing and Urban
Development

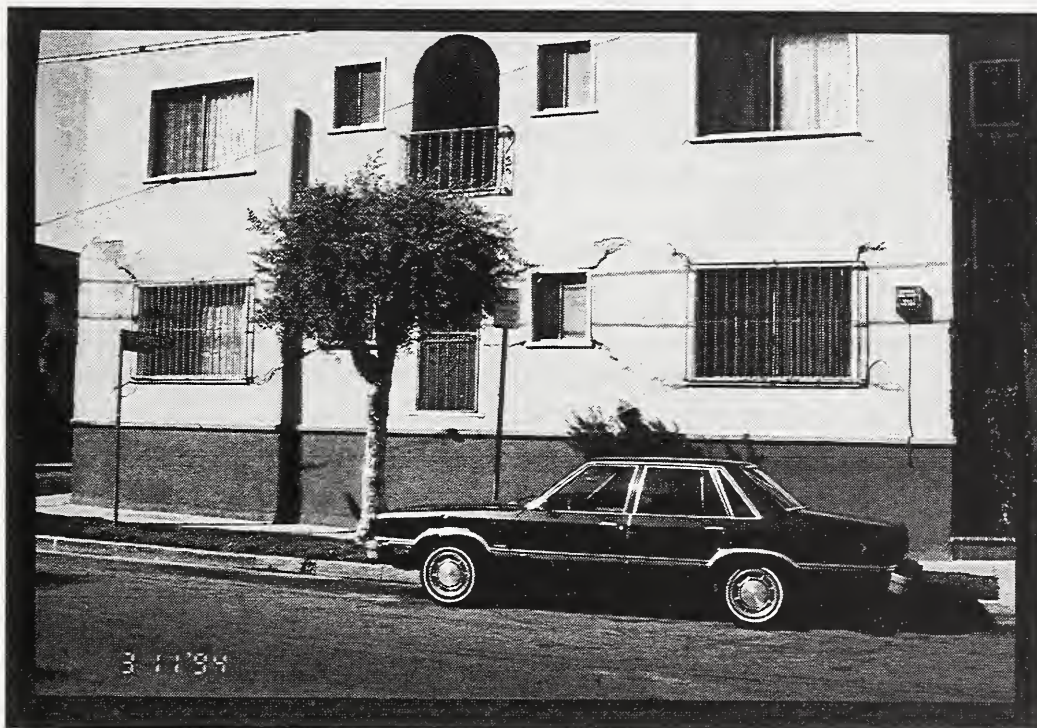
Figure 1 Residential construction is characterized by multiple door and window openings. The corners of these rectilinear openings create stress concentrations, making these locations particularly vulnerable to cracking.

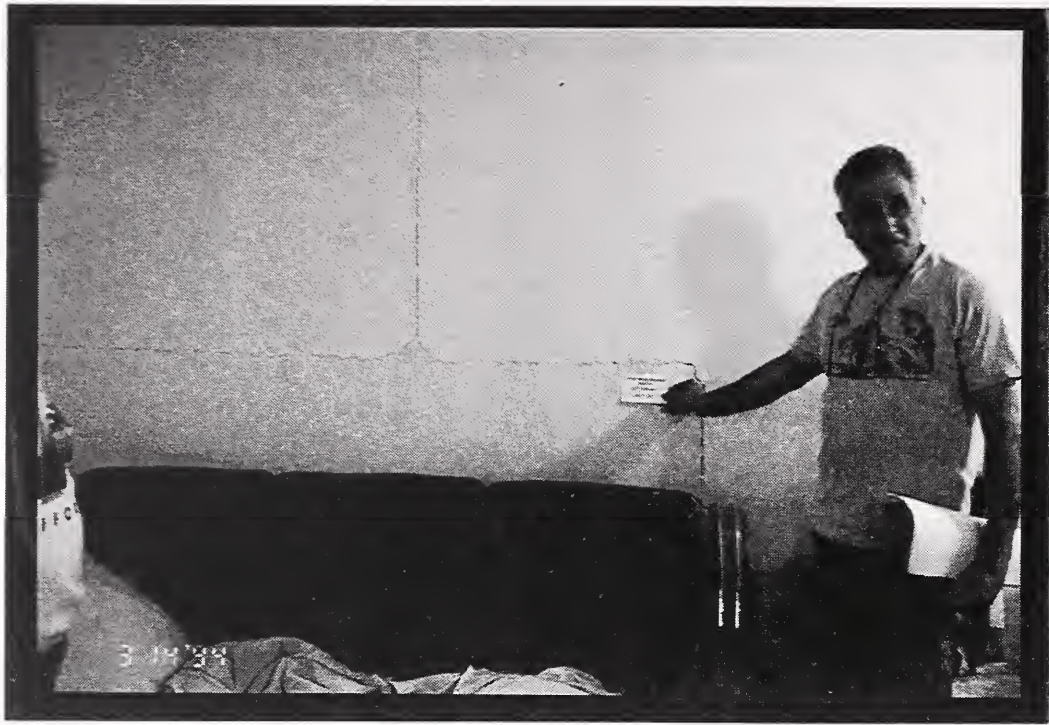
Figure 2 Typical nonstructural damage caused by the Northridge earthquake in residential buildings included cracks in interior partition walls, such as these horizontal and vertical cracks at the edges of the gypsum wallboard panels.

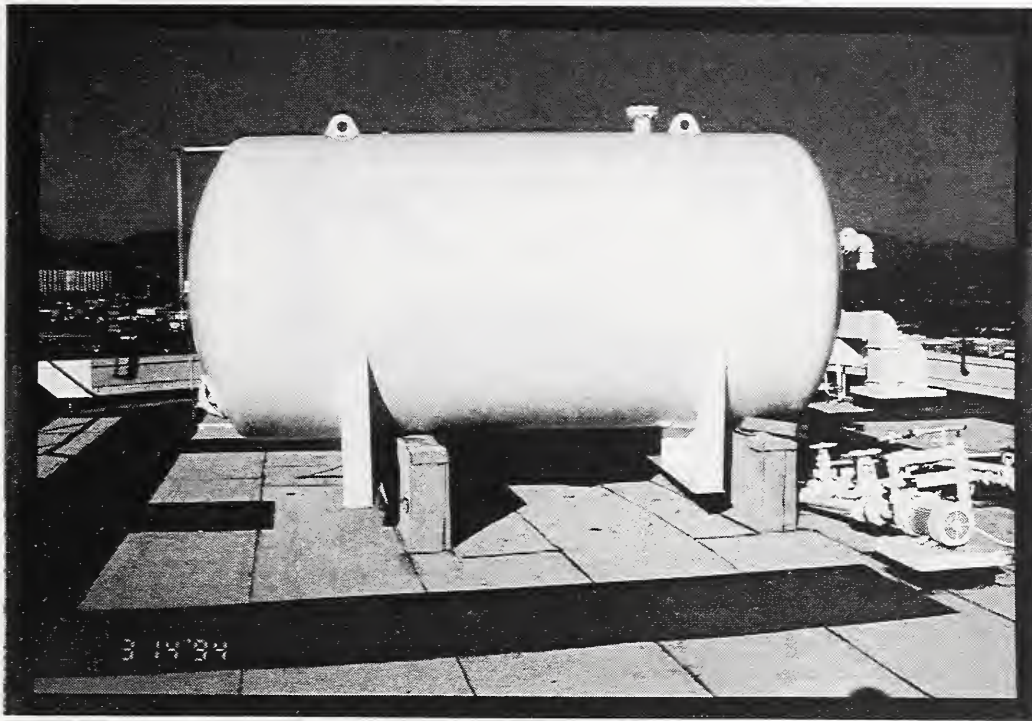
Figure 3 Movement of equipment, such as this 130,000 liter rooftop water tank at Fickett Towers, caused collateral damage in some cases. When this tank dropped from its supports, rupturing a water pipe, water damage to the building interior resulted.

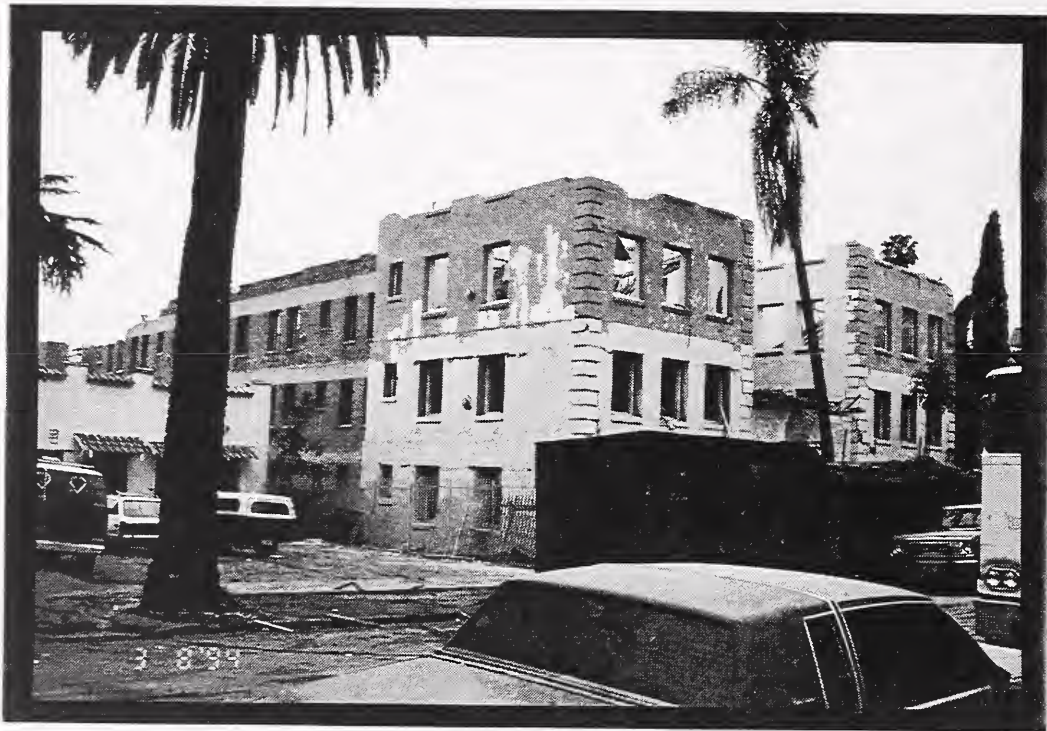
Figure 4 Vadehra IV, an unreinforced masonry building, was condemned because of extensive earthquake damage. When this photograph was taken, the top story had already been removed by the demolition team.

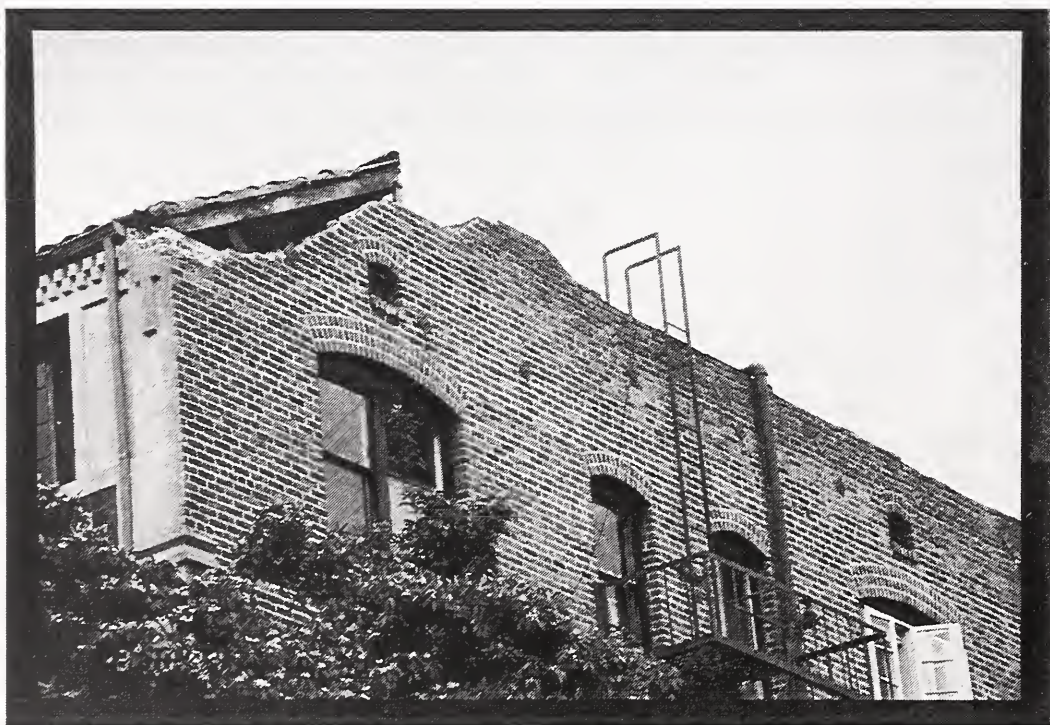
Figure 5 Loss of portions of the parapet and wall at Uptown Manor, an unreinforced masonry building, caused several living units to be declared unsafe by city inspectors.

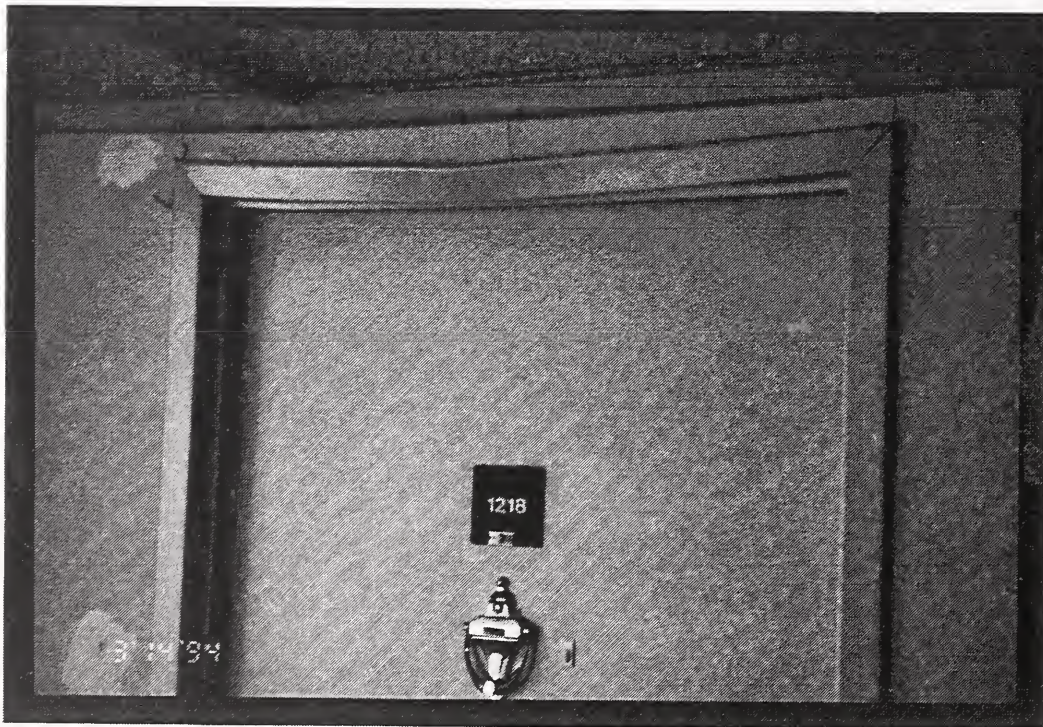
Figure 7 *Buckled door frames occurred in several buildings.*

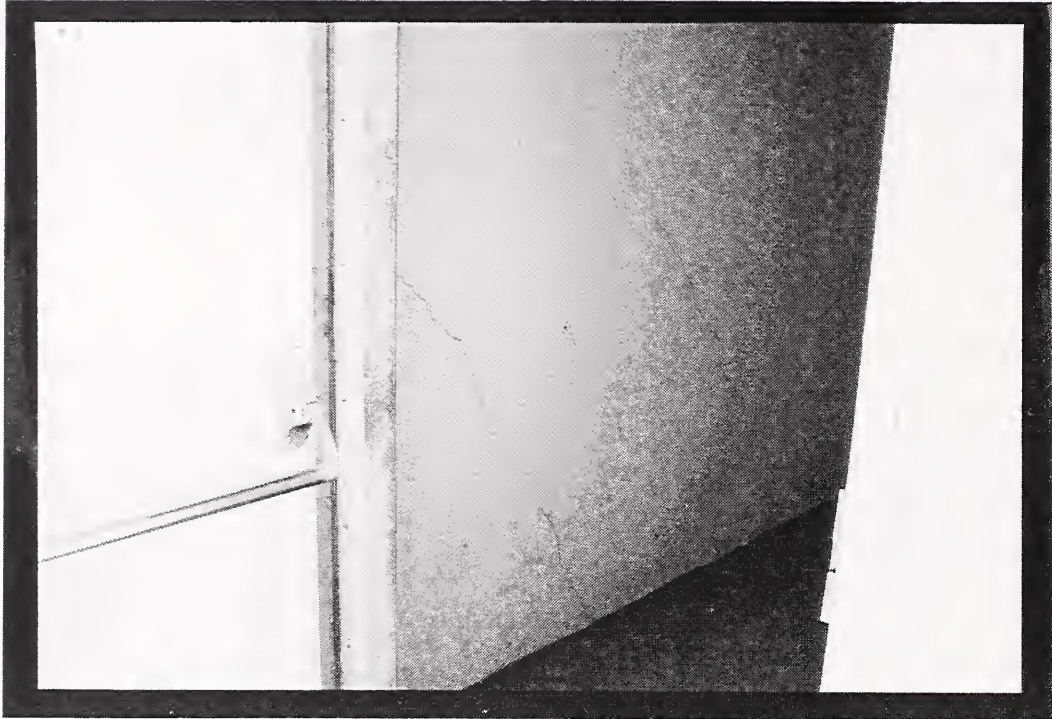
Figure 12 Structural damage in concrete buildings included diagonal cracks in shear walls, such as these in Beverly Towers.

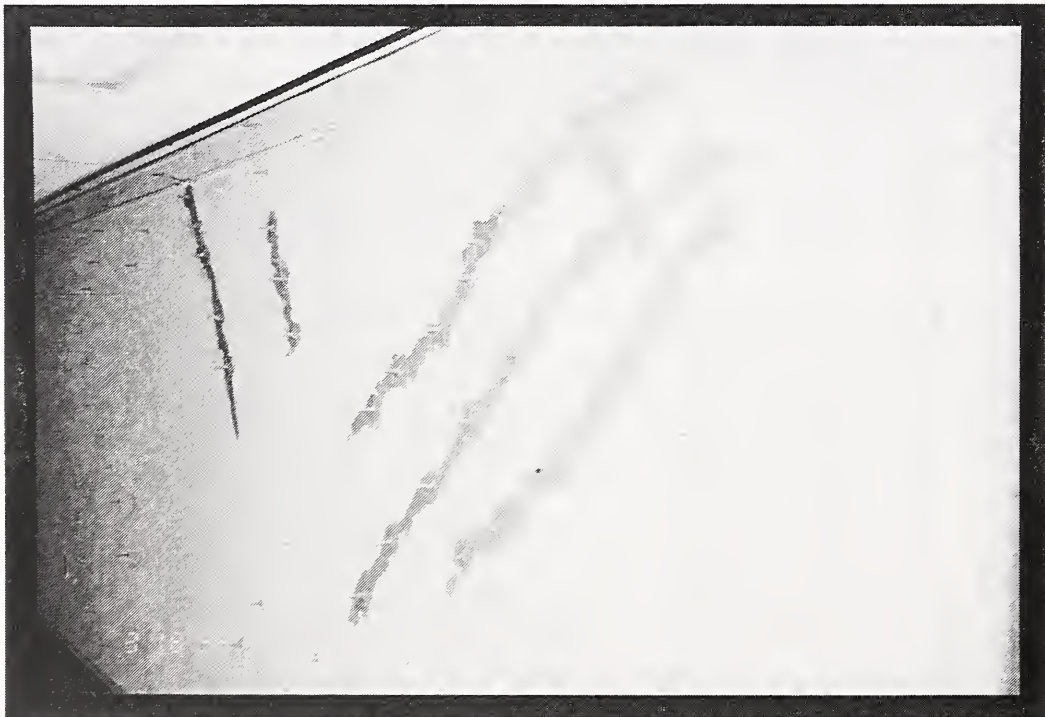
Figure 13 Some of the diagonal cracks in concrete shear walls were already under repair at the time of this study. At Santa Monica Christian apartments, cracks were being repaired using an epoxy injection technique.

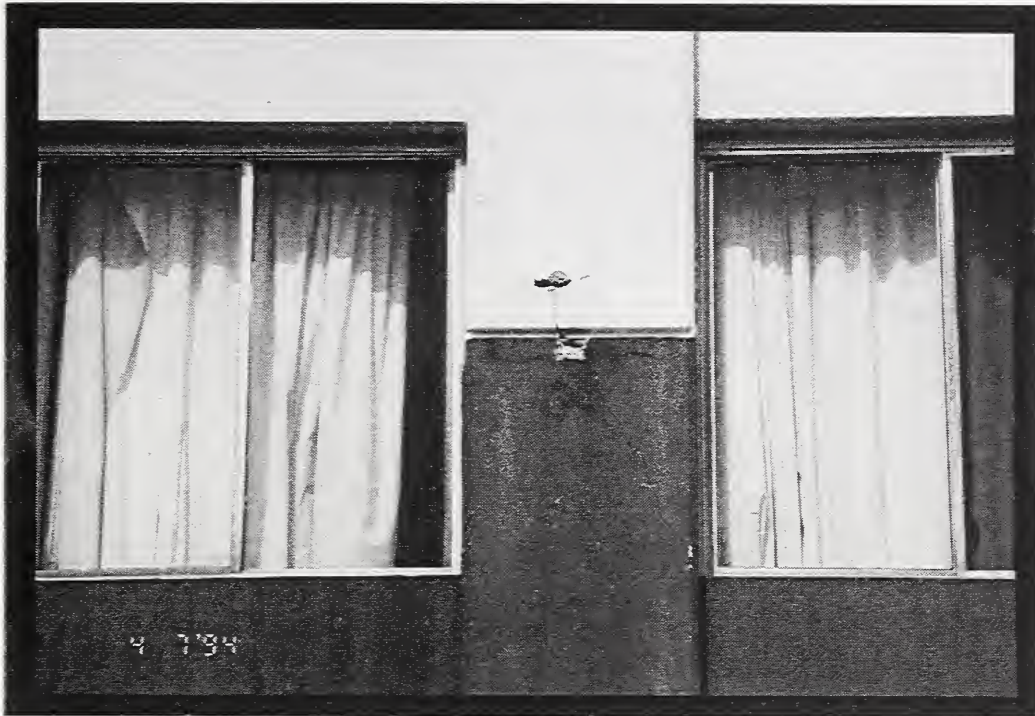
Figure 14 In concrete frame buildings, such as Westminster Towers, diagonal cracks in concrete columns were observed.

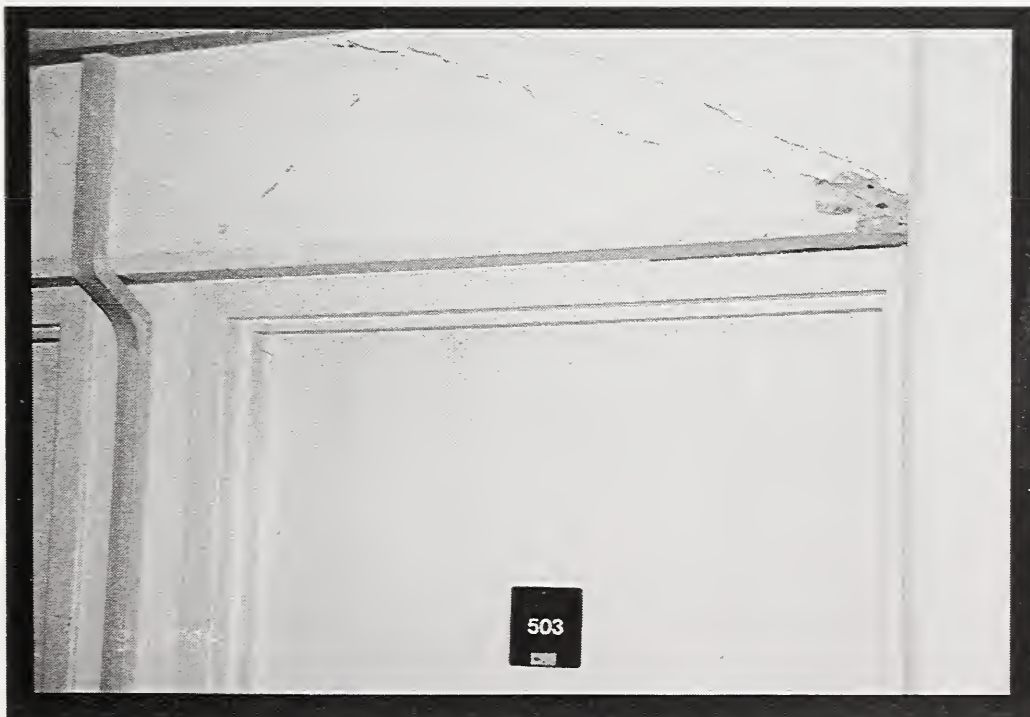
Figure 15 Diagonal cracks between openings in shear walls, such as these above a doorway at Fickett Tower, are examples of commonly observed earthquake damage in concrete shear wall buildings.

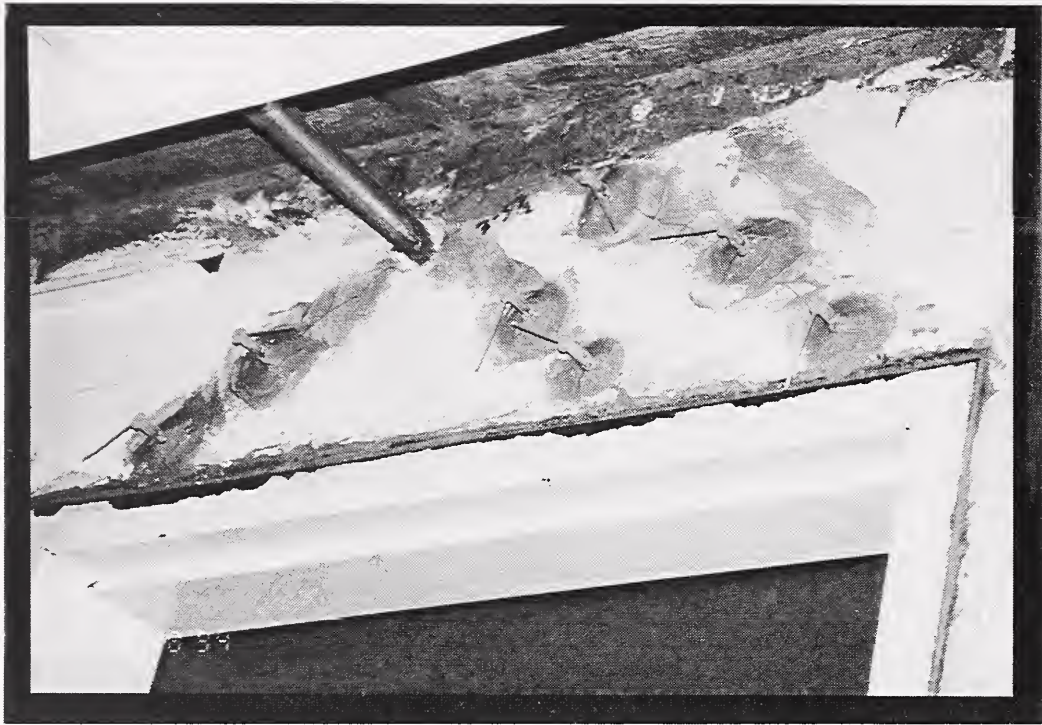
Figure 16 Diagonal cracks in the portions of the concrete shear wall above the doors at Santa Monica Christian apartments were being repaired using epoxy injection. This photograph shows the injection ports.

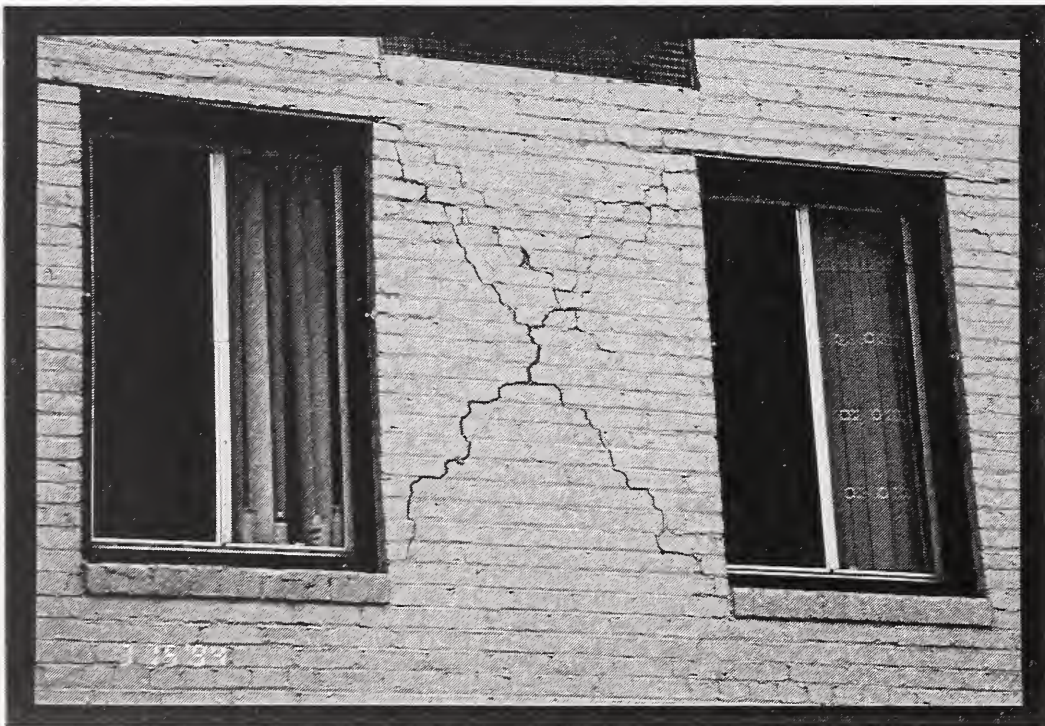
Figure 17 The masonry facade between windows at the Hollywood Knickerbocker, a 63-year old concrete frame building, displayed earthquake-induced X-cracking.

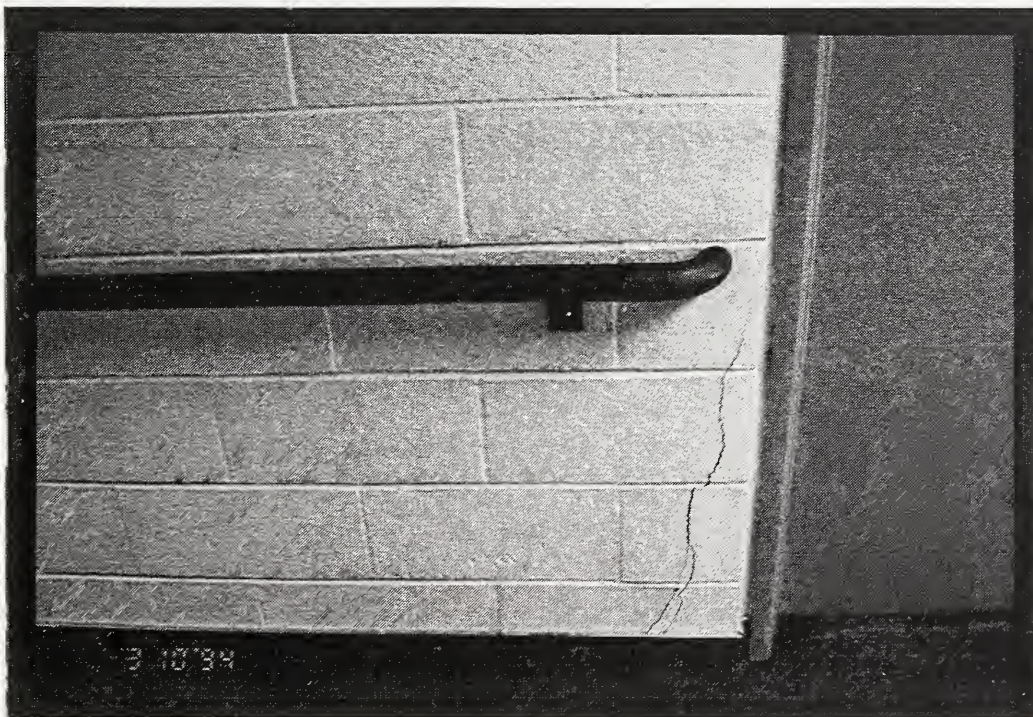
The other two sites had one building each. Casa La Merced is a 5-story building about 46 km from the epicenter which suffered only hairline cracks to interior nonstructural wall surfaces and no damage to structural or mechanical systems. Pledgerville Senior Citizens Villa is a 6-story building about 13 km from the epicenter that suffered vertical cracks in the walls near the base of the door openings (fig. 18).

Figure 18 At Pledgerville Senior Center, a 9-year old reinforced masonry building about 13 km from the epicenter, inclined vertical cracks were observed adjacent to door openings.

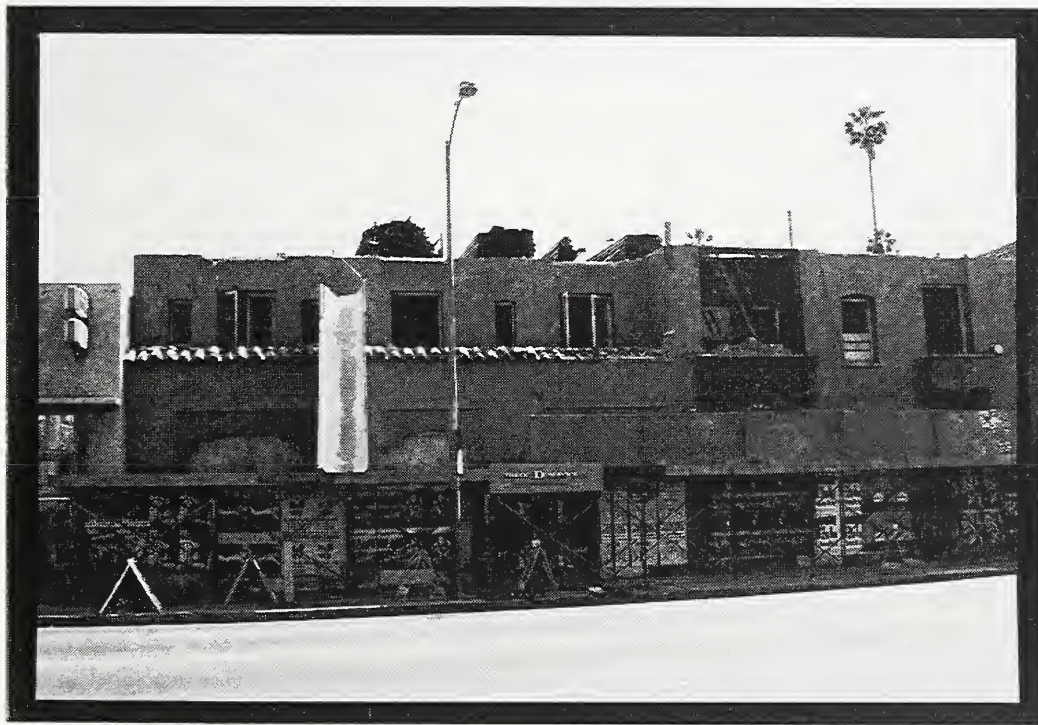
Figure 19 Vadehra Vb, an unreinforced masonry building, was already under demolition at the time of this study. The top floor of this four story building had already been removed at the time this photograph was taken.

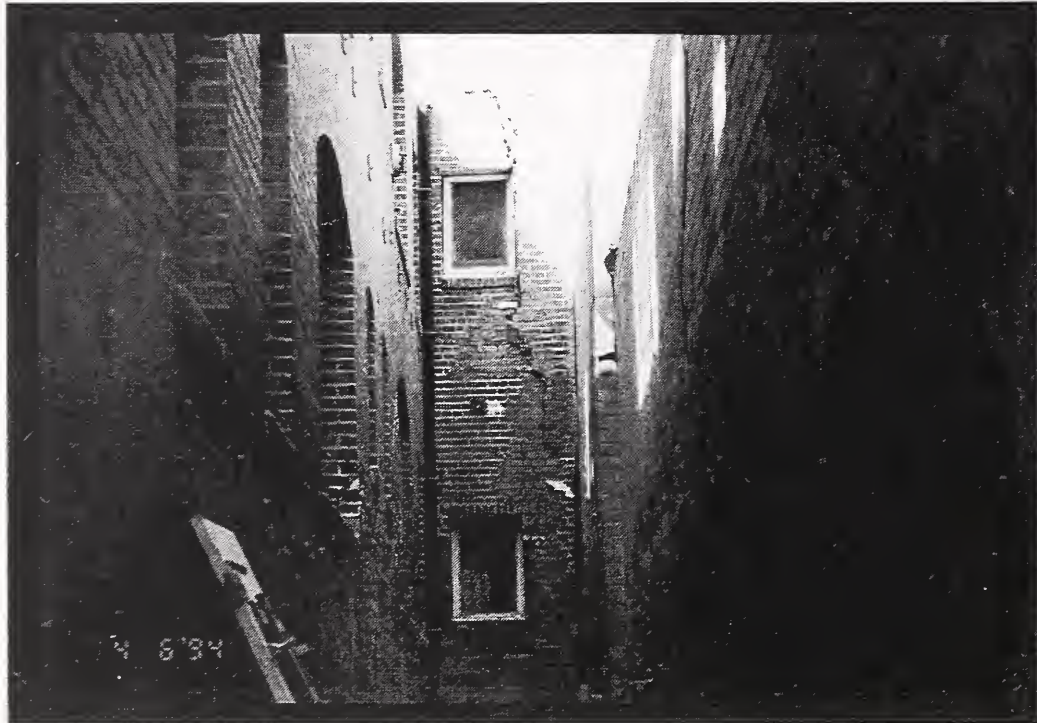
Figure 20 This view of an the inside corner of the T-shaped Vadehra Vb building shows substantial vertical cracks and movement of portions of the wall. Note that this building, which had been condemned and was under demolition, had been rehabilitated before the earthquake with through-bolts.

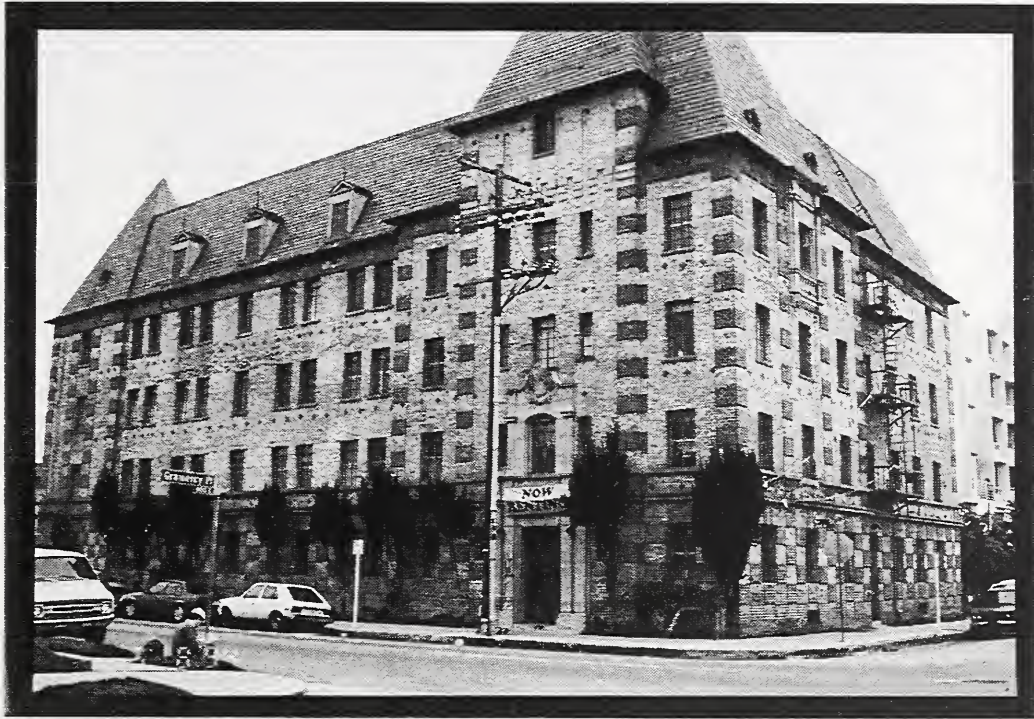
Figure 21 Villa Park Merridy, an unreinforced masonry building that had been rehabilitated prior to the Northridge earthquake, suffered no structural damage and only minor nonstructural damage.

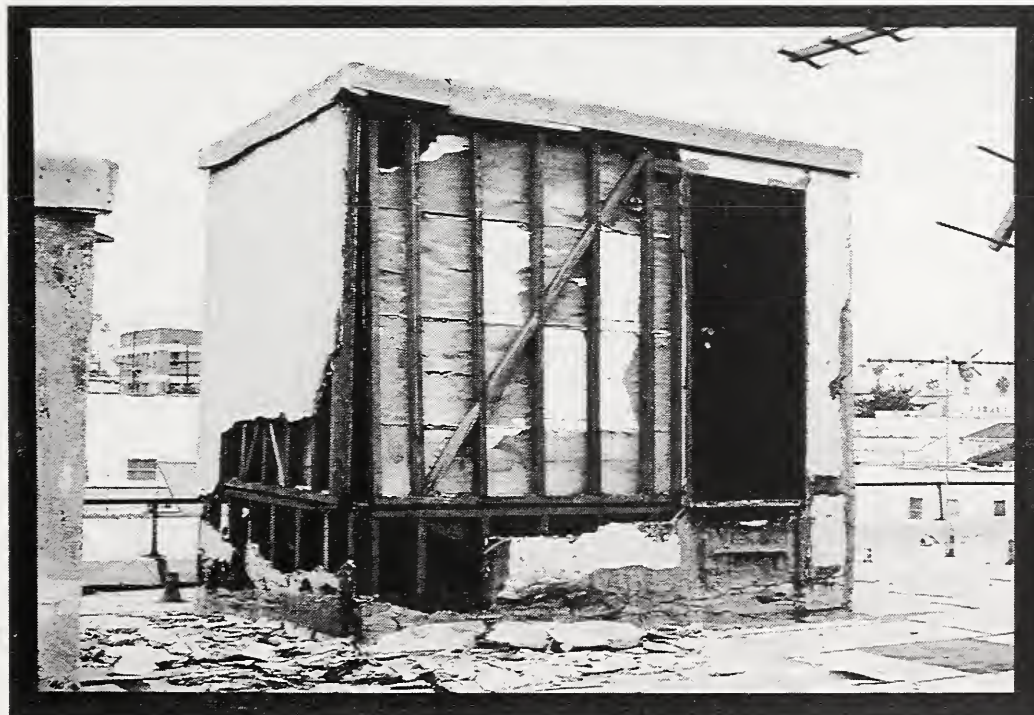
Figure 22 The wood-framed, stucco-clad elevator penthouse on the roof of the 3-story Vadehra IIIb building experienced extensive damage to the stucco, but the operation of the elevator was not affected.

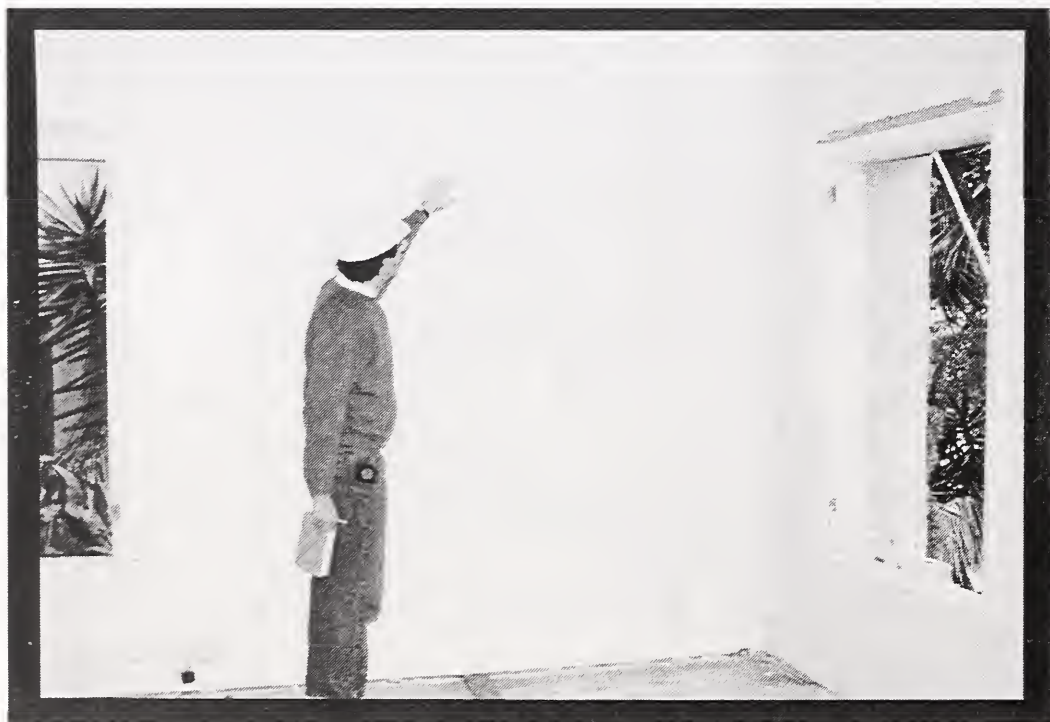
Figure 24 Damage observed in unreinforced masonry buildings included cracks in the interior plaster.

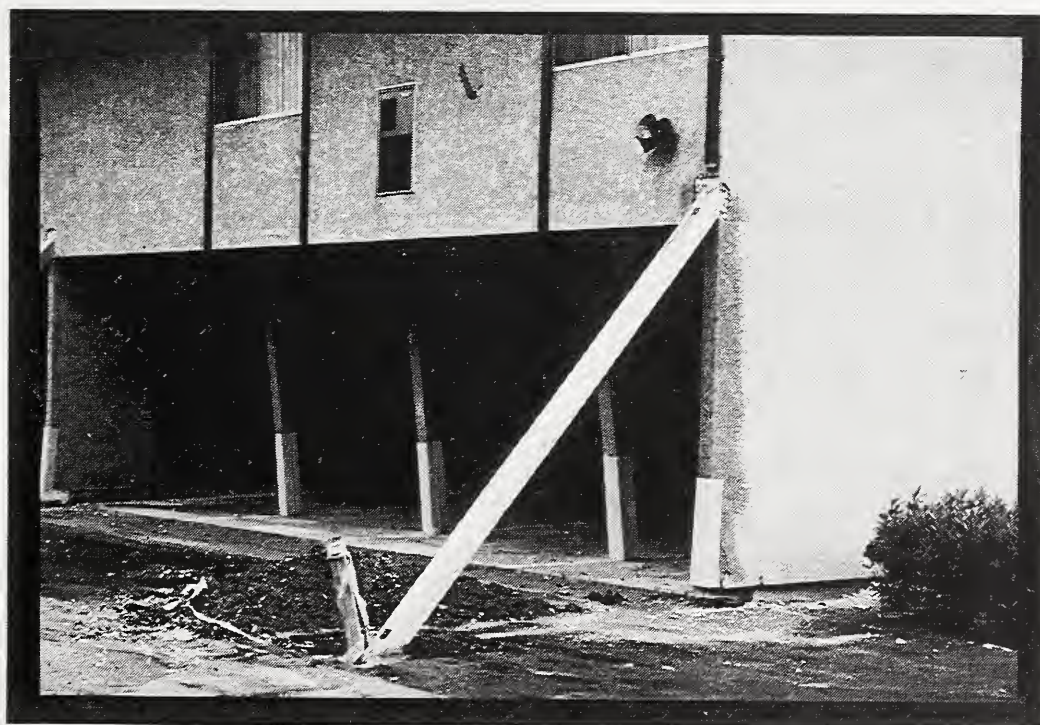
The most spectacular damage occurred at Grenada Gardens, a 51-building complex about 6.5 km from the epicenter: 120 out of 169 units were vacated. Those buildings with the first story open for parking underwent large displacements relative to the foundation, creating permanent offsets (fig. 25). Relative lateral displacements of 0.35-0.45 m were measured. None of the buildings suffered a complete collapse of the first story. The second story apartments in those buildings with first floor parking suffered less nonstructural damage, such as dislodged commodes, cracked gypsum wallboard (fig. 26), and broken glass in sliding doors, than did the apartments in buildings with living units on both levels.

Figure 25 At Granada Gardens, many of the two-story wood frame buildings that had open first levels for parking experienced significant racking and permanent offsets.

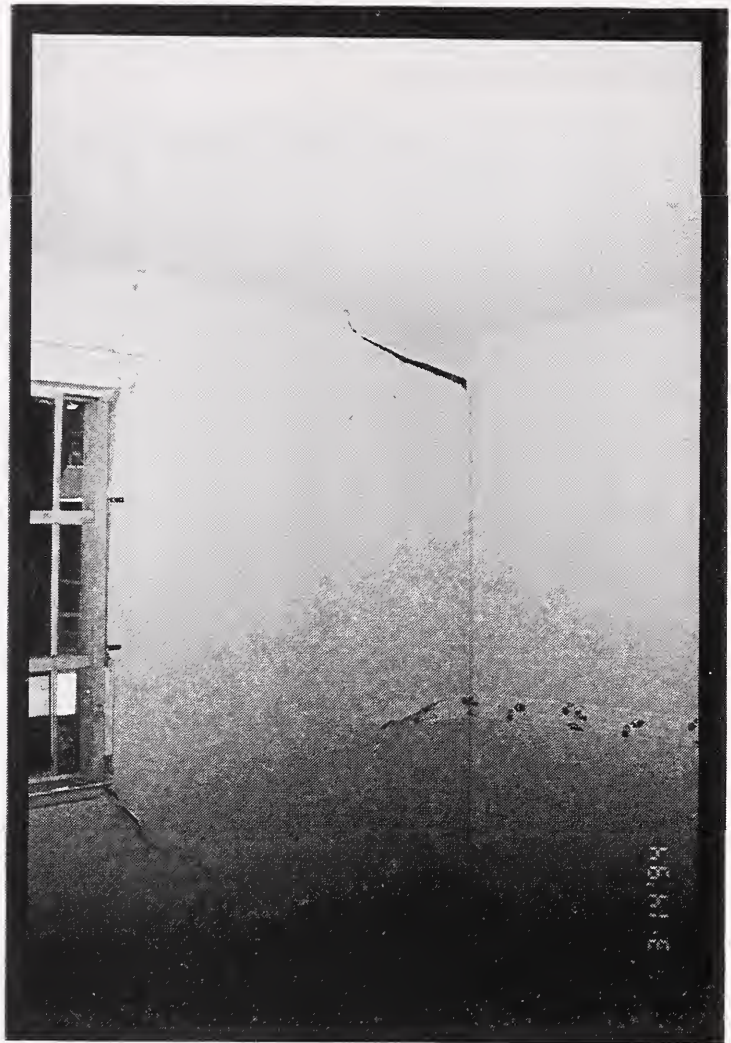
Figure 26 Interior damage at Granda Gardens included cracks in the gypsum wallboard.

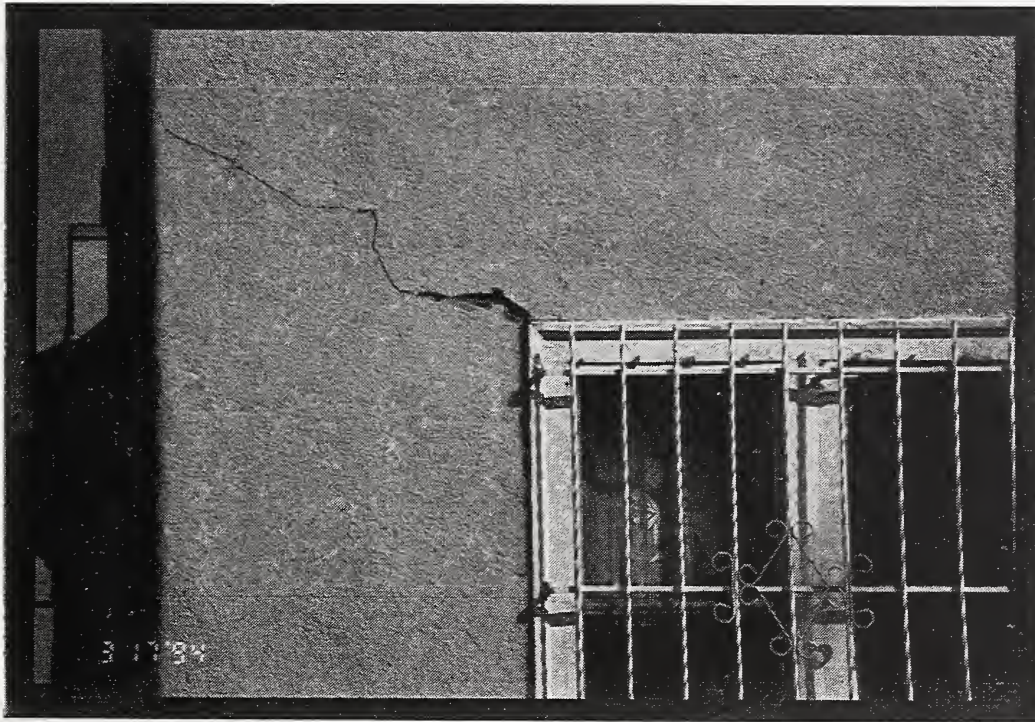
Figure 28 Diagonal cracks in exterior stucco at window openings in wood-framed buildings occurred in many locations, such as at this window at Miramar Manor.
