NISTIR 5492

Diagnosis of Causes of Concrete Deterioration in the MLP-7A Parking Garage

Paul E. Stutzman
James R. Clifton

June 1994
Building and Fire Research Laboratory
National Institute of Standards and Technology
Gaithersburg, MD 20899

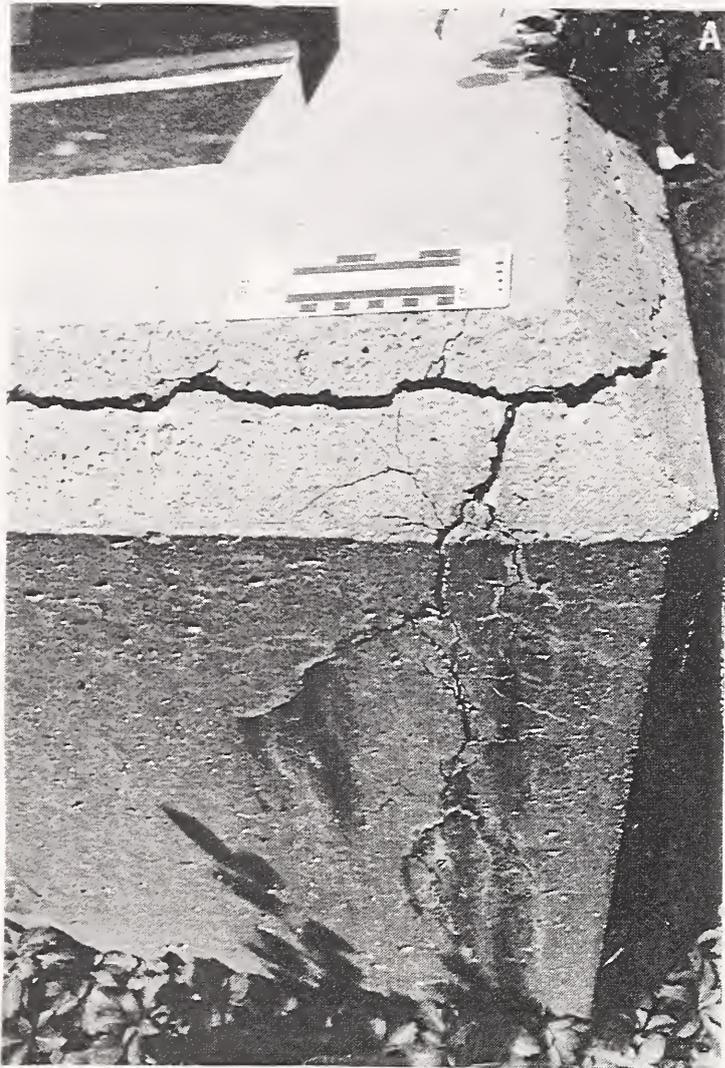
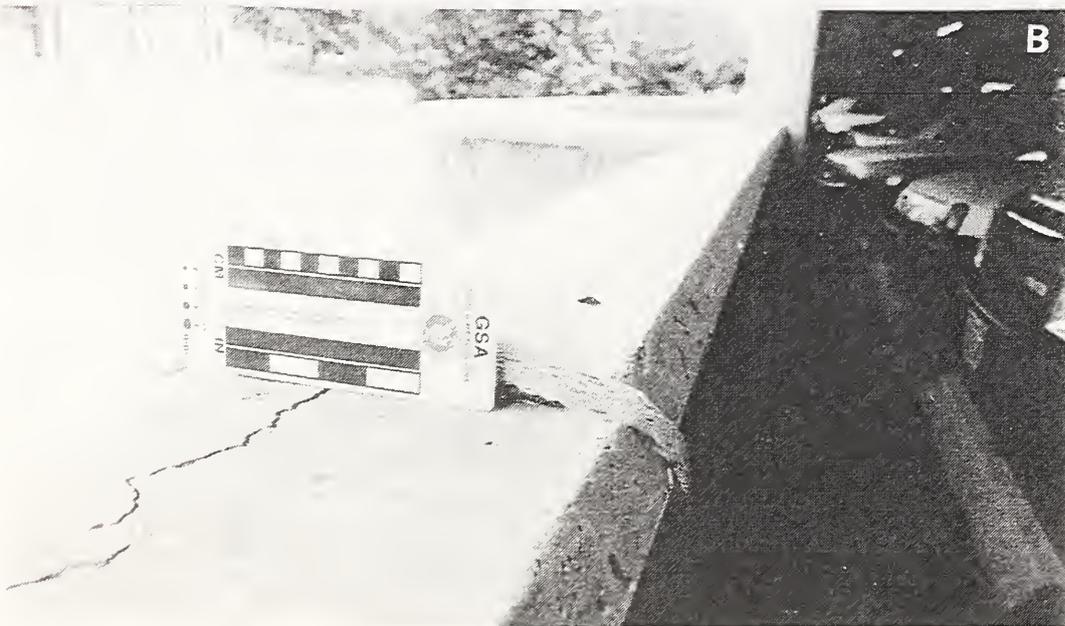
Parking garage MLP-7A is a four-level, cast-in-place concrete structure approximately seventeen years of age located on the grounds of the National Institutes of Health in Bethesda Maryland. The structure is exhibiting expansion and cracking in the parapet walls. A field inspection was carried out for the purpose of examining the structure, crack patterns and locations, selecting sampling areas, obtaining cores, and determining the causes and severity of degradation. Photographs of the parking garage presented in figs. 1 and 2 show the following evidence of degradation:

- extensive map cracking of parapet walls,
- localized exudation of lime (CaOH_2) precipitating as a white efflorescence in the form of calcite (CaCO_3),
- closure of expansion joints,
- longitudinal cracking along tops of parapet walls,
- diagonal cracking in columns on the second level,
- diagonal cracking across corners of some of the decks and in lower-level interior walls,
- spalling and exposed reinforcement on lower level decks and in the southwest stairwell.

Figure 1. Cracking, efflorescence (on face of wall), and joint closure of parapet wall concrete illustrate the severity of expansion and cracking on the upper wall (a) and slightly less severe damage to the second level wall (b).

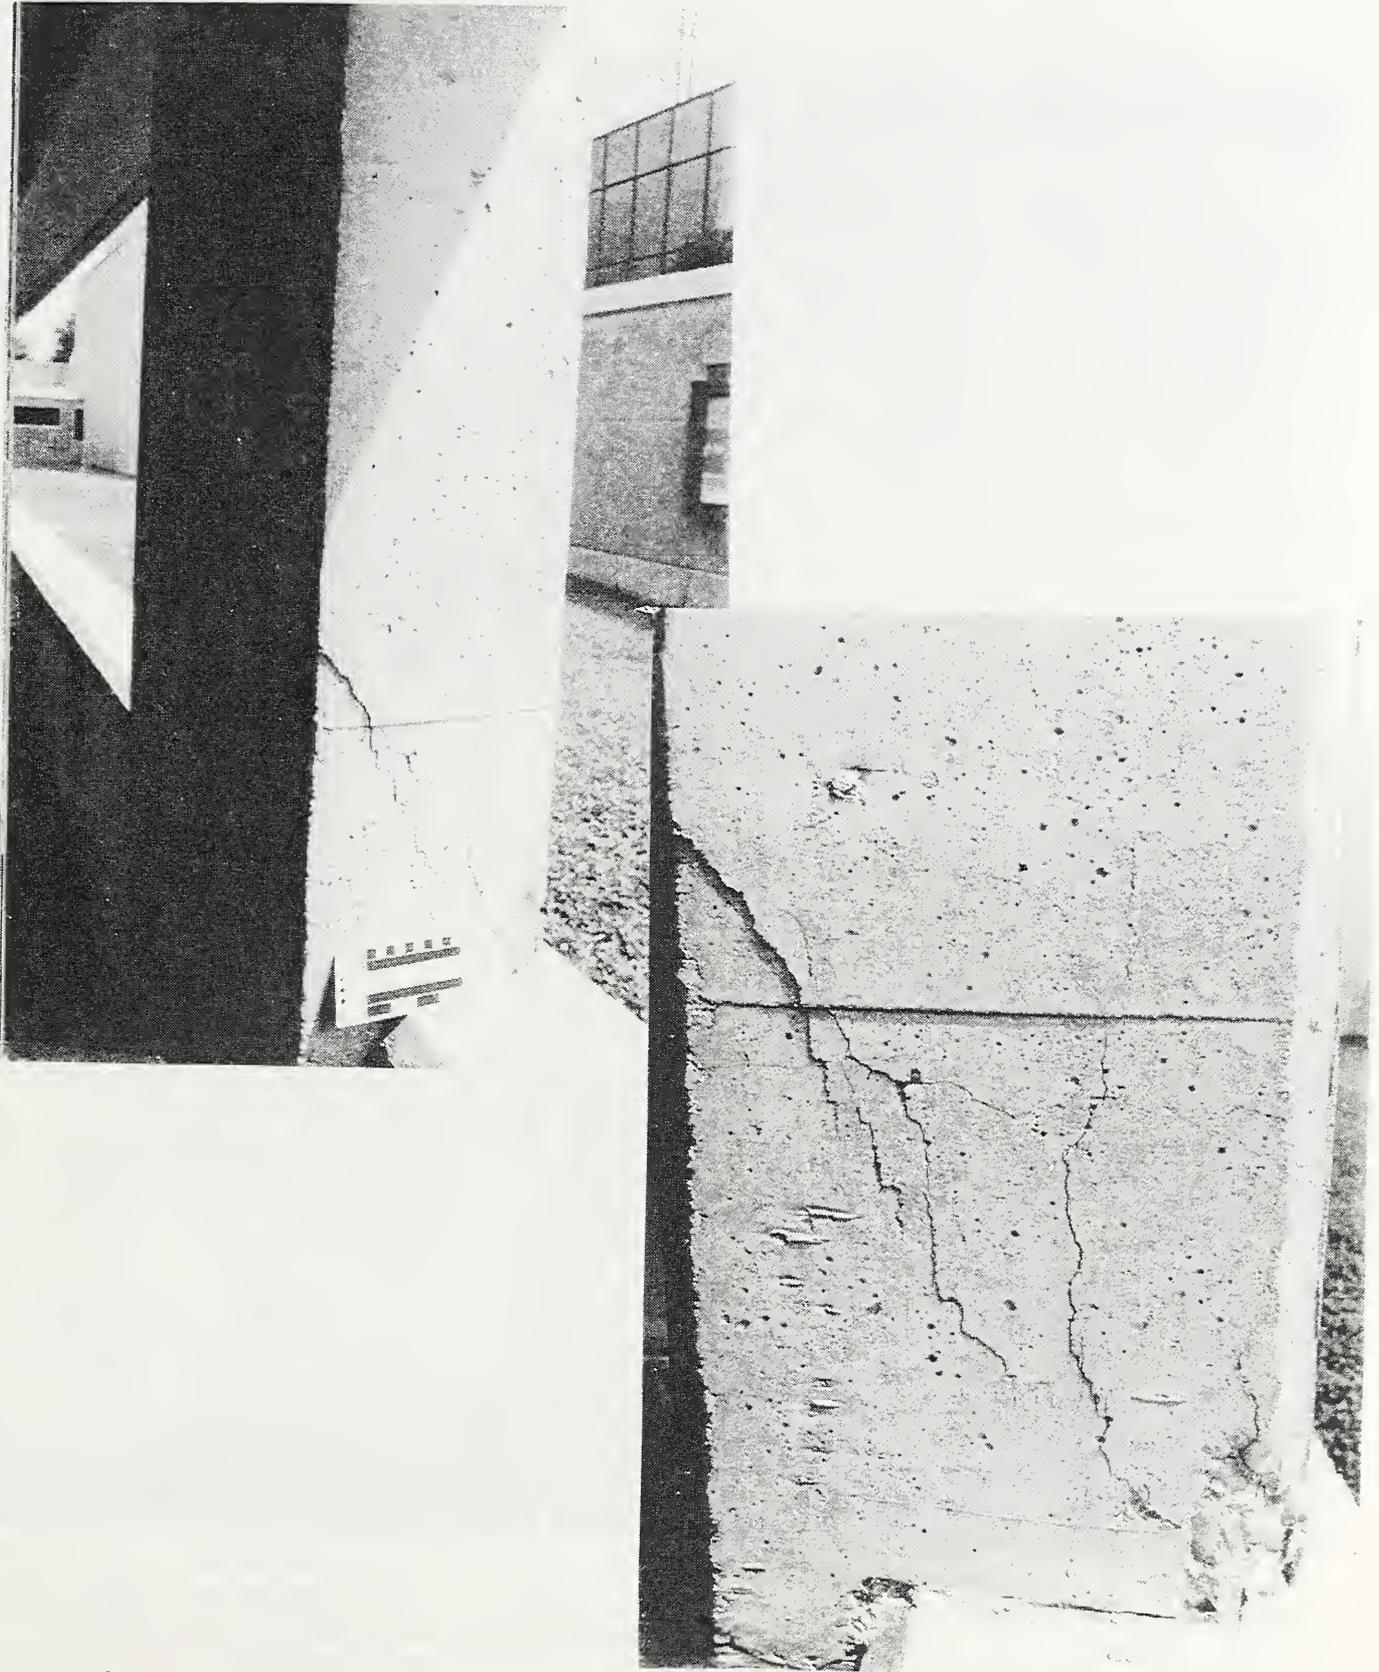
Figure 2. Cracking of column on second level. Exposed aggregate in each image is quartz gravel similar to that used in the parapet walls and lower decks. Columns on the second level, east side, exhibited the greatest amount of cracking. Efflorescence and reaction gel were not observed on any of the columns.

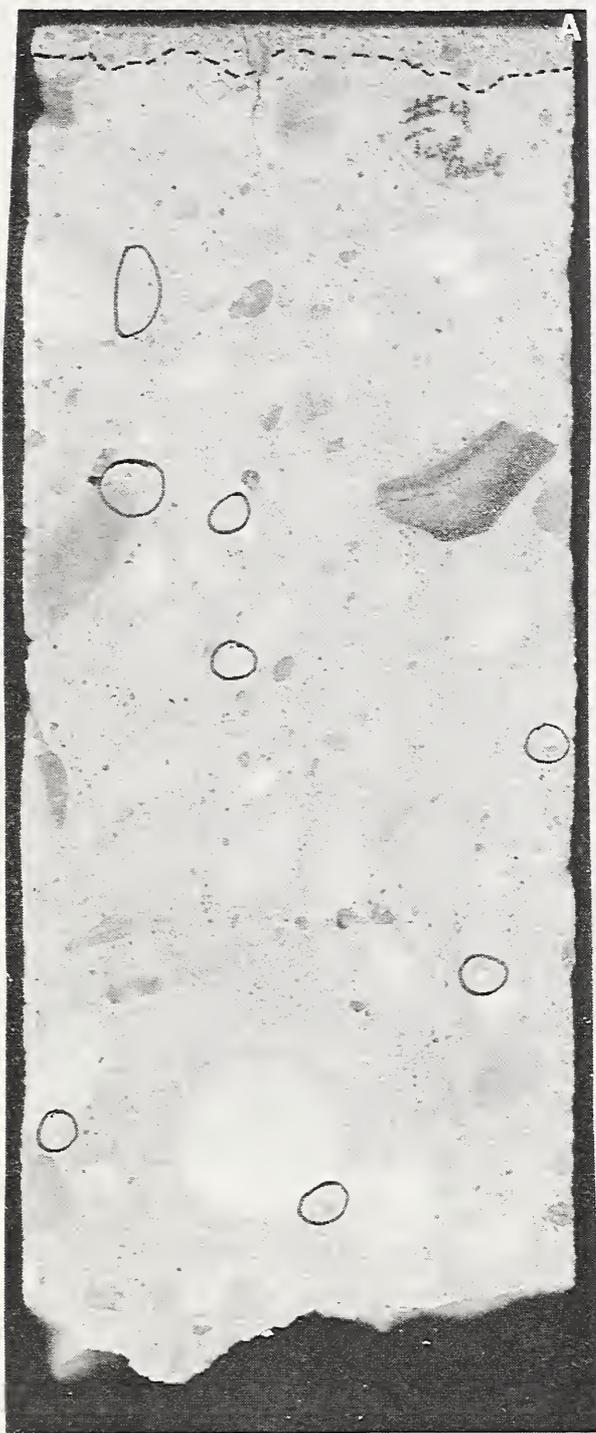
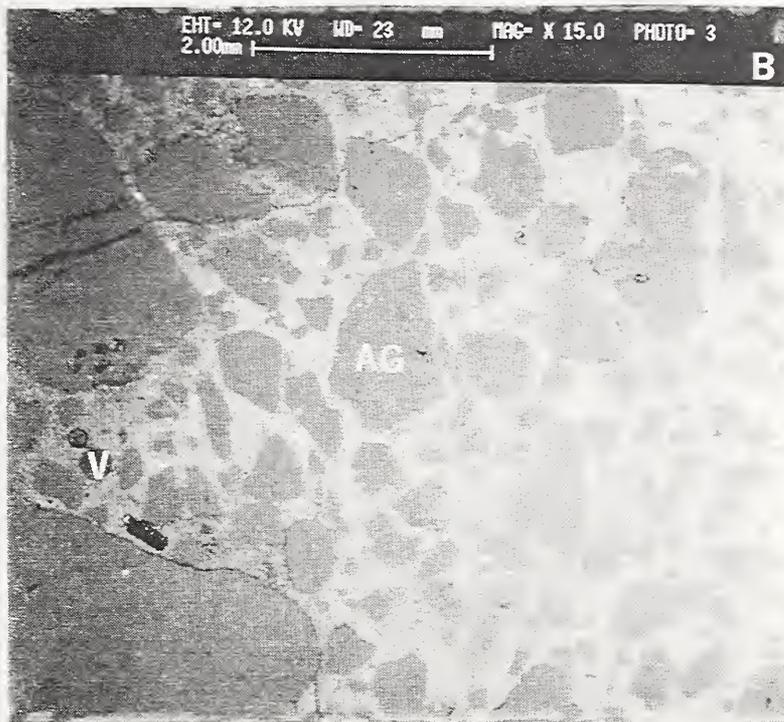
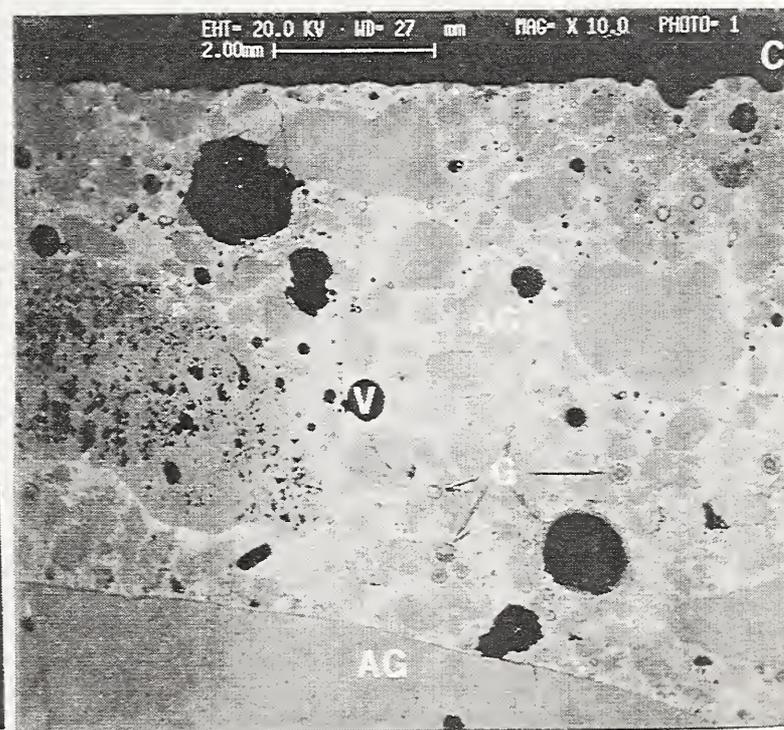
Full-section cores (horizontal) could not be extracted in one piece from the upper deck parapet wall suggesting that the prominent crack along the length of the wall extends the height of the wall. Full-section cores were successfully extracted from the parapet wall on level B-1. Polished sections of slabs sawn from these cores are presented in Figures 3-5. Aggregate in the parapet walls is a 25 mm maximum diameter quartz gravel coarse aggregate and quartz sand fine aggregate. Chert (very fine-grained, porous quartz) is present in both the coarse and sand portions of the aggregate. The aggregate-to-paste ratio and aggregate distribution appears normal. The paste microstructure is dense and the paste appears to be well-bonded to the aggregate. The carbonation depth of about 3 mm is normal considering the age of the structure. All core specimens exhibit evidence of alkali-silica reaction (ASR) gel as white, soft void-fillings up to 4 mm in diameter, and thin (0.25 mm) bands of white gel rimming some aggregates. The upper deck parapet wall specimens appear to contain the greatest amounts of gel and the interior wall on the lower level exhibit the least.

Figure 3A is a full size image of a polished slab from a core extracted from the upper parapet wall with the plane of the image parallel to the axis of the core. Reaction gel (circled) occurs as rounded inclusions and as rims around aggregate. A crack extending about 15 mm from the surface can be seen at the top of the image, while the slight discoloration of the top few millimeters marks the approximate depth of carbonation. Figs. 3B and 3C are higher-magnification scanning electron microscope (SEM) images of the concrete microstructure. The quartz aggregate appears as dark, angular fragments. Unhydrated cement appears as small, angular, bright grains in a light grey matrix of hardened cement paste. Air voids and cracks, filled with a resin during sample preparation, appear black. Entrained air voids 5 μm to 1 mm in diameter appear as black circles in the SEM micrographs. The entrained air void system appears low and poorly distributed, but SEM examination shows a large number of entrained air voids filled with secondary deposits of ettringite, calcium hydroxide, and occasionally gypsum. Idorn [1] notes that this secondary ettringite and gypsum may indicate sulfate attack; but, since fig. 3c shows that some space remains in the air voids, the presence of secondary ettringite and gypsum is more likely a product of deterioration and not a cause of cracking. While an adequate volume of entrained air voids may be present for freeze-thaw resistance, the partial loss and resulting heterogeneous distribution of air voids may result in a lowered resistance to freeze-thaw damage.

Figure 3. Full size polished slab (A) from core extracted from upper deck parapet wall. Slightly darker (tan) region across top indicates the approximate the depth of carbonation. A crack of about 15 mm depth can be observed at the top of the core. Reaction gel can also be seen (circled) as rounded masses and at paste/aggregate interfaces. Backscattered electron imaging (B and C) shows the aggregate (AG), paste (P), heterogeneity of entrained air void (V) distribution and some of the entrained air voids filled by ettringite, gypsum, or calcium hydroxide (G).

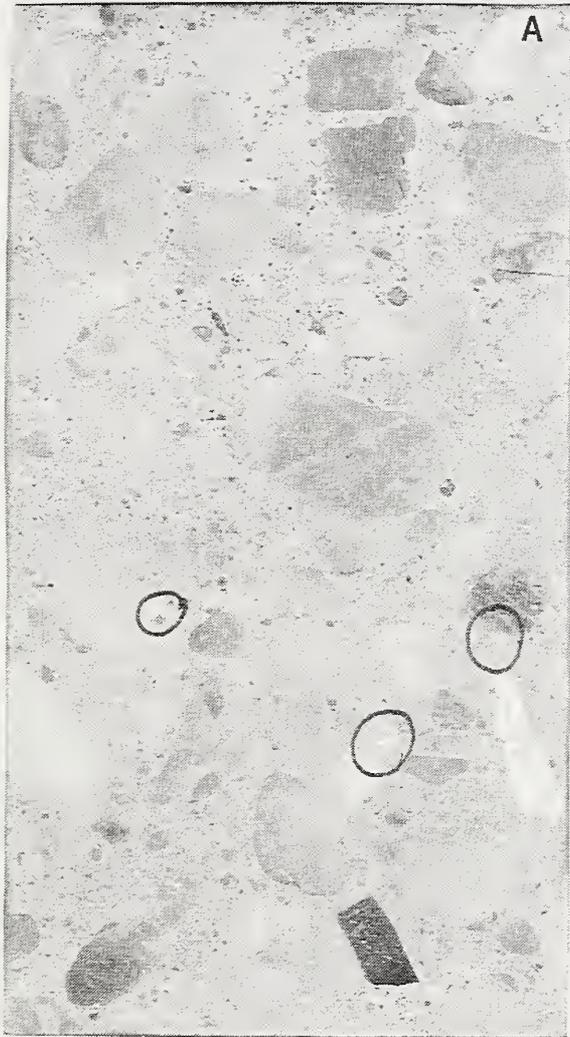
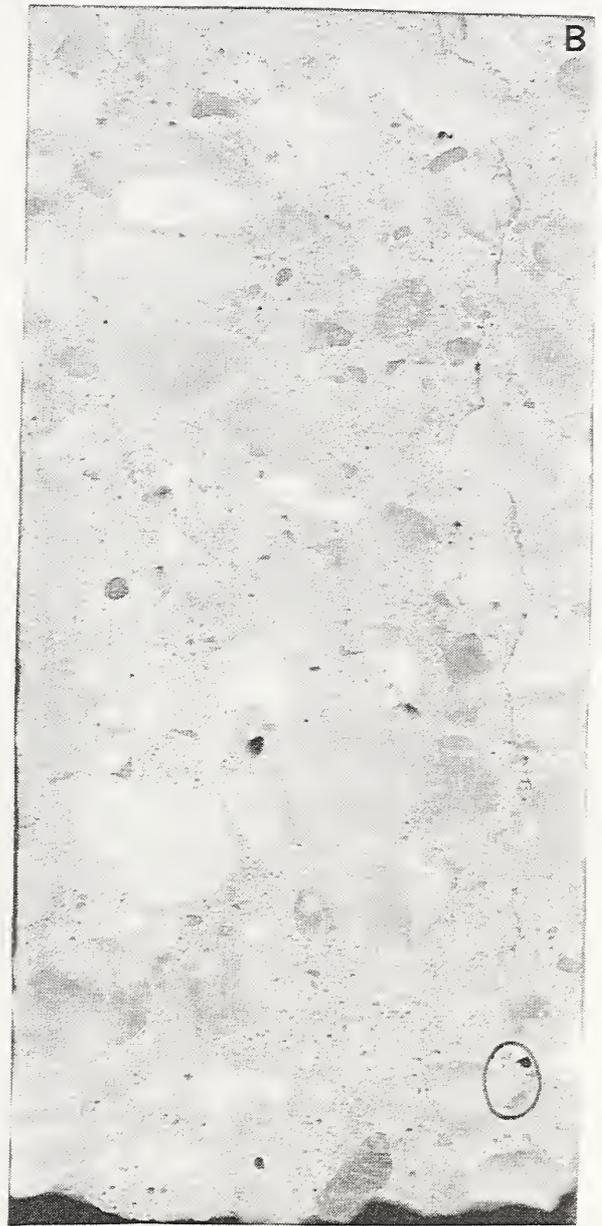
Figures 4A and 4B are polished slabs in the plane of the axis from cores extracted from garage level B-2 and the inside wall of the lowest level. The concrete in these locations exhibited little deterioration relative to the upper parapet walls. Similarly, cracking and exudation in the core slabs is not as common as in those extracted from the upper parapet walls. However, some ASR gel is present as round inclusions and aggregate rims. These cores also exhibit a heterogeneous air-void distribution and some cracking. Also, a low depth of carbonation is observed.

Figure 4. Full size polished slabs from (A) south parapet wall, level B-2, and of (B) the inside wall of lower-most level drilled parallel to the deck. Visible reaction gel (circled) fill voids and occurs at some paste/aggregate interfaces. Some cracking in (A) extends about 20 mm from the top surface and through the core depth in (B).

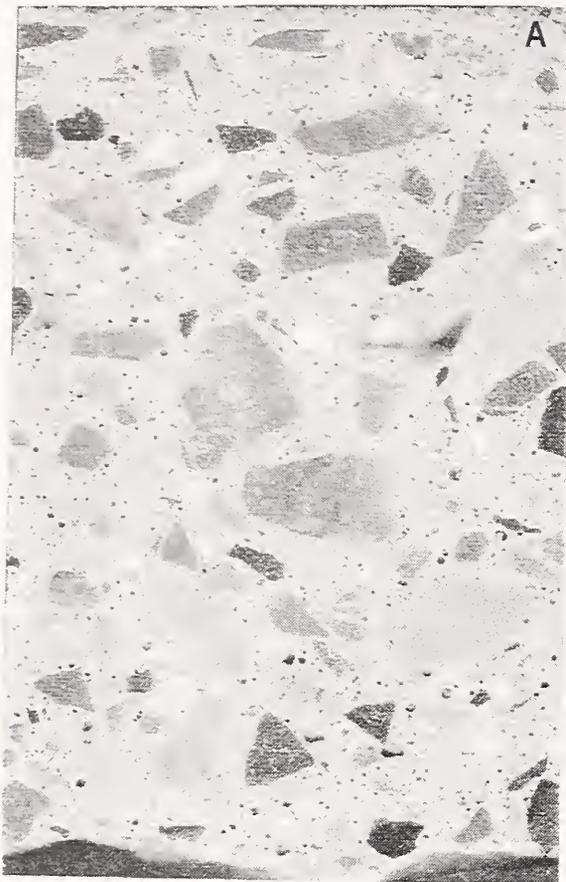
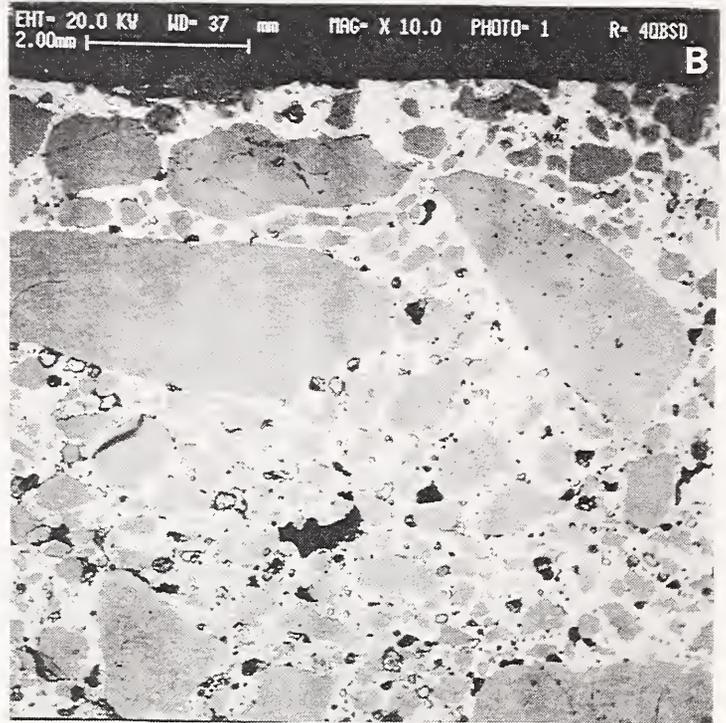
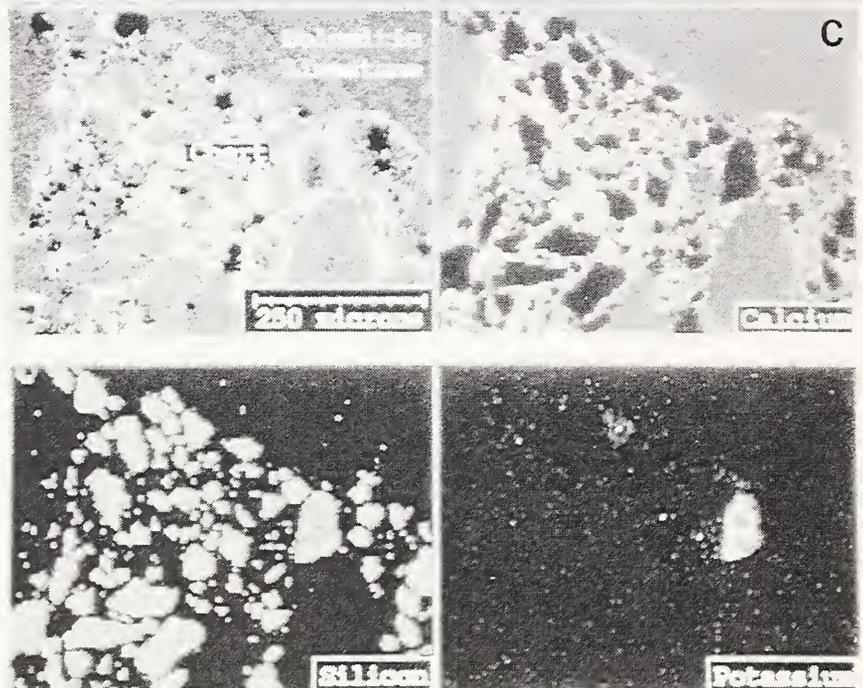
Figure 5 illustrates the microstructure of the core removed from the upper deck. This core was topped by a flexible membrane which is covered by about 45 mm of asphalt. Dampness around cracks observed on the underside of the slab indicate that water has bypassed the membrane. The upper deck and level B1 deck are made with a dark carbonate coarse aggregate and a silicious fine aggregate. X-ray powder diffraction analysis identified the coarse aggregate as a dolomitic limestone composed of calcite and dolomite, and the 18% insoluble residue is composed of quartz, clays, pyrite, and feldspar. Based on composition and textures described by Walker [2], the aggregate may be potentially reactive, but reaction sites identified by SEM were not common and were only associated with the chert fraction in the sand. No reactions were observed in the carbonate aggregate. Paste and aggregate proportions appear normal and the aggregate is well distributed. The paste is hard, appears dense, bonds well to the aggregate and appears to be carbonated to about 2 mm. The entrained air void system appears to be more uniformly distributed than in the parapet wall concretes. No secondary deposits were observed to fill the air voids. Over-finishing the surface has resulted in the loss of entrained air and preferred orientation of the aggregate in the top-most centimeter. If the membrane is damaged, allowing the concrete to become saturated, the loss of entrained air may result in scaling of the top-most layer of concrete by frost attack.

Location of reaction gel and identification of the reactive aggregate are facilitated by SEM imaging (Fig. 5). A SEM backscattered electron image shows a rimmed, mottled, porous chert grain (5 C) while the X-ray image indicates the presence of silicon and potassium. Alkali-silica reaction activity appears to be limited to chert grains in the sand fraction of this concrete.

Figure 5. Polished core slab from core drilled perpendicular to the upper deck surface (A), SEM micrographs (B) illustrate the microstructure with the dark dolomitic limestone (coarse) and quartz sand (fine) aggregate. X-ray imaging (C) of potassium distribution locates chert grains (silicon image, porous grains) containing reaction gel.

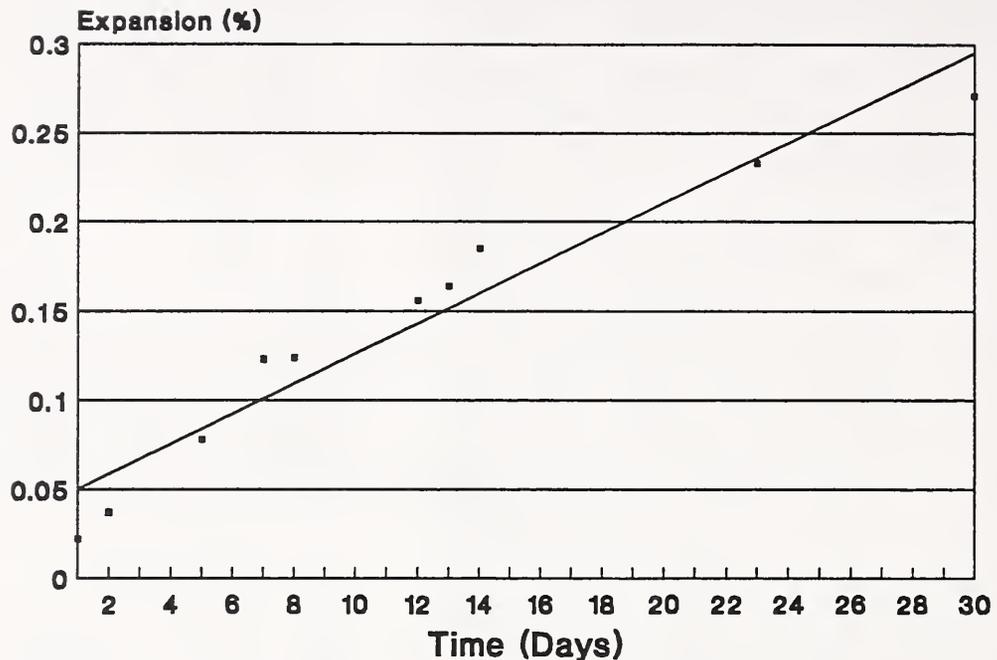
Expansion testing to examine the potential for continued reactivity of the aggregate utilized a modified version of the ASTM P 214 test [3]. An aggregate sample from the structure was extracted from the cores by crushing and sieving. The aggregate was crushed, sieved, graded, and cast in mortars. The mortars were cured for 24 hours, and placed in a 1N NaOH solution at 80°C while measuring length change. The elevated temperature and alkali content of the solution is intended to force potentially reactive aggregates to expand. A length increase of greater than 0.1% within 14 days indicates the aggregate is still reactive and further expansion could be anticipated. The results of this test indicated that the aggregate is still reactive and further expansion may take place. Expansion measurements after 140 days averaged 0.61%, continuing the trend presented in Figure 6.

Figure 6. Results of the modified P 214 test measuring expansion due to reaction of silicious aggregate from parking garage concrete. Failure criterion of 0.1% expansion was reached after one week of testing indicating the aggregate still contains reactive silica.
