Fire Performance of an Interstitial Space Construction System

J. R. Lawson, E. Braun, L. DeLauter and G. Roadarmel

NISTIR 5560

February 1995
Building and Fire Research Laboratory
National Institute of Standards and Technology
Gaithersburg, MD 20899

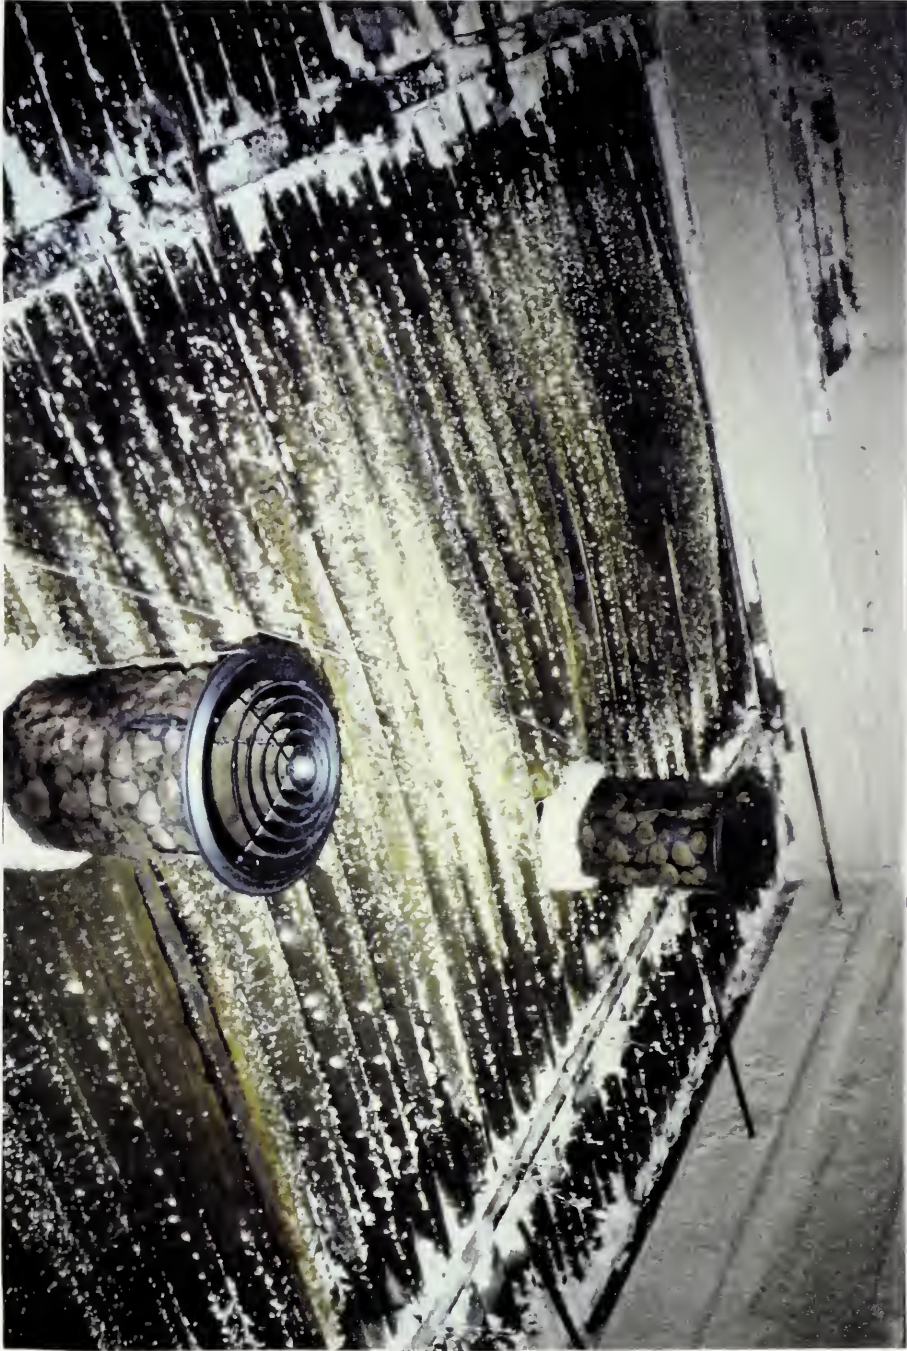
- All of the 2.946 m (9 ft 8 in) steel metal decking had separated along the lapped joints.
- After cooling, the metal deck lap joints had generally returned to a position which showed openings of about a 25 mm (1 in). Figure 14.
- All 965 mm (3 ft 2 in) metal deck spans appeared to show little damage with no noted joint openings.
- All fire-proofing had dropped away from both purlins. Bare metal was exposed along the full length of each purlin.
- The duct work which extended into the fire chamber showed significant damage. Large blisters were seen on all surfaces not covered with firesafing. Figure 15.
- All firesafing around the ducts and in the penetrations appeared to be in place.

Figure 14. Photograph showing damage to walk-on deck, metal decking

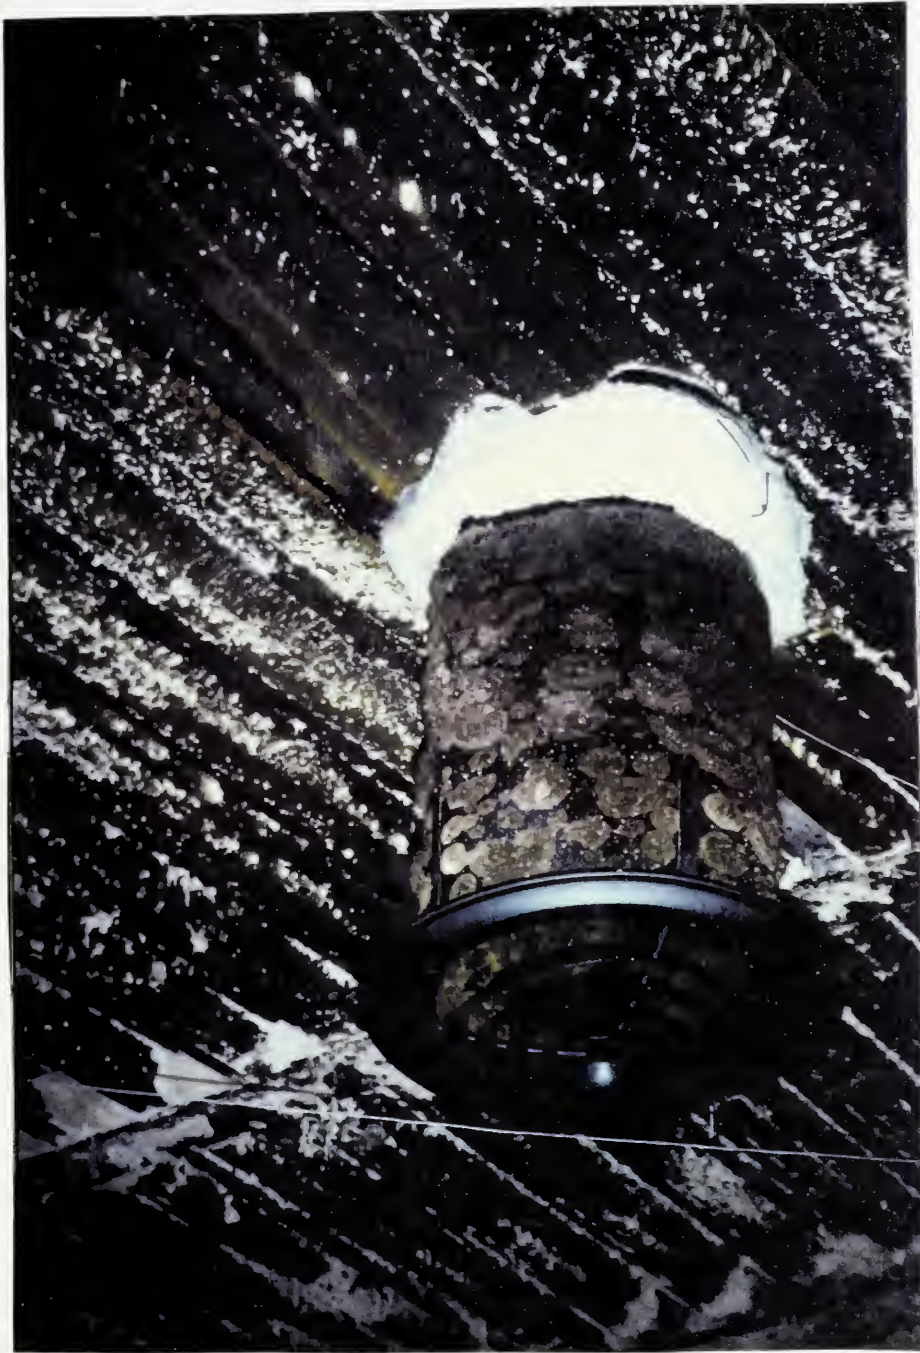
Figure 15. Photograph showing damage to air conditioning duct in fire compartment

Duct sections which extended into the fire environment maintained their integrity throughout the test period. However, large blisters were noted covering the duct's surfaces as the test ended. See the photograph in figure 15 of the main report.

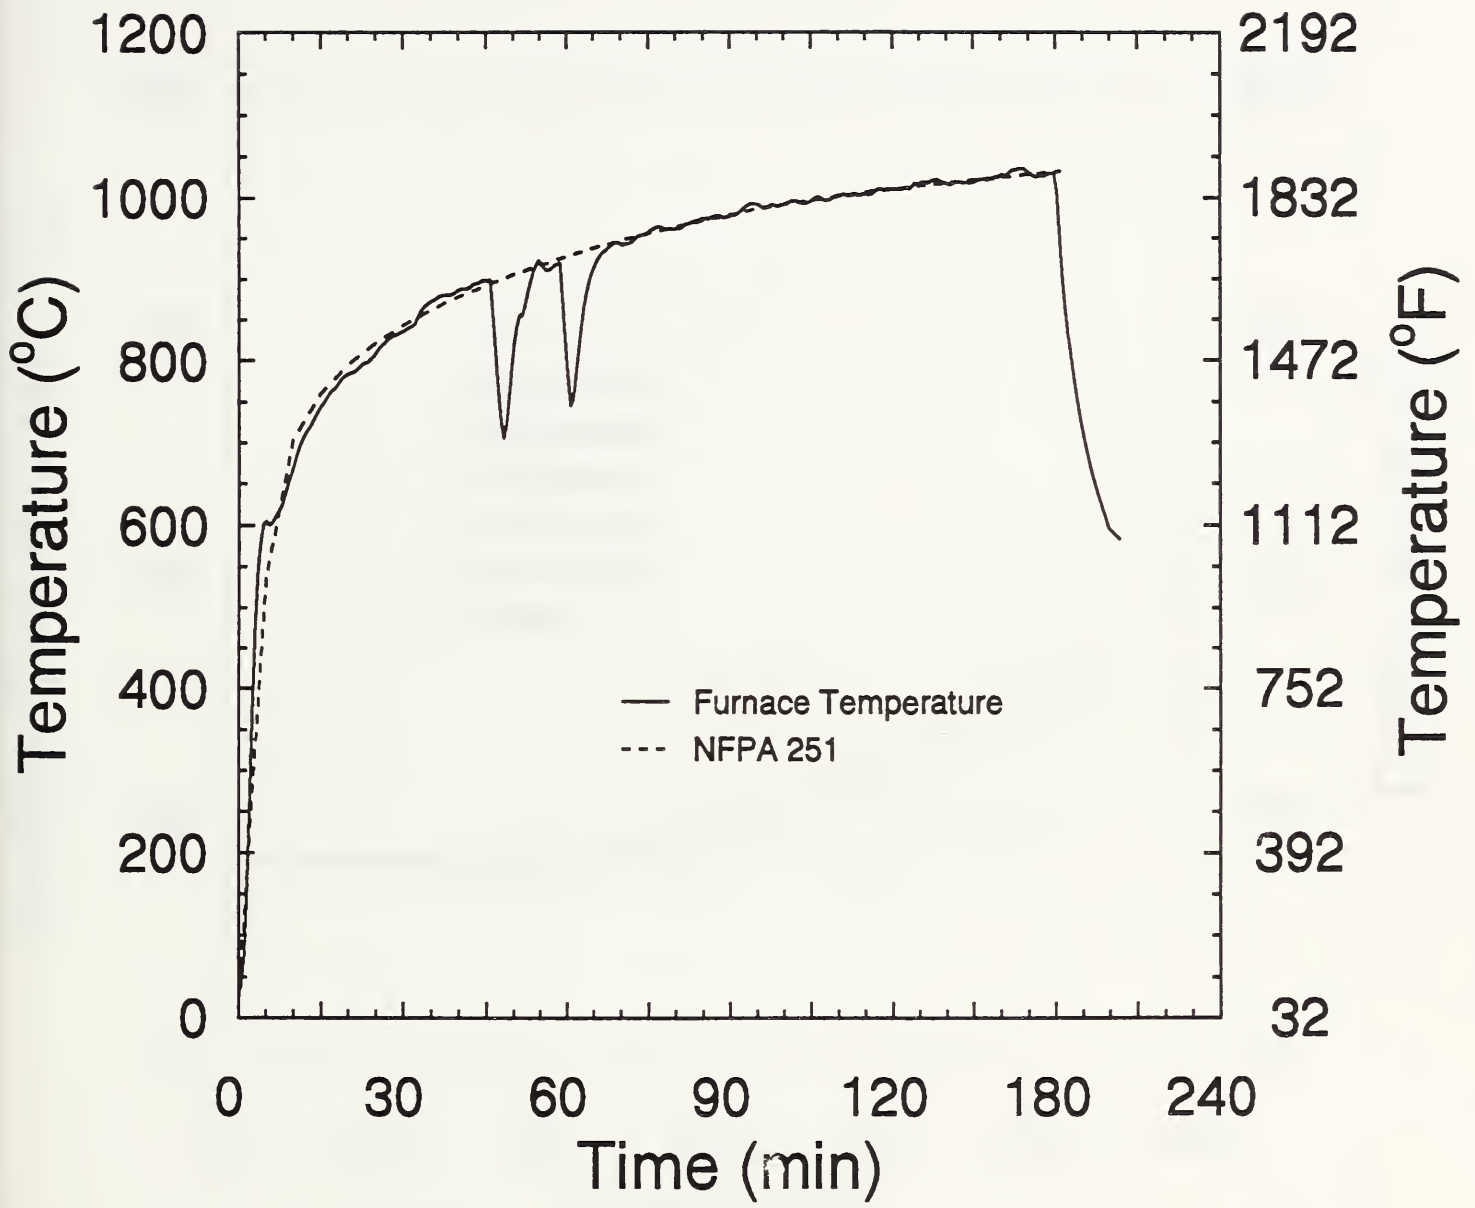
In accordance with section 2-2.3 of NFPA 251, the test assembly was exposed to an acceptable fire test environment required for a two hour rating. Figure 16 shows the standard time-temperature curve along with the actual temperature curve as measured during the fire test. The total furnace exposure was for 2 hours and 30 minutes. The area under the curve for the test was 104,360 °C-min as compared to the standard NFPA 251 area of 105,430 °C-min which was a difference of 1.01 percent. The main reason for the area differences resulted from two electrical failures during the test which caused the burner to shut down. These drops can be seen in figure 16. In each case, the burner was restarted within 2 minutes. Section 2-2.3 of the NFPA 251 standard allows an area difference of 7.5 percent between the actual test area and the standard time-temperature curve area for a two hour test. For tests longer than two hours, a difference of 5.0 percent is allowed.

Figure 16. Standard NFPA 251 time-temperature curve vs. actual fire test curve

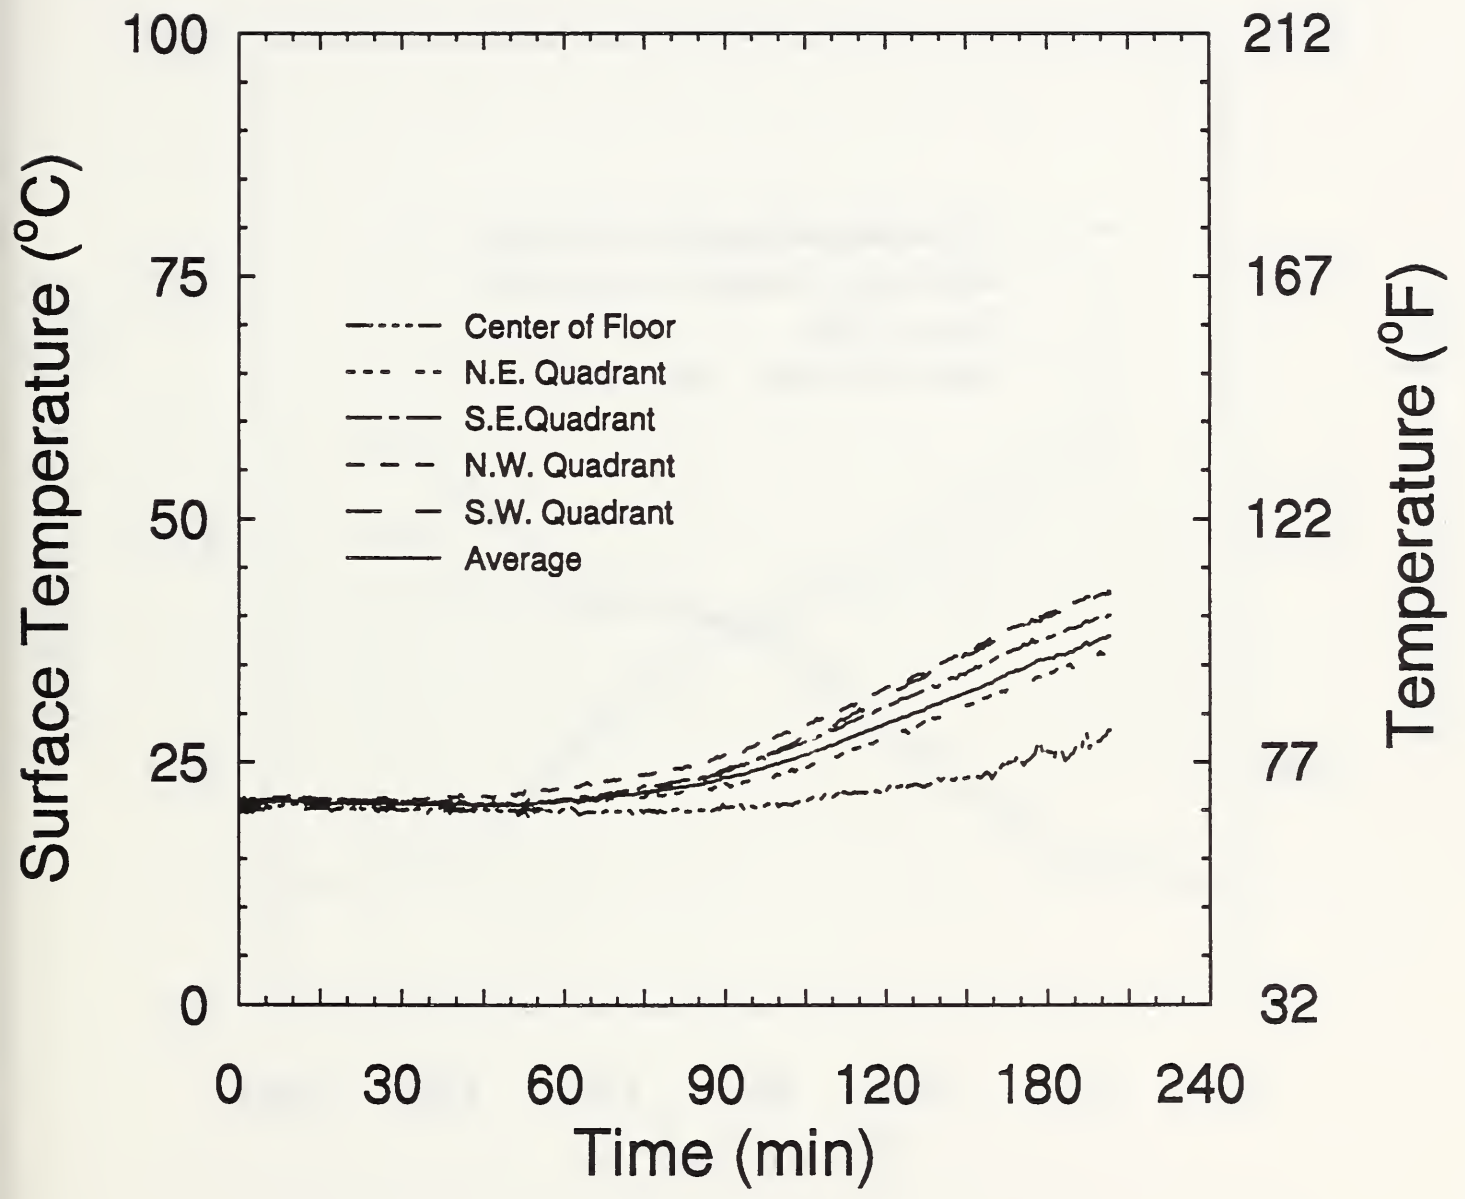
Temperature measurements for the functional floor's surface are shown in figure 17. These plots show that maximum temperature rise for the two hour test period was no greater than 33 °C (91 °F). No changes in floor temperature were noted until about 60 minutes into the test. At that point, temperatures generally began to rise across the deck. The center position thermocouple temperature becomes less than the others at about 75 minutes into the test. This is attributed to heat losses to a structural steel member located near the thermocouple. The maximum temperature rise above ambient for the functional floor's surface was 22 °C (72 °F) at the end of 2 hours and 30 minutes. The functional floor used in this test was the same one

Figure 17. Temperatures on surface of functional floor

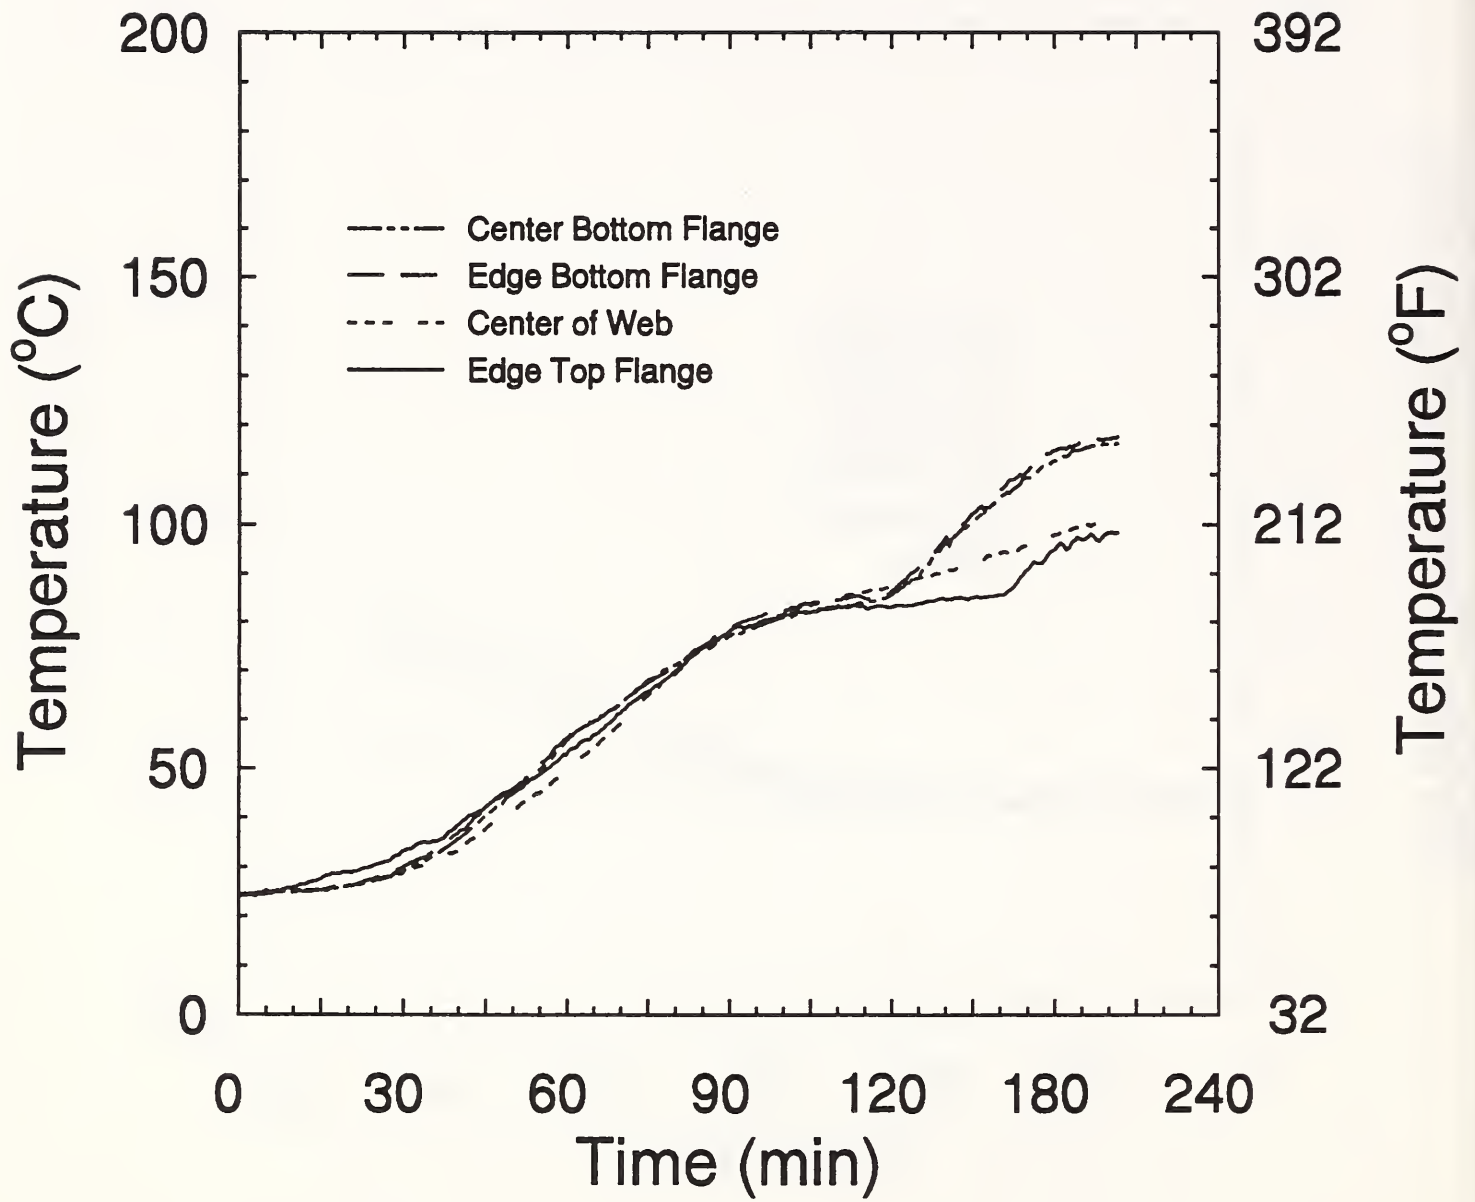
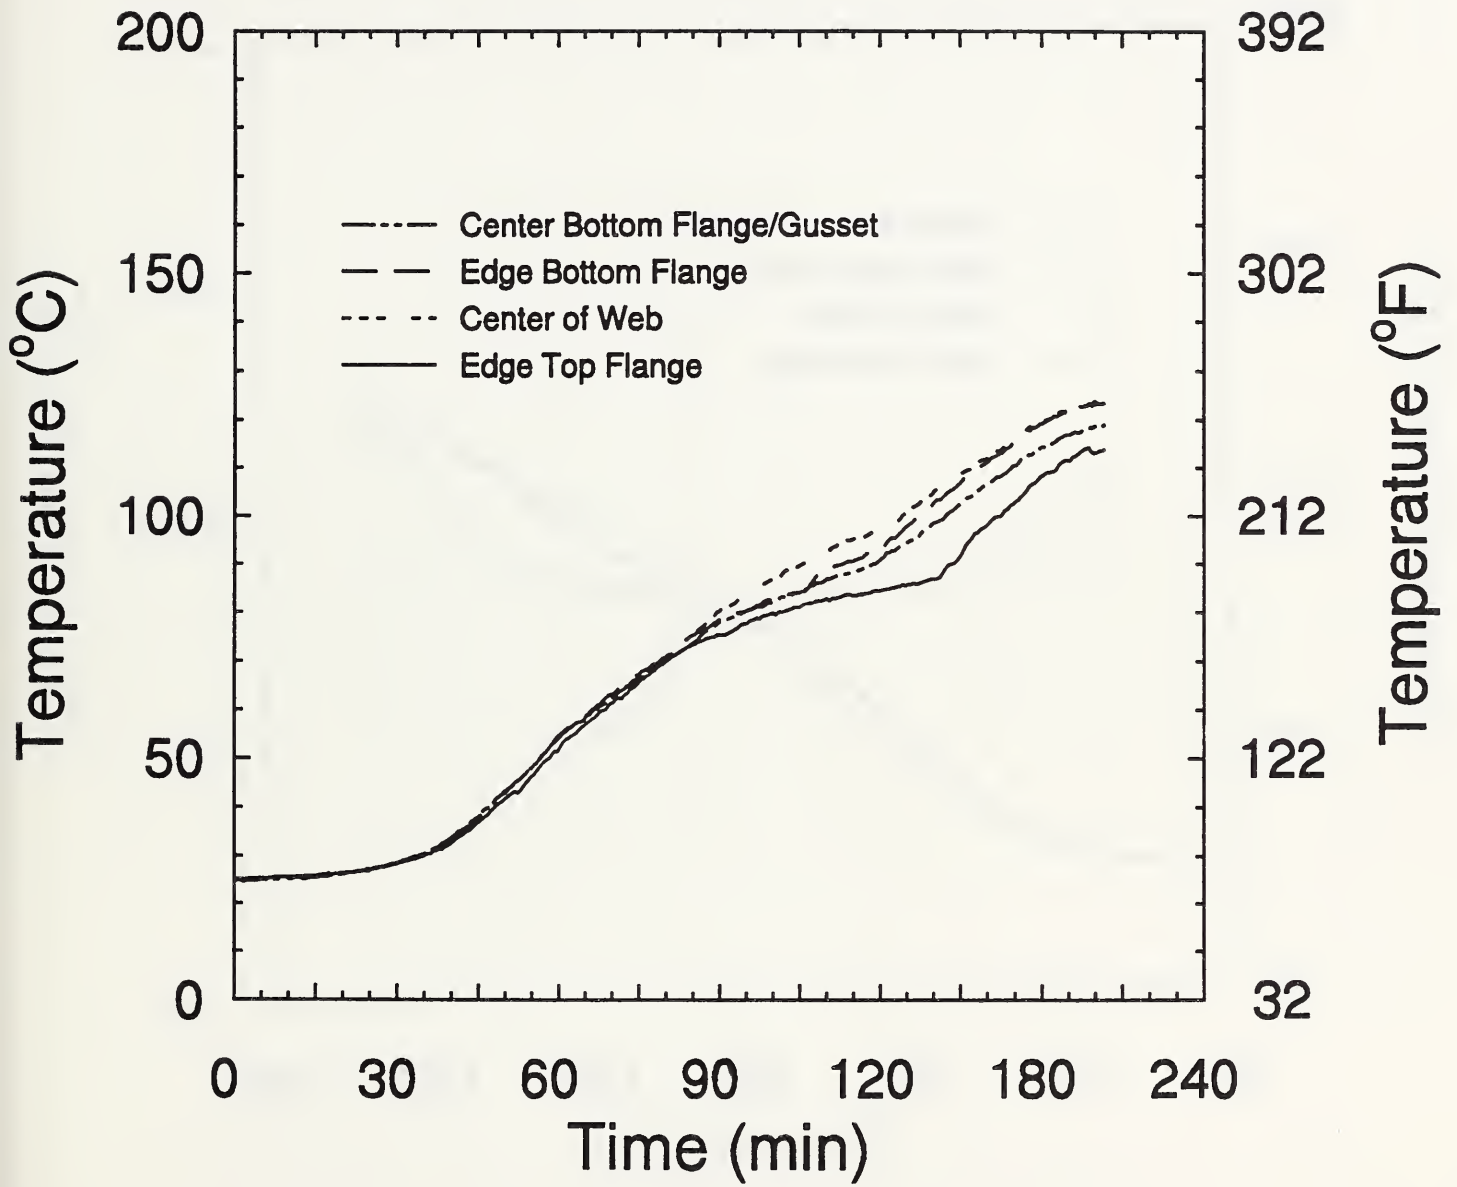
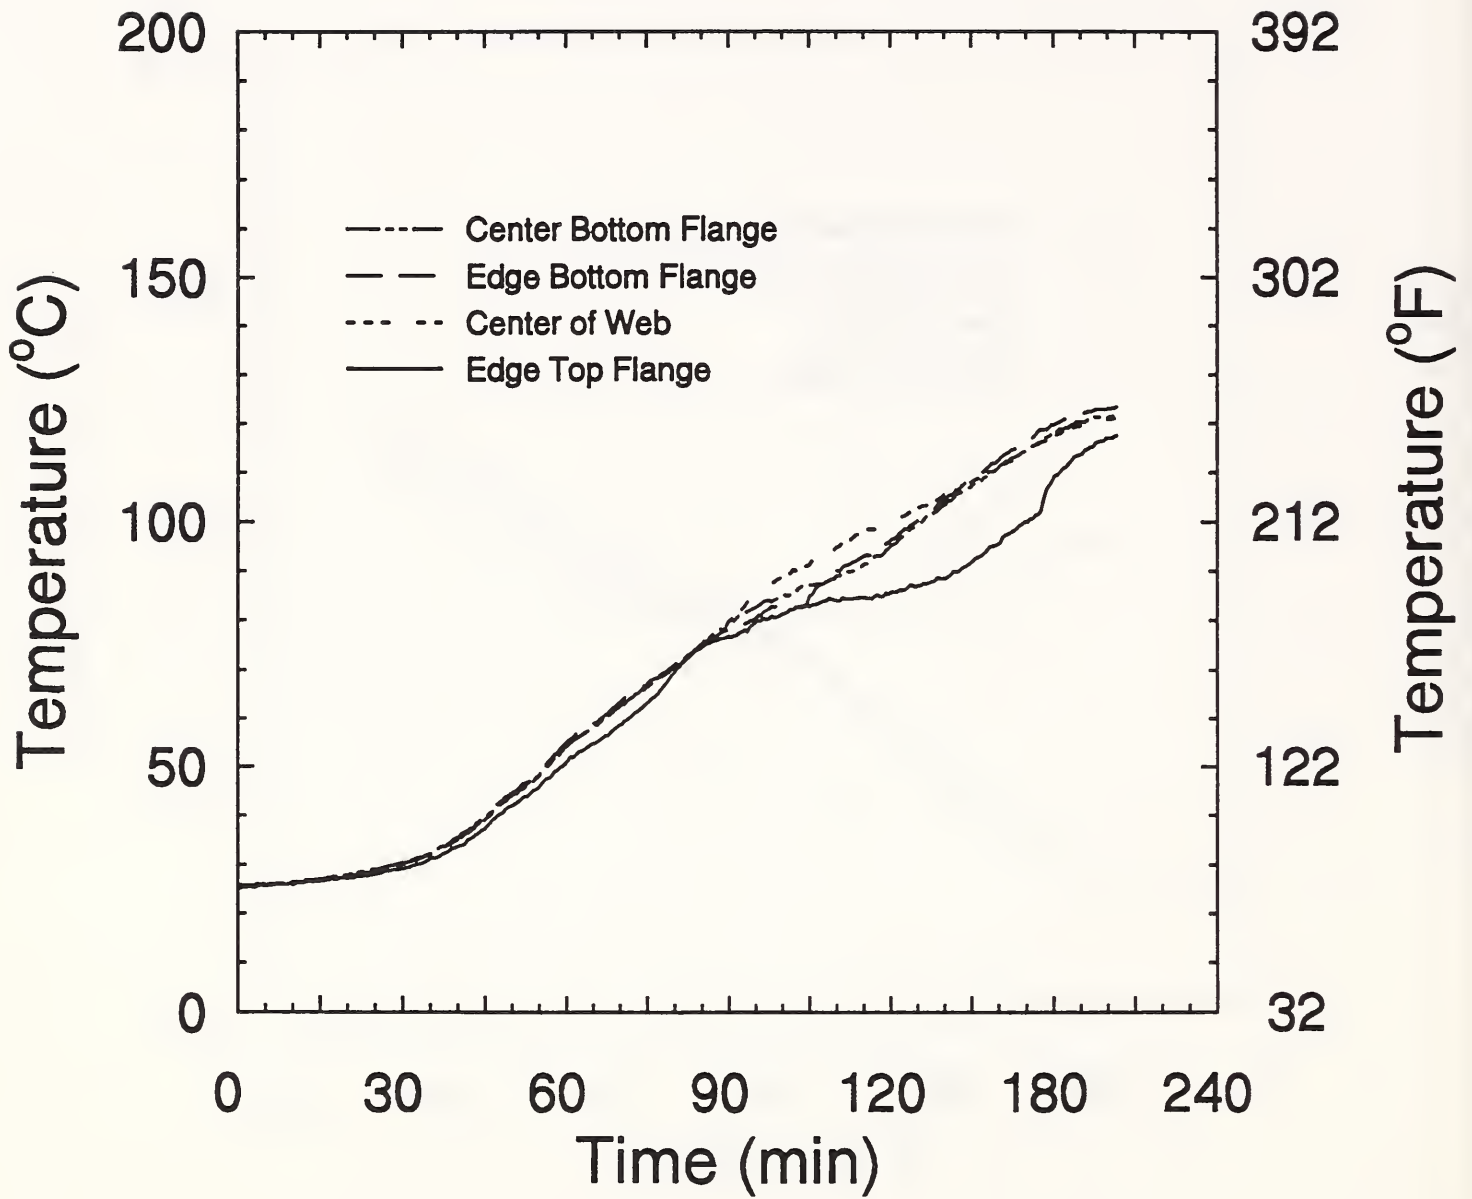
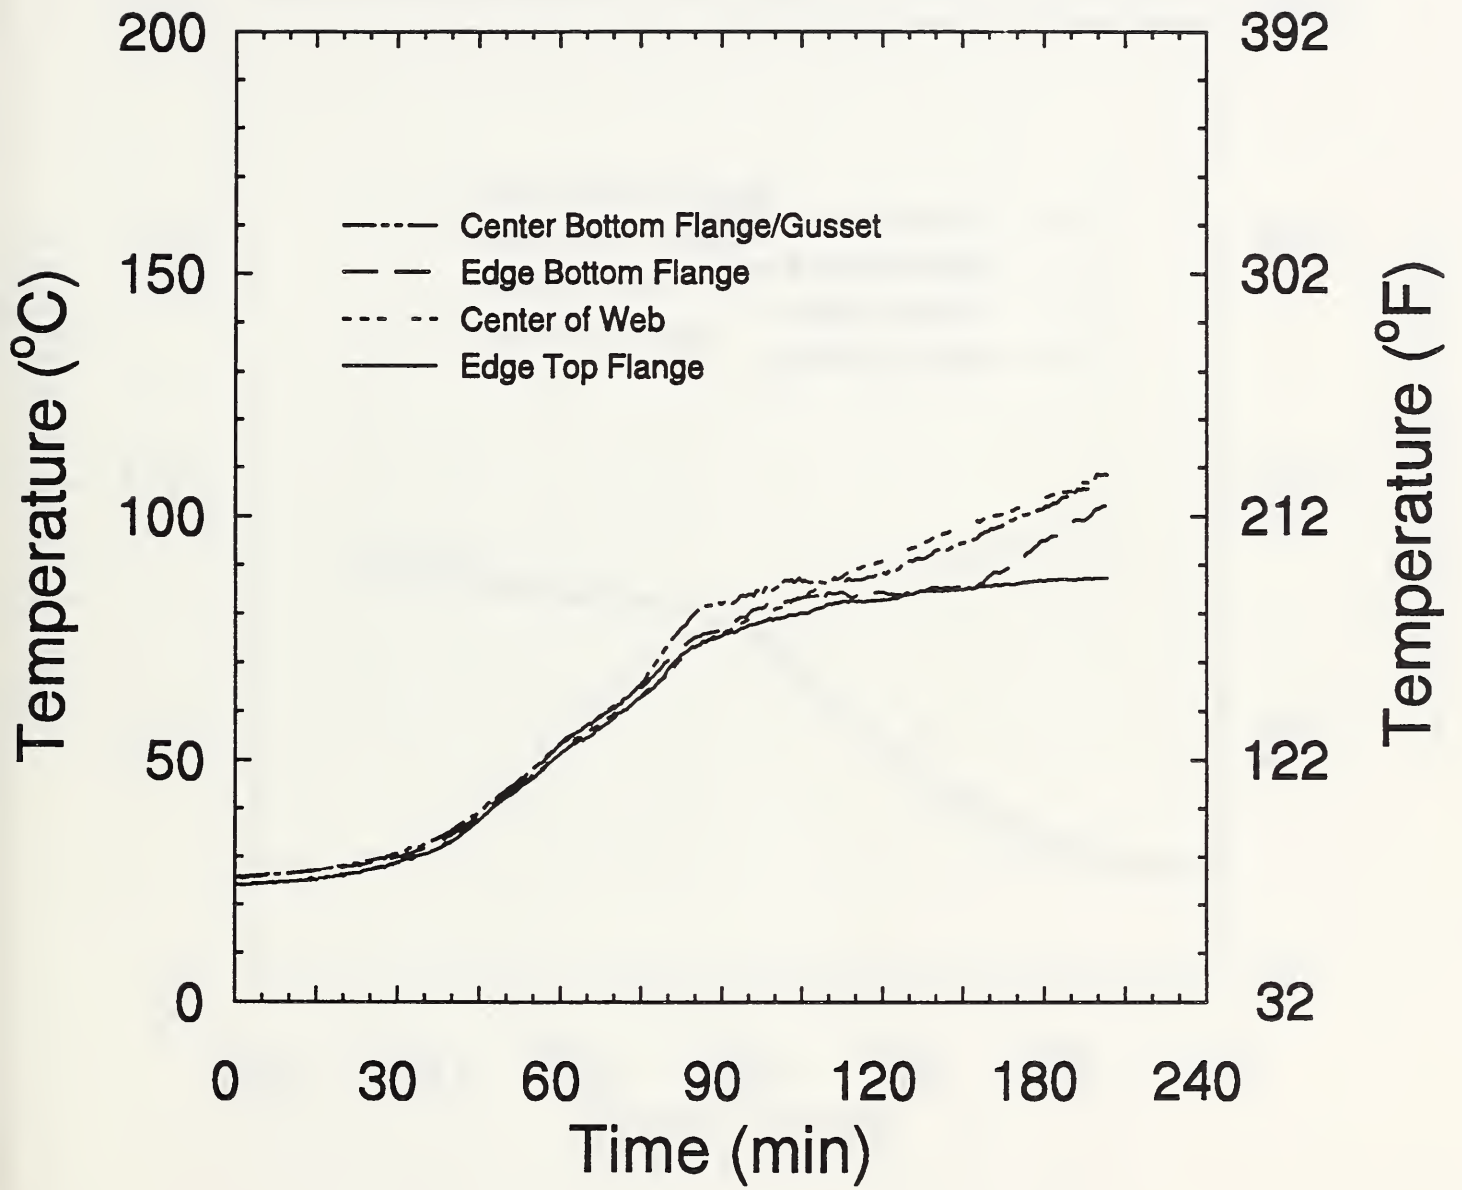
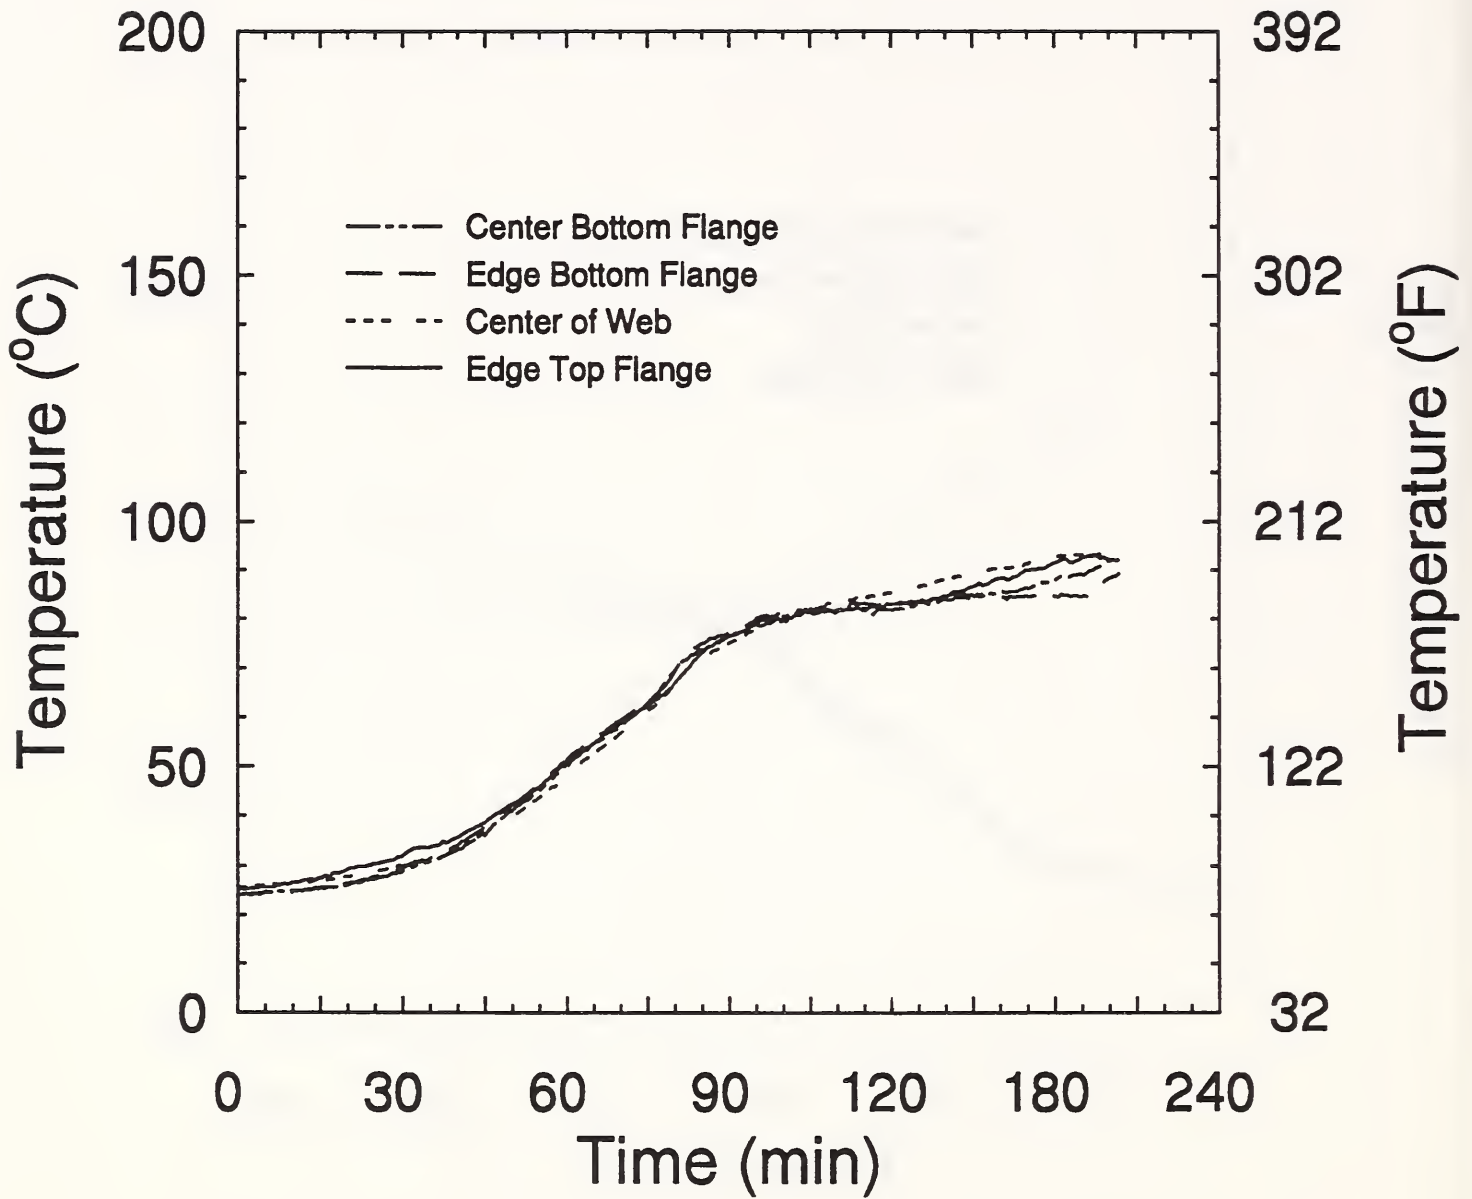
Figures 18-22 give temperature data plots for the W18x35 beam located on the east side of the test assembly. The temperatures show that the beam was protected by the walk-on deck. All temperatures on the east beam remained less than 100 °C (212 °F) over an elapsed time of 1 hour 50 minutes. At about 2 hours into the test, temperatures exceeded 100 °C (212 °F) on the beam at the center span position. For a two hour fire endurance rating, these temperatures are more than 590 °C (1094 °F) below the single-point failure temperature, 704 °C (1300 °F).
