Fire Performance of an Interstitial Space Construction System

J. R. Lawson, E. Braun, L. DeLauter and G. Roadarmel

NISTIR 5560

February 1995
Building and Fire Research Laboratory
National Institute of Standards and Technology
Gaithersburg, MD 20899

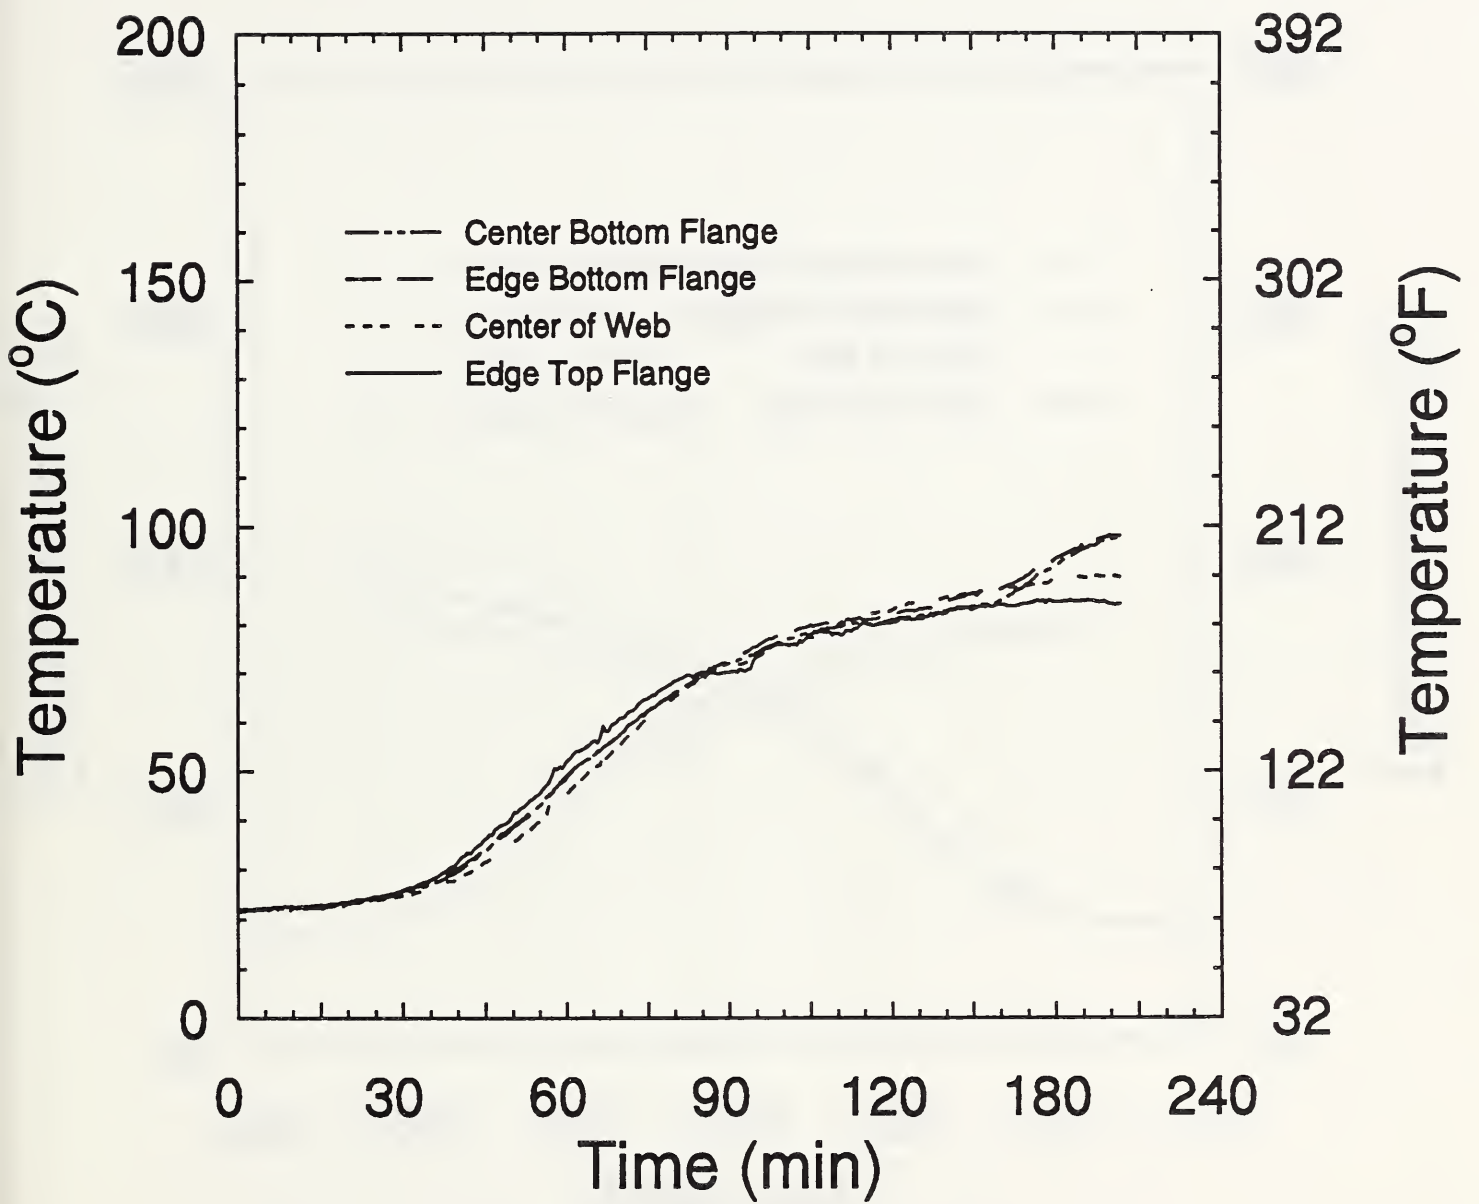
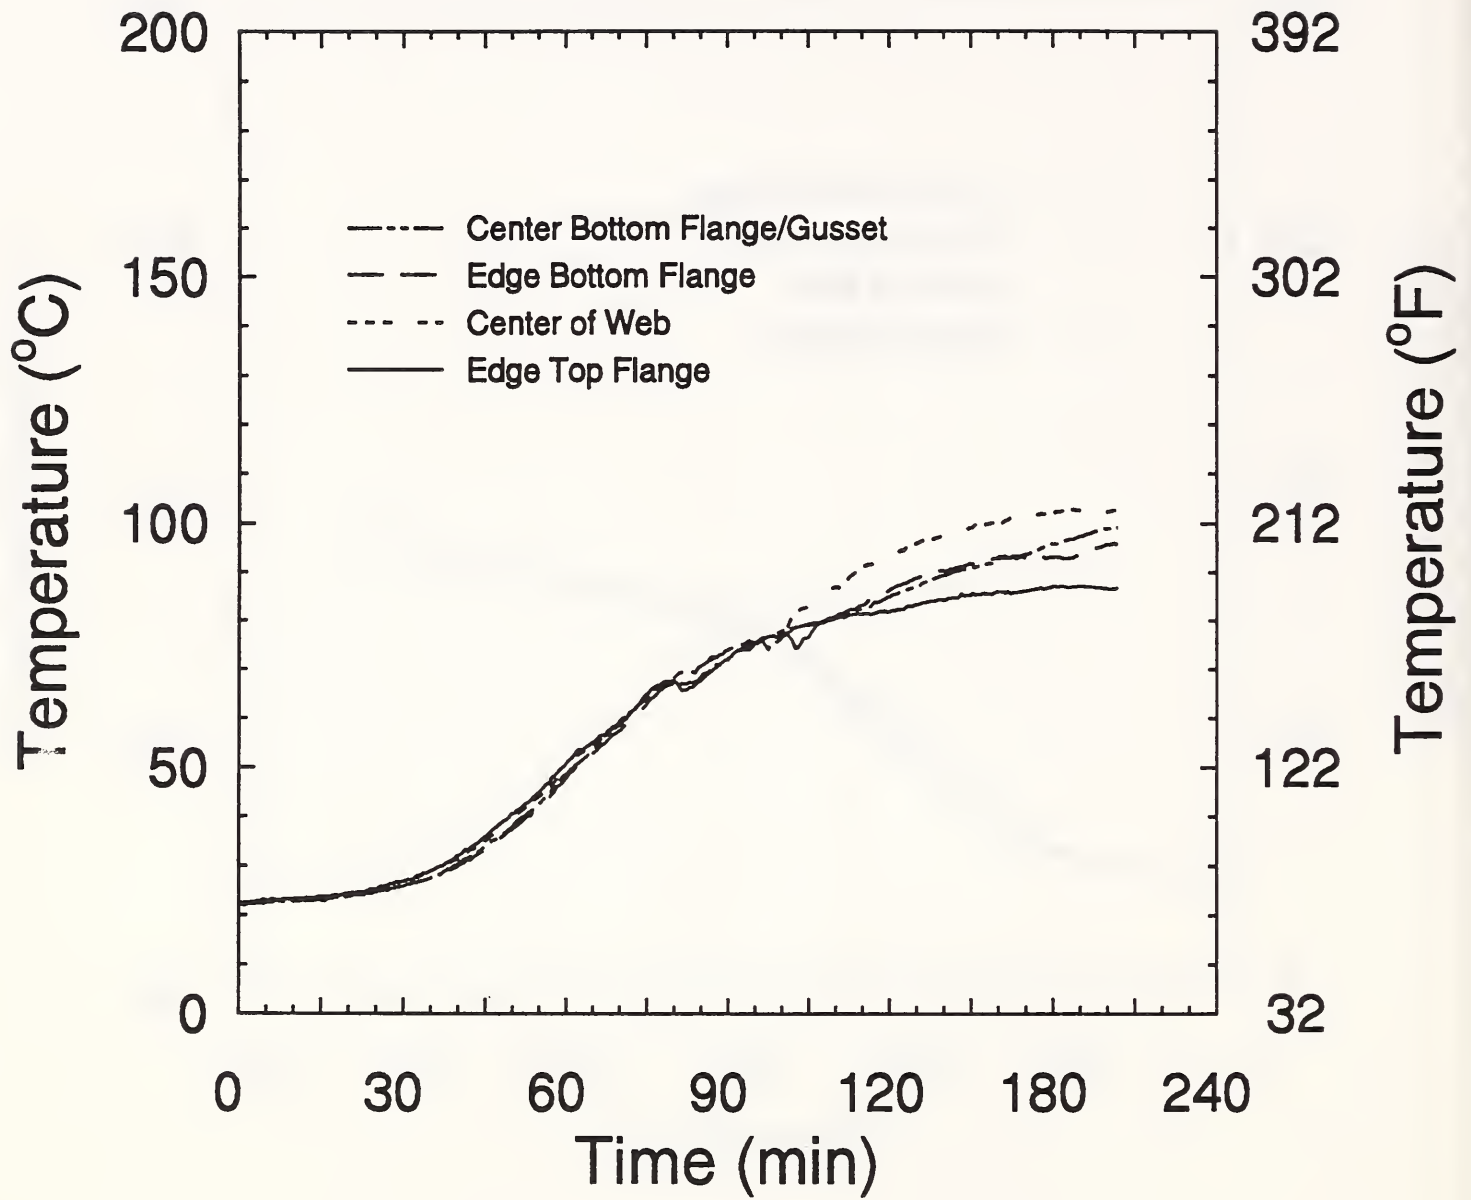
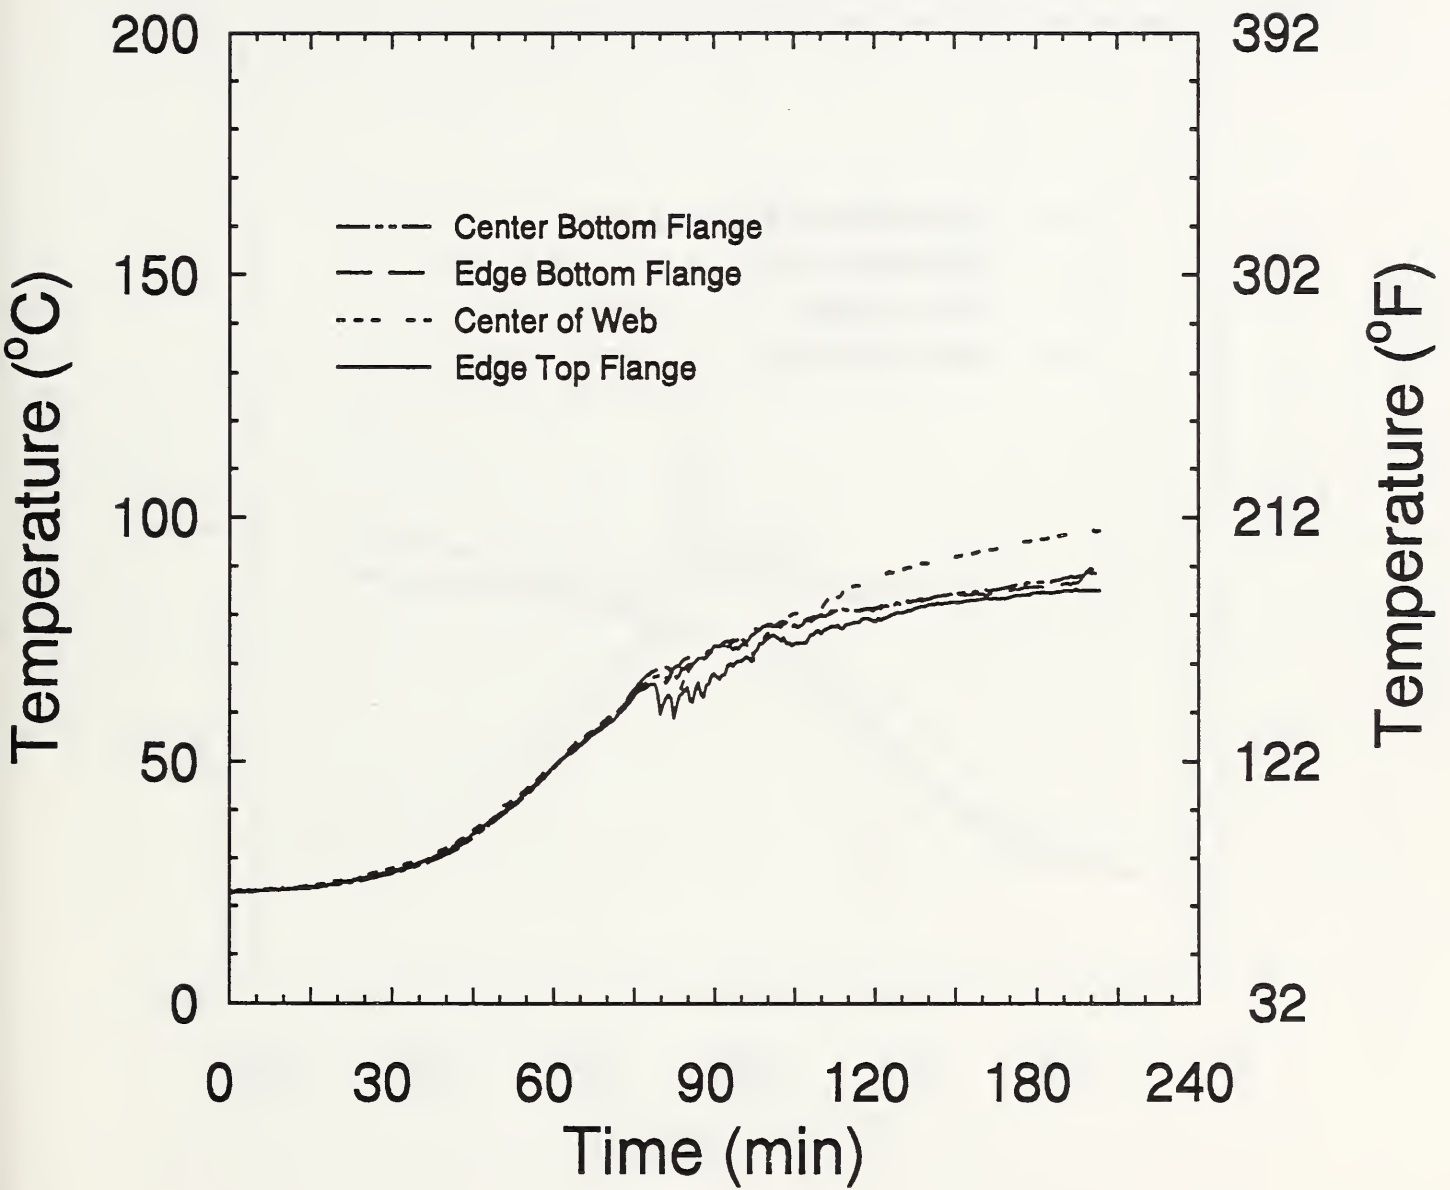
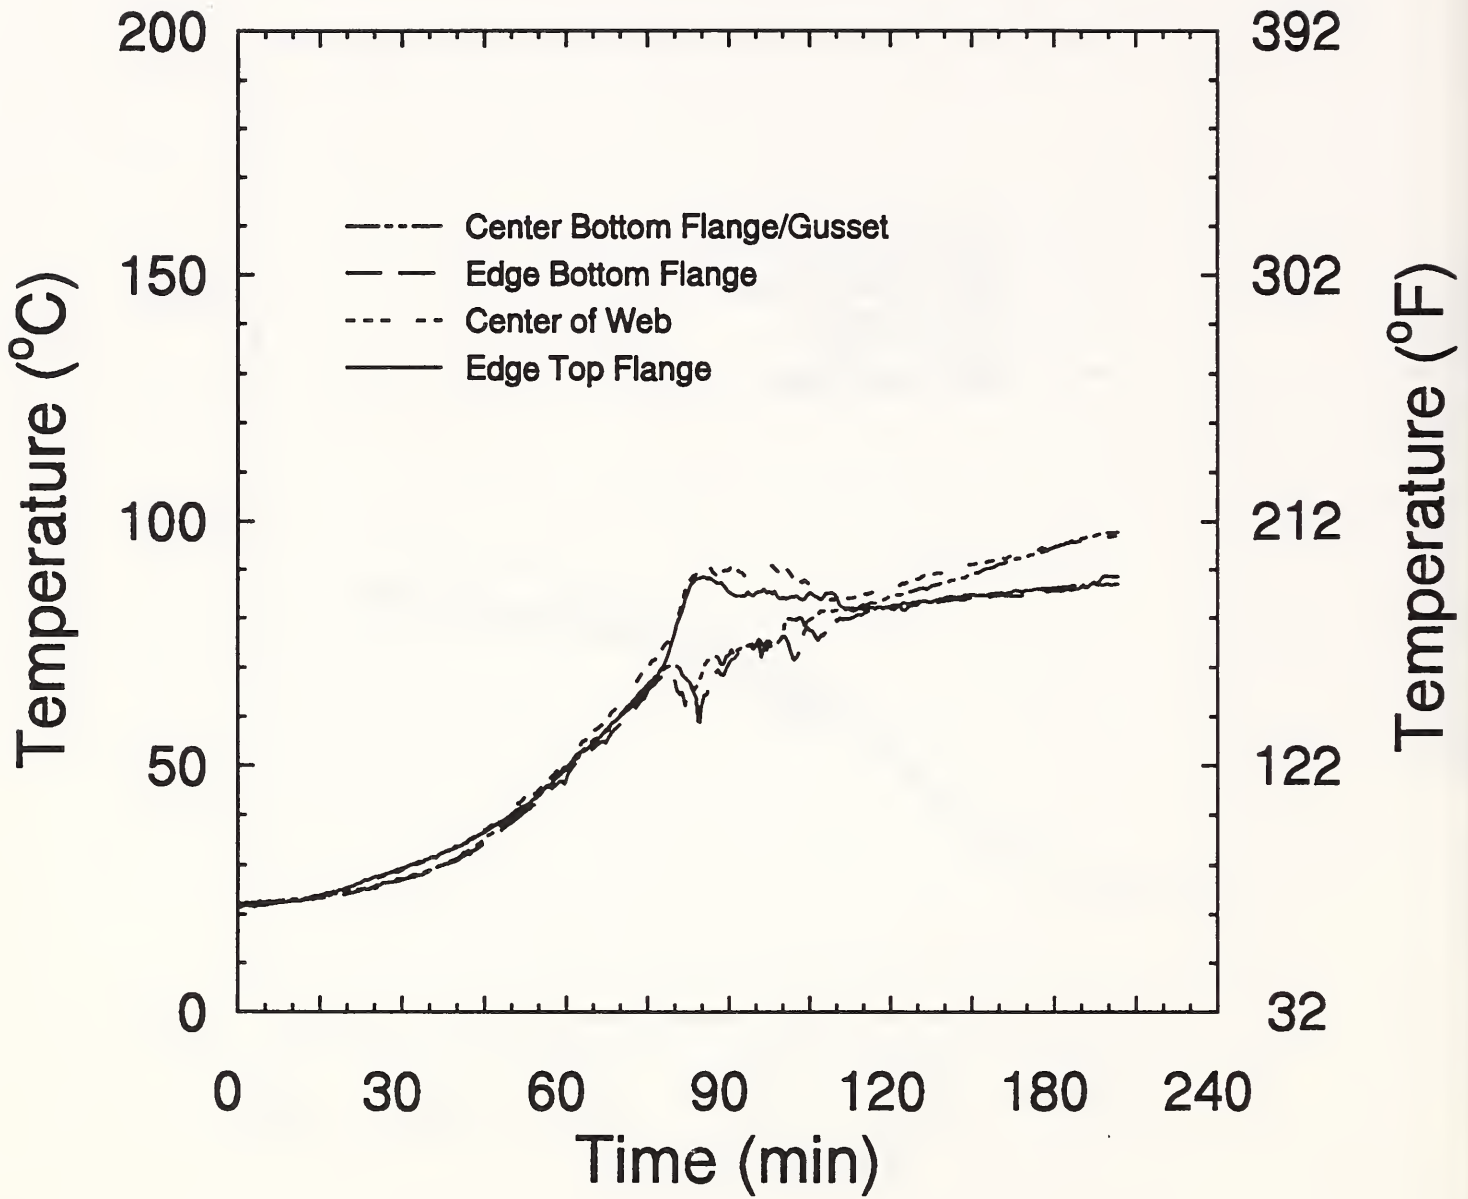
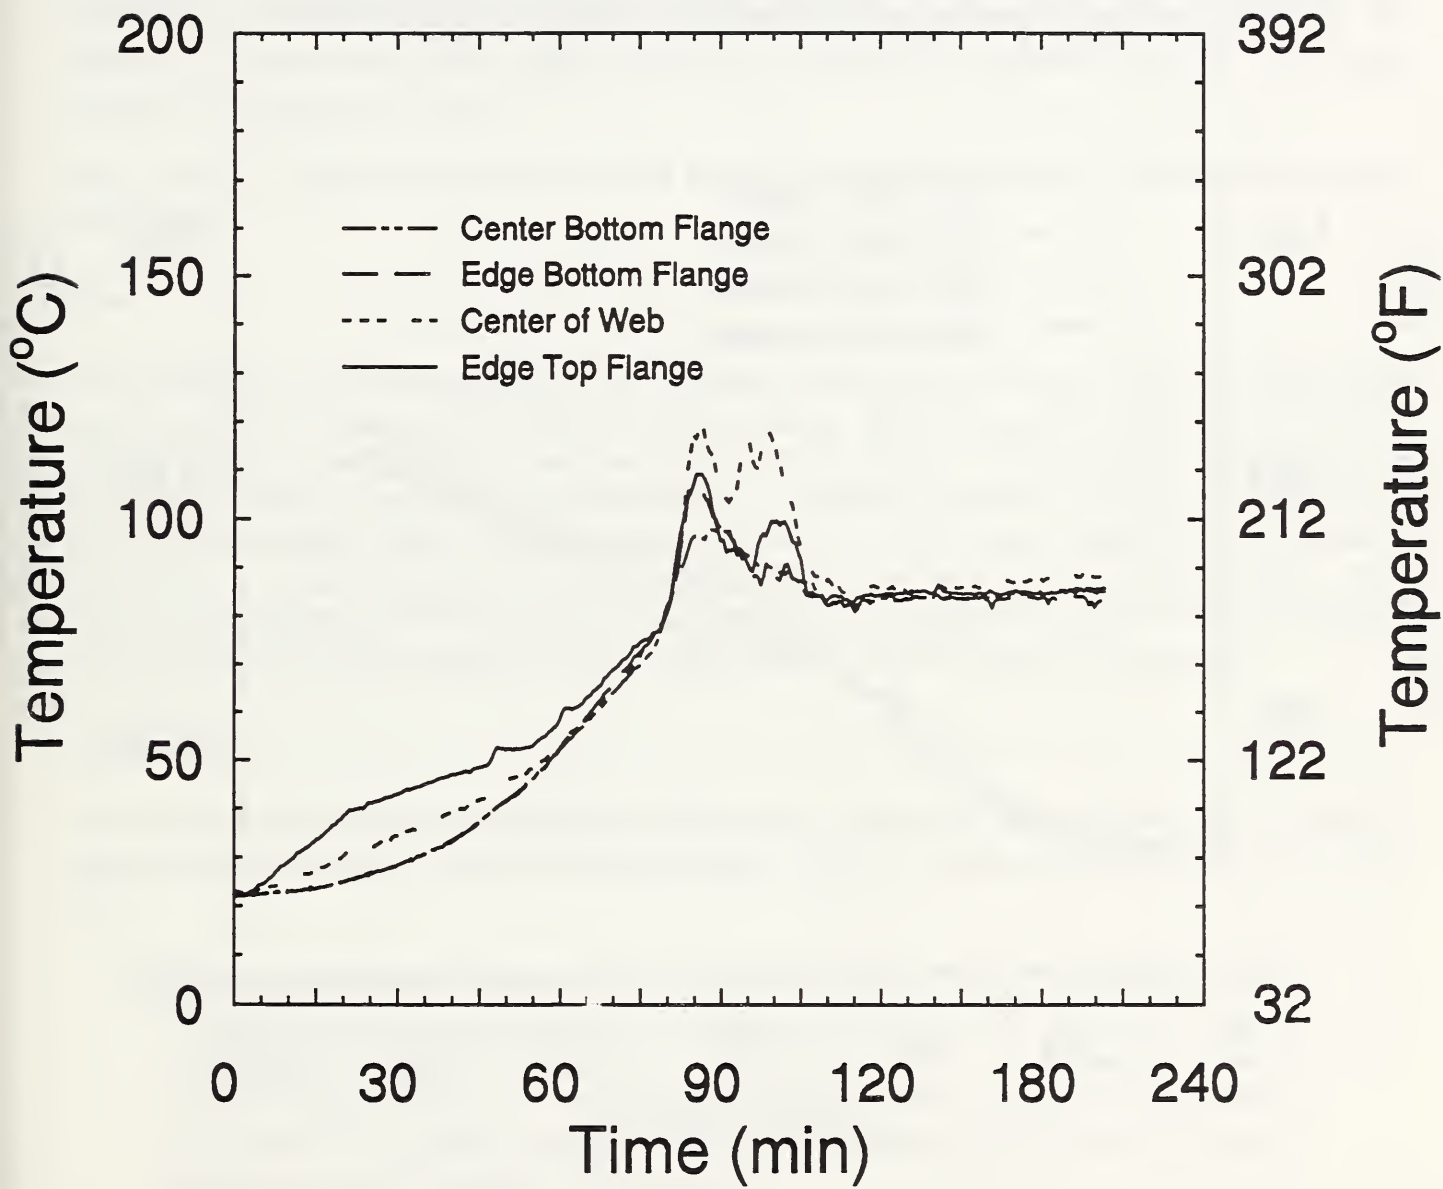
Figures 23-27 provide temperature measurements for the W18x35 beam located on the west side of the test assembly. Temperatures on these beams were generally slightly less than those on the east beam. It is also noted that temperatures showed more fluctuation for the measurement points at the beam's center, south west hanger and south end. These temperature variations coincide with that seen with the south west hanger discussed in section 8.2.3.2. The maximum recorded temperature for this beam was 123 °C (253 °F). Again, this likely resulted from changing air flow conditions within the interstitial space as the walk-on deck and enclosing walls moved.

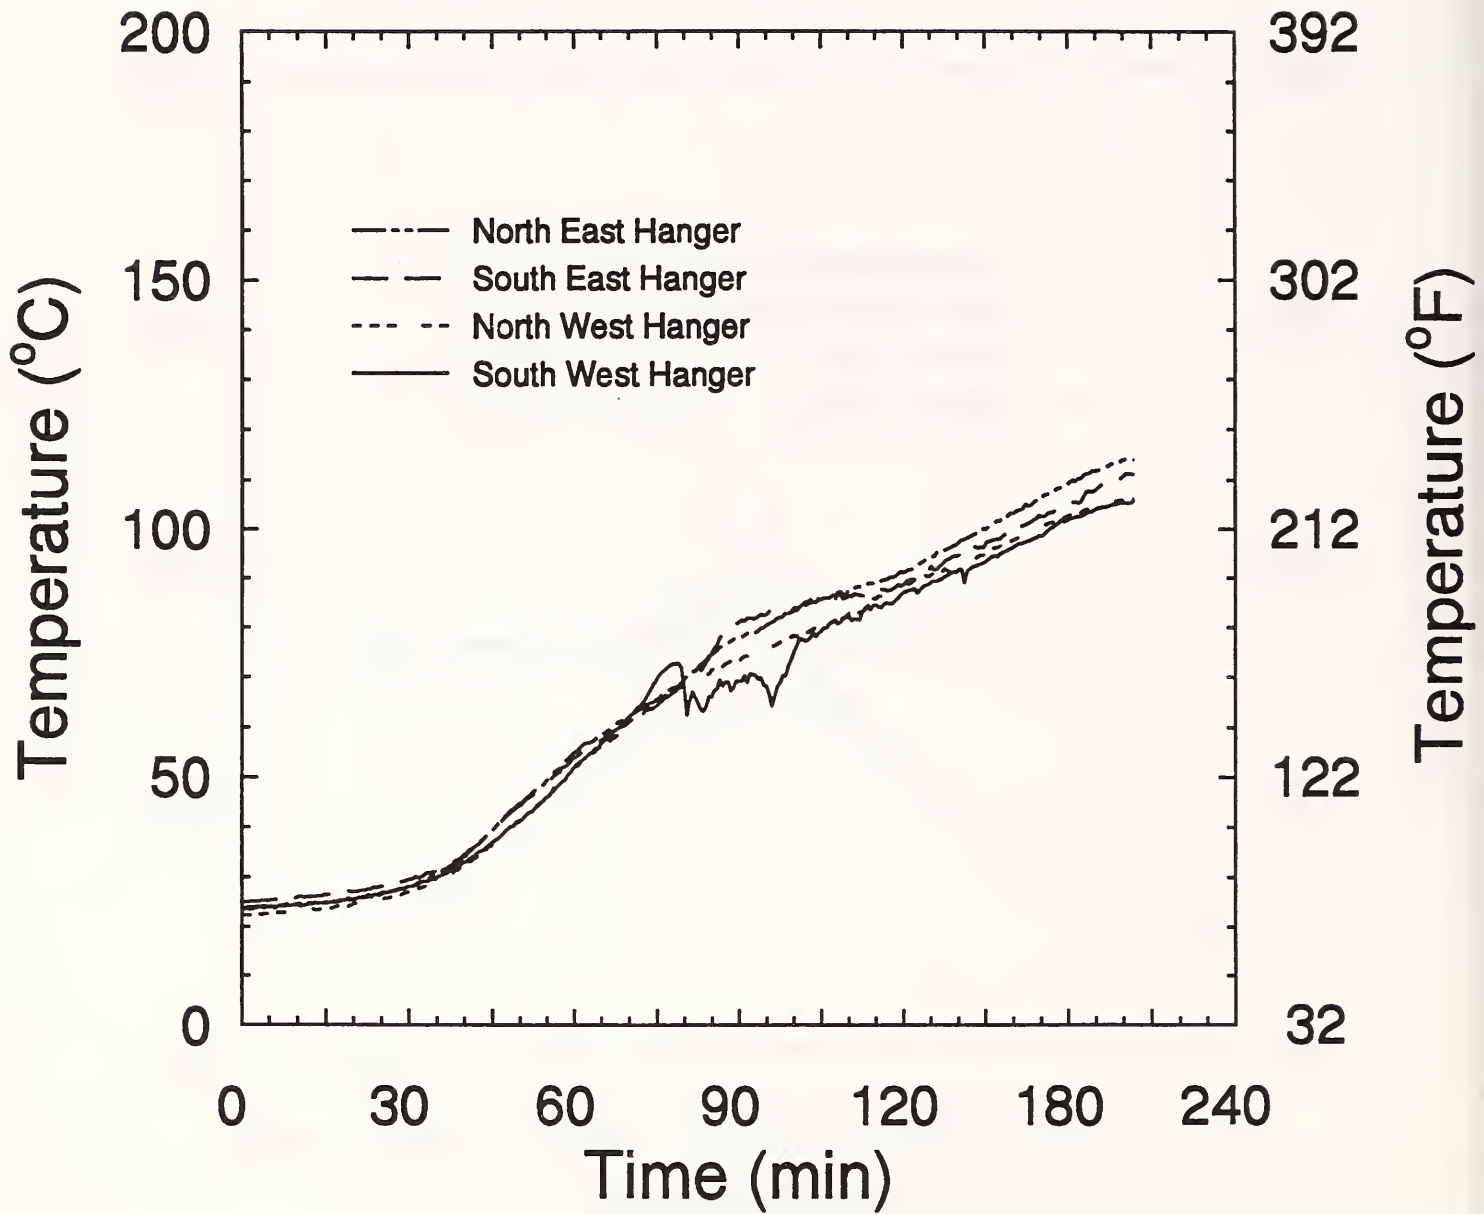
Figure 28 gives the temperature plots for the four mid-height thermocouples attached to the steel tube hangers which suspended the walk-on deck. As can be seen, the four hanger tubes easily passed the test with temperatures only slightly higher than 110 °C (230 °F). The single point failure temperature for steel is 704 °C (1300 °F). At about 75 minutes into the test, the south west quadrant hanger experienced some temperature variations. This may have resulted from changing air flow patterns within the interstitial space as the walk-on deck and enclosing walls began to move. After thirty minutes of variation, the hanger temperature stabilized and continued in a more uniform fashion for the remainder of the test.

Figure 28. Mid-height temperatures on deck hanger tubes

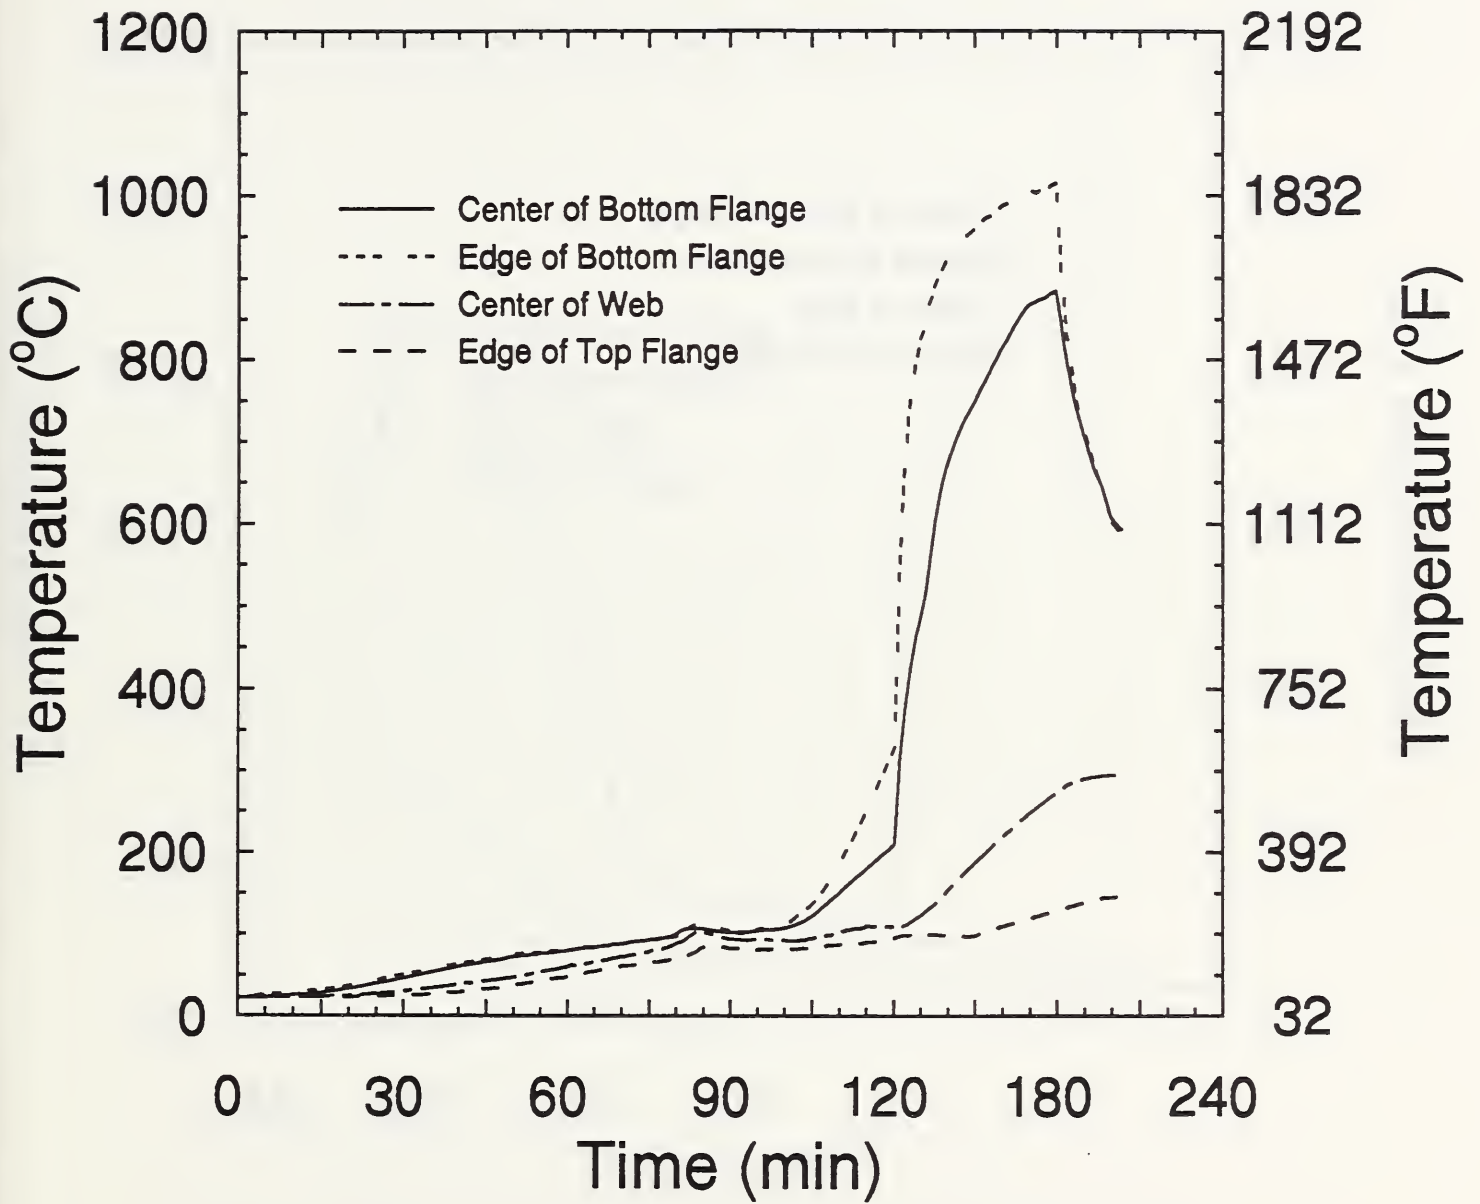
used with this and the earlier Veterans Administration (DVA) test assemblies, this temperature measurement has no influence on acceptance. With this interstitial space design, the walk-on deck, which is suspended from above, is successfully protecting the larger steel beams supporting the upper functional floor. Therefore, the high purlin temperature did not result in a failure of the system since the primary objective is protection of the steel within the interstitial space and the functional floor above. A second thermocouple also reached this critical temperature shortly after 2 hours 10 minutes into the test. Critical purlin temperatures were also reached at the north east quadrant location just after two hours into the test, as shown in figure B7.

Figure B7. Temperatures on east purlin, north east quadrant location

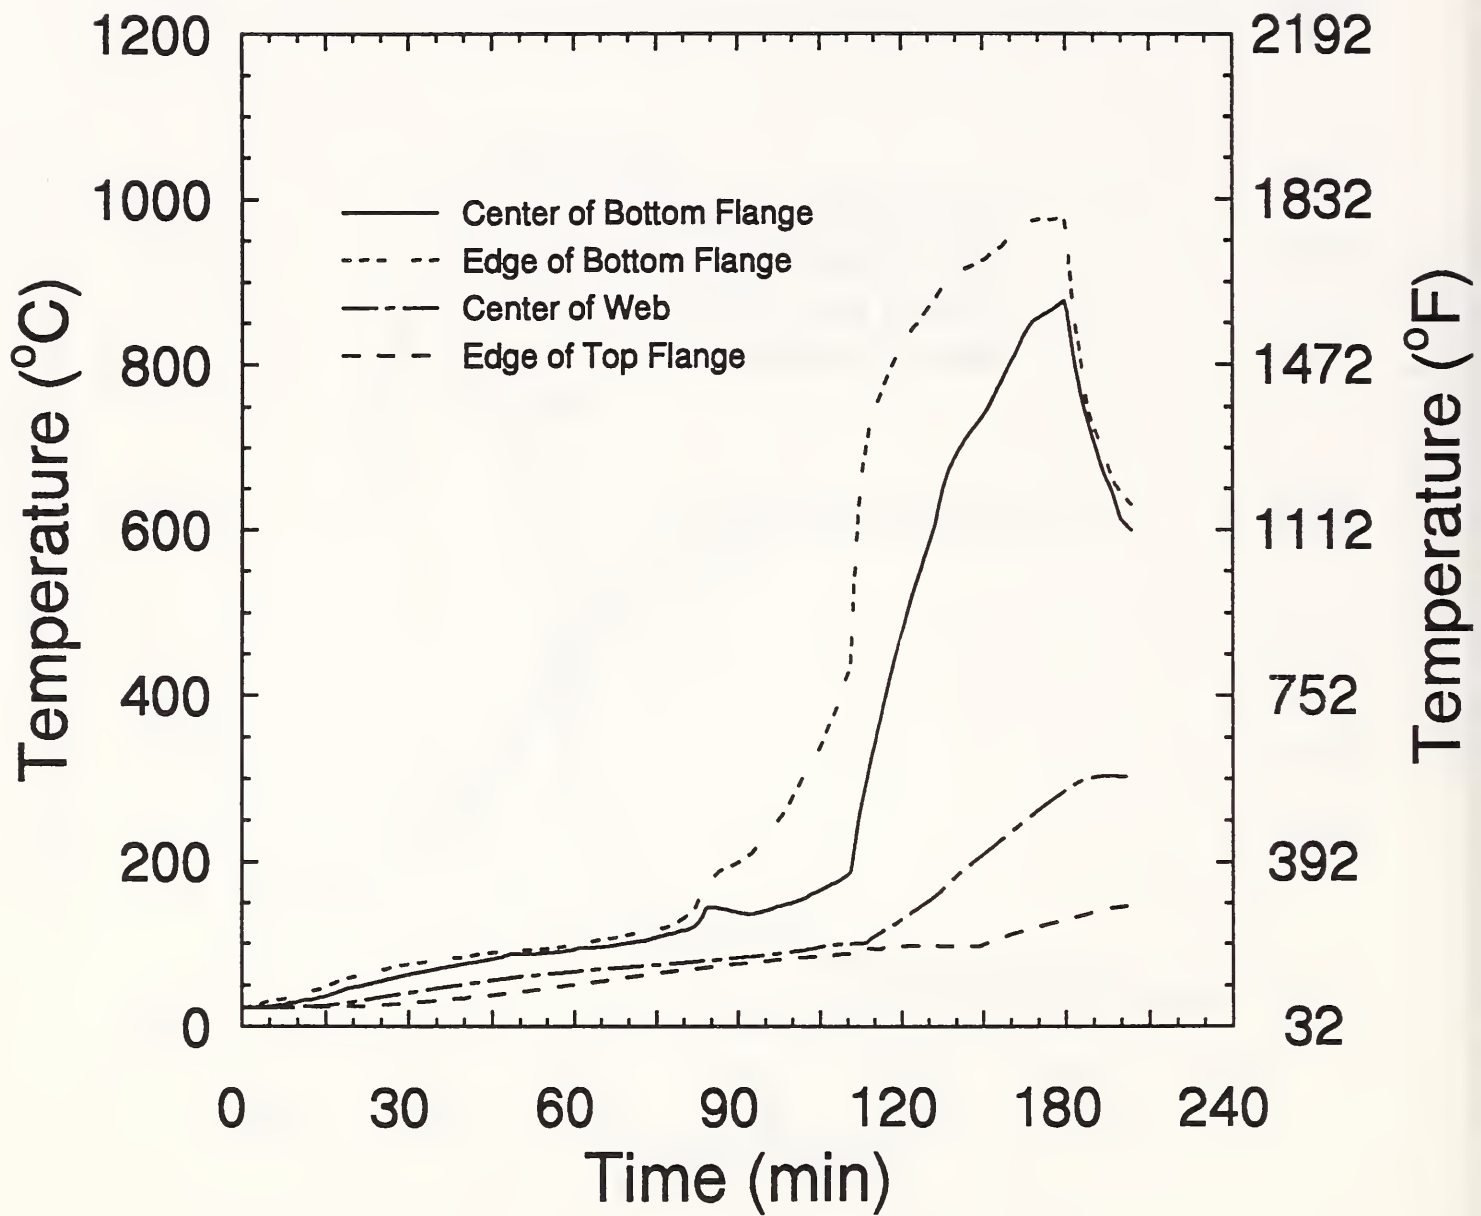
Purlin temperatures are shown in figures B7, B8, B9 and B10. Of these measurements, the most significant is related to a two hour rating for the fire proofing. The purlin performance is shown in figure B8. A rapid temperature rise is noted in the south east quadrant starting at 90 minutes into the test. This continued until a single point temperature measurement of 704 °C (1300 °F) was recorded at 1 hours 54 minutes into the test. Under standard NFPA 251 test criteria for a closely coupled flooring assembly, this would have been a failure. Under the acceptance criteria

Figure B8. Temperatures on east purlin, south east quadrant location

steel members approached a failure condition. Fire-proofing with a two hour rating is required for protecting the W6x9 steel purlins. Performance of this construction system may be significantly different if the purlin fire-proofing does not maintain its integrity. The firesafing methods used to protect duct penetrations met the requirements for a two hour system. This design prevented the passage of hot gases into the interstitial space. The air conditioning ducts maintained their integrity throughout the complete test period. As with the Veteran's Administration tests in 1983, the ducts were sealed on the unexposed end which did not allow hot gases to flow through. The steel decking used to support the lightweight concrete walk-on deck showed significant degradation early in the test. Decking joints opened across the long span between the W6x9 purlins.

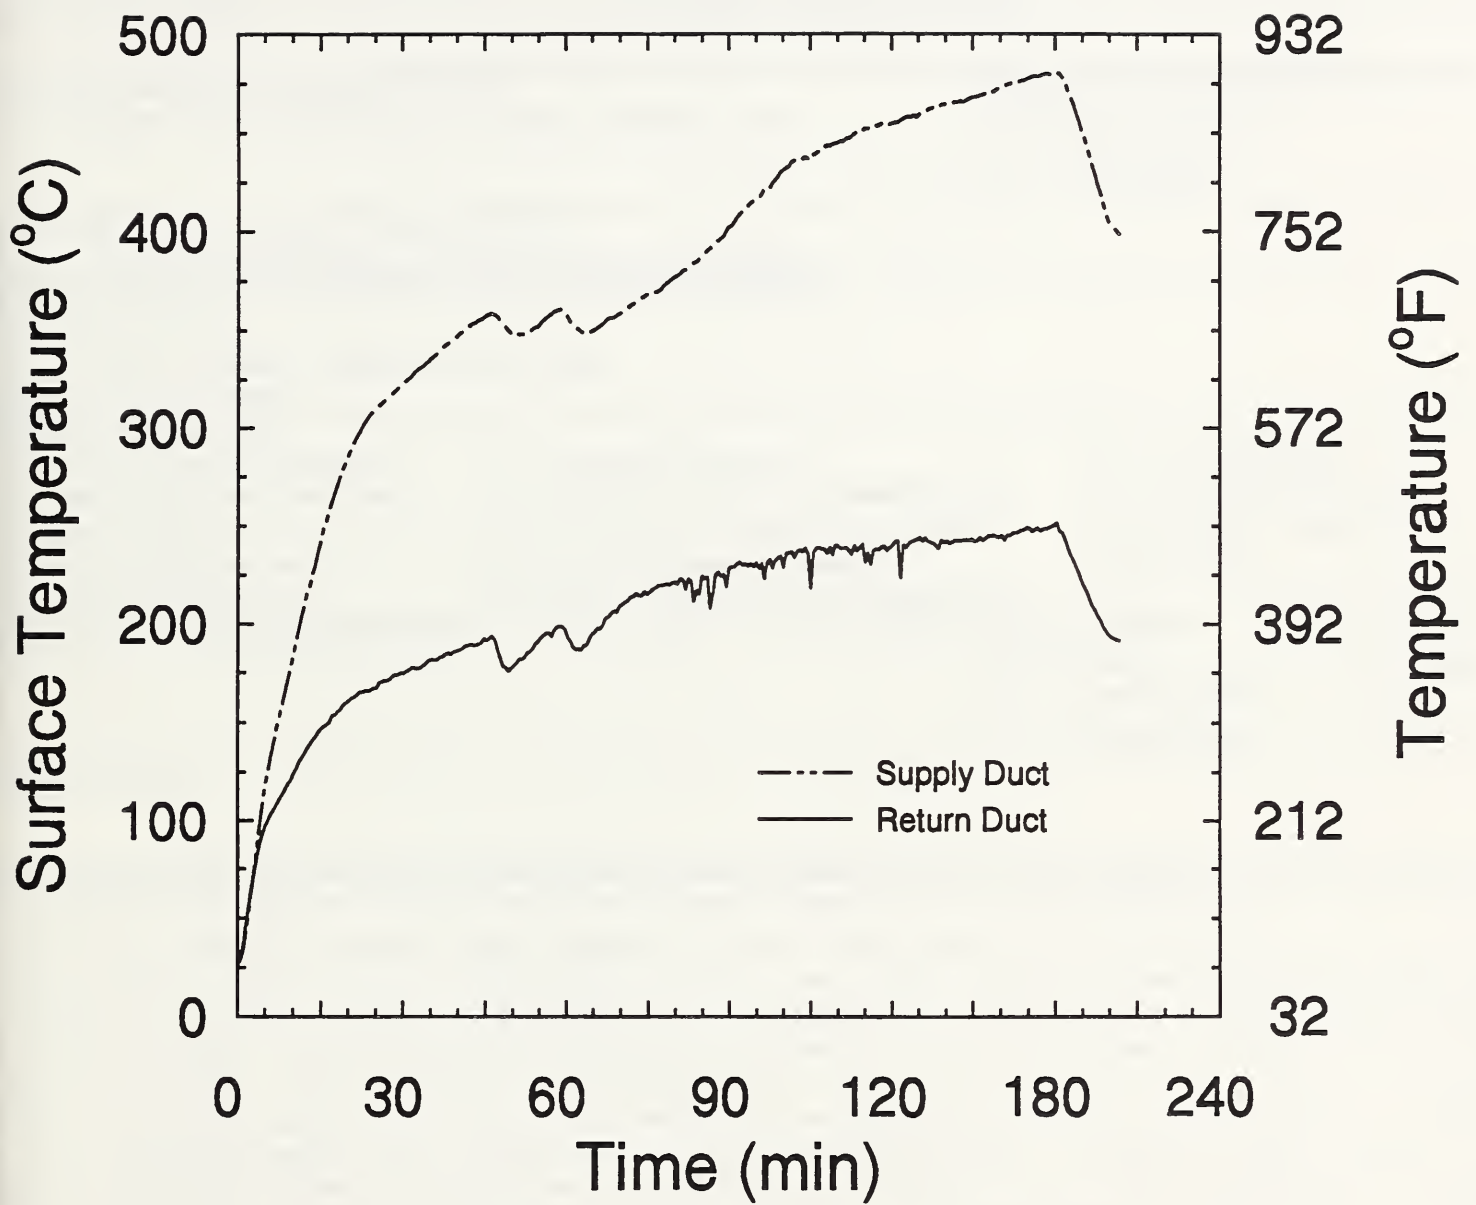
The two air conditioning ducts maintained their integrity throughout the test. As expected, the insulated supply duct exhibited higher temperatures than the uninsulated return duct, as shown in figure B11. By the end of the test, the insulated duct's surface temperature, as measured in the interstitial space, exceeded 480 °C (896 °F). The uninsulated duct had a maximum temperature of 252 °C (486 °F). This lower temperature is attributed to the duct's greater heat loss rate.

Figure B11. Surface temperatures on simulated air conditioning ducts
