**Failure Analysis of Welded Steel Moment Frames
Damaged in the Northridge Earthquake**

NISTIR 5944

January 1997
Building and Fire Research Laboratory
National Institute of Standards and Technology
Gaithersburg, MD 20899

A study was performed to characterize the origin of fracture and material properties of welded steel moment frame (WSMF) connections damaged in the Northridge earthquake. Sixteen connection fractures were obtained from five different buildings in the Los Angeles area which suffered damage in the earthquake. These fractures represented a variety of the types of fractures observed in post-earthquake building inspections. The mechanical and physical properties of the connection members and weld metal were determined including composition, strength, and fracture toughness. A fractographic examination of the fracture surfaces was performed to locate and characterize the fracture origin and determine the fracture mechanism. A fracture analysis was performed using linear elastic fracture mechanics. The analysis indicated that in all cases fracture resulted from crack instability which developed within the weld metal at the weld root at an incomplete fusion flaw contigu

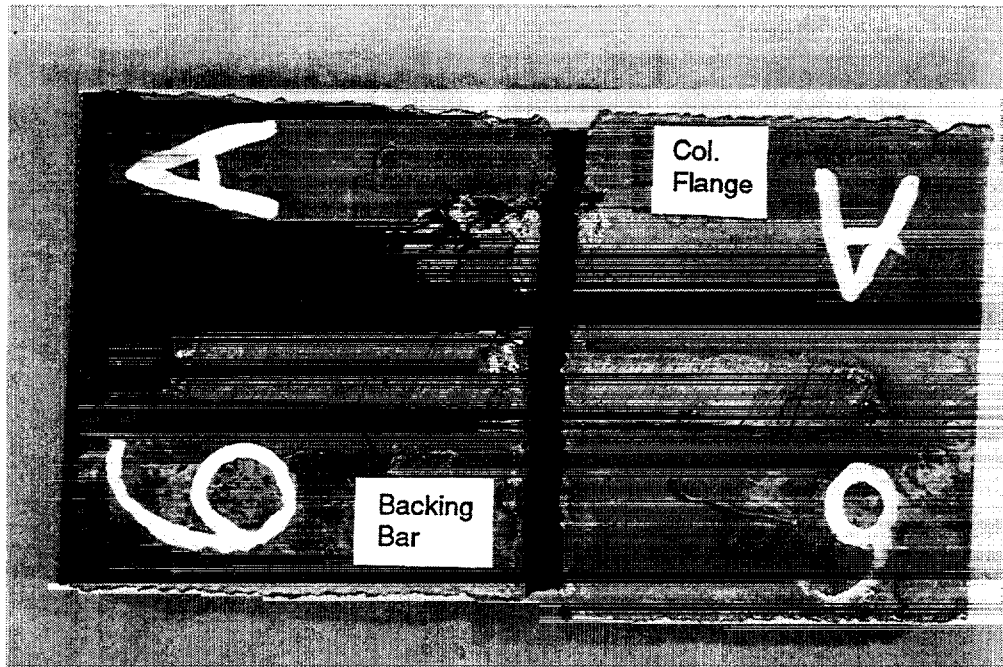
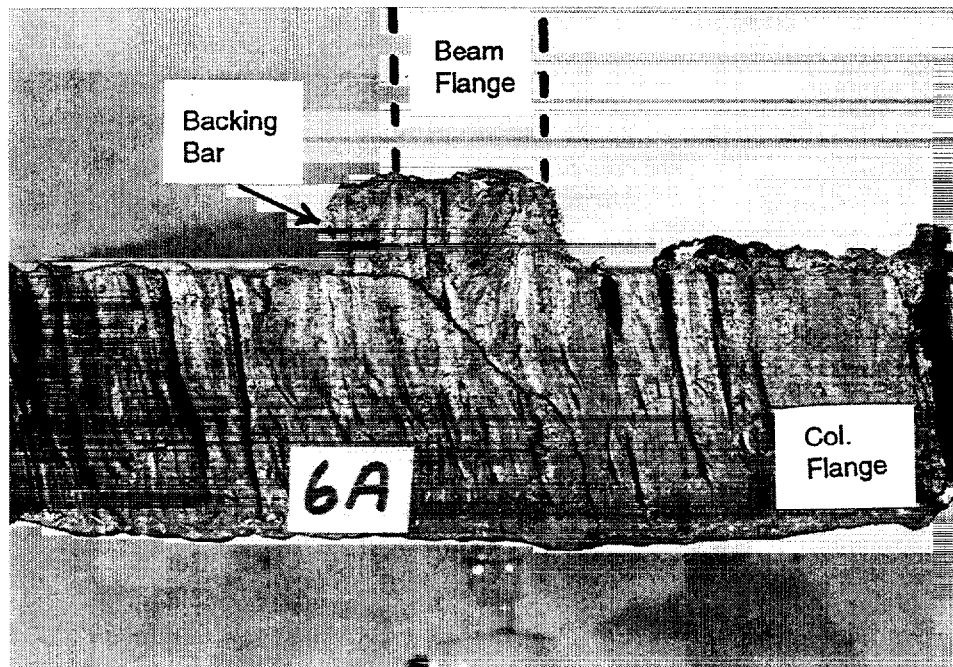
Figure 3 - Building Sample A6.
 Top: Column flange face with cut beam flange weld.
 Bottom: Edge view showing column flange fracture.

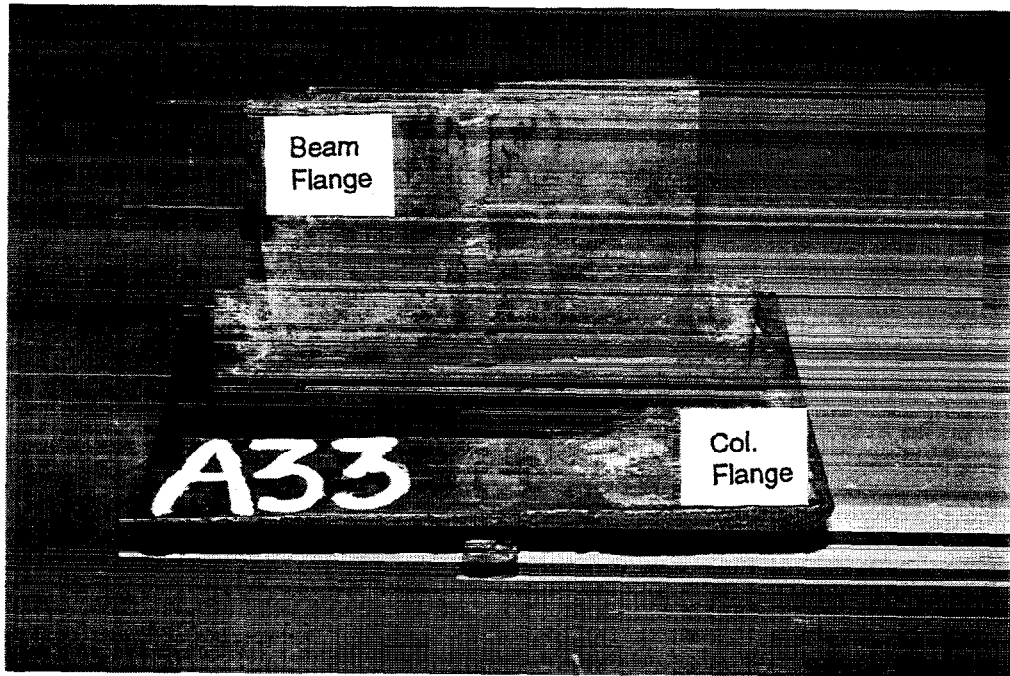
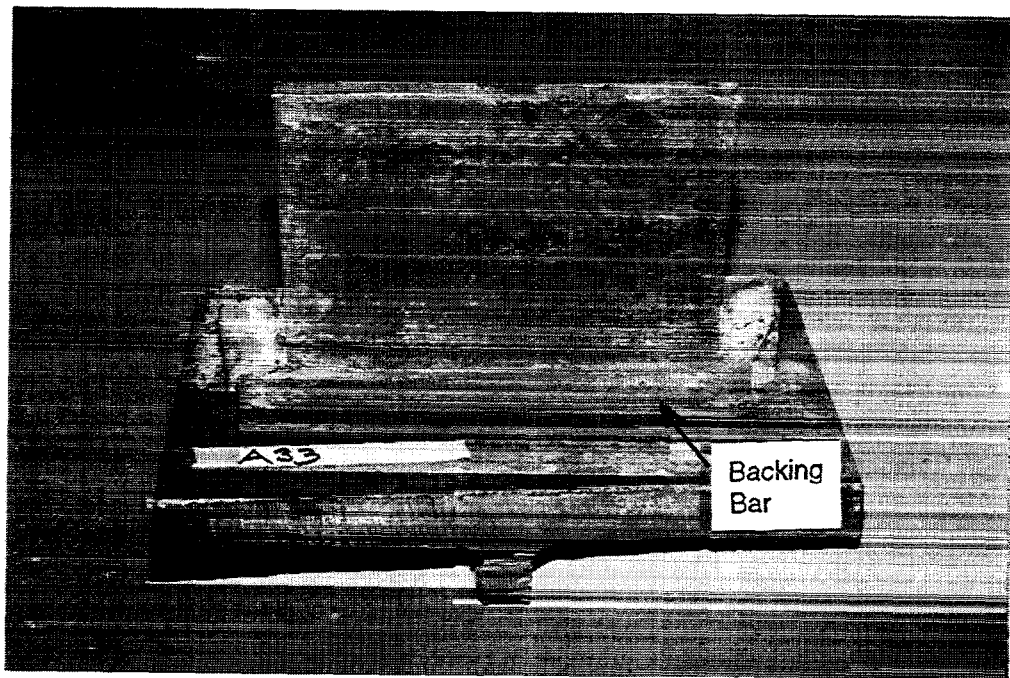
Figure 4 - Building Sample A33. No cracking is visible.

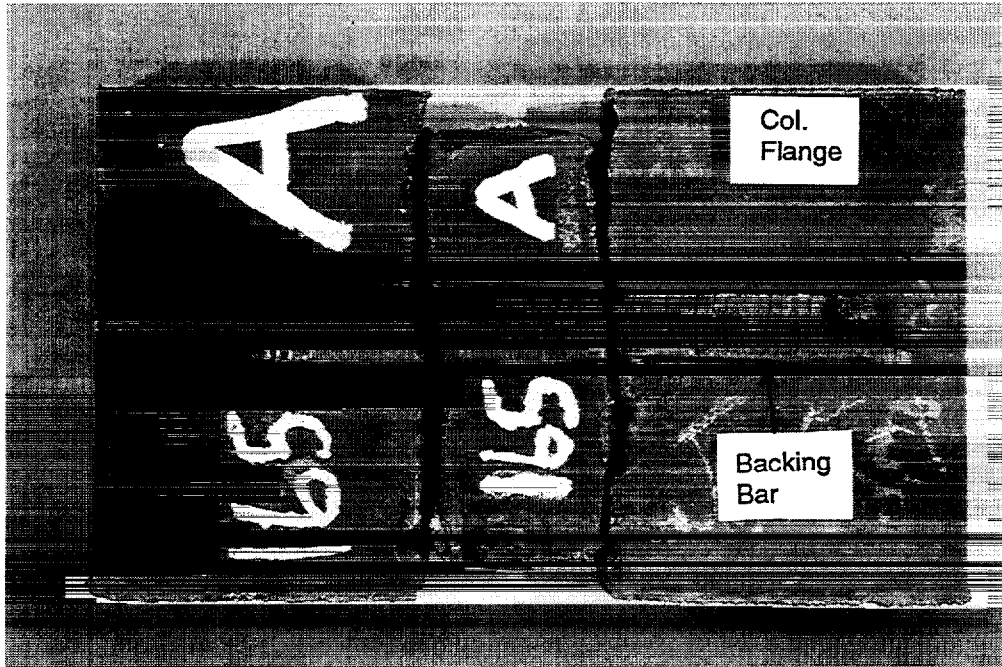
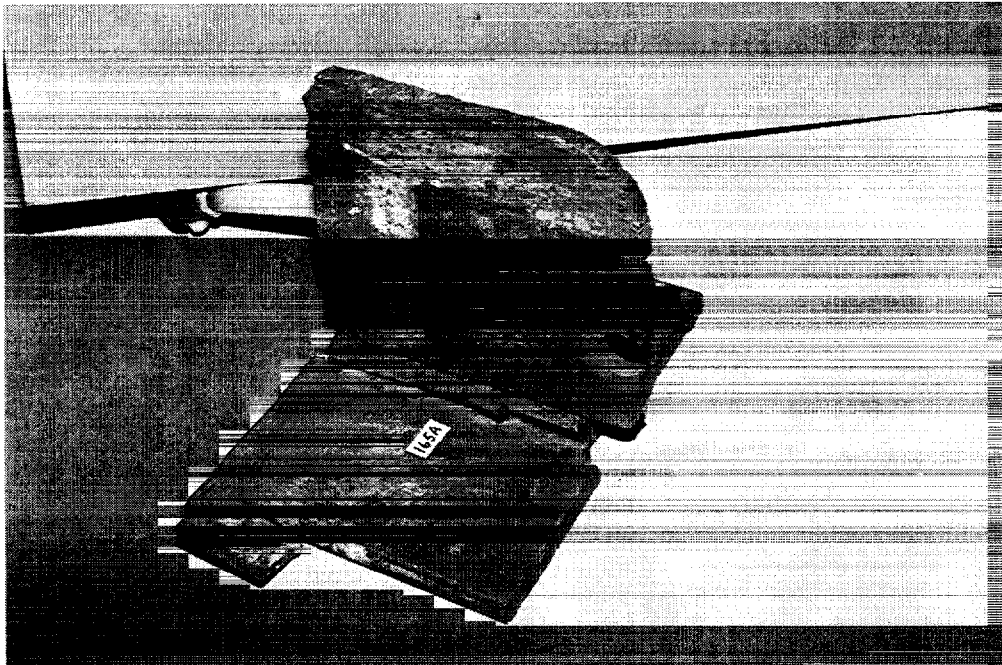
Figure 5 - Building Sample A165.
Top: Column flange face with cut beam flange weld.
Bottom: Beam bottom flange.

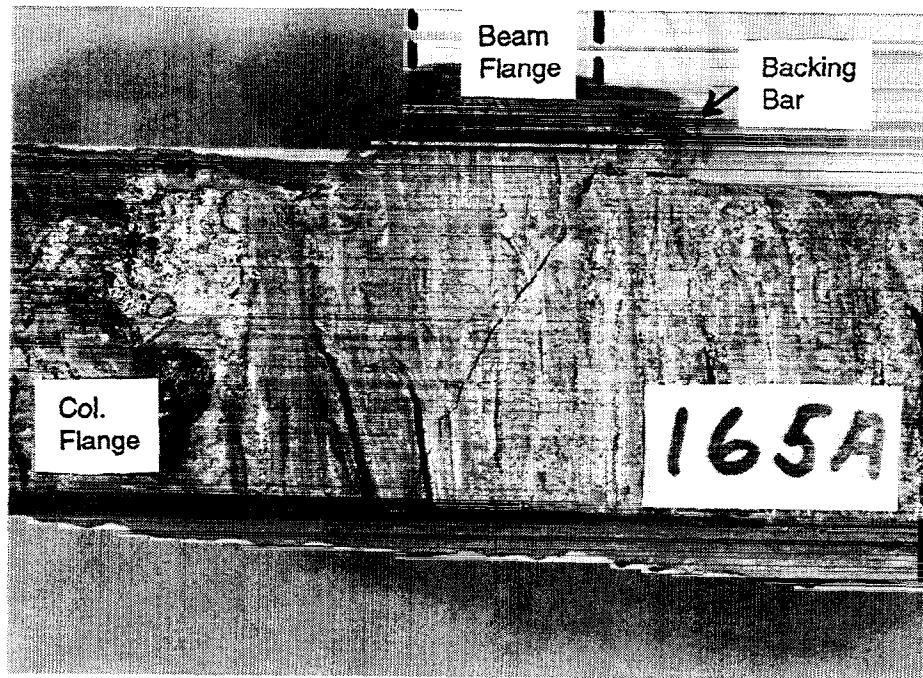
Figure 6 - Edge view of Sample A165 column flange showing fracture path.

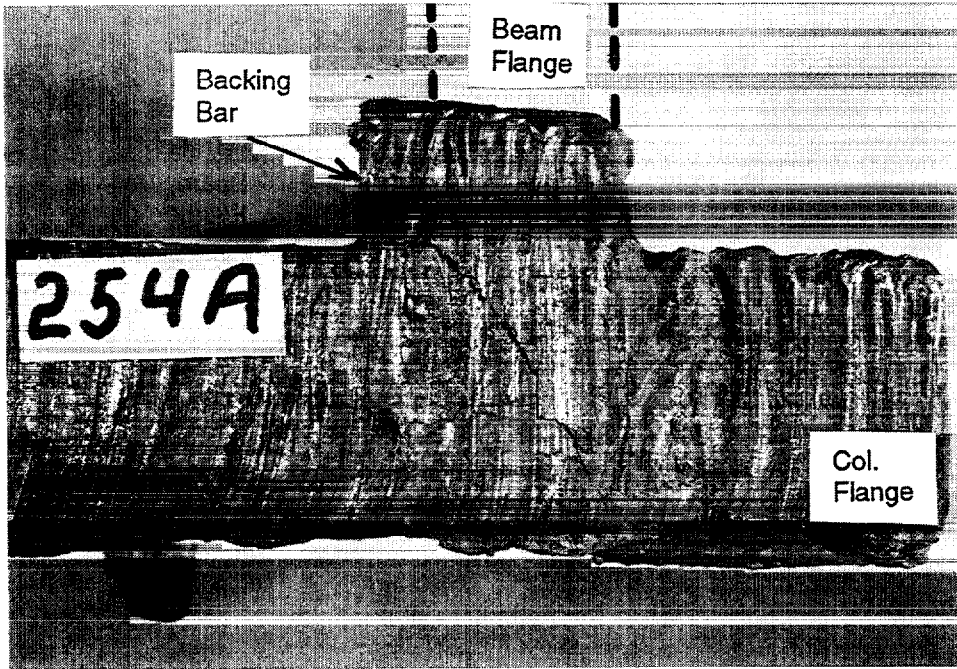
Figure 8 - Edge view of Sample A254 showing column flange fracture.

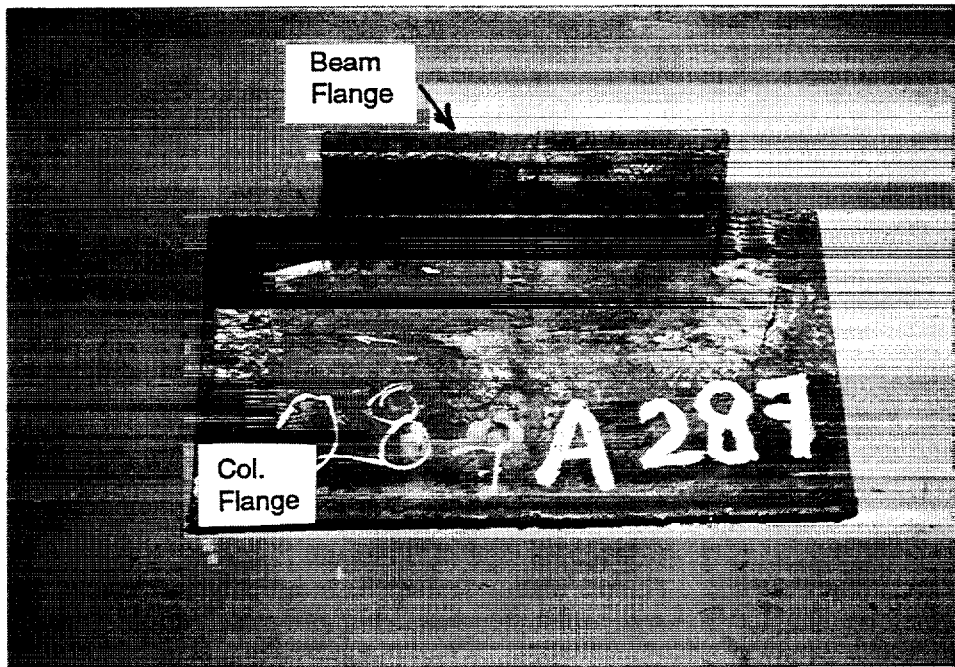
Figure 9 - Building Sample A287. No cracking is visible.

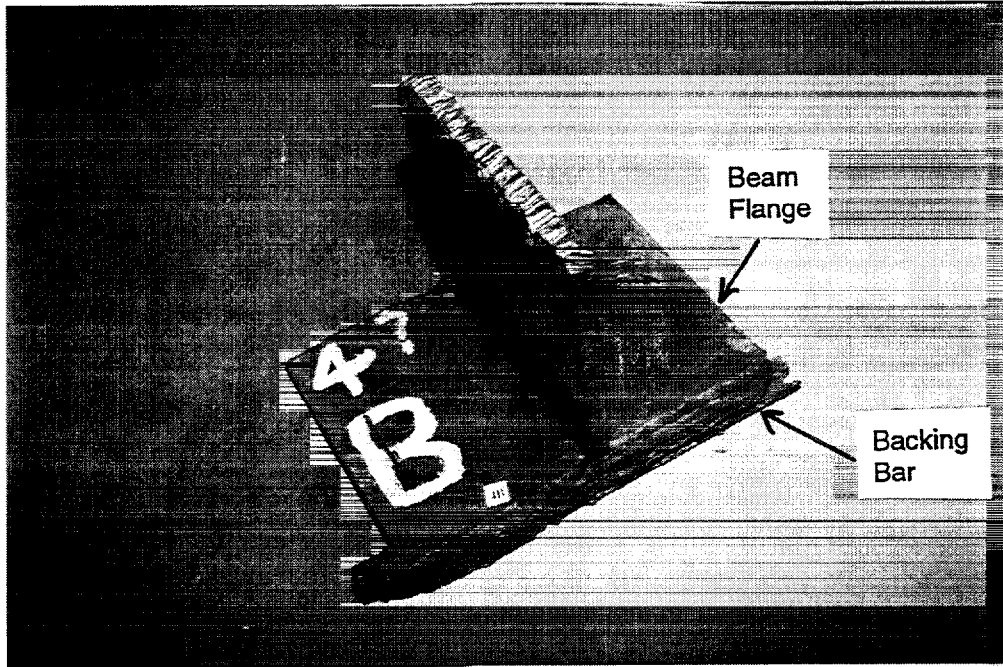
Figure 10 - Building Sample B4 showing beam bottom flange and fracture (Type W4).

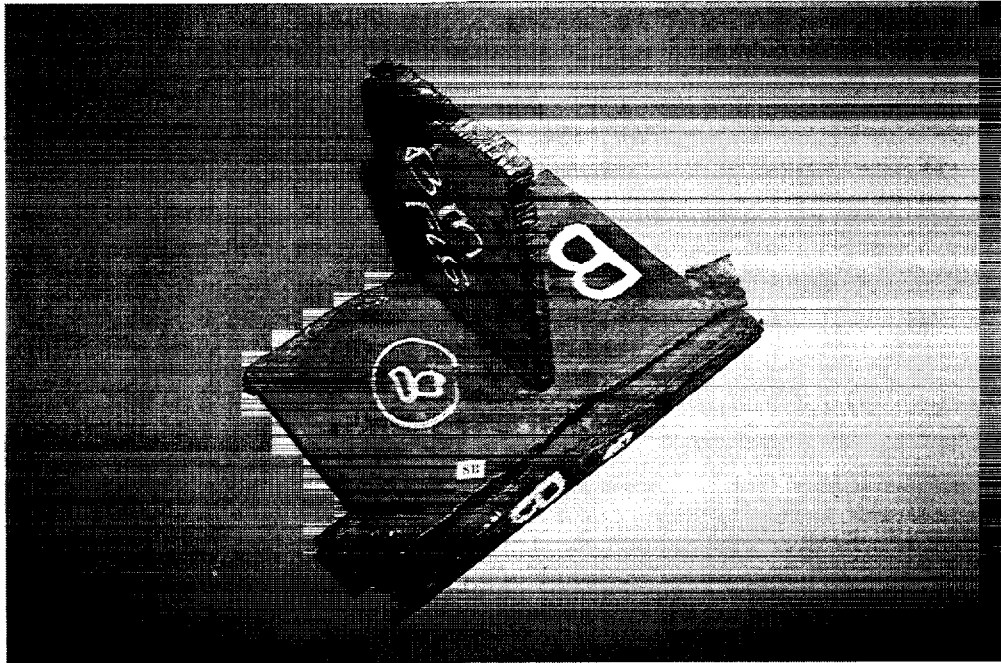
Figure 11 - Building Sample B8 showing beam bottom flange and fracture (Type W4).

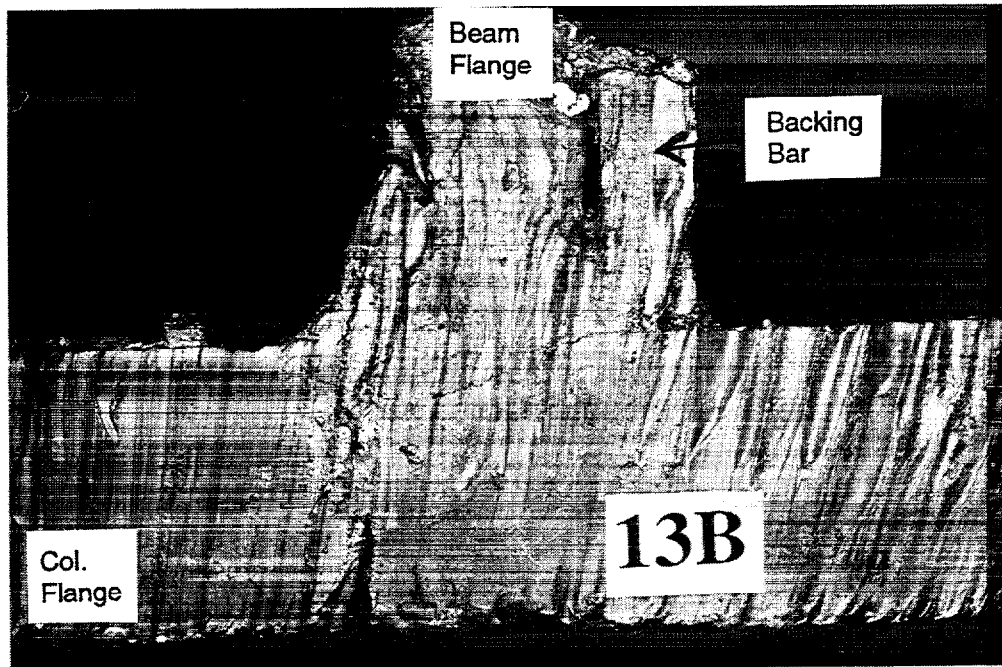
Figure 13 - Edge view of Sample B13 showing column flange fracture.

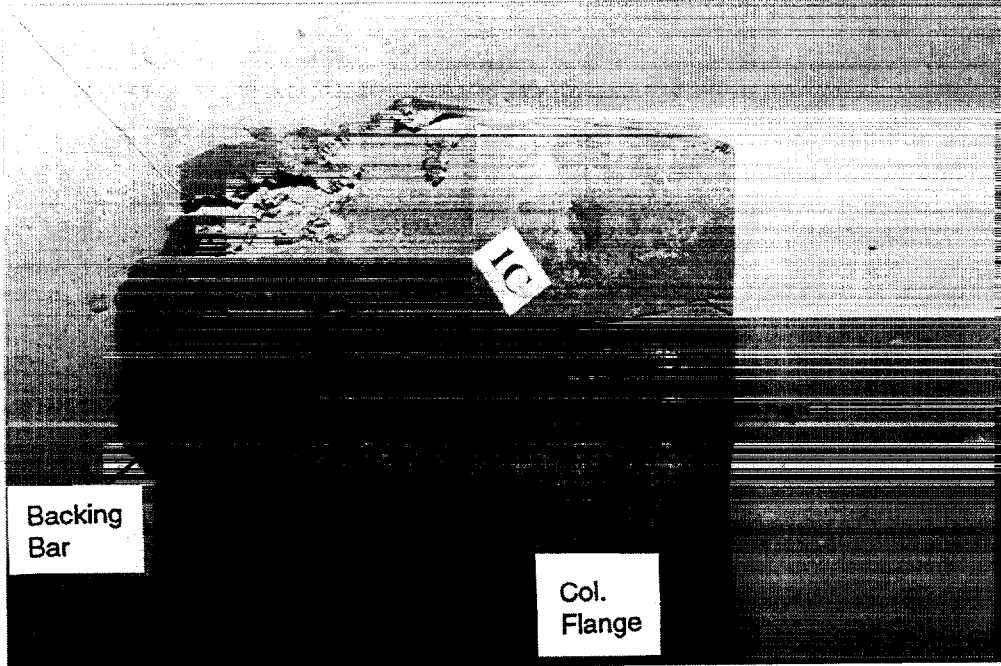
Figure 16 - Edge view of column flange fracture in Sample C1.

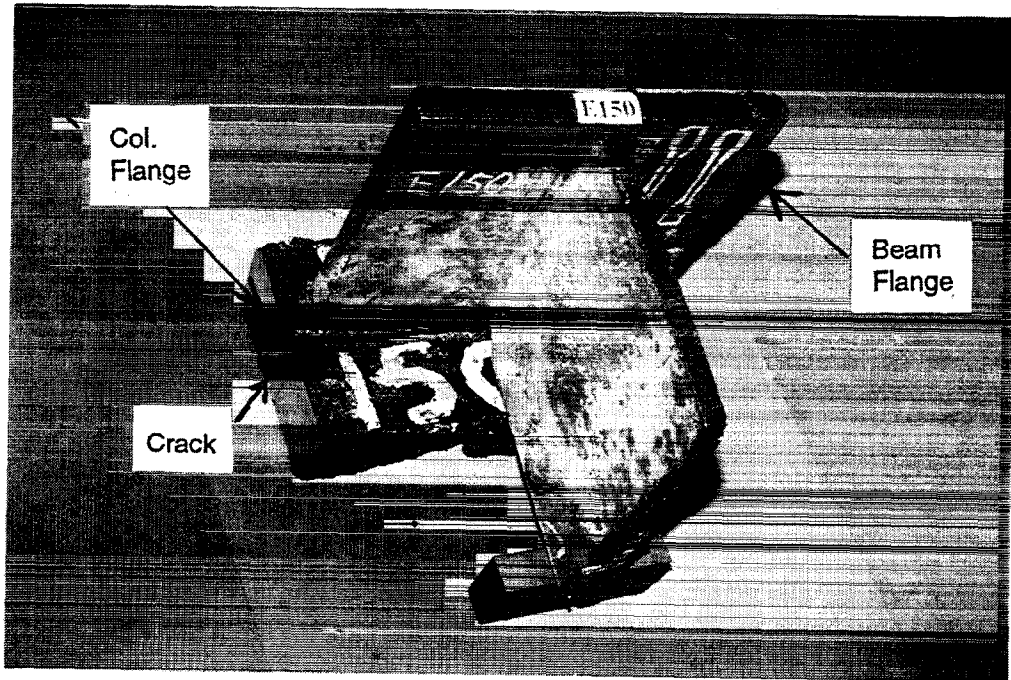
Figure 20 - Building Sample E150. Note column flange fracture.

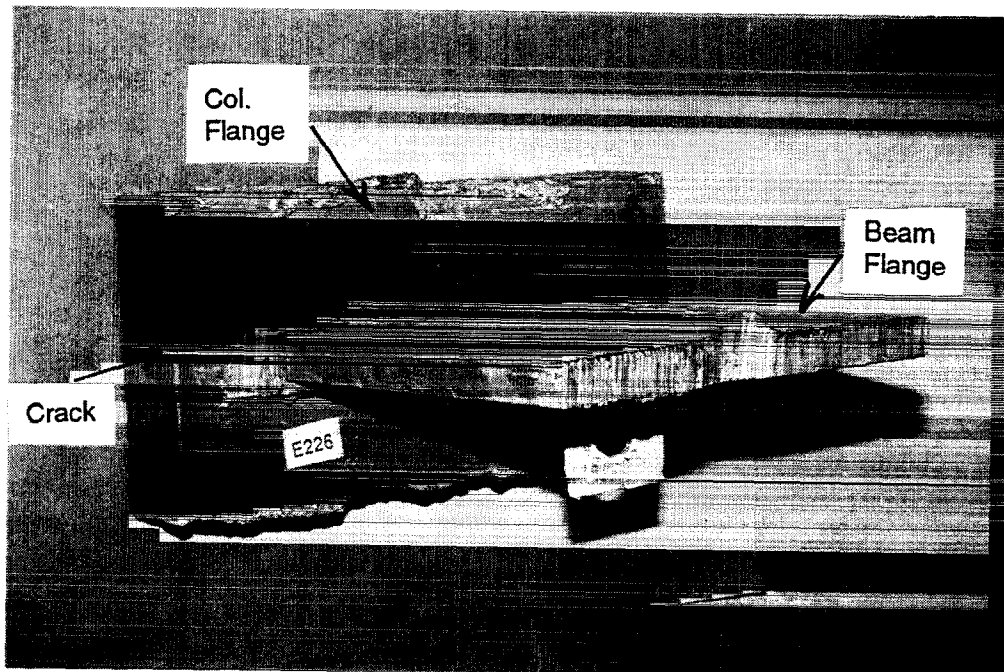
Figure 21 - Building Sample E226. Note column flange fracture.

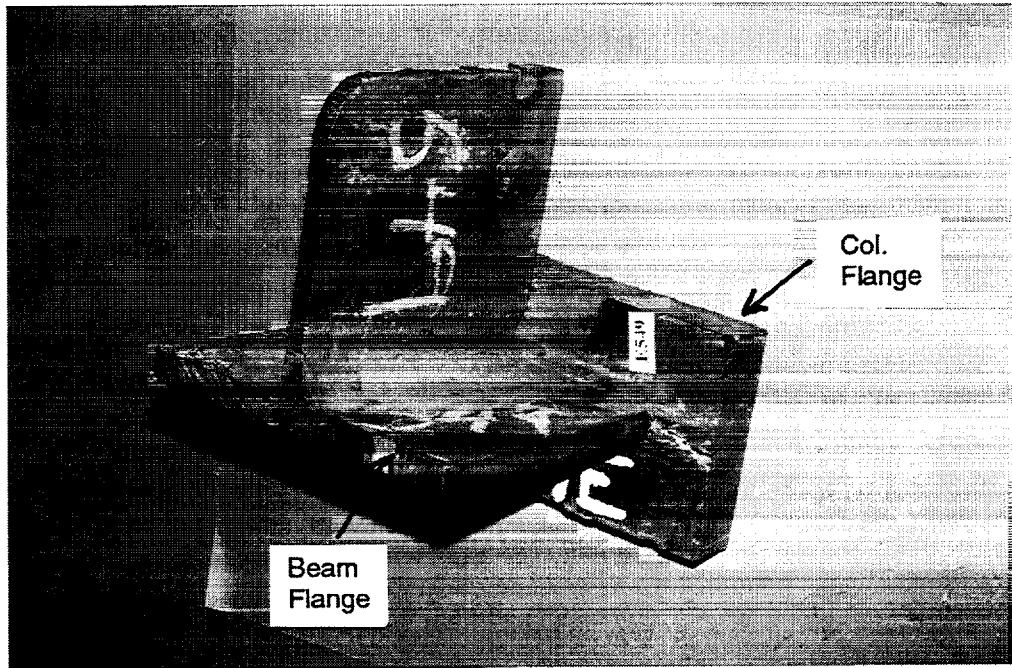
Figure 22 - Building Sample E549. No cracking is visible.

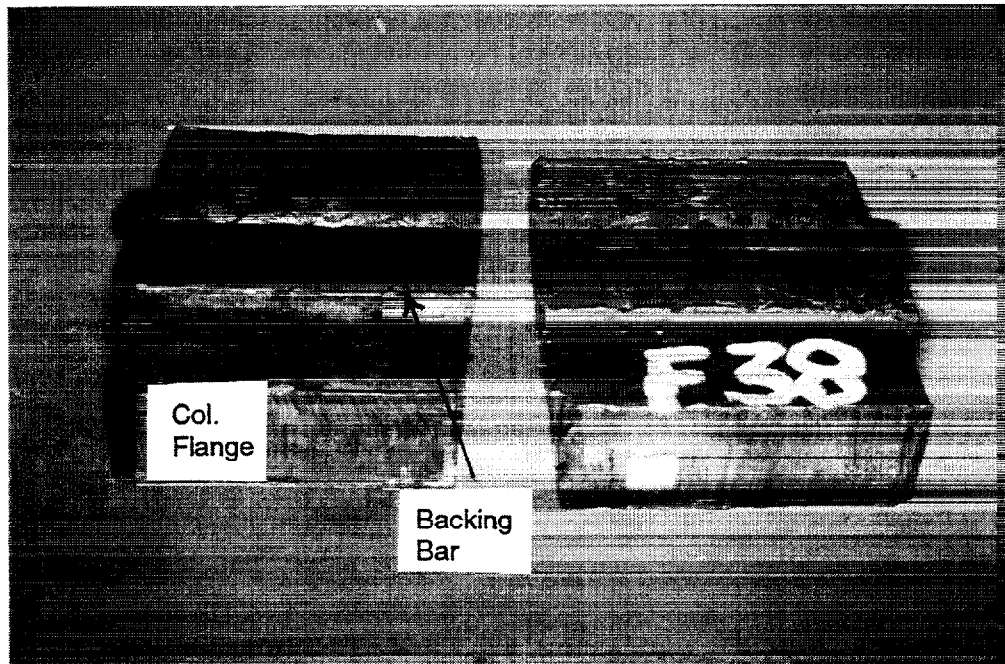
Figure 23 - Building Sample F38 showing column flange and cut beam flange weld.

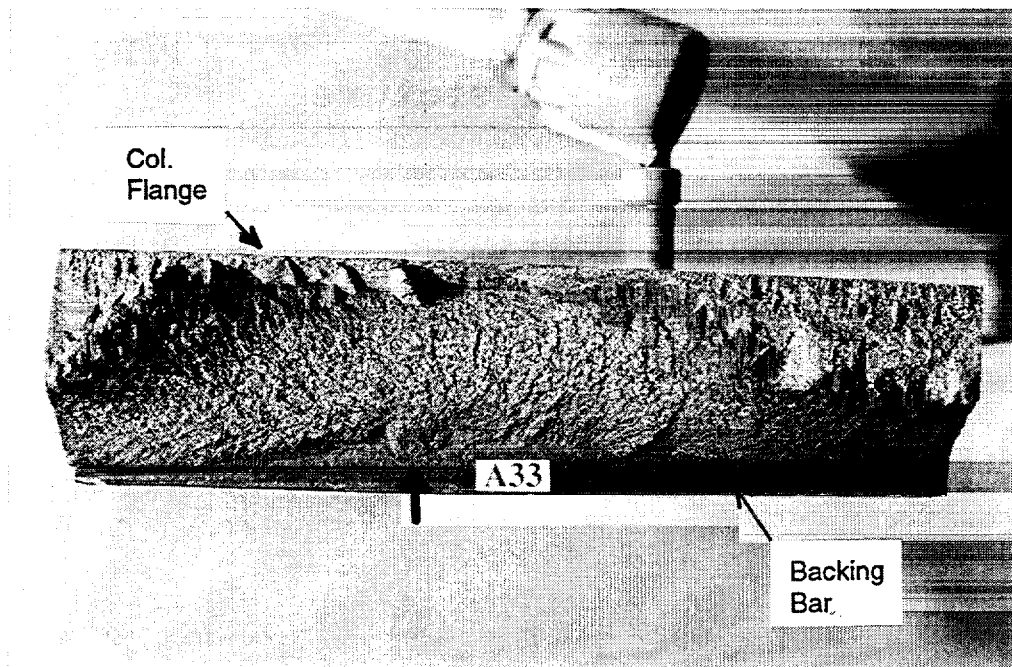
Figure 26 - Column flange fracture surface from Sample A33.
Arrow indicates location of fracture origin.

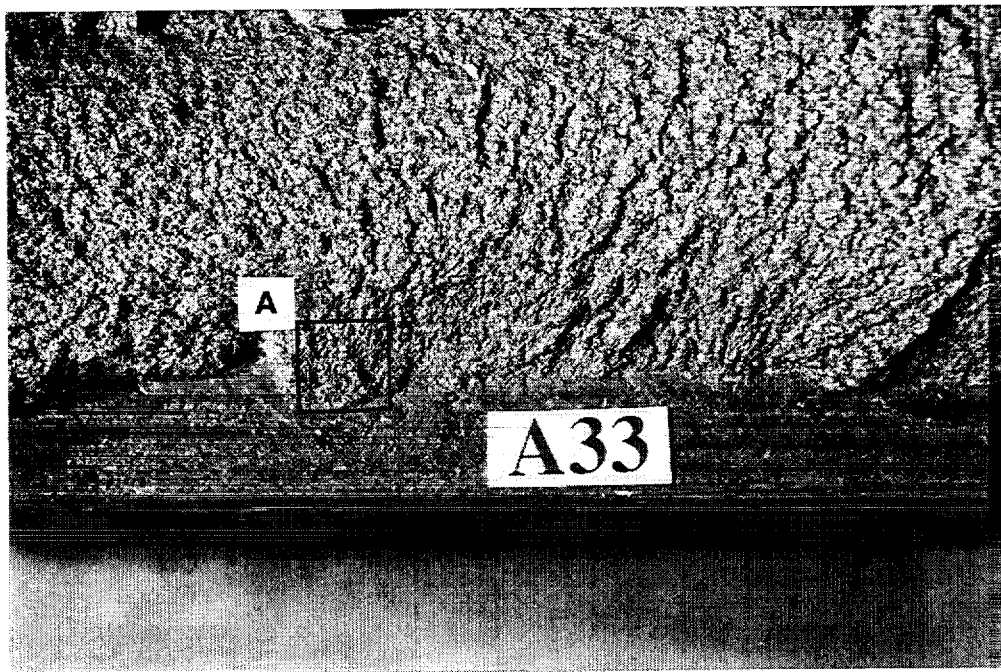
no visually detectable incomplete fusion flaw was found. In one sample (A33) fracture was found to initiate at the weld root immediately next to a weld root flaw (see Figure 28).

Figure 28 - Enlarged view of fracture origin area of Sample A33.
Note incomplete fusion along weld root.

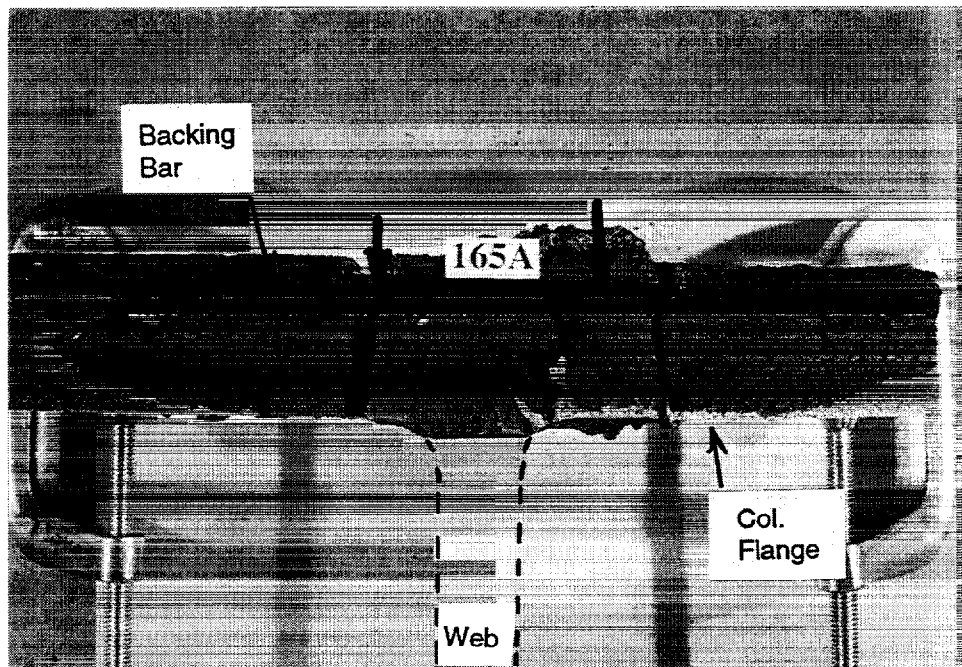
Figure 30 - Fracture surface of Sample A165. Arrow shows location of fracture origin.

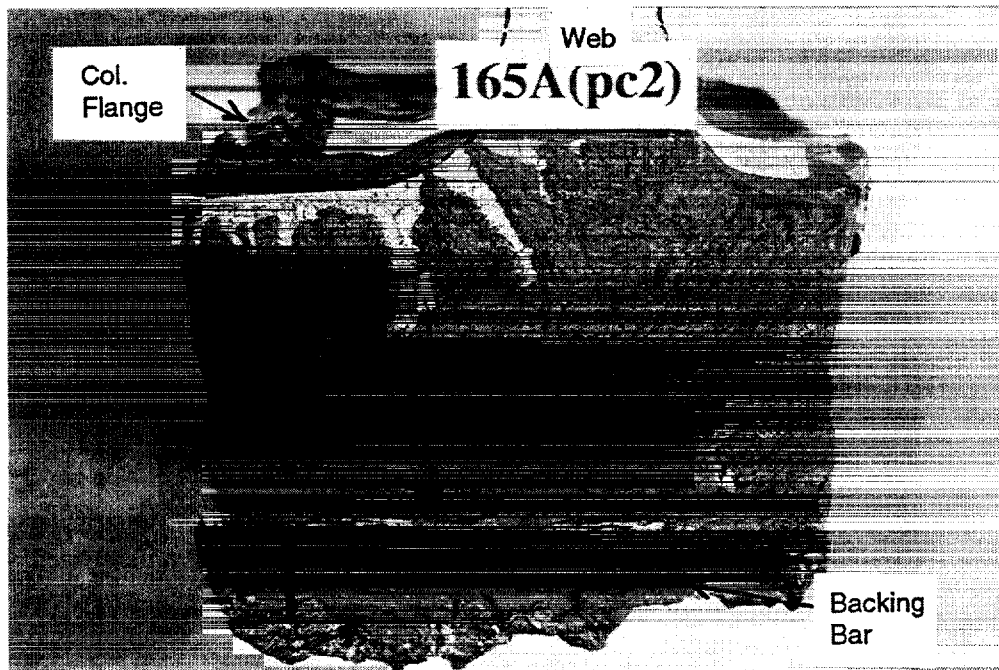
Figure 31 - Enlarged view of the fracture origin area at the weld root of Sample A165.

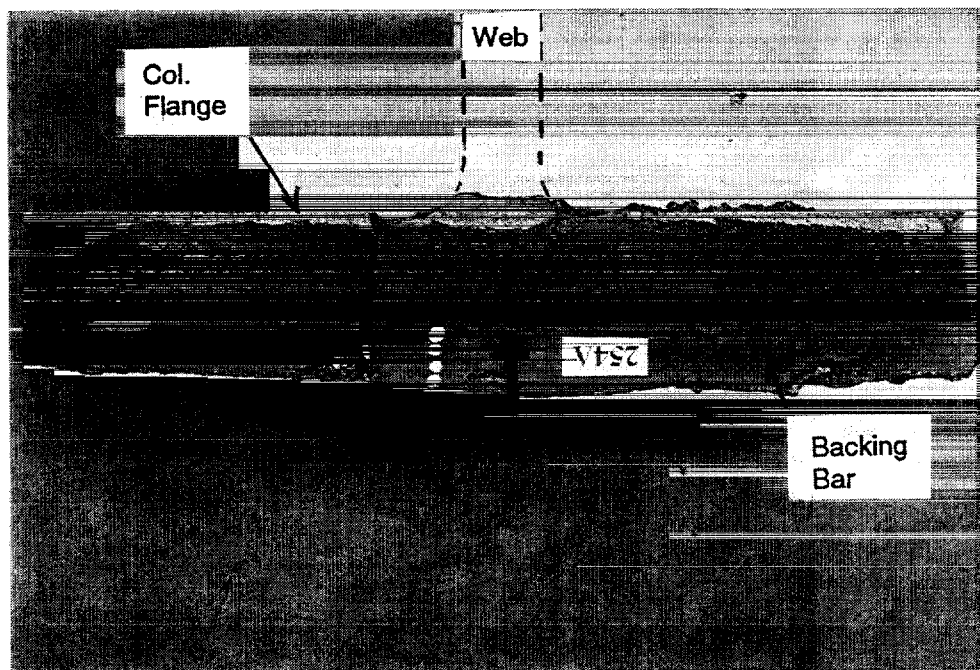
Figure 32 - Fracture surface from Sample A254. Arrow shows location of fracture origin.

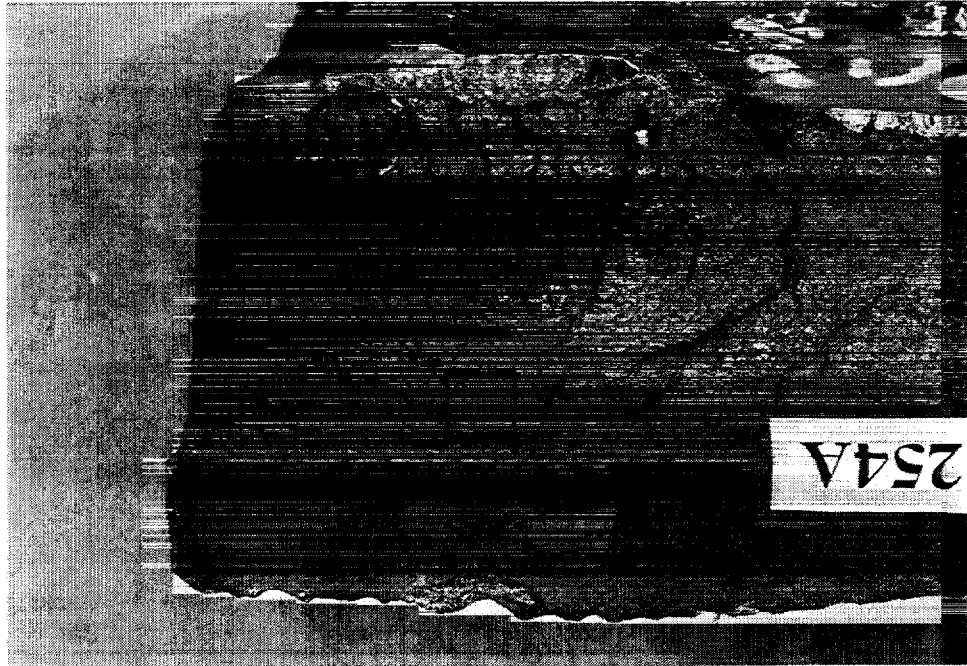
Figure 33 - Enlarged view of the fracture origin area at the weld root of Sample A254.

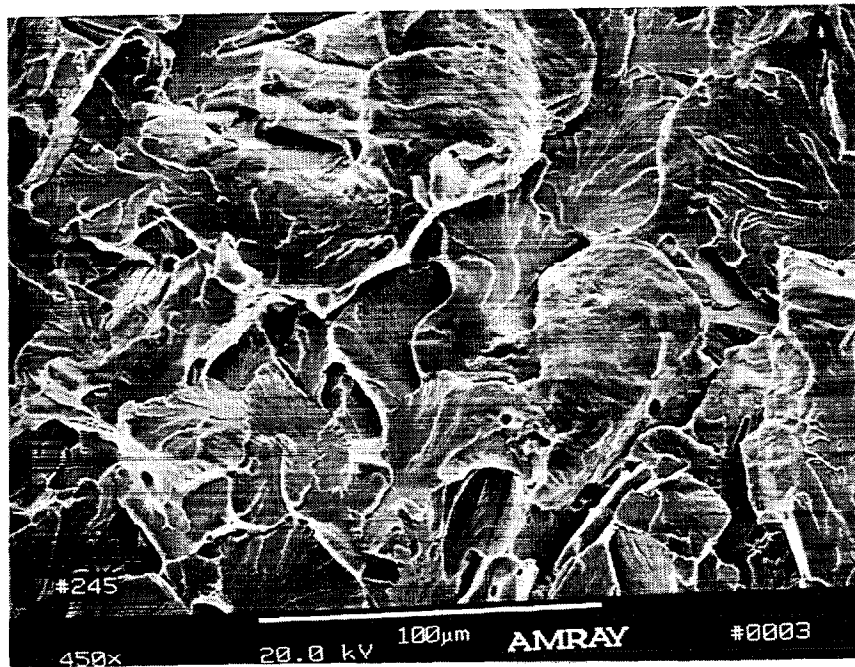
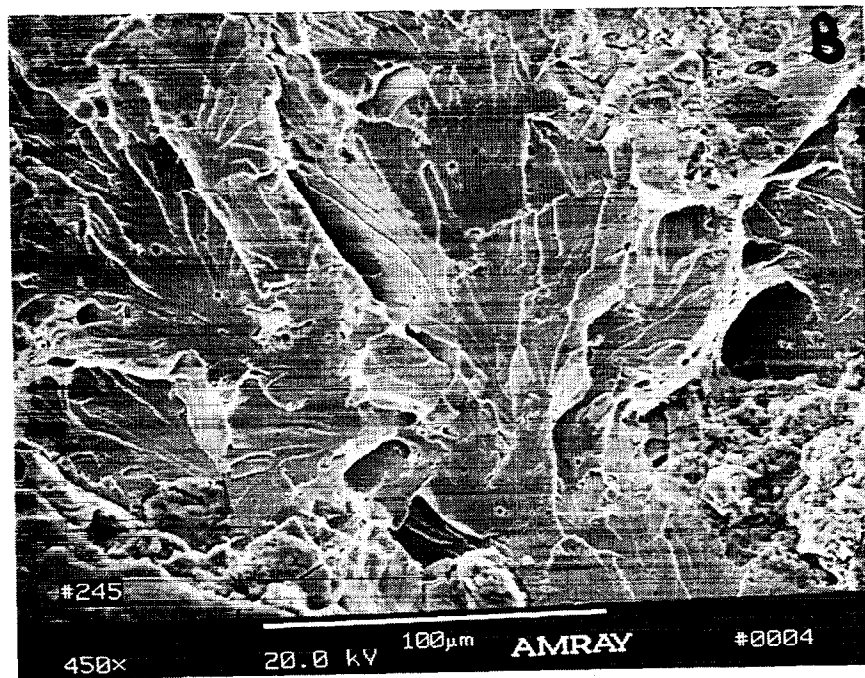
SEM examination of the origin area of Samples A33, A254, A287, E226, and E549 all showed that cleavage fracture initiation occurred directly from the weld root defect (see Figures 29, 35, 39, 53, and 56). No evidence of other fracture mechanisms associated with stable crack growth processes, such as low cycle fatigue from prior load cycles or hydrogen cracking during fabrication, was observed at the crack origin.

Figure 35 - Higher magnification micrographs of the fracture origin of Sample A254 showing cleavage fracture. (Mag. 450X)
Top: Boxed area "A" in Figure 34. Bottom: Boxed area "B" in Figure 34.

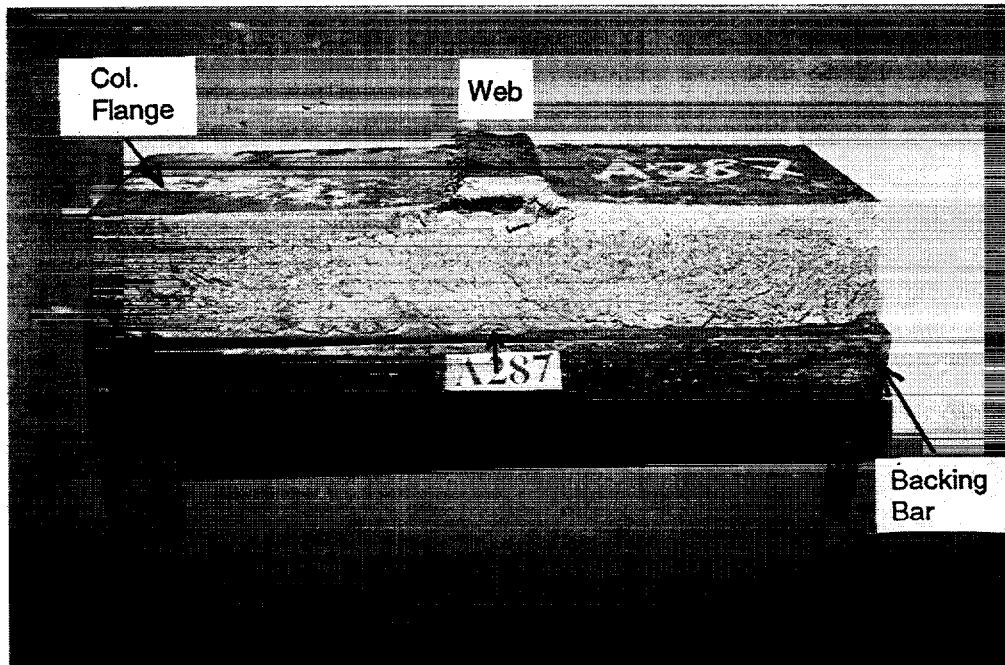
Figure 37 - Fracture surface of Sample A287. Arrow shows location of fracture origin.

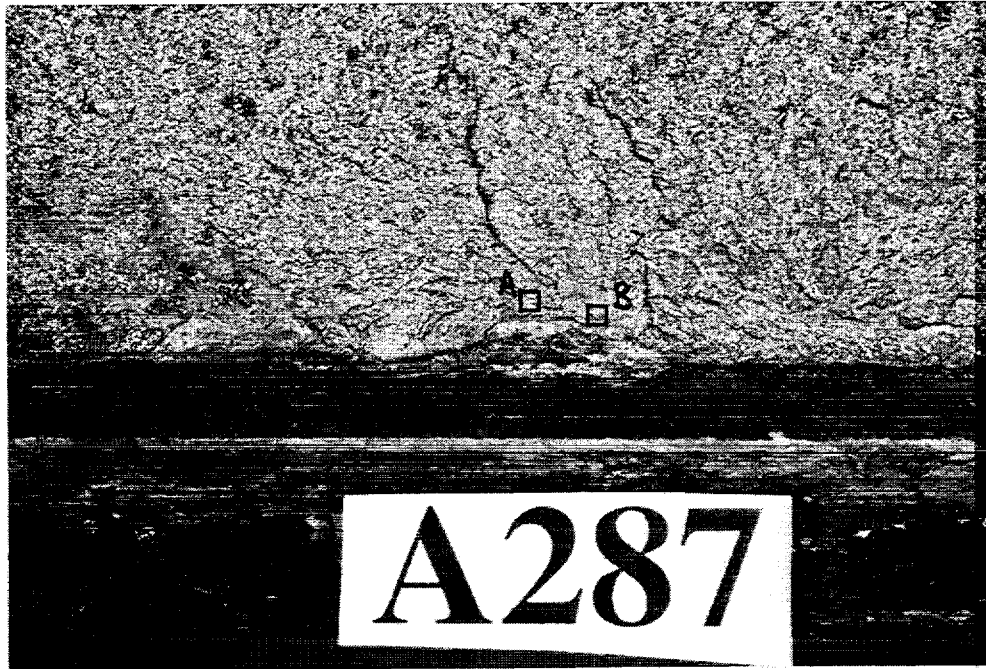
Figure 38 - Enlarged view of the weld root fracture origin in Sample A287.

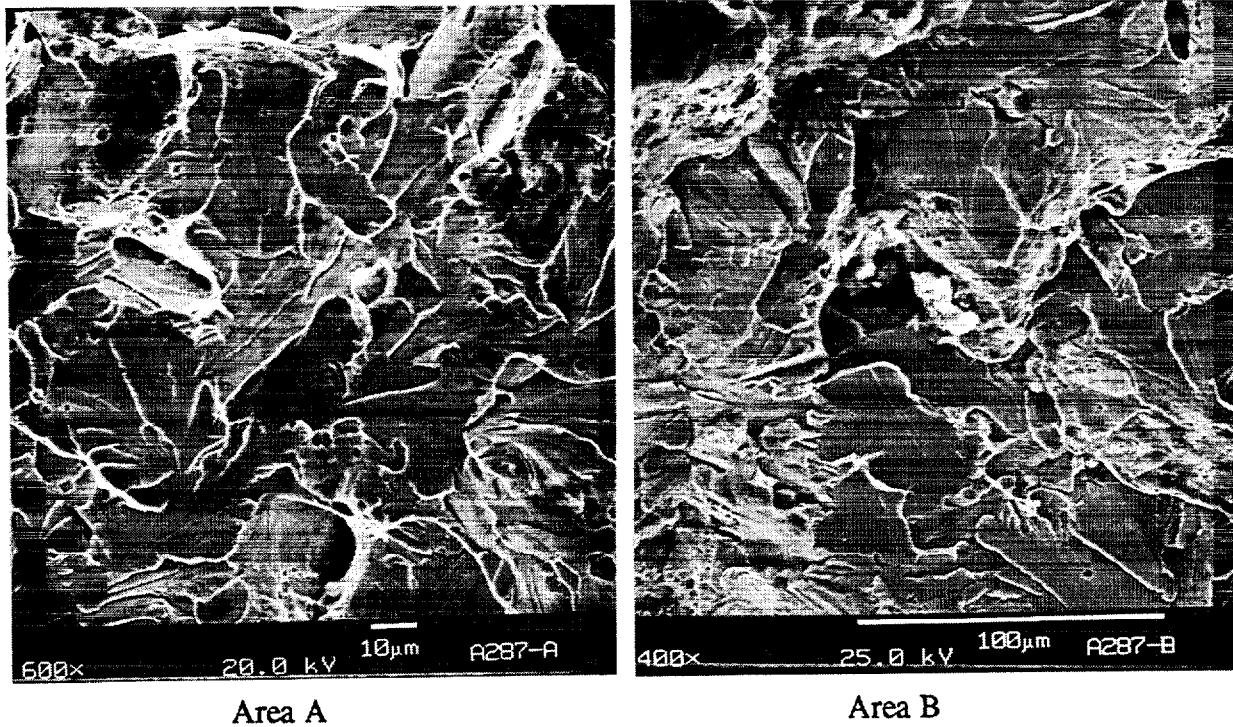
Figure 39 - SEM micrographs of the crack surface obtained adjacent to the weld root flaw in Sample A287. (Boxed areas "A" and "B" in Figure 38)

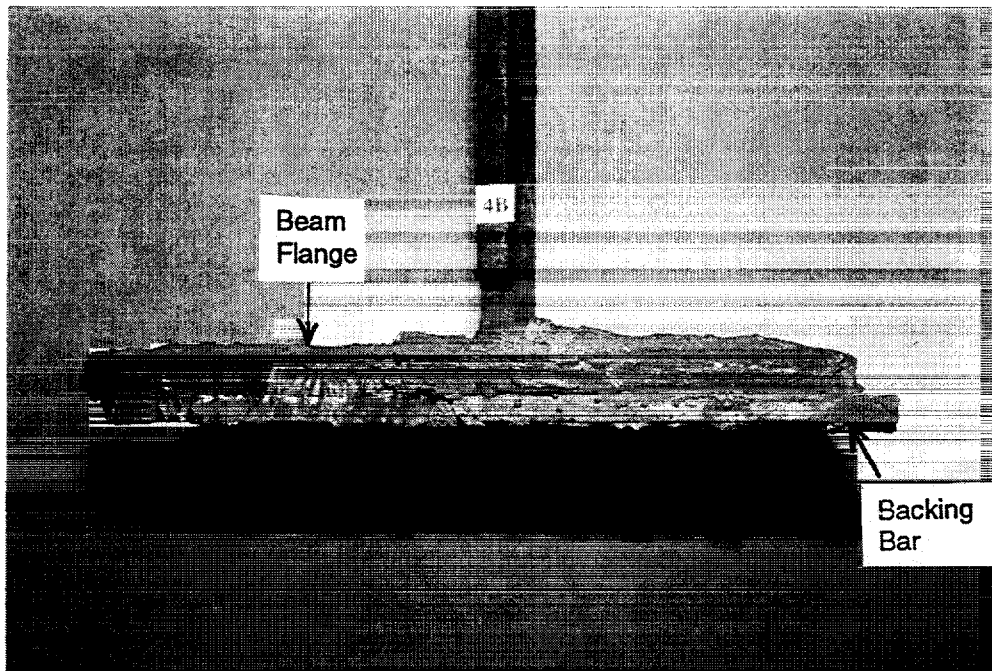
Figure 40 - Fracture surface from Sample B4 showing arc gouging damage. Fracture path is near the weld fusion line.

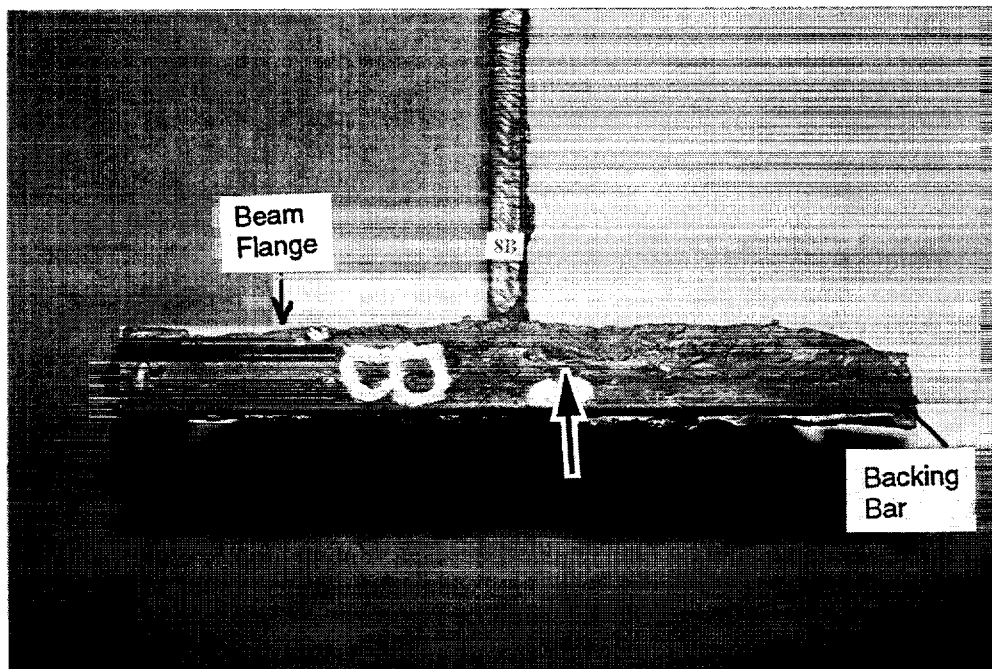
Figure 41 - Fracture surface from Sample B8. Fracture path is near the weld fusion line. Arrow shows location of fracture origin.

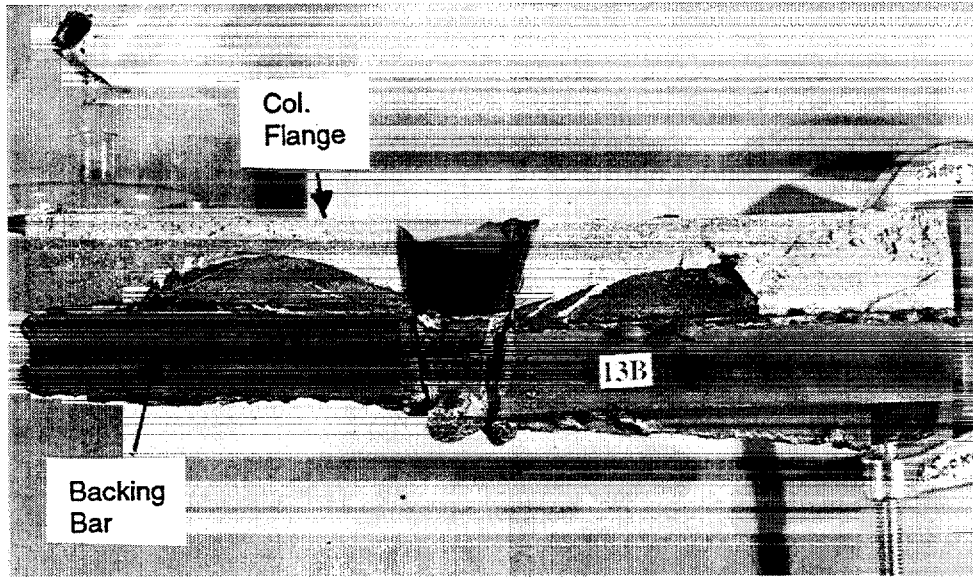
Figure 42 - Fracture surface from Sample B13 showing a portion of the divot fracture exposed. The fracture origin is located within the missing area of the surface at the web centerline.

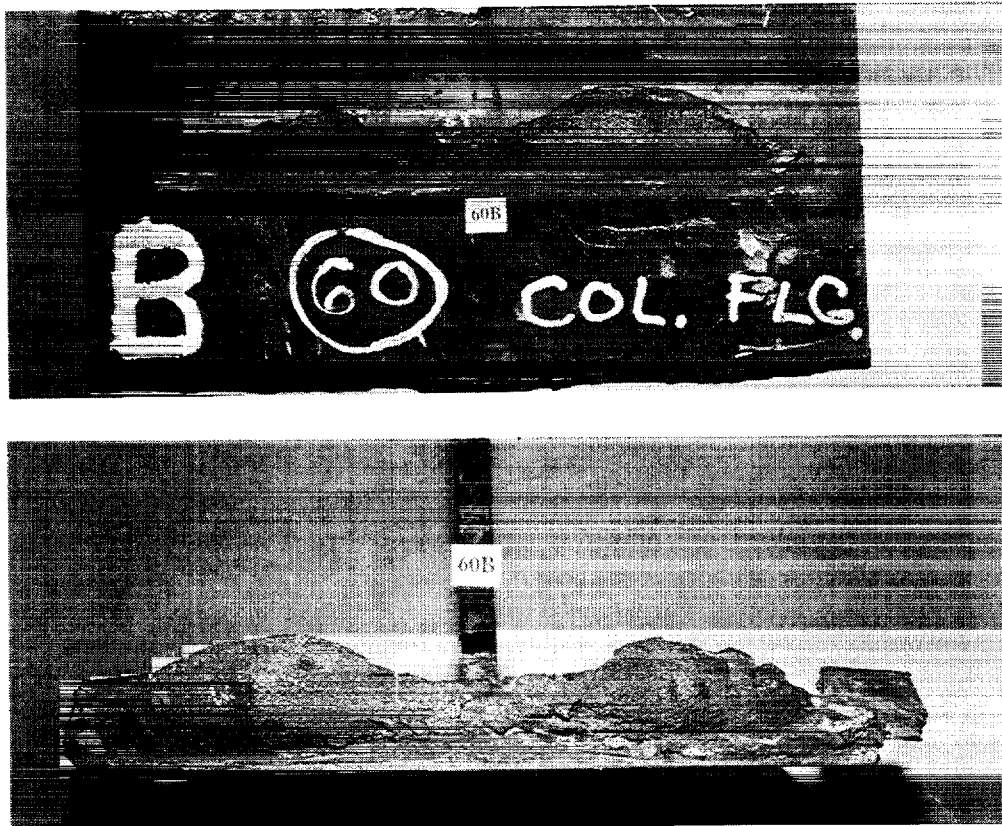
Figure 43 - Column divot fracture surface from Sample B60. Arrow shows the location of the fracture origin.

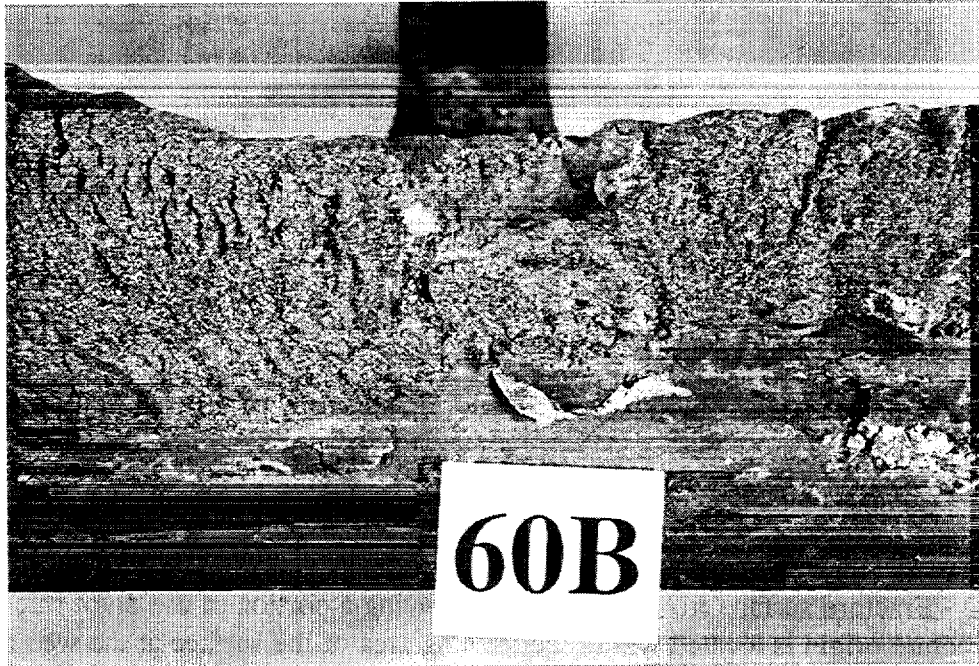
Figure 44 - Enlarged view of the fracture origin of Sample B60 showing a deep weld root incomplete fusion flaw.
