**Failure Analysis of Welded Steel Moment Frames
Damaged in the Northridge Earthquake**

NISTIR 5944

January 1997
Building and Fire Research Laboratory
National Institute of Standards and Technology
Gaithersburg, MD 20899

A study was performed to characterize the origin of fracture and material properties of welded steel moment frame (WSMF) connections damaged in the Northridge earthquake. Sixteen connection fractures were obtained from five different buildings in the Los Angeles area which suffered damage in the earthquake. These fractures represented a variety of the types of fractures observed in post-earthquake building inspections. The mechanical and physical properties of the connection members and weld metal were determined including composition, strength, and fracture toughness. A fractographic examination of the fracture surfaces was performed to locate and characterize the fracture origin and determine the fracture mechanism. A fracture analysis was performed using linear elastic fracture mechanics. The analysis indicated that in all cases fracture resulted from crack instability which developed within the weld metal at the weld root at an incomplete fusion flaw contigu

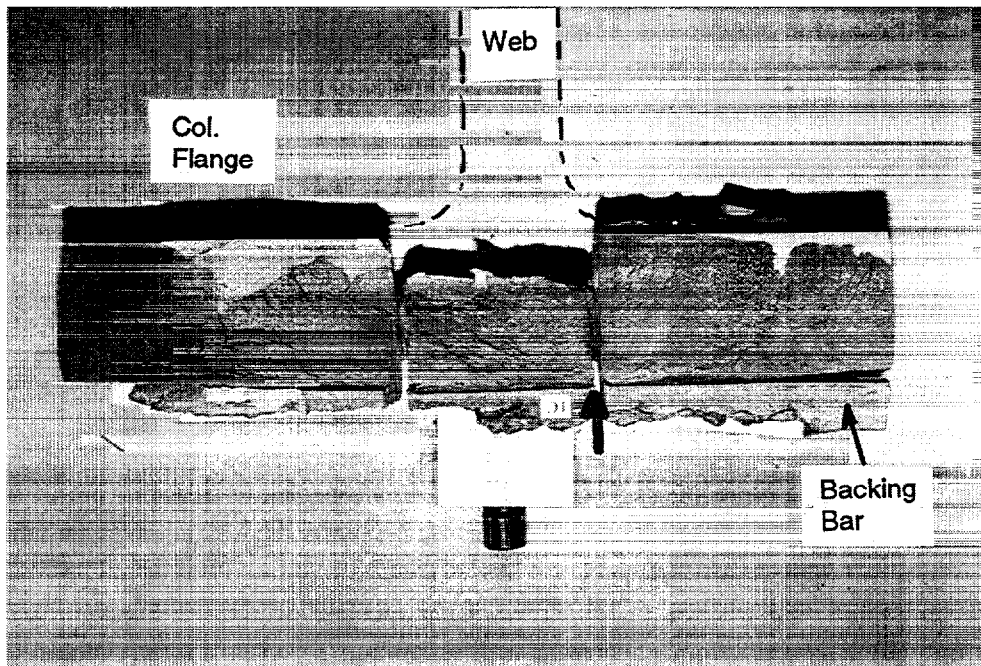
Figure 45 - Fracture surface of Sample C1. Arrow shows the location of the fracture origin eliminated during removal of the sample.

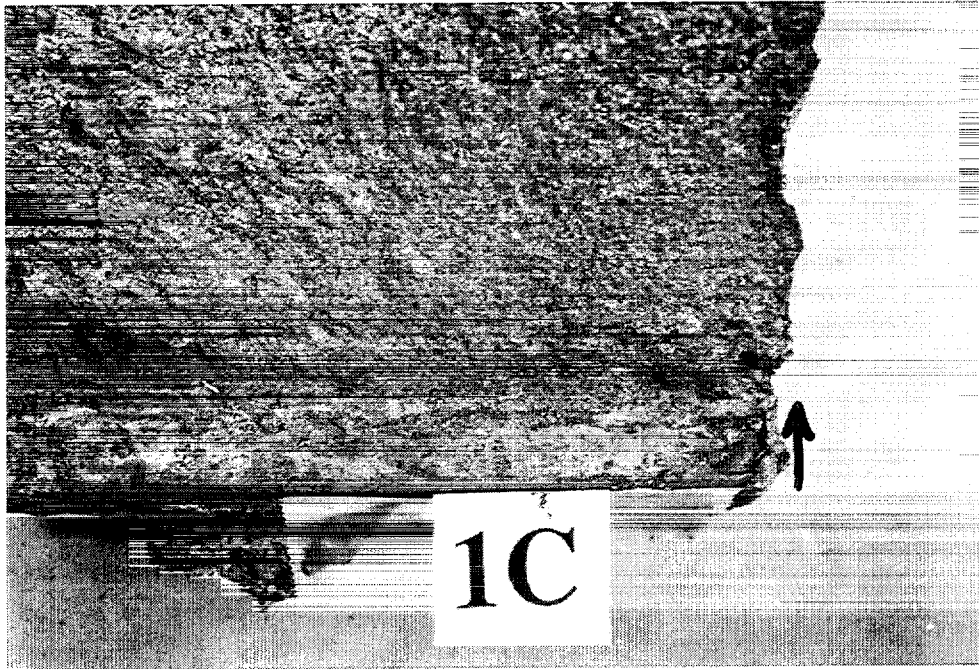
Figure 46 - Enlarged view of the crack surface from Sample C1 next to the fracture origin.

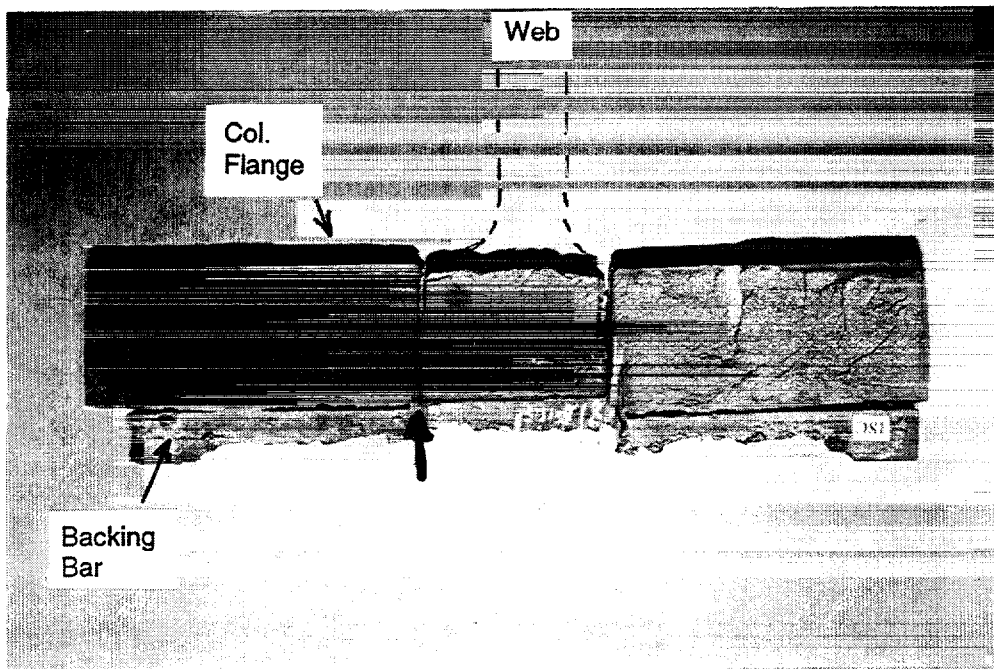
Figure 47 - Fracture surface from Sample C18. Arrow shows location of the fracture origin eliminated during sample removal.

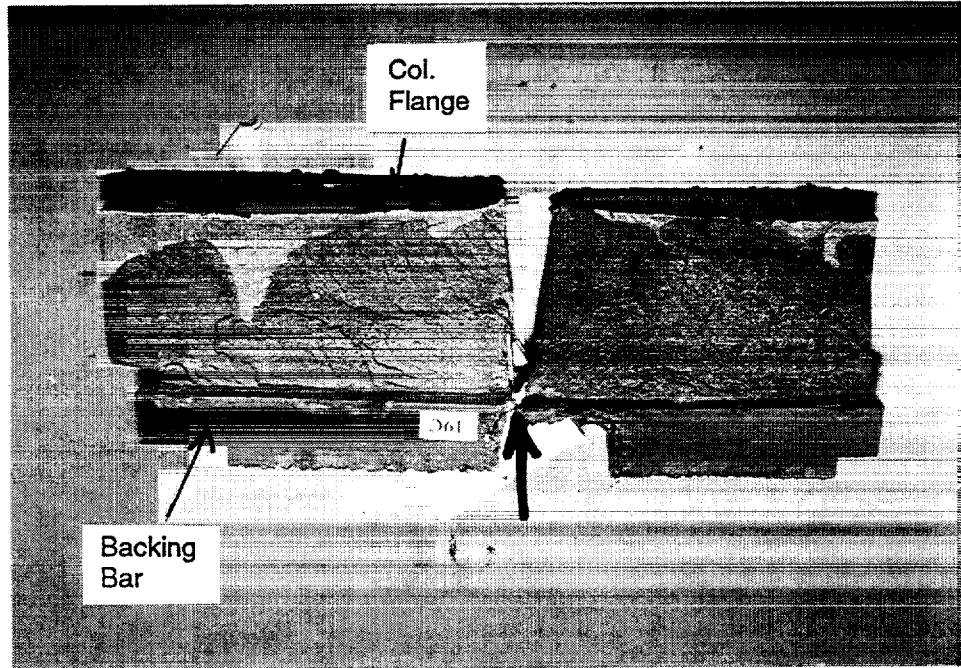
Figure 48 - Fracture surface from Sample C19. The fracture origin is located within the missing area of the fracture at the web centerline.

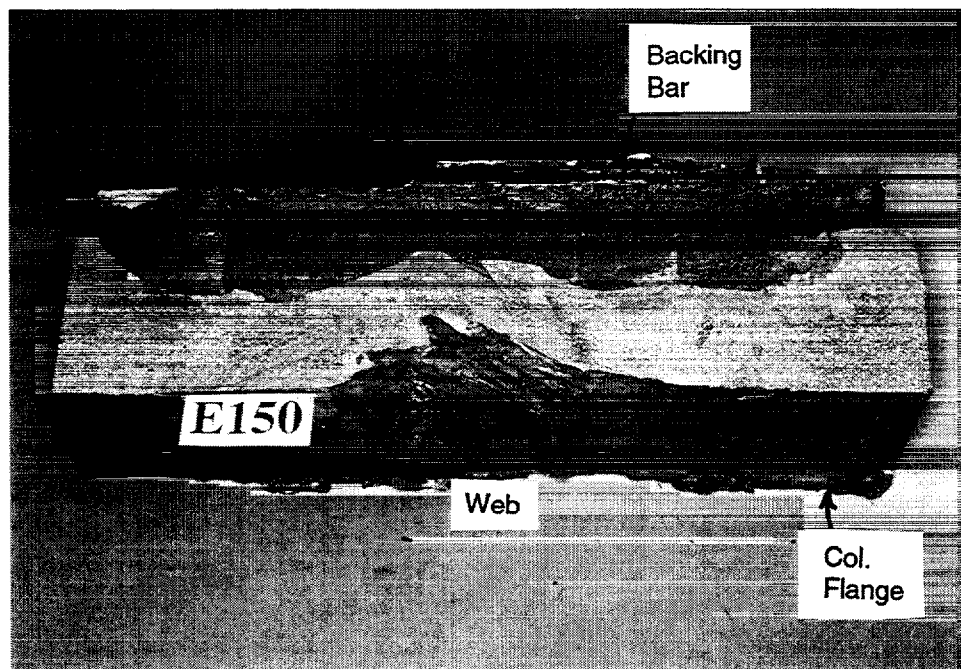
Figure 49 - Fracture surface from Sample E150 showing a portion of the divot fracture exposed. The fracture origin is located along the weld root at a location damaged by arc gouging (see arrow).

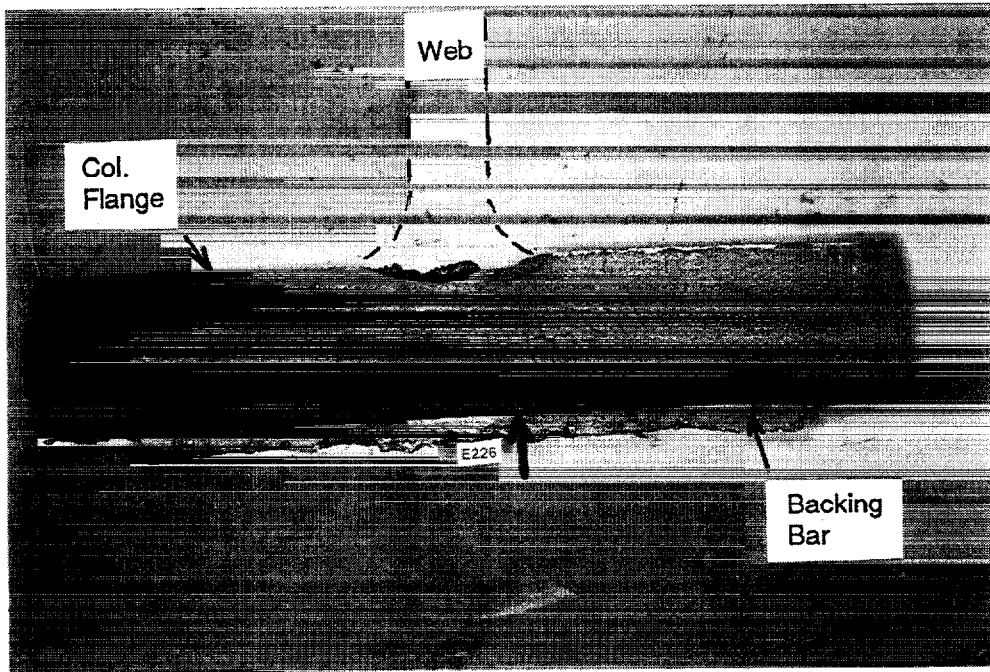
Figure 50 - Fracture surface from Sample E226. Arrow shows the location of the fracture origin.

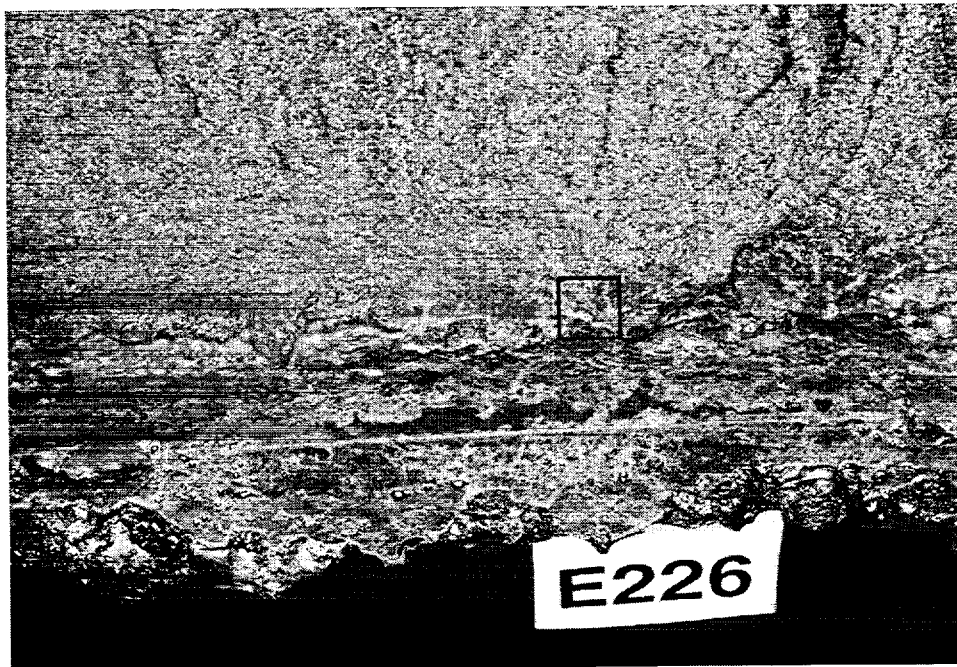
Figure 51 - Enlarged view of the fracture origin area of Sample E226. The fracture initiates from an incomplete fusion flaw at the weld root.

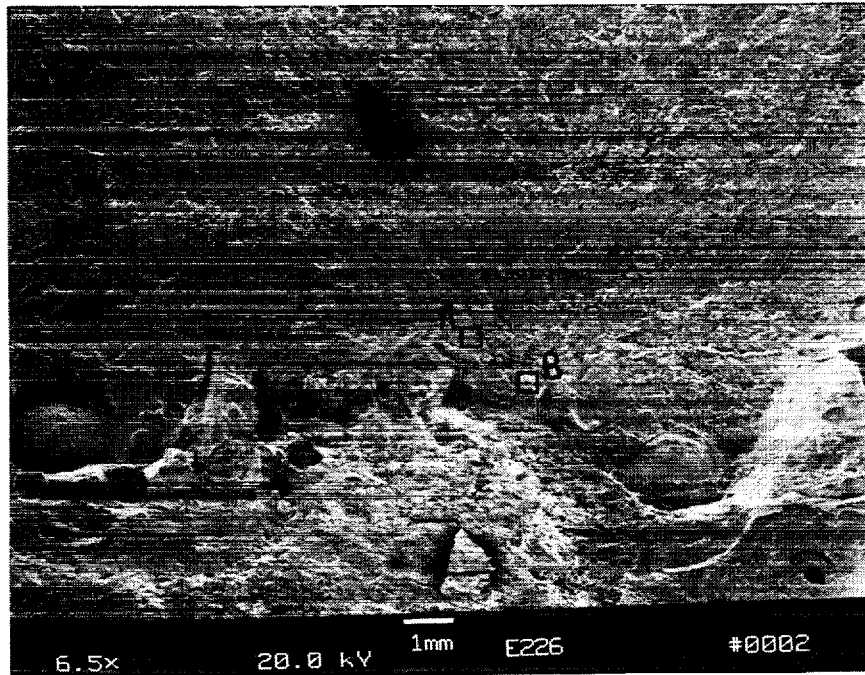
Figure 52 - Low magnification SEM micrograph of the fracture origin of Sample E226. (Boxed area in Figure 51) (Mag. 6.5X)

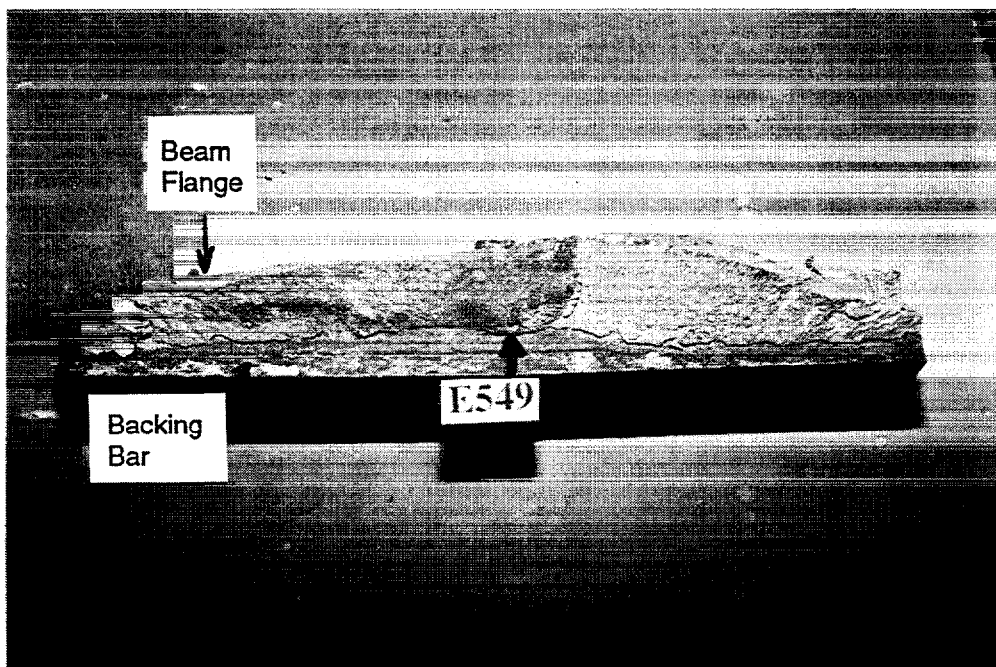
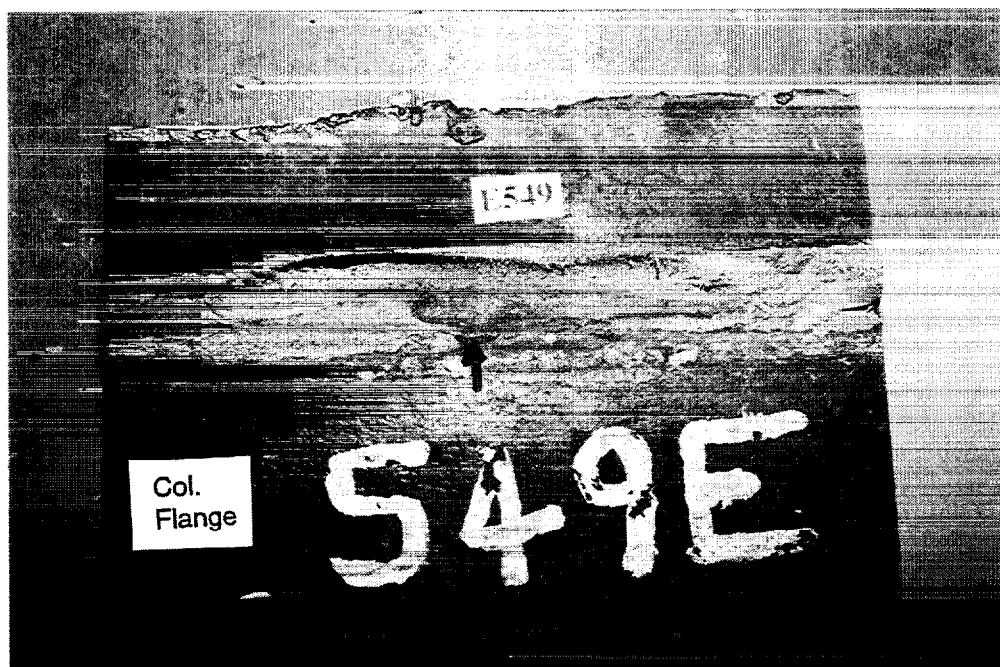
Figure 54 - Divot fracture surfaces from Sample E549. Arrow shows the location of the fracture origin. Note the deep incomplete fusion defect along the weld root.

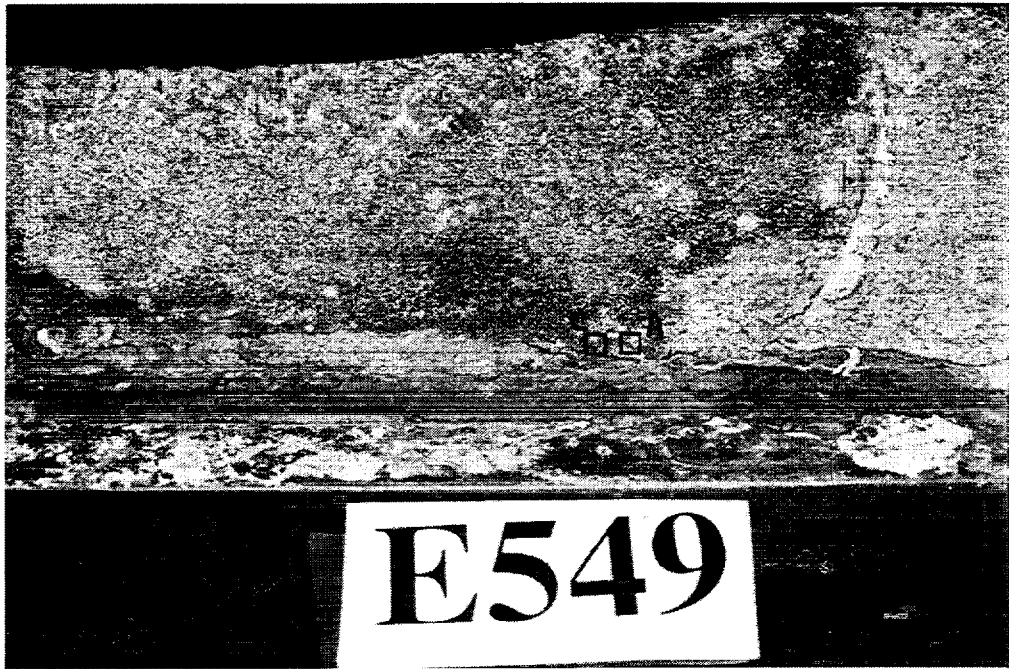
Figure 55 - Enlarged view of the fracture origin area from Sample E549.

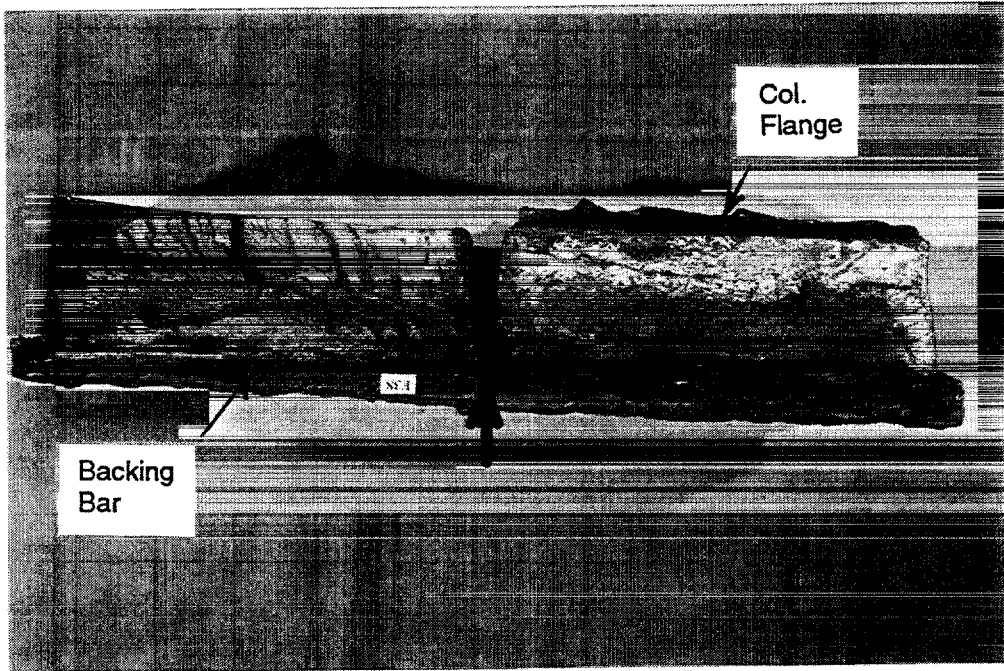
Figure 57 - Fracture surface from Sample F38. Arrow shows the location of the fracture origin eliminated during sample removal.
