**NISTIR 6315**

**Supporting Document for Rehabilitation Cost  
Estimates of FEMA Existing Buildings**

## Supporting Document for Rehabilitation Cost Estimates of FEMA Buildings

March 1999

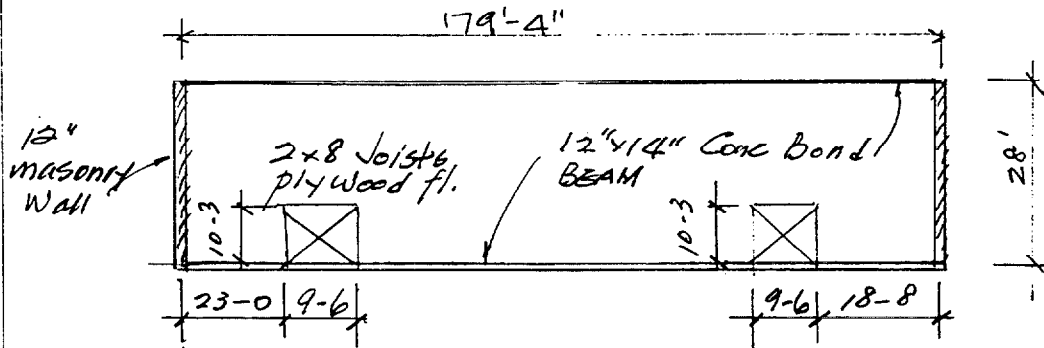
CHECK DIAPHRAGM ACTION AT 2<sup>nd</sup> FL.

In order for the floor to function as a diaphragm, the floor joists must be anchored adequately in the masonry walls or to the bond beams. A cross section of the building shows that the joists have fire-cut ends at the wall with about 90 mm (3 ½ in) to 100 mm (4 in) bearing. Analysis showed that this bearing length may not be adequate for the joists to remain supported in the wall when the floor deflects during an earthquake. Because of inadequacies found in the horizontal load path, both in stiffness and shear

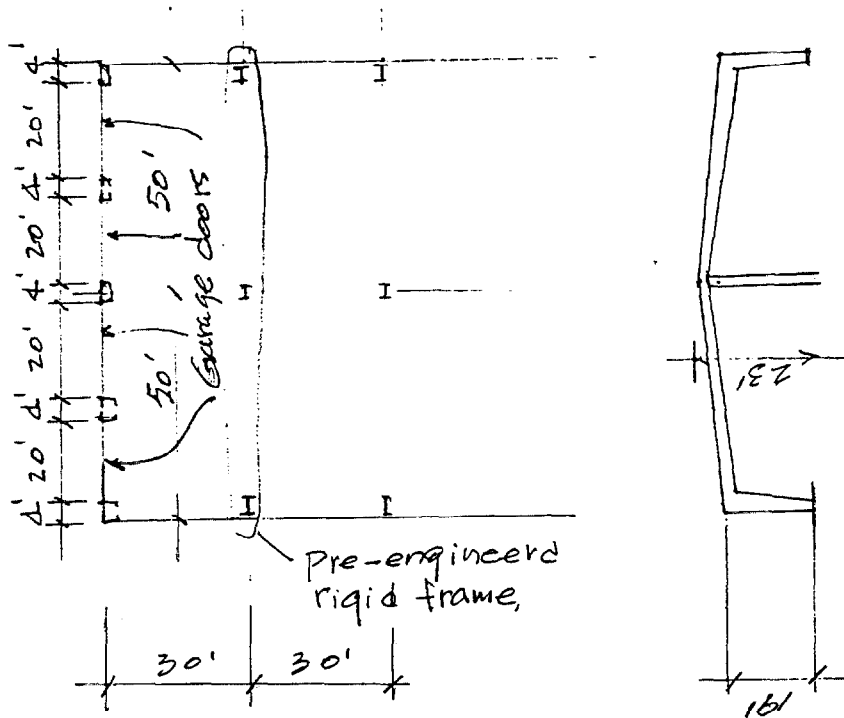
CHECK THE WEST END BAY OF THE VEHICLE BARN

The field investigation identified that the lateral load resisting system in the north-south direction of the west-end bay may be inadequate as the end wall has four large garage doors without any lateral bracing system. The structural framing of this bay is comprised of steel-channel columns and light I-shape beams. Assuming that the resistance to lateral displacement at the top of the end bay is provided by the roof framing, the lateral displacement is computed. The computed value is very small (6 mm) due to relatively light weight of the structure. Analysis shows that the roof diaphragm has adequate capacity to resist the shear load generated by the lateral displacement of the end bay. Thus, the deficiency of the end bay as identified in the preliminary evaluation using the checklist is removed, and the structure is judged to have no deficiencies.

THE WEST END WALL HAS A LARGE GARAGE DOORS AND JUDGED  
TO HAVE INADEQUATE LATERAL LOAD RESISTING STRENGTH.

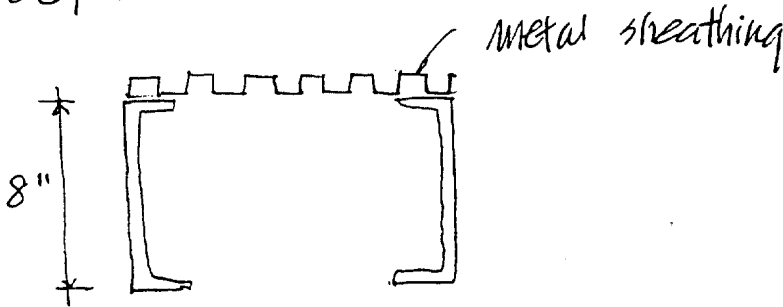
The end wall is comprised of 10 8" C in the vertical direction, spaced 4' between two adjacent channels.

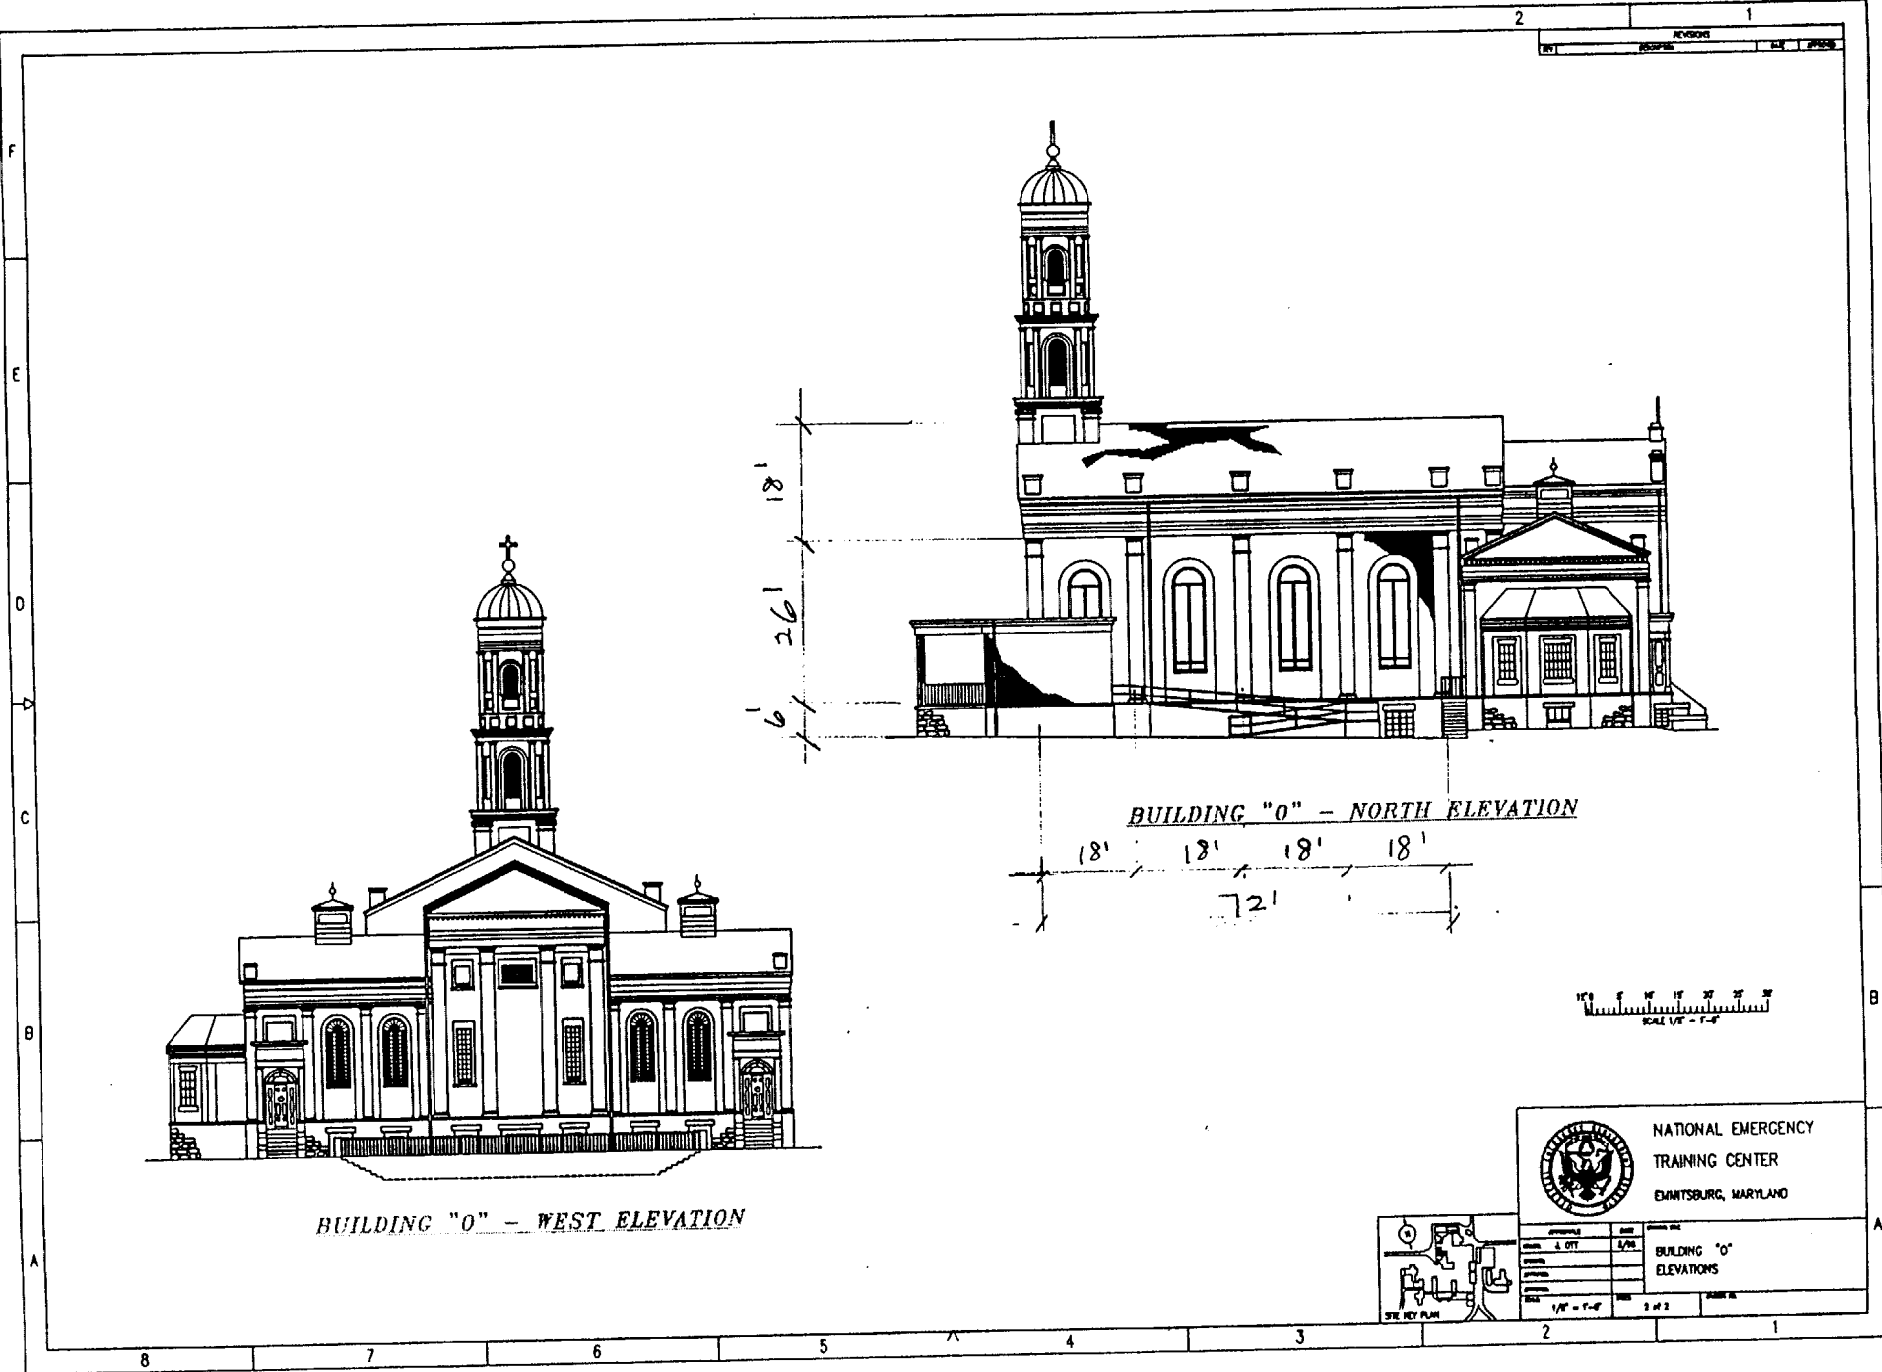
*BUILDING "O" - NORTH ELEVATION*

used in the structure. Timber trusses support the wood ceiling over the chapel. The wood lath and plaster ceiling is suspended from the bottom chords of the trusses. The building has an over 10 m (33 ft) high steeple of wood construction. The basement of the building was renovated in the late 1970s, and the timber columns in the basement below the altar were replaced with steel columns. Although the exterior masonry walls have many large window openings which may reduce the shear capacity of the walls, a check of shear stresses in the walls showed that the exterior walls have adequate capacity to resist seismic loads. Careful examination during the field investigation showed that there is no effective load path from the steeple to the foundation. Positive load path must be provided for the steeple to remain stable during an earthquake. For improved seismic safety, it is also recommended that the wood lath and plaster ceiling be replaced with one of lighter mass.

Historic resistor.  
Timber steeple needs a special attention.
