Deterioration of Iowa Highway Concrete Pavements: A Petrographic Study

Paul E. Stutzman

December, 1999

Building and Fire Research Laboratory
National Institute of Standards and Technology
Gaithersburg, MD 20899

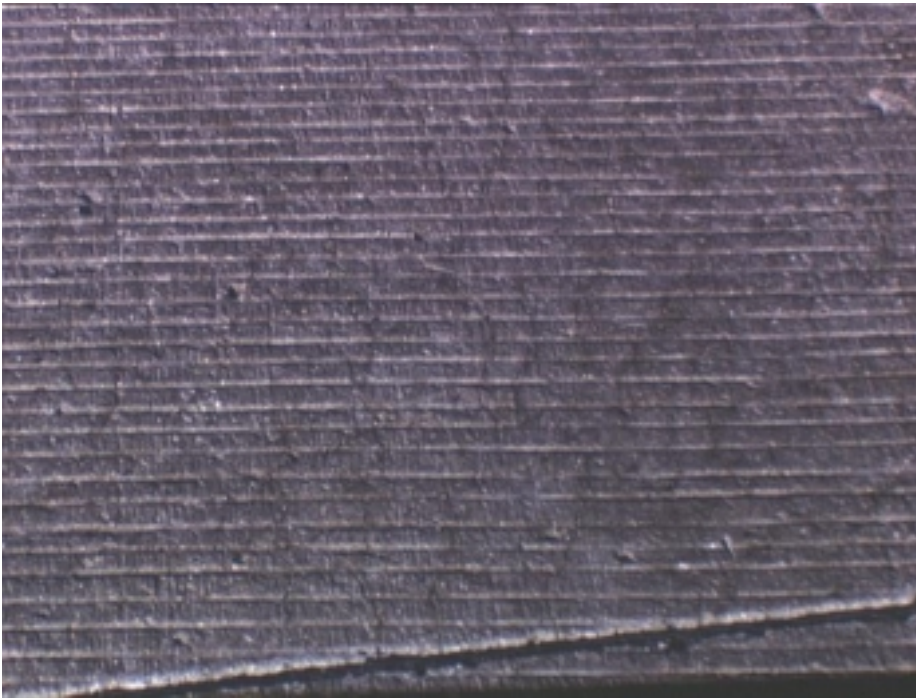
Figure 1. Onset of pavement deterioration is visible as a slight darkening of the concrete in the transverse joint region (top, I-80) and in pavements with advanced deterioration, a tightly-closed pattern cracking (bottom, US 20). Some of these pavements also have vibrator trails.

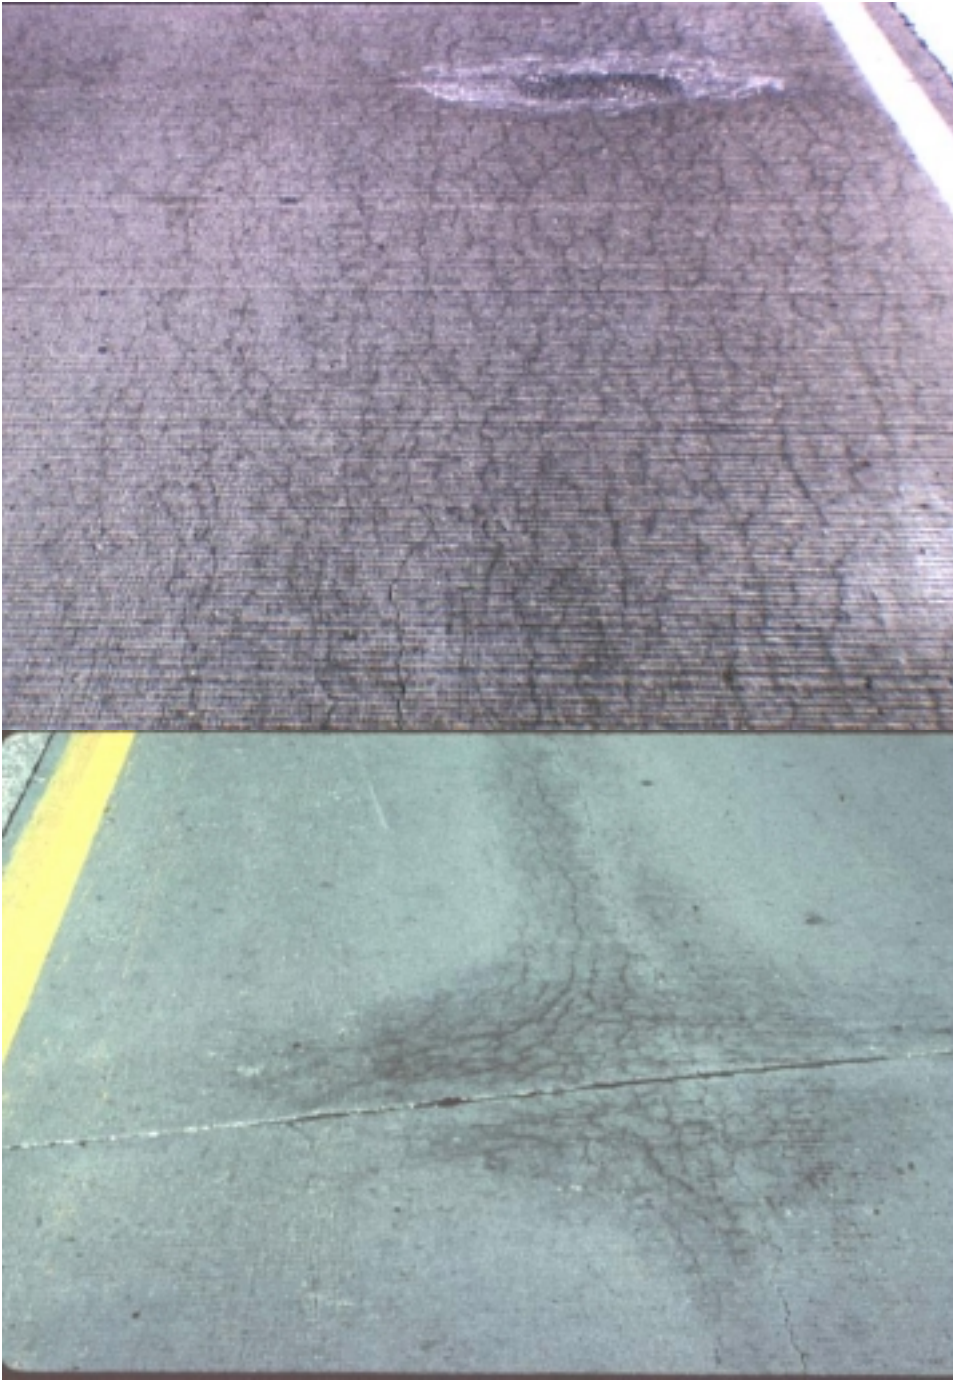
Figure 2. Map cracking oriented in the longitudinal direction of the pavement, interconnected by slightly finer cracks perpendicular to pavement direction becomes more prominent with progression of deterioration (top). Advanced degradation shows cracking paralleling the transverse joint and road edge, and along cracks within vibrator trails. The degradation would be characterized initially as “low” severity according to the SHRP Distress Identification Manual [17] and “moderate” as the deterioration progresses.

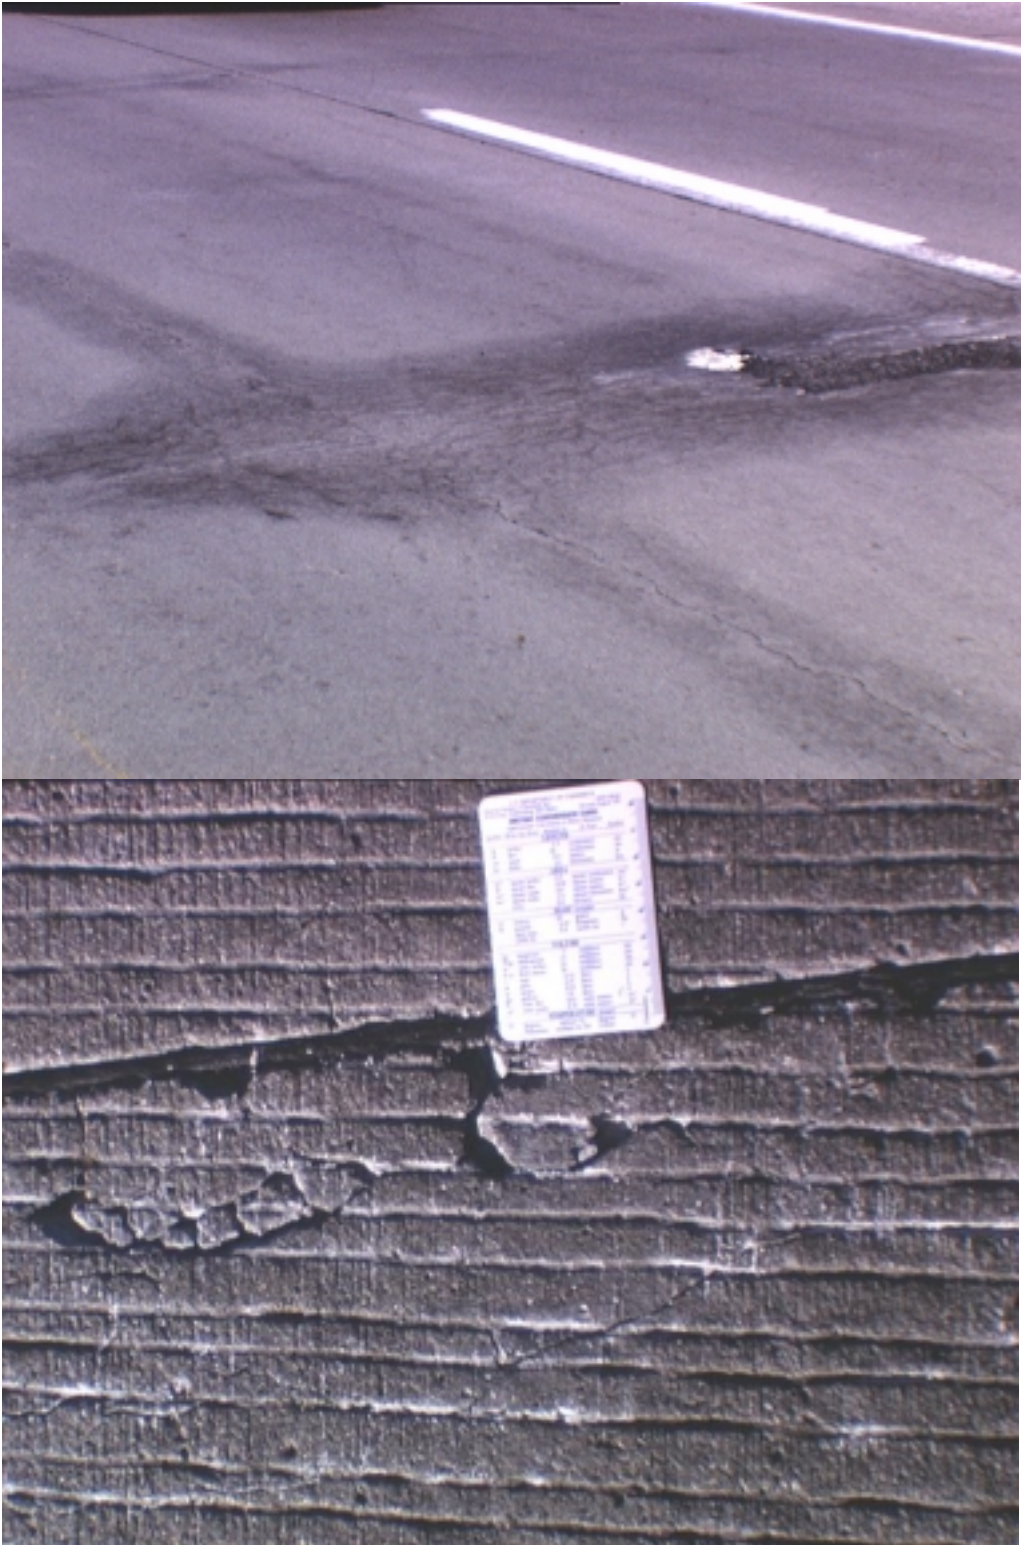
Figure 3. Pavements exhibiting severe deterioration show significant pattern cracking (here accentuated by moisture along the crack), cracking along joints, spalling along joint edges and white efflorescence. Open joints and lack of displacement along pavement slabs provides evidence against permanent expansive processes such as alkali-aggregate reaction and sulfate attack.

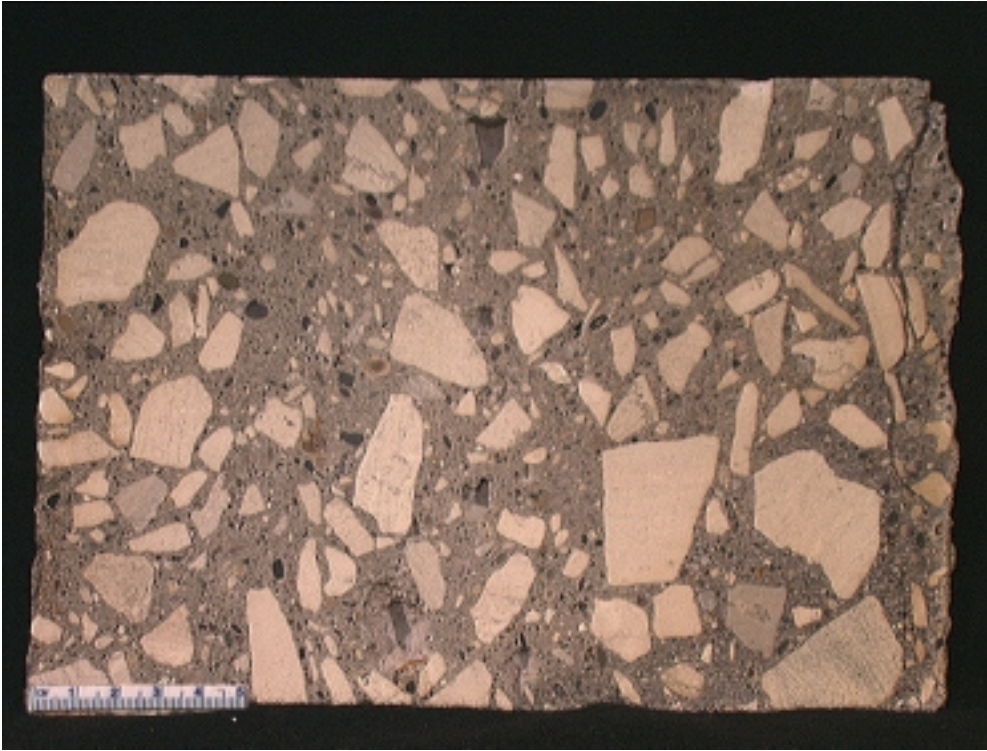
Figure 9: Iowa 175 Core 2 shows some aggregate / mortar segregation and cracking located near the core base (base to the right).

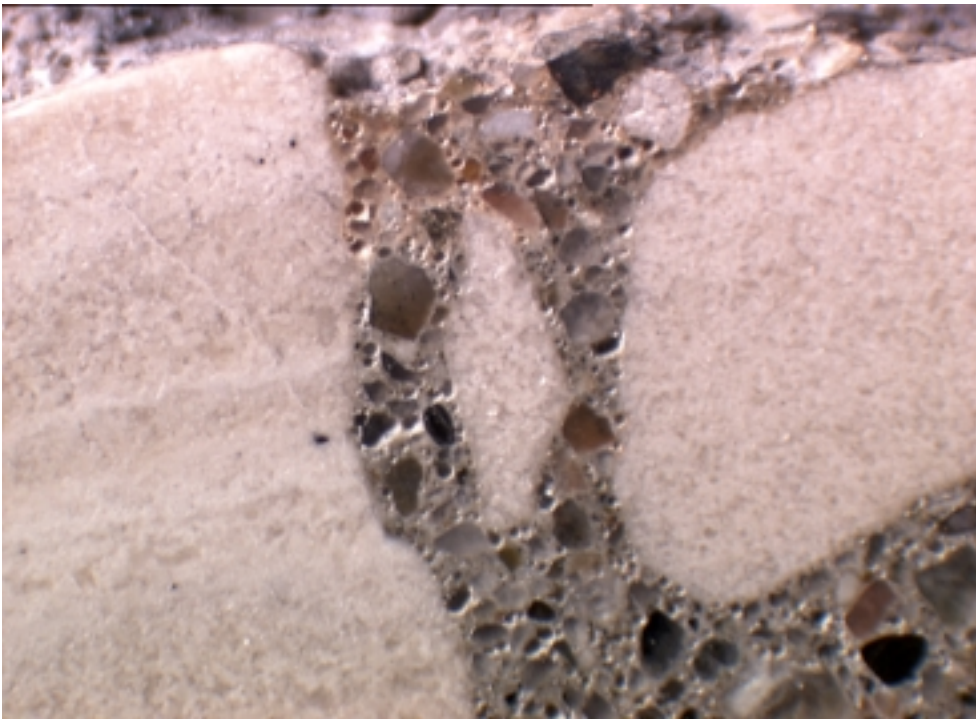
Figure 10. Iowa 175 Core 2 surface microstructure. Slight discoloration in the upper mortar indicates approximate depth of carbonation. Micrograph field width: 14 mm

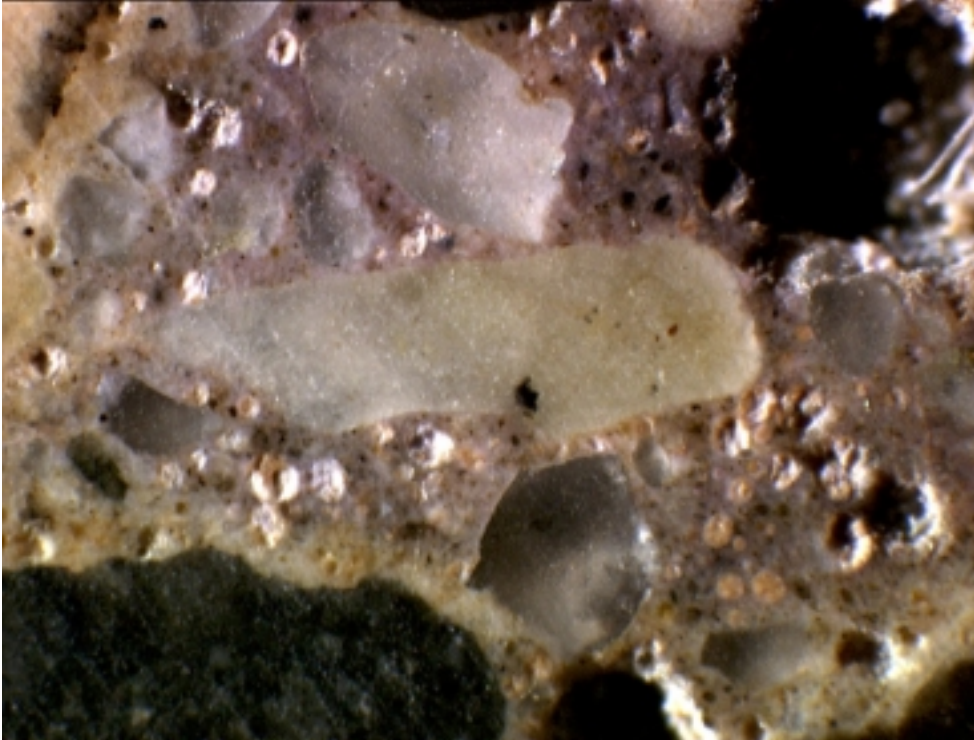
Figure 11. Iowa 175 Core 2 base mortar microstructure exhibiting partial filling of the entrained air void system. Micrograph field width: 4 mm

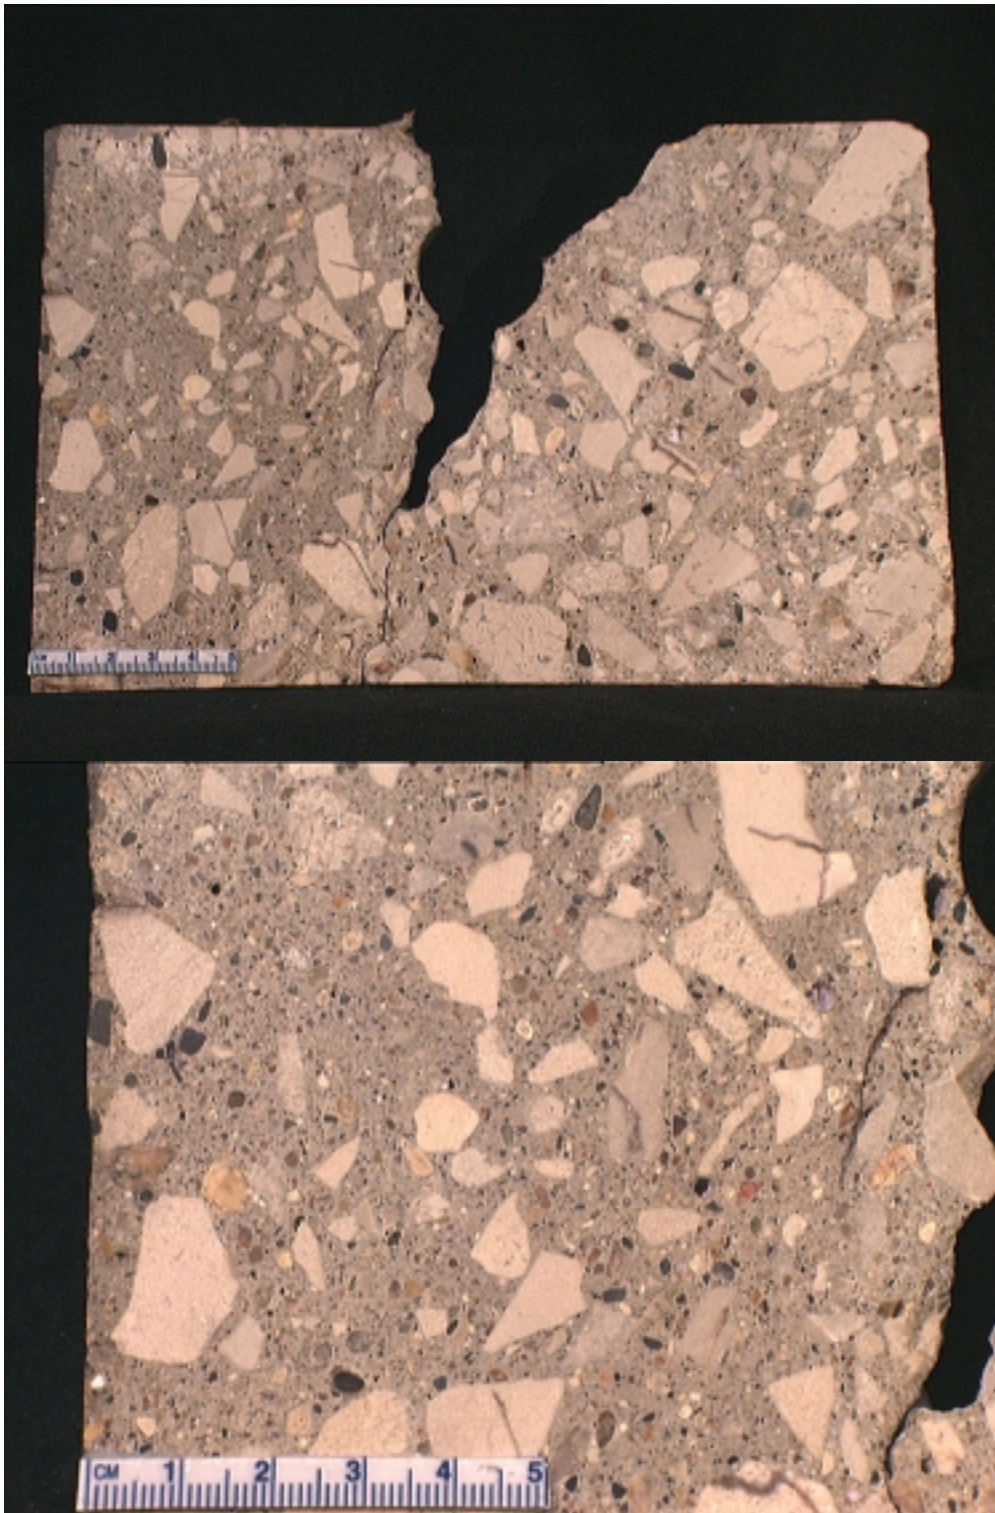
Figure 14. Core 7 (road surface is to the left) exhibits cracking of coarse aggregate, vertical cracks from the surface that are either drying shrinkage or freeze thaw-related. Segregation of mortar and coarse aggregate is visible in the whole core cross section (upper image) and the upper-core microstructure (lower).

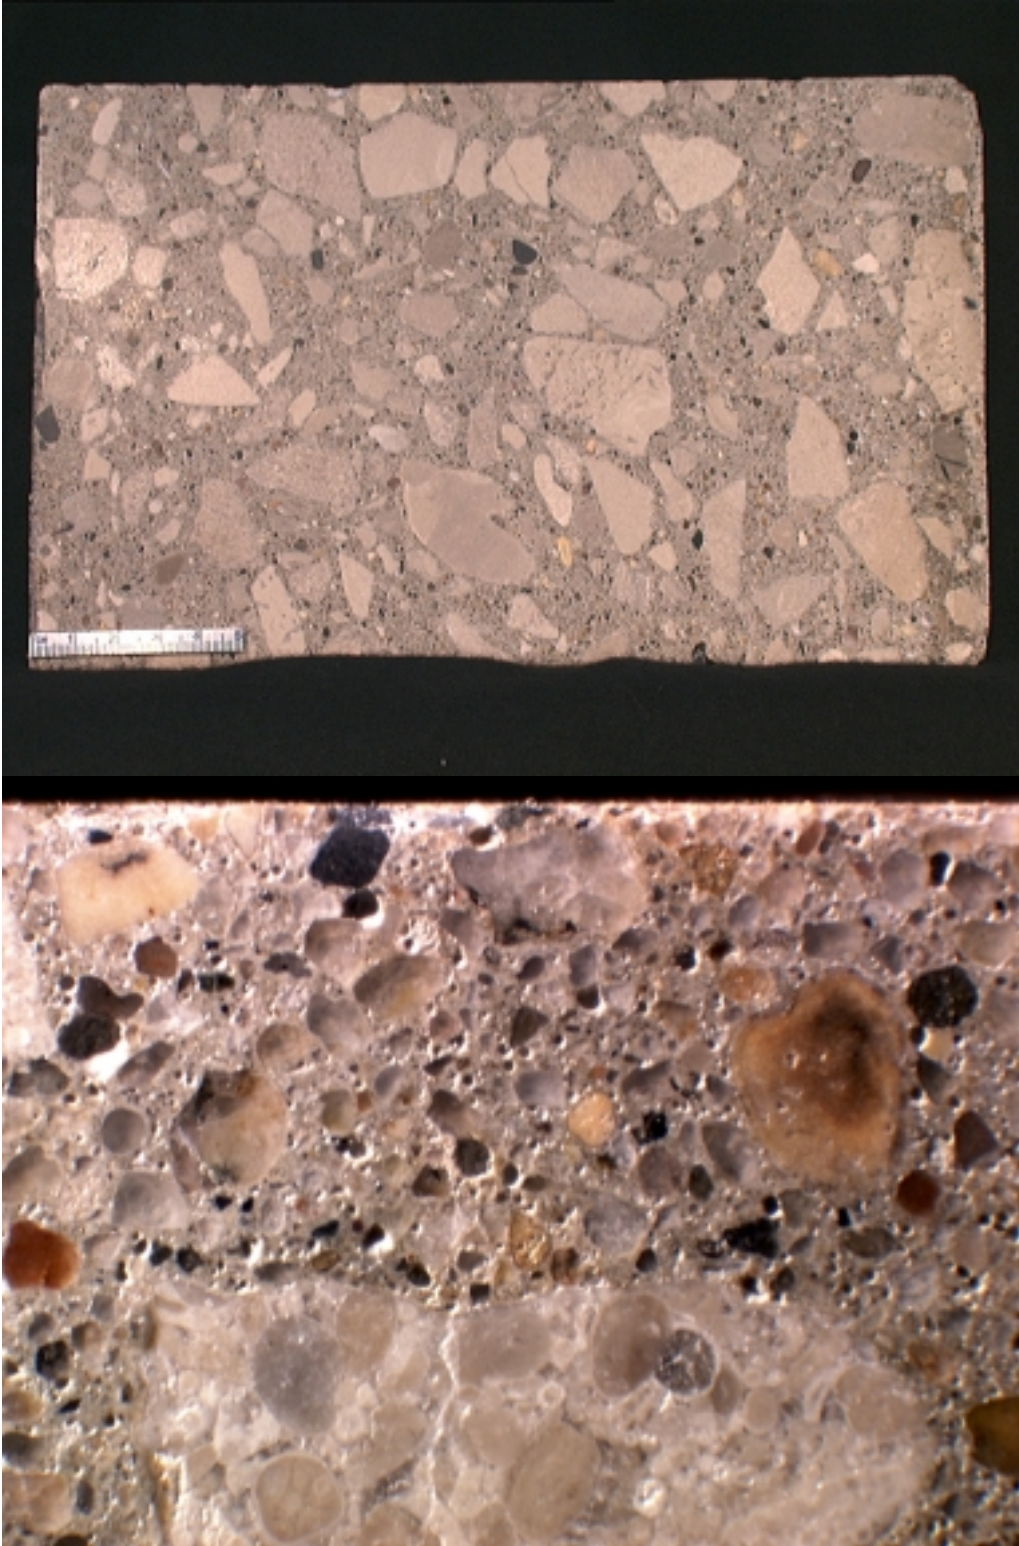
Figure 15. Core 8 exhibits less cracking but does have surface cracking to depths of 20 mm. Some of these cracks as seen in the lower image (13 mm field width) are associated with cracking within the coarse aggregate.

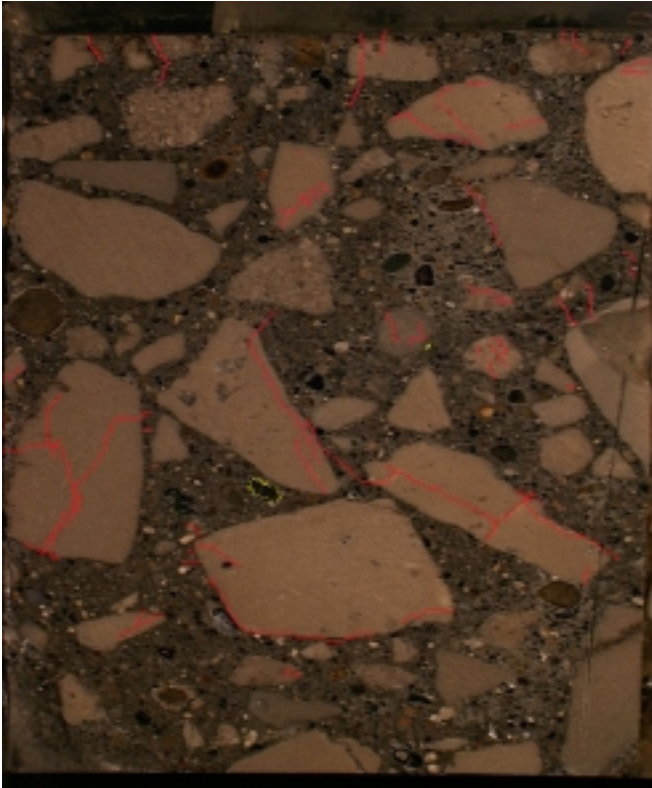
Figure 16. Cracking (red) and ASR (yellow) in Core 7 as observed using SEM. Cracking of aggregate is common. Surface cracks appear carbonated and terminate in both the mortar and the coarse aggregate. Micrograph field width is approximately 10 cm.

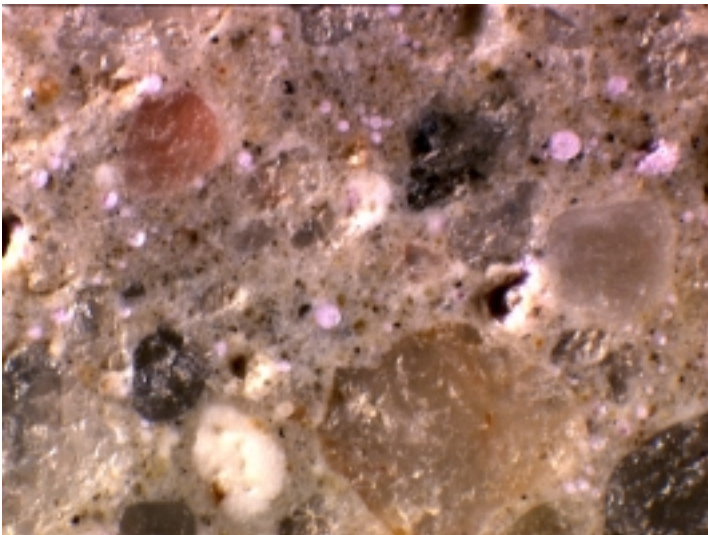
Figure 17. Filling of the smaller entrained air voids (purple) has significantly increased the air void spacing factor while only slightly decreasing the total entrained air void volume for both Cores 7 and 8. Field width: 4 mm.

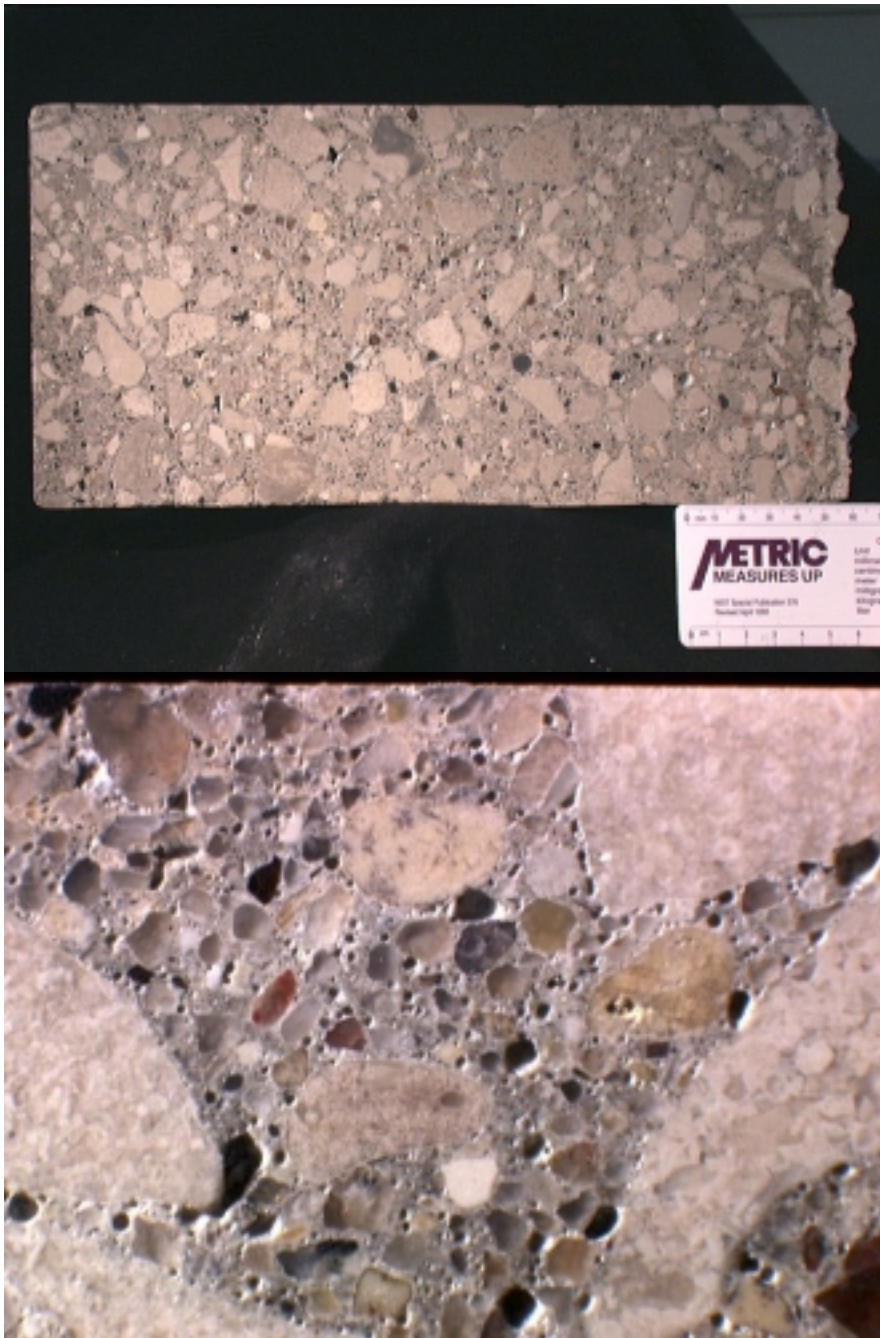
Figure 27. Core 18 contains about 12 % entrained air volume and a spacing factor of 0.08 mm. Aggregate gradation appears more uniform, and possibly smaller maximum size than the degraded pavement concretes. Low specific surface and common entrapped air voids are features common to other cores in this study.

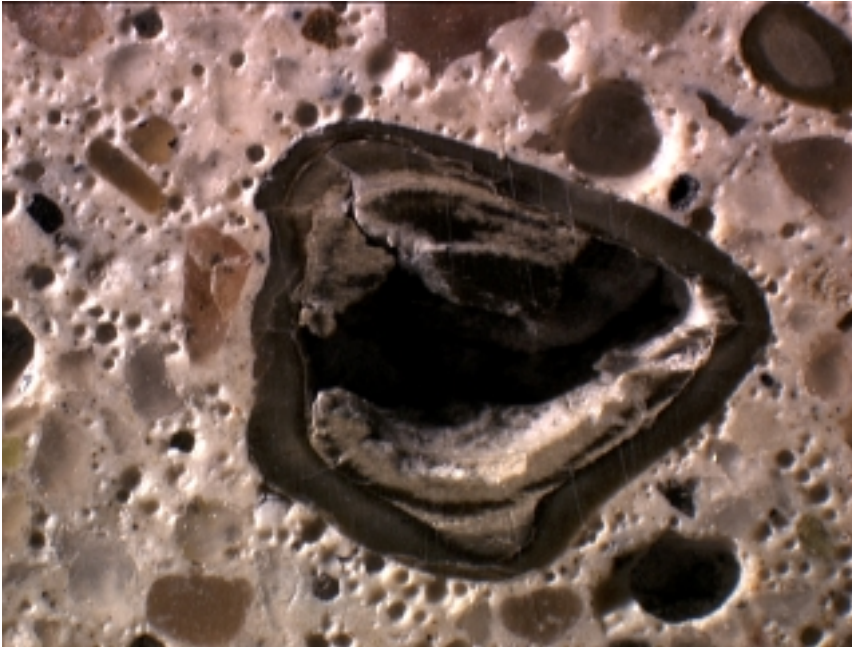
Figure 29. Core 18 mortar microstructure includes numerous shale fragments that appear to have undergone alkali-silica reaction, however little cracking of the mortar was evident. SEM examination indicated that some of the reaction product permeated the paste filling the capillary voids adjacent to the shale. Field width: 10 mm.

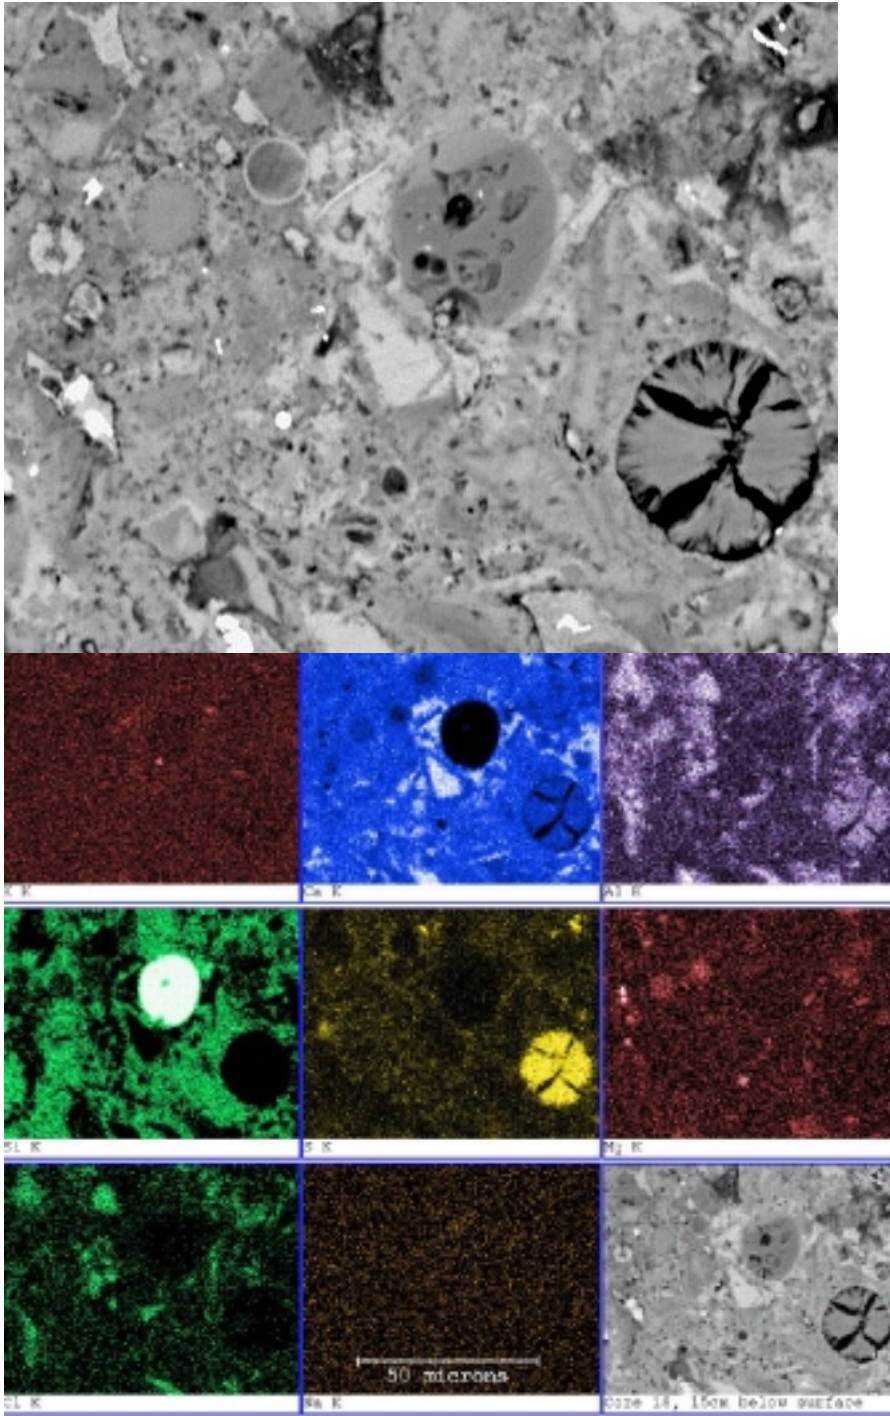
Figure 31. SEM of Core 18 shows an air void partially filled with ettringite (lower-right) and partially reacted fly ash particles (circular). X-ray element distribution (lower image) shows regions of high sulfur and aluminum that delineate locations of ettringite. Regions of chlorine and aluminum delineate regions of chloroaluminate. Field width: 75 μm .

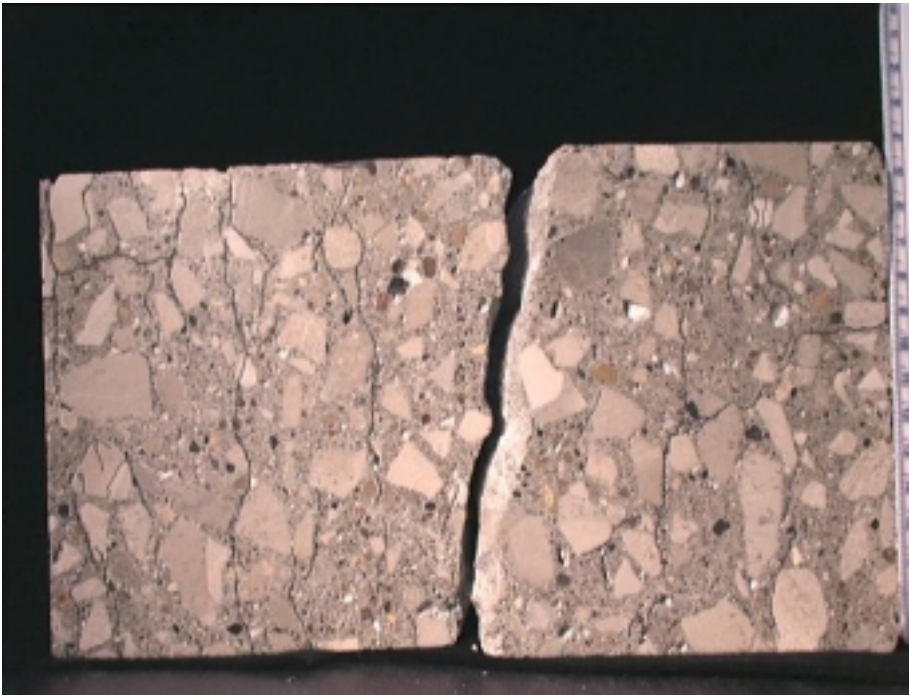
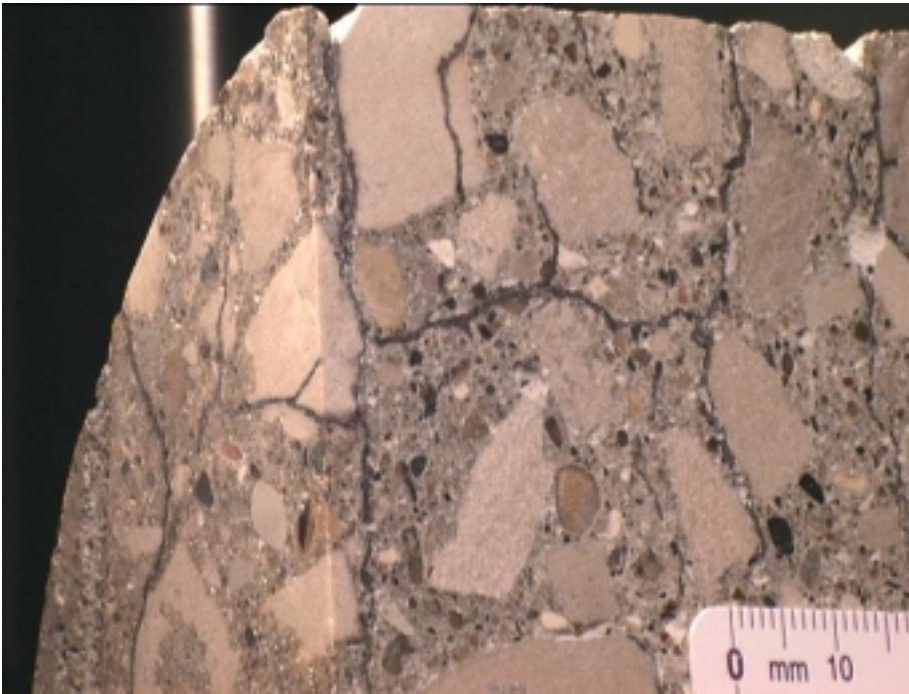
Figure 32. Core 19 exhibits extensive cracking of both the paste and coarse aggregate. Cracks trending parallel to the pavement surface (to the left) intersect perpendicular cracks; features typical of freeze-thaw cracking. The oblique view of the upper portion of core 19 shows cracking in both the surface (polished for clarity) and cross-section orientations.

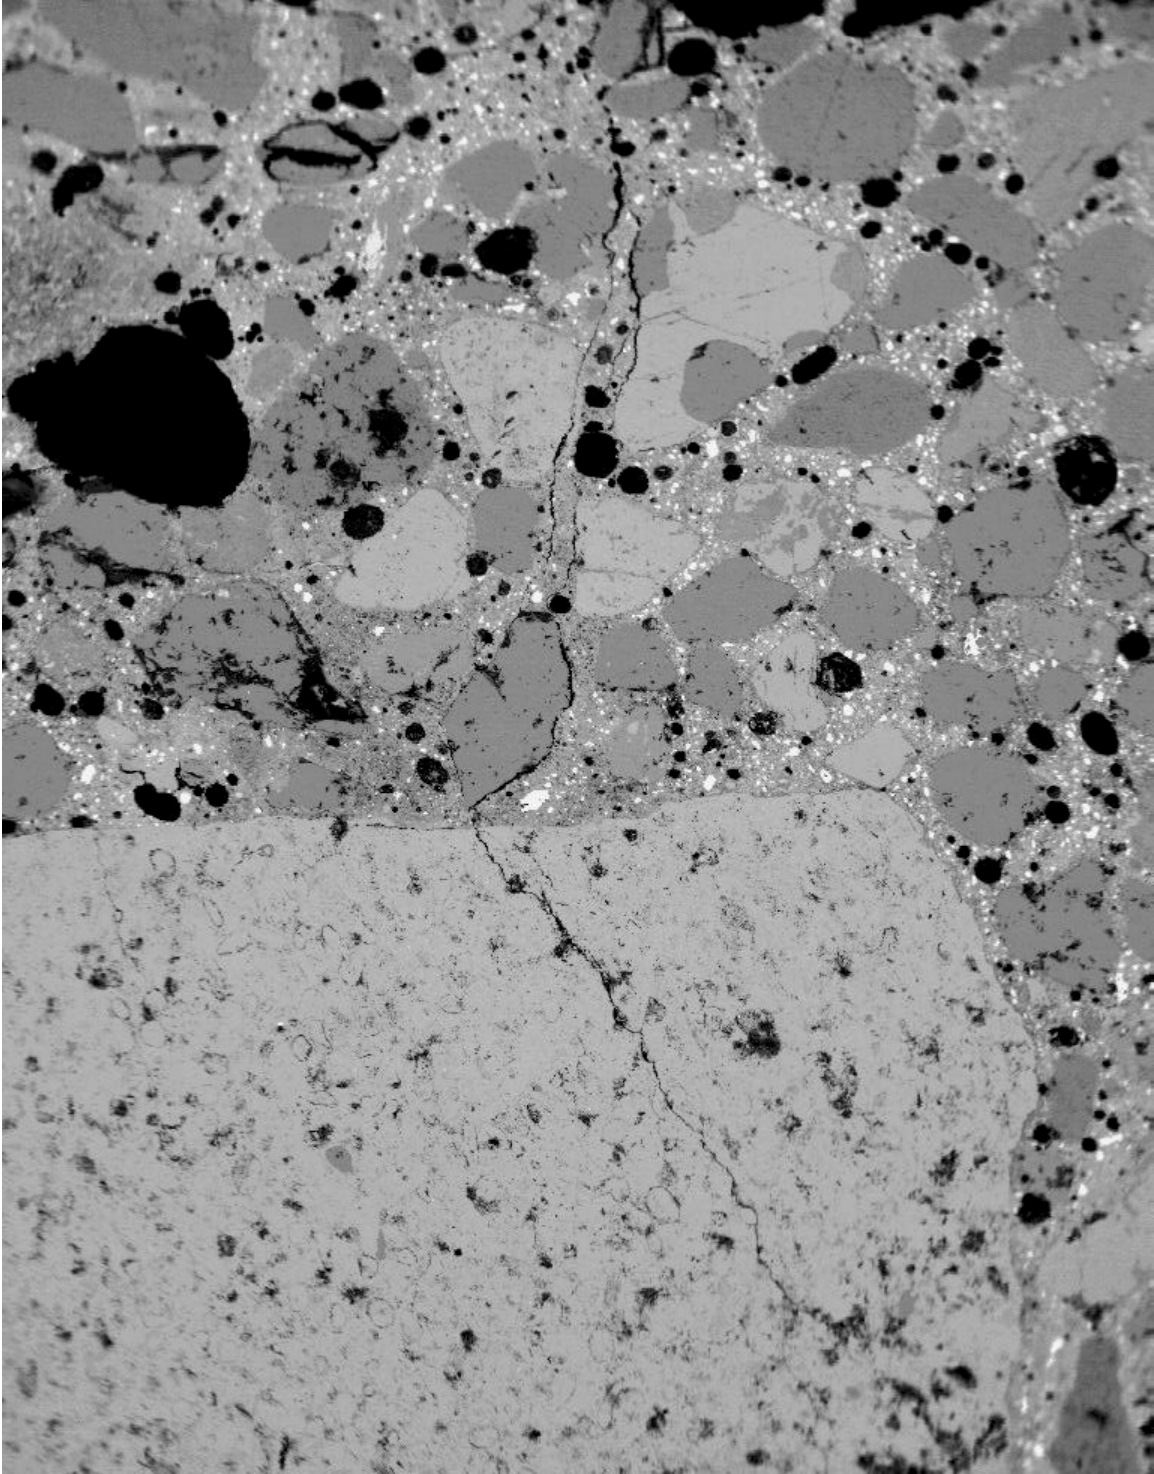
Figure 33. SEM image of a surface crack (road surface is at the top, 5 mm field width) extending through the paste portion of the mortar and terminating in a coarse aggregate.

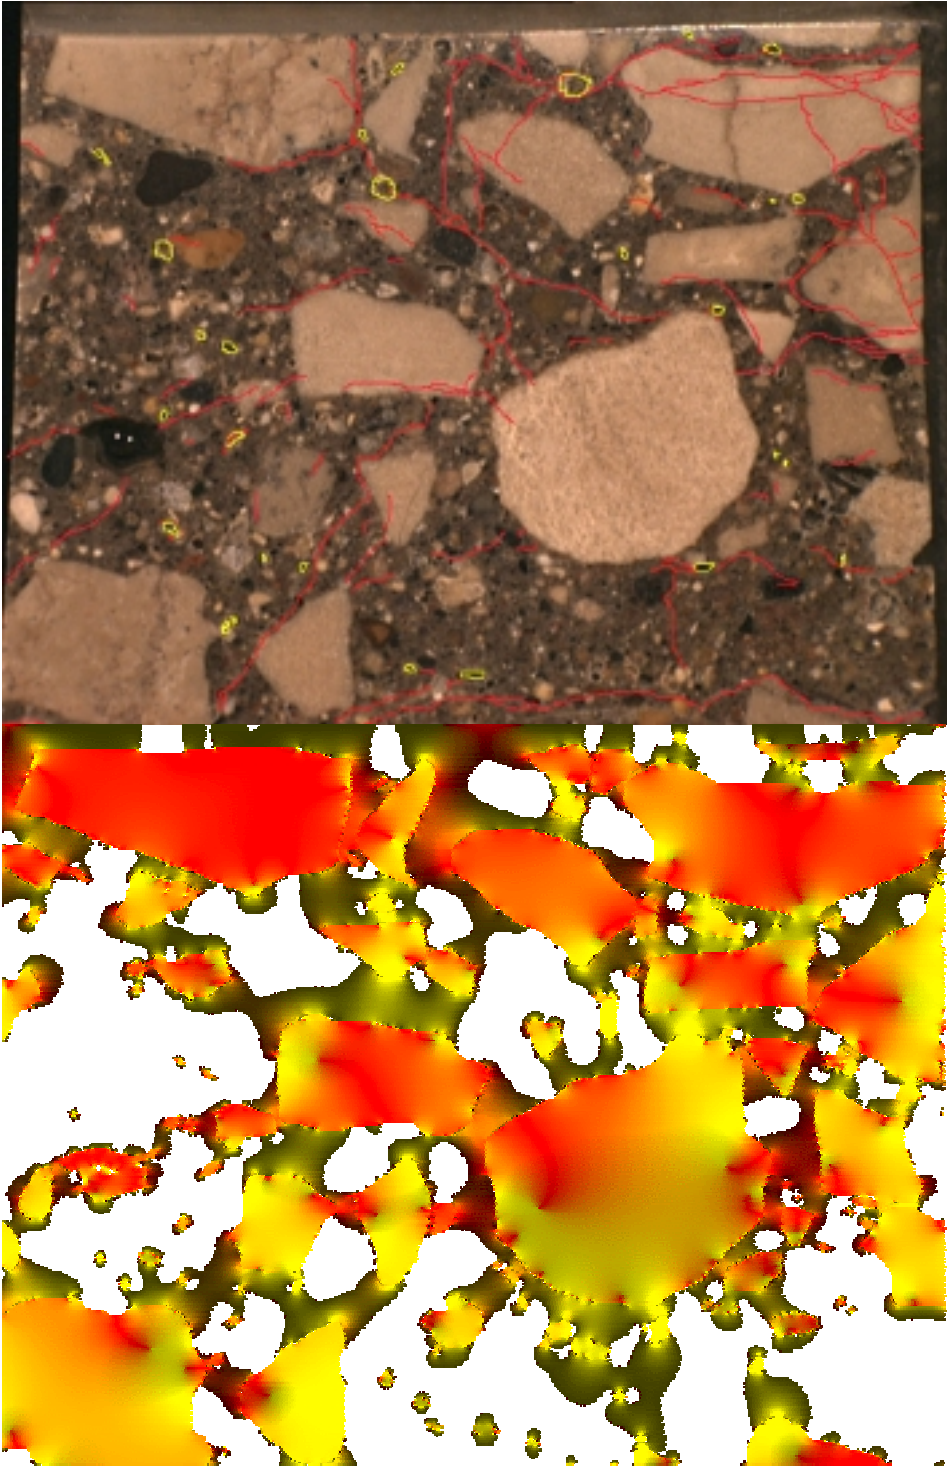
Figure 37. Top portion of core 19 with cracks (red) and ASR-affected shale grain (yellow) shows cracking through both the cement paste and coarse aggregate. A color-coded stress image resulting from a simulation of aggregate expansion showing regions of high stresses in red correlates well with some, but not all of the observed cracking.

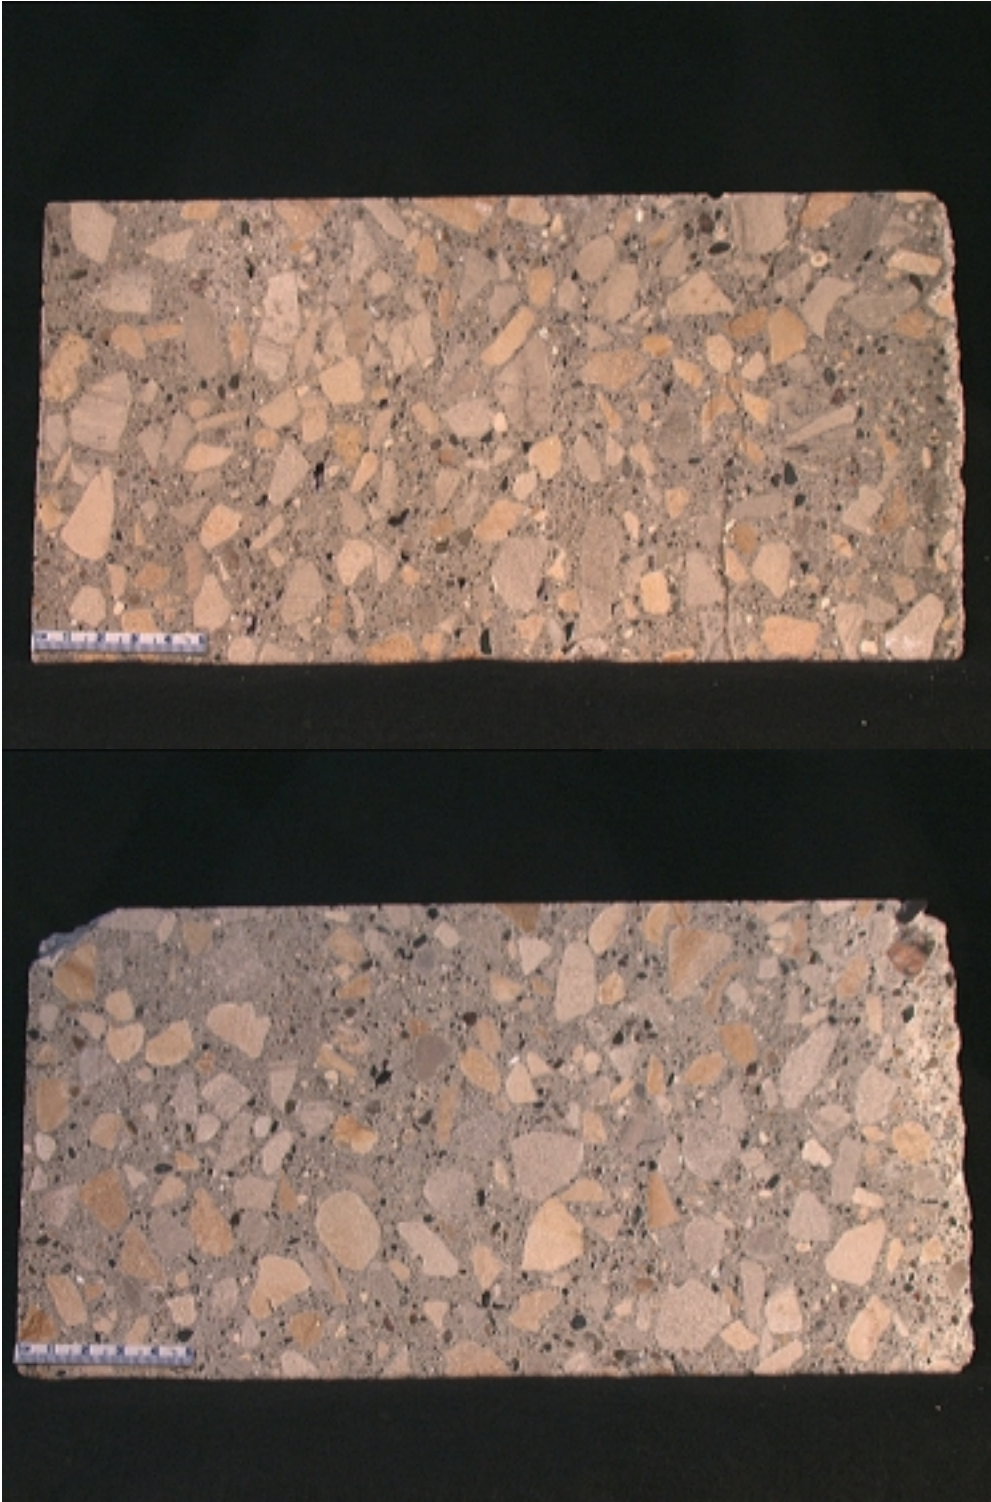
Figure 38. Cores 11, joint (top) and 12, mid-panel (bottom) cross section with horizontal crack in lower-most third. Some segregation is visible in both cores.

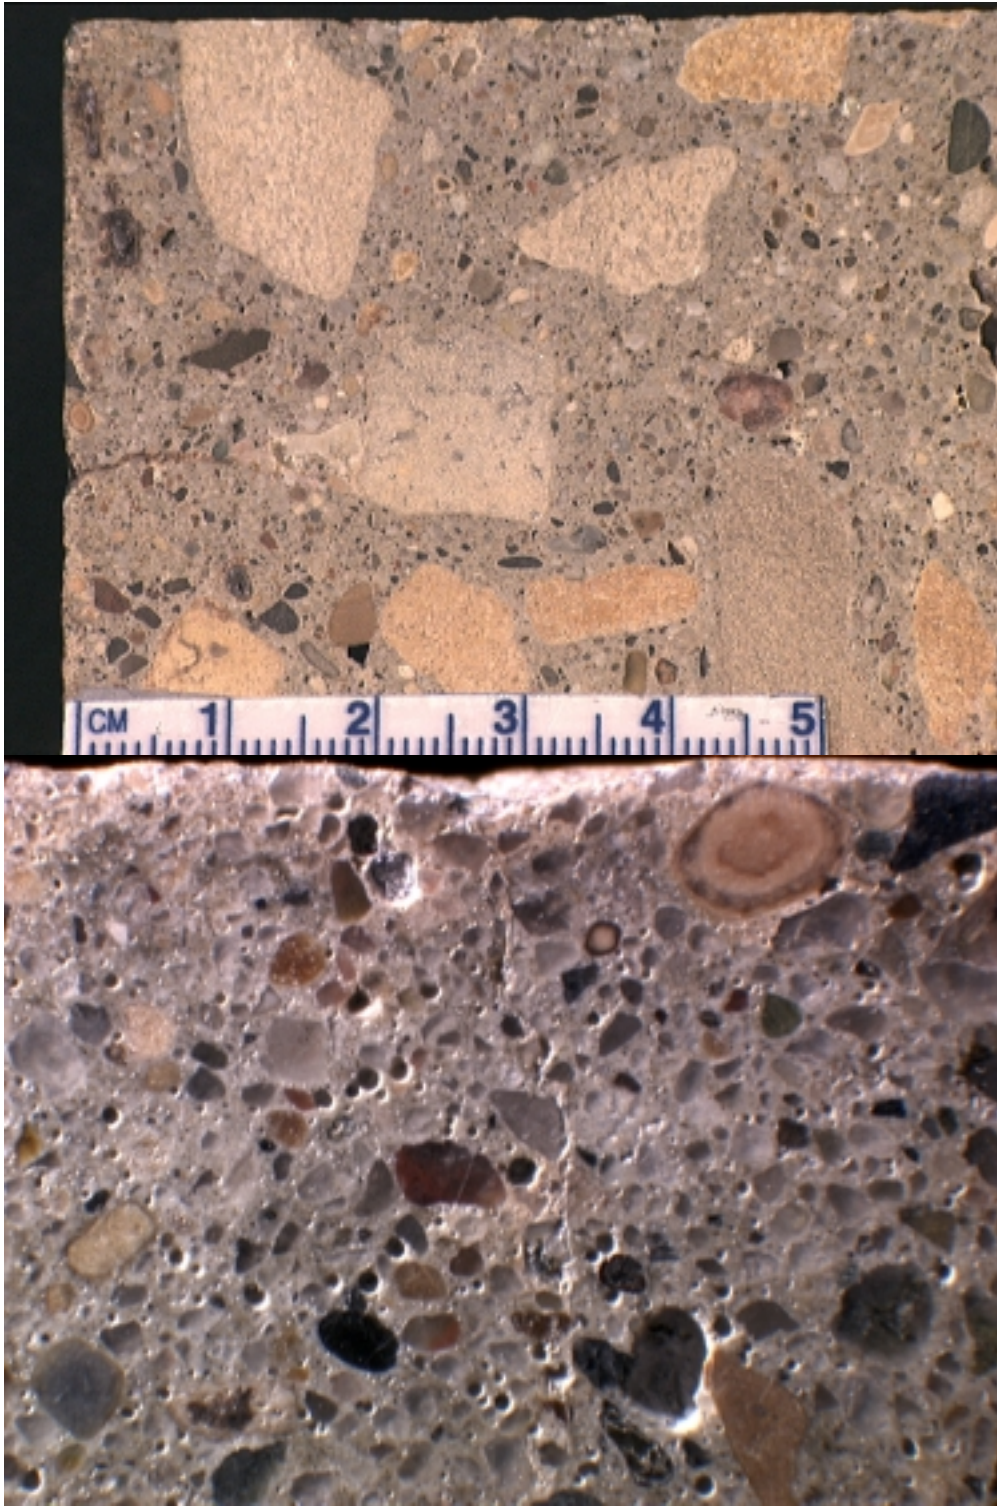
Figure 39. Surface cracking in Core 11 to about 20 mm passes through both the mortar and coarse aggregate. Lower image shows minor surface carbonation and cracking within the mortar. Field width 8 mm.

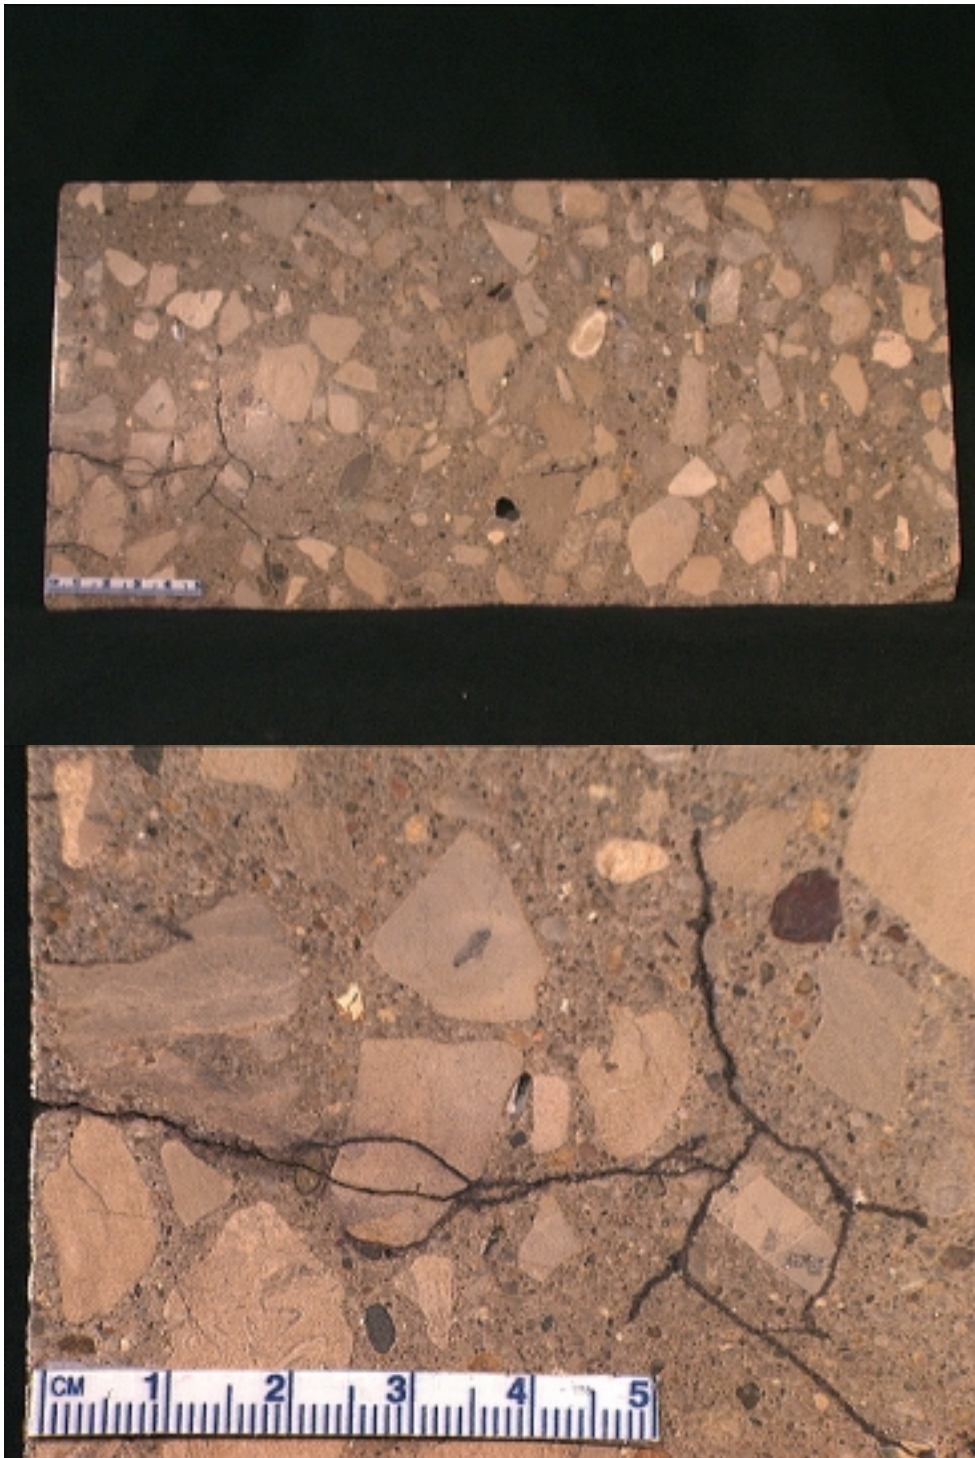
Figure 43. Core 29 cracking near surface passes through both the mortar and coarse aggregate. Cracking also follows close along paste-aggregate interface and is typical of a shrinkage crack. Cracking in aggregate and in the mortar at depth may reflect freeze-thaw damage, as the air void system in the upper half of this core is much poorer than that in the lower half.
