**RECONNAISSANCE REPORT ON DAMAGE TO
ENGINEERED STRUCTURES DURING
THE MAY 1999 OKLAHOMA CITY TORNADO**

August 2002

Building and Fire Research Laboratory
National Institute of Standards and Technology
Gaithersburg, MD 20899-8611

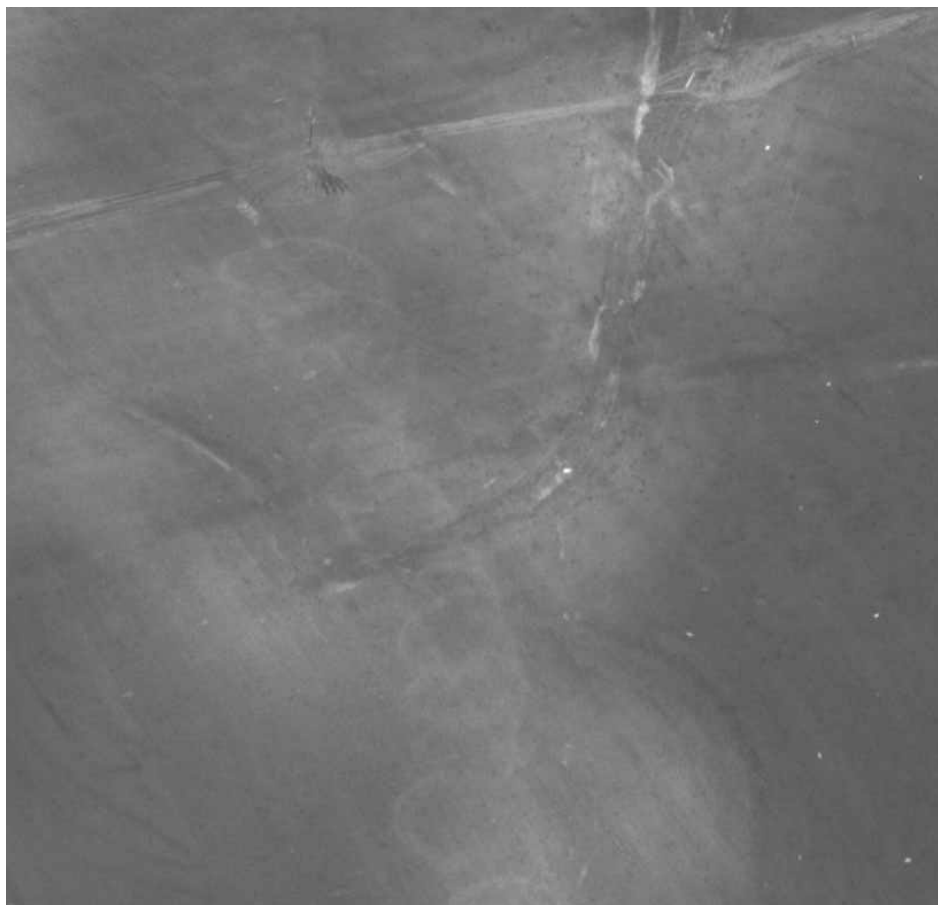
Figure 1-2: Tornado Vortex Scars in a Field near Crescent, Oklahoma.

age and destruction in addition to the structural damage described in detail in this report. Figure 1-1 shows the distinct scars left by one of the tornadoes as it passed through a field near Crescent, Oklahoma.

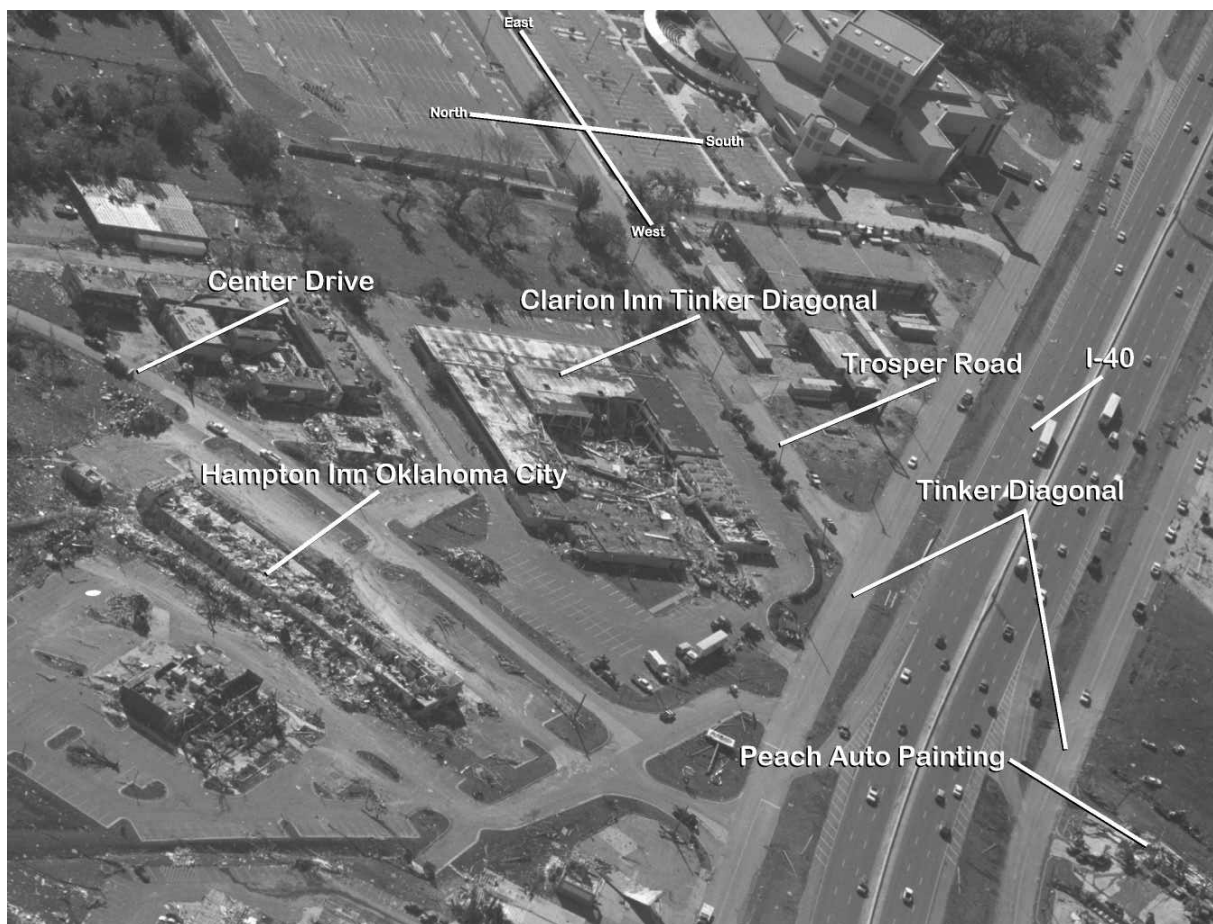
Figure 1-3. Damage to Structures along the Tinker Diagonal, Midwest City.

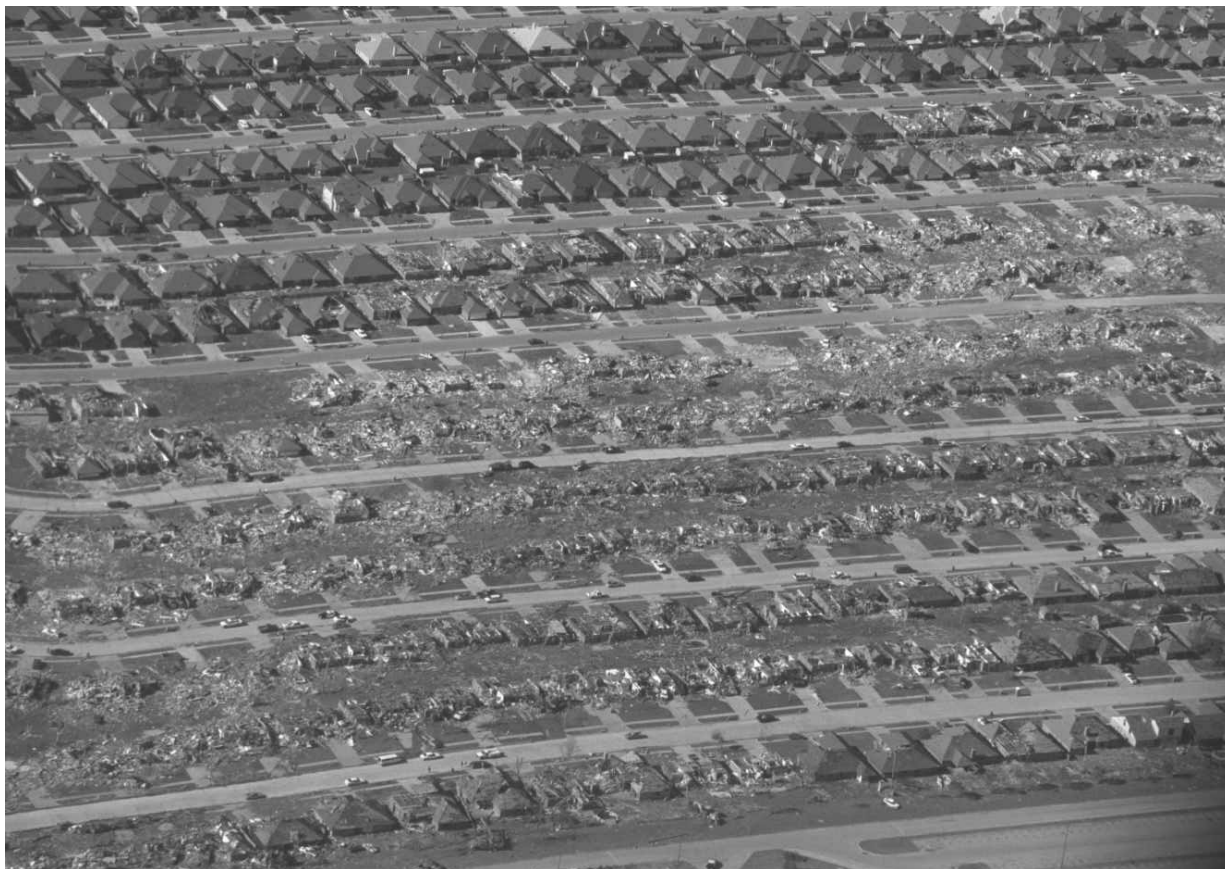
Figure 1-4. Damaged Housing Complex South of Westmoore High School, Oklahoma City.

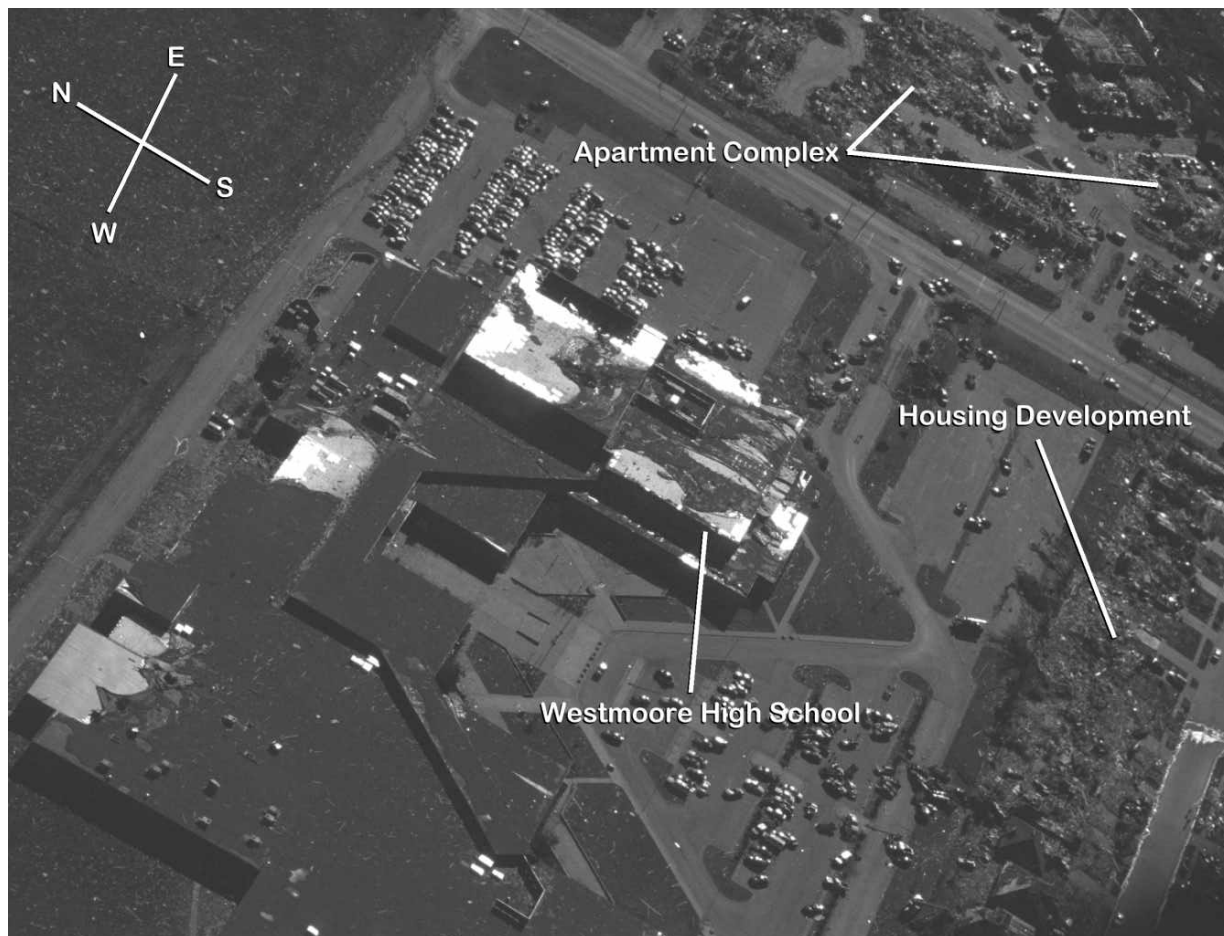
Figure 1-5. Damage to Westmoore High School and Surrounding Areas, Oklahoma City.

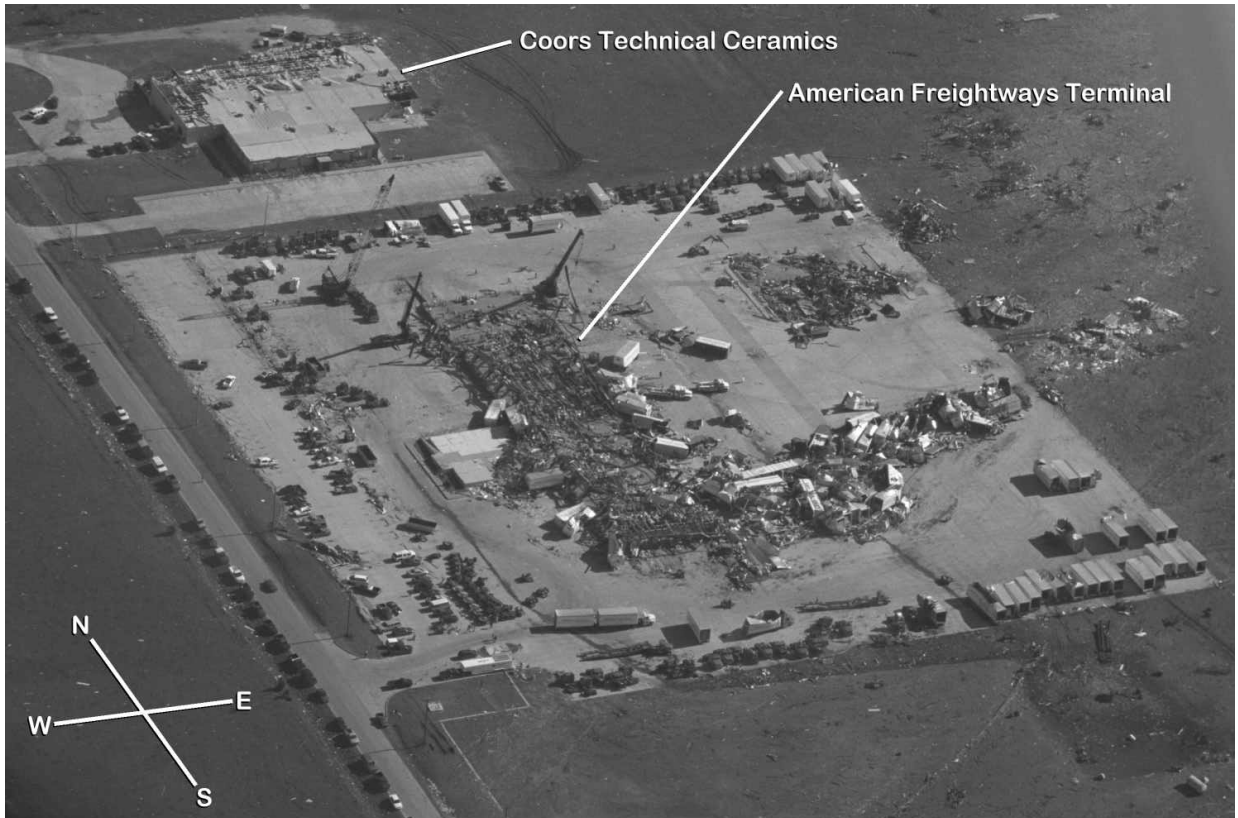
Next, the damage investigation was conducted in an industrial section of Oklahoma City. The American Freightways terminal, shown in Figure 1-6, could not be investigated because the cleanup of the debris was already at an advanced stage, and most of the wreckage had been moved. Of the remaining buildings damaged in that industrial section it was possible to investigate only the Coors Ceramics factory (Figure

Figure 1-6: Damage to the American Freightways Terminal and Coors Ceramics Factory, Oklahoma City.

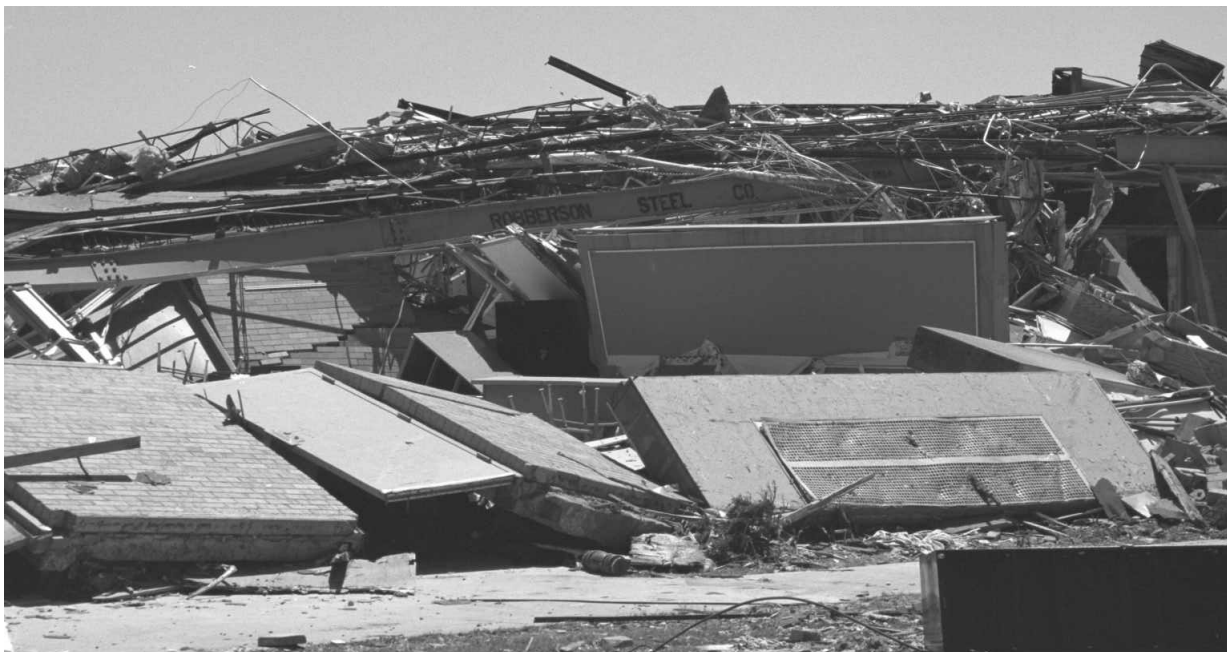
The front section of the building suffered varying damage. The main entrance was near the center of this section, and most of the structure north of the entrance was severely damaged or destroyed. As shown in Figure 2-2, most of the walls and the roof in this part of the building collapsed. The damage was less severe near and south of the entrance. Here some walls and some parts of the roof survived. Figure 2-3 shows the damage to the southern end of the front section. The front wall of the cafeteria had collapsed inward and a portion of the roof has collapsed, but much of the roof sur-

Figure 2-2: Remains of Northern End of the Front Section of Kelly Elementary School.

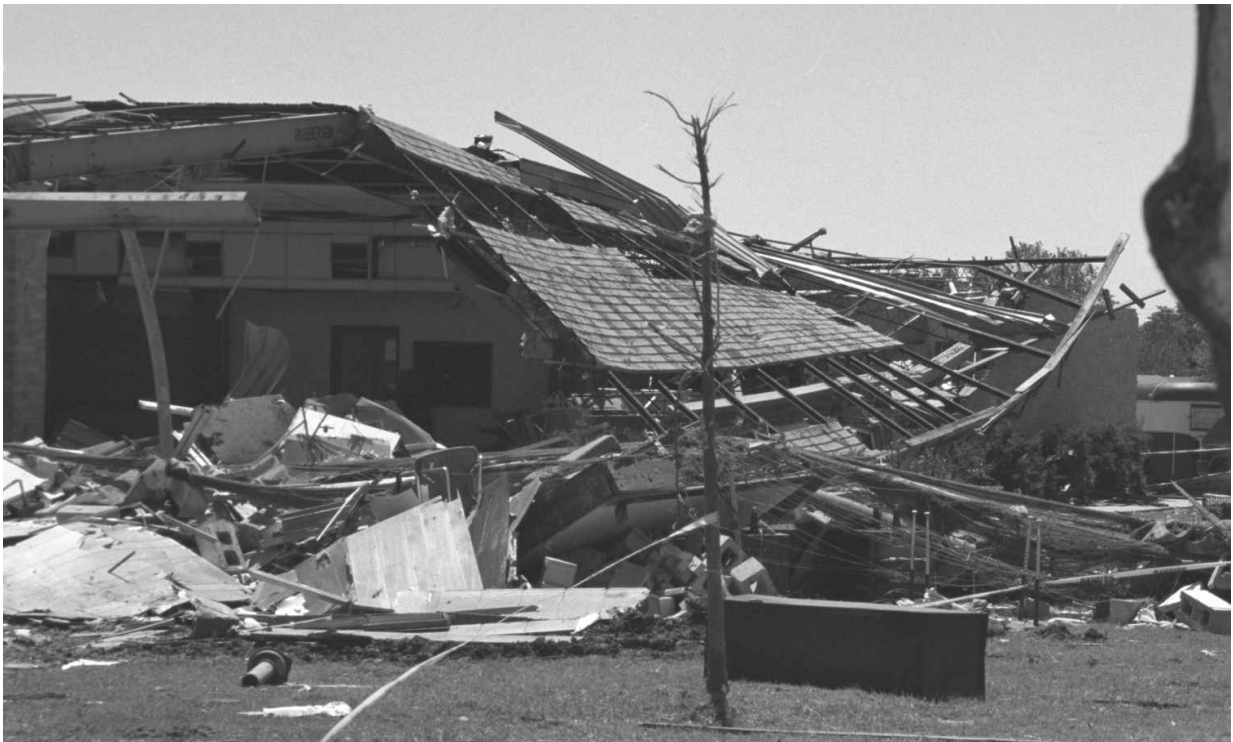
Figure 2-3: Damage to Southern End of Front Section of Kelly Elementary School.

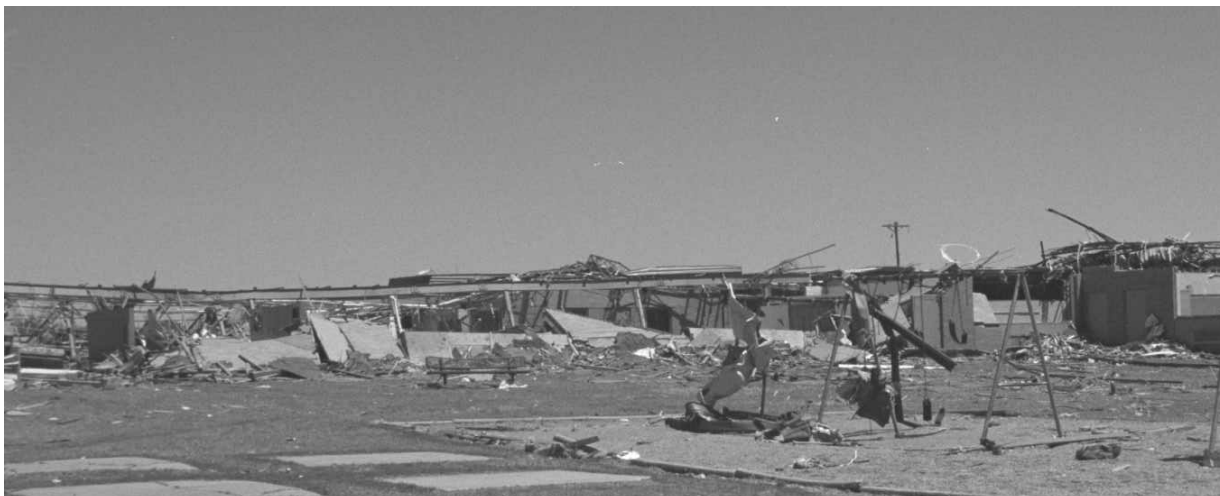
Figure 2-4: South Side of the Center Section of Kelly Elementary School.

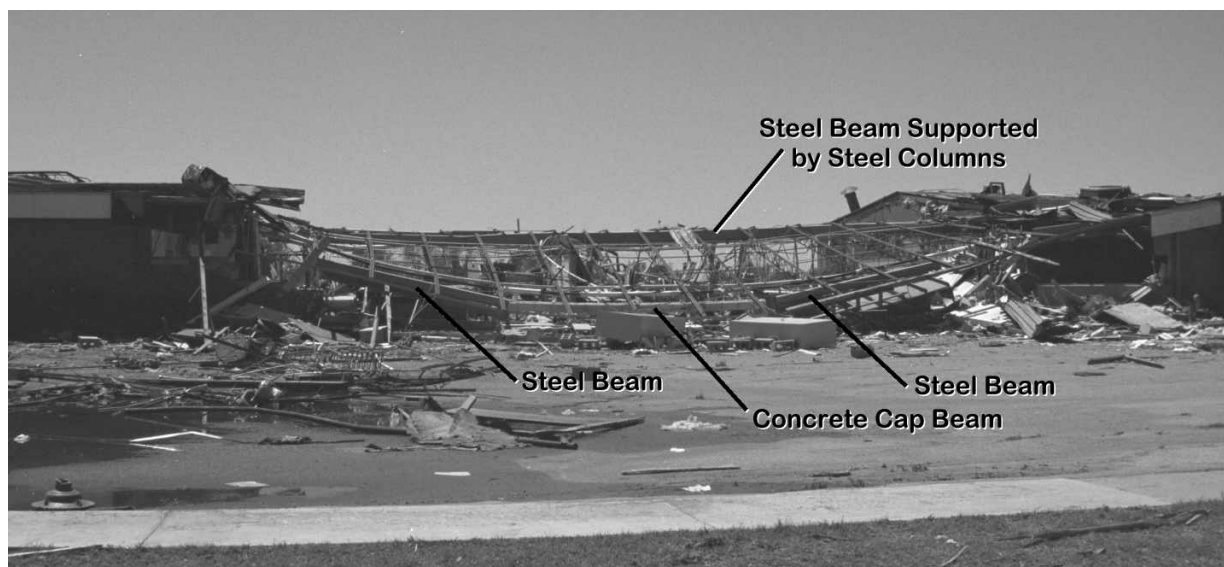
The center section of the building was the most severely damaged. Here the roof trusses ran north-south, with the southern ends supported by a steel beam on steel columns. The northern ends of the center-most trusses were supported by a reinforced concrete cap beam on a concrete block wall with brick facing, while the eastern and western trusses were supported on steel beams supported by the cap beam and the end walls. Both the southern and northern walls were destroyed and nearly all roof covering was removed. The steel columns along the south wall, visible in Figure 2-4, bent, but did not fail. The loss of the north wall, however, removed all support for the north side of the roof leading to its collapse, as shown in Figure 2-5.

Figure 2-5: North Side of the Center Section of Kelly Elementary School.

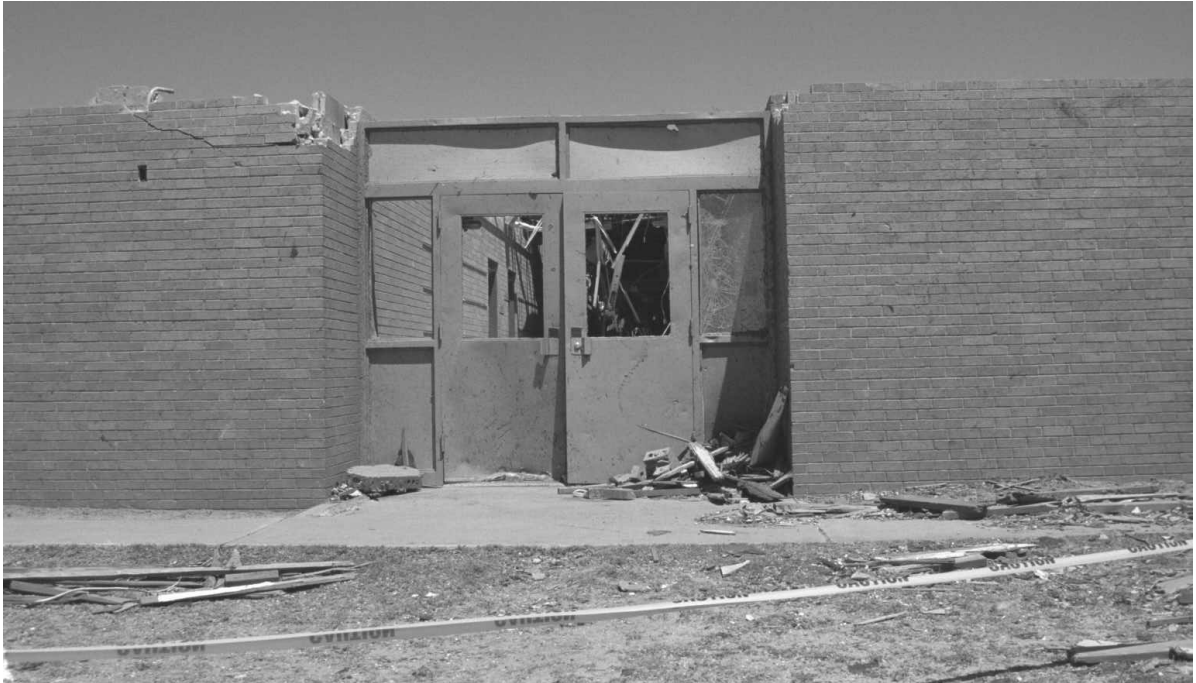
Figure 2-6: South Side of the East Section of Kelly Elementary School.

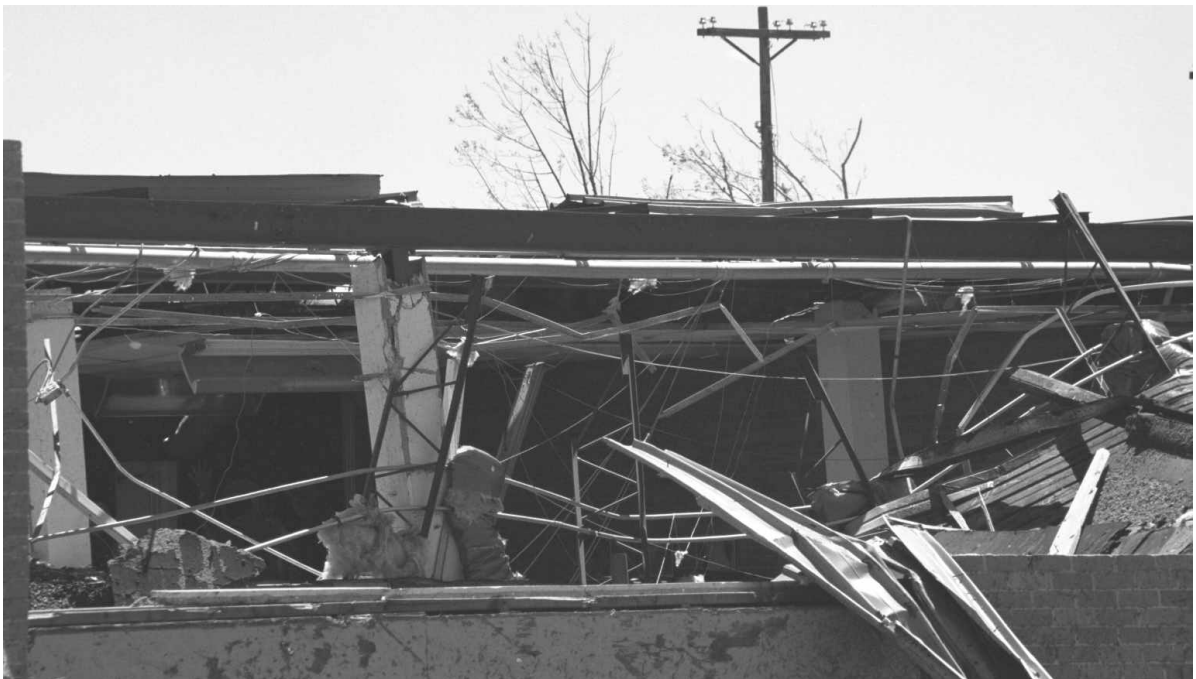
Figure 2-7: Collapsed Wall on West Side of the East Section of Kelly Elementary School.

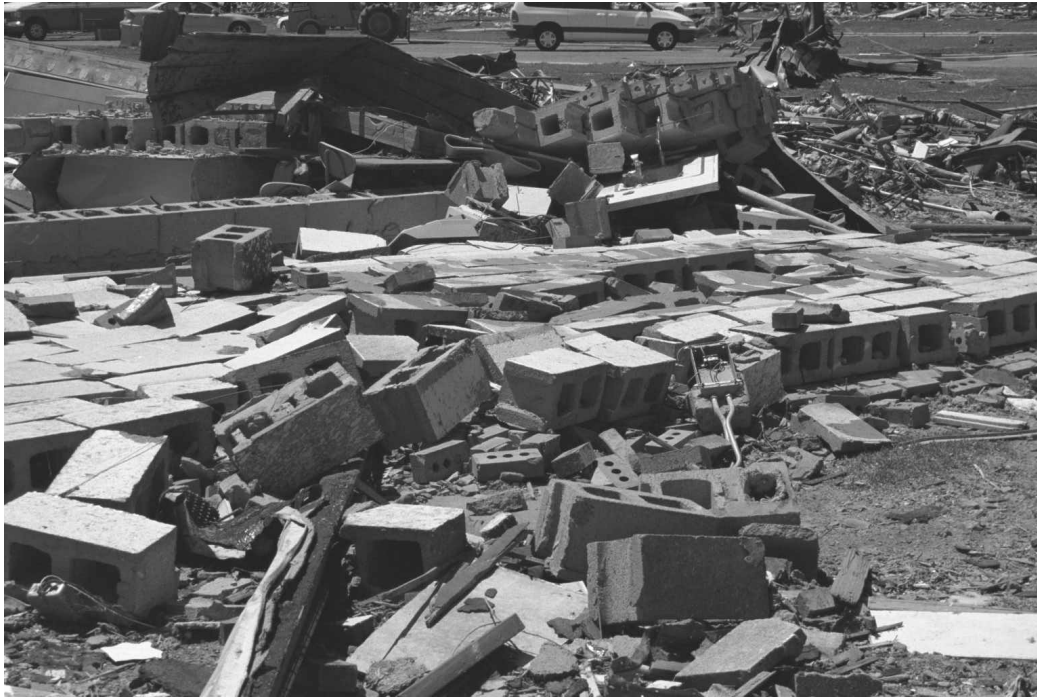
nearly its entire roof and a section of the western wall collapsed. Many of the roof trusses were lifted off and every window was broken. Although most of the walls survived, this section of the building could not have provided a safe space for the occupants. Figure 2-6 shows the south entrance to the central hallway in this section. Figure 2-7 shows the western side of the northern end of this section, where the wall and part of the roof collapsed.

Figure 2-8: Collapsed Wall at North End of West Section of Kelly Elementary School.

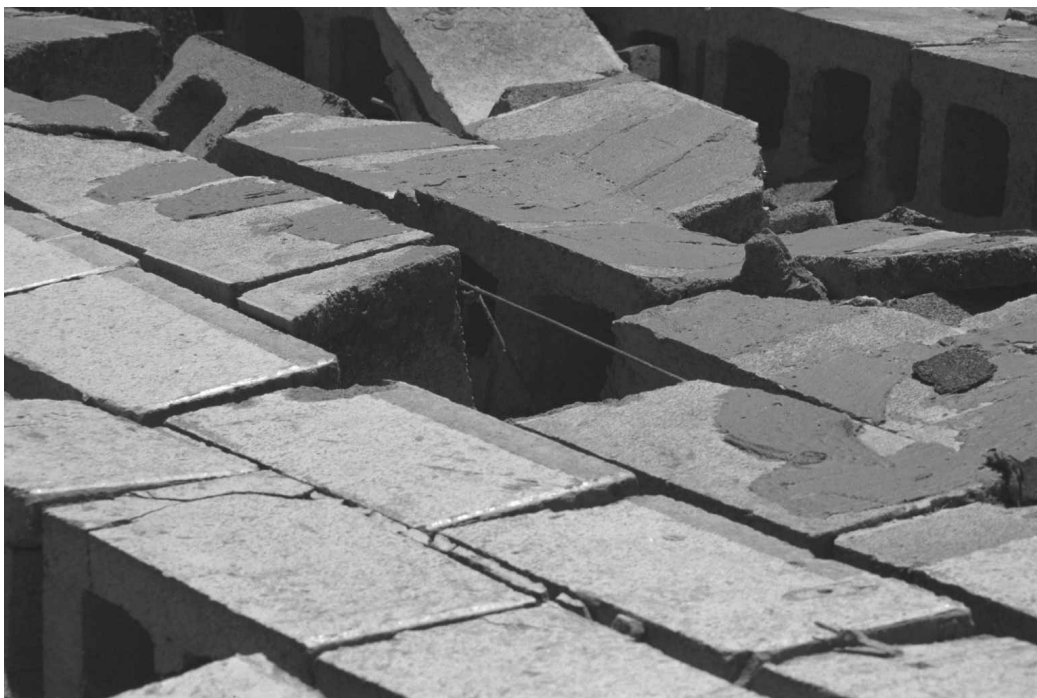
This school had numerous structural weaknesses, which contributed to the destruction. The most significant weakness that was observed was the inadequate reinforcement in the masonry walls. The walls had only minimal horizontal reinforcement and no vertical reinforcement. Inspection of one collapsed wall, shown in Figure 2-8, revealed that only every third course of the concrete block was reinforced. Moreover, the mortar was poorly bonded to both the reinforcing bars and the blocks (Figure 2-9).

Figure 2-9: Detail of Mortar and Reinforcement in the Collapsed Wall at North End of West Section of Kelly Elementary School.

Additional horizontal reinforcement, vertical reinforcement, and a better bond with the mortar would all have significantly increased the strength of the walls.

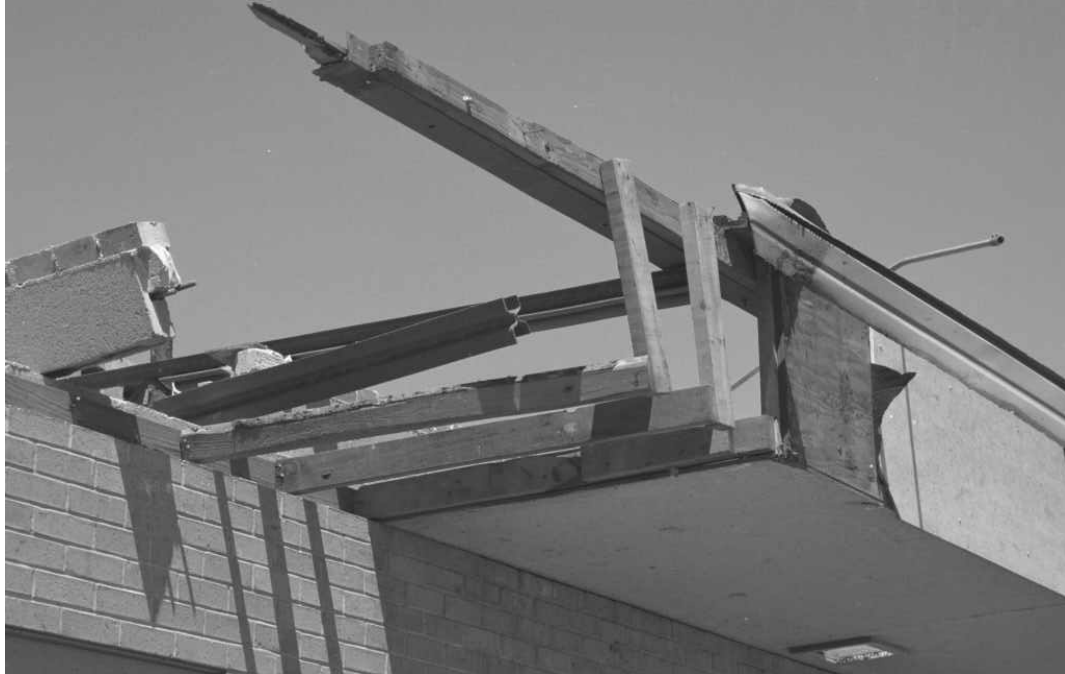
Another significant weakness was the wooden soffit beneath the cornice, shown in Figure 2-10. The failure of the soffit allowed the wind to penetrate under the roofing, thereby increasing the total wind load on the roof. The wood studs used to support the soffit were simply toe-nailed to the sup-

porting member. These connections could not withstand extreme loads, and failure of sections of the soffit contributed to the roof failures.

Figure 2-10: Detail of the Cornice and Soffit on East Side of Kelly Elementary School.

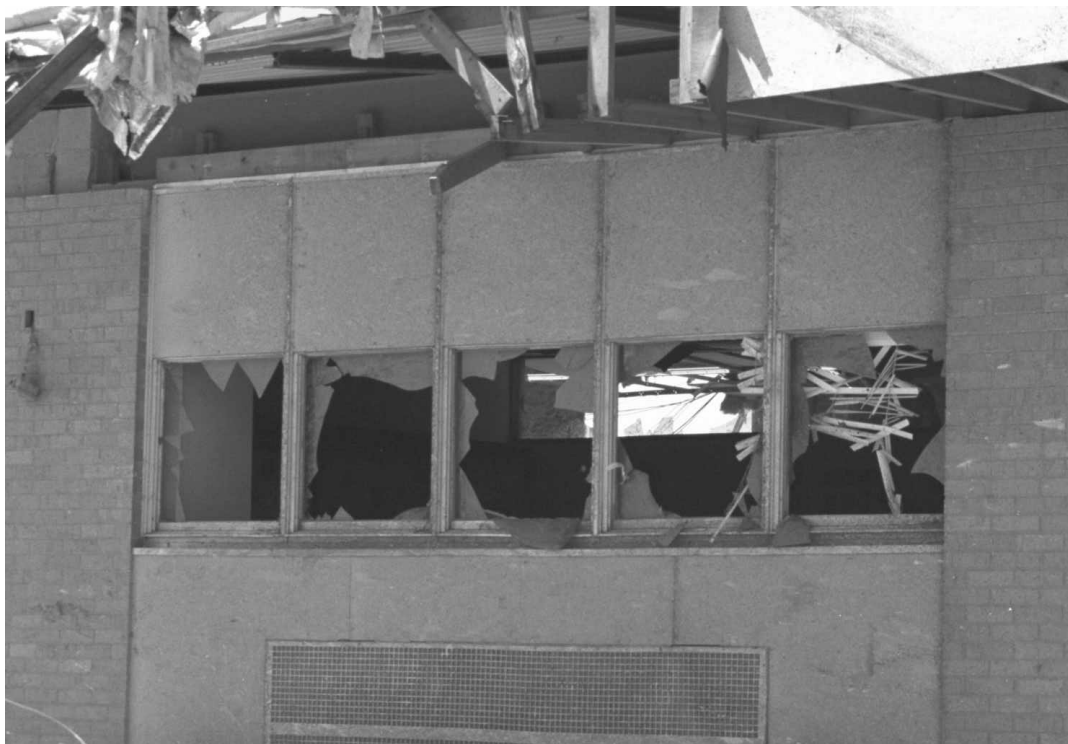
A third major weakness was the glazing. The glazing appeared to be standard weight, monolithic annealed glass, which was shattered by the wind and flying debris as shown in Figure 2-11. The glazing fragments would have posed a severe hazard to the building occupants.

Figure 2-11: Broken Windows on East Side of Kelly Elementary School.

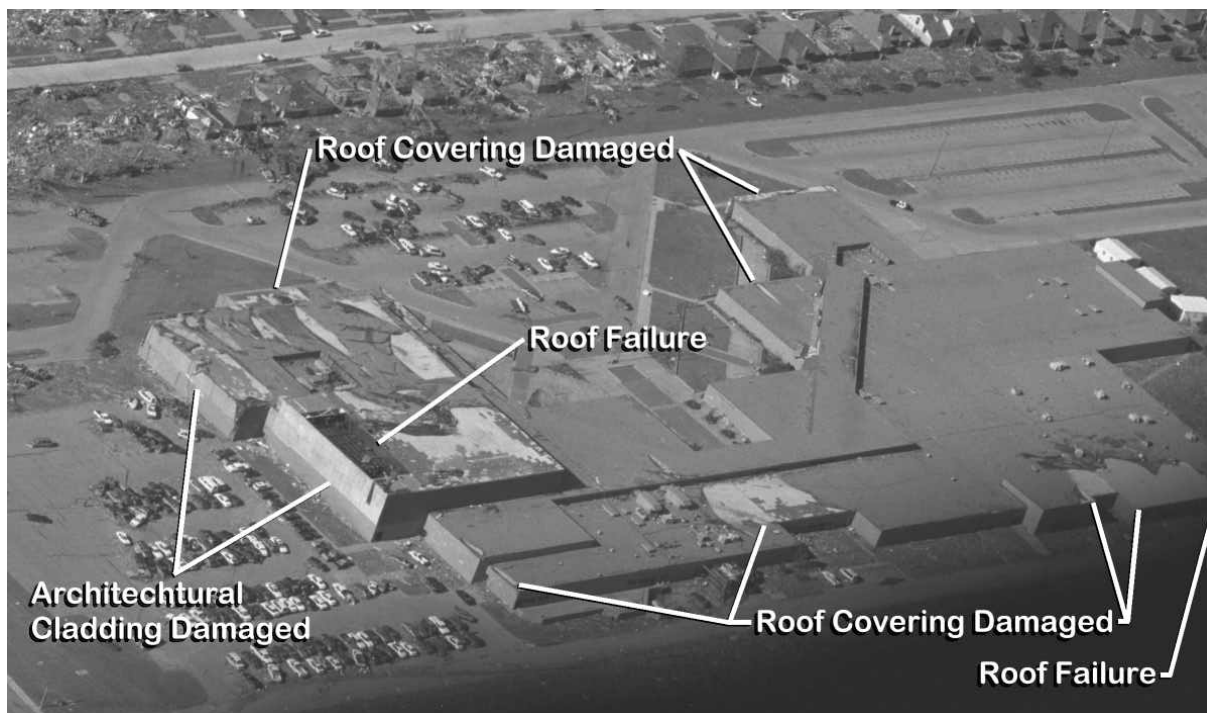
The school's roof had a wide variety of types of damage, as shown in Figure 2-12. As mentioned above and shown in Figure 2-13, a large section of the auditorium roof was destroyed. A smaller section of the northwest corner of the roof was also lost. The roof covering was heavily damaged in many locations, with the worst damage occurring in the southeast corner above the gymnasium and the auditorium. Many other sections of the roofing were damaged, including large sections near the center of

Figure 2-12: Aerial View of Westmoore High School.

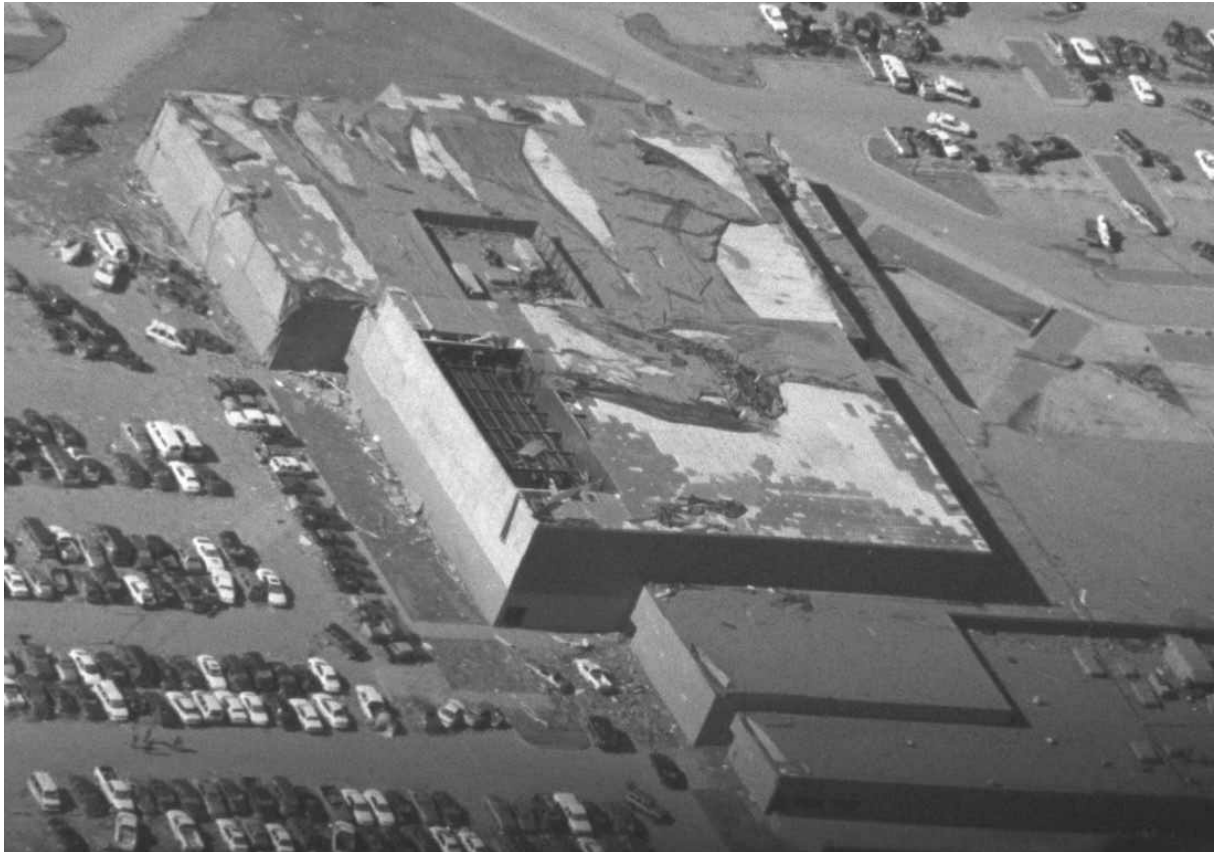
Figure 2-13: Detail of Roof Damage to Westmoore High School.

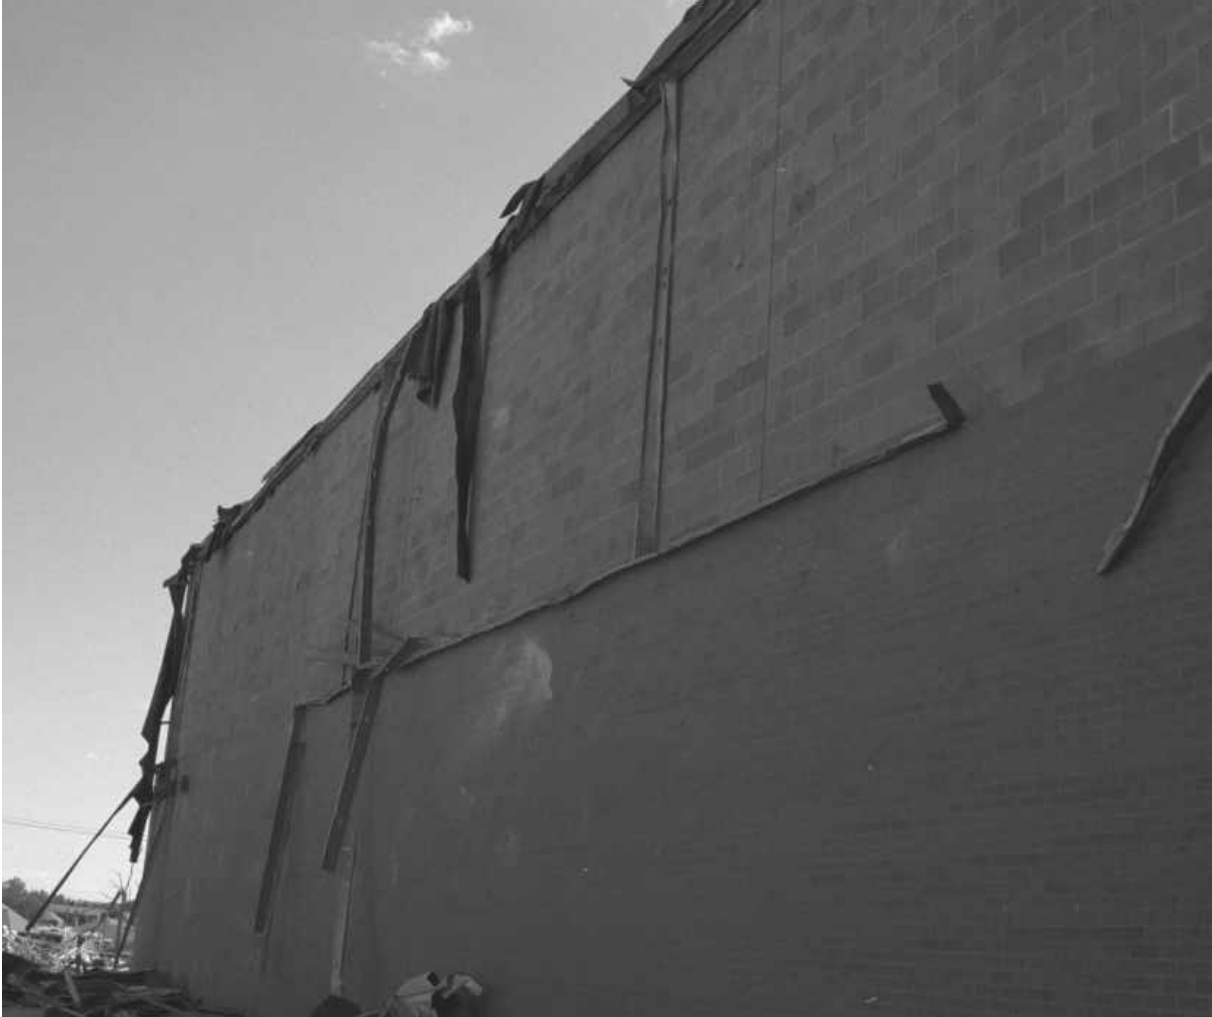
Figure 2-16: Damage to Cladding on East Side of Westmoore High School.

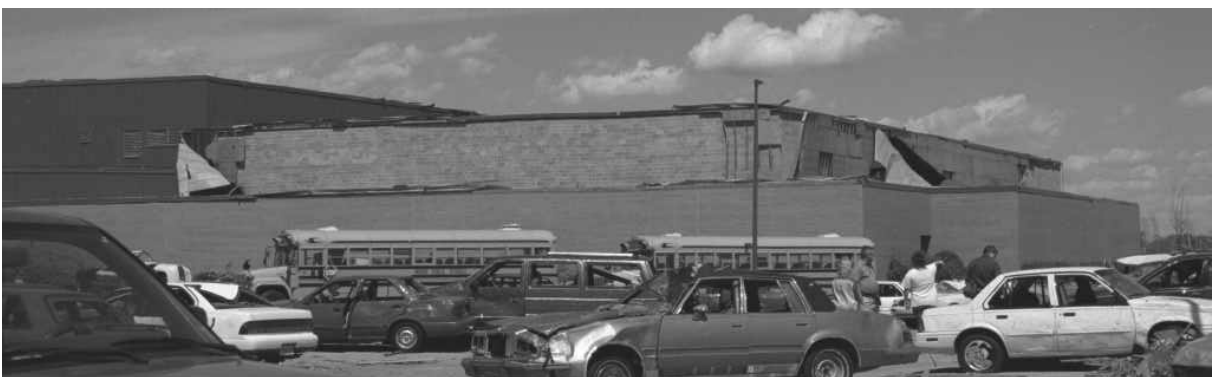
Figure 2-17: Damage to Westmoore High School and Vehicles, View From South.

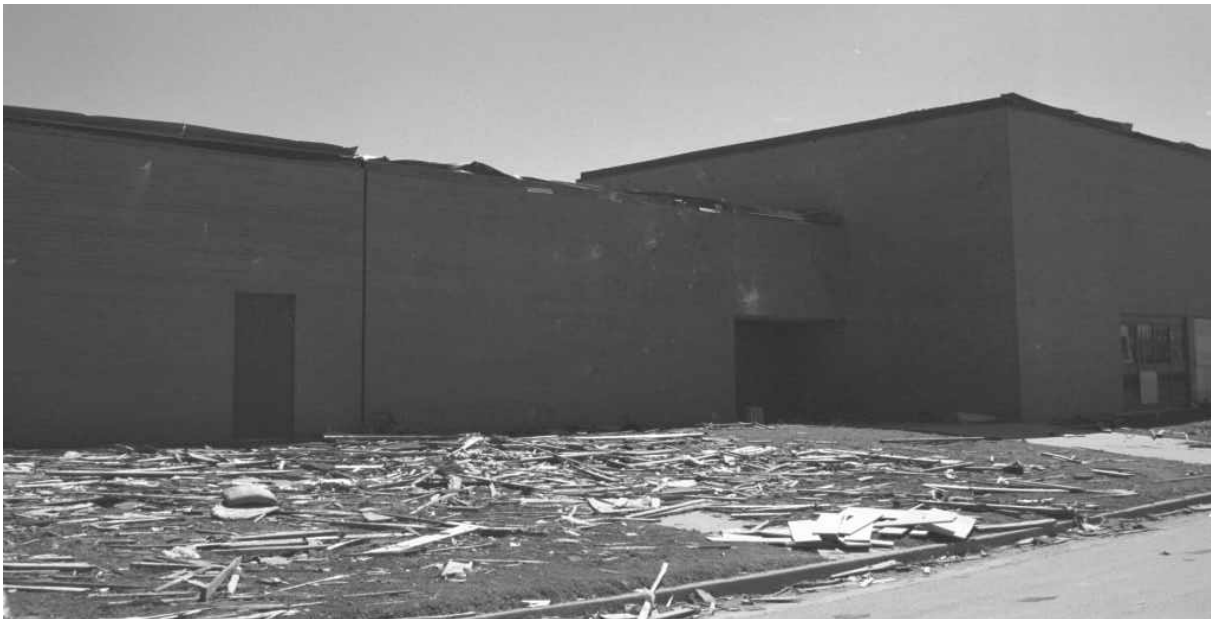
Of particular interest was the large quantity of debris in the vicinity of the school. Figure 2-18 shows some of the debris that had collected on the north side of the building. Much of this debris was likely from the large number of homes south of the high-school that were destroyed by the tornado, as shown in Figure 1-4.

Figure 2-18: Debris on North Side of Westmoore High School.

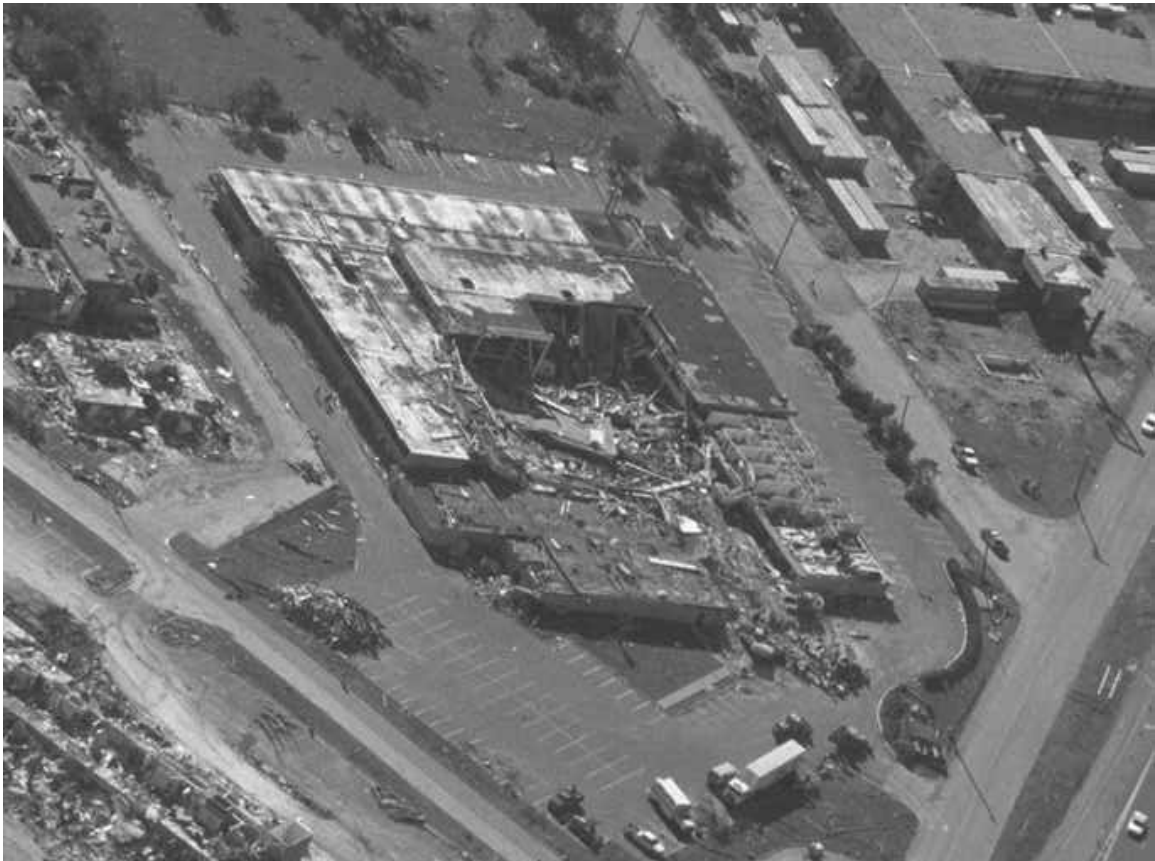
Figure 3-1: Aerial View of Damage to the Clarion Inn.

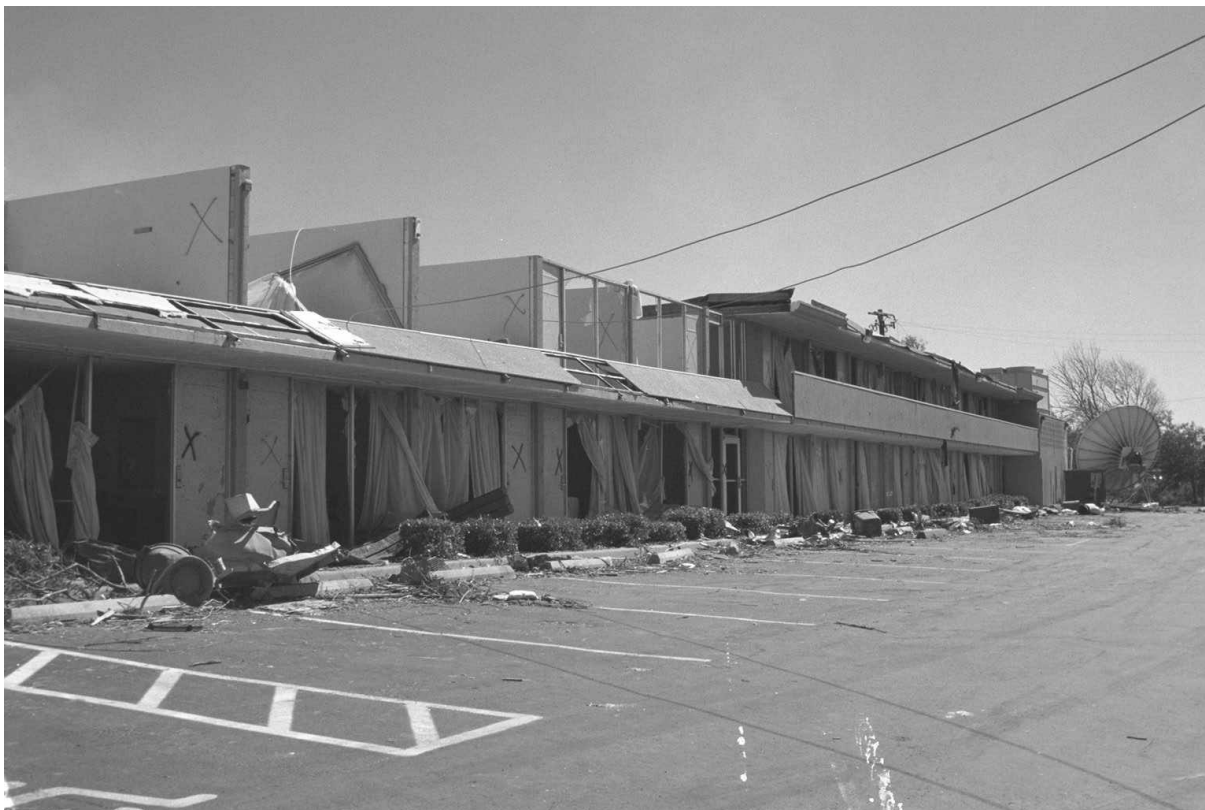
Figure 3-2: Damage to South Side of the Clarion Inn.

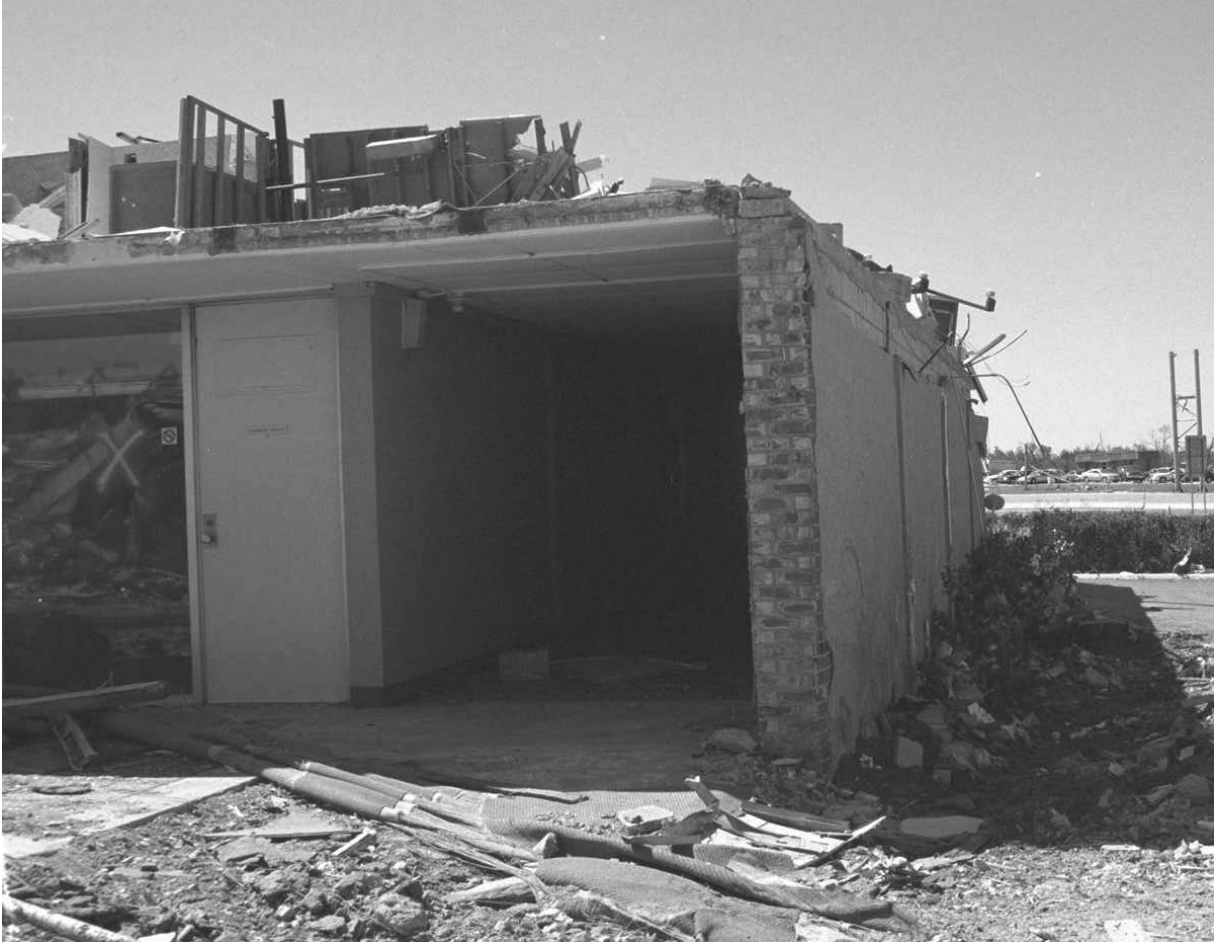
Figure 3-3: Damage to North Side of the Southwest Corner of the Clarion Inn.

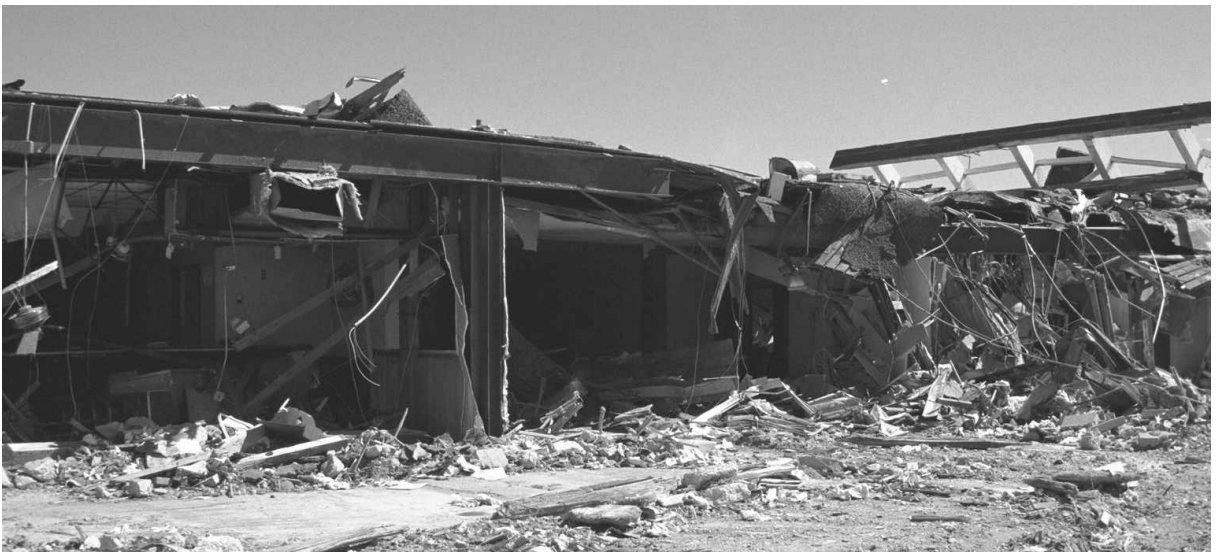
Figure 3-4: Damage to Western Section of the Clarion Inn.
