**RECONNAISSANCE REPORT ON DAMAGE TO
ENGINEERED STRUCTURES DURING
THE MAY 1999 OKLAHOMA CITY TORNADO**

August 2002

Building and Fire Research Laboratory
National Institute of Standards and Technology
Gaithersburg, MD 20899-8611

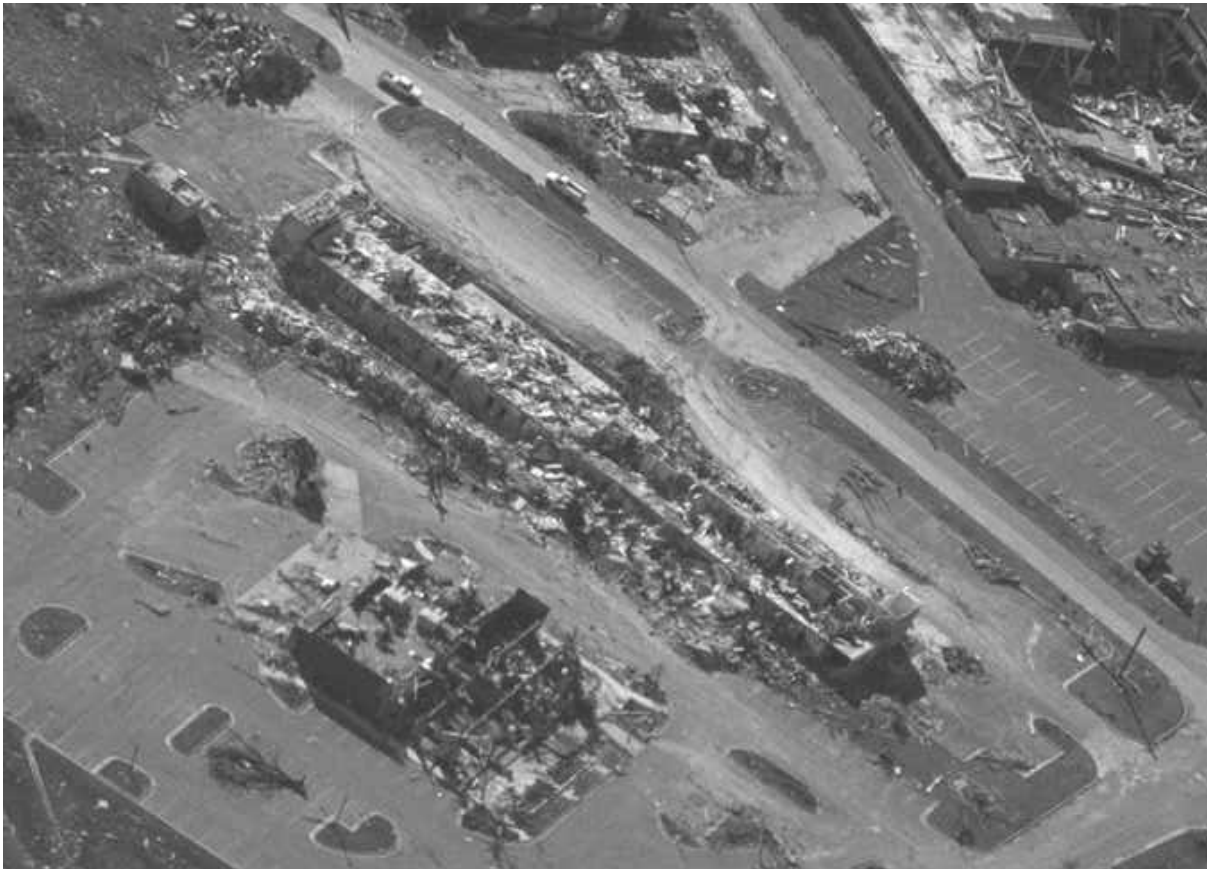
This hotel was completely destroyed as shown in Figure 1-3 and Figure 3-5. The precast concrete roof was lifted off and carried some distance. Much of the remainder of the second story collapsed and was swept off the floor slab. The outside walls of the south side of the lower floor were demolished, leaving only the masonry walls and the precast concrete floor slab of the second floor standing.

Figure 3-5: Aerial View of Damage to the Hampton Inn (long rectangular building).

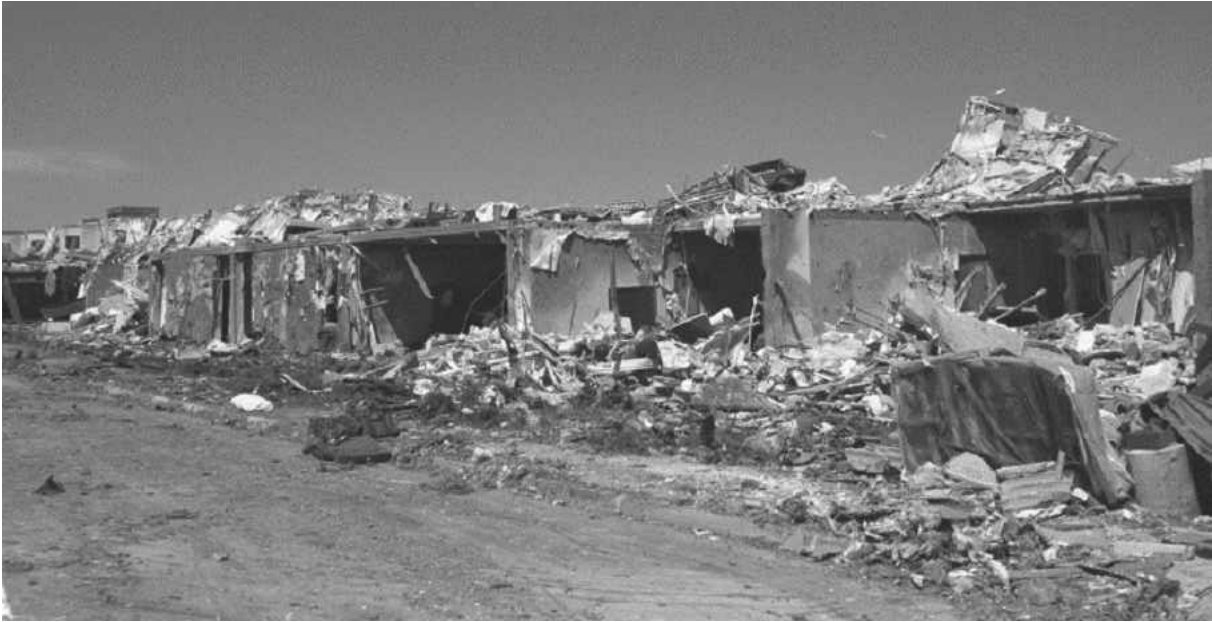
Figure 3-6: Damage to South Side of the Hampton Inn.

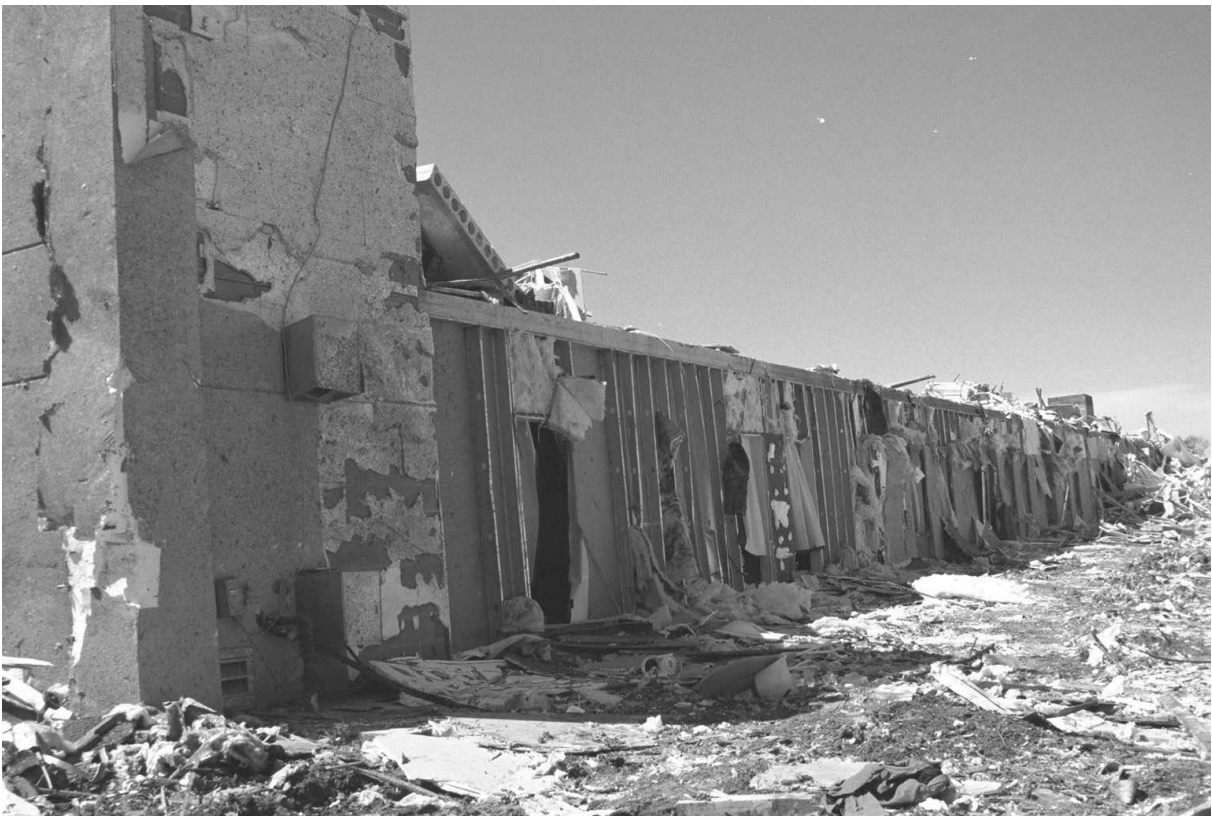
Figure 3-7: Damage to North Side of the Hampton Inn.

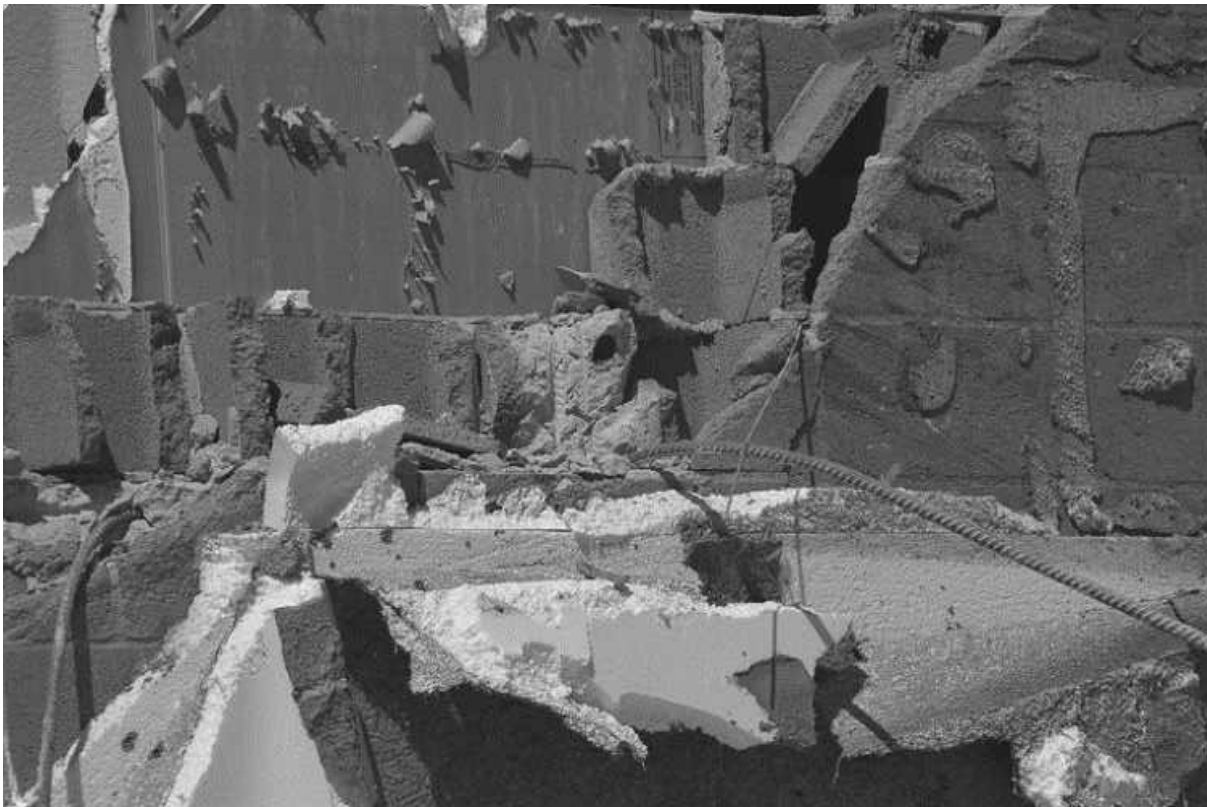
Figure 3-8 shows a detail of the damage to the masonry wall, including reinforcing bars that were exposed when the concrete block was demolished.

Figure 3-8: Detail of Damage to Masonry at the Hampton Inn.

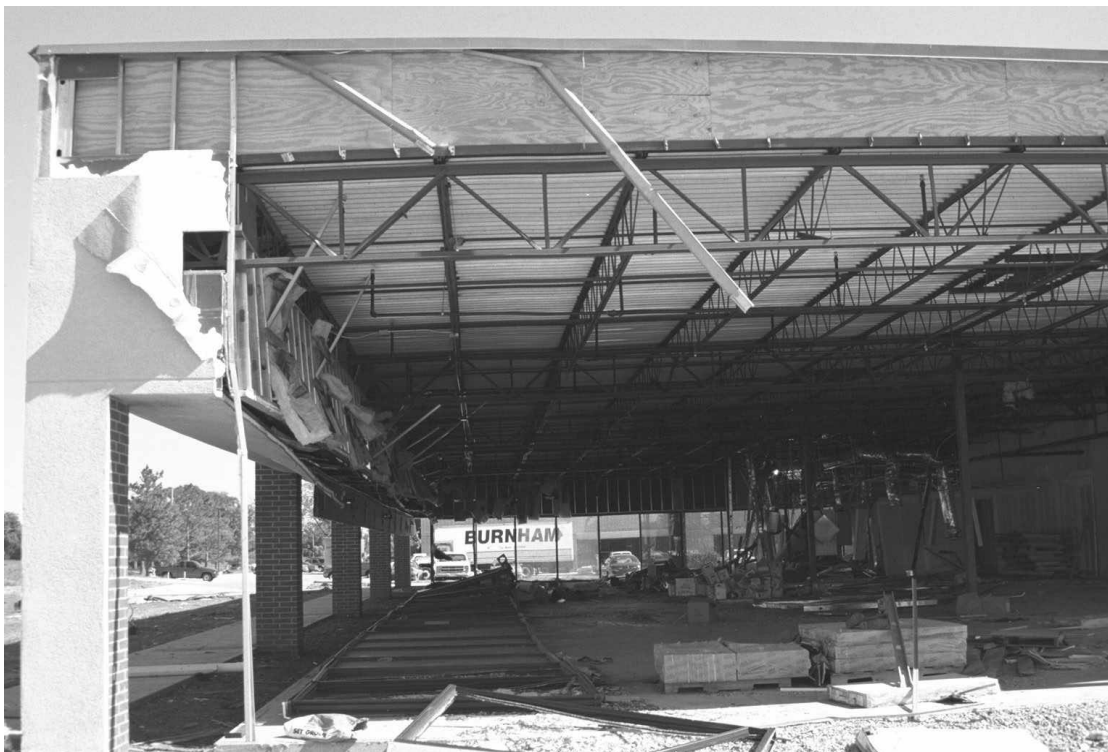
Figure 4-2: Damage to Western Section of the South Building at Tinker Industrial Park.

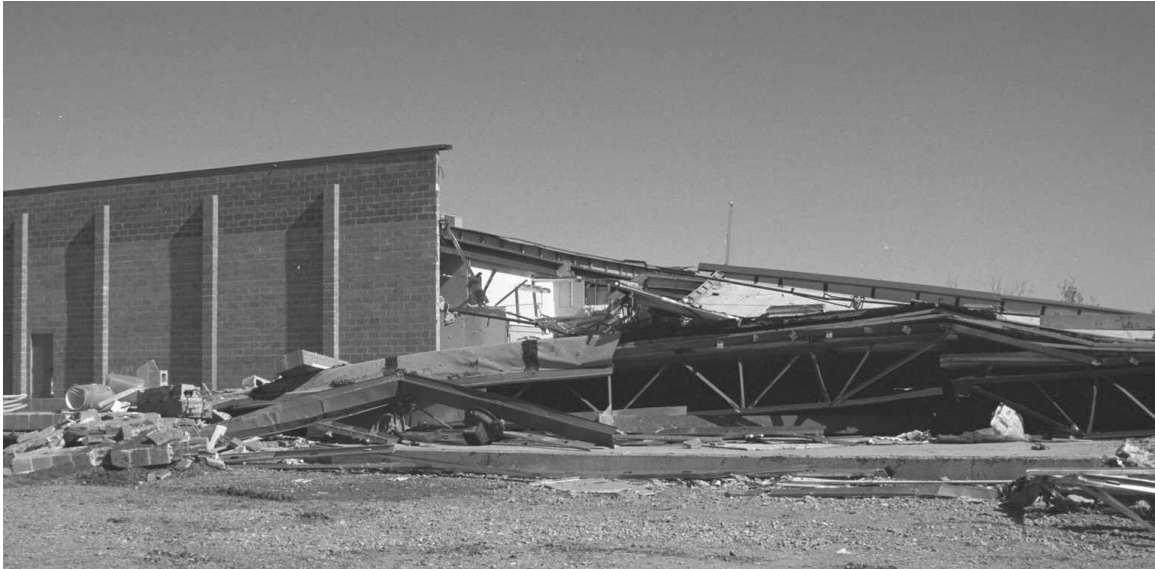
Figure 4-3: Collapsed Eastern Section of the South Building at Tinker Industrial Park (View from Southeast).

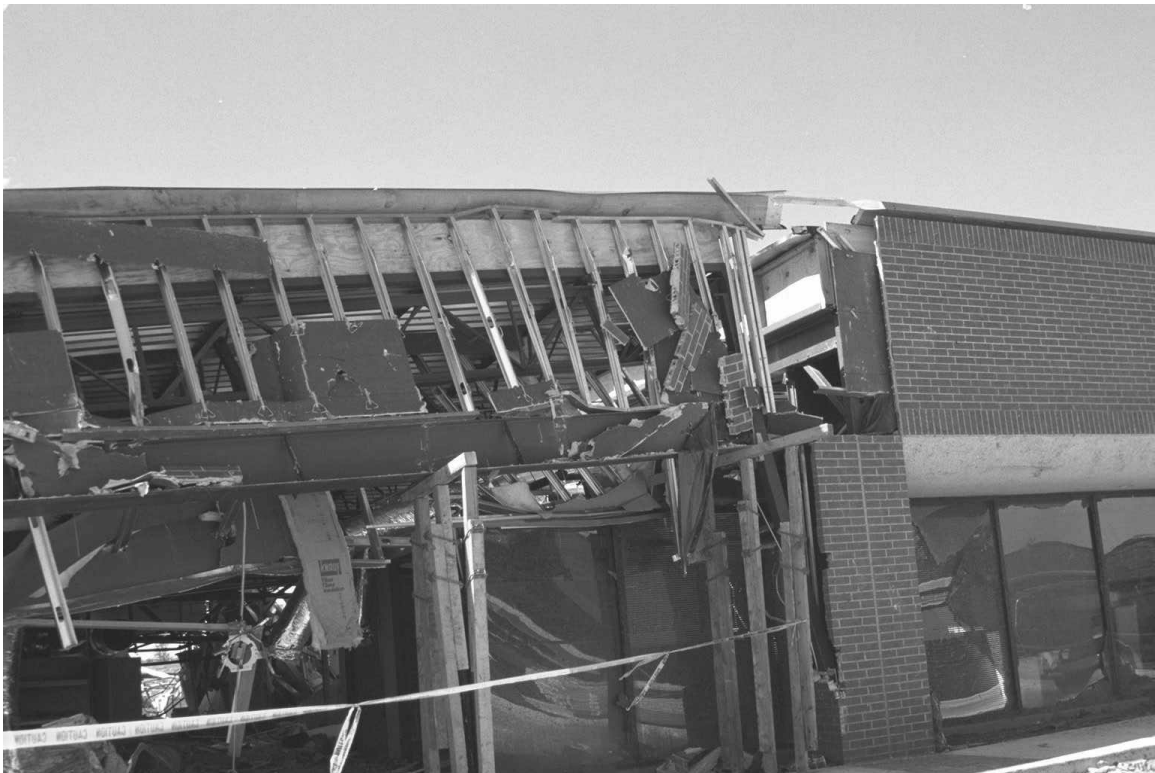
The tornado appears to have pushed this portion of the building towards the northeast, rotating it counterclockwise. The largest deformations occurred along the southern edge, while the northeast corner moved only a bit, as can be seen in Figure 4-4.

Figure 4-4: North Side of the South Building at Joint between Sections.

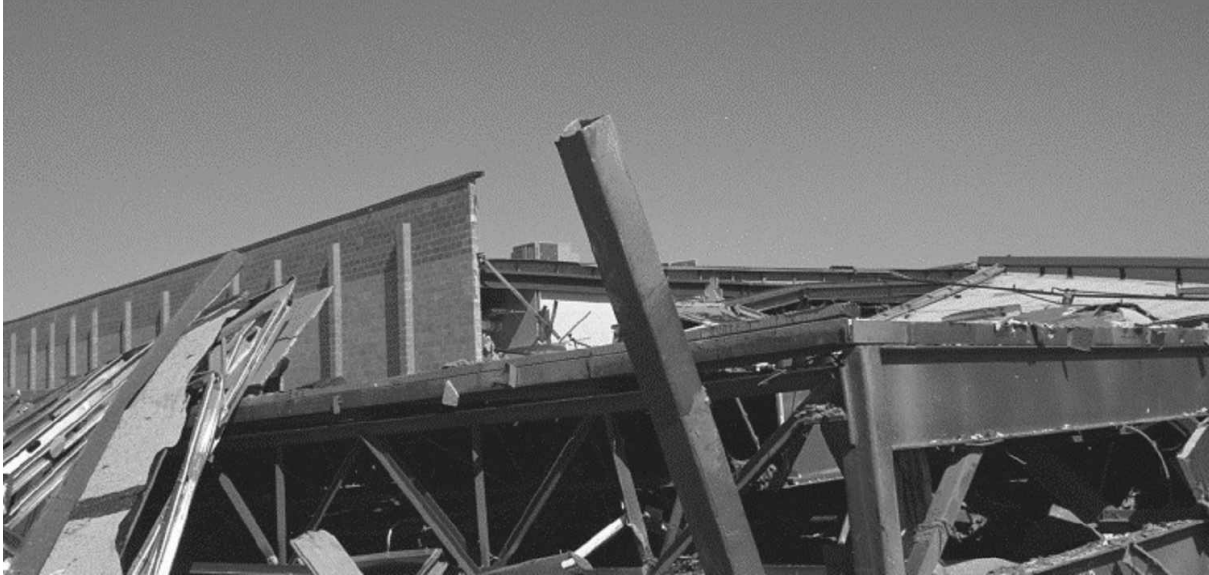
The columns on the eastern and southern sides of this portion failed, as shown in Figure 4-5, and the entire section collapsed with the roof largely intact. The relatively well-reinforced masonry wall on the west-

Figure 4-5: Detail of Failed Column and Collapsed Roof at the Southeast Corner of the South Building.

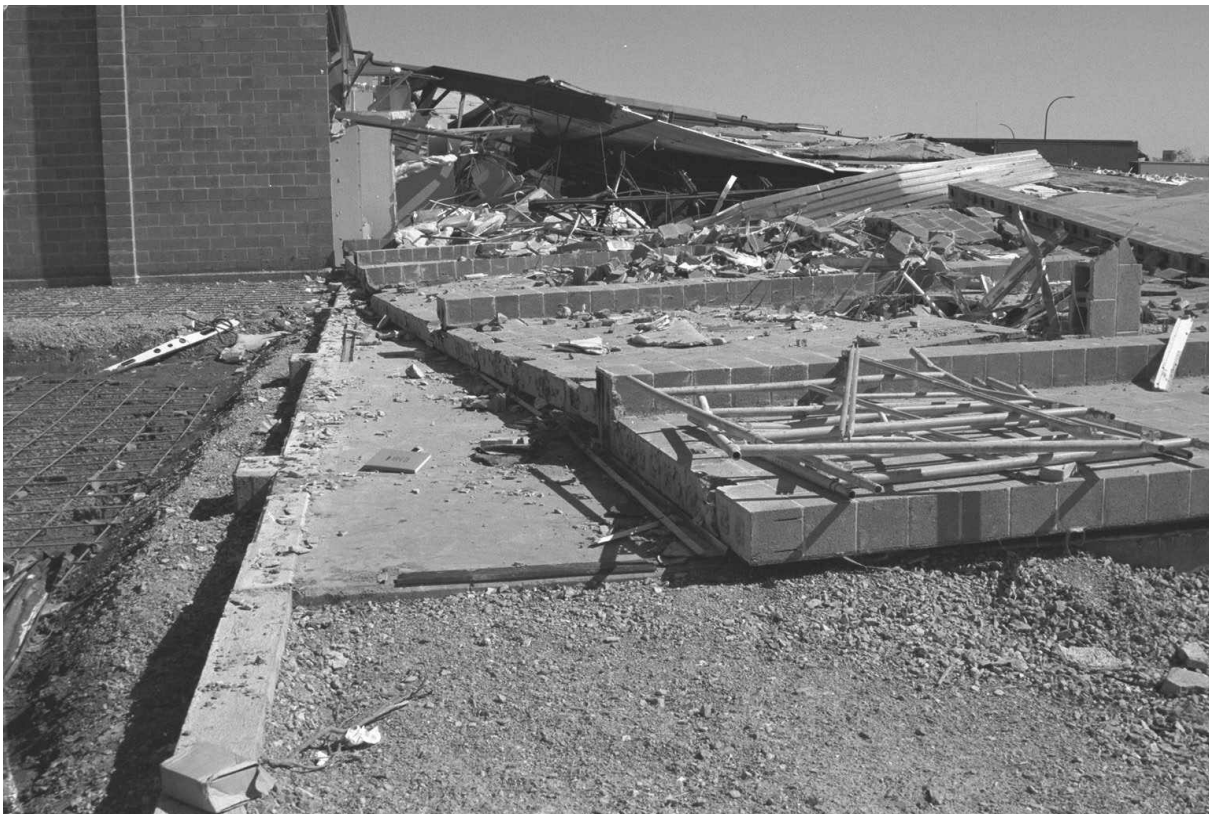
ern side of this section of the building, shown in Figure 4-6, collapsed to the east, and reinforcing bars that were anchored into the foundation pulled out or failed.

Figure 4-6: Reinforced Masonry Wall that Failed at South Building.

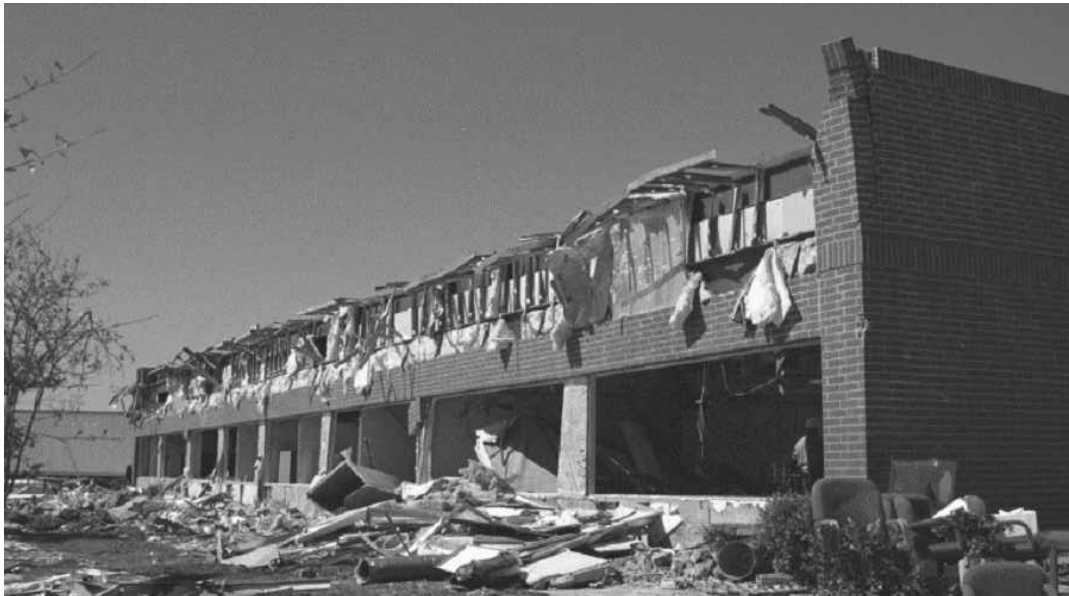
Figure 4-7: Damage to the East Side of the Middle Building at Tinker Industrial Park.

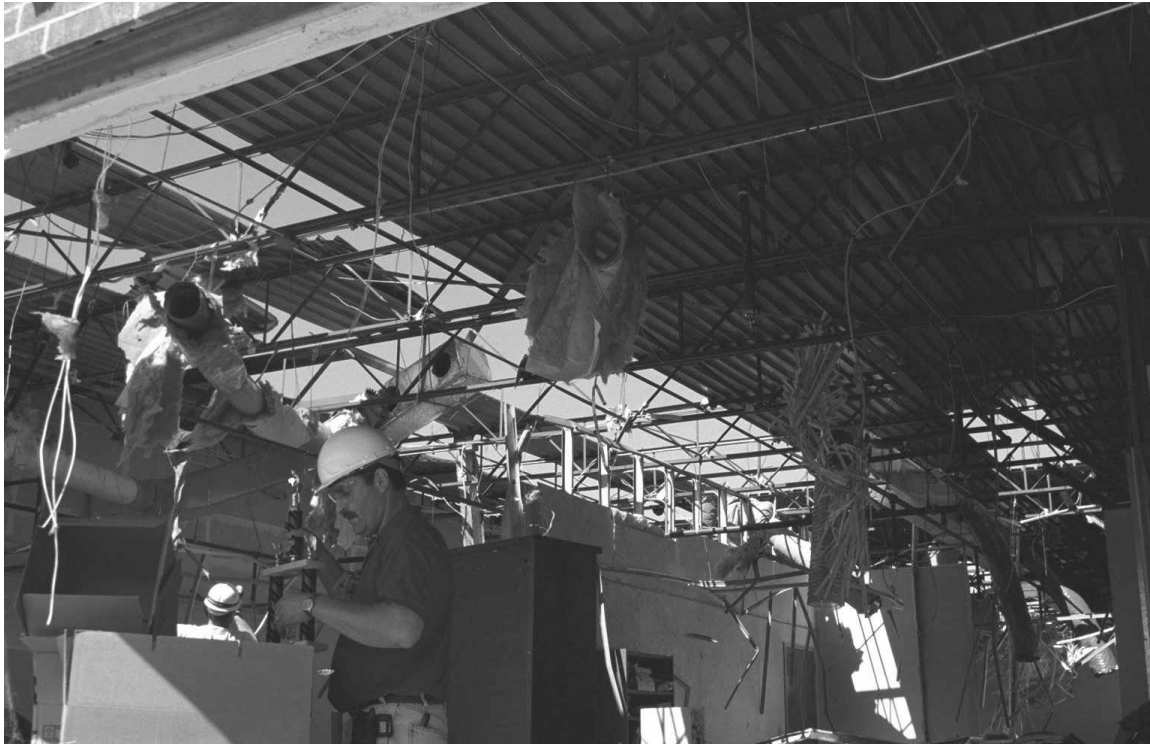
Figure 4-8: Detail of Damage to the Roof of the Middle Building.

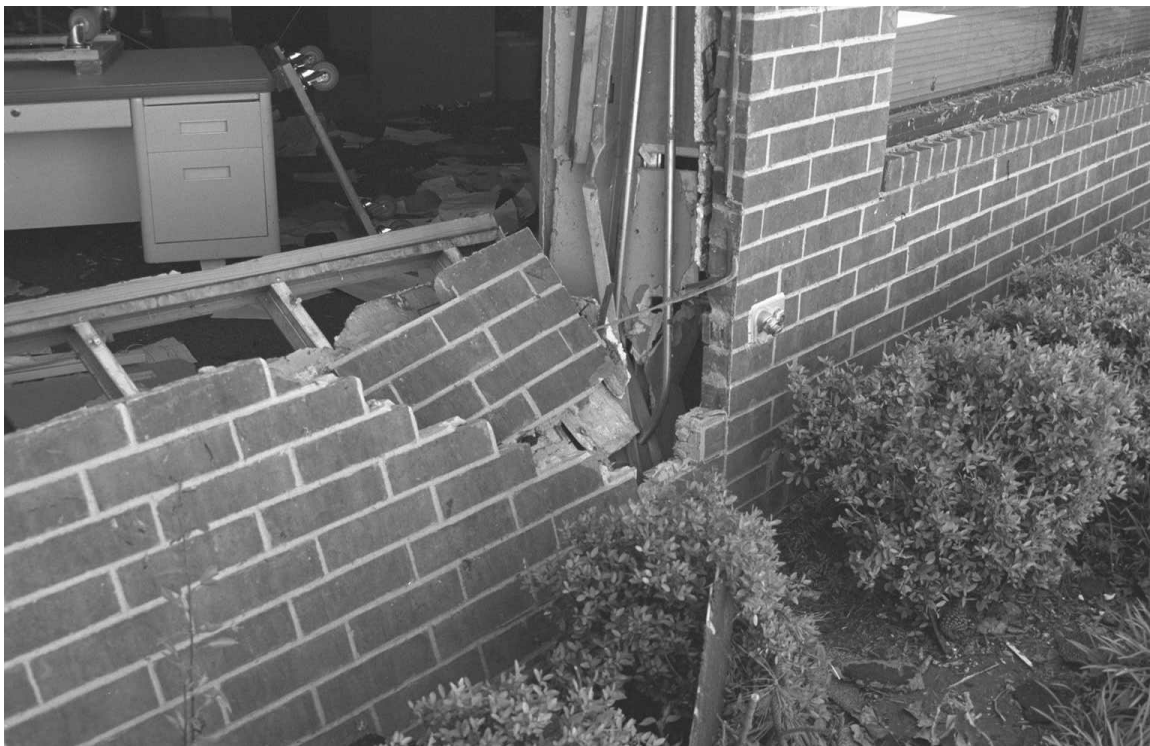
Figure 4-9: Detail of Damage to Western Wall of the Middle Building.

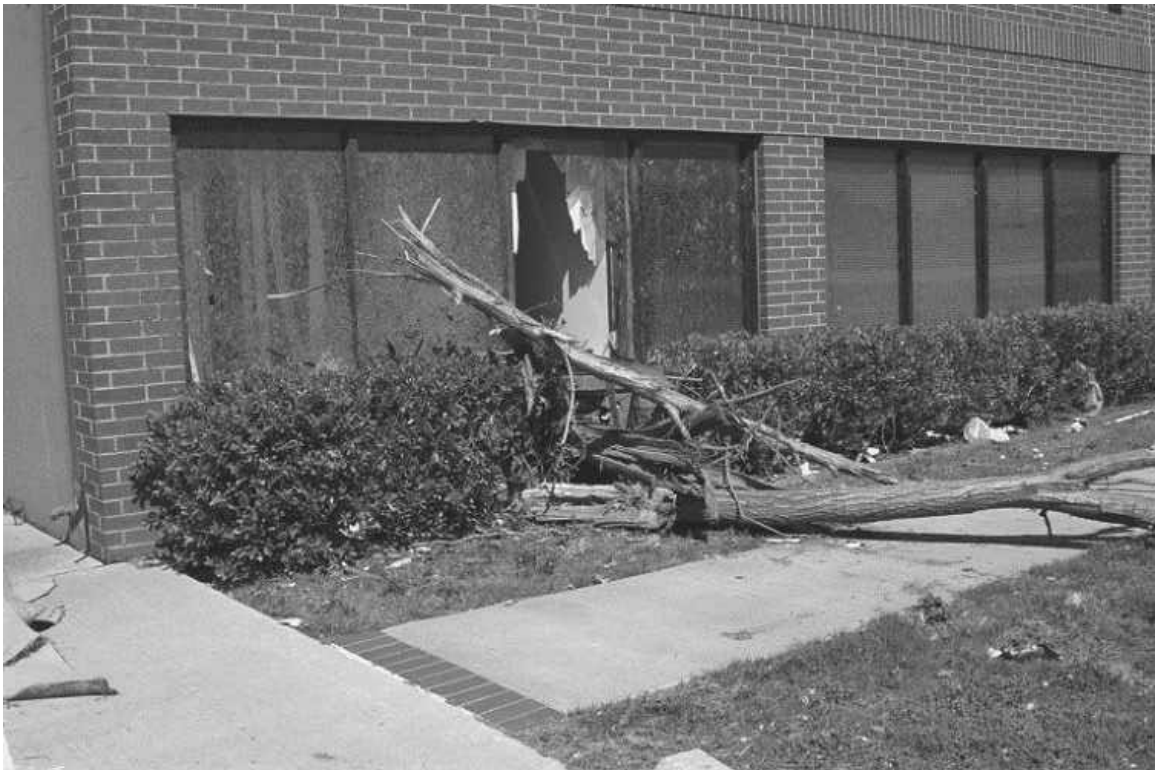
Figure 4-10: Damage to the East Side of the North Building at Tinker Industrial Park.

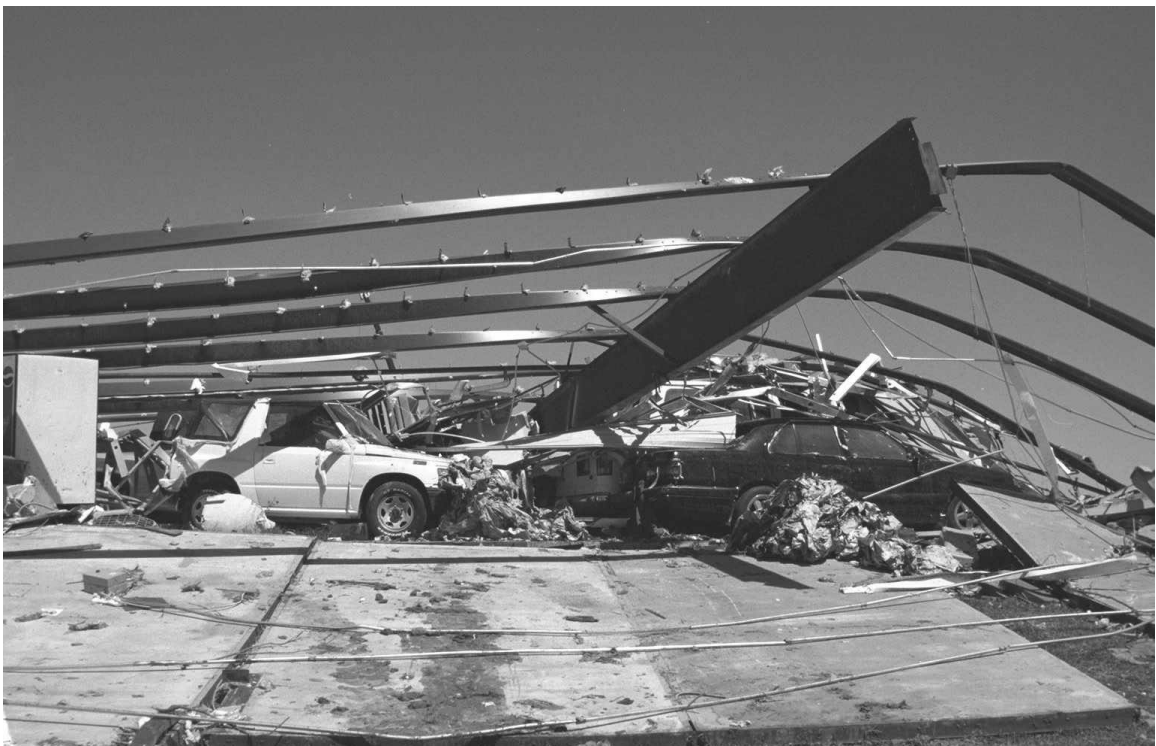
Figure 4-11: Roof Framing and Collapsed Walls (foreground) at Peach Auto Painting.

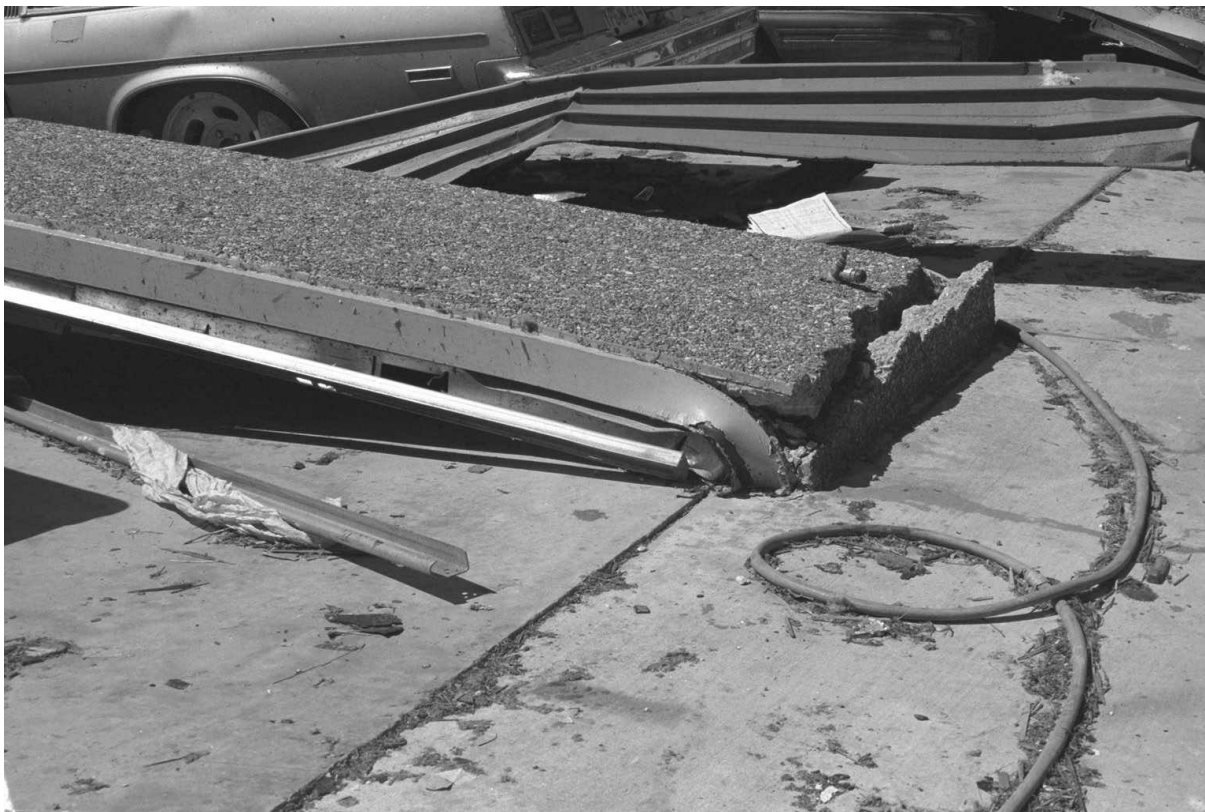
Figure 4-12: Detail of Base of Failed Wall at Peach Auto Painting.

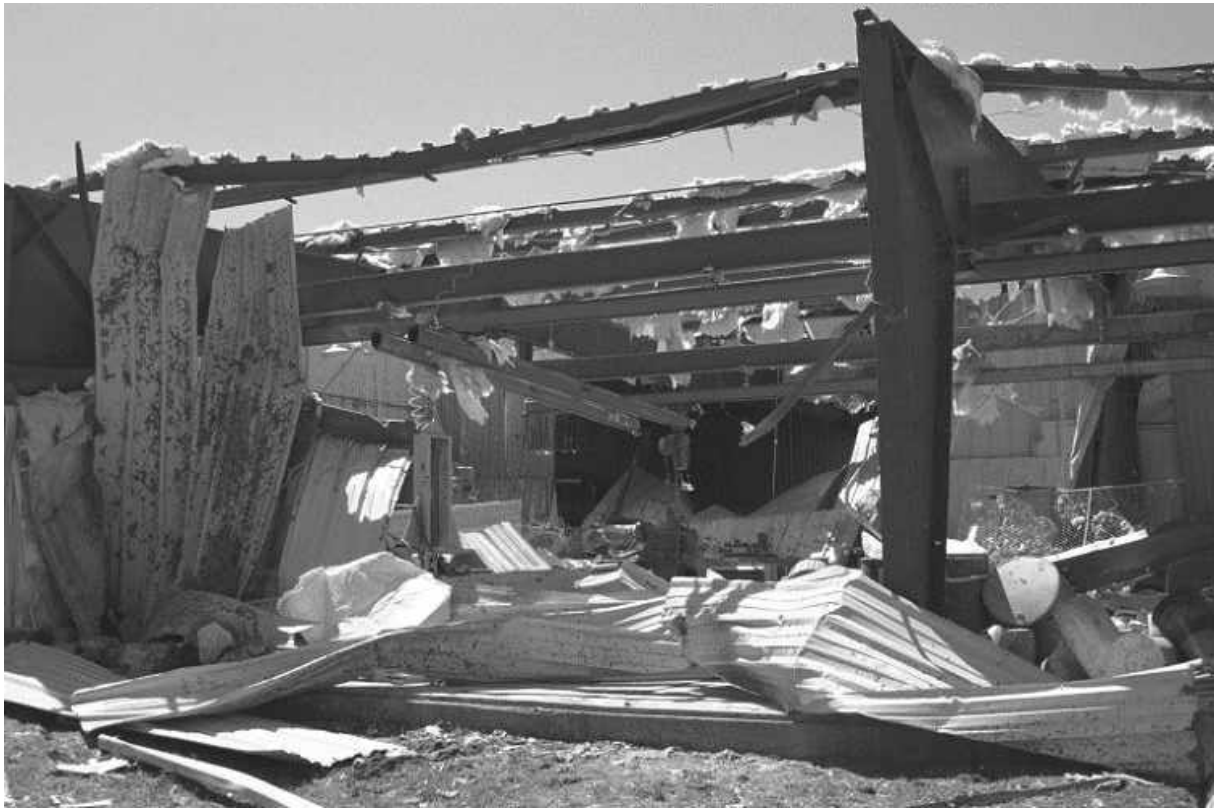
Figure 4-13: Damage to Coors Technical Ceramics Factory.

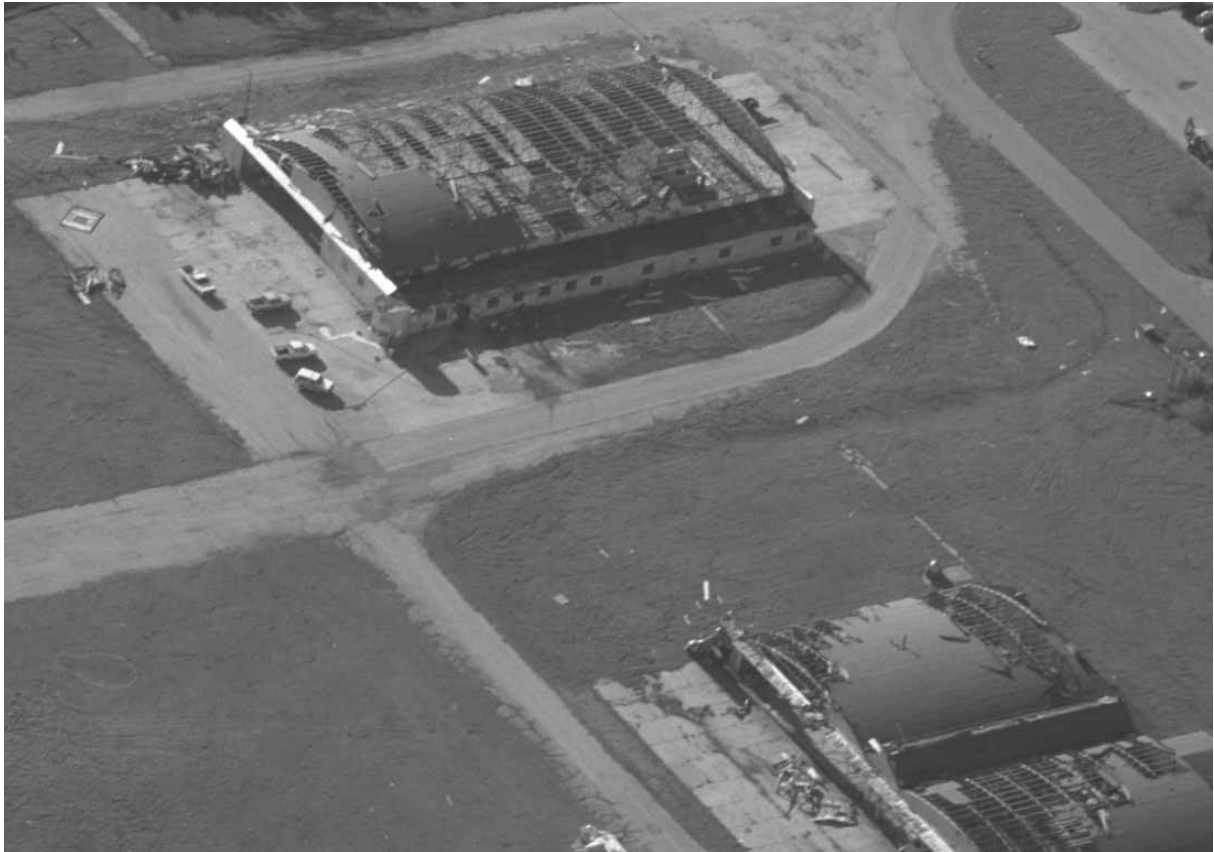
Figure 5-1: Aerial View of Damage to Hangars at Chickasha Airport

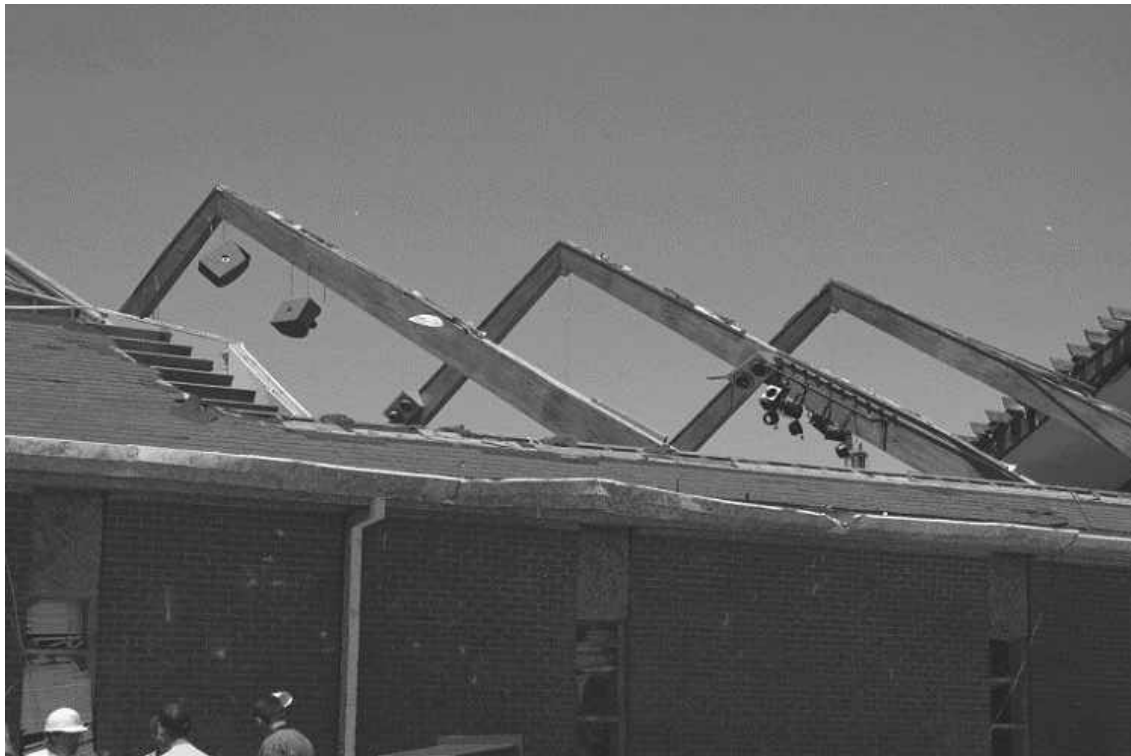
Figure 5-2: Damage to the Roof of the Regency Park Baptist Church.

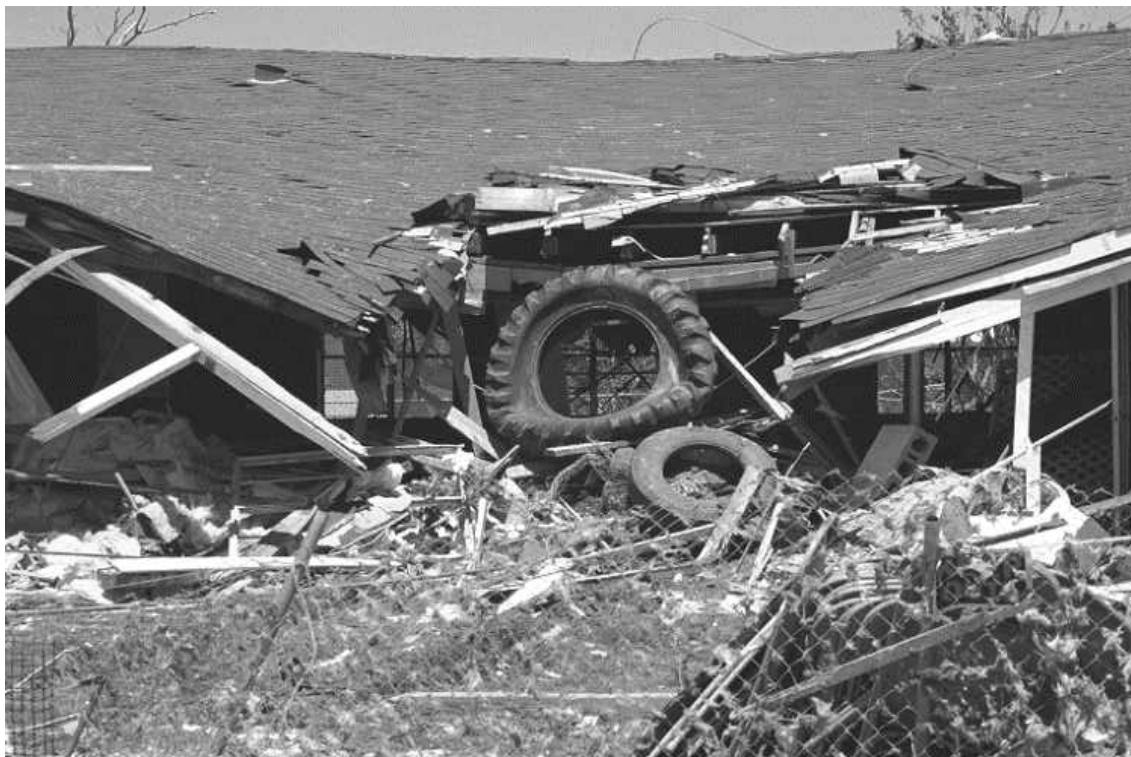
Figure 5-3: Debris Damage to Building Adjacent to Regency Park Baptist Church.

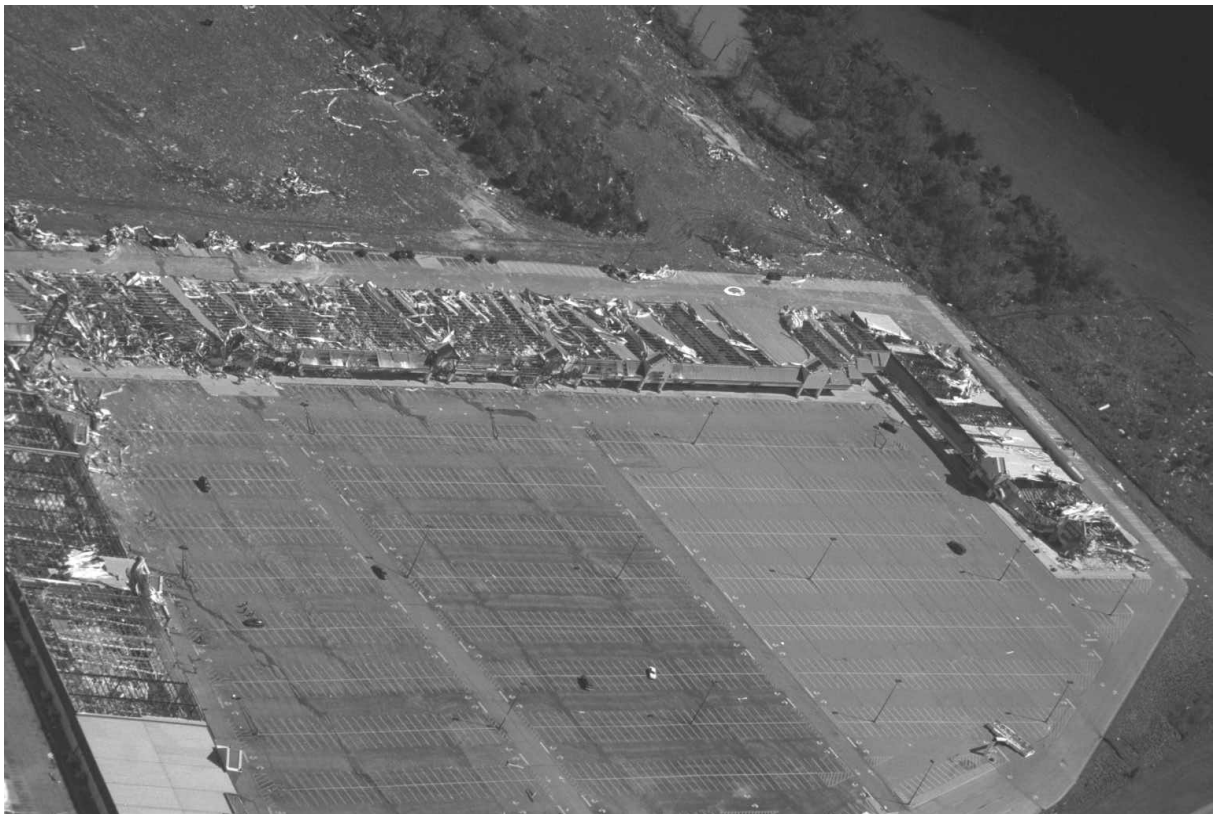
At the other extreme, the Tanger Outlet Center mall in Stroud was destroyed by tornado similar in size to the tornado that damaged the hangars at Chickasha airport. This tornado appeared to have passed directly over the mall. As shown in Figure 5-4, nearly the entire mall was destroyed. At least 53 stores demolished, and most of the roof was lost.

Figure 5-4: Aerial View of Damage to the Tanger Outlet Center Mall.

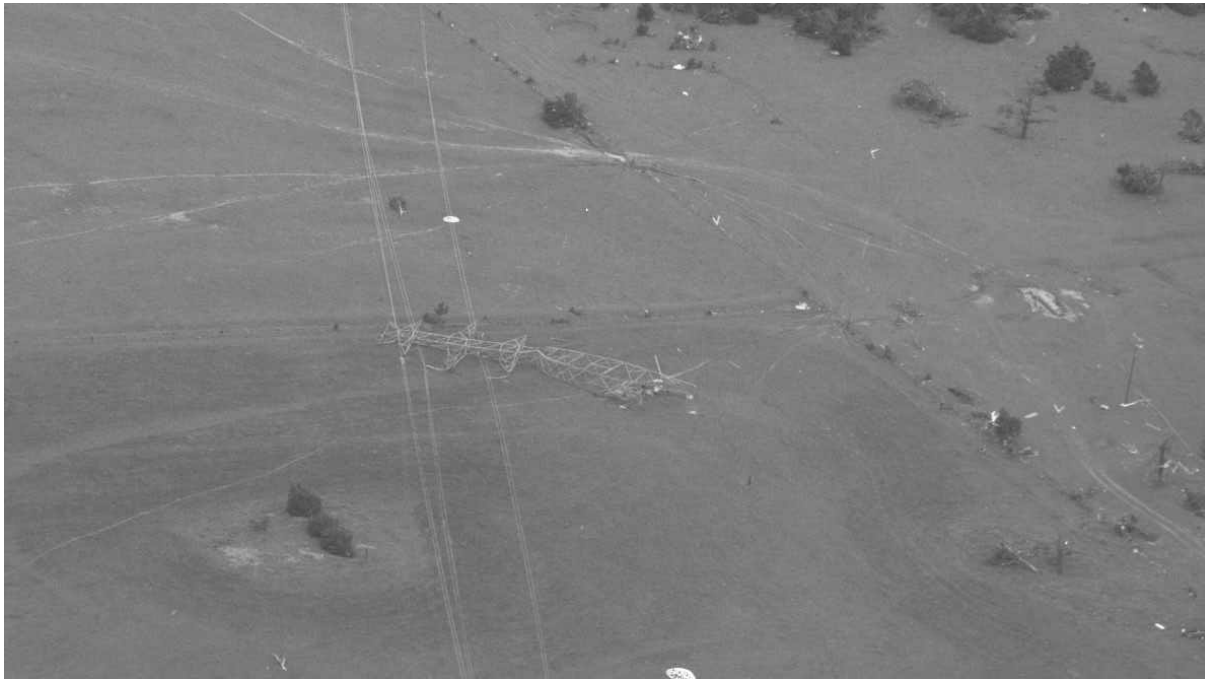
Figure 5-5: Destroyed Transmission Tower near Crescent, Oklahoma.

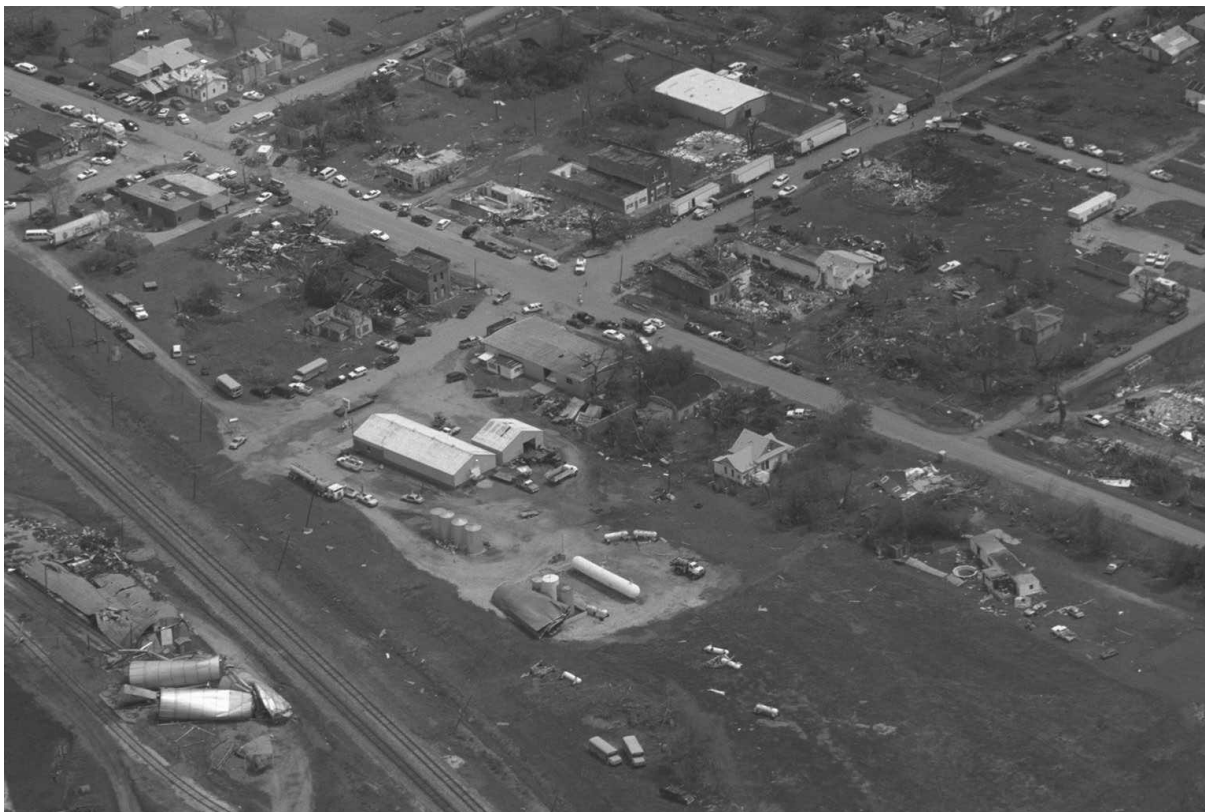
Figure 5-6: Damage to Mulhall, Oklahoma, and United Cooperative Silos.

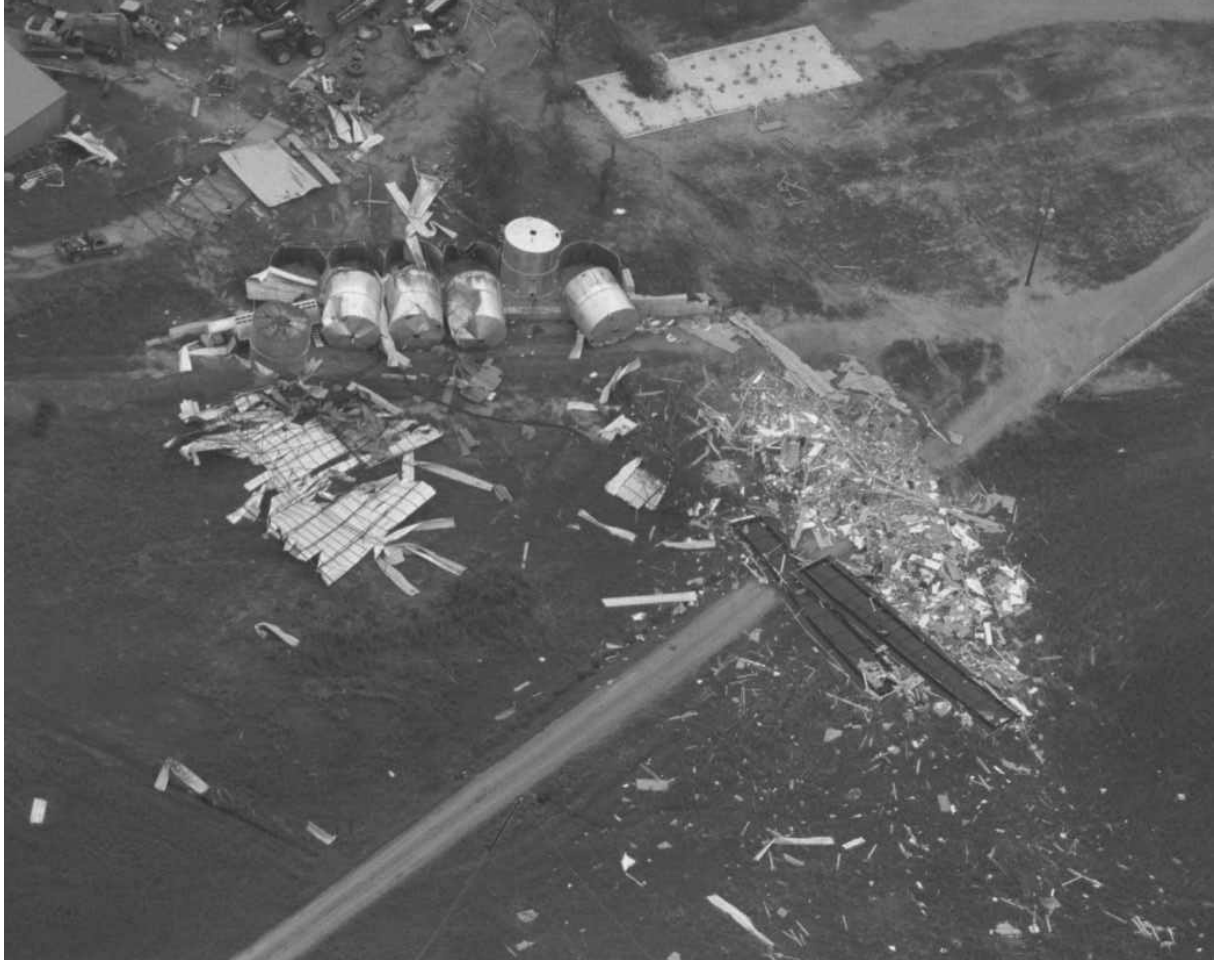
Finally, a wide variety of other infrastructure was damaged by the tornadoes. Extensive damage was observed to farm buildings and other agricultural related structures. Figure 5-6 shows some of the damage that occurred to the United Cooperative in Mulhall. A storage building and numerous grain silos (located in the lower left of the photo) were destroyed. The town of Mulhall (located in the center of the photo) was extensively damaged. Figure 5-7 shows the damage that occurred at one farm near Crescent. Here storage silos were overturned and destroyed, one farm building was leveled, and other buildings were damaged.

Figure 5-7: Damage to Farm buildings and Silos near Crescent, Oklahoma.
