NISTIR 7652

**Interim Report on the Examination of
Corrosion Damage in Homes
Constructed with Imported Wallboard
I. Examination of Samples Received
September 28, 2009**

Report prepared for the
U.S. Consumer Product Safety Commission
Directorate for Engineering Sciences
Bethesda, MD 20814

November 2009

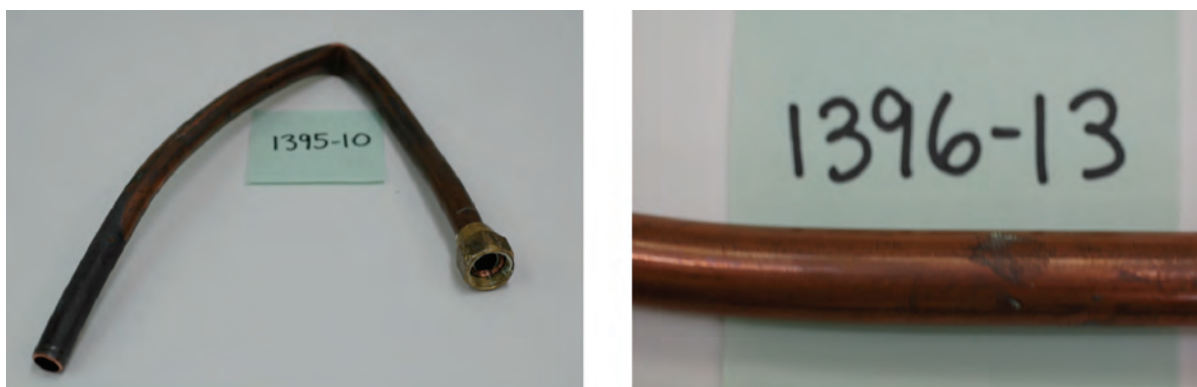
The lengths of copper tubing were discolored to varying degrees. This discoloration, which is illustrated in Figure 1, was found to be due to the presence of a thin adherent layer of a black substance. This is clearly illustrated in Figure 2 where the sample number has been scribed into the sample exposing fresh bare copper. The contrast in this figure is obvious. While this film adhered to the surface, physical contact would result in the transfer of a small quantity of a fine black powder from the film. In some cases, the discoloration was found to be very uniform, but in other cases it was irregular. The extent of discoloration varied with the thickness of the layer.

Figure 1 – Photographs of two representative samples of copper natural gas supply tubing.

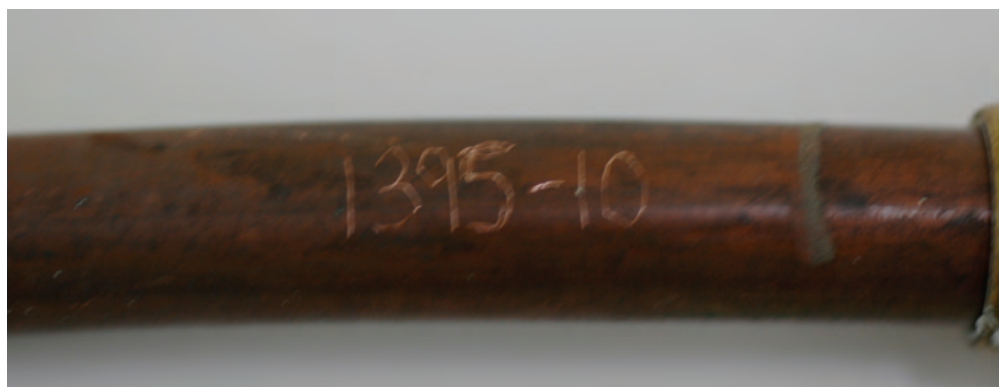
Figure 2 – Scribe marks illustrating the contrast between the color of bare copper and a sample of copper natural gas line tubing.

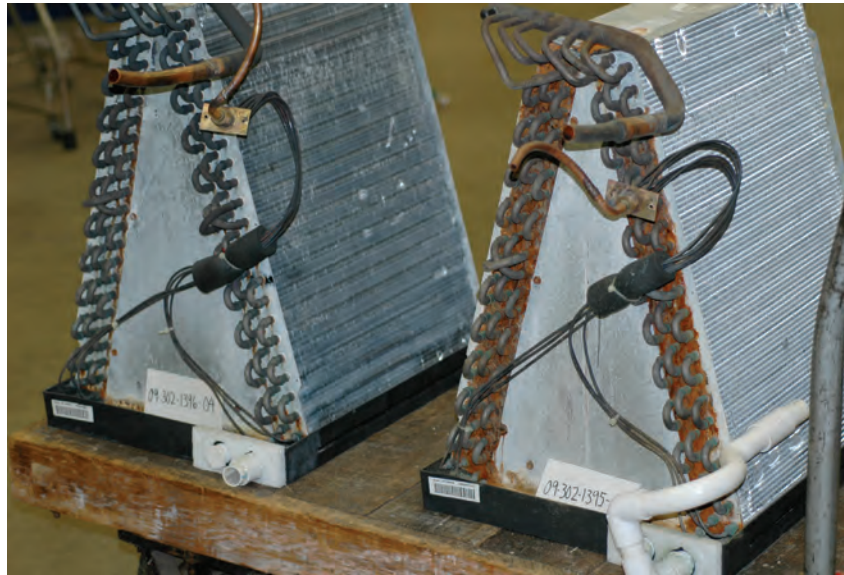
The air conditioner evaporator coils were also examined, Figure 3. From the two coils in this figure it can be seen that all exposed copper surfaces have turned dark. These coils are constructed out of parallel lines of copper tubing placed through thin sheets of aluminum that

Figure 3 – Photograph of the two air conditioner evaporator coils showing the black discoloration of the copper U-bends and corrosion of the end plate.

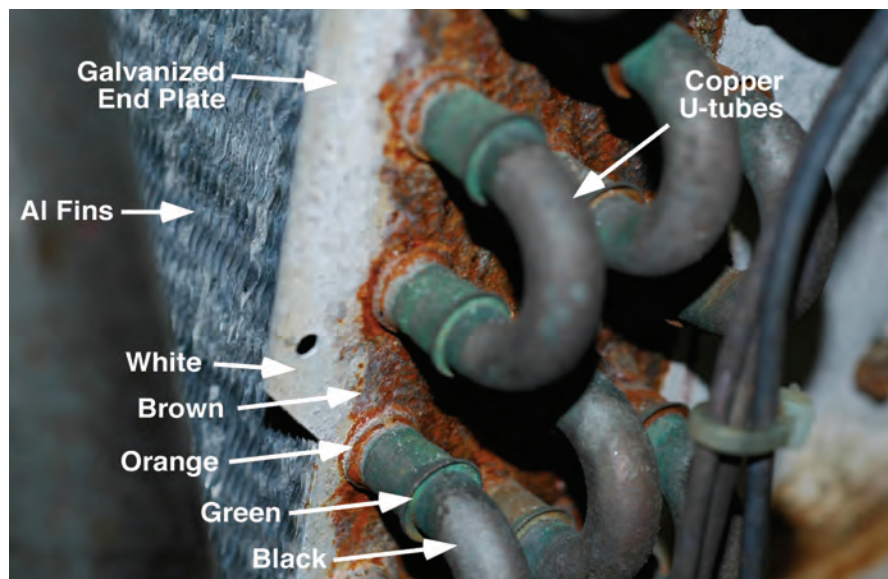
serve as the heat transfer fins. The copper tubing is linked together by soldered U-bends to the ends of adjacent lengths of copper tubing. The end plates that hold this assembly in place are made out of galvanized steel. Copper manifolds and valves complete the assembly. Figure 4 is a close-up of the end plates and the U-bend region. In this figure, brown and orange corrosion products can be seen on the galvanized end plates, while black and green corrosion products can be seen on the copper tubing. The normal patina that forms on copper in the cyclically wet and dry environment of an air conditioner evaporator coil would be expected to contain copper (I) or copper (II) ions in oxides (black to brownish-red), carbonates (green to blue), sulfates (bright blue), and chlorides (greenish white to blue-green) [1,2]. Again, the black color was found to be due to the presence of a thin layer of a loose black powder.

Figure 4 – Close-up photograph of the U-tubes and end plate of an air conditioner evaporator coil showing that there appears to be 5 colors associated with the corrosion products: white, brown, orange, green, and black.

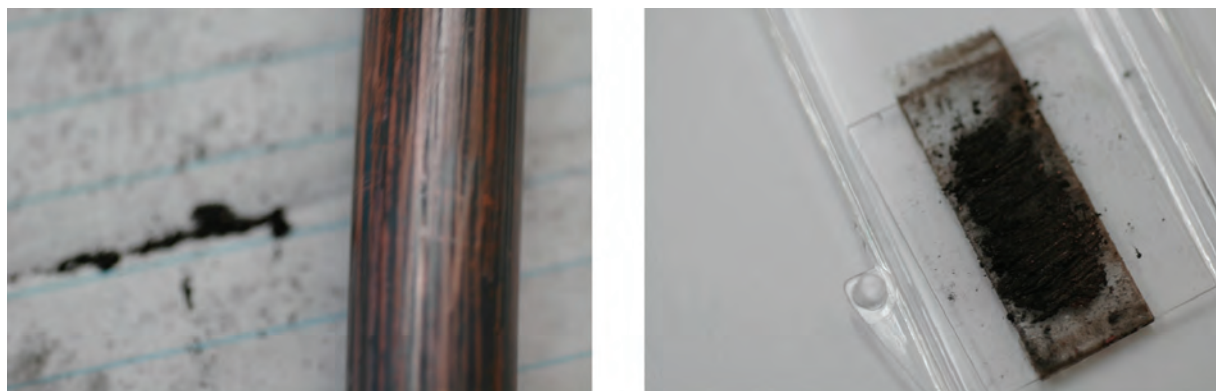
The black substance observed on the surfaces of the copper components was identified by X-ray diffraction. This was accomplished by scraping the black substance from the surface of one of the sample of copper natural gas line tubing using a razor blade. The powder removed in this manner was accumulated on double stick tape and attached to a glass slide as shown in Figure 5. A powder diffraction pattern was then obtained from this sample of scrapings using Siemens D500 X-ray diffractometer with a Cu K_α radiation source operated at 40 kV and 30 mA using a step size of 0.03 degrees, and a dwell time of 5 s.*

Figure 5 – Photographs of the scraped copper natural gas supply line and the slide holding the sample for X-ray diffraction.

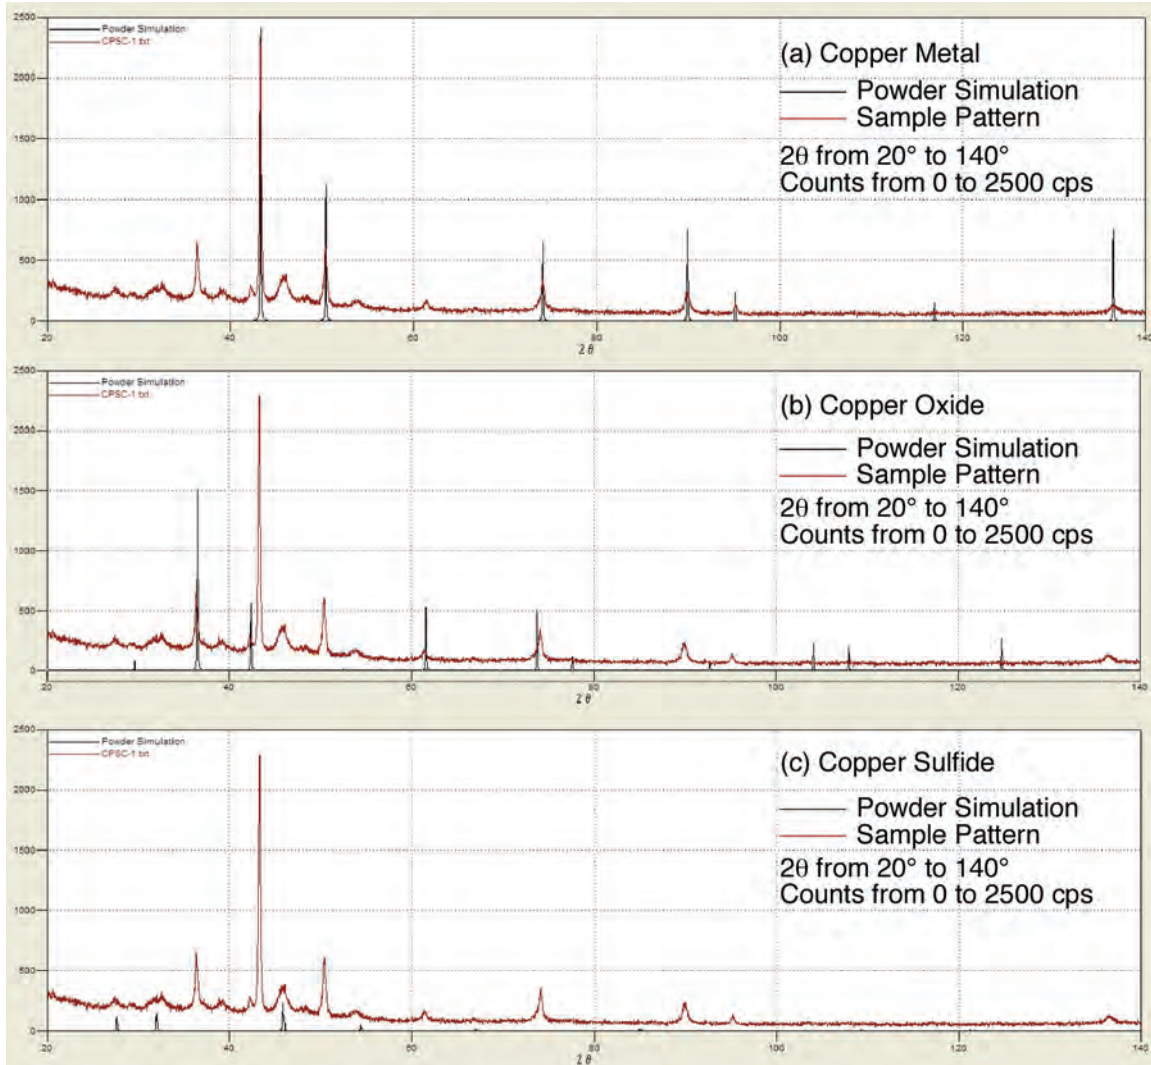
Figure 6 shows the results of these measurements in red along with the peak locations in black for copper metal (Figure 6a), copper (I) oxide (Figure 6b) and copper (I) sulfide (Figure 6c) as listed in the International Crystal Structure Database (ICSD). This figure shows that peaks corresponding to all three of these phases are present in the sample of scrapings from the surface of the copper natural gas supply line. Given that the sample was collected by scraping the surface of copper metal with a sharp razor blade, the peaks for copper and copper oxide were expected since copper is a soft metal compared to the steel of the razor blade and will normally form copper oxide when exposed to air. The third phase, copper sulfide (Cu_2S) is not a typical atmospheric corrosion product as the concentration of the reduced sulfur species, such as H_2S , required to form this product is usually very low under normal atmospheric conditions. [1, 3-5] Figure 7 is a summary of the XRD results showing that all but two small peaks, indicated by question marks, are accounted for by these three phases.

Figure 6 Powder diffraction patterns for the sample of corrosion products scraped off a copper natural gas supply line (red) with, identified in black, the peaks for (a) copper, (b) copper (I) oxide (ICSD #38233), and (c) copper (I) sulfide (ICSD #95395).

The copper metal surfaces of the samples provided for examination were covered with a black film that appears to be a corrosion product. The X-ray powder diffraction results unambiguously identified this substance as a copper sulfide phase. Copper sulfides (Cu_xS_y) can have a wide range of stoichiometry ranging from CuS_2 to Cu_2S with 9 distinctly different phases having been identified over this range depending on the stoichiometry. The powder diffraction pattern was consistent with the digenite phase of copper sulfide that has a stoichiometry of Cu_9S_5 or $\text{Cu}_{1.8}\text{S}$. The presence of a copper sulfide phase on the surface of the copper indicates that reduced sulfur compounds, such as hydrogen sulfide (H_2S), sulfur (S_8), or mercaptans (thiols), are present in the indoor atmosphere of the homes from which these samples were removed.

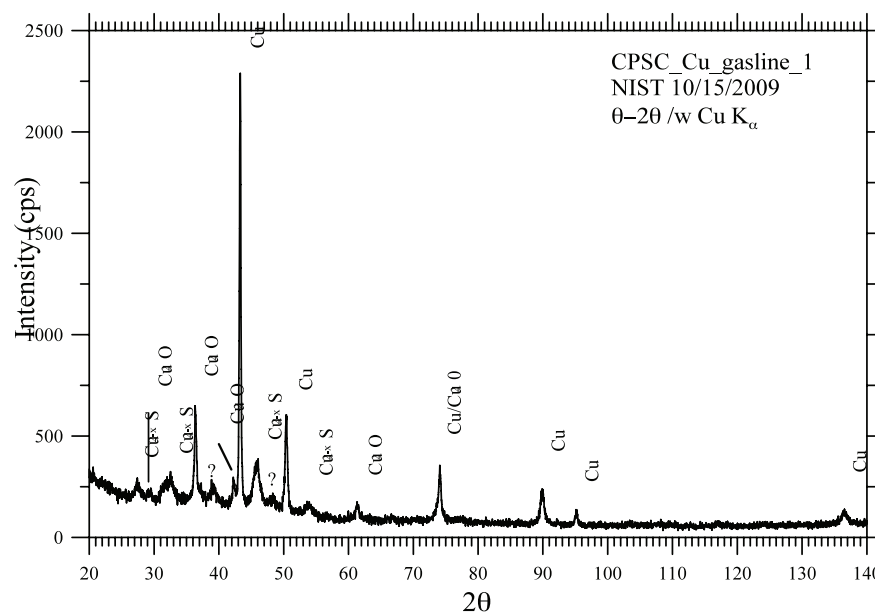
Figure 7 – Summary of peaks found in the corrosion product sample and their identification for showing that only two small peaks were unidentified by the three phases.

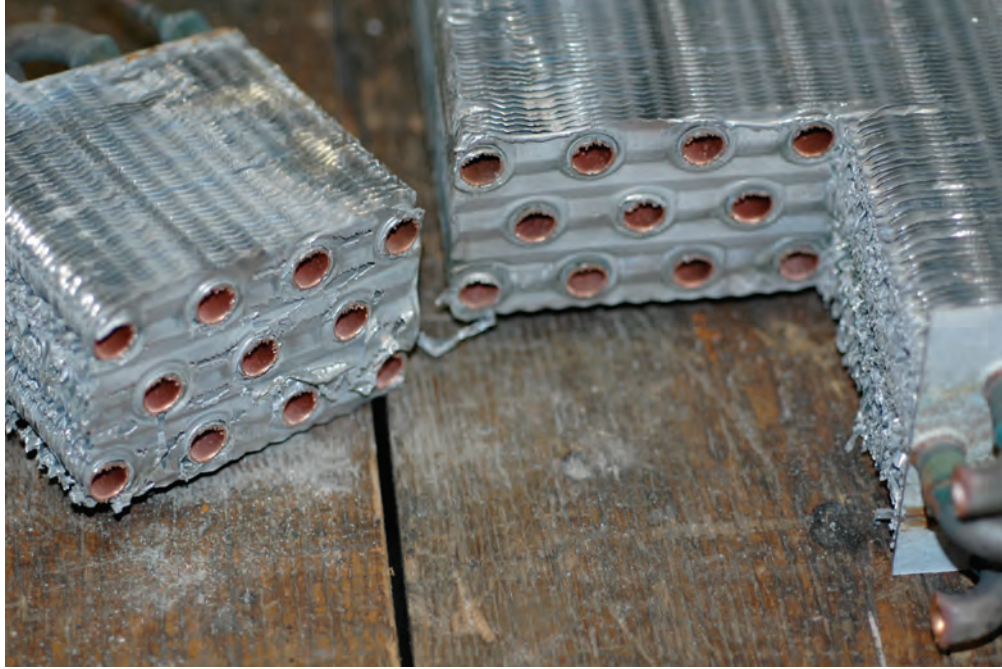
To evaluate the possibility of corrosion damage occurring between the aluminum heat transfer fins and the copper tubing inside them, the heat exchanger unit was sliced with a band saw as shown in Figure 8, to expose these internal surfaces for examination of the copper. No evidence of localized attack was found, and the black corrosion product layer was not detected by visual examination.

Figure 8 – Air conditioner evaporator coil after slicing to allow for examination for corrosion damage between the aluminum sheets and the copper tubing.

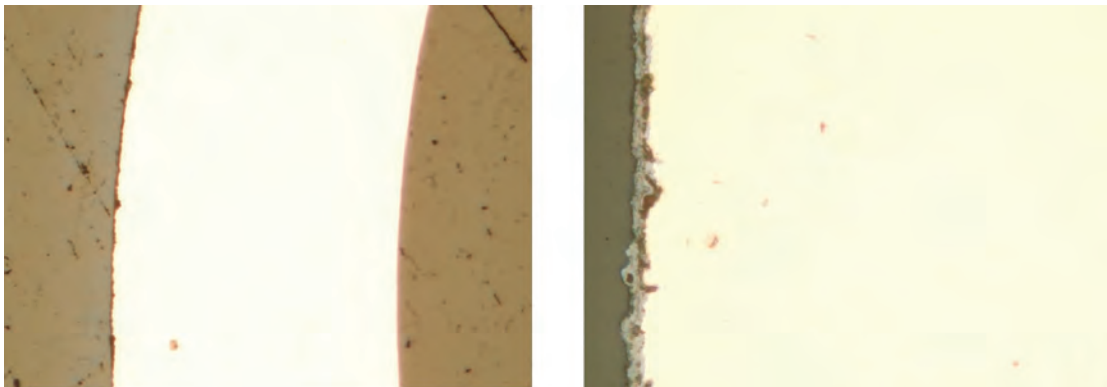
The thickness of the black corrosion product was measured using optical microscopy of samples prepared in cross section. For this analysis, samples of natural gas supply lines were cut, mounted in epoxy, and polished using standard metallurgical practice, exercising care to maintain the edge of the sample with the corrosion products in place. Figure 9 shows optical micrographs of this sample where the corrosion product layer varied from 5 μm to 10 μm thick.

Figure 9 – Optical micrographs of the wall of a copper natural gas supply line and the corrosion product layer at two magnifications (wall ≈ 1.2 mm thick).

While the results clearly indicate that a reduced sulfur species is present in the indoor atmosphere of the homes that these samples came from, the corrosion product layer observed on these samples was less than 10 μm thick. This layer makes the copper look dark due to the black
