# Report of Roof Inspection: Partial Delamination of Adhesive-Bonded Seams at an Army Facility

Walter J. Rossiter, Jr. and James F. Seiler, Jr.

November 1988

Prepared for:  
U.S. Army Engineer District, Baltimore  
P O Box 1715  
Baltimore, MD 21303-1715

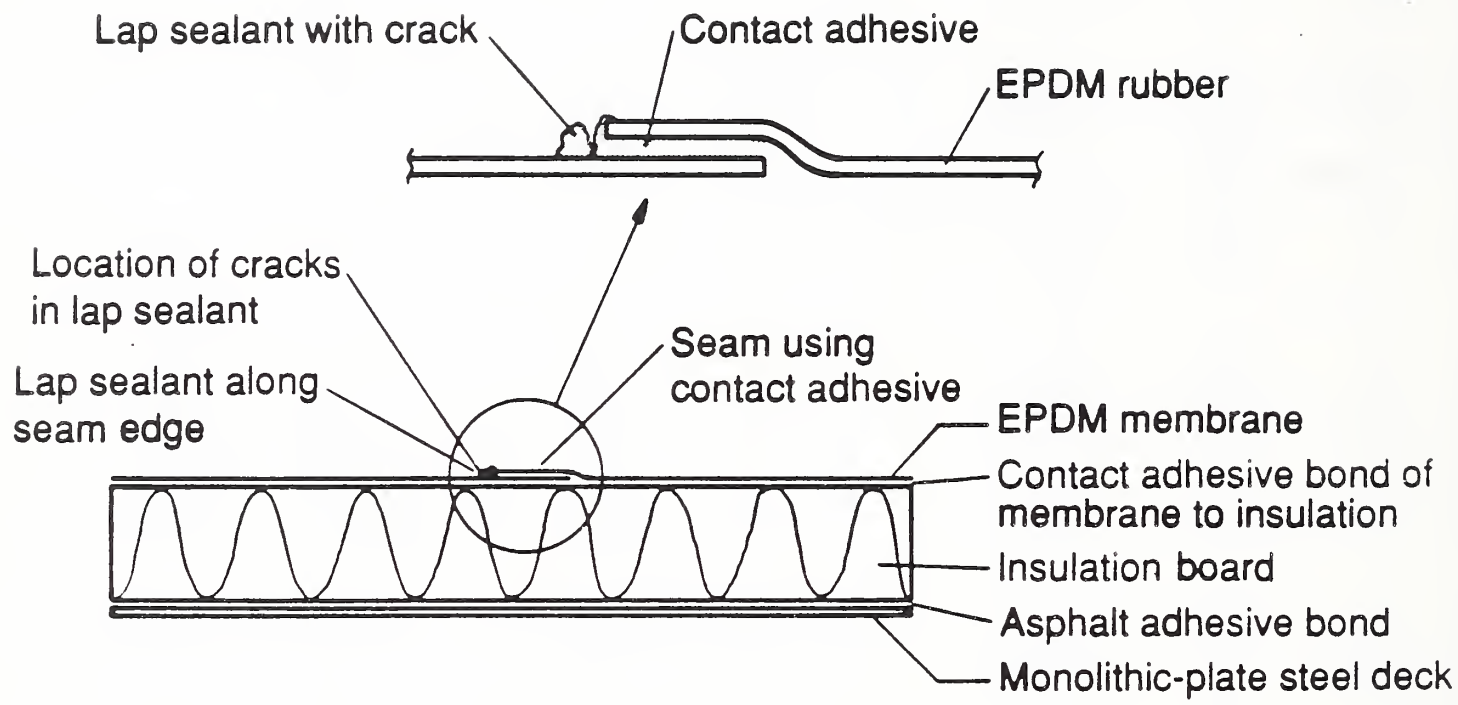
Figure 1. Cross Section of the Roof Construction Including a Seam and the Lap Sealant at the Seam Edge (Not to Scale).

- o In observing the in-place lap-sealant, many areas were seen where a hairline crack had formed parallel to the seam. The crack was along the edge of the upper sheet comprising the seam (Figure 1). (The hairline cracks were as described in the COE request for assistance, and were the reason for inspecting the roof.) In two small areas, a sample of sealant was removed from the seam using a knife. The removed sealant samples were judged to be pliable. Although the evidence from this observation was limited and subjective, it suggested that embrittlement of the lap-sealant had not occurred. Further testing of the lap-sealant was not performed.

- o Many areas of the seam where hairline cracks were observed in the lap-sealant were probed using the tip of a jack-knife blade. The blade tip was inserted into the hairline crack and into the edge of the seam. It was found that, in many areas probed in this manner, the lap seam had delaminated along its edge. The extent of delamination varied from location to location on the roof. No consistent pattern was observed. The amount of delamination into the seam ranged from tenths of inches to a couple of inches or more (a few millimeters to 50 mm or more). No areas were found where the seam had completely delaminated across its entire width. However, not all the seams of the roof were probed. Dirt

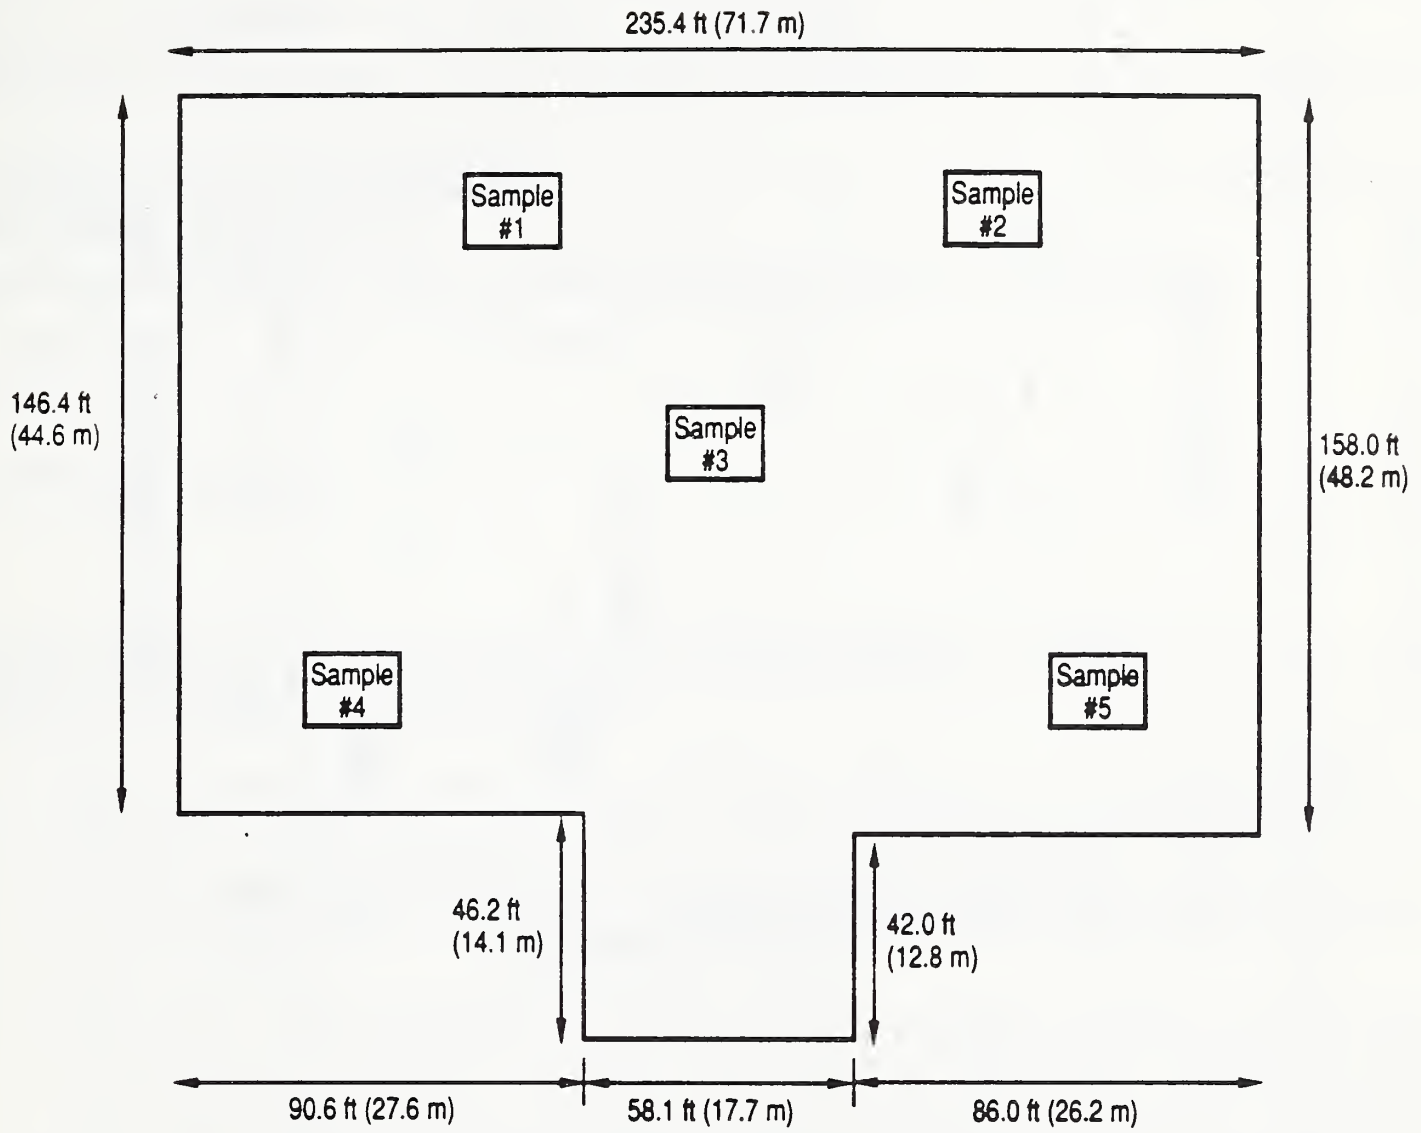
Figure 2. Plan Indicating Approximate Dimensions of the Roof and Locations of the Test Cuts.

Test samples of the lap seam were taken from five general sections of the roof: each corner and in the center of the building (Figure 1). Before cutting the membrane, it was decided to take both "good" and "bad" samples from each of the 5 sections. Good samples were those having no hairline cracks visible in the lap-sealant; whereas bad samples had a crack in the lap-sealant and some delamination of the bond along the seam edge, though not across the entire width of the seam.

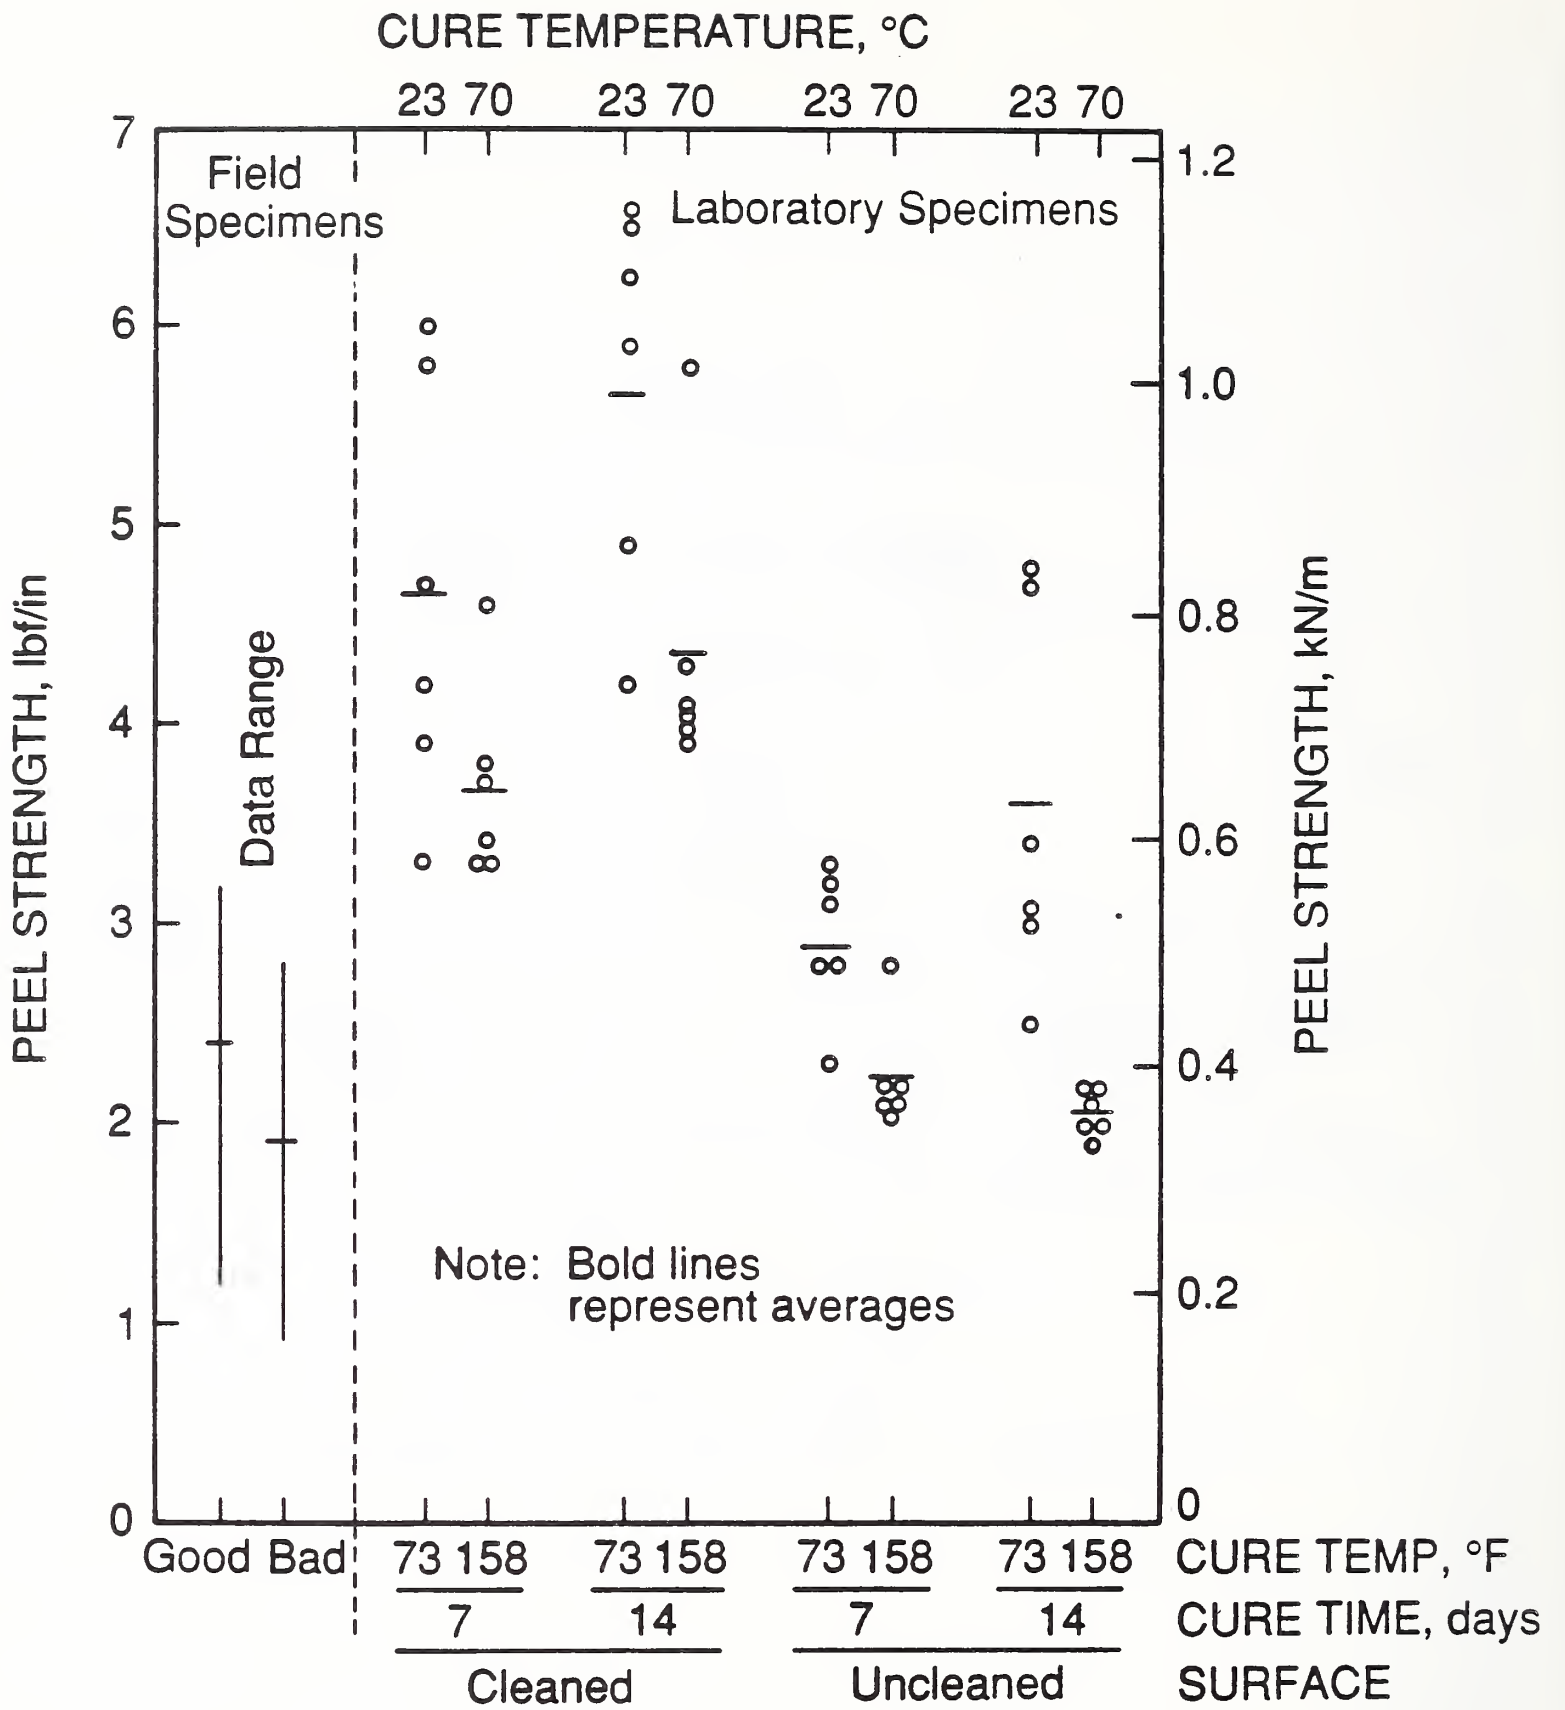
Figure 3. Results of the T-peel Tests for the Laboratory Samples in Comparison With Those of the Field Samples.

under close-to-optimum conditions of seam formation. (Longer cure times may produce stronger bonds, but this parameter was not further investigated in the present study.) The average maximum value of 5.7 lbf/in. (1.0 kN/m) was more than twice the average value of 2.8 lbf/in. (0.49 kN/m) found for all field specimens.

The importance of the three application conditions (Table 4) on seam strength is evident from Figure 2. For every comparable instance of cure time and temperature, the uncleaned specimens displayed lower bond strengths than the cleaned specimens. The reduction in strength was of the order of 40 percent. The finding was not unexpected, since previous studies using T-peel tests had indicated loss in T-peel strength due to uncleaned surfaces. Moreover, in the present study, the average bond strength of any set of uncleaned specimens had lower strength than all cleaned specimens. In fact, the averages for specimens representing three of the four uncleaned conditions (Figure 2) were between 2 and 3 lbf/in. (0.4 and 0.5 kN/m), which was the approximate range for the average values of all field samples

It is also evident from Figure 2 that, as the cure time lengthened from 7 to 14 days, the bond strength generally increased. This result was also consistent with previous NIST findings regarding a butyl-based contact adhesives which cures over time. An exception was for the uncleaned specimens cured at 158 °F (70 °C). In this case, a slight decrease in strength was observed in time. No reason for the observation was apparent.

From Figure 2, the effect of cure temperature was quite apparent. For every comparable instance of cure time and surface condition, the average bond strength of specimens cured at 158 °F (70 °C) was less than that for specimens cured at 73 °F (23 °C). The finding was not expected. Rather, it was expected that higher bond strengths would be found with increased cure temperatures due to an acceleration of the curing reaction. Although the data were limited for this observation, they did suggest that the adhesive/rubber system used to prepare the laboratory specimens tended to give lower strengths when cured at high temperatures.
