NISTIR 89-4061

AN ENGINEERING VIEW OF THE FIRE OF MAY 4, 1988 IN THE FIRST INTERSTATE BANK BUILDING LOS ANGELES, CALIFORNIA

Harold E. Nelson

March 1989

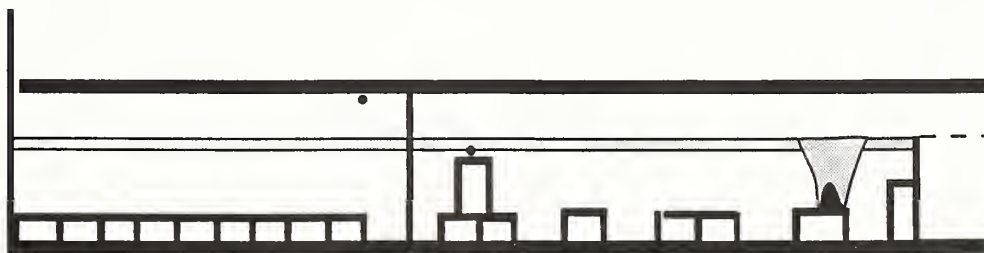
FIGURE 10. CONDITIONS AT 10:30 P.M.

**12 TH FLOOR - 10:30 PM - 250 KW FIRE - CEILING
JET <1FT. DEEP
SMOKE TEMPERATURE 150 F - DETECTOR RESPONDS IN
ZONE 3 - ONE OR MORE SPRINKLER HEADS FUSED**

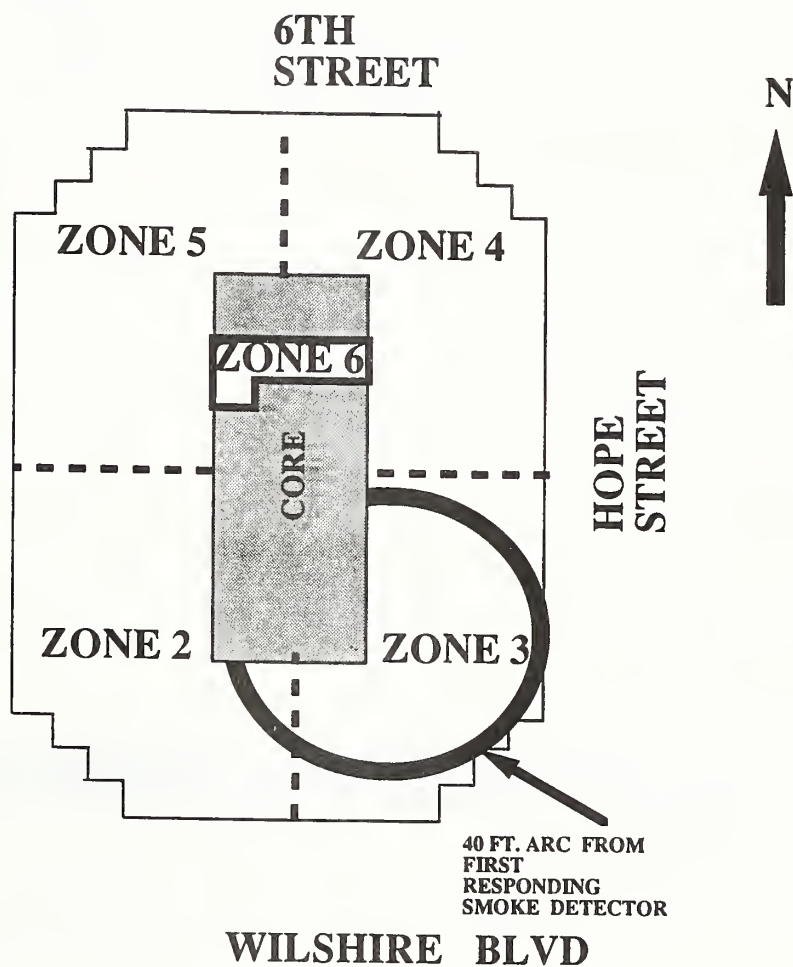
FIGURE 12 LIKELY POINTS OF FIRE INITIATION

If both the burn pattern evidence and the calculations related to detector response could be considered fully reliable the point of origin would be close to the arc shown in figure 12 at a point south of the end of the central core in a position closer to zone 4 than to zone 2. However, in view of the size and rate of development of this fire both the burn pattern evidence and the

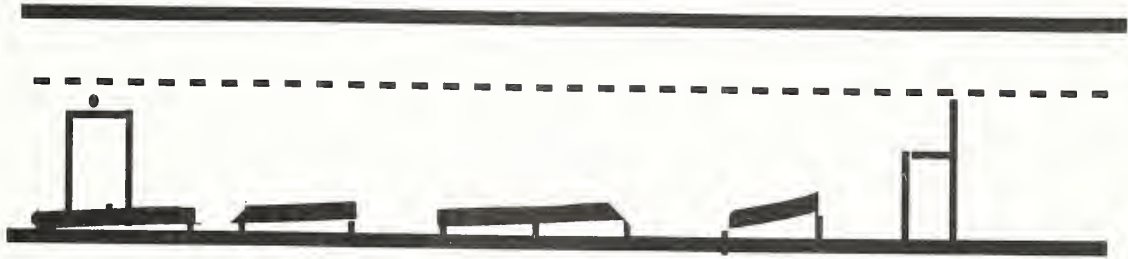
**FIGURE 13. BURN PATTERN IN WOODEN FURNITURE ON
HOPE ST. SIDE**

Figure 13 depicts the post fire remains of wooden workstations on the Hope Street side of the 12th floor. The portion depicted extends from the partition separating the private offices from the open trading floor space to the south end of the central core. A sloping pattern of destruction descends from the top of the workstations at the north end of the space shown to the floor at the south end of this area. Destruction extends to floor level from this point across most of the south end of the floor. In many fires the lowest point of burning is taken as indicative of the point of fire origin.

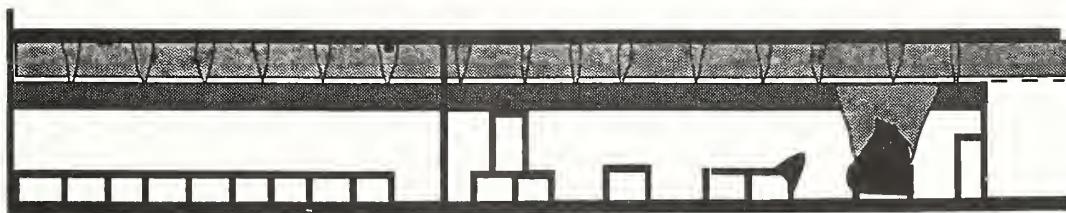
FIGURE 14. CONDITIONS AT 10:33 P.M.

**12TH FLOOR 10:33 - 1000KW - SMOKE <2 FT THICK - 200F - ZONE 2 -
PLENUM DETECTOR RESPONDS**

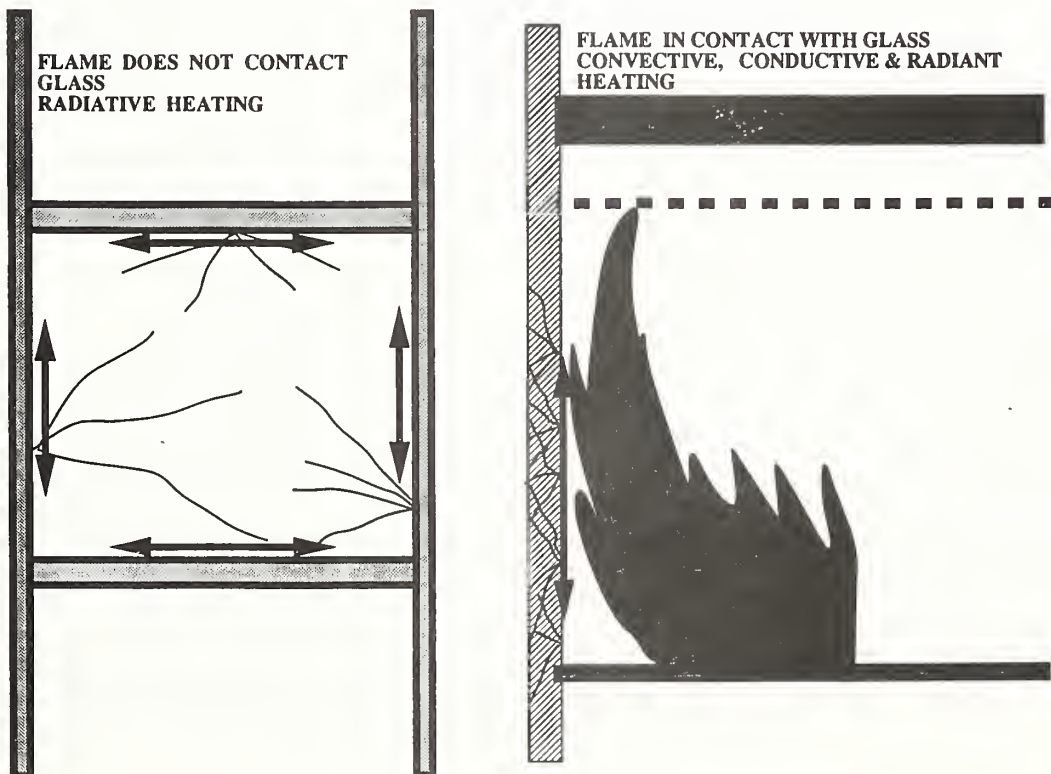
FIGURE 19. FIRE CAUSES OF GLASS BREAKAGE

Glass Breakage. (FIGURE 19)

One reason that it is not possible to determine whether the windows broke before or after flashover is that glass characteristically breaks in two manners.

- a. Radiant heating without flame contact. If flame does not contact the glass surface, heating of the glass is by radiant energy. In that case, the portions of the glass shielded from direct radiation do not heat-up as quickly as that portion exposed to direct radiation. As this occurs, internal stresses build up in the glass due to the greater thermal expansion of the more heated surface over the shielded surface. Theoretical calculations have indicated that when the temperature difference between the shielded and unshielded portions of the glass reaches about 100 F, radial cracks will travel from the boundaries quickly reaching a point of failure of the glass.

- b. Flame in contact with glass. Where direct contact is made between flame and glass, a thermal shock causing massive stresses between the hot side and the cool side of the plate occurs. This causes rapid cracking through the glass and failure of the glass whether or not general heating of the glass has taken place. The thicker the glass, the more likely this type of failure.

On this basis, if the fire source location is near the core, flames probably did not reach the glass prior to the development of flashover temperatures. Flashover conditions then produced radiation that heated the glass to its point of failure. Conversely, if the point of initiation was close to the windows, flame contacted the glass and the windows broke prior to flashover. In this latter case the early venting of the fire may have prevented the development of true flashover conditions.

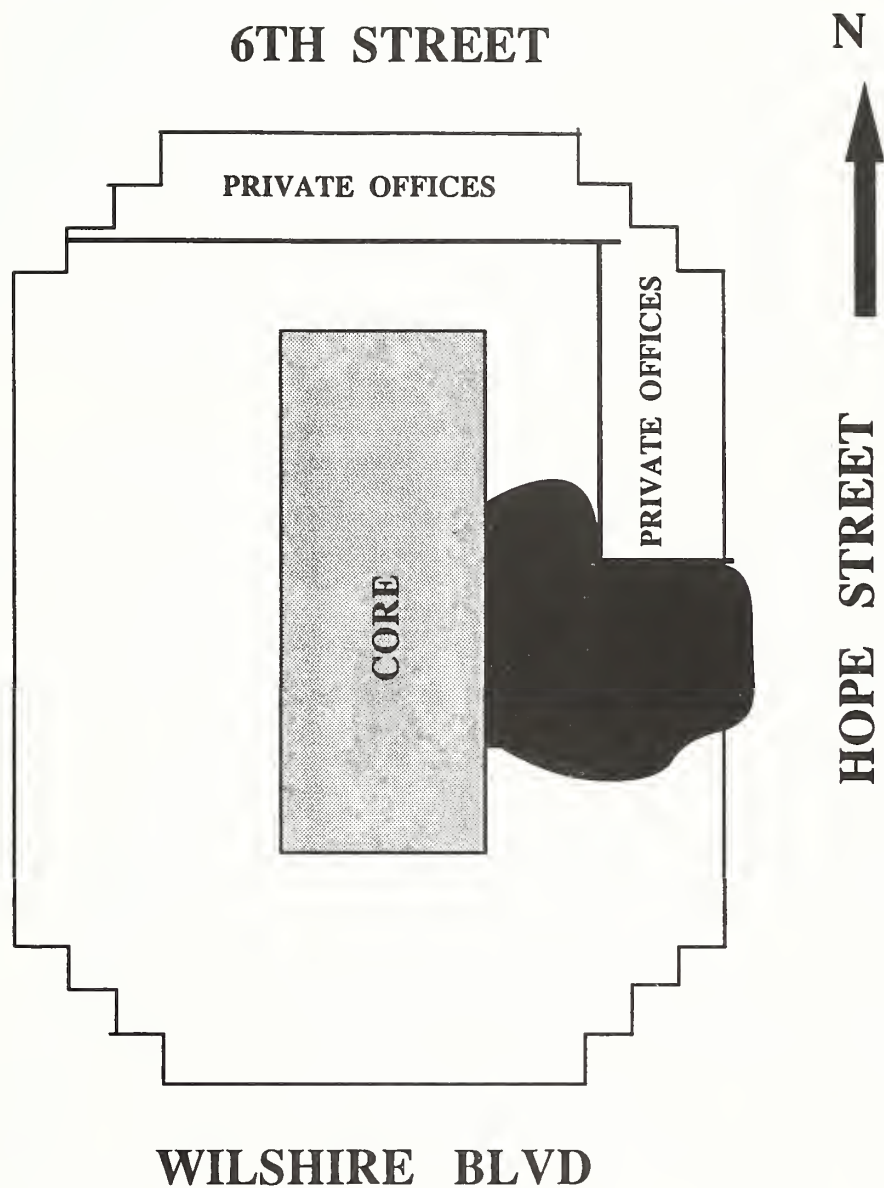
FIGURE 20. AREA OF FIRE INVOLVEMENT AT 10:37

The most likely occurrence is localized high (flashover range) temperatures produced by the flame and high temperature gases nearest the fire source. This caused window breakage in the immediate area. It is likely that the initial venting of the fire, depicted in figure 20, occurs before involvement of other portions of the floor. At the moment of breakage it is possible that the resulting opening is large enough to allow the fire to draw into the floor all of the air needed for the complete combustion of the material burning at that time.

ABOUT 10:37 FIRST WINDOWS BREAK

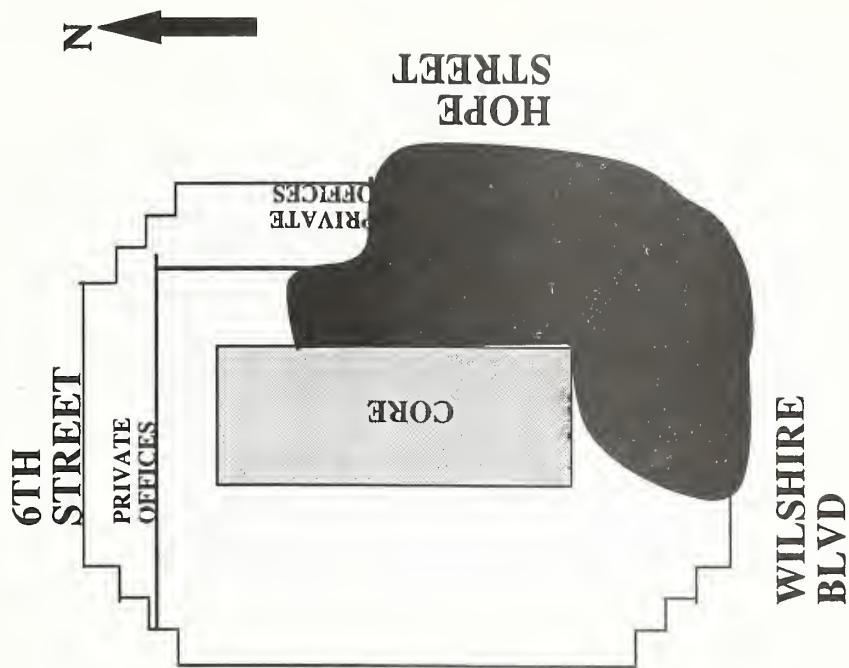
FIGURE 24. AREA OF INVOLVEMENT
AT 10:40 P.M.

Figure 24 estimates the extent of spread through the 12th floor at 10:40 p.m. As time progresses, the fire spreads across more surface area and windows are broken out over Wilshire Boulevard. By about 10:40 p.m., there are reports of extensive fire on both the Wilshire Boulevard and the Hope Street sides of the building. The prime means of fire spread continues to be radiant ignition of groups of workstations by the flame extension from the burning fuel. Shortly after 10:40 p.m., fire starts to progress along the west side of the building.

ABOUT 10:40 SPREAD COVERS
MORE THAN 1/4 OF PERIMETER

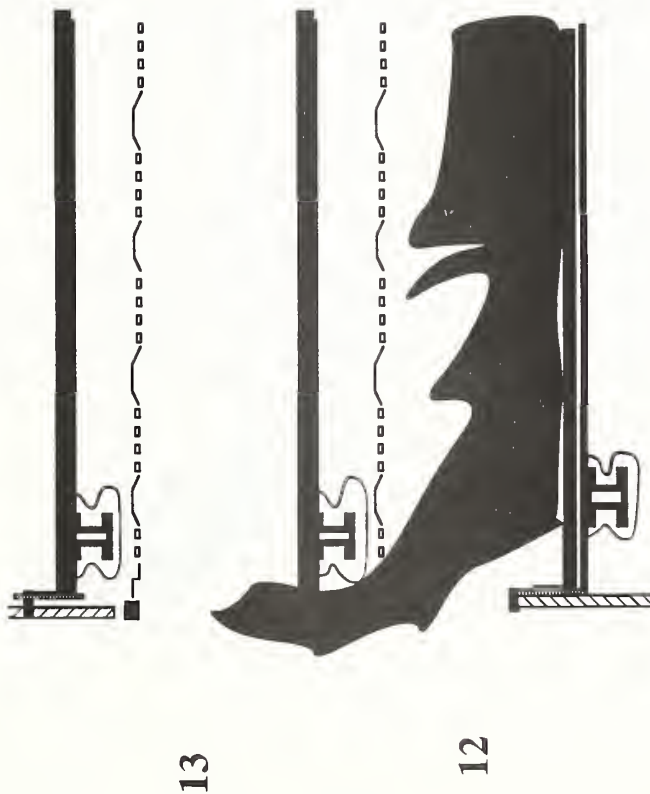
FIGURE 25. FIRE EXTENTION TO 13TH FLOOR

Fire spreads to the 13th floor at about 11:00 p.m. Flame emitting from most of the 12th floor windows. In view of the ventilation provided by the broken windows the length of flame extension is a function of air-rich burning. The extension is in the range shown in figure 25. Exceptions appear on video tapes where extensive flame emission come from windows of individual offices (presumably as the individual rooms flashover.) It is likely that at least portions of the suspended ceiling have failed by this time (11:00 p.m.) thereby exposing the spandrel panel and end of the floor slab to direct flame impingement.

Four different potential means of fire transmission between floors were noted from photographs, video tapes, fire department observations, and post fire evidence. It is impossible to determine which caused the first ignition or which was most prevalent. These four identified fire transmissions means are:

- a. Massive extension of flame covering the window area on the floor above.
- b. Failure of the suspended ceiling and glass spandrel panel, followed by lapping of the flame around the end of the floor slab.
- c. Flame transmission between the glass spandrel panel and the end of the floor slab. In this instance the actual transmission of fire may have resulted from failure of the gypsum board panel extending from the window sill on the floor above the fire to floor level, failure of the aluminum window sill or mullions, or failure of the glass spandrel panel.
- d. Passage of flame through spaces around pipes and other penetrations of the floor slab. This route was evidenced by burn traces in the core area.

ABOUT 11 PM IGNITION ESTABLISHED ON 13TH FLOOR

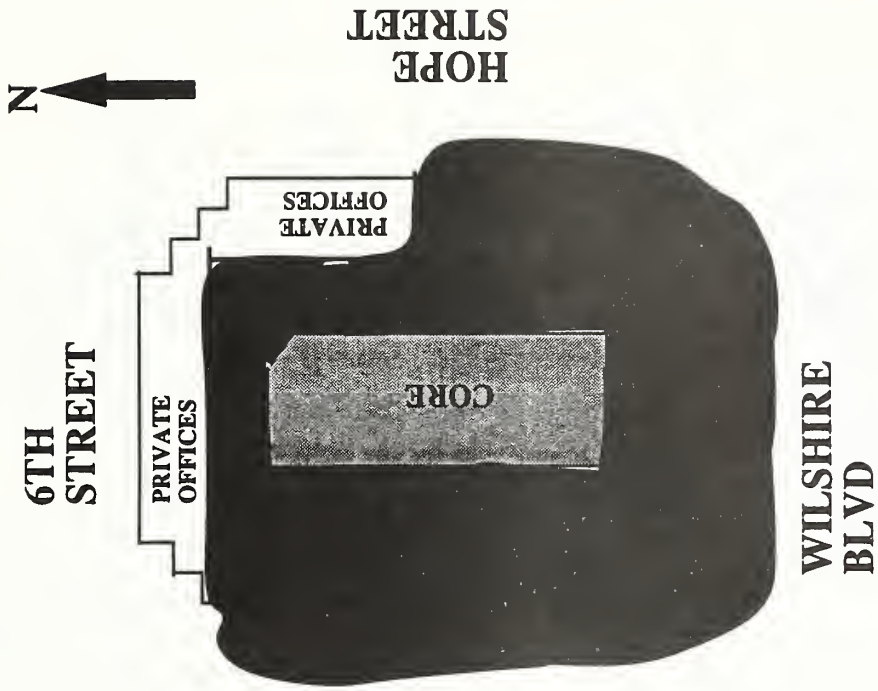
FIGURE 26. AREA OF INVOLVEMENT AT 11:30 P.M.

Photographs indicate that the fire reaches the northwest corner of the 12th floor at about 11:30 p.m. Fire involvement is estimated as shown in figure 26. Propagation around the floor slows as more of the floor becomes involved. It is possible that a portion of the flame is pulled towards the center of the building once the 13th floor is involved. This can reduce the flame extension along the ceiling, slowing down the rate of radiant ignition of new workstations and other fuel. Photographs indicate that during the next 30 minutes the fire progressively penetrates the offices along the north wall from west to east, reaching the northeast corner about midnight. It appears that the ceiling-high gypsum board partitions enclosing these offices retard their involvement.

ABOUT 11:30 PM FIRE WRAPS FLOOR EXCEPT OFFICES - FIRE EXTENDS TO OFFICES DURING NEXT HALF HOUR

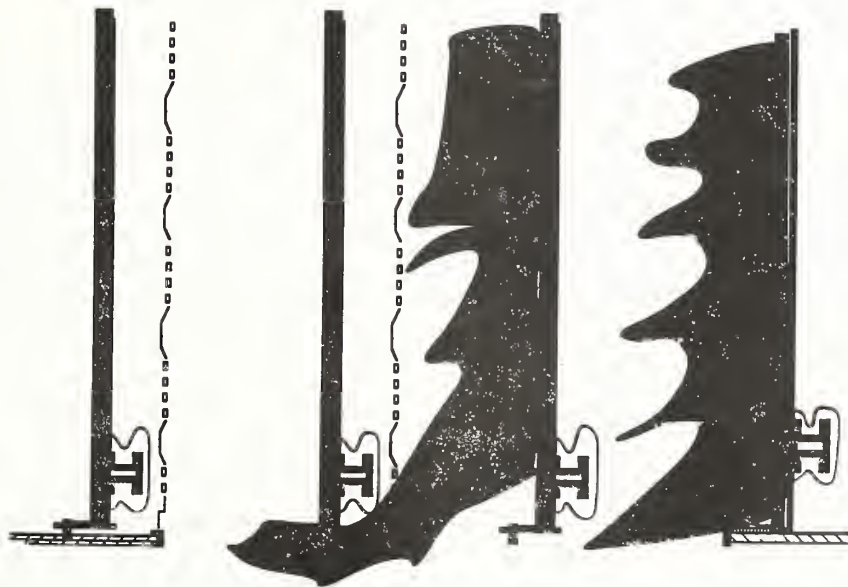
FIGURE 27. SPREAD TO 14TH FLOOR

ABOUT 11:40 PM IGNITION ESTABLISHED ON
14TH FLOOR

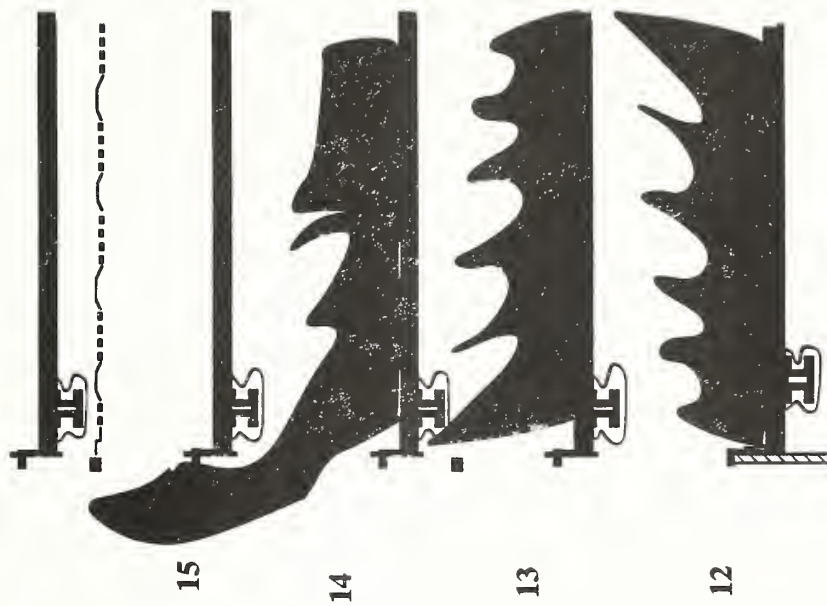
FIGURE 28. FIRE EXTENSION TO THE
15TH FLOOR

The reported time of extension to the 15th floor is about 12:20 a.m. Figure 28 depicts the envisioned relationship of flame orientations. This emphasizes the concept that flame being drawn in on the lowest floor and pushed out on the highest floor with the upward movement of the neutral plane.

ABOUT 12:20 AM IGNITION ESTABLISHED ON
15TH FLOOR

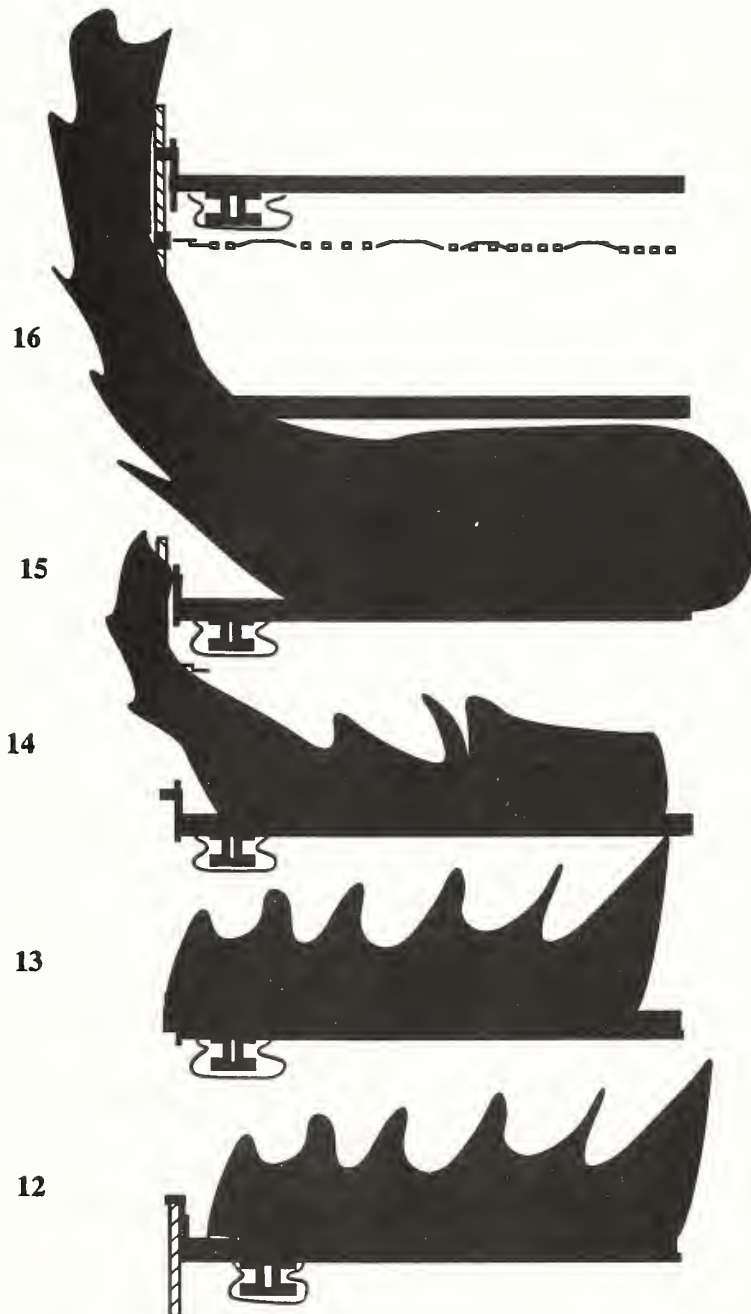
FIGURE 29. FIRE EXTENTION TO THE 16TH FLOOR

Figure 29 shows a very tall flame extension from the 15th to 16th floor. The fire department now stops the fire on the 16th floor. Direct fire damage is limited to the north end and the south west corner of the floor. The 16th floor is the only floor where a fire stop is made soon enough to preserve evidence of the means of fire propagation. The burned ceiling portion over unburned furniture in the south west section of this floor is evidence of exterior flame penetration lapping from the 15th floor onto the 16th floor ceiling. An extensive flame is necessary to produce this result.

ABOUT 12:50 AM IGNITION ESTABLISHED ON 16TH FLOOR
