Lightning and Surge Protection of Photovoltaic Installations

Two Case Histories: Vulcano and Kythnos

François D. Martzloff

June 1989

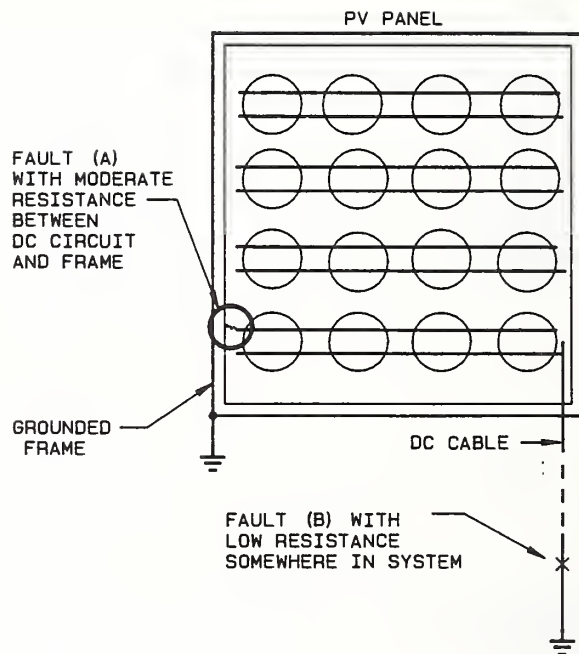
Figure 2-4. Scenario of double ground fault

In view of the reported insulation problems that occurred during the initial period of operation, one might ask whether the damage to that panel might be the result of a leakage of dc current to the frame, rather than the simple direct effect of a lightning strike. This dc leakage might be the consequence of a lightning induced overvoltage stress that created a double fault in one single event, or that created the second fault after the first had previously occurred but remained uncorrected. The scenario could unfold as follows:

In this manner, we have the elements that could create the observed effects, that is, an obvious fault with burning at (A), and a less obvious fault at (B), with a low resistance that may be eliminated during emergency maintenance work following the occurrence of the incident. The likelihood of such a double fault is admittedly low, but cannot be ruled out in view of the design of the ground fault detection system which indicates faults locally only. This scenario, still associated with lightning, would not be in contradiction with the observed low position of the damage since it does not require termination of the strike at that low point of the panel. Furthermore, the low point on the sloped array is also a place where moisture is more likely to accumulate and thus create a good candidate for a contributing cause in the scenario of two-stage insulation breakdown.

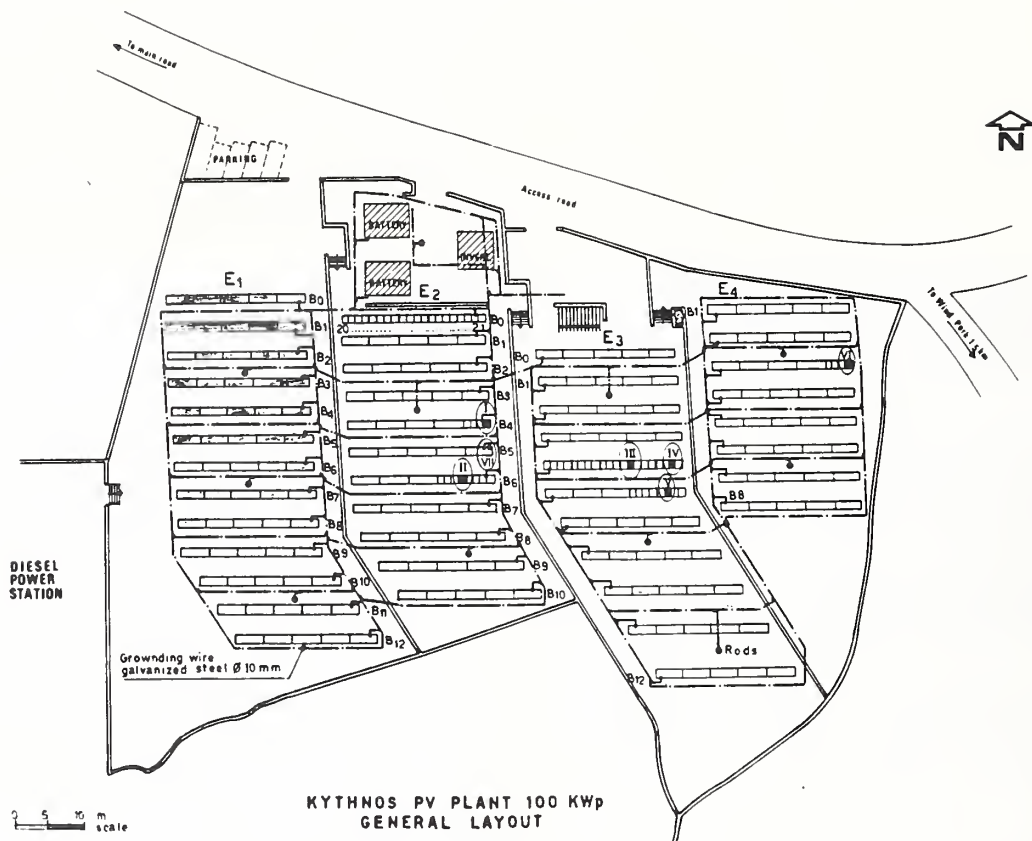
Figure 3-2. Location of ground cables, air terminals, and modules presumed damaged by lightning

Thus, five of the six damaged modules were beyond the 45° cone, and the sixth was on the fringe of the cone. Some panels in the array, not impacted by lightning, are further away from an air terminal, the greatest distance in the field being 15 meters. Another interesting statistic is the distribution of the panels with respect to being within a protected area of 8.5 meters radius (approximately 75%) or outside the protected area (25%).

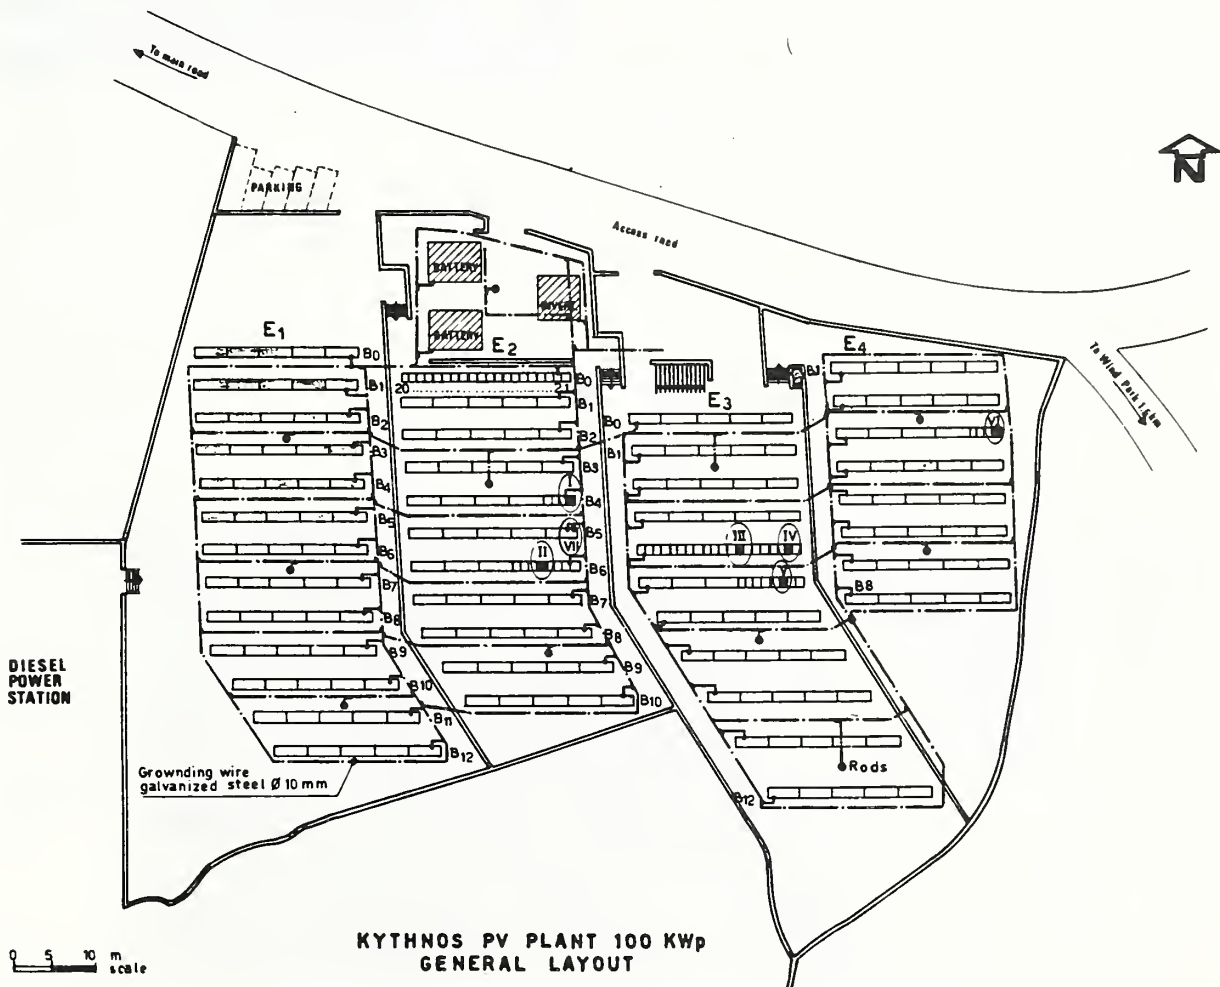
Figure B-1. Damages due lightning strokes in the PV field

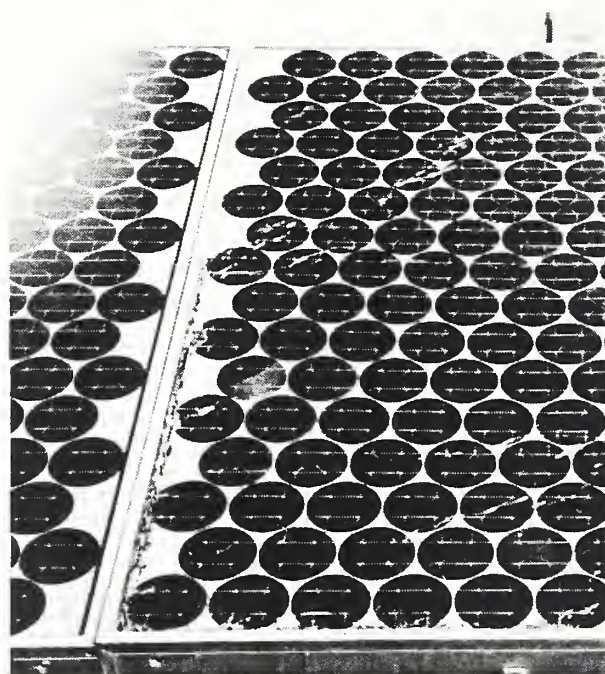
Module E2, B6, 5 damaged by lightning stroke at 5/2/87. Short circuited area along the frame

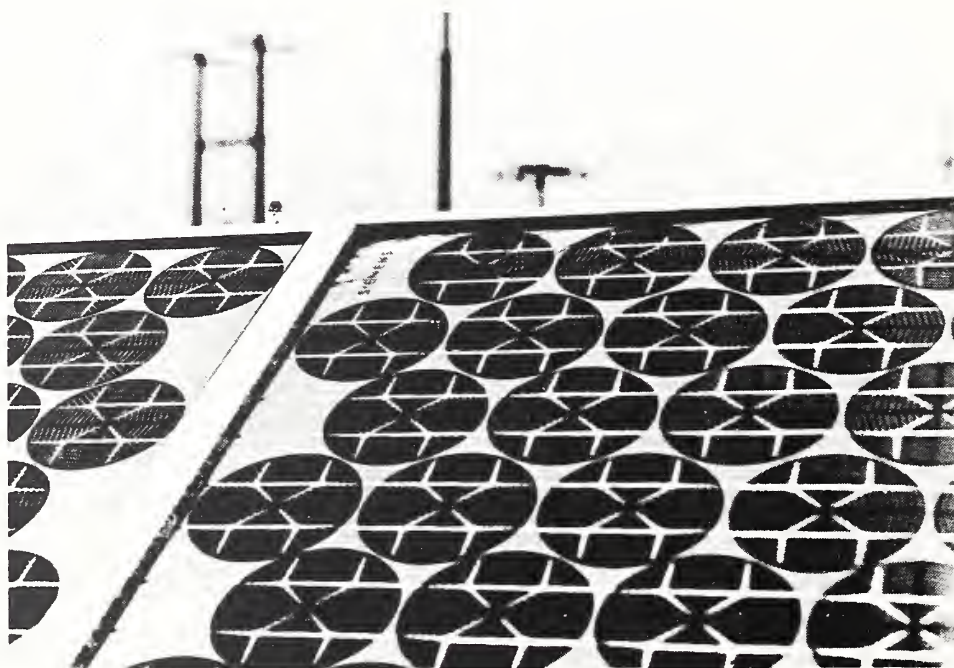
Module E3, B4, 13 damaged by lightning stroke at 5/2/87. Short circuited area along the frame

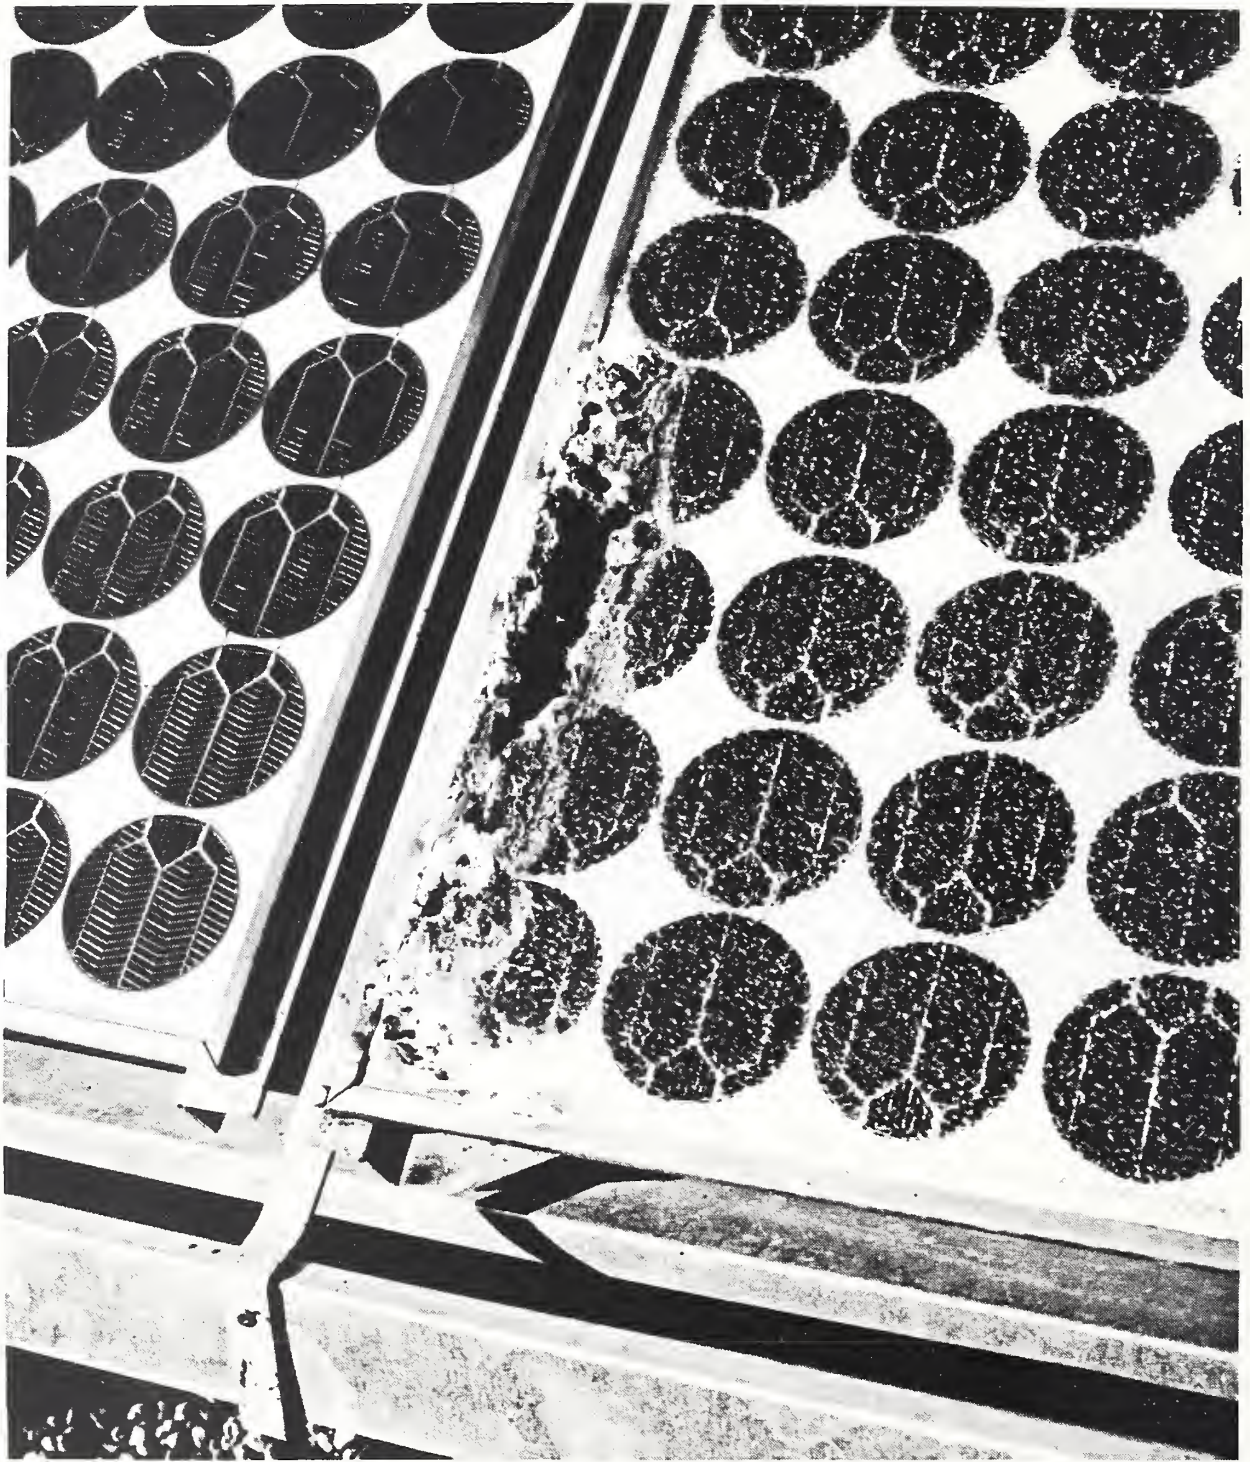
The damage caused to the PV panel by the presumed lightning strike is shown in Photograph 2-2. (The photograph was supplied by Previ as part of the background history; the damaged module was not available for examination.) This damage occurred during the commissioning period of the plant in the autumn of 1984; it was found early in the morning by the ENEL staff after a thunderstorm occurred during the

night. The glass and part of the cells were described as “melted near the metallic frame of the module.” No failure of the blocking diode nor of the varistor of that string was found as a result of that incident.

The damage to the module is located at the lower part of the array, as shown in Photograph 2-2. Postulating a scenario of a direct strike to the array, the point of attachment of the lightning would be the point of origin of the rising streamer that meets the descending stepped leader (Figure 2-3).

This position at the lower part of the array is rather unexpected for the point of initiation of the streamer. A more likely point for streamer initiation – and resulting termination of the strike – would be the upper edge of the array, which is 2 m above grade level (Photograph 2-15). Thus, there is some doubt on drawing a conclusion that the damage was the result of a direct strike terminating at the array.

2-2 Damaged panel, attributed to lightning

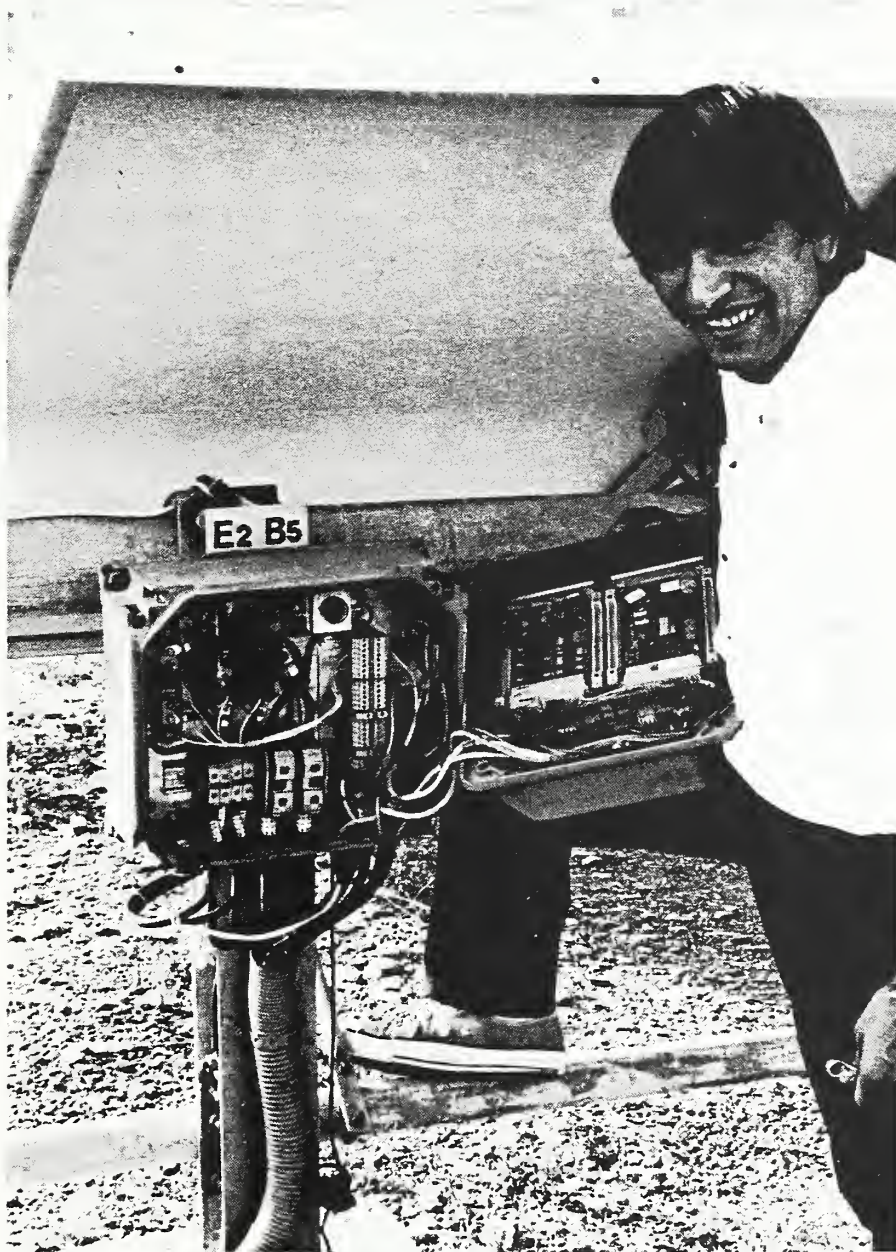
The string blocking diodes are mounted in the junction box and are protected by a metal-oxide varistor connected in parallel with each diode (Photograph 3-8). Photograph 3-9 shows another junction box with the additional data collection circuitry installed in the box cover. This particular box is the one where the lightning-suspected damage occurred, as shown in the close-up views of Photographs 3-10 and 3-11.

3-9 Terminal box damaged after February 4, 1987 incident

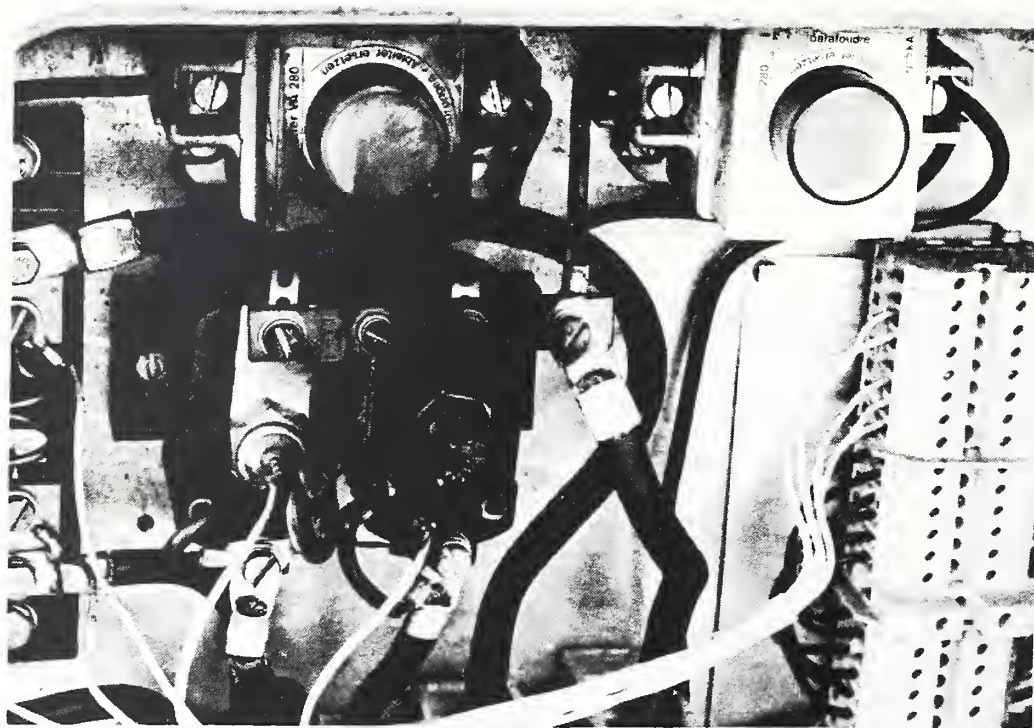
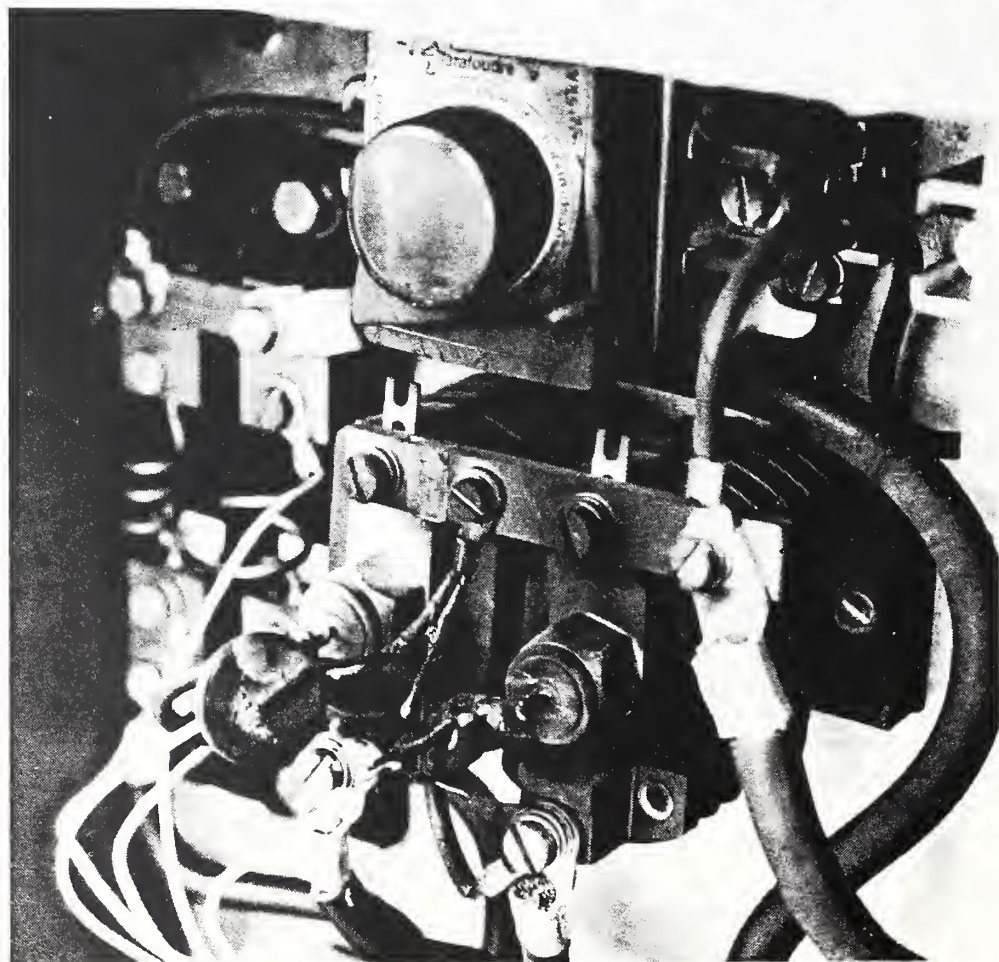
3-10 & 11 Close-up of E2 B5 box, showing remains of exploded varistor

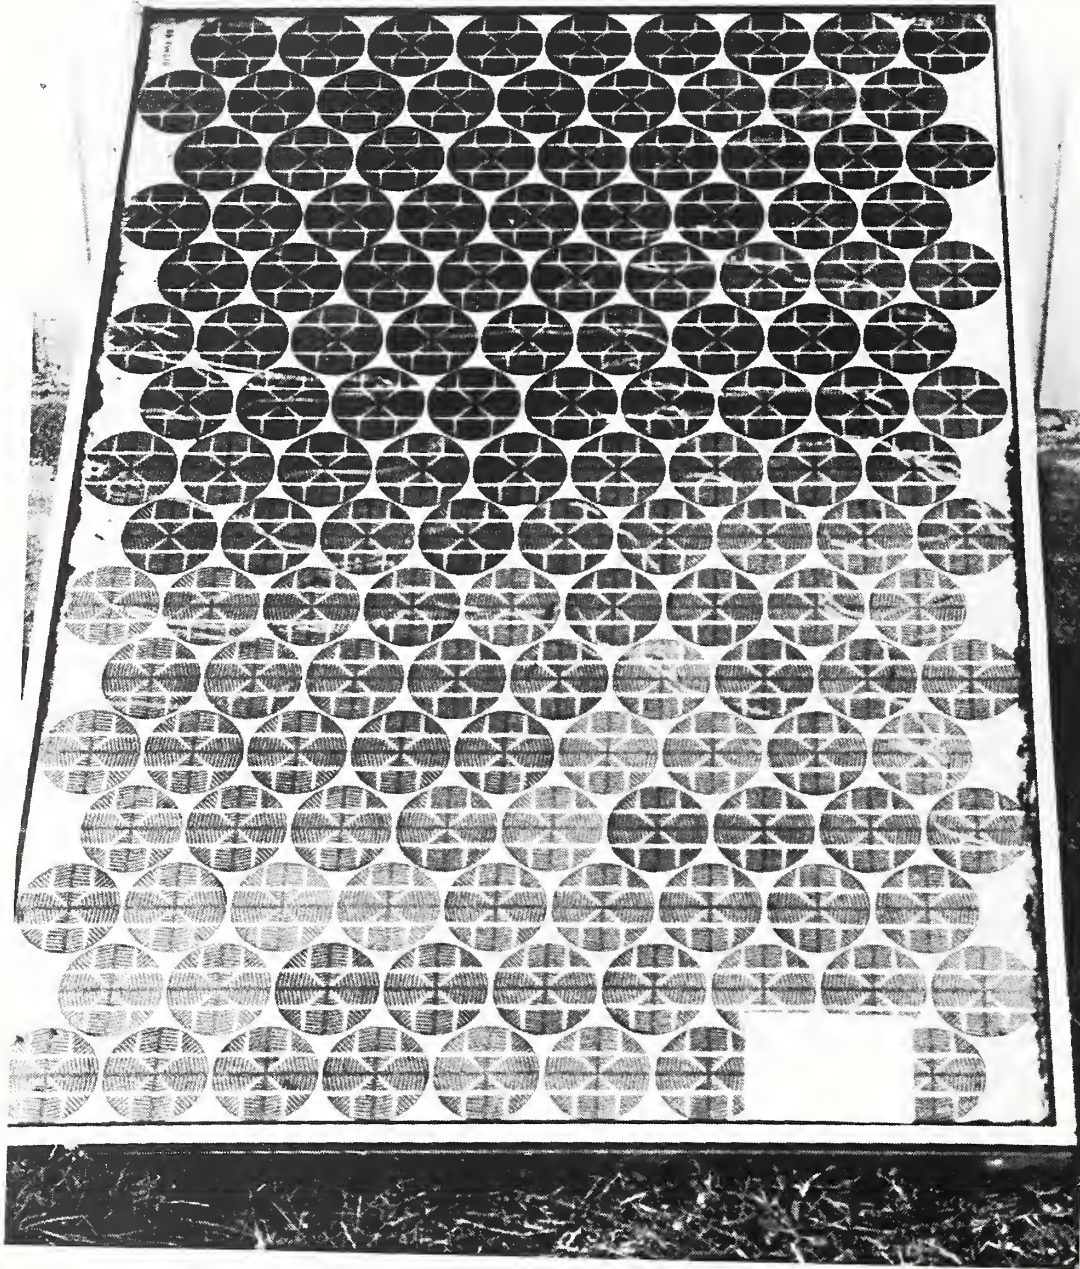
MODULE - 307 0423 This module was in storage and had been at location E2 B4 1 ("I" on Figure 3-2), 10 m from the nearest air terminal. There are burn marks along both long edges,

3-16 MODULE-307 0423 - Note burn marks at upper left
and lower right edges

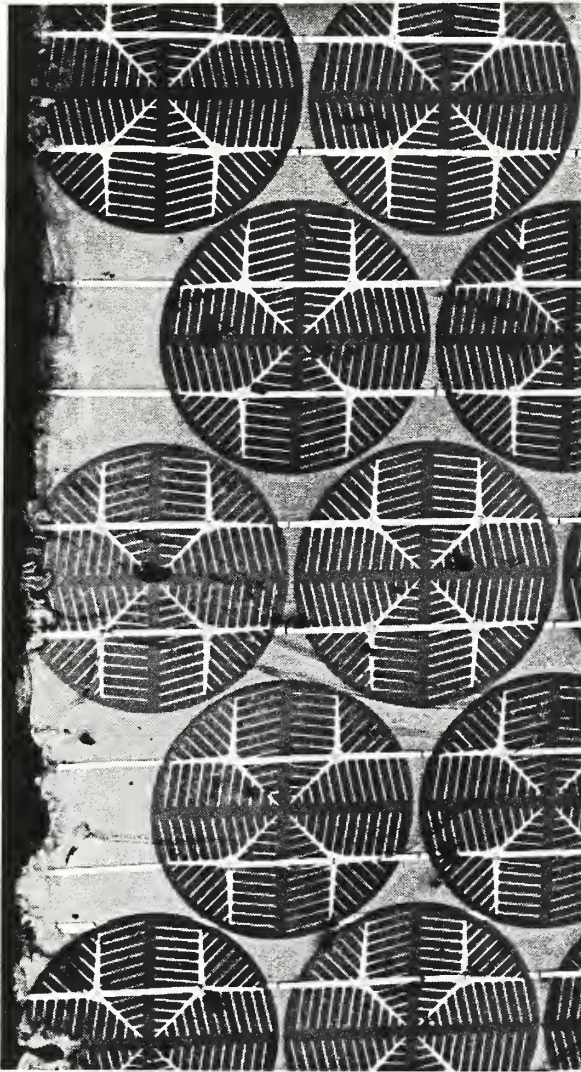
3-17 Detail of burn marks at left

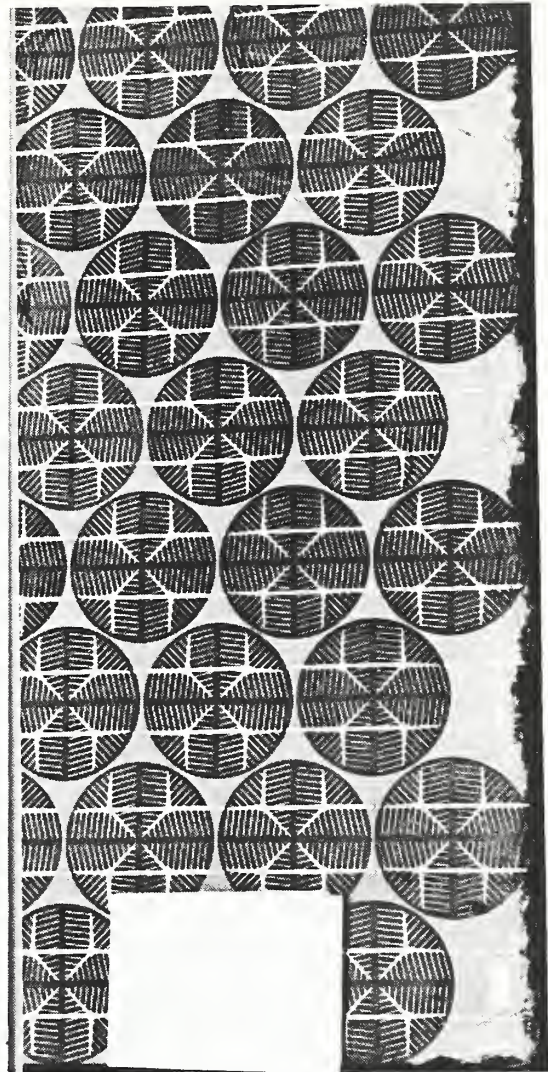
3-18 Details of burn marks at right

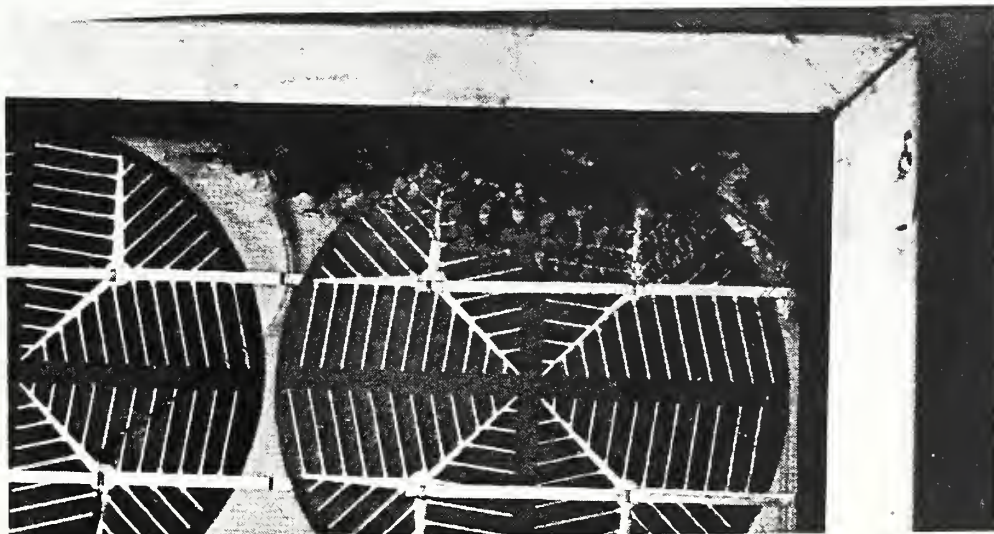
3-19 Detail of damage at top corner

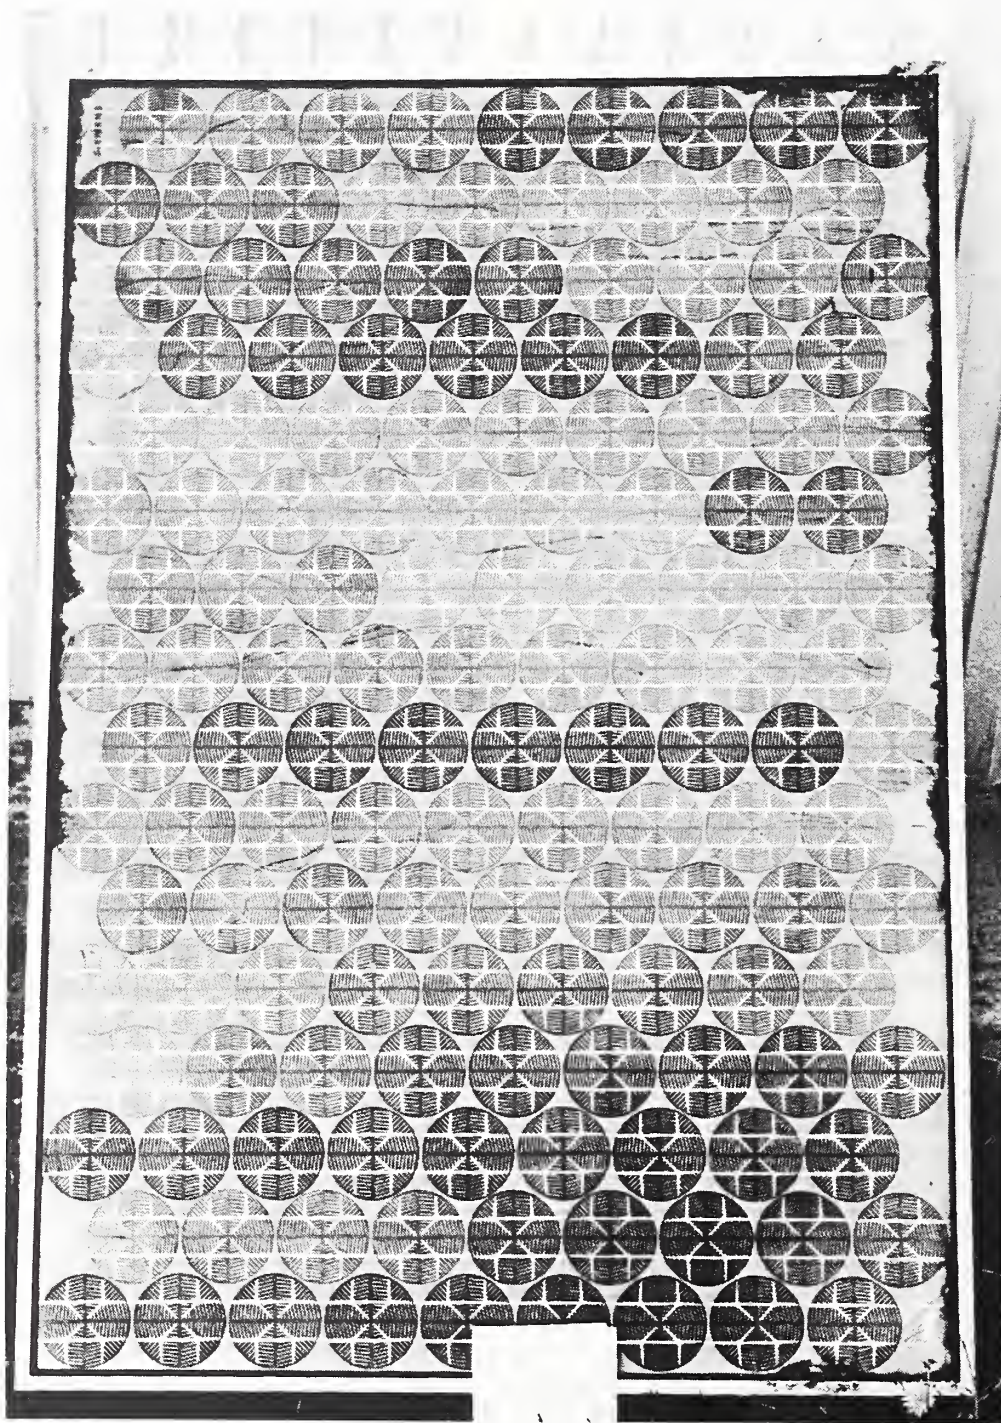
3-20 MODULE-303 0267 - Note burn marks at vertical edges and corners

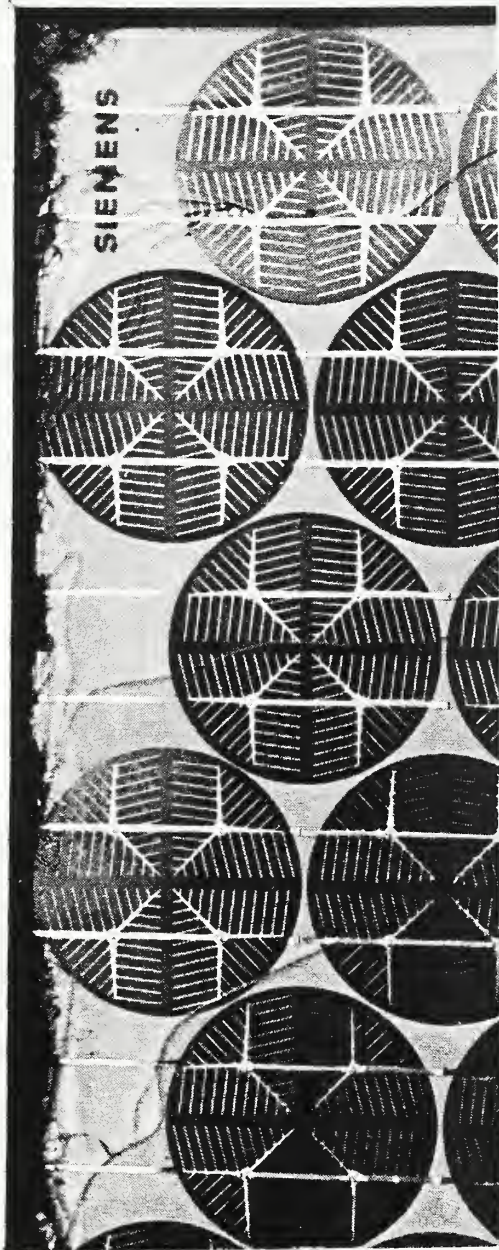
3-23 Detail of burns at left edge

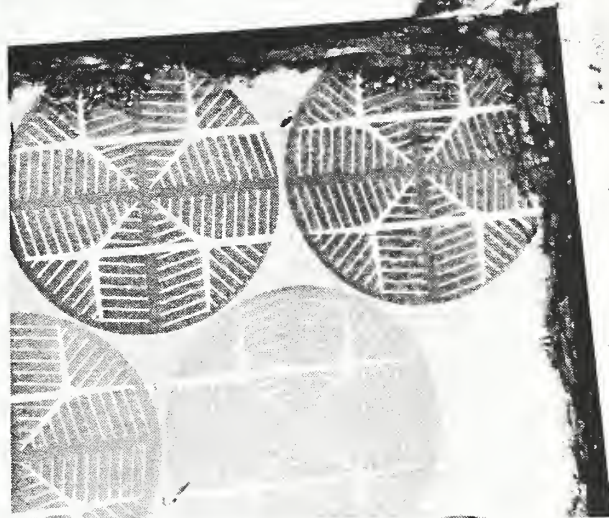
3-21 Detail of heavy burns at top corner

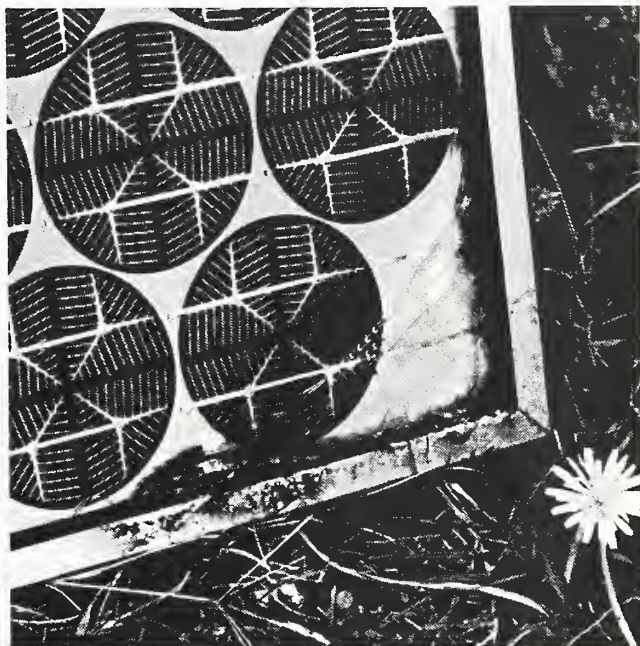
3-22 Detail of burn at bottom corner

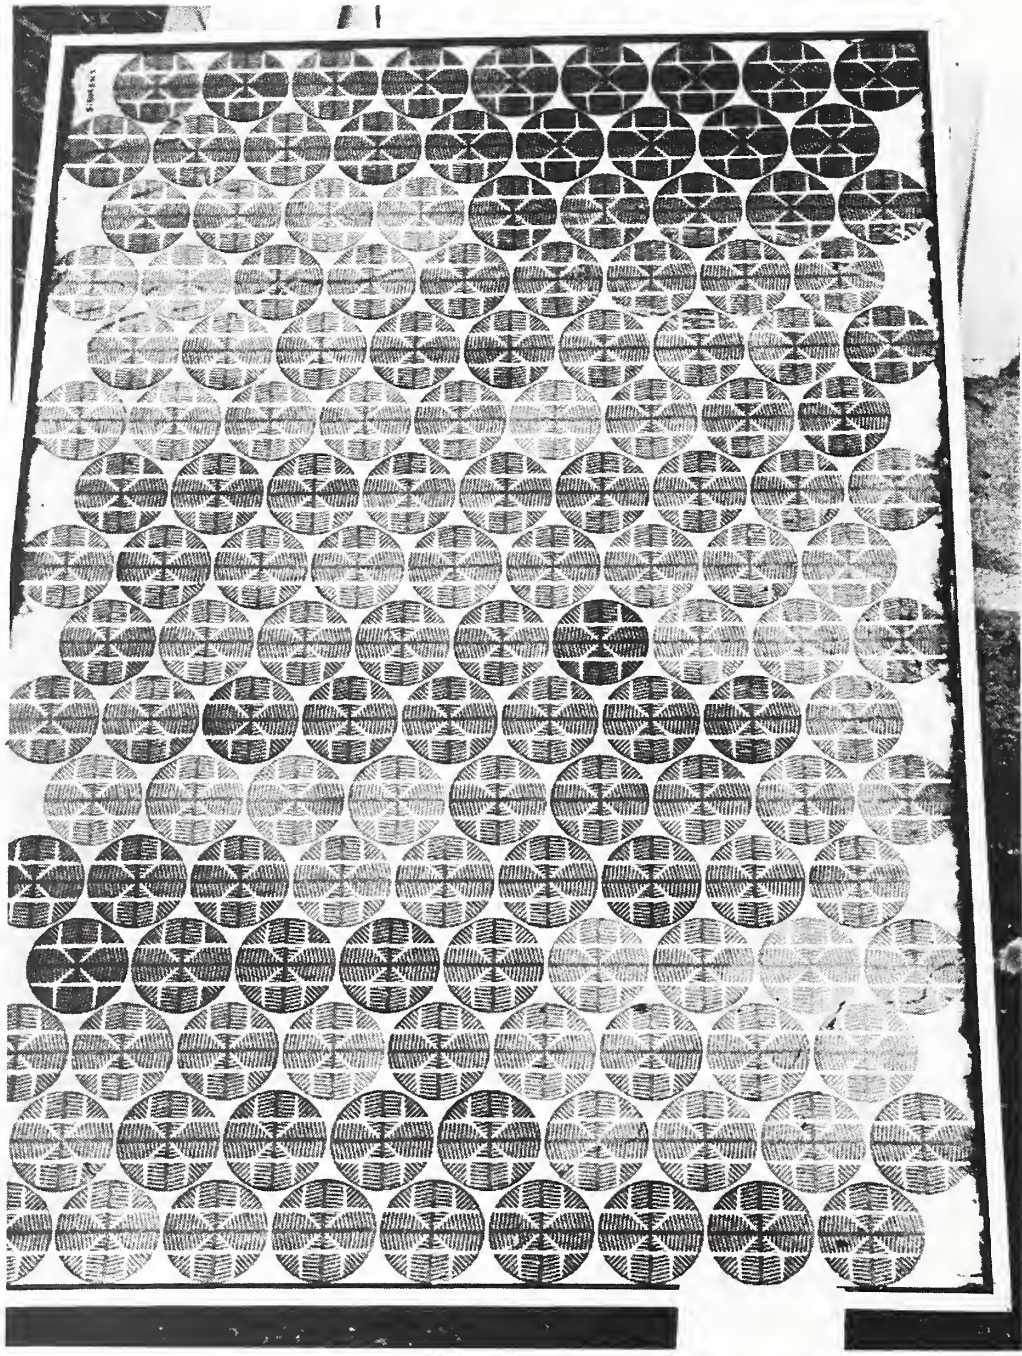
3-24 MODULE-304 0294 - Note burn marks on edges,
little damage at corners

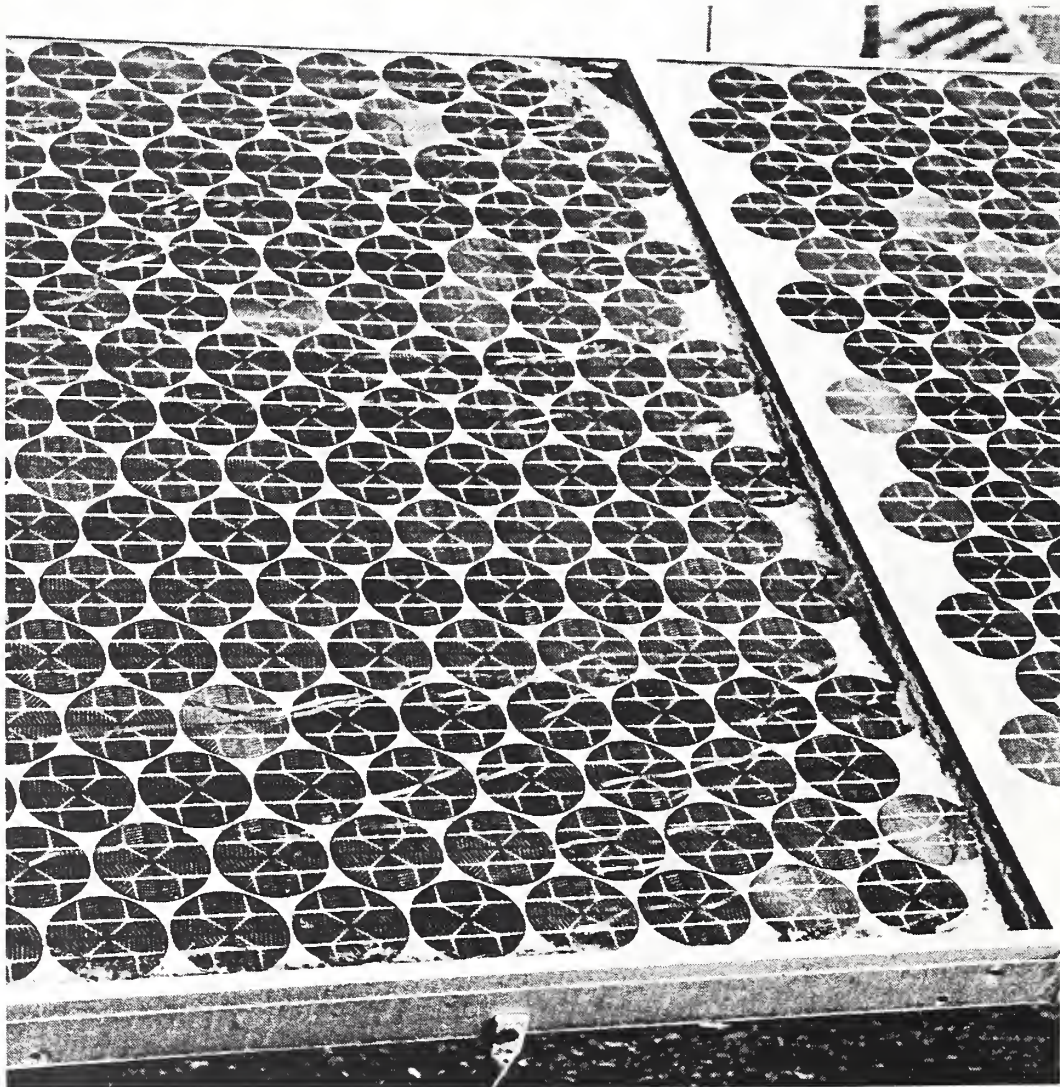
3-28 MODULE-306 0417 - Module left in array - Damage at right edge

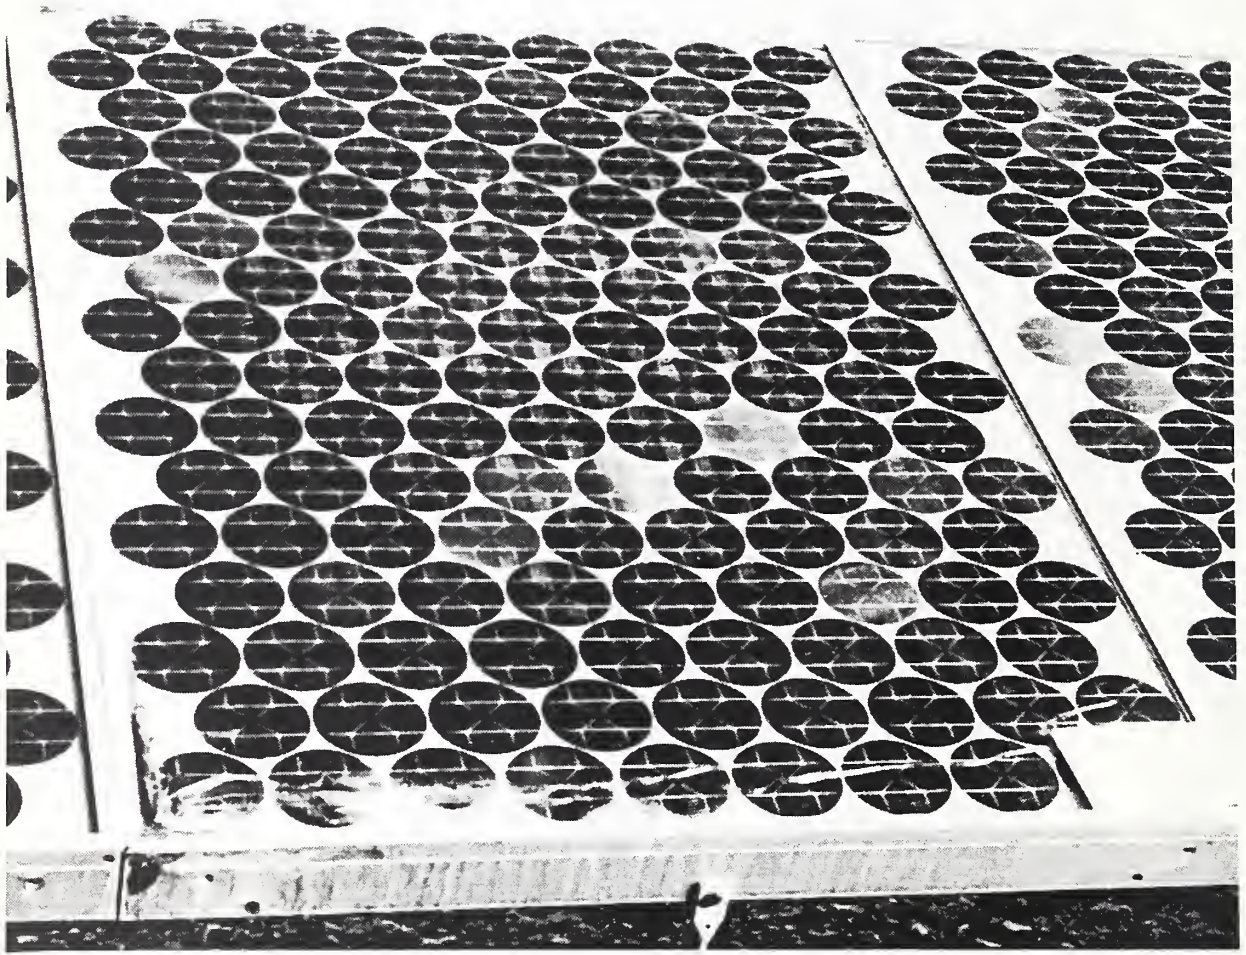
3-31 .MODULE-304 0300 - Damage mostly at corners

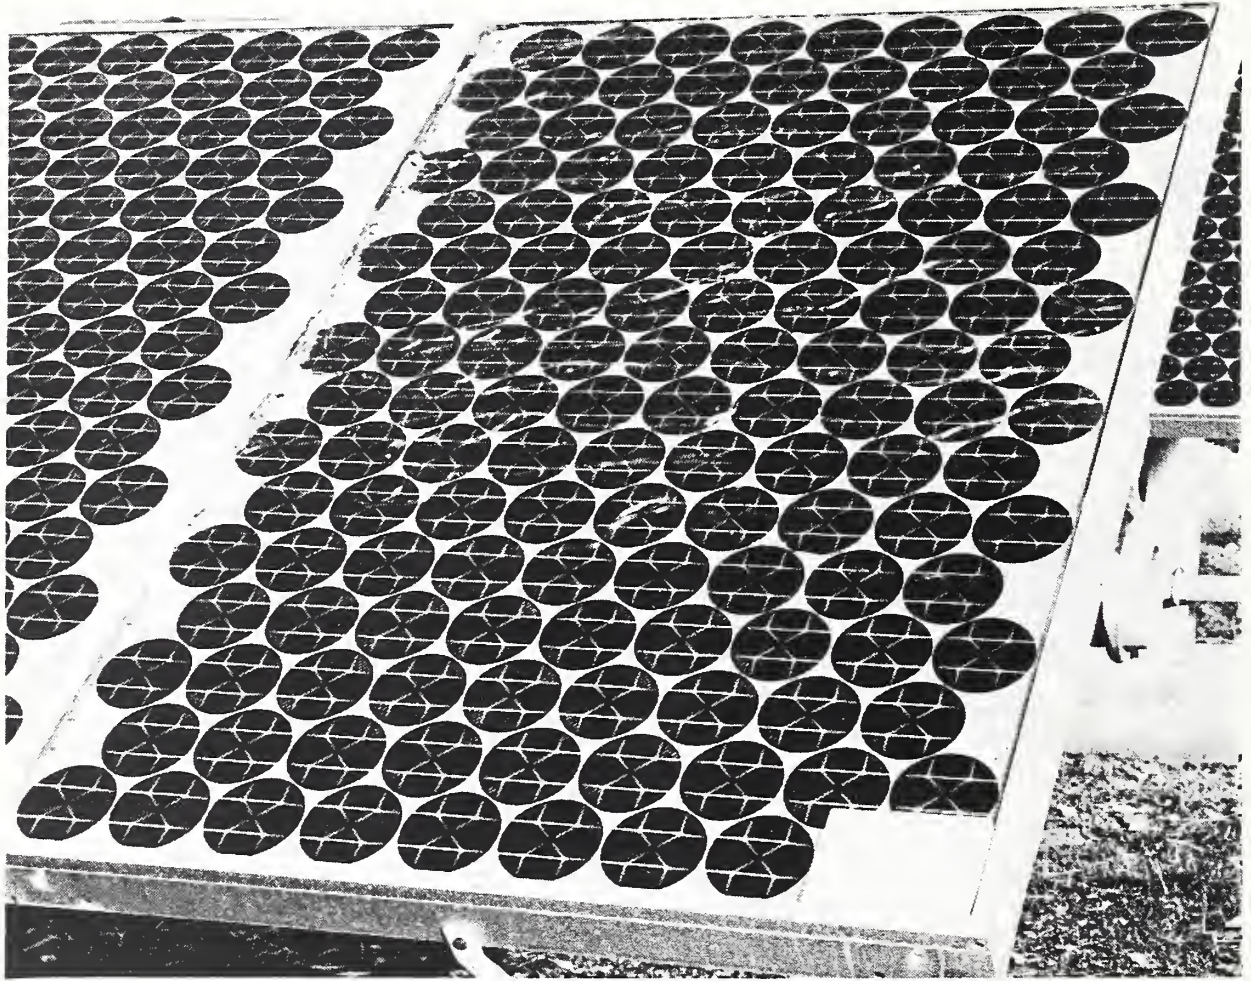
3-35 MODULE-310 0592 - Damage limited to left edge

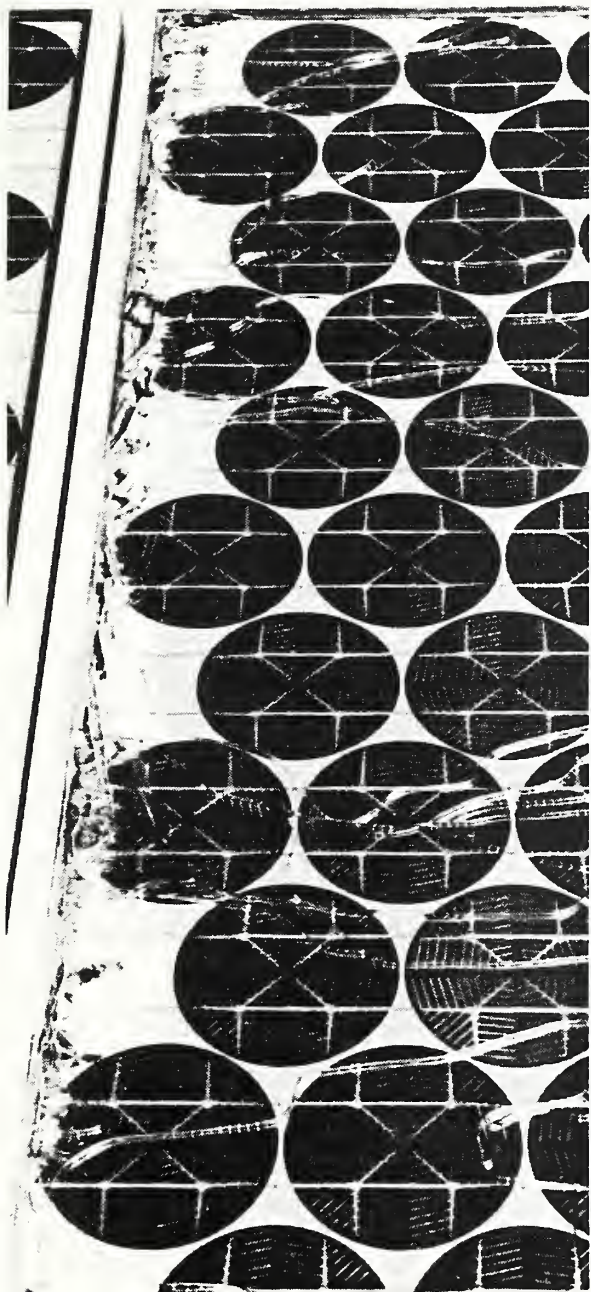
3-37 Damage on left edge

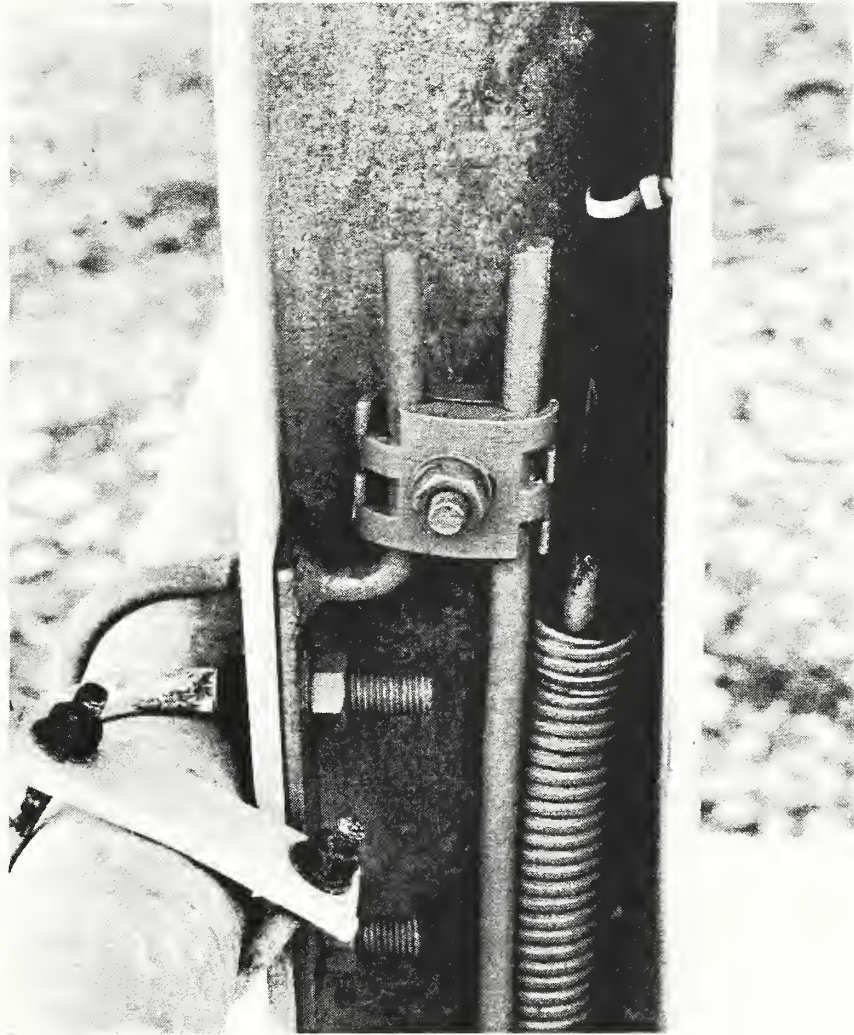
3-40 Hardware corrosion setting in (Detail of array footing)
