**AN ASSESSMENT OF
THE PERFORMANCE
AND RELIABILITY OF
OLDER ERW PIPELINES**

**R. J. Fields
E. N. Pugh
D. T. Read
J. H. Smith**

**U.S. DEPARTMENT OF COMMERCE
National Institute of Standards
and Technology
Institute for Materials Science
and Engineering
Gaithersburg, MD 20899**

Issued July 1989

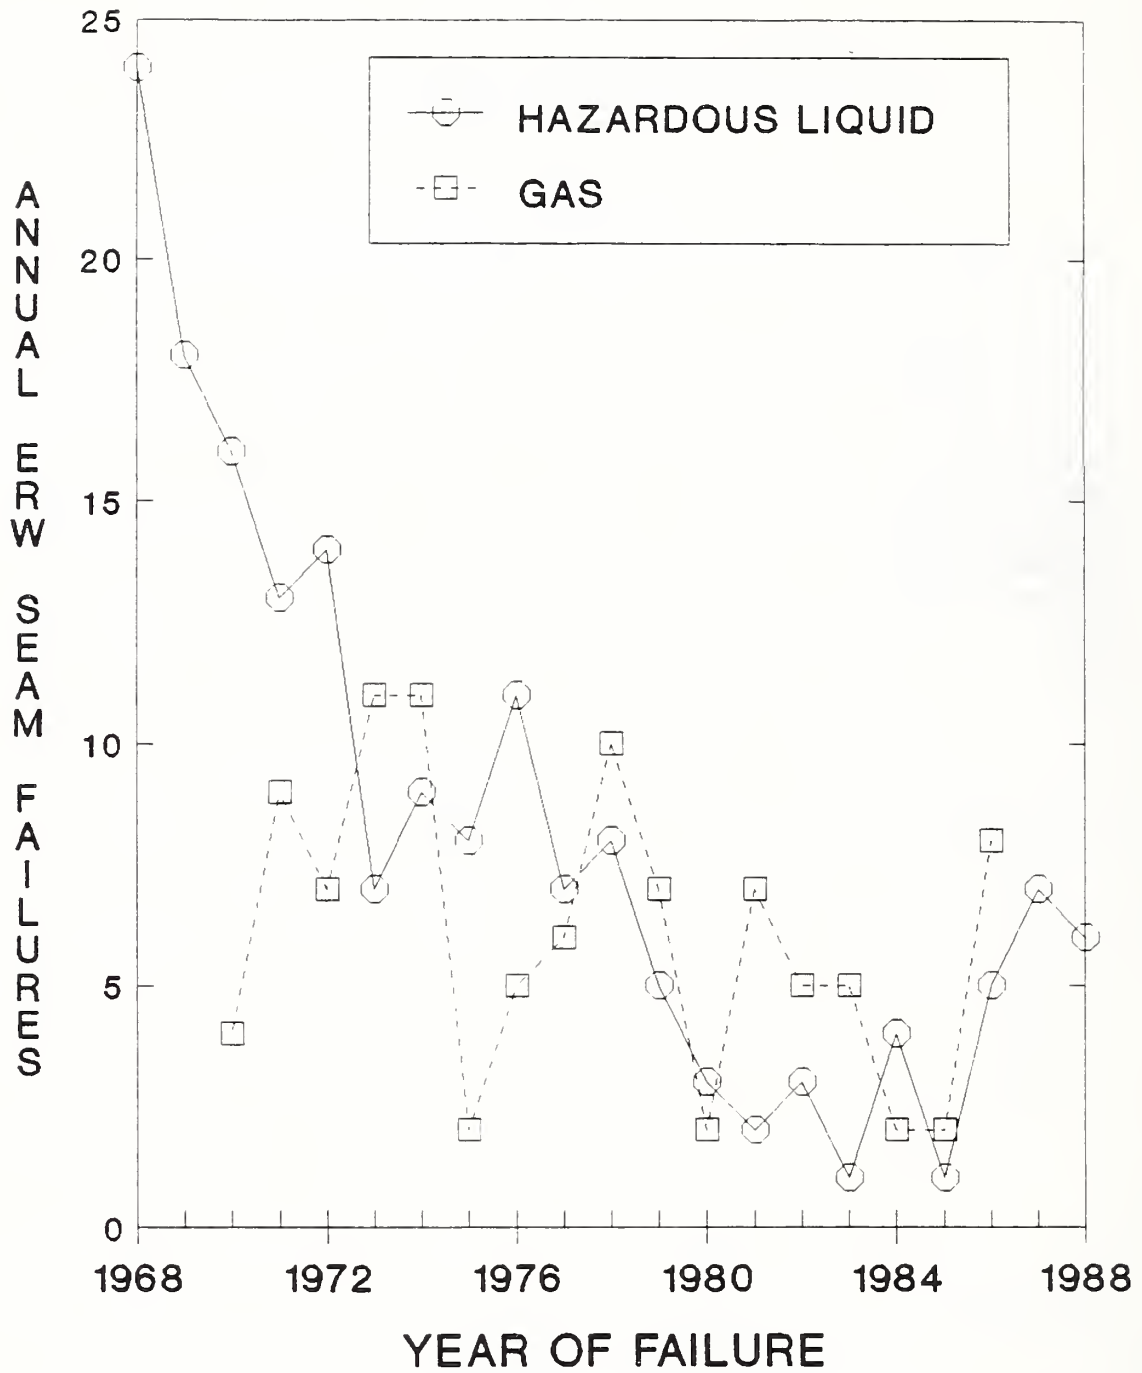
Figure 1. Annual Number of ERW Seam Failures in Hazardous Liquid Transmission Lines and Natural Gas Gathering and Transmission Lines During the Period 1968-1988 (15).

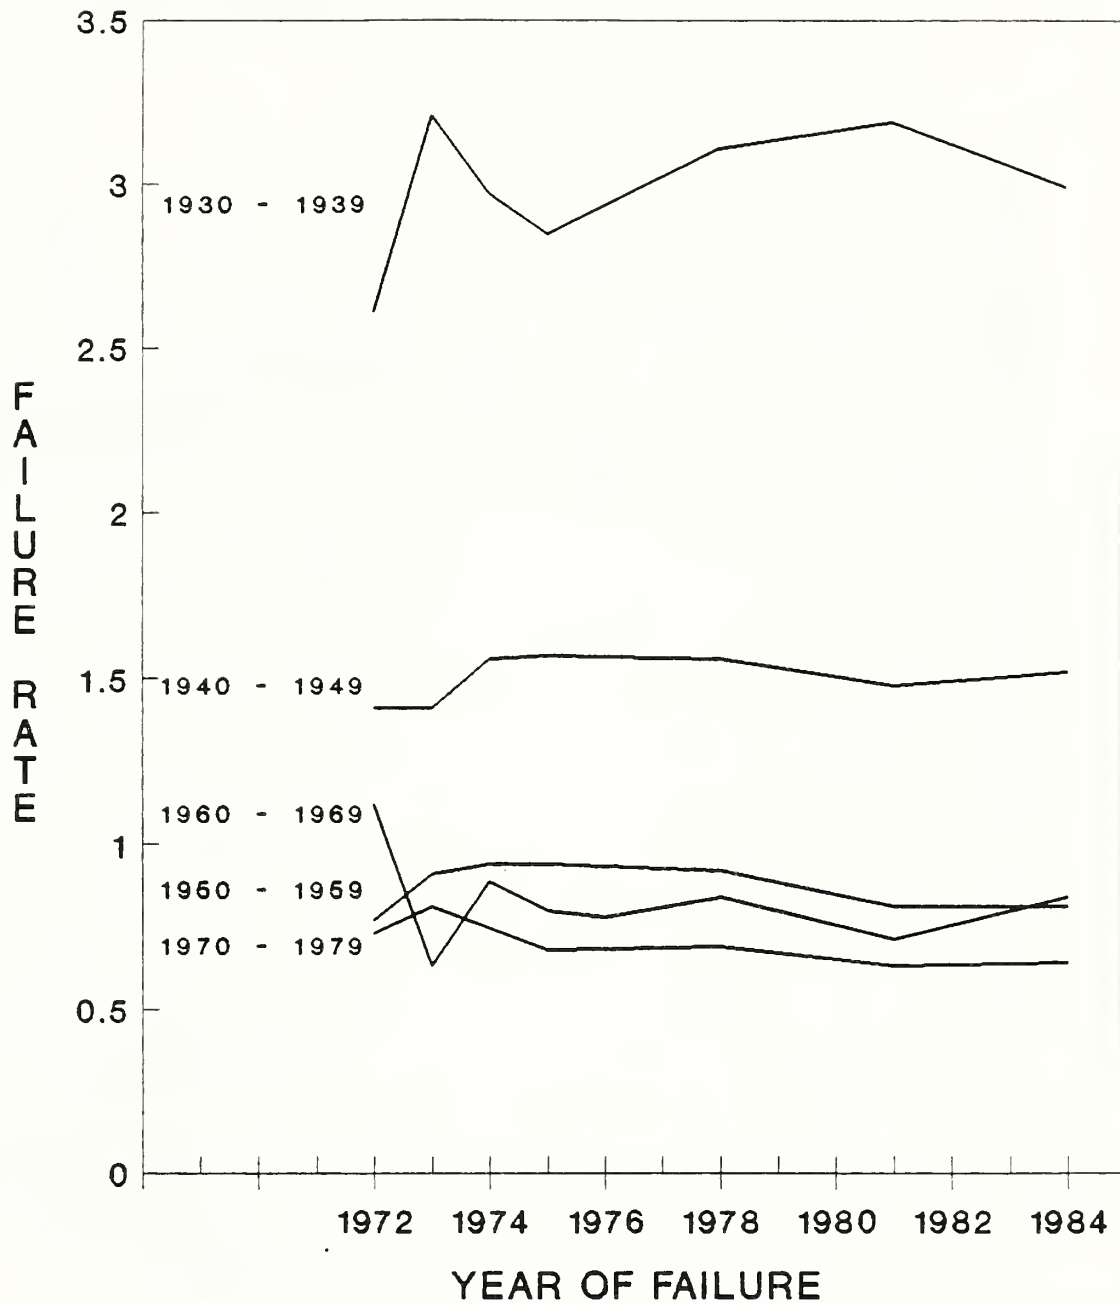
The Battelle report on NG pipelines (16) used mileage data similar to those of Table 3 to determine failure rate as a function of construction decade and incident year. Their findings, summarized graphically in Figure 2, show two important points:

- (1) Pipelines constructed in the 1930s and 1940s have significantly higher failure rates than those installed in the 1950s, 1960s and 1970s, the latter showing little differences. The fact that these older pipes show larger failure rates is worthy of attention, but is offset by the relatively small mileage installed in these decades, Table 3, and by the fact that many are being replaced (19).
- (2) As in the case of ERW seam failures, Section 4.2.3, it is somewhat surprising that the failure rate in the period 1970-1984 is essentially constant with incident year for each of the five decades represented in Figure 2. There is no evidence for an aging effect in these data.

Figure 2. Annual Rates of Failure (number per year per 1000 miles of pipeline) in Natural Gas Gathering and Transmission Pipelines for the Period 1970-1984 Classified by Decade of Construction (16).

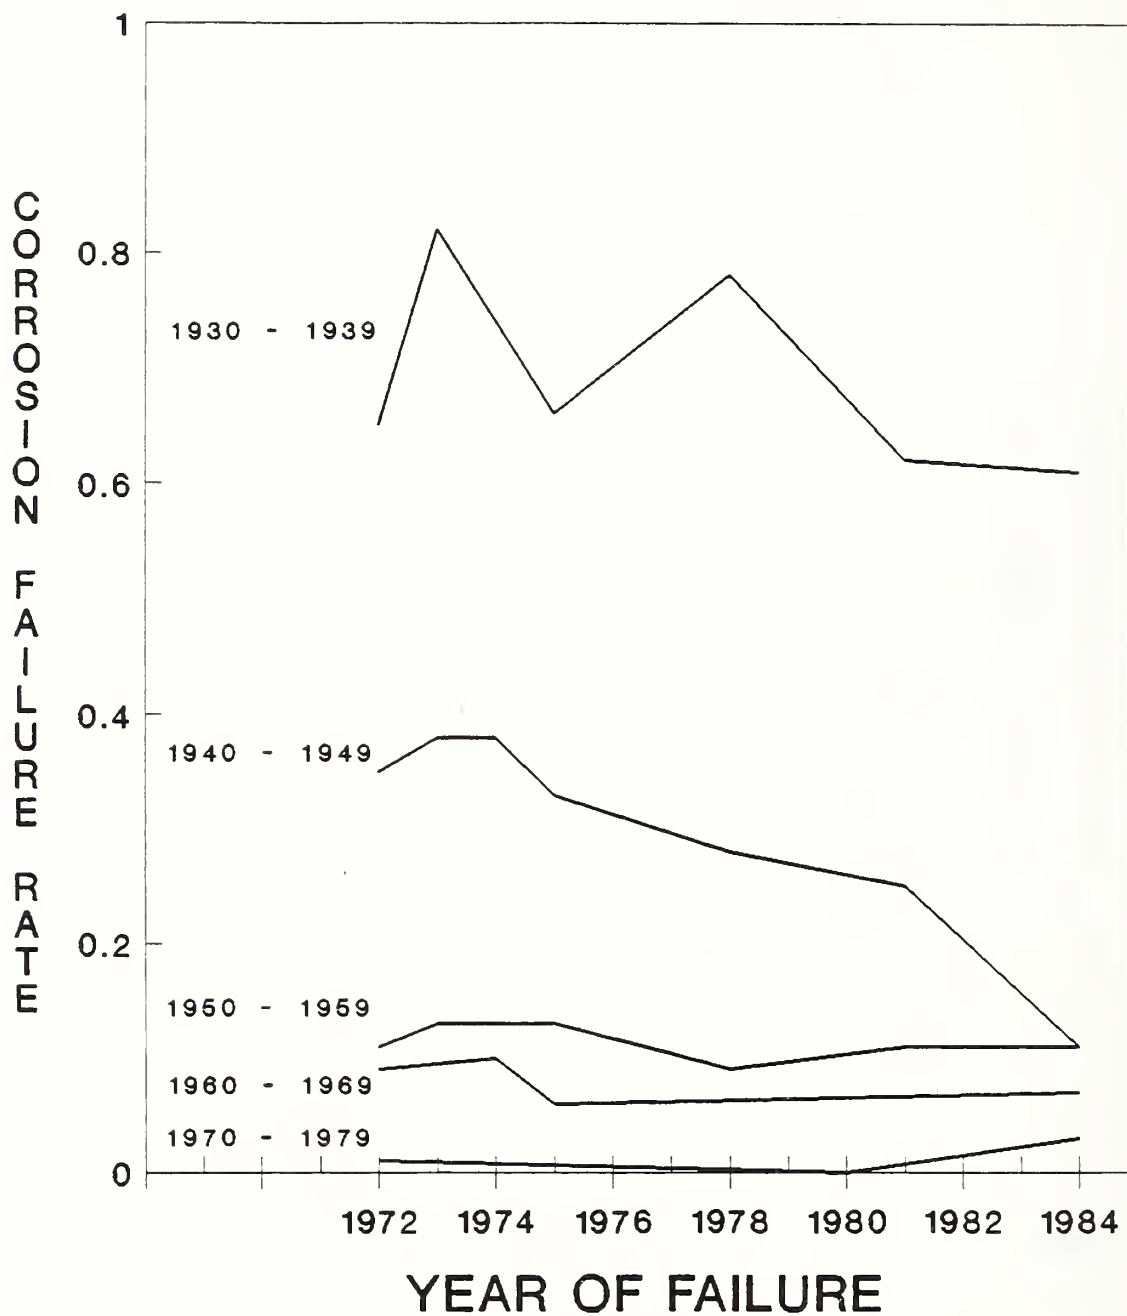
These data suggest that the corrosion problem in pipelines, in general, is being effectively combatted. However, it can be seen in Figure 3 that, with the exception of the 1940s, there is no evidence that the failure rate in each decade is decreasing with time. This would suggest that the most current methods of protection and monitoring are not being effectively retrofitted, despite the regulatory requirements (20,21). Thus, as the Transportation Research Board report (18) emphasized, there is a need to sustain and extend our advances in corrosion control. This has particular relevance to older ERW pipe, as indicated in Section 5.0.

Figure 3. Annual Rates of Corrosion Failures (number per year per 1000 miles of pipeline) in Natural Gas Gathering and Transmission Lines for the Period 1970-1984 Classified by Decade of Construction (16).
