AIR QUALITY INVESTIGATION IN THE NIH RADIATION ONCOLOGY BRANCH

**Andrew Persily
W. Stuart Dols
Steven J. Nabinger
David A. VanBronkhorst**

**Sponsored by:
Division of Engineering Services
National Institutes of Health
Bethesda, Maryland**

August 1989

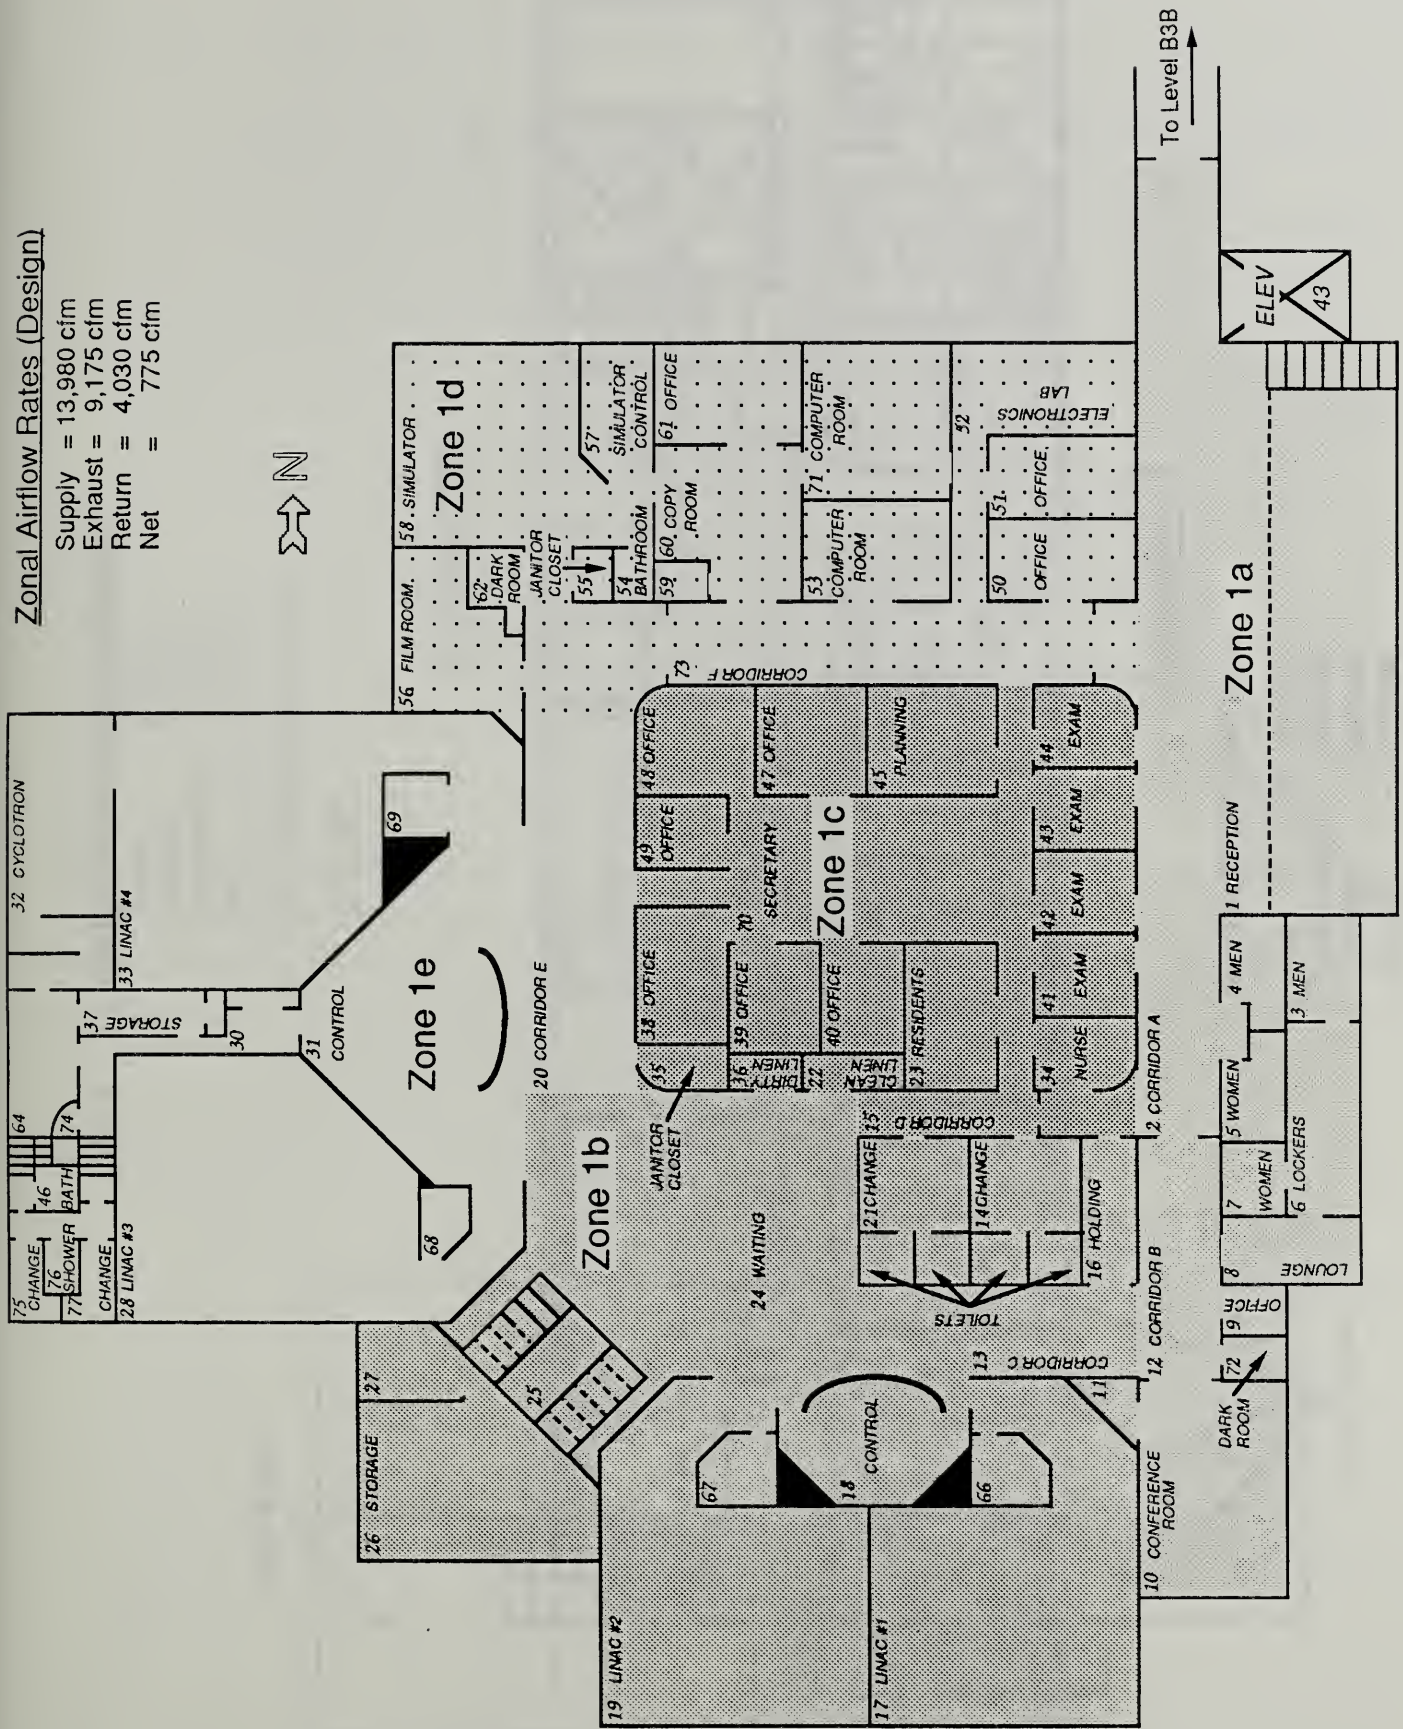
Figure 1.2 Floor Plan of Treatment Area (Zone #1)

Table 1.7 summarizes the total mechanical ventilation airflow rates into and out of each of the four ROB zones. Beginning with the Treatment Area, there is a slight excess of supply airflow to this zone, 775 cfm according to the diffuser and register design airflow rates and 300 cfm according to the fan airflow rates. If these design airflow rates were realized and there was no air infiltration through the building envelope, then the space would be under a slight positive pressure and air would tend to flow out of the zone. The Treatment Area is bounded only by the outdoors and Level B3B, and therefore the amount and direction of airflow to or from the Treatment Area also depends on its air pressure relative to these two zones. The amount of excess supply airflow is not very large (only 2 to 5% of the total supply airflow rate) relative to the expected discrepancies between design and actual mechanical airflow rates. A relatively small difference between the design airflow rates and the actual rates could result in the intended pressurization of the Treatment Area being reversed.

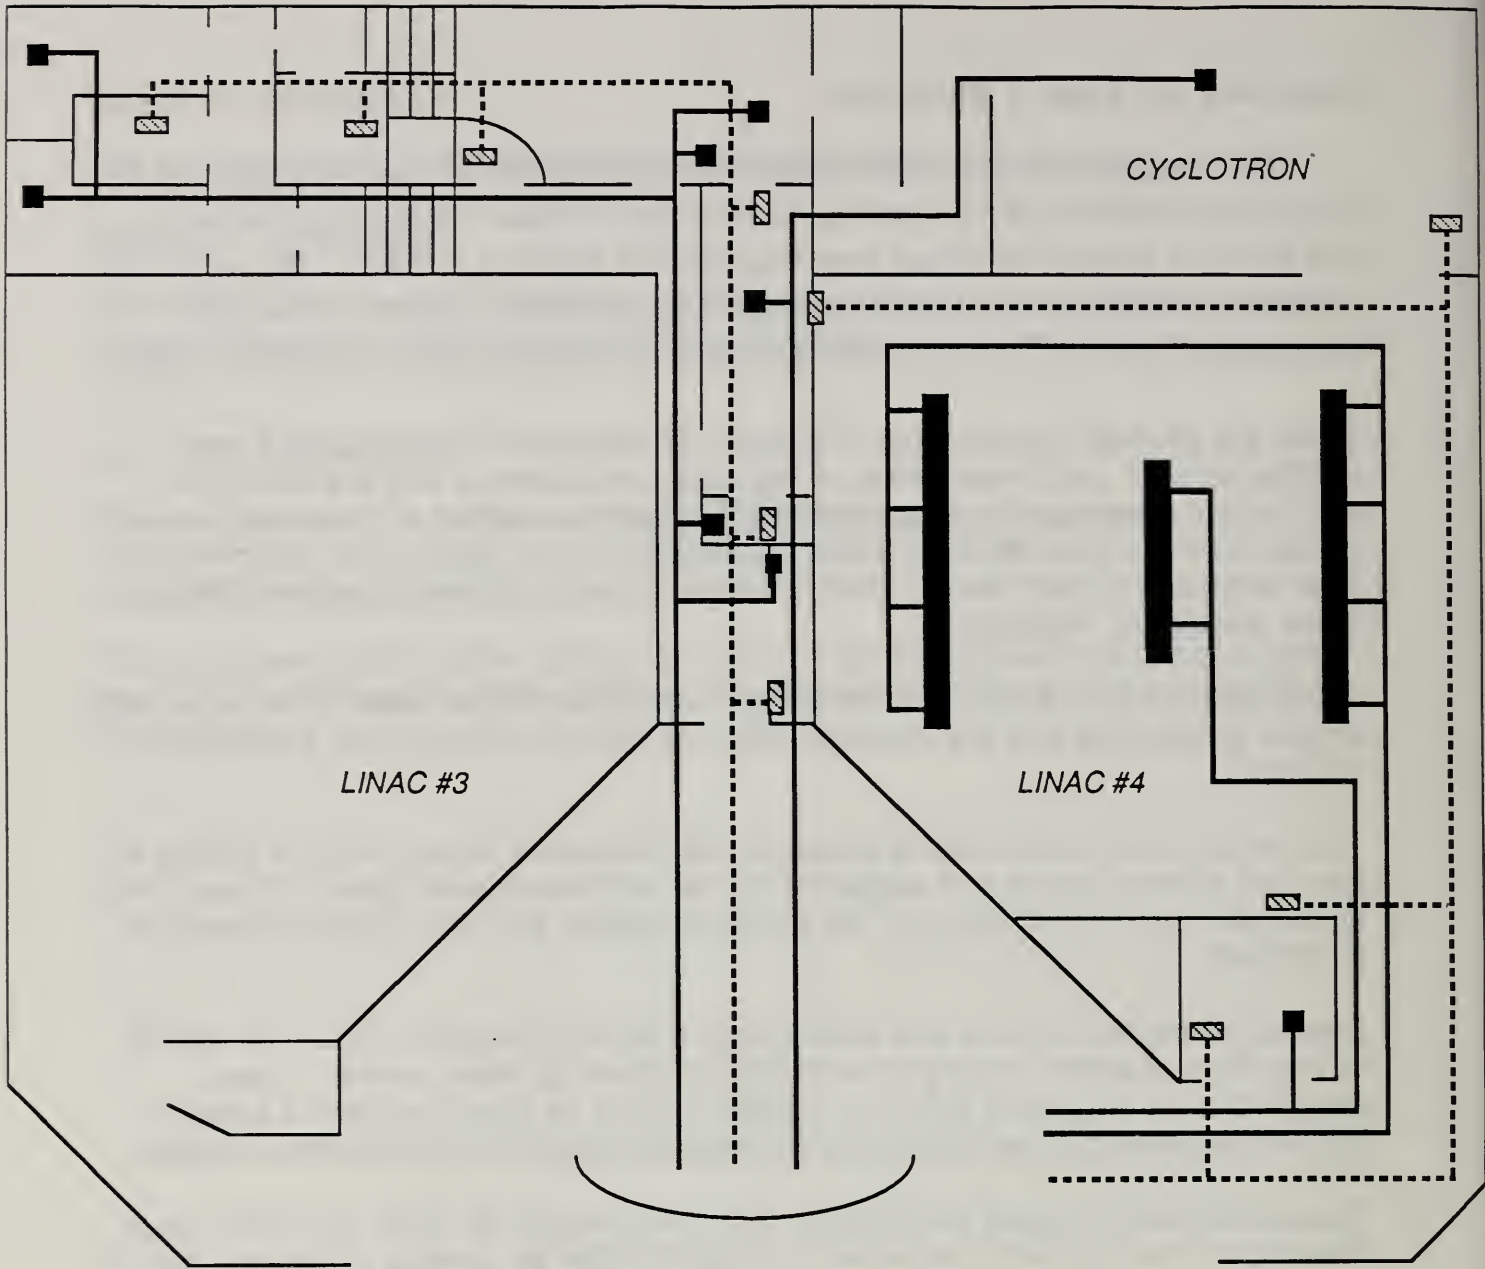
Figure 2.1 Actual Ductwork Layout in Linac #4 Area

The inspection of the Treatment Area revealed two features that are unique to this space. First, it was found that the actual layout of the ductwork, diffusers and registers in the Linac #4 area was very different from the layout in the mechanical drawings. The actual ductwork layout for this area, based on the Task 2 inspection, is shown in Figure 2.1. The individual diffusers and registers are shown in this drawing, but we have no information on their design airflow rates. The design airflow rates from the original drawings, which are different from the actual layout, were used in Table 1.1.

The supply air duct serving Linac #4 is disconnected just upstream of the fan box, discharging supply air directly into the plenum space and not providing the Linac space with its ventilation air. (REPAIRED SINCE INSPECTION)

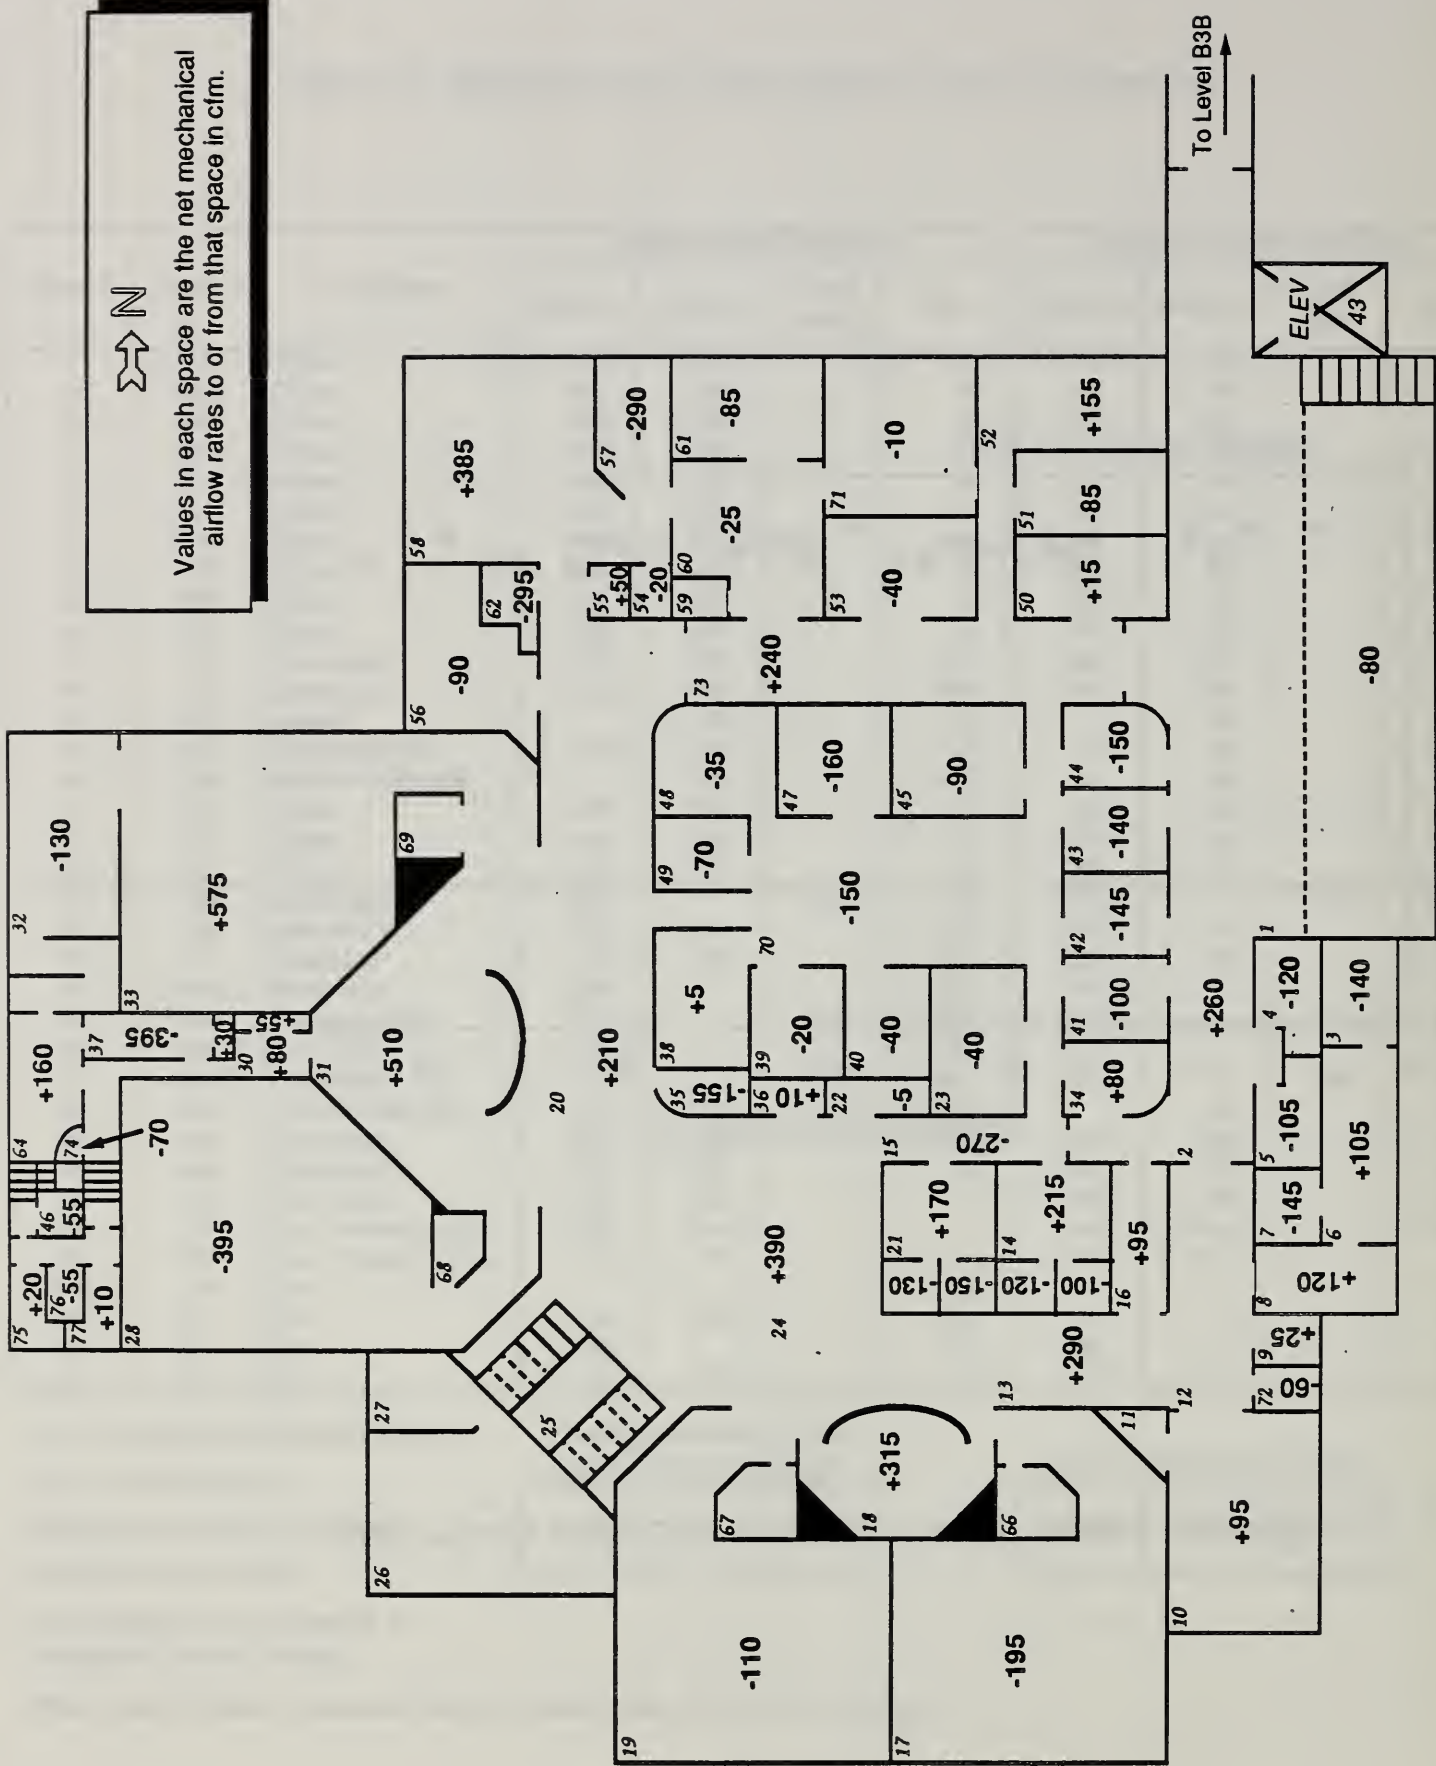
Figure 3.2 Measured Airflow Rates in Treatment Area (Zone #1)

The measurements of the Treatment Area air handling system showed that the supply airflow rate was close to its design value, the exhaust fan airflow rate was about 1300 cfm (14%) below design, and the return fan was about 1400 cfm (32%) above design. These differences cause insufficient exhaust airflow rates from some of the rooms of the Treatment Area and excessive return airflow rates from others. Such a situation could lead to ineffective removal of contaminants from the spaces with low exhaust airflow rates. In rooms with high return airflow rates, air could flow into the rooms from the surrounding areas, potentially bringing contaminants into these spaces. The measurements also showed that the outdoor air intake rate for the Treatment Area was about 1900 cfm (20%) below the minimum intake design value, and it was always operating at minimum intake

during the measurements. A significant amount of duct leakage was noted in the air handling system: supply air 18%, exhaust air 16%, and return air 28%. Air leakage in the supply air duct results in lower airflows to individual rooms, including lesser amounts of outdoor air. The return air duct leakage is a matter of particular concern because this leakage presumably occurs in spaces such as ceiling plenums, service chases, and equipment rooms. These spaces are generally quite dirty and the air that leaks into the return ducts from these spaces is recirculated into the supply airflow, along with any contaminants picked up in these spaces.

- A significant amount of duct leakage was identified in the air handling systems, and this needs to be repaired. This duct leakage is leading to some of the differences between measured and design airflow rates to individual rooms. The leakage in the Treatment Area return air duct is of particular concern because the air flowing into this duct is recirculated into the supply air for this space.

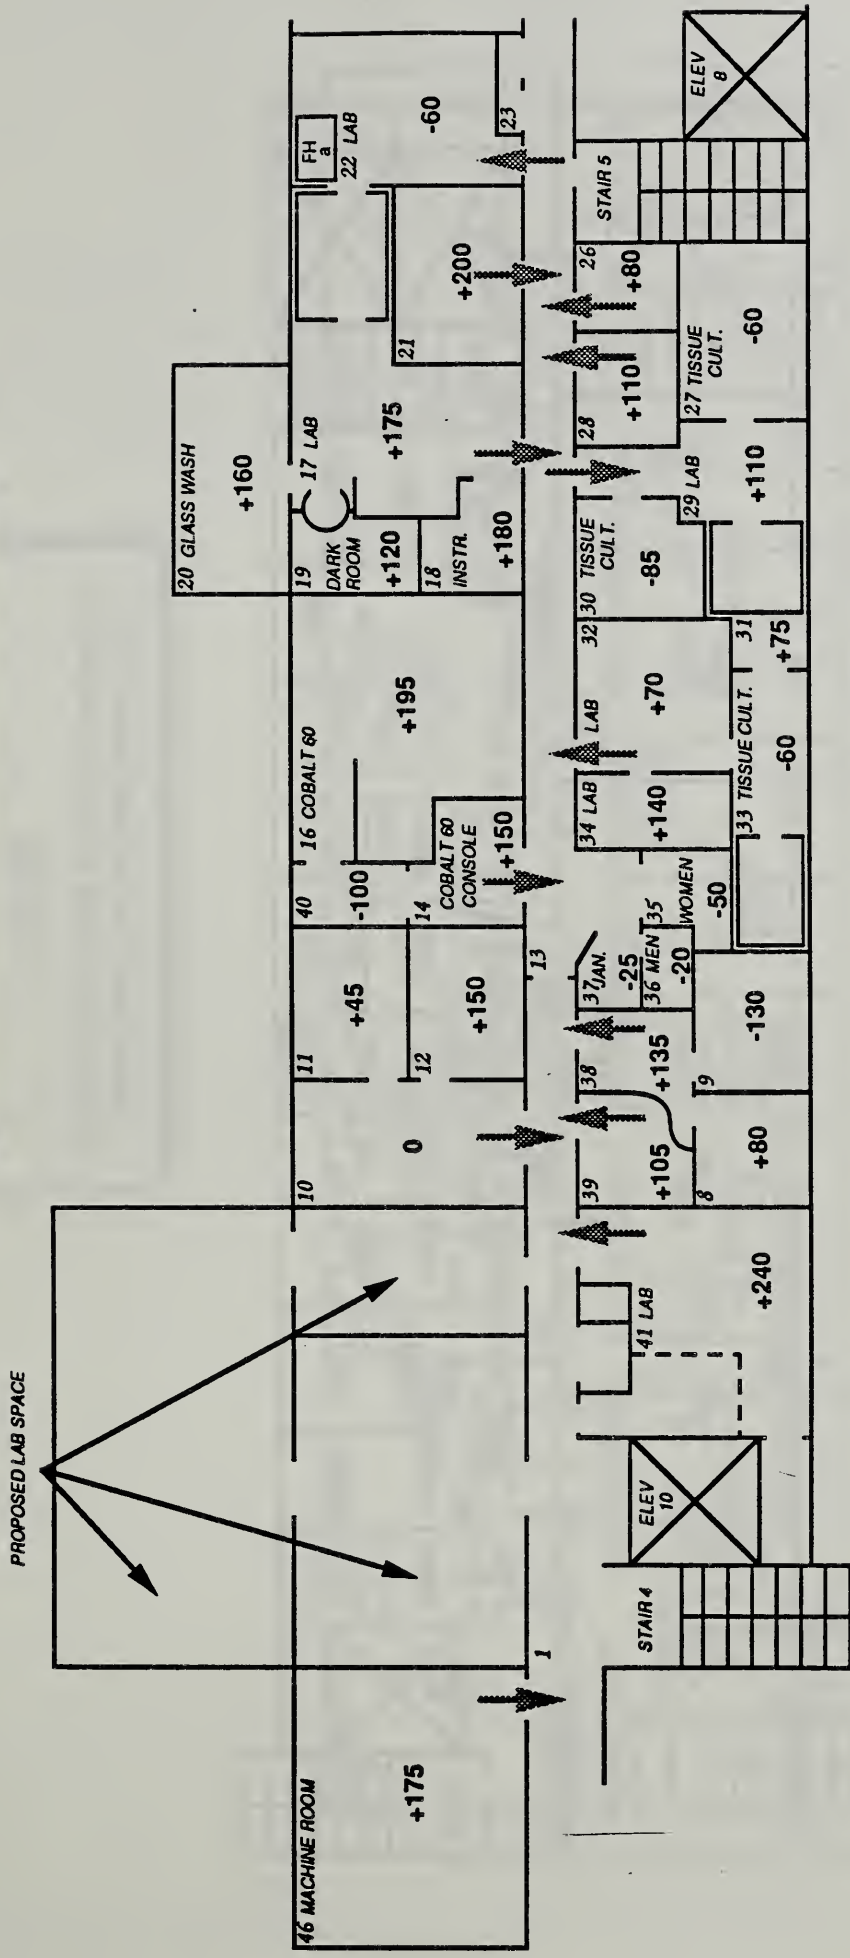
Figure 3.3 Measured Airflow Rates in Level B3B (Zone #2)

The supply fan serving Levels B3B and B2.5B has an airflow rate that is about 30% (3200 cfm) above its design value. The exhaust air system is moving about 1000 cfm less than design. There is also a significant amount of duct leakage in these two systems, about 40% in each. As in the Treatment Area, there are many rooms on these two levels with significant differences between the design and measured airflow rates at the supply diffusers and the exhaust grilles. The southeast portion of Level B3B tends to have low exhaust airflow rates compared to design, as does the entire west side of Level B2.5B. Most of the rooms on the west side of Level B3B have higher supply airflow rates than design. Three rooms on Level B3B-West have such high supply airflows rates that the occupants have attempted to block off the diffusers. Most of the laboratories on these two levels are at a positive pressure relative to the hallway because of the excessive supply airflow rates. Some of these cases of oversupplied laboratories are presumably due to the modification of the supply air fan without an accompanying change in the exhaust air system. This situation leads to contaminant transport from the laboratories to the hallway, where building occupants, including patients on their way to the Treatment Area, are exposed to these substances.

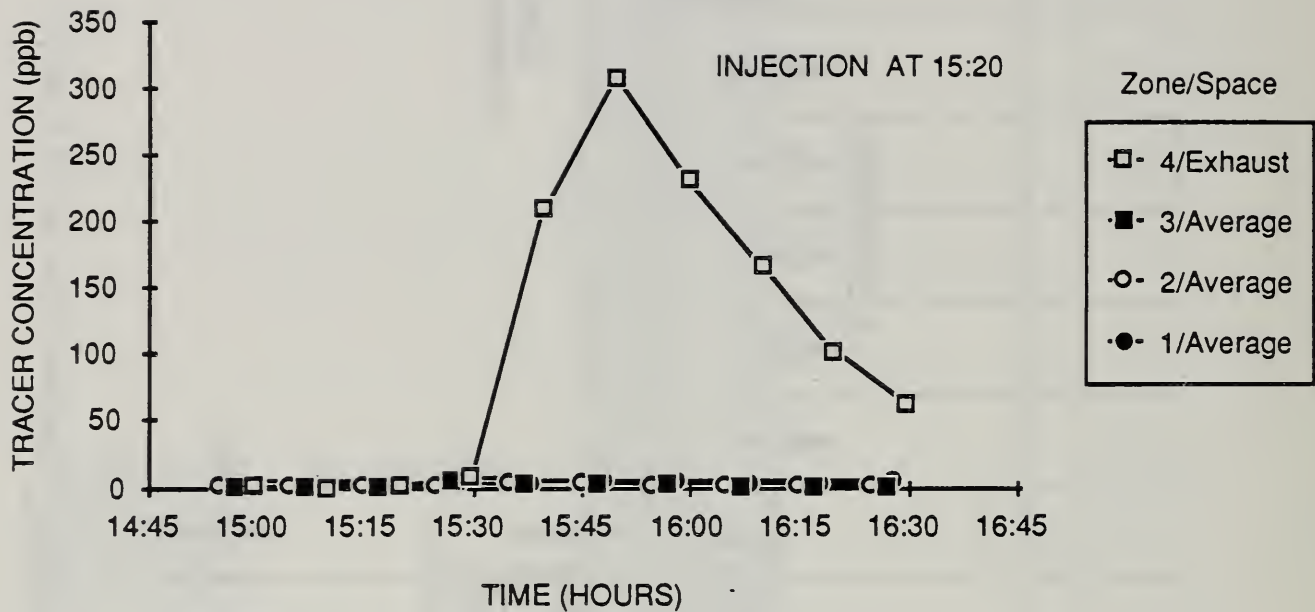
Figure 3.12 Tracer Gas Injection at Stair #5 Loading Dock

The movement of air, and potentially contaminants, into the ROB from several outdoor pollutant sources was examined with tracer gas testing. These tests showed that there was airflow from the loading dock by stair #5 to Level 1B, presumably via the freight elevator shaft. Airflow from the cafeteria loading dock to the Treatment Area was also identified, with lesser amounts of airflow to Levels 1B, B2.5B and B3B. Treatment Area exhaust air was also observed to flow into the occupied space of the Treatment Area. Some of the Treatment Area exhaust air was also seen in the rest of the ROB. Entrainment of exhaust air from the numerous exhaust air systems on the roof of the B corridor was also examined. Tests of an exhaust outlet pointing upward from the building showed that this outlet design did not result in significant exhaust air entrainment by the B corridor air handling systems. Tests of an outlet pointing downward revealed significant amounts of entrainment, enabling contaminant transport to the occupied space of the B corridor.
